Building and Timber Pest Inspection Report

Inspection Date: Mon, 2 Feb 2026

Property Address: 2 Manhattan Dr, Eagleby QLD 4207,
Australia

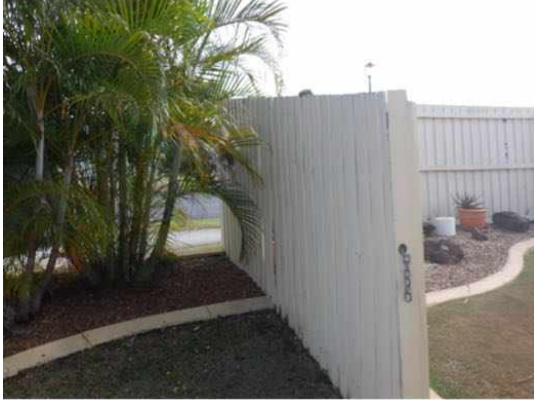
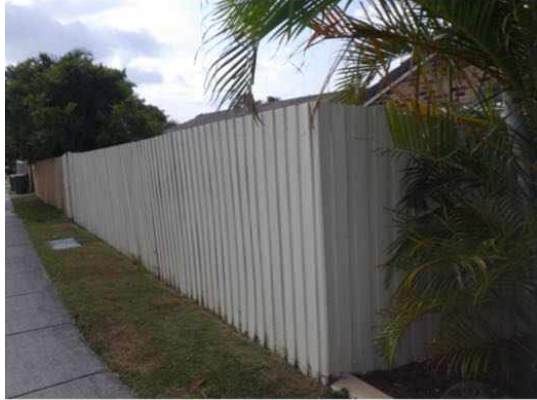
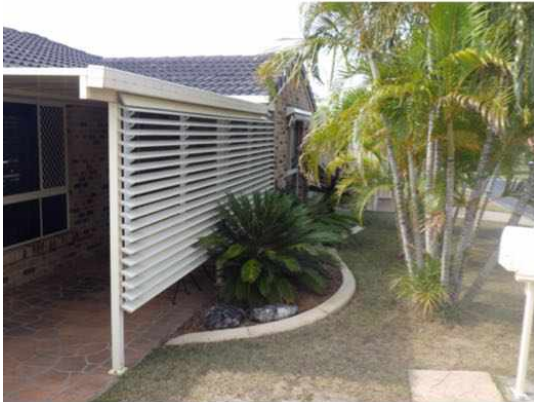
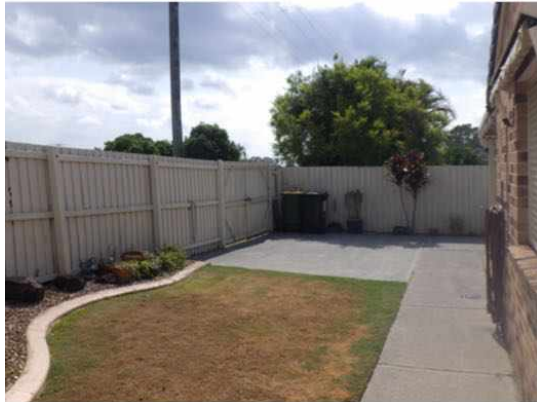
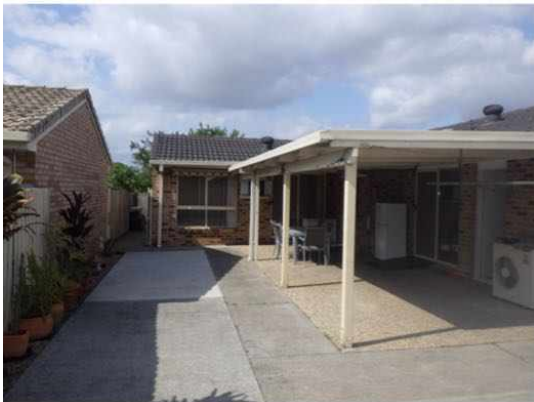
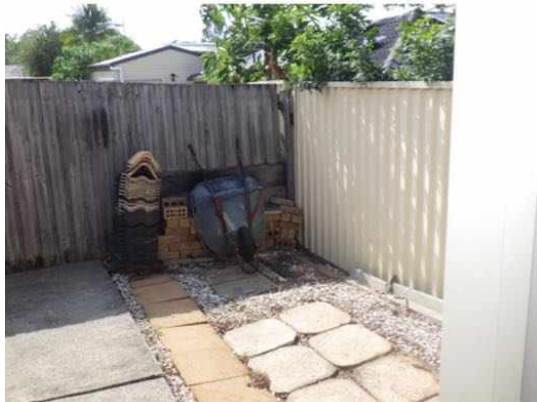
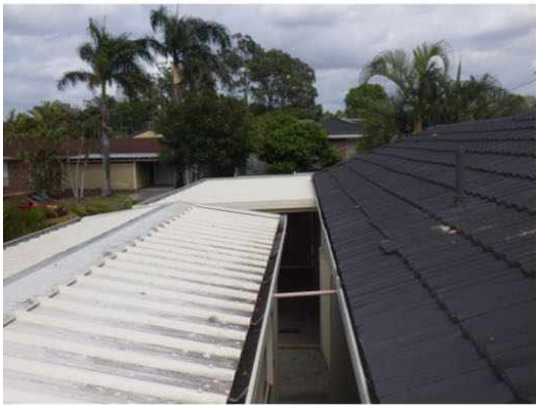
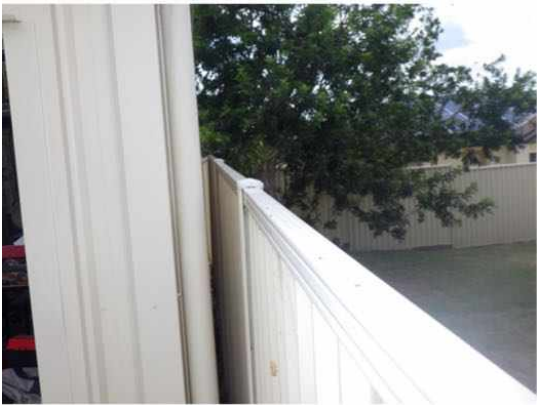
Building: Main Building
Location: External Areas > Existing
Finding: Additional Photos
Information: Additional photos are provided for your general reference
