Building Inspection Report

Inspection Date: Wed, 18 Feb 2026

Property Address: 9 Murray Rd, CROYDON, VIC, 3136,
Australia

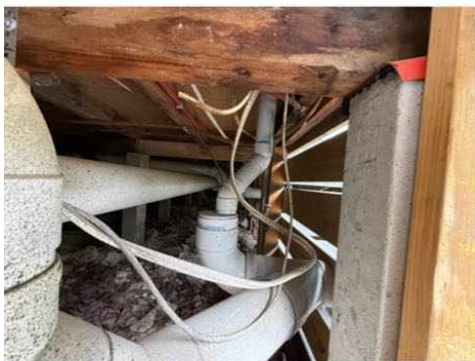
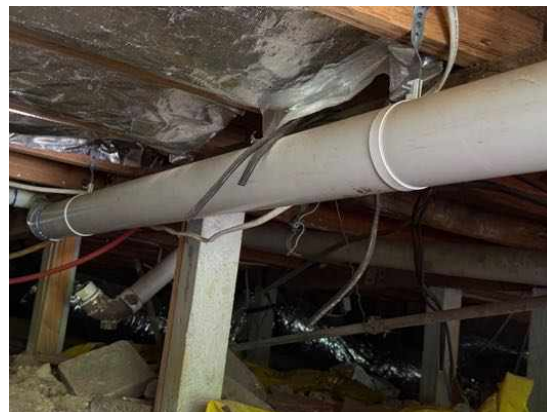
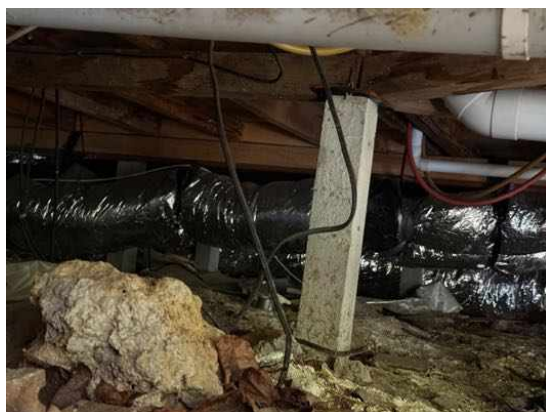
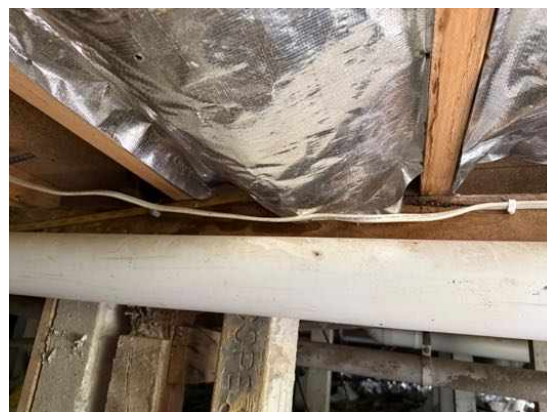
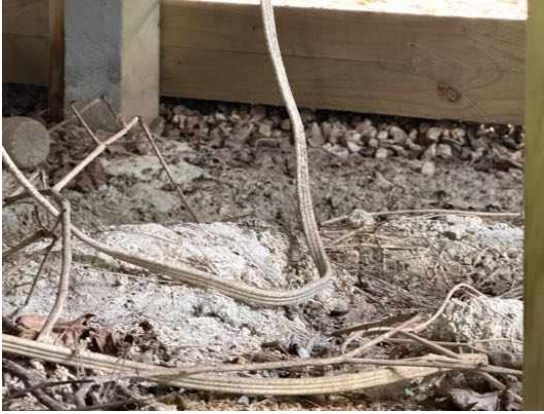
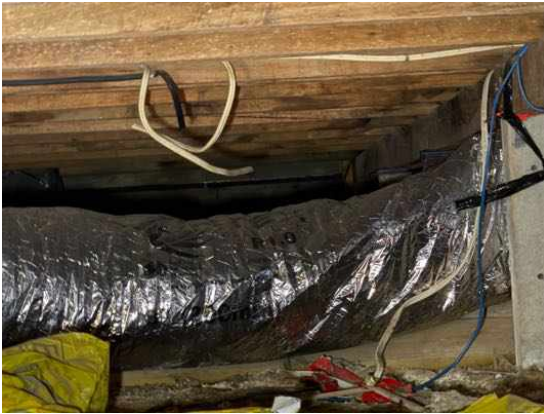
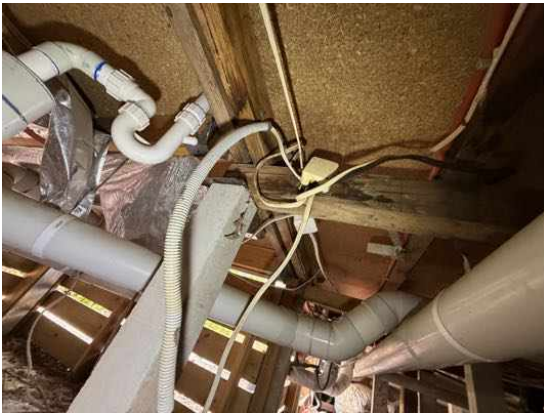
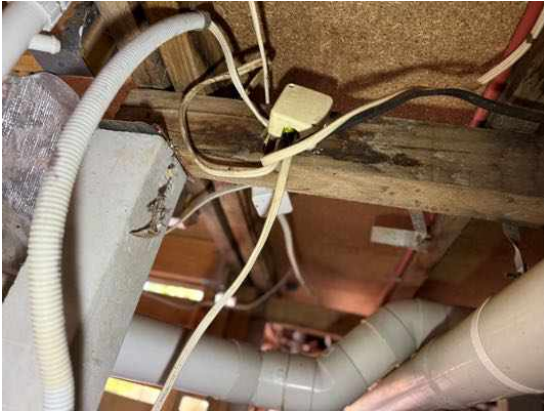
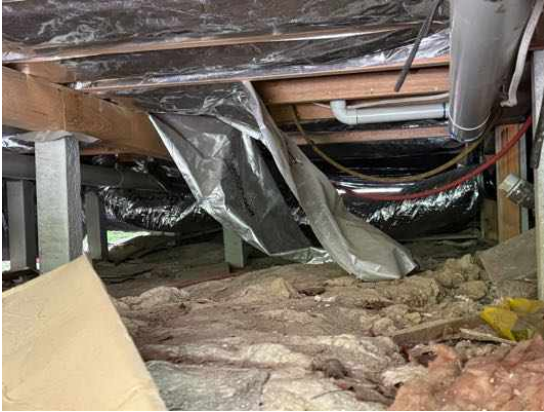
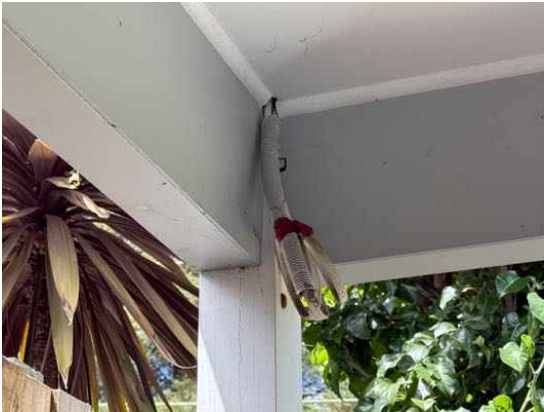
Defects 1.01

Building:	Building 1
Location:	All Areas > All Areas
Finding:	Electrical wiring in subfloor area
Information:	At the time of the inspection the subfloor area was considered to be a safety hazard to tradespersons and occupants that enter the subfloor area. Electrical wiring was observed in numerous areas not to be adequately clipped off and showed numerous areas of unprofessional work practices. Electrical wiring and fittings and not installed in a tradesmen like manner. With un-tradesmen like work practices shown in the subfloor areas, it is suspected that some areas may not have been installed by a licensed electrician and are considered a potential safety hazard including for fire and personal contact. Is recommended that the client contact a licensed electrician to investigate and carry out further inspection, where deemed necessary.

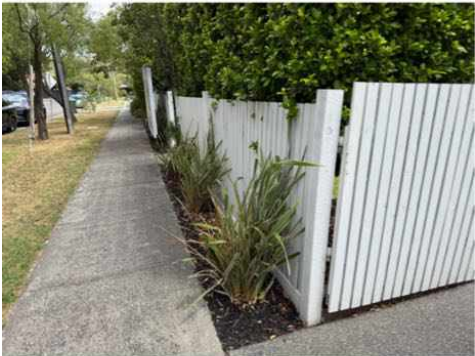
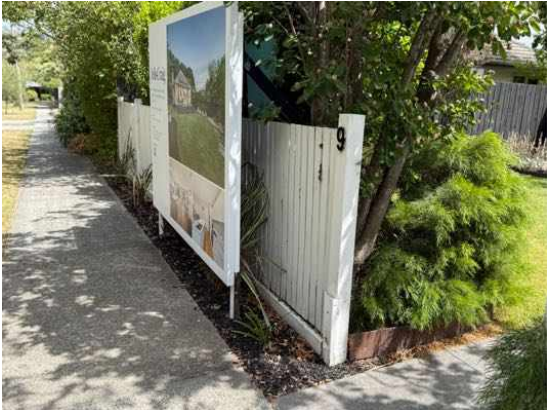
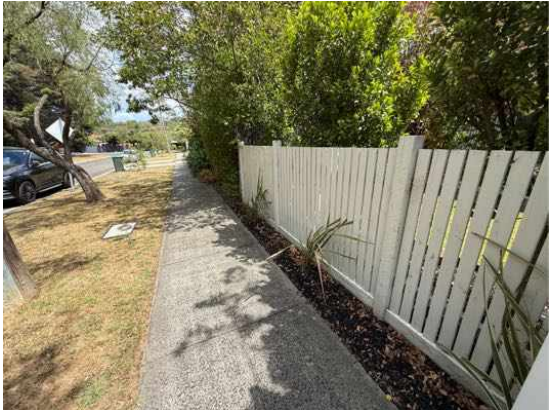
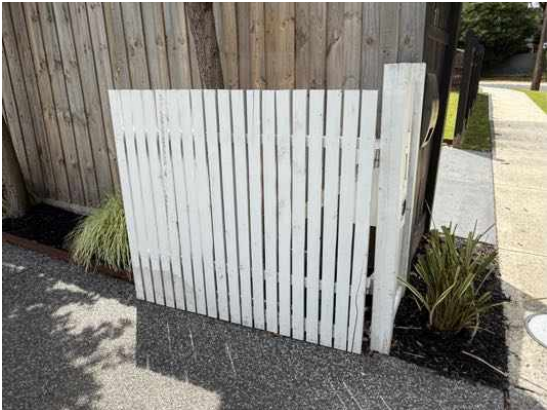
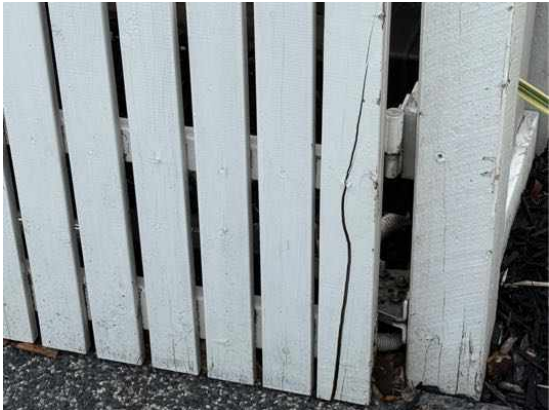
Defects 3.01

Building: Building 1
Location: All Areas > All Areas
Finding: Front picket fence show some damage and deterioration

Information: Some of the front picket fence posts appeared to be loose and wobble in the ground. Some areas showed some minor damage and deterioration. Some of the damage observed is suspected to have happened over time through normal exposure to extreme weather conditions.

However left unmanaged, further deterioration will develop over time, necessitating in further repair and or replacement of some sections. To maintain the security of the property these areas of the fencing should be repaired or replaced with either metal or pre-treated timbers. A qualified fencing contractor can be appointed to repair and replace the fencing where deemed to be necessary. This is at the client's discretion.

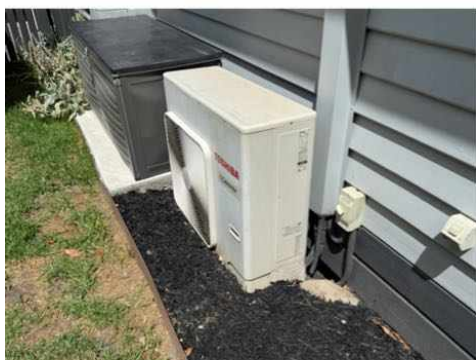
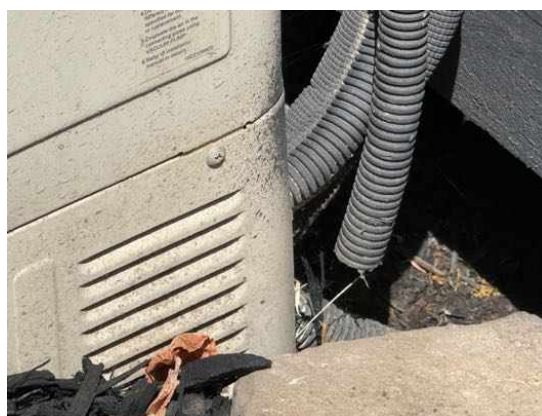
Defects 3.02

Building:	Building 1
Location:	All Areas > All Areas
Finding:	Air conditioner - disconnected overflow
Information:	The Air Conditioners (A/C) overflows were observed to be disconnected from storm water drainage point and may be creating excessive moisture during extended use, in the surrounding area. Such leaking from the waste pipe of the air conditioner creates an environment which is conducive to an array of defects, including water damage to associated building elements and the attraction of termite or timber pest infestation. It is highly recommended that a licensed plumber be appointed to connect the A/C overflow to a stormwater point in order to prevent such an environment from being created. These minor works should be carried out in the near future.

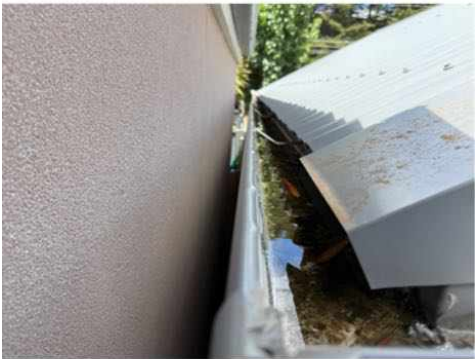
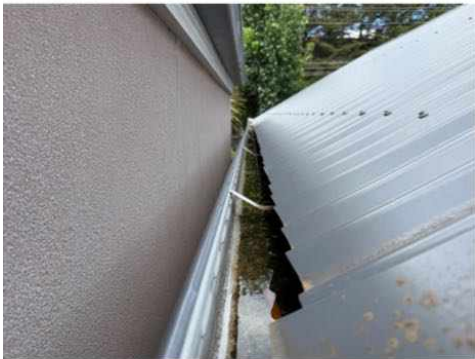
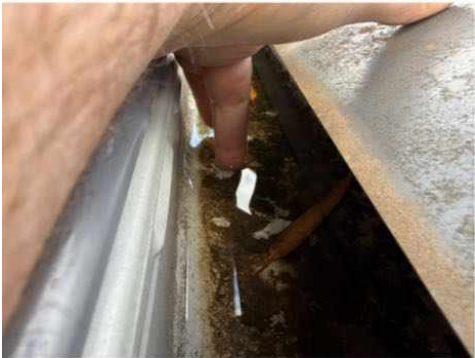
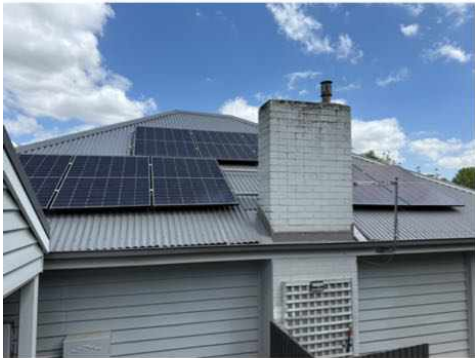
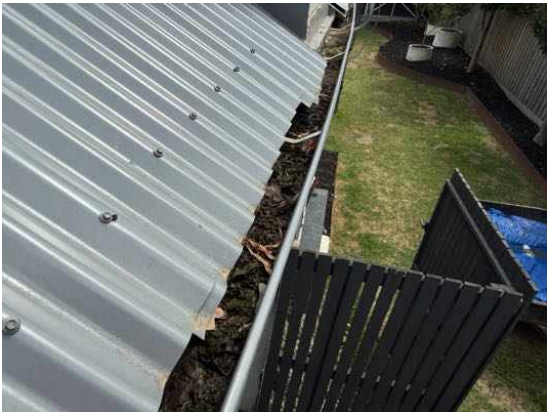
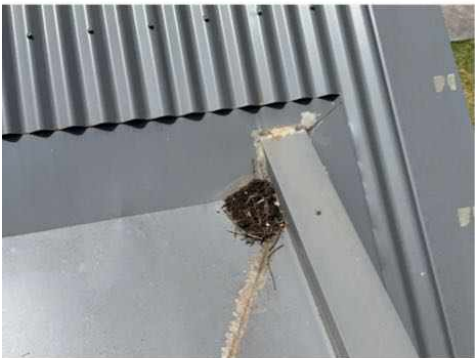
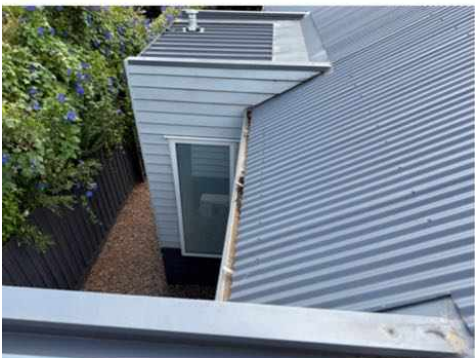
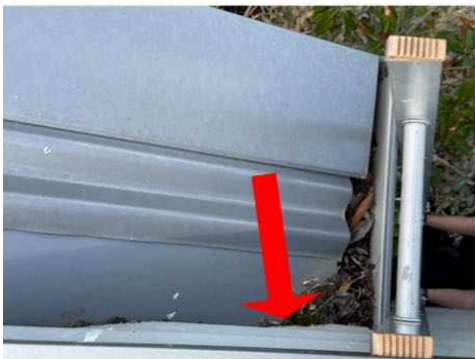
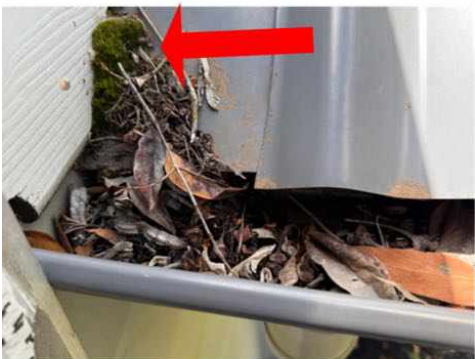
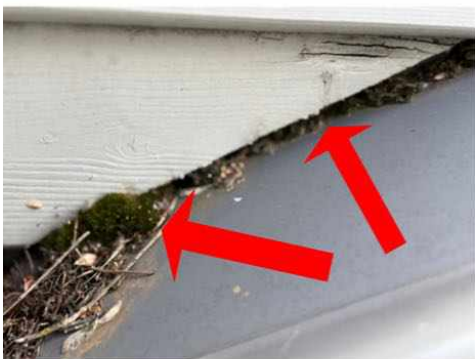
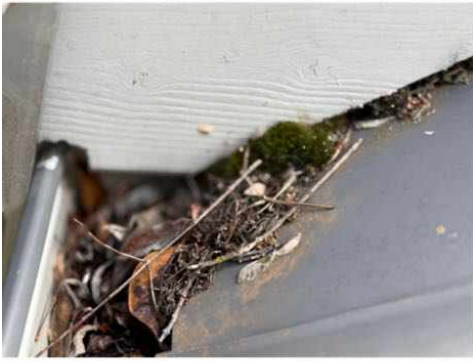
Defects 3.03

Building:	Building 1
Location:	All Areas > All Areas
Finding:	Gutters - partially blocked in some minor areas and minor water pooling
Information:	Gutters were observed to be partially blocked in some areas and water was found to be pooling in the carport roof guttering. Water pooling is generally a secondary defect caused by blocked or partially blocked gutters. Such blockages and subsequent water pooling is suspected to have rusted and deteriorated, water damage to

Any areas of guttering that shows evidence of water pooling should be checked for partial or full blockages and any secondary damage that may have occurred as a result. Depending on the extent, building elements may require repair or adjustment to ensure adequate roof drainage and function of plumbing system.

A roofing plumber should be appointed in the future to rectify these issues. It is highly recommended that all gutters be well maintained on a frequent and periodic basis to ensure the best condition of all roof plumbing.

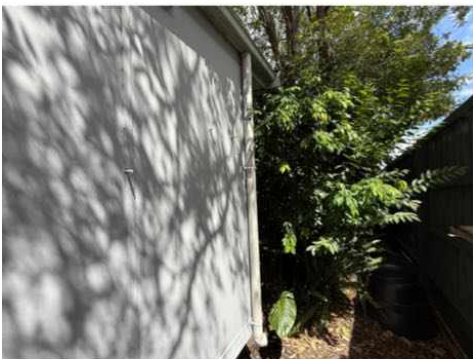
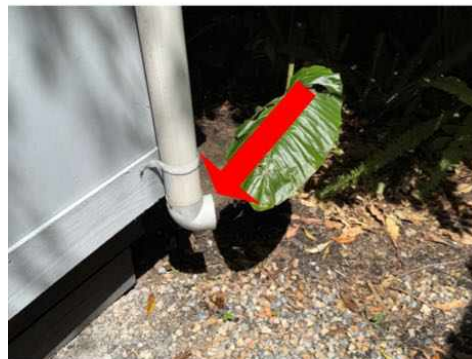
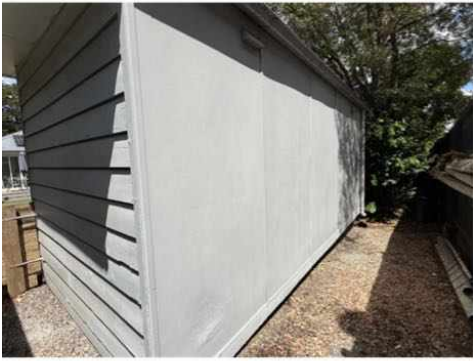
Defects 3.04

Building:	Building 1
Location:	All Areas > All Areas
Finding:	Bungalow down-pipe not connected to stormwater drainage system
Information:	It was observed at the time of inspection that the bungalow down-pipe was not connected to the stormwater drainage system, all downpipes should be all connected properly into the stormwater drainage system and fully inserted into stormwater drainage point. This makes these areas and the surrounding areas highly susceptible to excessive moisture, wood rot to surrounding timber and building elements and termites.

Where down-pipes are left unmanaged it is highly likely to accelerate wood rot, rust, corrosion and termite and pest. It is highly recommended that client appoint and seek advice and consultation with a licensed drainage plumber to gain advice and rectify affected down-pipes.

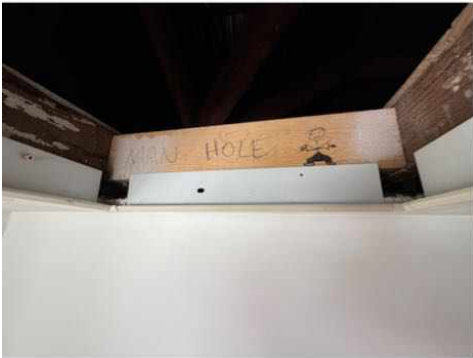
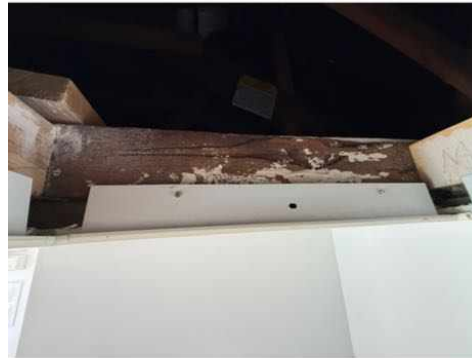
Defects 3.05

Building:	Building 1
Location:	All Areas > All Areas
Finding:	Roof space manhole
Information:	Roof space manhole was observed to not have adequate trimming or fixing's required for safe ingress and egress from the roof space. All trimming, nogging's and fixing should be installed and all sides of the manhole opening ensuring there is adequate support for tradesman and occupants to safely enter or wish to access these areas. The lack of adequate fixing and or support around the roof space manhole is considered to show poor trade practices. If the manhole framing gave way and dislodged from the opening it is highly likely to cause serious injury to tradespersons and or occupants. This is considered a safety hazard for any persons wishing to access to roof space.

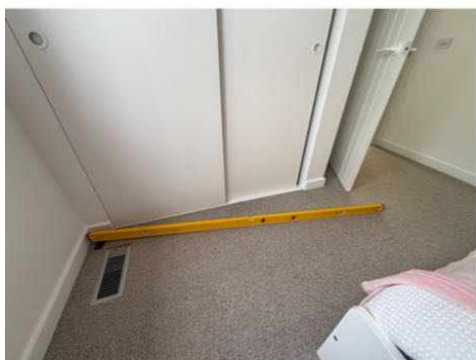
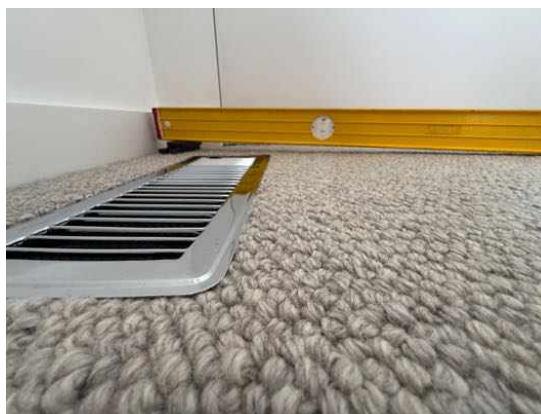
Defects 3.06

Building: Building 1
Location: Bedroom > All Areas
Finding: Bedroom floor levels
Information:

The internal bedroom floor was observed to be showing signs of being out of level and uneven. Uneven and out of level floors with a property of this age is considered in most cases to be normal however it was felt walking in this area meaning that in this area it was more than normal. The uneven and out of level floor is highly likely to indicate some subsidence and movement in the stumps and associated subfloor structures.

Floor levels can have complex and varying causes, which will influence the required remedial works where deemed to be necessary. Due to only observed in a small area of the home the client may continue to observe over a specific period of time for any changes or by consulting a registered builder who has expertise in re-stumping to determine the required scope of works that may be deemed necessary. This may include some form of packing the subfloor in some areas, at the same time as addressing the underlying cause of the uneven and out of level floors. Client may also consider an additional consultation with a geotechnical engineer to understand what and how the surrounding soil is reacting to surrounding moisture. These options are at the clients discretion.

It is advised that the floors be closely monitored to identify any further movement even after any floors have been rectified. Where flooring is uneven further, a potentially invasive inspection of the subfloor stumps and floor structures is required.

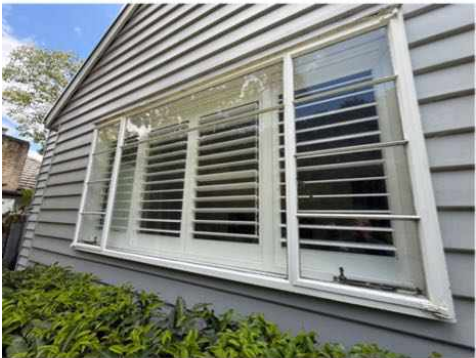
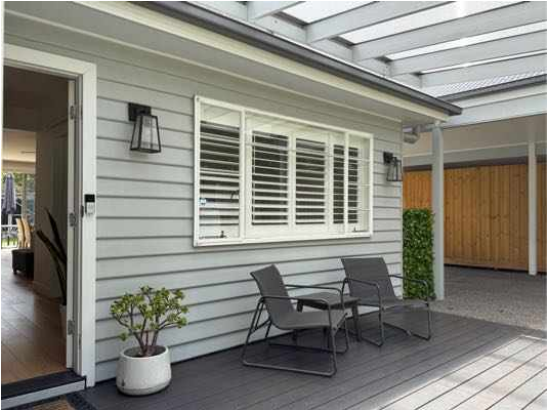
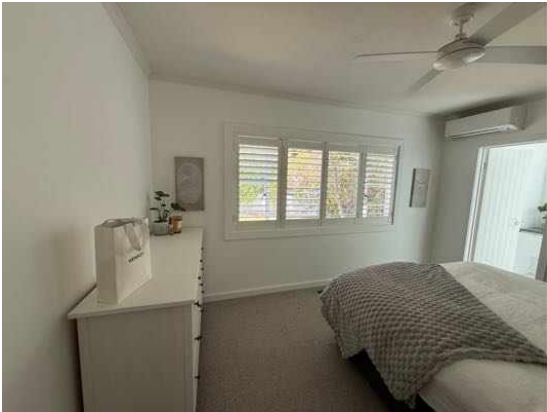
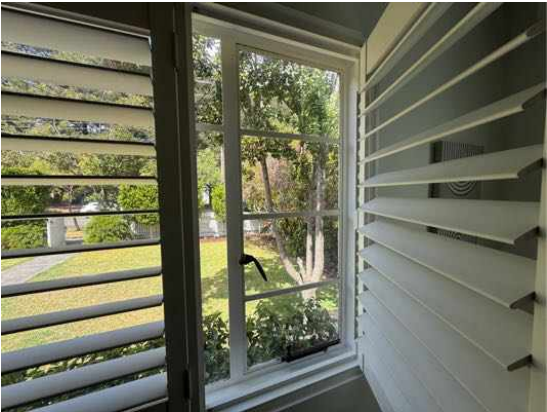
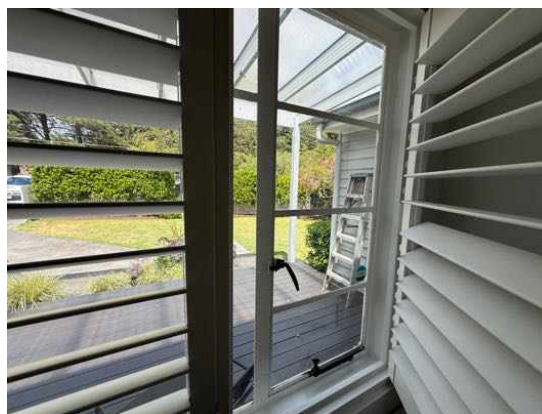
Defects 3.07

Building: Building 1
Location: All Areas > All Areas
Finding: Flyscreens
Information: Numerous flyscreens were found to be missing to the windows throughout the home at the time of inspection. Whether the flyscreens have not been installed or have been removed for maintenance and or painting purposes, this missing building element detracts from the operational state of the window.

Where not replaced, missing flyscreens allow pest and insect ingress into the adjoining room/s. It is advised that all missing building elements be installed or replaced in order to ensure the full function of all building structures.

A qualified carpenter may be appointed to replace flyscreens at the discretion of the client.

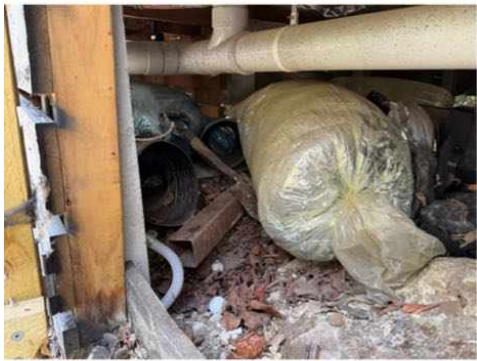
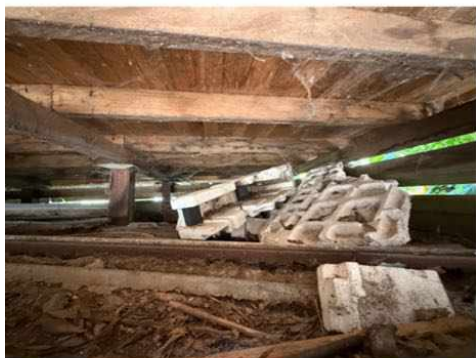
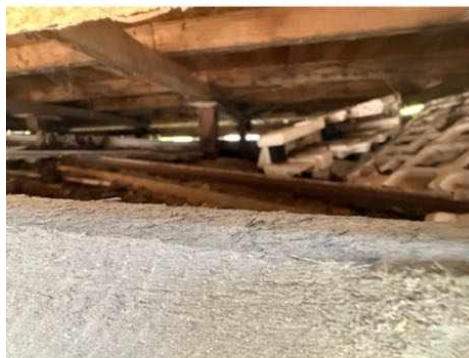
Defects 3.08

Building:	Building 1
Location:	All Areas > All Areas
Finding:	Subfloor - Debris
Information:	A minor array of debris was found in the subfloor area at the time of inspection. Debris in this area restricts subfloor ventilation and creates potential for concealed pest entry. Stored household goods and other materials may also make these areas susceptible to termite activity, insects and vermin. A clear and empty subfloor will be better ventilated and easier to maintain in a dry condition. The removal of any debris is vital in minimising the risk of termite, insects, rats, mice or wood borer activity.

Debris in the subfloor should be removed in the short to medium term future. Depending on the location and amount of debris and stored items, the homeowner may elect to undertake this task. Alternatively there are a large number of rubbish removal subcontractors that could undertake these works.

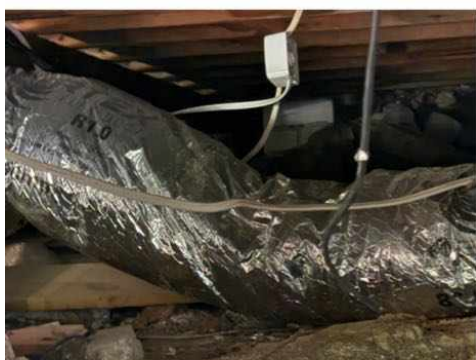
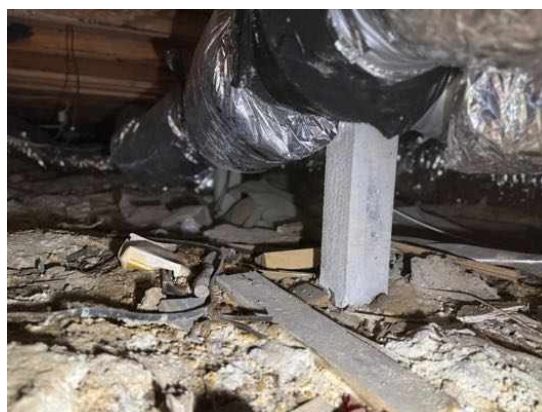
Defects 3.09

Building:	Building 1
Location:	All Areas > All Areas
Finding:	Subfloor heating / cooling ducts
Information:	Some of the subfloor heating / cooling ducts could be better supported so as not to sit on the ground. When ducting is found to be hanging down and rubbing on the ground, it is suspected that more support for the ducting is required to ensure ducts are as efficient as possible, subfloor ducting will not be running at a fully operational level. Generally, damage to ducts occurs as a result of aging and material deterioration, vermin damage or when they hang or touch the ground they are more likely to be impacted by rats, mice or other vermin and pests.

The ducts require remedial work to add better support throughout the subfloor area to ensure smooth air flow for increased energy efficiency. The airflow within the property is likely to be restricted, particularly in areas where ducting shows signs of minimal support or minor damage. A heating/cooling specialist or a relevant tradespersons should be appointed to provide remedial work and to perform any works deemed necessary.

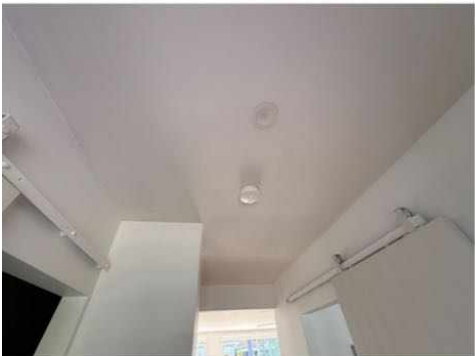
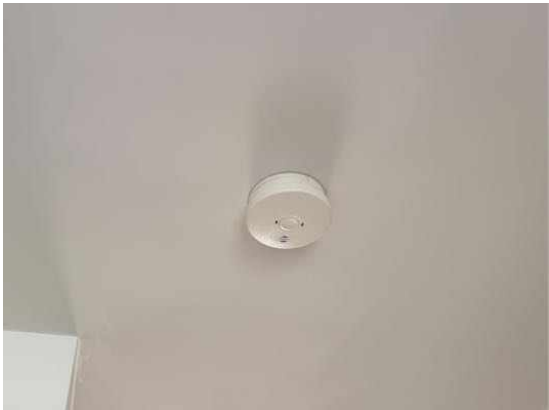
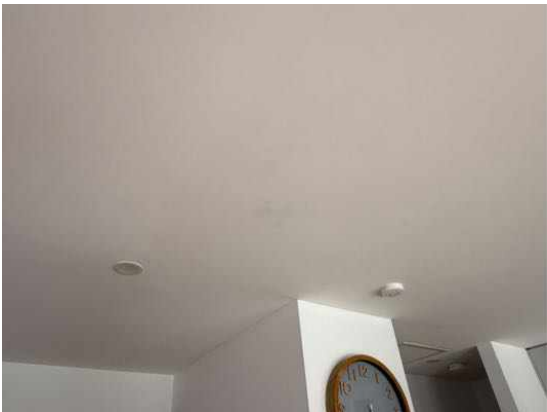
Building: Building 1
Location: All Areas > All Areas
Finding: Smoke detectors and alarms
Information: Reporting on Smoke Detectors or Alarms, including hard wired smoke detection systems and their legislative requirements, is outside the Scope of this Report. Please note that this defect is highlighted as a caution only. We suspect, based on our experience in the building industry, that smoke detectors are sometimes get overlooked, or they may be in a poor condition, so we recommend that they always should be addressed prior to occupation to improve occupant safety.

Always ensure sufficient working and suitable smoke detectors are installed prior and during to occupying any building. Additionally, it is advised that all smoke detectors be tested by the homeowner on a monthly basis.

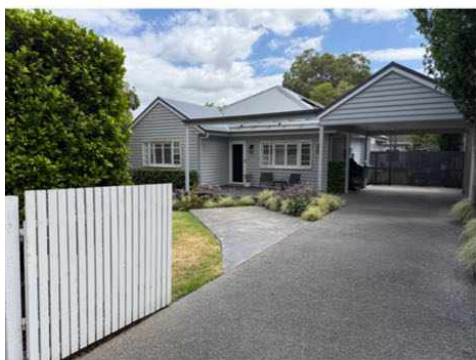
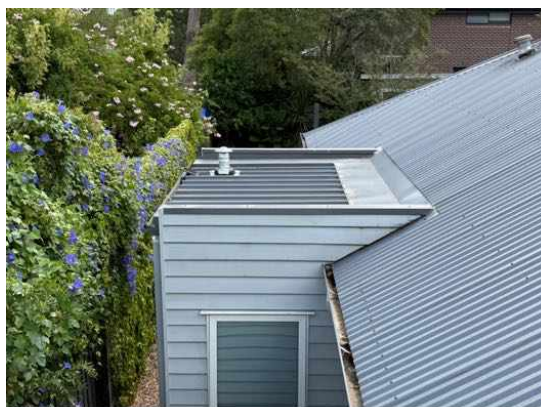
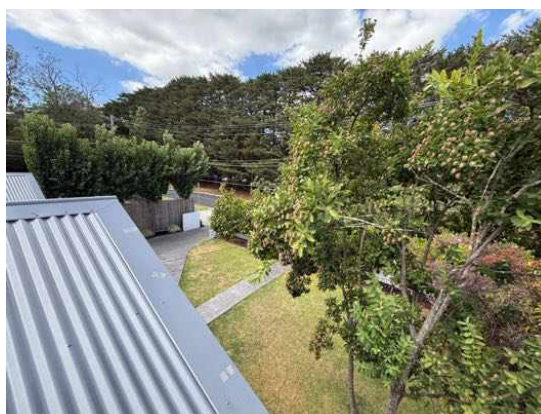
Information: Some trees around the property or neighbouring properties are highly suspected to be littering the roof with excessive leaf matter. The perimeter gutters, downpipes and drainage systems with excessive amounts of leaf matter and other debris which is suspected to eventually filter through the top holes of the gutter guard and into the gutters.

Gutters are a critical part of the building's management of storm water and rain. It is therefore important that they be kept clear to prevent secondary damage to associated building elements, including exterior and interior walls, ceiling linings and any adjoining building elements. It is therefore recommended that all trees close or near by the home be trimmed down and all overhanging tree branches be removed. Such works should be performed by the relevant tradespersons, appointed arborist or landscape contractor may be required.

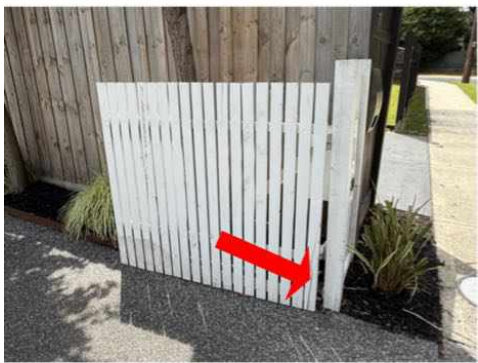
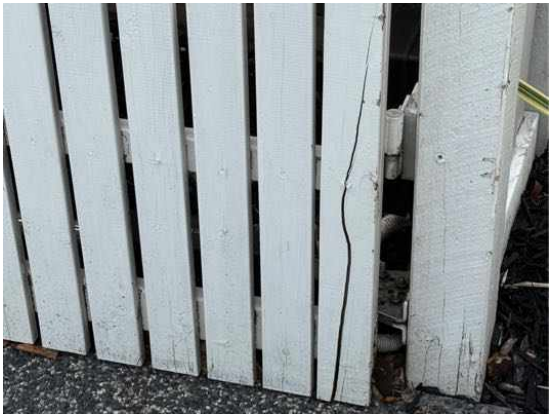
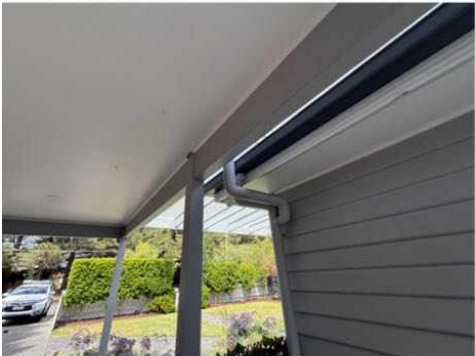
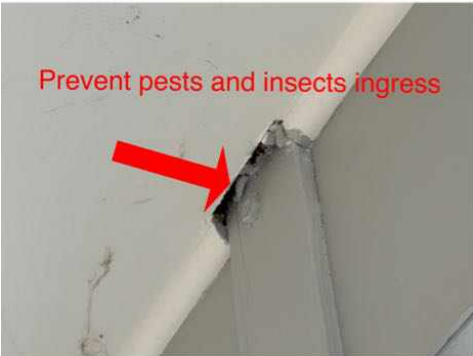
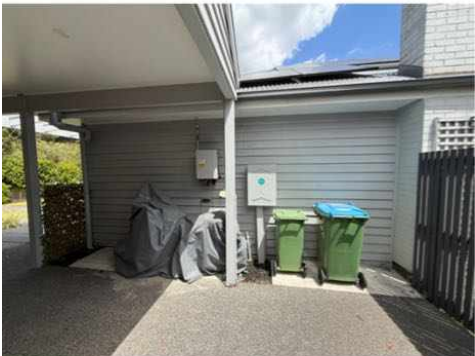
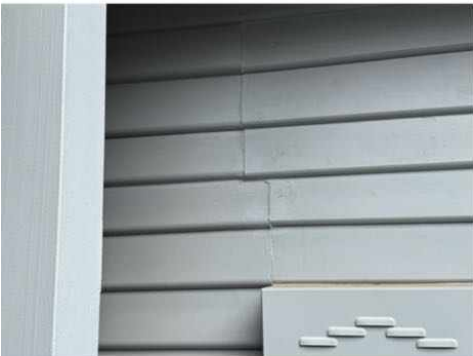
Building: Building 1
Location: All Areas > All Areas
Finding: Additional Photos
Information: Additional photos are provided for either future maintenance items for clients attention and or general reference. Arrows may have been included to highlight areas of importance. Please discuss these photos with your building consultant for clarification.

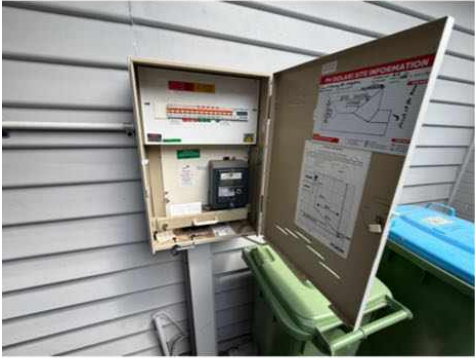
Building: Building 1
 Location: All Areas > All Areas
 Finding: Termite Management System - no evidence of a chemical installation or durable notice
 Information: At the time of the inspection no application of a chemical termite barrier or durable notice was observed. Such barriers are highly effective and highly recommended for all properties in preventing termite attack on any timber building elements throughout the property.

A durable notice should be placed in the switchboard unit or in the another accessible area to indicate current termite barriers. At the time of inspection, no evidence to suggest preventative works taking place. The client may consider gaining further advice from builders or a pest controller and as to the costs and procedures involved with this application. It is recommended that obtaining such advice be a short-term priority.

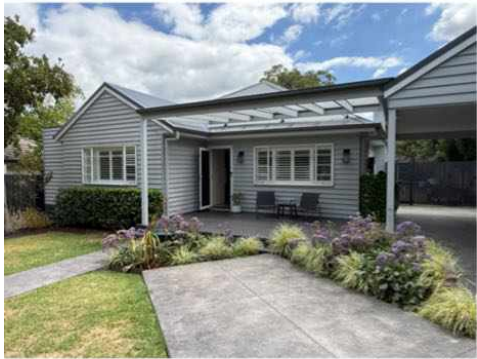
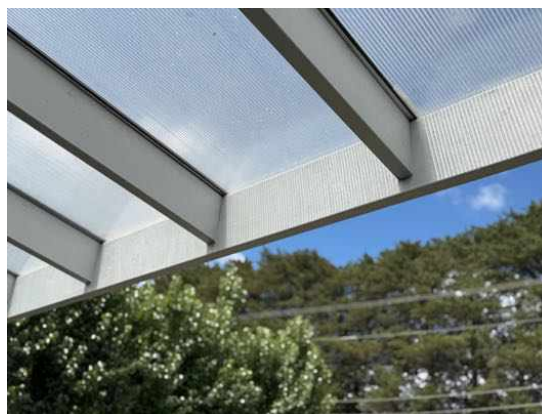
Building: Building 1
Location: All Areas > All Areas
Finding: Building elements such as rafter brackets and post bolts not installed
Information: The front pergola rafter brackets and post bolts were observed to have been omitted or missing at the time of the inspection. These roof areas have not had rafter brackets installed to the rafters and perimeter beams, these types of building elements will improve the longevity of the building structure as it becomes aged and deteriorated. Although some building elements may seem irrelevant or unnecessary, all building elements play a key role in the operation and function of the overall structure and its performance.

All maintenance or replacement of any missing building elements should be conducted to ensure that no secondary damage or functional issues occur in the future to associated building elements or materials not being installed. A qualified carpenter or another appropriate tradesperson should be appointed to maintain or replace the missing building elements or materials deemed necessary.

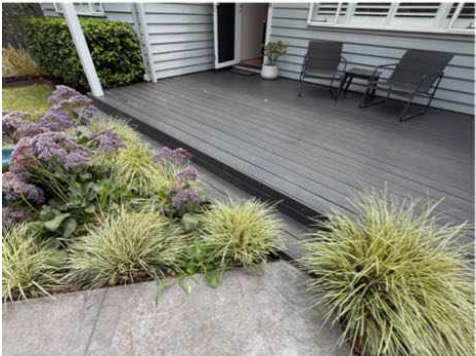
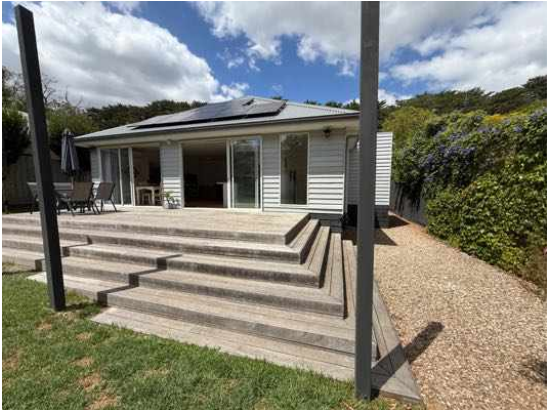
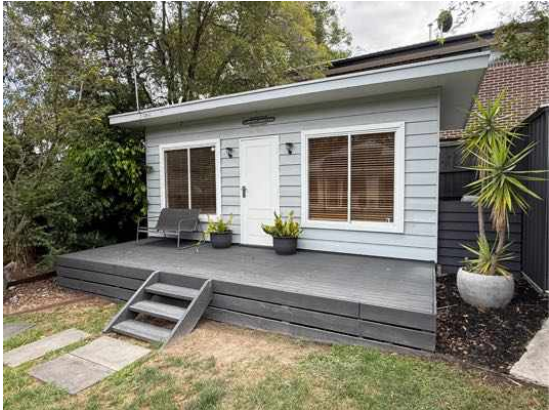
Building:	Building 1
Location:	All Areas > All Areas
Finding:	Deck timbers that are in or close to the ground and exposed to extreme weather conditions
Information:	It was observed that the timber deck structures were sitting close to the ground soil which exposes these timbers to accelerated damage and deterioration over time. It is good practice to have a minimum of at least 200mm away from the ground soil to the timber. Due to the susceptibility to wood rot and deterioration over a prolonged period of time. Good airflow through the subfloor areas should also be maintained to ensure a healthy environment. The client should be prepared that in purchasing a property, that some remedial work in the near future will be required to paint and preserve these timber deck areas that are frequently susceptible to excessive moisture from extreme exterior weather conditions.

External timbers that are frequently exposed to harsh and extreme weather conditions and sitting in the ground or close to the soil will require adequate protection and maintenance in order to maintain their condition. Any timbers that are exposed to harsh weather conditions and moisture from ground contact, exposes these areas to accelerated damage and deterioration. Where timbers have not been painted or protected properly or treated adequately, will show signs of general deterioration which is likely to occur at an accelerated rate. If left unattended, replacement of these timbers is likely to be necessary in the future. Adequate treatment of these timbers is

required by a painting contractor, home owner or general handyman.
