Building and Timber Pest Inspection Report

Inspection Date: Thu, 22 Jan 2026

Property Address: 21 St John St, Adelaide SA 5000, Australia

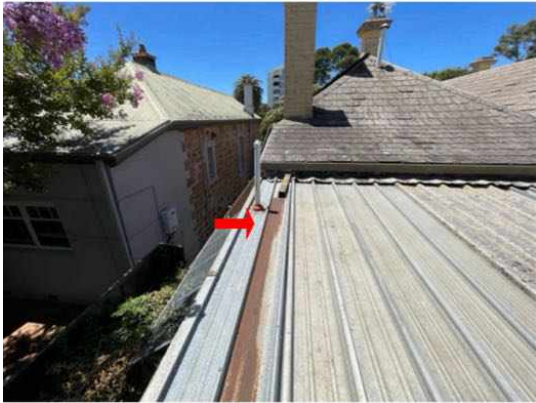
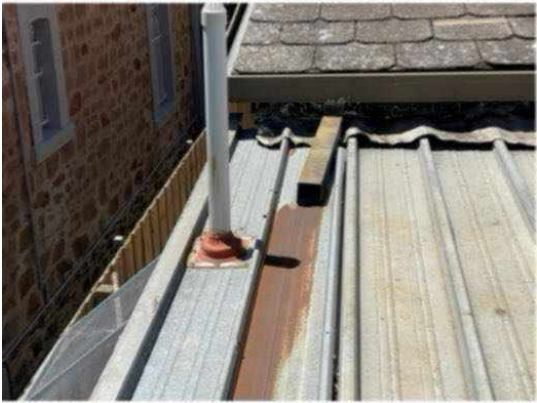
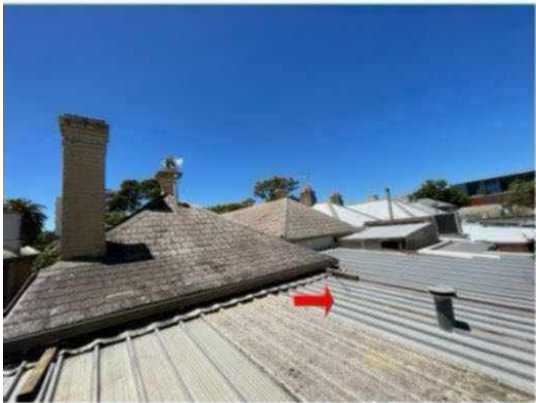
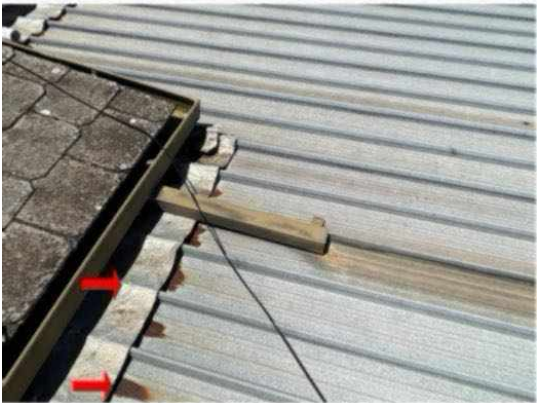
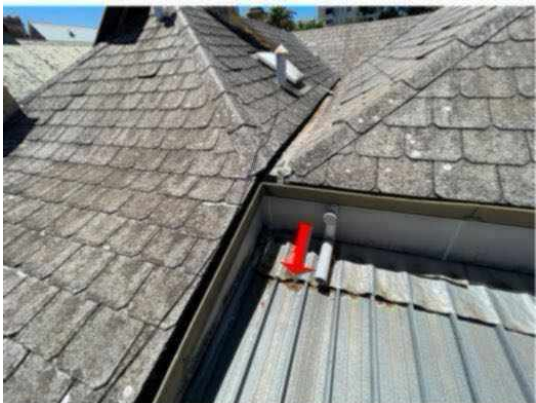
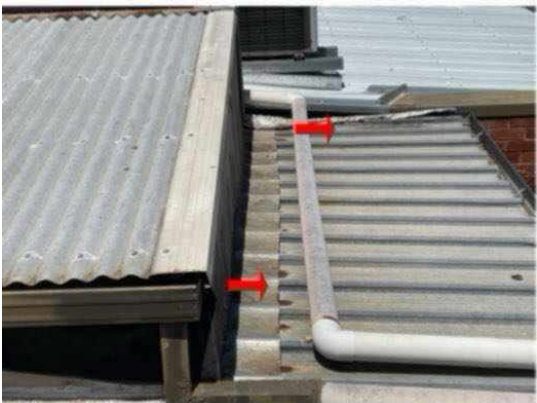
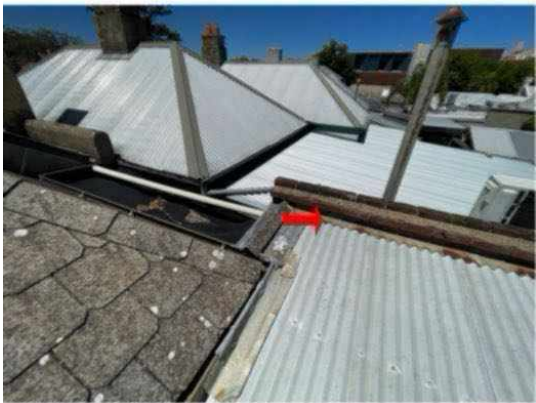
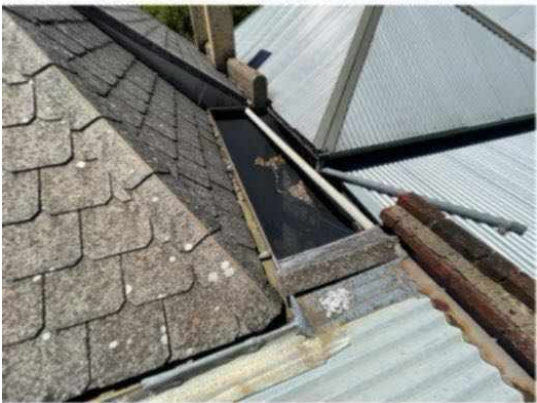
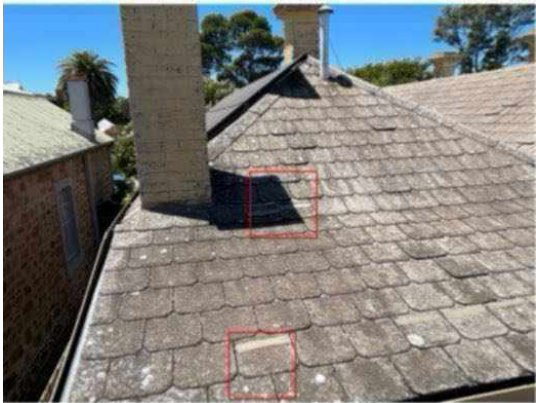
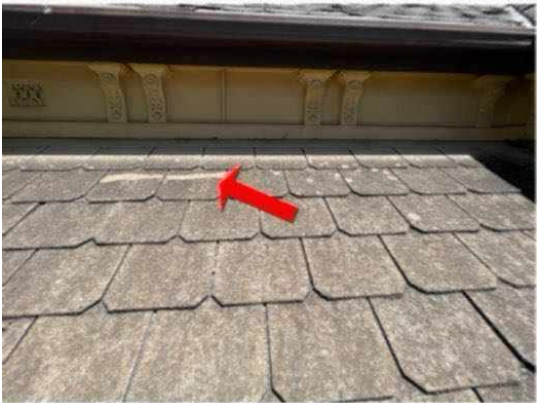
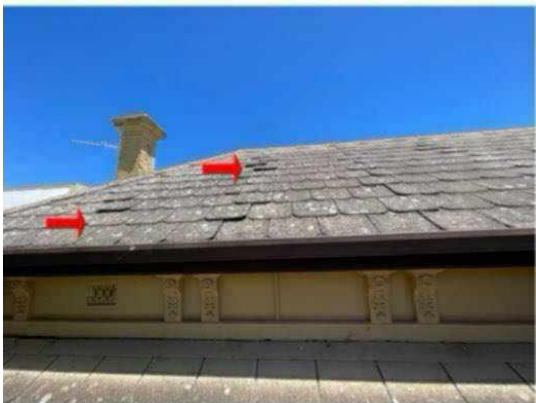
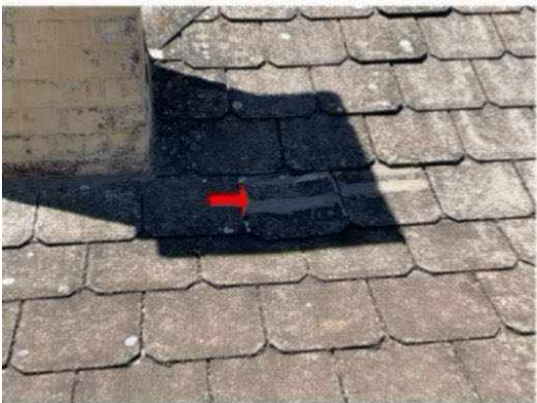
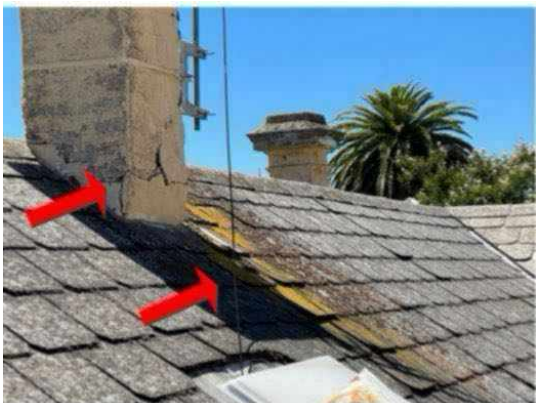
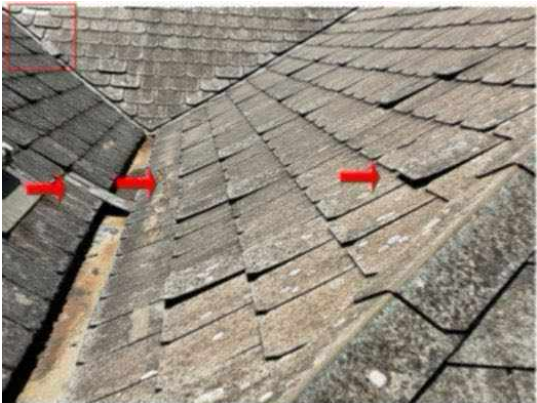
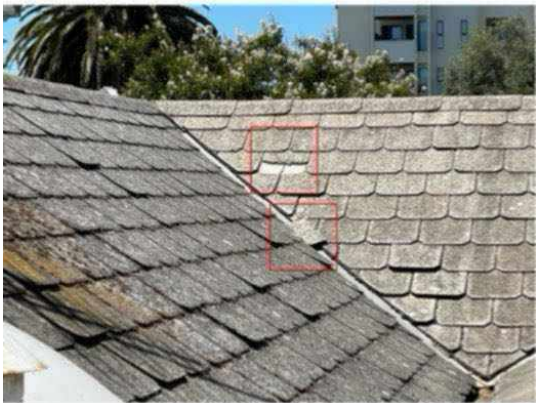
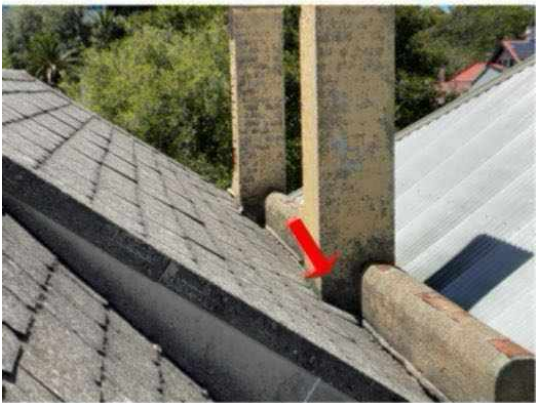
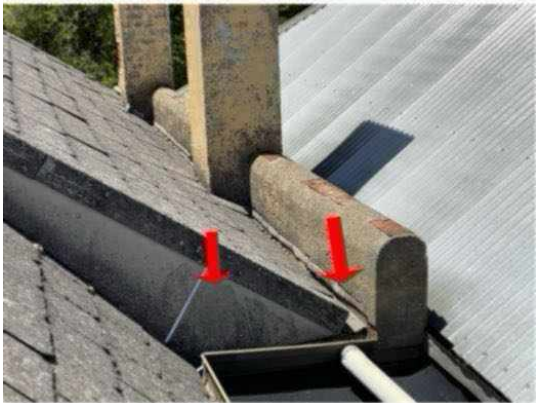
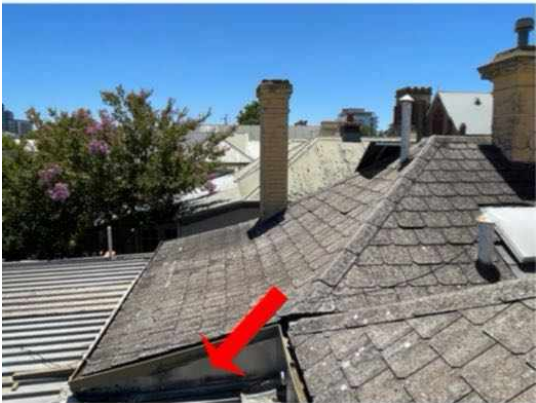
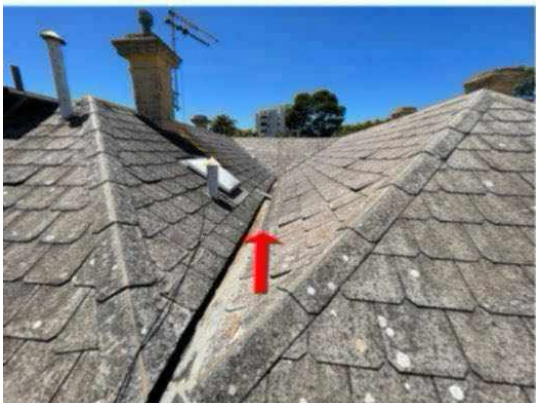
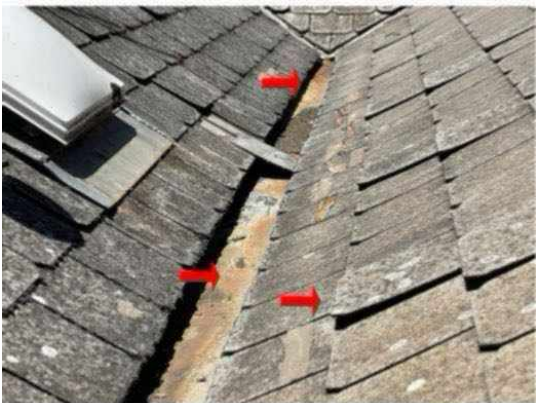
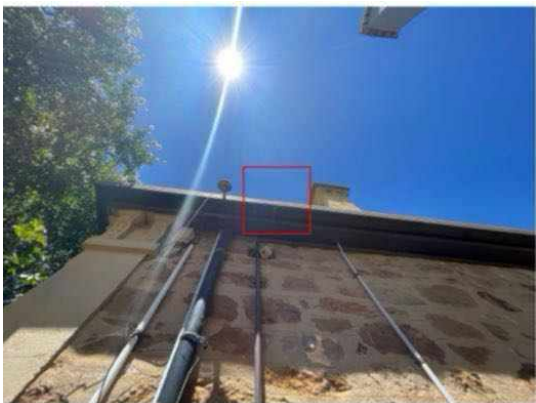
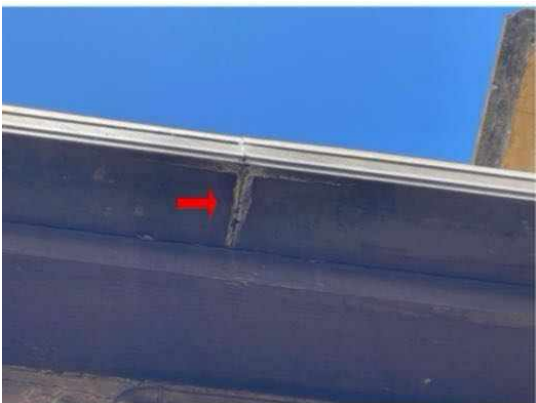
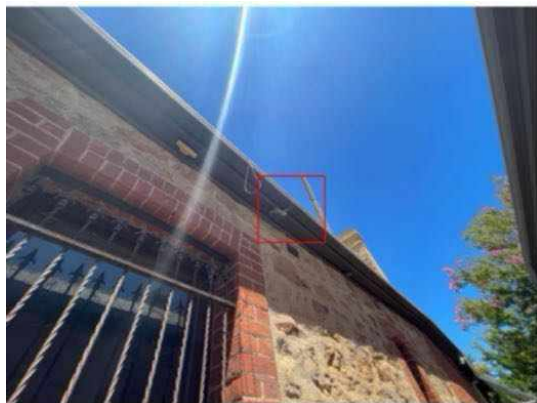
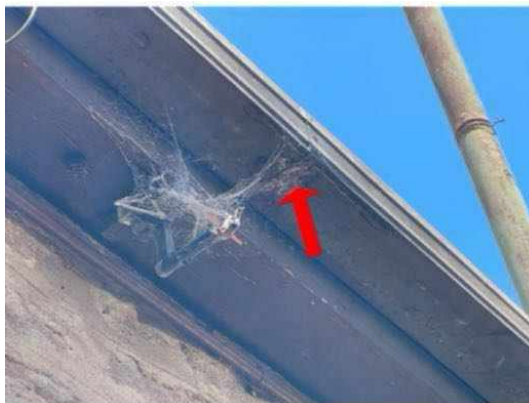
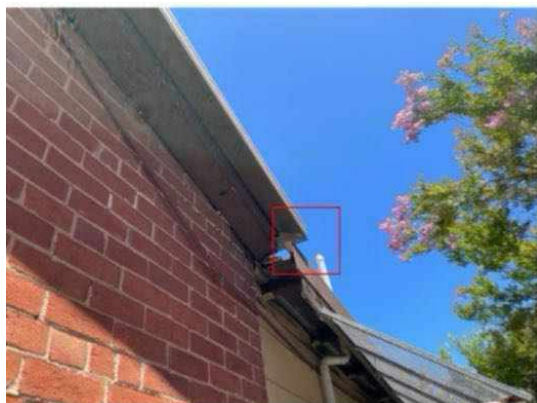
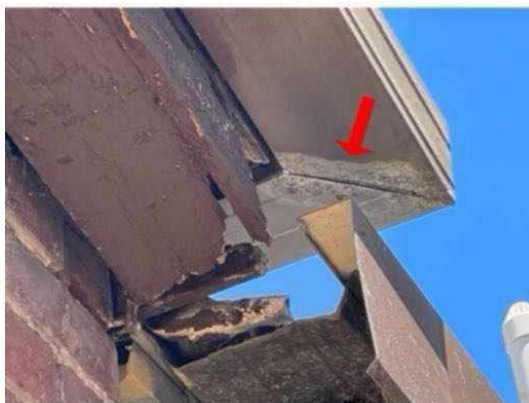
Building: Main Building
 Location: Roof Exterior
 Finding: Roofing - Deteriorated
 Information: Upon inspection of the exterior roofing, it was found that the multiple areas show signs of deterioration. The roofing has sustained an array of issues due to the age of the materials and a lack of general maintenance over time.

- Areas of rust were present to the roof sheeting to the rear flat section of the roof.
- The pitched areas of the exterior roof appears to be covered in (suspected) asbestos shingles, whilst the majority of the roof appears to be in a sound condition, multiple shingles have come loose or show signs of lifting and damage.

- Multiple areas of vertical cladding above the roof line show signs of moisture buildup and damages. This is likely due to being unpainted and poorly sealed. It is suspected these areas may be asbestos containing material.

- Multiple areas of the guttering shows some rust buildup, this mostly appears at the joints to the guttering around the pitched roof, however the gutter between the peaks in the centre of the roof shows slightly more advanced deterioration. A licensed roofing contractor should be appointed to assess whether the gutters require replacement and provide advice on the timeframe which that must occur.

Repair and/or replacement of damaged or rusted roof materials is required in the short term in order to reinstate the roof system to a fully operational level. To further

maintain these areas, gutters should be cleaned frequently, allowing the avoidance of any partial blockages.

A licensed roof restoration company should be appointed to undertake these works. It is advised that such works be completed as soon as possible to prevent any further damage and deterioration.

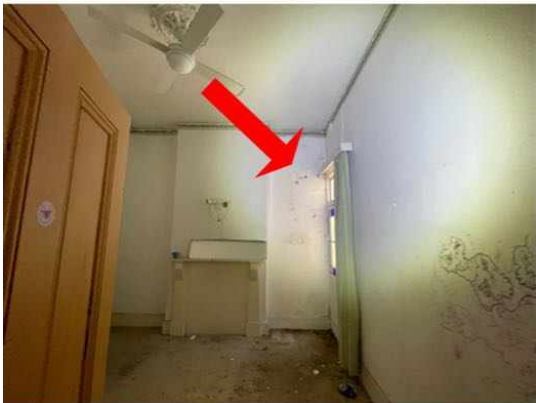
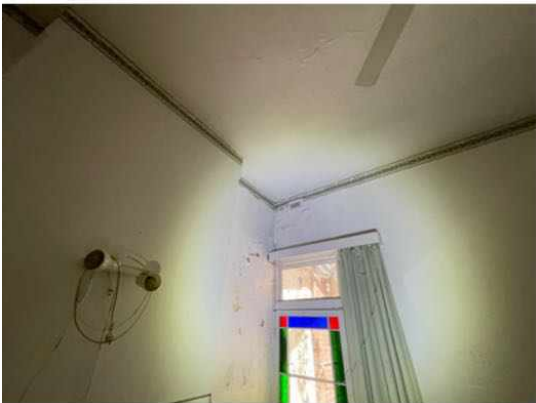
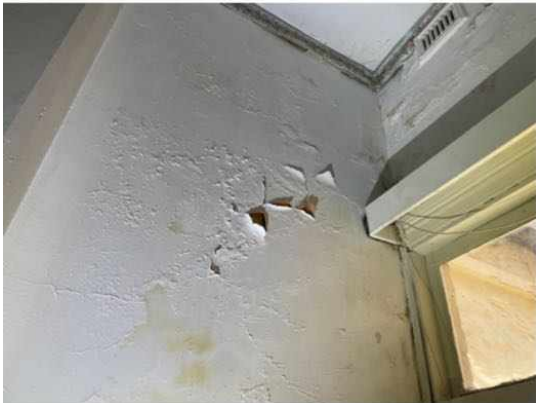
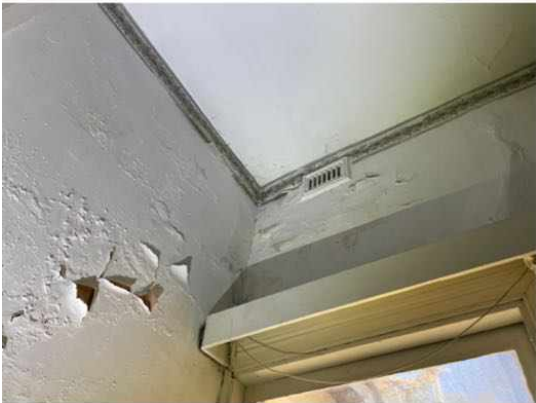
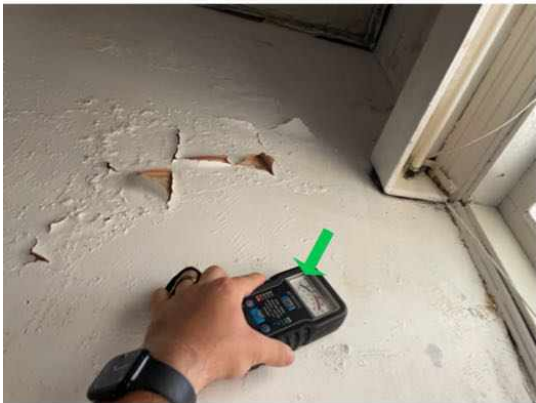
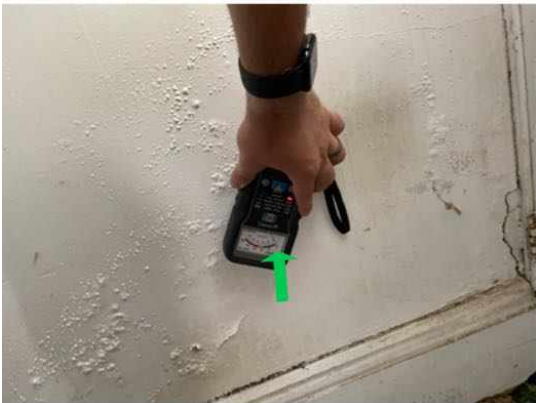
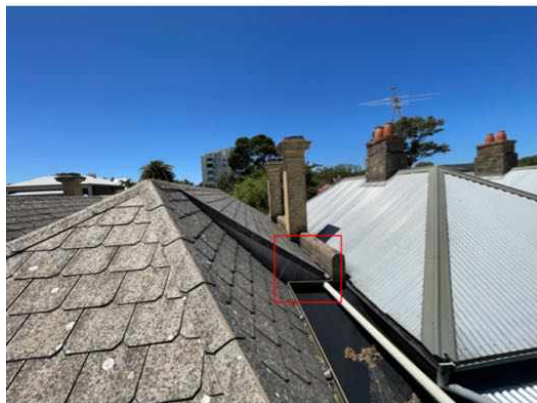
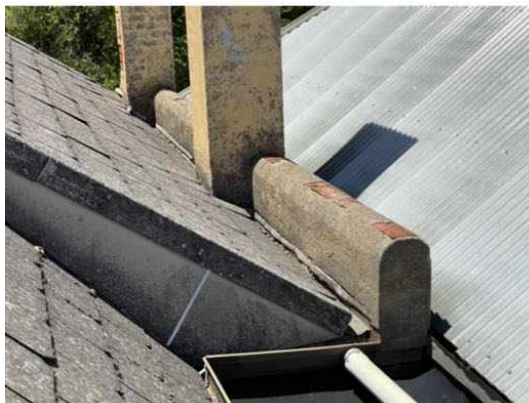
Finding 2.02

Building:	Main Building
Location:	Bedroom
Finding:	Water Leak Evident on Ceiling
Information:	The roof is suspected to be leaking to the bedroom in front of the left courtyard. Evidence of moisture damage and water staining was present to the walls in this area.

A licenced roofing plumber should be appointed as soon as possible to identify any and all sources of the leak and perform rectification works as necessary, ensuring the water damage is restricted, and the chance of further damage nullified.

Once the leak is repaired, consultation with relevant licenced tradespeople, including plasterers and painters, is advised. Rectification works may include replacement of ceiling lining or minor repainting, depending on the extent of the damage.

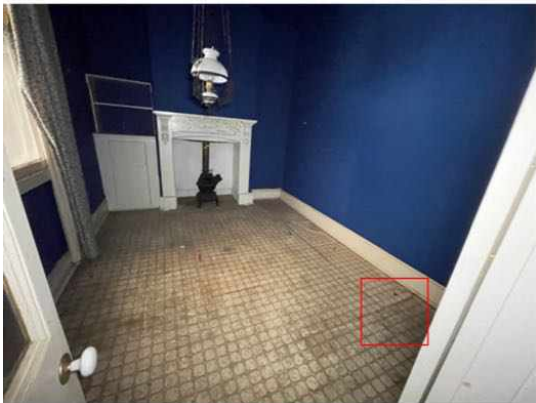
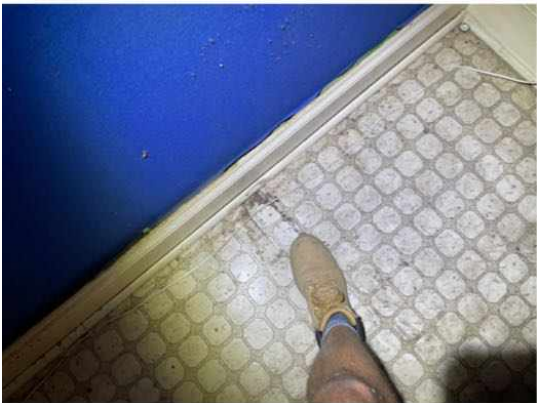
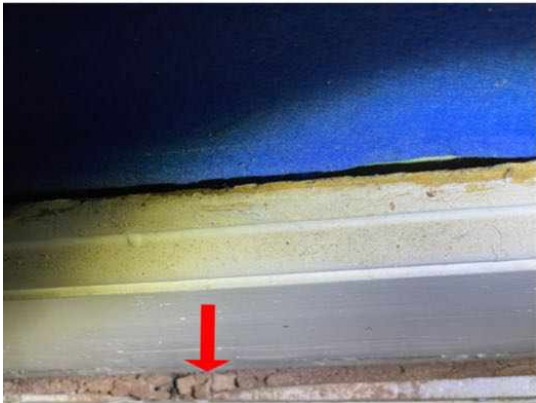
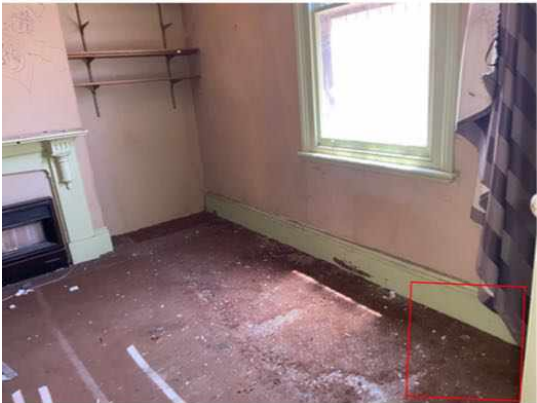
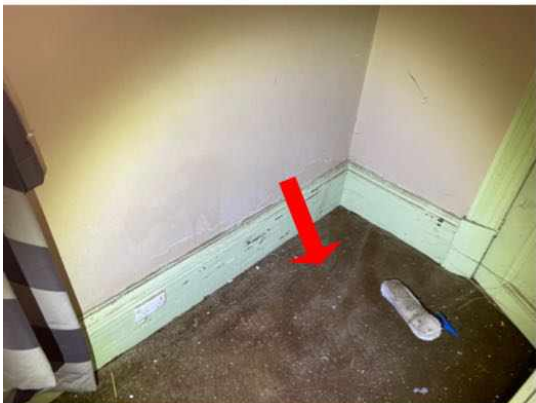
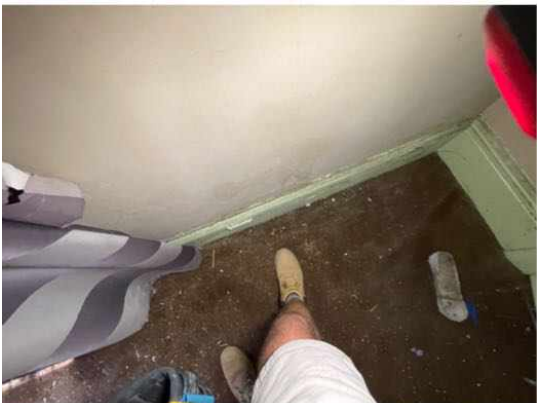
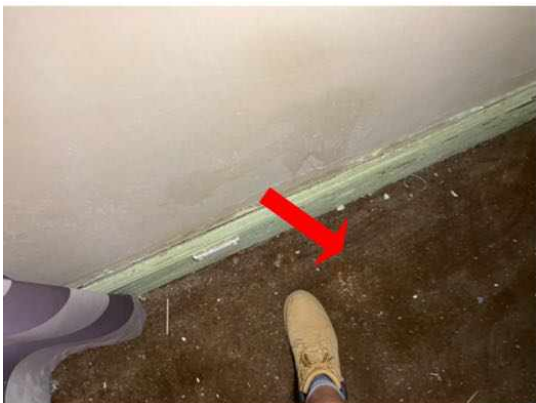
Building:	Main Building
Location:	Back living room and rear dining area
Finding:	Flooring/ Subfloor structure - termite damage
Information:	Multiple areas of termite damage was found to the skirting boards around the base of the lounge rooms and the back dining room as well as several other areas. Some areas of the flooring in the lounge room and the back dining room are suspected to have undergone extensive termite damage to the floorboards and or subfloor structure. This has been evidence by areas that are extremely soft underfoot with signs of mud buildup and nearby visible termite damage to adjacent building elements. These areas are covered in carpet or vinyl and the floorboards could not be physically observed at the time of inspection.

Floor joists are a critical part of the subfloor structure and damage to these areas may cause further strain on other areas of the structure as well as a lack of adequate support to the flooring.

Evidence of rising damp and damp conditions to the masonry walls were found in these areas and are likely contributing factor to the presence of termites.

Further invasive investigation is highly likely to reveal currently concealed or hidden termite damage and or defects.

As this defect involves a structural element and could not be fully assessed, further invasive investigation by a licenced timber pest inspector is recommended. A licenced structural engineer should also be engaged to assess the condition of the affected subfloor timbers and determine whether any structural remediation is required.

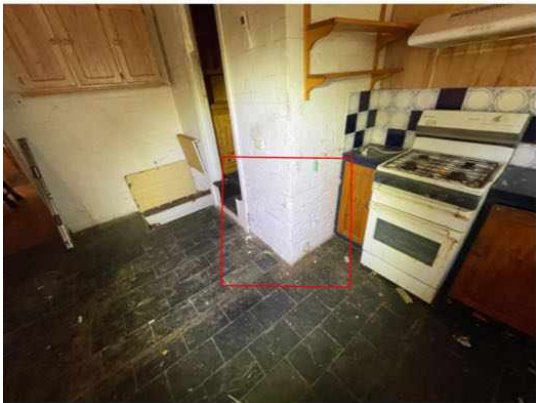
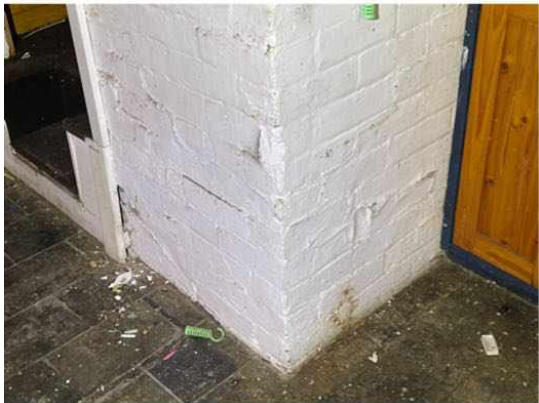
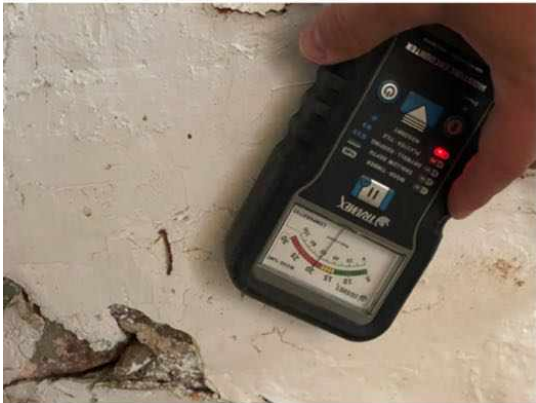
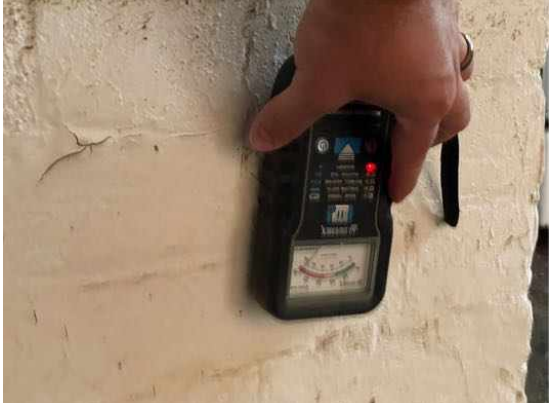
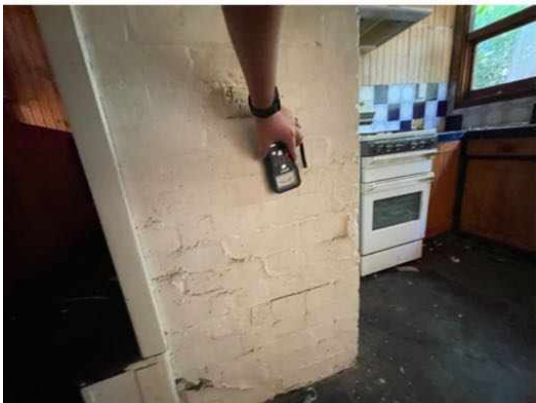
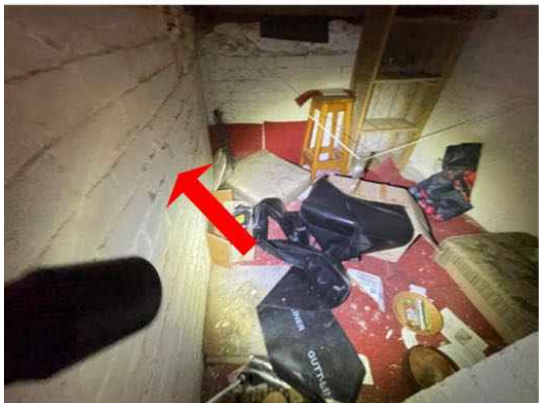
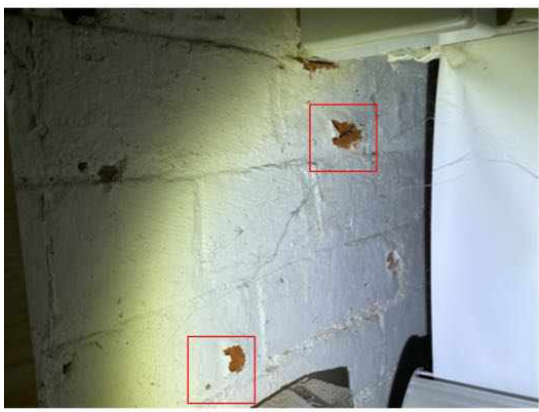
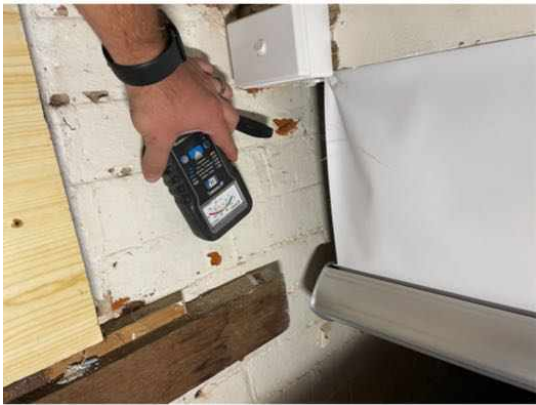
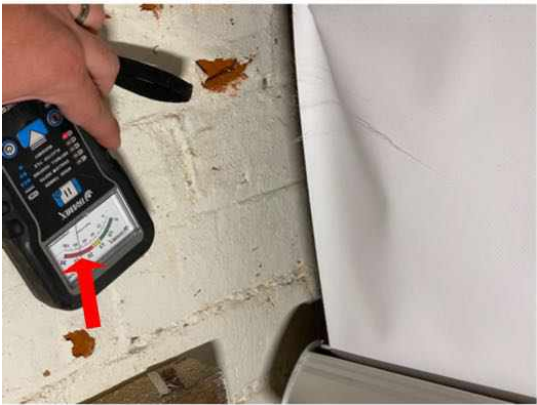
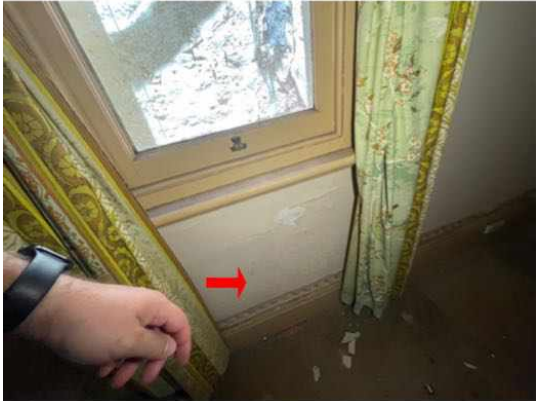
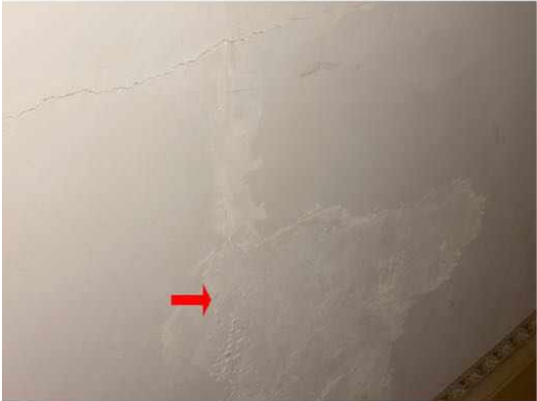
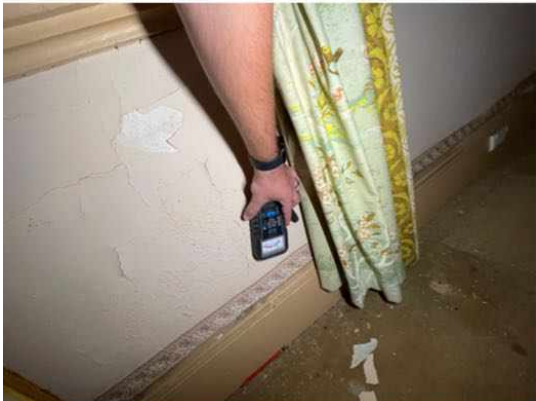
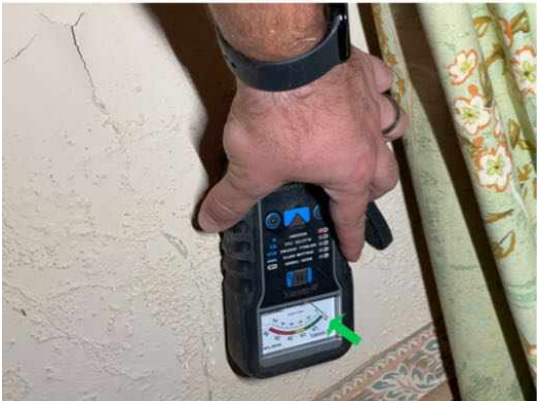
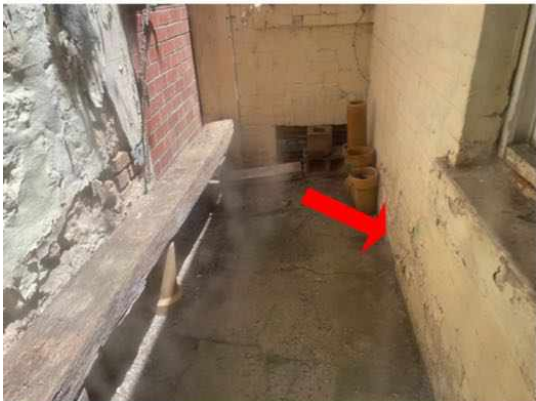
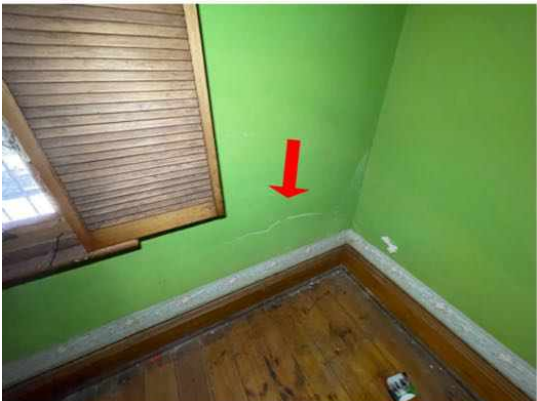
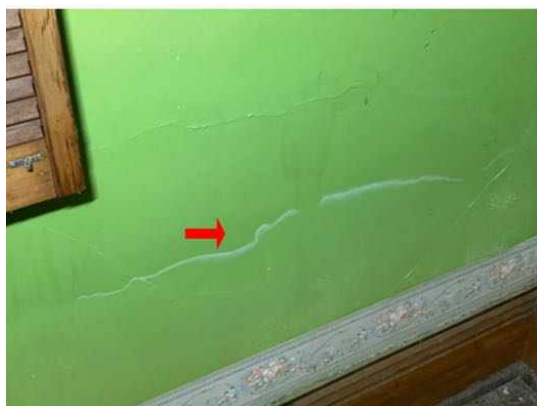
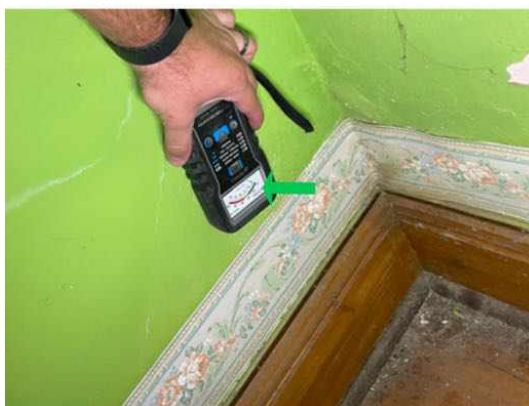
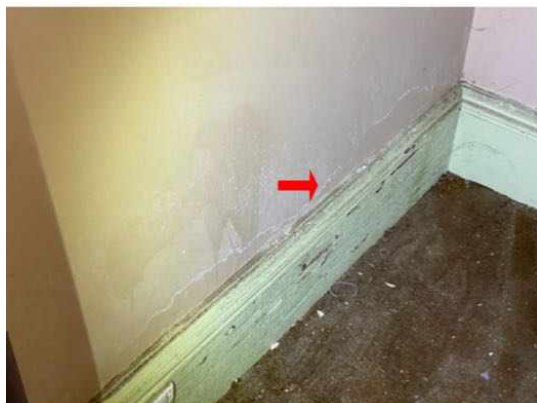
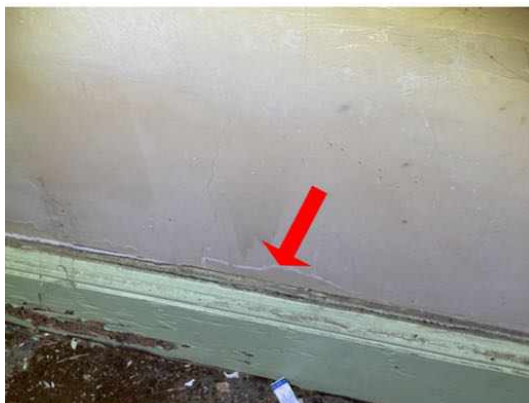
Finding 2.04

Building: Main Building
Location: All Areas
Finding: Damp - Rising
Information: Rising damp and evidence of damages likely caused by rising damp was identified throughout the masonry walls of the dwelling at the time of inspection. Although not all areas had high moisture recorded at the time of inspection, recent consistent dry weather may have contributed to a lack of moisture in the walls at this time of inspection. Changes in weather and return of damp or wet weather will likely lead to moisture issues returning in the future if the deteriorating areas are not rectified.

Damp damages were visible to the walls in the left side courtyard area, however this area was not accessible at time inspection. This damage could only be viewed through the window. It is suspected that this area may lack adequate drainage, provision for access should be made so further investigation can be carried out in this area.

The evidence of damp in this building includes areas of high moisture, a white salt line to several walls which is suspected to be an indicator of the height moisture has reached in the walls, and multiple areas of damaged, bubbling or deteriorating plaster. It is suspected that rising damp has been highly contributive to termite damage around these areas.

The first step in addressing rising damp is to diagnose the cause. The identified cause should be addressed first before addressing the appearance and other defects which have resulted from the rising damp. If the original cause is not resolved, further cases of damp are likely to ensue, resulting in secondary defects.

Consultation with a Damp proof specialist is advised immediately to identify the cause of the damp and perform remedial works as required.

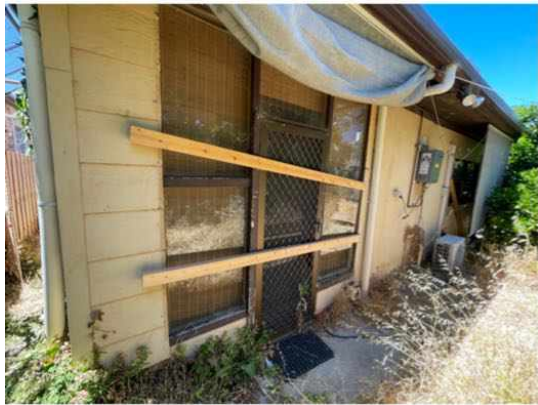
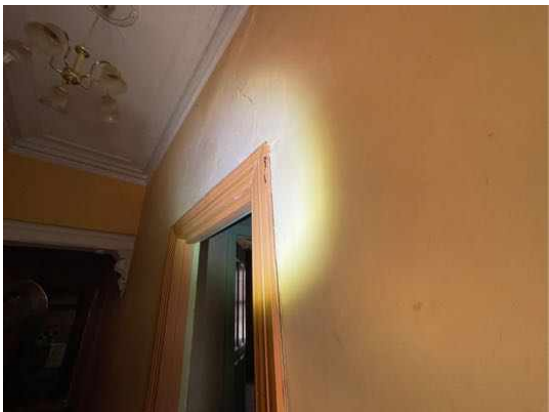
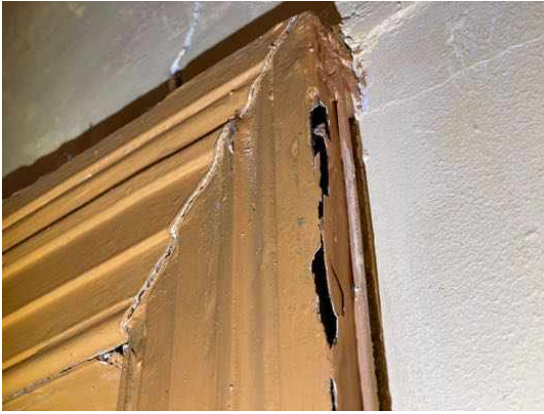
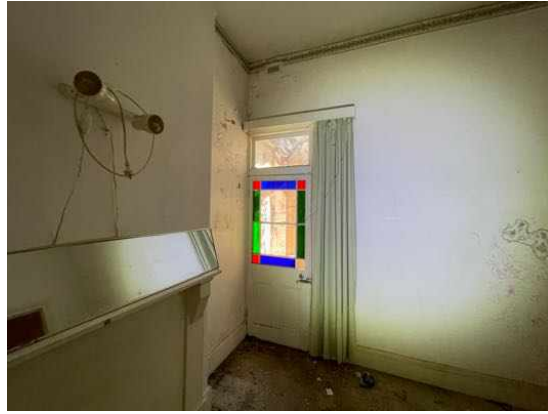
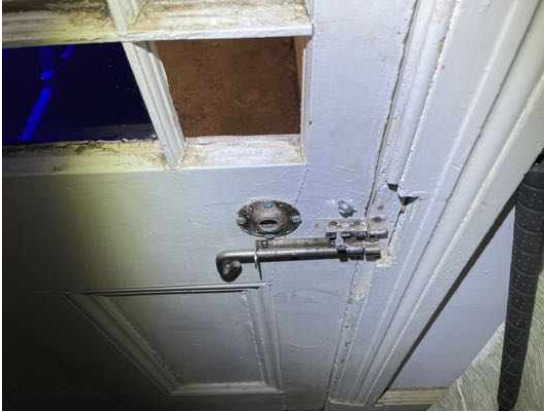
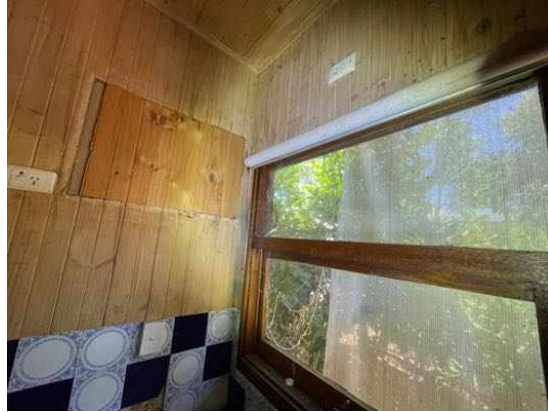
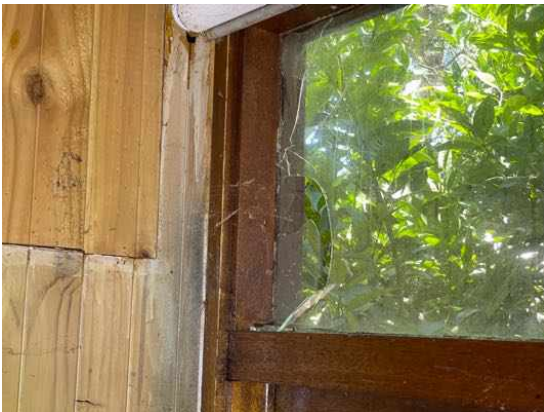
Finding 2.05

Building:	Main Building
Location:	All Areas
Finding:	Windows and Doors - Damaged
Information:	The building is in a poor condition at the time inspection with advanced deterioration, wear and tear damages, as well as physical vandal damages to most doors, door frames, window and window frames.

Damaged and deteriorated doors and windows will impair the weather tightness of the building, creating potential for water leaks.

Where replacement of the windows and doors is required a licenced builder or carpenter should be engaged. Please be advised that any persons coming into contact with broken glass windows should do so with due caution to avoid any personal injury that may ensue.

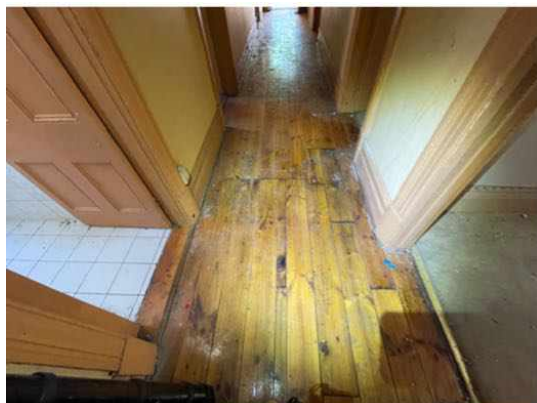
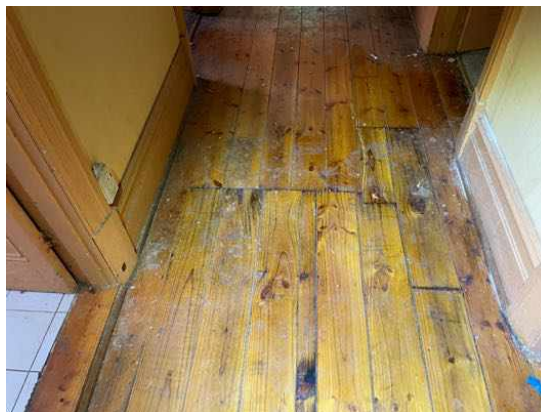
Finding 2.06

Building: Main Building
 Location: Hallway
 Finding: Damaged flooring - rot
 Information: The timber floors to the hallway directly outside the bathroom area showed dark staining likely to be signs of wood rot, indicating suspected damp either from the subfloor area or seeping through from the bathroom directly adjacent the area.

The deterioration has created discolouration and rot, it is possible further deterioration as well as potential compromise of the structural integrity of the section of floor could be present. Where moisture is present around timber, a highly conducive environment for termite activity is created. As termite damage was found to flooring in other areas it

is highly recommended that invasive inspection be performed to the subfloor section of this area to assess for termite damage and rot to the subfloor structure.

The damage to this area appears to be limited to the area closest to the bathroom door, however as the subfloor is not accessible in this area, the extent of the damage is not readily identifiable. Further, likely invasive inspections and quotes to repair should be sought from a licenced building contractor.

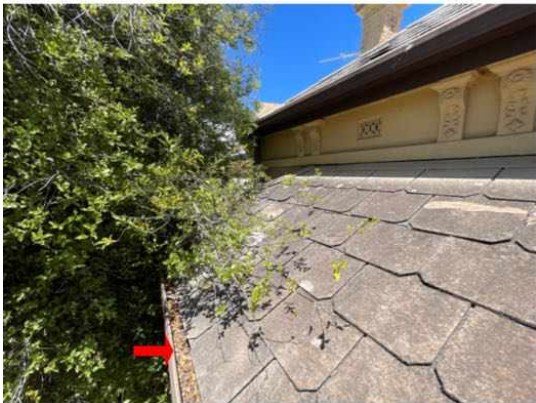
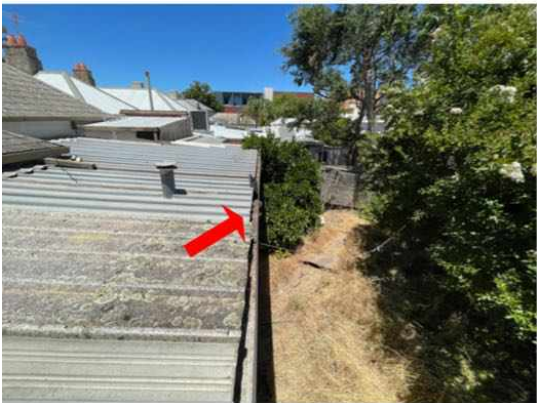
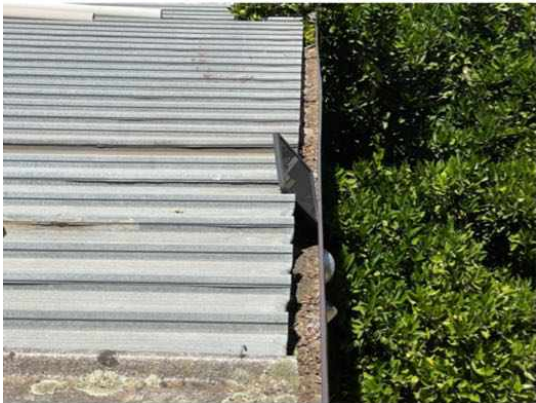
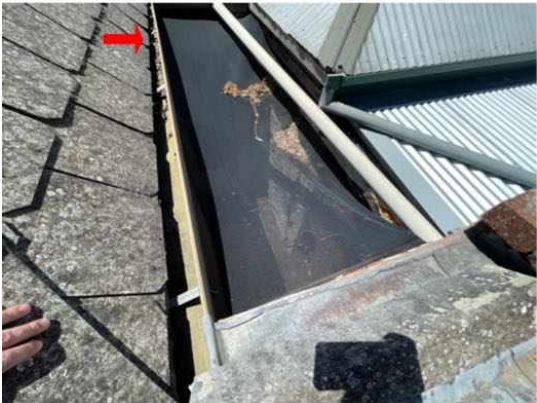
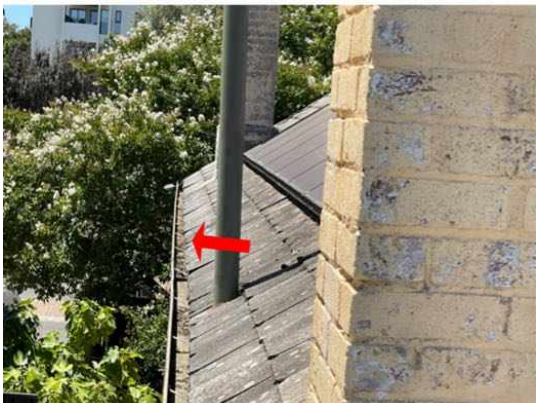
Finding 2.07

Building:	Main Building
Location:	Roof Exterior
Finding:	Guttering- Debris
Information:	Varying degrees of debris build up was identified throughout the guttering at the time of inspection.

Roof plumbing structures, such as guttering and downpipes, should be free of all debris to prevent blockages and the accelerated deterioration to the roof plumbing. Blockages and deterioration of the guttering and downpipes will lead to pooling and accumulated water overflows, which is likely to subsequently flood eaves and exterior walls.

Blocked gutters are likely to lead to high levels of moisture in the affected areas. Such moisture will not only cause rust and decay of the associated building materials, but can also provide conditions that are conducive to termite and timber pest activity. Blockages in gutters should therefore be removed immediately to ensure dry conditions are maintained.

It is highly advised that blocked gutters be removed by the homeowner or a general handyperson in the short term.
