Building and Timber Pest Inspection Report

Inspection Date: Thu, 22 Jan 2026

Property Address: 21 St John St, Adelaide SA 5000, Australia

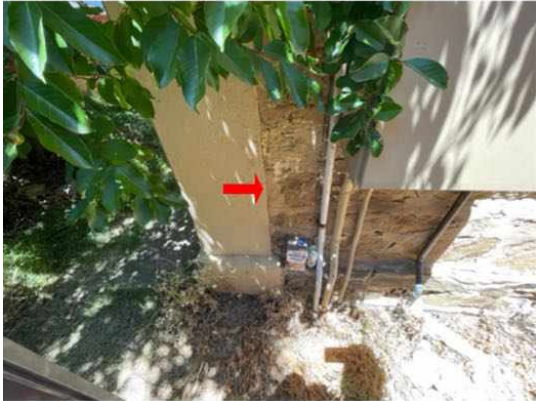
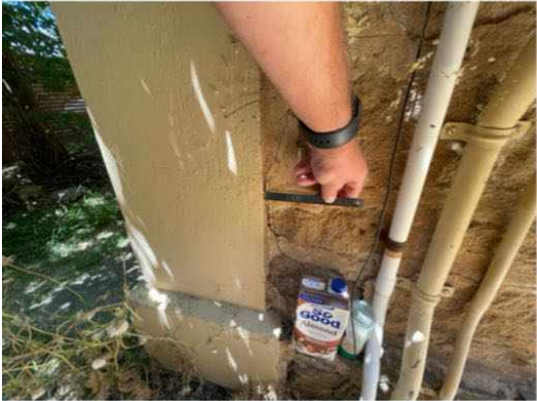
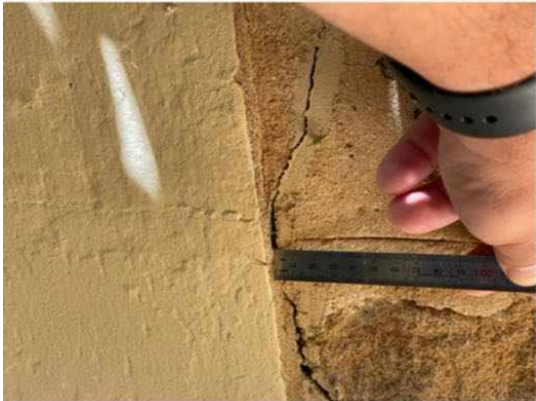
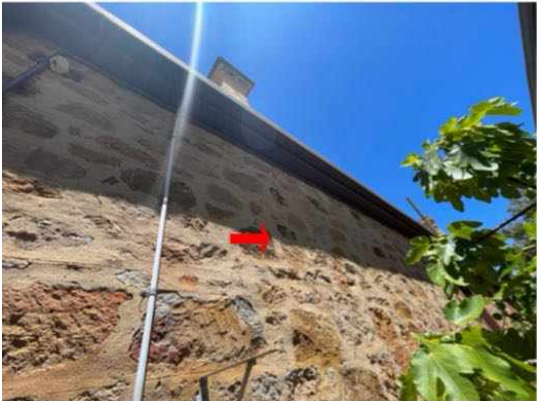
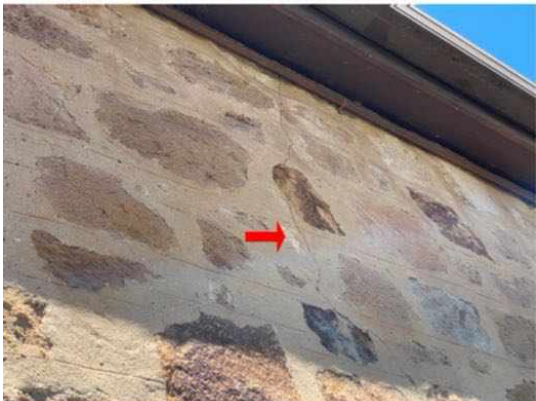
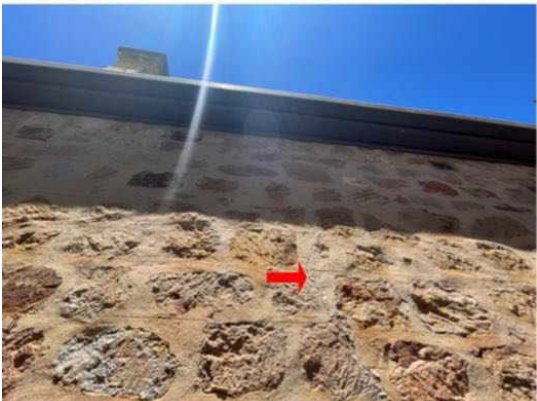
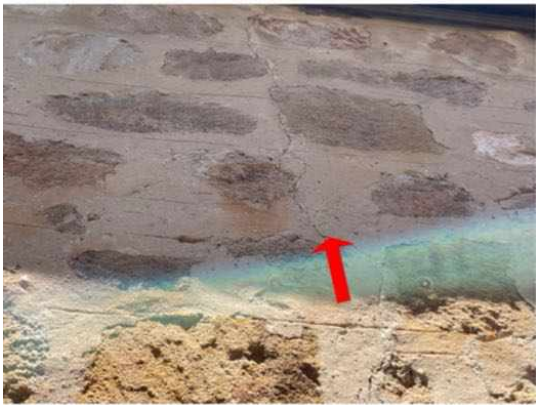
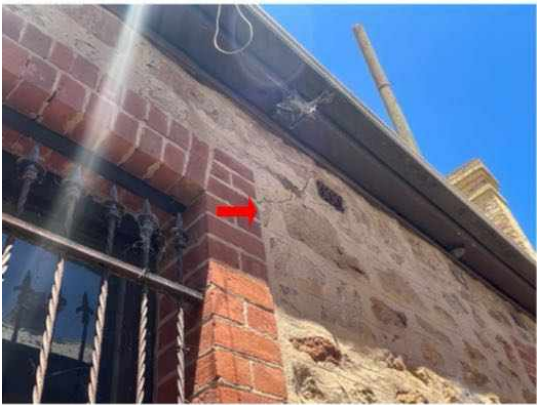
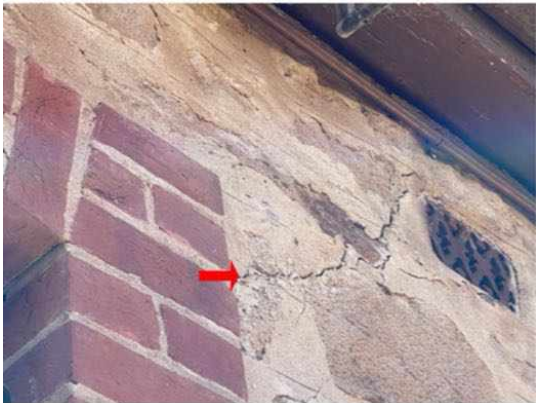
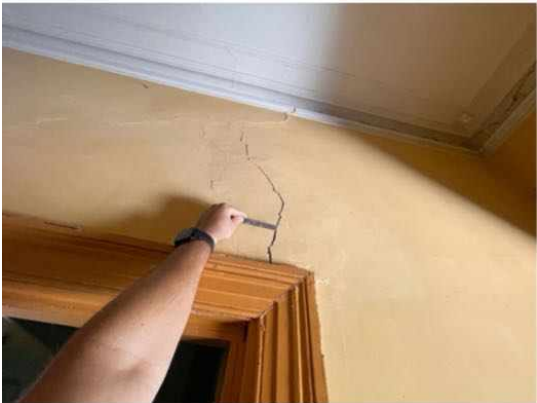
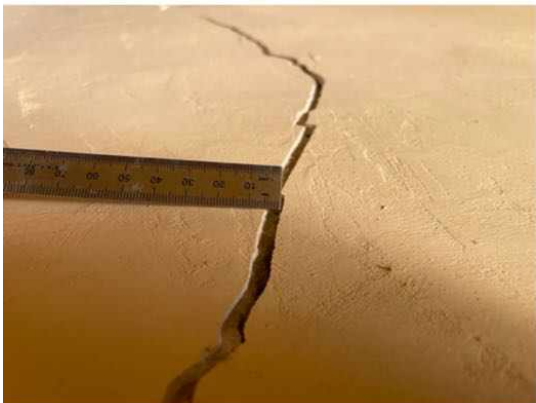
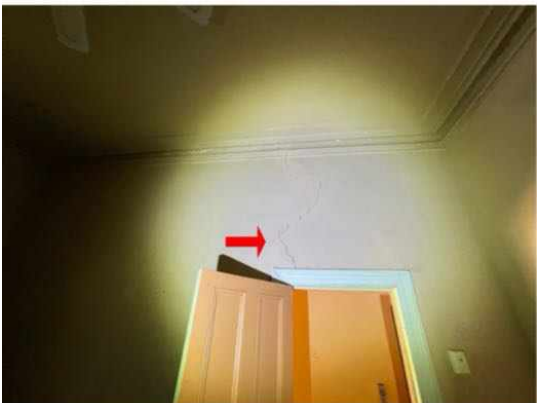
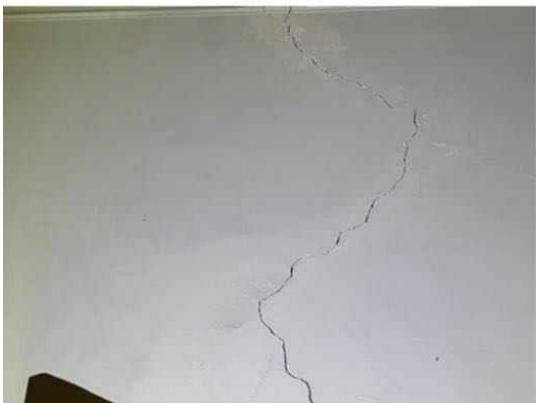
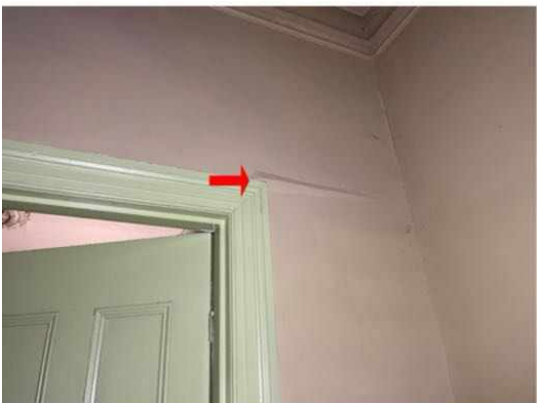
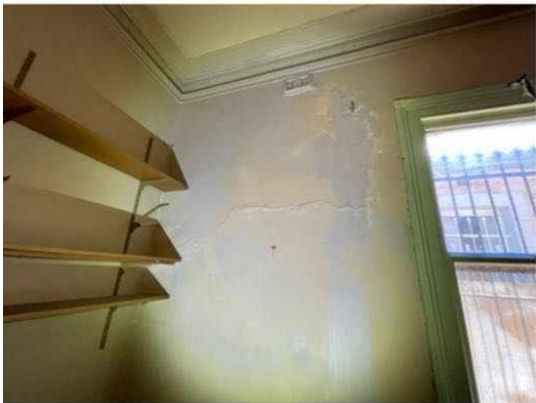
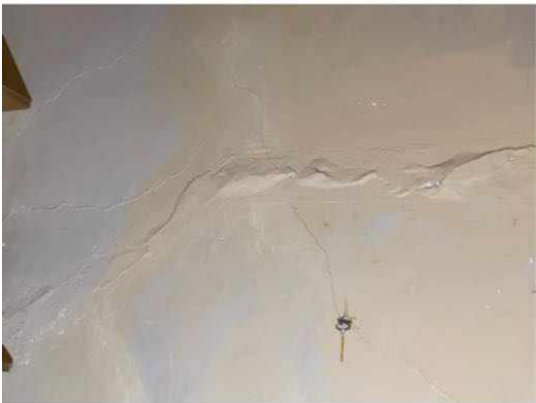
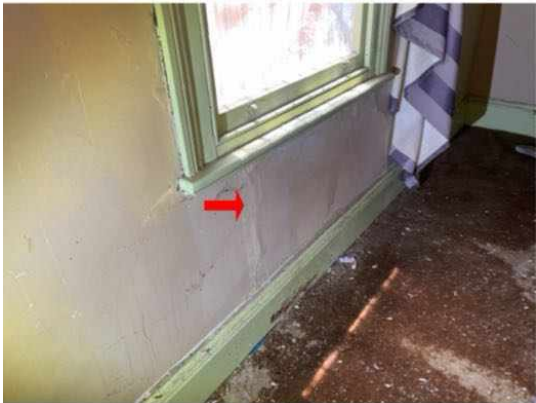
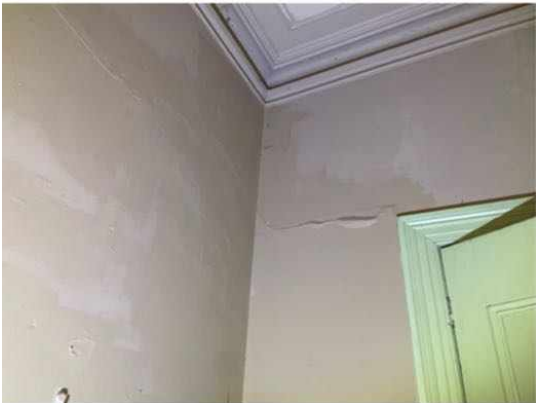
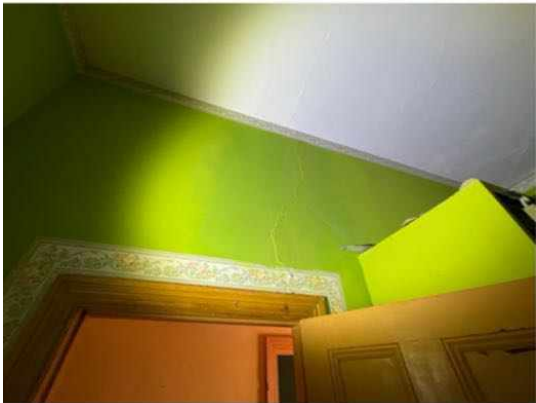
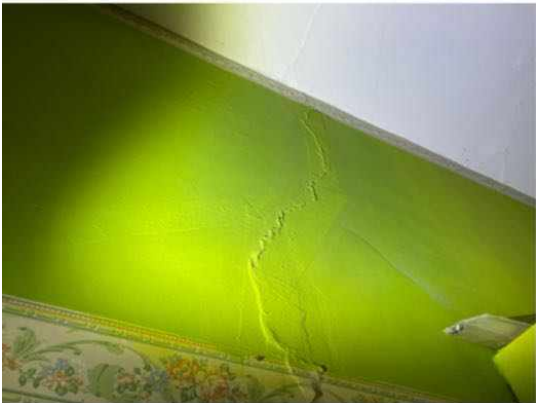
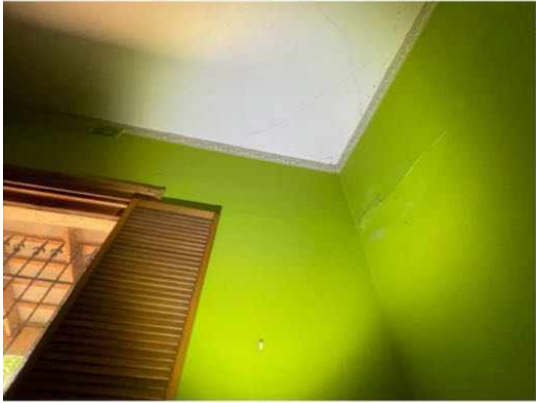
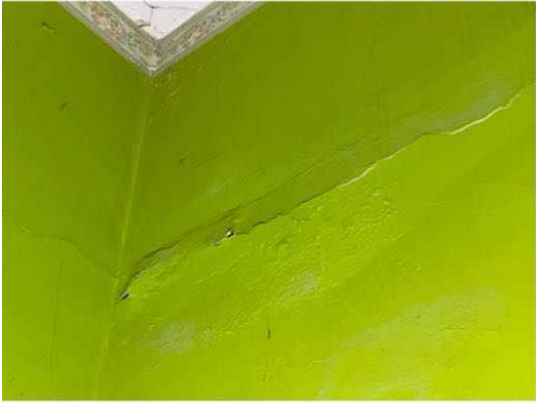
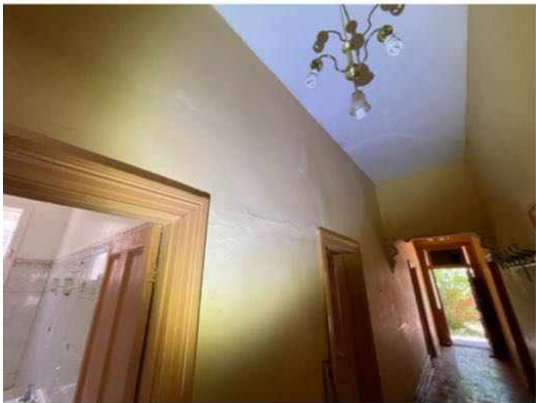
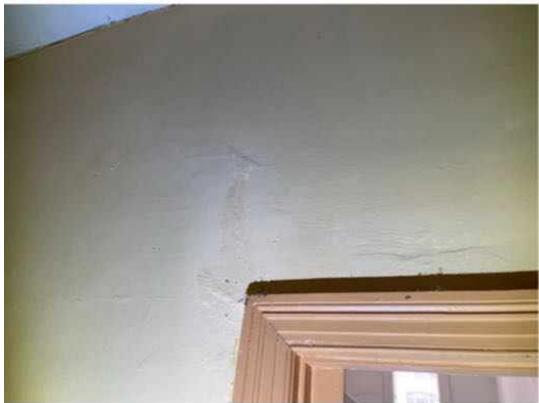
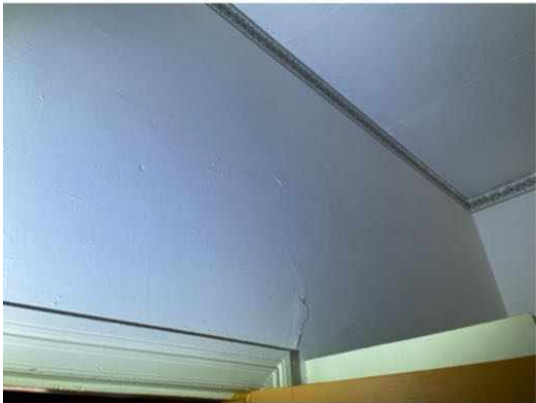
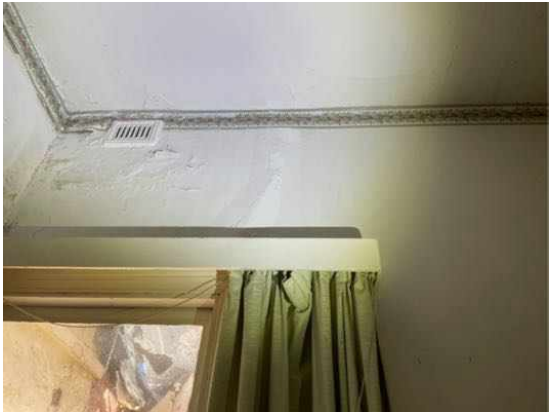
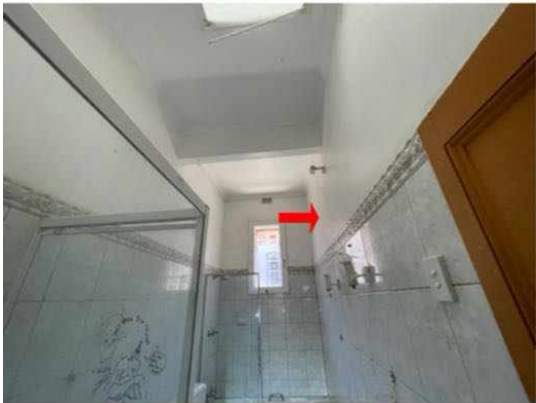
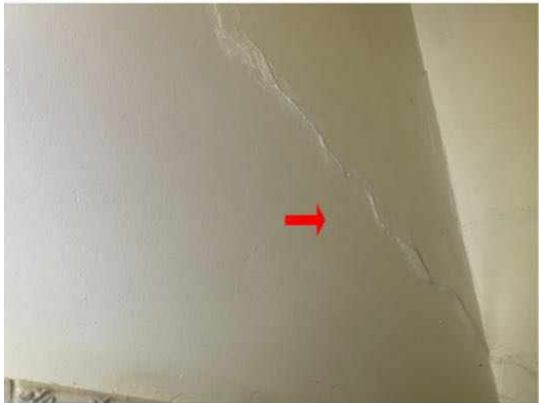
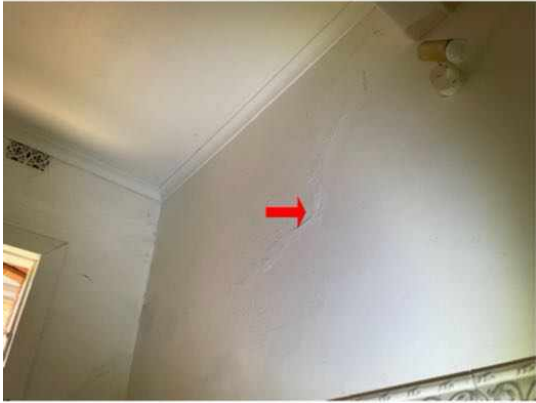
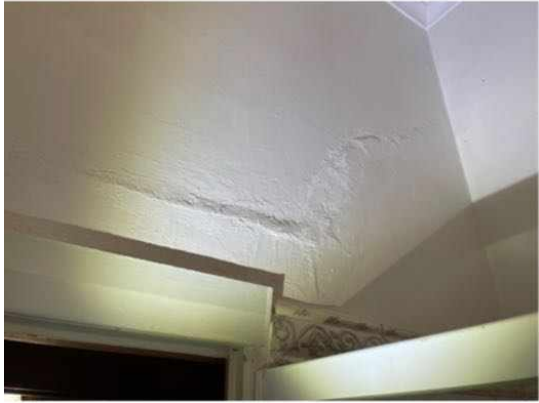
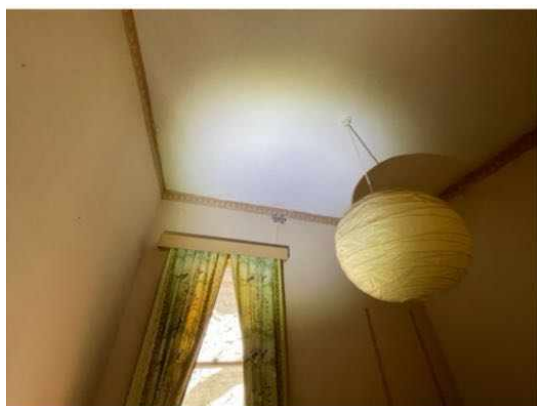
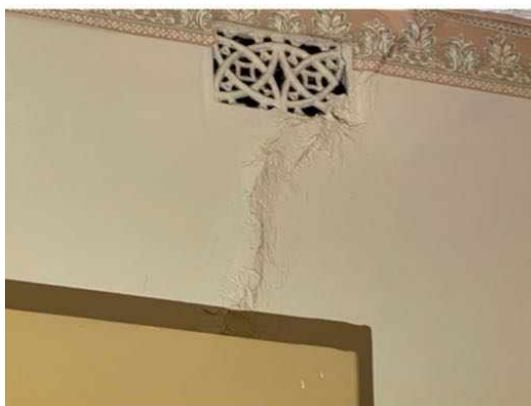
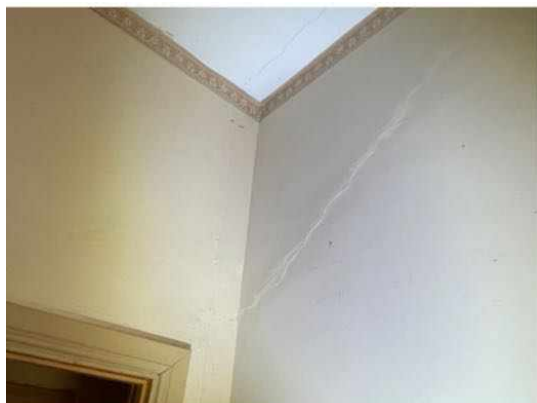
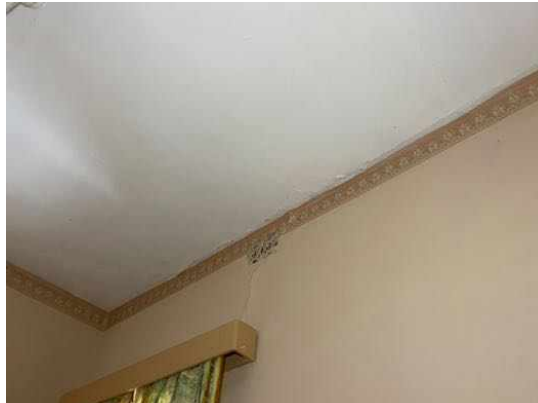
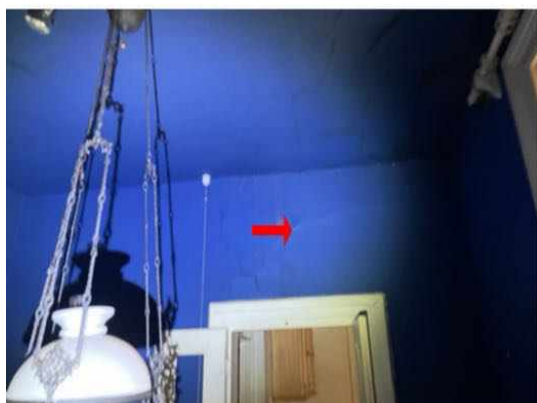
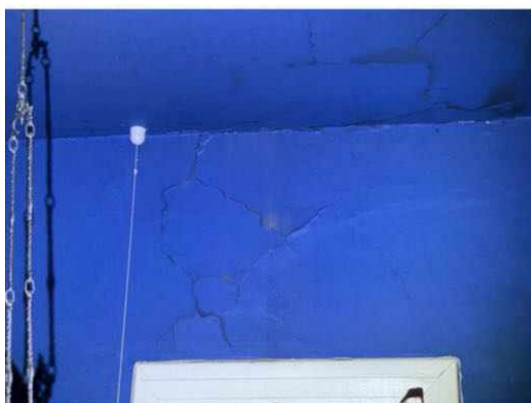
Building: Main Building
Location: All Areas >
Finding: Damage to Masonry Walls (Cracks)- Category 2
Information: It has been observed that damage to masonry walls, likely to have been caused by movement of slabs, footings, or other causes, appears to have occurred. Multiple cracks and or crack repairs have been found throughout the internal and external masonry walls of the building.

The degree of damage falls within Category 2, described as noticeable cracks which are easily filled. Such cracking may cause doors and/or windows to stick slightly, and are generally less than 5mm in width.

Damage of this category is required to be monitored for a period of 12 months, after which time a crack rated at Category 2 or above is considered a defect requiring rectification, such as minor repairs and repointing. Always contact your building inspector should cracks widen, lengthen, or grow more numerous.

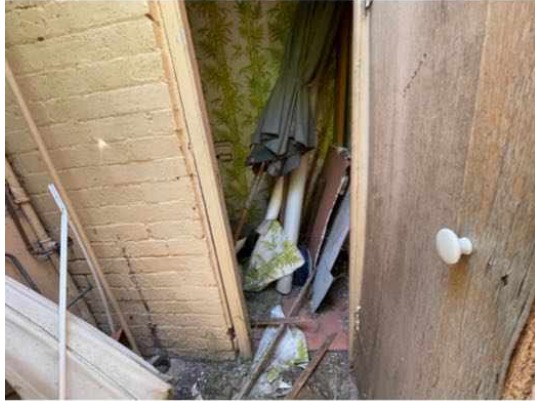
Finding 3.02

Finding: Bathroom - Poor condition

Information: The rear toilet access by the backyard was in an extremely poor condition at the time of inspection. This area appeared to be used as a storeroom and as such no access was available to test function of the toilet. The door and walls surrounding the area are all in a poor condition.

This bathroom is unlikely to function correctly and extremely likely to lead to further defects or deterioration of surrounding building elements.

Full renovation is likely required and should be performed before the building is occupied, its is recommended that further invasive inspection to the internals of the walls should be conducted to asses the condition of the walls.

Consultation with a licenced builder is required immediately.

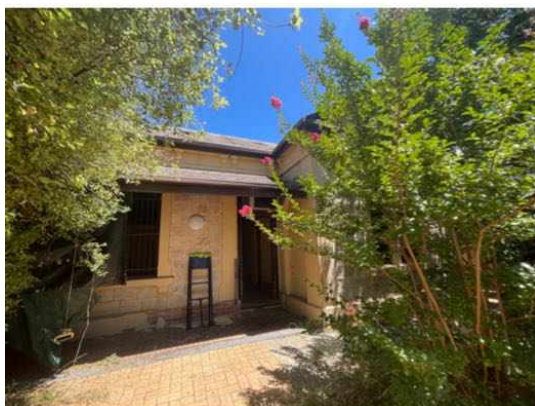
Finding 3.03

Finding: Verandah posts - Damaged

Information: The front verandah posts to the left corner is heavily twisted. Such damage will likely compromise the structural integrity of the verandah. A replacement of the damaged post may be required in this area to prevent the possible future failing of the front verandah.

A qualified carpenter or registered builder is required to repair or replace affected building materials as soon as possible.

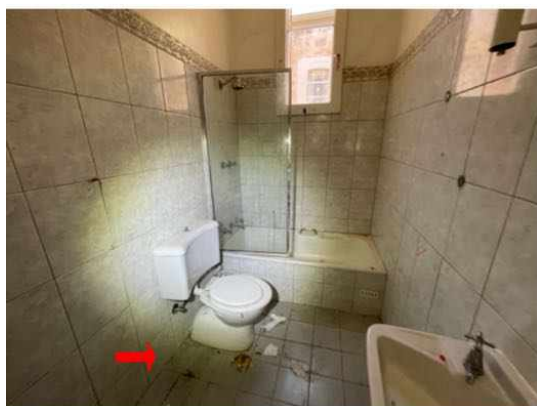
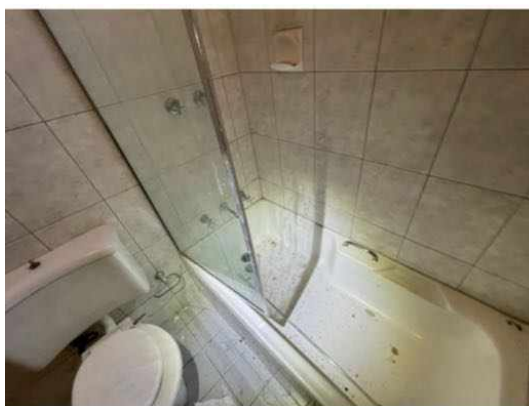
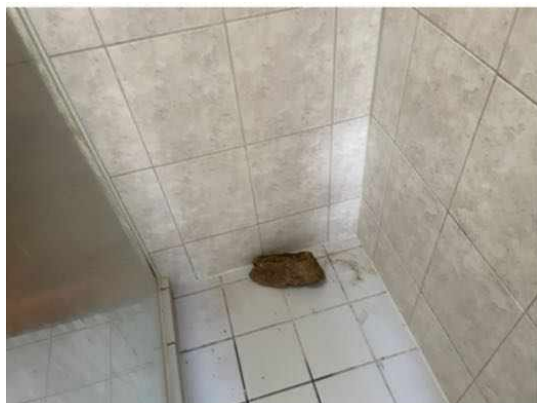
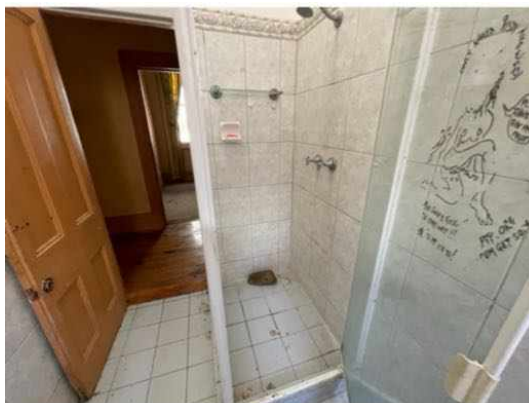
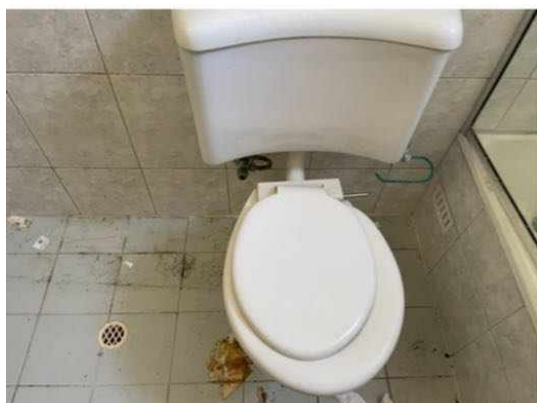
Building:	Main Building
Location:	Bathroom
Finding:	Shower sealant and or grout deterioration
Information:	It was noted on inspection that sealant or grout is degraded to the tiled shower alcove and or other areas of the bathroom.

Although no high moisture was recorded in this area at the time of inspection, the dwelling appears unoccupied and the shower may not have been used for a period of time. Deteriorating sealant and grouting makes a shower alcove significantly more prone to moisture ingress. Changes in use of the shower or further deterioration will likely lead to moisture issues in the future if the deteriorating areas are not rectified.

Different materials and floor areas move at different rates, generally causing cracking to grout or sealant at this point. A flexible sealant is required to allow for expected expansion and contraction, while keeping the joint water tight and protective of all associated building materials.

Flexible and mould resistant materials should be applied to affected areas to prevent any subsequent water damage that is likely to occur. Regular maintenance and replacement of damage or missing or damaged sealant and grout is highly recommended to the wet areas, as this is a regular wear and tear defect. Sealant and grouting in areas that come into regular contact with water should be maintained for the long term care of your property.

A sealant specialist or tiling contractor should be appointed to complete these works as soon as possible.

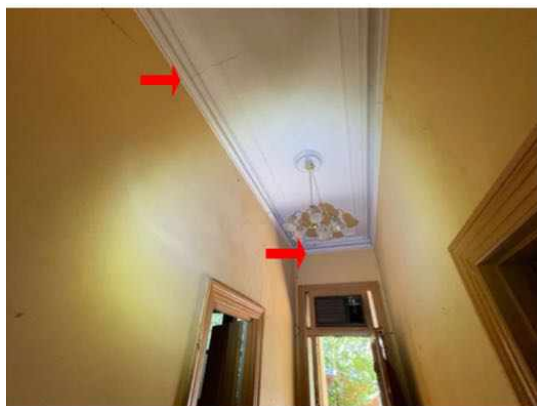
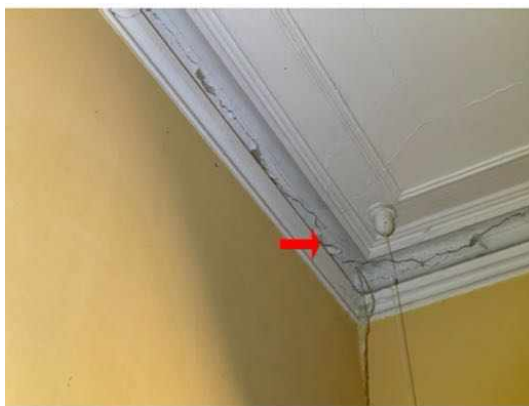
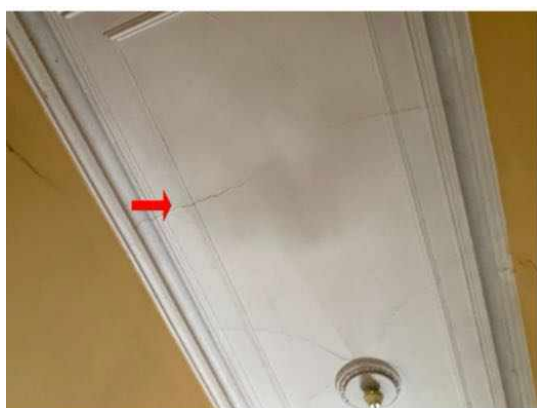
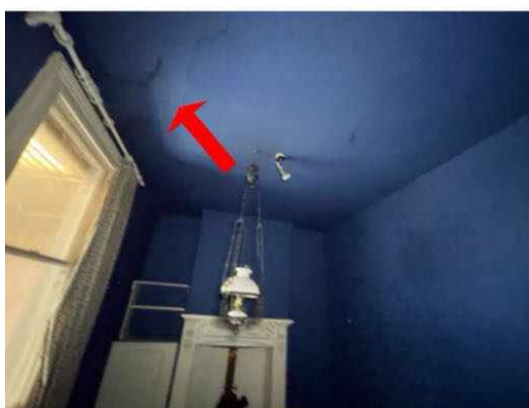
Finding 3.05

Building:	Main Building
Location:	All Internal Areas
Finding:	Cracking - Damage Category 2 - Noticeable (up to 5mm)
Information:	Several noticable cracks, separation cracks and or crack repairs were identified throughout the internal ceiling areas of the property at the time of inspection.

Noticeable cracks are a common occurrence as a result of many primary defects. Such causes may include age, general wear and tear, expected building movement, general expansion/contraction of building materials in different weather conditions, and/or minor failings in the installation or application of building materials.

Monitoring of all cracking should be conducted frequently. Always contact a building inspector should cracks widen, lengthen, or become more numerous. Additionally, your building inspector should also be contacted if associated building elements such as doors and windows become more difficult to operate over time.

Relevant tradespeople, such as carpenters, painters and plasterers, should be appointed to perform remedial works, as deemed necessary.

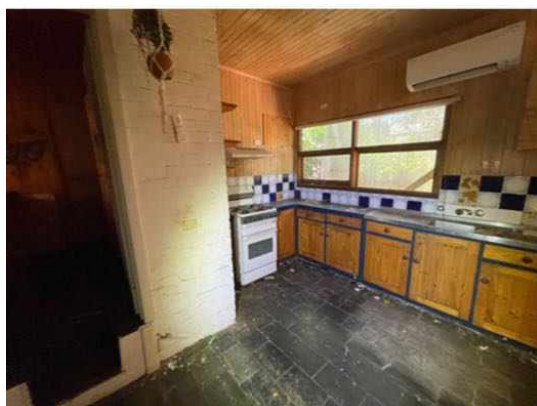
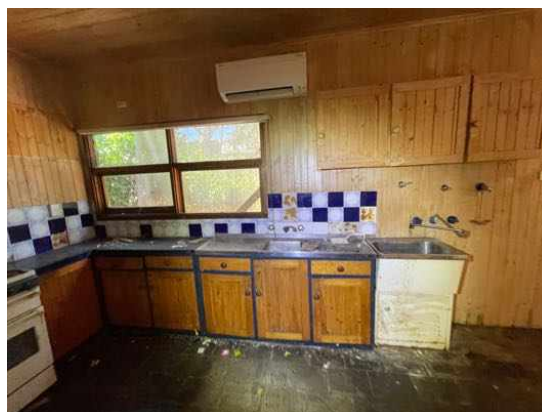
Finding 3.06

Building:	Main Building
Location:	Kitchen
Finding:	Kitchen- Poor condition
Information:	Upon inspection of the kitchen the cabinetry was found to be in a poor condition at the time of inspection.

Damage and deterioration to cabinetry as well as evidence swelling due to moisture ingress was present.

Renovation should be a consideration of the client.

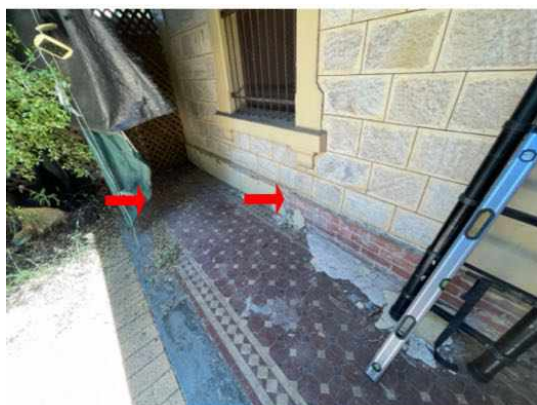
Finding 3.07

Building: Main Building
 Location: Porch
 Finding: Porch Heritage Tiling
 Information: Uneven areas to the surface of the porch tiling were identified at the time of inspection. This movement could have occurred for several reasons, these could include substandard instillation, tree roots, reactive clay soils and storm water issues.

Evidence of movement to some of the concrete border pieces was noted.

Multiple damaged tiles were also noted.

With reactive clay soils, it is extremely important to ensure that all storm water flows including roof and ground flows, contained and continually maintained. High moisture also creates an environment that is conducive to termite attack.

A licensed Plumber should be appointed at the discretion of the client to ensure that the storm water pipework is in tact and adequate, and the area should be monitored for further movement.

A specialist tiling contractor specialising in heritage tiling may be required at the clients discretion to porch area.

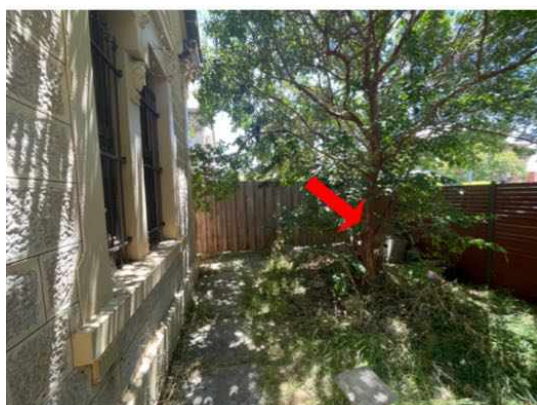
Finding 3.08

Building:	Main Building
Location:	Yard - Front
Finding:	Tree in close proximity to the building
Information:	Trees are located in close proximity to the building.

The proximity of the trees poses several risks to the building. Falling branches can cause structural damage to the building. Additionally, the root system may affect the building's foundation.

It is highly advised that the trees be assessed by a qualified arborist as soon as possible to determine the health of the trees and limit potential damage. Removal of the trees may be required to ensure safety and prevent damage to the building.

Where the trees has affected areas of the building, repair and/or replacement of any affected building elements may also be required where the extent of the damage necessitates. Consultation with a structural engineer is recommended if there are concerns about foundation damage.

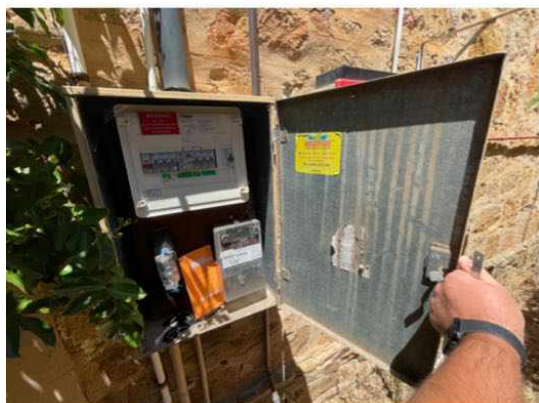
Finding 6.01

Building:	Main Building
Location:	All Areas >
Finding:	Termite Management System - no evidence of a chemical installation
Information:	The application of a post-construction chemical termite barrier is highly recommended for all properties, particularly if live termite activity has been found on the site previously. Such barriers are highly effective in preventing termite attack on any timber building elements throughout the property.

A durable notice should be placed in the switchboard unit to indicate current termite barriers. At the time of inspection, it appeared as though no termite management system has been installed, with no evidence to suggest preventative works taking place.

The client may consider gaining further advice from a pest controller as to the costs and procedures involved with this application. It is recommended that obtaining such advice be a short-term priority.

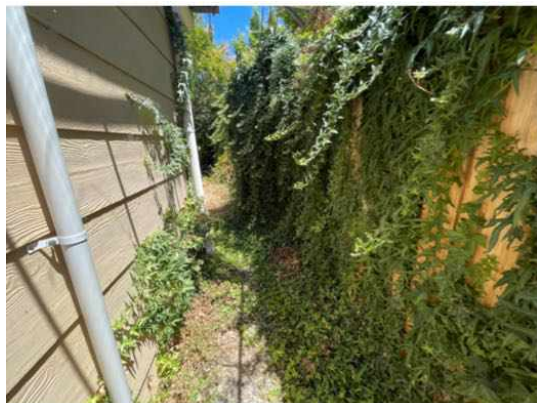
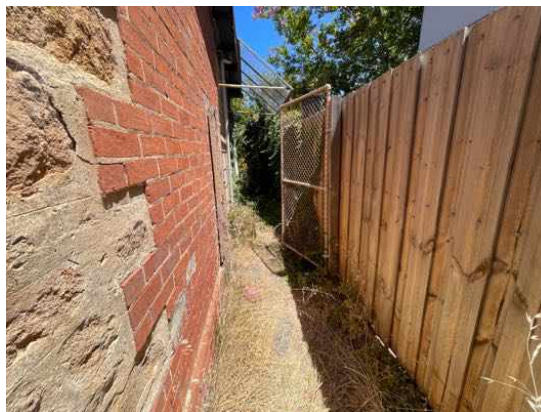
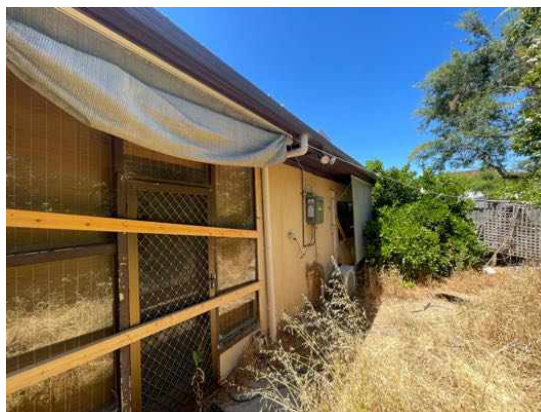
Finding 6.02

Building:	Main Building
Location:	All External Areas
Finding:	Garden Beds and Bare Ground Against Building
Information:	The presence of bare ground / garden beds against the building creates conditions conducive to excessive moisture, which creates potential for water and structural damage, as well as making the area susceptible to termite and timber pest activity. There is also a high likely hood of the damp proof course being bridged or breached by garden materials.

Perimeter bare ground levels should fall away from the house by 50mm in the first meter. This standard ensures that water cannot pool against the sides of the building.

Where ground levels do not have adequate fall, a licensed paving contractor should be appointed to install pavement to a correct fall. Garden beds should be removed from close proximity to the building.

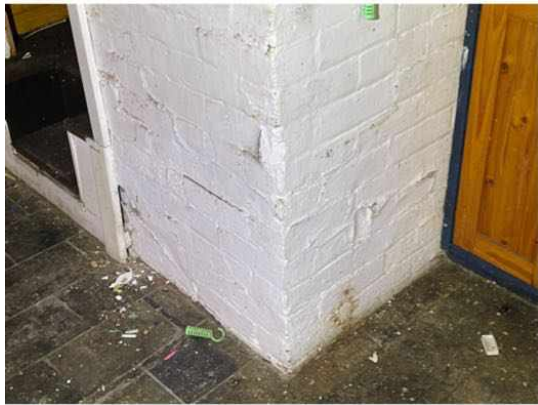
Finding 6.03

Building:	Main Building
Location:	All Areas
Finding:	Evidence of current or previous excessive moisture was present at the time of inspection
Information:	Excessive moisture can attract termites and produce conditions that promote termite attack fungal growth and wood decay.

Excessive moisture is generally caused by deterioration or leaking to wet areas, inadequate or missing roof drainage leaking plumbing pipes or fixtures poorly plumbed HWS overflows or condenser units and poor site drainage.

It is highly recommended that all plumbing and drainage fixtures and fittings be maintained regularly in order to prevent excessive moisture being present in the external / internal property.

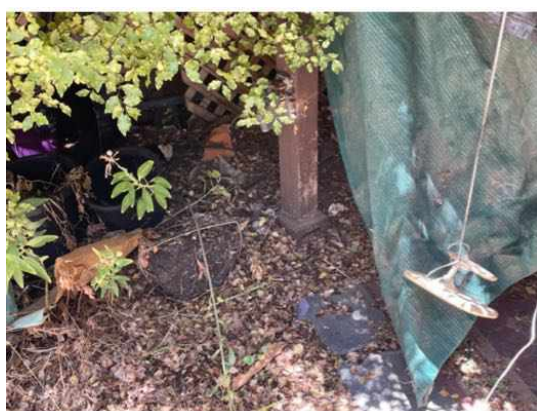
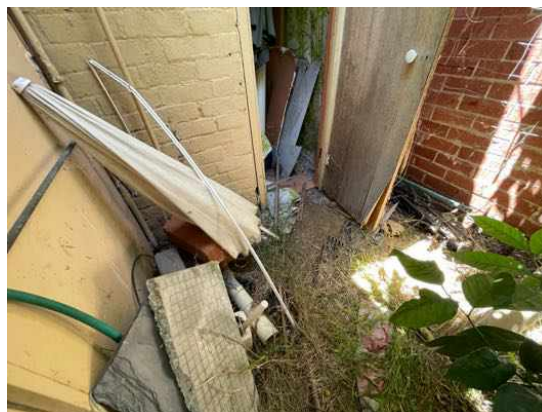
Finding 6.04

Building: Main Building
Location: All External Areas
Finding: Timber - In ground contact
Information: Any timbers in direct ground contact provide opportunity for concealed termite entry and are likely to be subject to premature rot and decay as the soil retains moisture or damp conditions against the timbers. This includes but is not limited to, tree stumps, timber sleepers, loose branches, timber pallets and loose timbers, firewood piles and timber elements of external structures.

Remove untreated timber that is in direct contact with external grounds. Consider replacement with more durable materials i.e. treated timber or non timber elements. Frequent pest inspections are advised to readily identify any termite activity in these areas.

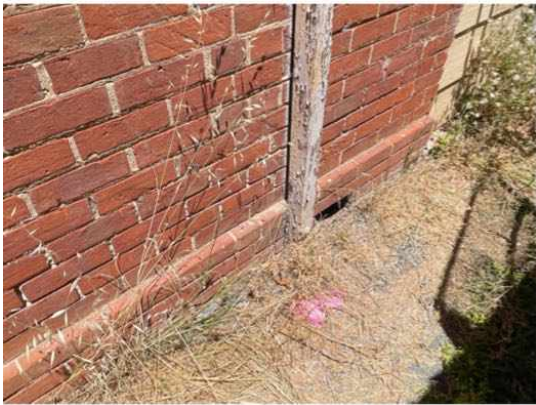
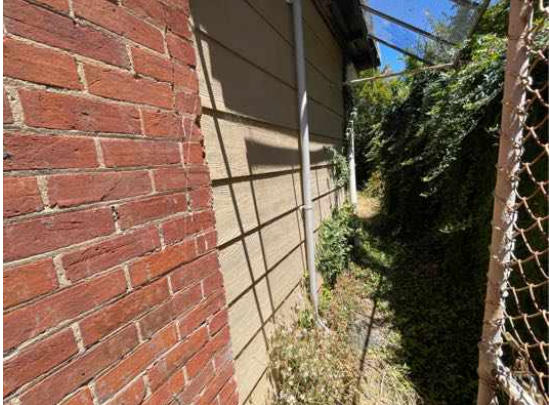
Finding 6.05

Building:	Main Building
Location:	All External Areas
Finding:	Bridging
Information:	Bridging is the spanning of a termite barrier or inspection zone so that subterranean termites are provided with passage over or around that barrier.

Generally this takes the form of finished ground levels external paving or concrete being retrospectively installed above the damp course level, the adjacent internal floor level or weep and ventilation holes, but may also take the form of building elements (ie; gate or fence posts, down pipes, air conditioning units, etc) or stored items covering the span of the inspection zone.

Where bridging has occurred full inspection is prevented and termites may enter a property in a concealed or undetectable manner.

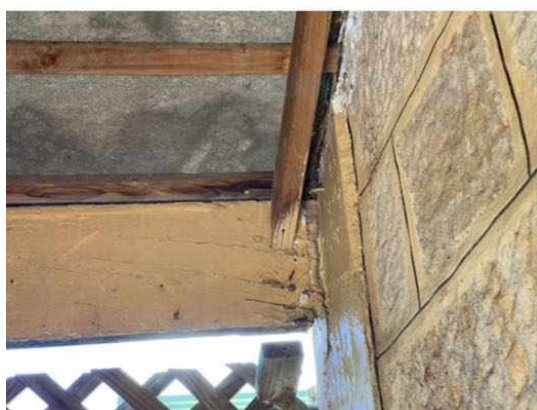
Finding 7.01

Building:	Main Building
Location:	All External Areas
Finding:	Wood Rot
Information:	Several building elements around the property show evidence varying levels of wood rot.

Wood rot, also known as Fungal Decay, occurs when timbers and other cellulose building materials are exposed to damp conditions on an ongoing basis. This could be the result of exposure to weathering over a prolonged period of time, or the attraction of excessive moisture from other abutting building materials. Contributing factors also include poor air ventilation in the area.

Wood rot is often associated with general damp problems and is evidenced by a 'musty' smell or mould and mildew occurring on surfaces. If left unmanaged, damp conditions can lead to further health problems and the decay of timbers will continue.

Early intervention and regular maintenance, particularly of exterior timbers, will prolong the useful life of these building elements. Prior to any works being performed, the cause of the moisture that has created the visible wood rot should be identified and addressed in a suitable manner. Replacement of affected timbers may then be a necessary step in protecting surrounding building elements from such deterioration.

A qualified plumber may be appointed to assess the cause of excessive moisture and to provide advice on any remedial works as required. A qualified carpenter or registered builder may also be required to replace affected building materials.

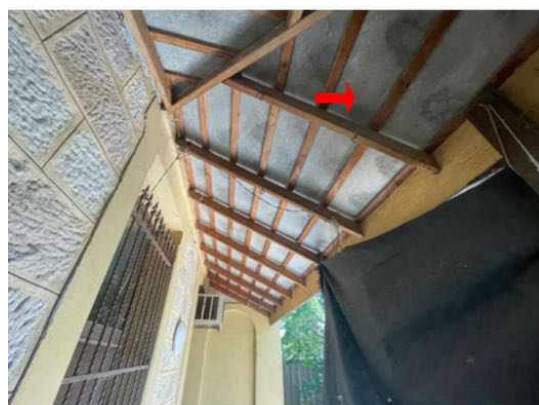
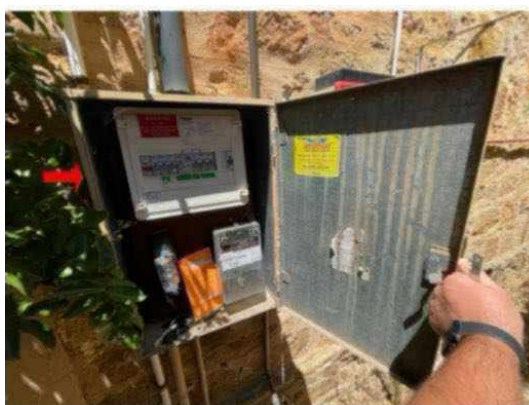
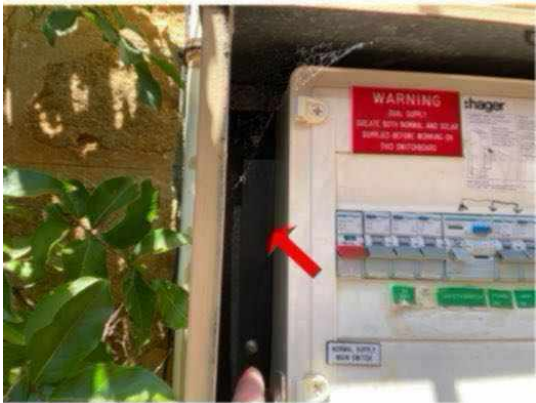
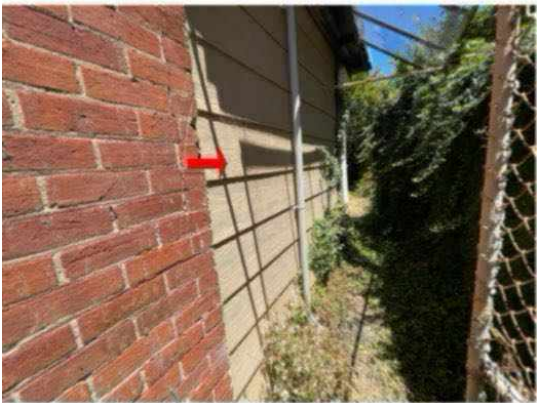
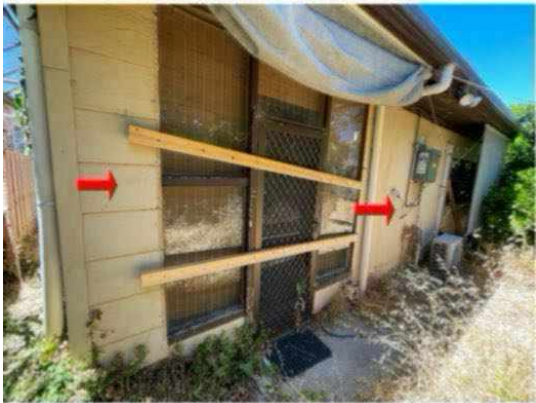
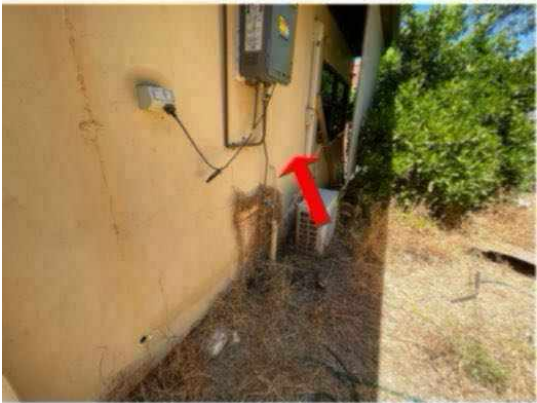
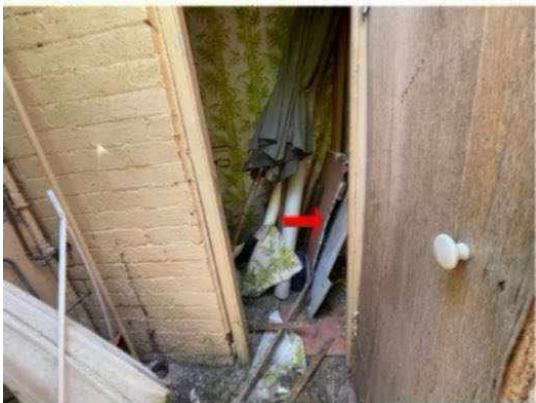
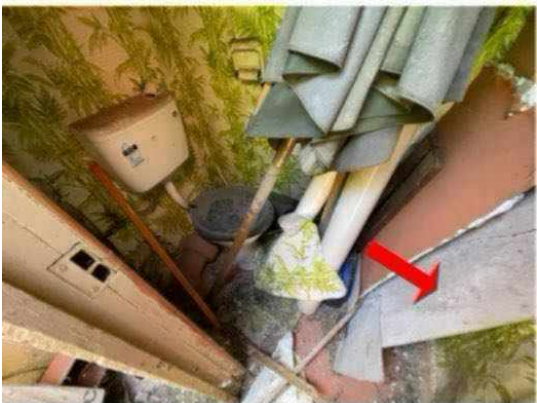
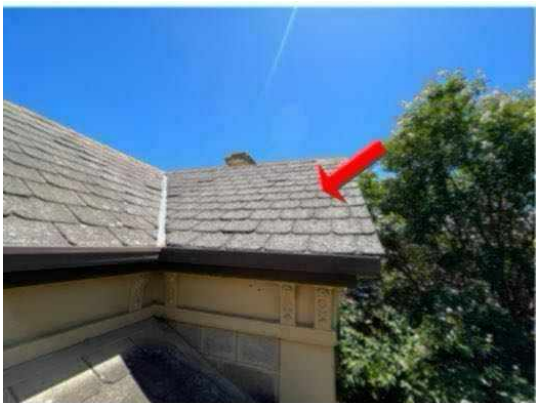
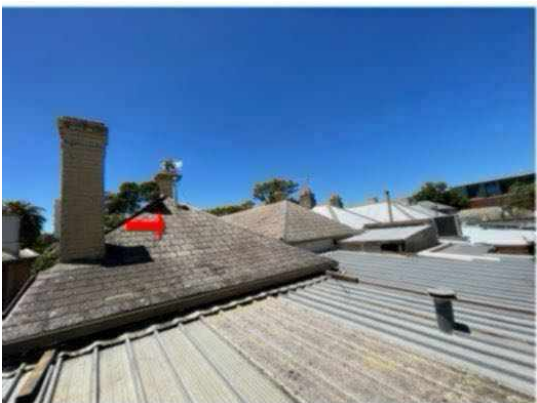
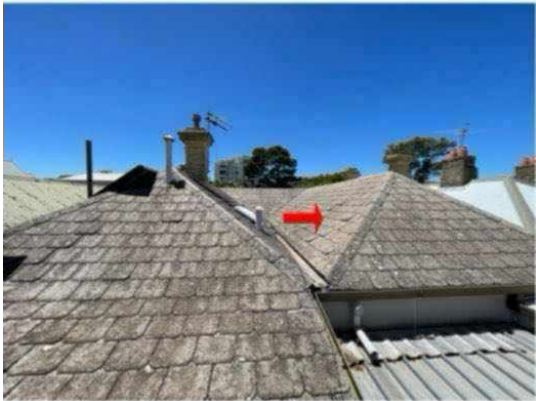
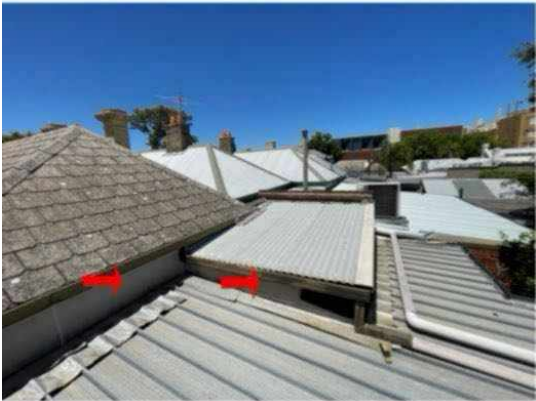
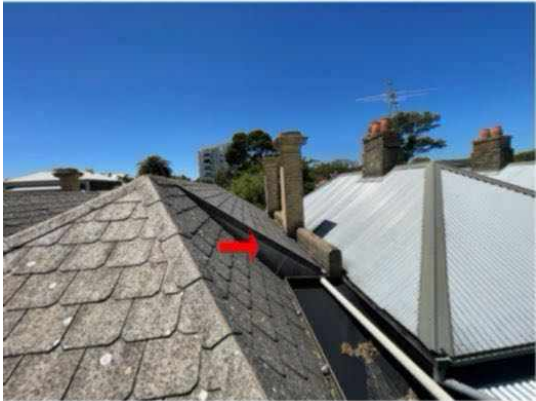
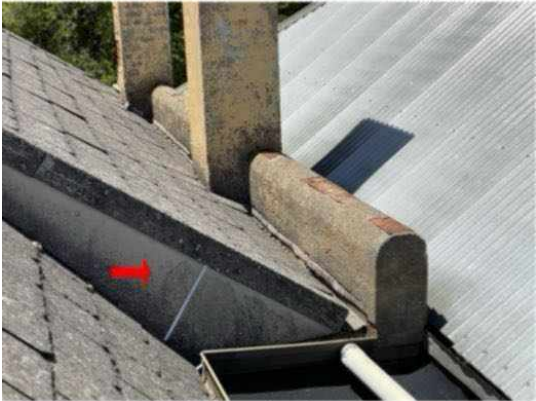
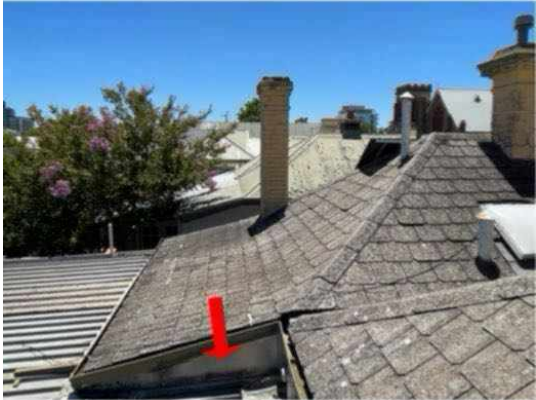
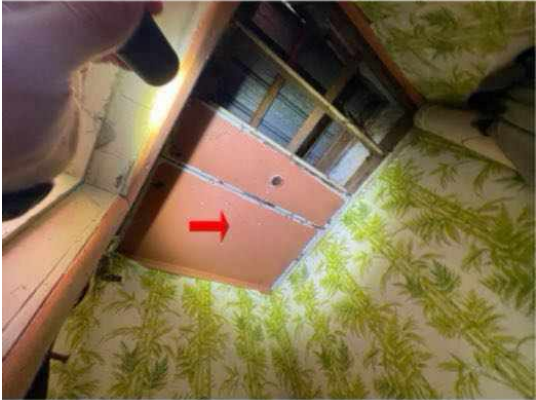
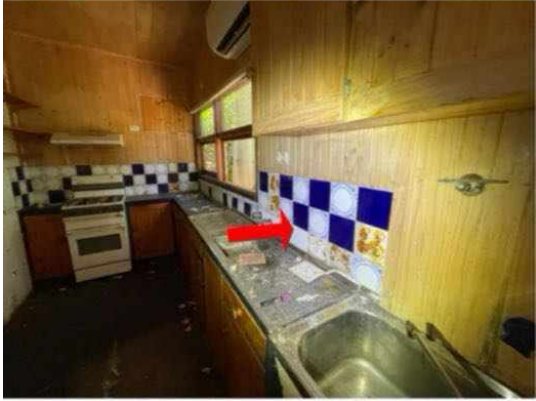
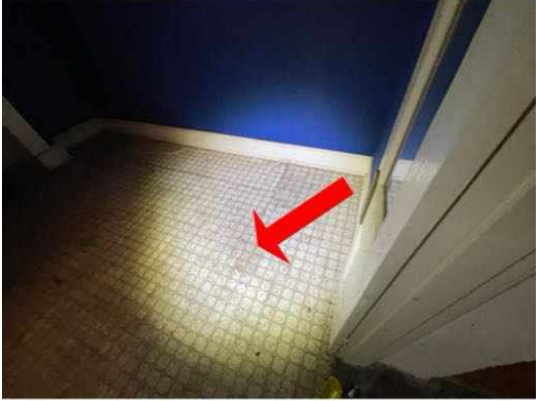
Building: Main Building
Location: All Areas
Finding: Asbestos - Suspected ACM Identified on Site
Information: Reporting on Asbestos is outside the Scope of this Report. This suspected defect is highlighted as a caution only. We suspect, based on our experience in the building industry, that there is a higher risk of the following areas or building elements containing asbestos.

As Asbestos Reporting is outside the scope of this report, we advise that you consider a separate Asbestos Inspection and Condition Audit, which can include the taking of samples for definitive confirmation of the presence of Asbestos.

In the interim, the client is advised to act with caution, especially when considering any damage to building materials general wear and tear renovations extensions demolition and general maintenance activities due to the suspected presence of Asbestos.
