Building and Timber Pest Inspection Report

Inspection Date: Thu, 22 Jan 2026

Property Address: 21 St John St, Adelaide SA 5000, Australia

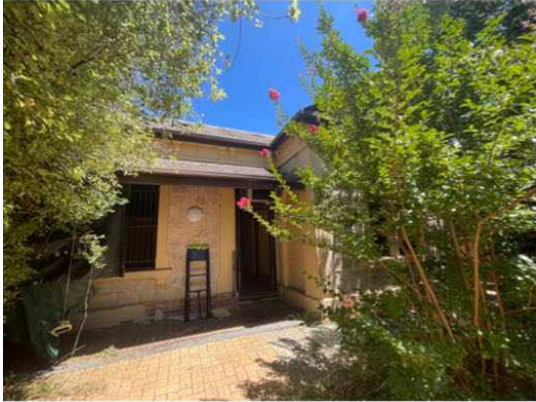
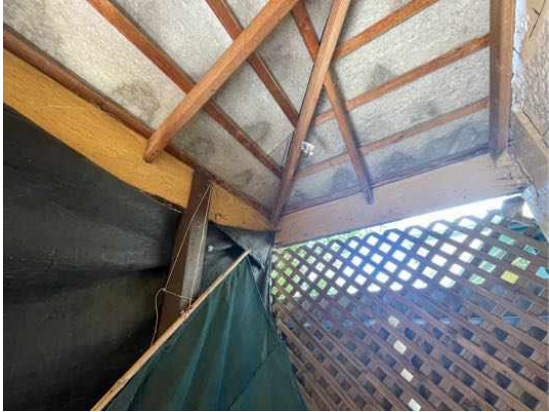
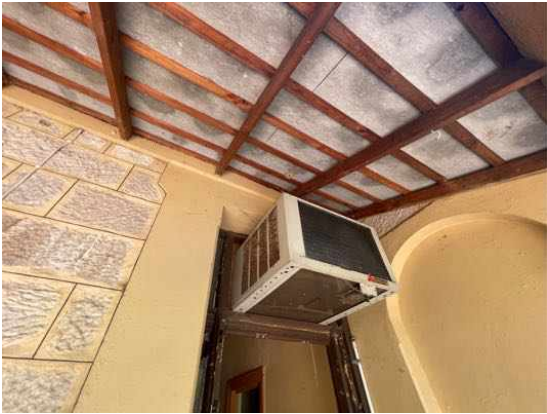
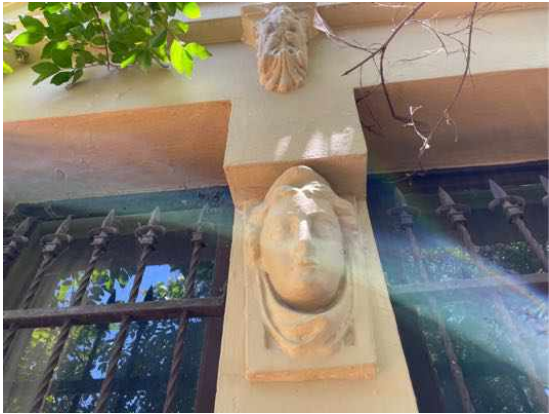
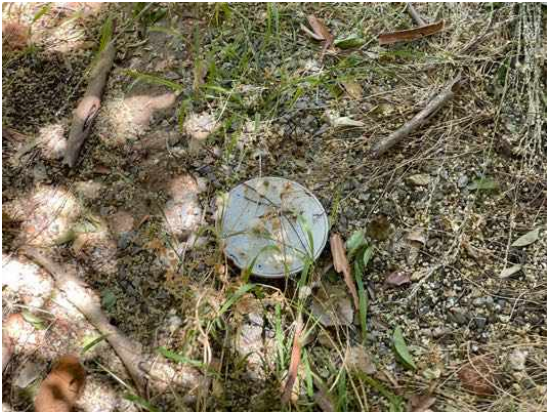
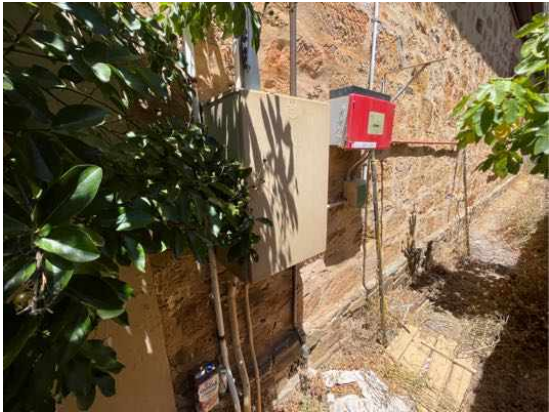
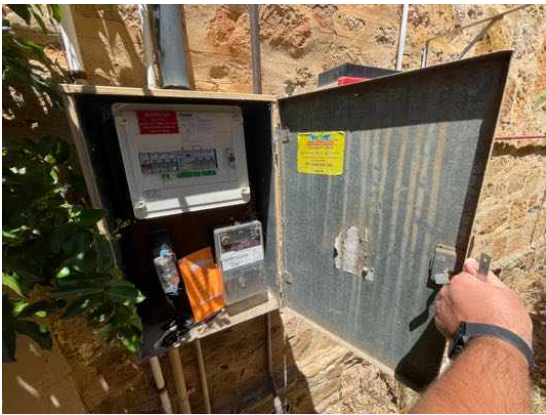
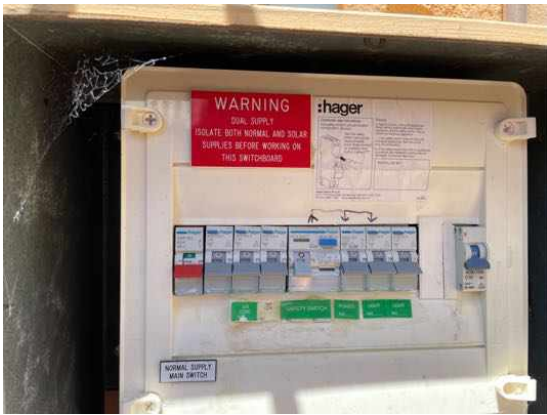
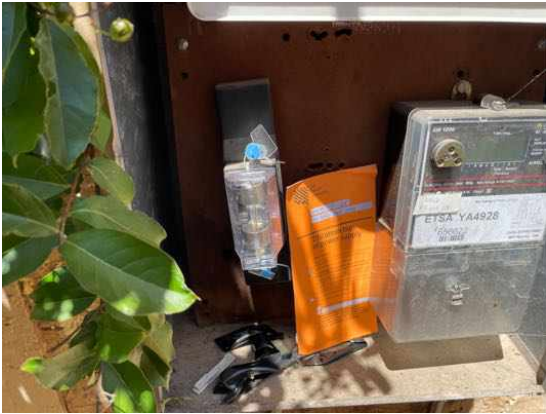
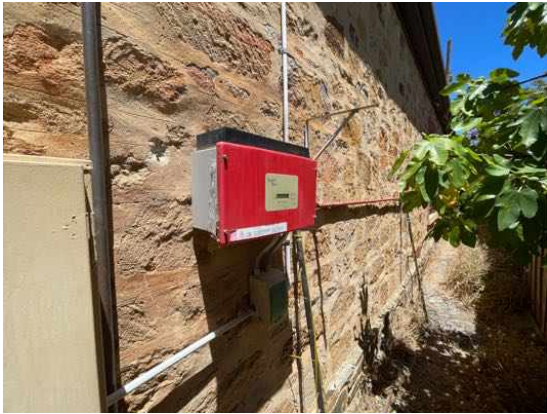
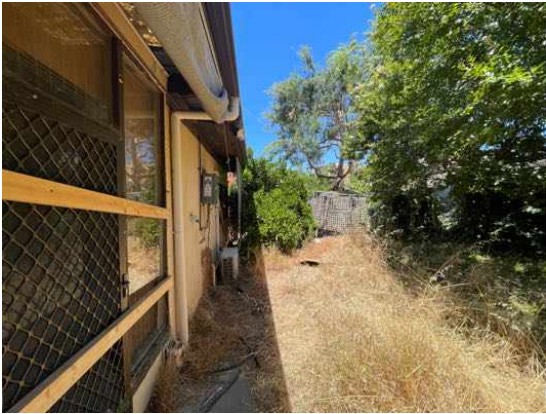
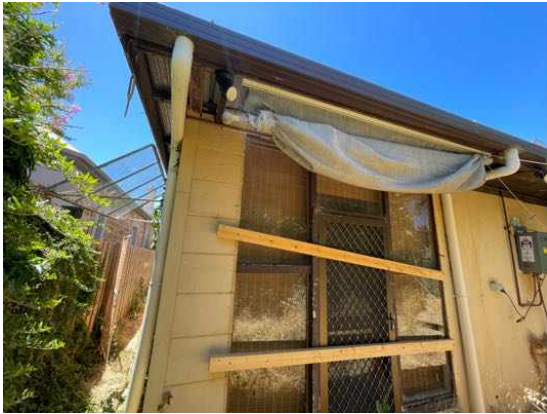
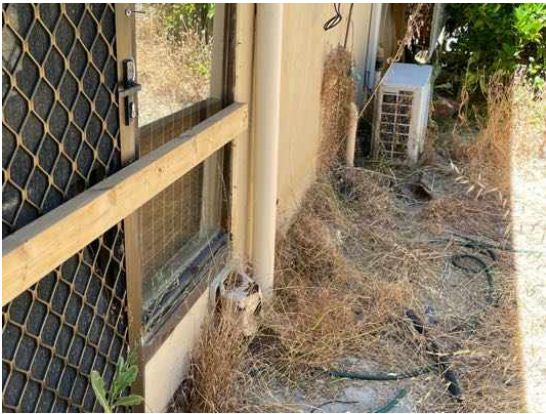
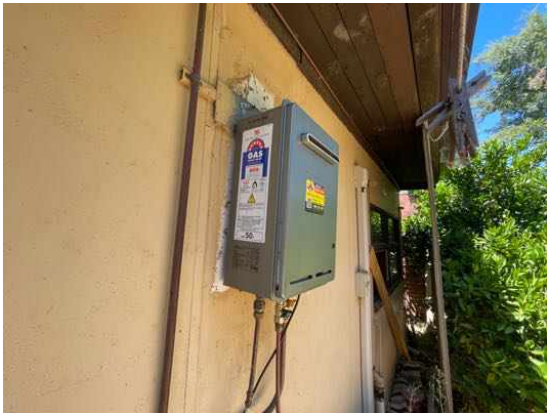
Building: Main Building
Location: All Areas >
Finding: Additional Photos
Information: Additional photos are provided for your general reference.

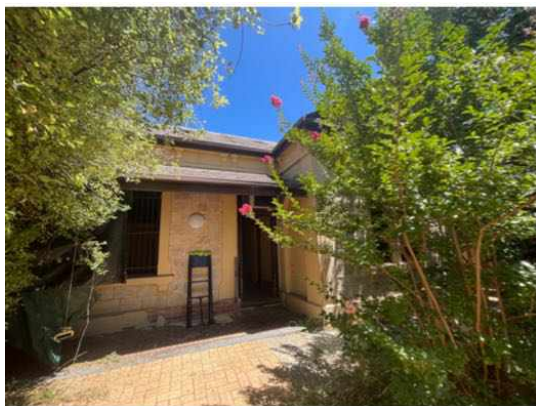
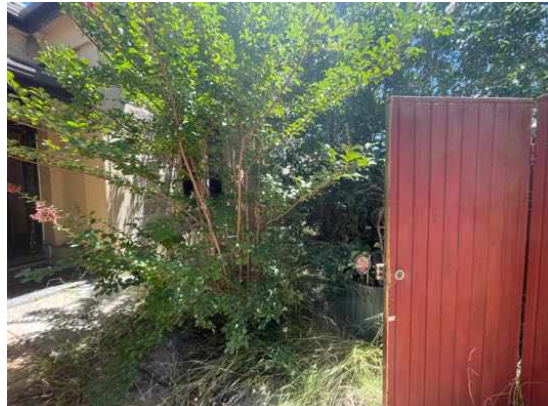
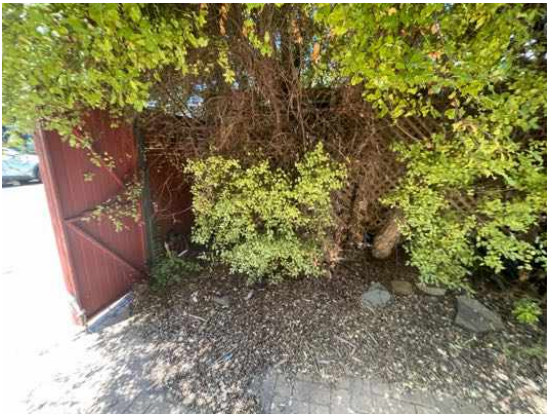
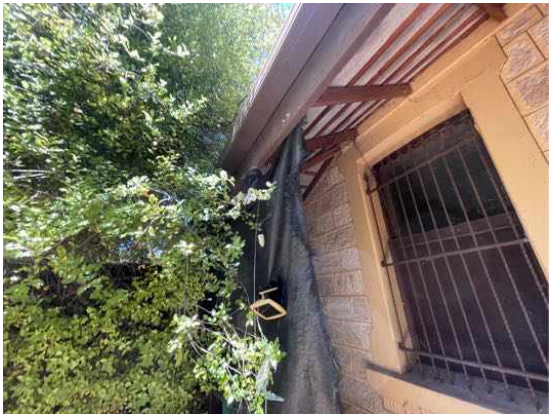
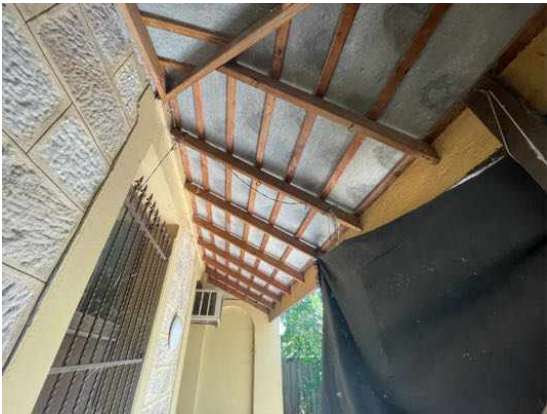
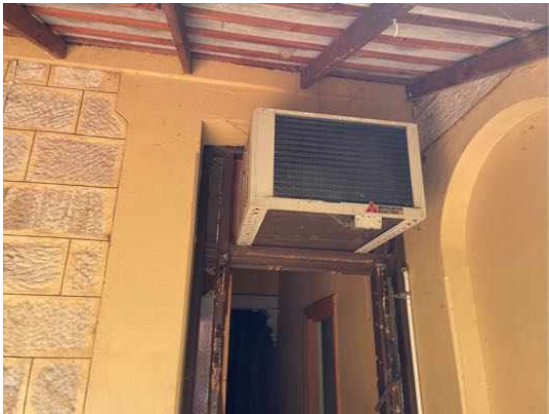
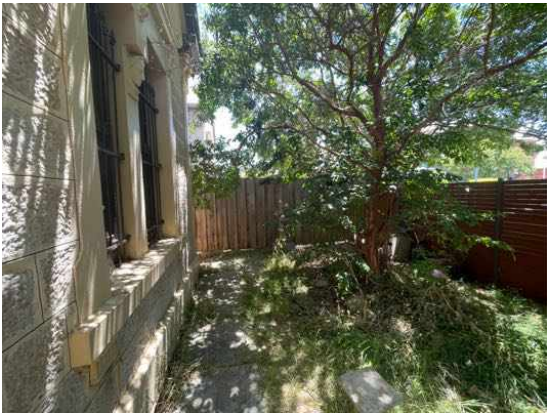
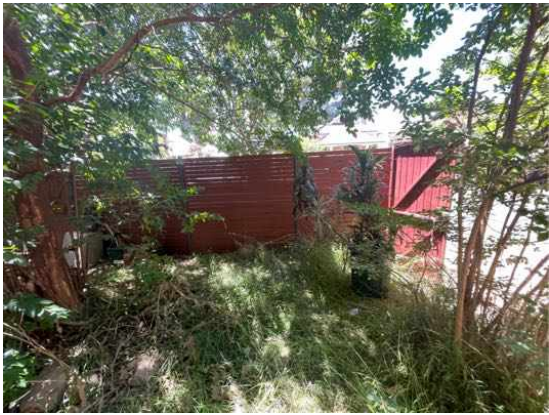
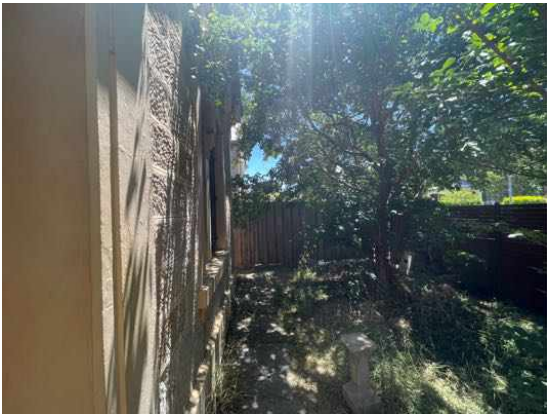
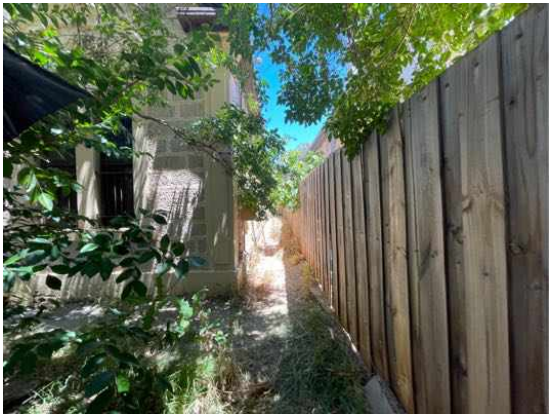
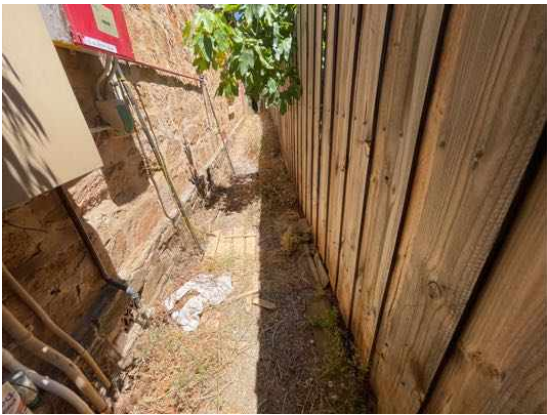
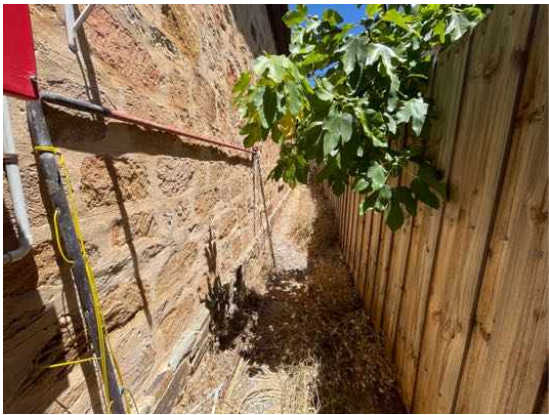
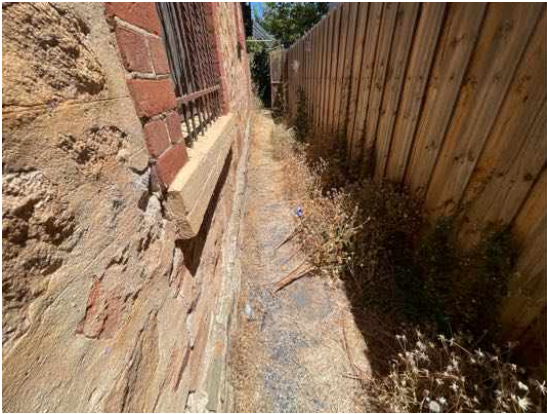
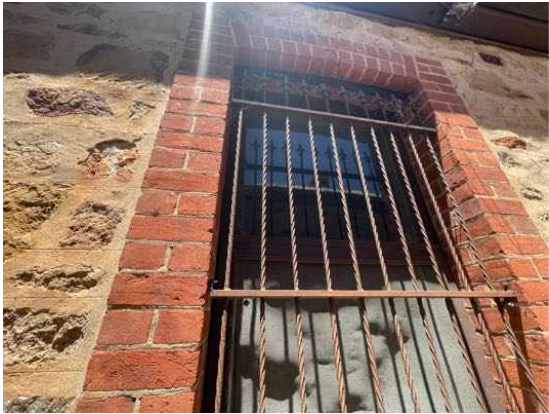
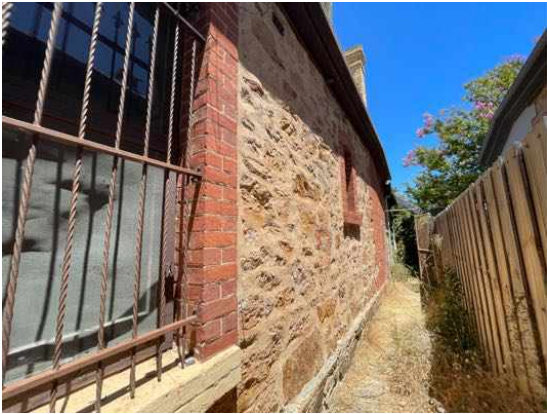
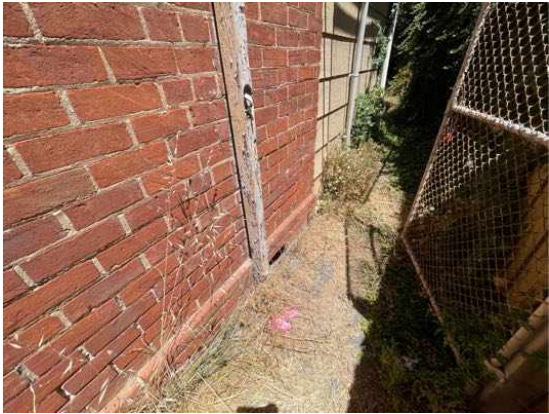
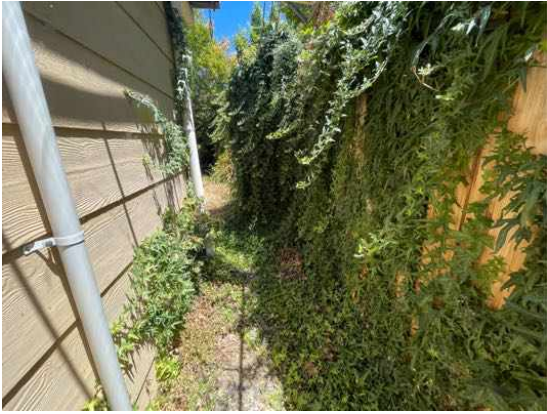
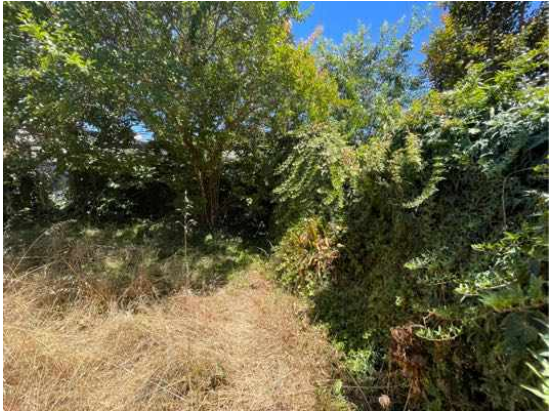
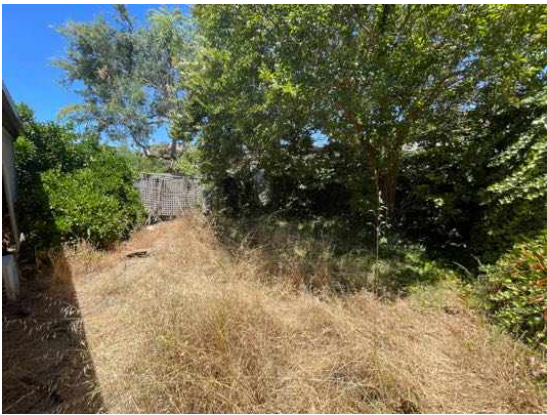
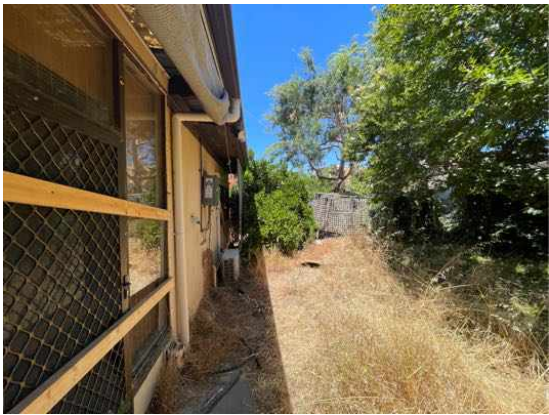
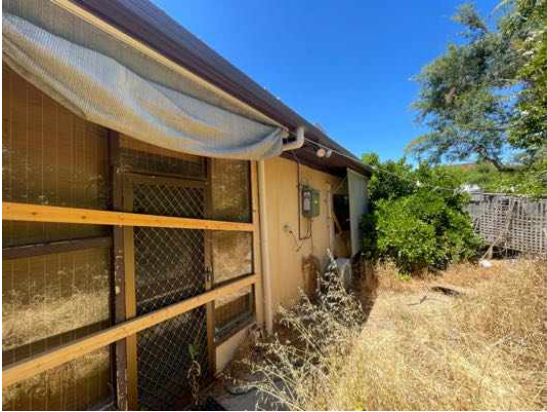
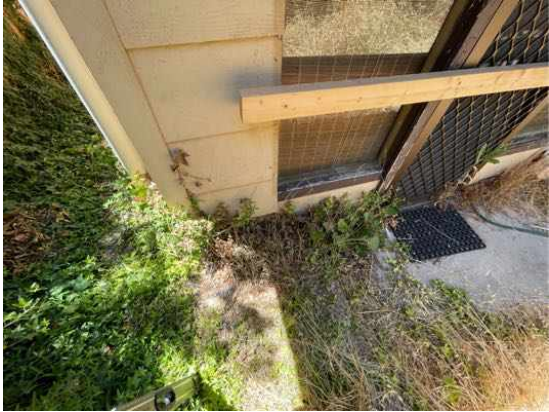
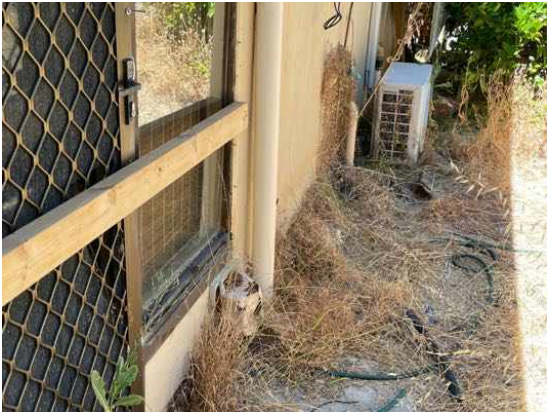
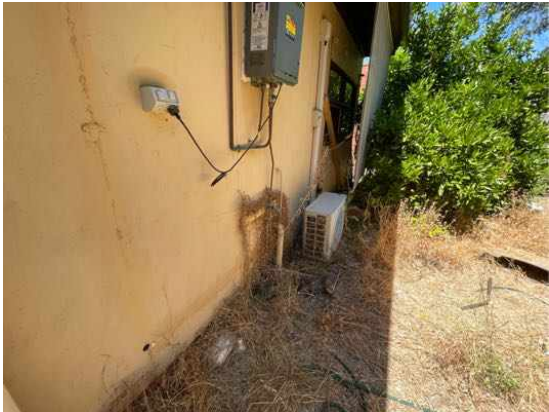
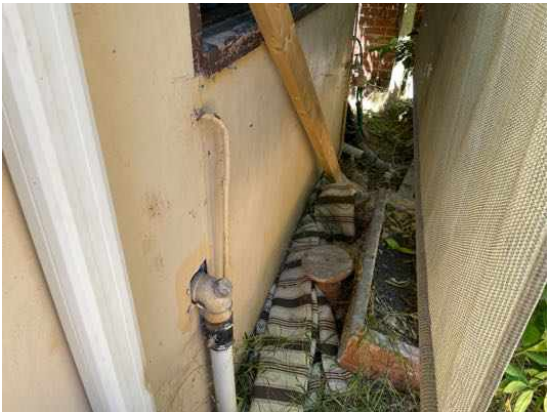
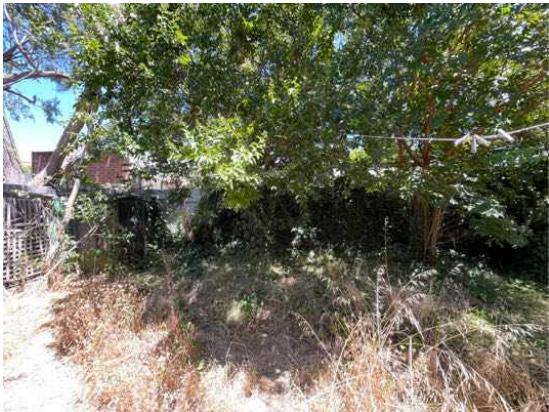
Information: These photographs are an indication of the obstructions and limitations which impeded full inspection of the property at the time of inspection. These obstructions can hide an array of defects and should be removed to allow full inspection to be carried out. A re-inspection is recommended once the areas are made accessible.

The roof void was not accessible during inspection with no access hatch available. No power or water was available for inspection.
