Building and Timber Pest Inspection Report

Inspection Date: Wed, 28 Jan 2026

Property Address: 131 Fern St, Gerringong NSW 2534,
Australia

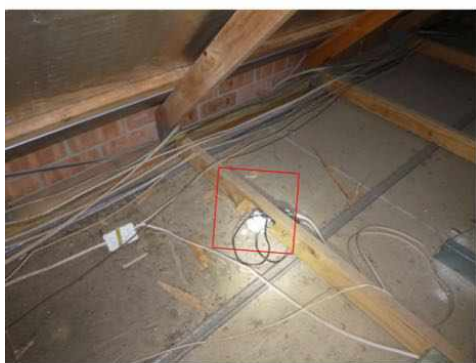
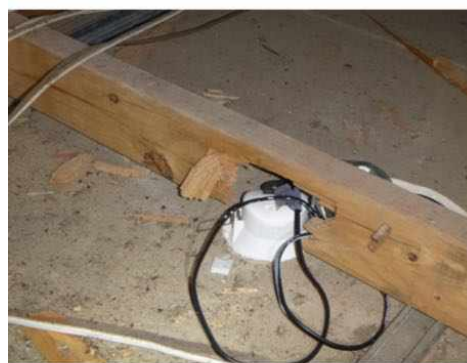
Building: Building 3
 Location: Roof Void
 Finding: Installation - substandard or incomplete (Roof truss cut for down light and not reinforced)
 Information: The installation of this building element appears to have been completed to a substandard level of workmanship or is incomplete. Generally substandard repairs or installation are related to poor workmanship, the use of inappropriate materials, or a failure to complete installation to a suitable standard.

Where installation is substandard and/or incomplete, the client should contact the responsible trade to undertake rectification. Unfinished and substandard building works are likely to degrade more quickly and may create potential for secondary defects to associated building elements.

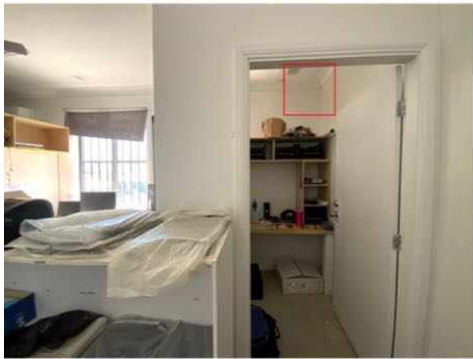
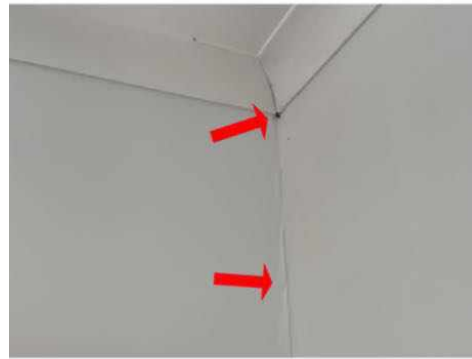
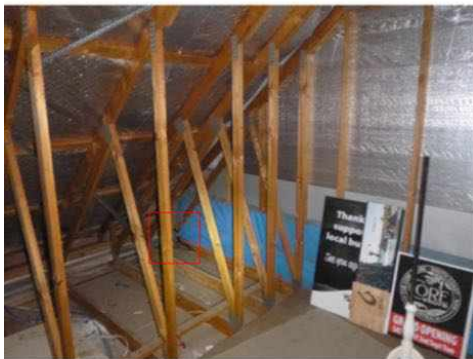
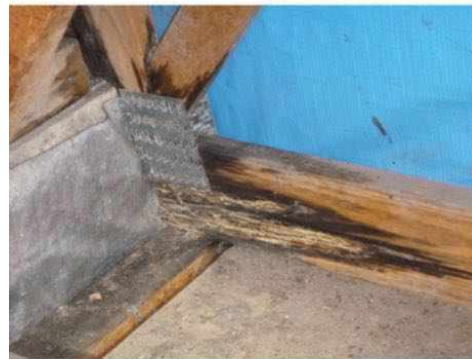
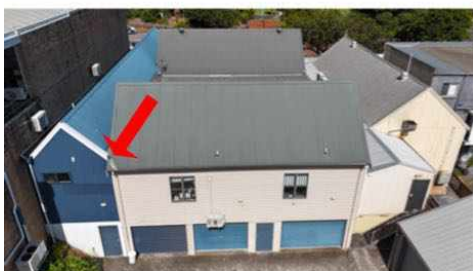
Finding 2.02

Building: Building 2
 Location: Main Shop - Back storage Rear
 Finding: Painted surface - Bubbling (Rotted roof trusses - Reinforcing recommended)
 Information: Sections of paint in this area was found to have bubbled and deteriorated. Paint bubbling is generally an indication of excessive moisture in the area, that is currently hidden by the painted surface.

The presence of excessive moisture can have major implications on associated

building elements if left unattended. While only seemingly minor at this stage, the damage cannot be determined due to the paint obstructing any further inspection of the damage.

It is highly advised that the affected paint be cleaned to allow a further, more invasive inspection by a licensed plumber. Failure to act on this defect may necessitate major works in the future.

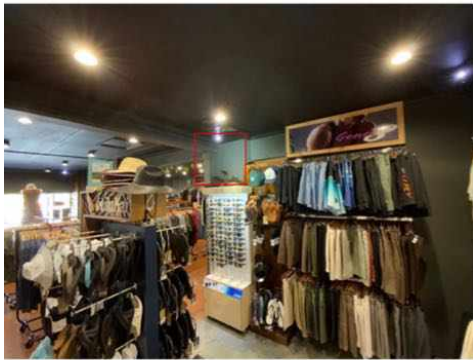
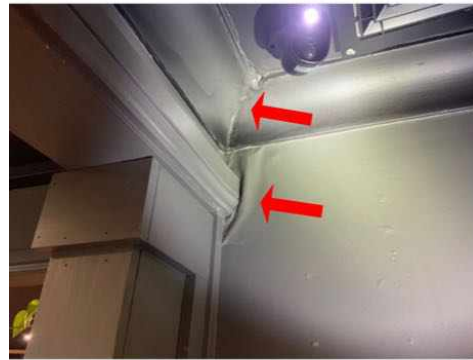
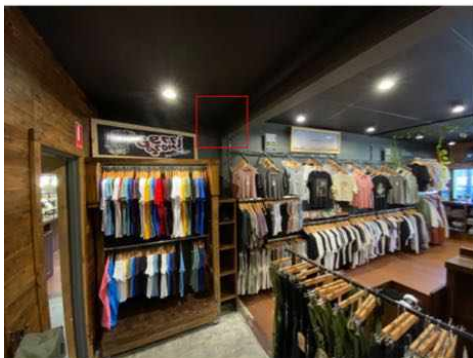
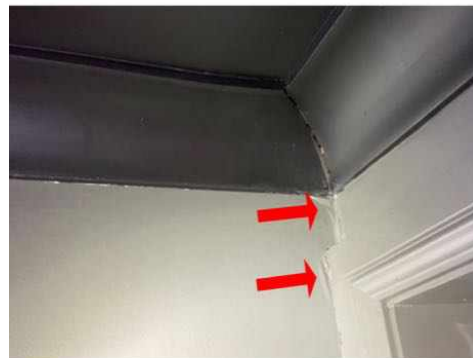
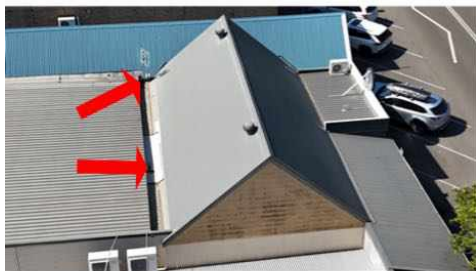
Finding 2.03

Building: Building 2
 Location: Main Shop - front and Back storage - Rear

The presence of excessive moisture can have major implications on associated building elements if left unattended. While only seemingly minor at this stage, the damage cannot be determined due to the paint obstructing any further inspection of the damage.

It is highly advised that the affected paint be cleaned to allow a further, more invasive inspection by a licensed plumber. Failure to act on this defect may necessitate major works in the future.

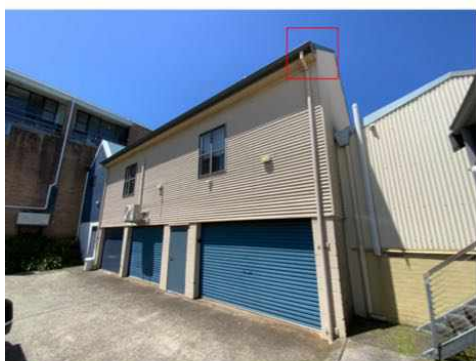
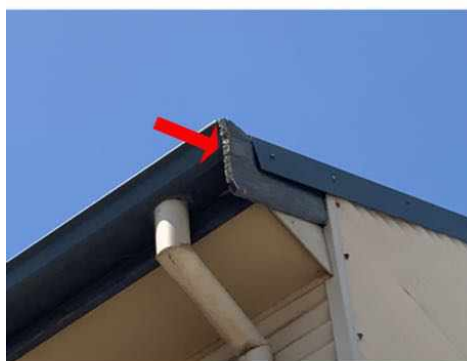
Finding 3.02

Building: Main Building
Location: Roof Exterior

It is advised that a roof plumber be appointed to inspect all roof plumbing and subsequently identify the cause of the wood rot. Replacement of affected fascias and barges may then be a necessary step in protecting surrounding building elements from such deterioration.

A qualified plumber may be appointed to assess the cause of excessive moisture and to provide advice on any remedial works as required. A qualified carpenter or registered builder may also be required to replace affected building materials.

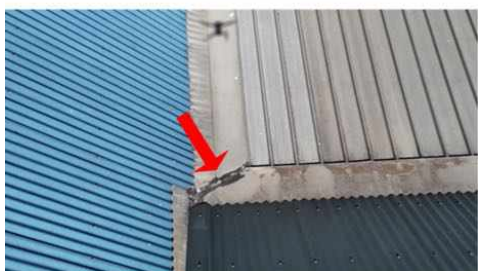
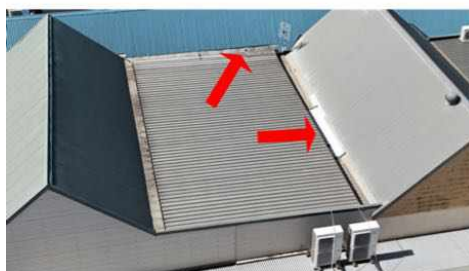
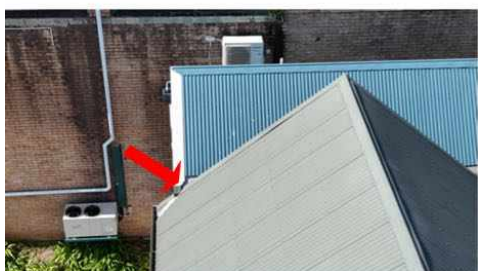
Finding 3.03

Building: Main Building
 Location: Roof Exterior
 Finding: Roof plumbing - Flashing inadequate (patching and sealant to flashings is only a temporary fix - constant monitoring of the sealant is recommended)
 Information: Some sections of the roof are missing or have inadequate roof flashings. Flashings are metal and other materials which are applied to seals and intersections between roof coverings and building elements. They are designed to aid in weatherproofing of roof joins.

Flashings that are not installed adequately or are missing are likely to result in water

Premature ageing and secondary building defects are imminent where roof plumbing is missing or inadequately installed. Additionally, water pooling also creates an environment that is susceptible to termite and pest infestation.

A roofing plumber should be appointed as soon as possible to install relevant roof plumbing materials, ensuring that no further damage is sustained.

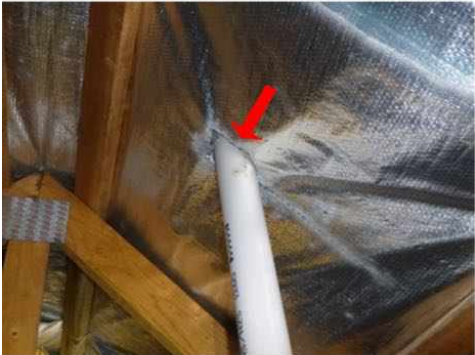
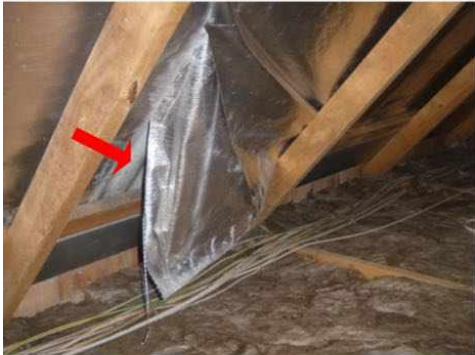
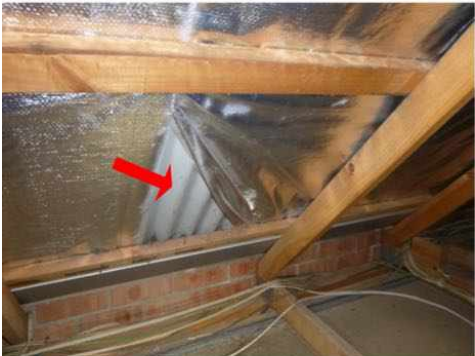
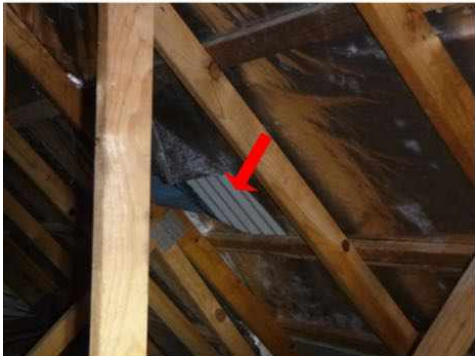
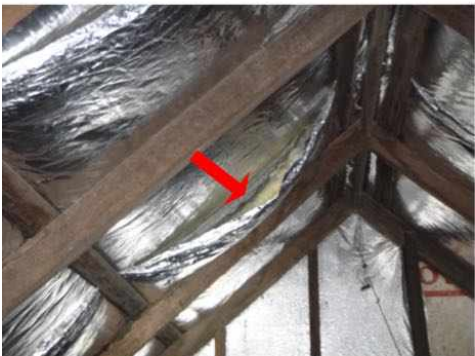
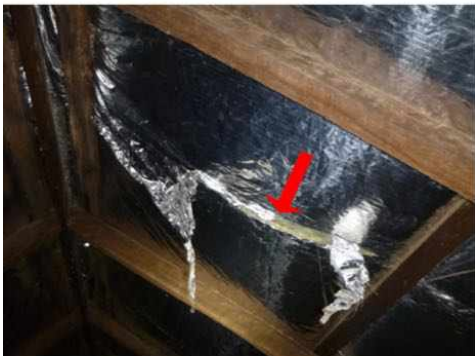
Finding 3.04

Building:	Main Building
Location:	Roof Void - All Shops
Finding:	Sarking - Damaged or Loose
Information:	Sarking to under the roofing material is damaged, loose or has holes and gaps. Sarking acts as an insulator, helps with noise reduction & is a second barrier against water penetration from broken or slipped tile leaks & condensation.

A Builder, Carpenter or handyman will be able to repair the holes with pieces of sarking and AS4254 tape specific foil tape for this product.

Consult a builder or insulation specialist for further advice.

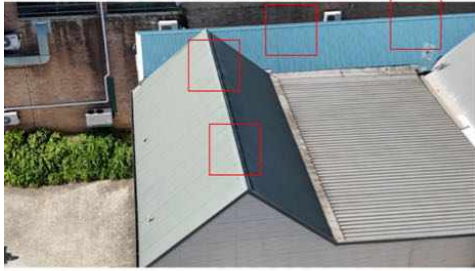
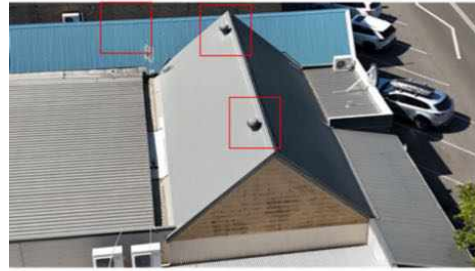
Finding 3.05

Building:	Main Building
Location:	Roof Void - All Shops
Finding:	Exhaust fans - Sarking on roof (Ducting, Roof Vent or Eave Vents are recommended)
Information:	On inspection of the roof void, it was observed that the exhaust fans to the bathroom and ensuite do not exhaust directly to the outside of the building, which is required by the NCC if sarking has been fitted, as it has in this home.

NCC 3.8.5.1 states: An exhaust fan or other means of mechanical ventilation may be used to ventilate a sanitary compartment, laundry or bathroom, or where mechanical ventilation is provided in accordance with 3.8.5.3(b), provided contaminated air exhausts:

- (i) directly to outside the building by way of ducts or
- (ii) into a roof space that;
 - (A) is adequately ventilated by open eaves, and/or roof vents or
 - (B) is covered by roof tiles WITHOUT SARKING or similar materials which would prevent venting through gaps between the tiles.

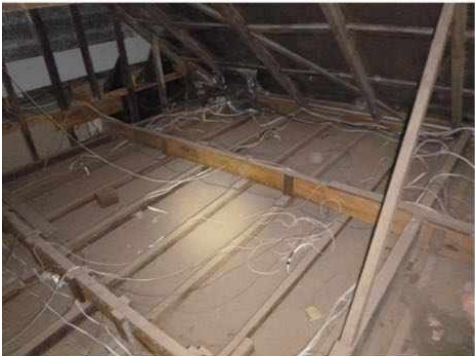
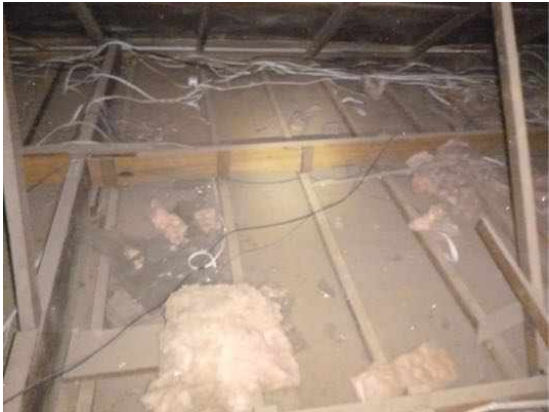
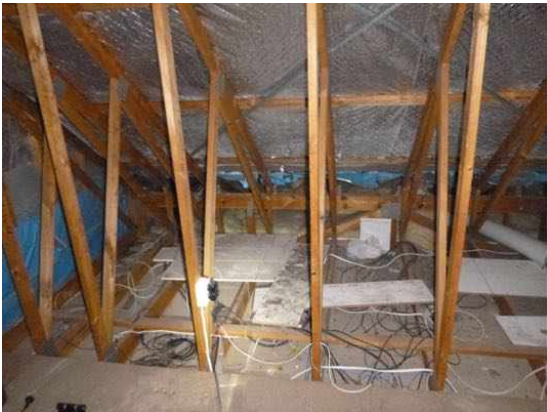
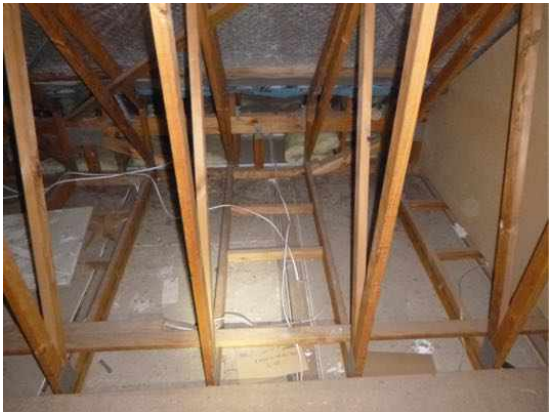
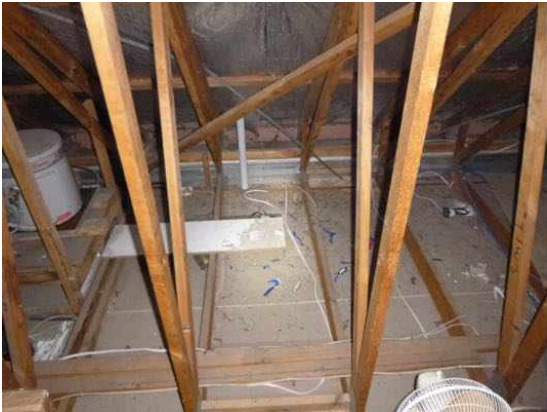
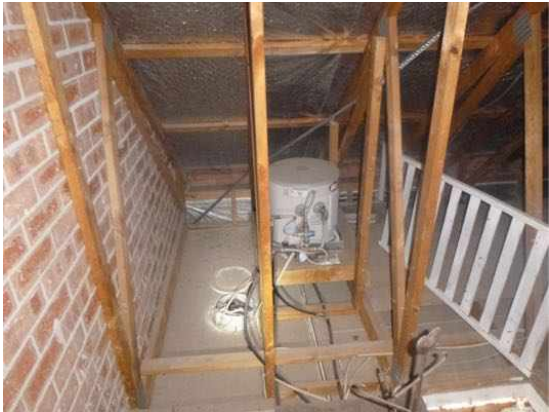
Building:	Building 2
Location:	Roof Void
Finding:	Ceiling Insulation - Missing
Information:	Upon inspection of the roof void it was noted that insulation is not present.

Insufficient insulation will result in a comparatively higher cost to heat and cool a property as there is a lack of Insulation (or uneven coverage of insulation) which works as a barrier to heat transfer. This helps to keep out unwanted heat in summer and preserves warmth inside your home in winter. It can also help soundproof your home from unwanted airborne noise transfer.

Where insulation is absent, the area does not meet current Australian Standards. Installation of adequate insulation is required and should be conducted as soon as possible.

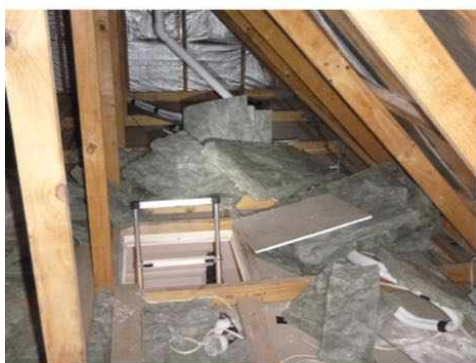
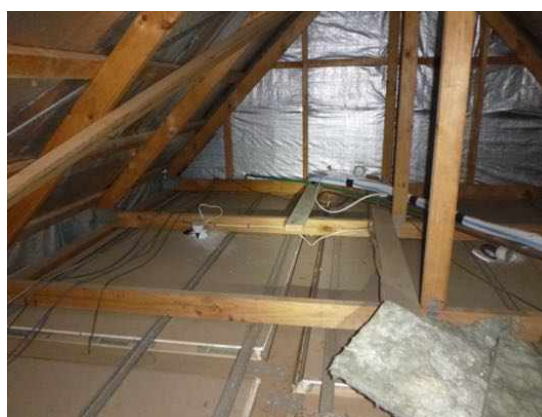
Finding 3.07

Building:	Building 3
Location:	Roof Void
Finding:	Ceiling Insulation - Inadequately installed to some areas
Information:	Upon inspection of the roof void it was noted that the insulation has been pulled back from a few areas and not adequately put back in place.

The level of insulation in the property does not meet current Australian Standards. Installation of adequate insulation is required and should be conducted as soon as possible.

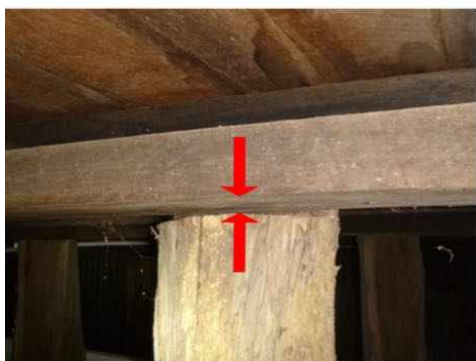
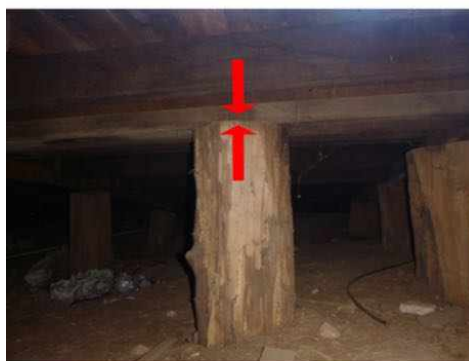
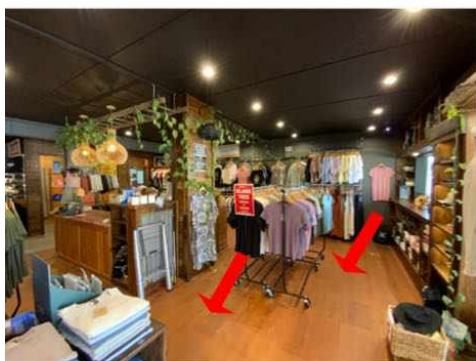
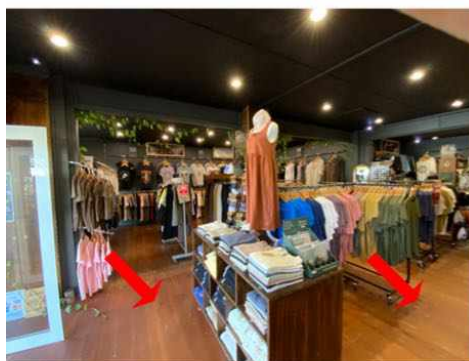
Finding 3.08

Building: Main Building
Location: Subfloor
Finding: Floors - bouncy (Gaps between flooring and stumps require packing to some areas)
Information: The internal flooring in this area was identified as being bouncy at the time of inspection. A bouncy floor surface generally presents as a discernible change in level as they are walked across, in noisy or creaking flooring, or in consequent movement of surrounding furniture and fixtures.

Bouncy floors generally indicate that the floorboards or the subfloor structures are coming loose from the joists that they are installed on. Bouncy flooring may also be the result of gaps between flooring and stumps or joist structures, which require packing.

The client is advised to seek quotations for required repairs from a Registered Builder specialising in re-stumping. The potential resolution may range from packing gaps in subfloor structures through to replacement of subfloors stumps and refixing of flooring.

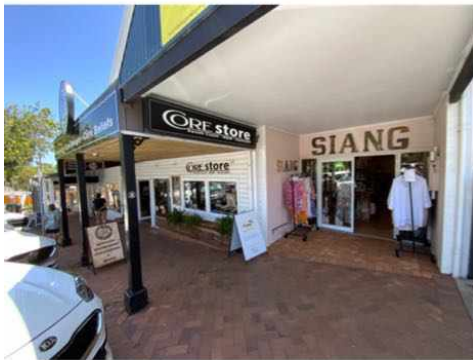
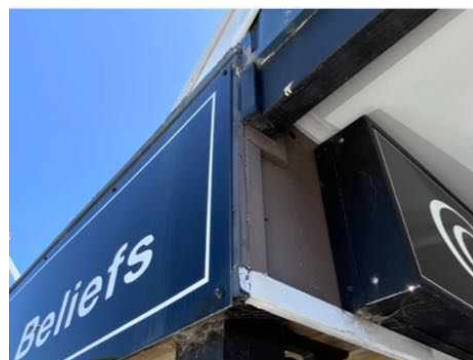
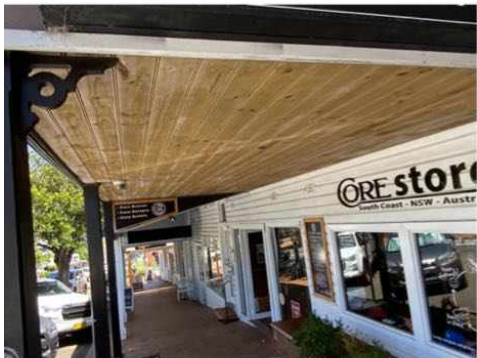
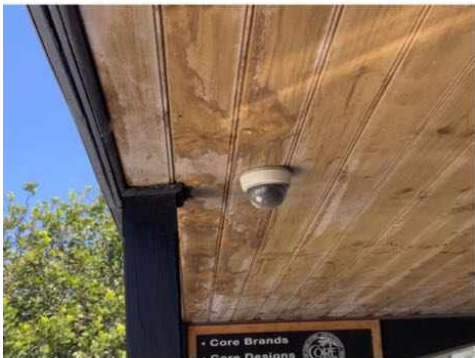
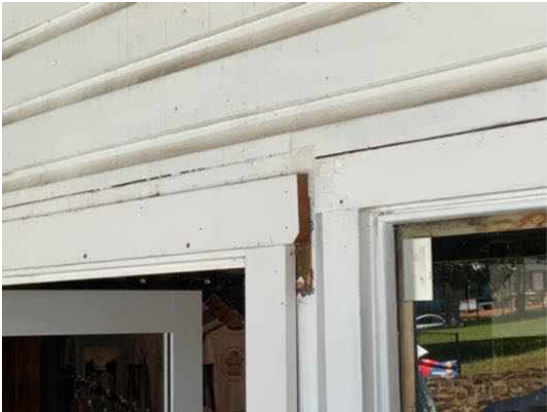
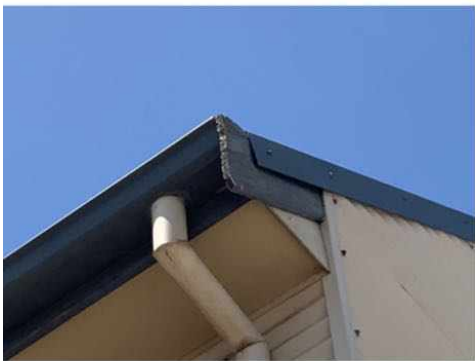
Finding 3.09

Building: Main Building
Location: All Areas

Finding: External paint to timbers - deteriorated
 Information: Much of the external paintwork including but not limited to external timbers and trims have been neglected and require attention to prepare and re-paint.

Whilst incomplete or missing paint finish is generally an appearance defect, it can also lead to the development of secondary building defects over time. Incomplete areas of paint finish expose the area to moisture, potentially accelerating the deterioration of underlying building materials.

Degraded paint finishes should be sanded back, filled, leveled and painted, as applicable. Where inadequate or missing paint protection has led to the deterioration of the associated building element, repair and/or replacement of this building element may be required.

A painting contractor should be appointed as soon as possible to perform necessary works to aid the appearance of the affected area and to ensure the area is protected against further deterioration. Alternatively, the homeowner following manufacturer instructions may perform these works.

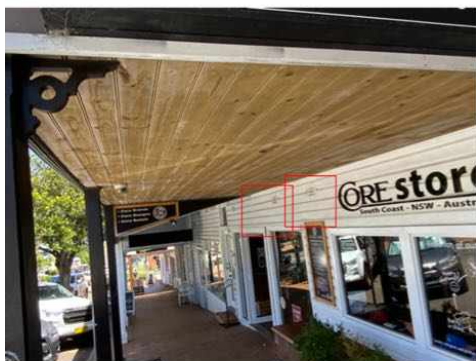
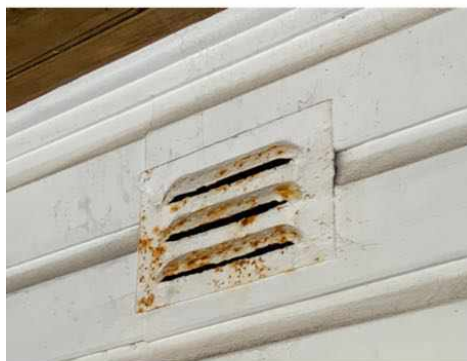
Finding 3.10

Building:	Main Building
Location:	Exterior walls - front
Finding:	Building element - Rusted or corroded
Information:	This building element shows evidence of rusting and corrosion, which is likely to have developed as a result of excessive exposure to moisture and or inadequate coatings.

As surface rust provides no protection to the underlying iron, the deteriorating condition is likely to worsen if not addressed in the short-term future.

Where possible, the use of galvanized (treated) metals or aluminium coated metals aid in rust prevention, as does regular general maintenance. Rust formation can be controlled with coatings, such as paint, that isolate the iron from the environment.

Rusting and corrosion should be managed by ideally removing or limiting the affected surface from exposure to moisture. A registered builder may be appointed to replace any building elements that have been severely affected by rust or water damage.

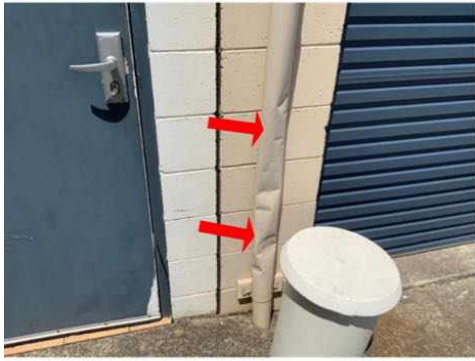
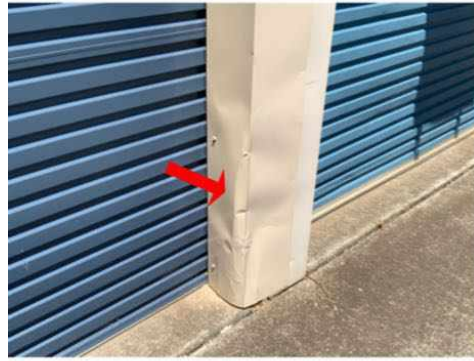
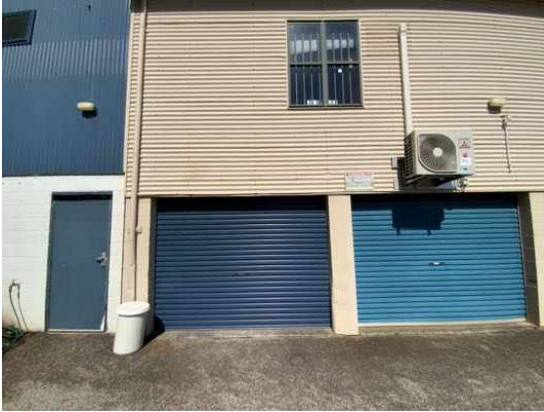
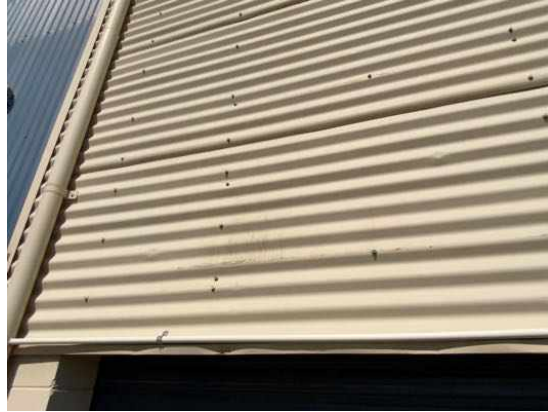
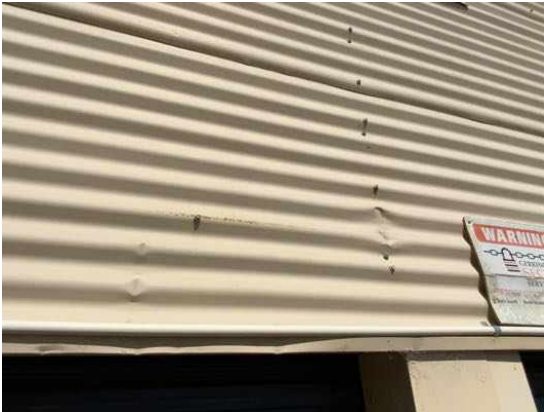
Finding 3.11

Building:	Main Building
Location:	Exterior walls - rear
Finding:	Building elements - Damaged (Downpipe, wall & Flashing)
Information:	Breakage occurs generally when the building materials have either aged and decayed, or as a result of damage (accidental or deliberate).

Repair and/or replacement of broken elements is advised to ensure that additional secondary defects do not arise as a consequence. Such works are necessary, as all building elements play a key role in the operation and function of the overall structure and its performance.

A relevant tradesperson should be appointed to repair or replace the affected building element prior to any subsequent damage being caused.

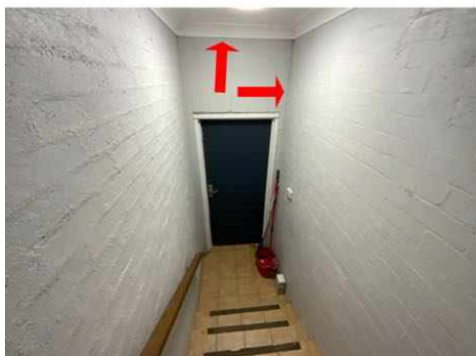
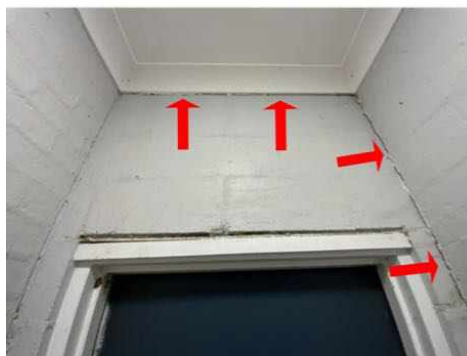
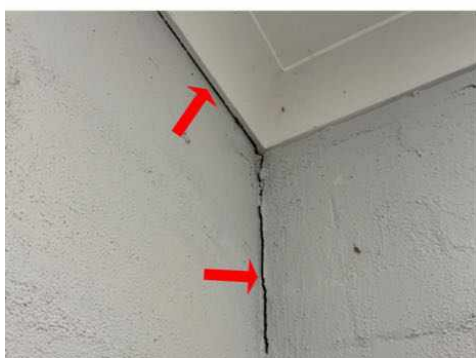
Finding 3.12

Building:	Building 3
Location:	Stairs - Internal
Finding:	Brickwork - Cracking noticeable
Information:	There were several cracks and or crack repairs evident to external brickwork.

Noticeable cracks are a common occurrence in external brickwork and are a likely result of age expected building movement, general expansion, and/or contraction of building materials in different weather conditions. Noticeable cracks in brickwork may develop if left unattended, with potential for necessitating major remedial works or replacement of the brickwork.

It is highly advised that a qualified bricklayer be appointed to provide necessary works to cracked brickwork to prevent any further damage. Such works should be conducted as soon as possible.

Always monitor these cracks and contact a building inspector should cracks widen, lengthen, or become more numerous.

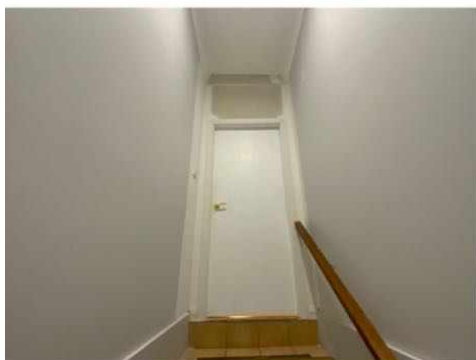
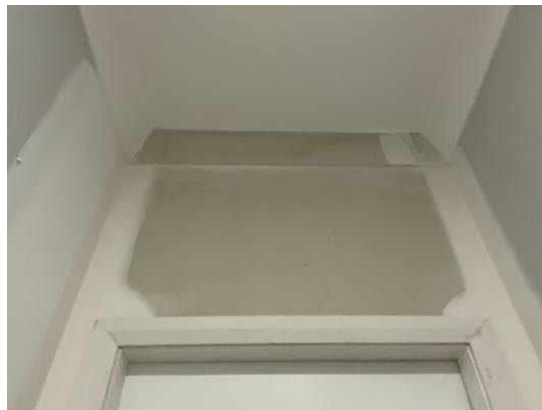
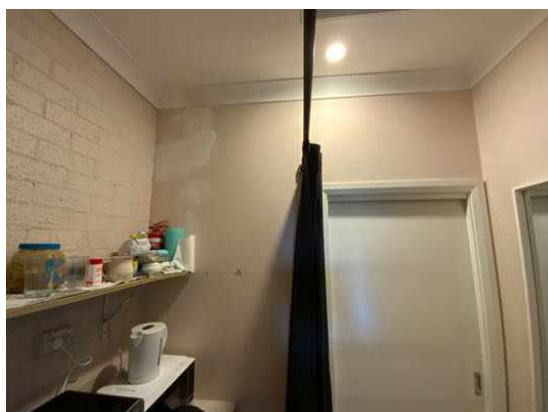
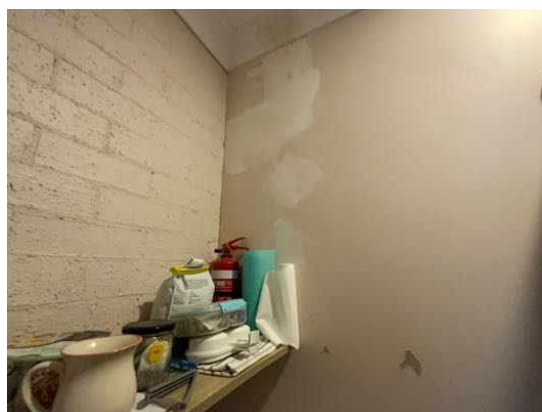
Finding 3.13

Building:	Building 3
Location:	Stairs - Internal & Kitchenette
Finding:	Paint finish - Incomplete
Information:	The paint finish in this area was identified as being incomplete at the time of inspection.

Whilst incomplete or missing paint finish is generally an appearance defect, it can also lead to the development of secondary building defects over time. Incomplete areas of paint finish expose the area to moisture, potentially accelerating the deterioration of underlying building materials.

Incomplete paint finishes should be sanded back, filled, leveled and painted, as applicable. Where inadequate or missing paint protection has led to the deterioration of the associated building element, repair and/or replacement of this building element may be required.

A painting contractor should be appointed as soon as possible to perform necessary works to aid the appearance of the affected area and to ensure the area is protected against further deterioration. Alternatively, the homeowner following manufacturer instructions may perform these works.

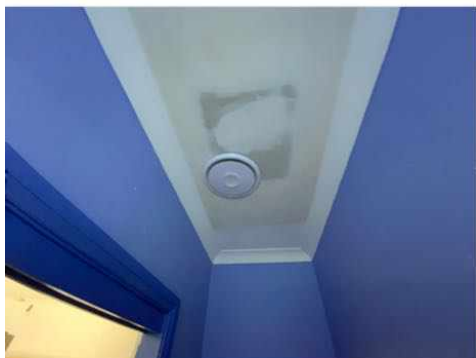
Finding 3.14

Building:	Building 2
Location:	Toilet (WC)
Finding:	Paint finish - Incomplete to ceiling
Information:	The paint finish in this area was identified as being incomplete at the time of inspection.

Whilst incomplete or missing paint finish is generally an appearance defect, it can also lead to the development of secondary building defects over time. Incomplete areas of paint finish expose the area to moisture, potentially accelerating the deterioration of underlying building materials.

Incomplete paint finishes should be sanded back, filled, leveled and painted, as applicable. Where inadequate or missing paint protection has led to the deterioration of the associated building element, repair and/or replacement of this building element may be required.

A painting contractor should be appointed as soon as possible to perform necessary works to aid the appearance of the affected area and to ensure the area is protected against further deterioration. Alternatively, the homeowner following manufacturer instructions may perform these works.

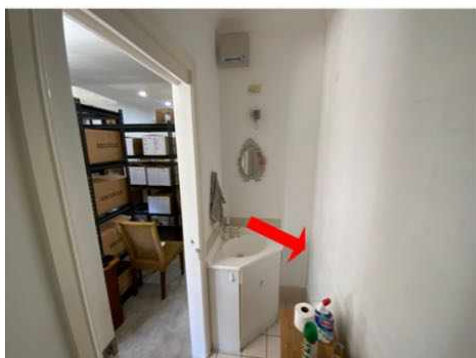
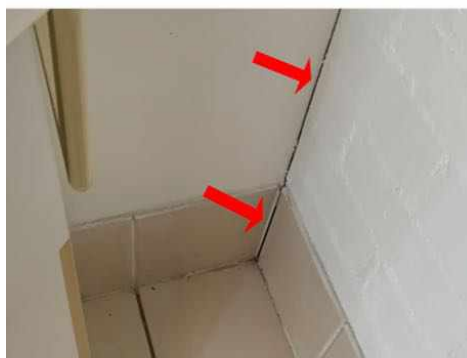
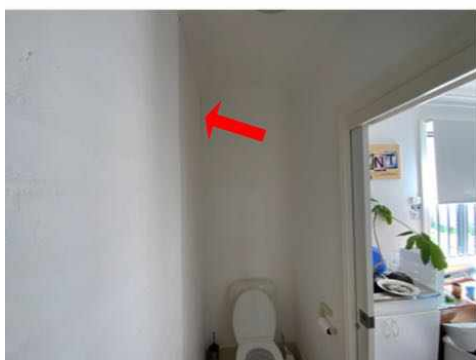
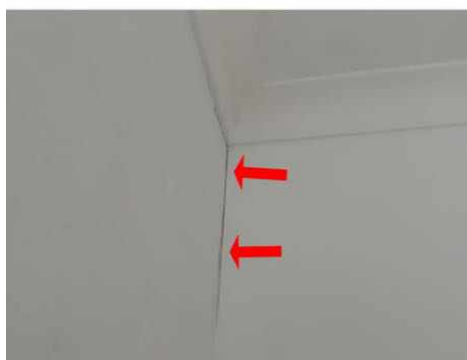
Monitoring of all cracking should be conducted frequently. Always contact a building inspector should cracks widen, lengthen, or become more numerous. Additionally, your building inspector should also be contacted if associated building elements such as doors and windows become more difficult to operate over time.

Relevant tradespeople, such as carpenters, painters and plasterers, should be appointed to perform remedial works, as deemed necessary.

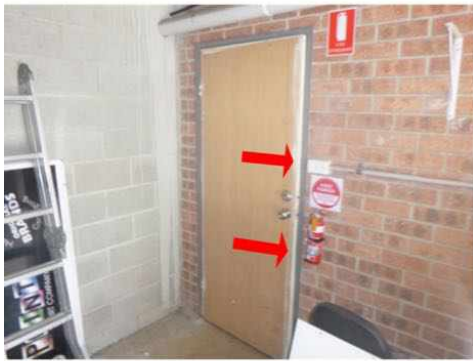
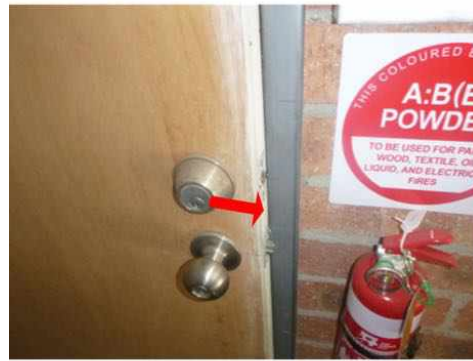
Finding 3.16

Building:	Building 2
Location:	Garage
Finding:	Door - Binding/jamming
Information:	Binding and/or jamming of this door is evident during standard operation. This defect inhibits the functionality of the affected door as well as creating potential for secondary defects to associated building elements, such as damage to the floor covering.

A door that binds to flooring or to the associated door frame may have several causes, ranging from minor defects, such as poor installation of the door or deteriorated hinges, through to major structural issues, such as damage to subfloor structures.

Where door binding/jamming appears to indicate major structural issues, a registered builder specialising in re-stumping should be appointed to provide an estimate on the cost of rectification.

For minor causes, a qualified carpenter or general handyperson should be appointed to perform minor rectification works at client discretion.

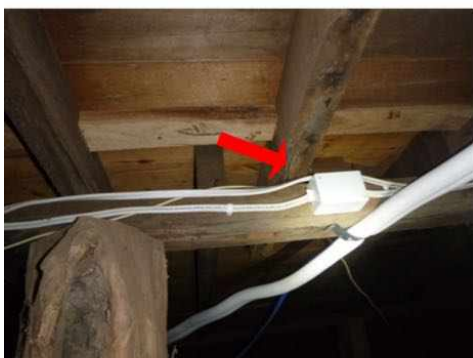
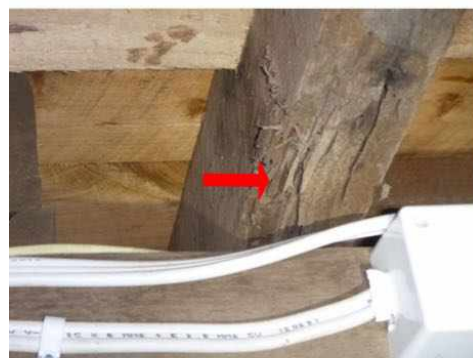
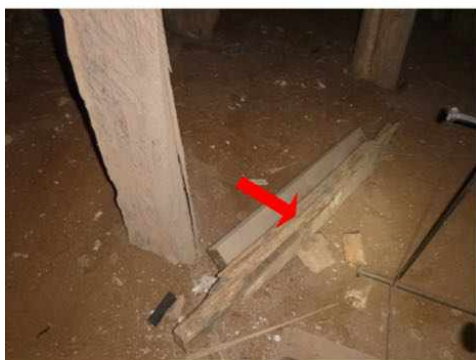
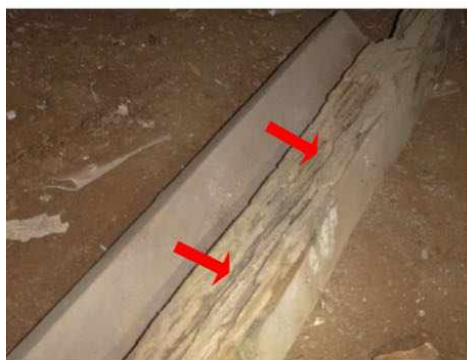
Building:	Main Building
Location:	Subfloor
Finding:	Evidence of previous termite damage - minor
Information:	Despite no live termite or timber pest activity being indicated, previous termite damage was found to have affected this area. This damage is considered to be inactive and is minor in nature.

It is advised that the area be visually inspected frequently to ensure that the condition of affected building materials does not worsen. At the time of inspection, damage is not structural and is only considered to be superficial.

A building contractor may be appointed to provide a further invasive inspection if further damage is evident.

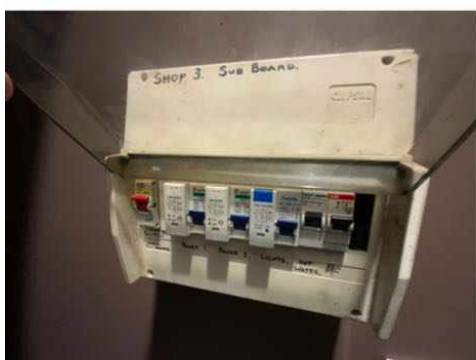
Finding 6.01

Building:	Main Building
Location:	All Areas
Finding:	Termite Management System - no evidence of a chemical installation
Information:	The application of a post-construction chemical termite barrier is highly recommended for all properties, particularly if live termite activity has been found on the site previously. Such barriers are highly effective in preventing termite attack on any timber building elements throughout the property.

A durable notice should be placed in the switchboard unit to indicate current termite barriers. At the time of inspection, it appeared as though no termite management system has been installed, with no evidence to suggest preventative works taking place.

The client may consider gaining further advice from a pest controller as to the costs and procedures involved with this application. It is recommended that obtaining such advice be a short-term priority.

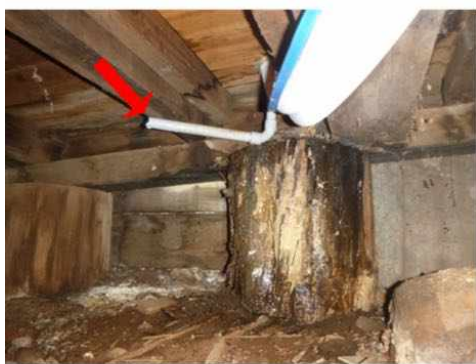
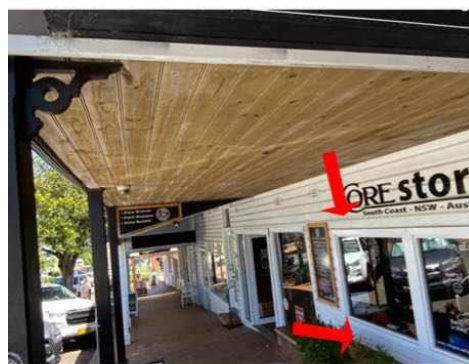
Finding 6.02

Building:	Main Building
Location:	Subfloor
Finding:	Air conditioner - Disconnected overflow
Information:	The Air Conditioner (A/C) overflow was found to be disconnected from storm water drainage and is creating excessive moisture in the surrounding area.

Such leaking creates an environment which is conducive to an array of defects, including water damage to associated building elements and the attraction of termite or timber pest infestation.

It is highly recommended that a licensed plumber be appointed to connect the A/C overflow in order to prevent such an environment from being created. These minor works should be carried out as soon as possible.

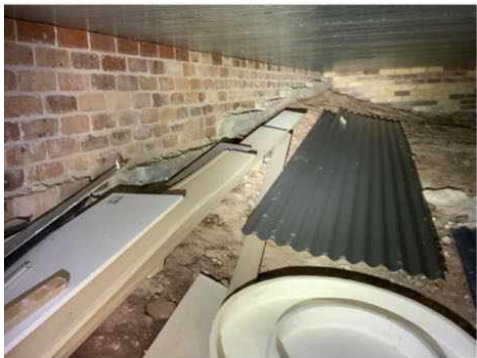
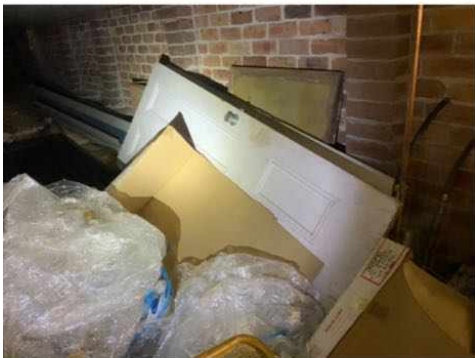
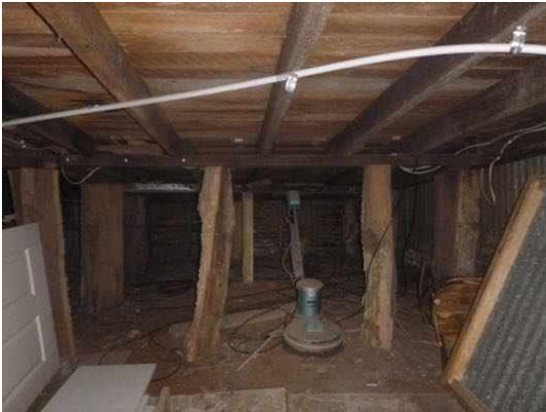
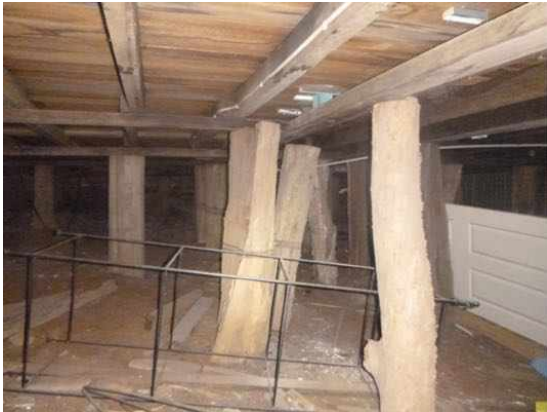
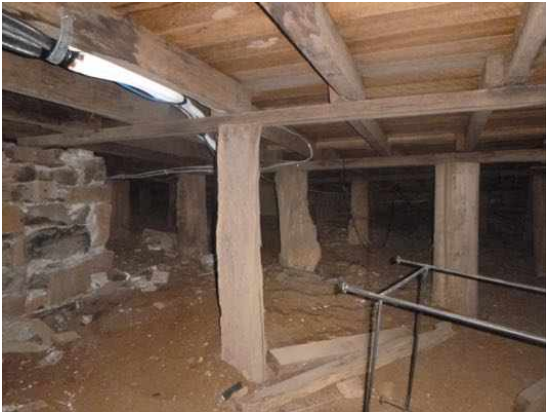
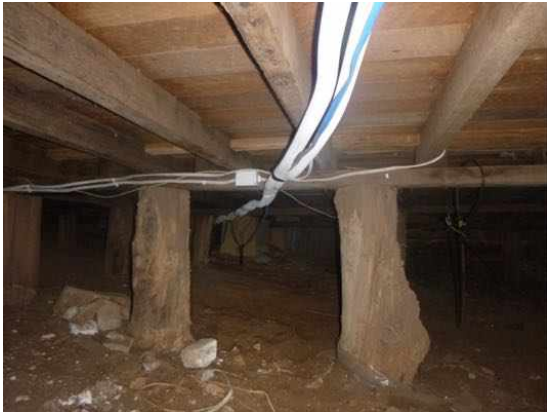
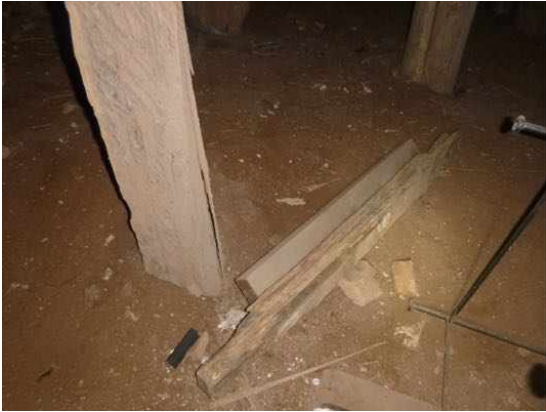
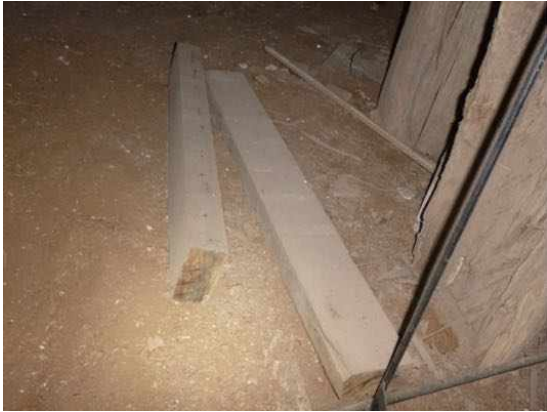
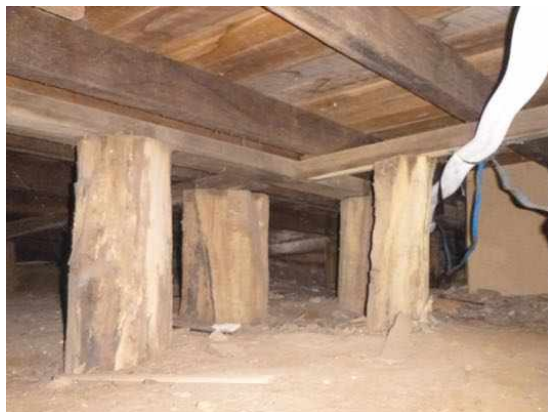
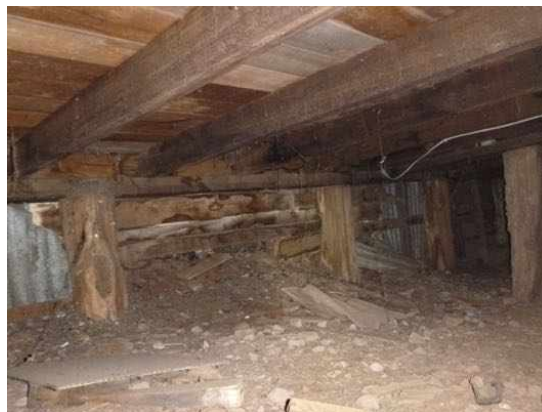
Finding 6.03

Building:	Main Building
Location:	Subfloor
Finding:	Timber in ground contact
Information:	To reduce the risk of timber pest attack it is essential that timber used in a hazardous environment (e.g. in direct contact with the ground or frequently exposed to damp conditions) is of sufficient durability and/or is adequately preservative treated.

Untreated timbers in direct contact with the ground are likely to develop severe wood rot and/or fungal decay if left unattended creating attraction for subterranean termites to infest the timbers from surrounding areas.

If untreated or non-durable timbers are found to be in a hazardous environment it is highly advised that replacement of these building elements be performed as soon as possible to aid the protection of the property against termite / timber pest attack.

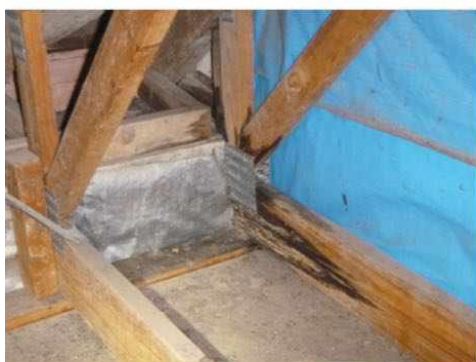
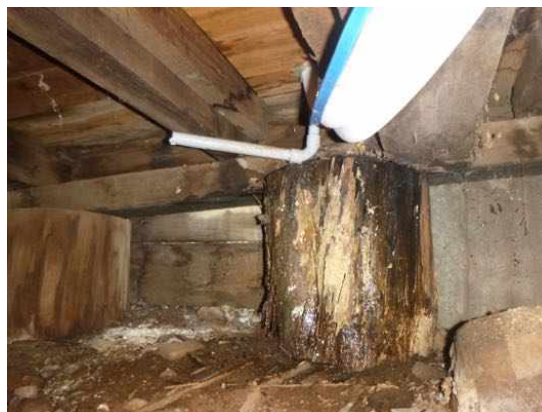
Finding 6.04

Building:	Main Building
Location:	Subfloor
Finding:	Evidence of excessive moisture was present at the time of inspection
Information:	Excessive moisture can attract termites and produce conditions that promote termite attack fungal growth and wood decay.

Excessive moisture is generally caused by deteriorated inadequate or missing roof drainage, leaking plumbing pipes or fixtures, poorly plumbed HWS overflows or condenser units and poor site drainage.

It is highly recommended that all plumbing and drainage fixtures and fittings be maintained regularly in order to prevent excessive moisture being present in the external / internal property.

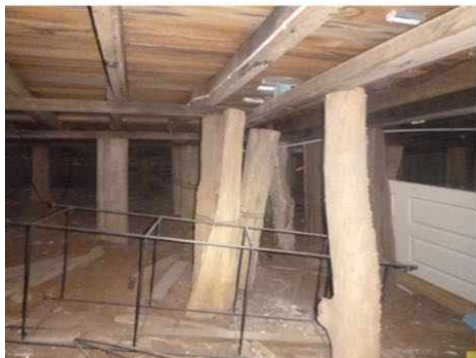
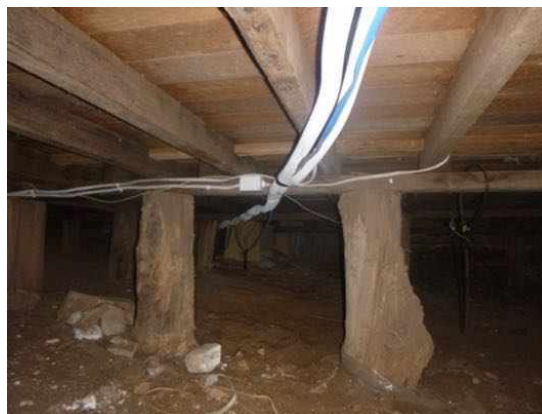
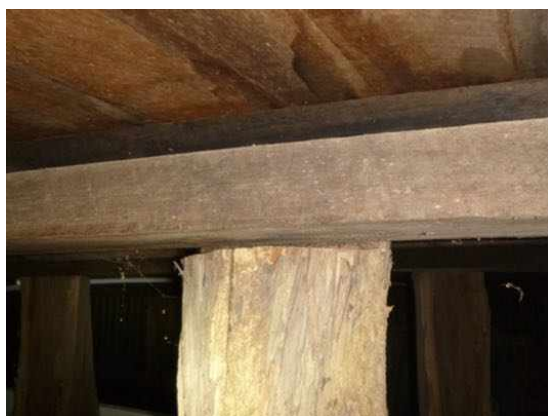
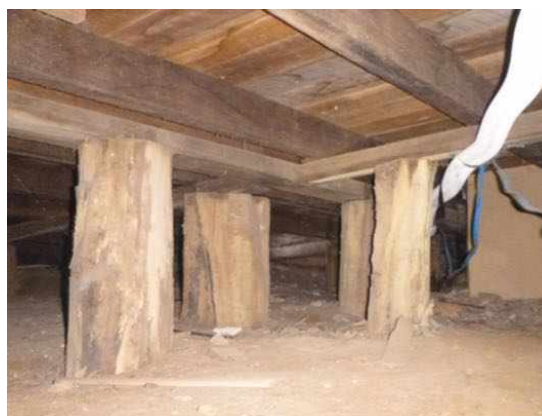
Finding 6.05

Building:	Main Building
Location:	Subfloor
Finding:	Ant caps - Not installed to the tops of the timber stumps/piers
Information:	Ant caps have not been installed to the subfloor structure at the time of inspection. Generally, ant caps are installed to the intersection between the top of the stumps (or

Installed during the construction process, ant caps are designed to easily identify termite or pest ingress from stumps to the adjoining bearers.

Where ant caps have not been installed, frequent monitoring of these areas should be carried out in order to identify any signs of termite or timber pest workings.

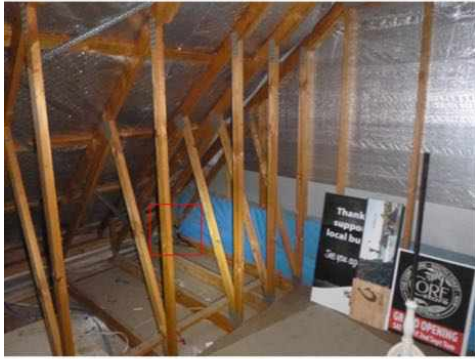
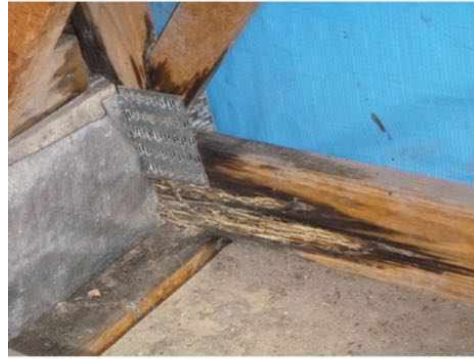
Finding 7.01

Building:	Main Building
Location:	All Areas
Finding:	Fungal decay - present (localised)
Information:	Fungal decay also known as wood decay or wood rot generally refers to the deterioration of timber elements when in contact with excessive levels of moisture for a prolonged period of time.

The development of fungal decay is accelerated by temperatures in the range of 5degreeC to 40degreeC as well as the presence of oxygen. Generally fungal decay develops on timber elements that are in use in an external environment which are

exposed to rain penetration.

In this case although the affected timber element is in a decaying state the extent of any visible damage appears to be localised to a specific area and is yet to spread to other parts of the building element or affect adjoining structures. The fungal decay is therefore likely to be of a relatively superficial nature with minimal impact on the structural integrity or tensile strength of the timber element.
