Building and Timber Pest Inspection Report

Inspection Date: Wed, 28 Jan 2026

Property Address: 131 Fern St, Gerringong NSW 2534,
Australia

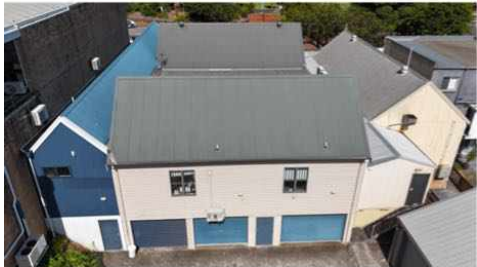
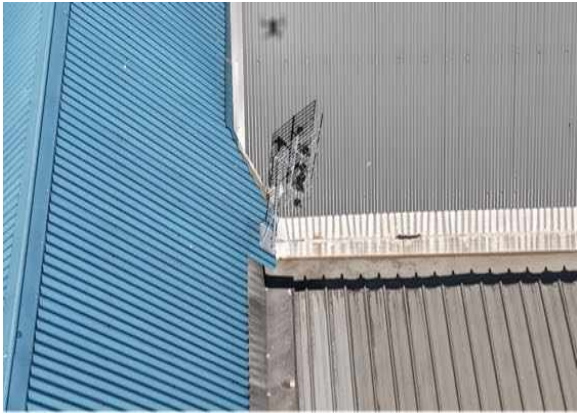
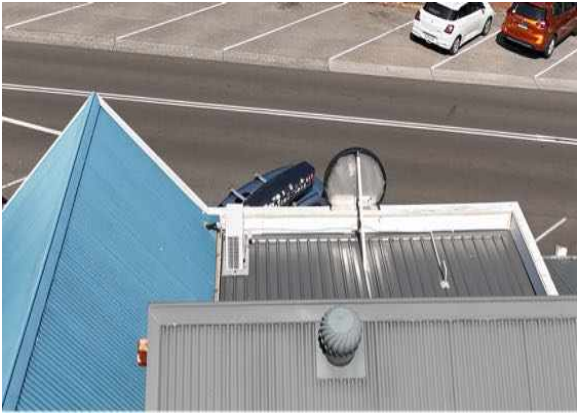
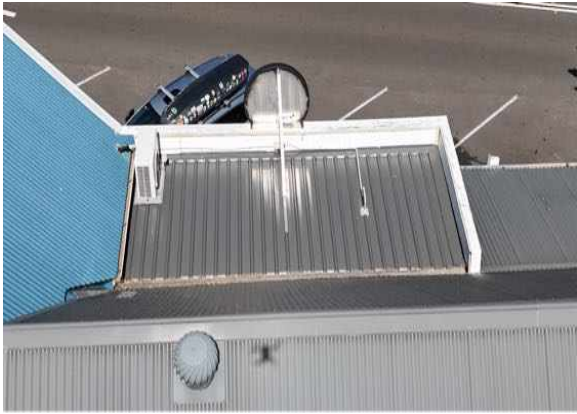
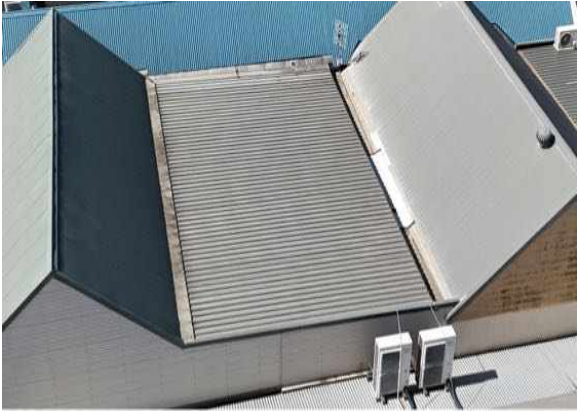
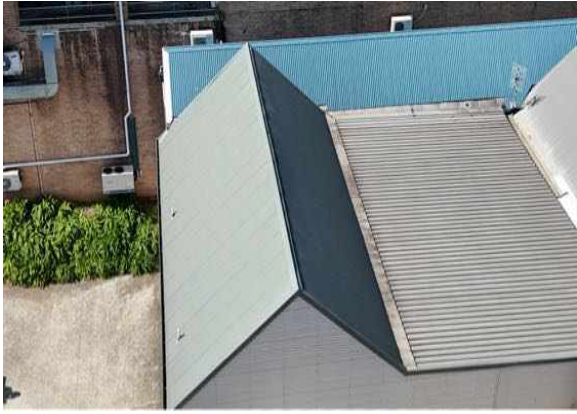
Noted Item

Building: Main Building
Location: Roof Exterior
Finding: Additional Photos - Obstructions and Limitations
Information: These photographs are an indication of the obstructions and limitations which impeded full inspection of the property at the time of inspection. These obstructions can hide an array of defects and should be removed to allow full inspection to be carried out. A re-inspection is recommended once the areas are made accessible.

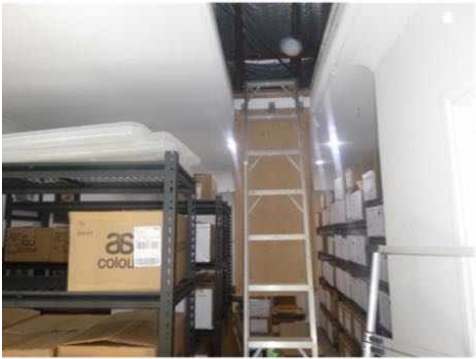
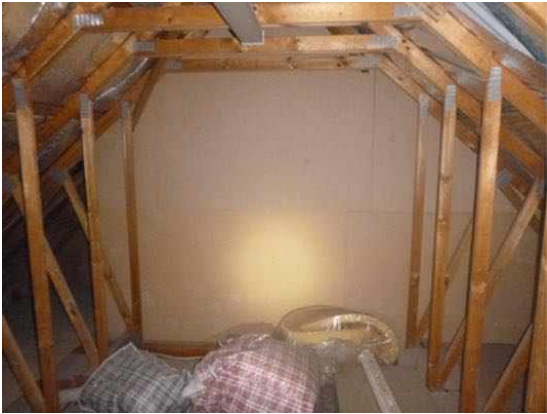
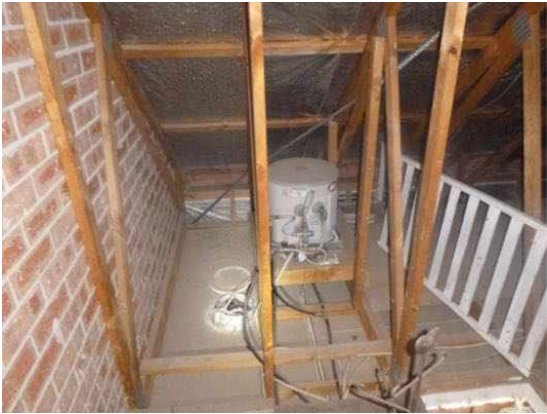
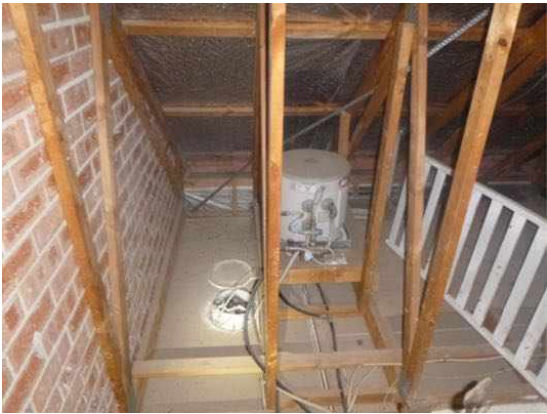
Building: Building 1
Location: Roof Void
Finding: Additional Photos - Obstructions and Limitations
Information: These photographs are an indication of the obstructions and limitations which impeded full inspection of the property at the time of inspection. These obstructions can hide an array of defects and should be removed to allow full inspection to be carried out. A re-inspection is recommended once the areas are made accessible.

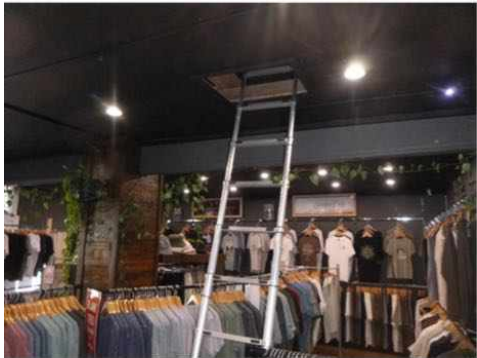
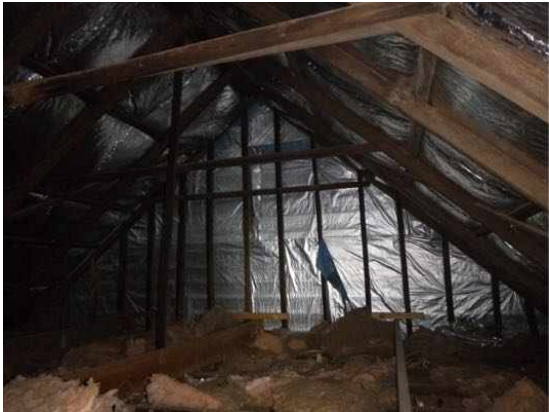
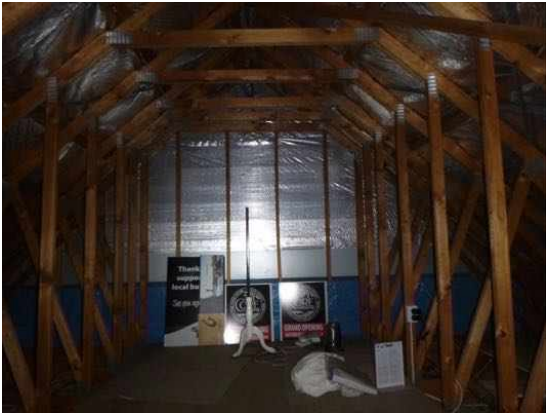
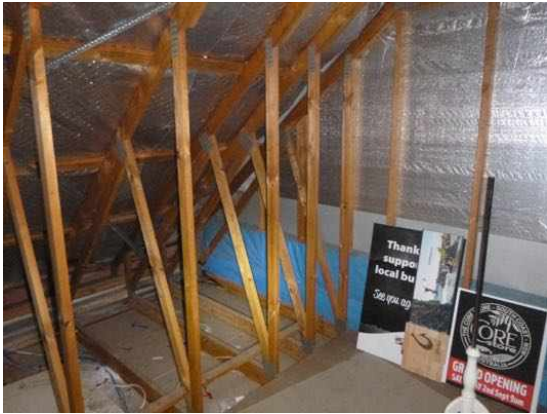
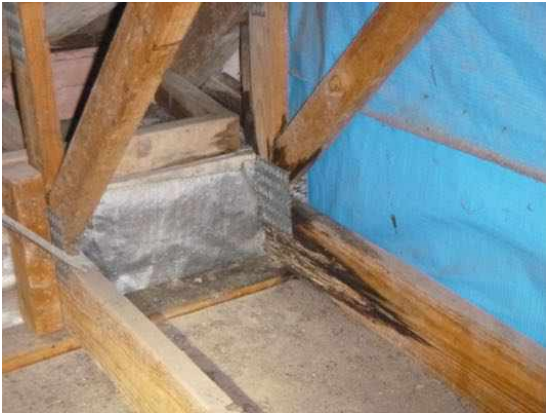
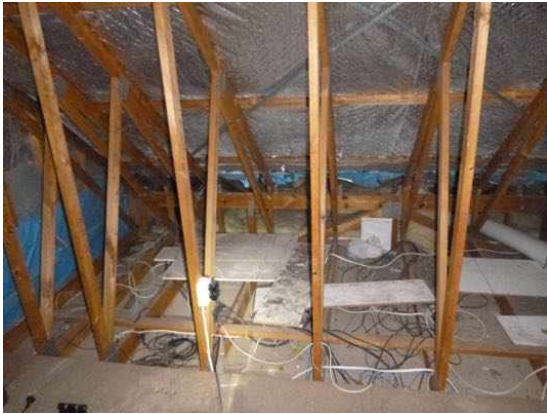
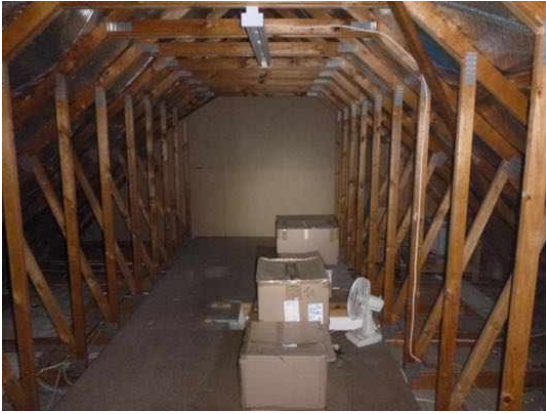
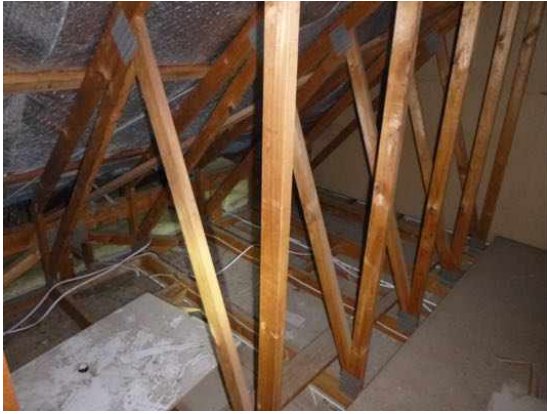
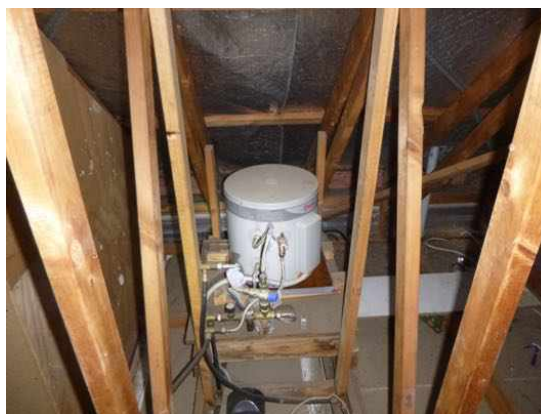
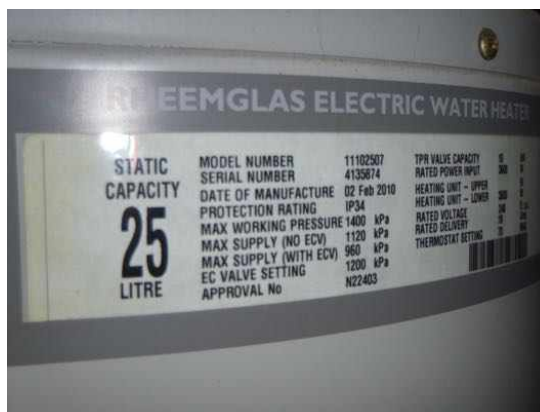
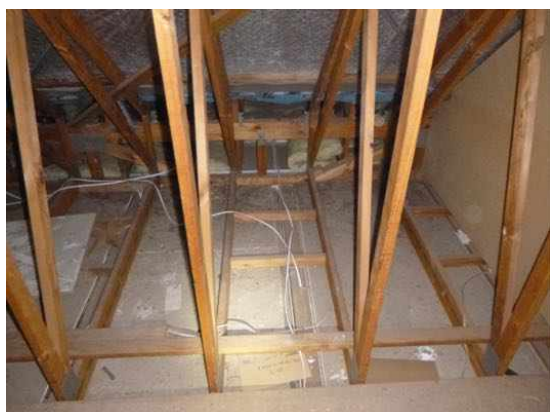
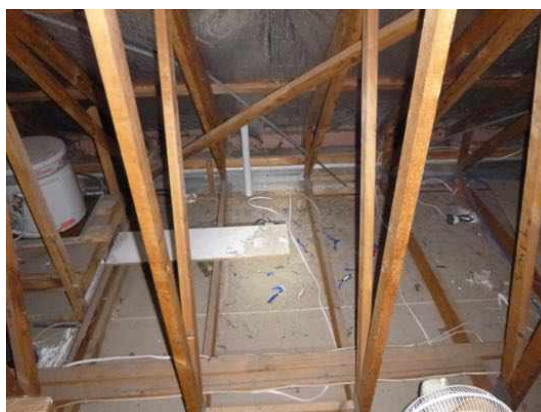
Building: Building 2
Location: Roof Void
Finding: Additional Photos - Obstructions and Limitations
Information: These photographs are an indication of the obstructions and limitations which impeded full inspection of the property at the time of inspection. These obstructions can hide an array of defects and should be removed to allow full inspection to be carried out. A re-inspection is recommended once the areas are made accessible.

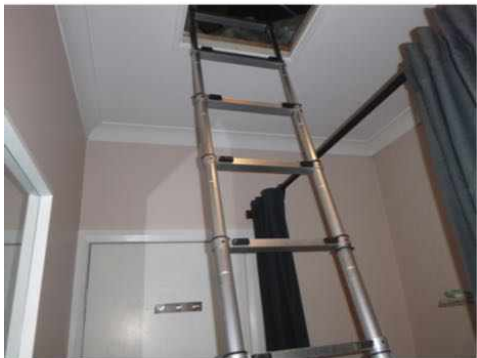
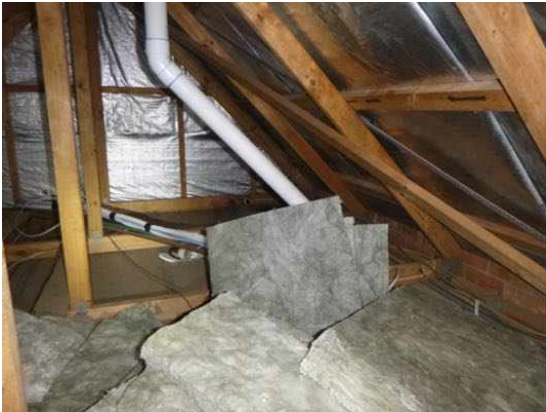
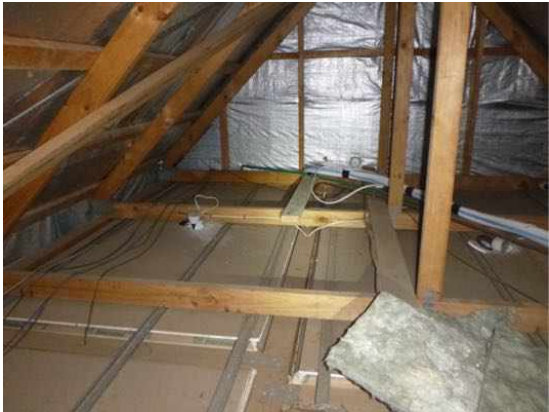
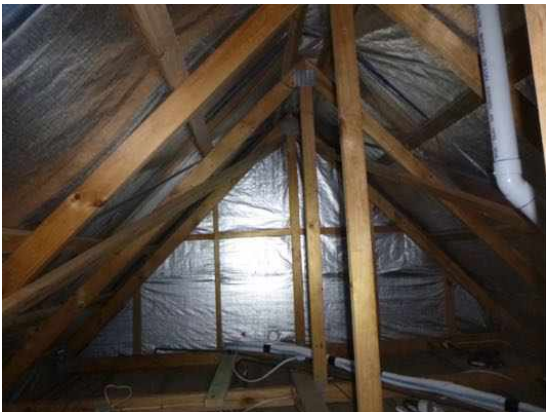
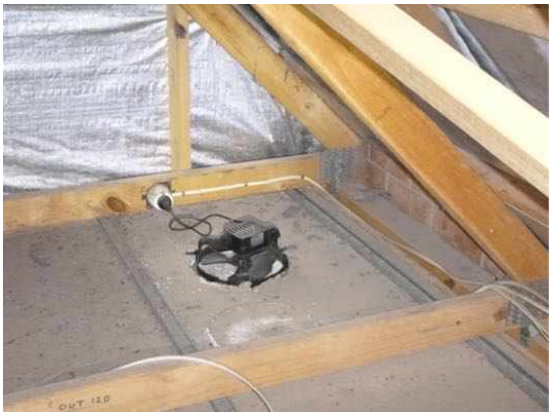
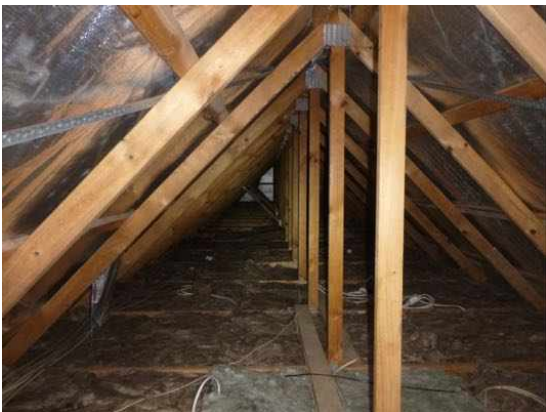
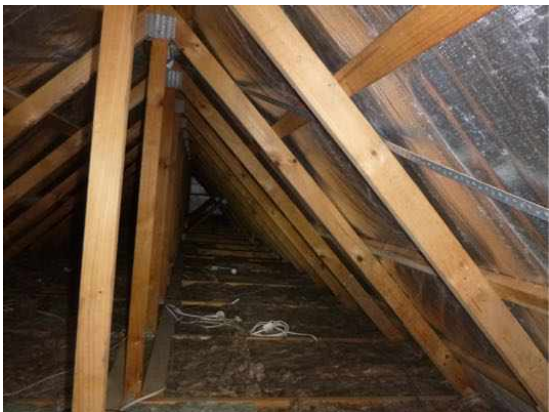
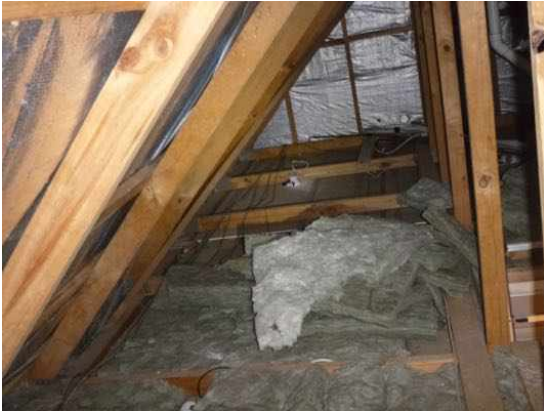
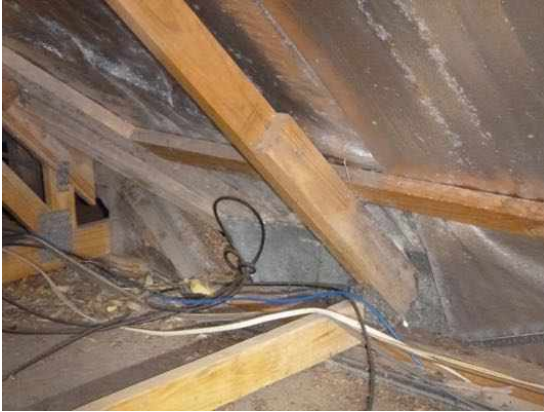
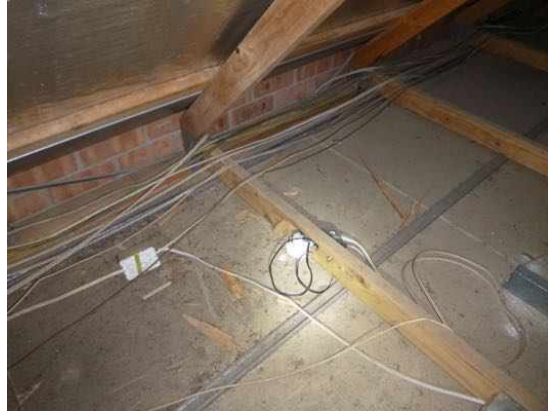
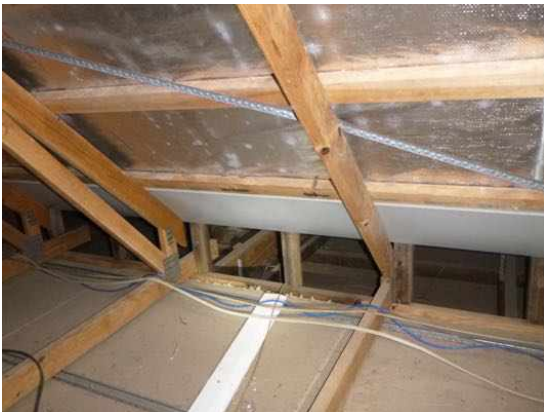
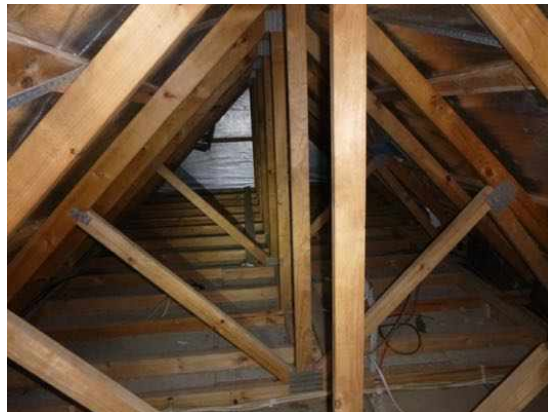
Building: Building 3
 Location: Roof Void
 Finding: Additional Photos - Obstructions and Limitations
 Information: These photographs are an indication of the obstructions and limitations which impeded full inspection of the property at the time of inspection. These obstructions can hide an array of defects and should be removed to allow full inspection to be carried out. A re-inspection is recommended once the areas are made accessible.

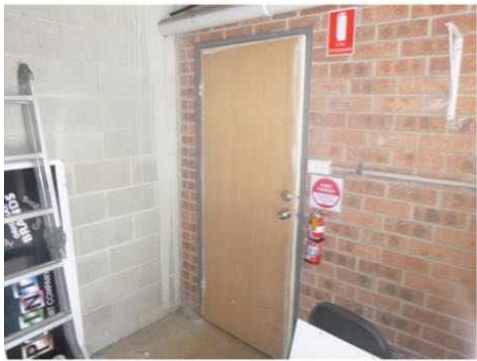
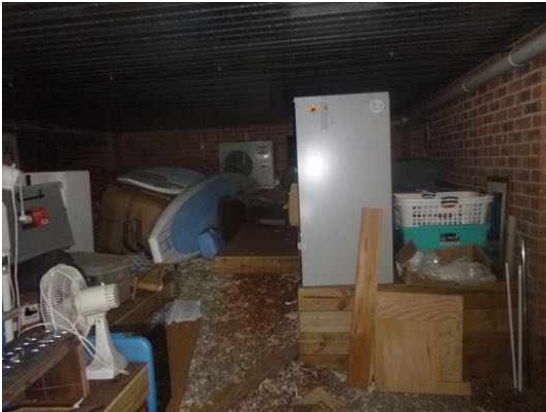
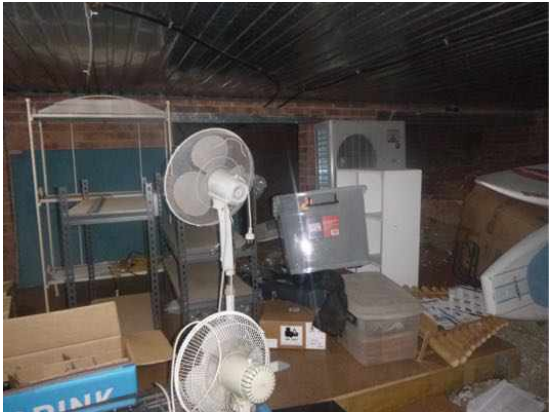
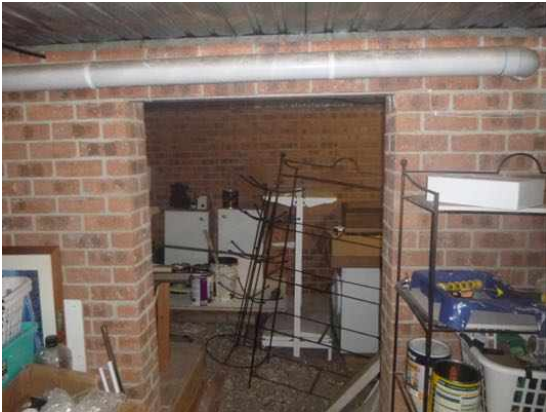
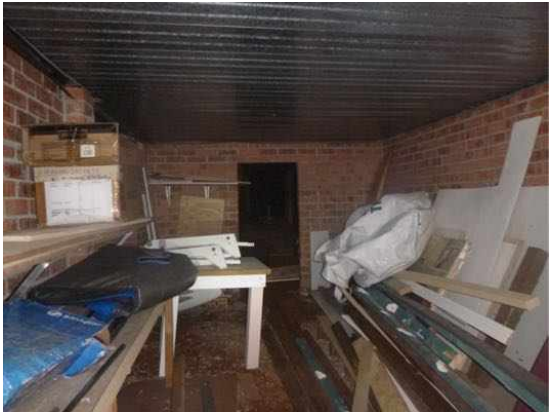
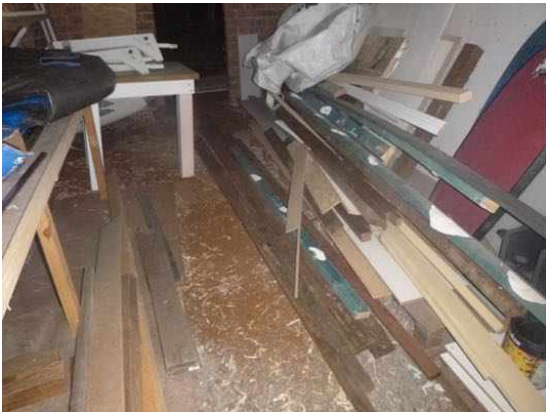
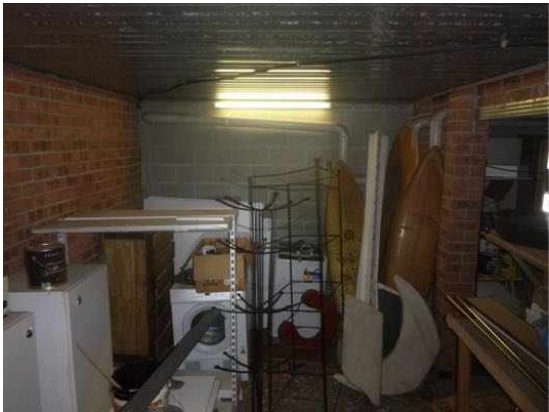
Building:	Building 1
Location:	Subfloor below shops 1 & 2
Finding:	Additional Photos - Obstructions and Limitations
Information:	These photographs are an indication of the obstructions and limitations which impeded full inspection of the property at the time of inspection. These obstructions can hide an array of defects and should be removed to allow full inspection to be carried out. A re-inspection is recommended once the areas are made accessible.

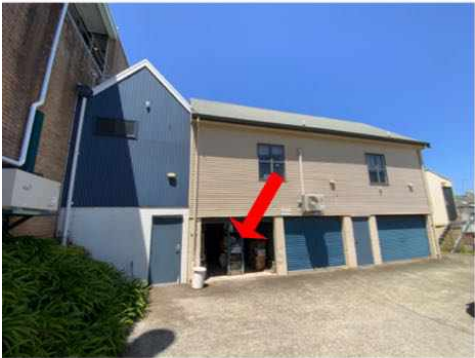
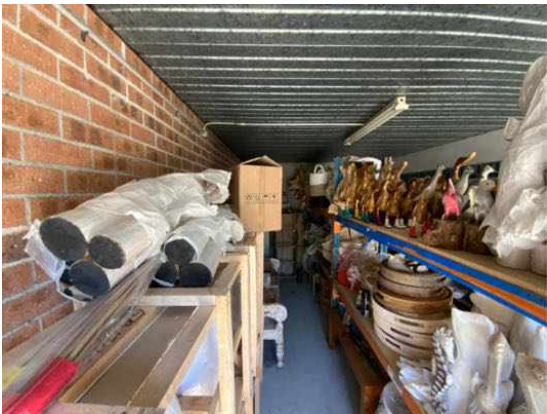
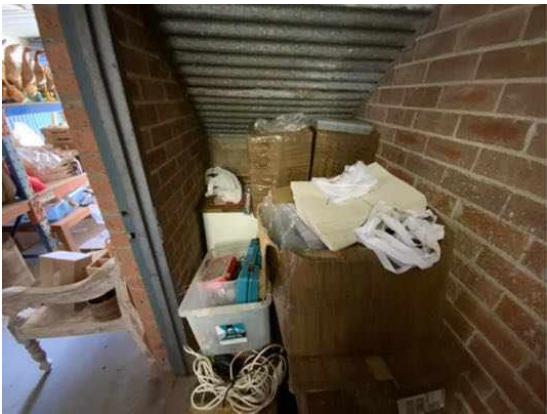
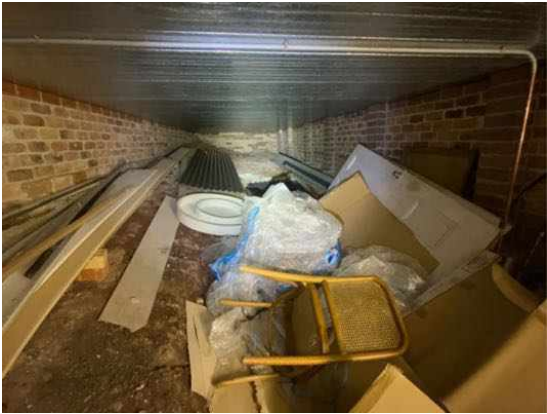
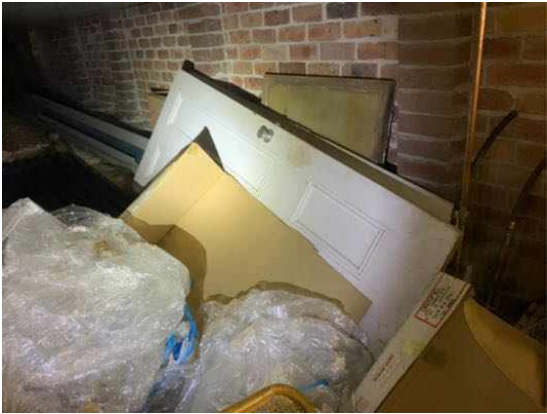
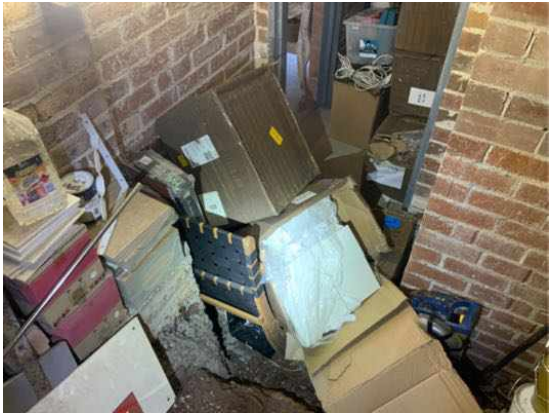
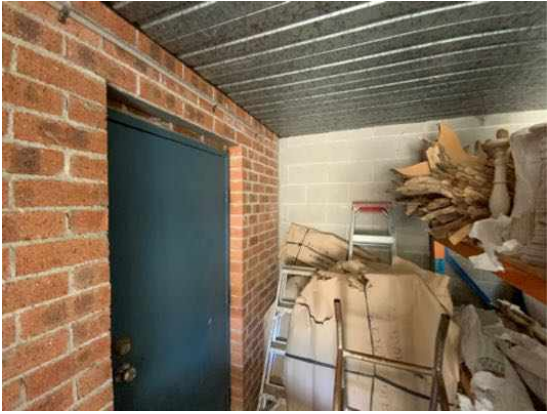
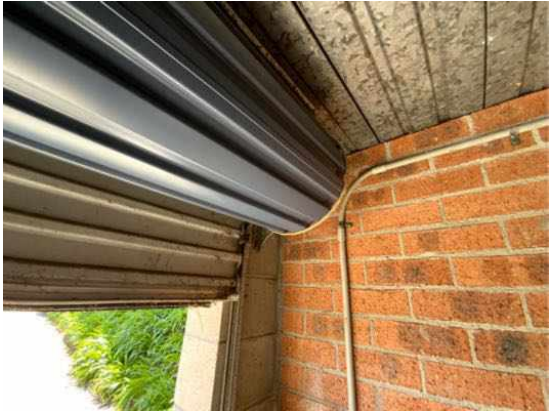
Building: Building 3
Location: Subfloor
Finding: Additional Photos - Obstructions and Limitations
Information: These photographs are an indication of the obstructions and limitations which impeded full inspection of the property at the time of inspection. These obstructions can hide an array of defects and should be removed to allow full inspection to be carried out. A re-inspection is recommended once the areas are made accessible.

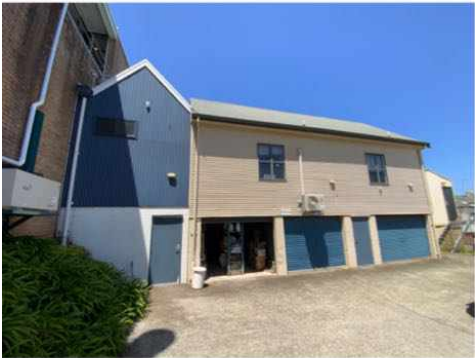
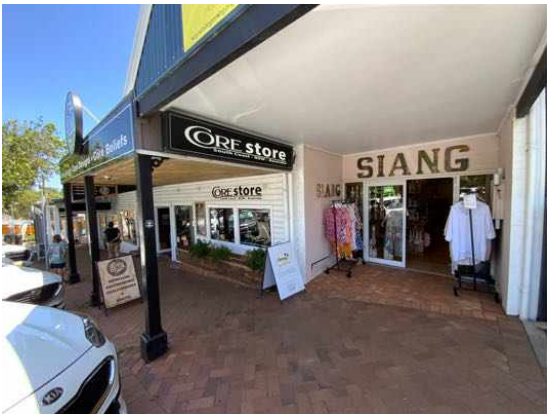
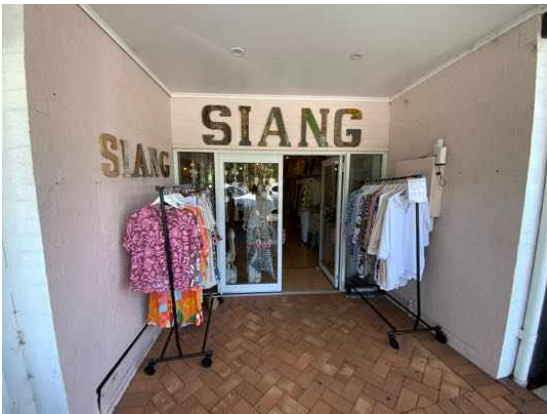
Building: Main Building
Location: All Areas
Finding: Additional Photos - Obstructions and Limitations
Information: These photographs are an indication of the obstructions and limitations which impeded full inspection of the property at the time of inspection. These obstructions can hide an array of defects and should be removed to allow full inspection to be carried out. A re-inspection is recommended once the areas are made accessible.

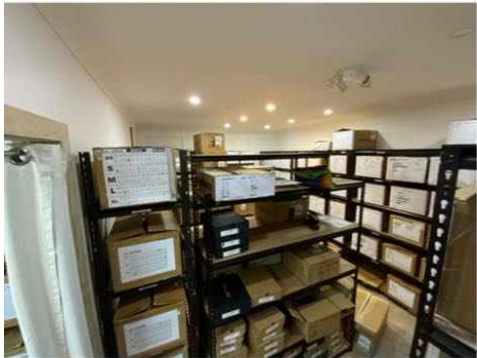
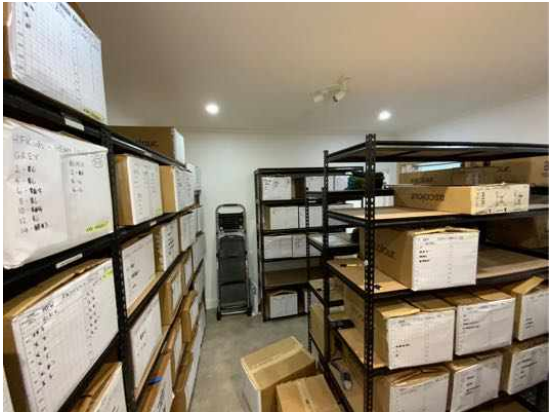
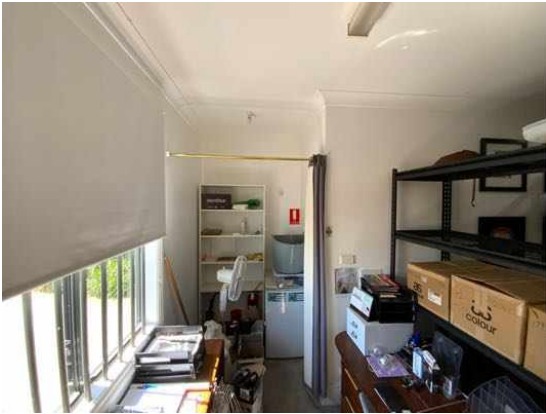
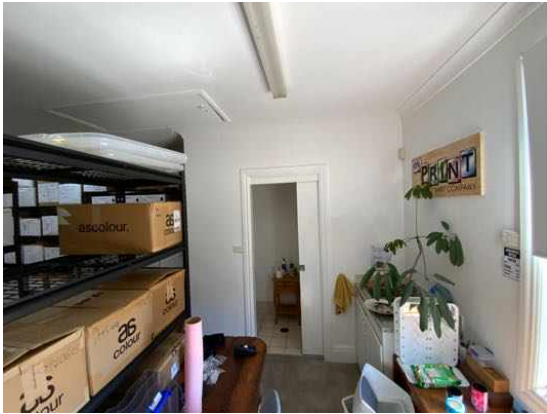
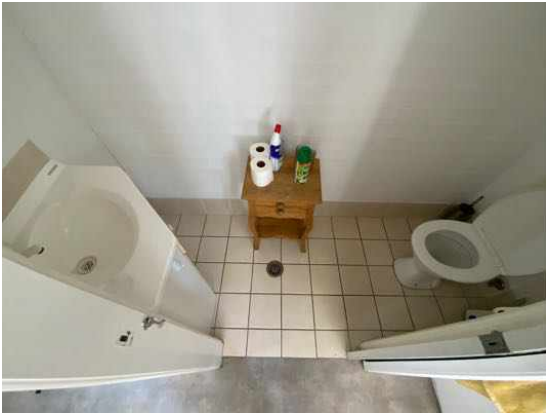
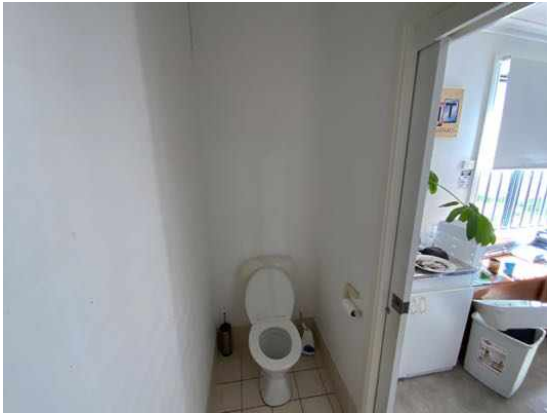
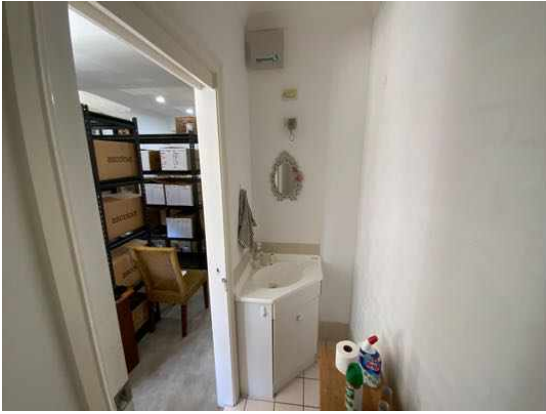
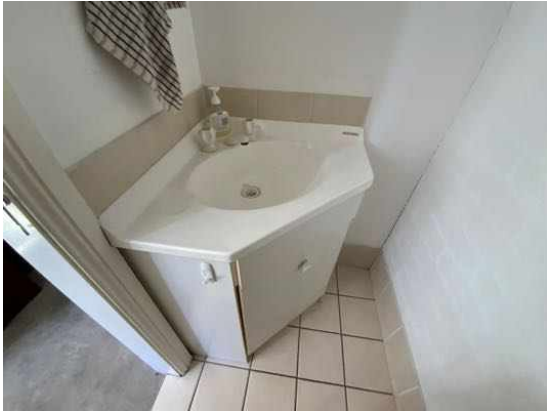
Building: Building 1
Location: Interior - All Areas
Finding: Additional Photos - Obstructions and Limitations
Information: These photographs are an indication of the obstructions and limitations which impeded full inspection of the property at the time of inspection. These obstructions can hide an array of defects and should be removed to allow full inspection to be carried out. A re-inspection is recommended once the areas are made accessible.

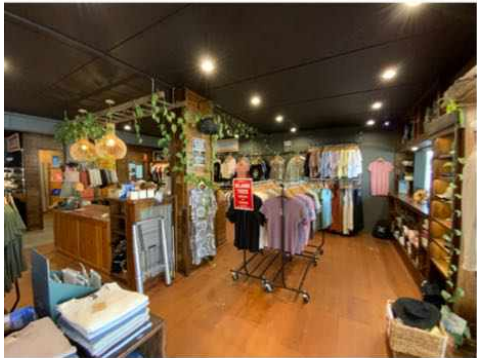
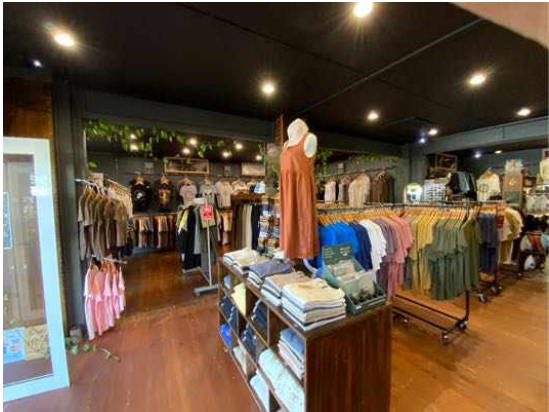
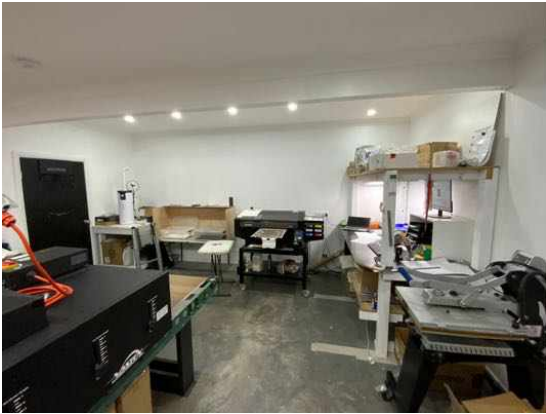
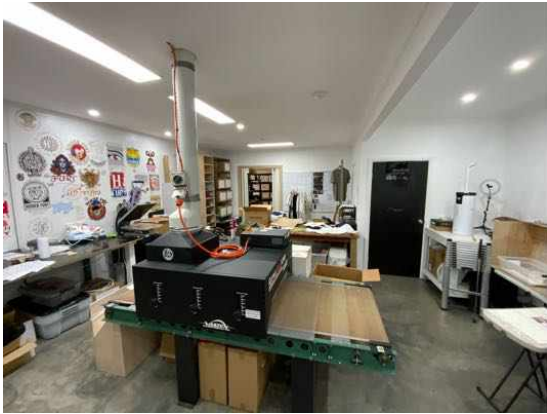
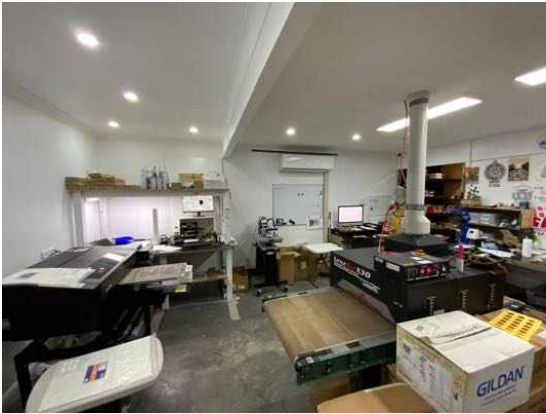
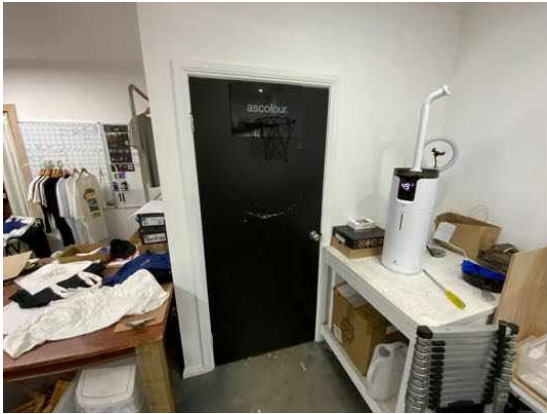
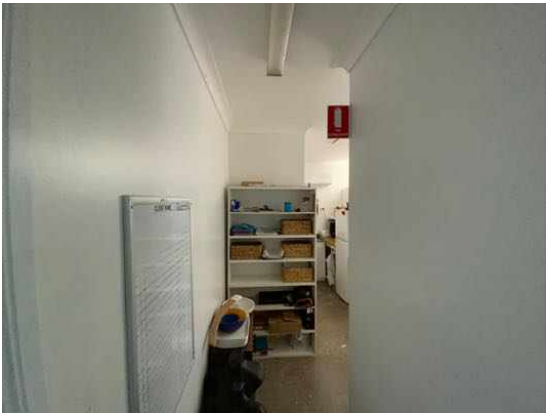
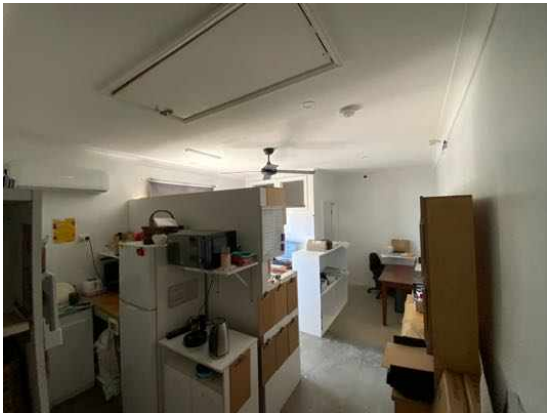
Building: Building 2
Location: Interior - All Areas
Finding: Additional Photos - Obstructions and Limitations
Information: These photographs are an indication of the obstructions and limitations which impeded full inspection of the property at the time of inspection. These obstructions can hide an array of defects and should be removed to allow full inspection to be carried out. A re-inspection is recommended once the areas are made accessible.

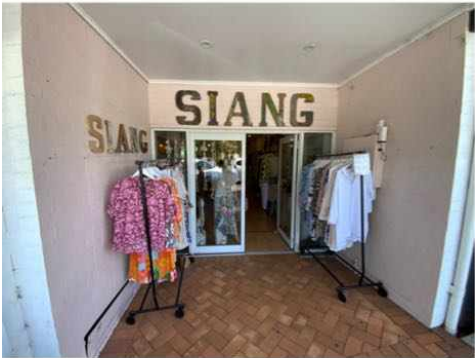
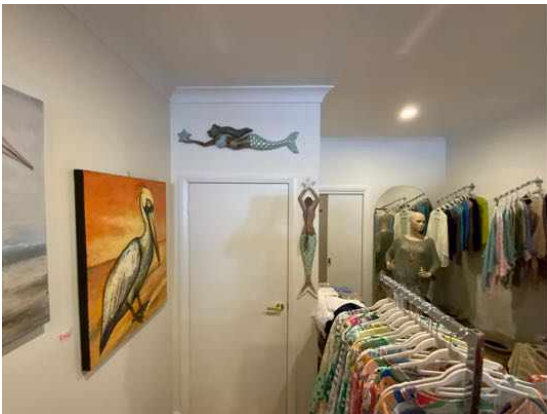
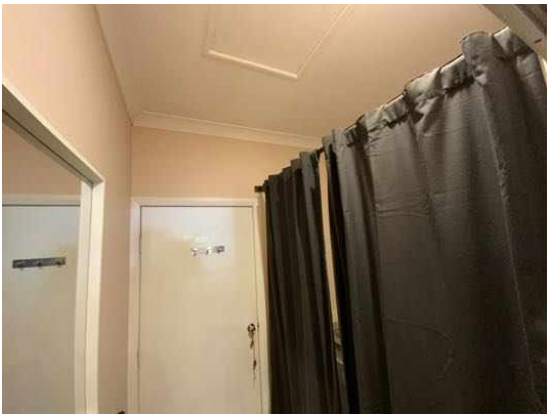
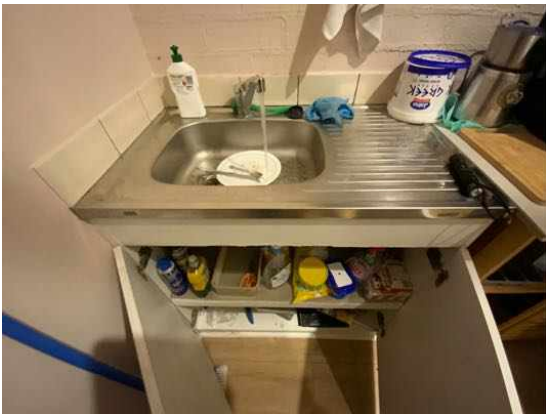
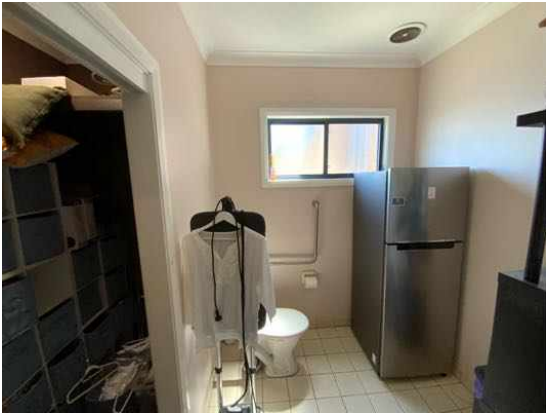
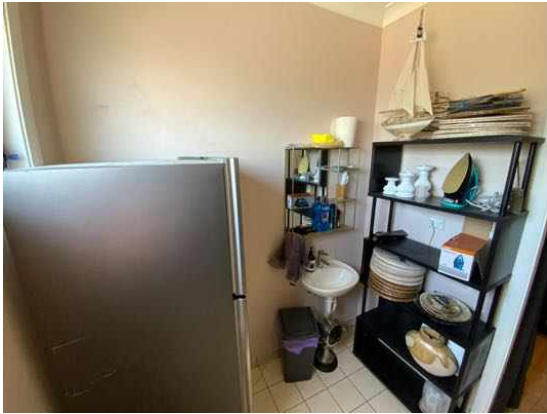
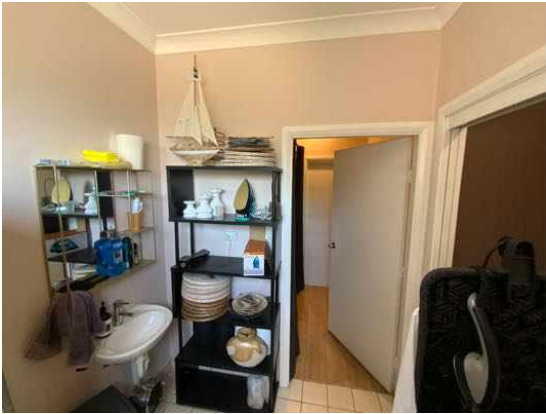
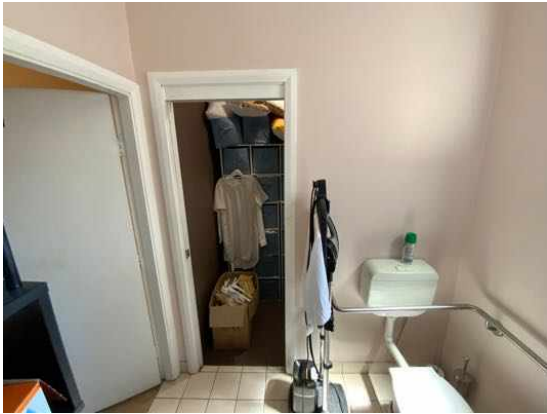
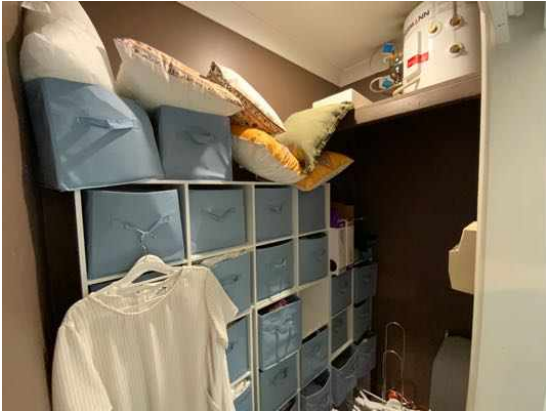
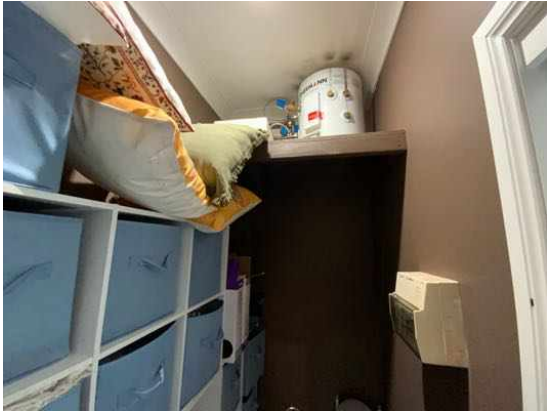
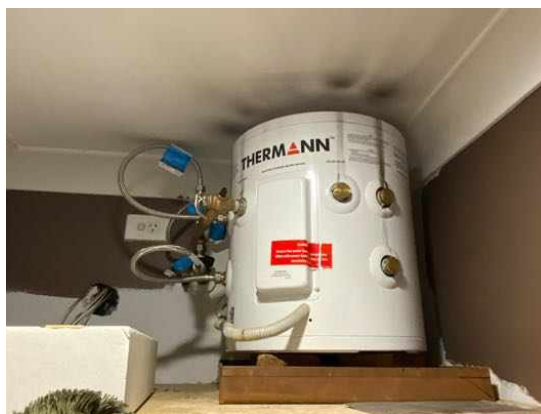
Building: Building 3
Location: Interior - All Areas
Finding: Additional Photos - Obstructions and Limitations
Information: These photographs are an indication of the obstructions and limitations which impeded full inspection of the property at the time of inspection. These obstructions can hide an array of defects and should be removed to allow full inspection to be carried out. A re-inspection is recommended once the areas are made accessible.

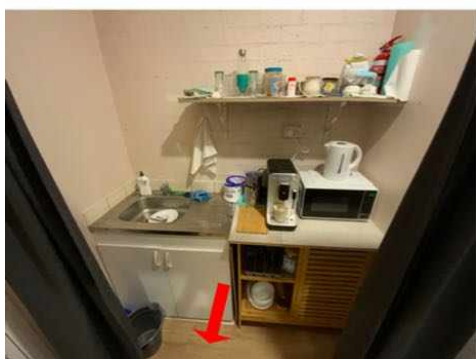
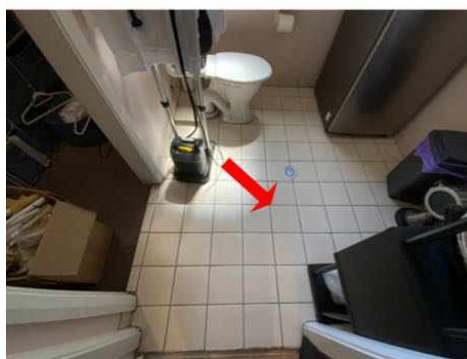
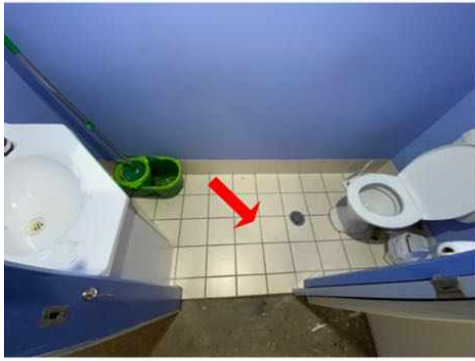
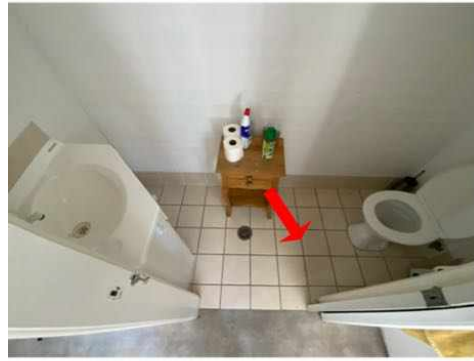
Building:	Main Building
Location:	All Wet Areas
Finding:	Water Proofing Membranes - Information Only
Information:	Internal Water Proofing Membranes, are crucial in preventing water ingress into the property is important to know that the Membrane System used is to Australian Standards and has been installed correctly.

With older property's where this information is unavailable all wet areas should be monitored. Generally waterproofing certificates are only valid for approximately 7-8yrs. If any leaks, water staining, peeling or bubbling of the paint become evident to any adjacent walls or ceilings below a licensed builder or waterproofing specialist is recommended to investigate further.
