Building and Timber Pest Inspection Report

Inspection Date: Thu, 5 Mar 2026

Property Address: 15 Grandiflora St, Rouse Hill NSW 2155,
Australia

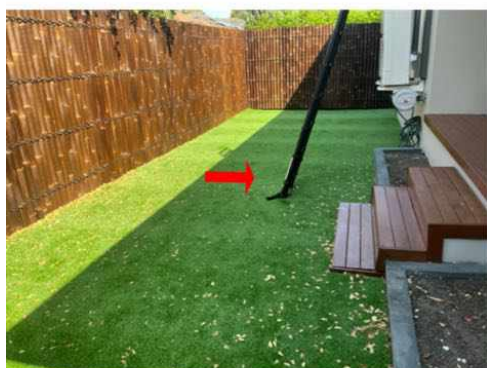
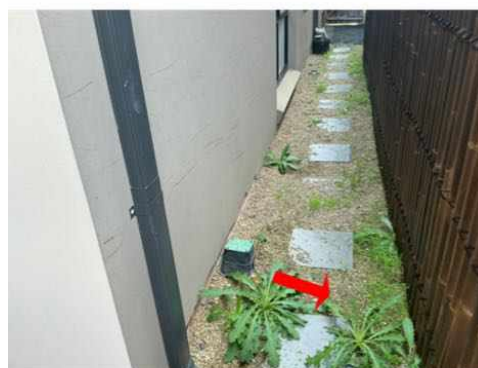
Building: Main Building
Location: Yard - Back
Finding: Inadequate Site Drainage - Exterior Areas
Information: At the time of inspection, inadequate site drainage was observed around the perimeter of the building, which may lead to water pooling and insufficient runoff management. The entire backyard area has been covered with artificial turf, which limits visibility of the underlying ground surface. As a result, it could not be confirmed whether any appropriate drainage system has been installed beneath the turf, and the covering may act as an obstruction to natural drainage.

Inadequate drainage around the building can allow water to accumulate near the structure, potentially leading to moisture-related issues over time.

It is recommended that proper site drainage be installed or verified, such as redirecting water flow away from the building or incorporating suitable drainage systems. A qualified landscaper or drainage specialist should be engaged to assess the area

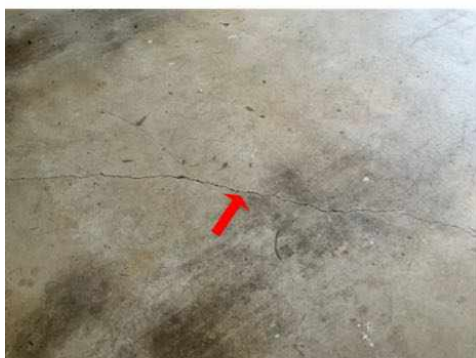
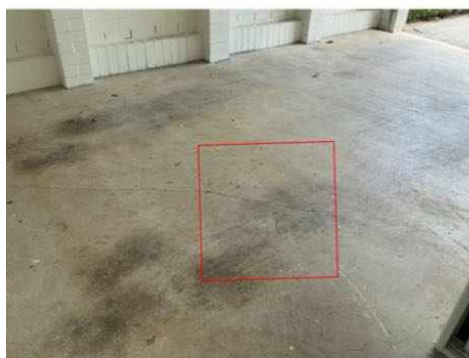
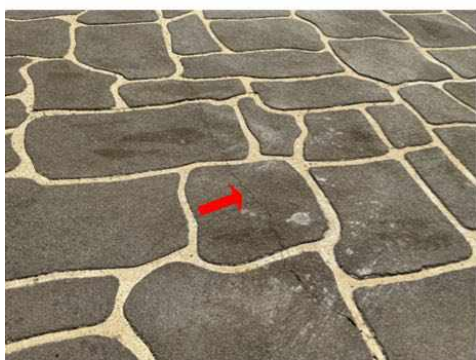
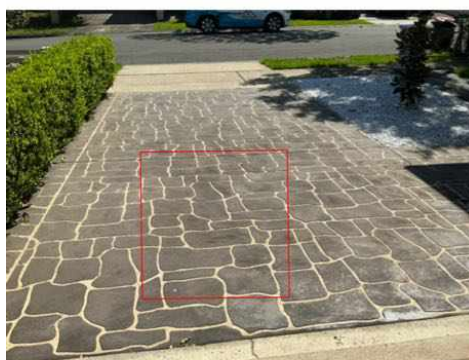
Finding 3.02

Building: Main Building
 Location: Garage, Driveway
 Finding: Crack in concrete slab - Category 2
 Information: A crack coded as Category 2 was identified in the slab. A Category 2 crack is described as a distinct crack, with the slab being noticeably curved or changed in level.

To be considered Category 2, the approximate width of the crack is less than 2.0mm, or a change in offset of less than 15mm when a 3m straight edge is placed over the defect.

Category 2 cracks to slabs should be monitored for a period of 12 months. At the end of the monitoring period, cracks rated greater than Category 2 are considered defects that require rectification.

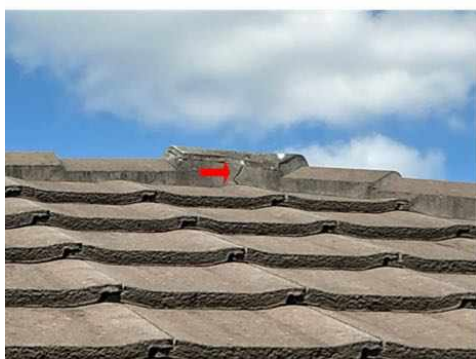
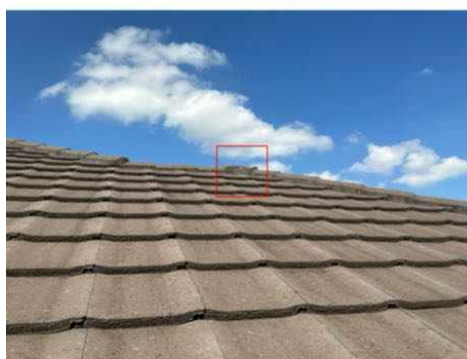
Finding 3.03

Building: Main Building
 Location: All Areas
 Finding: Roof Mortar - Deterioration
 Information: Mortar, or 'bedding', is the material which fills joins and intersections between tiles and other building elements on the exterior roof covering, such as gable ends, hip capping and valleys.

Upon inspection of the exterior roof, it was noted that sections of the mortar show varying levels of deterioration.

Mortar generally deteriorates as a result of frequent exposure to weather conditions over a prolonged period of time. Mortar that is deteriorating may allow water ingress into the roof void, putting associated building elements and roofing structures at risk of water damage. Deteriorated mortar also detracts from the functionality of roof tiles and other roofing elements, potentially decreasing weather tightness and roof drainage.

Mortar deterioration can be attended to by a licensed roofing contractor.

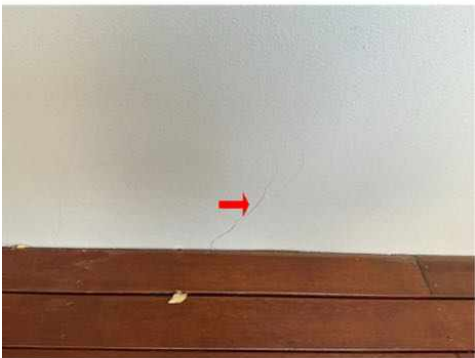
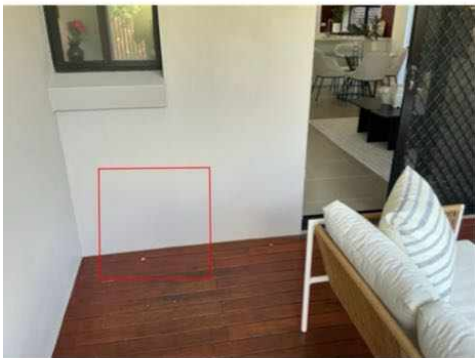
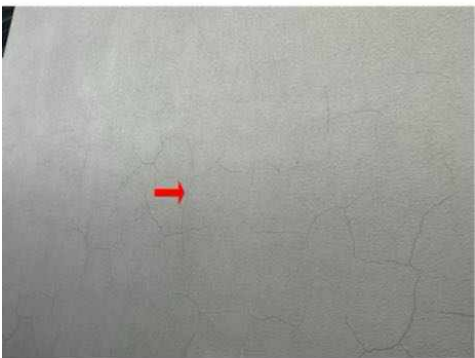
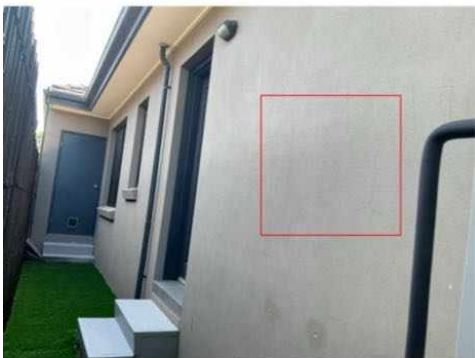
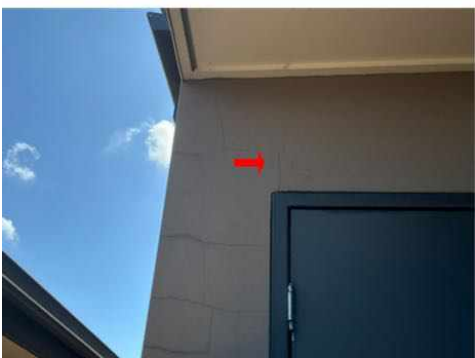
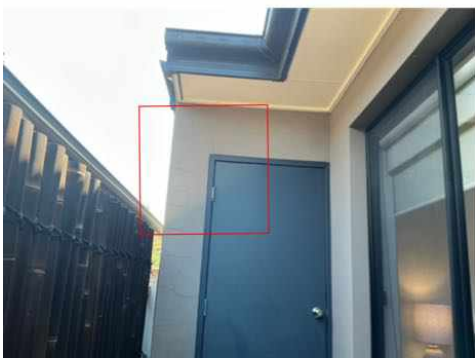
Finding 3.04

Building:	Main Building
Location:	All Areas
Finding:	Brickwork Rendering - Cracking [Fine]
Information:	At the time of inspection, minor cracking was noted to the external rendered brickwork. This is commonly associated with normal building movement or shrinkage of the render over time.

Cracking of this nature can generally be repaired with minor filling and should be conducted by a rendering specialist or painter.

Always contact a building inspector should cracks widen lengthen or become more numerous.

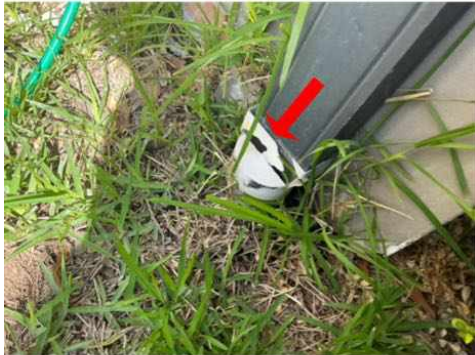
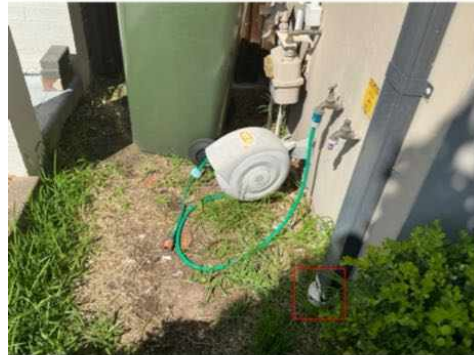
Finding 3.05

Building: Main Building
Location: Yard - Front
Finding: Roof Plumbing - Damaged
Information: The downpipe was noted as damaged in this area at the time of inspection.

Possible cause of the damage could be deterioration or accidental damage.

When a downpipe is damaged, it can lead to several issues. Water may not be properly directed away from the building, causing potential water damage, foundation problems, or soil erosion. Additionally, a damaged downpipe can compromise the overall efficiency of the drainage system, leading to water pooling, leaks, and other

structural concerns. It's crucial to address downpipe damage promptly to prevent further complications.

It is advised to engage the services of the roof plumber to rectify the issue.

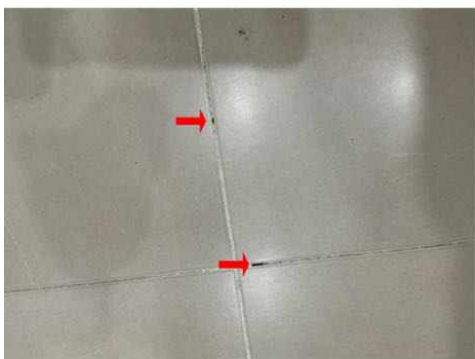
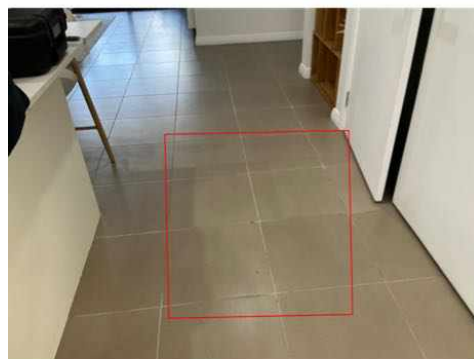
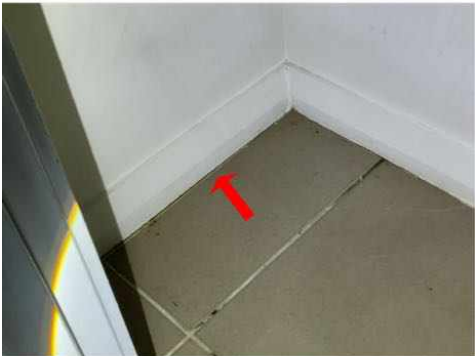
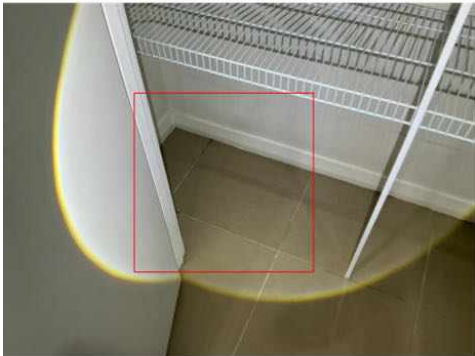
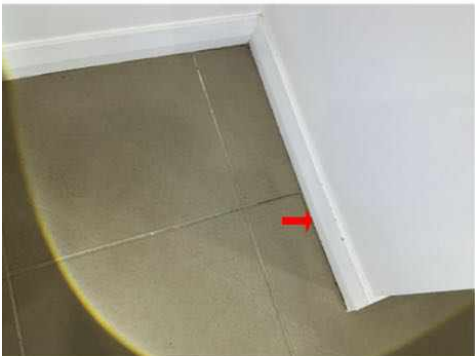
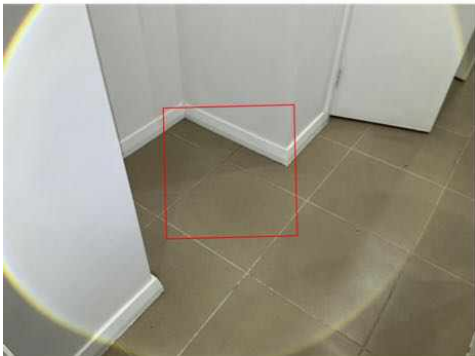
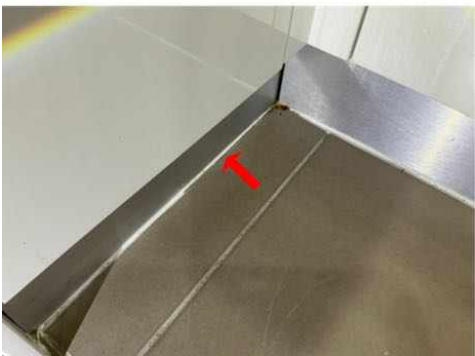
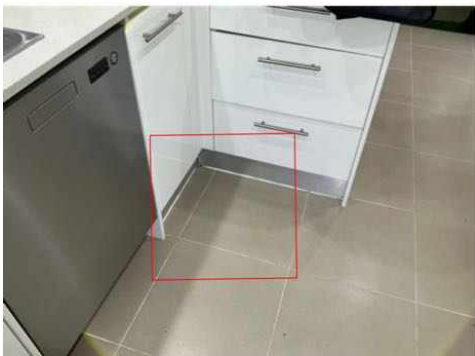
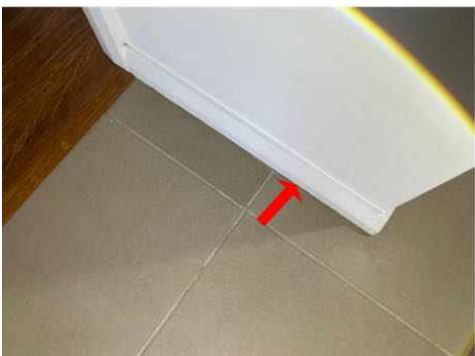
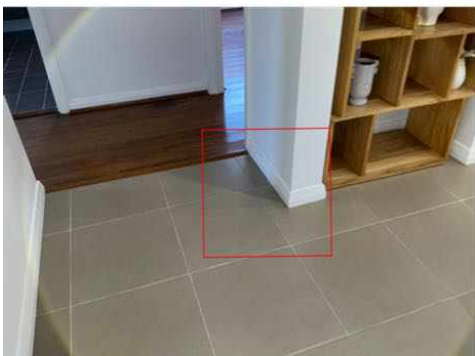
Finding 3.06

Finding: Sealant and Grouting - Missing/Damaged (Common Areas)

Information: At the time of inspection, missing or deteriorated sealant and grout were noted in common areas of the house. Gaps of this nature can allow dust and moisture to accumulate, leading to minor surface damage or staining over time. It is recommended to engage a handyman or tiling specialist to reapply flexible sealant or grout to restore a neat finish at own discretion.

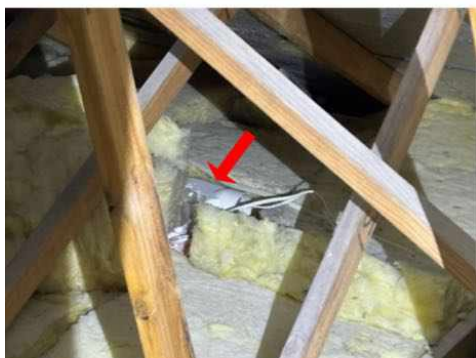
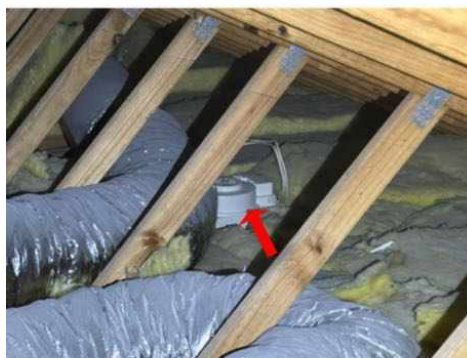
Finding 3.07

Building: Main Building
 Location: Roof Void
 Finding: Vent - Extracted into Roof Space
 Information: During the inspection, it was noted that the exhaust vent has been improperly terminated into the roof space instead of being ducted to the exterior of the property.

This configuration is a defect as it allows moist air to accumulate within the roof cavity, increasing the risk of condensation, mould growth, and deterioration of insulation or timber framing. Proper ventilation is essential to maintain a healthy indoor environment and protect the structural integrity of the building. It is recommended that the vent be appropriately re-routed to discharge externally in compliance with relevant building standards.

A licensed mechanical ventilation contractor/electrician should be appointed as soon as possible to provide further consultation on the scope of these works and to provide quotations for any necessary works.

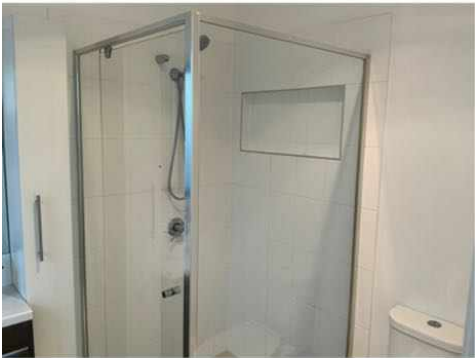
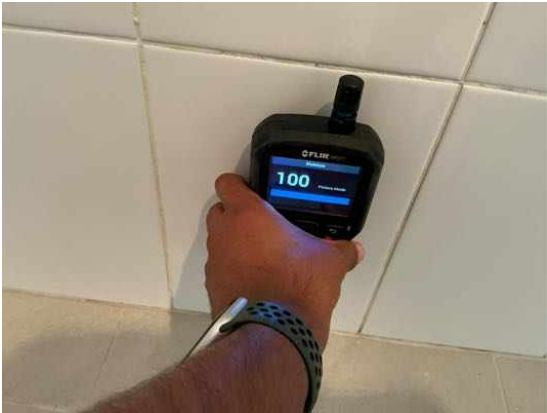
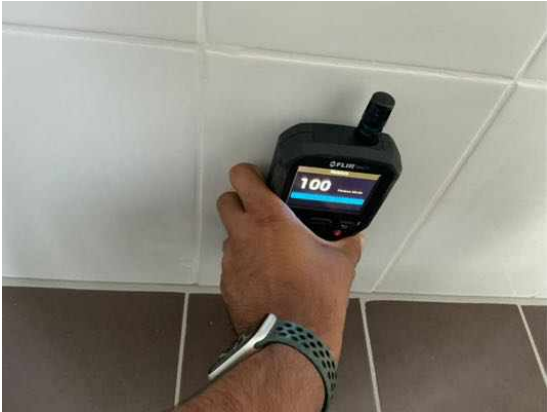
Finding 3.08

Building: Main Building
 Location: Both Bathrooms
 Finding: Excessive Moisture - Shower Damp
 Information: At the time of inspection, excessive moisture was noted within the shower area, which

is a common issue in wet areas due to the continual exposure to water. This condition is typically caused by moisture seeping through grout lines and settling behind tiles, resulting in localised high-moisture zones. Provided there is no evidence of water staining or elevated moisture readings on the opposite side of the wall, this is considered a minor defect.

However, persistently damp conditions may act as conducive conditions for termite activity, as termites are strongly attracted to moisture-rich environments. It is recommended that the client ensures regular use of the exhaust fan and maintains adequate ventilation after shower use to promote drying and reduce long-term moisture build-up, thereby also reducing the risk of attracting termites.

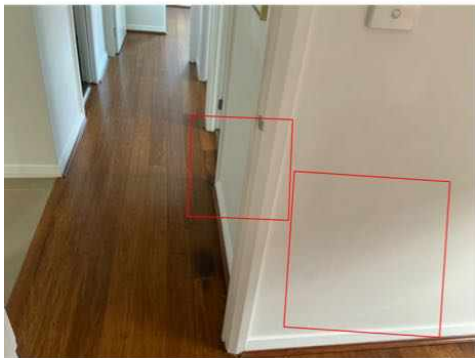
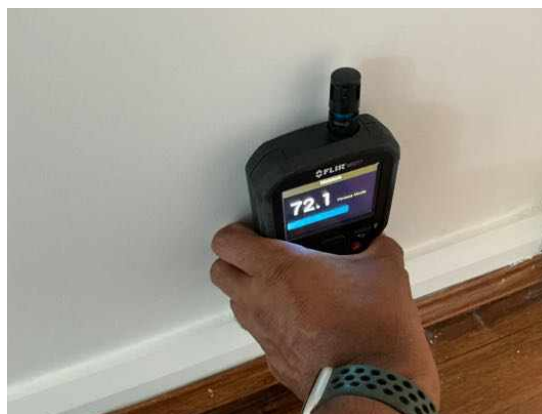
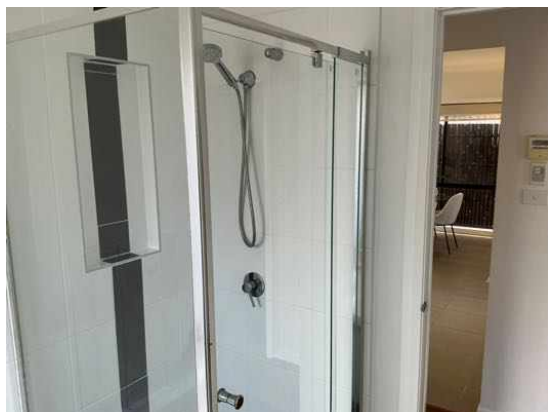
Finding 3.09

Information: At the time of inspection, elevated moisture levels were detected on the wall adjacent to the shower area. While no visible water damage or deterioration was noted, the presence of moisture suggests possible seepage or condensation associated with regular shower use.

At this stage, no immediate action is required. However, the area should be monitored over the next 12 months for any signs of deterioration such as staining, bubbling paint, or mould growth. It should be noted that moisture ingress of this nature does not generally resolve without intervention, and at some point remedial works are likely to be required. Should conditions worsen, the client is advised to engage services of a licensed plumber or waterproofing specialist to rectify the issue of moisture before this minor defect turns into major defect.

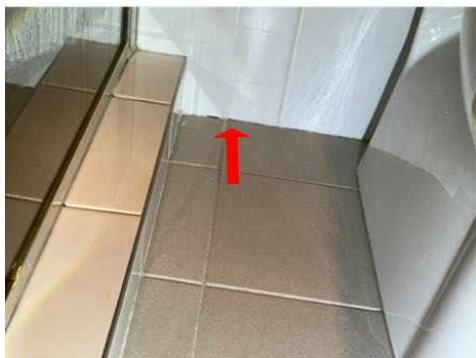
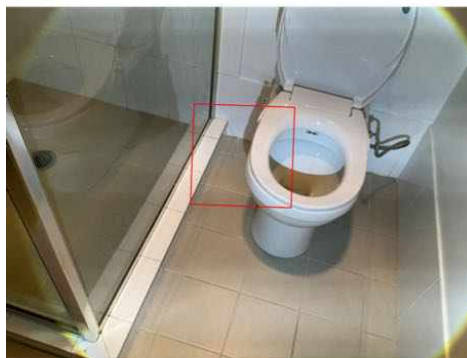
Finding 3.10

Building:	Main Building
Location:	Ensuite - Master
Finding:	Sealant/Grouting - Missing or Damaged
Information:	At the time of inspection, areas of missing and/or deteriorated sealant and grout were noted in this area. This condition can allow water to penetrate behind finishes, which may lead to moisture ingress, deterioration of waterproofing membranes, mould growth, and potential leaks into adjoining areas over time. If left unaddressed, this may result in costly repairs and hidden water damage.

It is recommended that a licensed plumber (or suitably qualified tradesperson experienced in wet area sealing) be engaged to assess the affected areas and reinstate compliant waterproof sealant and grout as required, ensuring all junctions are properly sealed to prevent further water ingress.

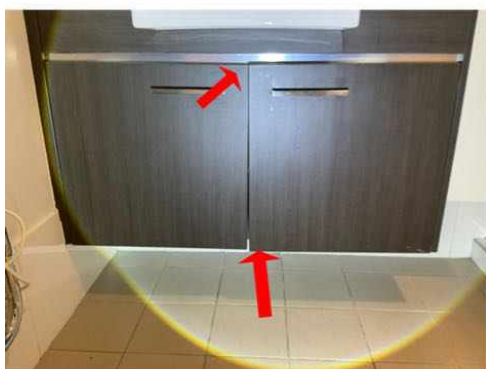
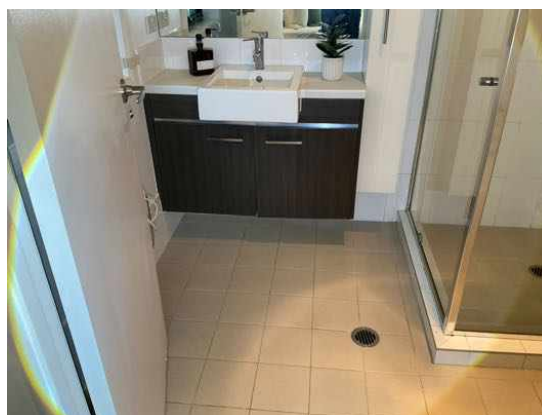
Finding 3.11

Building: Main Building
 Location: Ensuite - Master
 Finding: Cabinet Doors - Misaligned
 Information: At the time of inspection, some cabinets were observed to be misaligned, with uneven door and panel alignment noted. This affects the overall appearance and may impact the smooth operation and closing of the cabinet doors over time.

It is recommended that the client engage the services of a handyman to realign and adjust the cabinetry to restore proper alignment and functionality.

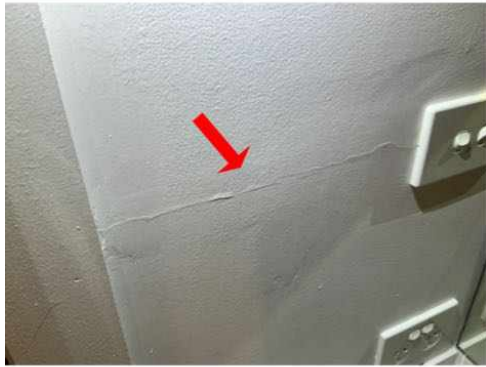
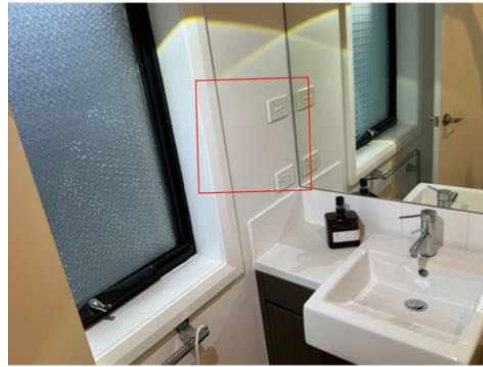
Building: Main Building
 Location: Ensuite - Master
 Finding: Cracking - Damage Category 1 - Fine (up to 1mm)
 Information: Although fine cracks are quite noticeable, they are often only considered to be an appearance defect, and usually do not indicate any structural damage. Generally, the cause of a fine crack is indicative of a separation between building materials and finishes (e.g. paint, plaster, etc.) along joins.

Cracking of this nature can generally be repaired with minor sanding, filling and/or

repainting. Such works should be performed by a qualified painter or a general handyman.

Monitoring of all cracking should be conducted frequently. Always contact a building inspector should cracks widen, lengthen, or become more numerous.

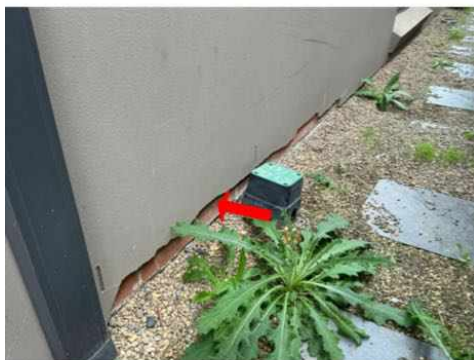
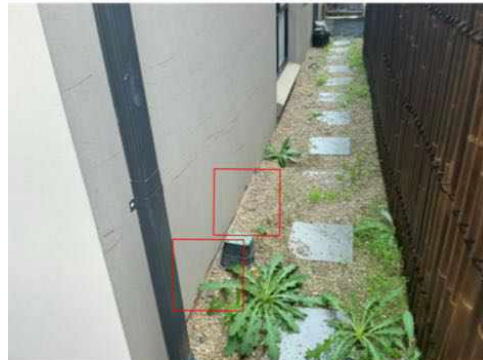
Finding 3.13

Building:	Main Building
Location:	Exterior walls - right side
Finding:	Render - Damaged
Information:	It was noted at the time of inspection, the rendering exhibits minor damage, including a section where the render has delaminated and broken away, exposing the underlying structure. This deterioration is likely due to moisture ingress, impact damage, or poor adhesion during application. The exposed area poses a risk of further degradation, compromising the structural integrity and aesthetic appeal of the wall. Remedial action is recommended, including repairing or reapplying the render and addressing any underlying causes, such as drainage issues or substrate instability, to prevent recurrence.

The client is advised to engage a rendering specialist at their own discretion.

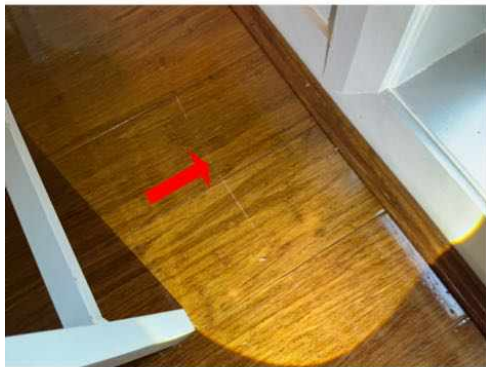
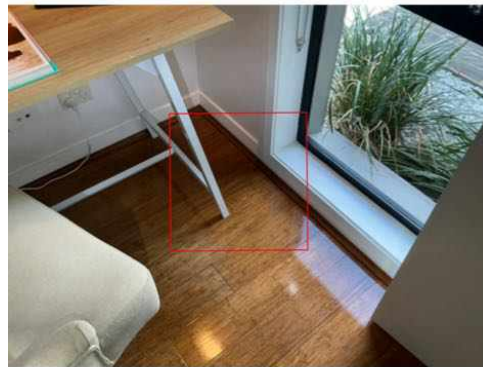
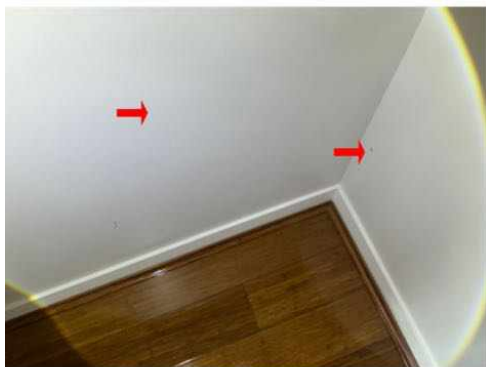
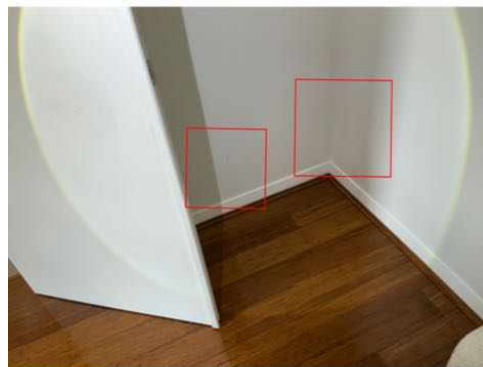
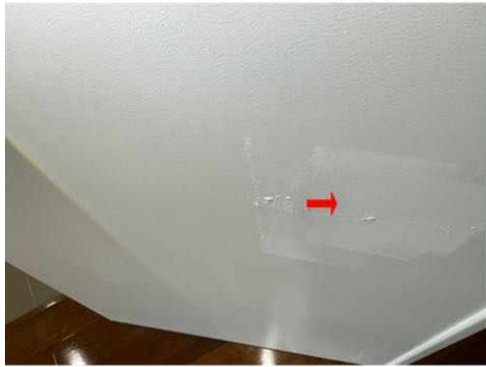
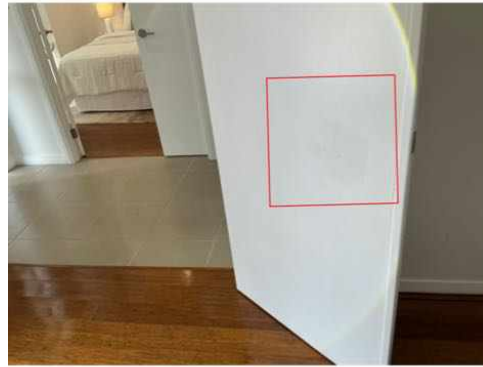
Finding 3.14

Building: Main Building
Location: All Areas
Finding: Maintenance and/or Wear and tear on building elements
Information: It was observed at the time of inspection that some building elements and areas around the property require general maintenance and/or exhibit signs of wear and tear. These typically include minor imperfections such as paint scuff marks, scratches on surfaces, small chips, nails or hooks left in walls from previous picture hanging, and other superficial blemishes.

These are generally considered minor items that are common in established homes. While they may be noticeable on visual inspection, they do not affect the structural integrity or functionality of the property. In most cases, these issues can be easily addressed by a qualified handyman as part of routine maintenance.

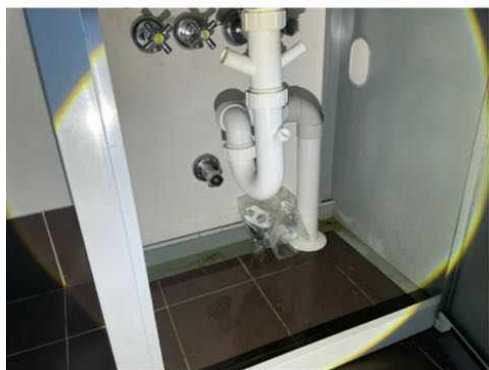
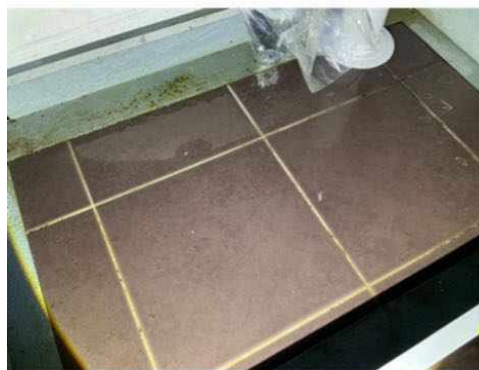
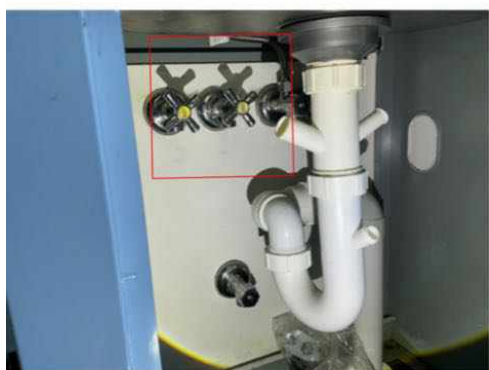
Finding 3.15

Information: At the time of inspection, minor dripping was noted from one of the washing machine connection taps within the laundry cabinet. This appears to be due to the washing machine hoses having been removed, which is common when the previous occupants take their appliance with them.

The dripping is likely occurring because the outlet is not currently sealed by a hose connection. Once the client installs their washing machine and properly connects the hose to the tap, the issue is expected to resolve.

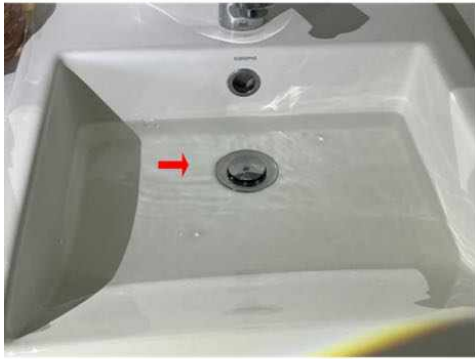
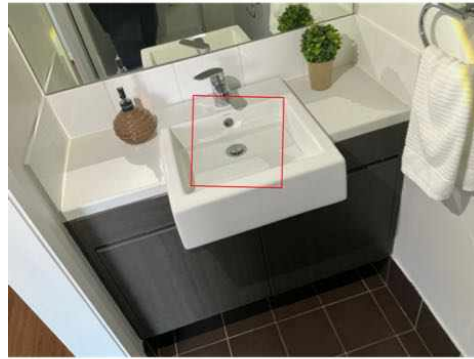
Finding 3.16

Building:	Main Building
Location:	WC
Finding:	Sink - Slow Draining
Information:	The sink drain appeared to be slow draining at the time of inspection.

Blockages prevent building elements from operating as intended. If left unmanaged, a lack of general maintenance may lead to the development of more significant defects, such as water damage to surrounding building materials. It is advised that the blockage be removed as soon as possible.

If blockage remains, a licensed plumber should be appointed as soon as possible to perform any remedial works where required.

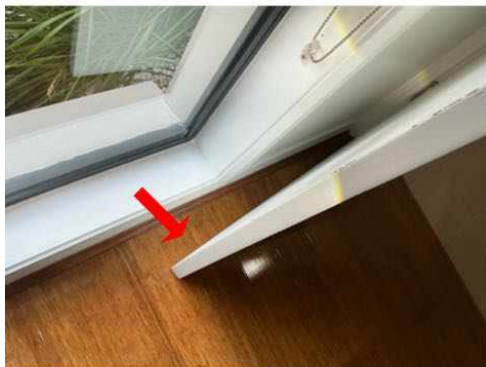
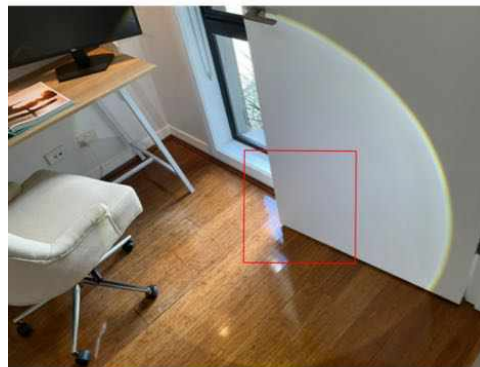
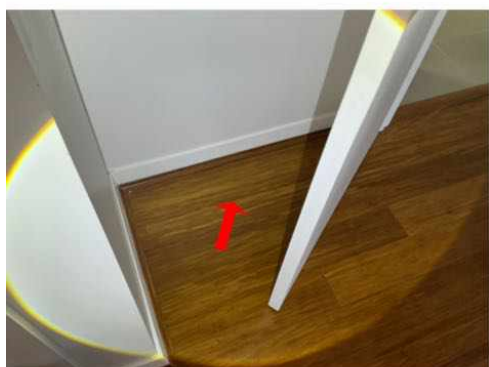
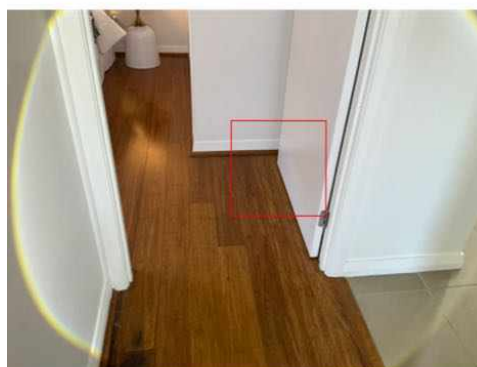
Finding 3.17

Building: Main Building
 Location: Study, Bedroom 2
 Finding: Door Stopper(s) - Missing
 Information: At the time of inspection, it was noted that a door stopper was missing in this area.

The absence of a door stopper can lead to potential damage to the door, wall, or surrounding finishes, as the door may swing open too far and impact the wall or adjacent objects. Over time, this can cause dents, scuffs, or even structural damage to the wall or door. It is recommended that a door stopper be installed to prevent further damage and ensure the protection of both the door and the surrounding area.

The client is advised to engage services of a handyman to install the door stopper.

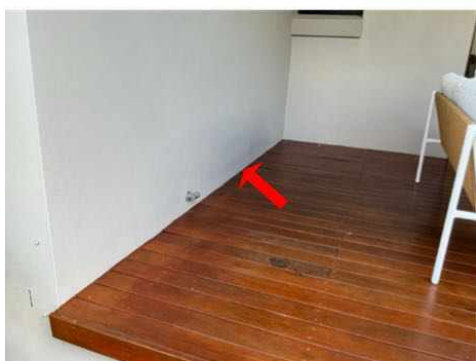
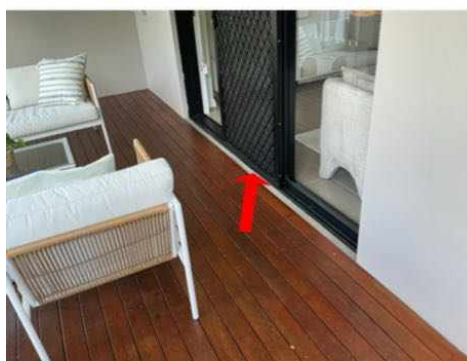
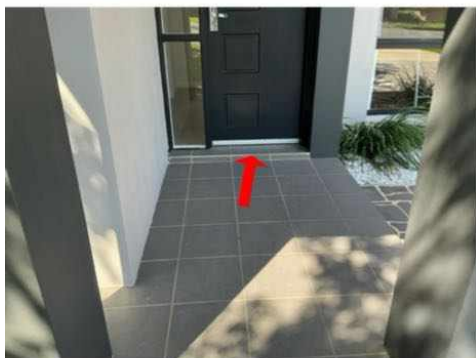
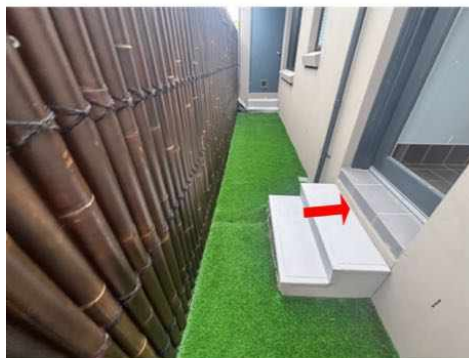
Finding 6.02

Building:	Main Building
Location:	All Entries
Finding:	Bridging or Breaching of Termite Barriers - Adjacent Internal Flooring
Information:	Bridging is the spanning of a termite barrier or inspection zone so that subterranean termites are provided with passage over or around that barrier.

It is important for internal flooring to be raised above adjacent external ground levels. Where external ground levels are above or same level as internal flooring, water pooling and subsequent internal flooding is likely to occur which may attract termite activity to the internal area.

It is highly advised that a landscaper or relevant tradesperson be appointed to lower external grounds that are raised above or same as adjacent internal flooring. Alternatively if external grounds and internal flooring is level installation of a raised door sill may be appropriate in preventing any water pooling in the area. If the client wishes not to make any changes, then a qualified pest controller is recommended for termite treatment around the perimeter of the house and subfloor (if any) as soon as possible.

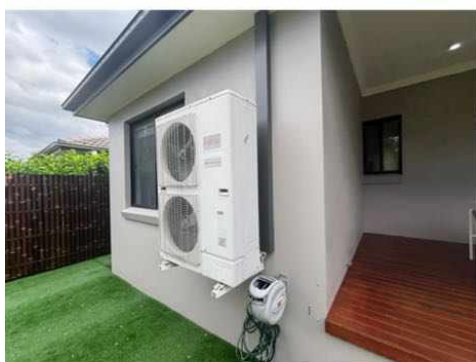
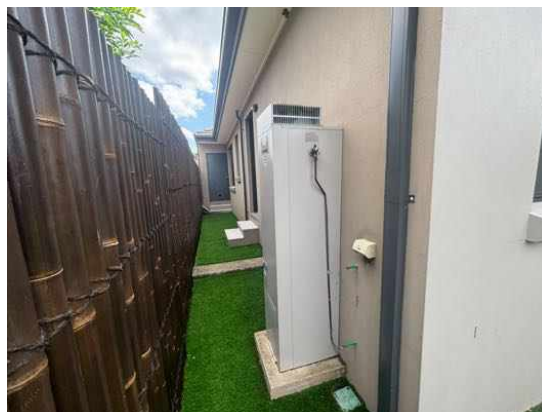
Finding 6.03

Building:	Main Building
Location:	All Areas
Finding:	Bridging Appliances - Attachment to Buildings
Information:	Bridging occurs when items against a building provide a concealed entry point for termites into the building or by passing around a termite management system.

Where any part of an attachment to a building is not isolated and is not provided with a clear gap of not less than 25mm from the building, bridging occurs. Attachments to buildings such as hot water services, downpipes, verandahs, decks, steps, fences, service conduits and the like provide the opportunity for concealed entry.

Building attachments of this nature need to be frequently inspected for termite activity by a qualified inspector.

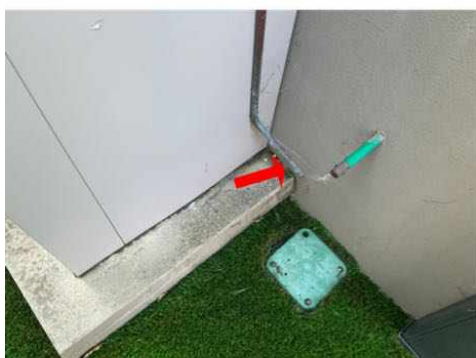
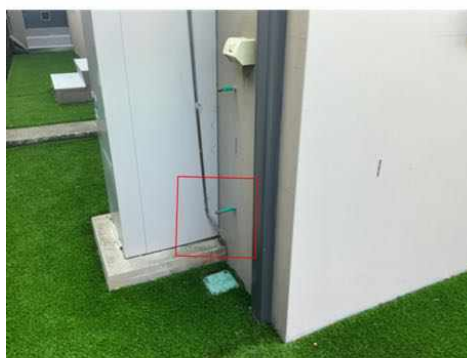
Finding 6.04

Building:	Main Building
Location:	Exterior walls - right side
Finding:	Overflow Disconnected - HWS/AC/Gas - Conducive Conditions to Termites
Information:	The overflow to this service was found to be disconnected from stormwater drainage and is creating excessive moisture in the surrounding area.

Such leaking creates an environment that is conducive to an array of defects, including water damage to associated building elements and the attraction of termite or timber pest infestation. These damp conditions can lead to secondary defects such as rot, rust, or corrosion of associated building elements, the formation of fungal decay, or even the creation of potential slip hazards. When coupled with poor site drainage, pooling of water may also attract termite activity to this area.

It is highly recommended that a licensed plumber be appointed to connect the overflow in order to prevent such an environment from being created. These minor works should be carried out as soon as possible.

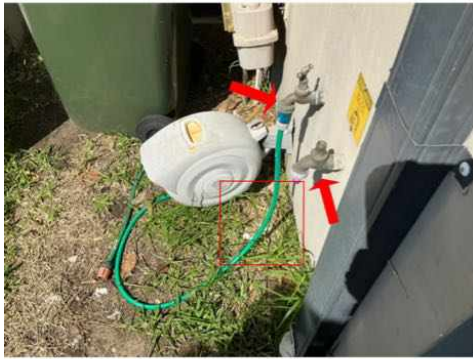
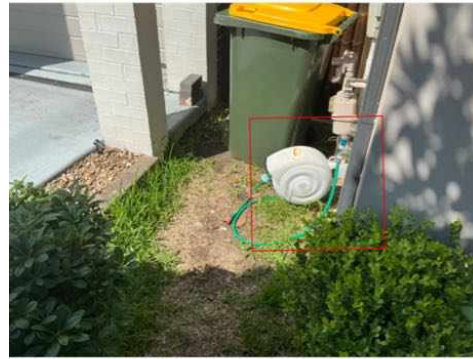
Finding 6.05

Building:	Main Building
Location:	Exterior walls - left side
Finding:	No Stormwater Drain - Under Exterior Tap
Information:	The inspection identified that the exterior tap is not connected to a stormwater drainage system, allowing water to pool around the base. This can lead to moisture-related issues such as deterioration of nearby building materials, mould growth, and increased risk of termite activity—each of which may compromise the property's structural integrity and create health or safety concerns.

To prevent these risks, it is strongly recommended that a licensed plumber be engaged to assess the area and install appropriate drainage, such as a stormwater connection or splash block, to redirect water away from the property. Ongoing maintenance and monitoring of external water sources are also advised to ensure long-term protection.

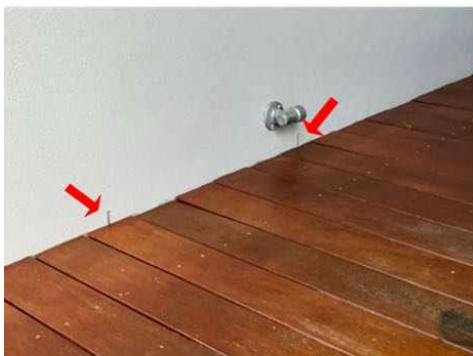
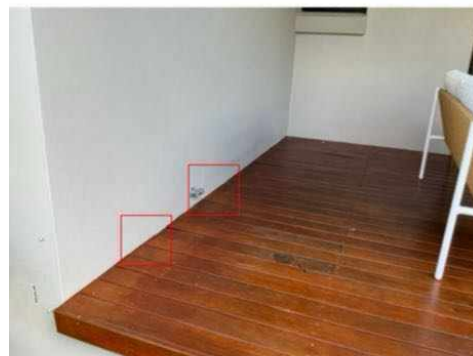
Finding 6.06

Information: It was noted during the time of inspection that some of the weep holes to the brickwork were partially blocked. Weep holes are designed to allow water from leaks or seepages in brickwork to be directed to the external environment, prior to entering the wall cavity or associated building materials. Weep holes should therefore be kept clean and free of debris or blockages.

Blocked weep holes are likely to result in the presence of excessive moisture within the brickwork and associated structures, creating potential for water damage and moisture problems.

The client is advised to engage services of registered builder to remove the blockages.

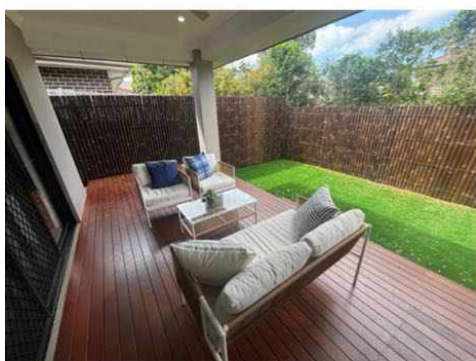
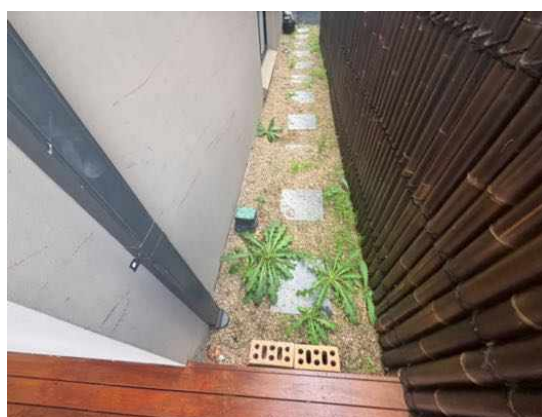
Building: Main Building
Location: All External Areas
Finding: Obstructions and Limitations - External Areas
Information: The attached photographs provide a visual representation of the obstructions and limitations that impeded a full inspection of the external areas of the property at the time of assessment. These obstructions, which may include vegetation, stored items, debris, or other physical barriers, can obscure potential defects and prevent a thorough evaluation of the property's condition. Obstructions of this nature can conceal a wide range of issues, such as structural damage, water ingress, pest infestations, or deteriorating building materials, which may not be visible during the initial inspection.

It is essential that these obstructions be cleared to allow for a comprehensive inspection of the external areas. Removing these barriers will enable a more accurate assessment of the property's condition and allow any hidden defects to be identified and addressed promptly. Failure to do so could result in undetected issues worsening over time, potentially leading to more costly repairs in the future.

Therefore, it is strongly recommended that the obstructions be removed and a re-inspection be scheduled once the affected areas are made fully accessible. This will ensure a complete evaluation of the property's exterior and provide the client with a clear understanding of any potential issues that may have been concealed during the initial inspection.

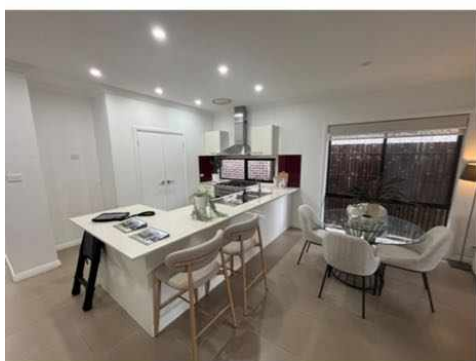
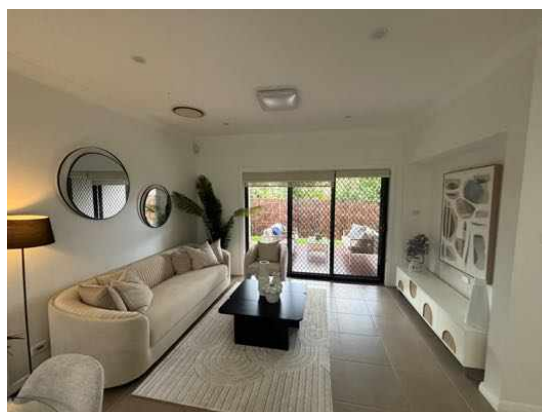
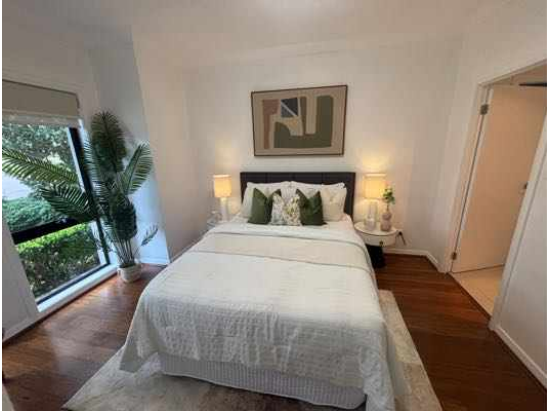
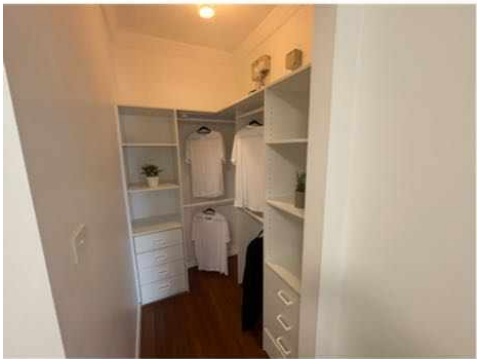
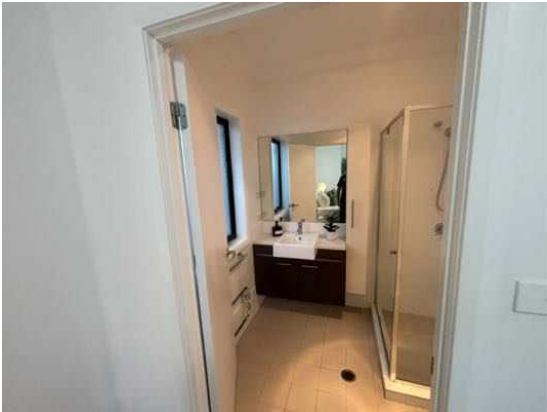
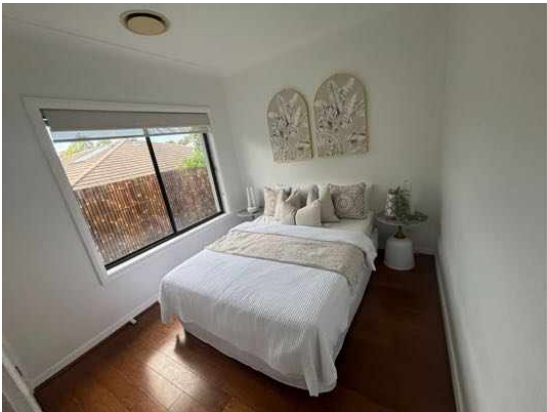
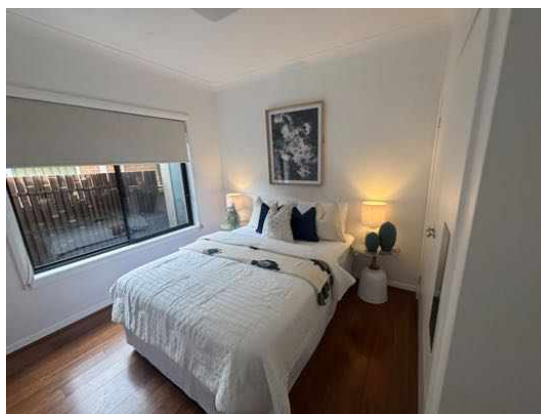
Building:	Main Building
Location:	All Internal Areas
Finding:	Obstructions and Limitations - Internal Areas
Information:	<p>The accompanying photographs provide clear evidence of the obstructions and limitations that restricted a comprehensive inspection of the internal areas of the property at the time of assessment. These obstructions, which may include furniture, personal belongings, stored items, or structural elements such as wall coverings and built-ins, significantly hindered the ability to thoroughly evaluate these areas. It is important to note that such obstructions can potentially conceal a wide array of defects, ranging from hidden structural damage, water leaks, pest infestations, or electrical issues, to deteriorating materials that may not be visible during the initial inspection.</p>

The presence of these impediments means that critical areas of the property were not accessible, and therefore, any underlying defects that may affect the integrity and safety of the property could remain undetected. These hidden defects, if left unaddressed, could worsen over time and may result in costly repairs or pose potential safety hazards to the occupants.

It is highly recommended that all obstructions be cleared to facilitate a complete and thorough inspection of the internal areas. Once the obstructions have been removed and full access is available, a re-inspection should be carried out to ensure that any previously concealed issues can be properly identified and rectified. This follow-up inspection will provide a more accurate assessment of the property's internal condition and help the client make informed decisions about any necessary repairs or maintenance.

In summary, the limitations encountered during the inspection highlight the importance of ensuring full access to all areas of the property to accurately assess its overall condition. A re-inspection is strongly advised once these areas are made accessible.

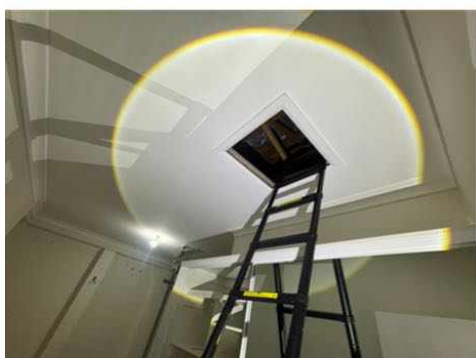
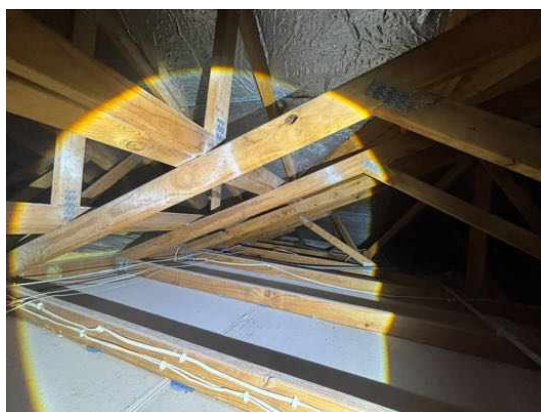
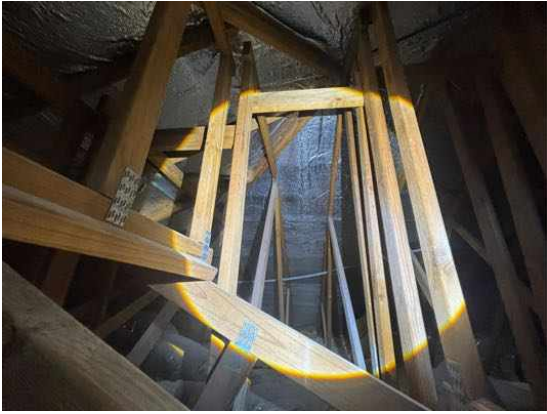
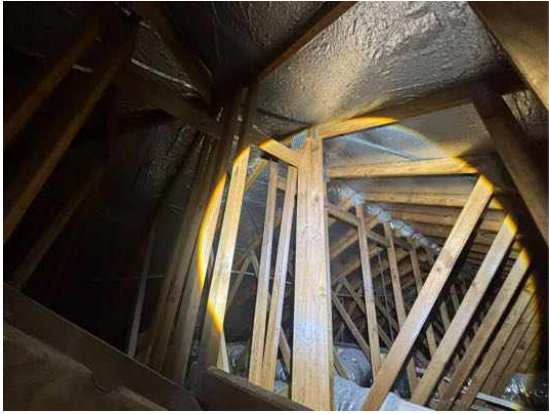
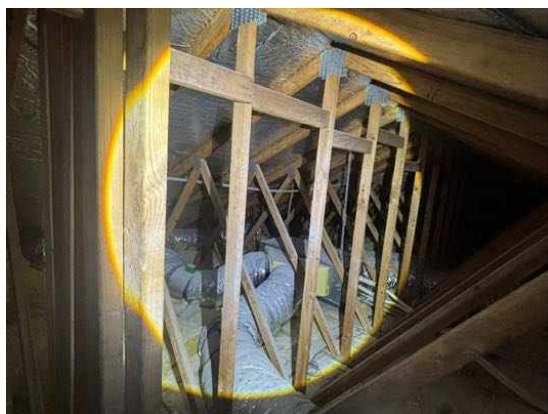
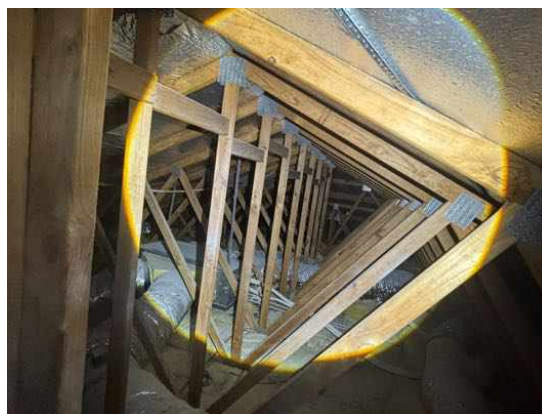
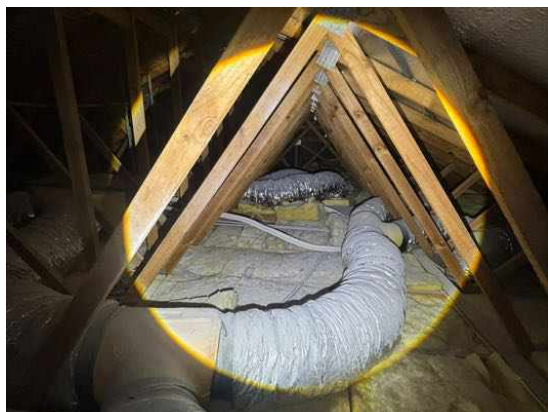
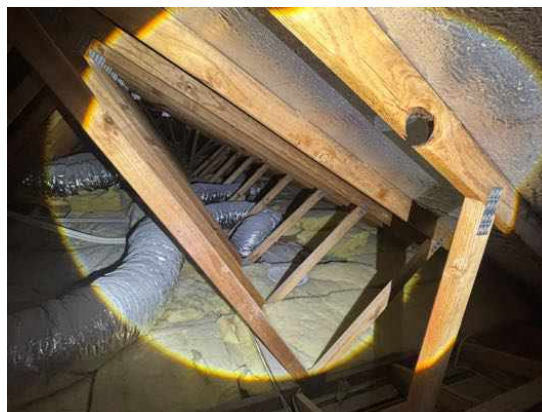
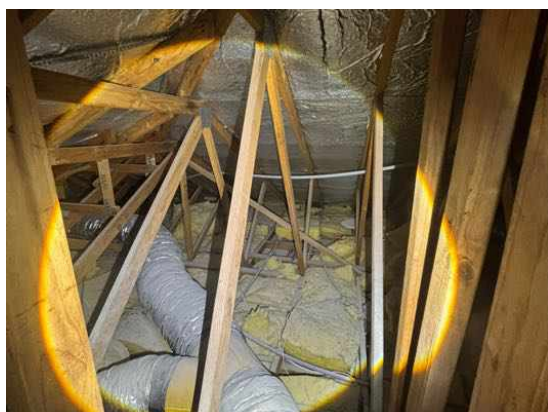
Building:	Main Building
Location:	Roof Void
Finding:	Obstructions, Limitations, and General Roof Space Condition
Information:	The photographs provided document both the general condition and the obstructions and limitations that were present in the roof cavity of the main building at the time of inspection. These obstructions—such as insulation materials, stored items, structural elements, or electrical wiring—restricted safe and adequate access to key areas within the roof space. As a result, a comprehensive inspection of all components could not be completed.

Obstructions of this nature may conceal a variety of potential defects, including damaged framing, compromised insulation, evidence of moisture ingress, pest activity, or electrical hazards. While no major issues were observed in the visible areas, the presence of these limitations means that some defects may remain undetected.

It is recommended that these barriers be removed or repositioned to facilitate full and safe access to the roof space. Once clear, a follow-up inspection should be conducted to allow for a thorough assessment of all concealed areas. This will help ensure that the condition of the roof cavity is accurately evaluated and any hidden issues are appropriately identified and addressed.
