Building and Timber Pest Inspection Report

Inspection Date: Thu, 5 Mar 2026

Property Address: 15 Grandiflora St, Rouse Hill NSW 2155,
Australia

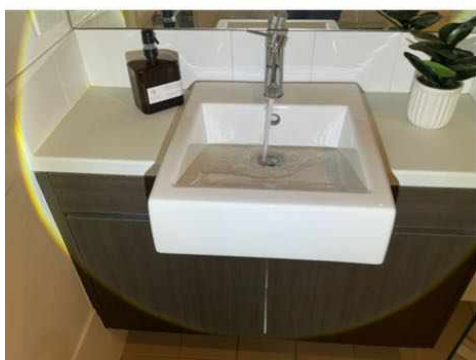
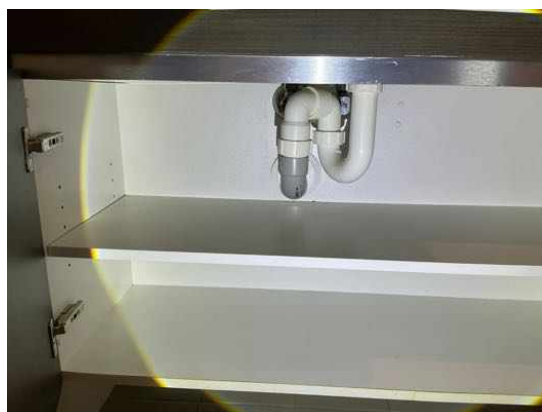
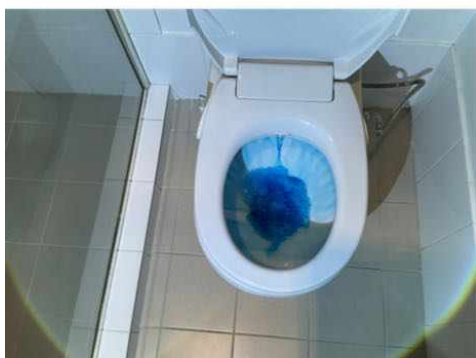
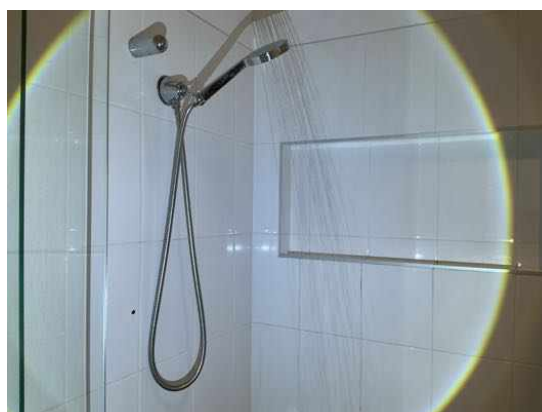
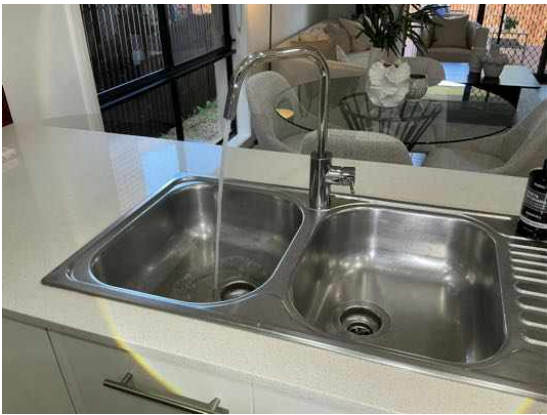
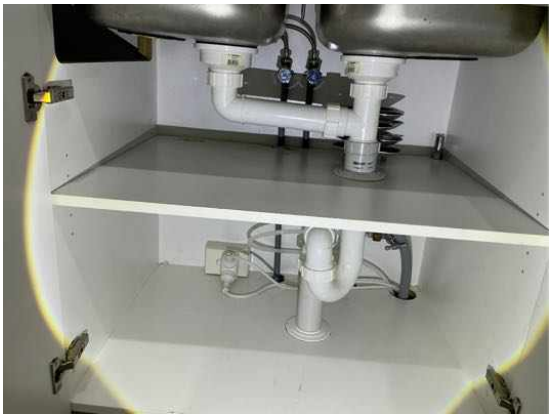
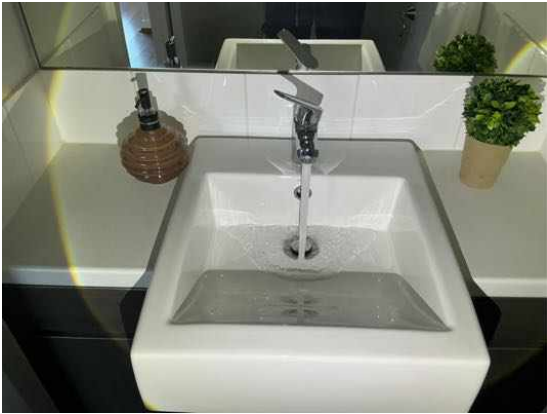
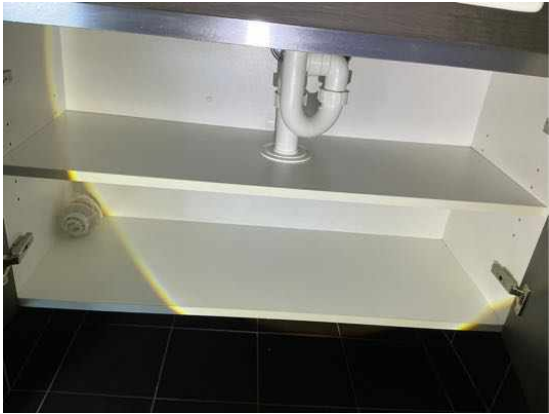
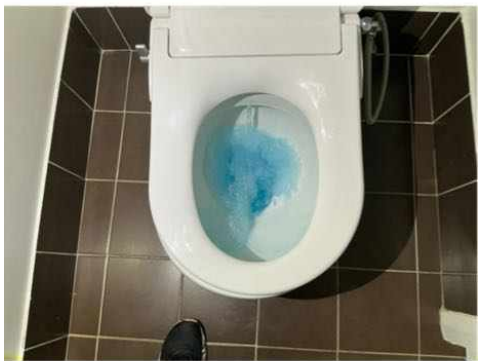
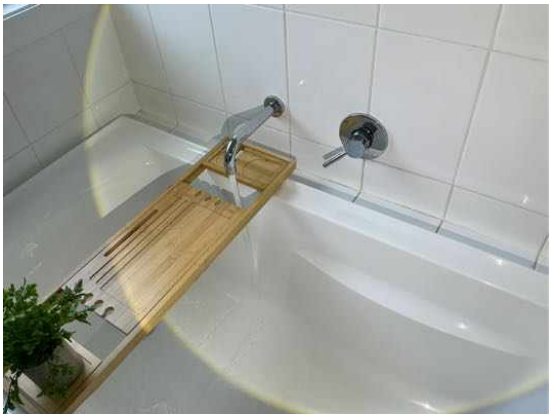
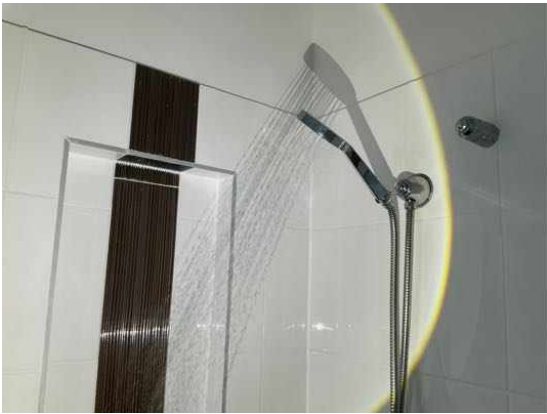
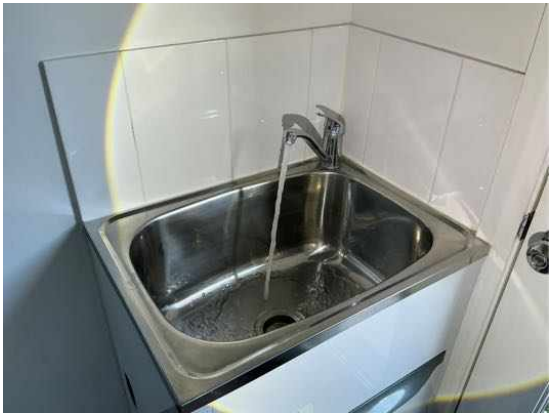
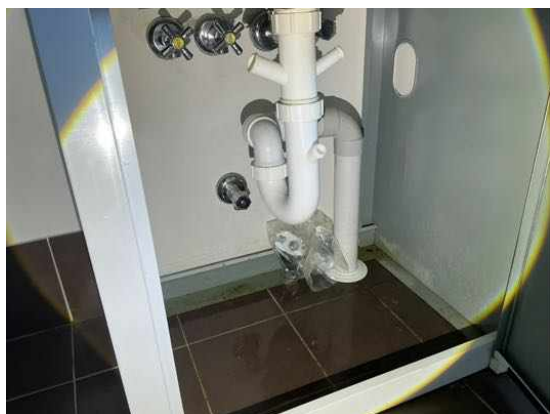
Building: Main Building
Location: All Areas
Finding: FYI - Taps, Drainage & Toilets Tested and Cabinetry Obstructions
Information: During the inspection, all accessible taps, drainage systems, and toilets were tested for water flow and drainage efficiency, and checked for any visible signs of leakage. At the time of the inspection, no issues were noted in these areas. Unless highlighted in a separate defect statement, no immediate remedial work appears necessary. Supporting images may be found in the additional photos section for reference.

It is important to note that while a visual inspection of cupboards and cabinetry beneath sinks and vanities was undertaken, stored personal items and fixtures presented obstructions that limited full visibility of the internal areas. As per standard inspection practices, inspectors are not permitted to move or disturb personal belongings during the inspection process. Therefore, only visible and accessible sections were inspected, and concealed water damage or plumbing defects may not have been detected.

Given this, a re-inspection is recommended after all obstructions have been cleared to allow for a comprehensive assessment of these areas. Regular maintenance and monitoring of plumbing and drainage systems is also advised to ensure ongoing functionality and early detection of potential issues.

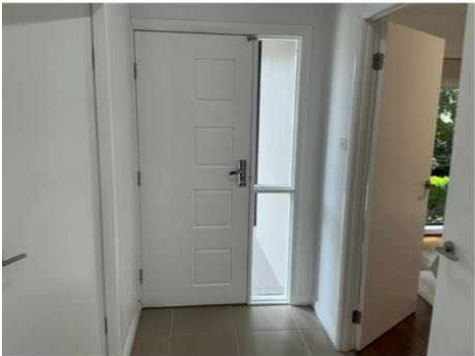
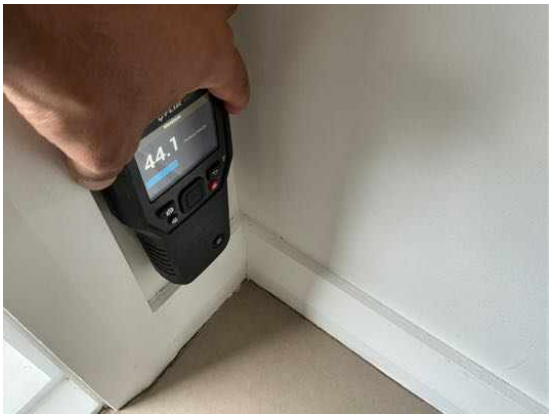
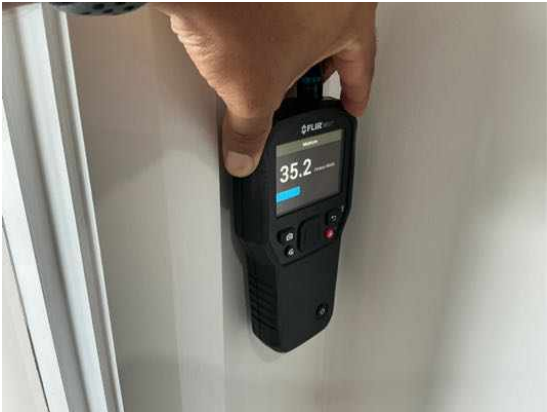
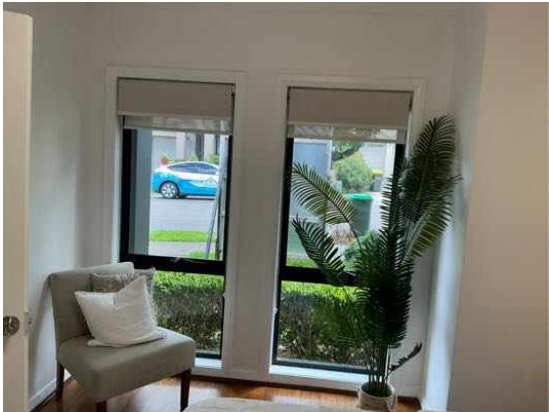
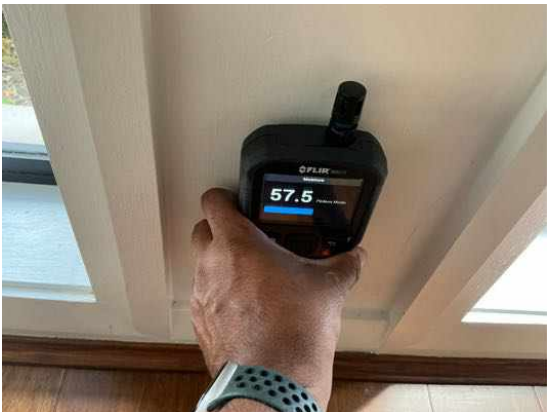
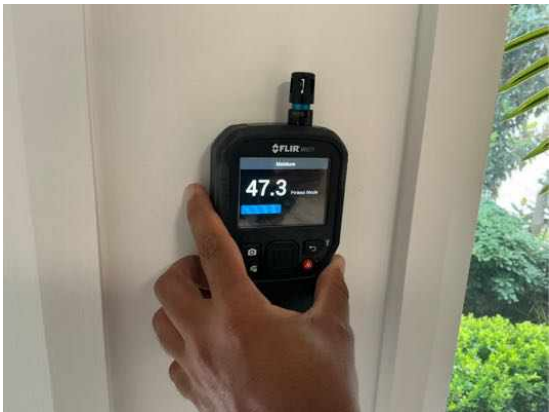
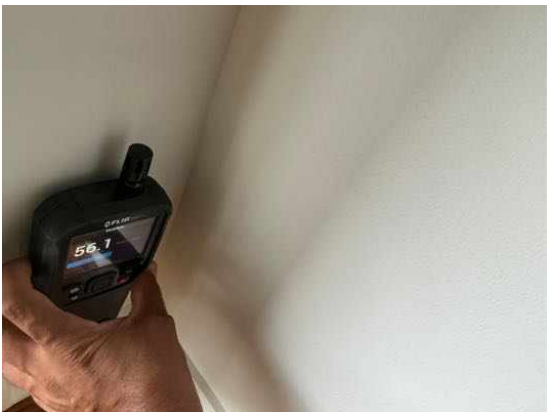
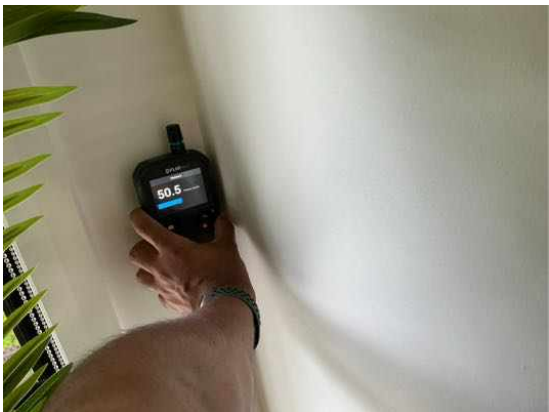
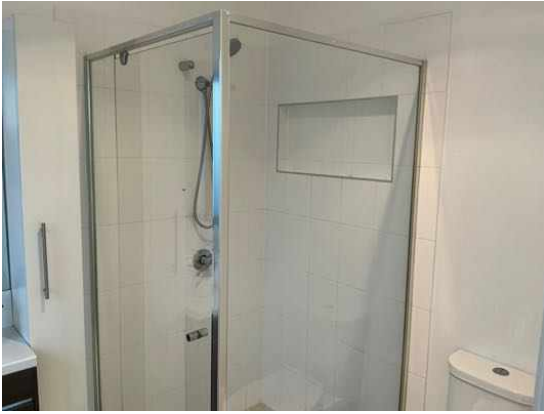
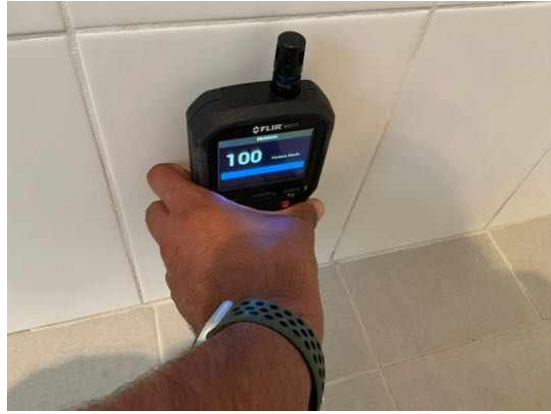
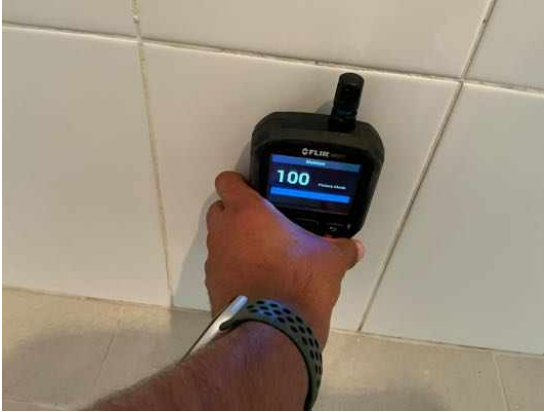
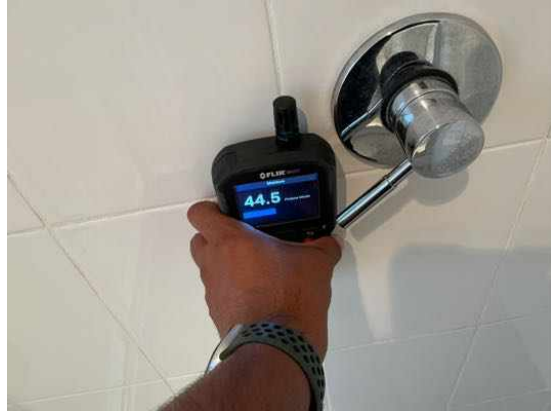
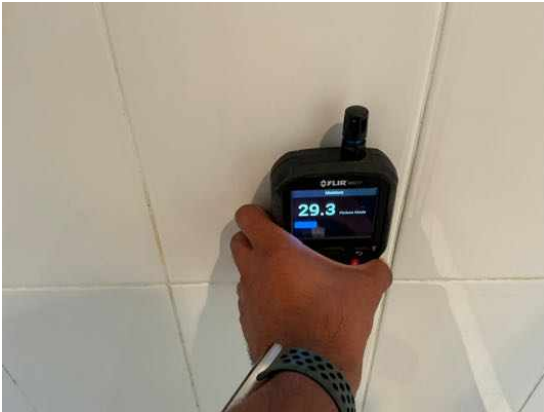
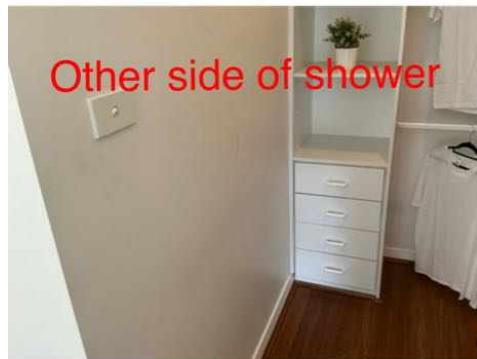
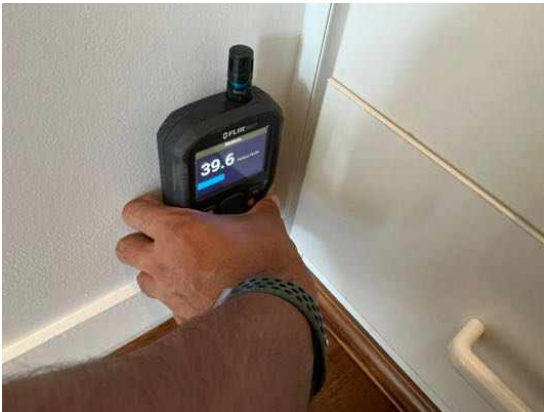
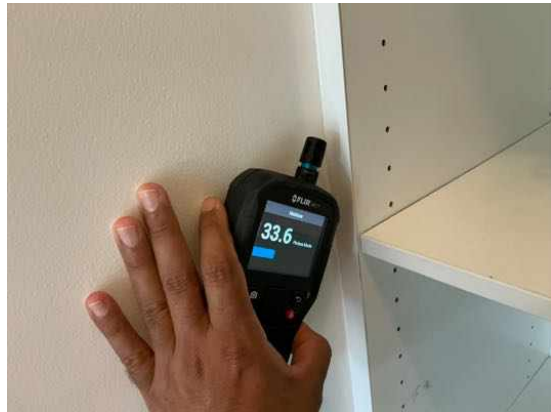
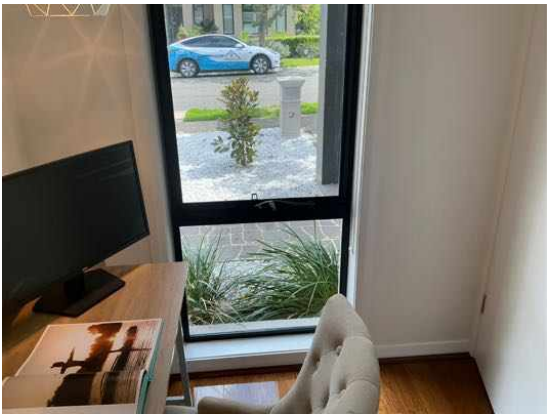
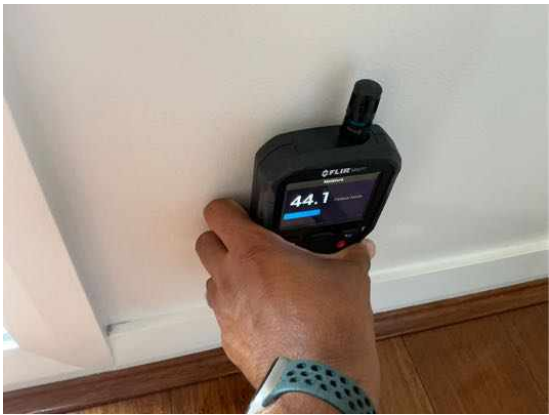
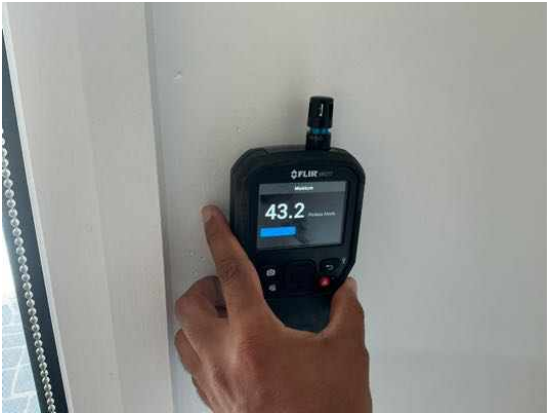
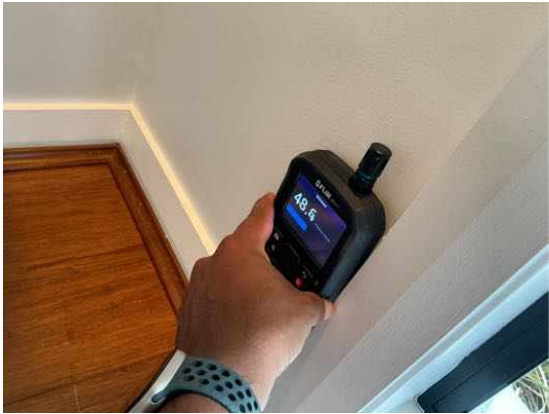
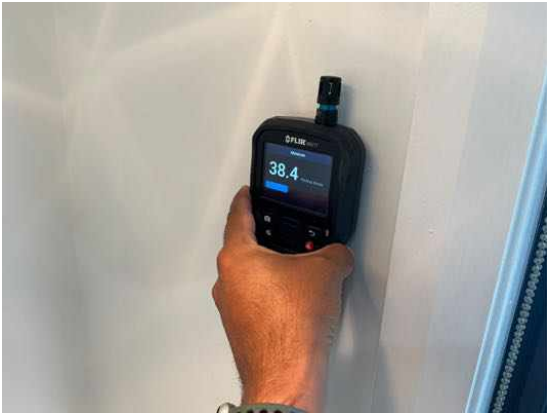
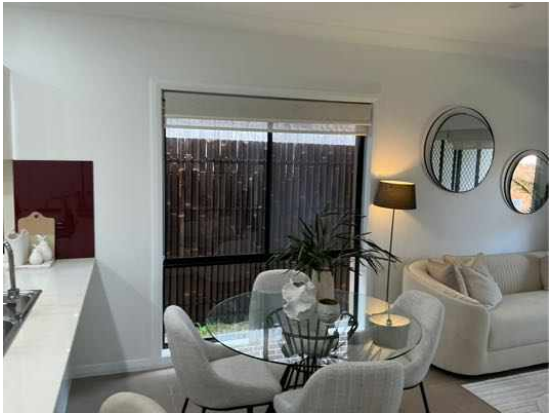
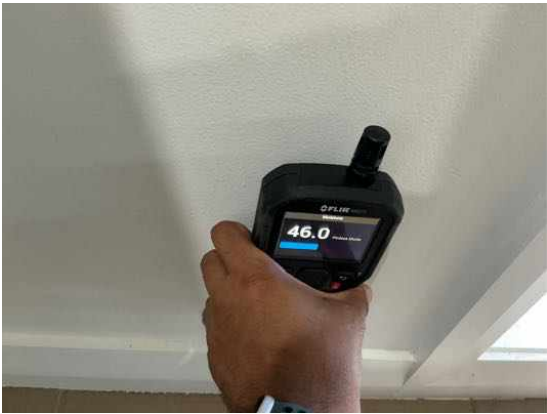
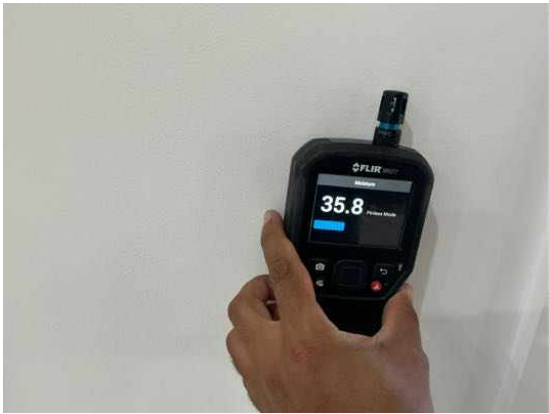
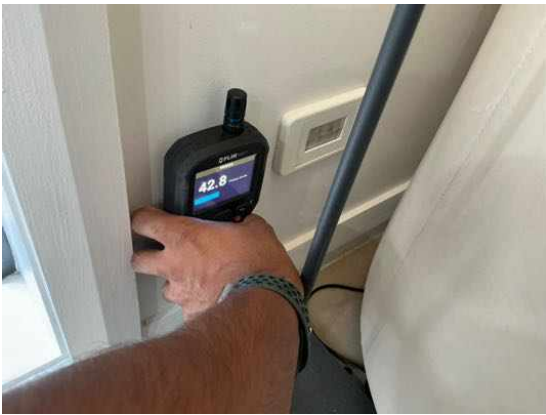
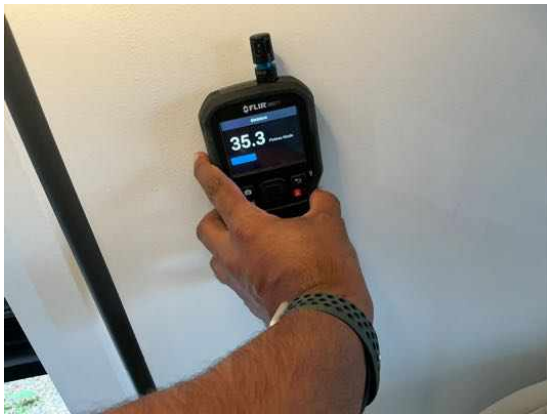
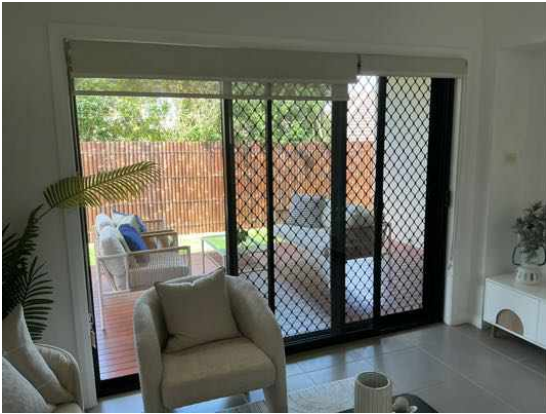
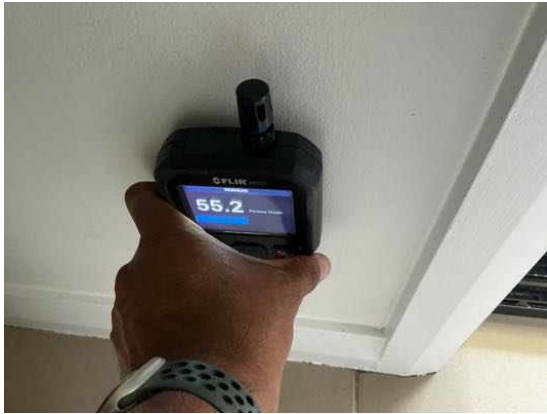
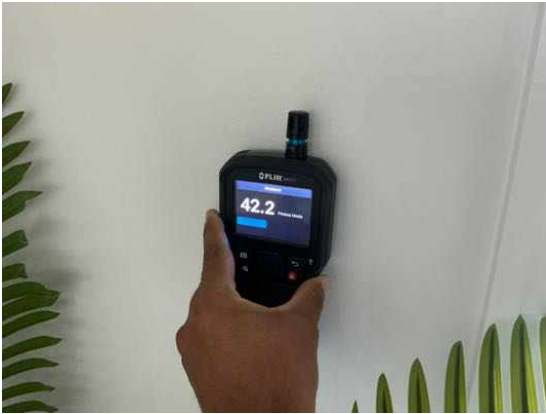
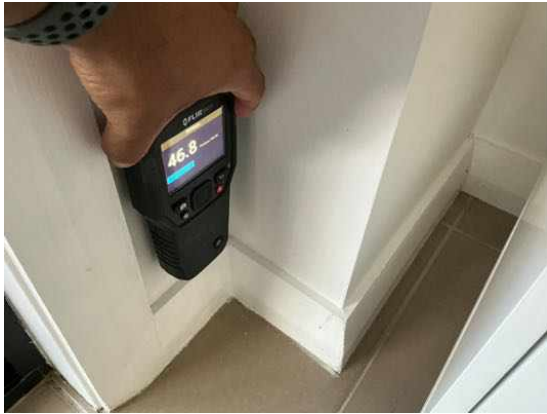
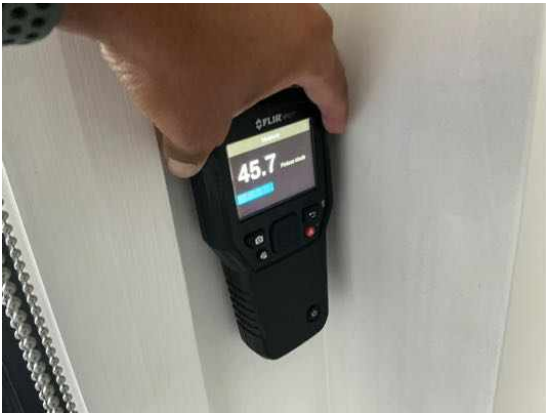
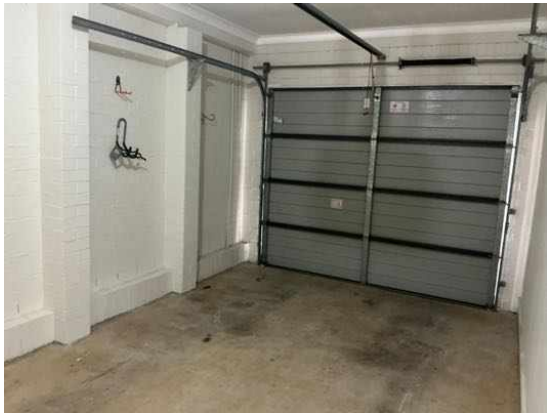
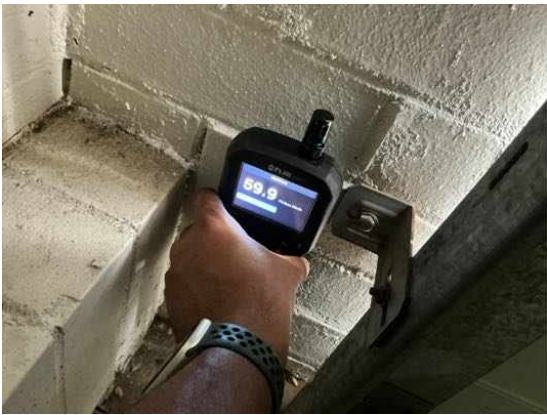
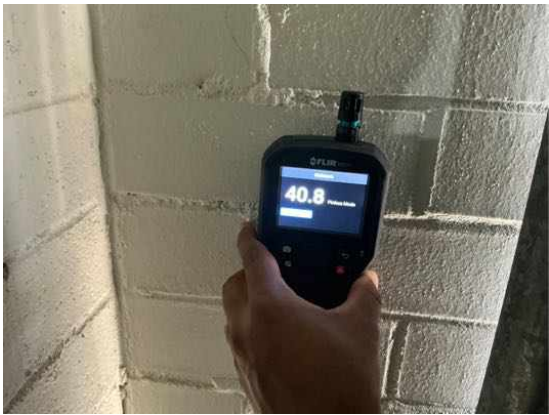
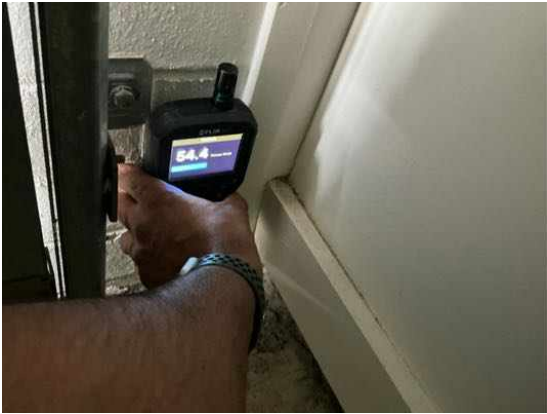
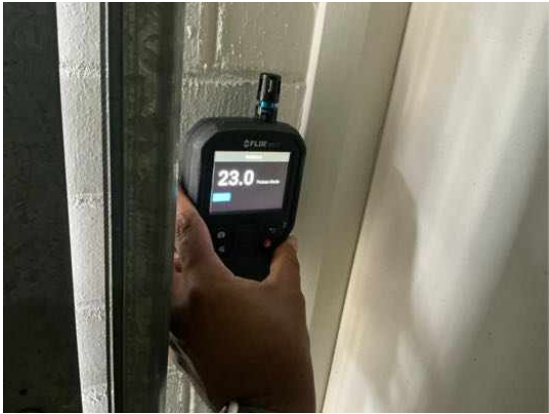
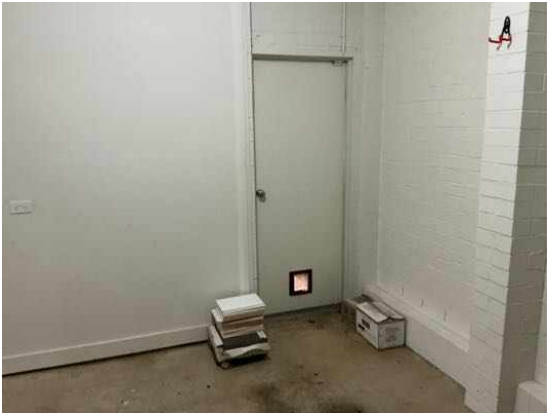
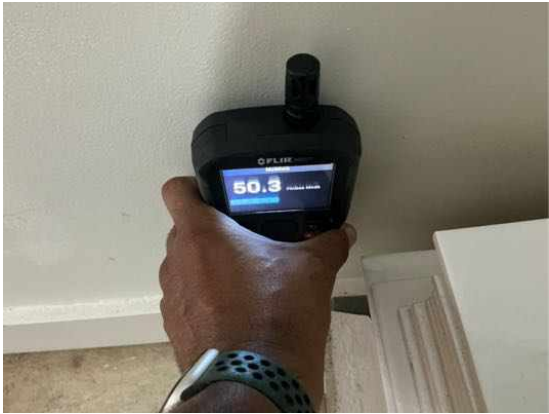
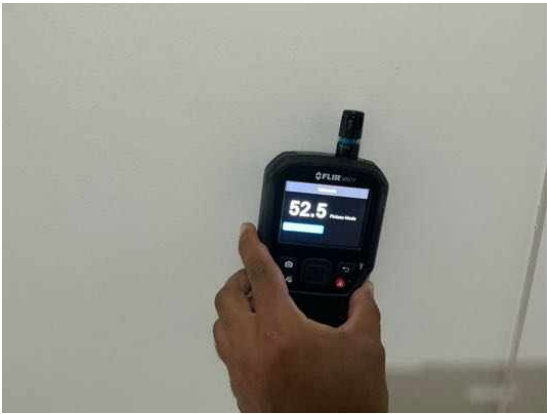
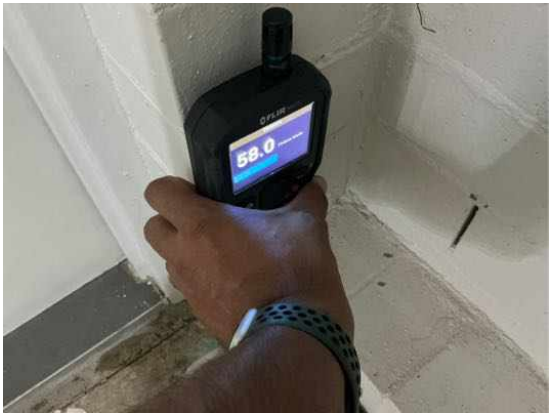
Building:	Main Building
Location:	All Areas
Finding:	Additional Photos - Moisture Meter Readings
Information:	Additional moisture meter reading photos have been provided for the property to offer further clarity on areas tested during the inspection. These photos are intended to give a visual reference for the specific locations where moisture levels were measured. These readings were taken at the time of the inspection to assess any potential moisture-related issues within the property. Any defects related to moisture that were identified during the inspection have been separately mentioned in the defect statements within the report.

It is important for the client to understand that moisture levels can fluctuate over time due to various factors, including changes in weather, humidity, and environmental conditions. While the readings reflect the property's moisture levels during the inspection, they may not represent future conditions, and increased moisture could lead to issues such as dampness, mould growth, or deterioration of building materials if left unmonitored.

For further clarification or additional information regarding the moisture readings, the client is encouraged to contact the building inspector directly. Regular monitoring of moisture-prone areas is recommended to ensure any emerging concerns are addressed promptly, particularly during wetter seasons or in high-humidity conditions.

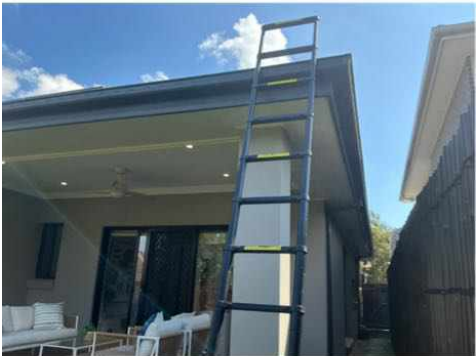
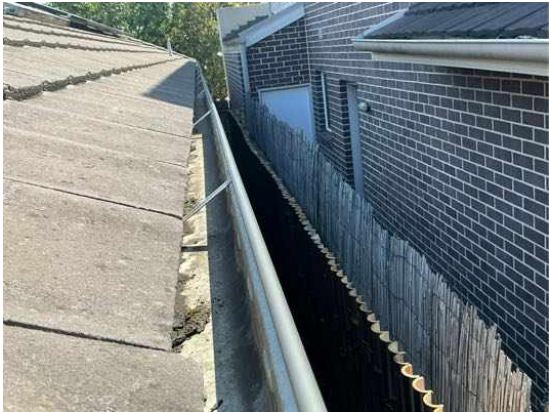
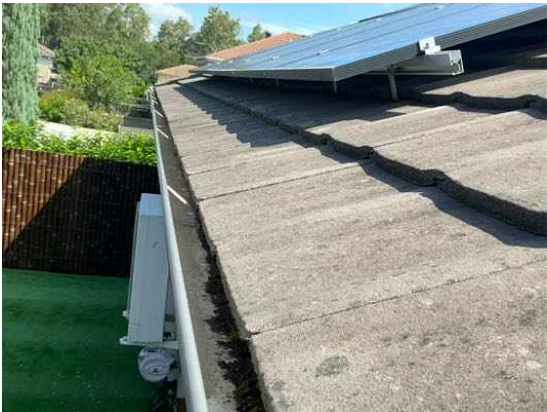
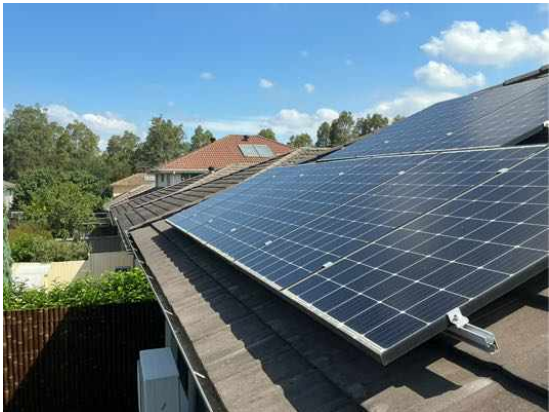
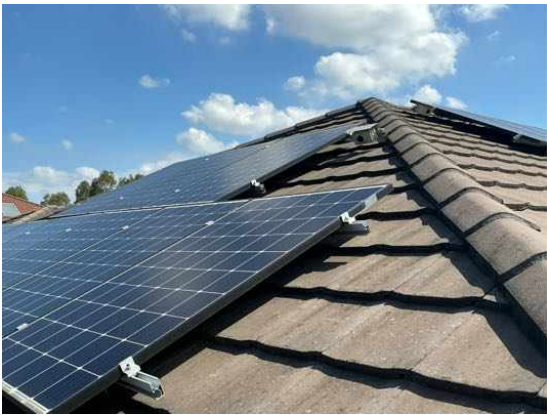
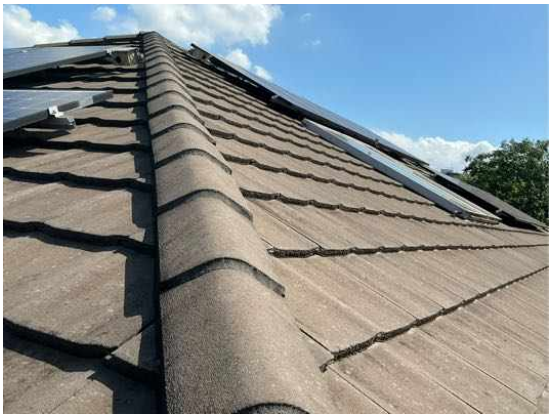
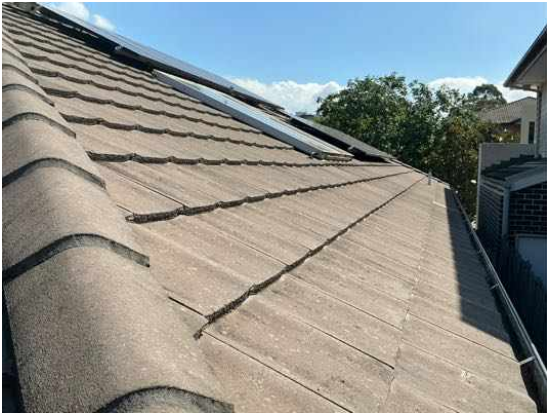
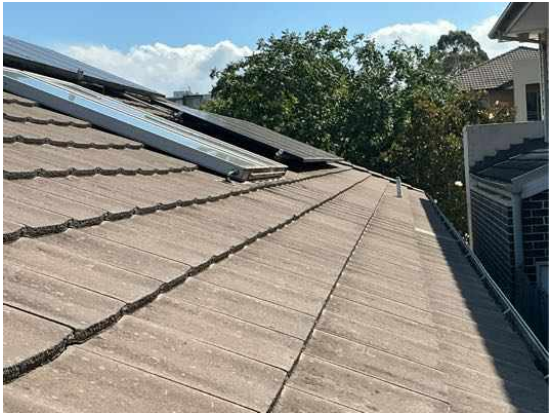
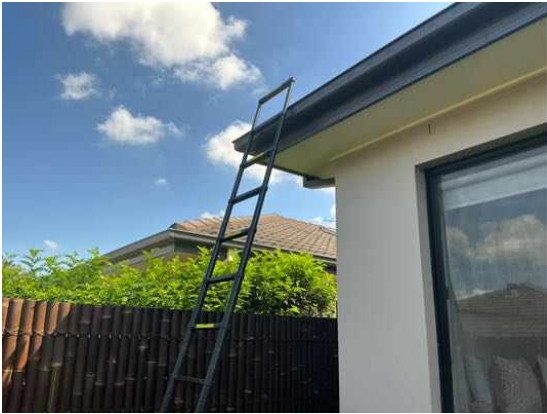
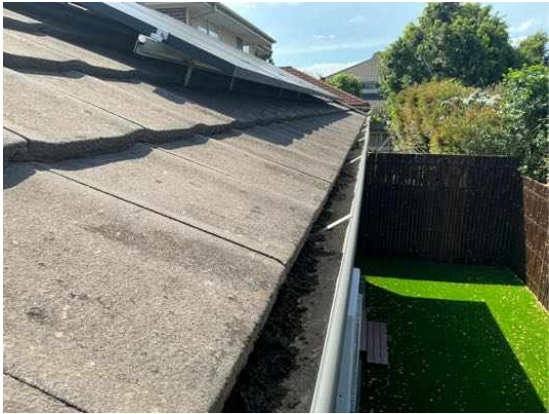
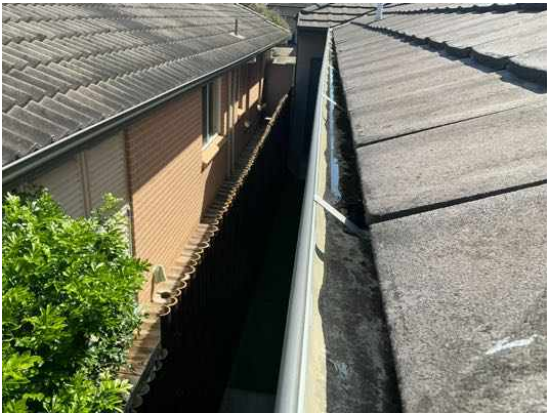
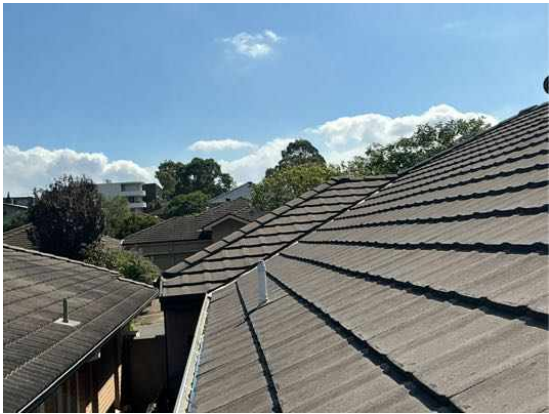
Building: Main Building
Location: Roof Exterior
Finding: Additional Roof Photos
Information:

As part of the information provided, please note that the attached roof photos represent the condition of the roof at the time of inspection. These photos are for visual reference only and do not constitute a detailed roofing assessment. Any defects or issues identified with the roof are mentioned separately in the defect statements. It is strongly recommended that the client engage a qualified roofer to conduct a thorough inspection of the roof, ensuring that any potential issues, such as leaks, structural integrity, or wear and tear, are properly identified and addressed.

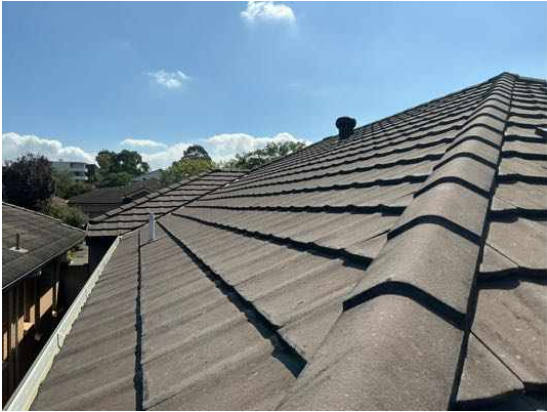
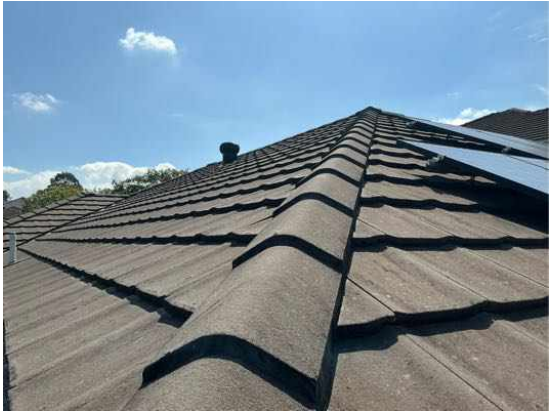
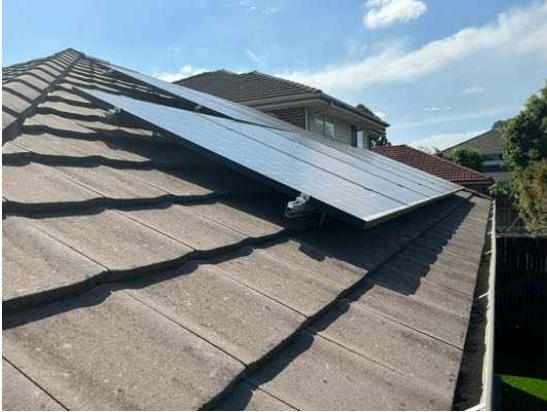
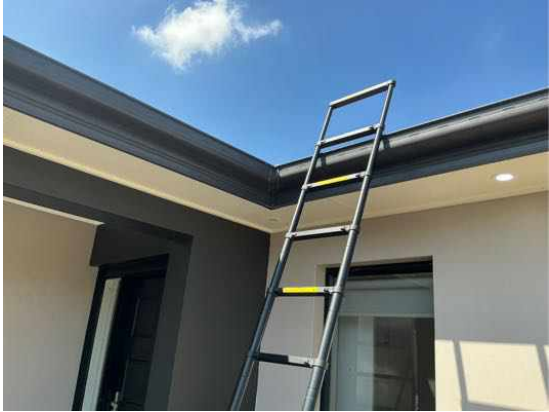
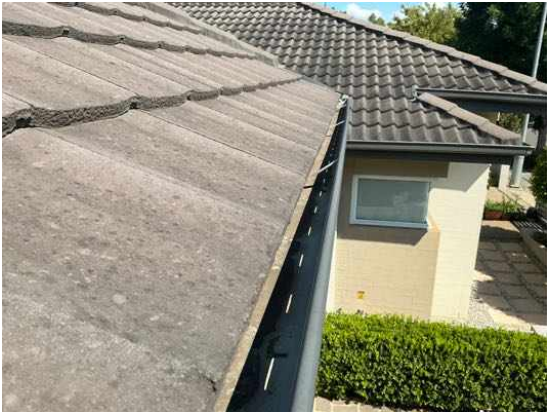
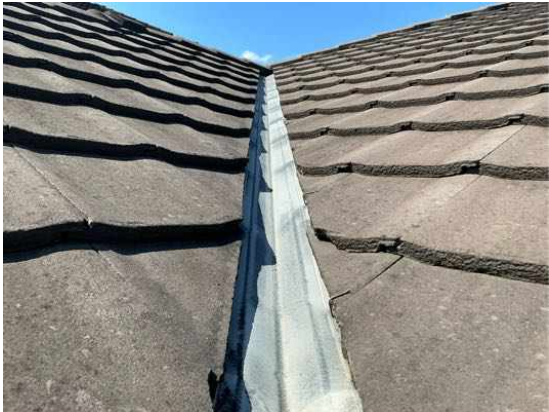
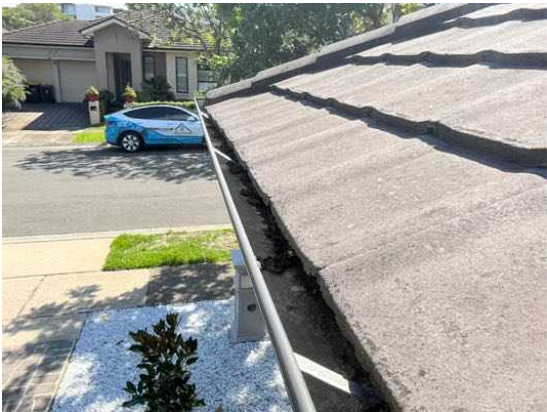
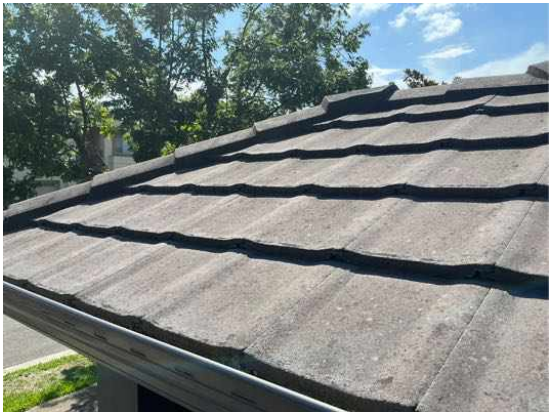
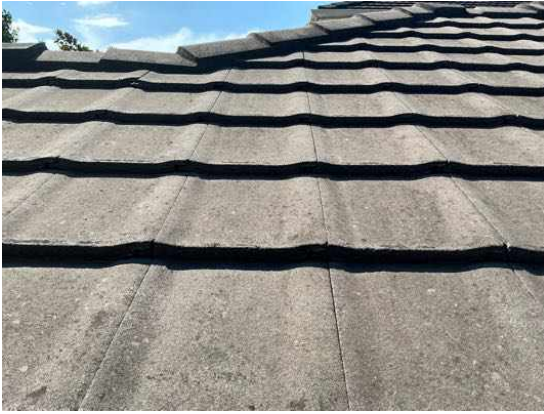
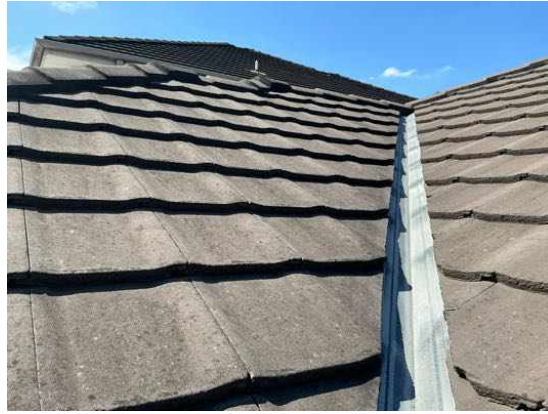
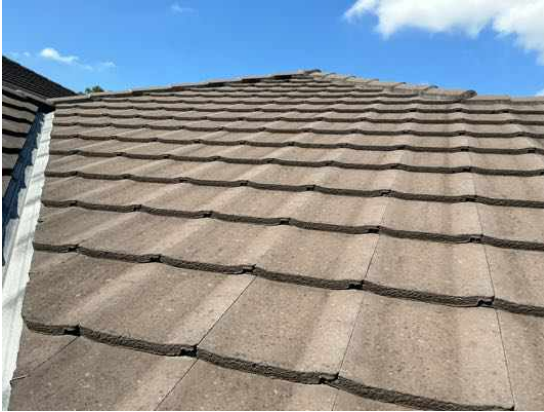
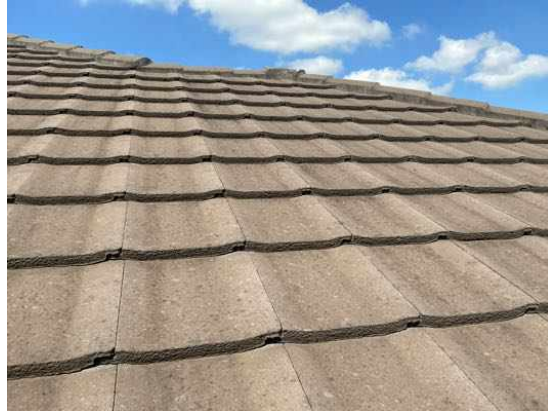
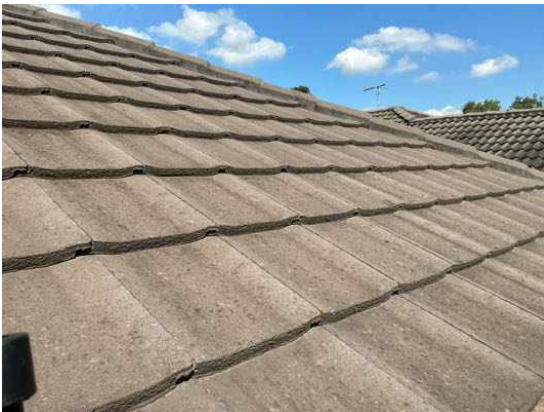
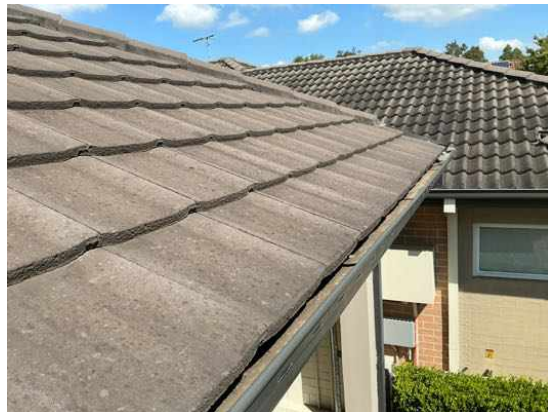
Additionally, the condition of the roof may change over time due to weather, natural wear, or other unforeseen factors. Regular maintenance and inspections by a licensed professional are advised to ensure the roof remains in good condition and to avoid costly repairs in the future. The information provided in these photos should be considered a snapshot of the roof's condition during the time of inspection and not a guarantee of its future performance.

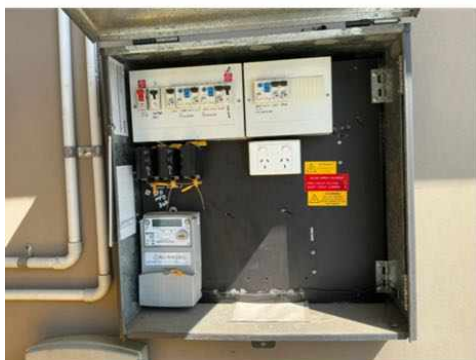
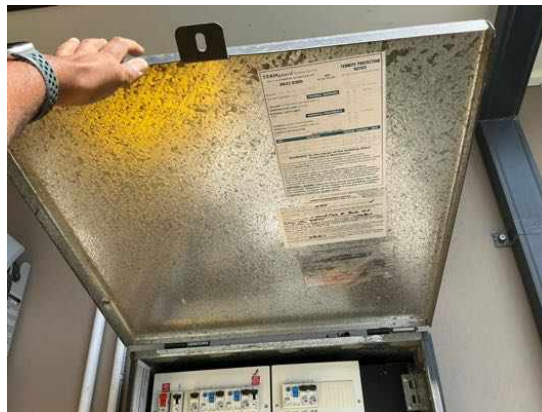
Noted Item

Building: Main Building
 Location: Meter Box
 Finding: Termite Management Recommendation – No Evidence of Chemical Installation
 Information: At the time of inspection, there was no visible evidence of a chemical termite management system installed around the property. Chemical barriers are a key component of termite protection and are particularly important in preventing concealed termite entry into timber elements of the structure.

In accordance with standard requirements, a durable notice should be located within the electrical switchboard to detail any termite protection systems applied, including chemical treatments. No such notice was observed during the inspection.

It is recommended that the client engage a licensed pest controller to assess the suitability of installing a chemical barrier, and to provide advice on associated costs and procedures. This should be considered a short-term priority, particularly if the property has any history of termite activity or is located in a high-risk area.

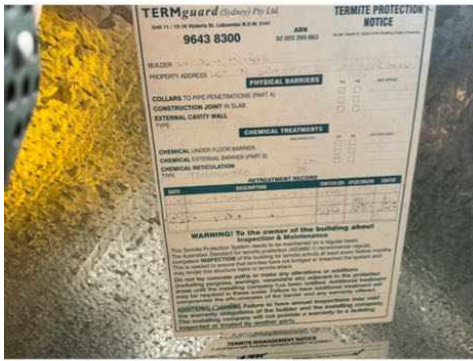
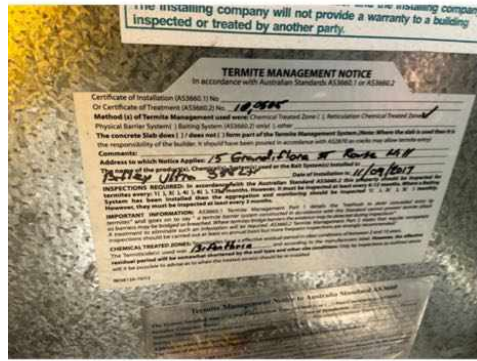
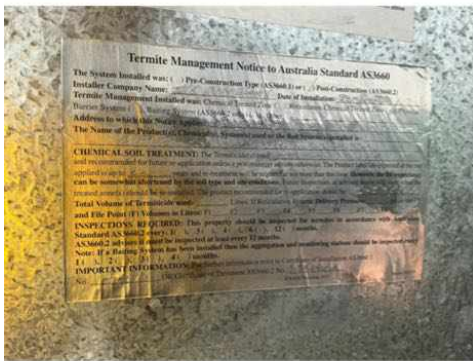
Noted Item

The following items were noted as - Evidence of a previous termite management program

Where a Termite Management System has been identified you should refer to the type of barrier date of installation warranty conditions and any documentation provided by a builder or past owner. Consult the company who installed the barrier to confirm whether the system is still under warranty.

Most chemical termite management systems expire and require replenishment and all physical systems are primarily designed to prevent concealed entry.
