Building and Timber Pest Inspection Report

Inspection Date: Mon, 16 Feb 2026

Property Address: 29 Myall St, Gympie QLD 4570, Australia

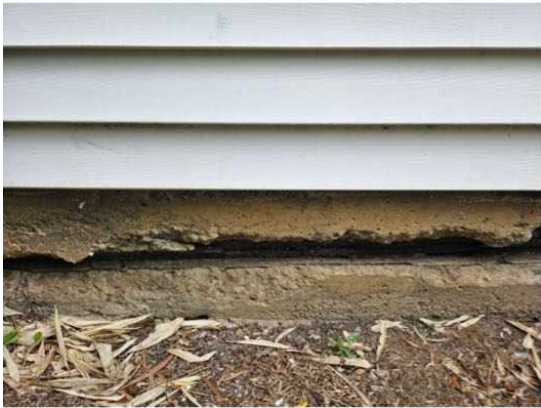
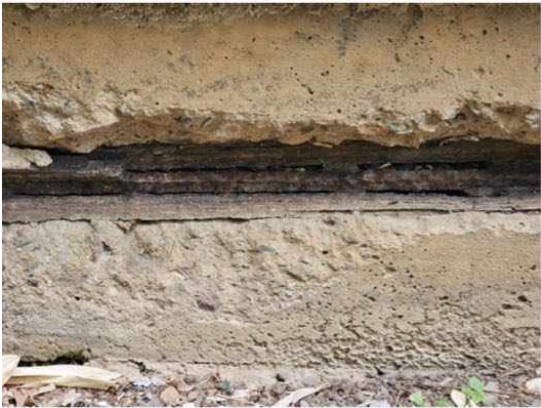
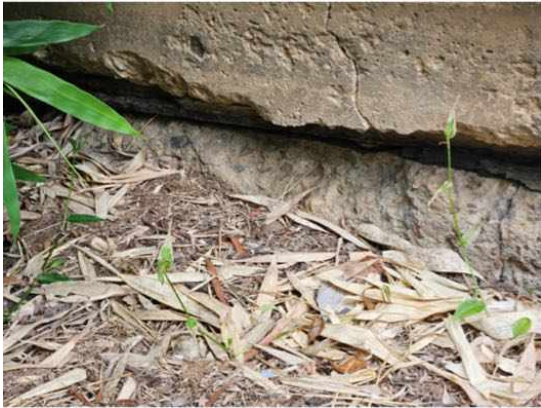
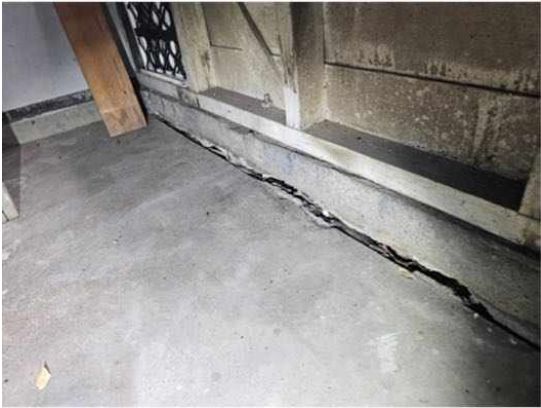
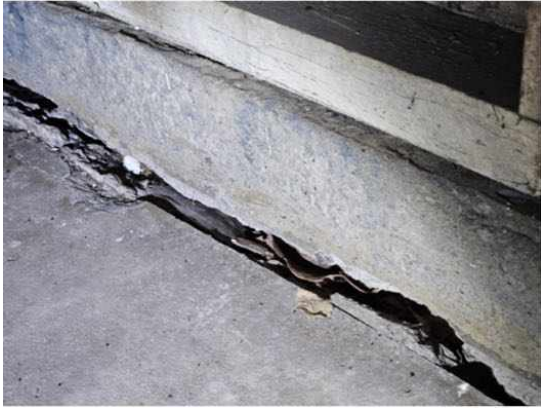
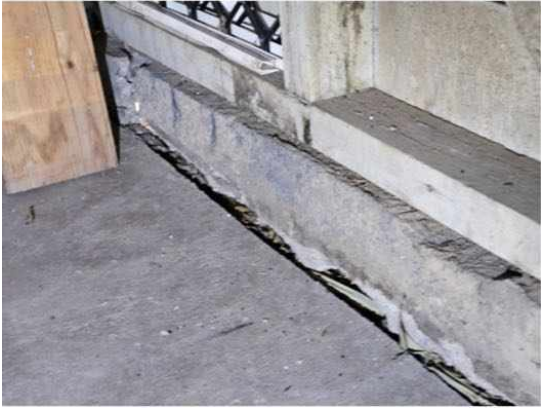
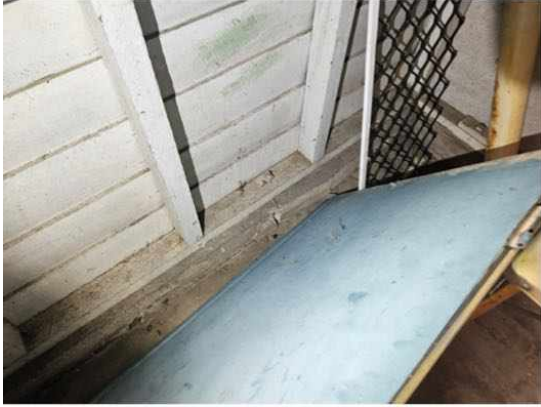
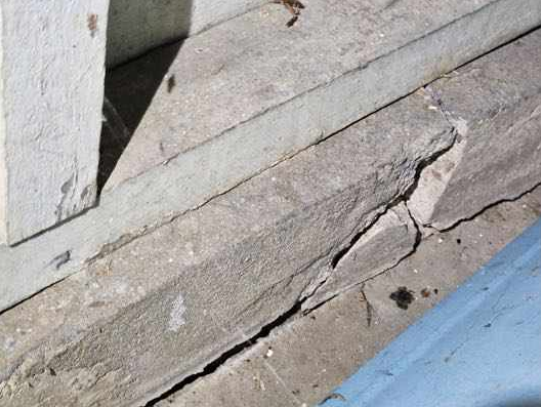
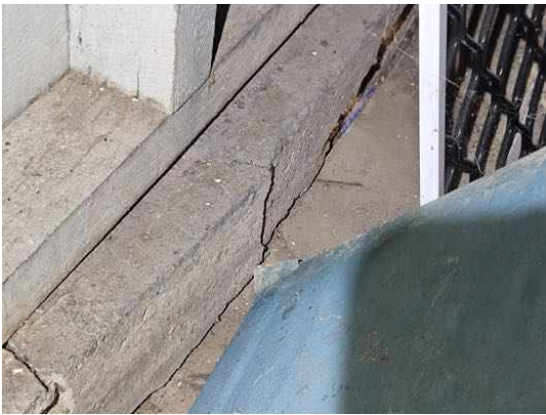
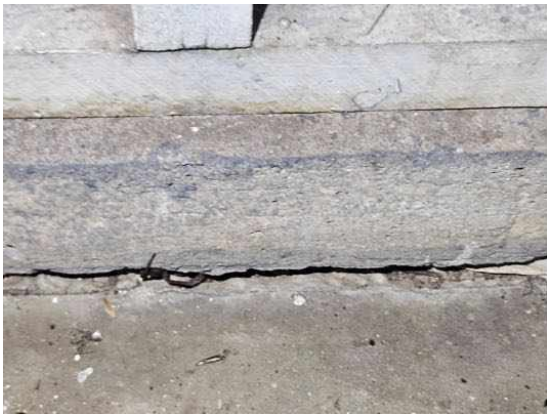
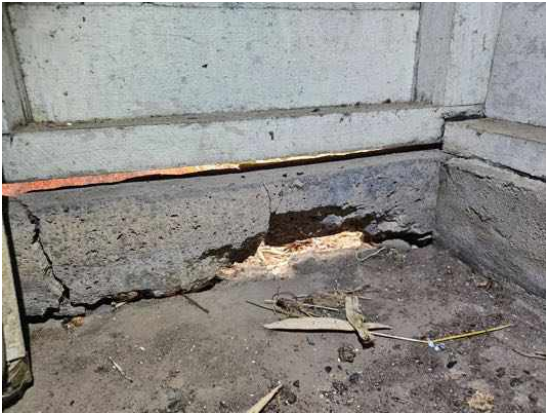
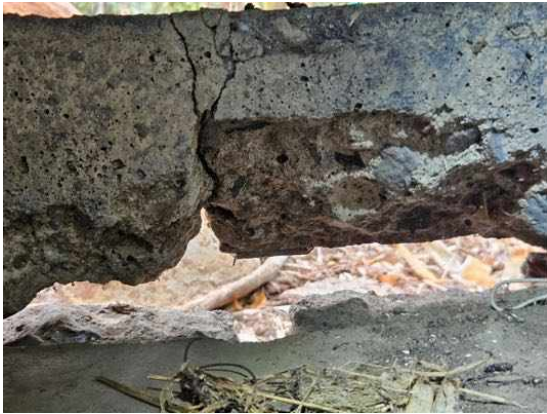
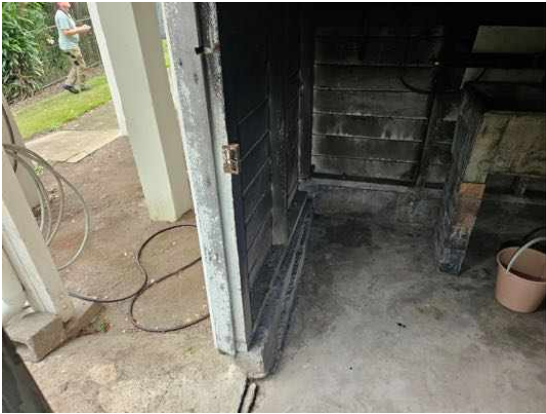
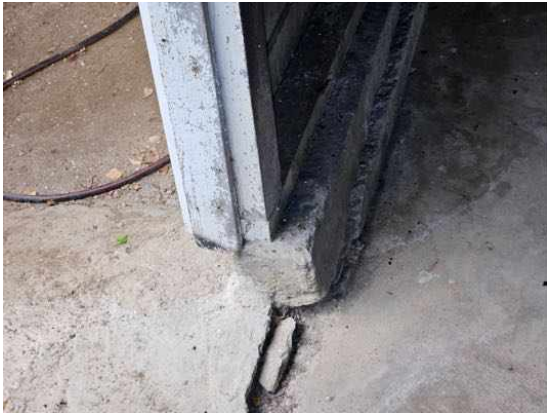
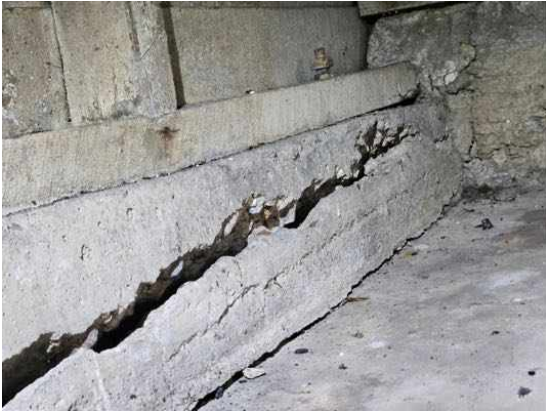
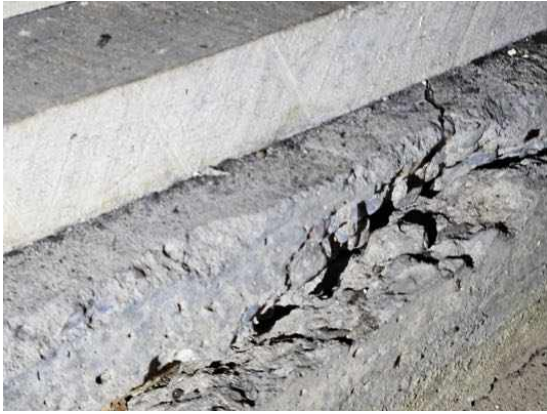
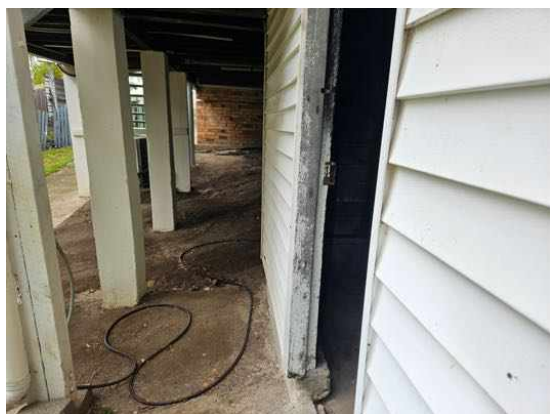
As this section of the building is supporting the full height of the two storey section of the floor and wall framing, it appears to be structurally compromised.

It is advised that the services of a structural engineer and a licensed builder be sought to investigate and provide a repair solution for the foundation without delay.

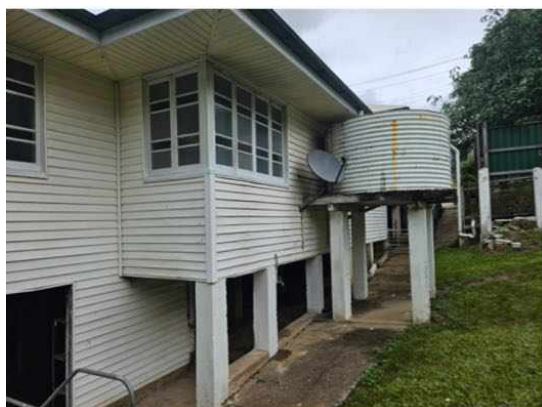
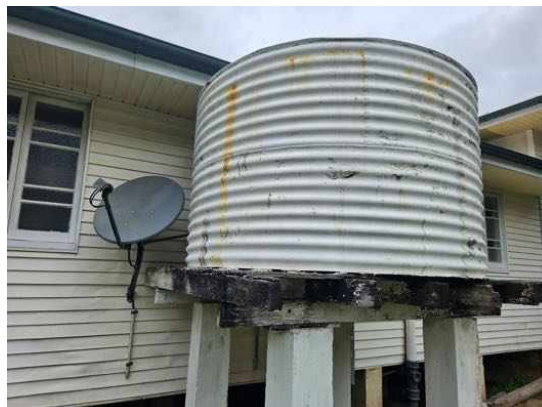
| Finding: | Wood rot - tank stand |
| Information: | The rain water tank stand shows evidence of severe wood rot in the slats and structural frame. The fungal decay appears to be compromising the integrity of the structure. |

Wood rot, also known as Fungal Decay, occurs when timbers and other cellulose building materials are exposed to damp conditions on an ongoing basis. This could be the result of exposure to weathering over a prolonged period of time, or the attraction of excessive moisture from other abutting building materials. There appears to be chemical delignification developing in some sections of the slats.

A licensed carpenter or licensed builder should be consulted for a repair solution. This would be considered as urgent.

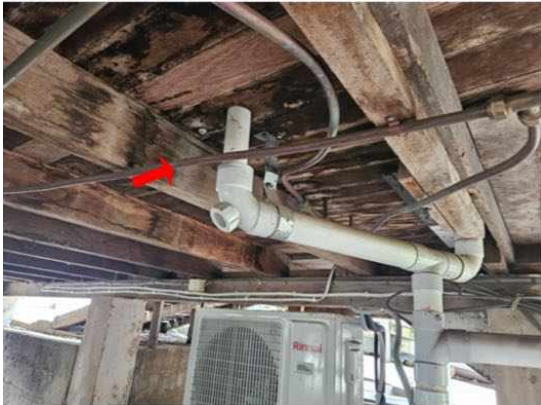
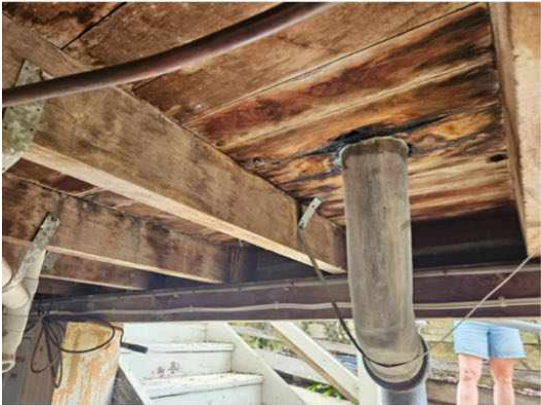
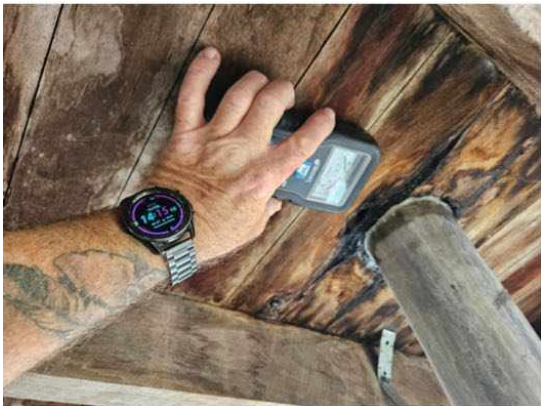
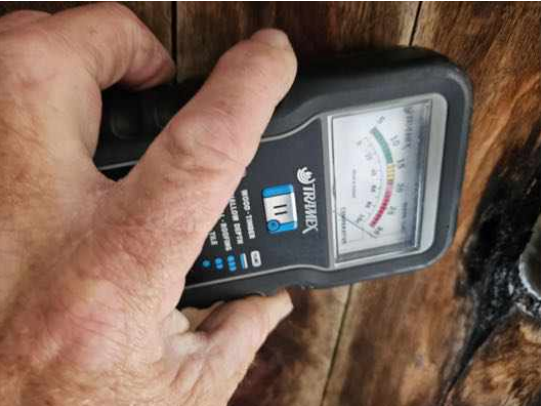
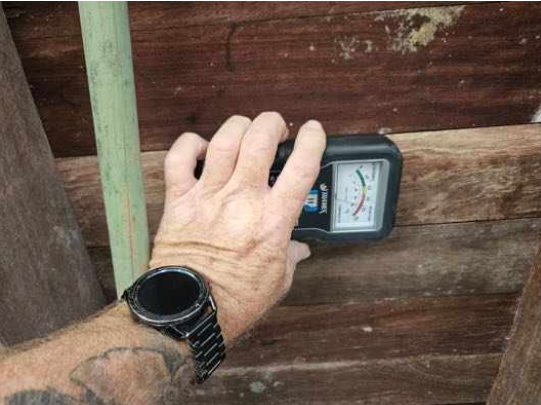
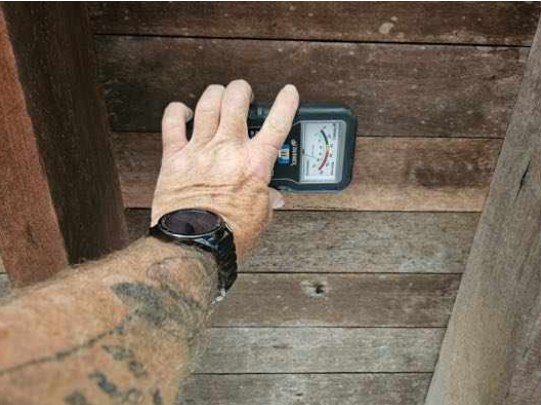
| Finding: | Subfloor / flooring moisture |
| Information: | During the inspection of the subfloor area, moisture staining and elevated levels were noted in the floorboards. This may be due to a number of factors such as residual moisture retained in the flooring, environmental conditions, retained moisture under vinyl flooring and preformed shower alcoves. |

This should be monitored and if conditions change, an assessment be carried out on the floors and the plumbing fixtures and fittings.

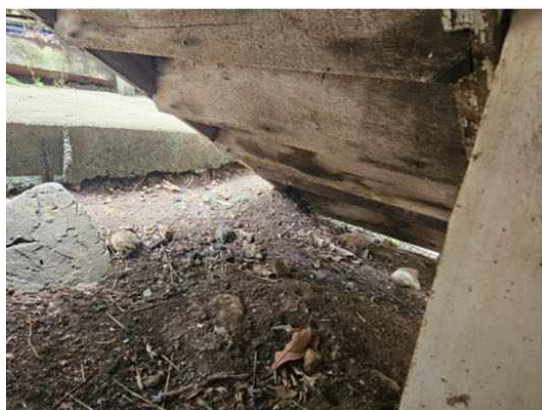
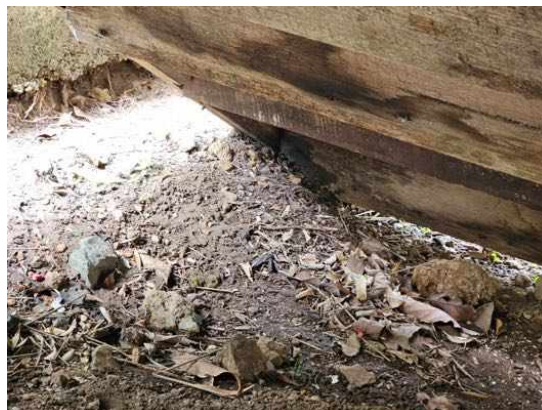
| Information: | It was noted during inspection, that the timber stair stringer of the external steps of unit 1 is in contact with the ground and does not have sufficient clearance to provide an adequate inspection zone. |

These could be a possible entry point for timber pests.

The soil and debris should be cleared away from the base of all timber structural members to provide clear visible access to view the post bases.

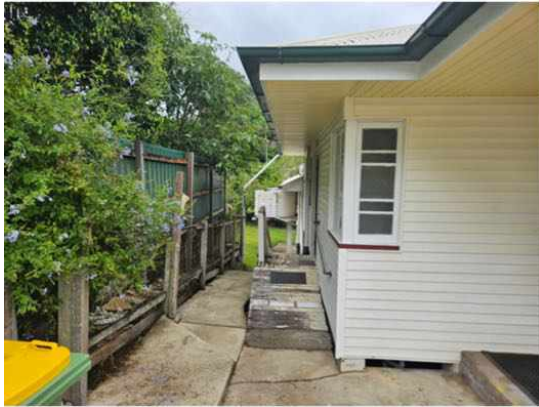
Finding 6.02

| Finding: | Wood rot / fungal decay |
| Information: | The timber components show evidence of wood rot beginning in various sections of the timber. |

Wood rot, also known as Fungal Decay, occurs when timbers and other cellulose building materials are exposed to damp conditions on an ongoing basis. This could be the result of exposure to weathering over a prolonged period of time, or the attraction of excessive moisture from other abutting building materials.

Early intervention and regular maintenance, particularly of exterior timbers, will prolong the useful life of these building elements. Prior to any works being performed, the cause of the moisture that has created the visible wood rot should be identified and addressed in a suitable manner. Replacement of affected timbers may then be a necessary step in protecting surrounding building elements from such deterioration.

A licensed carpenter or licensed builder should be consulted to advise on a solution for the affected building materials.

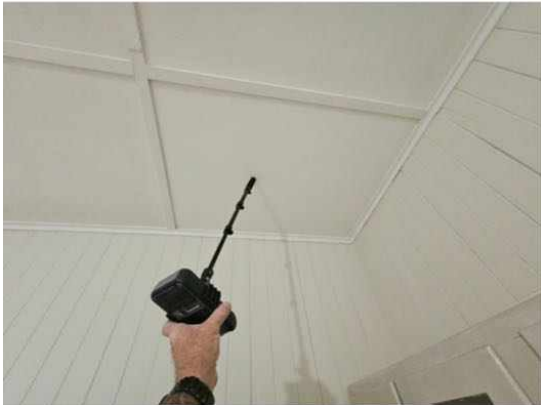
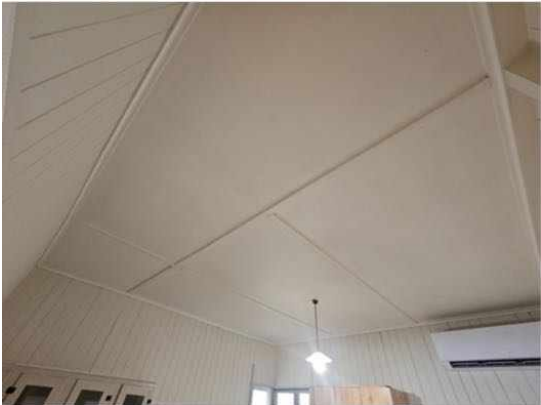
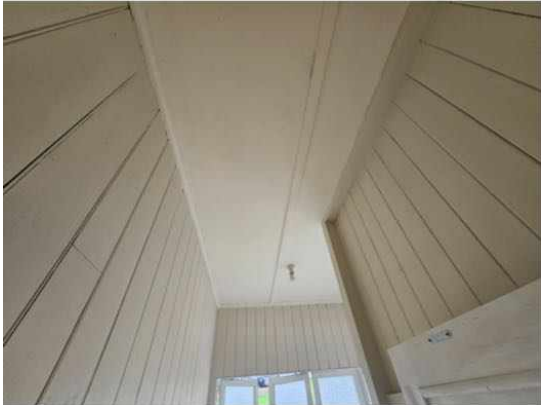
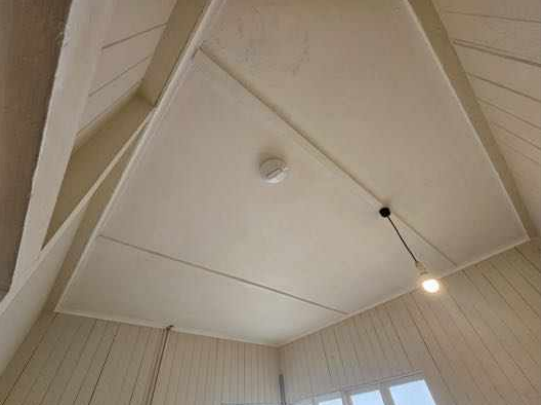
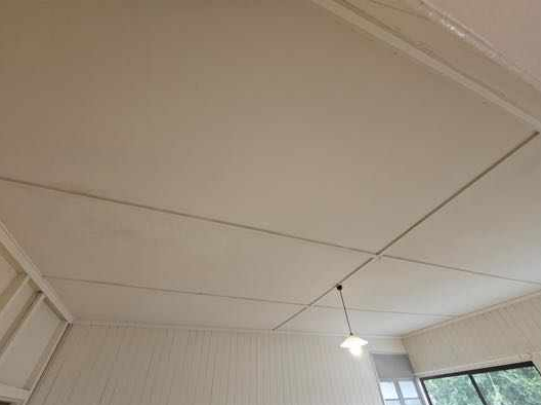
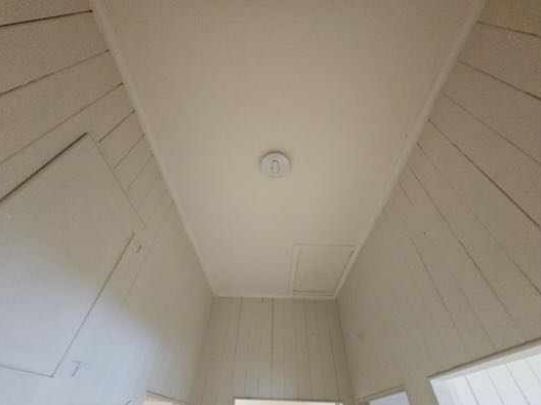
| Finding: | ACM - Suspected ceiling sheet - good condition |
| Information: | The ceiling sheets throughout the building are suspected to have been constructed with the use of asbestos-containing materials (ACM). The observable areas of ceiling sheeting appear to have minimal obvious signs of damage or deterioration, indicating that the asbestos is currently reasonably encapsulated and reasonably well contained. The sheet indicated by a pointer is the only sheet not suspected to be ACM. |

If maintained in good condition, ACM sheets pose little risk; therefore care should be taken to maintain the walls. As shown in the photos, there are small holes where the screws were removed from decorative lace work at the top of the posts. Carefully filling and painting these holes prior to painting should encapsulate any reasonable defects on the sheet surface. At the driveway end of the ceiling there is a patch fitted into the sheet. This is suspected to be ACM as well as the surrounding sheets, these gaps should be carefully filled and wet tooled. DO NOT sand these sheets under any circumstance. Painting should be done as soon as possible to complete the surface sealing. This should be maintained until it is scheduled for renovation.

Where the client elects to retain the ACM, the client should regularly monitor the condition of the wall sheets to identify any further damage or deterioration. Such monitoring should be conducted at least annually, but more frequently should damage or evidence of deterioration occur. Additional remedial work is a potential short to medium term solution to reduce the risk presented by the ACM.

No works should be carried out to the ACM or associated building elements without further specialist advice.

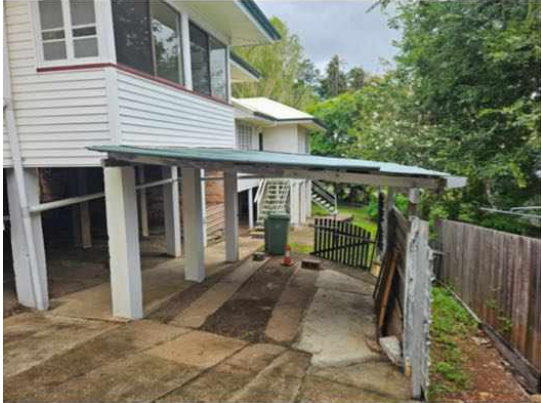
Building: Out Building
 Location: Carport
 Finding: Suspected - non certified construction, deteriorating
 Information: On the day of inspection additional building works constructed on the property, suspected as being non certified, were noted. It is suspected that these works, whilst being functional and have been in position for a lengthy period, are deteriorating, and may not be approved construction works.

building area not requiring council approval, the client should seek advice regarding council approval / certification if they wish to make further alterations.

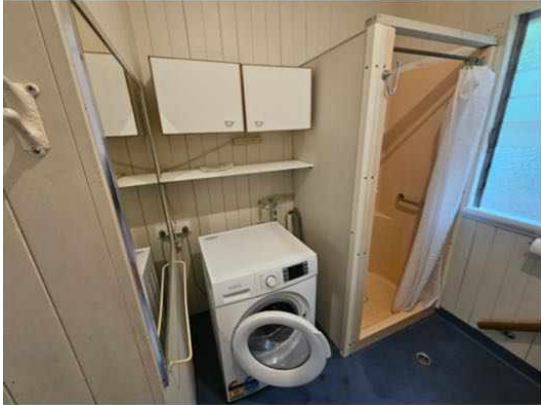
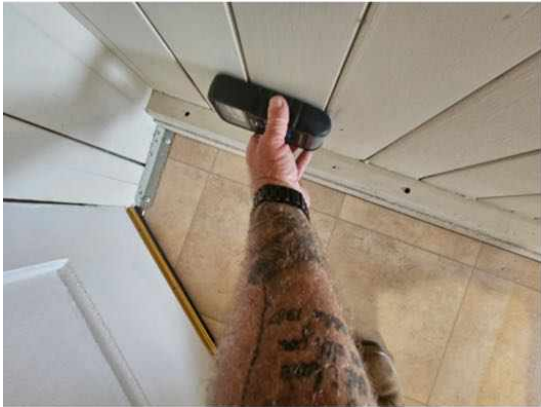
Building: Main Building
Location: Bathrooms
Finding: No moisture detected in bathrooms
Information: On the day of inspection the showers in the bathroom/s are measure for moisture

using a "Tramex" moisture meter. During this inspection no moisture was detected in these areas and the tiled / sheeted surfaces appear to be in good order.

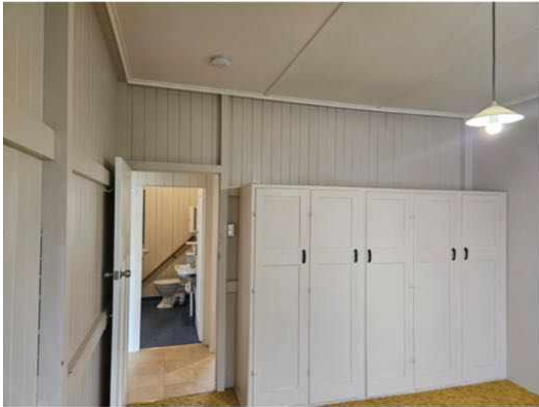
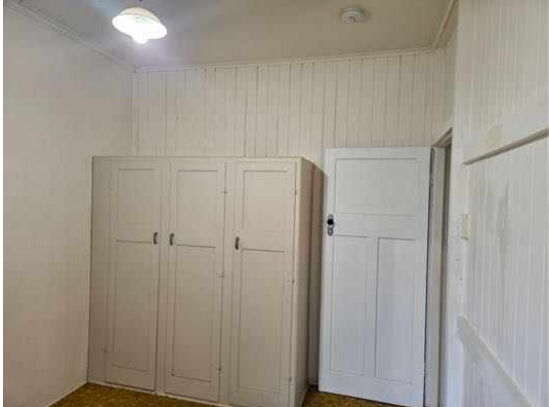
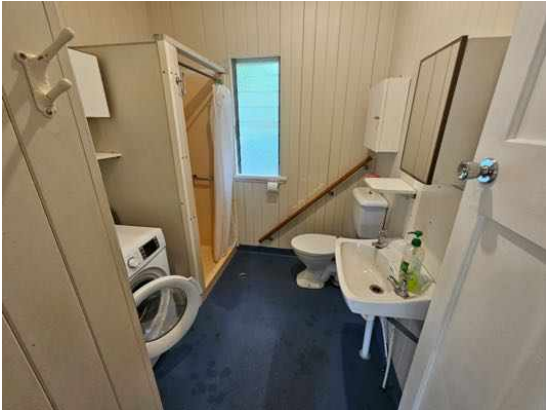
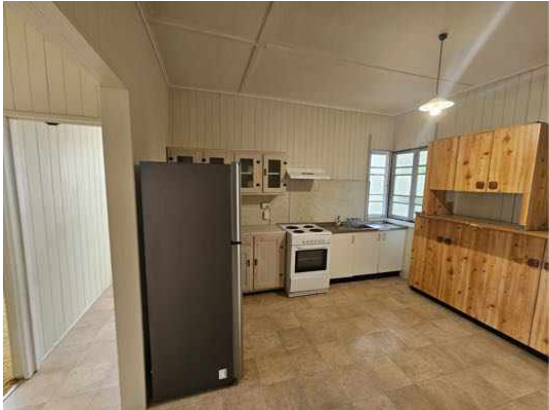
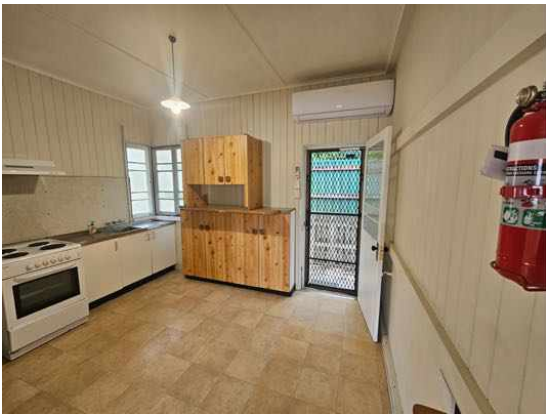
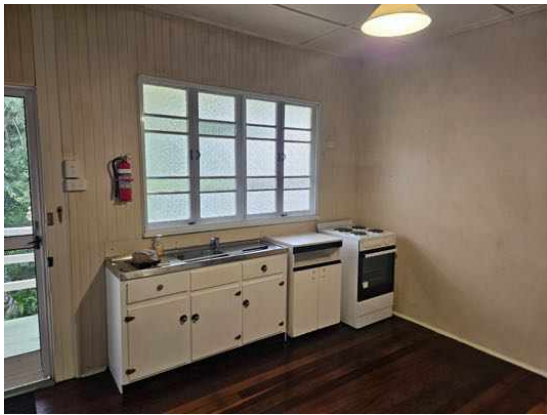
Building: Main Building
Location: All Areas
Finding: Additional Photos - Obstructions and Limitations
Information: These photographs are an indication of the obstructions and limitations which impeded full inspection of the property at the time of inspection. These obstructions can prevent full inspections of the areas shown.

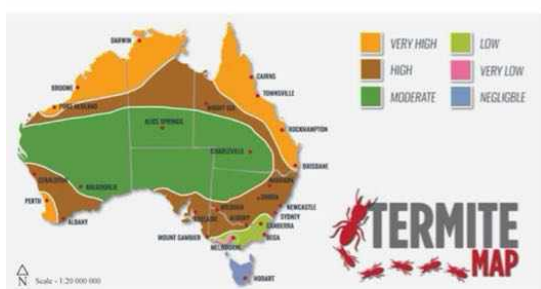
Review the attached map for Australia's termite zones and their risk profile.

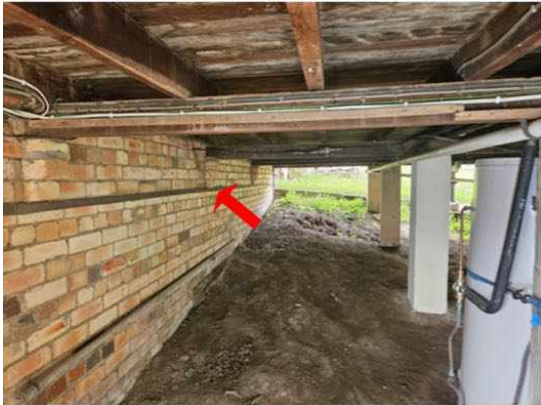
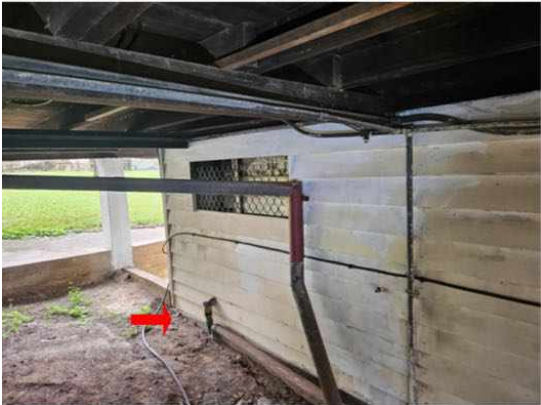
The building employs a physical barrier system to the perimeter of the party wall and the ground floor laundry area, the balance of the subfloor is considered a visual inspection zone. In order for a barrier system to be effective, the property must have regular inspections at intervals of not greater than 12 months. Depending on the risk profile attributed to the property, these inspections may be recommended at lesser time periods.

Where a Termite Management System has been identified you should refer to the type of barrier, date of installation, warranty conditions and any documentation provided by a builder or past owner. Consult the company who installed the barrier to confirm whether the system is still under warranty.
