# Building and Timber Pest Inspection Report

Inspection Date: Wed, 4 Mar 2026

Property Address: 2B Dingle Street, Riverstone, NSW 2765

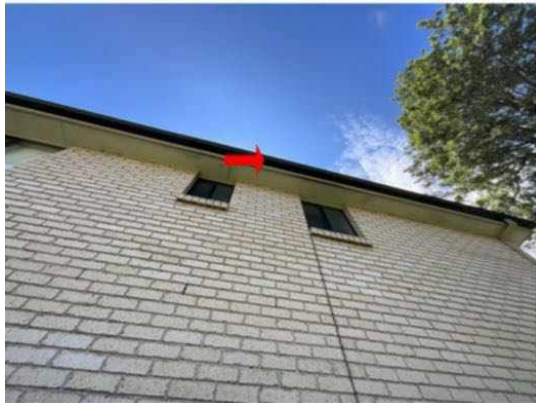
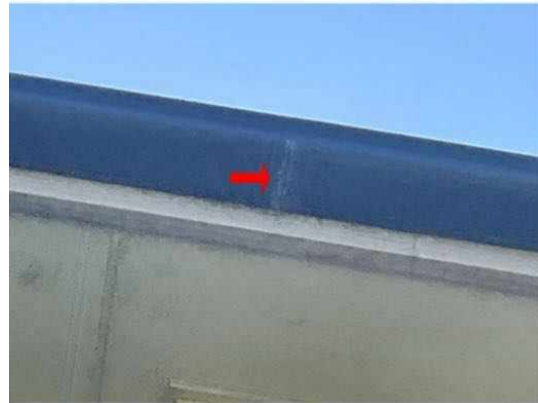
Building:	Main Building
Location:	Multiple areas of roof plumbing
Finding:	Water leak - External
Information:	Water leaks were found to be present to exterior plumbing work. Leaks are generally caused by deterioration of the plumbing elements over time, due to exposure to weather conditions, but may have also been caused by minor impact damage.

Such leaking creates damp conditions in the affected area, causing potential for water pooling and subsequent water damage if left unattended. These conditions may also attract termite attack, particularly if the area is subject to minimal levels of sun throughout daylight hours.

It is highly advised that a licensed plumber be appointed to rectify any water leaks that may be present. Areas of repair and replacement of plumbing fittings and fixtures may be required and, as such, a quotation should be sought.

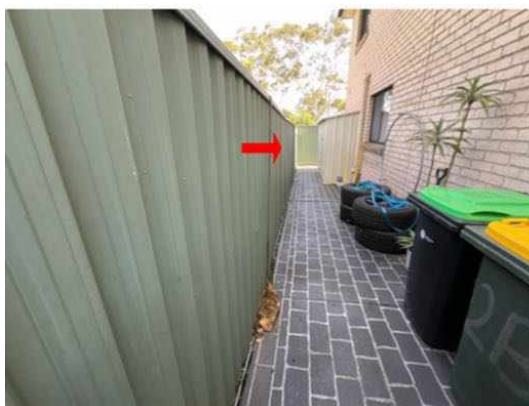
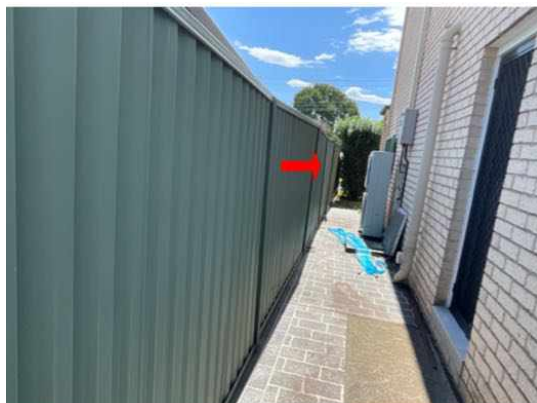
### Finding 3.04

Finding: Fencing - Deteriorated

Information: It was noted at the time of inspection that sections of the fencing in this area has deteriorated. Typically fencing deteriorates due to age and or wear, rot and or rust which is generally expected for a structure of this age, due to prolonged exposure to weather conditions. Sometimes inadequate installation or maintenance can be to blame.

If left unattended, it is likely that further damage will occur. It is suspected that repair of several elements of the fencing may be required however replacement may be a consideration of the client also.

A licensed fencing contractor should be appointed to provide further advice and perform rectification works as necessary.

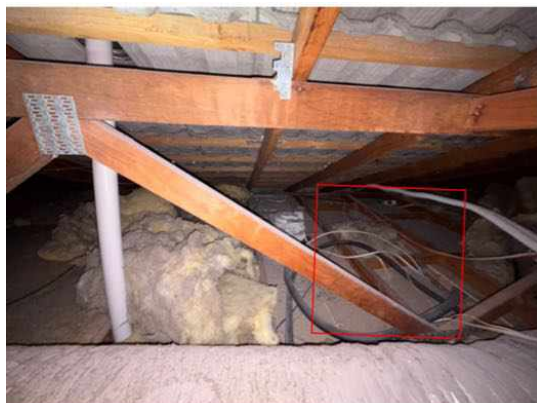
### Finding 3.05

Building:	Main Building
Location:	Roof Void
Finding:	Insulation - Inadequate
Information:	Upon inspection of the roof void it was noted that there is a lack of adequate insulation.

The level of insulation in the property does not meet current Australian Standards. Installation of adequate insulation is required and should be conducted as soon as possible.

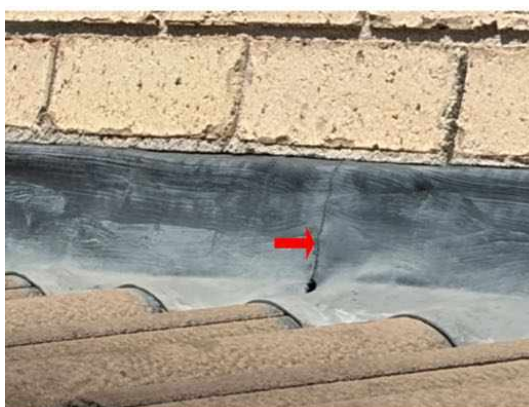
### Finding 3.06

Building:	Main Building
Location:	Front Elevation
Finding:	Roof plumbing - Flashing cracked
Information:	Water leaks generally occur when a particular area of the property is not weather or water tight. Cracks were evident to the roof flashing in this area at the time of inspection.

Regardless of the location, if left unmanaged, even minor leaks can lead to serious damage of associated building elements, potentially resulting in the need for replacement of building materials. Damage to ceilings, wood rot, mould and other hazards, such as electrical hazards, may also arise if left unmanaged.

Further inspection and repair by a roof specialist or a licensed roof plumber is advised to adequately rectify the potential leak.

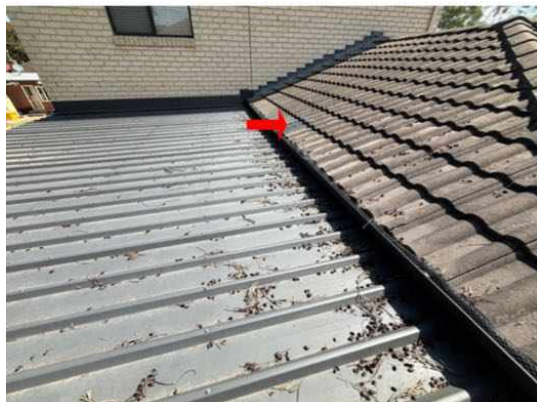
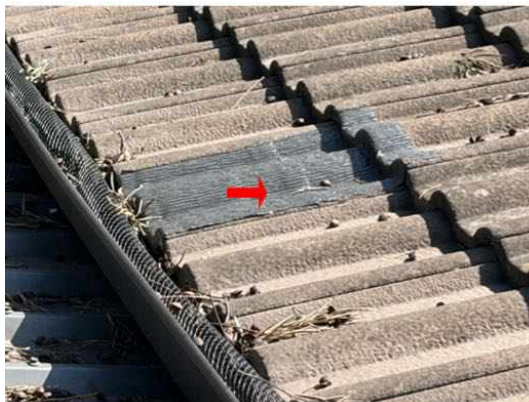
### Finding 3.07

Building:	Main Building
Location:	Rear Elevation
Finding:	Cracked roof tile - Sealed (defective)

Information: Cracked roofing tile was noted to have been sealed. This handyman work appears to have been completed to a substandard level and does not comply with regular building practices. Further deterioration will inevitably cause cracking at the seal allowing moisture penetration.

All cracked or damaged tiles must be replaced rather than repaired.

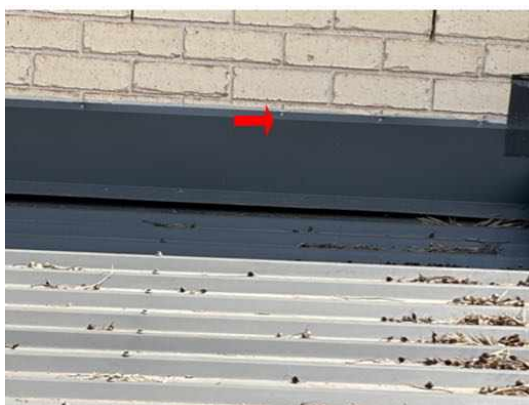
### Finding 3.08

Building: Main Building  
 Location: Alfresco  
 Finding: Roof flashing (acceptable) - Non-standard  
 Information:

The roof flashing that has been installed does not appear to comply with current building practice. However the flashing appears to be in an acceptable condition and is fulfilling its purpose in ensuring the roof covering is weather-tight.

Whilst retrospective fixing is not required if flashing begins to come loose from its fixing or deteriorates as evidenced by roof leaks a licensed roofing plumber should be appointed immediately to replace the building element.

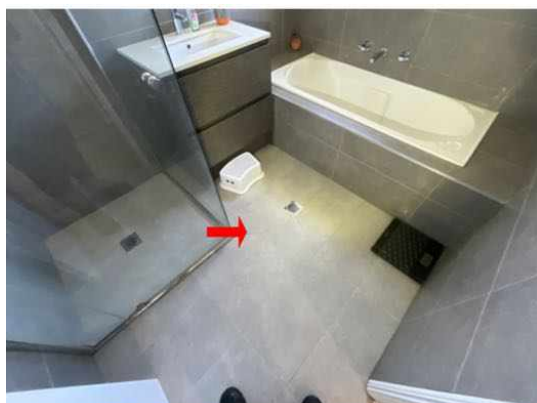
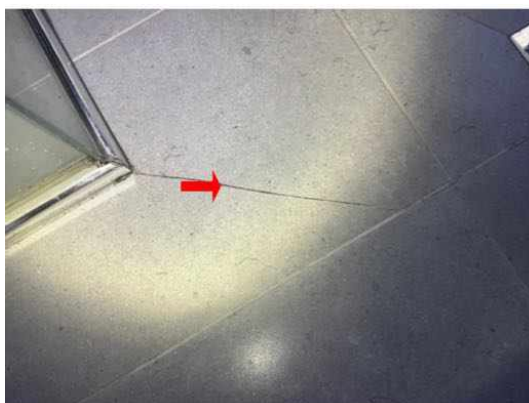
### Finding 3.09

Building: Main Building  
 Location: Bathroom  
 Finding: Wet area tiles - Cracked or damaged  
 Information: Cracking was evident to the tiling in this area at the time of inspection. While the cracking appears to be minor, this area is frequently exposed to water, allowing potential for water penetration into adjoining sections of walls or flooring.

If left unmanaged, water penetration to these areas may lead to subsequent water damage, which is likely necessitate repair work to affected building elements.

A bathroom specialist should be appointed to determine the integrity of the bathroom waterproofing membrane. If the membrane was found to be intact then relatively minor works to replace the cracked tiles should be carried out to ensure no further damage occurs. The re-application of silicone and grouting throughout remaining tile work is also advised, to further protect the area against water penetration.

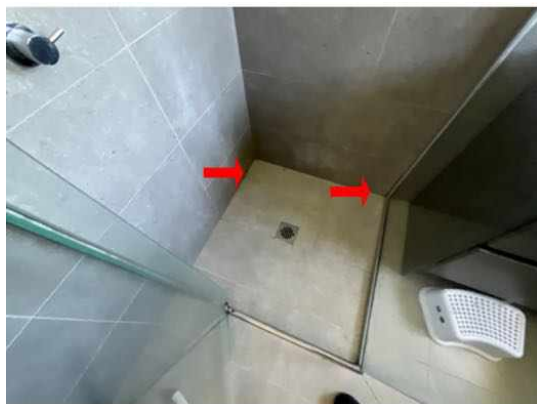
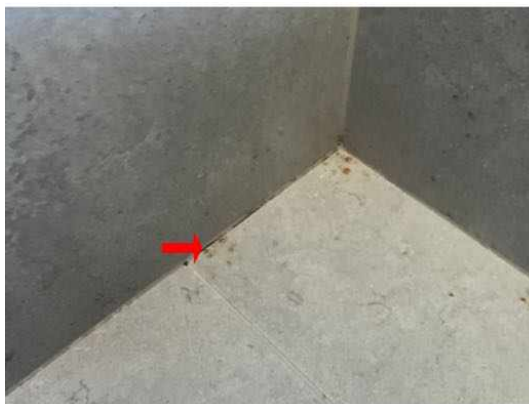
### Finding 3.10

Building: Main Building  
 Location: All Wet Areas  
 Finding: Sealant and grouting - Missing or damaged  
 Information:

It was noted on inspection that sealant or grout is degraded to this area.

Different materials and floor areas move at different rates, generally causing cracking to grout or sealant at this point. A flexible sealant is required to allow for expected expansion and contraction, while keeping the joint water tight and protective of all associated building materials.

Flexible and mould resistant materials should be applied to affected areas to prevent any subsequent water damage that is likely to occur. Regular maintenance and replacement of damage or missing or damaged sealant and grout is highly recommended to the wet areas, as this is a regular wear and tear defect. Sealant and grouting in areas that come into regular contact with water should be maintained for

the long term care of your property.

A sealant specialist should be appointed to complete these works as soon as possible.

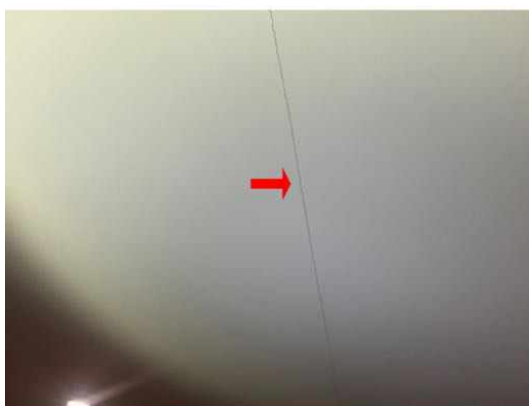
### Finding 3.11

Building:	Main Building
Location:	Garage
Finding:	Cracking - Damage Category 1 - Fine (up to 1mm)
Information:	Although fine cracks are quite noticeable, they are often only considered to be an appearance defect, and usually do not indicate any structural damage. Generally, the cause of a fine crack is indicative of a separation between building materials and finishes (e.g. paint, plaster, etc.) along joints.

Cracking of this nature can generally be repaired with minor sanding, filling and/or repainting. Such works should be performed by a qualified painter or a general handyman.

Monitoring of all cracking should be conducted frequently. Always contact a building inspector should cracks widen, lengthen, or become more numerous.

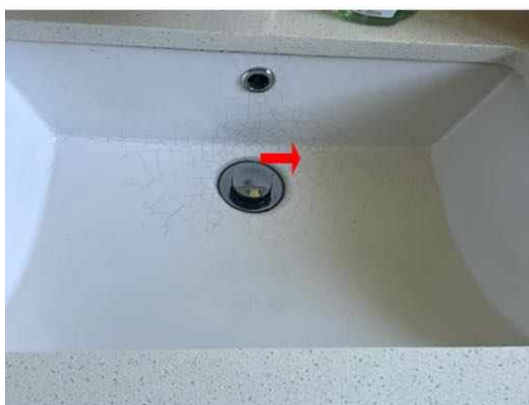
### Finding 3.12

Building: Main Building  
 Location: Bathroom  
 Finding: Basin - Cracked  
 Information: Cracking was evident to the basin at the time of inspection, which is suspected to have been by minor impact damage. While the cracking appears to be minor, any further impact damage sustained by the basin may lead to additional cracking.

As the cracking provides potential ingress for water, secondary water damage may occur to associated cabinetry, walls or flooring, if the cracking is left unmanaged.

Consultation with a plumber regarding basin repair or replacement is required. Remedial works may be required to protect against any further damage.

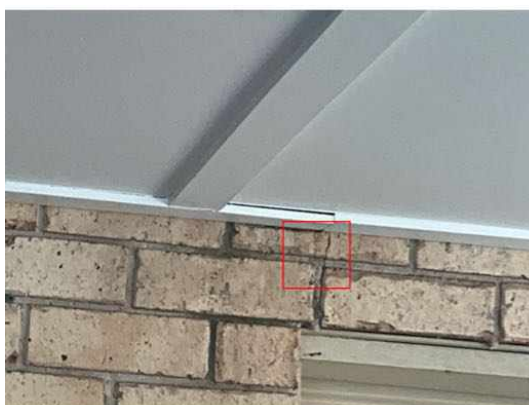
Finding: Brickwork - Cracking [Fine]

Information: Although fine cracks are quite noticeable, they are often only considered to be an appearance defect and usually do not indicate any structural damage. Generally, the cause of a fine crack is indicative of a separation between brickwork and mortar throughout the structure, but single bricks may also show cracks of this nature.

Cracking of this nature can generally be repaired with minor filling and should be conducted by a qualified bricklayer.

Always contact a building inspector should cracks widen lengthen or become more numerous.

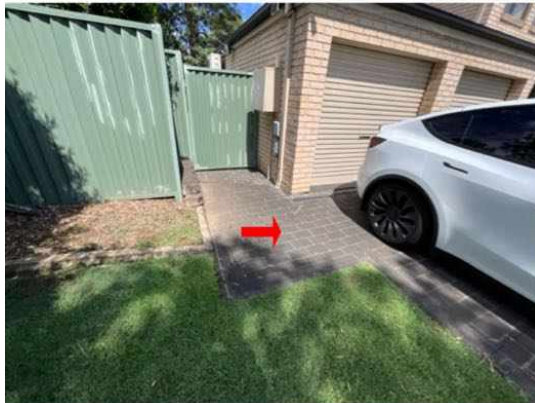
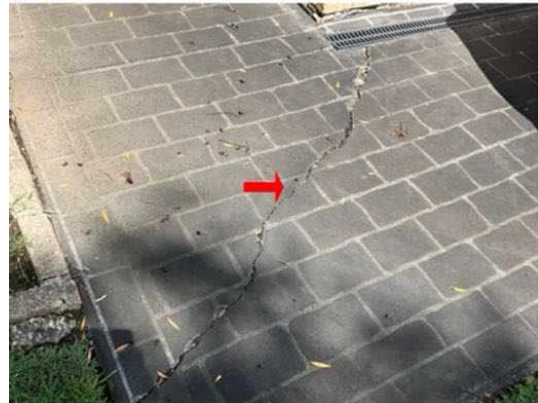
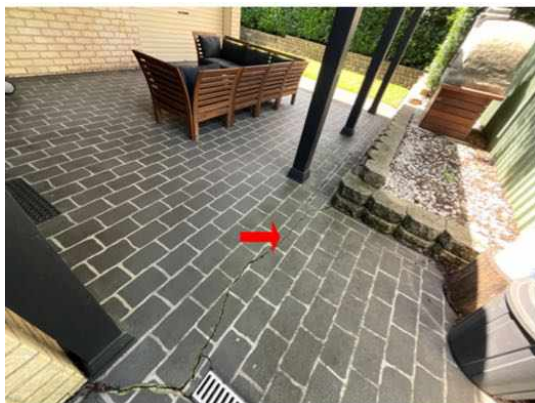
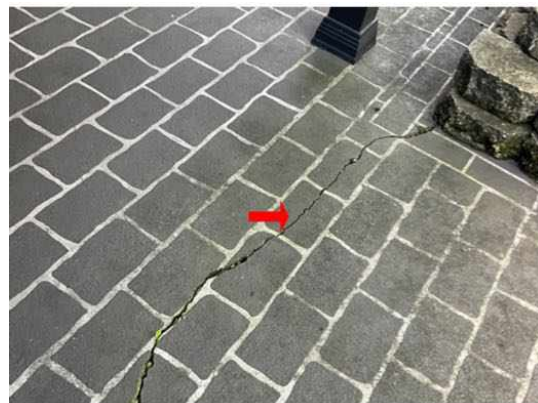
### Finding 3.15

Finding: Cracking - External Concrete Paving Damage Category 3 - Wide Cracks (2mm - 4mm)

Information: Wide cracks were identified in external concrete paving Wide cracks are significant and are likely to lead to the development of safety hazards and secondary defects if

General age and expected deterioration of the paved areas is a common cause of this type of cracking. However, expansion and contraction of the slab may also have occurred due to environmental factors. Such factors include variable moisture and weather conditions, the presence of trees and their roots having a settling or lifting affect on the soil, or the effect of load bearing, e.g. heavy vehicles over a sustained period of time.

Cracking to this degree may also be due to poor original installation of the concrete. Factors such as poor compaction of the sub surface and/or inadequate reinforcing of the slab may create cracking and other secondary defects. Wide cracks may also have a more significant structural cause, such as subsidence of soils.

Where the crack is located adjacent to structural elements of the building, the advice of a Structural Engineer is advisable before undertaking repairs. Significant repair and likely replacement of the concrete paving is probable.

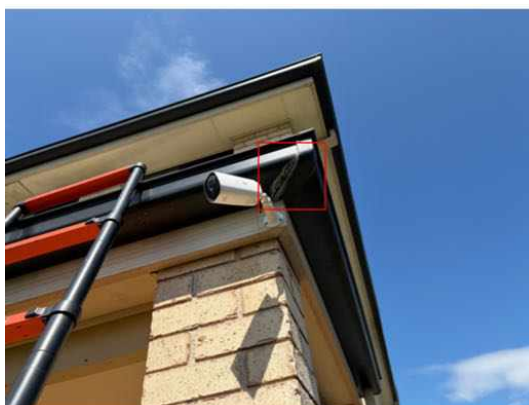
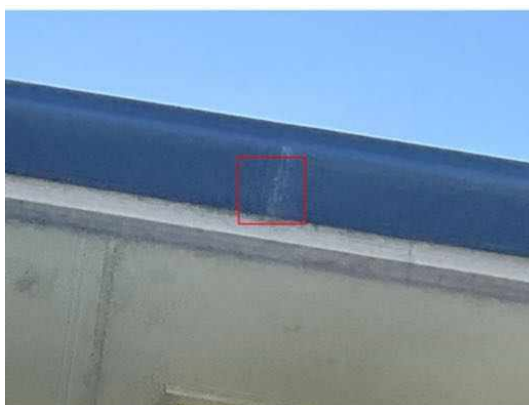
Building:	Main Building
Location:	Multiple areas of roof plumbing
Finding:	Water leak - External
Information:	Water leaks were found to be present to exterior plumbing work. Leaks are generally caused by deterioration of the plumbing elements over time, due to exposure to weather conditions, but may have also been caused by minor impact damage.

Such leaking creates damp conditions in the affected area, causing potential for water pooling and subsequent water damage if left unattended. These conditions may also attract termite attack, particularly if the area is subject to minimal levels of sun throughout daylight hours.

It is highly advised that a licensed plumber be appointed to rectify any water leaks that may be present. Areas of repair and replacement of plumbing fittings and fixtures may be required and, as such, a quotation should be sought.

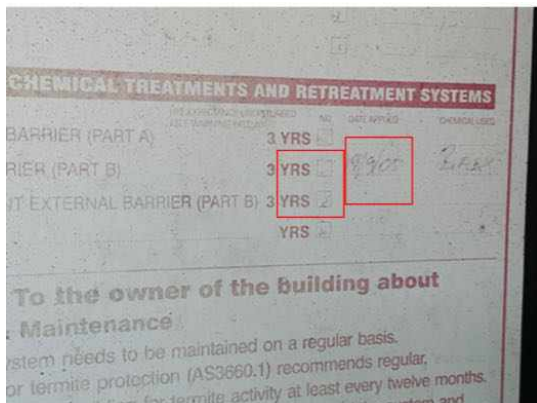
### Finding 6.03

Building:	Main Building
Location:	All Areas
Finding:	Re-application of chemical termite barrier - required
Information:	Chemical treated barriers deteriorate over time necessitating the need for re-application of a barrier every 6-10 years depending on the product type environment etc. Due to this deterioration chemical barriers decline in their effectiveness exponentially if not replenished.

Consult the record of installation to identify the type of chemical and date of application. It is then advised to consult a licensed pest controller regarding reapplication intervals. Annual inspections are almost always required for all system types.

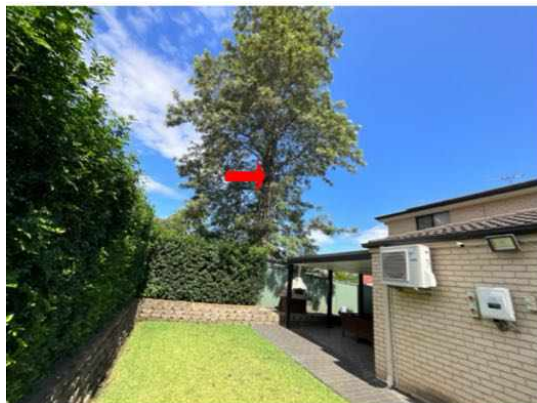
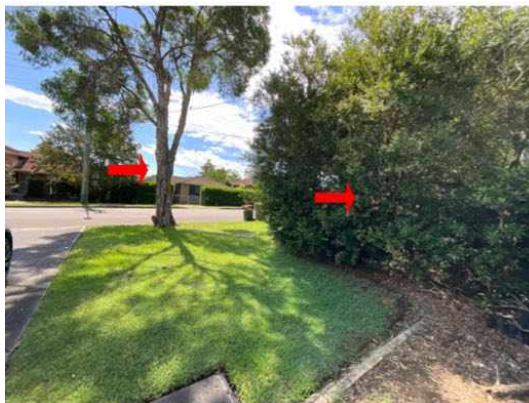
### Finding 6.06

Building:	Main Building
Location:	
Finding:	Surrounding bushland - Conducive
Information:	Home and or building is situated in a high risk area for termite activity, due to close proximity to surrounding bushland.

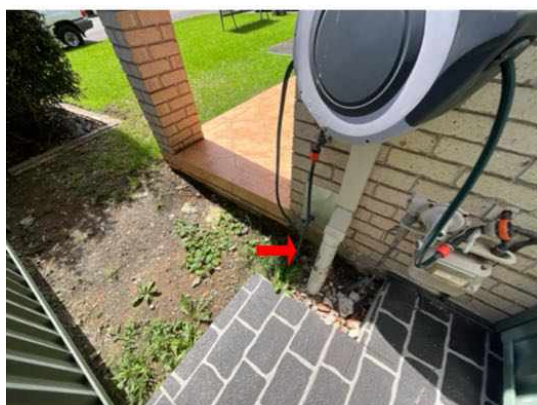
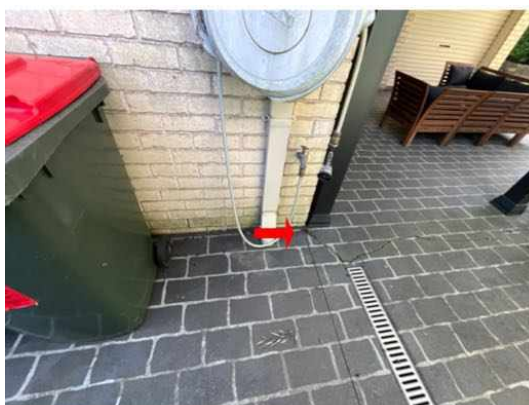
### Finding 6.07

Building: Main Building  
 Location: External tap  
 Finding: Tap - No drain  
 Information: The external tap in this area was noted to have no drain at the time of inspection.

This keeps the surrounding surfaces damp while using the tap, which becomes conducive to termite activity.

A licensed plumber must be appointed to ensure an appropriate drain is installed.

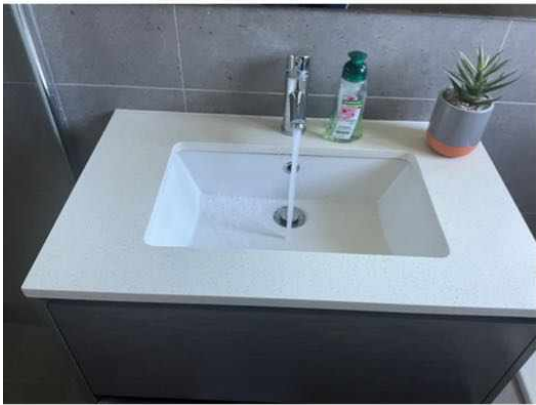
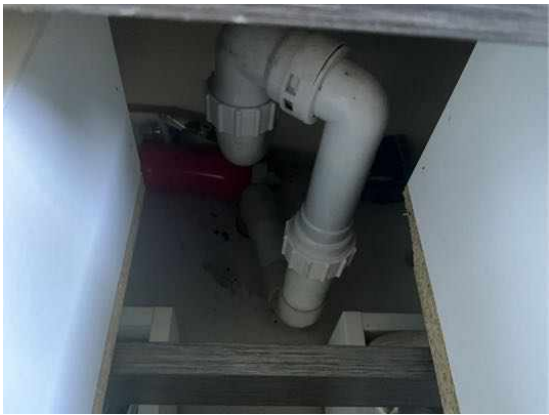
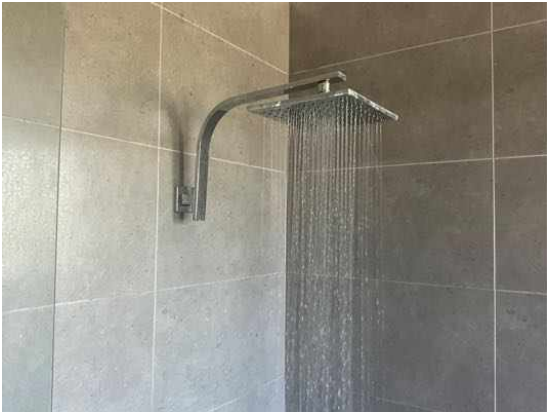
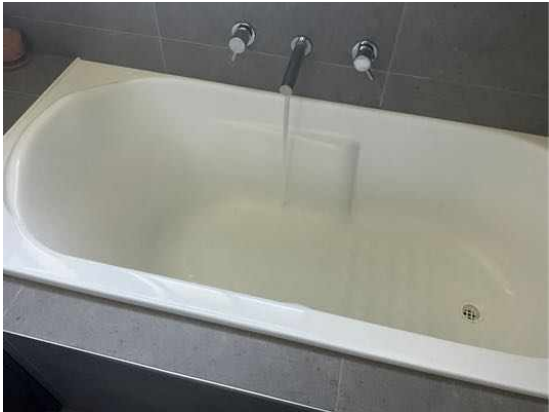
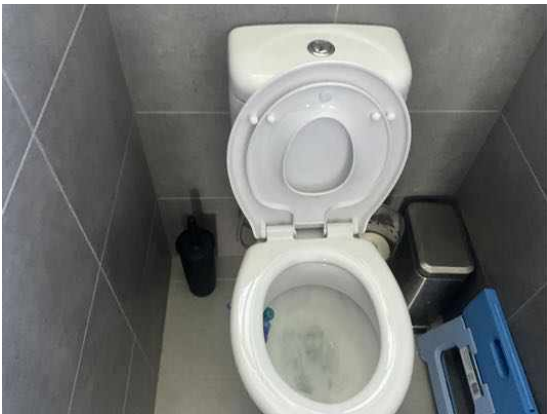
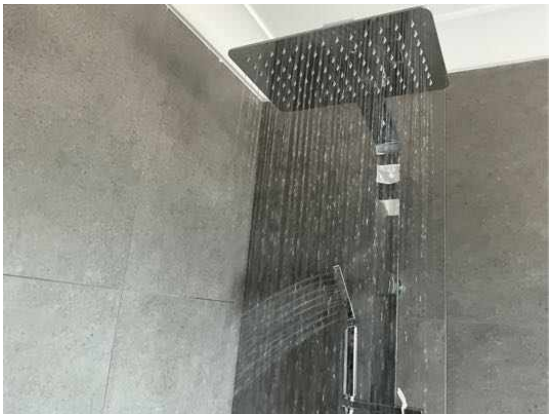
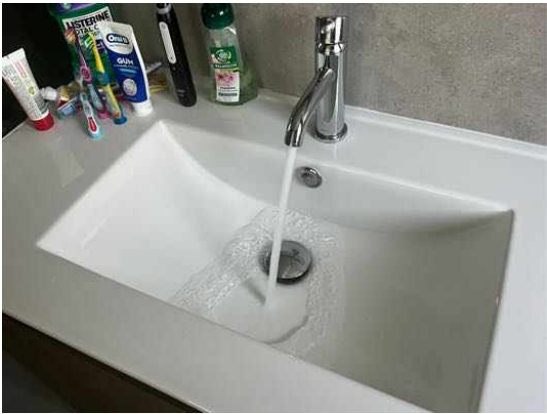
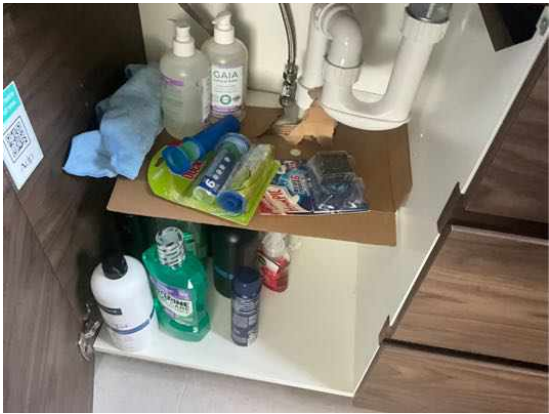
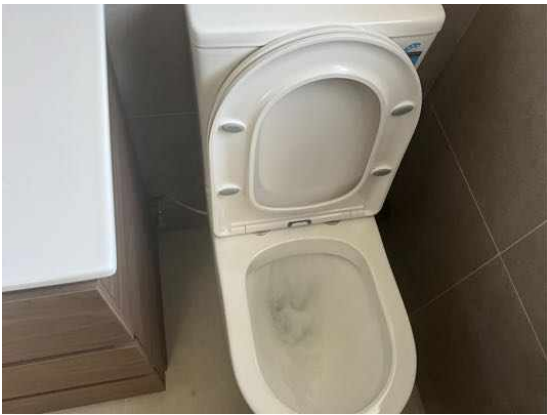
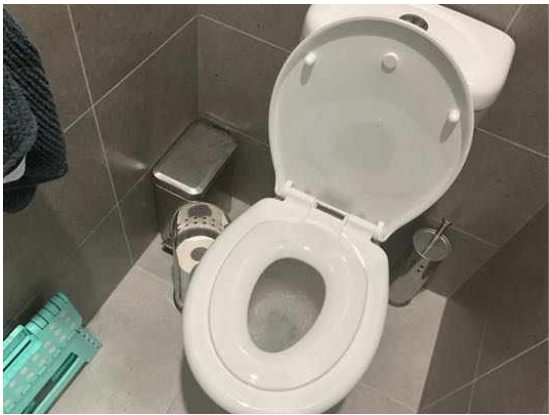
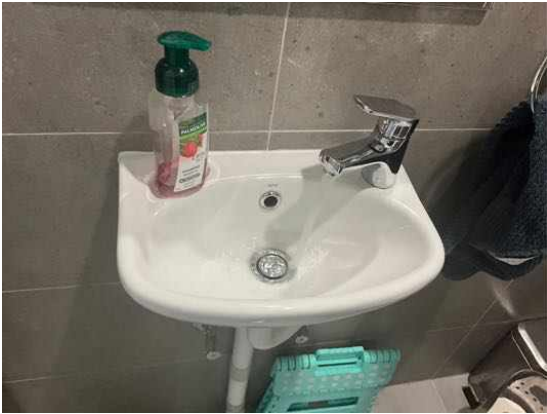
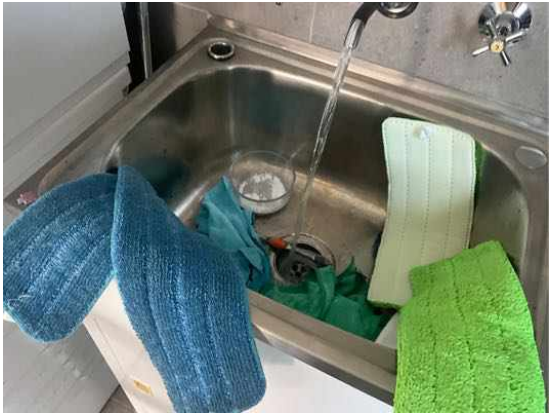
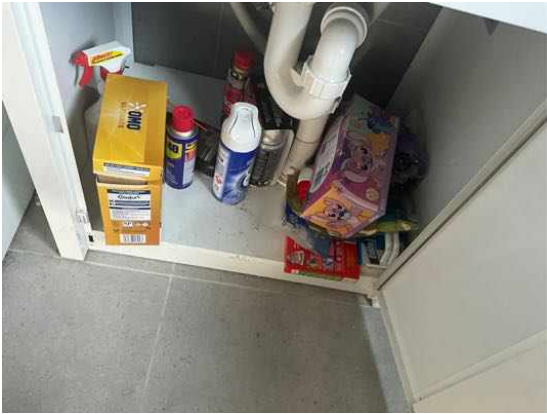
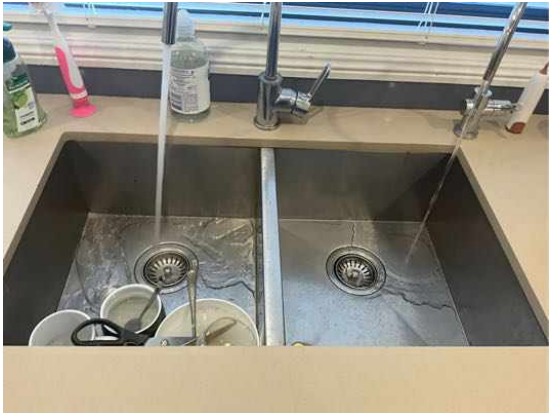
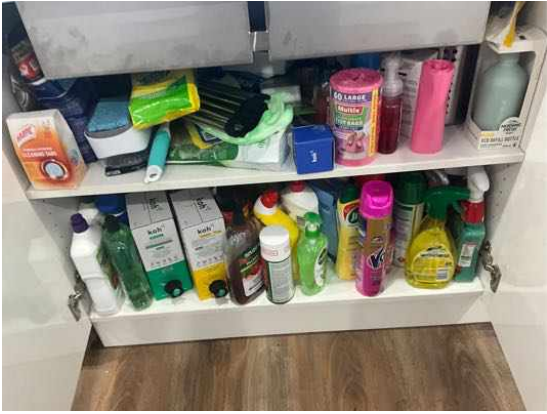
Building: Main Building  
Location: All Wet Areas  
Finding: Additional Photos  
Information:

Additional photos are provided for your general reference.

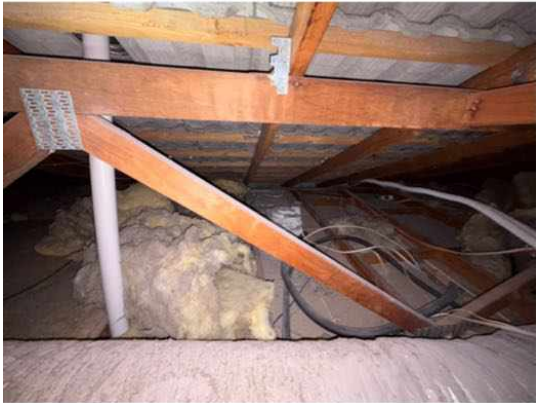
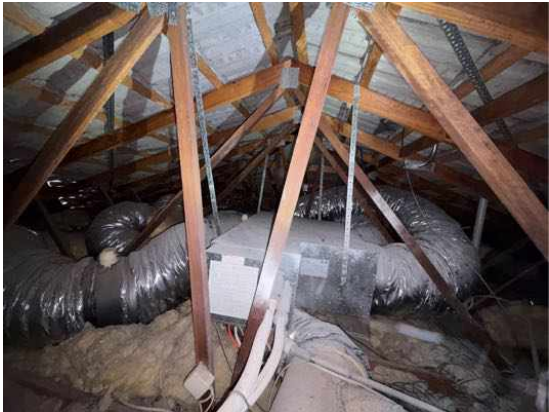
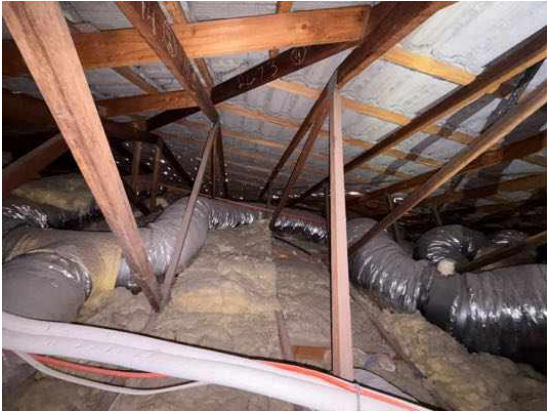
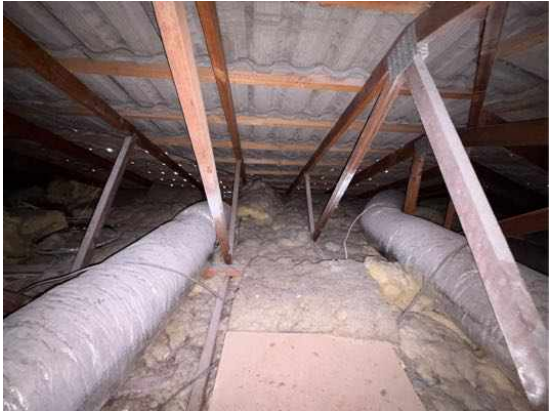
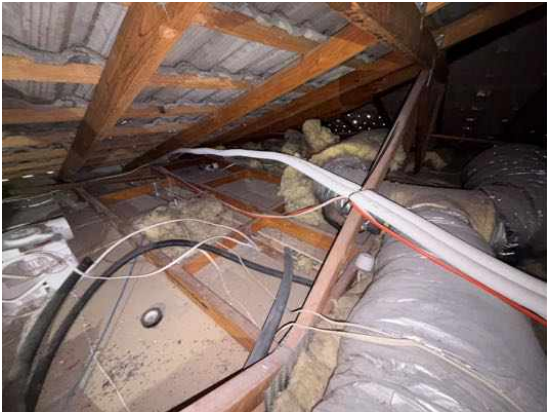
Building: Main Building  
Location: Roof Void  
Finding: Additional Photos  
Information:

Additional photos are provided for your general reference.

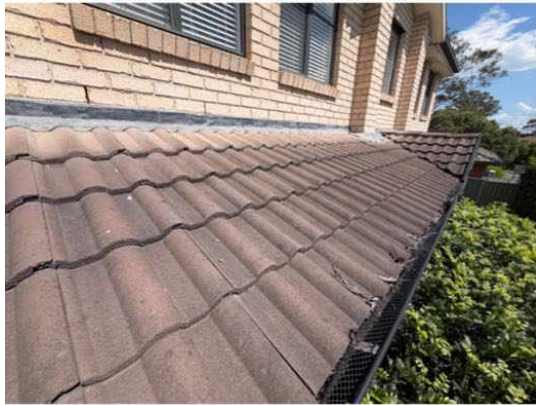
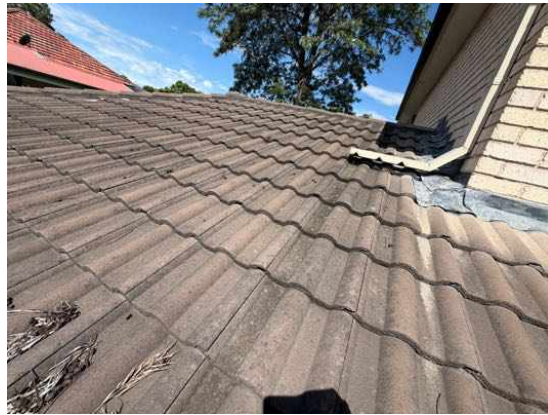
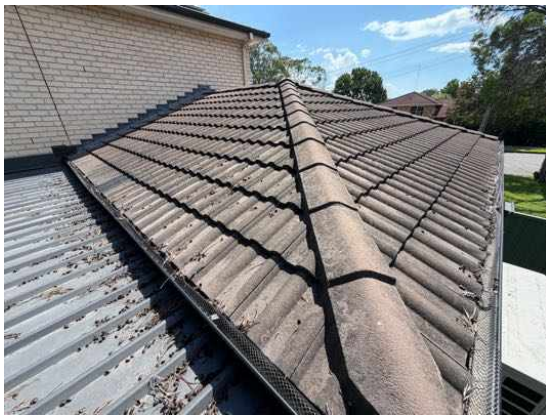
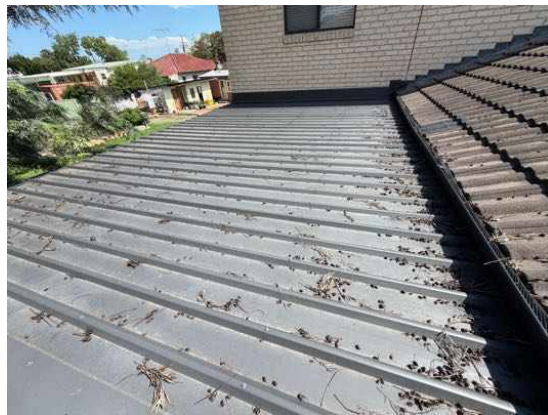
Building: Main Building  
Location: Roof Exterior  
Finding: Additional Photos  
Information:

Additional photos are provided for your general reference.

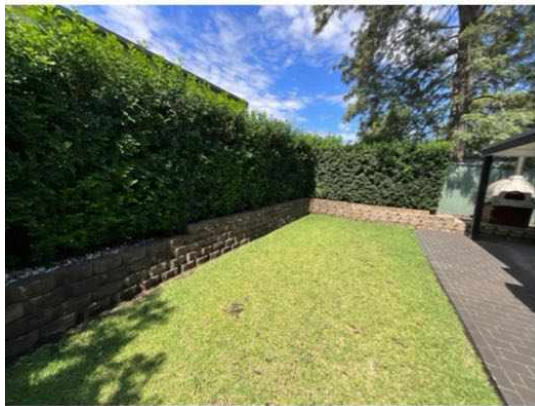
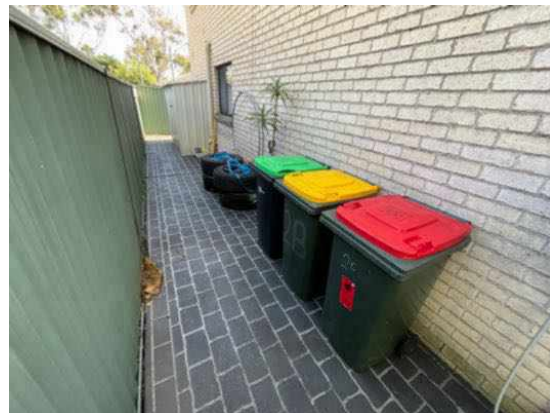
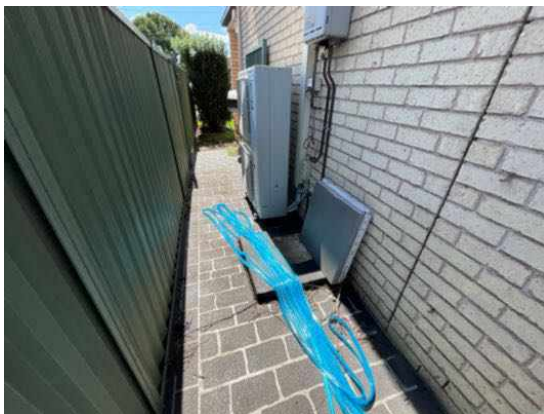
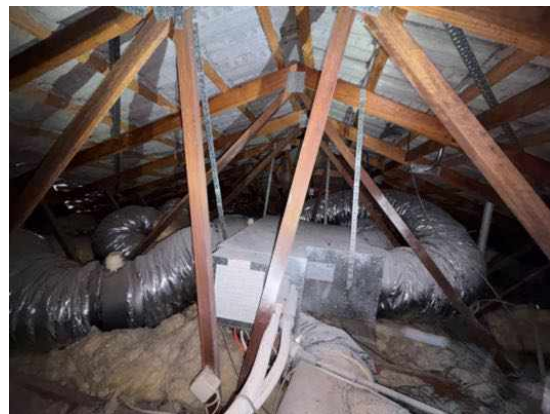
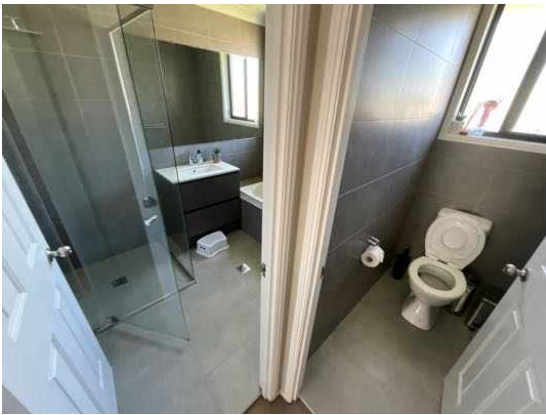
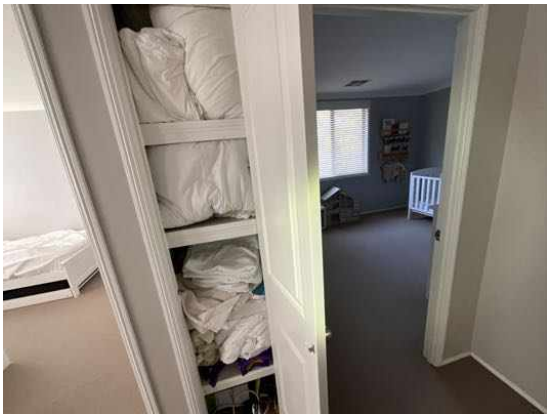
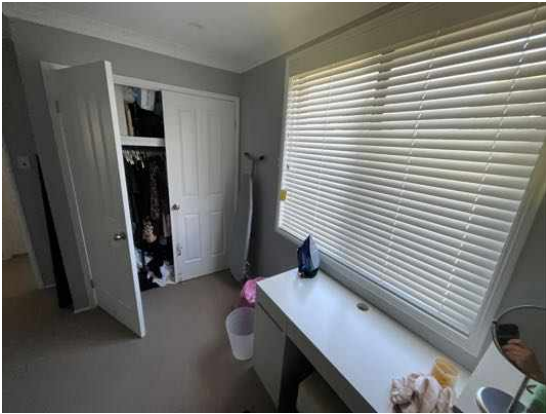
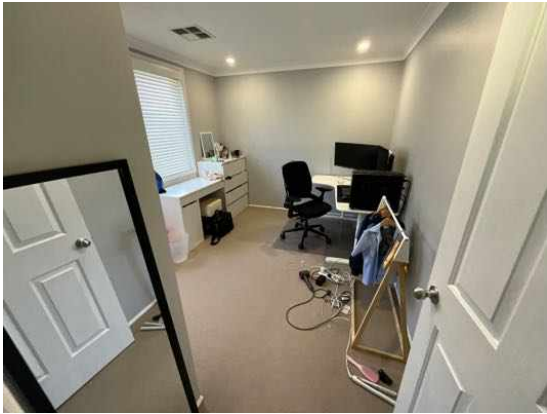
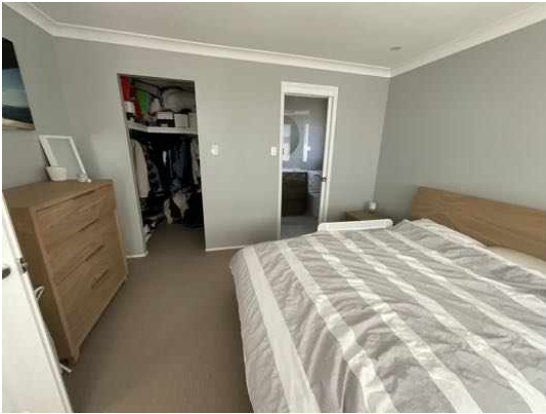
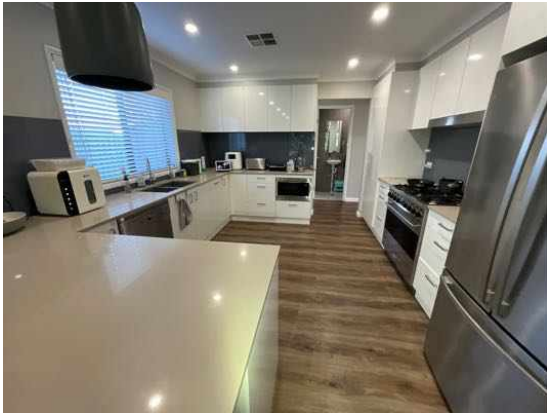
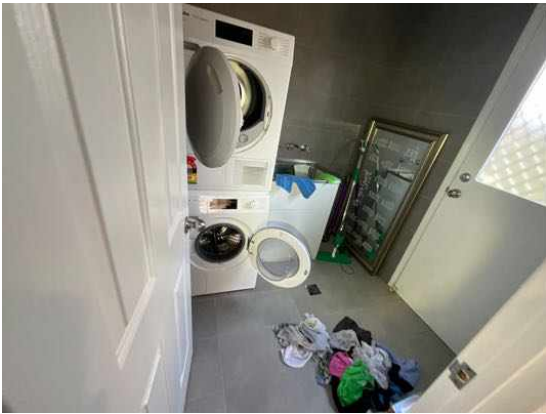
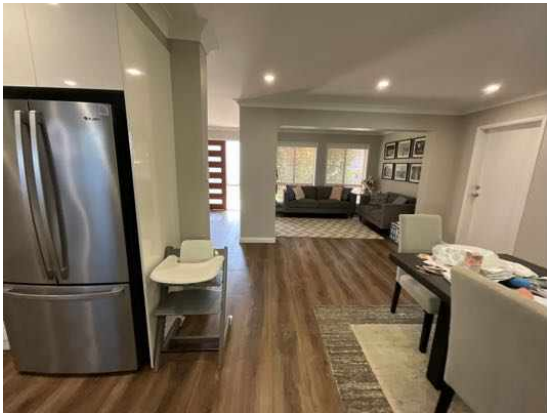
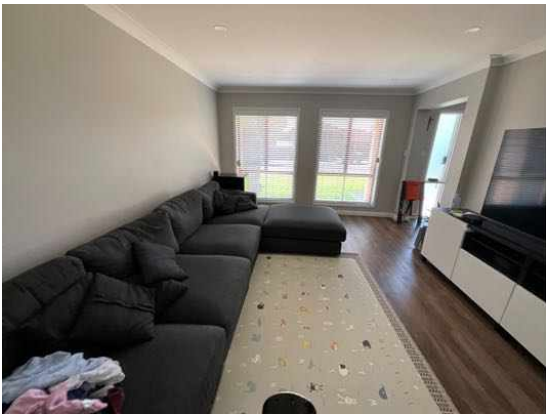
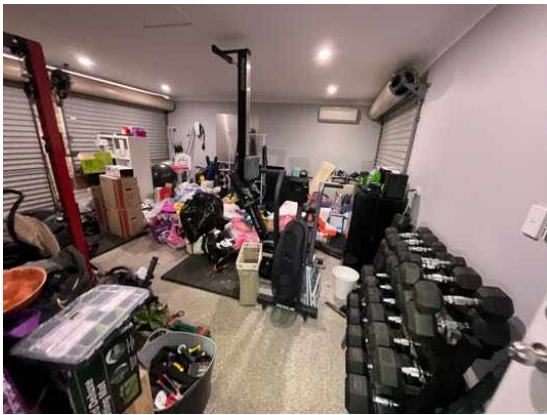
Building: Main Building  
 Location: All Areas  
 Finding: Additional Photos - Obstructions and Limitations  
 Information:

These photographs are an indication of the obstructions and limitations which impeded full inspection of the property at the time of inspection. These obstructions can hide an array of defects and should be removed to allow full inspection to be carried out. A re-inspection is recommended once the areas are made accessible.

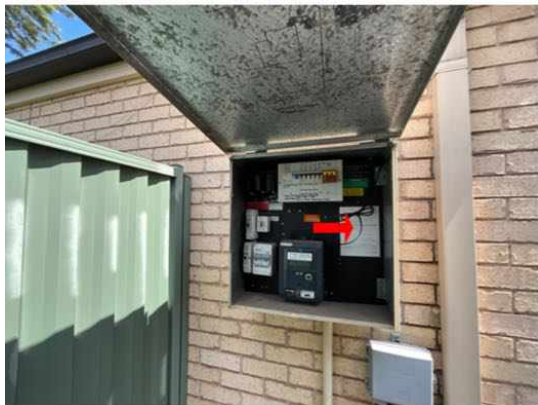
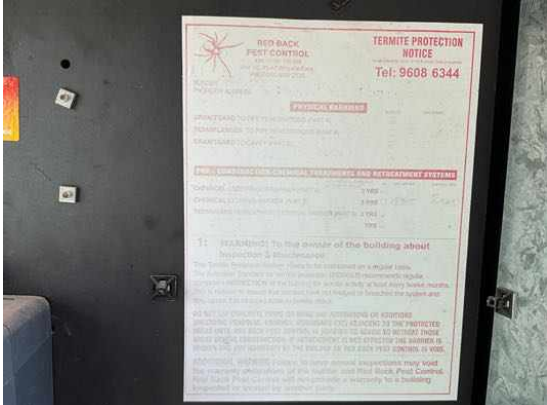
Where a Termite Management System has been identified you should refer to the type of barrier date of installation warranty conditions and any documentation provided by a builder or past owner. Consult the company who installed the barrier to confirm whether the system is still under warranty.

Most chemical termite management systems expire and require replenishment and all physical systems are primarily designed to prevent concealed entry.
