Building and Timber Pest Inspection Report

Inspection Date: Wed, 18 Mar 2026

Property Address: 3-14 Moodie St, Caulfield East VIC 3145,
Australia

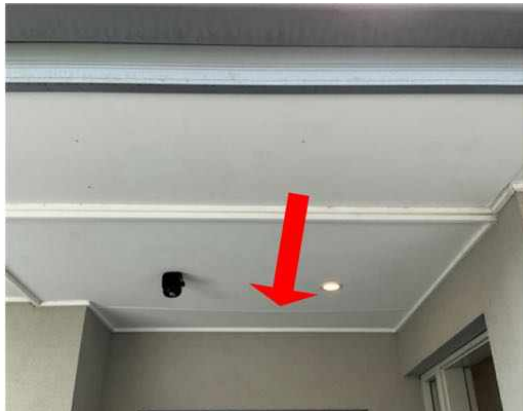
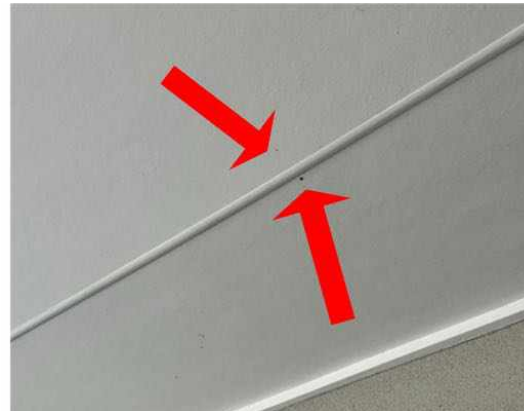
Information: Parts of the entry eaves are sagging and some nails are coming loose. It is suspected water is getting into the eaves through blocked gutters or missing flashings.

Recommend engaging a roof plumber to clean gutters and install flashings where appropriate to reduce the risk of water penetration to the building as soon as possible.

Recommend engaging a carpenter to repair as necessary to reduce the risk of further deterioration as soon as possible.

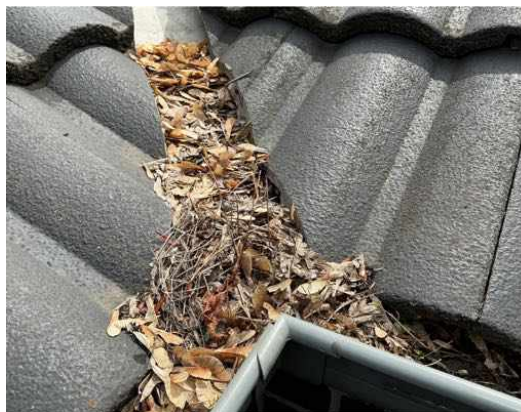
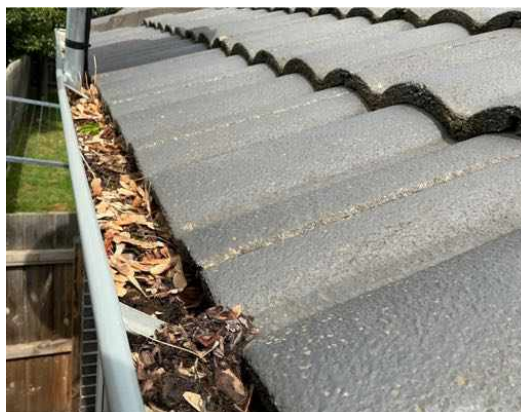
Blocked gutters are likely to lead to high levels of moisture in the affected areas. Such moisture will not only cause rust and decay of the associated building materials, but can also provide conditions that are conducive to termite and timber pest activity. Blockages in gutters should therefore be removed immediately to ensure dry conditions are maintained.

Consult a Licensed Plumber for further specific advice on remedial works that may be required. In the interim, it is highly advised that blocked gutters be removed by the homeowner or a general handyperson as a matter of urgency.

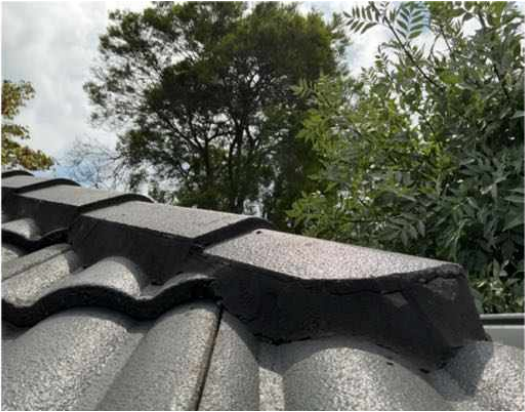
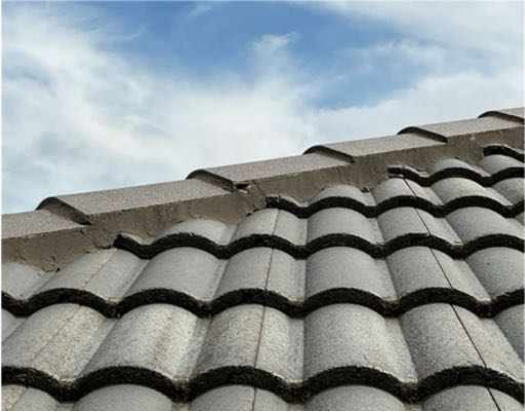
Building:	Main Building
Location:	Roof Exterior
Finding:	Roof tile mortar deterioration and cracking
Information:	Cracking and deterioration was observed in the ridge and hip tile mortar bedding. The mortar has separated in several areas, with visible gaps forming between ridge tiles and the underlying bedding. This condition indicates age-related degradation and exposure to the elements, which has caused the mortar to become brittle and lose its bonding integrity.

Compromised mortar may lead to further deterioration, potentially allowing water ingress and structural damage to the roof structure below.

Recommend engaging a qualified roofing contractor to carry out repointing or full re-bedding of affected ridge and hip tiles as necessary. All deteriorated mortar should be removed and replaced with new flexible roof bedding compound in accordance with current Australian Standards (AS 2050).

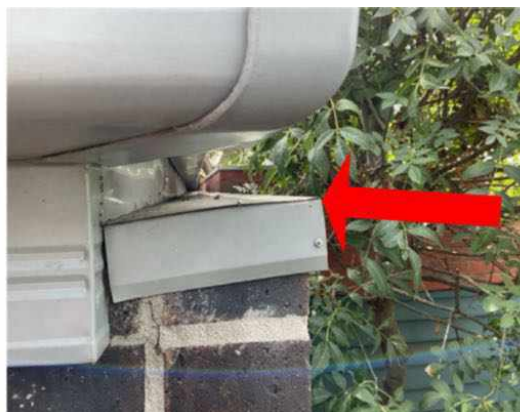
Finding 3.06

Building: Main Building
Location: Roof Exterior
Finding: Flashing leaning wrong way and could hold water.
Information: The flashing on the right hand rear side of the building is leaning the wrong way and could hold water. Flashings are metal and other materials which are applied to seals and intersections between roof coverings and building elements. They are designed to aid in weatherproofing of roof joins.

Flashings that are not installed adequately or are missing are likely to result in water penetration to the interior of the property, as well as creating excessively damp conditions against the exterior surfaces and around the base perimeter of the building.

Premature ageing and secondary building defects are imminent where roof plumbing is missing or inadequately installed. Additionally, water pooling also creates an environment that is susceptible to termite and pest infestation.

A roofing plumber should be appointed as soon as possible to install relevant roof plumbing materials, ensuring that no further damage is sustained.

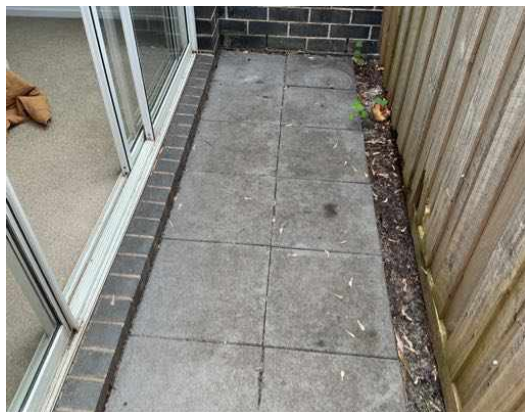
Information: Sections of the external paved areas are uneven, creating a potential trip hazard. It appears as though the area has been subject to rough installation, or that paving sections have lifted due to movements in the foundation of the property.

Where paving creates a trip hazard, personal injury may ensue if due caution is not taken by all persons within this area.

Re-paving of the area is required as soon as possible to remedy this situation. Further consultation with a specialist paver is advised.

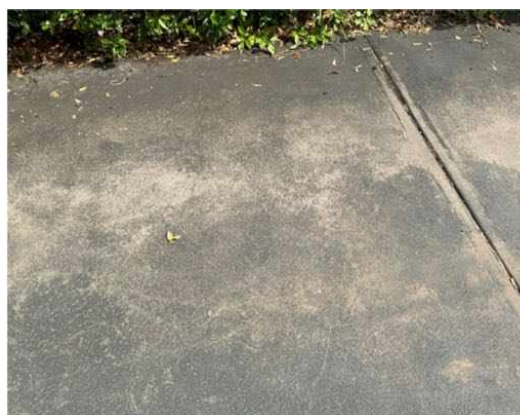
Finding 3.09

Building:	Main Building
Location:	Driveway
Finding:	Driveway Cracking - External Concrete Paving Damage Category 1 - Fine (less than 2mm)
Information:	Fine cracks were identified in the driveway external concrete paving. Although fine cracks are quite noticeable, they are often only considered to be an appearance defect, and usually do not indicate any structural damage. To be considered a Category 1 or fine crack, the crack is found to be less than 2mm in width.

Generally the cause of a hairline crack in existing concrete paving such as driveways and pathways is indicative of the expansion and contraction of the concrete. Such causes are generally due to environmental factors, such as moisture levels, weather conditions, root systems of nearby trees or the soil types on which they are laid.

Fine cracks may also be due to poor original installation of the concrete. Factors such as poor compaction of the sub surface and/or inadequate reinforcing of the slab may create cracking and other secondary defects.

Monitoring of all cracking should be conducted frequently. Always contact a building inspector should cracks widen, lengthen, or become more numerous.

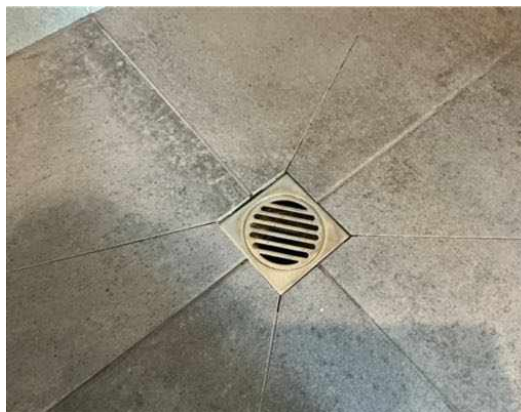
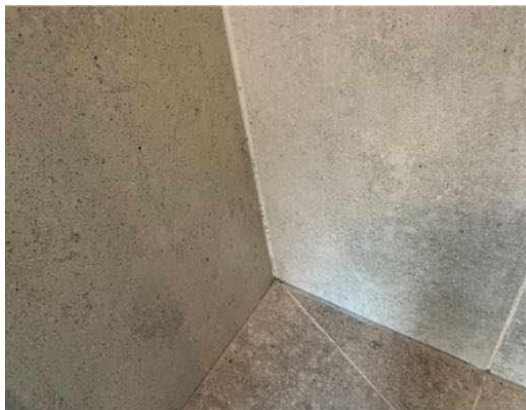
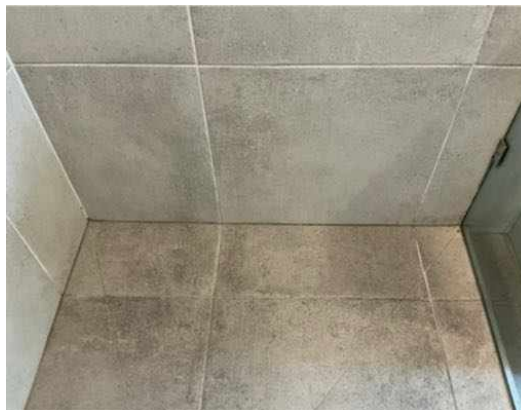
Finding 3.11

Building:	Main Building
Location:	Bathroom
Finding:	Bathroom Sealant and grouting - Missing or damaged
Information:	It was noted on inspection that sealant or grout is degraded to the tiled shower alcove and or other areas of the bathroom.

Different materials and floor areas move at different rates, generally causing cracking to grout or sealant at this point. A flexible sealant is required to allow for expected expansion and contraction, while keeping the joint water tight and protective of all associated building materials.

Flexible and mould resistant materials should be applied to affected areas to prevent any subsequent water damage that is likely to occur. Regular maintenance and replacement of damage or missing or damaged sealant and grout is highly recommended to the wet areas, as this is a regular wear and tear defect. Sealant and grouting in areas that come into regular contact with water should be maintained for the long term care of your property.

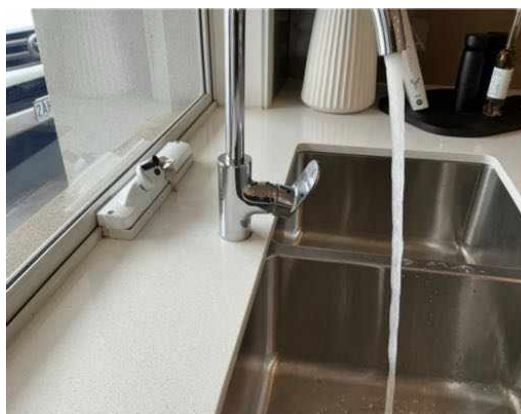
Building:	Main Building
Location:	Kitchen
Finding:	Kitchen Tap - Loose
Information:	The tap in the kitchen has not been installed correctly, or has deteriorated with age, and is consequently loose. This tap being loose creates potential for water leaks and subsequent water damage to the surrounding area.

Where taps or spouts are loose, a qualified plumber should be appointed to re-fix the plumbing fitting.

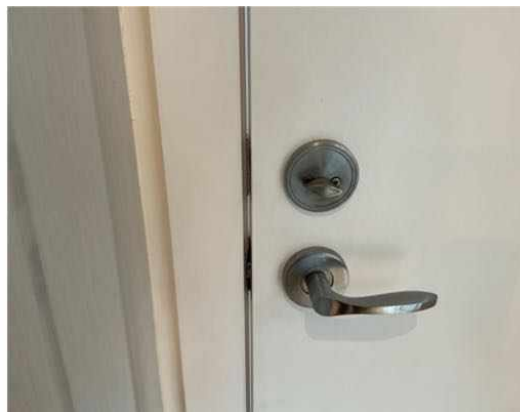
Finding 3.14

Building:	Main Building
Location:	Garage
Finding:	Garage Door - Binding/jamming
Information:	Binding and/or jamming of the garage door is evident during standard operation. This defect inhibits the functionality of the affected door as well as creating potential for secondary defects to associated building elements, such as damage to the floor covering.

A door that binds to flooring or to the associated door frame may have several causes, ranging from minor defects, such as poor installation of the door or deteriorated hinges.

For minor causes, a qualified carpenter or general handyperson should be appointed to perform minor rectification works at client discretion.

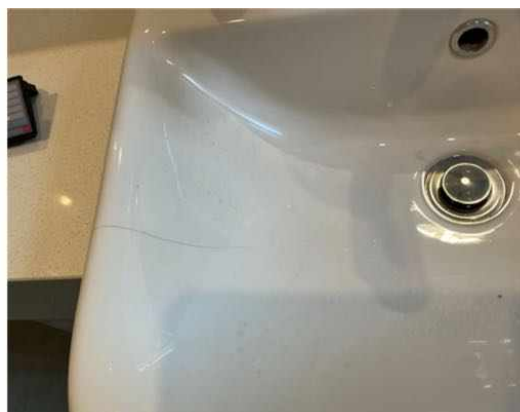
Finding 3.15

Building:	Main Building
Location:	Ensuite - Master
Finding:	Basin cracked
Information:	The basin in the ensuite bathroom is cracked. This can happen with deterioration over time or accidental impact damage. Recommend engaging a plumber to replace to reduce the risk of further deterioration as soon as possible.

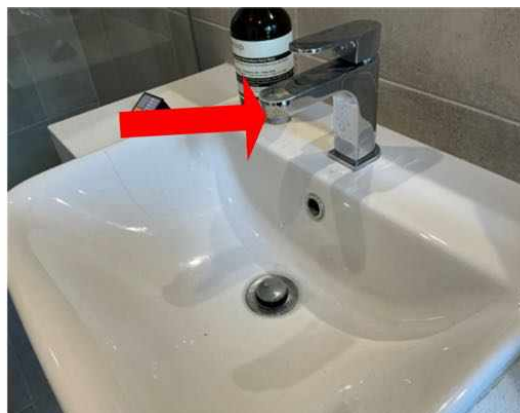
Finding 3.16

Building:	Main Building
Location:	Ensuite - Master
Finding:	Tap - Leaking bathroom
Information:	<p>The tap in the ensuite bathroom was found to be leaking at the time of inspection. This is a common defect that is consistent with general ageing of the building element. However, it may be indicative of substandard plumbing workmanship if the tap is relatively new.</p> <p>While this defect only seems minor, if left unmanaged, it is likely to result in the development of rust, water damage and/or extensive water usage and can attract termites and other pests.</p>

It is advised that a handyman or licensed plumber be appointed to perform remedial works on the affected tap. Such works should be performed prior to the development of secondary defects to ensure adequate functionality of all associated building elements.

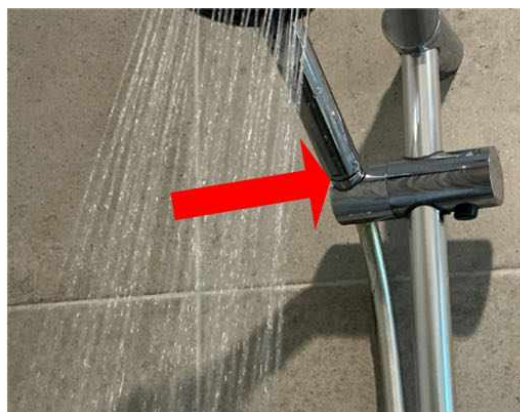
Finding 3.17

Building:	Main Building
Location:	Ensuite - Master
Finding:	Ensuite Shower head is dripping/leaking
Information:	The shower head to the ensuite bathroom is loose and dripping/leaking. This can often happen over time with deterioration or if the shower head is loose and needs tightening. Recommend engaging a plumber to repair/replace the shower head to reduce the risk of further deterioration and water leaks as soon as possible.

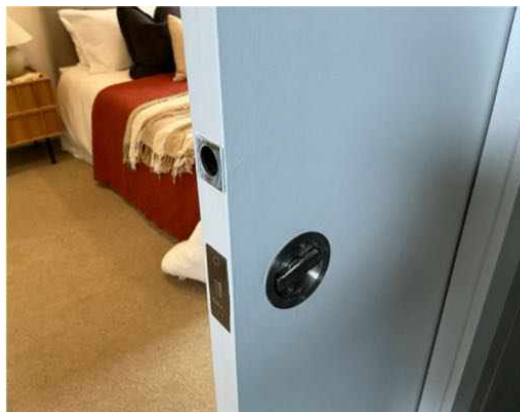
Finding 3.18

Building:	Main Building
Location:	Ensuite - Master
Finding:	Door lock requires adjustment
Information:	The ensuite bathroom door lock is not operating correctly and requires adjustment to make it operate properly. This can happen overtime with deterioration or lack of

maintenance. Recommend engaging a carpenter to repair/maintain at the owners discretion.

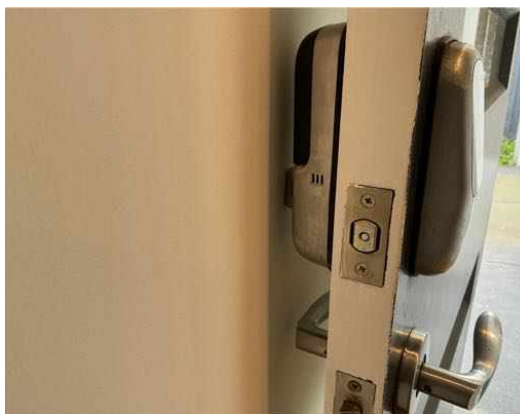
Finding 3.19

Building: Main Building
 Location: Entry
 Finding: Door stop- missing
 Information: The entry doorstop is missing and is unable to stop the door handle/lock from damaging the wall. Although some building elements may seem irrelevant or unnecessary, all building elements play a key role in the operation and function of the overall structure and its performance.

Re-installation or replacement of the door stop is advised as soon as possible to prevent any subsequent damage to the door or associated structures. A general handyman may be appointed to perform these works at client discretion.

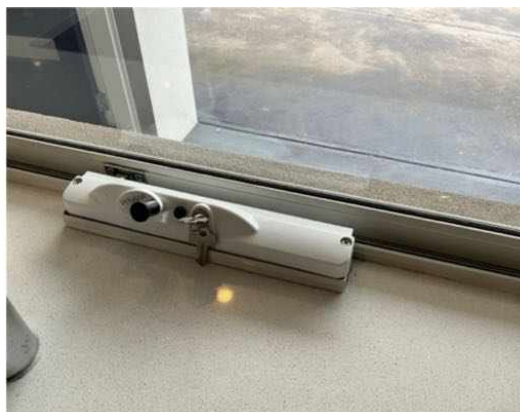
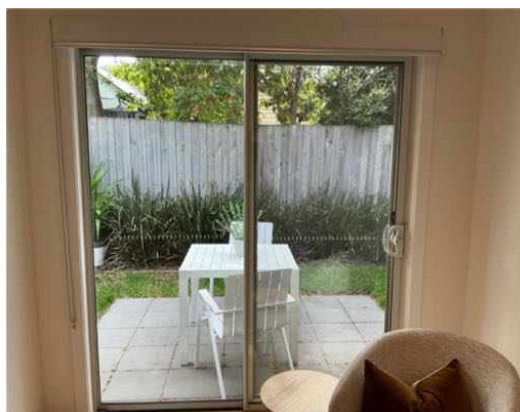
Finding 3.20

Building: Main Building
 Location: Various parts of the building
 Finding: Doors and windows required maintenance
 Information: Some of the doors and windows to the building require some maintenance to make

them operate more smoothly. This can happen overtime with deterioration or lack of maintenance. Recommend engaging a carpenter to repair/maintain windows and doors at the owners discretion.

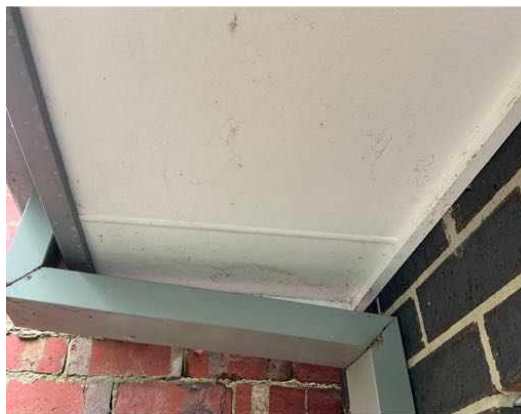
Building:	Main Building
Location:	Eaves
Finding:	Eaves- Evidence of excessive moisture was present at the time of inspection
Information:	Evidence of excessive moisture was found to parts of the eaves using a moisture meter. It is suspected that this has been caused by blocked gutters. Recommend cleaning gutters and monitoring, and if further staining is noticed engage a roof plumber as soon as possible to rectify. Excessive moisture can attract termites and produce conditions that promote termite attack, fungal growth and wood decay. Excessive moisture is generally caused by deteriorated, inadequate, blocked or missing roof drainage, leaking plumbing pipes or fixtures, poorly plumbed HWS overflows or condenser units and poor site drainage. It is highly recommended that all

plumbing and drainage fixtures and fittings be maintained regularly in order to prevent excessive moisture being present in the external / internal property.

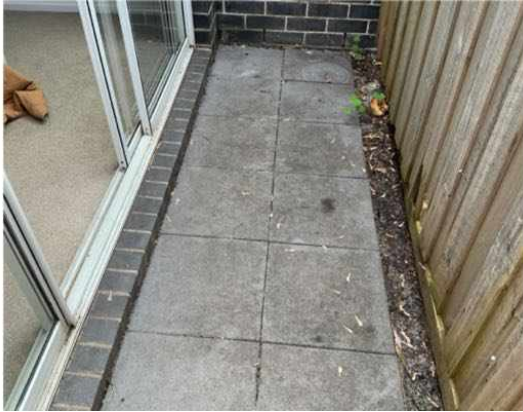
Finding 6.03

Building:	Main Building
Location:	Yards
Finding:	Site drainage - poor/inadequate
Information:	The site drainage to parts of the yards was found to be inadequate at the time of inspection, creating potential for subsequent water damage to associated building elements. Excessive moisture will attract termites.

It is important that water does not lie against the base of walls; surrounding paths and ground levels should be sloped to drain water away from walls. Downpipes should not discharge stormwater onto lower walls or plinths. Stormwater should be carried away by large, regularly cleaned drains. Ground levels may need to be lowered to expose a buried DPC.

Where site drainage is inadequate, installation of an Agricultural (Aggie) Drain may be required. A qualified plumber should be appointed to further inspect the property and perform any remedial works as necessary. Water damage and secondary defects are likely to occur if left unmanaged.

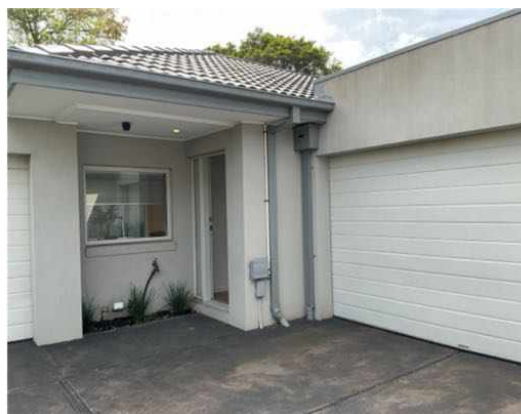
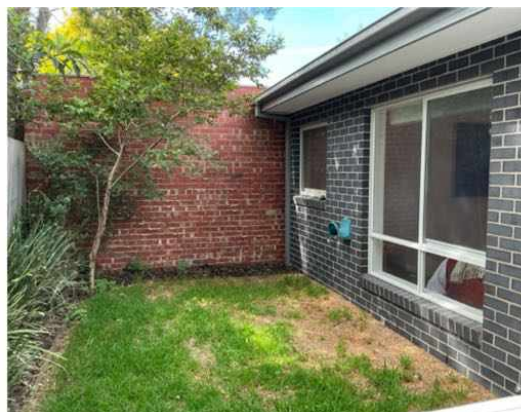
Finding 6.04

Building:	Main Building
Location:	Various parts of the building
Finding:	Bridging attachments to buildings
Information:	Bridging occurs when items against a building provide a concealed entry point for termites into the building or by passing around a termite management system.

Where any part of an attachment to a building is not isolated and is not provided with a clear gap of not less than 25mm from building, bridging occurs. Attachments to buildings such as hot water services, downpipes, verandahs, decks, steps, fences, service conduits and the like provide the opportunity for concealed entry.

Building attachments of this nature need to be frequently inspected for termite activity by a qualified inspector.

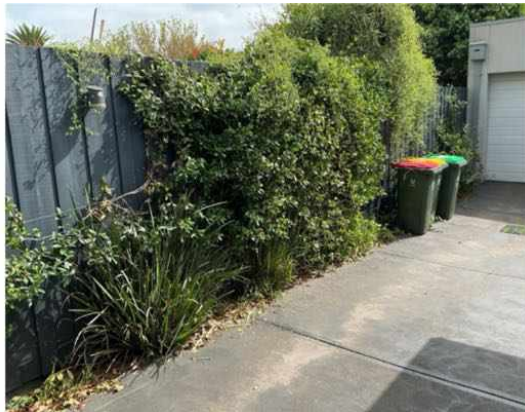
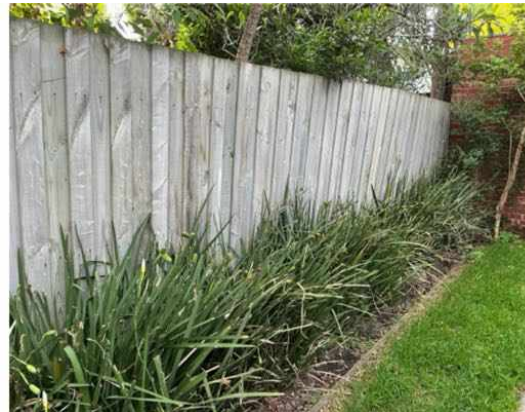
If left unattended, it is likely that further damage will occur. It is suspected that repair of several elements of the fencing may be required however replacement may be a consideration of the client also.

A licensed fencing contractor should be appointed to provide further advice and perform rectification works as necessary.

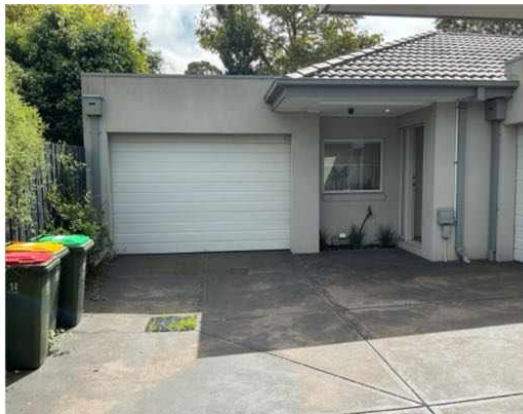
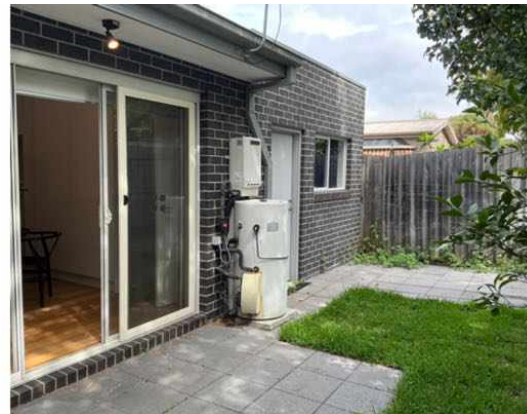
Building: Main Building
Location: All External Areas
Finding: Additional Photos - Obstructions and Limitations
Information: These photographs are an indication of the obstructions and limitations which impeded full inspection of the property at the time of inspection. These obstructions can hide an array of defects and should be removed to allow full inspection to be carried out. A re-inspection is recommended once the areas are made accessible.

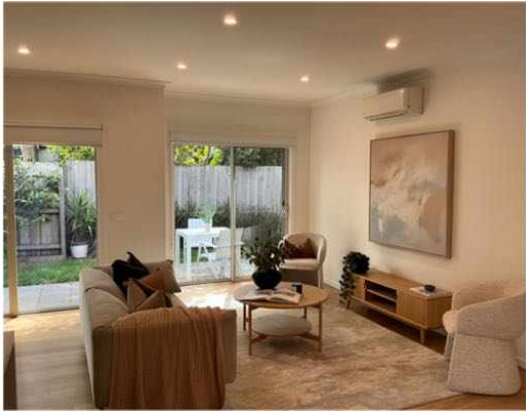
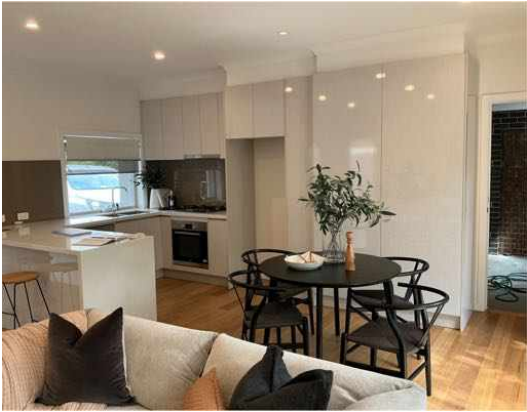
Building: Main Building
Location: All Internal Areas
Finding: Additional Photos - Obstructions and Limitations
Information: These photographs are an indication of the obstructions and limitations which impeded full inspection of the property at the time of inspection. These obstructions can hide an array of defects and should be removed to allow full inspection to be carried out. A re-inspection is recommended once the areas are made accessible.

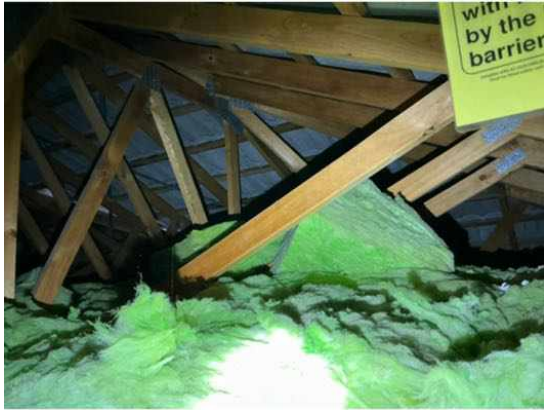
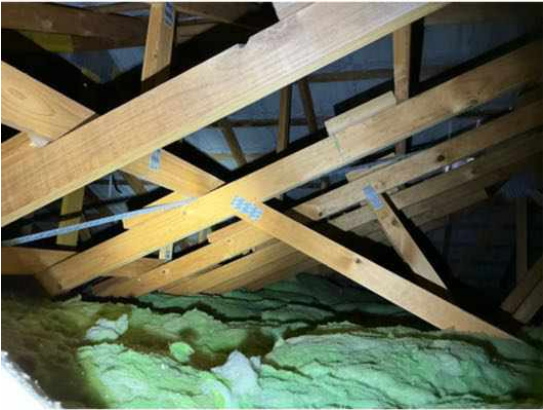
Building: Main Building
Location: Roof Void
Finding: Obstructions and Limitations -roof cavity
Information: These photographs are an indication of the obstructions and limitations which impeded full inspection of the roof cavity at the time of inspection. These obstructions can hide an array of defects and should be removed to allow full inspection to be carried out. A re-inspection is recommended once the areas are made accessible.
