# Building and Timber Pest Inspection Report

Inspection Date: Tue, 3 Feb 2026

Property Address: 2/1 Maritana Ave, Reservoir VIC 3073, Australia

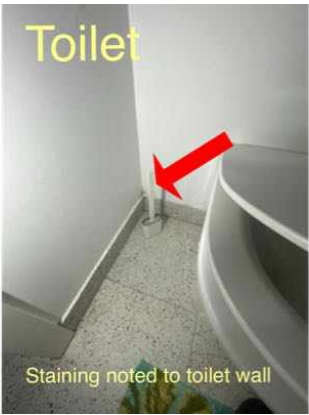
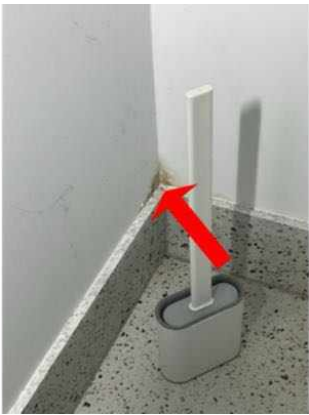
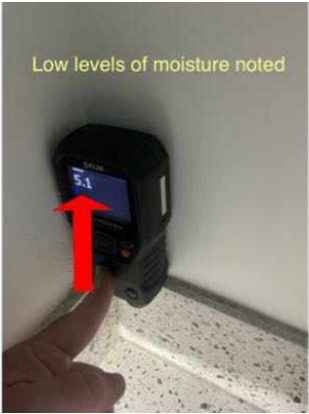
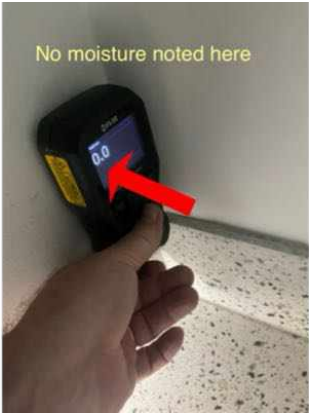
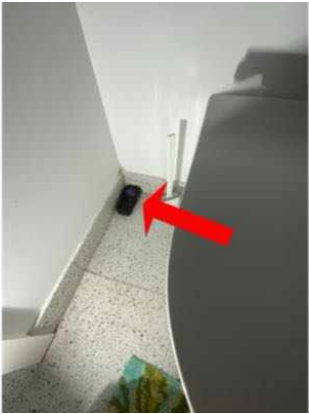
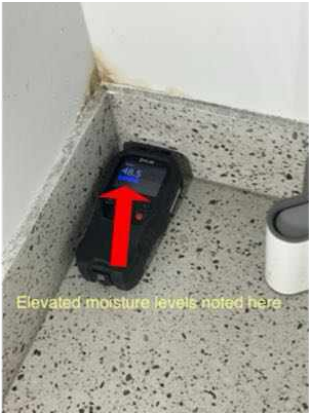
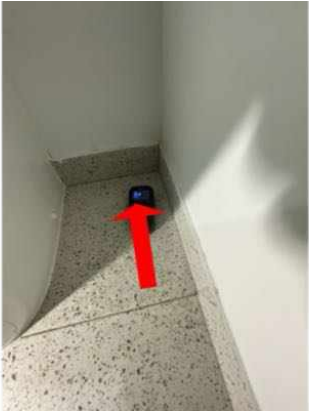
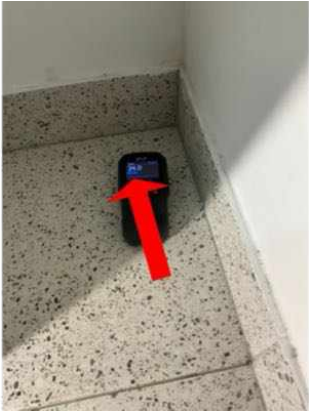
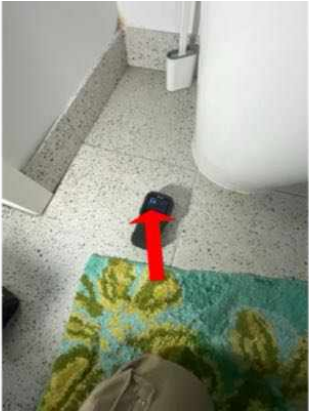
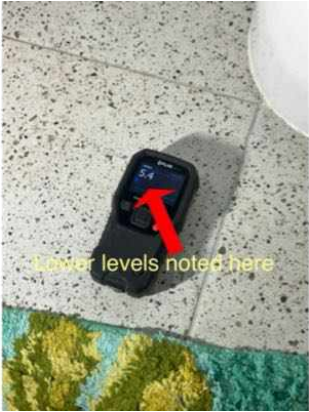
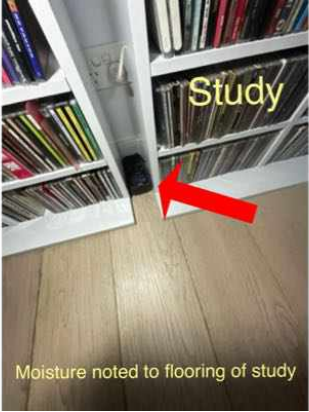
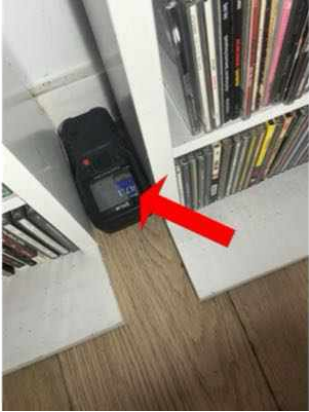
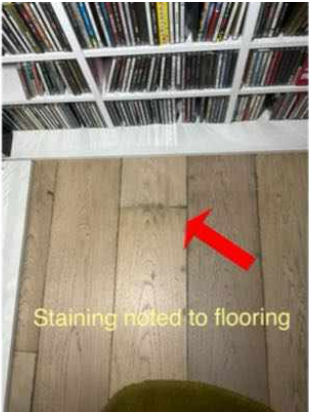
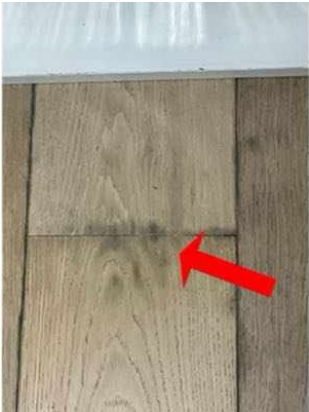
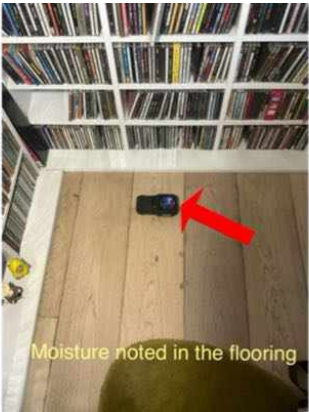
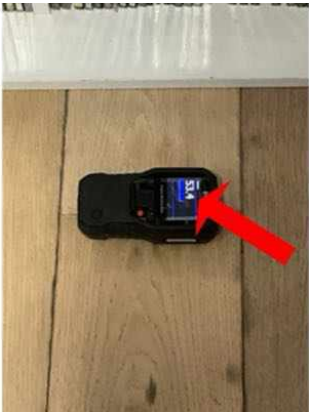
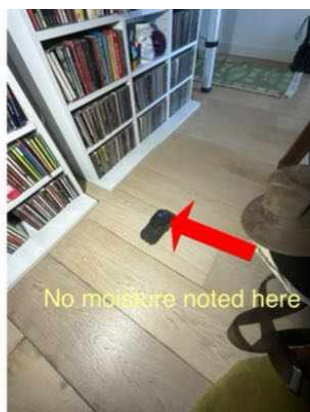
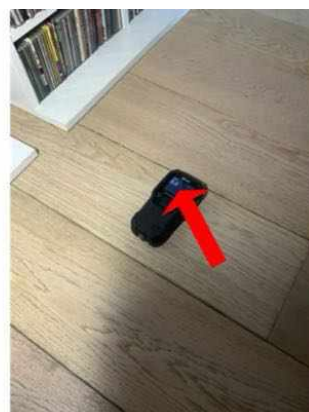
Finding: Staining and current moisture noted to the wall and floor in this area.

Information: Evidence of moisture staining was identified to the lower wall of the toilet at the time of inspection. Current Moisture was noted within parts of the area, along with elevated moisture readings being noted in areas of the tiled flooring of the toilet when tested with a moisture meter. Elevated moisture readings along with some suspected staining was also noted in the flooring of the study behind this toilet area. As dampness has been found in areas where it shouldn't be, which can cause further determine of the property, this defect is classified as a major defect\*

It is unclear as to the source of the suspected dampness. The toilet operated as intended with no obvious signs of leaking visible. The dampness may be from damaged pipes within the walls or flooring or from moisture coming up through the concrete slab under the tiles.

Please note: a major defect as per the Australian standards for residential pre-purchase building inspections (AS4349.1-2007) is defined as "a defect of sufficient magnitude where rectification needs to be carried out in order to avoid unsafe conditions, loss of utility, or further deterioration of the property."

It is highly recommended that a licensed plumber or damp specialist be engaged to inspect the area to determine the source of the dampness. This would most likely involve an invasive inspection ie cutting open the wall to inspect inside the wall cavity for the cause of the moisture. Once this cause has been determined, repairs would then be carried out which may involve repairs to any plumbing work, replacing any damaged insulation or replastering the section of the wall which has been opened up and repainting.

This defect should not be ignored and should be acted on as a matter of urgency.

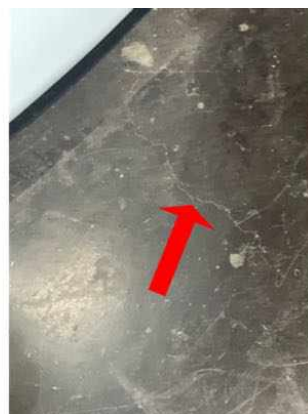
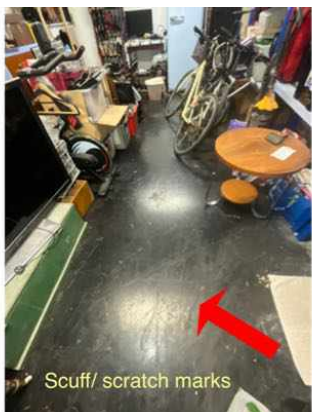
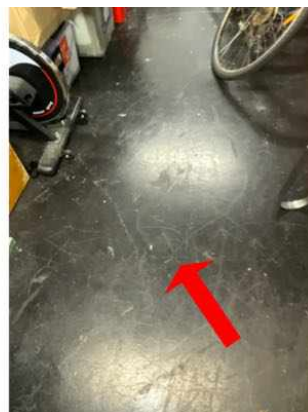
Monitoring of all cracking should be conducted frequently. Always contact a building inspector should cracks widen, lengthen, or become more numerous.

Please note: several scratch and scuff marks were noted to the flooring. These can cover other hairline cracks which may not be noted here.

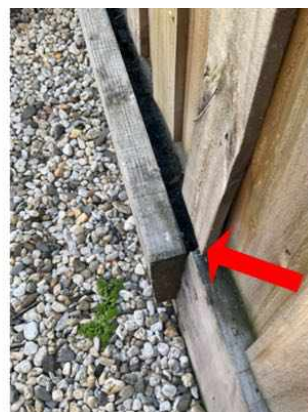
### Finding 3.13

Building:  
 Location: All Areas  
 Finding: Additional Photos - minor defects  
 Information: Additional photos are provided for your general reference.

Arrows have been included where necessary to highlight areas of importance.

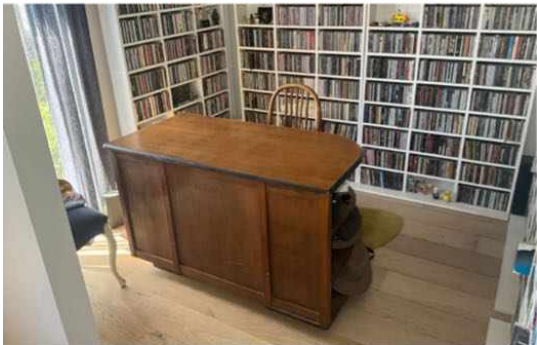
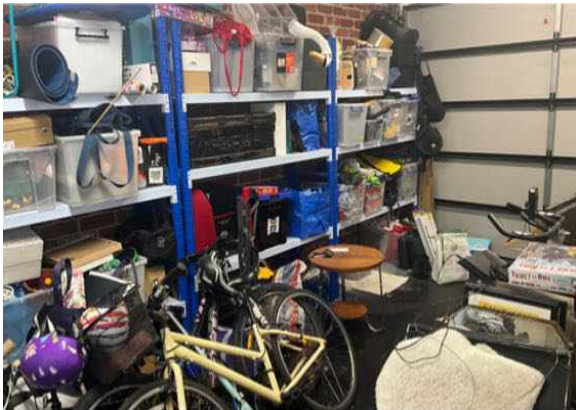
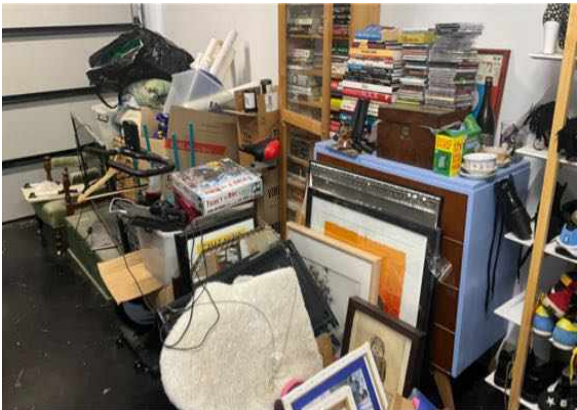
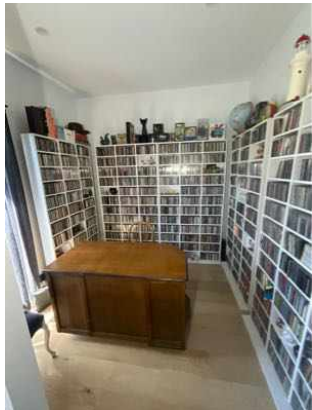
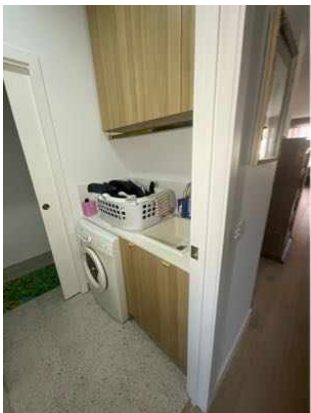
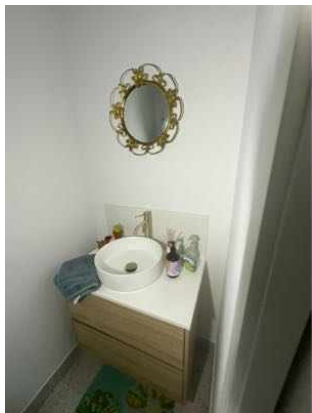
**Noted Item**

Building:  
Location: All Areas  
Finding: Additional Photos - Obstructions and Limitations  
Information: These photographs are an indication of the obstructions and limitations which impeded full inspection of the property at the time of inspection. These obstructions can hide an array of defects and should be removed to allow full inspection to be carried out. A re-inspection is recommended once the areas are made accessible.
