Building and Timber Pest Inspection Report

Inspection Date: Tue, 24 Mar 2026

Property Address: 5A Gordon St, Burwood NSW 2134,
Australia

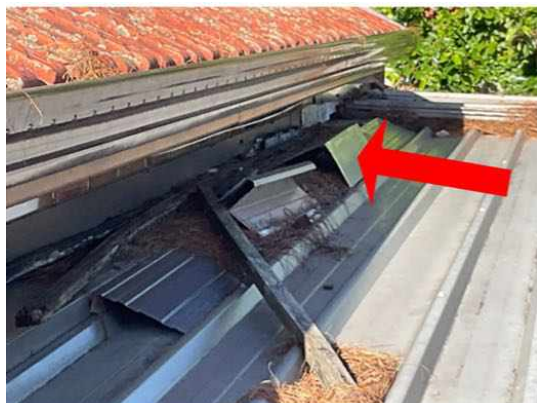
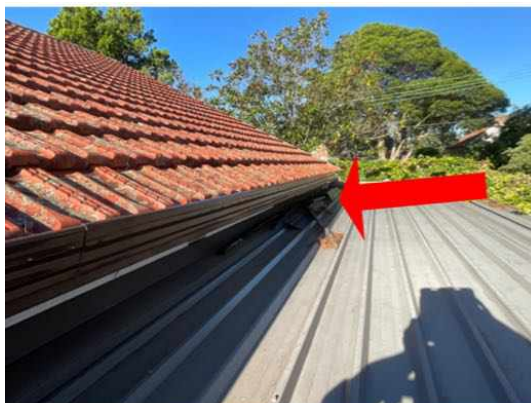
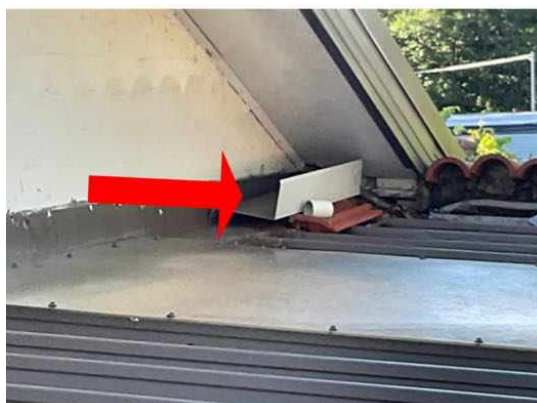
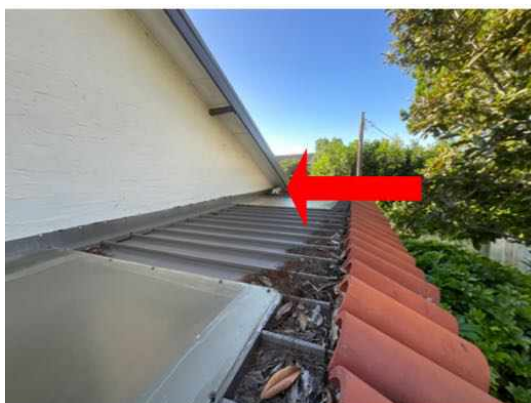
Finding 1.01

Building:	Main Building
Location:	All Areas
Finding:	Building Materials - Loose
Information:	Upon inspection of the exterior roof covering, it was noted that numerous of tiles were left on the roof exterior. It is suspected that this defect has developed as a result of a lack of poor workmanship. Loose tiles can potentially become a safety hazard. If left unaddressed, it is likely that secondary damage to associated building elements will develop. It is highly recommended removing of the loose roof tiles as soon as possible, to improve the safety of the area. Appropriate contractor should be appointed to remove the roof tiles.

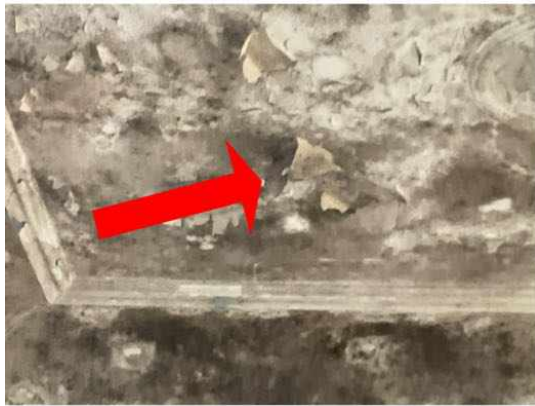
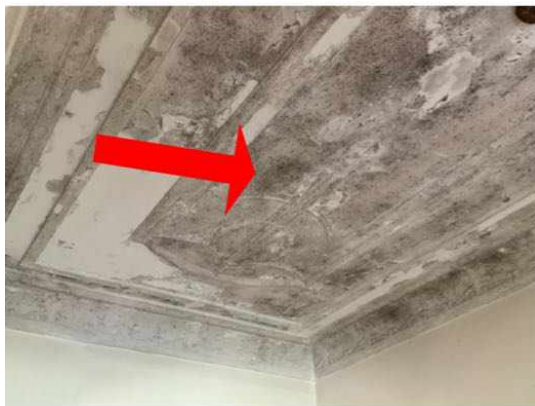
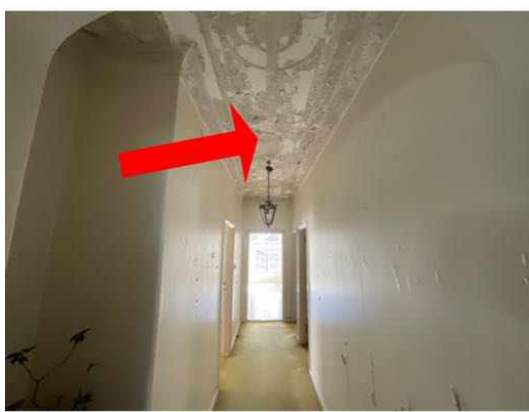
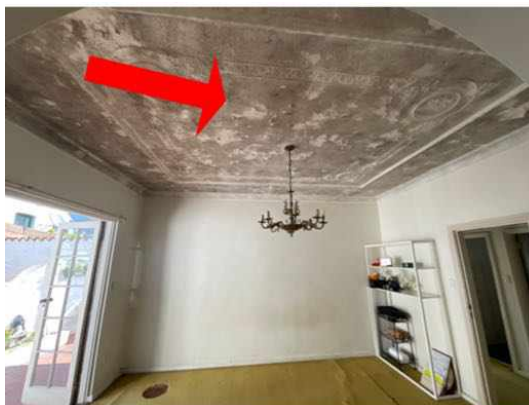
Finding 1.02

Building:	Main Building
Location:	All Internal Areas
Finding:	Ceiling - Mould Growth

Information: Major mould growth was observed to the ceilings. This is likely due to condensation and elevated moisture levels within the subfloor environment.

While the mould appears localised and minor at the time of inspection, prolonged moisture exposure may lead to further deterioration of paint finishes and potential substrate damage.

- Clean and treat affected areas with an appropriate mould removal solution.
- Repaint with mould-resistant paint if required.
- Improve ventilation (ensure exhaust fan is operational and ducted externally).
- Monitor for recurrence.

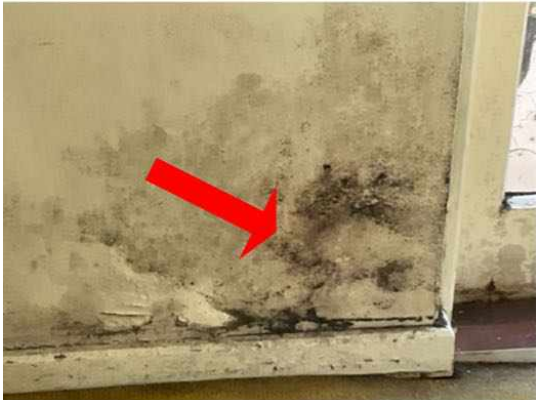
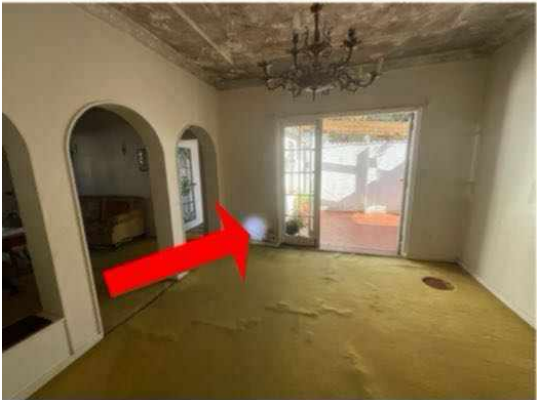
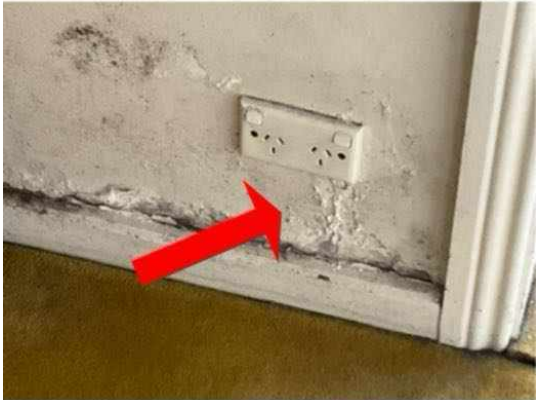
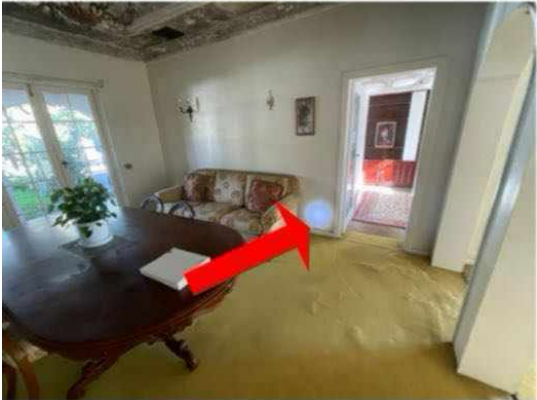
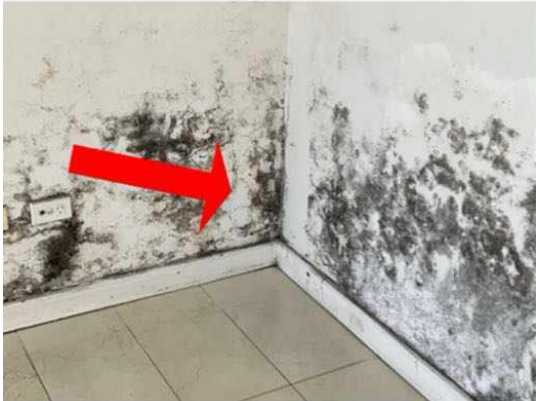
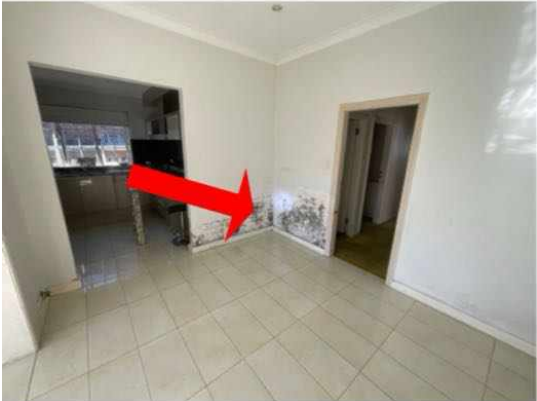
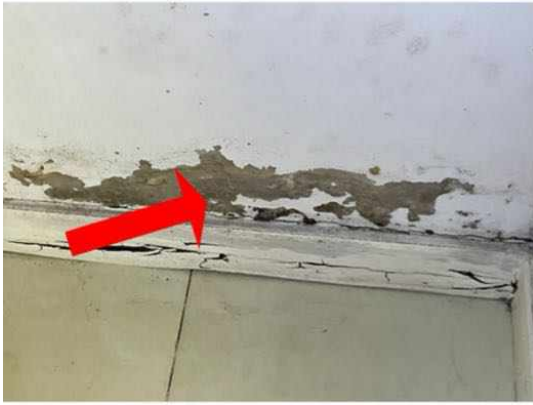
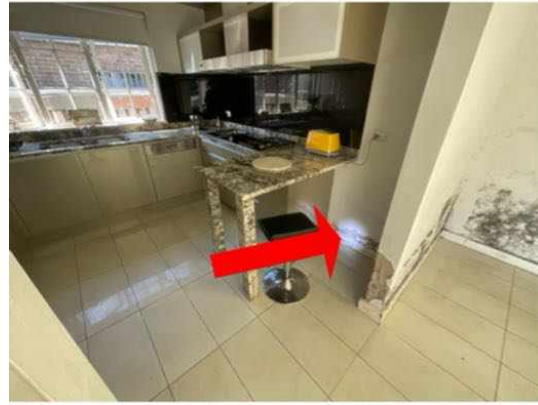
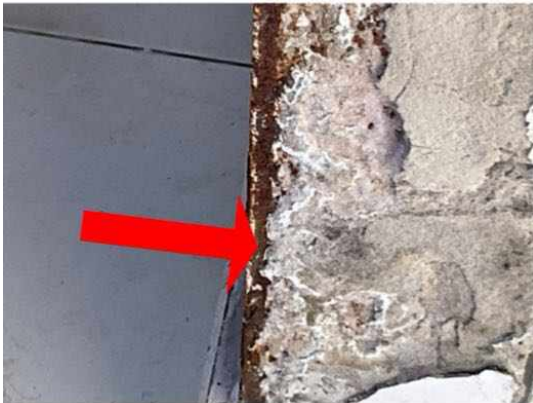
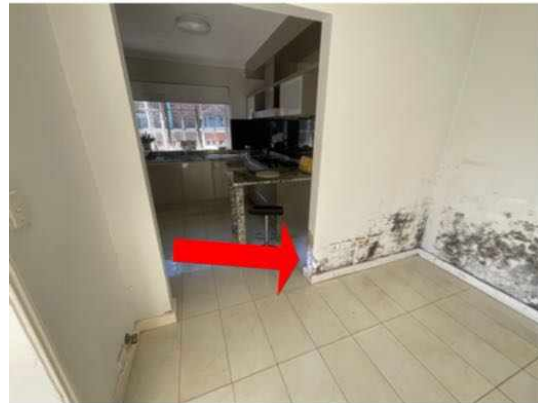
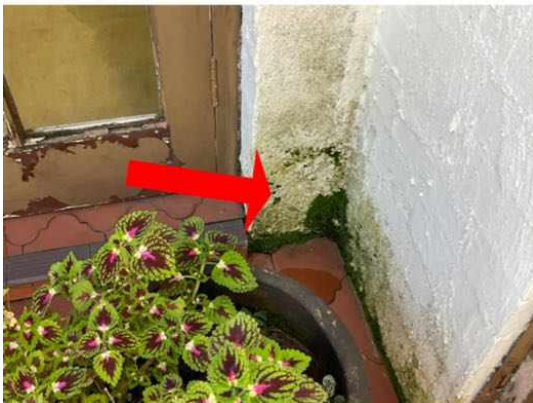
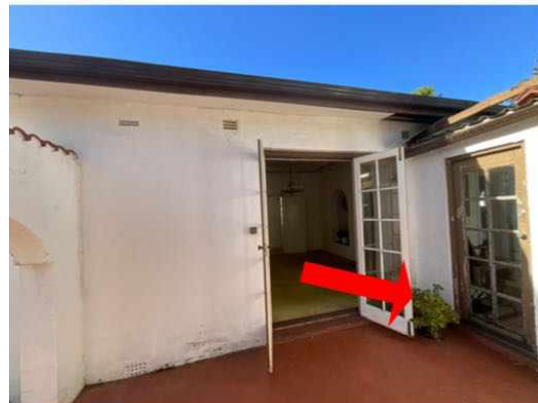
Finding 2.01

Rising damp is generally managed by the installation of a damp proof course during construction. A Damp Proof Course (DPC) is an impermeable barrier at the base of the wall above ground level. However, many 19th Century buildings have no damp course installed, or the materials have failed. The DPC may have been omitted as a consequence of poor workmanship, or it may have been bridged where materials built up against the side of the house allow moisture ingress above the DPC level.

The first step in addressing rising damp is to diagnose the cause. The identified cause

should be addressed first before addressing the appearance and other defects which have resulted from the rising damp. If the original cause is not resolved, further cases of damp are likely to ensue, resulting in secondary defects.

Consultation with a qualified plumber is advised immediately to identify the cause of the damp and perform remedial works as required.

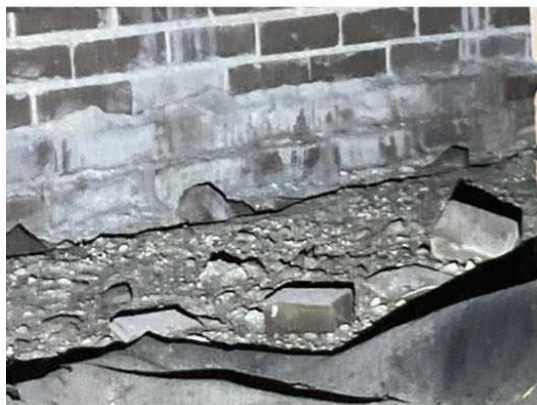
Finding 2.02

Building:	Main Building
Location:	Subfloor
Finding:	Subfloor ventilation - Inadequate
Information:	Adequate subfloor ventilation aids in preventing excessive moisture wood rot and termite activity by ensuring a dry subfloor environment.

Where ventilation is substandard it is usually caused by factors such as failure to install adequate vents during construction subsequent building works or earth and vegetation covering over vents low subfloor clearance and items or debris in the subfloor restricting airflow.

Subfloor ventilation can be improved in most cases by addressing the causes such as exposing subfloor vents installing additional new vents installing mechanical (forced airflow) ventilation and removing debris from the subfloor.

A registered builder should be appointed as soon as possible to perform these works as necessary.

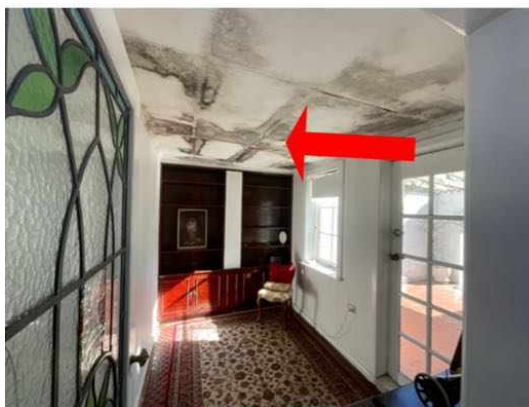
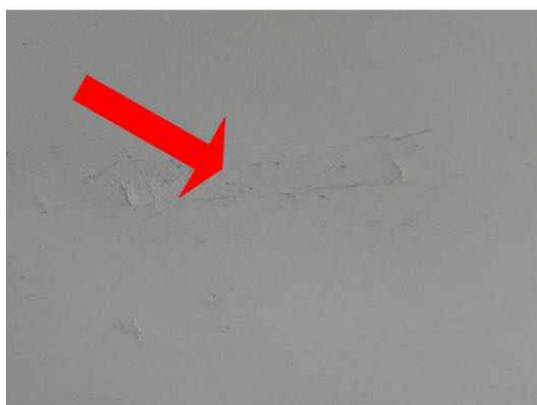
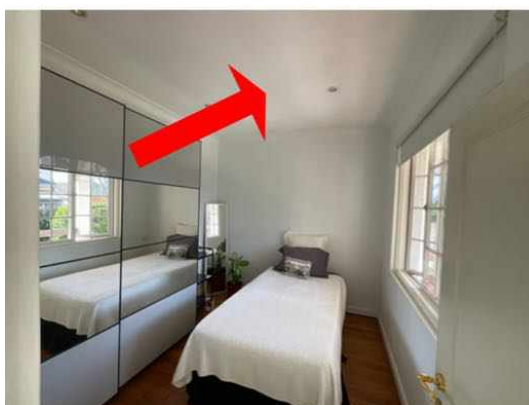
Finding 2.03

Building:	Main Building
Location:	All Internal Areas
Finding:	Ceiling - Water damaged
Information:	Water damage to the ceiling lining is generally an indication of excessive moisture being present in the roof void, usually via a leak to the roof covering.

Where water damage is evident to the ceiling, the primary requirement is to identify and rectify the source of the leak. A roofing plumber should be appointed as soon as possible to identify the leak and perform rectification works as necessary, ensuring the water damage is restricted.

Once the leak is repaired, consultation with relevant tradespeople, including plasterers and painters, is advised. Rectification works may include replacement of ceiling lining or minor repainting, depending on the extent of the damage.

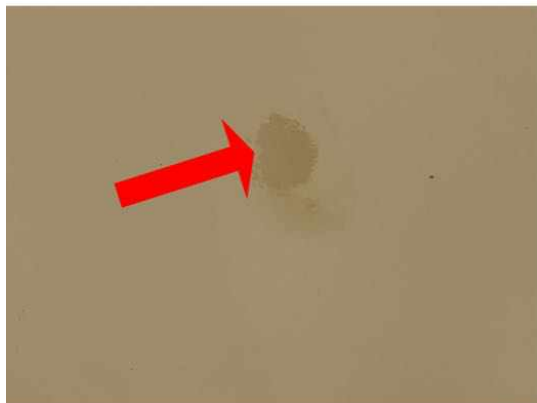
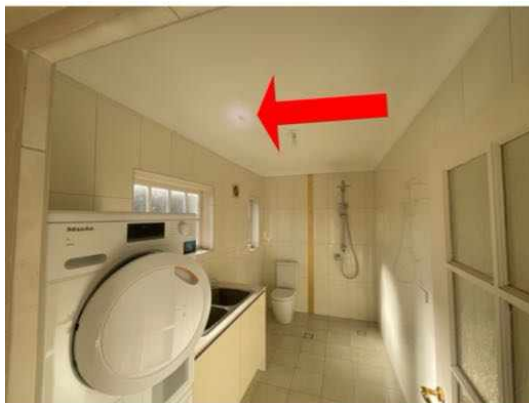
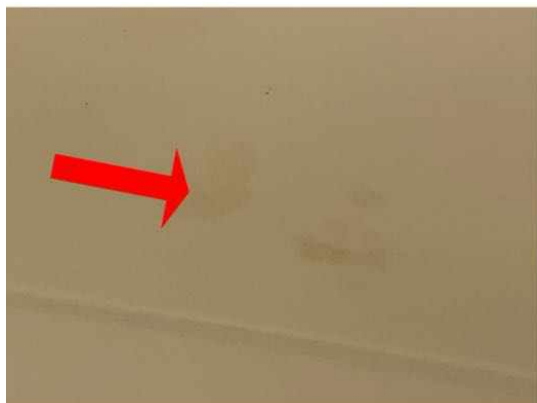
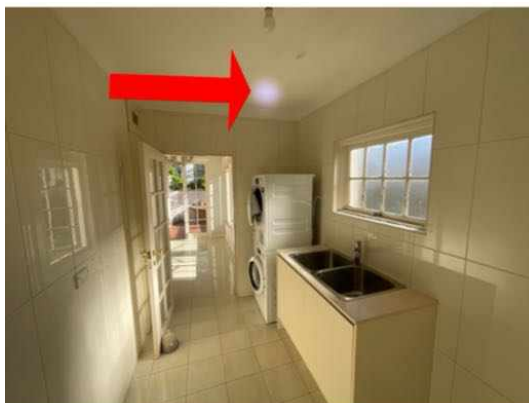
Finding 2.04

Building:	Main Building
Location:	Laundry / Internal Areas
Finding:	Ceiling - Water stained
Information:	Water staining to ceiling linings in this area was evident at the time of inspection. Water staining indicates that surfaces have been exposed to excessive moisture over time. The minerals and other elements in the water lead to staining, which may graduate to corrosion and deterioration if left unmanaged.

While mostly an appearance defect, water staining can be indicative of more serious defects, which may be currently concealed by interior ceilings.

Where water staining is active, a licensed plumber must be consulted to identify the cause of the staining and to provide advice on any reparation works that may be required. Replacement of any damaged structures is advised.

Conversely, where water staining is old and inactive, affected building materials may be repaired or replaced at client discretion.

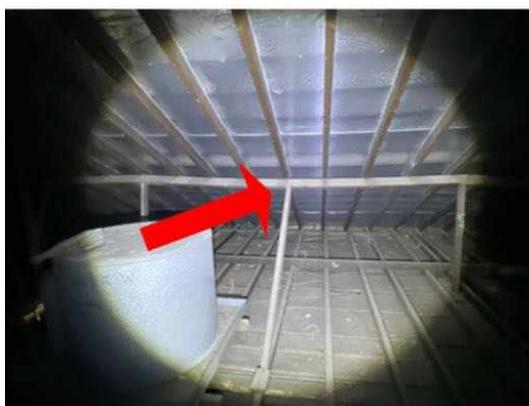
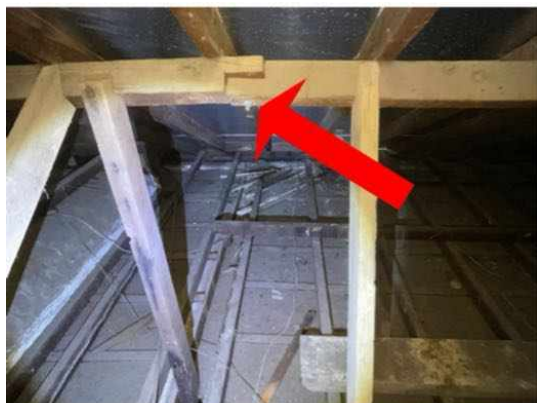
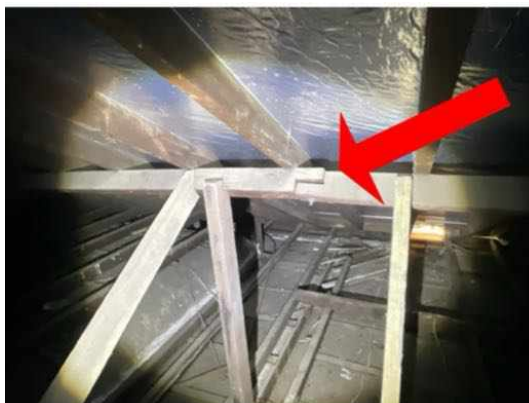
Finding 2.05

Information: The roofing structure was found to be sagging in certain sections at the time of inspection. Upon closer inspection within the ceiling void, it is suspected that the sagging is a direct result of inadequate connections, which appear to have deteriorated over a prolonged period of time.

Sagging roof structures are likely to create strain on associated building elements, creating potential for secondary damage. The roof is also unlikely to have sufficient support, which will lead to further sagging if left unmanaged.

It is critical to ensure that the fastenings holding important roof elements together remain structurally sound (i.e. not corroded) and tightly fastened. Any failure in fastenings can lead to movement of roof members, which is likely to result in an uneven or sagged appearance of the roof exterior. Improper nailing at the point where the ceiling joist connects to the bottom of the rafter may also cause sagging.

Remedial works are highly advised and should be performed by a registered builder or roofing contractor as soon as possible.

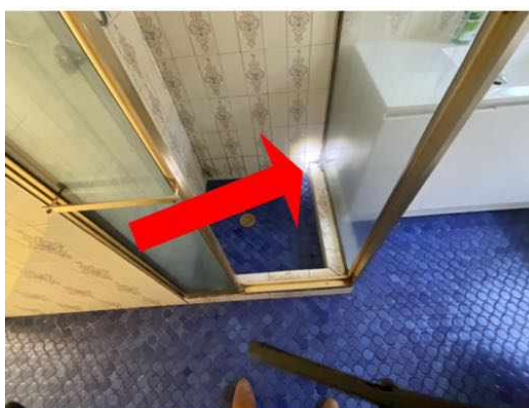
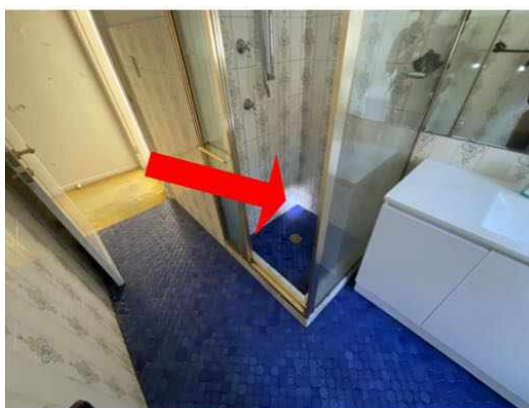
Finding 3.01

Building:	Main Building
Location:	Bathroom
Finding:	Shower damp - Sealant and grout
Information:	Damp is evident to the lower 400mm of wall to the shower alcove. This defect is quite common, and is suspected to have been caused by moisture permeating or leaching through the grouting and sealant in this area, which shows evidence of deterioration. Leaking pipes within the wall is also a possible cause however this seems unlikely in this instance as there is no moisture build up around the taps or transferring to the other side of the wall. There appears to be no sealant around the tap spindles which may be a small contributing factor.

Consultation with a bathroom sealant specialist is advised immediately to identify the cause of damp and to perform remedial works as required.

Always ensure that sealant and grout is in good condition to prevent any moisture issues occurring in the future.

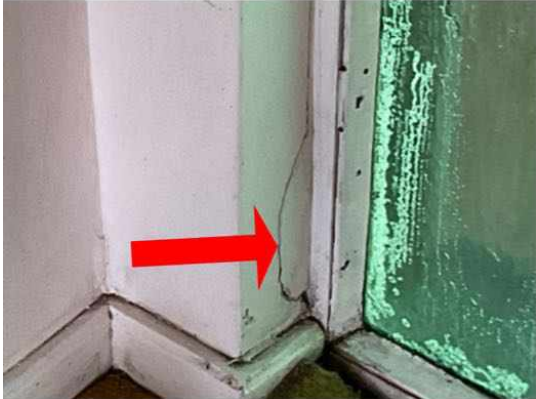
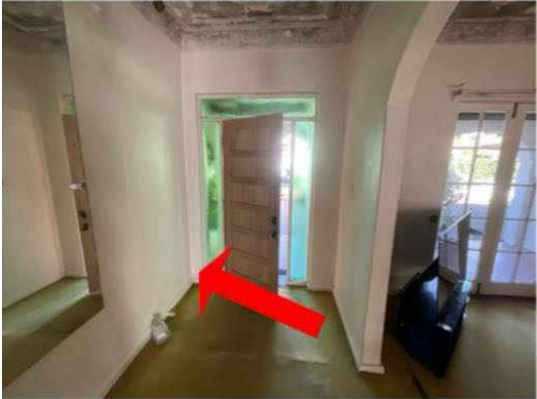
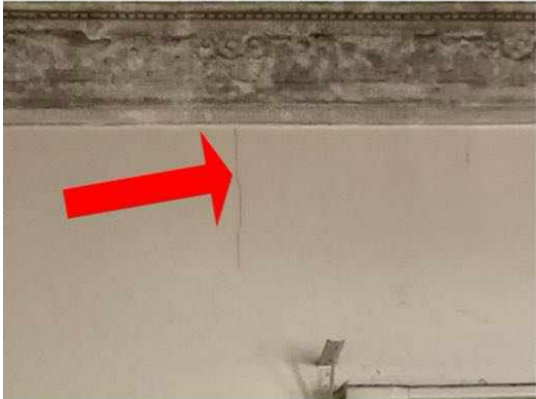
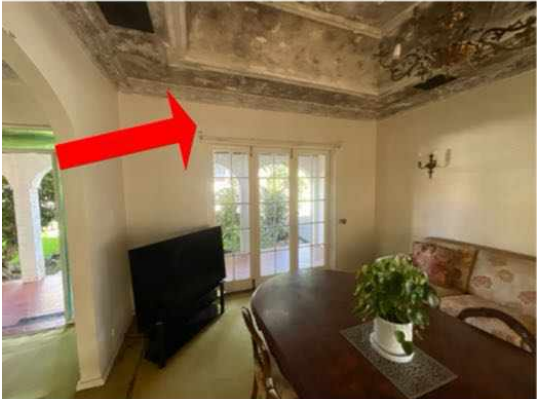
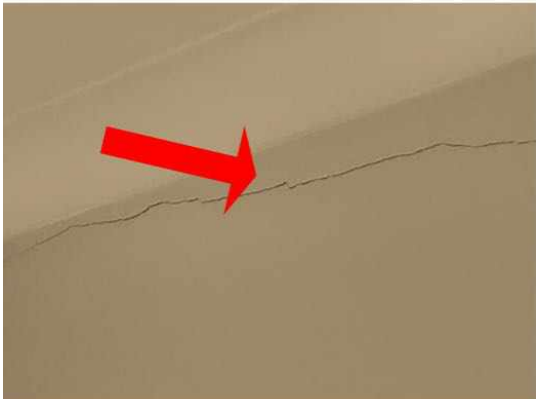
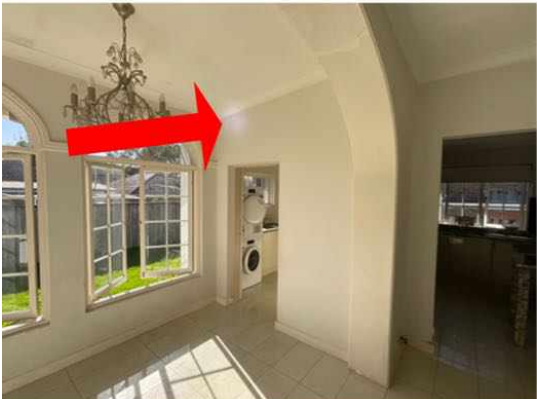
Building:	Main Building
Location:	All Internal Areas
Finding:	Cracks to internal render - Category 2
Information:	It has been observed that cracking to internal rendered surfaces has occurred. The degree of damage falls within Category 2, described as noticeable cracks which are easily filled. Cracking of this size are generally less than 5mm in width.

Category 2 damage is required to be monitored for a period of 12 months. After the

monitoring period, a crack rated at Category 2 or above is considered a defect requiring rectification.

Always contact your building inspector should cracks widen, lengthen, or become more numerous.

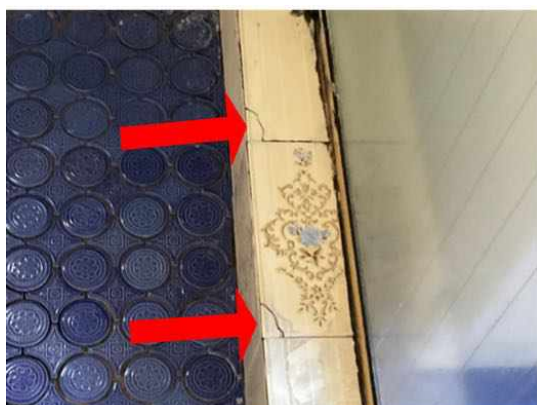
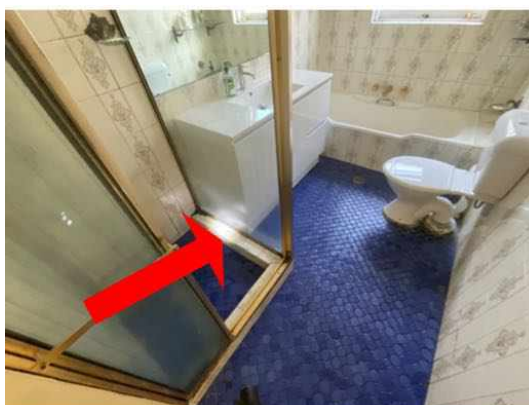
Finding 3.03

Building: Main Building
Location: Bathroom
Finding: Tiles - Cracked or damaged
Information: Cracking was evident to the tiling in this area at the time of inspection. While the

cracking appears to be minor, this area is frequently exposed to water, allowing potential for water penetration into adjoining sections of walls or flooring.

If left unmanaged, water penetration to these areas may lead to subsequent water damage, which is likely necessitate repair work to affected building elements.

A tiling contractor should be appointed to ensure that no further water damage occurs. The re-application of silicone and grouting throughout remaining tile work is also advised, to further protect the area against water penetration.

Where water penetration has led to water damage, appointment of a relevant tradesperson may be required to repair damaged building elements.

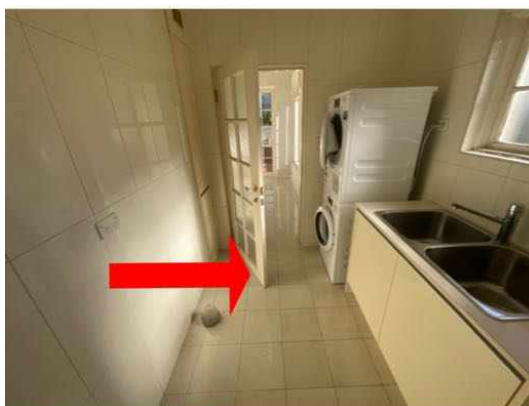
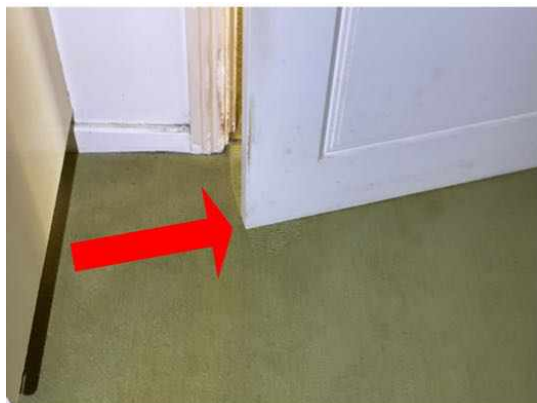
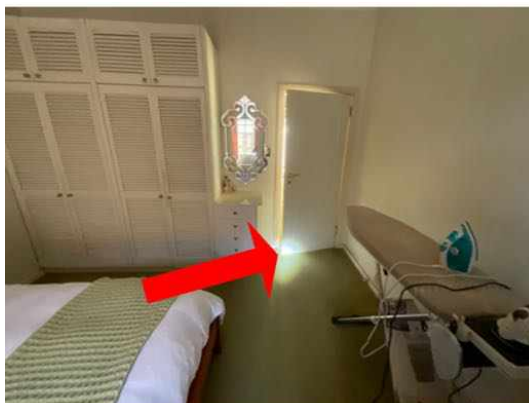
Finding 3.04

Building:	Main Building
Location:	All Internal Areas
Finding:	Door - Binding/jamming
Information:	Binding and/or jamming of this door is evident during standard operation. This defect inhibits the functionality of the affected door as well as creating potential for secondary defects to associated building elements, such as damage to the floor covering.

A door that binds to flooring or to the associated door frame may have several causes, ranging from minor defects, such as poor installation of the door or deteriorated hinges, through to major structural issues, such as damage to subfloor structures.

Where door binding/jamming appears to indicate major structural issues, a registered builder specialising in re-stumping should be appointed to provide an estimate on the cost of rectification.

For minor causes, a qualified carpenter or general handyperson should be appointed to perform minor rectification works at client discretion.

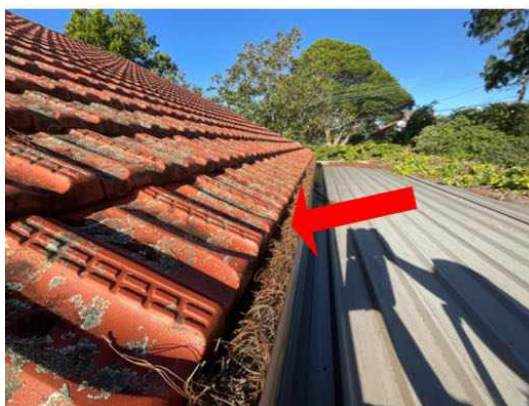
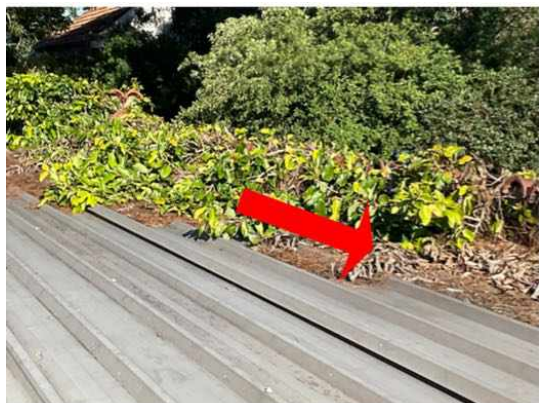
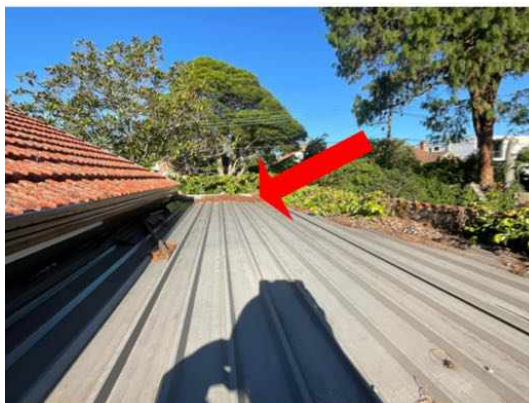
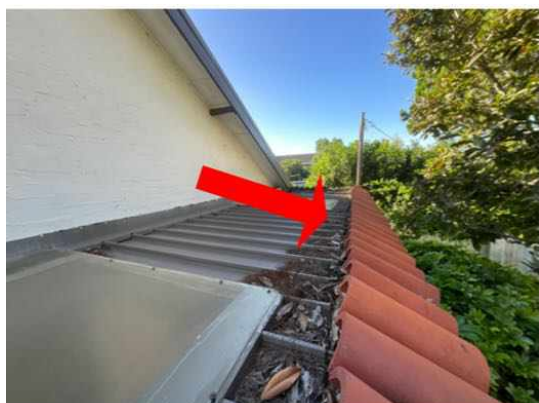
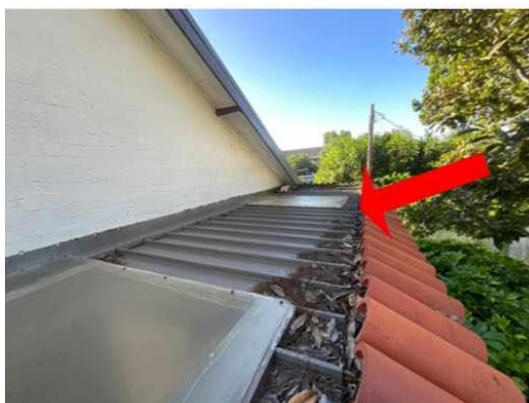
Finding 3.05

Building:	Main Building
Location:	Roof Exterior
Finding:	Gutters - Blocked
Information:	Roof plumbing structures, such as guttering and downpipes, should be free of all debris to prevent blockages. Blockages of the guttering and downpipes will lead to pooling and accumulated water overflows, which is likely to subsequently flood eaves and exterior walls.

Blocked gutters are likely to lead to high levels of moisture in the affected areas. Such moisture will not only cause rust and decay of the associated building materials, but can also provide conditions that are conducive to termite and timber pest activity. Blockages in gutters should therefore be removed immediately to ensure dry conditions are maintained.

Consult a Licensed Plumber for further specific advice on remedial works that may be required. In the interim, it is highly advised that blocked gutters be removed by the homeowner or a general handyperson as a matter of urgency.

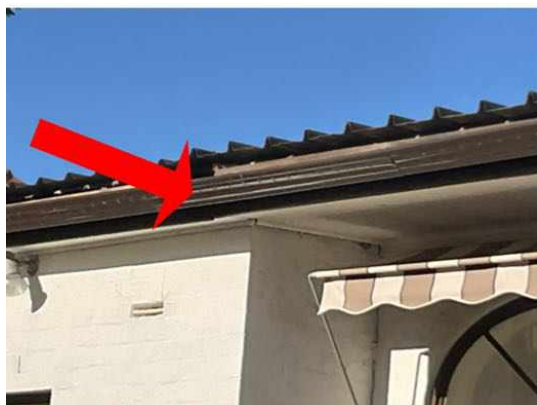
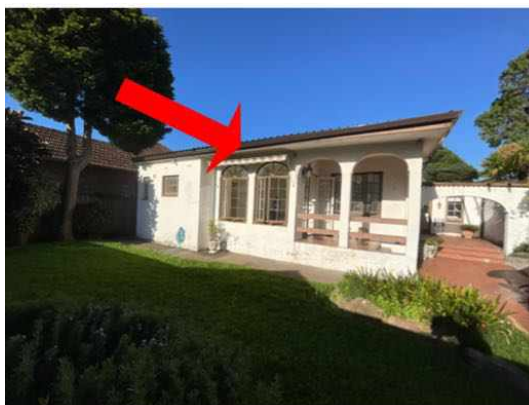
Finding 3.06

Building:	Building 4
Location:	Roof Exterior
Finding:	Building Element (Gutter) - Damaged
Information:	Damaged gutter were found to be present to roof plumbing work. The damage of gutter creates damp conditions in the affected area , causing potential for water pooling and subsequent water damage if left unattended. These conditions may also attract termite attack, particularly if the area is subject to minimal levels of sun throughout daylight hours.

It is highly advised that a licensed roof plumber or proper tradesperson be appointed to rectify any water leaks that may be present. Areas of repair and replacement of

plumbing fittings and fixtures may be required and, as such, a quotation should be sought.

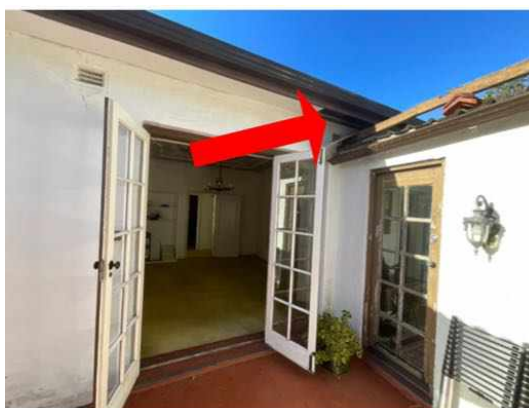
Finding 3.07

Finding: Eaves - Damaged

Information: The eaves around the external property were found to be in a visibly poor condition. The damage may have been sustained as a result of a number of possible causes, including poor roof drainage, leaking roof plumbing or minor impact damage.

The damage to the eave sheeting in this area detracts from the appearance of the structure, as well as potentially compromising the structural integrity of the roofing area.

Where eaves show moderate to severe damage, remedial works may be required. Where water damage is suspected as being the underlying cause, appointment of a licensed plumber is advised as a matter of urgency to identify the source of the water leak.

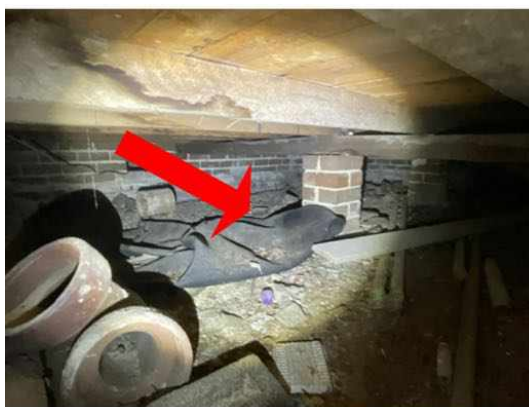
Finding 3.08

Building:	Main Building
Location:	Subfloor
Finding:	Subfloor - Debris
Information:	An array of debris was found in the subfloor area at the time of inspection. Debris in this area restricts subfloor ventilation and creates potential for concealed pest entry. Stored timbers and other materials may also make the area susceptible to termite activity and wood rot.

A clear and empty subfloor will be better ventilated and easier to maintain in a dry condition. The removal of any timber debris is vital in minimising the risk of termite or wood borer activity.

Debris in the subfloor should be removed as soon as possible. Depending on the location and amount of debris and stored items, the homeowner may elect to undertake this task. Alternatively there are a large number of rubbish removal subcontractors that could undertake these works.

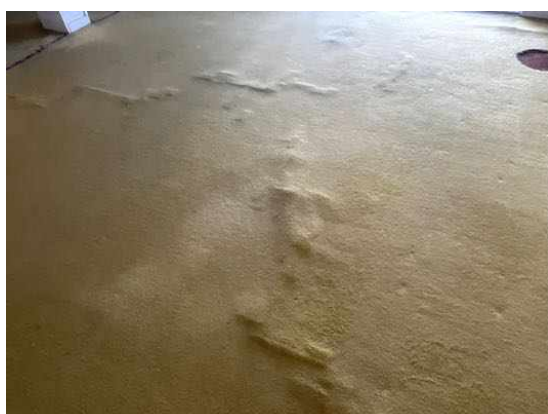
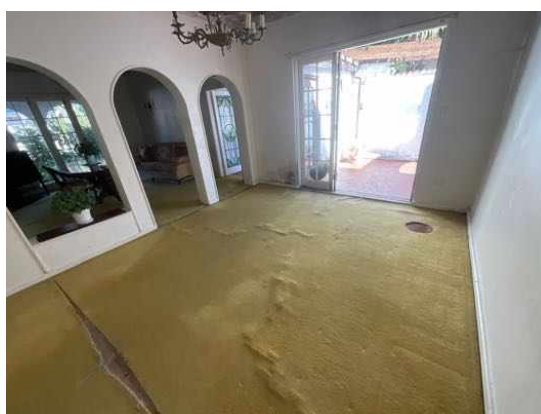
Finding 3.09

Building:	Main Building
Location:	All Internal Areas
Finding:	Carpet - damaged / deteriorated
Information:	Static Damage

Static is created through friction and as a result, the carpet snaps, crackles and pop as you walk across. Due to the dry weather and low humidity, static charges are formed within the carpet thus resulting to static damage. Although new types of carpets have anti-static agents like conductive agents and fine metal wires that protects the carpet.

Replacement of the affected carpet is required as a matter of urgency to ensure the safety of the area. Where required, remedial works should be undertaken to any associated walls and flooring showing evidence of mould.

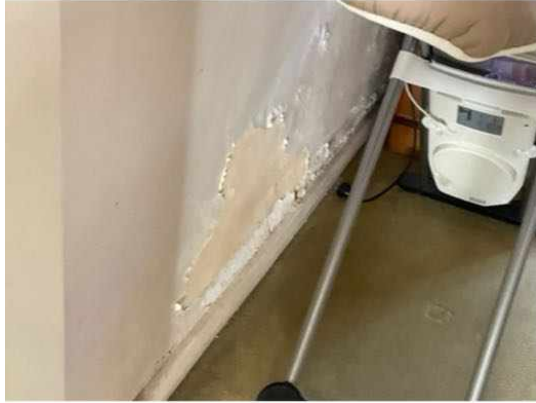
Finding 3.10

Building: Main Building
 Location: All Internal Areas
 Finding: Painted surface - Bubbling
 Information: Sections of paint in this area was found to have bubbled and deteriorated. Paint bubbling is generally an indication of excessive moisture in the area, that is currently hidden by the painted surface.

The presence of excessive moisture can have major implications on associated building elements if left unattended. While only seemingly minor at this stage, the damage cannot be determined due to the paint obstructing any further inspection of the damage.

It is highly advised that the affected paint be cleaned to allow a further, more invasive inspection by a licensed plumber. Failure to act on this defect may necessitate major works in the future.

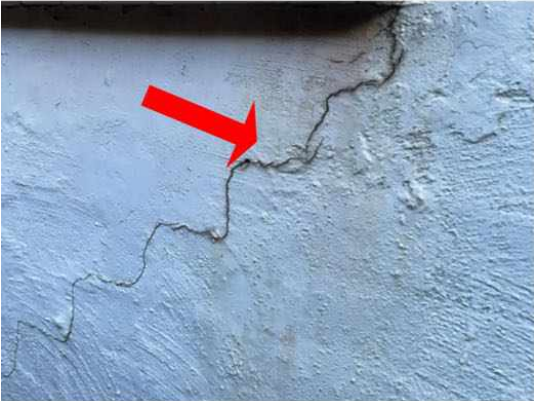
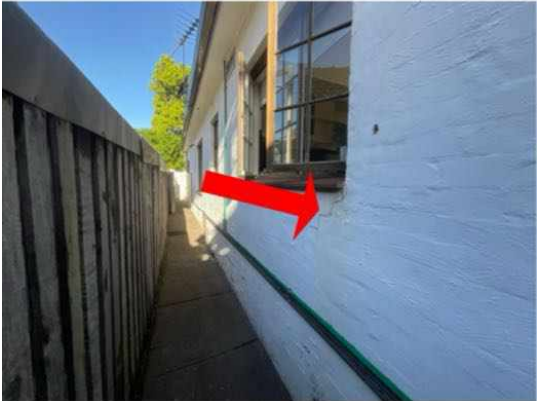
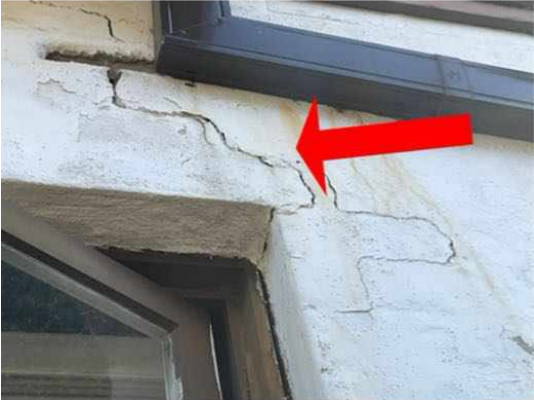
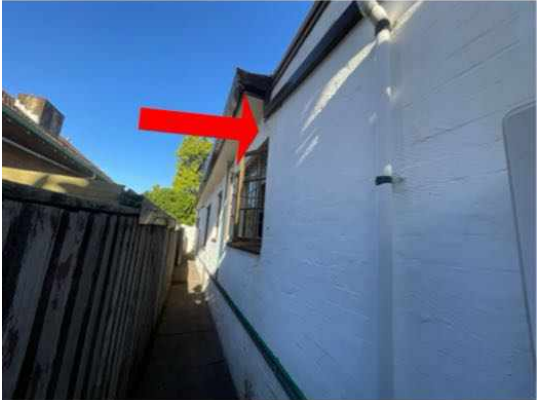
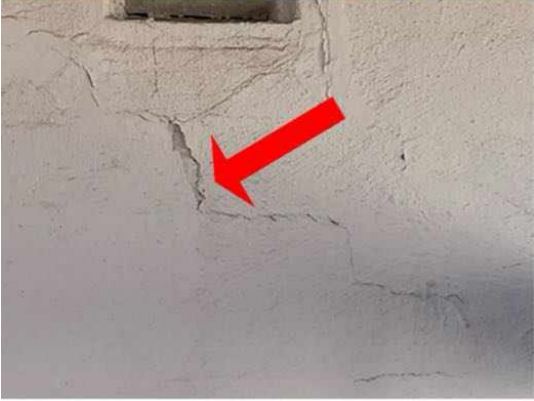
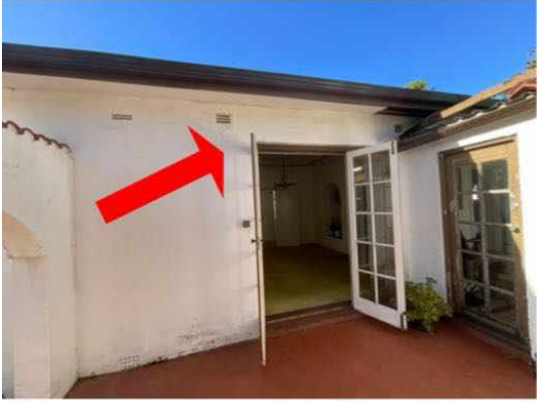
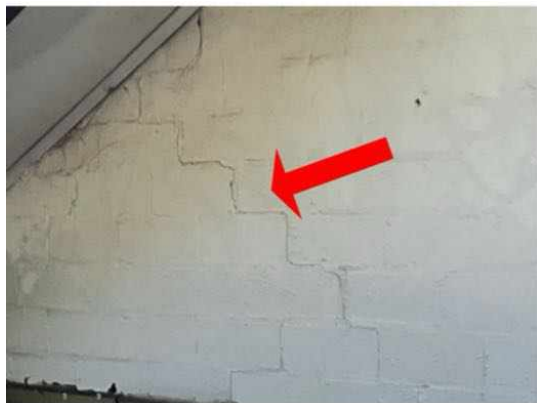
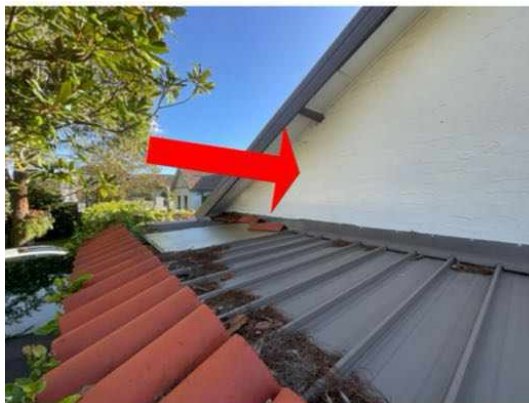
Finding 3.11

Building:	Main Building
Location:	Exterior walls
Finding:	Brickwork - Step cracking
Information:	Step cracking was identified to the brickwork in this area at the time of inspection. Step cracking, which is similar to other forms of cracking, has a variety of possible

causes. However, the most common is the subsidence of adjacent footings.

Step cracking is a relatively common defect, and is most likely to occur adjacent to windows, doors and other openings. Mortar failure in the gaps between affected bricks indicates the stresses and tensions affecting the wall.

Where step cracking is extensive or severe, the client is advised to consult a structural engineer. Minor step cracking can be used as a warning sign to address factors causing stress to the wall, which can include the effect of surrounding trees, water leaks, soil erosion, or even the presence of reactive soils in the surrounding area.

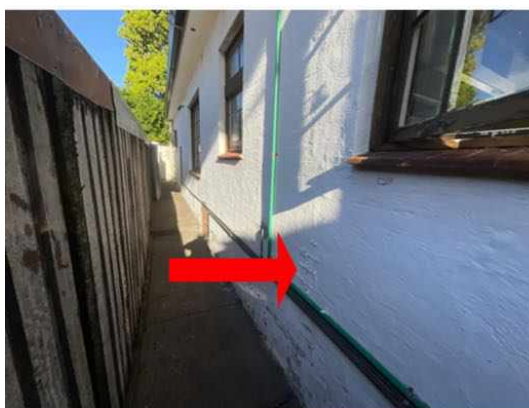
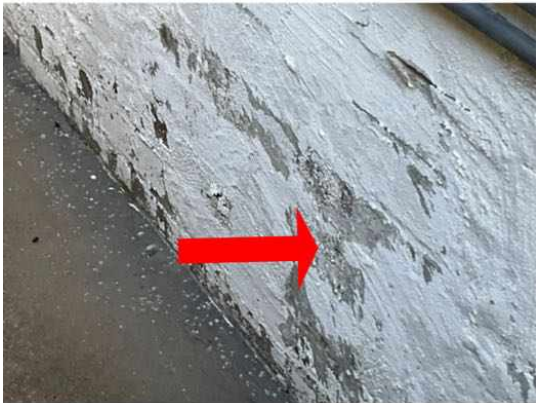
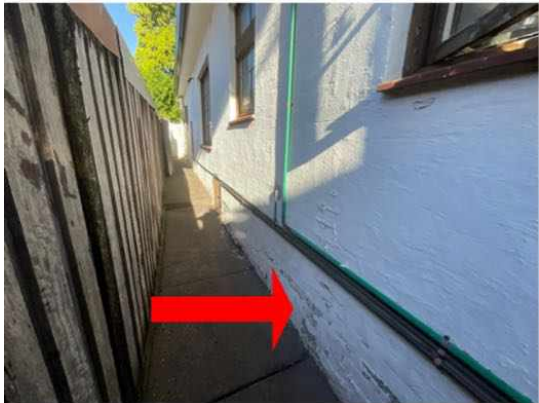
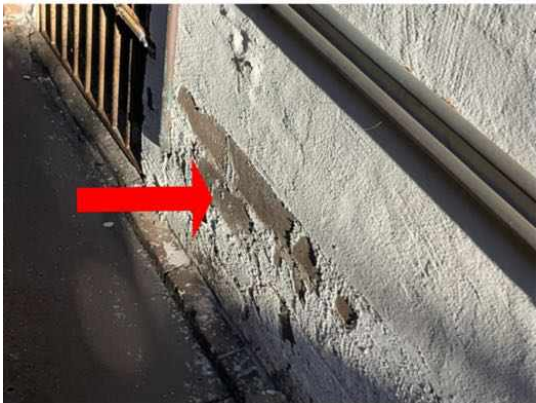
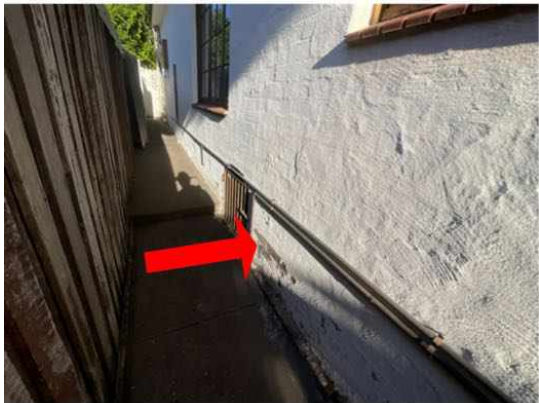
Finding 3.12

Building:	Main Building
Location:	All External Areas
Finding:	External painting deteriorated
Information:	Much of the external paintwork including but not limited to windows, fascias, guttering, veranda and other external fitments have been neglected and require attention to prepare and re-paint.

Whilst incomplete or missing paint finish is generally an appearance defect, it can also lead to the development of secondary building defects over time. Incomplete areas of paint finish expose the area to moisture, potentially accelerating the deterioration of underlying building materials.

Degraded paint finishes should be sanded back, filled, leveled and painted, as applicable. Where inadequate or missing paint protection has led to the deterioration of the associated building element, repair and/or replacement of this building element may be required.

A painting contractor should be appointed as soon as possible to perform necessary works to aid the appearance of the affected area and to ensure the area is protected against further deterioration. Alternatively, the homeowner following manufacturer instructions may perform these works.

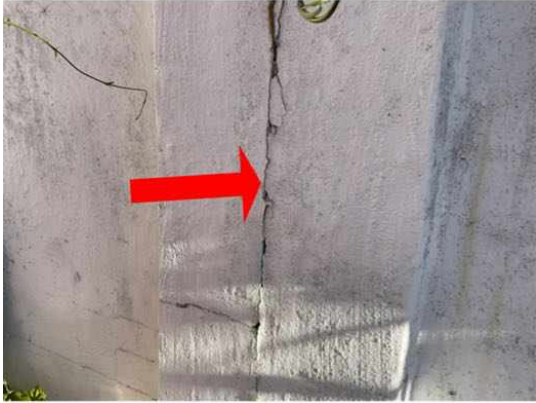
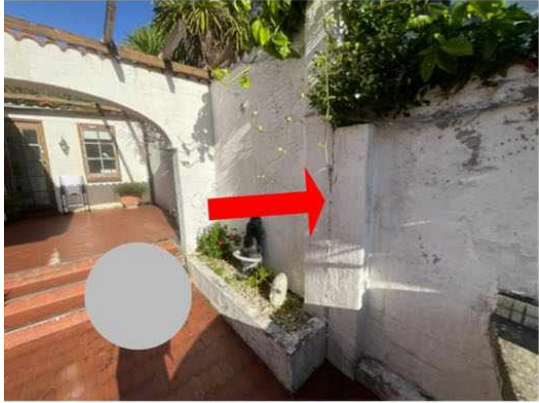
Finding 3.13

Building: Main Building
Location: All External Areas
Finding: Cracks to external render - Category 1
Information: It has been observed that cracking to internal rendered surfaces has occurred. The degree of damage falls within Category 1, described as fine cracks that do not need repair and which are less than 1.0mm in width limit.

Damage of this category is not considered a defect for rectification. Always contact your building inspector should cracks widen, lengthen, or become more numerous.

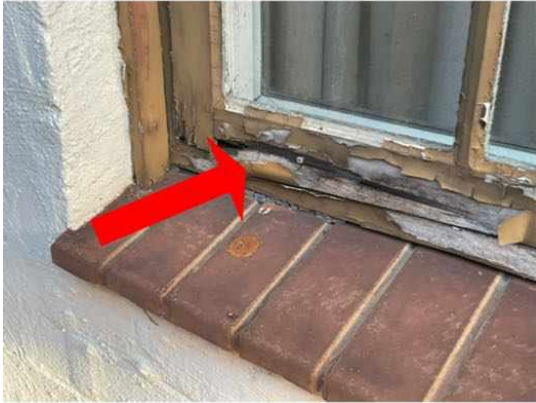
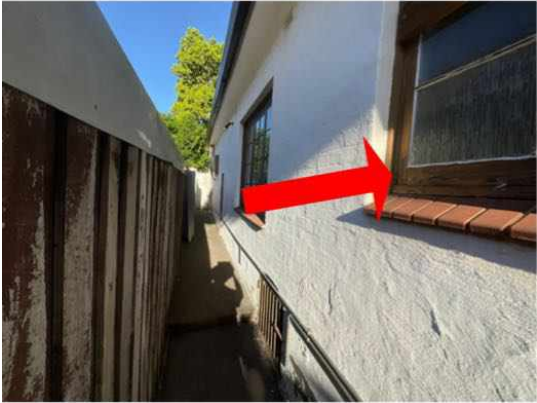
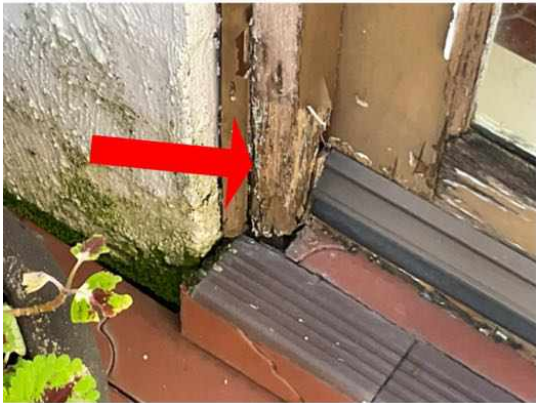
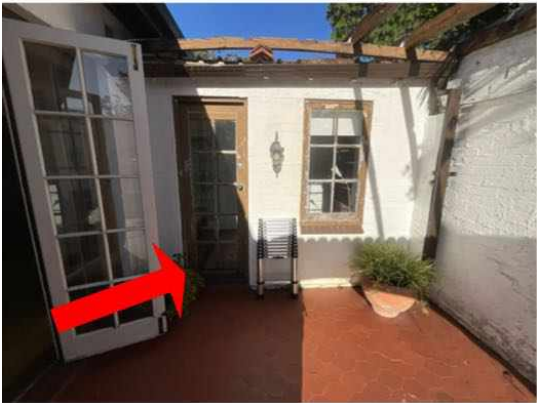
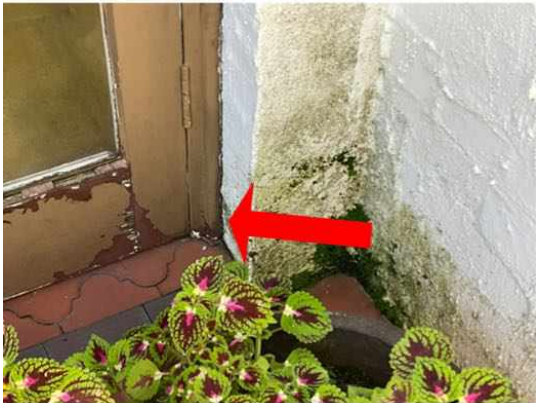
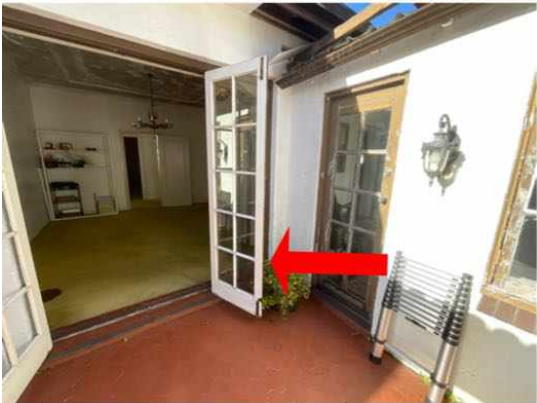
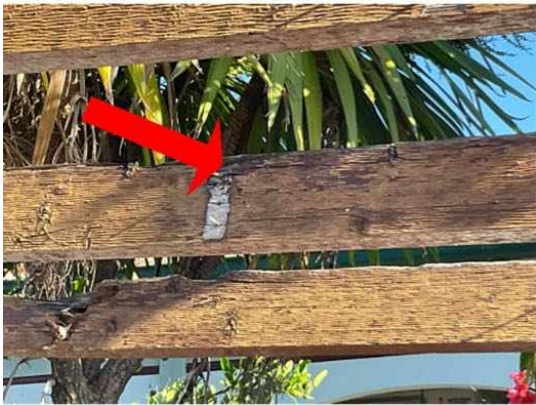
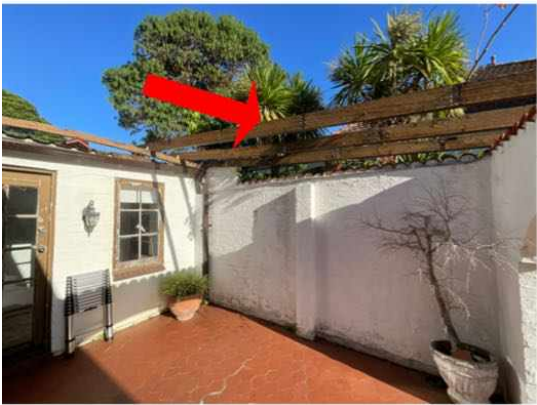
Finding 3.14

Building: Main Building
Location: All External Areas
Finding: External Timber - Weather damaged
Information: Damaged external timber were found during the inspection. External timber structures are constantly exposed to weather elements and can deteriorate in an accelerated manner, ongoing assessments are required.

It is highly recommended that a Structural engineer further assess the external timber balcony/deck to inform the client of its load capacity. Regular maintenance inspections by competent practitioners is needed.

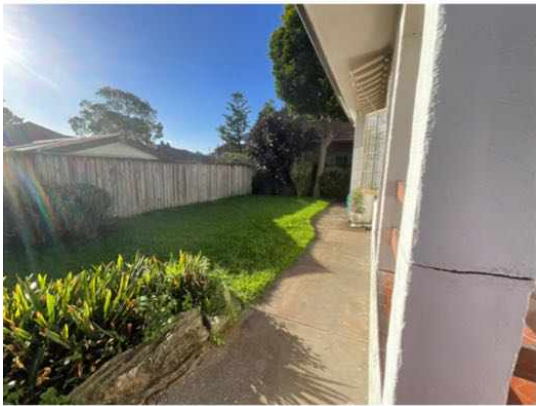
Finding 6.01

Building: Main Building
Location: All Areas
Finding: Garden Beds - Conditions Conducive to Termites
Information: Garden beds were found to be evident in the garden area. These garden beds can include untreated timber, and with a combination of moisture from watering hosing can make conditions conducive to termite activity and termite ingress.

- Clear any debris, garden beds or soil covering weep holes or vent holes (to prevent concealed termite entry). (If this is not possible then the installation of a Chemical Termite management system is even more highly recommended). Consult a suitably qualified termite expert for further advice.
