Building and Timber Pest Inspection Report

Inspection Date: Tue, 24 Mar 2026

Property Address: 5A Gordon St, Burwood NSW 2134,
Australia

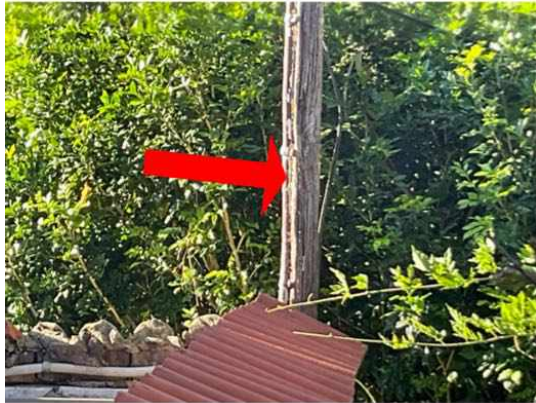
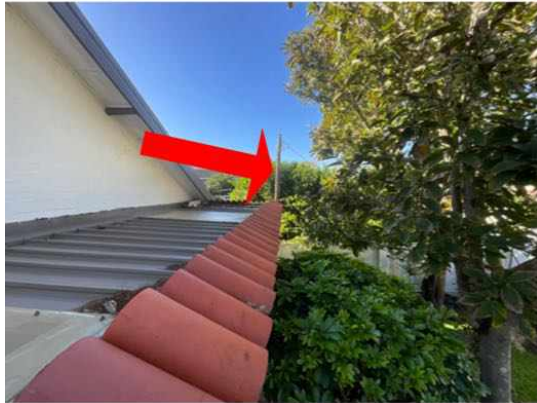
Building:	Main Building
Location:	All Areas
Finding:	Wood rot
Information:	This building element shows evidence of wood rot. Wood rot, also known as Fungal Decay, occurs when timbers and other cellulose building materials are exposed to damp conditions on an ongoing basis. This could be the result of exposure to weathering over a prolonged period of time, or the attraction of excessive moisture from other abutting building materials. Contributing factors also include poor air ventilation in the area.

Wood rot is often associated with general damp problems and is evidenced by a 'musty' smell or mould and mildew occurring on surfaces. If left unmanaged, damp conditions can lead to further health problems and the decay of timbers will continue.

Early intervention and regular maintenance, particularly of exterior timbers, will prolong the useful life of these building elements. Prior to any works being performed, the cause of the moisture that has created the visible wood rot should be identified and addressed in a suitable manner. Replacement of affected timbers may then be a necessary step in protecting surrounding building elements from such deterioration.

A qualified plumber may be appointed to assess the cause of excessive moisture and to provide advice on any remedial works as required. A qualified carpenter or registered builder may also be required to replace affected building materials.

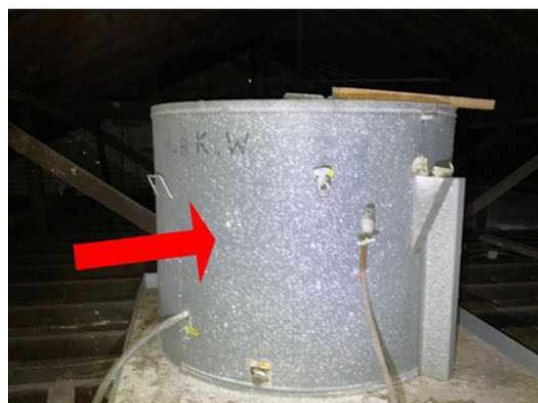
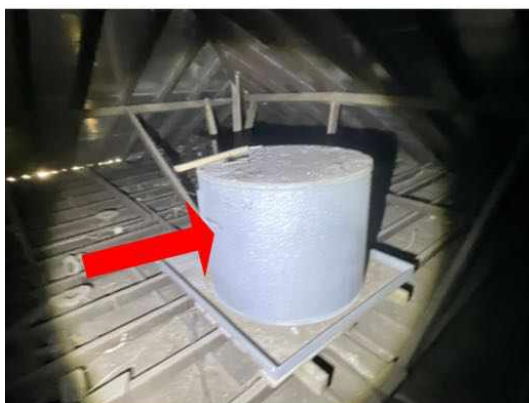
Building:	Main Building
Location:	All Areas
Finding:	Gravity-Fed HWS - Disconnected
Information:	It was noted at the time of inspection that a disconnected gravity-fed hot water system (HWS) remains in this area.

Despite this plumbing structure being unused, it is likely to be storing residual water, and is therefore susceptible to rust and corrosion. If allowed to continue, rust and corrosion is likely to lead to damage to adjoining building elements, and may also make the area susceptible to termite or timber pest activity.

While it is a costly exercise to remove the disused gravity-fed HWS, it is advisable in the short-term future to prevent any further damage to the area. Further consultation with a licensed plumber is required to gain further advice on removal of the structure.

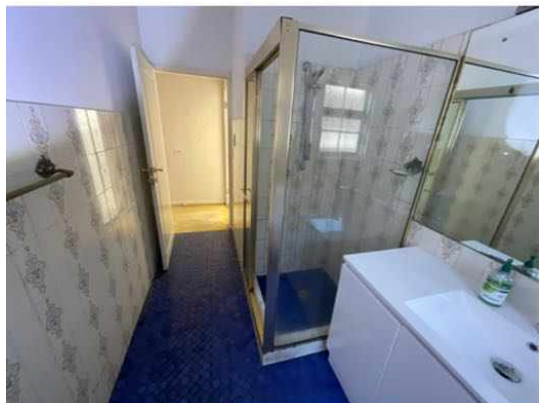
Building:	Main Building
Location:	All Areas
Finding:	Water Proofing Membranes - Information Only
Information:	Internal Water Proofing Membranes, are crucial in preventing water ingress into the property is important to know that the Membrane System used is to Australian Standards and has been installed correctly. Please refer to the original Building Documents or Maintenance Schedule for the relevant information including; - Membrane used and Manufacturers Specifications. - The Installer and Installation Certification. Especially with older property's where this information is unavailable, all wet areas should be monitored. Generally new waterproofing with a certificate may only have a guarantee of 8yrs. If any leaks, water staining, peeling or bubbling of the

paint become evident to any adjacent walls or ceilings below a licensed builder or waterproofing specialist is recommended to investigate further.

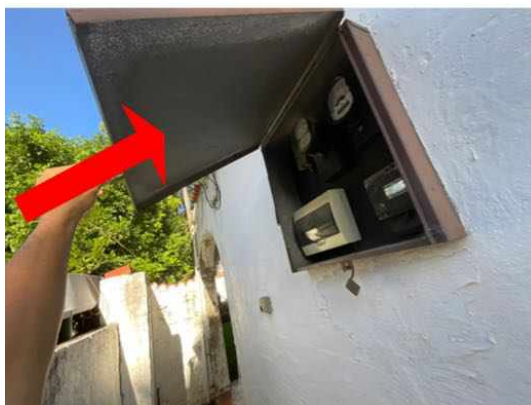
Building: Main Building
Location: All Areas
Finding: Termite Management System - no evidence of a chemical installation
Information: The application of a post-construction chemical termite barrier is highly recommended for all properties, particularly if live termite activity has been found on the site previously. Such barriers are highly effective in preventing termite attack on any timber building elements throughout the property.

A durable notice should be placed in the switchboard unit to indicate current termite barriers. At the time of inspection, it appeared as though no termite management system has been installed, with no evidence to suggest preventative works taking place.

The client may consider gaining further advice from a pest controller as to the costs and procedures involved with this application. It is recommended that obtaining such advice be a short-term priority.

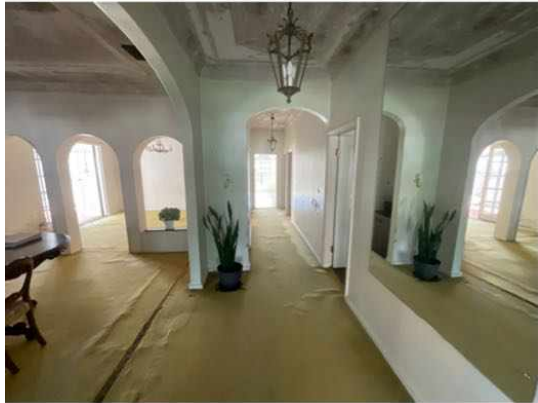
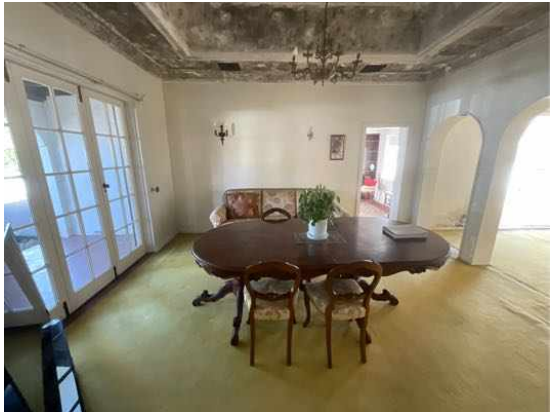
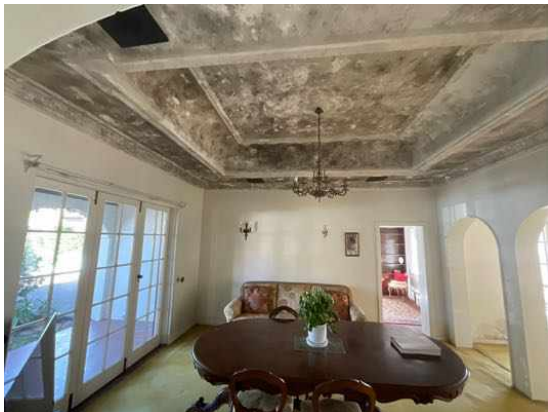
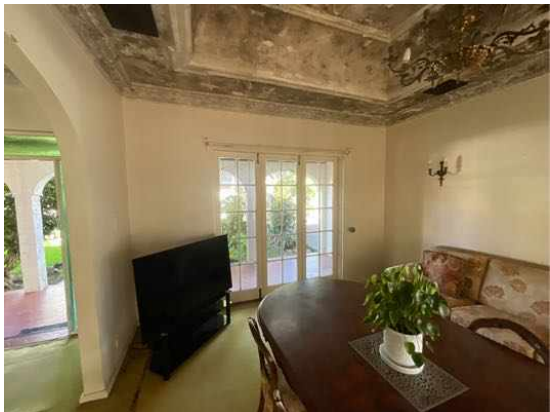
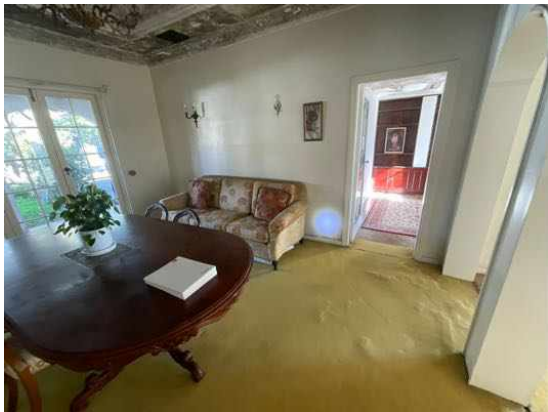
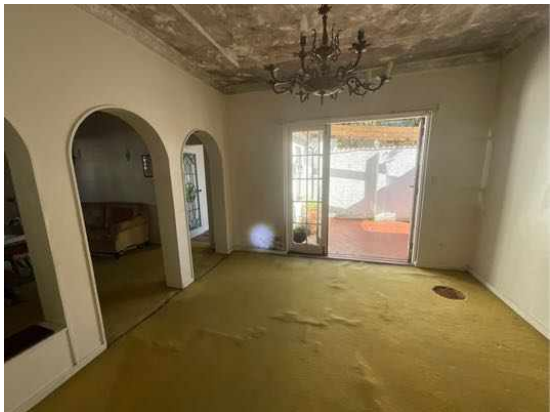
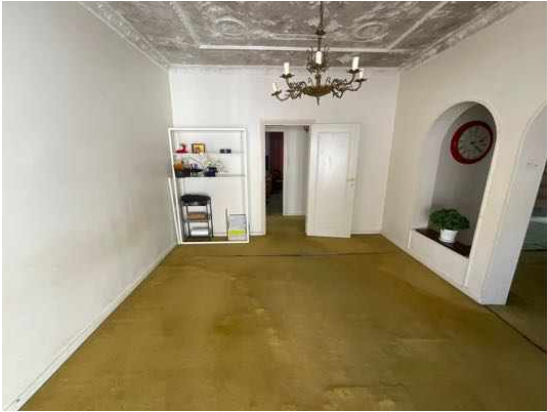
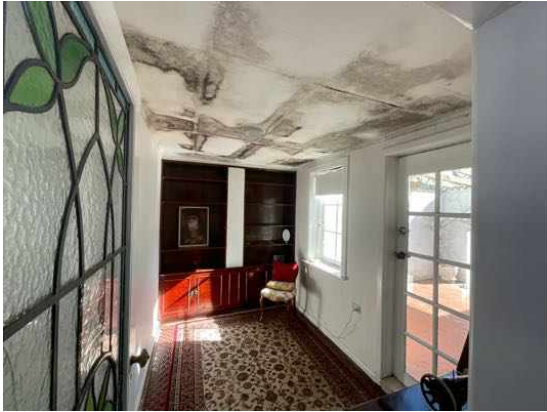
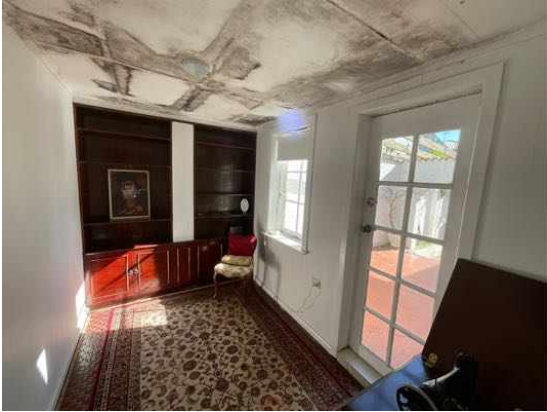
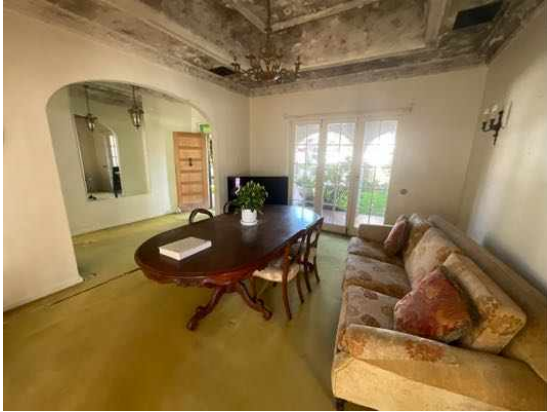
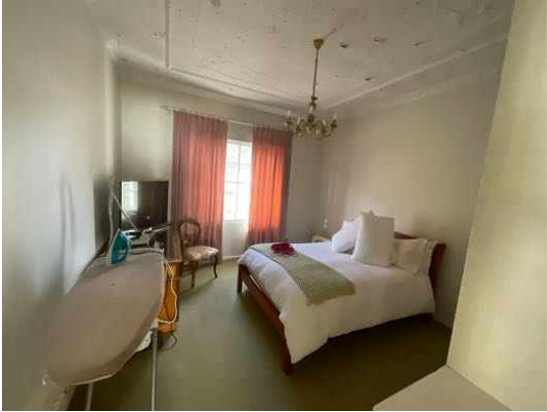
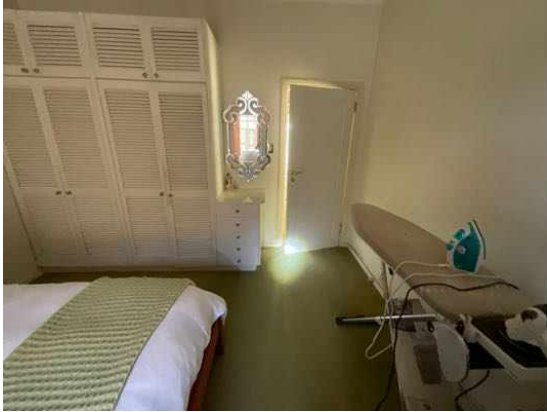
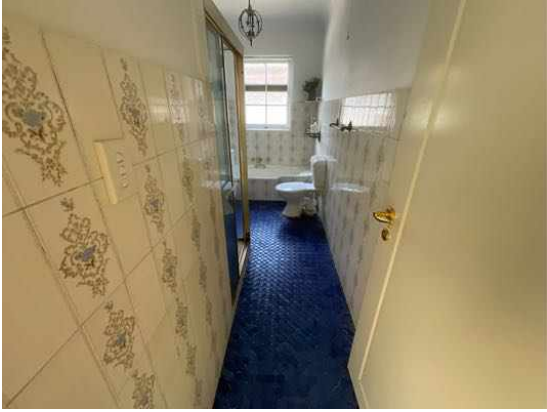
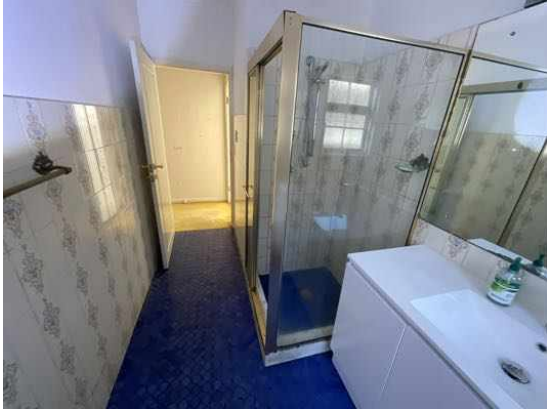
Building: Main Building
Location: All Areas
Finding: Additional Photos - Obstructions and Limitations
Information: These photographs are an indication of the obstructions and limitations which impeded full inspection of the property at the time of inspection. These obstructions can hide an array of defects and should be removed to allow full inspection to be carried out. A re-inspection is recommended once the areas are made accessible.
