Building and Timber Pest Inspection Report

Inspection Date: Thu, 12 Feb 2026

Property Address: 5/56 Belmore St, North Parramatta NSW
2151, Australia

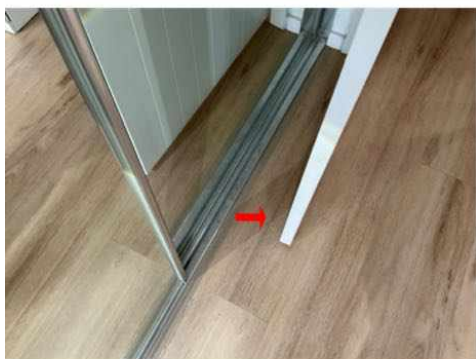
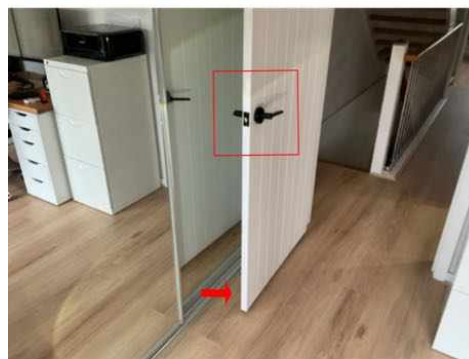
Building:	Main Building
Location:	Bedroom 2
Finding:	Door Stopper (Glass) - Missing
Information:	At the time of inspection, no door stop was installed behind the hinged door located adjacent to the mirrored glass wardrobe panel. When fully opened, the door handle is capable of making direct contact with the glass surface of the closet door. This condition presents a safety hazard, as repeated impact may cause cracking or shattering of the glass panel, potentially resulting in injury and property damage.

It is recommended that a suitable door stop (wall-mounted or floor-mounted type) be installed to prevent the door from contacting the glass surface. A qualified handyman should be engaged.

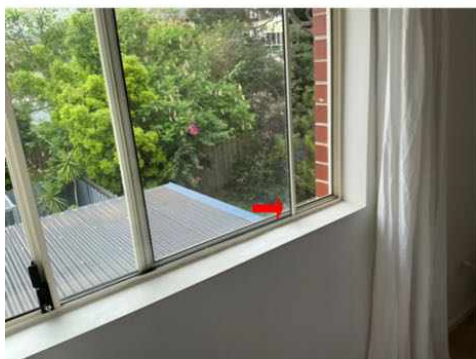
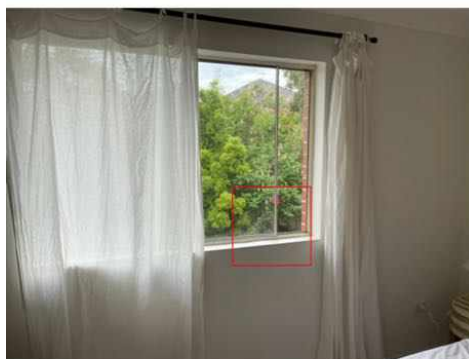
Finding 1.02

Building:	Main Building
Location:	Bedroom - Master
Finding:	Window Restrictors - Recommended
Information:	Upstairs windows did not have window restrictors installed. Although not a requirement at the time of construction, it is advisable to install window opening restrictors on all second storey windows with sill heights below 1.7 meter and potential fall of 2 meters or more.

If you live in a strata scheme, window safety devices must be installed on all applicable windows by 13 March 2018. Residents with safety devices installed can still fully open their windows but it's recommended that devices be engaged whenever children are present, to prevent falls.

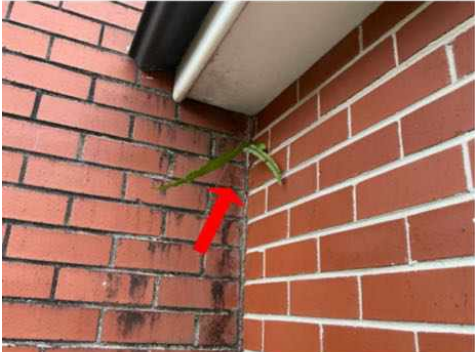
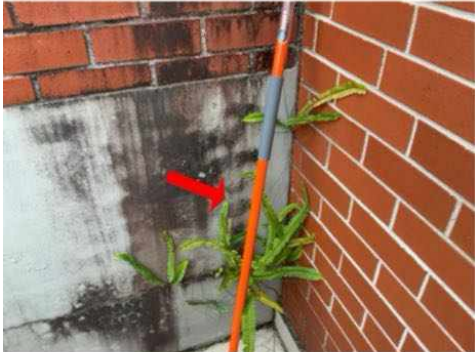
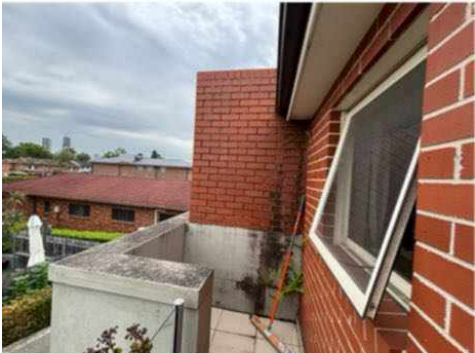
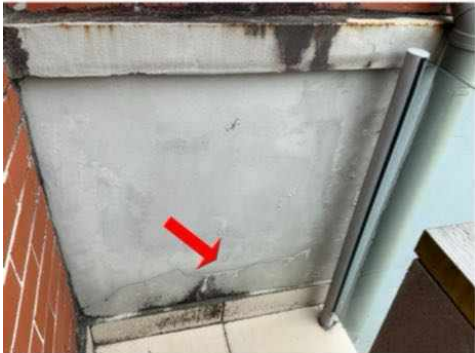
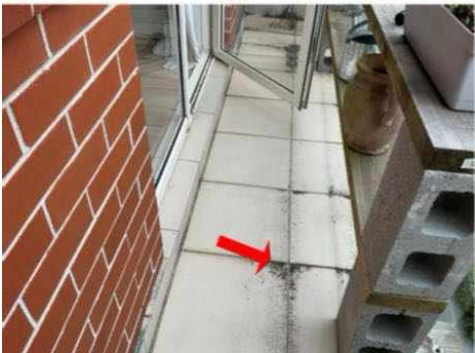
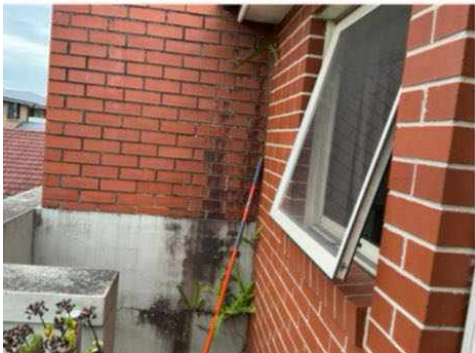
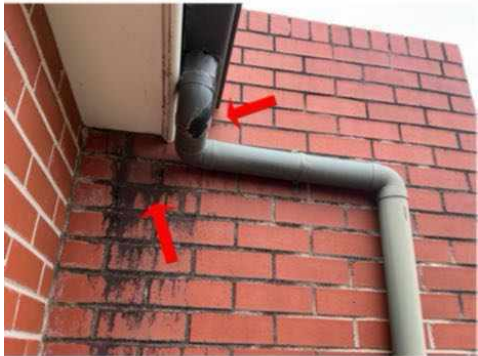
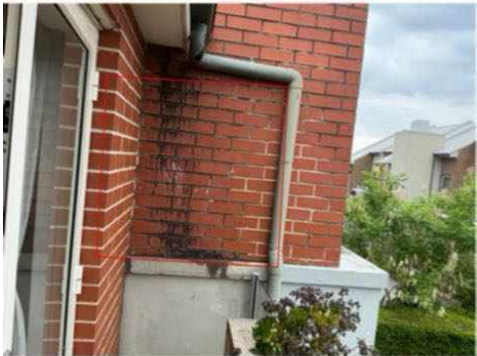
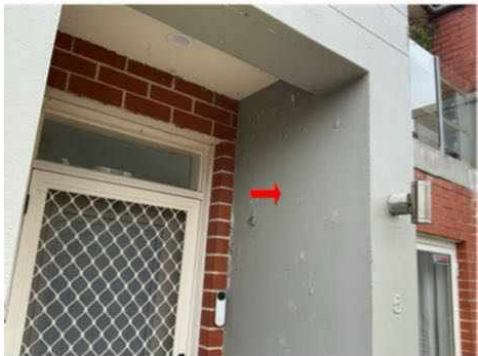
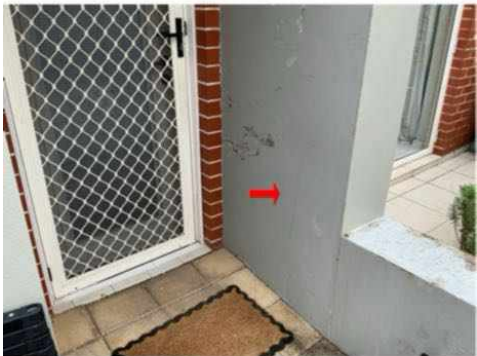
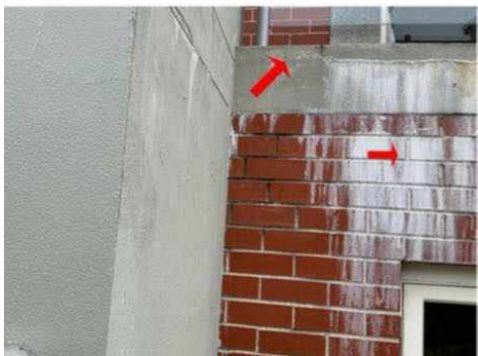
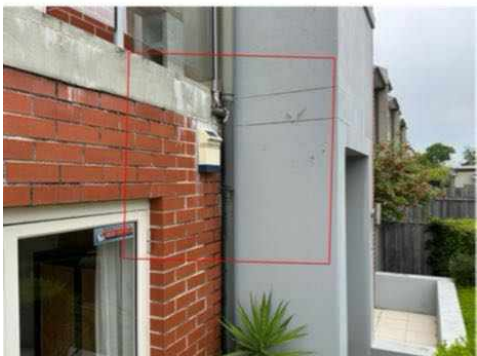
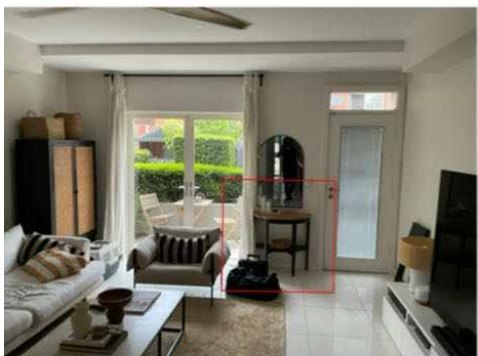
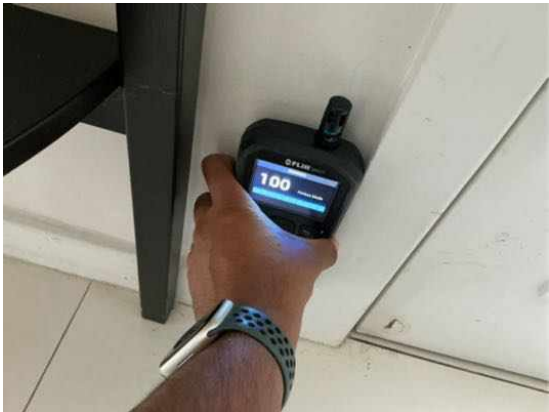
Finding 2.01

Building:	Main Building
Location:	All Areas
Finding:	External Moisture Ingress, Drainage Issues & Surface Deterioration
Information:	At the time of inspection, multiple moisture-related defects were observed to the external areas of the property. The guttering and associated downpipe sections showed signs of leakage and overflow staining to the brickwork, indicating possible blockage, joint failure, or inadequate drainage. Significant water staining and dampness were noted to the external walls below the balcony and roof drainage discharge points, consistent with prolonged moisture exposure.

The balcony floor tiles exhibited deteriorated and failing sealant to joints and perimeter junctions. Evidence of water leakage from the balcony area was visible, with staining and surface breakdown to the walls below, suggesting possible waterproofing failure and/or inadequate drainage falls. The rendered wall surfaces displayed moisture-related deterioration, including blistering, staining, cracking and previous patch repairs, likely due to ongoing water penetration from above.

Vegetation growth was observed emerging from wall junctions and cavities, indicating persistent moisture retention within the structure. Plant growth within wall systems can accelerate deterioration of mortar joints, render finishes and brickwork over time.

As a result of the above external moisture defects, elevated moisture readings were recorded to the internal wall surfaces in the front living area using a moisture meter. These high readings are consistent with water ingress from the external balcony and drainage areas and indicate that moisture is tracking internally through the wall system.

These conditions collectively present a risk of continued water ingress, concealed damage, potential mould development, and long-term structural deterioration if not rectified. As the affected elements appear to form part of the common property, the

client is advised to formally notify and engage Strata Management to arrange comprehensive investigation and rectification by appropriately qualified contractors as a matter of priority.

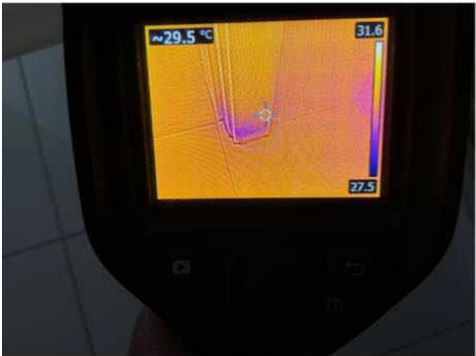
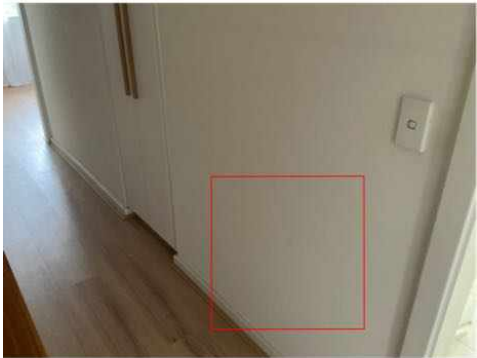
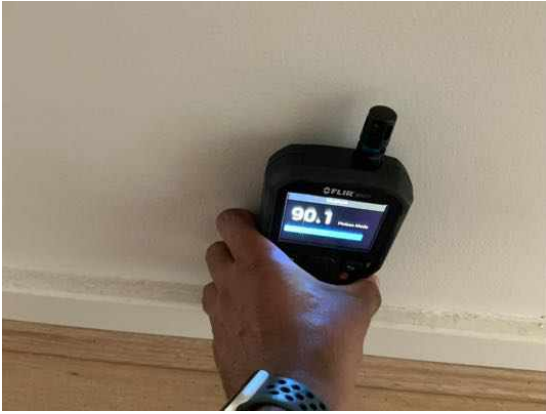
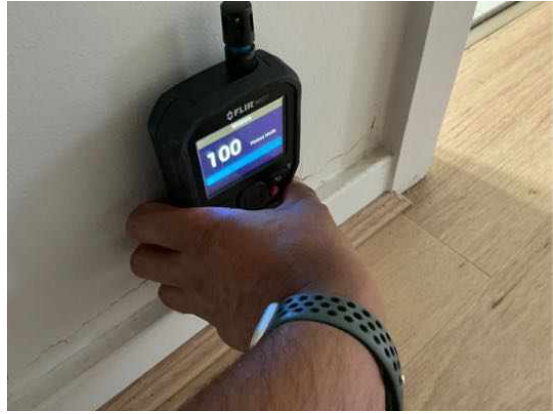
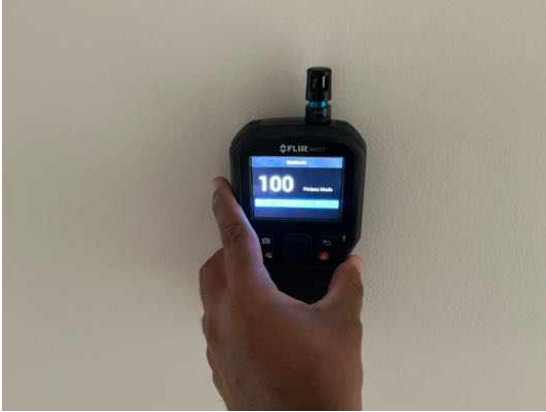
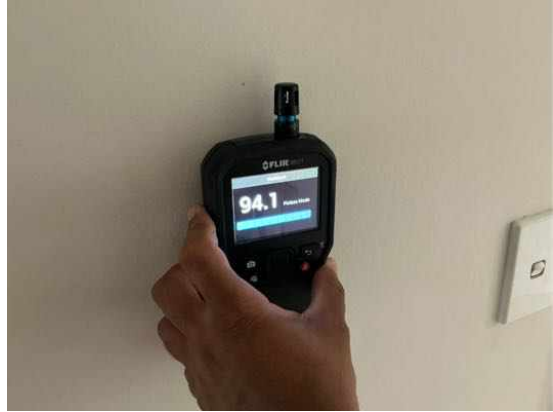
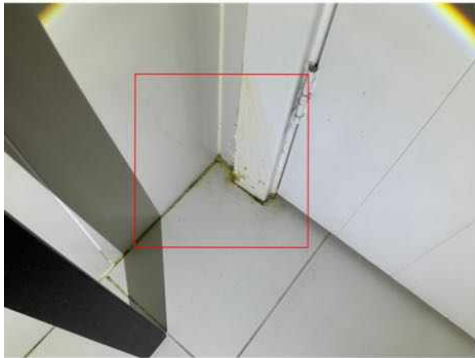
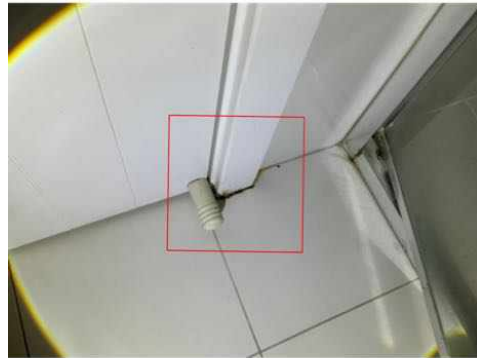
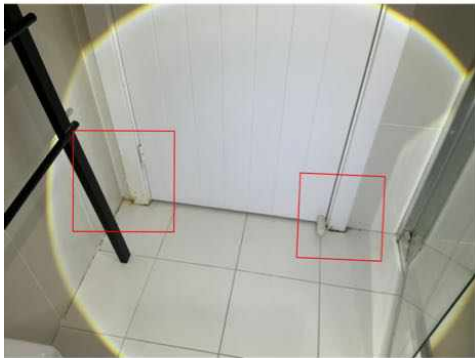
Finding 2.02

Building:	Main Building
Location:	Bathroom
Finding:	Excessive Moisture on Walls (Adjacent Bathroom) - Major Defect
Information:	A major defect was identified during the inspection, with evidence of moisture penetration noted on the walls adjoining the bathroom and shower area. The presence of moisture raises serious concerns about the integrity of the waterproofing system, which is a critical component in preventing water ingress into adjoining structures.

The moisture penetration is likely due to a failure or inadequacy in the waterproofing membrane beneath the tiled surfaces in the bathroom and shower area. Waterproofing systems are designed to act as a barrier, and any breach can result in water escaping into adjacent walls. This could also be exacerbated by inadequate sealing around fixtures, joints, or tiles, which are common entry points for water. Additionally, the defect may be attributed to substandard installation practices or the natural wear and tear of waterproofing materials over time, both of which can compromise the membrane's effectiveness.

If left unaddressed, this issue could lead to significant consequences. Persistent moisture can weaken the structural integrity of the walls, resulting in costly repairs or replacement. Damp conditions also create an ideal environment for mould growth, which poses health risks and further compromises the interior condition of the property. Moreover, unresolved waterproofing issues can adversely impact the property's value and marketability.

The client is advised to use services of a professional waterproofing specialist as soon as possible.

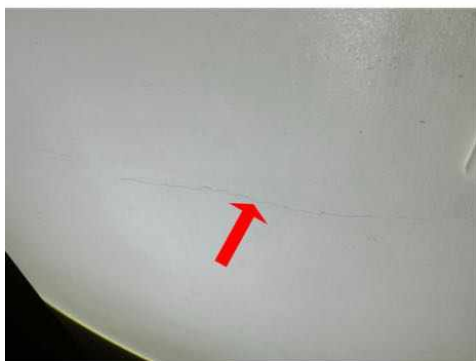
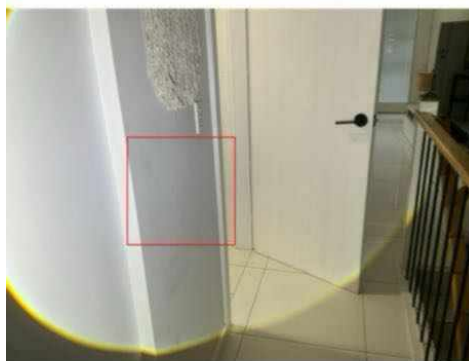
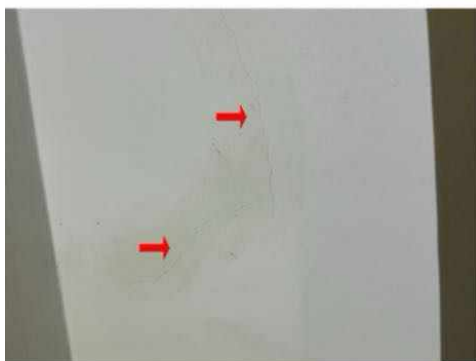
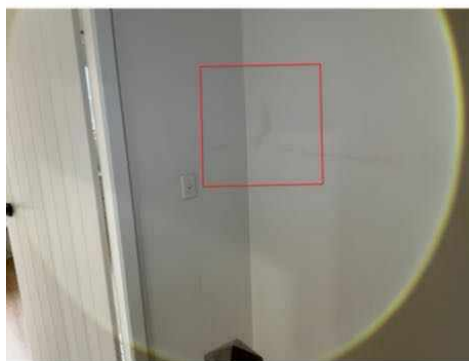
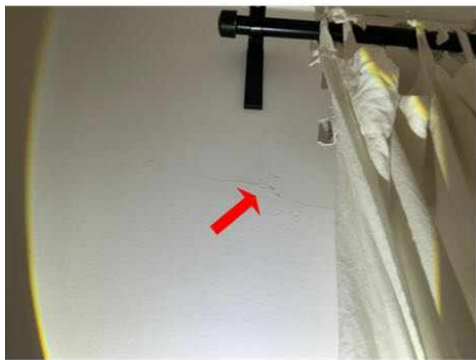
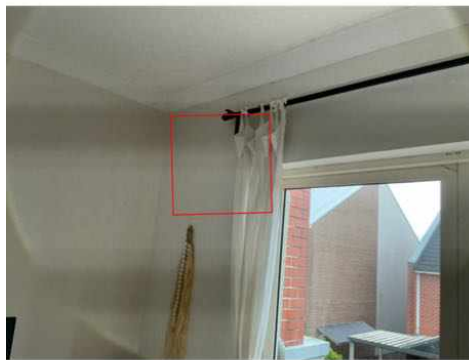
Finding 3.02

Building:	Main Building
Location:	All Areas
Finding:	Cracking - Damage Category 1 - Fine (up to 1mm)
Information:	Although fine cracks are quite noticeable, they are often only considered to be an

Cracking of this nature can generally be repaired with minor sanding, filling and/or repainting. Such works should be performed by a qualified painter or a general handyman.

Monitoring of all cracking should be conducted frequently. Always contact a building inspector should cracks widen, lengthen, or become more numerous.

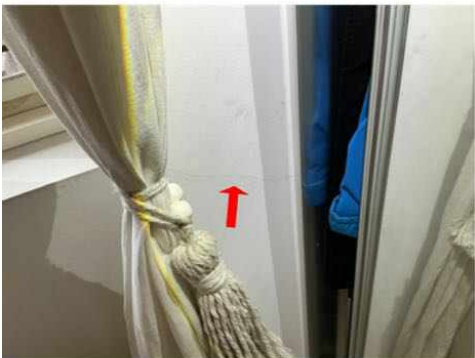
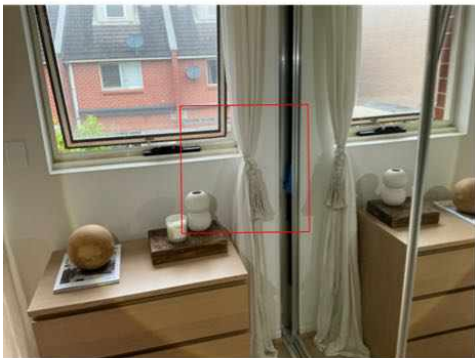
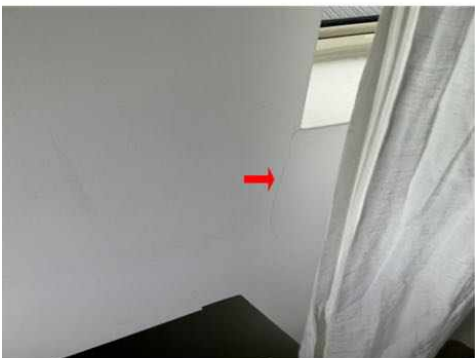
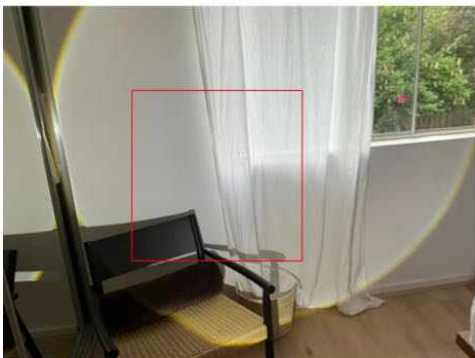
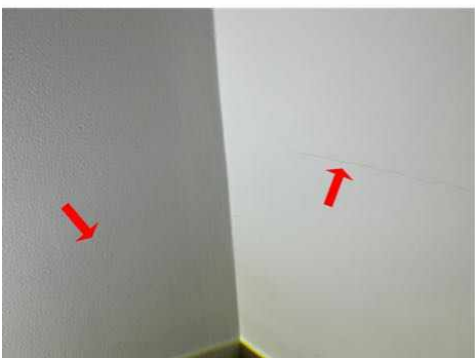
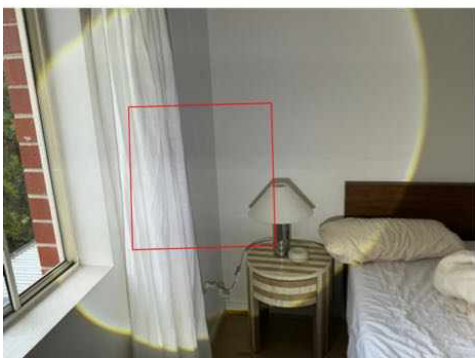
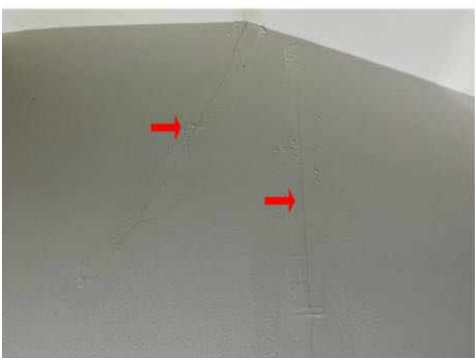
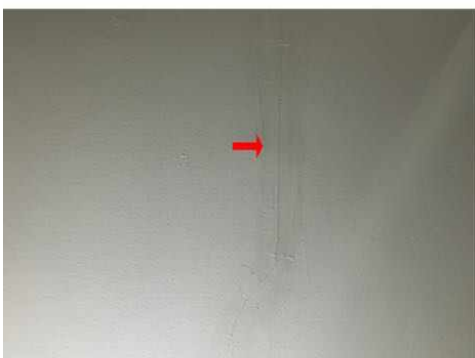
appearance defect, and usually do not indicate any structural damage. Generally, the cause of a fine crack is indicative of a separation between building materials and finishes (e.g. paint, plaster, etc.) along joints.

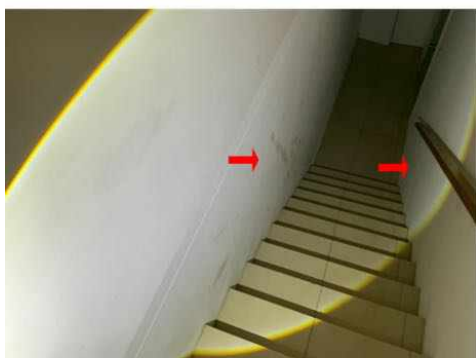
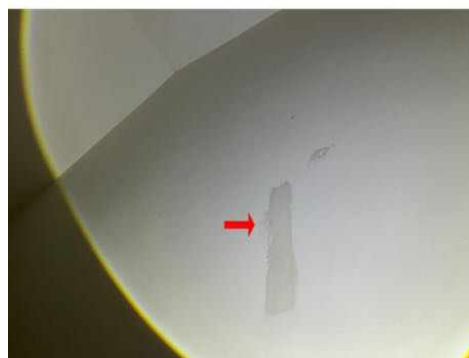
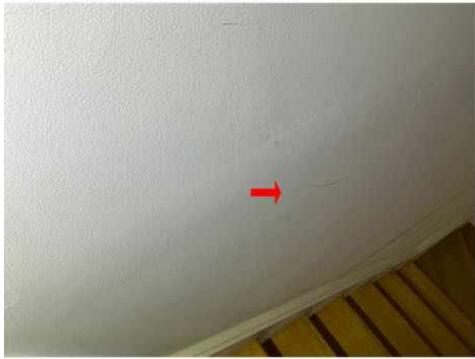
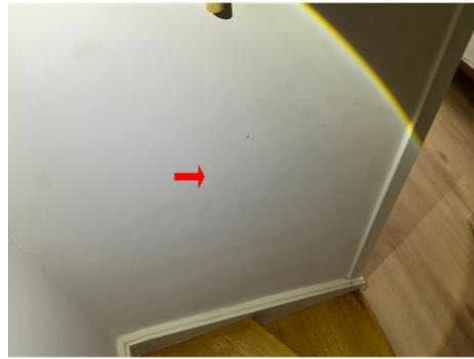
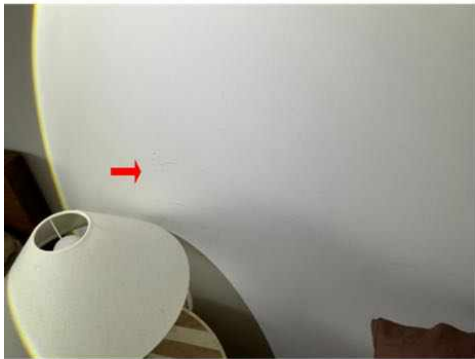
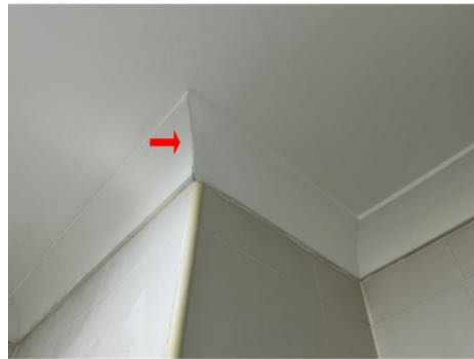
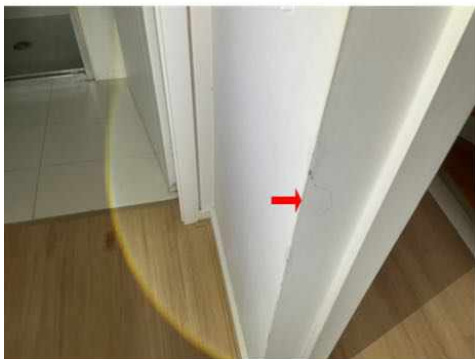
Finding 3.14

Building: Main Building

Finding: Maintenance and/or Wear and tear on building elements

Information: It was observed at the time of inspection that some building elements and areas around the property require general maintenance and/or exhibit signs of wear and tear. These typically include minor imperfections such as paint scuff marks, scratches on surfaces, small chips, nails or hooks left in walls from previous picture hanging, and other superficial blemishes.

These are generally considered minor items that are common in established homes. While they may be noticeable on visual inspection, they do not affect the structural integrity or functionality of the property. In most cases, these issues can be easily addressed by a qualified handyman as part of routine maintenance.

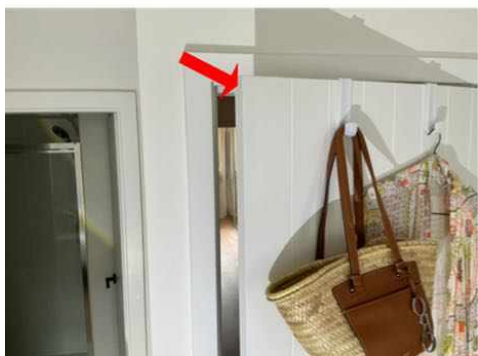
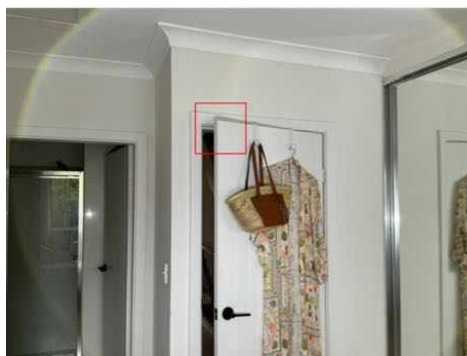
Finding 3.15

Building:	Main Building
Location:	Bedroom - Master
Finding:	Door(s) - Binding/Jamming
Information:	At the time of inspection, it was noted that the door was binding or jamming in this area.

Several factors could contribute to this issue, including swelling due to moisture, which can cause wooden doors to expand and fit tightly in the frame. Misaligned or loose hinges may also result in the door sagging or becoming misaligned, making it difficult to close. Over time, wooden doors may warp due to fluctuations in temperature or humidity, leading to improper closure.

It is recommended that a qualified carpenter or handyman be engaged to carry out the necessary repairs to ensure proper door operation.

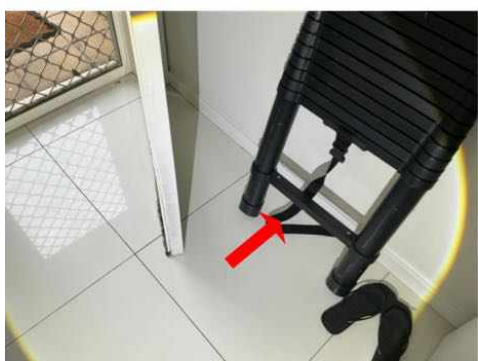
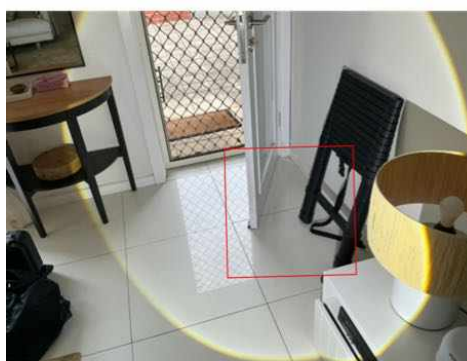
Finding 3.16

Finding: Door Stopper(s) - Missing

Information: At the time of inspection, it was noted that a door stopper was missing in this area.

The absence of a door stopper can lead to potential damage to the door, wall, or surrounding finishes, as the door may swing open too far and impact the wall or adjacent objects. Over time, this can cause dents, scuffs, or even structural damage to the wall or door. It is recommended that a door stopper be installed to prevent further damage and ensure the protection of both the door and the surrounding area.

The client is advised to engage services of a handyman to install the door stopper.

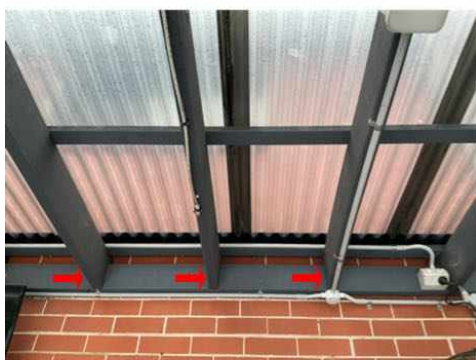
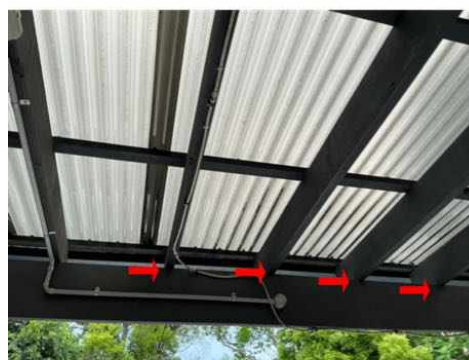
Finding 3.17

While fastening is insufficient, and there is potential for movement warping or deformation of the joists and potentially structural failures. This generally only occurs in old homes which do not have more contemporary building approaches.

Where the joist to the walling plate/beam is inadequate, repairs are likely to be required as soon as possible. A registered builder or carpenter should be appointed to perform remedial works as soon as possible.

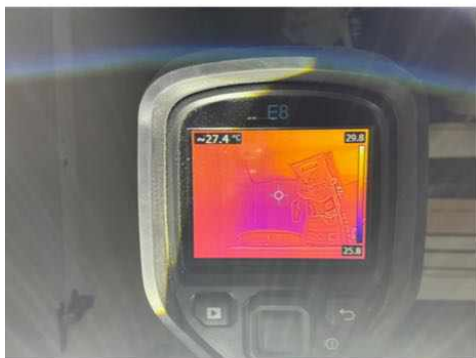
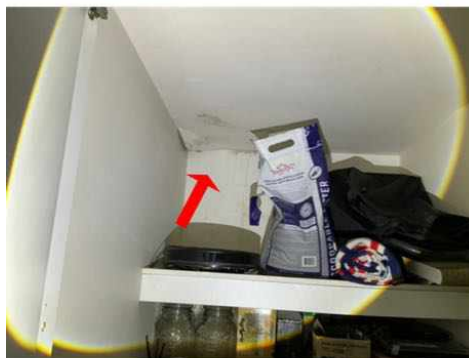
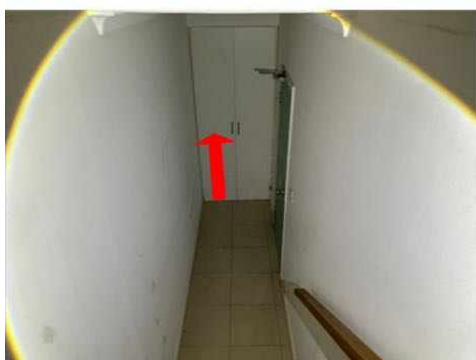
Finding 3.18

Building: Main Building
 Location: Store Room
 Finding: Ceiling Stains - Dry at the time of Inspection (Thermal Camera)
 Information: At the time of inspection, stains were noted on the ceiling in this area. Thermal imaging indicated the surface was dry at the time of assessment, suggesting that the staining may be the result of a past moisture event rather than an active leak. While no elevated moisture was detected, the possibility of intermittent leaks (for example, during heavy rainfall) cannot be fully ruled out.

It is recommended that the area be monitored over time, particularly following periods of rain, to confirm whether any active moisture ingress recurs. Should new dampness or water staining become evident, further inspection by a licensed roofing or plumbing contractor is advised to carry out any necessary repairs.

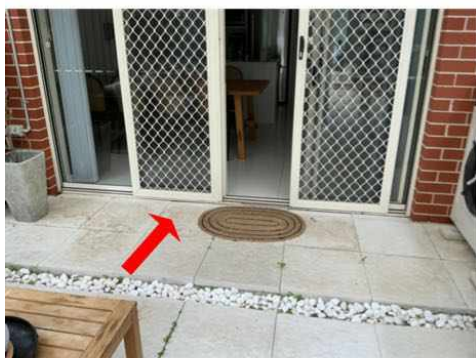
pooling and subsequent internal flooding is likely to occur which may attract termite activity to the internal area.

It is highly advised that a landscaper or relevant tradesperson be appointed to lower external grounds that are raised above or same as adjacent internal flooring. Alternatively if external grounds and internal flooring is level installation of a raised door sill may be appropriate in preventing any water pooling in the area. If the client wishes not to make any changes, then a qualified pest controller is recommended for termite treatment around the perimeter of the house and subfloor (if any) as soon as possible.

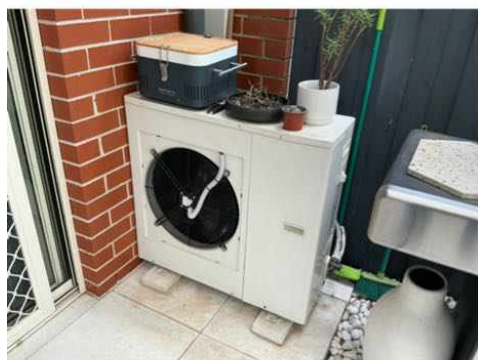
Finding 6.02

Building:	Main Building
Location:	Yard - Back
Finding:	Bridging Appliances - Attachment to Buildings
Information:	Bridging occurs when items against a building provide a concealed entry point for termites into the building or by passing around a termite management system.

Where any part of an attachment to a building is not isolated and is not provided with a clear gap of not less than 25mm from the building, bridging occurs. Attachments to buildings such as hot water services, downpipes, verandahs, decks, steps, fences, service conduits and the like provide the opportunity for concealed entry.

Building attachments of this nature need to be frequently inspected for termite activity by a qualified inspector.

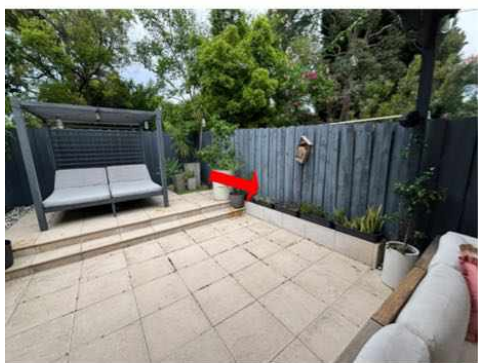
Finding 6.03

Building:	Yard
Location:	Fencing
Finding:	Building Materials in Direct Ground Contact - Conducive to Termites
Information:	Timber elements that are in direct contact with the ground and exposed to moisture or damp conditions are highly conducive to termite activity. This susceptibility arises because timber, when in contact with soil and dampness, creates an environment that is particularly attractive to termites, encouraging infestation and potential structural compromise. Whether the timber is used as a part of the building's construction or incorporated into fencing, its presence near or on the ground can become a pathway for termites to access and damage the property.

When exposed to excessive moisture, timber begins to deteriorate, developing conditions such as wood decay and rot. These compromised areas of timber are even more appealing to termites, as they are easier to infest and consume. This is especially true for untreated or non-durable timber, which lacks the protective treatments that can deter or withstand termite attacks. Termites can use these weakened, moisture-laden elements as a bridge into other parts of the structure, creating an entry point for potential infestations that can spread and cause extensive damage if left unchecked.

For any timber in direct contact with the external ground, special attention is required. The combination of moisture, untreated wood, and direct ground contact not only accelerates the decay process but also provides subterranean termites with a straightforward means of ingress into the structure. This entry can lead to termites moving undetected into other vulnerable areas, resulting in potentially significant structural issues and costly repairs.

To mitigate the risk of termite activity, it is imperative that any such materials or timber elements be appropriately treated or removed as soon as possible. Timbers that are necessary for use should be made durable through appropriate treatments and maintained to ensure they do not create conditions conducive to termites. Additionally, the client is advised to schedule regular termite treatments to maintain an effective barrier against infestations and ensure ongoing protection.

The client is strongly advised to assess the property for any timber elements that may be in direct contact with the ground and ensure prompt action is taken to remove or treat them effectively. Regular inspections, proactive maintenance, and consistent termite treatment are essential steps in minimising the risk of termite attack and protecting the structural integrity of the property. Taking these preventive measures is crucial for maintaining a termite-free environment and avoiding potentially costly damage and future repairs.

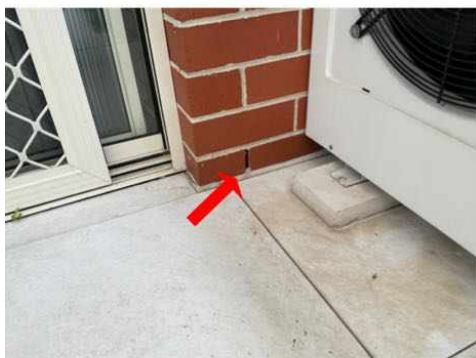
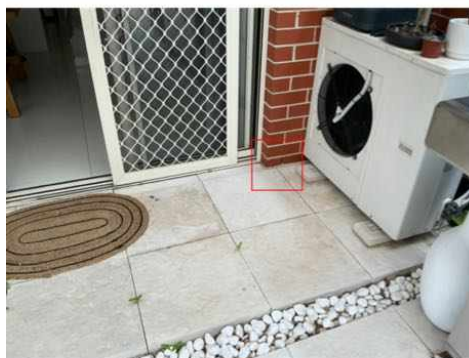
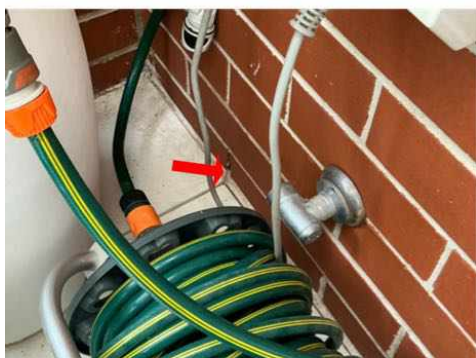
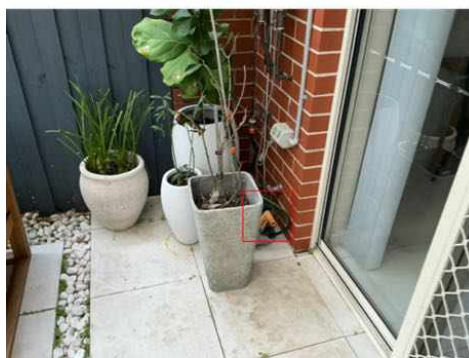
Building: Main Building
 Location: Alfresco
 Finding: Weep Holes - At Ground Level
 Information: It was noted at the time of inspection, the weep holes have been identified at ground level, which constitutes a defect.

According to building standards, weep holes should be positioned above the finished ground level to ensure proper drainage and to prevent water ingress into the wall cavity. Weep holes located at ground level can lead to water entering the structure, causing potential damage to the masonry, insulation, and internal finishes. This placement fails to provide the necessary protection against moisture and does not comply with standard building practices.

The relevant tradesperson must address this issue by ensuring that weep holes are correctly positioned above ground level to meet the required standards and to maintain the integrity of the building.

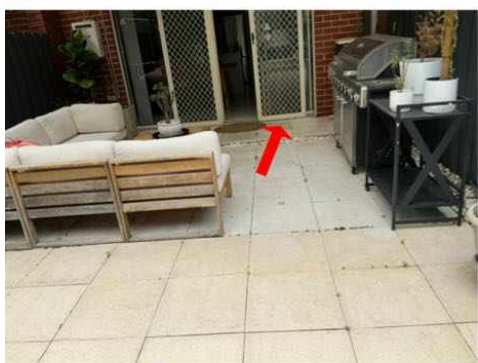
Finding 6.06

Building: Main Building
 Location: Alfresco
 Finding: Slab Edge - Exposure
 Information: An inspection zone of at least 75mm in relation to the exposed slab edge, between

If the slab edge is not properly exposed there is a high risk of termite attack. Sometimes, in order to determine the type of slab, a suitably qualified person such as an architect or builder may be required to consult the construction plans.

Where the slab edge cannot be properly inspected, it is highly recommended that termite or timber pest inspections be carried out every 6-12 months to aid protection of the property against infestation.

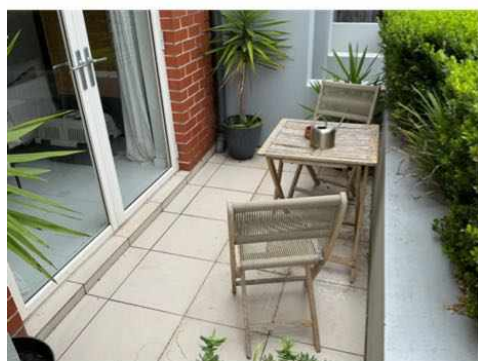
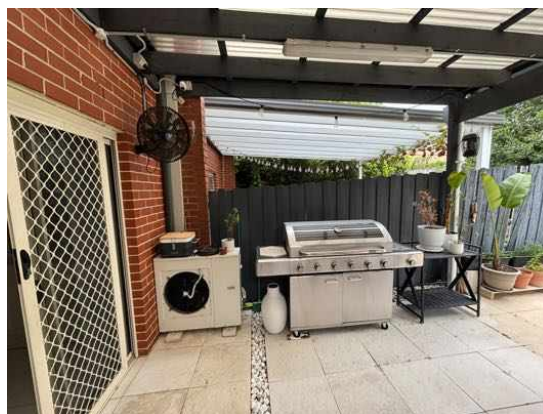
Building: Main Building
Location: All External Areas
Finding: Obstructions and Limitations - External Areas
Information: The attached photographs provide a visual representation of the obstructions and limitations that impeded a full inspection of the external areas of the property at the time of assessment. These obstructions, which may include vegetation, stored items, debris, or other physical barriers, can obscure potential defects and prevent a thorough evaluation of the property's condition. Obstructions of this nature can conceal a wide range of issues, such as structural damage, water ingress, pest infestations, or deteriorating building materials, which may not be visible during the initial inspection.

It is essential that these obstructions be cleared to allow for a comprehensive inspection of the external areas. Removing these barriers will enable a more accurate assessment of the property's condition and allow any hidden defects to be identified and addressed promptly. Failure to do so could result in undetected issues worsening over time, potentially leading to more costly repairs in the future.

Therefore, it is strongly recommended that the obstructions be removed and a re-inspection be scheduled once the affected areas are made fully accessible. This will ensure a complete evaluation of the property's exterior and provide the client with a clear understanding of any potential issues that may have been concealed during the initial inspection.

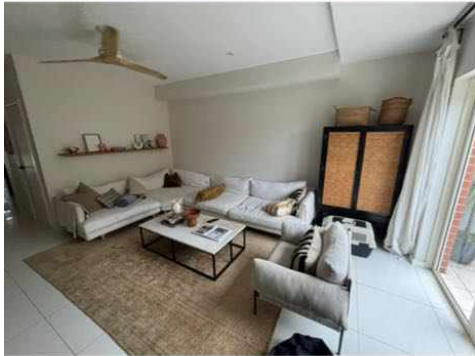
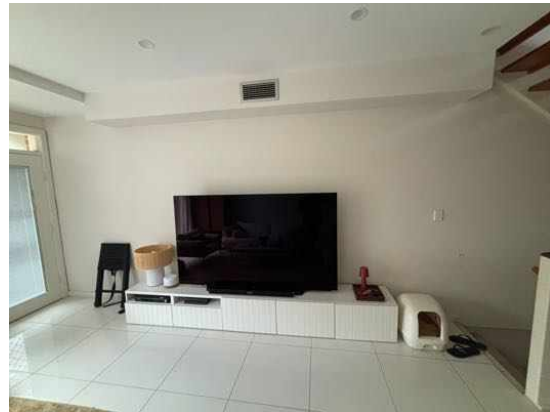
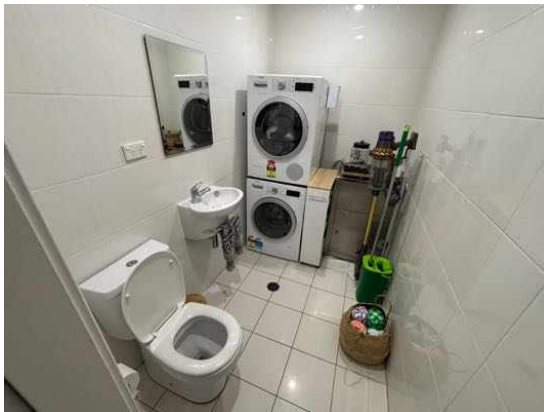
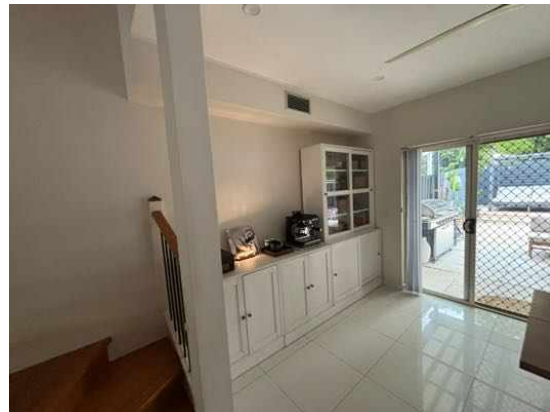
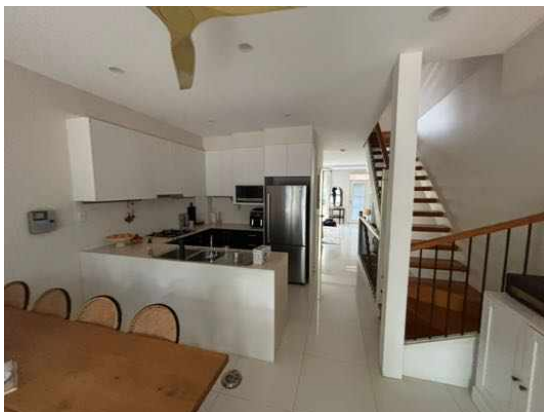
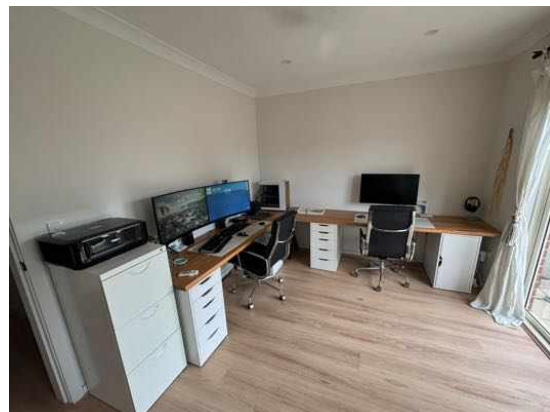
Information: The accompanying photographs provide clear evidence of the obstructions and limitations that restricted a comprehensive inspection of the internal areas of the property at the time of assessment. These obstructions, which may include furniture, personal belongings, stored items, or structural elements such as wall coverings and built-ins, significantly hindered the ability to thoroughly evaluate these areas. It is important to note that such obstructions can potentially conceal a wide array of defects, ranging from hidden structural damage, water leaks, pest infestations, or electrical issues, to deteriorating materials that may not be visible during the initial inspection.

The presence of these impediments means that critical areas of the property were not accessible, and therefore, any underlying defects that may affect the integrity and safety of the property could remain undetected. These hidden defects, if left unaddressed, could worsen over time and may result in costly repairs or pose potential safety hazards to the occupants.

It is highly recommended that all obstructions be cleared to facilitate a complete and thorough inspection of the internal areas. Once the obstructions have been removed and full access is available, a re-inspection should be carried out to ensure that any

previously concealed issues can be properly identified and rectified. This follow-up inspection will provide a more accurate assessment of the property's internal condition and help the client make informed decisions about any necessary repairs or maintenance.

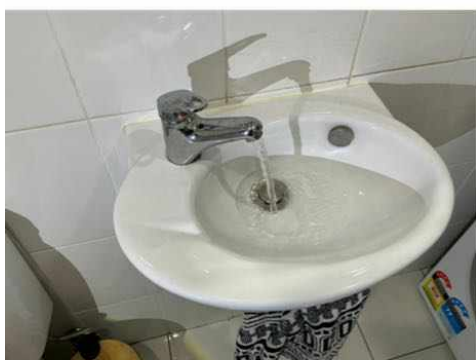
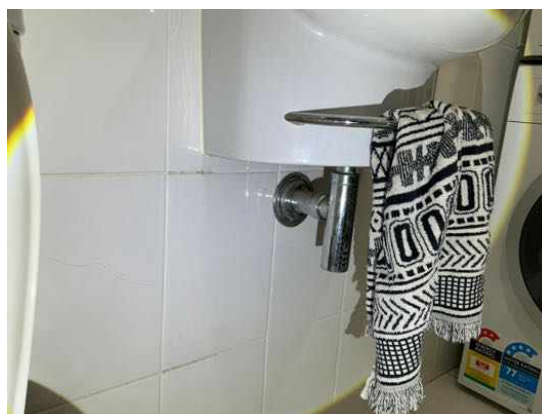
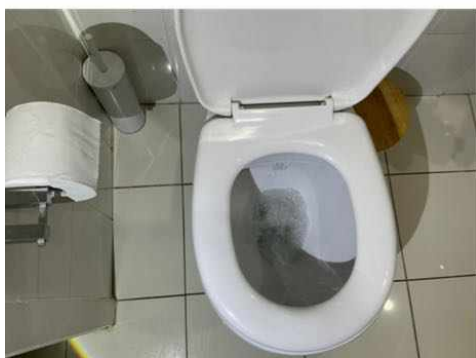
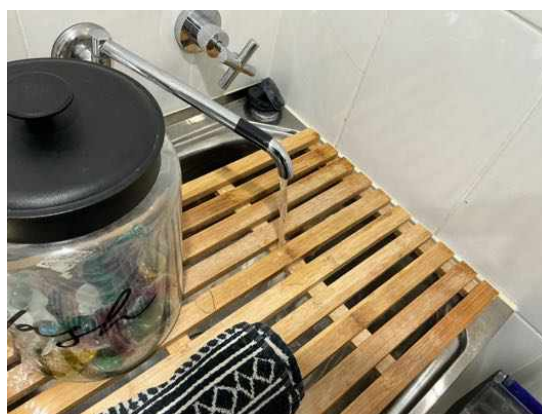
Building: Main Building
Location: All Areas
Finding: FYI - Taps, Drainage & Toilets Tested and Cabinetry Obstructions
Information: During the inspection, all accessible taps, drainage systems, and toilets were tested for water flow and drainage efficiency, and checked for any visible signs of leakage. At the time of the inspection, no issues were noted in these areas. Unless highlighted in a separate defect statement, no immediate remedial work appears necessary. Supporting images may be found in the additional photos section for reference.

It is important to note that while a visual inspection of cupboards and cabinetry beneath sinks and vanities was undertaken, stored personal items and fixtures presented obstructions that limited full visibility of the internal areas. As per standard inspection practices, inspectors are not permitted to move or disturb personal belongings during the inspection process. Therefore, only visible and accessible sections were inspected, and concealed water damage or plumbing defects may not have been detected.

Given this, a re-inspection is recommended after all obstructions have been cleared to allow for a comprehensive assessment of these areas. Regular maintenance and monitoring of plumbing and drainage systems is also advised to ensure ongoing functionality and early detection of potential issues.

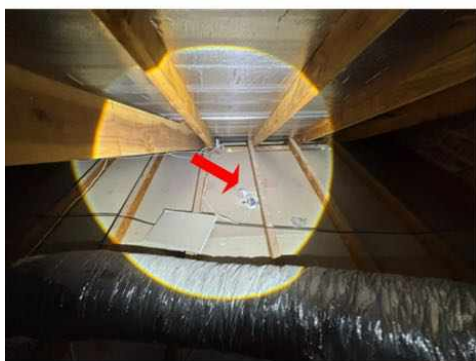
Building:	Main Building
Location:	Both Roof Voids
Finding:	Insulation - Not Installed
Information:	It was noted during inspection, that insulation has not been installed. Although not considered a defect, it undermines the thermal efficiency of the property, leading to increased energy consumption for heating and cooling. Properly installed insulation is crucial for maintaining a consistent indoor temperature, reducing energy costs, and enhancing overall comfort. Immediate corrective action is required to install the insulation as per the manufacturer's guidelines, ensuring it provides the intended thermal performance and complies with building standards.
