Building Inspection Report

Inspection Date: Fri, 16 Jan 2026

Property Address: 21 Yunga Ct, Broadbeach Waters QLD
4218, Australia

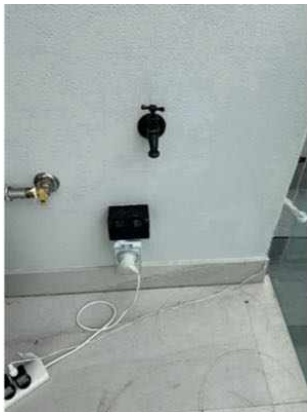
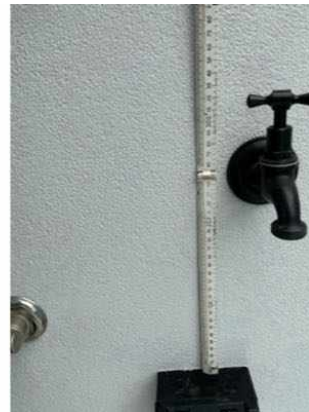
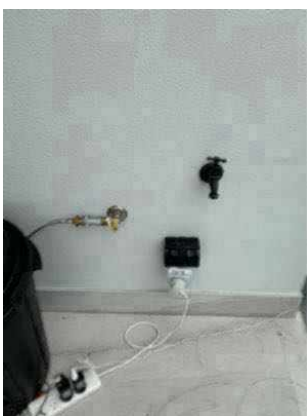
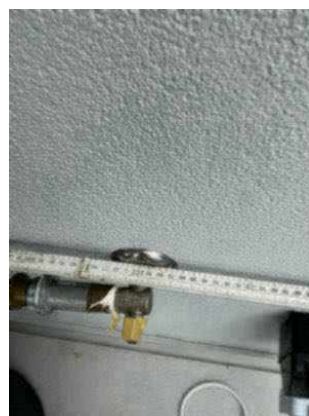
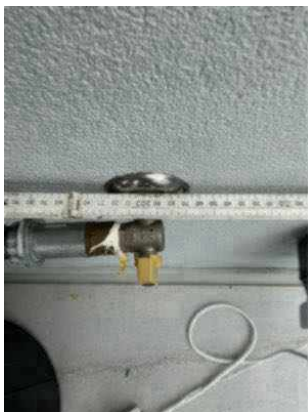
Defects 1.01

this arrangement exposes the electrical outlet to potential water dripping and spray, which does not comply with AS/NZS 3000 requirements for electrical installations to be protected from water exposure.

A qualified electrician or plumber should relocate the power outlet or tap to achieve compliant separation.

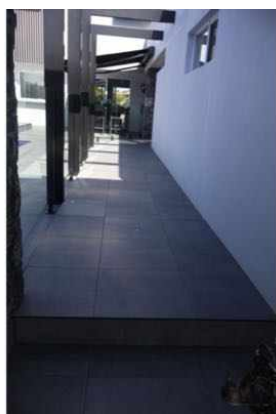
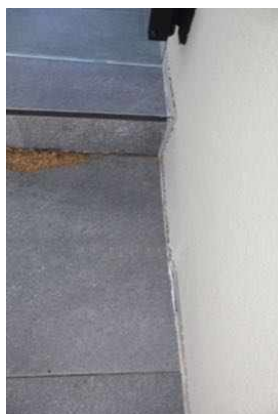
Defects 3.01

This may allow water ingress rain water can track cavities or slab edges, dampness efflorescence, render/paint failure, or internal moisture issues.

Rectification works are required.

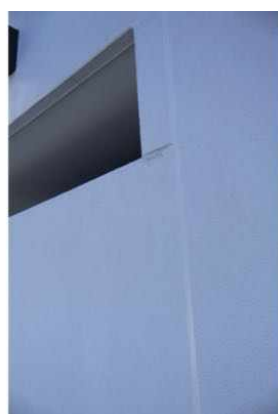
Defects 3.02

Building:	Main Building
Location:	Walls > Front
Finding:	External wall weatherboard- cracks
Information:	Cracks to the external weatherboard wall right side of building was found at the time of the inspection.

Weatherboard walls cracking can be signs of underlying defects or issues with the building due to natural expansion and contraction of timber due to moisture and temperature changes, uneven settling of foundations or soil movement, buckling splitting or separation between boards.

This may also be due to frequent exposure to weather.

It is recommended that repairs to wall be carried out to prevent moisture ingress.

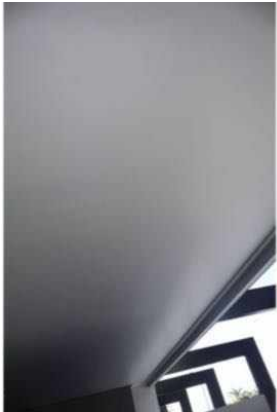
Defects 3.03

Building:	Main Building
Location:	Bathroom > Front
Finding:	Plaster/paint - substandard works
Information:	The works to the plaster/paint appear to be incomplete or have been completed to a substandard level.

Works that have not been completed to a satisfactory level create potential for the development of building defects and may impede on the safety and integrity of the overall structure.

It is highly recommended that the relevant trades be appointed to complete these works and ensure the safety of the area and the longevity of all associated building elements.

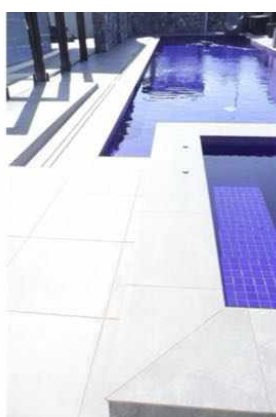
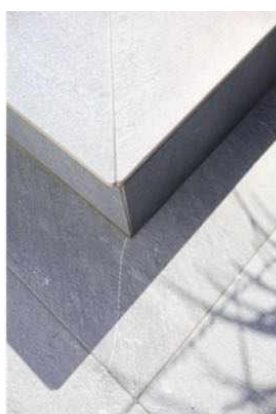
Defects 3.04

Building: Yard

Location: Pool Area > Front
 Finding: Tiles - Cracked or damaged
 Information: Cracking was evident to the tiling in this area at the time of inspection. While the cracking appears to be minor, this area is frequently exposed to water, allowing potential for water penetration into adjoining sections of walls or flooring.

If left unmanaged, water penetration to these areas may lead to subsequent water damage, which is likely necessitate repair work to affected building elements.

A tiling contractor should be appointed to ensure that no further water damage occurs. The re-application of silicone and grouting throughout remaining tile work is also advised, to further protect the area against water penetration.

Where water penetration has led to water damage, appointment of a relevant tradesperson may be required to repair damaged building elements.

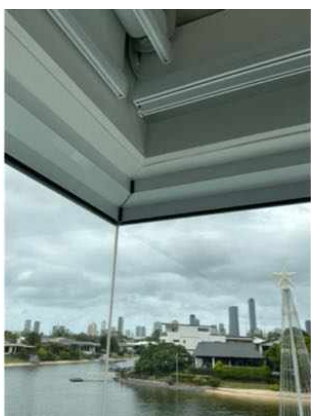
Defects 3.07

Building:	Main Building
Location:	Bedroom - Master > Rear Right
Finding:	Water staining
Information:	Water staining was evident in this area at the time of inspection. Water staining indicates that surfaces have been exposed to excessive moisture over time. The minerals and other elements in the water lead to staining, which may graduate to corrosion and deterioration if left unmanaged.

While mostly an appearance defect, water staining can be indicative of more serious defects, which may be currently concealed by other building elements.

Where water staining is active, a licensed plumber must be consulted to identify the cause of the staining and to provide advice on any reparation works that may be required. Replacement of any broken or damaged structures is advised.

Conversely, where water staining is old and inactive, affected building materials may be repaired or replaced at client discretion. A qualified carpenter or registered builder may be appointed to perform these works.

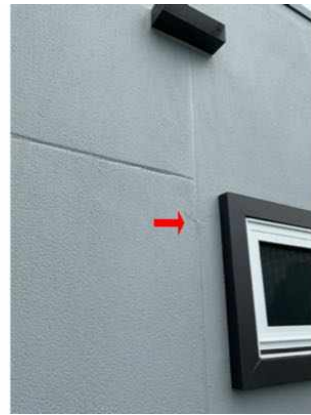
Defects 3.08

Building:	Main Building
Location:	Weather board > Front
Finding:	External weather board - cracks
Information:	Cracking was observed to sections of the external weather board cladding.

This condition may allow moisture ingress and indicates movement of the cladding material.

Repair and maintenance are recommended.

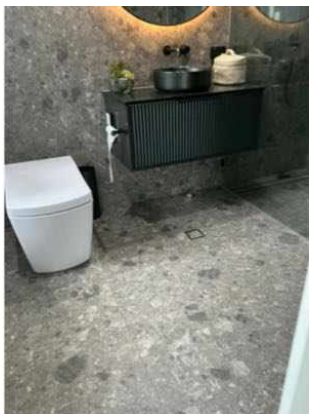
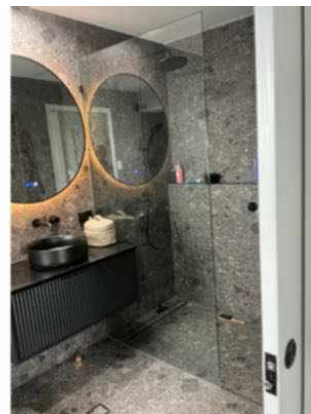
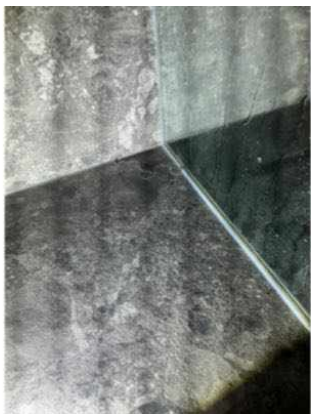
Defects 3.09

Building: Main Building
Location: Bathroom > Rear
Finding: Shower screen- leaks
Information: At the time of inspection it was noted that the shower screen has minor leak.

Although minor leaks to shower screens may seem insignificant, they may cause damage to other fixtures such as grout ,vanities

And create mould damage which may become costly.

Re-Sealing of screen is recommended to be rectified as soon as possible to stop further deterioration.

A handyman may be required to rectify this condition.

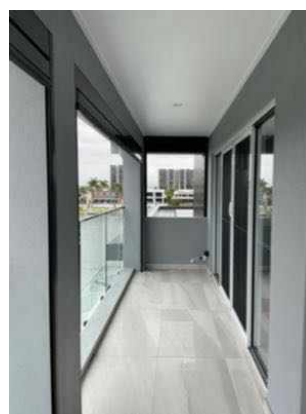
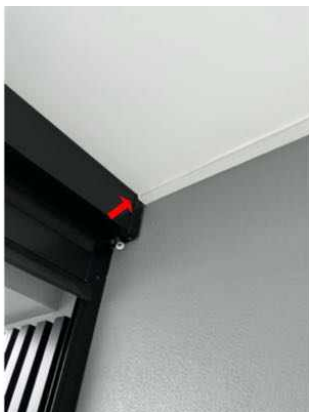
Defects 3.10

Building:	Main Building
Location:	Upper alfresco > Rear Right
Finding:	Ceiling - Water stained
Information:	Water staining to ceiling linings in this area was evident at the time of inspection. Water staining indicates that surfaces have been exposed to excessive moisture over time. The minerals and other elements in the water lead to staining, which may graduate to corrosion and deterioration if left unmanaged.

While mostly an appearance defect, water staining can be indicative of more serious defects, which may be currently concealed by interior ceilings.

Where water staining is active, a licensed plumber must be consulted to identify the cause of the staining and to provide advice on any reparation works that may be required. Replacement of any damaged structures is advised.

Conversely, where water staining is old and inactive, affected building materials may be repaired or replaced at client discretion.

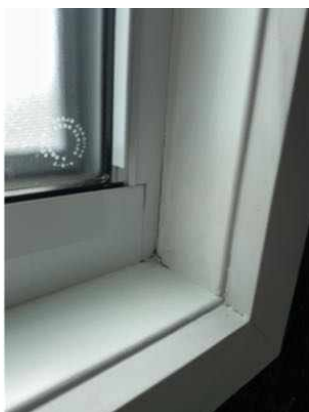
Defects 3.11

Building: Main Building
Location: Toilet (WC) > Rear
Finding: Window - reveal-gaps
Information: At the time of the inspection it was noted that there are gaps in the bathroom timber reveal.

Gaps should be sealed to prevent moisture penetration and damage to internal building members.

Moisture to internal wall cavities may also create mould and become conducive to timber pest.

A handyman or painter may be required to rectify this condition.

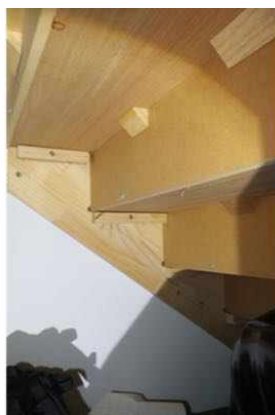
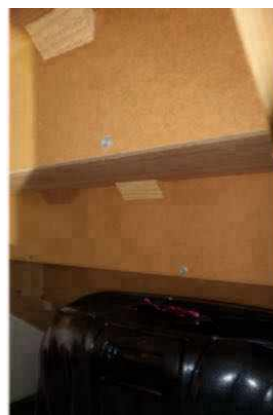
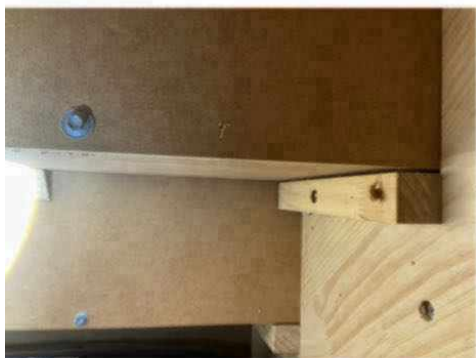
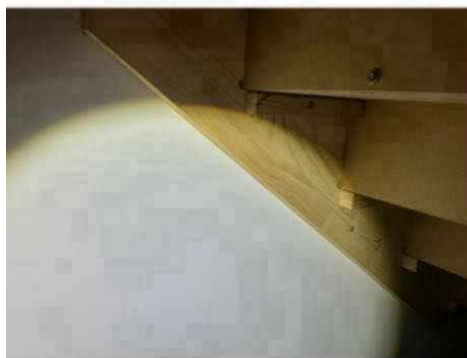
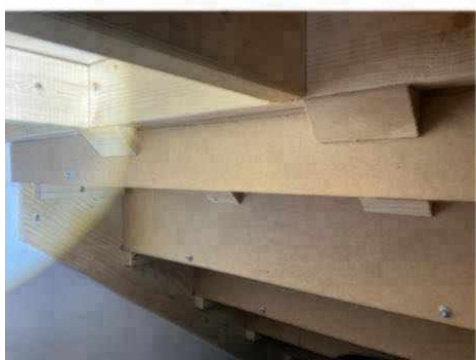
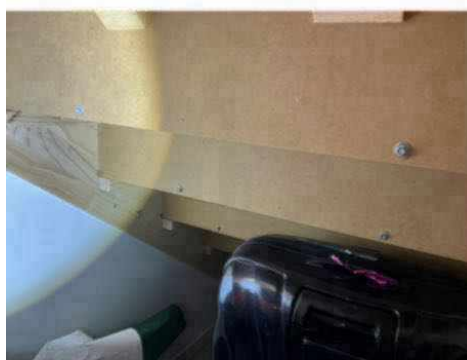
If the stairs case fixings are structural connections designed by an engineer, typically sheet metal screws alone may not provide sufficient strength, those usually require structural fasteners, bolts or engineered brackets.

If screws don't comply with AS.3566 or equivalent performance criteria, or are not suitable for the material thickness.

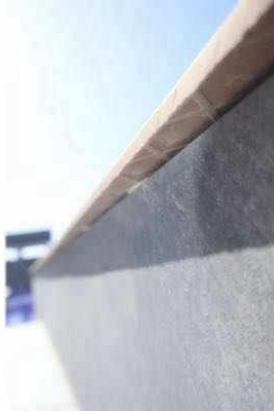
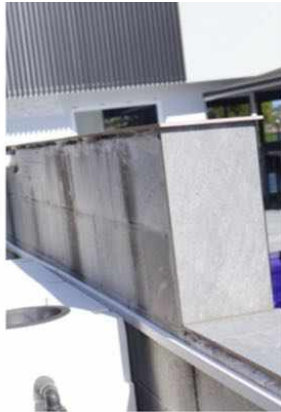
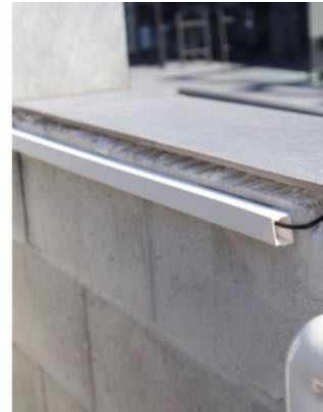
Building:	Yard
Location:	Pool Area > Front
Finding:	Pool tile - junctions sealant missing
Information:	The junctions where the pool tiles meet the coping/ pool edging has no flexible sealant.

This may also allow cracking to junctions due to thermal and structural movement.

It is recommended that sealant be carried out as soon as possible.

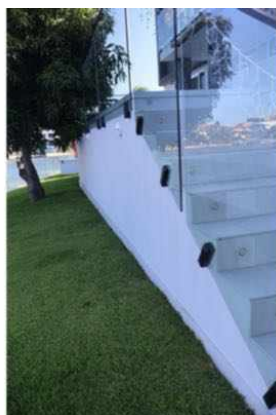
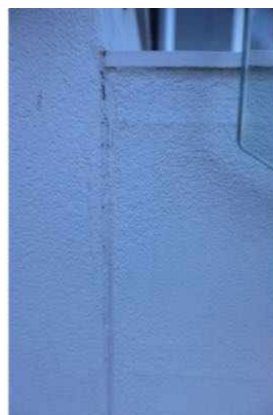
Building: Main Building
 Location: Alfresco > Rear
 Finding: External wall weatherboard- cracks
 Information: Cracks to the external weatherboard wall right side of building was found at the time of the inspection.

Weatherboard walls cracking can be signs of underlying defects or issues with the building due to natural expansion and contraction of timber due to moisture and temperature changes, uneven settling of foundations or soil movement, buckling splitting or separation between boards.

This may also be due to frequent exposure to weather.

It is recommended that repairs to wall be carried out to prevent moisture ingress.

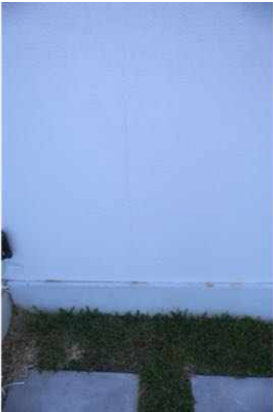
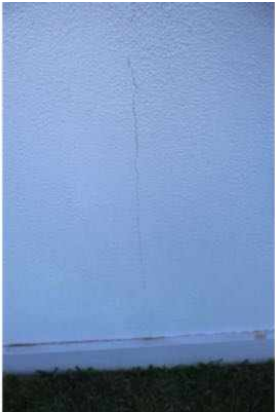
Building:	Main Building
Location:	Alfresco > Rear
Finding:	Cracks to external render - Category 2
Information:	It has been observed that cracking to external rendered surfaces has occurred. The degree of damage falls within Category 2, described as noticeable cracks which are easily filled. Cracking of this size are generally less than 5mm in width.

Category 2 damage is required to be monitored for a period of 12 months. After the monitoring period, a crack rated at Category 2 or above is considered a defect requiring rectification.

Always contact your building inspector should cracks widen, lengthen, or become more numerous.

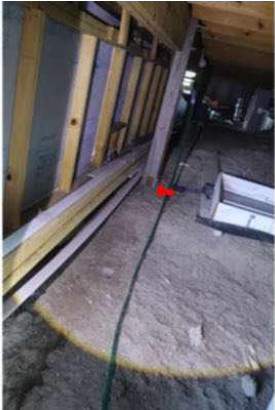
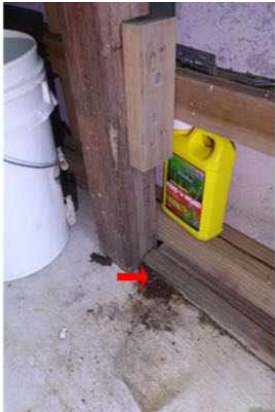
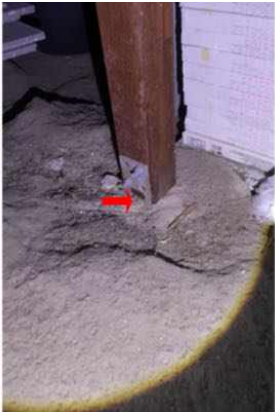
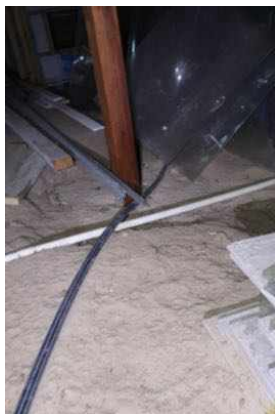
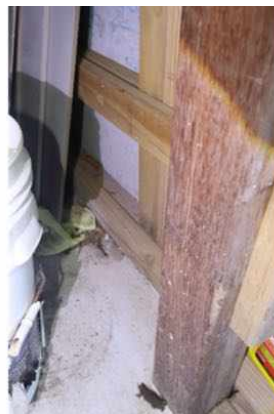
Building: Main Building
 Location: Subfloor > Rear
 Finding: Building materials in direct ground contact - conducive to termites
 Information: Where timber elements are in direct contact with the ground and consequently moisture or dampness they become conducive to termite activity. Whether timber is used as a building element part of a fencing structure they can provide an environment that is attractive to termite infestation.

When met with excessive moisture timber begins to decay and develop wood rot. Any timbers that are in direct contact with external grounds especially if left untreated or non-durable also provide ingress for subterranean termites into that particular element.

Regular inspections of materials that may be conducive to termite activity should be regularly monitored to minimise the risk of termite attack.

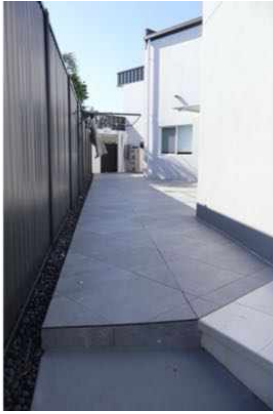
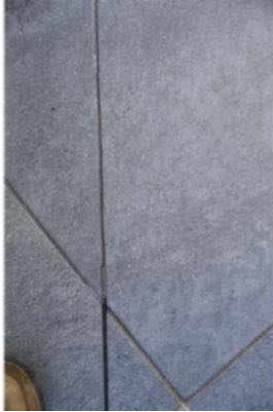
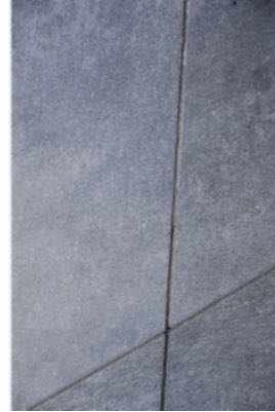
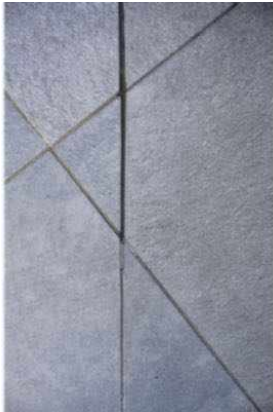
Building: Main Building
 Location: Paving > Rear Right
 Finding: Grout cracking - external tile area
 Information: Cracks are visible in the grout joints between external floor tiles.

The cracking may be isolated across a section of tiled surface.

Movement or flexing of the substrate (e.g slab or screed) due to temperature changes ground movement or inadequate control joints.

A tiler or handyman may be required to rectify this condition.

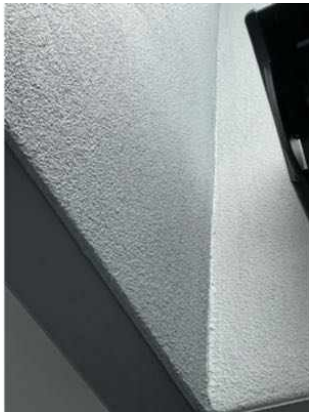
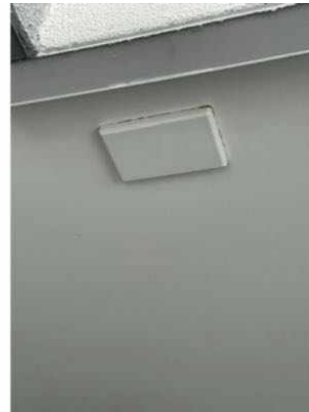
Finding: External wall weatherboard- cracks

Information: Cracks to the external weatherboard wall right side of building was found at the time of the inspection.

Weatherboard walls cracking can be signs of underlying defects or issues with the building due to natural expansion and contraction of timber due to moisture and temperature changes, uneven settling of foundations or soil movement, buckling splitting or separation between boards.

This may also be due to frequent exposure to weather.

It is recommended that repairs to wall be carried out to prevent moisture ingress.

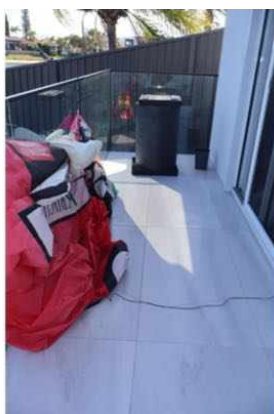
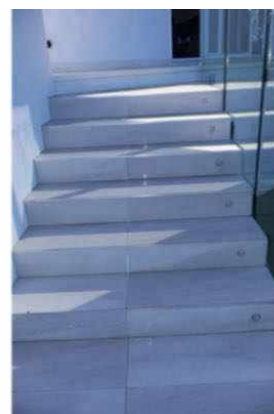
Building: Main Building
Location: Sunroom/balcony > Front
Finding: Balcony sealant discoloured - edge
Information: Sealant to balcony edges/ joints shows premature and uneven discolouration inconsistent with a new installation.

The condition indicates possible use of incorrect or low-grade sealant, inadequate surface preparation or moisture ingress.

The finish is not uniform and does not meet acceptable standards of workmanship.

Rectification works are required.

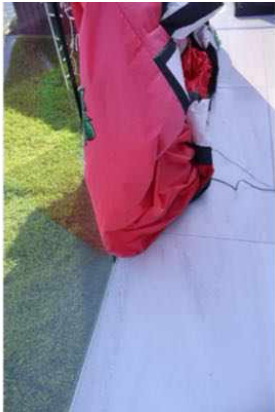
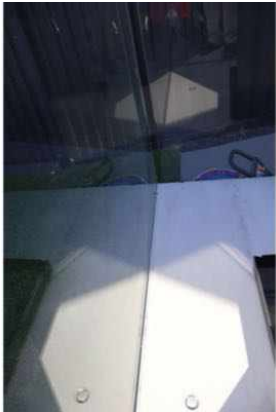
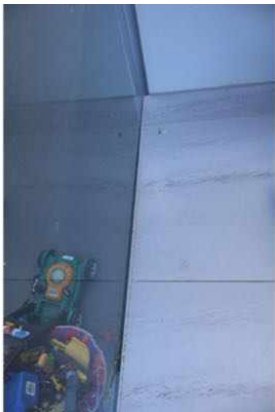
Building: Main Building
Location: Alfresco > Front
Finding: Balcony sealant discoloured - edge
Information:

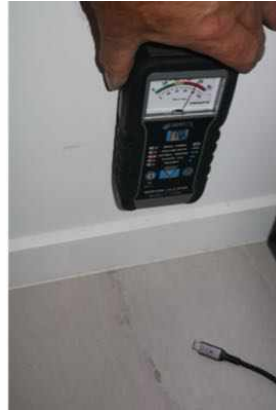
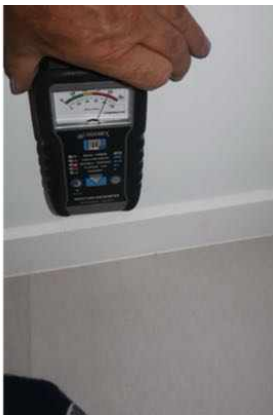
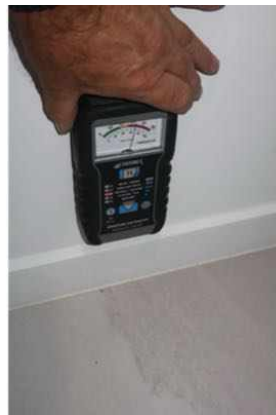
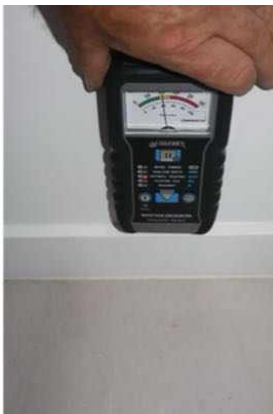
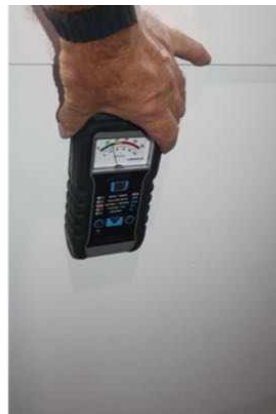
Building:	Main Building
Location:	Bedroom > Rear
Finding:	Excessive moisture - identified walls
Information:	Excessive moisture can attract termites and produce conditions that promote fungal growth and wood decay.

Excessive moisture is generally caused by inadequate external sealing to walls or poor site drainage.

Prior to any remedial works being performed, further inspection of the property drainage to identify the cause of the excessive moisture. Works to affected building

elements may then be necessary and should be performed by an appropriate tradesperson.

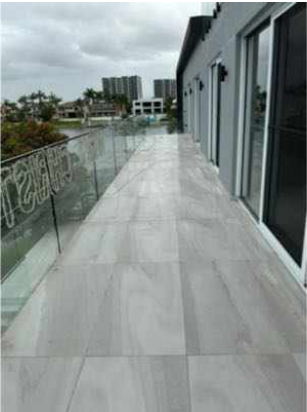
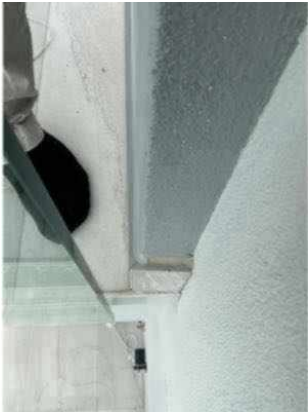
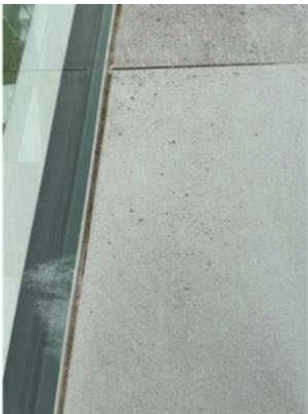
Building: Main Building
Location: Balcony > Rear
Finding: Sealant gaps - deterioration
Information: Gaps and deterioration were observed to the sealant to balcony edge junctions.

Associated moisture staining is visible to adjacent finishes below indicating water staining occurring at the balcony perimeter.

The likely causes are; Poorly applied flexible sealant, inadequate sealant to balcony edge and tile terminations.

Implications/ risks of moisture damage to substrates, soft fits and external finishes.

It is recommended a licensed water proofer or sealant technician be engaged to inspect condition and make recommendations.

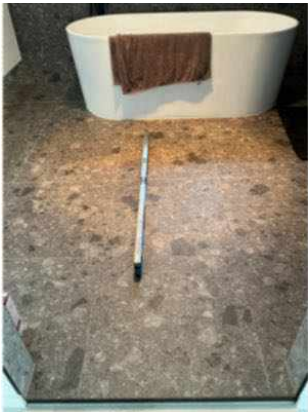
Risk of water flowing out of the wet area

There is no tolerance for incorrect falls that compromise drainage or waterproofing performance.

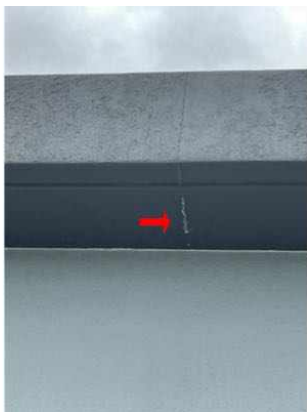
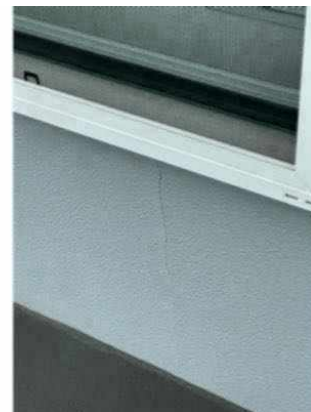
Building: Main Building
 Location: Weatherboard > Front
 Finding: External weather board - cracking
 Information: Cracking was observed to sections of the external weatherboard cladding at the time of inspection.

The cracking may be associated with age related deterioration, thermal movement, moisture exposure or inadequate fixing and maintenance.

Cracked weatherboards can allow moisture penetration into wall cavity, increasing the risk of timber decay, mould growth and potential termite access.

If left un-rectified ongoing movement and water ingress may lead to further deterioration of the cladding and underlying framing.

A suitable qualified builder should be should asses the affected areas to determine the extent of the deterioration.

Repairs may include sealing minor cracks, replacing damaged weatherboards and repainting with an appropriate exterior coating.

On going maintenance is recommended to prevent further deterioration.

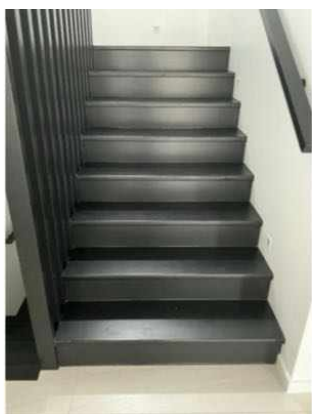
Building: Main Building
 Location: Stairs - Internal > Existing
 Finding: Stair case tread loose (going)
 Information: The internal staircase contains a loose tread (going) 3rd from top that moves under load.

There no allowable tolerance for movement in stairs components.

Where movement is noted rectification works should be undertaken to prevent further deterioration.

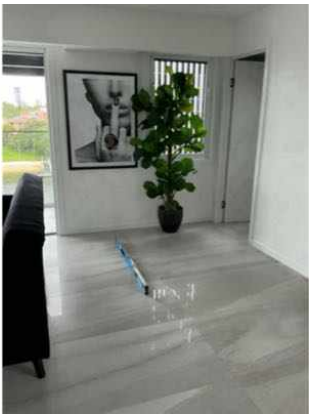
Building: Main Building
 Location: Upstairs living > Front Right
 Finding: Flooring out of level
 Information: Under the QBCC guidance which adopts the NCC and AS.3958.1 ceramic tiles, the key tolerance applied to finished tiled floor is as follows:

Maximum allowable tolerance, 10mm over a 3 metre straight edge.

This is measured over finished tiled surface.

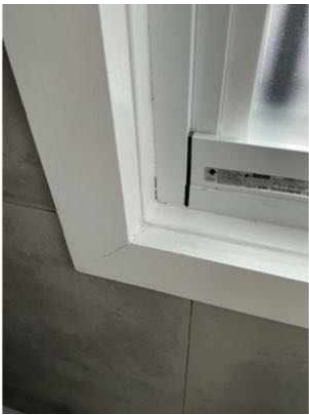
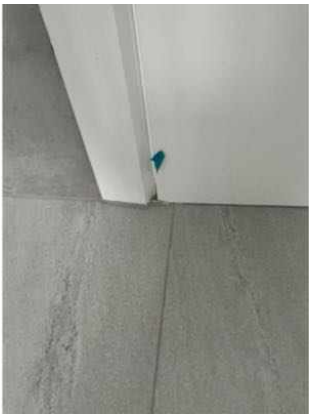
Building: Main Building
Location: Toilet (WC) > Front
Finding: Door - Binding
Information: Binding of this door is evident during standard operation. This defect inhibits the functionality of the affected door as well as creating potential for secondary defects to associated building elements, such as damage to the door jamb.

For minor causes, a qualified carpenter or general handyperson should be appointed to perform minor rectification works at client discretion.

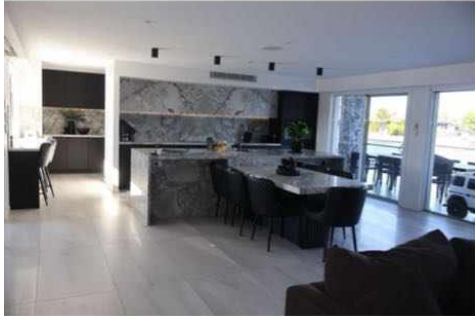
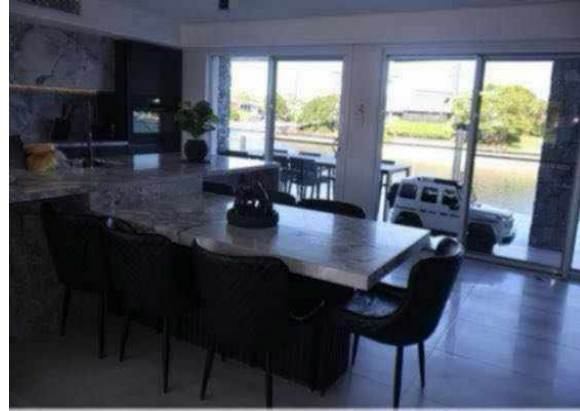
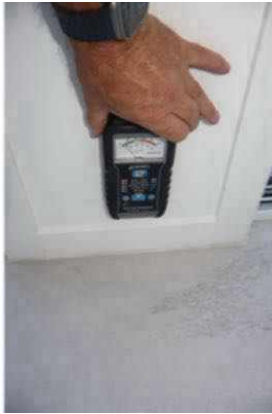
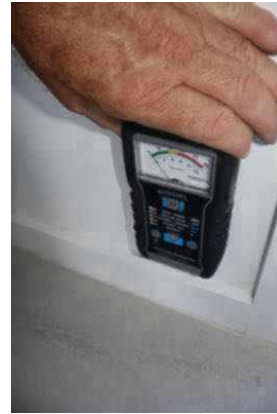
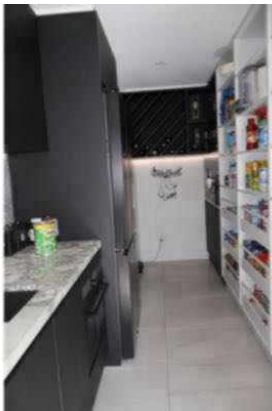
Building: Main Building
Location: Dining/kitchen > Existing
Finding: Additional Photos
Information: Additional photos are provided for your general reference

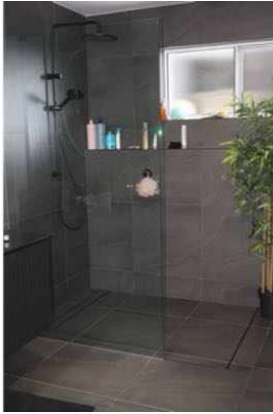
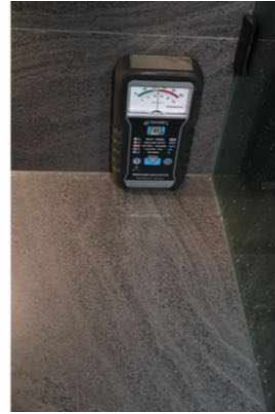
Building: Main Building
Location: Bathroom > Existing
Finding: Bathroom - satisfactory
Information: Bathroom was found in satisfactory condition at the time of the inspection.

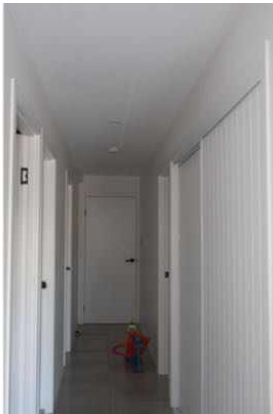
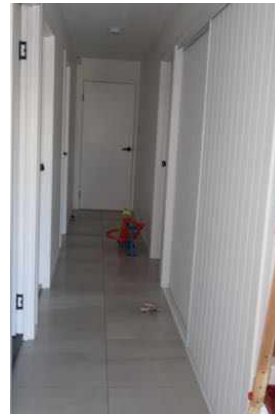
Building: Main Building
Location: Hallway > Existing
Finding: Additional Photos
Information: Additional photos are provided for your general reference

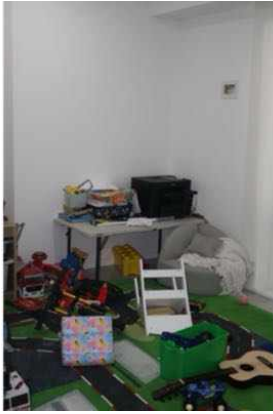
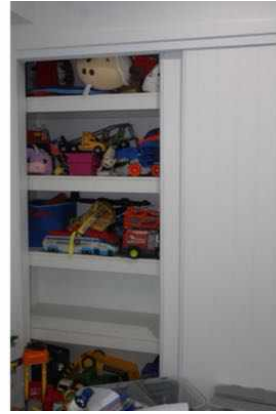
Building: Main Building
Location: Bedroom > Existing
Finding: Bedroom - satisfactory
Information: Bedroom was found to be in satisfactory condition at the time of the inspection.

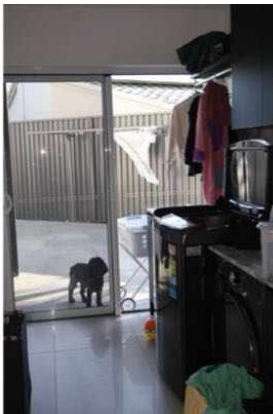
Building: Main Building
Location: Laundry > Existing
Finding: Laundry - satisfactory
Information: Laundry room was found in satisfactory condition at the time of the inspection.

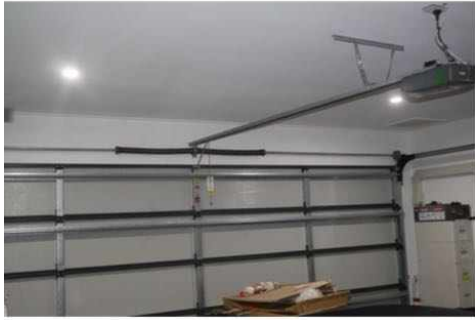
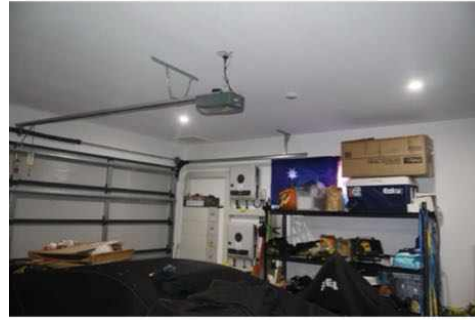
Building: Main Building
Location: Garage > Existing
Finding: Additional Photos
Information: Additional photos are provided for your general reference

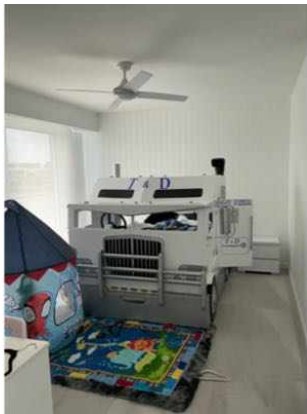
Building: Main Building
Location: Bedroom > Existing
Finding: Bedroom - satisfactory
Information: Bedroom was found to be in a satisfactory condition.

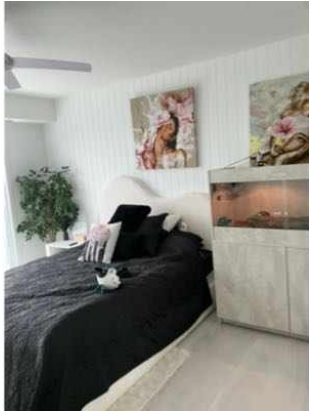
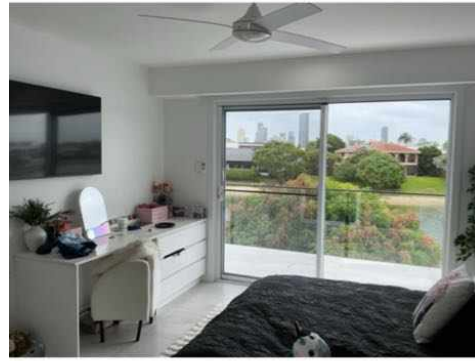
Building: Main Building
Location: Bedroom > Existing
Finding: Bedroom - satisfactory
Information: Bedroom was found to be in a satisfactory condition.

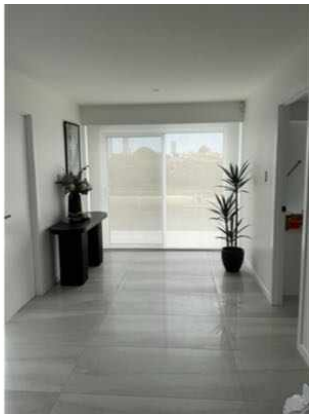
Building: Main Building
Location: Stairs - Internal > Existing
Finding: Additional Photos
Information: Additional photos are provided for your general reference

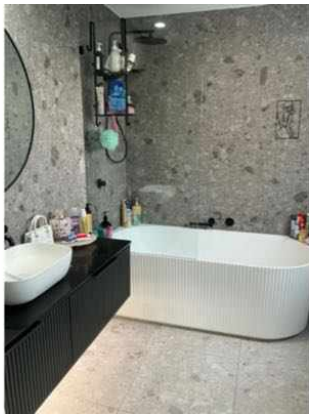
Building: Main Building
Location: Bathroom > Existing
Finding: Bathroom - satisfactory
Information: Bathroom was found in satisfactory condition at the time of the inspection.

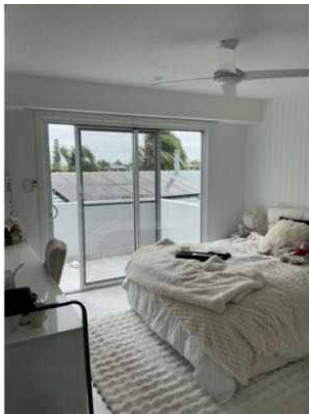
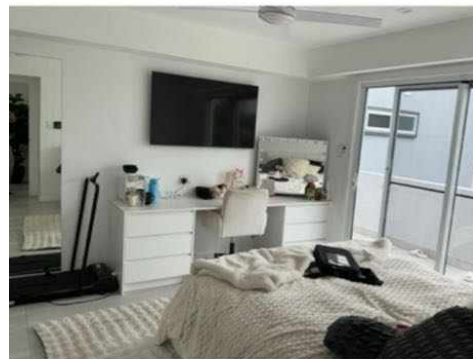
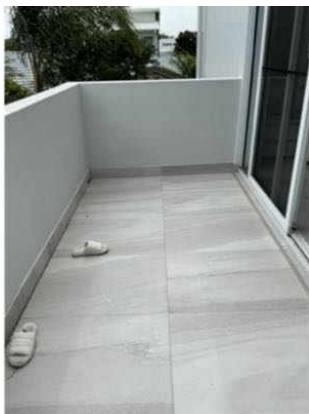
Building: Main Building
Location: Bedroom > Existing
Finding: Bedroom - satisfactory
Information: Bedroom was found in satisfactory condition at the time of the inspection.

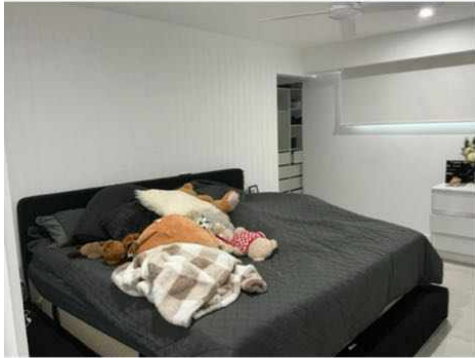
Building: Main Building
Location: Bedroom > Existing
Finding: Bedroom - satisfactory

Information: Bedroom was found to be in satisfactory condition at the time of the inspection.

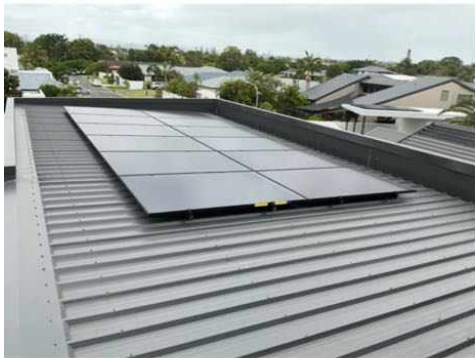
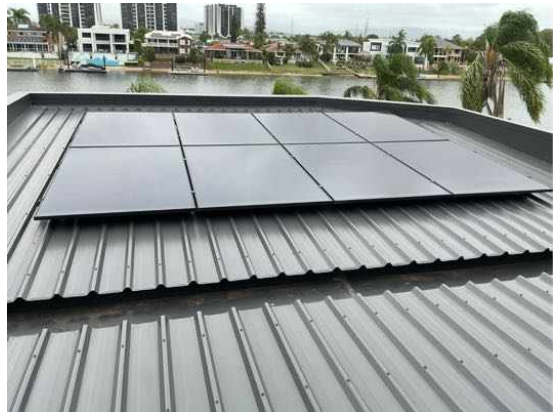
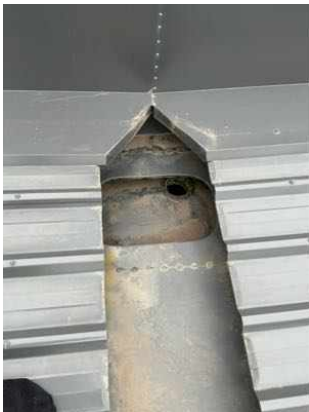
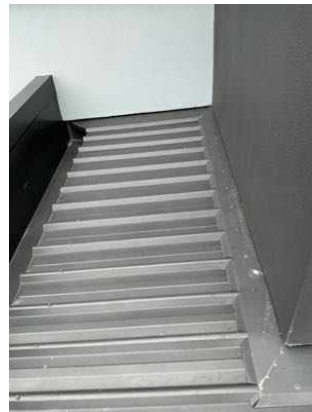
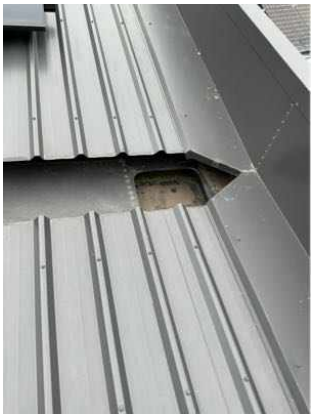
Building: Main Building
Location: Roof Exterior > Existing
Finding: Additional Photos
Information: Additional photos are provided for your general reference
