# Building and Timber Pest Inspection Report

Inspection Date: Fri, 6 Mar 2026

Property Address: 7 Lachlan Cres, St Georges Basin NSW  
2540, Australia

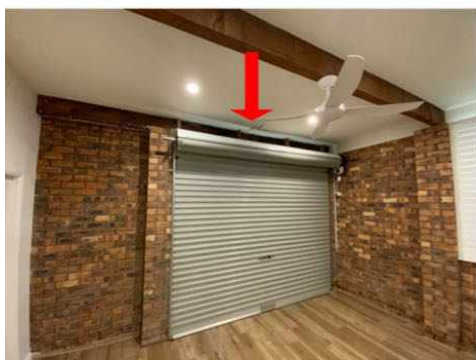
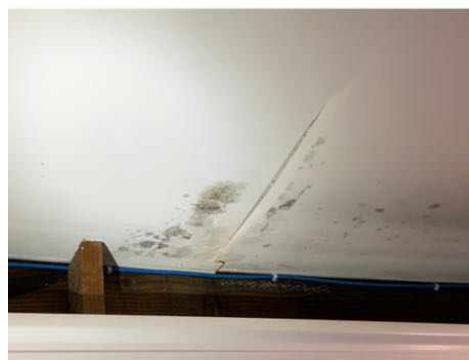
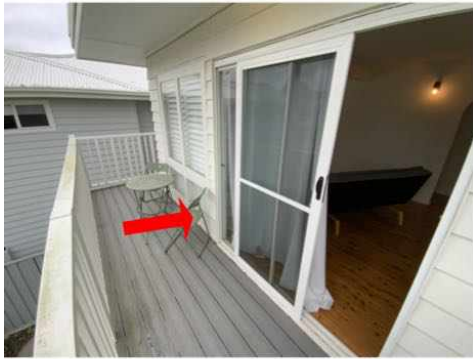
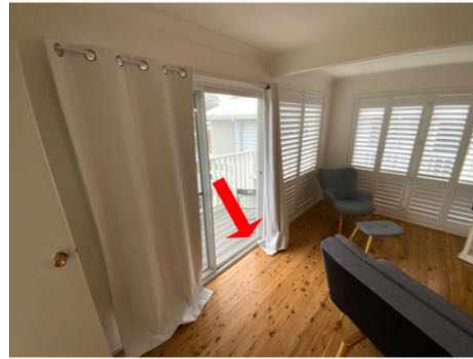
Building: Main Building  
Location: Rumpus Room/Garage  
Finding: Water leak - Internal (likely from inadequate flashings to balcony)  
Information: A water leak was found in this area at the time of inspection. Internal water leaks can be detrimental to surrounding building elements; their potential causes include damage to plumbing fittings and fixtures, through to water damage and deterioration of associated building elements.

Rust, corrosion, decay and water damage are potential outcomes where a minor water leak is left unattended. More serious defects may also result, such as electrical hazards, or water damage to structural building elements.

In extreme cases, structural damage may develop due to a prolonged water leak. It is highly advised that internal water leaks be addressed by a licensed plumber as a matter of relative urgency.

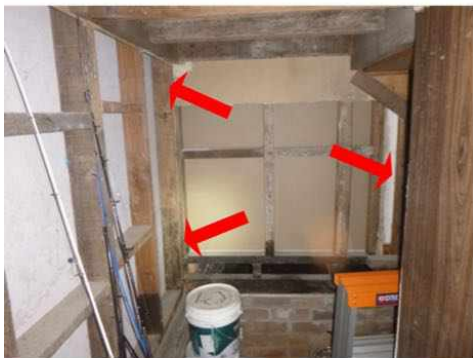
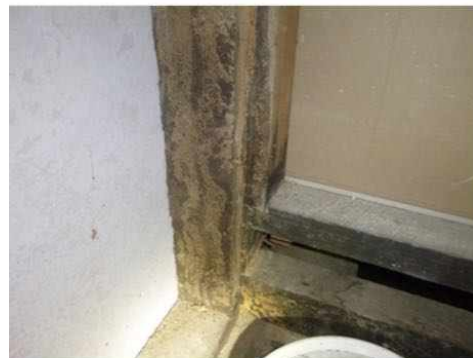
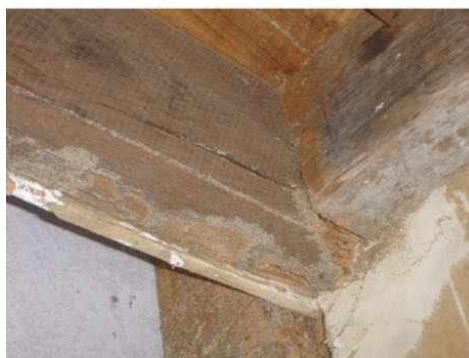
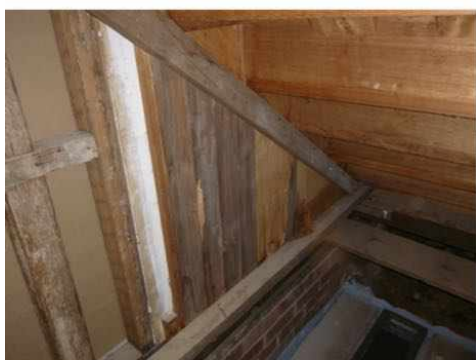
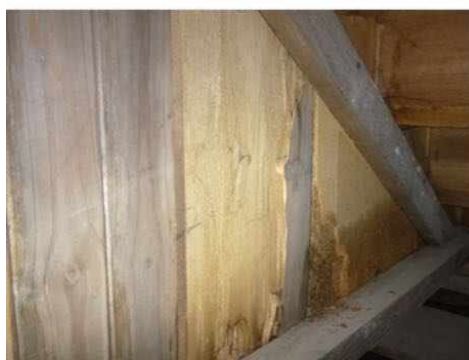
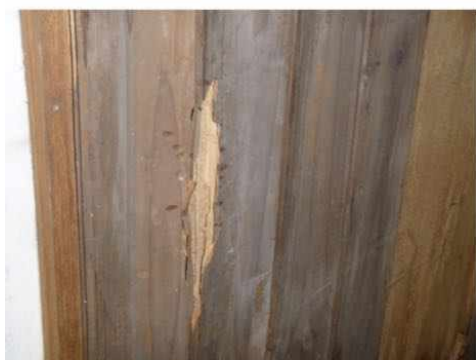
## Finding 2.02

Building:	Main Building
Location:	Subfloor
Finding:	Evidence of termite workings and damage was present at the time of inspection
Information:	Despite no live termite or timber pest activity being indicated, previous termite damage was found to have affected this area.

Evidence was found at the time of inspection to suggest that termite activity has been present on the property including past workings to wall framing and panelling to the store room and subfloor below the stairs. Further damage could be evident inside the walls.

A licensed building contractor and a suitably qualified termite specialist should be appointed to provide a further invasive inspection as soon as possible.

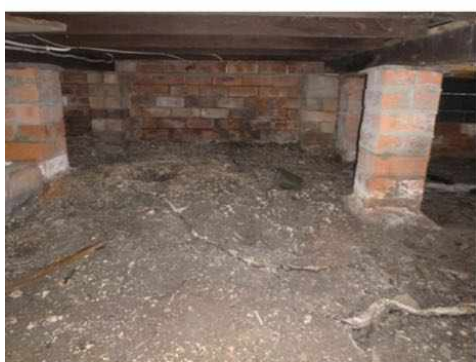
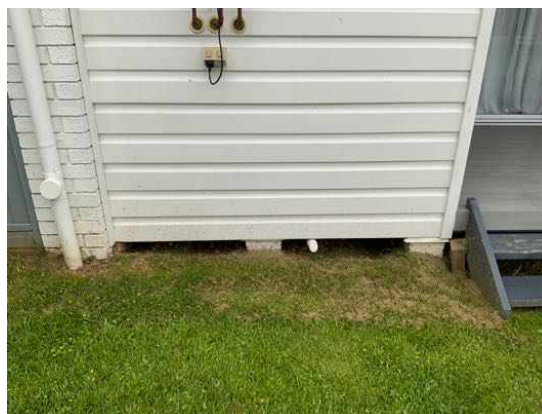
### Finding 3.01

Building: Main Building  
Location: Subfloor  
Finding: Subfloor Ventilation - Inadequate (mouldy subfloor soil to some areas)  
Information: Adequate subfloor ventilation and drainage aids in preventing excessive moisture, mouldy subsoil, wood rot and termite activity by ensuring a dry subfloor environment.

Subfloor ventilation can be improved in most cases by addressing the causes such as exposing subfloor vents, replacing access doors with a gauze or slat door, installing additional new vents (large gauze type is best- 2 bricks high x 2 bricks wide), installing mechanical (forced airflow) ventilation and removing debris & obstructions to air flow from the subfloor.

A registered builder or sub floor ventilation specialist should be appointed as soon as possible to look at improving ventilation & drainage to the perimeter of the building and to perform these works as necessary.

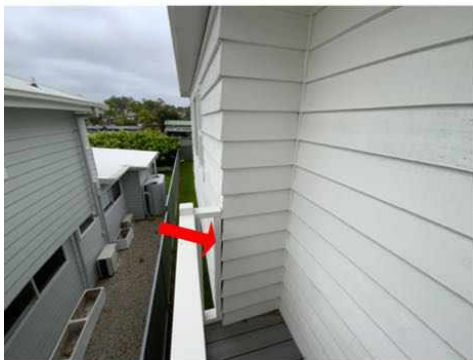
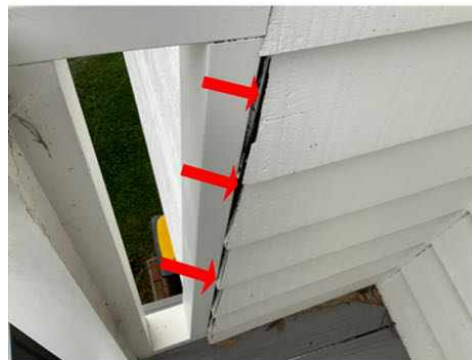
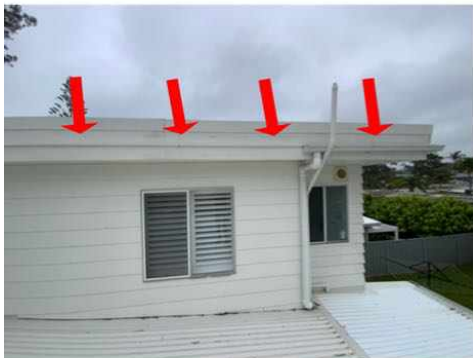
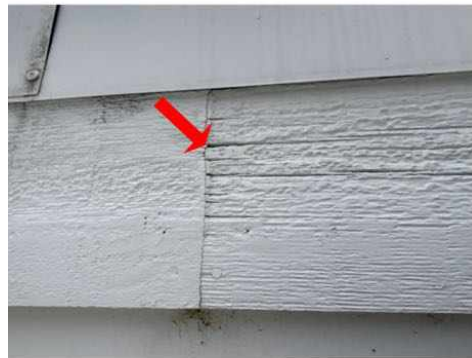
### Finding 3.02

Building:	Main Building
Location:	All Areas
Finding:	Paint finish - Incomplete to some areas of weatherboards and fascias
Information:	The paint finish in this area was identified as being incomplete at the time of inspection.

Whilst incomplete or missing paint finish is generally an appearance defect, it can also lead to the development of secondary building defects over time. Incomplete areas of

Incomplete paint finishes should be sanded back, filled, leveled and painted, as applicable. Where inadequate or missing paint protection has led to the deterioration of the associated building element, repair and/or replacement of this building element may be required.

A painting contractor should be appointed as soon as possible to perform necessary works to aid the appearance of the affected area and to ensure the area is protected against further deterioration. Alternatively, the homeowner following manufacturer instructions may perform these works.

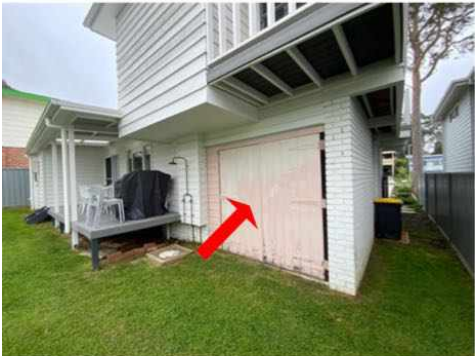
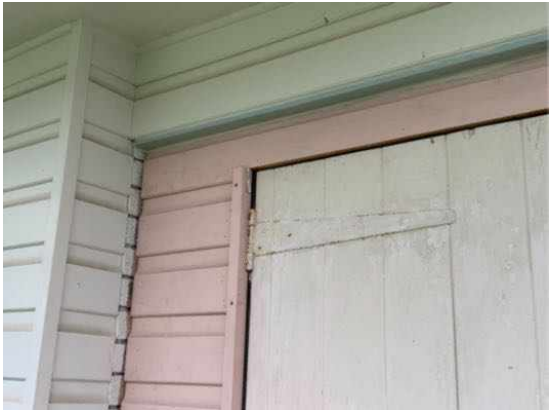
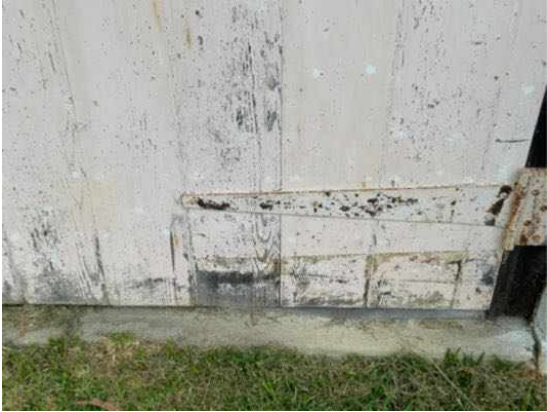
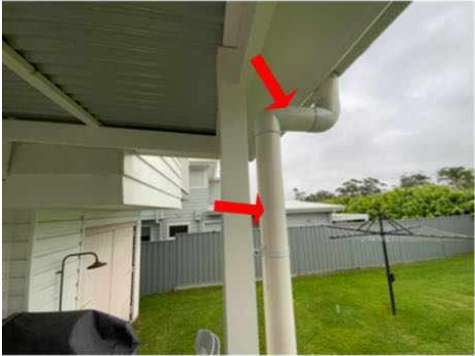
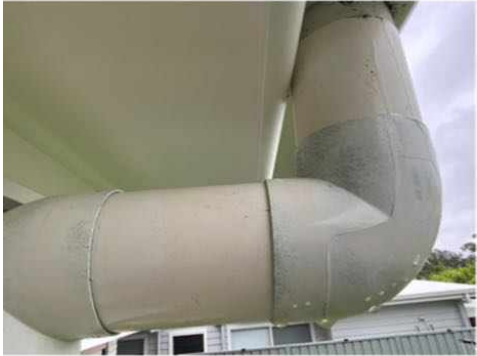
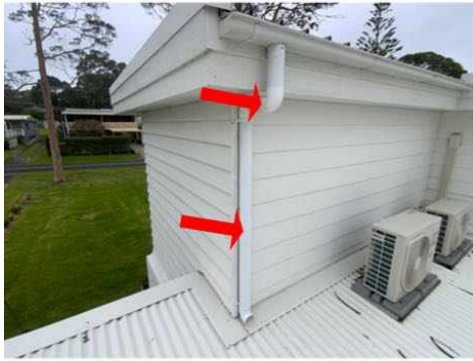
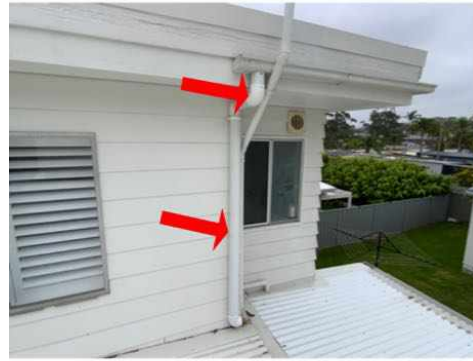
### Finding 3.03

Building:	Main Building
Location:	Exterior walls - rear
Finding:	Paint finish - Incomplete
Information:	The paint finish in this area was identified as being incomplete at the time of inspection.

Incomplete paint finishes should be sanded back, filled, leveled and painted, as applicable. Where inadequate or missing paint protection has led to the deterioration of the associated building element, repair and/or replacement of this building element may be required.

A painting contractor should be appointed as soon as possible to perform necessary works to aid the appearance of the affected area and to ensure the area is protected against further deterioration. Alternatively, the homeowner following manufacturer instructions may perform these works.

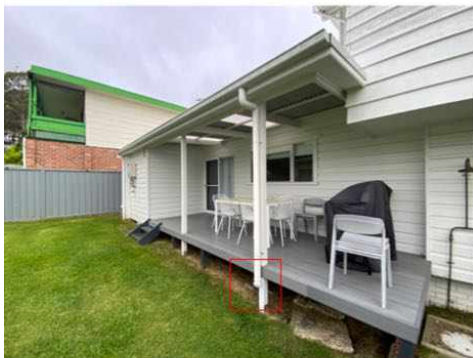
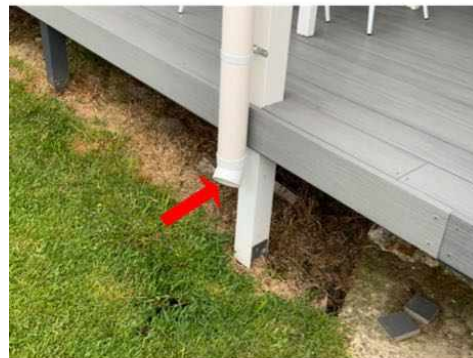
### Finding 3.04

Finding: Overflow - Not plumbed for drainage

Information: The overflow is not plumbed or connected to suitable drainage, which has resulted in the surrounding area becoming excessively damp. These damp conditions can lead to secondary defects such as rot, rust or corrosion of associated building elements, the formation of fungal decay, or even the creation of potential slip hazards. When coupled with poor site drainage, pooling of water may also attract termite activity to this area. It is highly recommended that a qualified plumber be appointed to install adequate drainage to the overflow. These works will ensure that the area remains dry and free of any secondary defects.

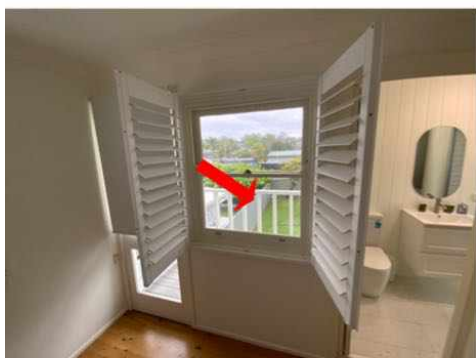
### Finding 3.06

Building:	Main Building
Location:	Bedroom 3
Finding:	Windows - Sash painted shut
Information:	Where window sashes have been painted shut, it is generally indicative of poor, rushed workmanship. The window is difficult if not impossible to open and close until remedial works have been undertaken.

Windows provide ventilation to the adjoining area and should be at a fully operational level to ensure user comfort. Restricted function of the window may also pose as a potential safety hazard if required for emergency egress from the building.

Where windows have been painted shut the seal of the paint needs to be broken. This is generally done by breaking the seal of the paint and then maintaining the sash tracks clearing and lubricating them with silicone. Remedial paint work will likely be required and can be completed along with the rest of the remedial works necessary by a general handyman.

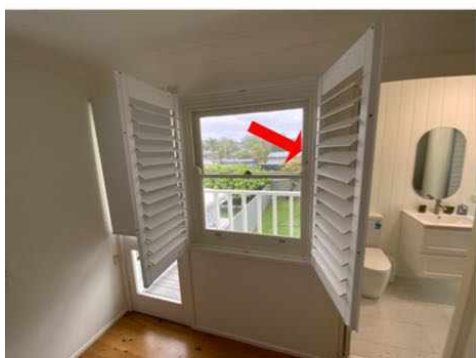
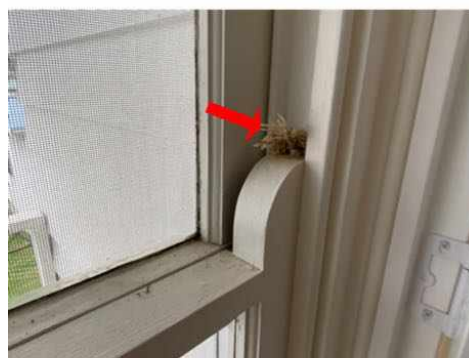
### Finding 3.07

Building:	Main Building
Location:	Bedroom 3
Finding:	Windows - Sash cord broken
Information:	Sashes are the moveable panes of windows that primarily slide vertically over each other to expose one half of the window area. Each sash is provided with springs balances and/or compression weather-stripping, which act to hold the window in place in one position.

To facilitate this operation the weight of the glazed panel is usually balanced by steel weights or counterbalances. The sash weight is connected by a cord or chain that runs over a pulley at the top of the frame. These cords are prone to degradation over time and replacement is required.

Repairing or replacing sash cords involves some work and is often best completed by an experienced carpenter or specialist window restorer. It is advised that such works be completed to improve the operational state of the affected window.

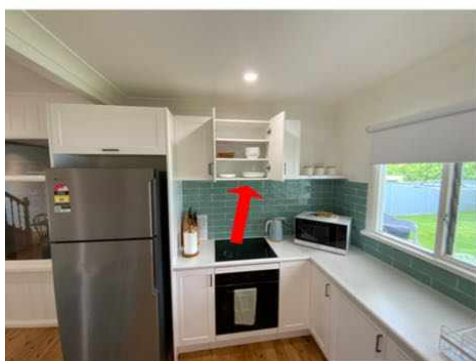
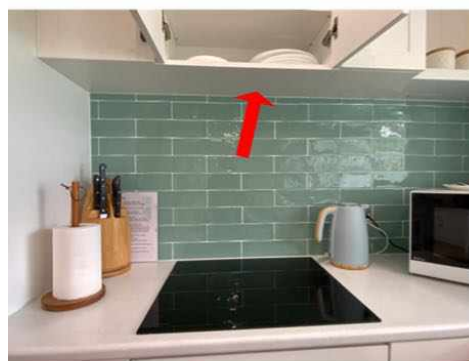
### Finding 3.09

Building:	Main Building
Location:	Kitchen
Finding:	Exhaust fan or Rangehood - Missing (above stove) - window & door may not always be opened while cooking
Information:	An exhaust fan or rangehood has not been installed in this area. Missing exhaust fans may lead to the development of more significant defects such as moisture damage to surrounding building materials from inadequate ventilation.

Inadequate ventilation in internal areas creates an environment that is conducive to the formation and development of mould and other respiratory hazards.

It is highly advised that a licensed electrician be appointed to retrospectively install an exhaust fan. Failure to perform works to aid the ventilation of the area may lead to the development of these secondary defects.

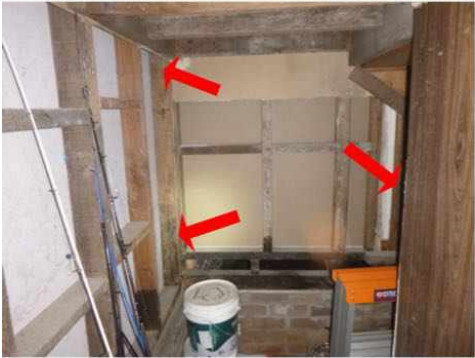
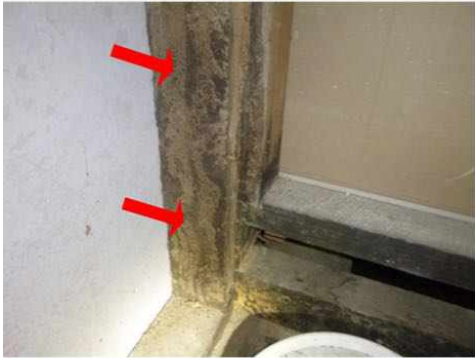
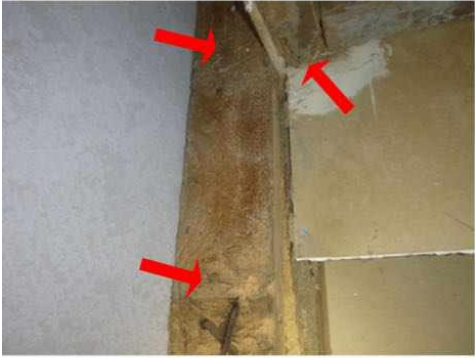
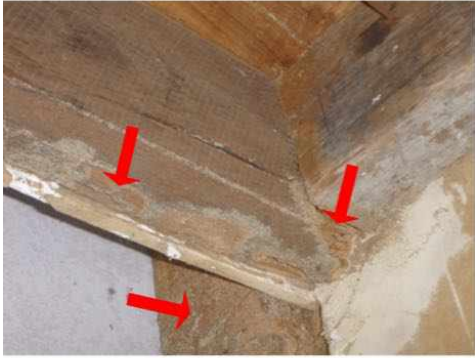
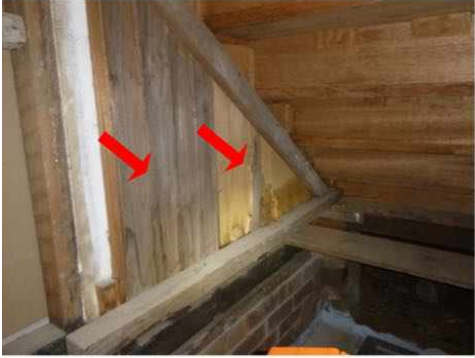
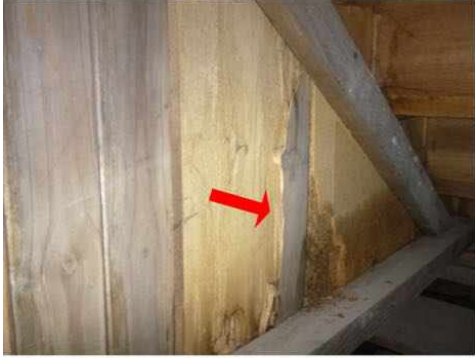
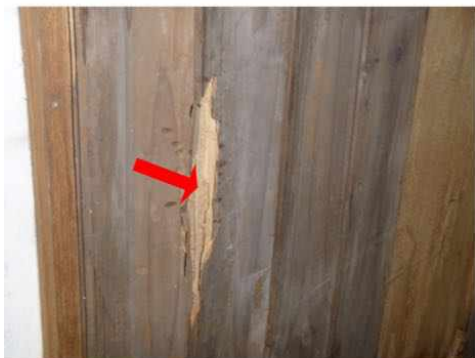
Building:	Main Building
Location:	Subfloor
Finding:	Evidence of termite workings and damage was present at the time of inspection
Information:	Evidence was found at the time of inspection to suggest that termite activity has been present on the property including past workings to wall framing and panelling to the store room and subfloor below the stairs. Further damage could be evident inside the walls.

A further invasive inspection and investigation by a suitably qualified termite expert is highly recommended to determine the extent of the damage.

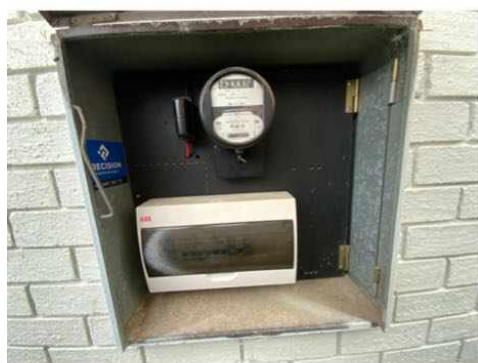
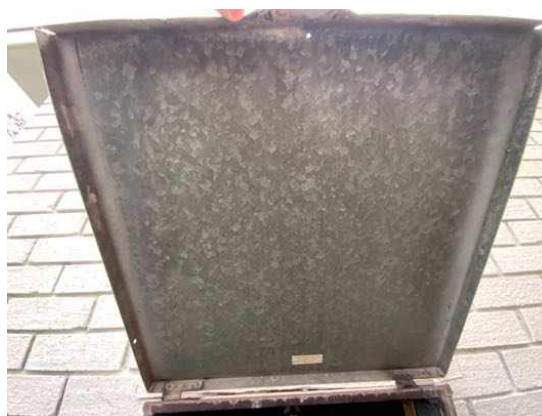
### Finding 6.01

Building:	Main Building
Location:	All Areas
Finding:	Termite Management System - no evidence of a chemical installation
Information:	The application of a post-construction chemical termite barrier is highly recommended for all properties, particularly if live termite activity has been found on the site previously. Such barriers are highly effective in preventing termite attack on any timber building elements throughout the property.

A durable notice should be placed in the switchboard unit to indicate current termite barriers. At the time of inspection, it appeared as though no termite management system has been installed, with no evidence to suggest preventative works taking place.

The client may consider gaining further advice from a pest controller as to the costs and procedures involved with this application. It is recommended that obtaining such advice be a short-term priority.

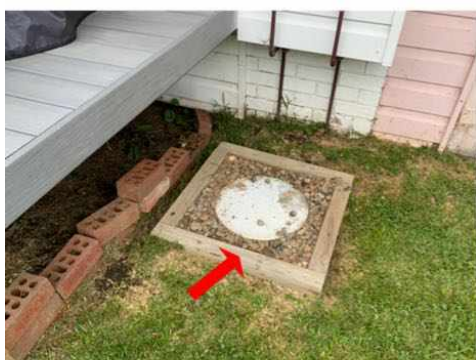
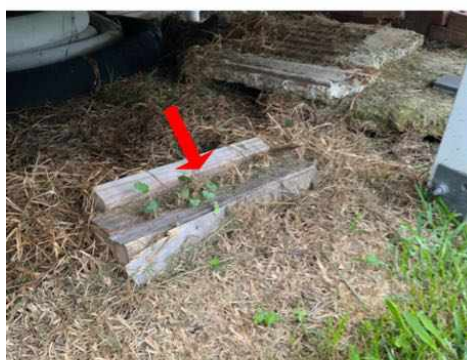
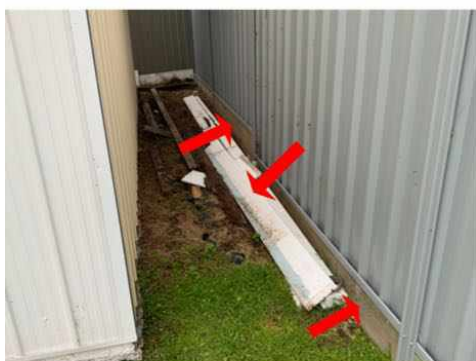
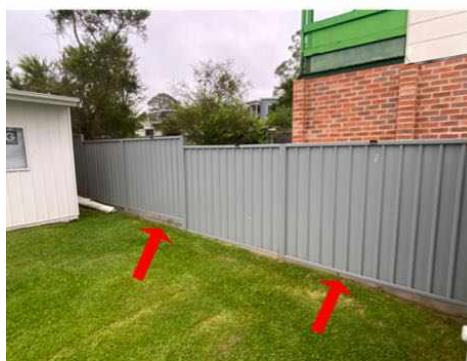
### Finding 6.02

Building: Main Building  
 Location: All Areas  
 Finding: Timber in ground contact  
 Information: To reduce the risk of timber pest attack it is essential that timber used in a hazardous environment (e.g. in direct contact with the ground or frequently exposed to damp conditions) is of sufficient durability and/or is adequately preservative treated.

Untreated timbers in direct contact with the ground are likely to develop severe wood rot and/or fungal decay if left unattended creating attraction for subterranean termites to infest the timbers from surrounding areas.

If untreated or non-durable timbers are found to be in a hazardous environment it is highly advised that replacement of these building elements be performed as soon as possible to aid the protection of the property against termite / timber pest attack.

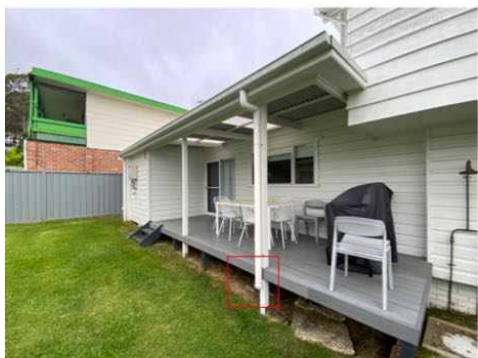
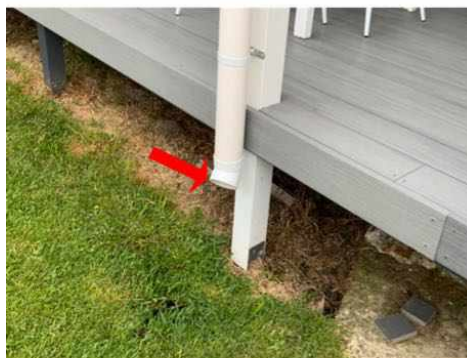
### Finding 6.03

Building: Main Building  
 Location: All Areas  
 Finding: Evidence of excessive moisture was present at the time of inspection  
 Information: Excessive moisture can attract termites and produce conditions that promote termite attack fungal growth and wood decay.

Excessive moisture is generally caused by deteriorated inadequate or missing roof drainage, leaking plumbing pipes or fixtures, poorly plumbed HWS overflows or condenser units and poor site drainage.

It is highly recommended that all plumbing and drainage fixtures and fittings be maintained regularly in order to prevent excessive moisture being present in the external / internal property.

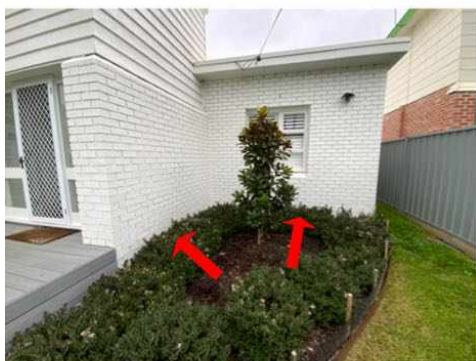
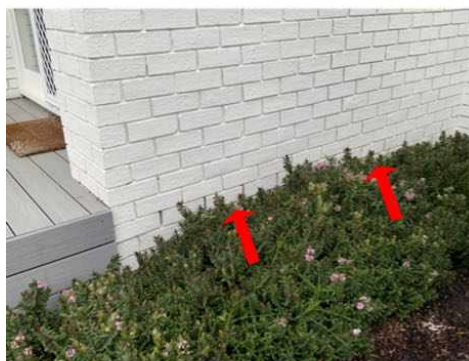
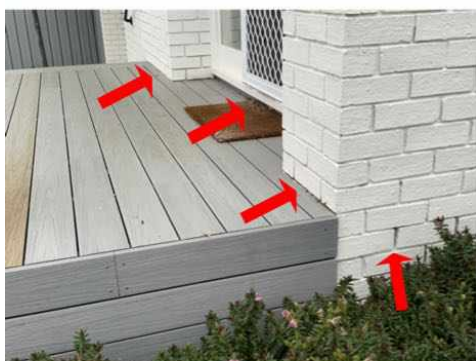
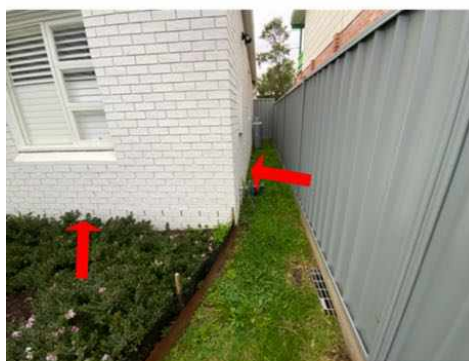
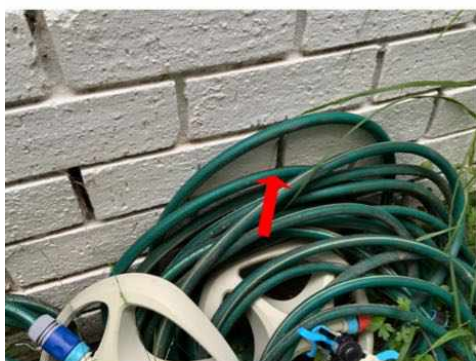
## Finding 6.04

Building:	Main Building
Location:	Exterior walls
Finding:	Bridging or breaching of termite barriers - weep holes
Information:	Bridging is the spanning of a termite barrier or inspection zone so that subterranean termites are provided with passage over or around that barrier.

Weep holes in the exterior brickwork of the property are designed to allow condensation that may build up between the brickwork and subsequent timber framework to drain from within the wall hence preventing any deterioration of the timber building elements.

Additionally build-up of moisture is likely to occur if weep holes are covered further attracting termite activity to these areas.

It is highly recommended that weep holes are left exposed in all areas throughout the external property. Therefore if any termite activity leading into weep holes becomes easily detectable during frequent pest inspections.

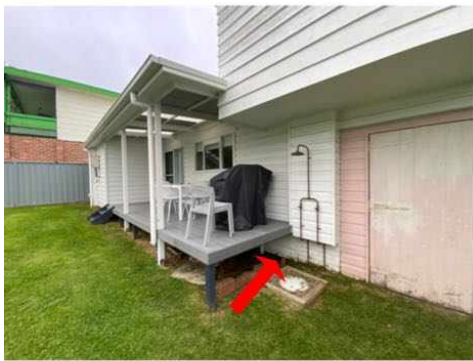
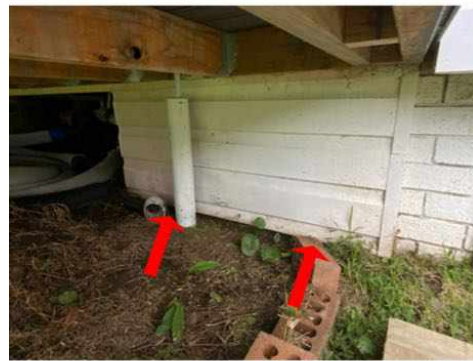
### Finding 6.05

Building:	Main Building
Location:	Exterior walls
Finding:	Slab Edge - Exposure
Information:	An inspection zone of at least 75mm in relation to the exposed slab edge, between the bottom brick and the perimeter pavement, is required. This inspection zone should be maintained in order to force termites into the open where they can be detected more readily during regular inspections. The slab edge should not be concealed by anything that may prevent inspection of the area, including render, landscaping, soil, turf, paving, concrete cladding or other structures.

If the slab edge is not properly exposed there is a high risk of termite attack. Sometimes, in order to determine the type of slab, a suitably qualified person such as an architect or builder may be required to consult the construction plans.

Where the slab edge cannot be properly inspected, it is highly recommended that termite or timber pest inspections be carried out every 6-12 months to aid protection of the property against infestation.

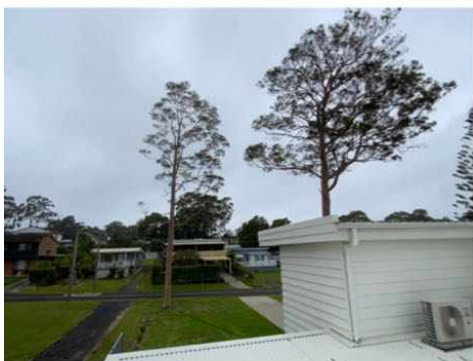
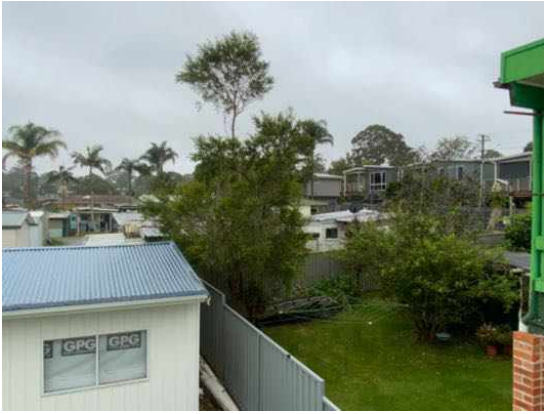
### Finding 6.06

Building:	Main Building
Location:	All Areas
Finding:	Trees within 50m of the property
Information:	Trees within 50m of the property can be conducive to termite activity. It is recommended an invasive inspection of all trees with 50m to the property be carried out by a qualified pest control expert.

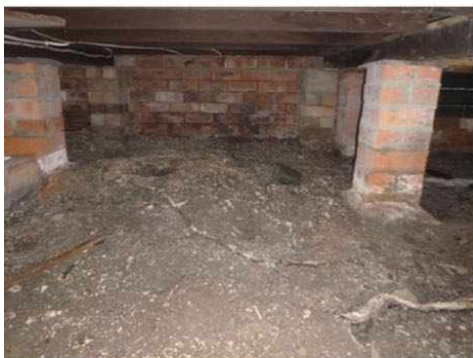
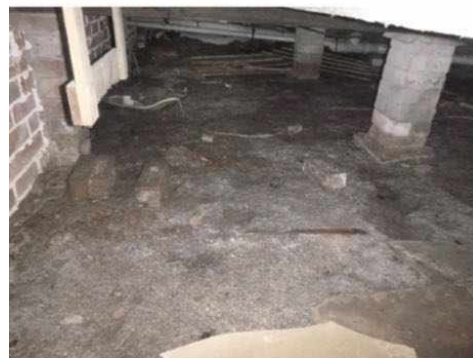
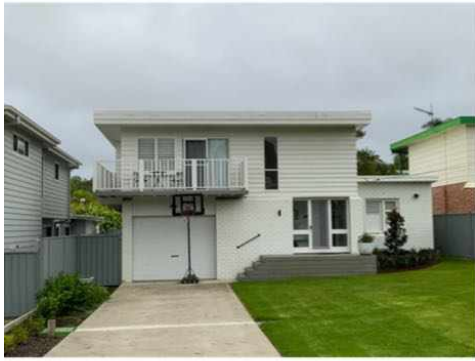
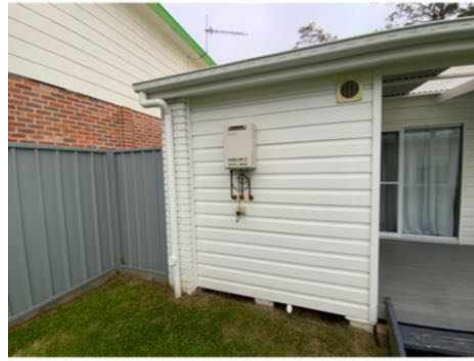
### Finding 6.07

Information: It was noted at the time of inspection that the subfloor area lacks adequate ventilation. Ventilation can be restricted by a variety of minor defects, including obstructions in the subfloor space, a lack of vents or a low clearance.

A well ventilated subfloor aids in maintaining dry conditions, preventing secondary damage such as wood rot and pest activity, as well as preventing the development of mould and mildew (which can lead to respiratory safety hazards for occupants).

The initial step in improving ventilation is to ensure that the subfloor area is free of any debris or stored items. Where ventilation is still inadequate, it is advised to ensure that all vents are clear of blockages, and additional vents may be installed.

The client may also consider mechanical ventilation (powered fans) to improve subfloor airflow. Remedial works should be conducted as a matter of urgency to protect against the development of potentially harmful subfloor conditions.

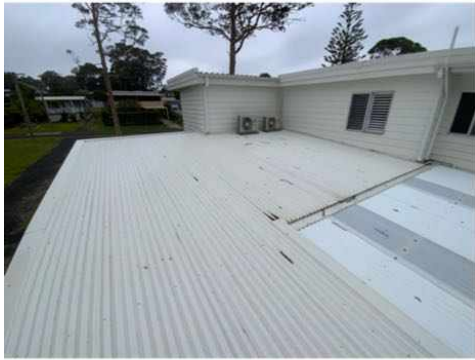
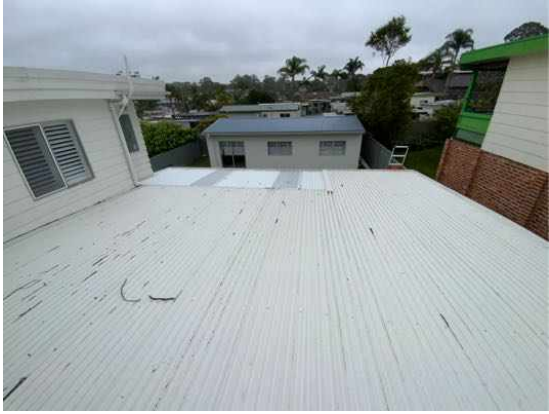
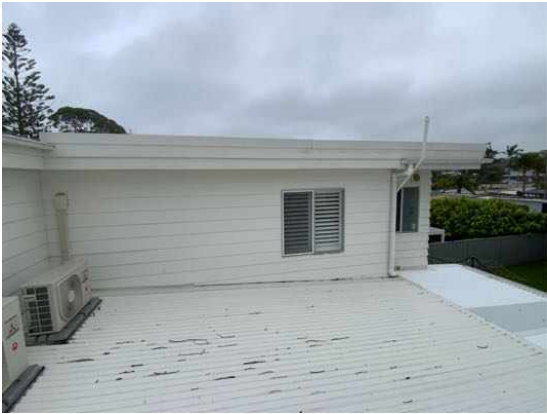
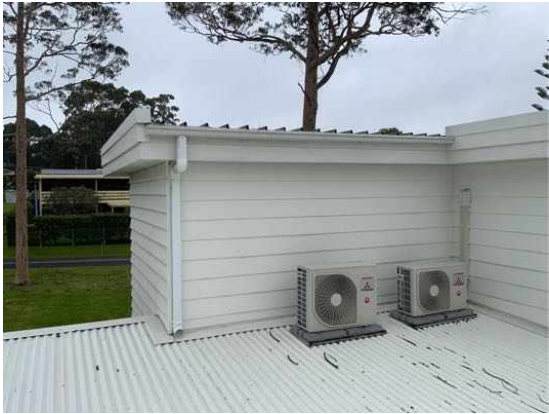
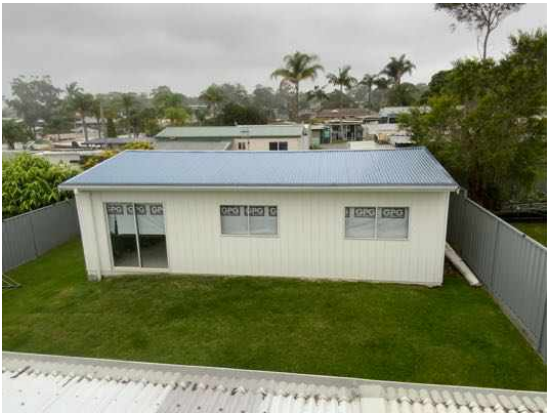
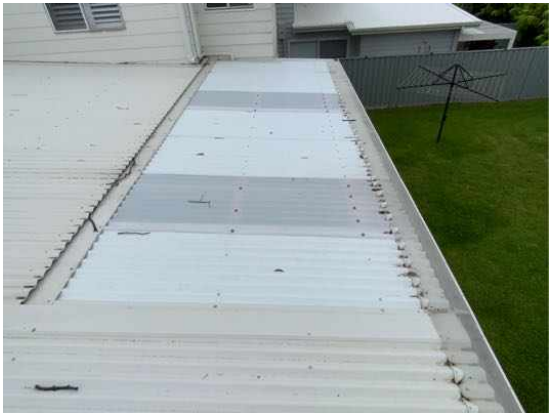
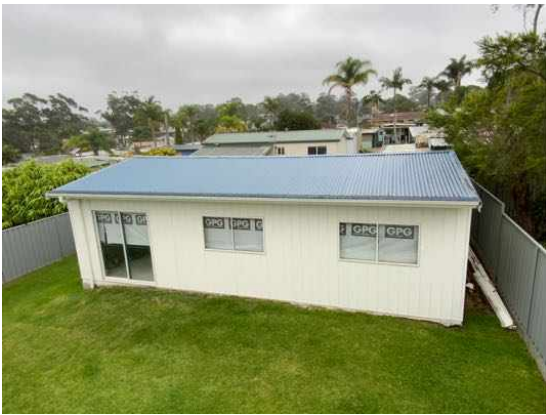
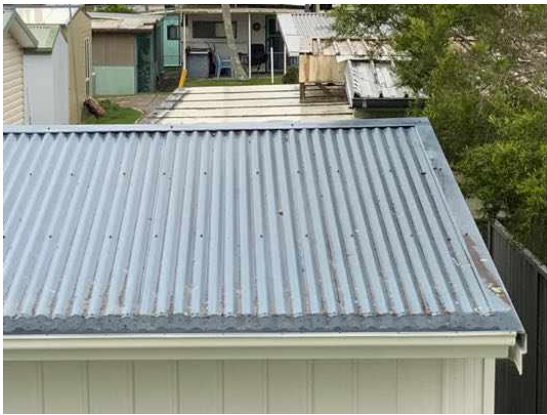
Building: Main Building  
Location: Roof Exterior  
Finding: Additional Photos - Obstructions and Limitations  
Information: These photographs are an indication of the obstructions and limitations which impeded full inspection of the property at the time of inspection. These obstructions can hide an array of defects and should be removed to allow full inspection to be carried out. A re-inspection is recommended once the areas are made accessible.

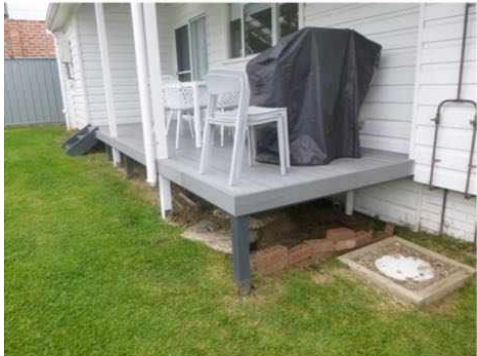
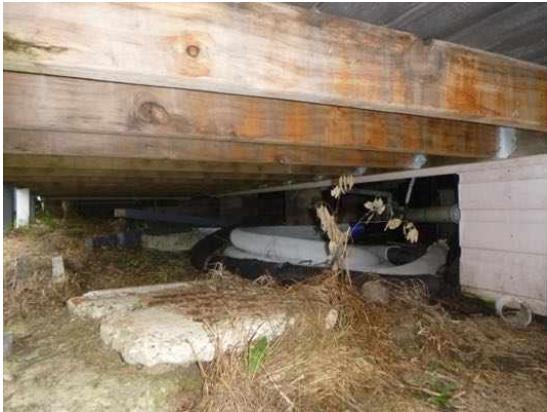
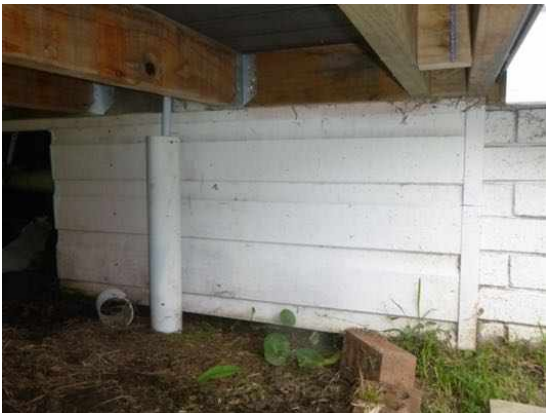
Building: Main Building  
Location: Subfloor  
Finding: Additional Photos - Obstructions and Limitations  
Information: These photographs are an indication of the obstructions and limitations which impeded full inspection of the property at the time of inspection. These obstructions can hide an array of defects and should be removed to allow full inspection to be carried out. A re-inspection is recommended once the areas are made accessible.

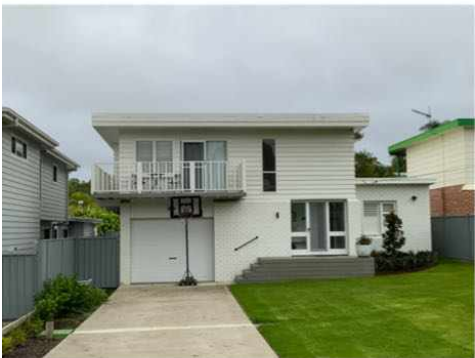
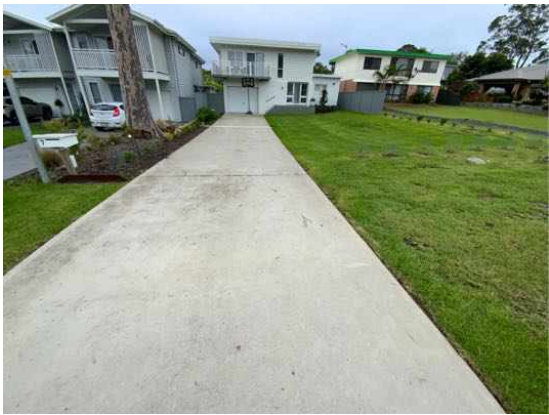
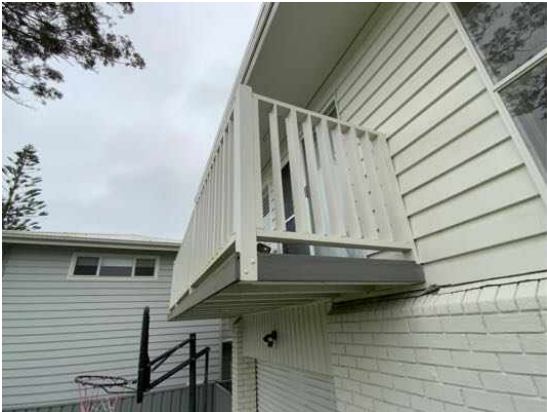
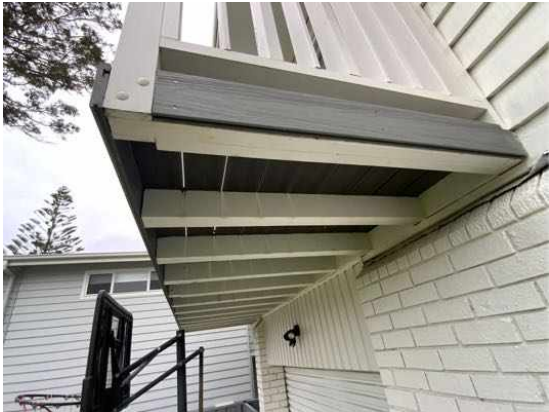
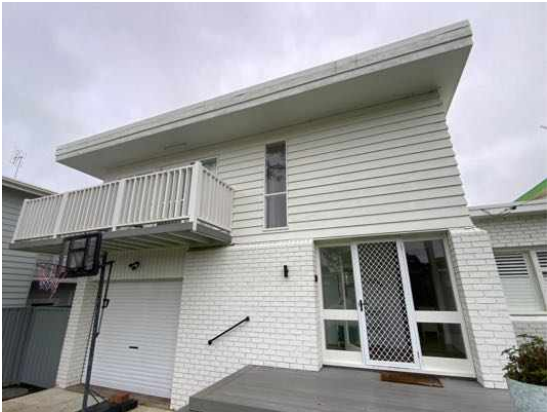
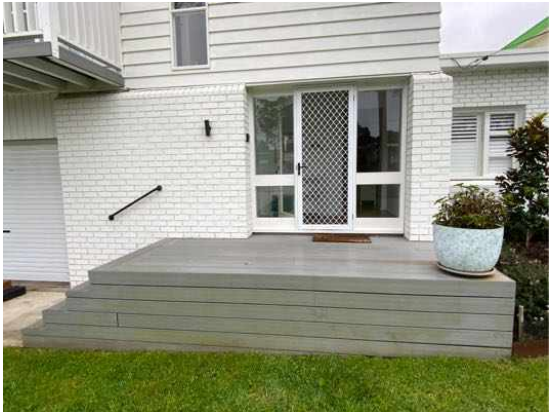
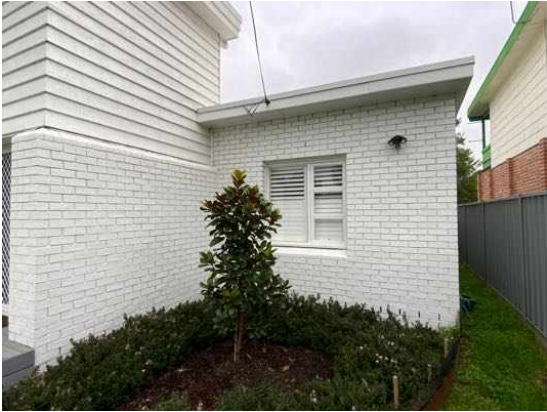
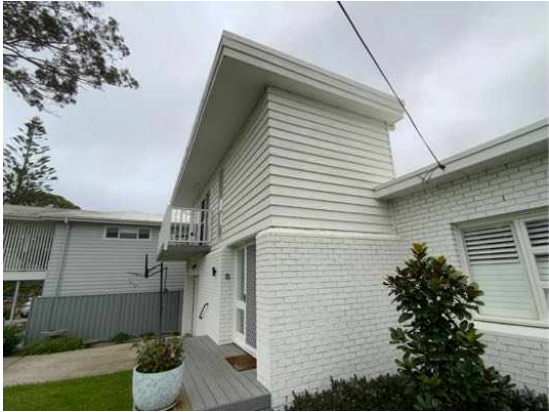
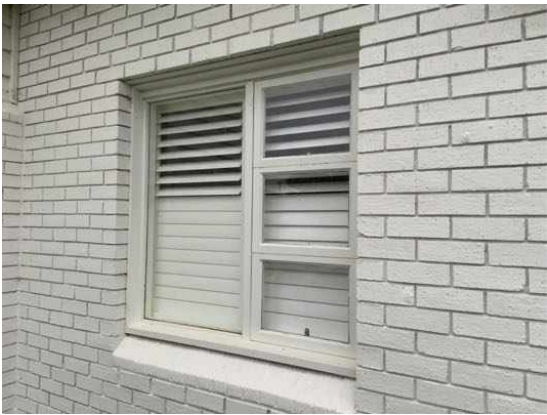
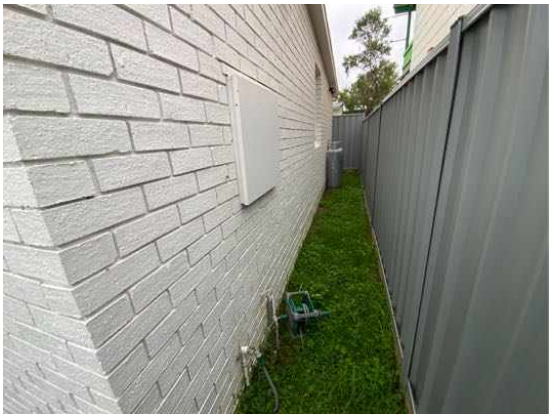
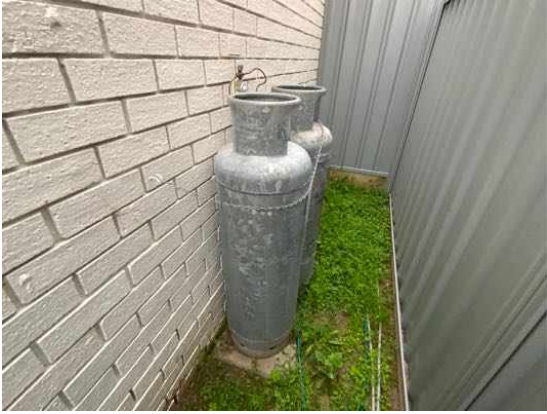
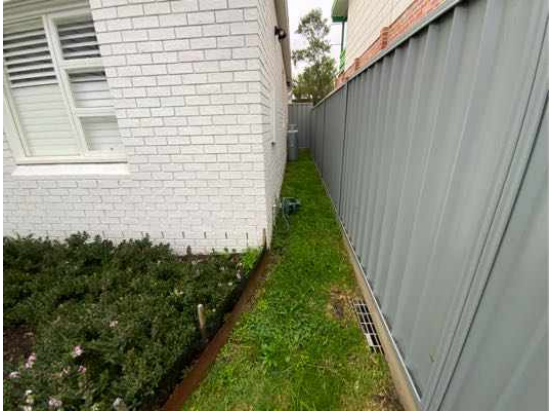
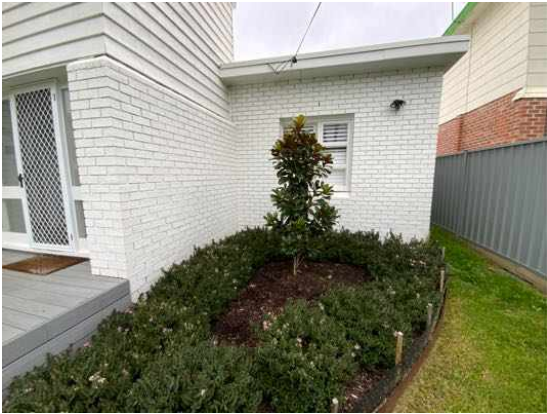
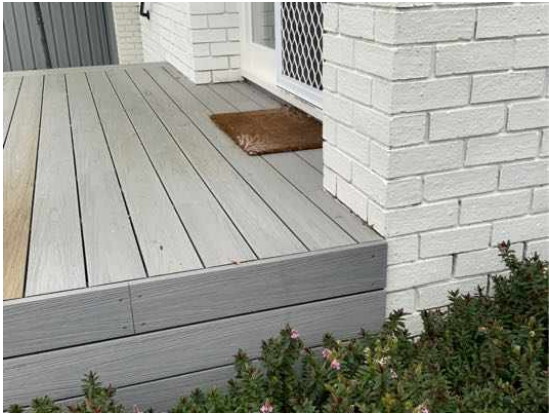
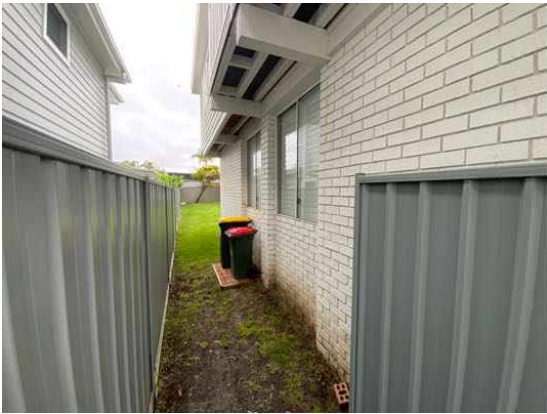
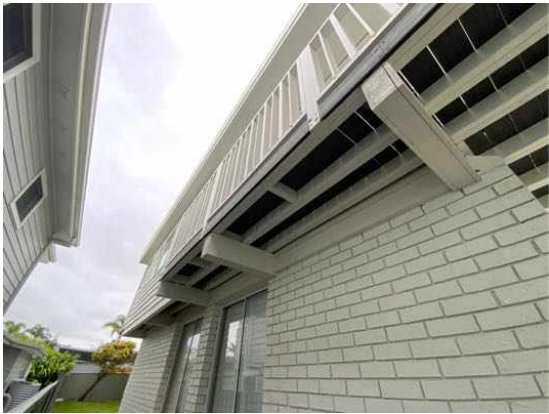
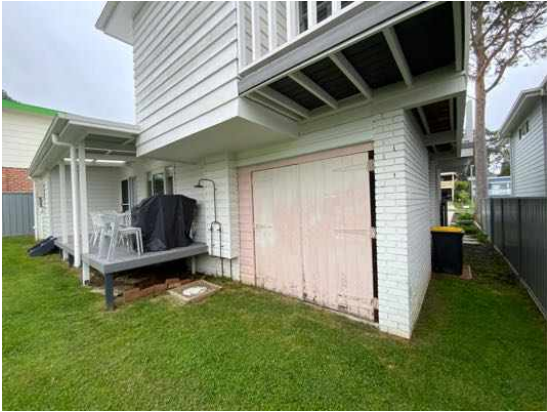
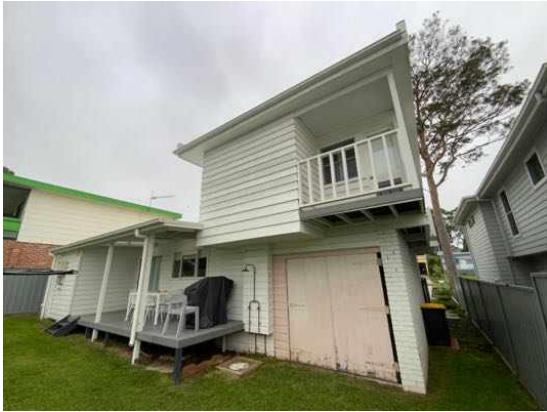
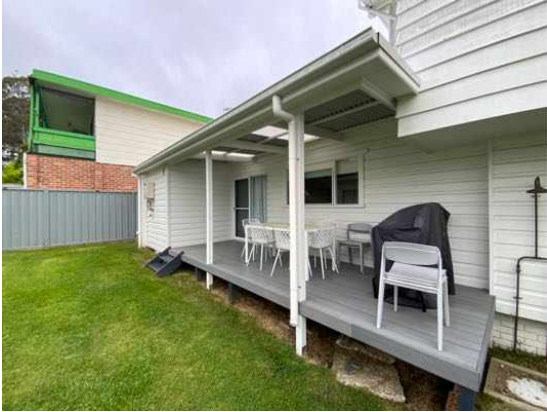
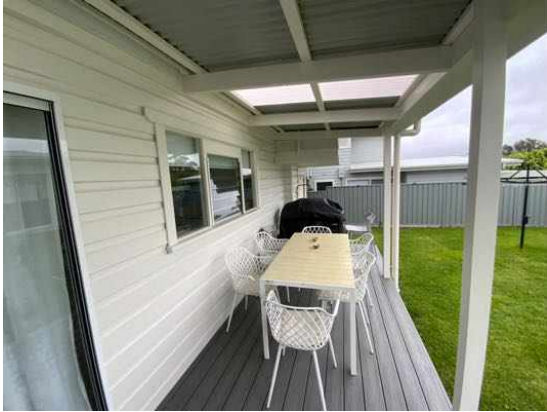
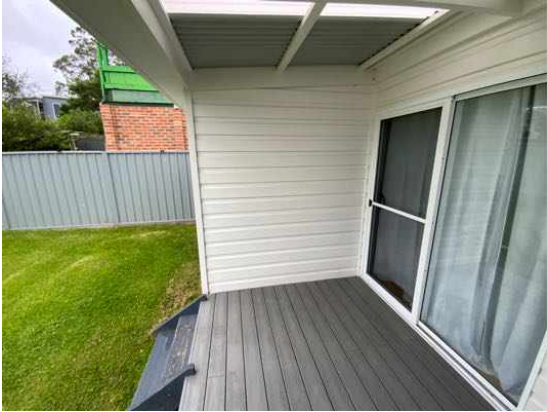
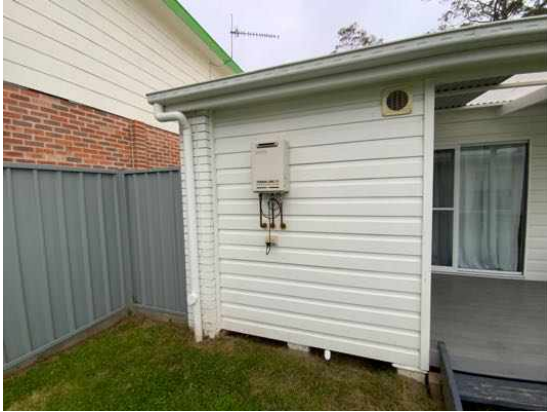
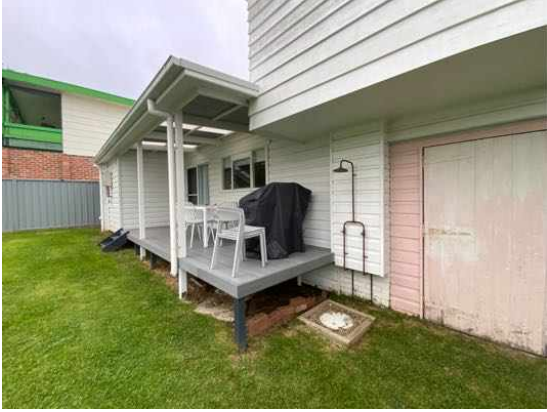
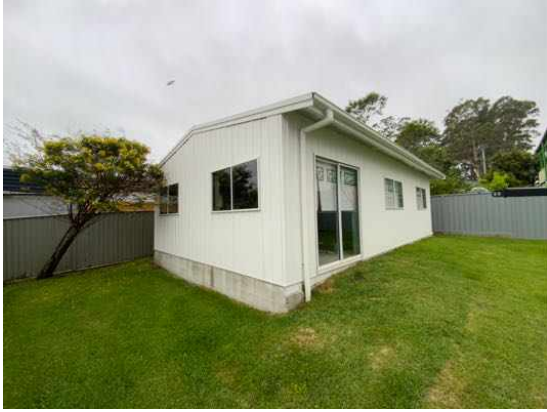
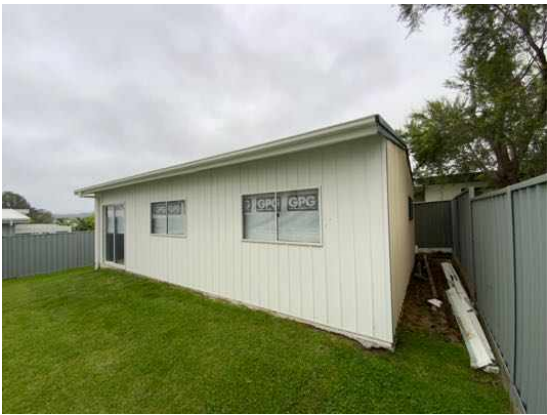
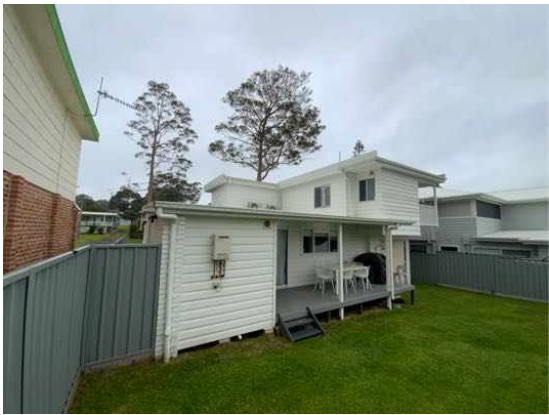
Building:	Main Building
Location:	All Areas
Finding:	Additional Photos - Obstructions and Limitations
Information:	These photographs are an indication of the obstructions and limitations which impeded full inspection of the property at the time of inspection. These obstructions can hide an array of defects and should be removed to allow full inspection to be carried out. A re-inspection is recommended once the areas are made accessible.
