# Building and Timber Pest Inspection Report

Inspection Date: Fri, 6 Mar 2026

Property Address: 7 Lachlan Cres, St Georges Basin NSW  
2540, Australia

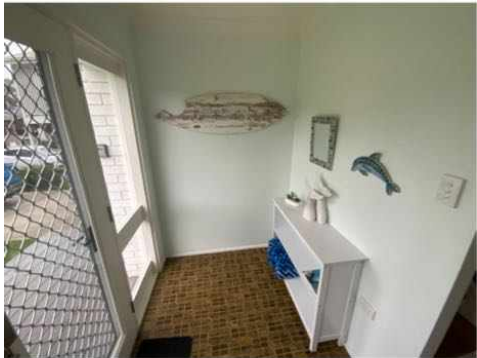
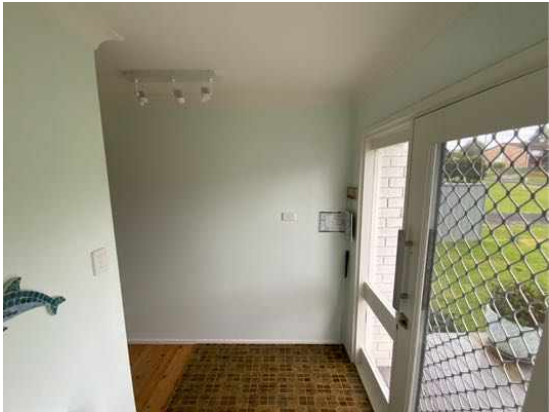
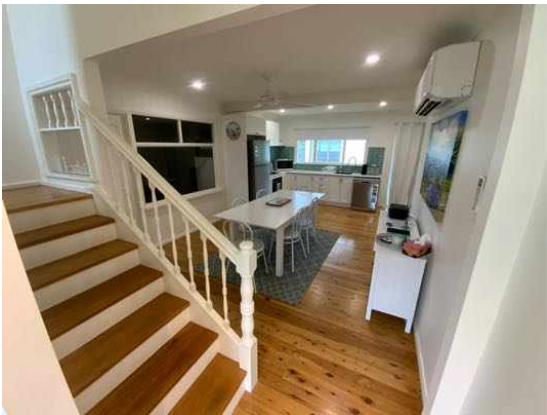
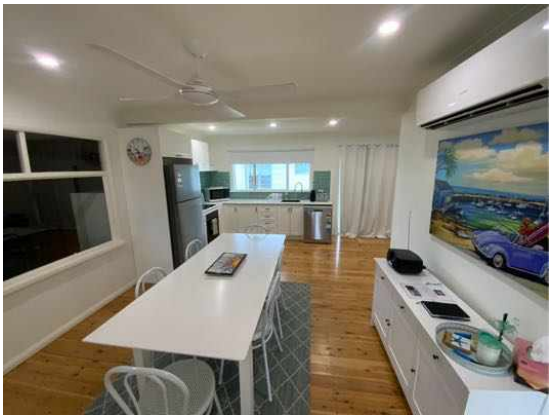
Building: Main Building  
Location: All Areas  
Finding: Additional Photos - Obstructions and Limitations  
Information: These photographs are an indication of the obstructions and limitations which impeded full inspection of the property at the time of inspection. These obstructions can hide an array of defects and should be removed to allow full inspection to be carried out. A re-inspection is recommended once the areas are made accessible.

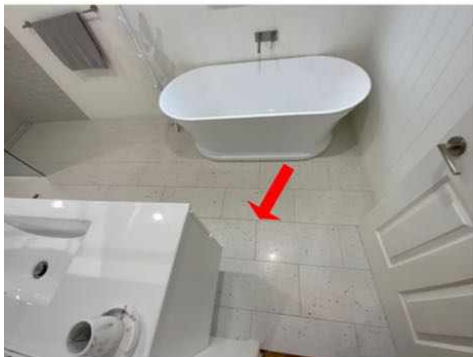
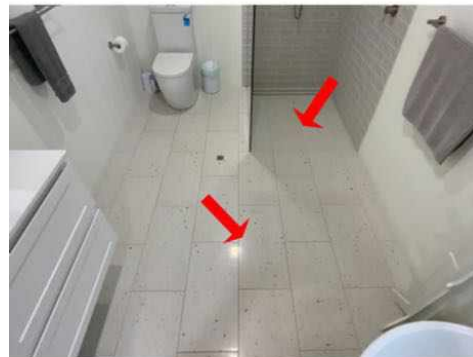
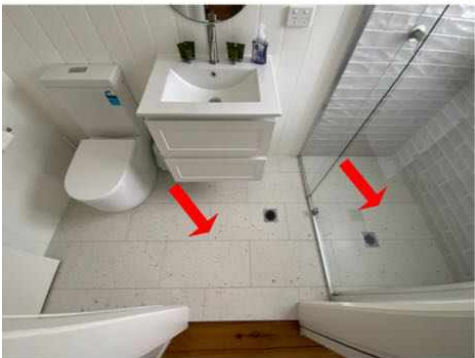
Building: Main Building  
 Location: All Wet Areas  
 Finding: Water Proofing Membranes - Information Only  
 Information: Internal Water Proofing Membranes, are crucial in preventing water ingress into the property is important to know that the Membrane System used is to Australian Standards and has been installed correctly.

With older property's where this information is unavailable all wet areas should be monitored. Generally waterproofing certificates are only valid for approximately 7-8yrs. If any leaks, water staining, peeling or bubbling of the paint become evident to any adjacent walls or ceilings below a licensed builder or waterproofing specialist is recommended to investigate further.

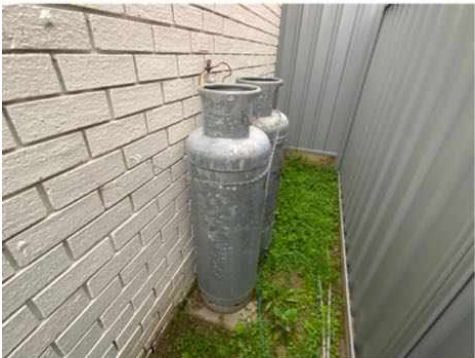
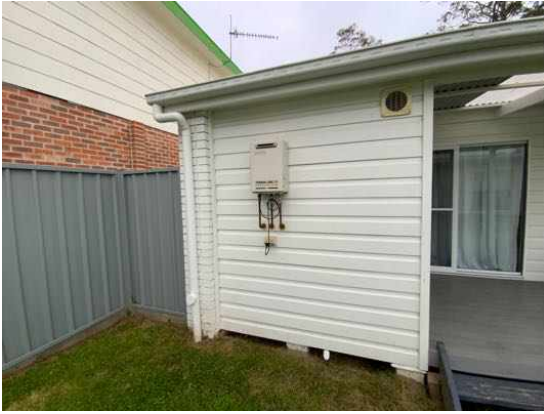
Building: Main Building  
Location: All Areas  
Finding: Additional Photos  
Information:

Additional photos are provided for your general reference. Arrows have been included to highlight areas of importance. Please discuss these photos with your building consultant for clarification.

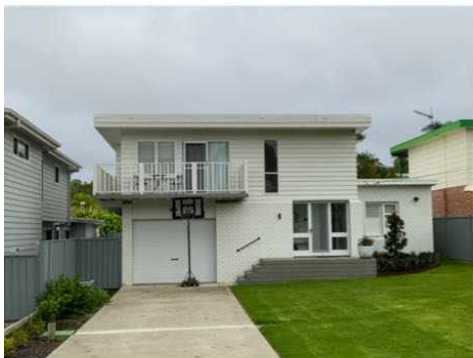
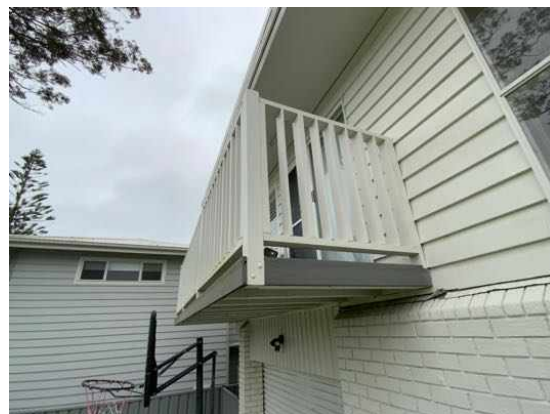
Building: Main Building  
 Location: Balcony, Deck, Verandah or Similar  
 Finding: Elevated structure inspections (Elevated Structure)  
 Information: Where any elevated Structure (deck, balcony, verandah etc) is present, and this elevated structure is designed to accommodate people, you MUST have this structure checked by an engineer or other suitably qualified person.

You should also arrange annual inspections of the structure by an engineer or other suitably qualified person to ensure any maintenance, that may become necessary, is identified. Care must be taken not to overload the structure.
