Building Inspection Report

Inspection Date: Mon, 23 Feb 2026

Property Address: 1106/2 Kingfisher St, Lidcombe NSW 2141,
Australia

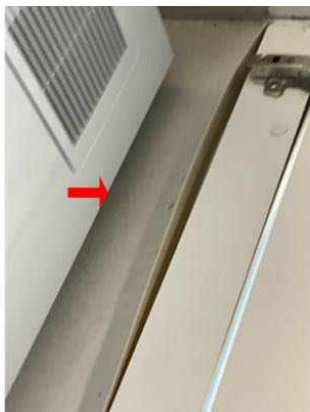
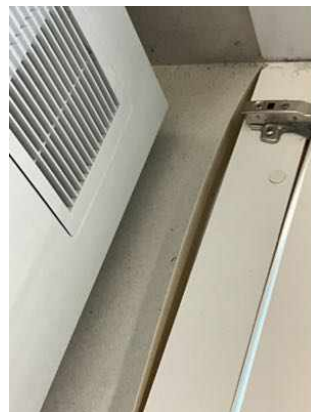
Defects 1.01

Building: Main Building
Location: Laundry
Finding: Mould - Present
Information: Mold growth is present throughout the property, primarily due to inadequate ventilation. Poor airflow and moisture accumulation within the house have created ideal conditions for mold to thrive.

A licensed mold remediation specialist should be engaged to remove the mold and treat affected areas. In addition, a ventilation expert or builder should assess and improve the house's ventilation system, possibly installing exhaust fans, vents, or mechanical ventilation systems to ensure adequate airflow and prevent future mold growth.

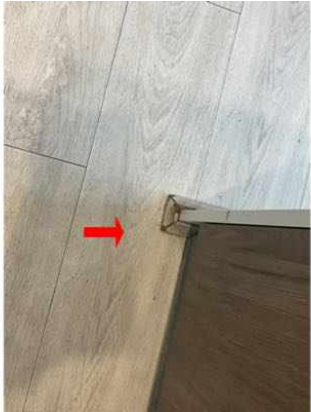
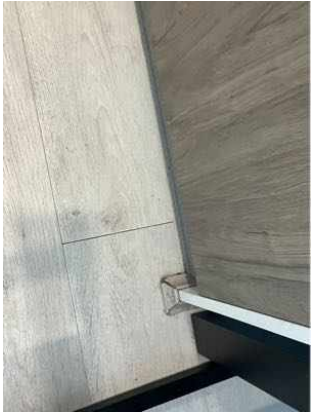
Defects 3.04

Building: Main Building
Location: Kitchen
Finding: Trim – Deteriorated
Information: Deterioration and delamination were noted to the trim, consistent with moisture exposure. Ongoing deterioration may occur if not rectified. Repair or replacement by a licensed carpenter is recommended.

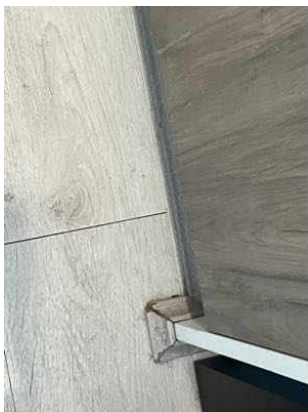
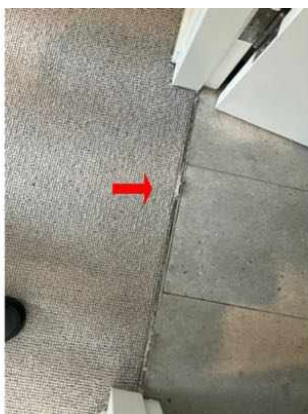
Defects 3.05

Building: Main Building
 Location: Bedroom - Master
 Finding: Carpet - Tear
 Information: Tear observed in the carpet, posing a risk of further damage and creating an unsightly appearance.”

Risk: Potential tripping hazard, accelerated wear and tear, and a negative impact on the overall aesthetics of the space.

Resolution: A carpet repair specialist or professional installer should be engaged to assess and fix the tear, ensuring a seamless and safe carpet surface.
