# Building and Timber Pest Inspection Report

Inspection Date: Wed, 18 Feb 2026

Property Address: 50 Undercliffe Rd, Earlwood NSW 2206,  
Australia

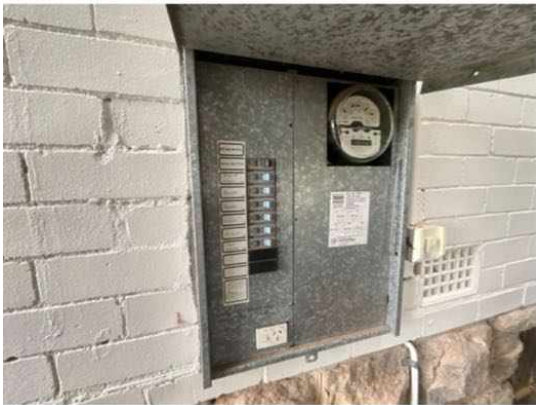
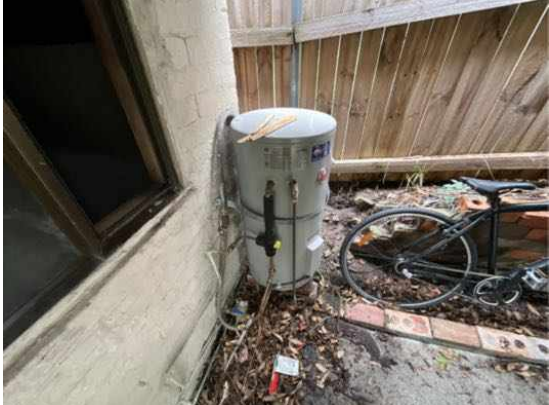
Building: Main Building  
Location: All Areas  
Finding: Photos Added  
Information: Additional photos are provided for your general reference.

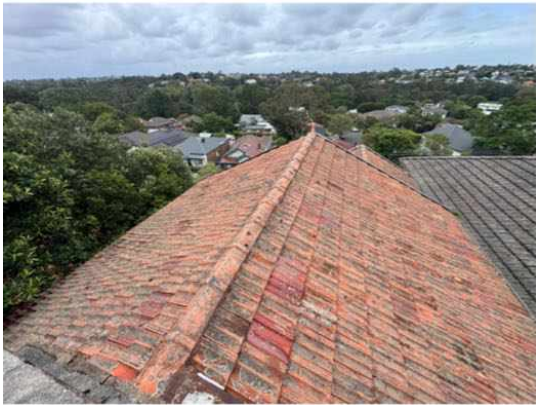
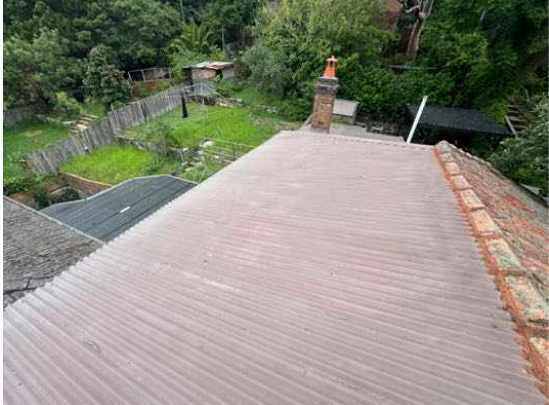
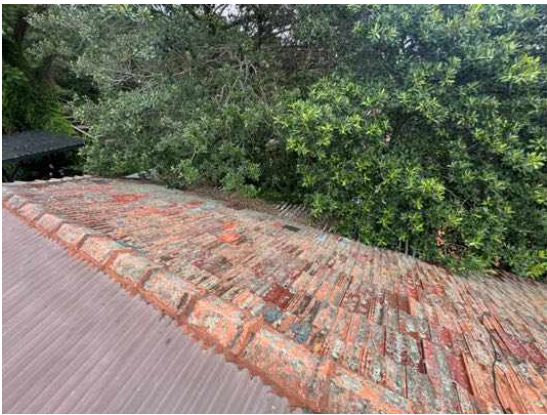
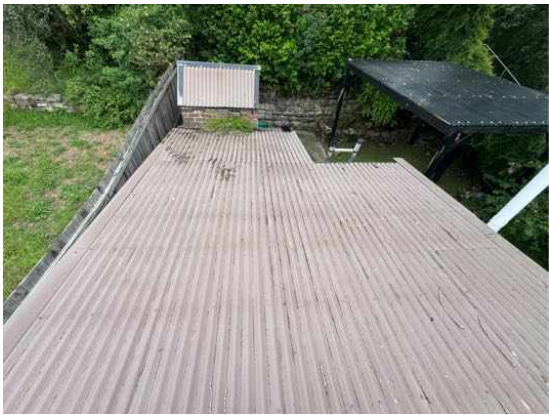
Building: Main Building  
Location: Roof Exterior  
Finding: Photos Added  
Information: Additional photos are provided for your general reference.

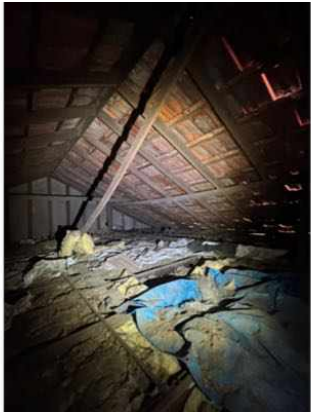
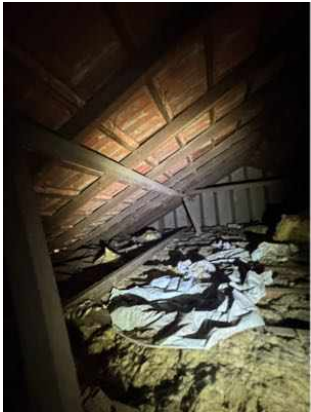
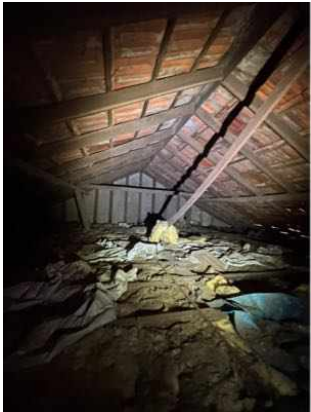
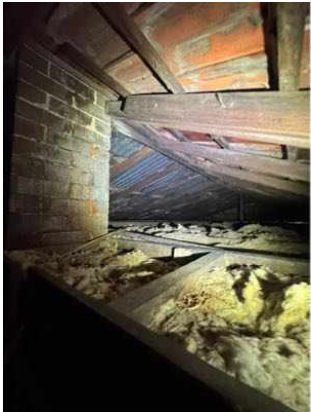
Building: Main Building  
 Location: Roof Void  
 Finding: Photos Added  
 Information: Additional photos are provided for your general reference.
