Building and Timber Pest Inspection Report VR

Inspection Date: Fri, 23 Jan 2026

Property Address: 29 Kiora St, Panania NSW 2213, Australia

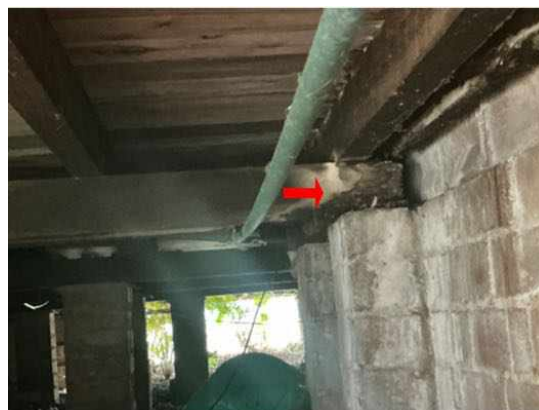
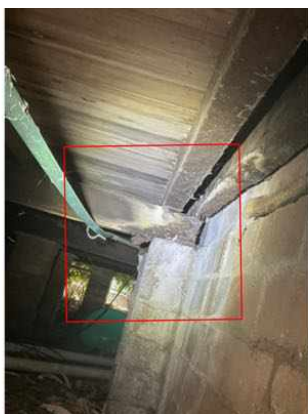
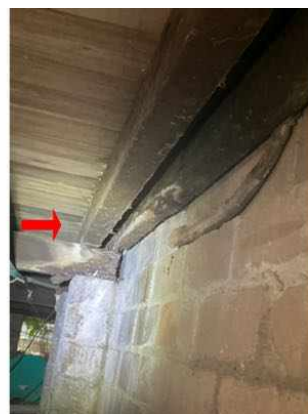
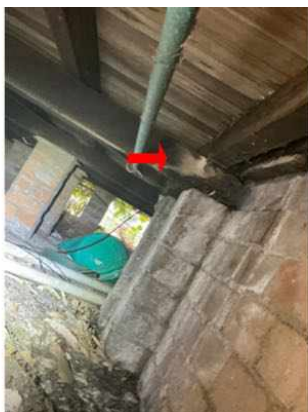
Finding: Subfloor structure - Wood rot

Information: The subfloor structures underneath the bathroom area are showing signs of deterioration. It is suspected that this defect has developed as a result of damp conditions in the subfloor or the possibility of previous excessive moisture from the bathroom above.

Damp conditions cause the timbers to fail, resulting in the subfloor structures failing to bear the load (or weight) of the building as originally intended. Without repairs and maintenance, including potential replacement of affected elements, it is likely that serious structural faults will result, as well as an array of minor defects.

A licensed builder or carpenter is highly advised to attend to the issue and undertake further investigation for rectification works as soon as possible.

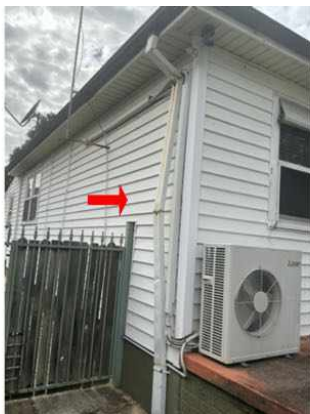
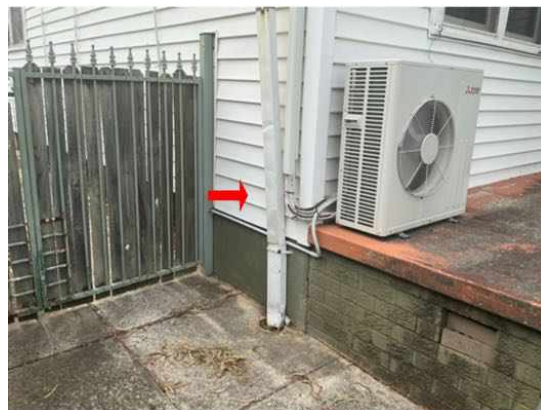
Finding 3.01

Building:	Main Building
Location:	Exterior walls - left side
Finding:	Down Pipe - Deteriorated
Information:	The damage of the down pipe has occurred as shown in the photos.

Breakage and deterioration occurs generally when either the metal/timber has aged and decayed with excessive moisture, or as a result of damage (accidental or deliberate).

Repair and/or replacement of the down pipe is advised to ensure that additional secondary defects do not arise as a consequence. Such works are necessary, as all building elements play a key role in the operation and function of the overall structure and its performance.

A licensed roof plumber should be appointed immediately to repair or replace the damaged gutter prior to any subsequent damage being caused.

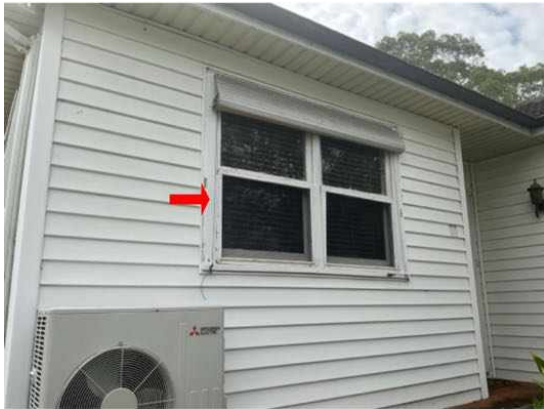
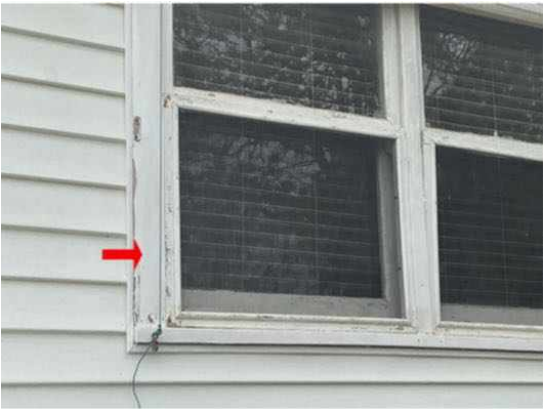
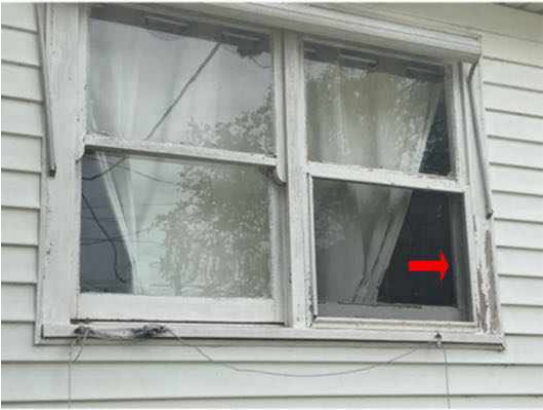
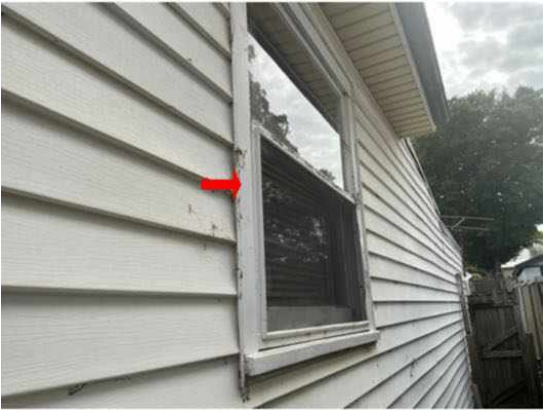
Finding 3.02

Building:	Main Building
Location:	All External Areas
Finding:	Timber Windows - Weathered
Information:	The timber-framed windows throughout the property are showing signs of weathering and deterioration, including peeling paint, surface cracking, and general wear, likely resulting from prolonged exposure to the elements and a lack of routine maintenance.

Timber windows require regular sealing, painting, and inspection to prevent moisture ingress, timber decay, and eventual structural compromise. If left unaddressed, ongoing deterioration may lead to rot, air and water leaks, and costly repair or replacement.

It is recommended that a qualified tradesperson assess the extent of the damage and undertake repairs or restoration, followed by an appropriate maintenance schedule to preserve the condition of the timber.

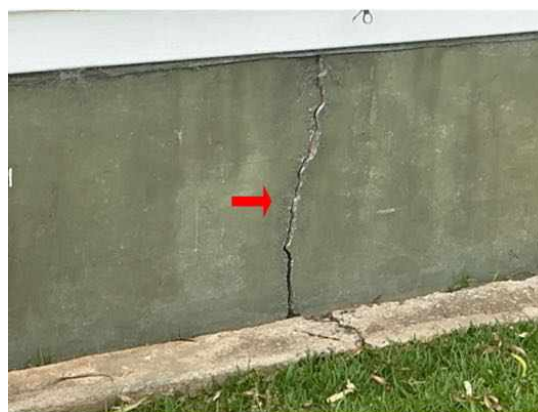
Finding 3.03

Building:	Main Building
Location:	Exterior walls - front
Finding:	Brickwork - Cracking Foundations General
Information:	Cracking was identified to the brickwork in various areas at the time of inspection. Cracking, has a variety of possible causes. However, the most common is the subsidence of adjacent footings.

Cracking is a relatively common defect, and is most likely to occur adjacent to windows, doors and other openings. Mortar failure in the gaps between affected bricks indicates the stresses and tensions affecting the wall.

Where cracking is extensive or severe, the client is advised to consult a structural engineer. Minor step cracking can be used as a warning sign to address factors causing stress to the wall, which can include the effect of surrounding trees, water leaks, soil erosion, or even the presence of reactive soils in the surrounding area.

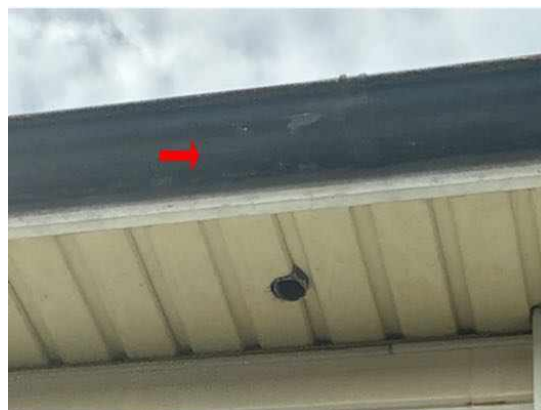
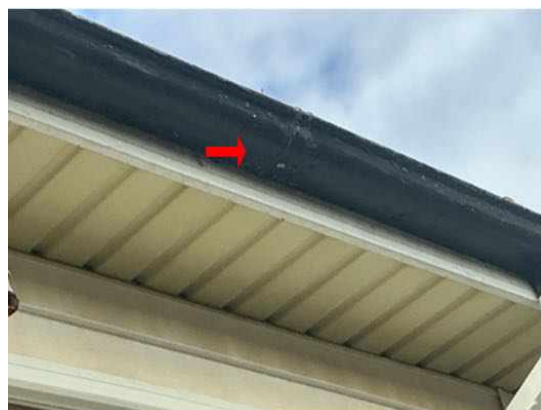
Finding 3.04

Building:	Main Building
Location:	All External Areas
Finding:	Gutters Damaged/Deteriorated
Information:	Breakage and deterioration occurs generally when the building materials have either aged and decayed with excessive moisture, or as a result of damage (accidental or deliberate).

Repair and/or replacement of these materials is advised to ensure that additional secondary defects do not arise as a consequence. Such works are necessary, as all building elements play a key role in the operation and function of the overall structure and its performance.

A licensed roof plumber should be appointed to repair or replace the affected building element prior to any subsequent damage being caused.

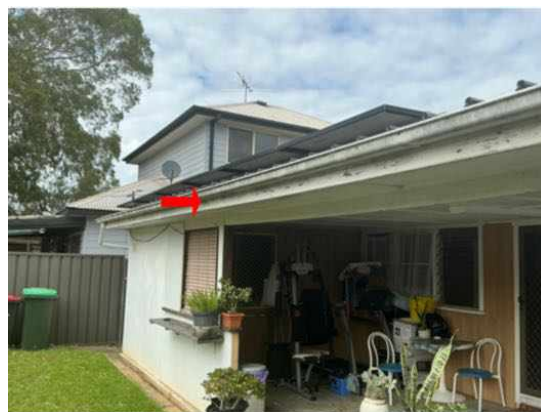
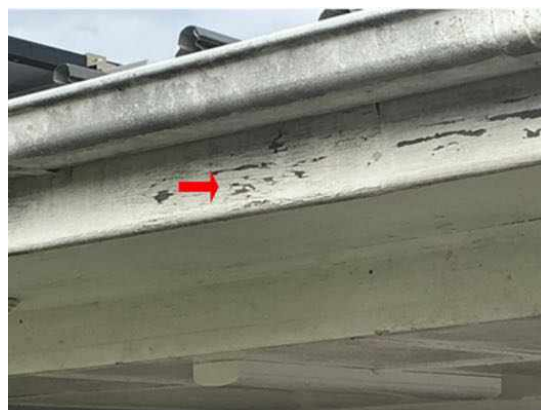
Finding 3.05

Information: External timber elements around the property were observed to be showing signs of general wear and tear, including surface deterioration, fading, and early signs of weather exposure. These conditions are commonly caused by prolonged exposure to sunlight, moisture, and temperature fluctuations, which can lead to cracking, splitting, or degradation over time if not properly maintained.

It is recommended that all external timber be inspected and maintained to ensure ongoing protection. This may include sanding, sealing, or repainting affected sections. Regular maintenance will help preserve the timber's integrity, extend its lifespan, and prevent more extensive damage in the future.

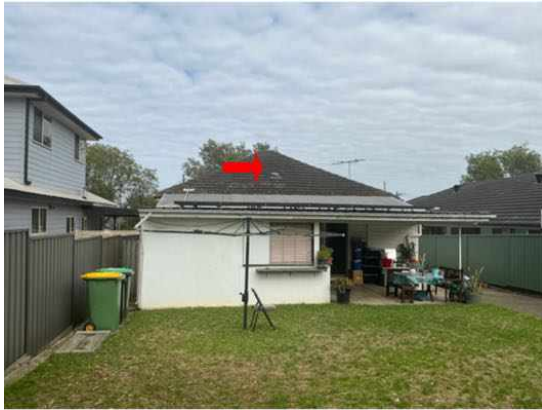
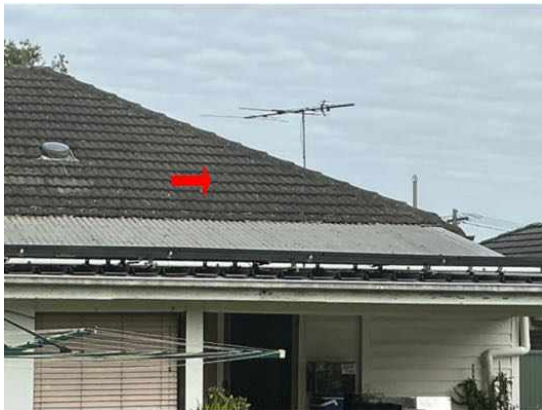
Finding 3.06

Building:	Main Building
Location:	Roof Exterior
Finding:	Roof tiles - Weathered
Information:	Upon inspection of the exterior roofing, the majority of roof tiles were considered to be in a fair condition. While weathering of the tiles is consistent with the age of the property, maintenance works are required.

Isolated areas of mortar have come loose on the ridges and minor cracking is also present. Re-pointing and re-sealing the may be considered as an interim solution by the client to help preserve and extend the life span of the tiles.

Where left unmanaged, deteriorating roof tiles are likely to lead to a number of secondary defects, including minor water leaks and weather exposure to internal roofing structures.

Consultation with a roofing contractor is highly advised to gain advice on cost of remedial works that may be required in the short to medium term. Remedial works are likely to increase the longevity of the exterior roofing structure.

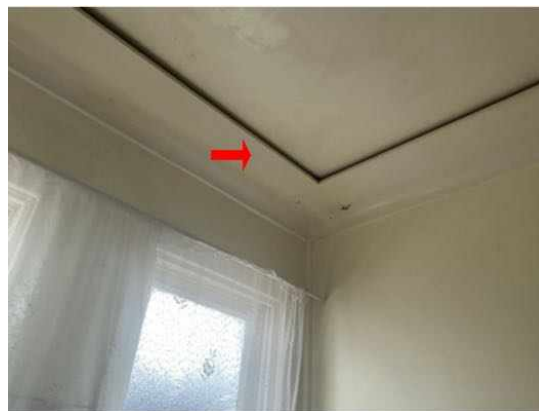
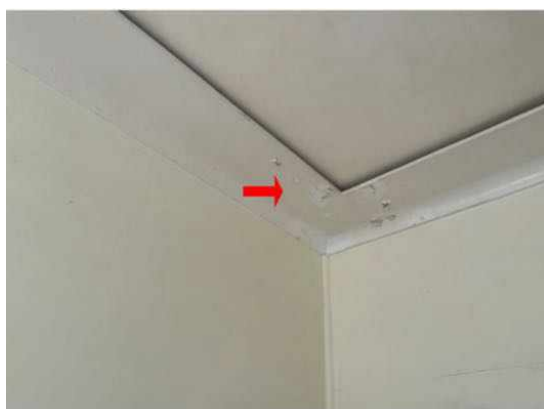
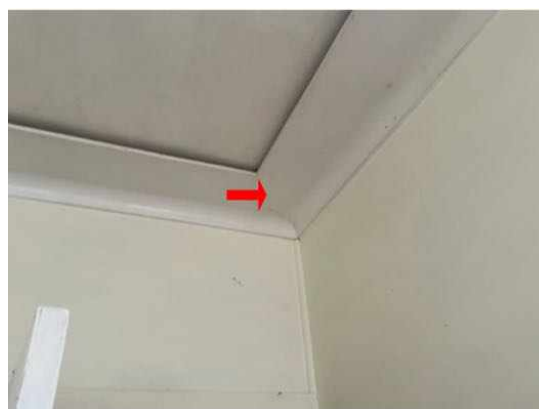
Finding 3.07

Information: Sections of paint in this area was found to have peeled and deteriorated. Paint peeling and or bubbling is generally an indication of excessive moisture in the area, that is currently hidden by the painted surface.

The presence of excessive moisture can have major implications on associated building elements if left unattended. While only seemingly minor at this stage, the damage cannot be determined due to the paint obstructing any further inspection of the damage.

It is highly advised that the affected paint be cleaned to allow a further, more invasive inspection by a licensed plumber. Failure to act on this defect may necessitate major works in the future.

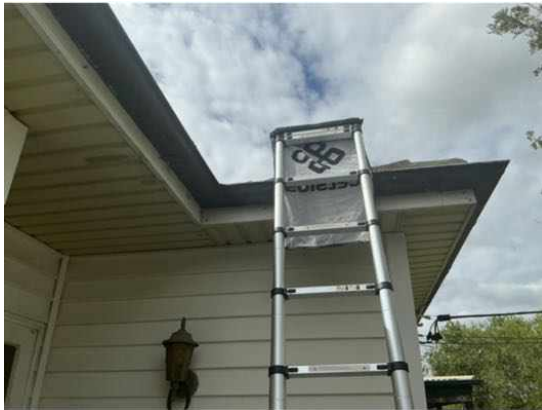
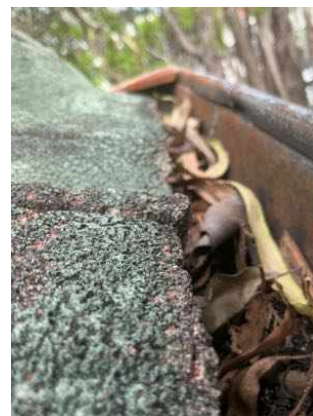
Finding 3.08

Building:	Main Building
Location:	Roof Exterior
Finding:	Gutters - Debris
Information:	Roof plumbing structures, such as guttering and downpipes, should be free of all debris to prevent blockages. Blockages in the guttering and downpipes will lead to pooling and accumulated water overflow, which is likely to flood the eaves and exterior walls.

In addition to blockages, leftover materials in the gutters could also cause damage. These materials, if not cleared, may contribute to rust, decay, and further deterioration of the building materials. Over time, moisture buildup caused by blockages and debris can also create conditions which could lead to additional structural issues.

Blockages and debris should be removed immediately to ensure dry conditions are maintained.

It is recommended to consult a licensed plumber for specific advice on any necessary

remedial works. In the interim, it is strongly advised that a general handyperson clear the building material as a matter of urgency to prevent further damage.

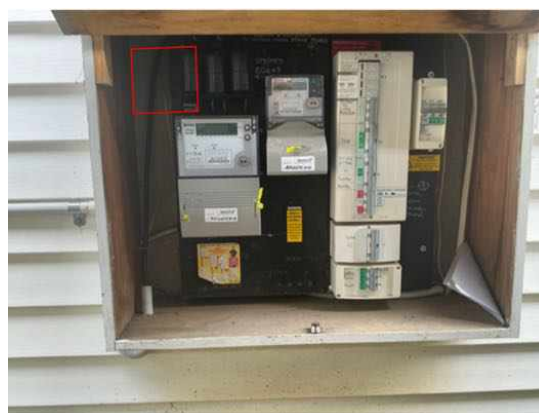
Evidence of this sticker has NOT been located in the meter box. Please see photos attached

Where a Termite Management System has not been identified you should consult a licensed pest inspector immediately to undergo further investigation in what measures would be necessary to maintain a functional pest management system. It is also recommended that a Licensed Pest Controller attend to determine the viability of the current or past treatments

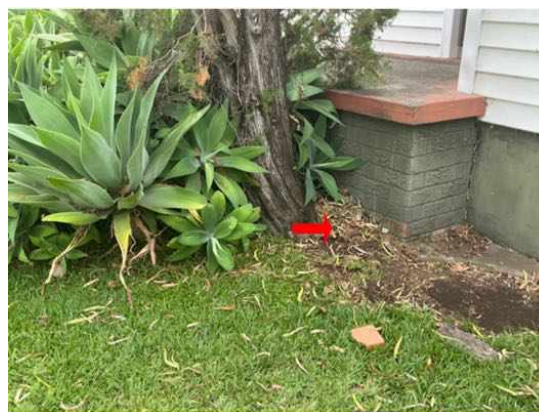
Finding 6.02

Building:	Main Building
Location:	All External Areas
Finding:	Garden Beds - Conditions Conducive to Termites
Information:	Garden beds were observed in direct contact with the building's perimeter across various areas of the property. In some areas, untreated timber and mulch were used. This configuration, combined with regular watering or hosing, creates conditions conducive to termite activity and increases the risk of termite ingress into the structure.

Garden beds placed against external walls, particularly those incorporating untreated timber or excessive mulch, can retain moisture and create hidden entry points for termites. This undermines the effectiveness of termite barriers, compromises weep hole visibility, and elevates the risk of concealed termite activity that may lead to structural damage.

Implement regular pest inspections and engage a licensed pest control specialist to assess and manage termite protection systems.

The current placement and construction of garden beds present a termite risk and deviate from best practice recommendations for termite management. Rectification and professional input from both a landscaper and pest management specialist are advised to ensure the building remains protected while achieving the desired landscape design.

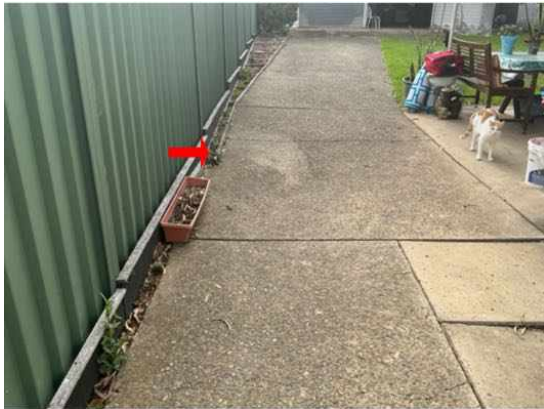
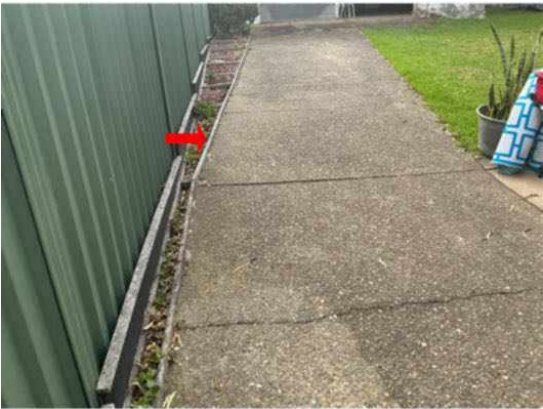
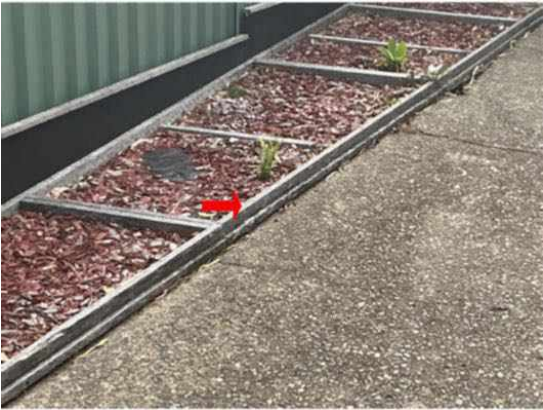
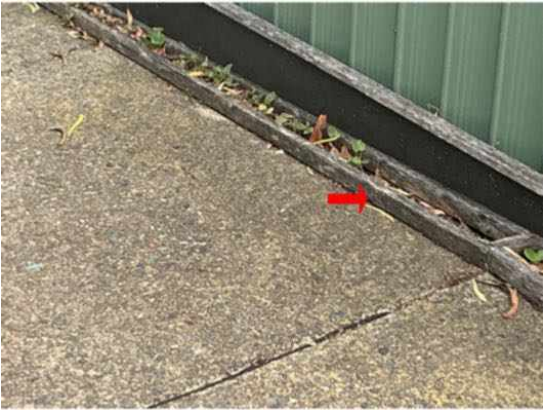
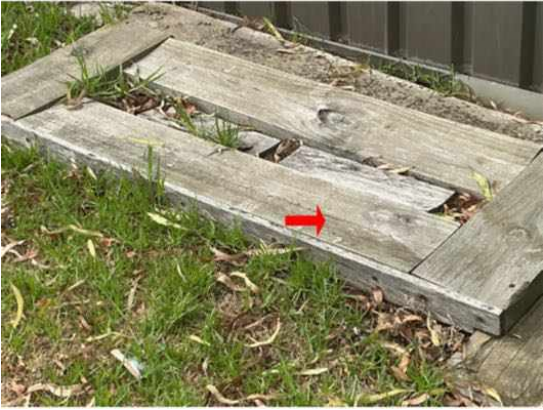
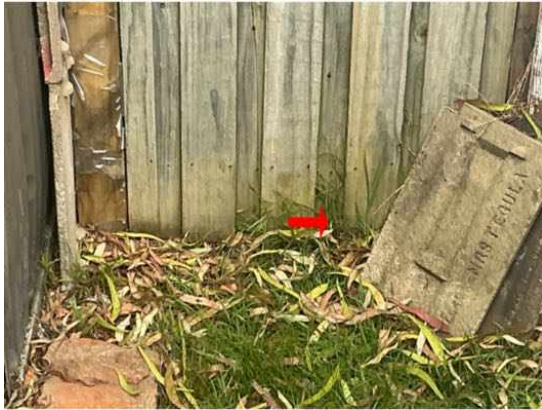
Finding 6.03

Building:	Main Building
Location:	All External Areas
Finding:	Timber Materials In Direct Ground Contact- Conducive to Termites
Information:	Timber elements that are in direct contact with the ground and exposed to moisture or damp conditions are highly conducive to termite activity. This susceptible arises because of timber, when in contact with soil and dampness, create an environment that is particularly attractive to termites, encouraging infestation and potential structural compromise. Whether the timber is used as part of the building construction or incorporated into fencing, the presence near or on the ground can become a pathway for termites to access And damage the property.

When exposed to excessive moisture, timber begins to deteriorate developing condition such as wood decay or rot. These compromised areas of timber are even more appealing to termites as they are easier to infest and consume. This is especially true for untreated or non-durable timber, which lacks the protective treatments that can deter or withstand termite attacks. Termites can use these weakened moisture laden elements as a bridge into other parts of the structure, creating an entry point for potential infestations that can spread and cause extensive damage if left unchecked.

For any timber in direct contact with the external ground special attention is required the combination of moisture untreated wood and direct ground contact not only accelerate the decay process but also provide subterranean termites with a straightforward means of ingress into the structure this can lead to termites moving undetected into other vulnerable areas resulting in potentially significant structural issues and costly repairs.

To mitigate the risk of termite activity it is imperative that any such materials or timber elements be appropriately treated or removed as soon as possible. Timbers that are necessary for use should be made durable through appropriate treatments and maintained to ensure they do not create conditions conducive to termites. Additionally the client is advised to schedule regular termite treatments to maintain an effective barrier against infestations and ensure ongoing protection.

Regular inspections, proactive maintenance and consistent termite treatment are essential steps in minimising the risk of termite attack and protecting the structural integrity of the property. Taking these preventative measures is crucial for maintaining a termite free environment and avoiding potentially costly damage and future repairs.

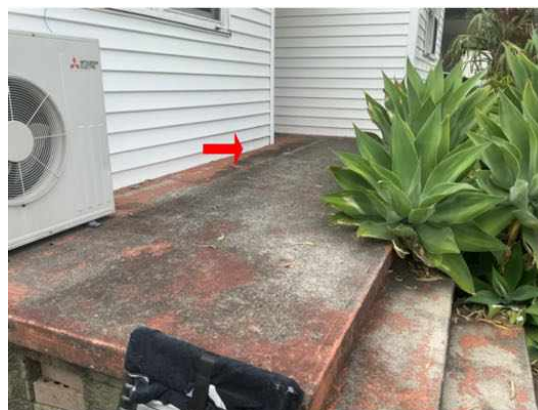
Finding 6.04

Building:	Main Building
Location:	All External Areas >
Finding:	Bridging Of Physical Barriers - Patios/Porches
Information:	Breaching is the spanning of a physical termite barrier or inspection zone so that subterranean termites are provided with an entry point over or around that barrier.

The concrete porch/patios are providing a concealed entry point at the time of the inspection. Where the location of the porch is retrospectively installed against an external wall this will provide a concealed entry point for termites.

The client should consider gaining further advice from a timber pest technician as to treatments required in this area. It is recommended that obtaining such advice be a short-term priority.

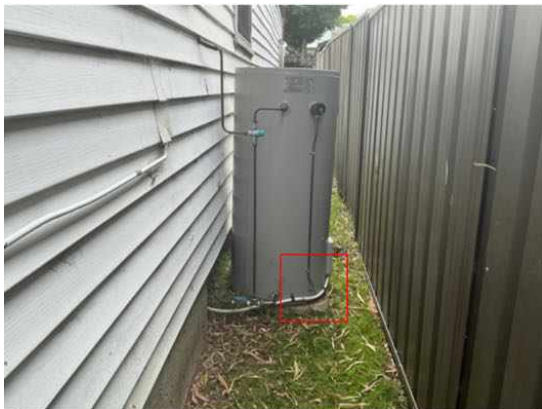
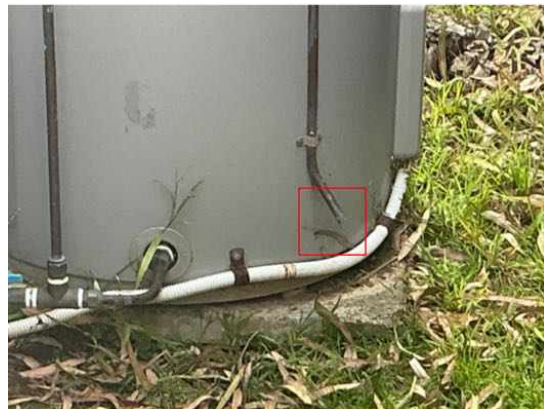
Building:	Main Building
Location:	Exterior walls - right side
Finding:	HWS - Disconnected overflow
Information:	The Hot Water System overflow was found NOT to be connected to the storm water drainage and is creating excessive moisture in the surrounding area.

Poorly aligned materials can and will lead to further damage to nearby areas.

It is highly recommended that a licensed plumber be appointed to connect the A/C overflow in order to prevent such an environment from being created. These minor works should be carried out as soon as possible.

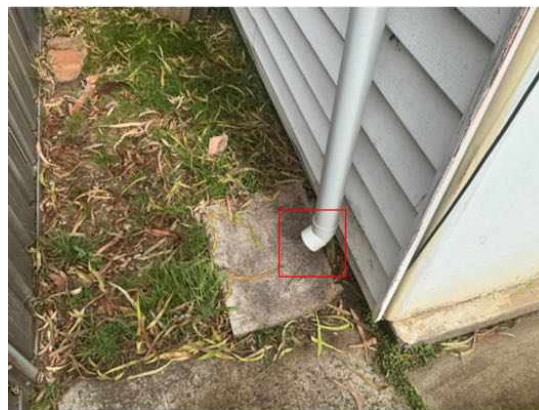
Finding 6.07

Building:	Main Building
Location:	Exterior walls - right side back
Finding:	Down Pipe - Not connected
Information:	The roof plumbing is not adequately connected to stormwater drainage on the site. This disconnection negatively impacts the functional capacity of the roof plumbing.

rust and corrosion of surrounding building elements, as well as attracting termites and other pests.

It is highly recommended that a plumber be appointed to further inspect the area and to install adequate drainage equipment where necessary.

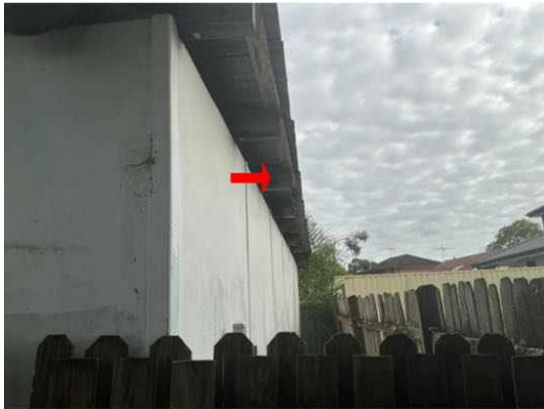
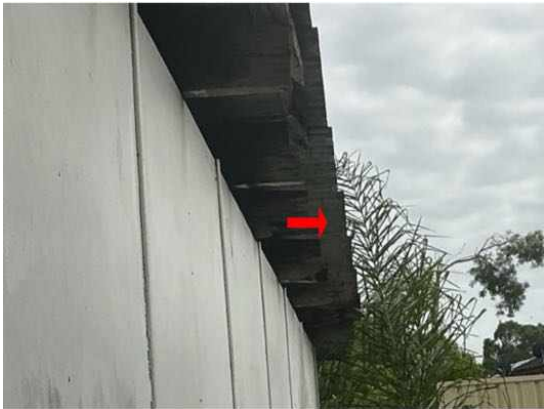
Finding 7.01

Building:	Main Building
Location:	Garage
Finding:	Fascias - Wood rot
Information:	Wood rot was found to be affecting fascias and barges in this area. Wood rot, also known as Fungal Decay, occurs when timbers and other cellulose building materials are exposed to damp conditions on an ongoing basis.

It is likely that this wood rot has developed as a result of faults in the roof plumbing, creating excessive moisture in this areas. Frequent exposure to rain and other weather conditions also make fascias and barges susceptible to accelerated deterioration.

Early intervention and regular maintenance will prolong the useful life of these building elements. Prior to any works being performed, the cause of the moisture that has created the visible wood rot should be identified and addressed in a suitable manner.

It is advised that a roof plumber be appointed to inspect all roof plumbing and subsequently identify the cause of the wood rot. Replacement of affected fascias and barges may then be a necessary step in protecting surrounding building elements from such deterioration.

A qualified plumber may be appointed to assess the cause of excessive moisture and to provide advice on any remedial works as required. A qualified carpenter or registered builder may also be required to replace affected building materials.

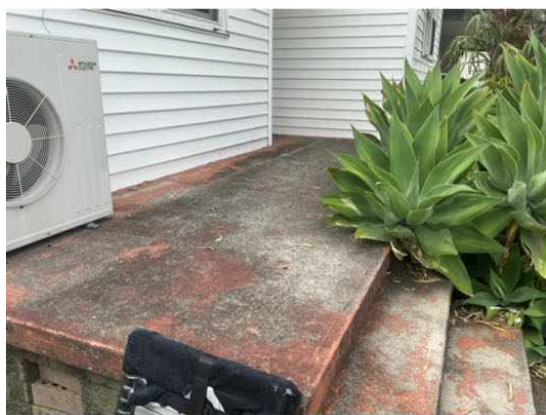
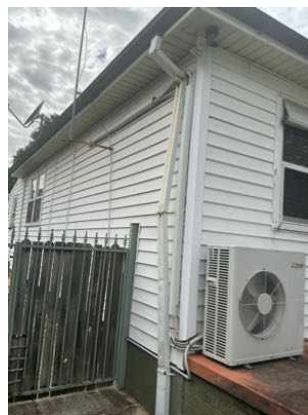
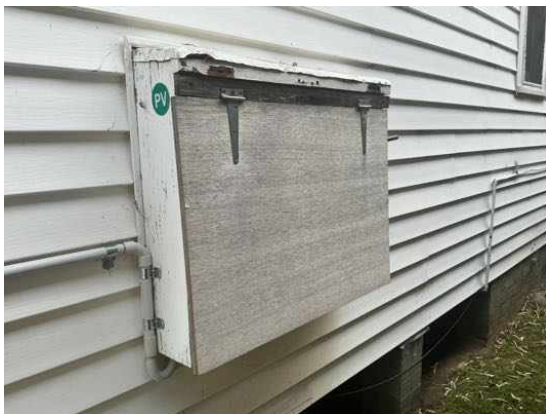
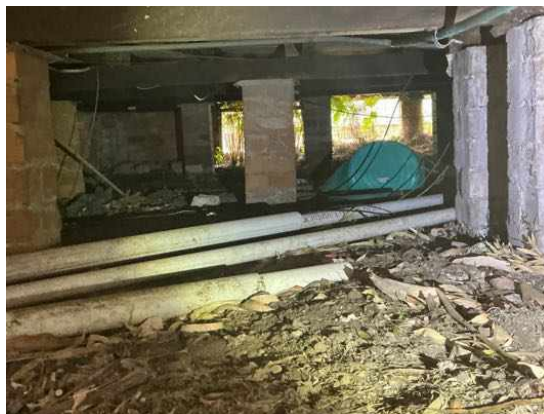
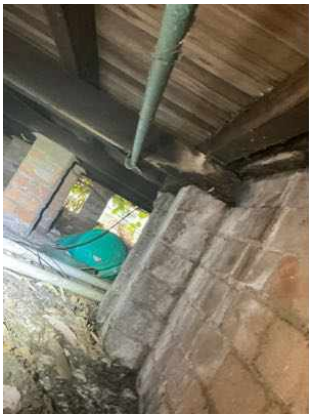
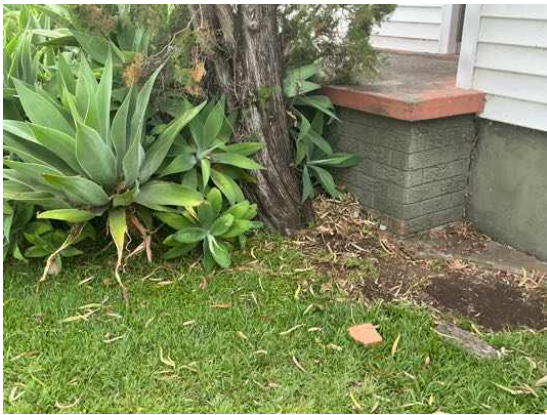
Building: Main Building
Location: All Areas
Finding: Additional Photos - Obstructions and Limitations
Information: These photographs are an indication of the obstructions and limitations which impeded full inspection of the property at the time of inspection. These obstructions can hide an array of defects and should be removed to allow full inspection to be carried out. A re-inspection is recommended once the areas are made accessible.

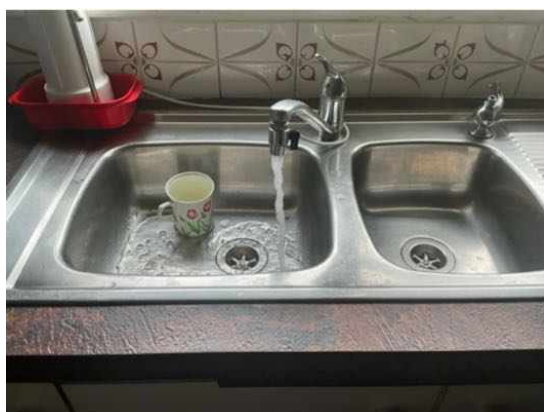
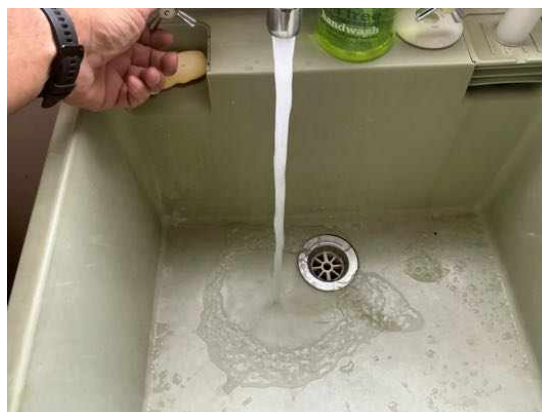
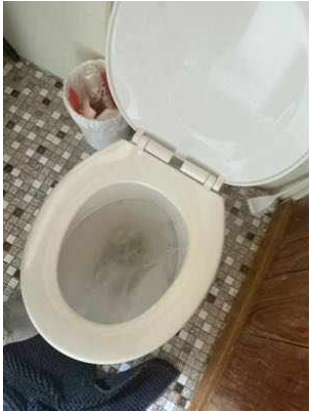
Building: Main Building
Location: All Wet Areas
Finding: Taps, Drainage and Toilets Tested
Information: During the inspection, taps, draining systems and toilets were checked for both water flow and drainage efficiency, as well as inspected for any visible signs of leakage at the time of the inspection. No issues were noted in these areas ,unless highlighted in a separate ,no immediate remedial work appears to be necessary for these items. Any relevant photo's Documenting these inspections may be found in the additional photo section for reference.

However, it is important to note that while a thorough inspection of cupboards and cabinetry was conducted the presence of instructions such as stored items or fixtures may have limited full visibility of potential water damage or hidden defects. These obstructions can conceal underlying issues that may not be immediately visible during the initial inspection. Furthermore, conditions can change after the inspection has been carried out and defects or damage could be revealed once obstructions are removed or as time progresses.

Given this, it is strongly recommended that a reinspection be conducted after all obstructions have been removed from the cupboards to allow for a full thorough assessment of these areas. This will ensure that any concealed damage or defects are identified and addressed in a timely manner. Regular maintenance and monitoring of plumbing and drainage systems are also advised to insure long-term functionality and to prevent future problems from arising.

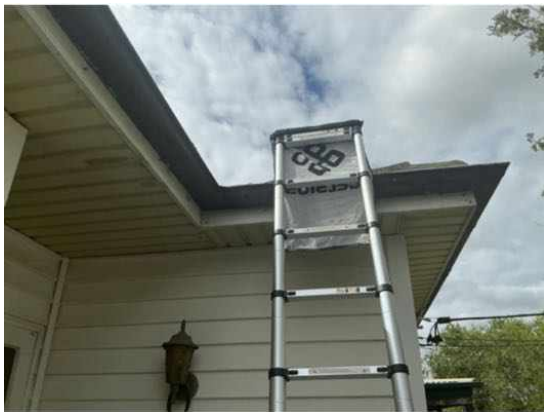
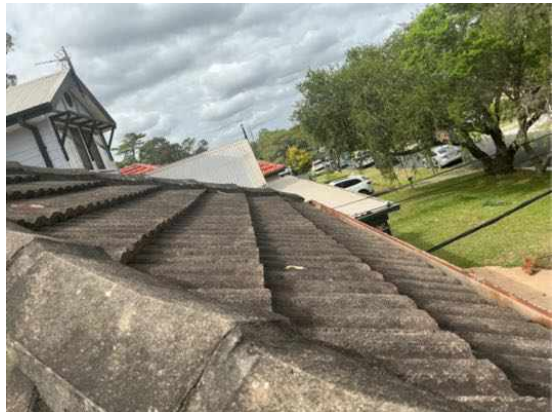
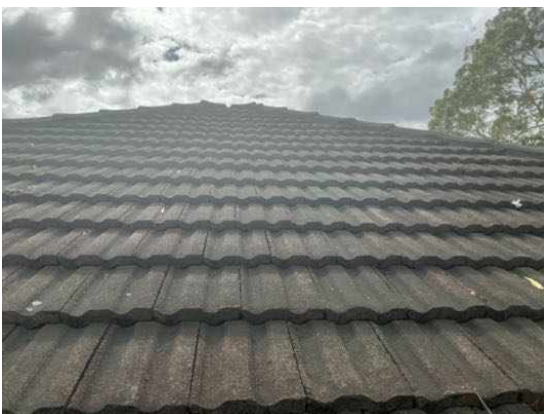
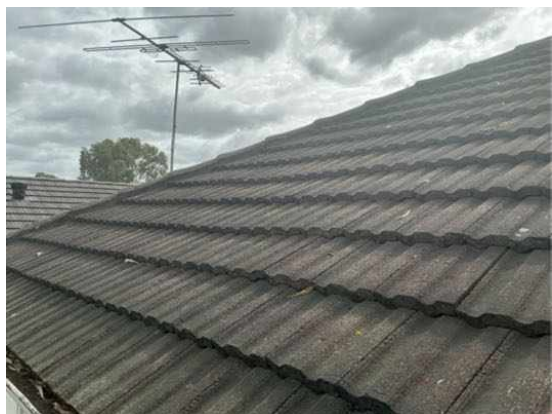
Building: Main Building
Location: Roof Exterior
Finding: Additional Photos Roof
Information: Additional photos are provided of the general roof for your general reference at the time of inspection.

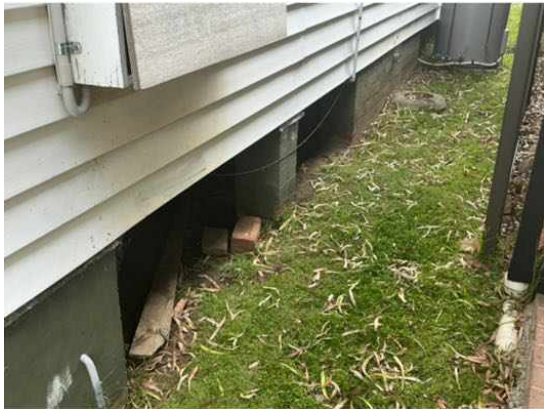
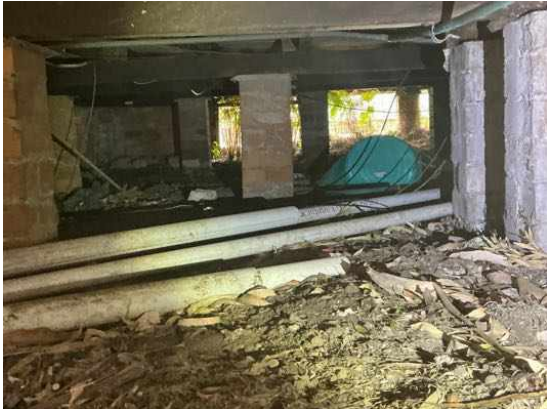
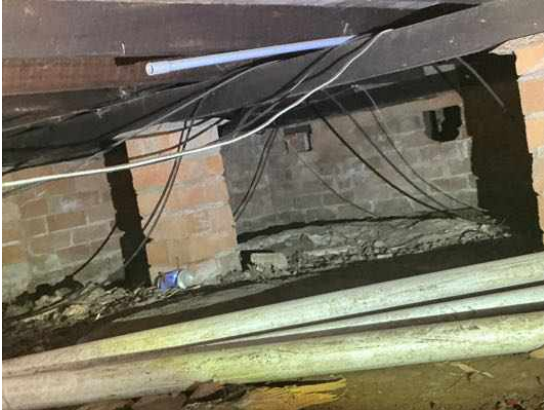
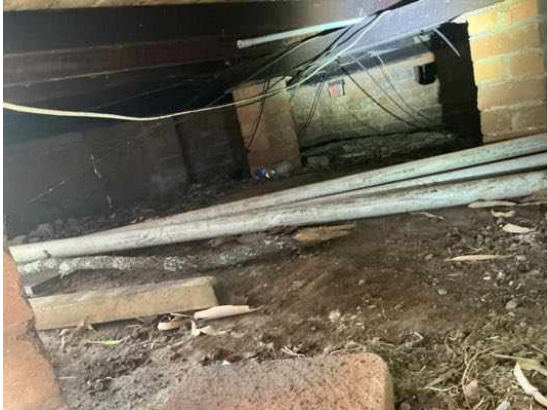
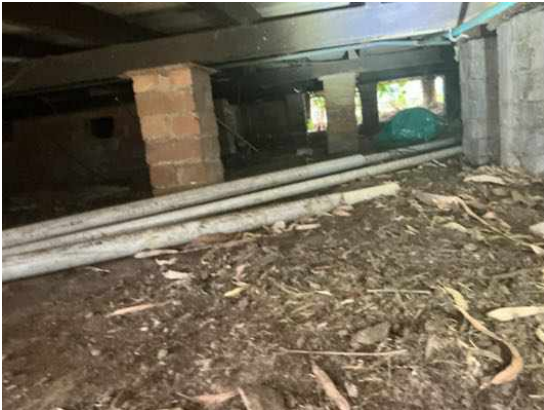
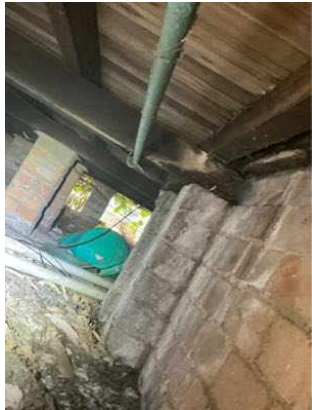
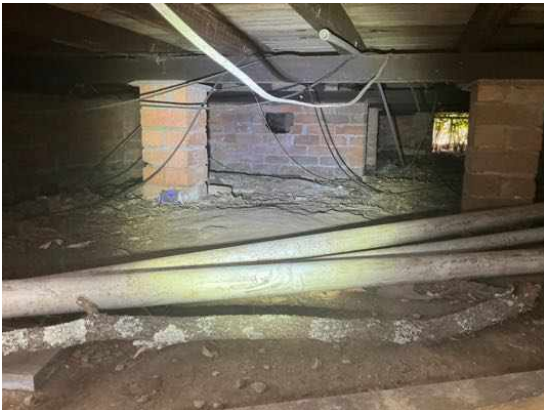
Building: Main Building
 Location: Subfloor
 Finding: Additional Photos - Subfloor
 Information: Additional photos are provided for your general reference

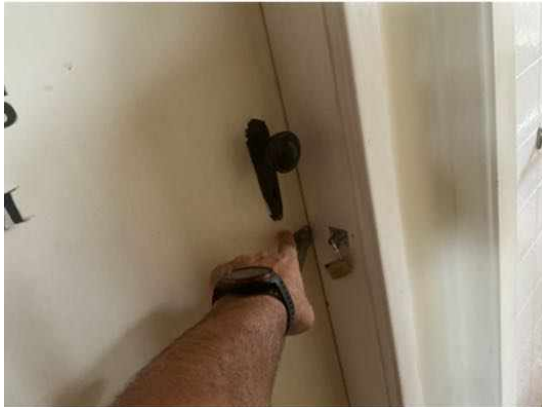
Building: Main Building
Location: Bedroom
Finding: Locked Or Inaccessible
Information: At the time of the inspection the associated room was locked or inaccessible.

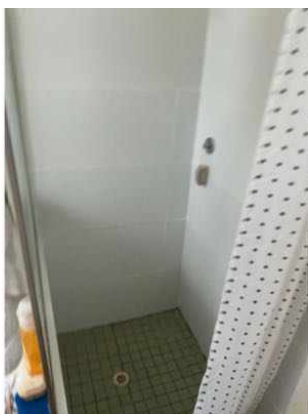
Building: Main Building
Location: Bathroom
Finding: Shower - Recently Used Shower
Information: Moisture testing to the shower area could not be undertaken at the time of inspection as the shower had recently been used, with water present on the tiles.

Accordingly, the moisture condition of the underlying wall and floor areas could not be determined at the time of inspection.
