# Building and Timber Pest Inspection Report

Inspection Date: Wed, 8 Apr 2026

Property Address: 48 Combermere St, Goulburn NSW 2580,  
Australia

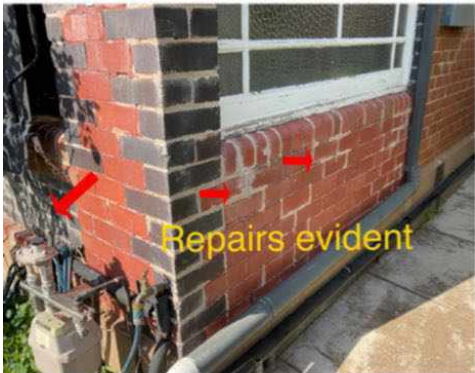
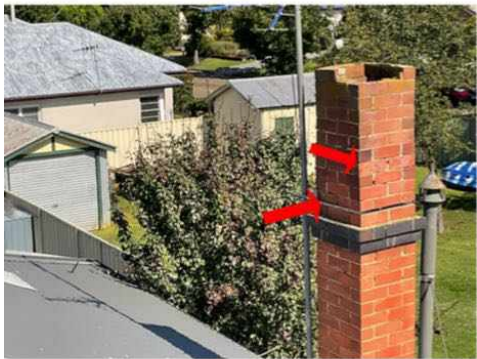
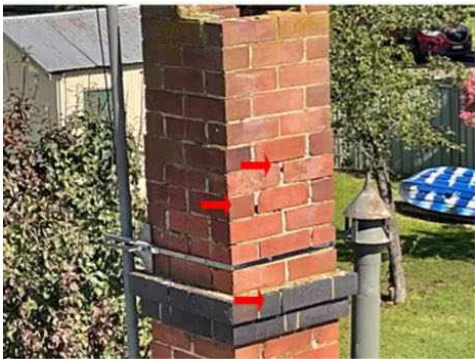
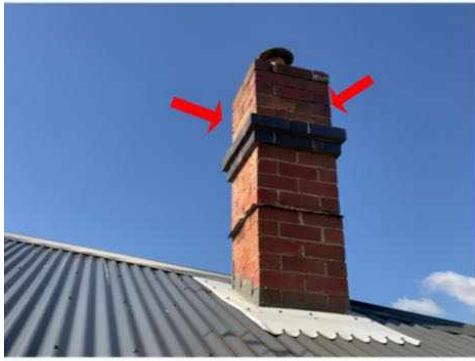
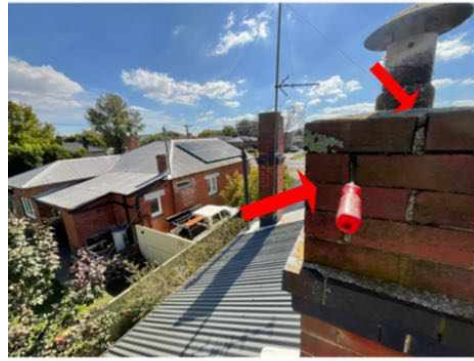
Finding: Brickwork mortar missing (major on front wall, minor on chimneys)  
Information: Many areas of mortar was found to be missing at the time of the inspection. Some areas have been repaired, more repairs are now required (next few months).

Mortar that is missing may allow water ingress into these areas, putting associated building elements at risk of water damage.

Missing mortar should be attended to by bricklayer as soon as possible.

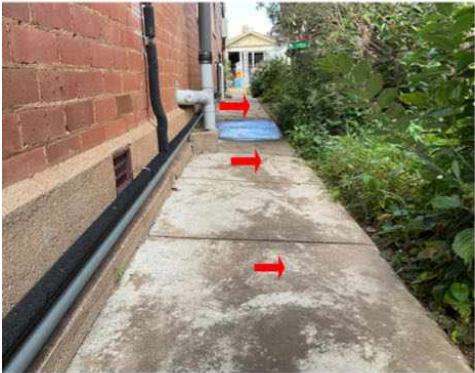
### Finding 3.01

Building:	Building 1
Location:	Front wall and right path areas
Finding:	Subsidence - monitor annually
Information:	It appears that this some paved areas has been affected by movement, often referred to as sinking or subsidence. General subsidence is usually initiated by changes in soil moisture content. The most critical factor is identifying the specific causes, and identifying if this is a recurring or ongoing problem, or one that has been resolved by previous works in the past.

At this point it is recommended to contain storm water flows, ensure pavements flow away from buildings to lessen any excessive wetting and drying effects.

A landscaping contractor can repair these path areas when convenient. Levelling the front walls would not be economically viable.

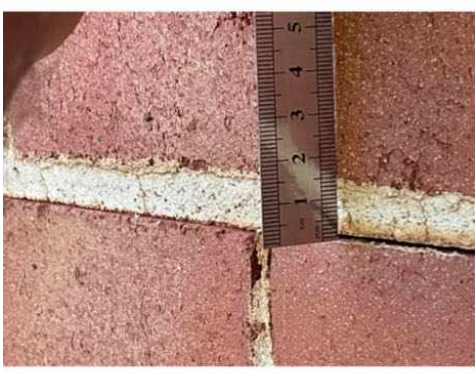
**Finding 3.02**

Building: Building 1  
Location: Exterior walls  
Finding: Step cracking to brickwork (minor)  
Information: Step cracking was identified to the brickwork in these areas at the time of inspection. This minor step cracking can be used as a warning sign to address factors causing stress to the wall, which can include the effect of surrounding trees, water leaks, soil erosion, or even the presence of reactive soils in the surrounding area.

As the front fence is only 3 bricks high, this is described as a minor defect in this report.

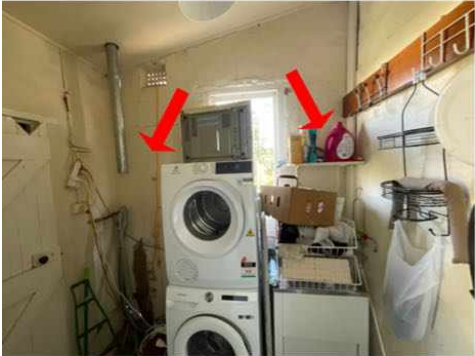
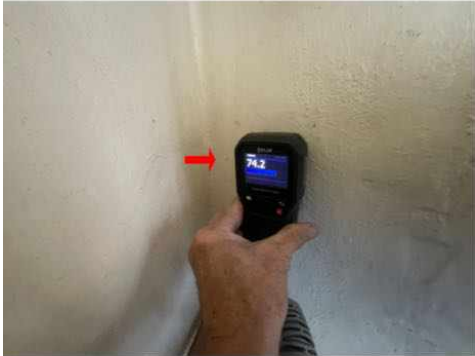
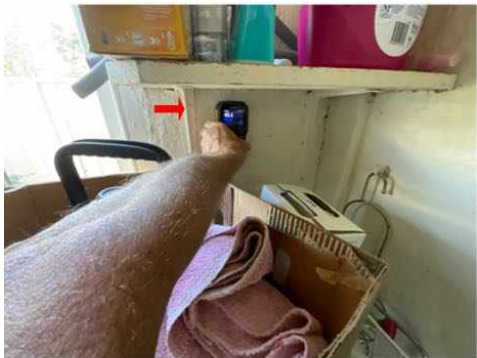
**Finding 3.03**

Building: Building 1  
Location: Laundry  
Finding: Evidence of excessive moisture was present at the time of inspection  
Information: Excessive moisture was found in the laundry wall. High readings of up to 74.2. and render damage was evident. This can attract termites and produce conditions that promote termite attack, fungal growth and wood decay. Excessive moisture is generally caused by deteriorated, inadequate or missing roof drainage, leaking plumbing pipes or fixtures, poorly plumbed HWS overflows or condenser units and poor site drainage. It is highly recommended that all plumbing and drainage fixtures and fittings be maintained regularly in order to prevent excessive moisture being present in the internal property. All external wall areas require sealing from rain ingress.

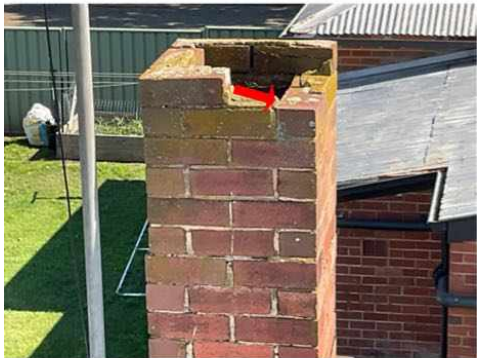
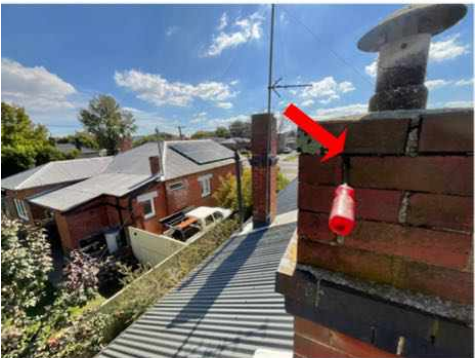
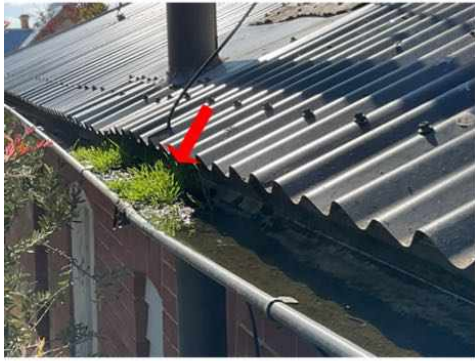
**Finding 3.04**

Building: Building 1  
Location: Some perimeter roof areas  
Finding: Roofing areas - Weathered  
Information: Upon inspection of the exterior roofing, the majority of the roof areas were considered to be in a good condition. While weathering of these pictured areas is consistent with the age of the property, maintenance works are required.

Re-sealing and replacing small areas of gaps, damage or rust the may be considered as an interim solution by the client to help preserve and extend the life span of these roofing areas. Where left unmanaged, deteriorating roofing materials are likely to lead to a number of secondary defects, including minor water leaks and weather exposure to internal roofing structures.

Consultation with a roofing contractor is highly advised to gain advice on cost of remedial works that may be required in the short to medium term.

Remedial works are likely to increase the longevity of the exterior roofing structure.

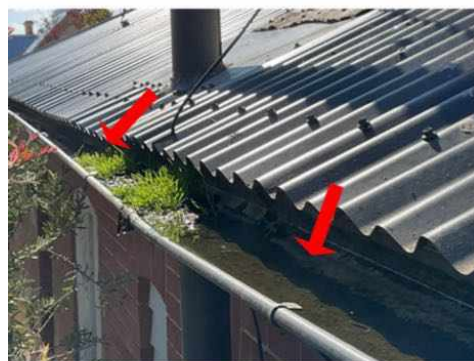
### Finding 3.05

Building:	Building 1
Location:	Laundry toilet and right middle gutter
Finding:	Gutters - Water pooling
Information:	Water was found to be pooling in sections of the roof guttering. This is generally a secondary defect caused by blocked or partially blocked gutters. Such blockages and subsequent water pooling are likely to lead to rust and water damage to associated structures if left unattended.

Any areas of guttering that shows evidence of water pooling should be checked for partial or full blockages and any secondary damage that may have occurred as a result. Depending on the extent of the damage, building elements may require repair and/or replacement to ensure adequate roof drainage and function of exterior plumbing system.

A roofing plumber should be appointed as soon as possible to rectify this issue. It is highly advised that all gutters be maintained on a frequent basis to ensure the condition of roof plumbing.

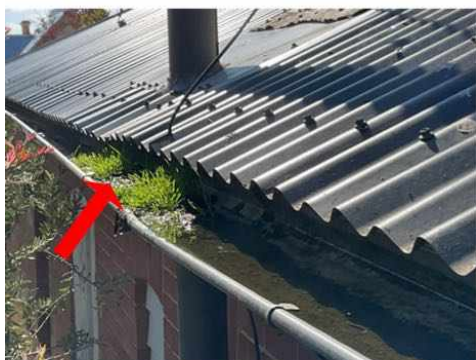
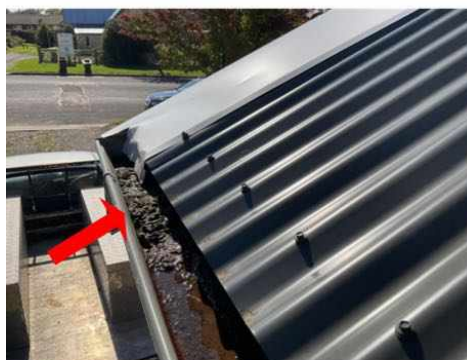
### Finding 3.06

Building:	Building 1
Location:	Path areas

Blocked gutters are likely to lead to high levels of moisture in the affected areas. Such moisture will not only cause rust and decay of the associated building materials, but can also provide conditions that are conducive to termite and timber pest activity. Blockages in gutters should therefore be removed immediately to ensure dry conditions are maintained.

Consult a Licensed Plumber for further specific advice on remedial works that may be required. In the interim, it is highly advised that blocked gutters be removed by the homeowner or a general handyperson as a matter of urgency.

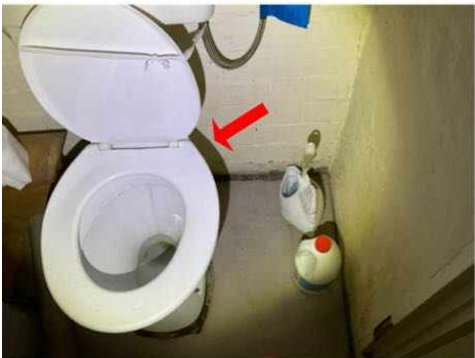
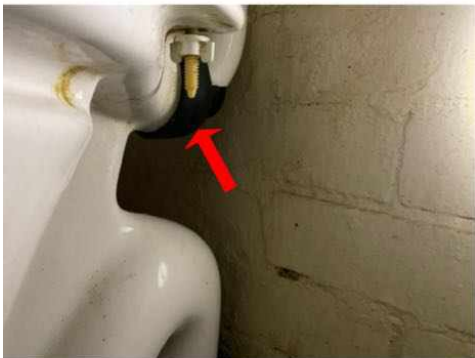
### Finding 3.07

**Building:** Building 1  
**Location:** Laundry toilet and right middle gutter  
**Finding:** Toilet and gutter sagging and leaking  
**Information:** The laundry toilet rear seals from the tank need replacement by a plumber due to leaks. The left gutter is also leaking onto the path.

Non-operational building elements such as this are vital to the function of the household and must be fixed.

A qualified plumber should be appointed immediately to repair the toilet and gutter and return these areas to an operational state.

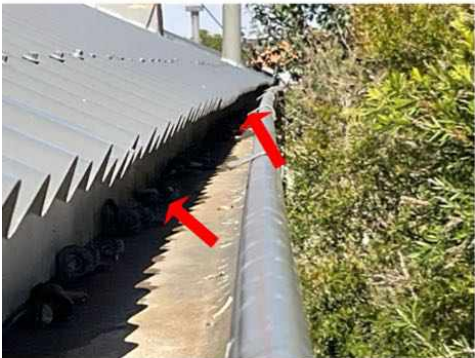
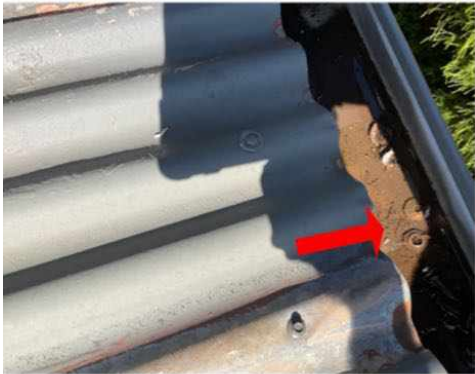
**Finding 3.08**

Building: Building 1  
 Location: Gutters  
 Finding: Building waste in gutters  
 Information: Builders waste was found inside this gutter at the time of the inspection. Builders waste has the potential to interrupt the normal function of these gutters and may lead to blockages and flooding of surrounding areas.

A handy person or plumber is required to remove this waste from this gutter as soon a possible .

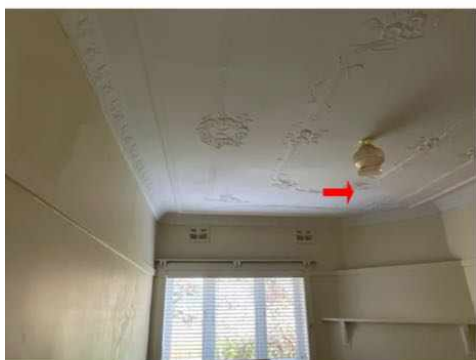
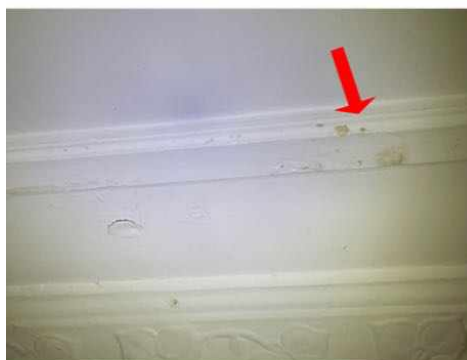
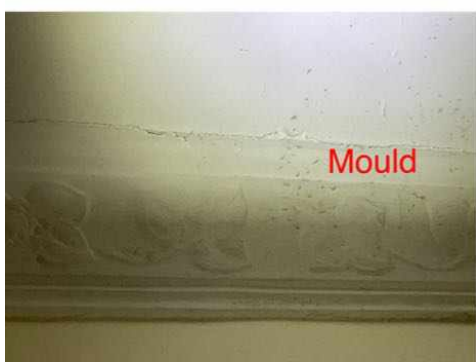
Building:	Building 1
Location:	Lounge Room
Finding:	Ceiling - Water stained and minor mould
Information:	Water staining to ceiling linings in this area was evident at the time of inspection. Water staining indicates that surfaces have been exposed to excessive moisture over time. The minerals and other elements in the water lead to staining, which may graduate to corrosion and deterioration if left unmanaged.

While mostly an appearance defect, water staining can be indicative of more serious defects, which may be currently concealed by interior ceilings.

It is suspected this minor staining is old damage before the roof was replaced.

Where water staining is active, a licensed plumber must be consulted to identify the cause of the staining and to provide advice on any reparation works that may be required.

Conversely, where water staining is old and inactive, affected building materials may be repaired or replaced at client discretion.

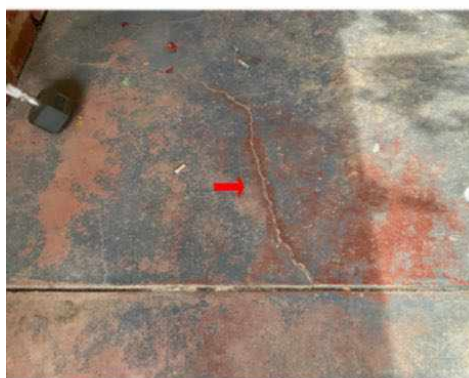
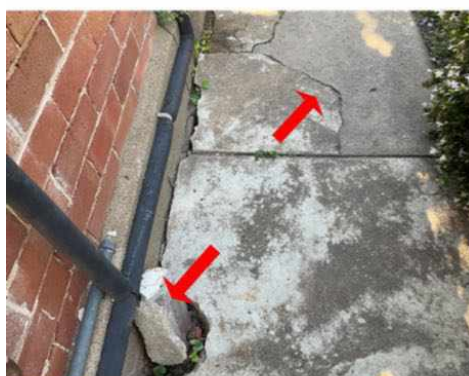
### Finding 3.11

Building:	Building 1
Location:	Yard - front and rear
Finding:	Crack in concrete slab - Category 3
Information:	Cracks coded up to Category 3 was identified in these slabs. A Category 3 crack is described as a wide crack with obvious curvature or change in level, affecting the slab.

The approximate width of the crack to be considered Category 3 is greater than 2.0mm, or a change in offset of 15-25mm when a 3m straight edge is placed over the defect.

Category 3 cracks to slabs exceed allowable Standards and Tolerances, and are considered defects requiring rectification.

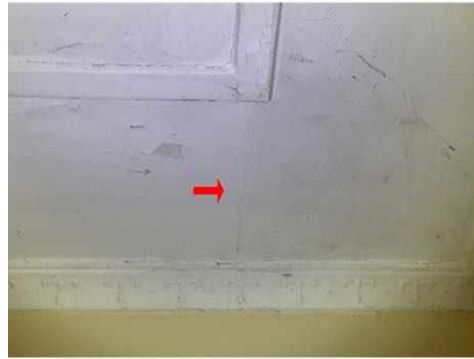
### Finding 3.12

Building:	Building 1
Location:	Small areas of each room
Finding:	Cracking - Damage Category 1 - Fine (up to 1mm)
Information:	Although fine cracks are quite noticeable, they are often only considered to be an appearance defect, and usually do not indicate any structural damage. Generally, the cause of a fine crack is indicative of a separation between building materials and finishes (e.g. paint, plaster, etc.) along joints.

Cracking of this nature can generally be repaired with minor sanding, filling and/or repainting. Such works should be performed by a qualified painter or a general handyman.

Monitoring of all cracking should be conducted frequently. Always contact a building inspector should cracks widen, lengthen, or become more numerous.

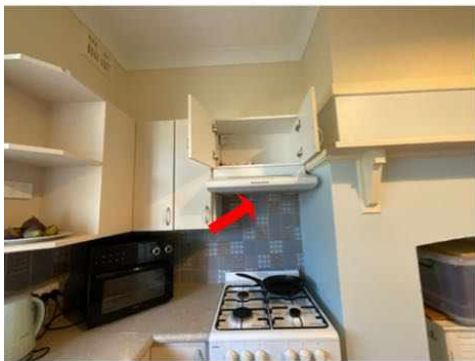
### Finding 3.13

Building:	Building 1
Location:	Kitchen
Finding:	Rangehood - Light not working
Information:	While the range hood appears to be working at a satisfactory level, the light to the appliance was not working at the time of inspection.

A licensed electrician should be appointed to replace the light on the range hood to restore it to a fully operational state.

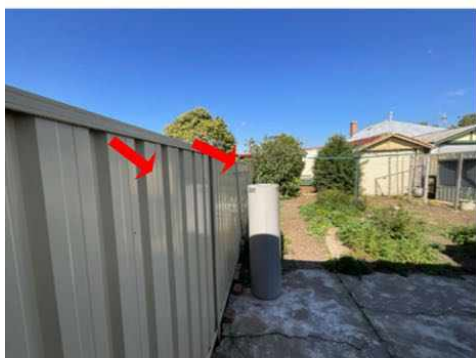
### Finding 3.14

Building: Building 1  
 Location: Pictured fence  
 Finding: Fences damaged - leaning  
 Information: Evidence of damage to the pictured fence was identified at the time of the inspection. The likely cause of this fence leaning is not enough concrete used in the post footings.

If left unmanaged this fence may deteriorate further. It is suggest a fencing contractor be engaged for rectification when convenient.

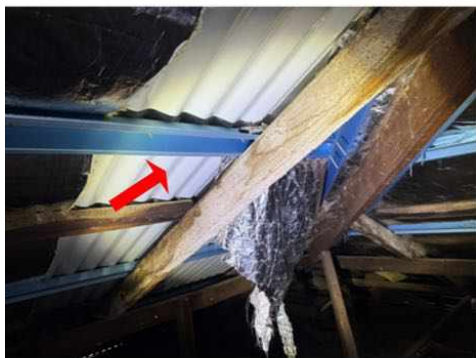
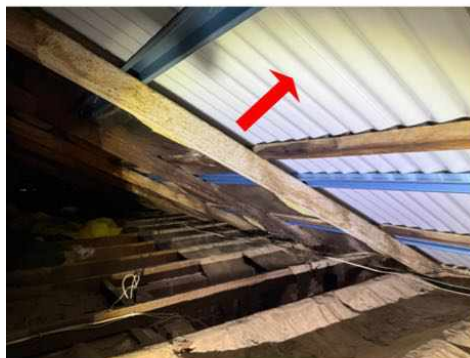
### Finding 3.15

Building: Building 1  
 Location: Some Roof cavity areas  
 Finding: Sarking - Damaged  
 Information: Sarking, a laminated aluminium foil applied to the interior of the roof covering, assists in insulating the property and acting as a vapour-barrier to the roof void and, subsequently, to the household.

Where sarking is damaged, both insulation and moisture protection of the property are inhibited. This creates a loss of energy and thus negatively impacts the energy efficiency of the property, allowing potential for moisture ingress from condensation or leaking roof tiles.

It is important to repair any holes or damaged sections of sarking to ensure that the building material is fully functional. A registered builder or qualified carpenter should be consulted to provide further advice on this defect and to perform rectification works at client discretion.

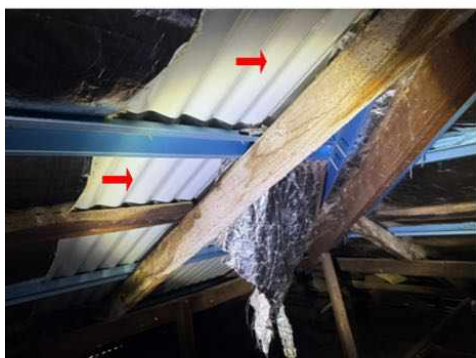
### Finding 3.16

Building: Building 1  
Location: Roof cavity areas  
Finding: Insulation - Partly Missing  
Information: Upon inspection of the roof void it was noted that some insulation is missing.

Insufficient insulation will result in a comparatively higher cost to heat and cool a property as there is a lack of Insulation (or uneven coverage of insulation) which works as a barrier to heat transfer. This helps to keep out unwanted heat in summer and preserves warmth inside your home in winter. It can also help soundproof your home from unwanted airborne noise transfer.

Where insulation is absent, the area does not meet current Australian Standards. Installation of adequate insulation is required and should be conducted as soon as possible.

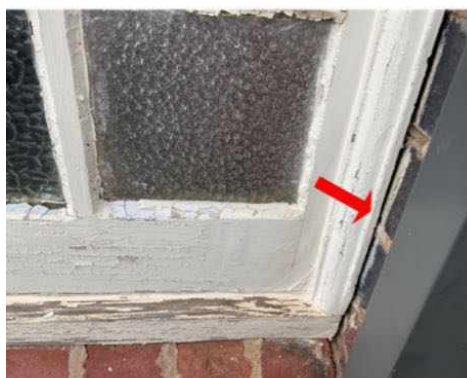
### Finding 3.17

Building: Building 1  
Location: Some window and eave areas  
Finding: Sealant (external) - Missing.  
Information: It was noted on inspection that areas of external sealant was missing to small areas of

Flexible sealants should be applied to these affected areas to prevent any subsequent water damage that is likely to occur.

A sealant specialist or skilled handy person should be appointed to complete these works as soon as possible

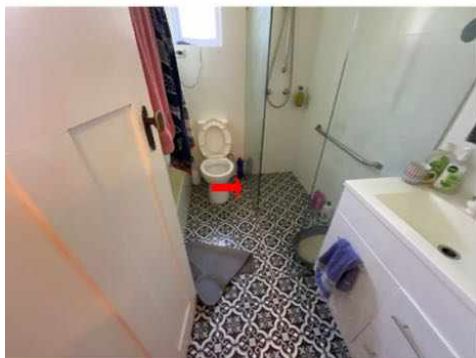
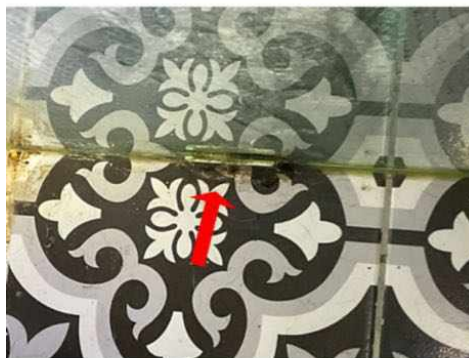
### Finding 3.18

Building:	Building 1
Location:	Bathroom
Finding:	Shower screen - Leaking
Information:	Leaking was evident to the shower screening at the time of inspection. It is suspected that the leaking has occurred as a result missing sealant. Leaking from the shower , where left unattended, is likely to lead to water damage to adjoining flooring and walls. Such damage can lead to water damage and necessitate extensive remedial works being required. Active water leaks may also create an environment that is susceptible to the formation and development of mould.

Appointment of a sealant expert is required to repair or replace this missing sealant. Such works should be performed as soon as possible to ensure that no further damage occurs.

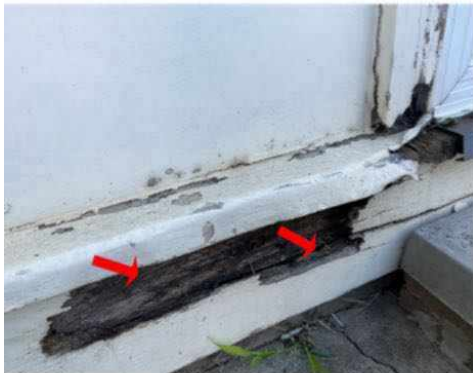
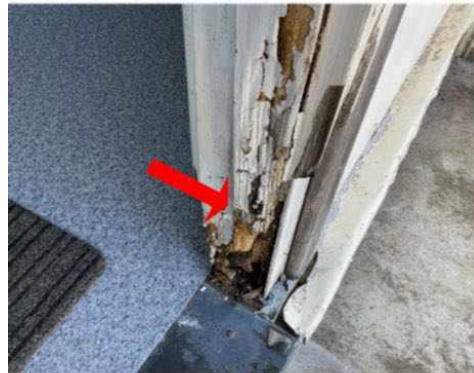
Building: Building 1  
Location: Pictured areas  
Finding: Wood rot  
Information: The building shows evidence of wood rot in many areas. The rear verandah lower timber shows severe rot and wood bora damage required replacement. The flashing above this timber slopes toward the house allowing all rain to rot away this timber over time. There still appears to be supportive timber under the floorboards.

The base of the door frame is loose due to this wood rot. Wood rot, also known as Fungal Decay, occurs when timbers and other cellulose building materials are exposed to damp conditions on an ongoing basis. This could be the result of exposure to weathering over a prolonged period of time, or the attraction of excessive moisture from other abutting building materials.

Early intervention and regular maintenance, particularly of exterior timbers, will prolong the useful life of these building elements. Prior to any works being performed, the cause of the moisture that has created the visible wood rot should be identified and addressed in a suitable manner. Replacement of affected timbers may then be a necessary step in protecting surrounding building elements from such deterioration.

A qualified carpenter or registered builder may also be required to replace affected building materials.

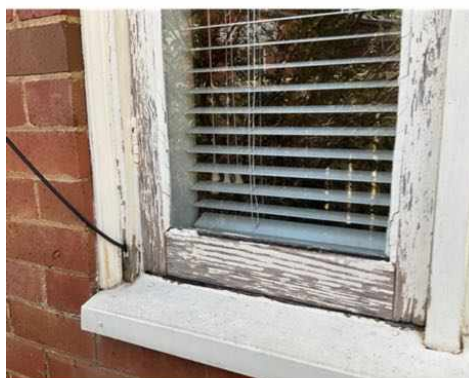
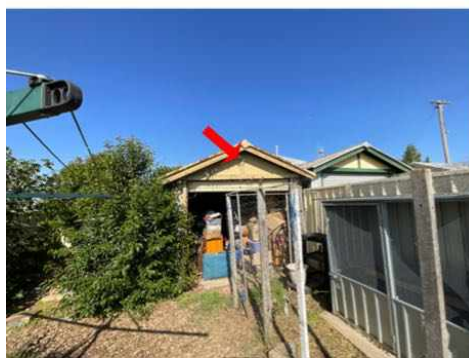
Building:	Building 1
Location:	All windows, facias and garage
Finding:	Painting deteriorated
Information:	Much of the external paintwork has been neglected and require attention to prepare and re-paint.

Whilst incomplete or missing paint finish is generally an appearance defect, it can also lead to the development of secondary building defects over time. Incomplete areas of paint finish expose the area to moisture, potentially accelerating the deterioration of underlying building materials.

Degraded paint finishes should be sanded back, filled, leveled and painted, as applicable. Where inadequate or missing paint protection has led to the deterioration of the associated building element, repair and/or replacement of this building element may be required.

A painting contractor should be appointed as soon as possible to perform necessary works to aid the appearance of the affected area and to ensure the area is protected against further deterioration. Alternatively, the homeowner following manufacturer instructions may perform these works.

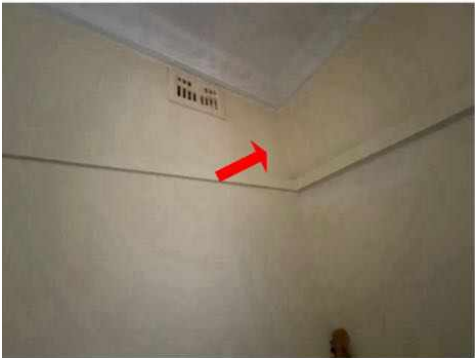
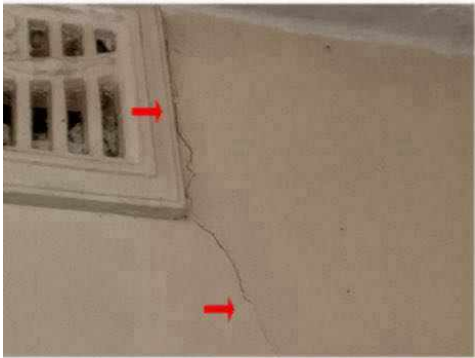
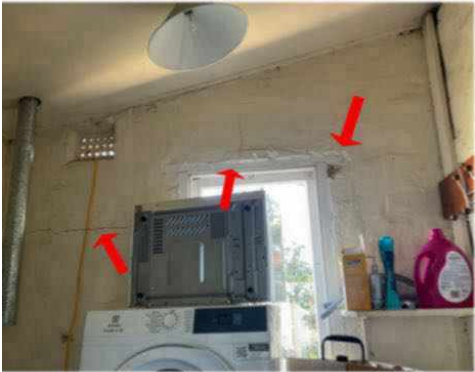
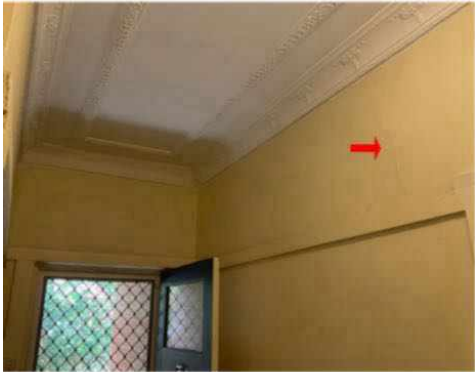
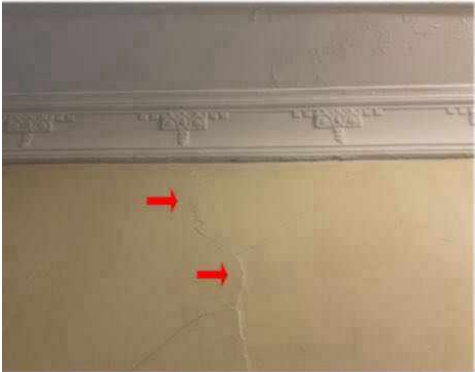
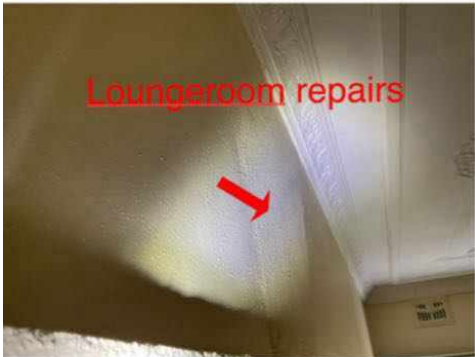
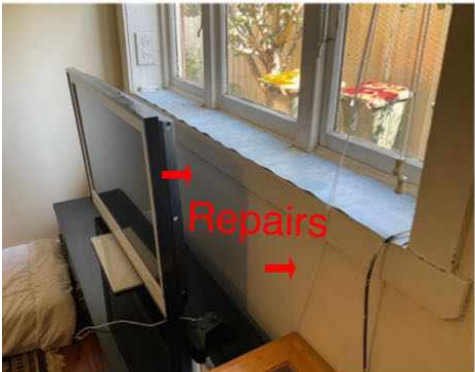
Building:	Building 1
Location:	Many areas
Finding:	Cracks to internal render and repairs
Information:	It has been observed that cracking to internal rendered surfaces and some repairs has occurred. The degree of damage falls within Category 1, described as fine cracks that do not need repair and which are less than 1.0mm in width limit.

Damage of this category is not considered a defect for rectification. Always contact your building inspector should cracks widen, lengthen, or become more numerous.

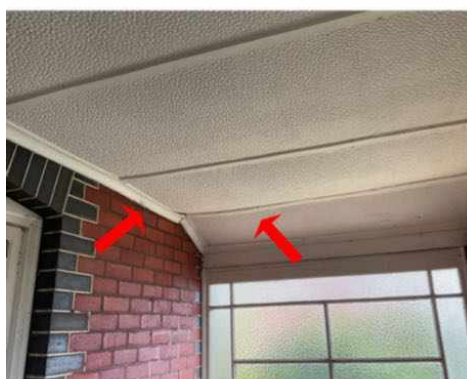
### Finding 3.26

Building:	Building 1
Location:	Porch
Finding:	Ceiling - Sagging/deflection evident
Information:	The cornice/ceiling in the porch was found to have minor sagging / deflection at the time of inspection. Where minor sagging is evident, comparatively minor works, such as re-gluing of ceiling sheets, may be required. Such works may be performed by relevant tradespeople, such as plasterers and painters. This may be general sagging of timbers over time. If excessive moisture has caused the roofing structure to swell and sag, the source of the water leak should primarily be identified prior to any remedial works being performed.

In some cases, sagging ceiling linings may also indicate that there are structural issues, causing surfaces to warp, twist or sag, or that structural timber elements have been weakened from termite activity. An invasive inspection is required to check this area for the cause of this minor deflection.

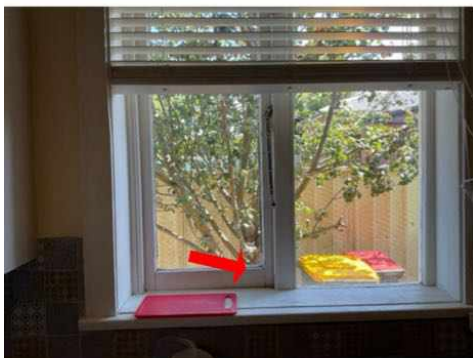
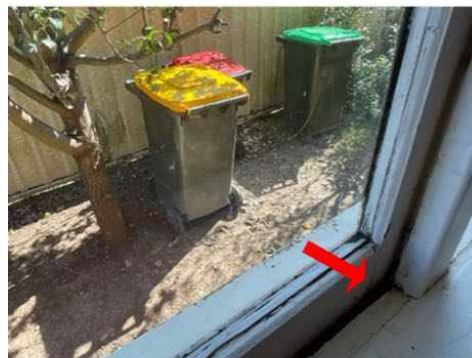
Building:	Building 1
Location:	Pictured areas
Finding:	Windows - jamming and damaged
Information:	Binding and/or jamming and damage to these windows was evident during standard operation. This defect inhibits the functionality of the windows.

A window that binds to frame may have several causes, ranging from minor defects, such as deteriorated hinges, through to major structural issues, such as wall movement.

Where binding/jamming appears to indicate major structural issues, a registered builder should be appointed to provide an estimate on the cost of rectification.

For minor causes like these, a qualified carpenter should be appointed to perform minor rectification works at client discretion.

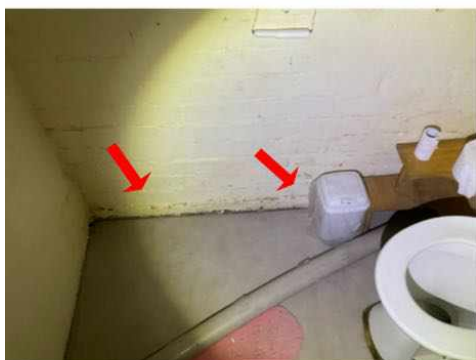
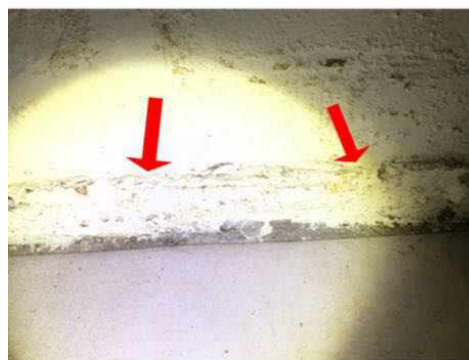
### Finding 3.29

Building:	Building 1
Location:	Laundry toilet
Finding:	Damp - Rising
Information:	Rising damp describes the upward movement of water in low sections of building elements (e.g. walls) by capillary action - the movement of water through porous materials such as bricks, sandstone or mortar.

Rising damp is generally managed by the installation of a damp proof course during construction. A Damp Proof Course (DPC) is an impermeable barrier at the base of the wall above ground level. However, many 19th Century buildings have no damp course installed, or the materials have failed. The DPC may have been omitted as a consequence of poor workmanship, or it may have been bridged where materials built up against the side of the house allow moisture ingress above the DPC level.

The first step in addressing rising damp is to diagnose the cause. The identified cause should be addressed first before addressing the appearance and other defects which have resulted from the rising damp. If the original cause is not resolved, further cases of damp are likely to ensue, resulting in secondary defects.

Consultation with a qualified plumber is advised immediately to identify the cause of the damp and perform remedial works as required.

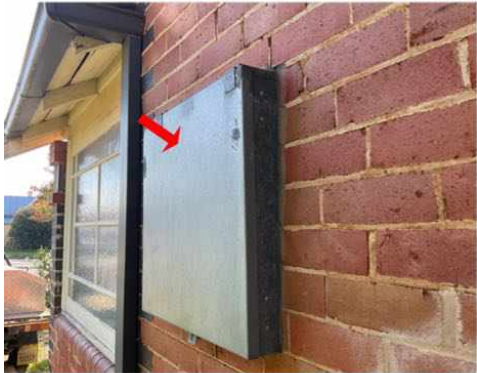
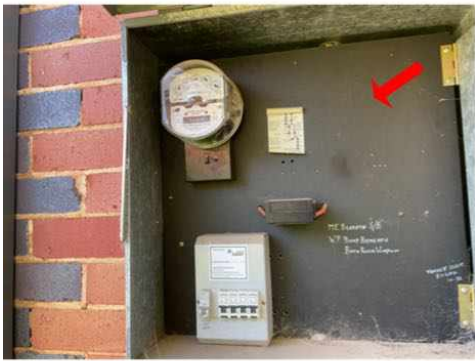
Building:	Building 1
Location:	Meter Box
Finding:	Termite Management System - no evidence of a chemical installation
Information:	The application of a post-construction chemical termite barrier is highly recommended for all properties. Such barriers are highly effective in preventing termite attack on any timber building elements throughout the property.

A durable notice should be placed in the switchboard unit to indicate current termite barriers. At the time of inspection, no durable notice was evident and it appeared as though no chemical termite management system has been installed, with no evidence to suggest preventative works taking place since the property was built.

The client may consider gaining further advice from a pest controller as to the costs and procedures involved with a 'chemical' application. It is recommended that obtaining such advice be a short-term priority.

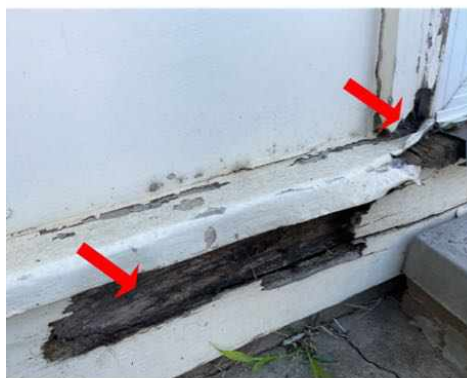
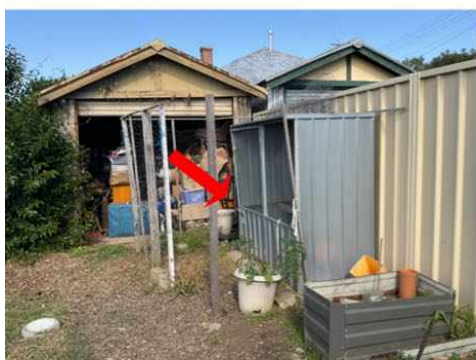
Building:	Building 1
Location:	Rear verandah, windows, small rood areas, garage
Finding:	Fungal decay - present (localised)
Information:	Fungal decay also known as wood decay or wood rot generally refers to the deterioration of timber elements when in contact with excessive levels of moisture for a prolonged period of time.

The development of fungal decay is accelerated by temperatures from 5degreeC to 40degreeC as well as the presence of oxygen. Generally fungal decay develops on timber elements that are in use in an external environment which are exposed to rain penetration.

In this case, the affected timber element is in a decaying state and will need replacement by a carpenter or licensed builder.

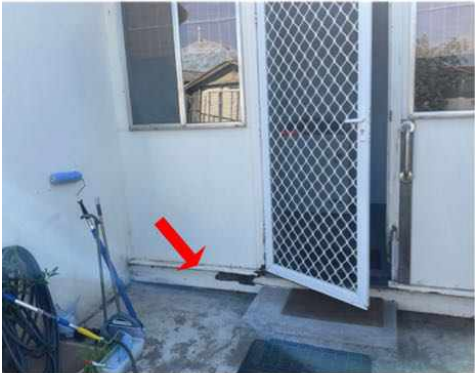
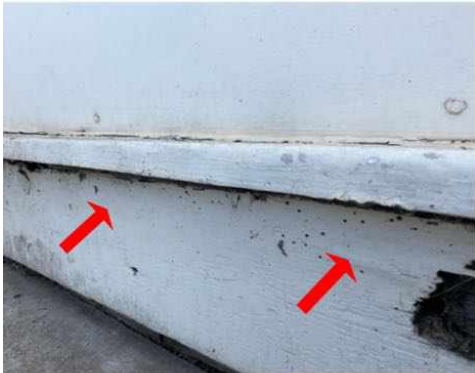
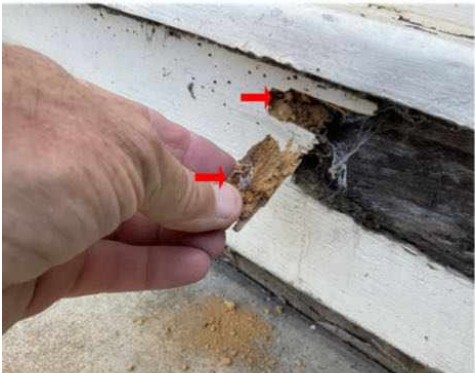
### Finding 8.01

Building:	Building 1
Location:	Rear wall
Finding:	Evidence of wood borer activity identified
Information:	Wood borers small beetles that colonise in exposed timber elements are a common timber pest that are regularly mistaken for termites. Although wood borer activity is generally not detrimental to the affected timber they may lead to serious damage and necessitate replacement of certain building elements if left unattended.

The other commonly known borer the Anobium borer is more likely to attack floorboards and may cause severe structural damage to flooring areas.

As no live wood borer activity was identified treatment is not required at this time. Replacement of affected timbers may be considered by the client for superficial reasons.

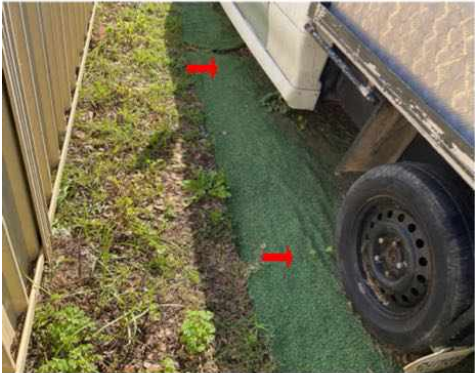
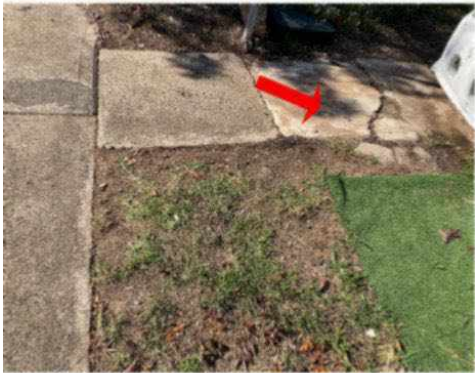
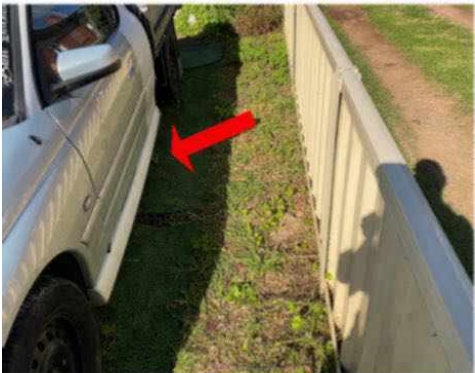
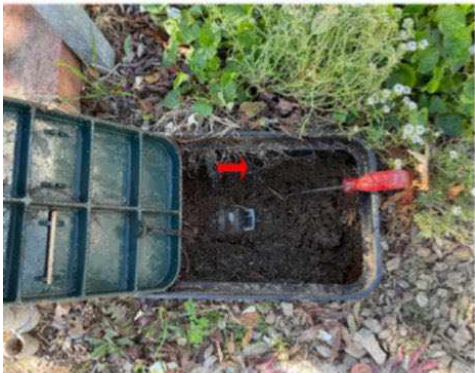
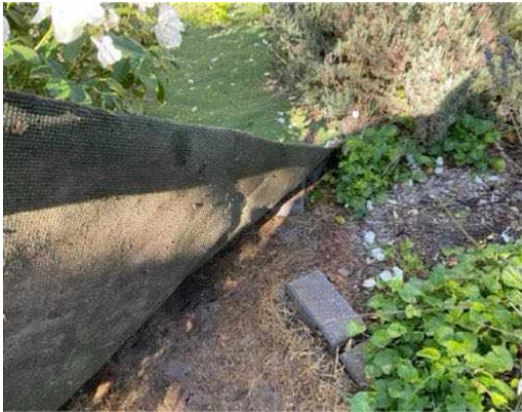
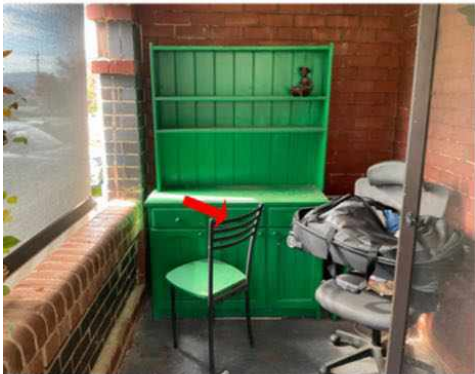
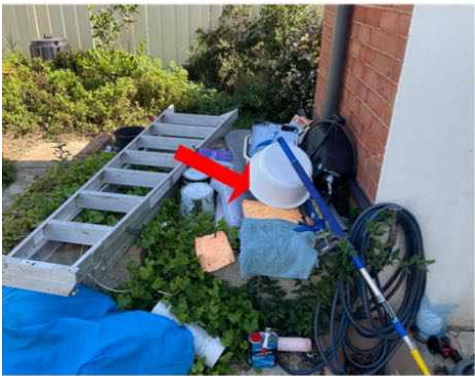
Building: Building 1  
 Location: All External Areas  
 Finding: Additional Photos - Obstructions and Limitations of EXTERNAL AREAS  
 Information: These photographs are an indication of the obstructions and limitations which impeded full inspection of external areas at the time of inspection. These obstructions can hide an array of defects and should be removed to allow full inspection to be carried out. A re-inspection is recommended once the areas are made accessible.

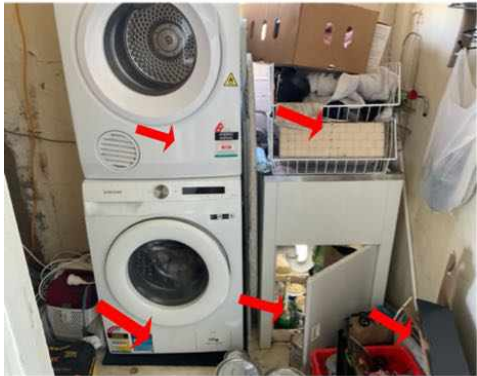
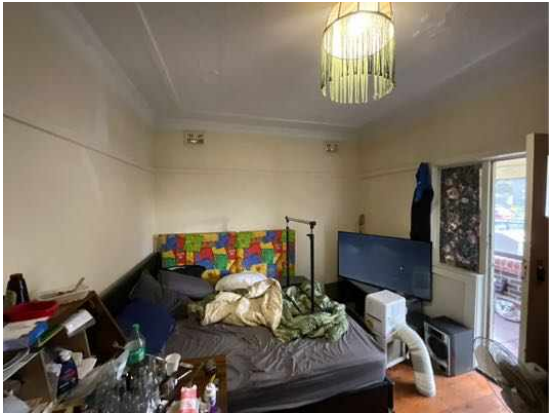
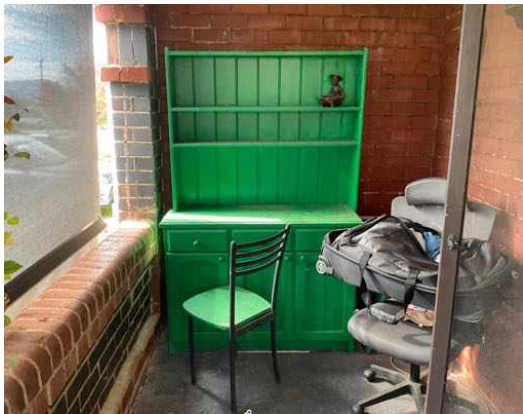
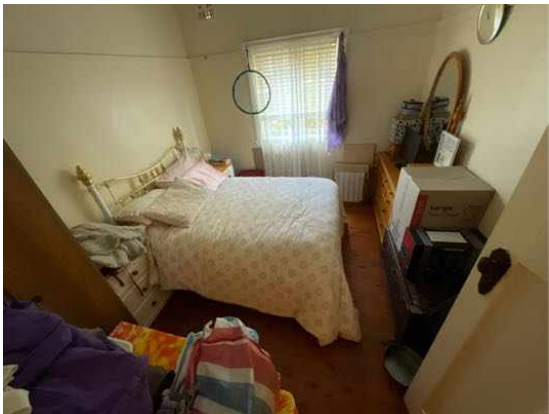
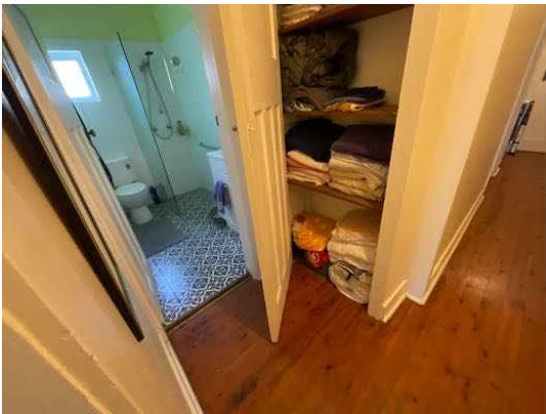
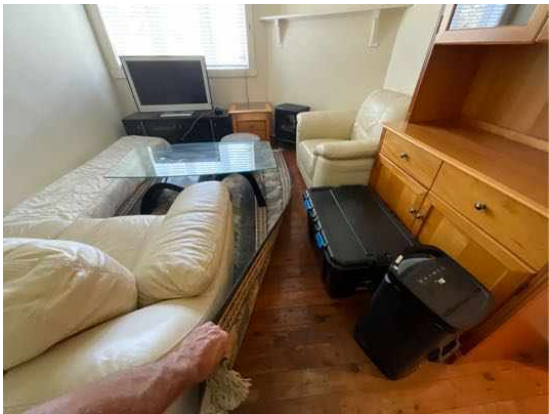
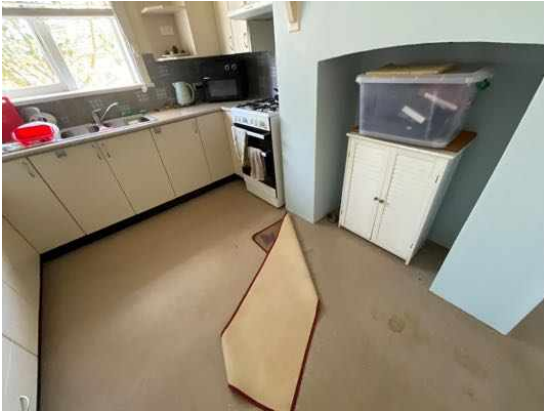
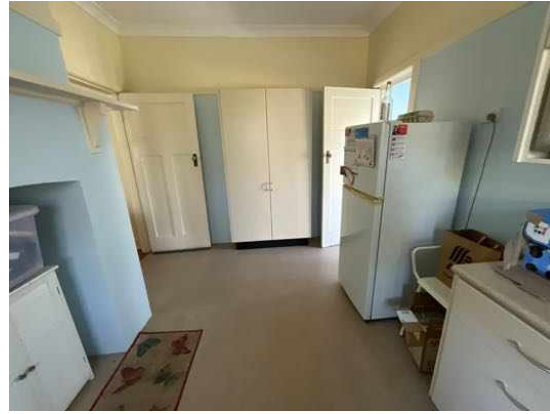
Building: Building 1  
Location: All Internal Areas  
Finding: Additional Photos - Obstructions and Limitations of INTERNAL AREAS  
Information: These photographs are an indication of the obstructions and limitations which impeded full inspection of Internal areas at the time of inspection. These obstructions can hide an array of defects and should be removed to allow full inspection to be carried out. A re-inspection is recommended once the areas are made accessible.

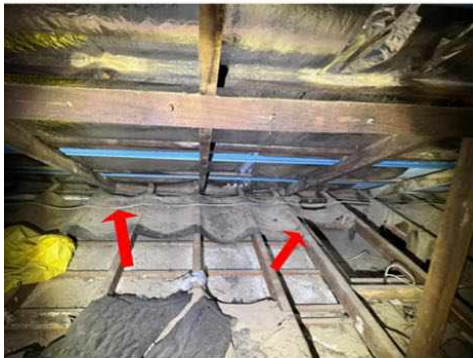
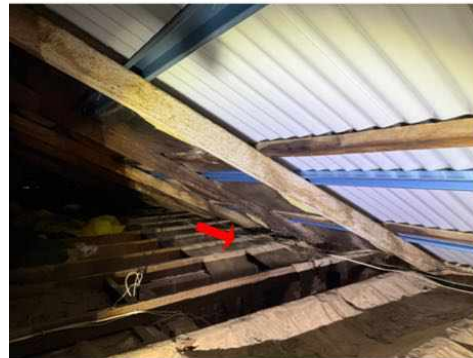
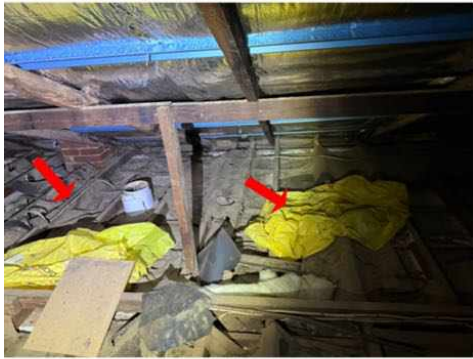
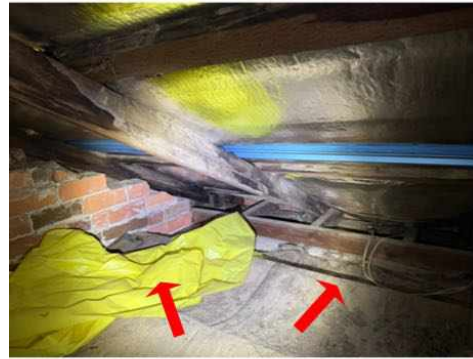
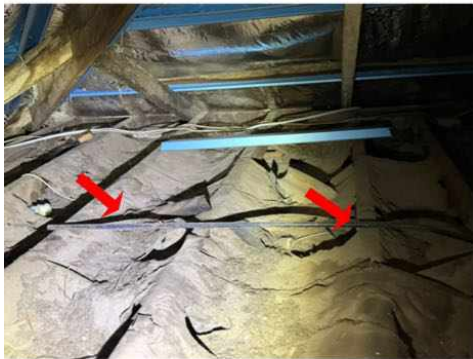
Building: Building 1  
 Location: All Roof cavity areas  
 Finding: Additional Photos - Obstructions and Limitations of the ROOF CAVITY  
 Information: These photographs are an indication of the obstructions and limitations which impeded full inspection of roof cavity areas at the time of inspection. These obstructions can hide an array of defects and should be removed to allow full inspection to be carried out if applicable. A re-inspection is recommended once the areas are made accessible.

The inspection was also limited to areas with an allowable crawl space of 600mm x 600mm, in particular towards the external walls where the roof line diminishes, these areas were not accessible.

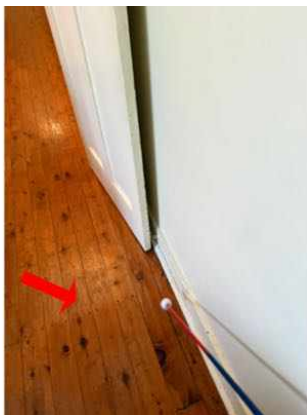
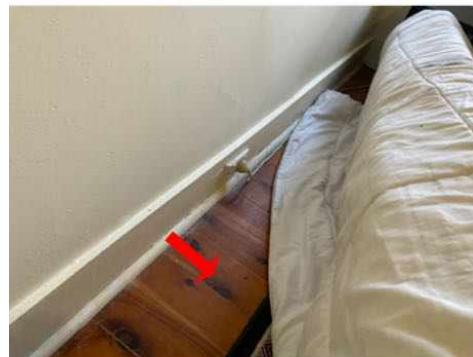
Building:	Building 1
Location:	All Subfloor Areas - no access
Finding:	Additional Photos - Obstructions and Limitations of SUBFLOOR AREAS
Information:	These photographs are an indication of the obstructions and limitations which impeded full inspection of subfloor areas at the time of inspection. These obstructions can hide an array of defects and should be removed to allow full inspection to be carried out. A re-inspection is recommended once the areas are made accessible.

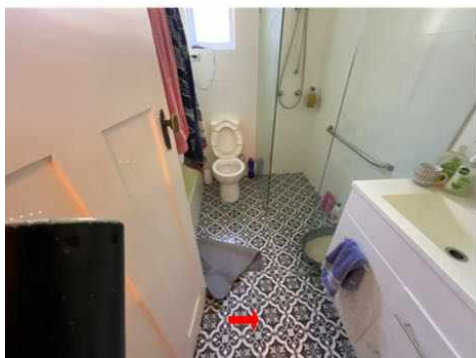
Building: Building 1  
Location: Bathrooms and laundry  
Finding: Waterproofing membranes - Information Only  
Information: Internal Water Proofing Membranes, are crucial in preventing water ingress into the property is important to know that the Membrane System used is to Australian Standards and has been installed correctly.

With older property's where this information is unavailable all wet areas should be monitored. If any leaks, water staining, peeling or bubbling of the paint become evident to any adjacent walls or ceilings below a licensed builder or waterproofing specialist is recommended to investigate further.
