Building and Timber Pest Inspection Report

Inspection Date: Wed, 28 Jan 2026

Property Address: 5 Karoon Ave, Canley Heights 2166

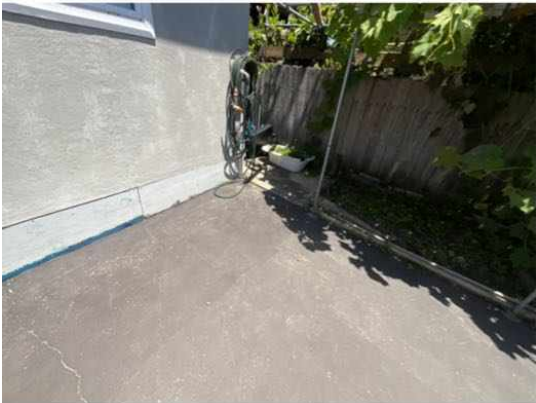
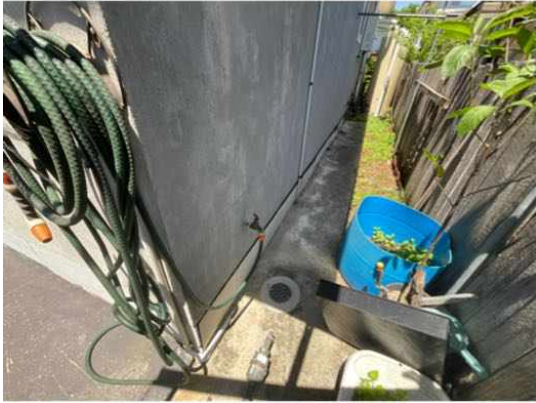
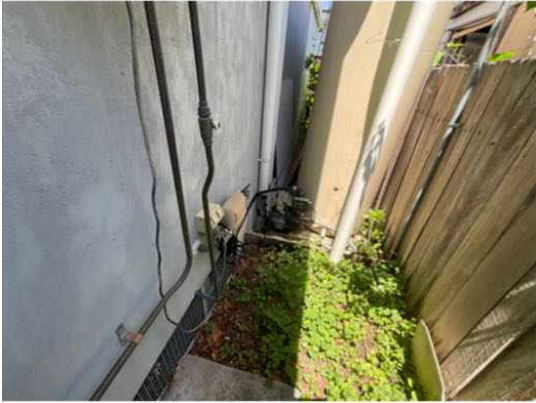
At the time of inspection, the subfloor areas to both the main dwelling and the granny flat were inaccessible. As a result, a full internal assessment of subfloor conditions, including moisture levels, ventilation effectiveness, and evidence of timber pest activity, could not be undertaken. Observations were therefore limited to the external perimeter of the buildings and any visible ventilation provisions.

External inspection identified perimeter subfloor ventilation openings forming part of a passive ventilation system. To the main dwelling, several vents were observed to be partially covered or obstructed, which may restrict airflow into the subfloor space. To the granny flat, no subfloor vents were observed; fibre cement sheeting has been installed around the perimeter, effectively preventing natural airflow to the subfloor area.

While no obvious external signs of moisture distress or timber pest activity were noted at the time of inspection, the actual condition and performance of the subfloor ventilation system could not be confirmed due to access restrictions. Blocked vents, inadequate airflow, elevated moisture levels, or concealed defects may be present but remain undetected.

It is recommended that the subfloor areas to both the main dwelling and the granny flat be reinspected once safe and practical access is made available, to allow for a comprehensive assessment of internal conditions, including moisture levels, ventilation effectiveness, and signs of timber pest activity.

- Assess the adequacy and performance of the existing subfloor ventilation system
- Remove obstructions to existing vents where applicable
- Install additional passive vents or mechanical ventilation, where required
- Confirm that the subfloor environment is suitably managed to minimise moisture build-up and reduce termite-conducive conditions
- Identify and rectify any defects or deterioration identified within the subfloor space

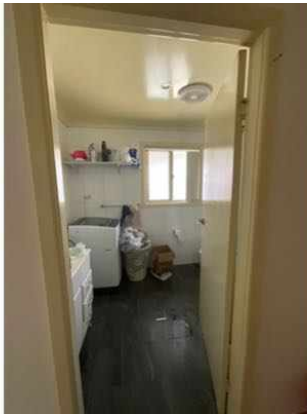
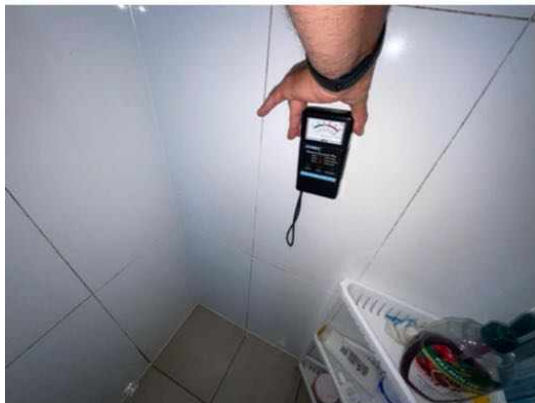
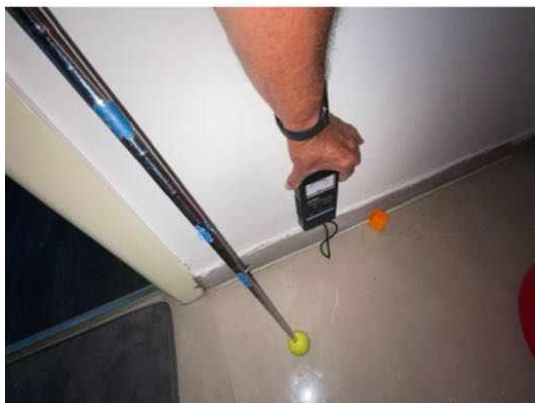
Finding 2.02

Building:	Main Building
Location:	Bathroom - Retreat/Sleepout
Finding:	Major Defect – Dampness to Shower Alcove
Information:	Observation

Evidence of dampness was identified within the shower alcove at the time of inspection. Elevated moisture meter readings were recorded to the wall on the right-hand side of the shower, with additional elevated moisture readings detected behind the shower area. No visible water staining, surface deterioration, or obvious signs of active water damage were observed at the time of inspection; however, moisture levels were above what would be expected for dry internal wall linings.

- Check plumbing pipes, fittings, and fixtures for leaks
- Undertake necessary remedial works, which may include repair or replacement of waterproofing membranes, plumbing components, or affected building materials

Prompt rectification is advised to prevent further deterioration, reduce health risks associated with mould growth, and limit the potential for more extensive and costly structural repairs in the future.

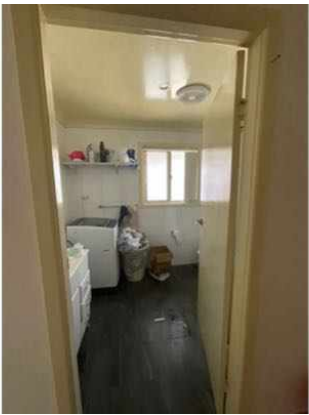
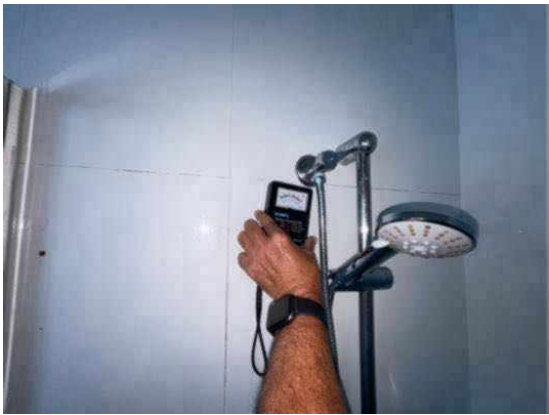
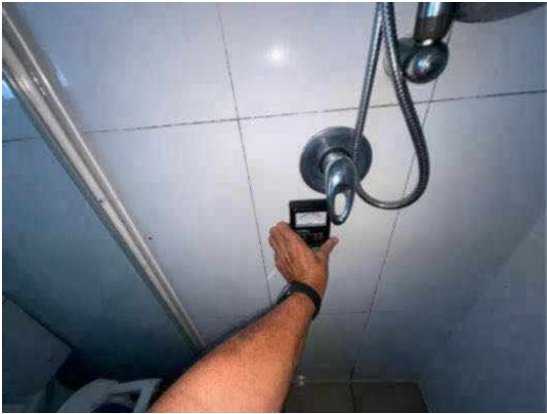
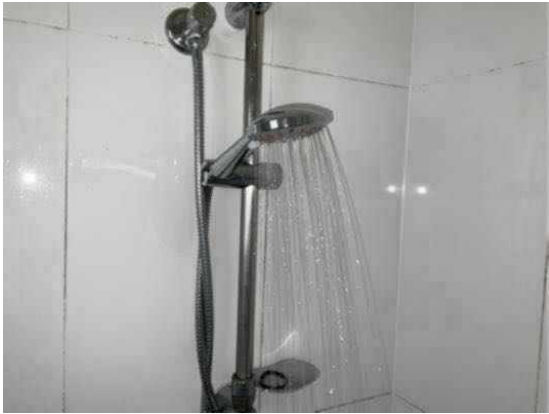
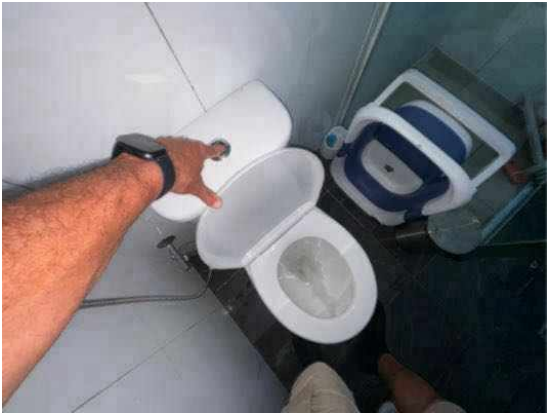
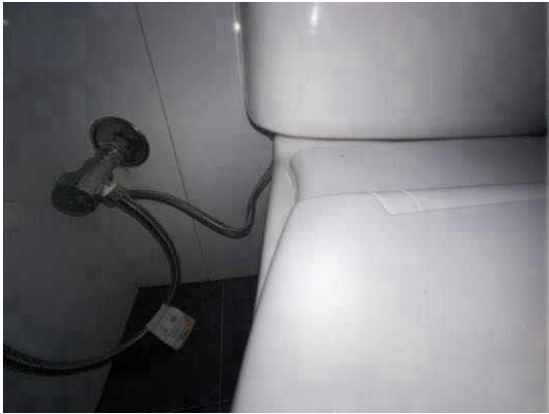
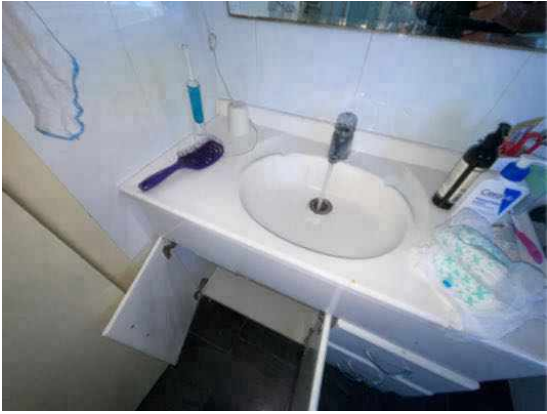
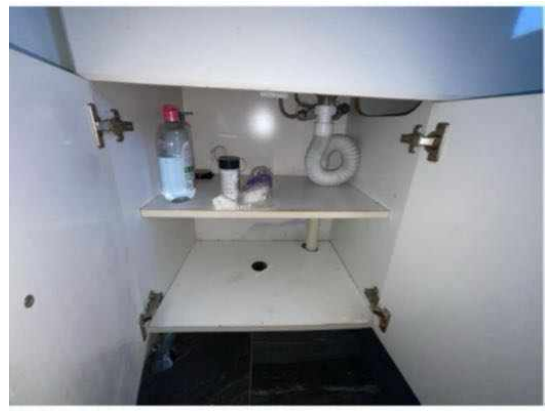
Building: Studio
 Location: Bathroom - Sleepout
 Finding: Wet Areas - Bathroom(s) - Overall Condition & Recommendations.
 Information: Overall Condition & Recommendations

- No elevated moisture readings were detected around the tap fittings, however, elevated moisture readings were found in the right shower wall (as documented)

- Moisture readings (as documented in the report) suggest some retained moisture in the shower walls. Further investigation by a qualified plumber or waterproofing specialist is advised to confirm any underlying issues.

- The condition of grout and sealant appeared to be below average, with some areas potentially requiring maintenance or replacement.
- Grout in wall and/or floor junctions may crack and deteriorate over time. It is recommended to remove any rigid grout from junctions and replace with flexible, mould-resistant sealant in accordance with best building practices.

- Mould growth was noted in some areas of grout/sealant. Cleaning or, if necessary, replacing affected grout or sealant is recommended to maintain hygiene and waterproofing integrity.
- The exhaust fan appeared to be operational, which supports moisture control in the bathroom.

- Basin(s) were water tested and inspected, with no leaks or blockages identified in the plumbing or drainage system at the time of inspection.
- Flexi drainage pipes used on the basin is substandard and recommend replacing.
- Further monitoring is recommended after the basin(s) are placed under regular use to confirm ongoing performance and cleanliness.
- Water damage was noted to the vanity unit, appearing minor.
- Stored items inside the vanity obstructed full visibility during the inspection. It is advised that the area be re-inspected once all obstructions are removed.

- Flood testing of the shower recess is recommended. This may reveal inadequacies in the waterproofing or shower screens, which could lead to water damage in surrounding areas.
