# Building and Timber Pest Inspection Report

Inspection Date: Wed, 25 Mar 2026

Property Address: 5/9 Mason St, North Parramatta NSW 2151, Australia

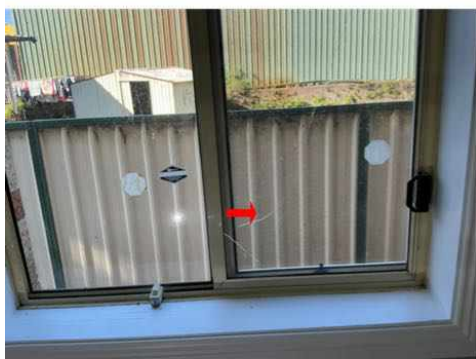
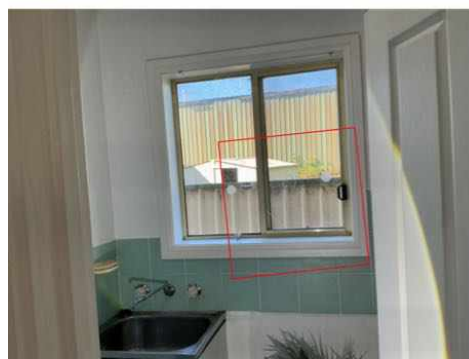
Building:	Main Building
Location:	Laundry
Finding:	Window/s - Cracked
Information:	At the time of the inspection, cracks were identified in the glazing in this area of the property.

Cracking in glazing is generally the result of impact damage, and is likely to develop further when left unmanaged. The likelihood of this window pane further cracking and shattering is increased exponentially, providing a safety hazard in the area. The cracked window also impairs the weather tightness of the building, creating potential for minor water leaks.

A qualified glazier is required to repair the window as soon as possible. Depending on the extent of the cracking, replacement of the window may be required. Please be advised that any persons coming into contact with the cracked window should do so with due caution to avoid any personal injury that may ensue.

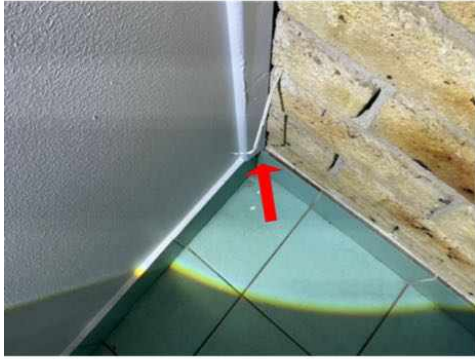
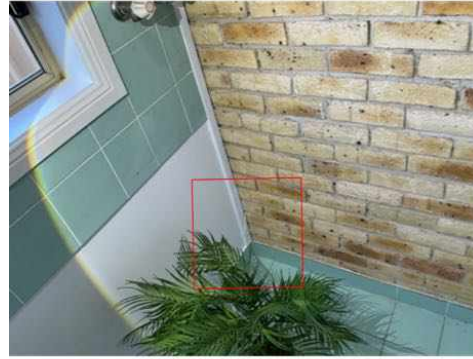
#### Finding 1.02

Building:	Main Building
Location:	Laundry
Finding:	Exposed Wiring
Information:	At the time of inspection, wiring was observed to be exposed and not properly concealed. Exposed wiring presents a safety hazard, as it may be susceptible to damage, accidental contact, and potential electrical risks.

It is recommended that all wiring, whether electrical or communication/cable wiring, be properly enclosed and secured to ensure safety and compliance with acceptable

standards. Where the wiring is electrical in nature, a licensed electrician should be engaged to assess and rectify the installation. For non-electrical wiring, a suitably qualified handyman may be engaged to neatly conceal and secure the wiring in a professional manner.

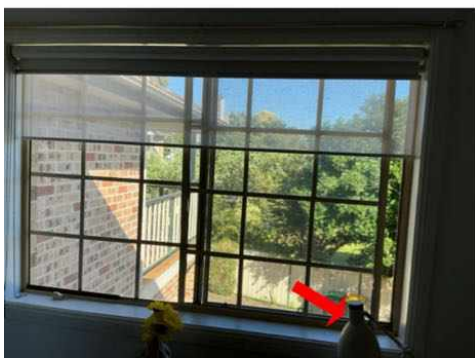
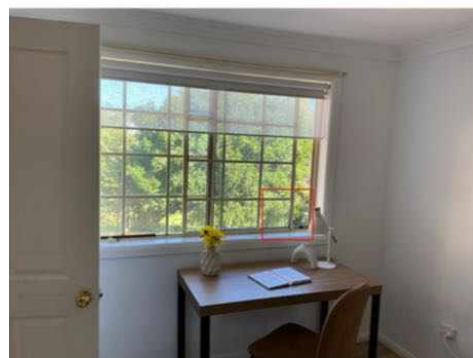
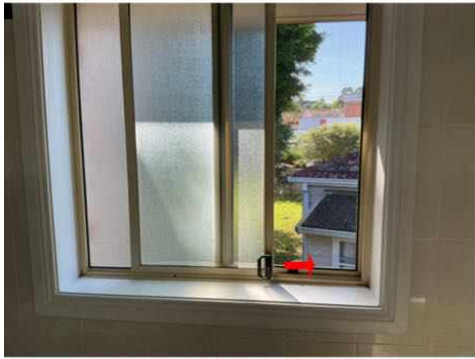
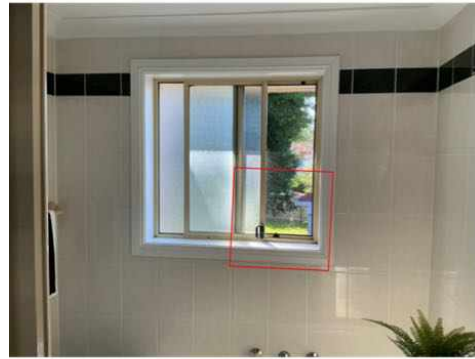
### Finding 1.03

Building:	Main Building
Location:	All Areas Upstairs
Finding:	Window Restrictors - Recommended
Information:	Upstairs windows did not have window restrictors installed. Although not a requirement at the time of construction, it is advisable to install window opening restrictors on all second storey windows with sill heights below 1.7 meter and potential fall of 2 meters or more.

If you live in a strata scheme, window safety devices must be installed on all applicable windows by 13 March 2018. Residents with safety devices installed can still fully open their windows but it's recommended that devices be engaged whenever children are present, to prevent falls.

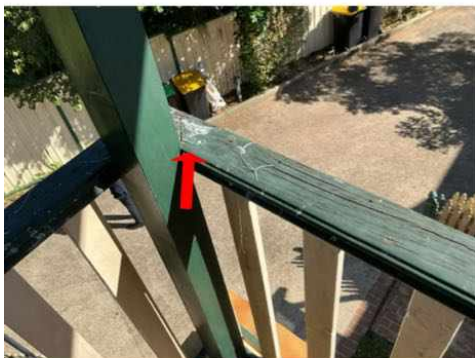
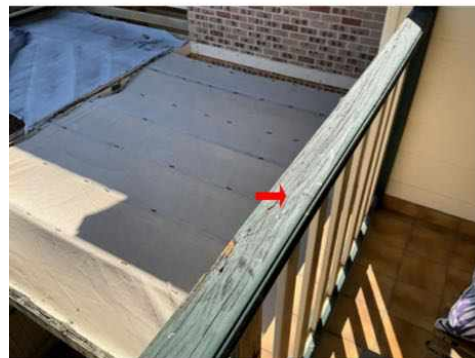
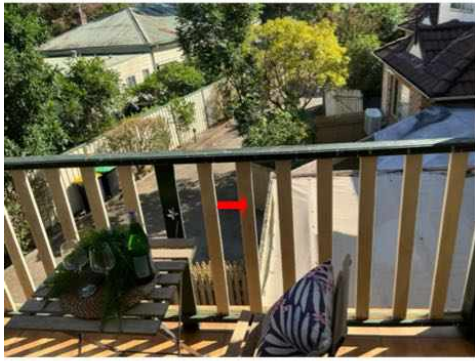
### Finding 1.04

Finding: Loose Balcony Railing

Information: At the time of inspection, sections of the balcony railing were found to be loose, damaged at corner and not securely fixed to the supporting structure. Loose or unstable railings can pose a potential safety risk, particularly where there is a significant change in level adjacent to the balcony edge.

It is recommended that a qualified builder or metal fabricator be engaged to inspect the railing system, tighten or replace any inadequate fixings, and ensure the barrier is securely anchored to meet the intended performance and safety standards.

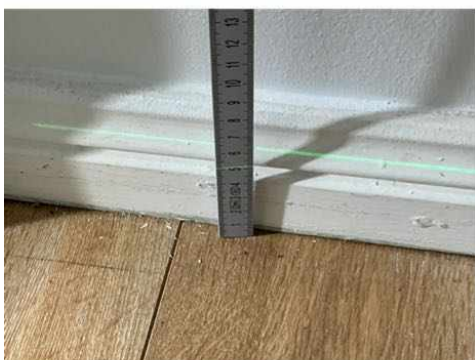
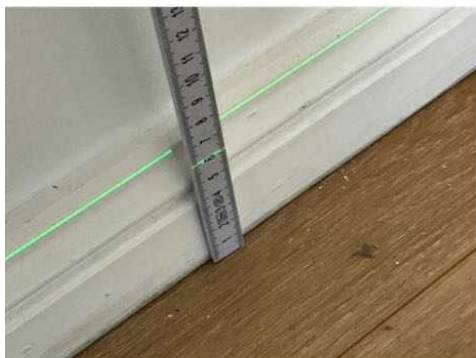
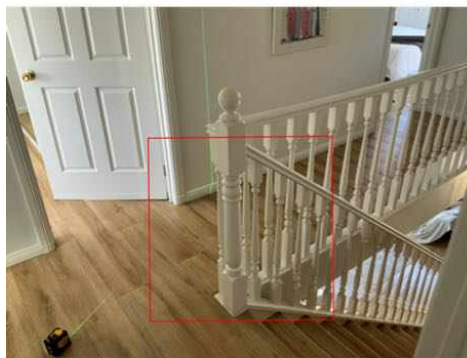
### Finding 2.01

Building:	Main Building
Location:	Hallway Upstairs
Finding:	Flooring - Uneven
Information:	It was noted during inspection, the flooring exhibits noticeable unevenness, which may be due to floor cavity irregularities, structural movement, or improper installation.

This can result in gaps, creaking, or an unstable walking surface. While the issue may not pose an immediate structural risk, it can affect the overall durability and appearance of the flooring. Further actions are recommended such as leveling the subfloor, adjusting the flooring material, or reinforcing the underlying structure.

The client is advised to engage services of a flooring specialist at their own discretion.

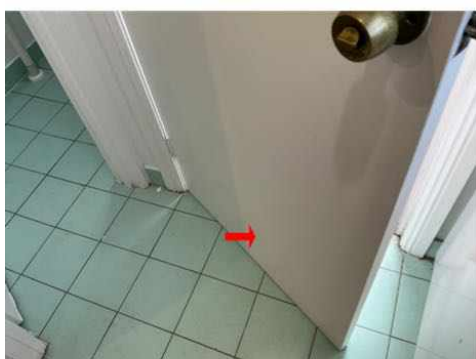
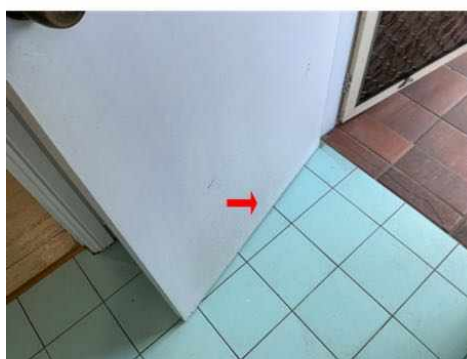
### Finding 3.01

Building:	Main Building
Location:	Laundry
Finding:	Door Weatherstrip - Missing
Information:	It was noted at the time of inspection, the door weatherstrip was missing.

The absence of a door weatherstrip could be due to wear and tear, improper installation, or deliberate removal. The implications include increased energy loss, reduced insulation, potential water leaks during rain, and a compromised seal, allowing drafts and noise to enter the space. Replacing the missing weatherstrip is advisable to maintain energy efficiency, weather protection, and overall comfort within the enclosed area.

A general handy man should be appointed to install the weatherstrip at owners discretion.

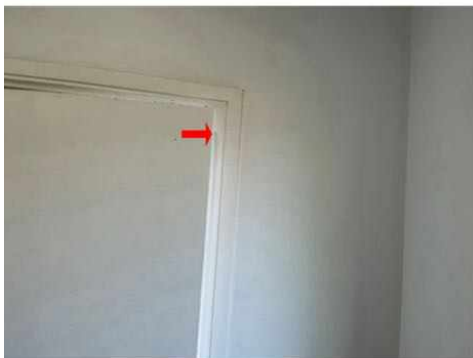
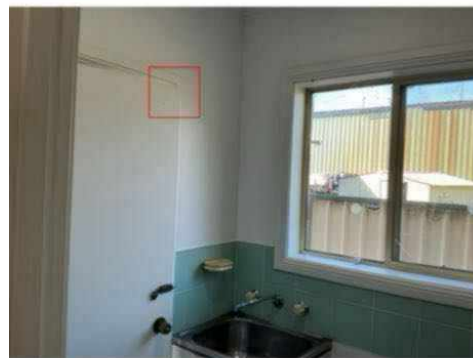
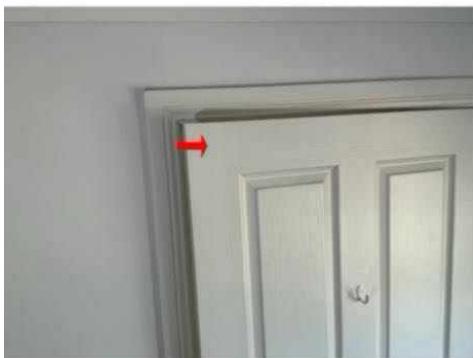
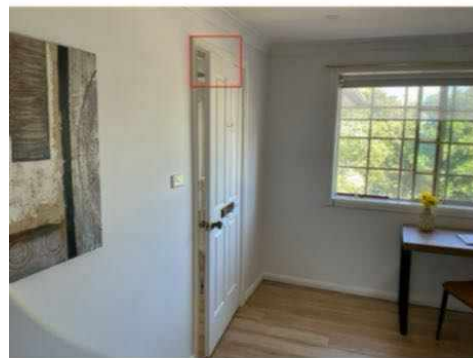
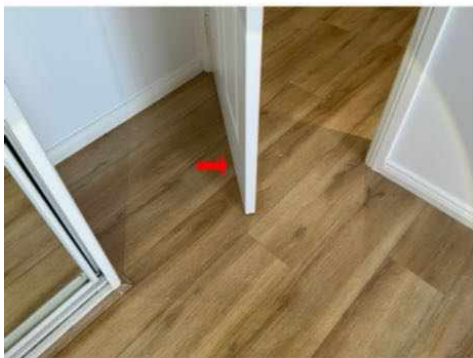
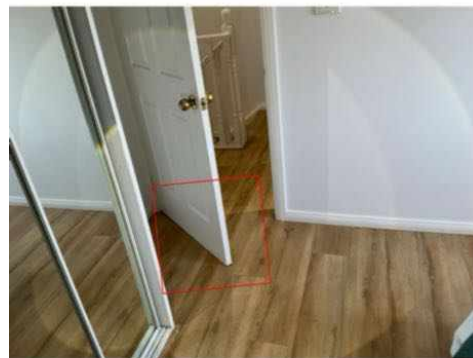
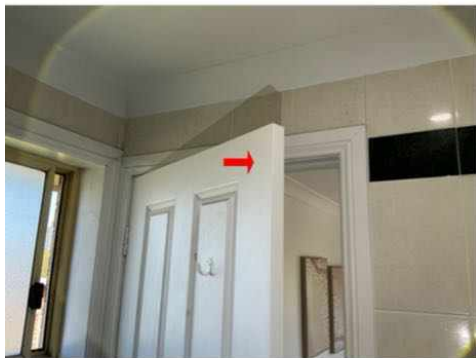
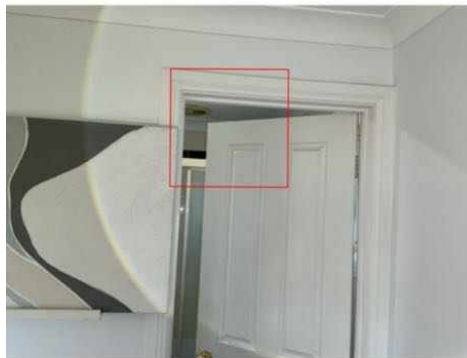
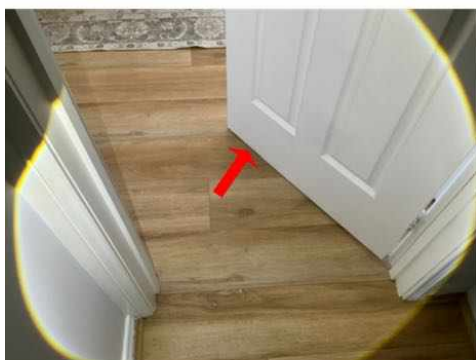
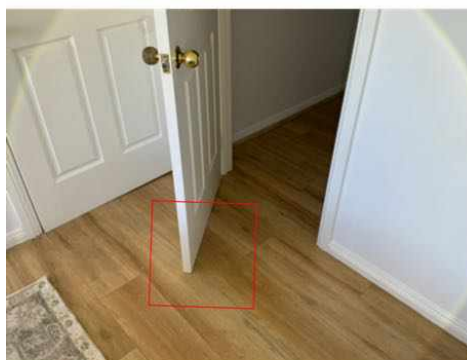
### Finding 3.02

Building:	Main Building
Location:	Laundry, Bedroom 3, Bedroom 2, Master Bathroom, Master Bedroom Closet

Information: At the time of inspection, it was noted that the door was binding or jamming in this area.

Several factors could contribute to this issue, including swelling due to moisture, which can cause wooden doors to expand and fit tightly in the frame. Misaligned or loose hinges may also result in the door sagging or becoming misaligned, making it difficult to close. Over time, wooden doors may warp due to fluctuations in temperature or humidity, leading to improper closure.

It is recommended that a qualified carpenter or handyman be engaged to carry out the necessary repairs to ensure proper door operation.

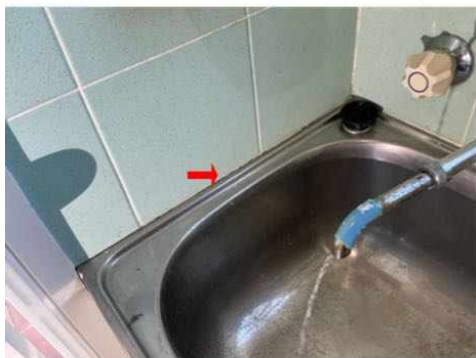
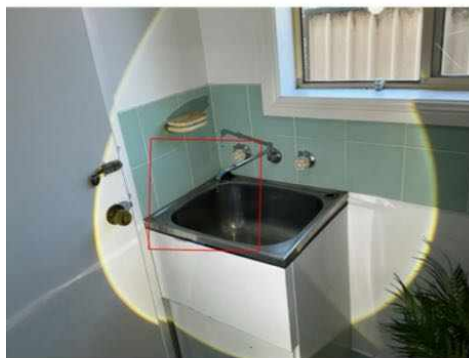
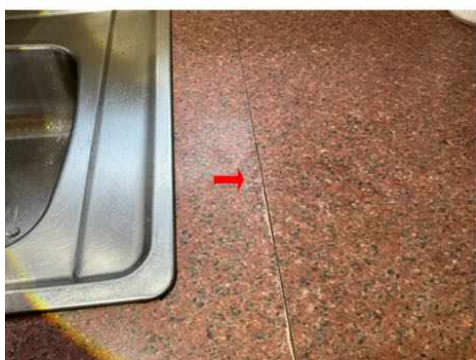
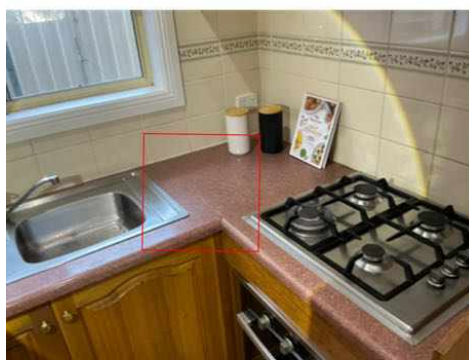
### Finding 3.03

Building:	Main Building
Location:	Laundry, Kitchen
Finding:	Sealant/Grouting - Missing or Damaged
Information:	At the time of inspection, areas of missing and/or deteriorated sealant and grout were noted in this area. This condition can allow water to penetrate behind finishes, which may lead to moisture ingress, deterioration of waterproofing membranes, mould growth, and potential leaks into adjoining areas over time. If left unaddressed, this may result in costly repairs and hidden water damage.

It is recommended that a licensed plumber (or suitably qualified tradesperson experienced in wet area sealing) be engaged to assess the affected areas and reinstate compliant waterproof sealant and grout as required, ensuring all junctions are properly sealed to prevent further water ingress.

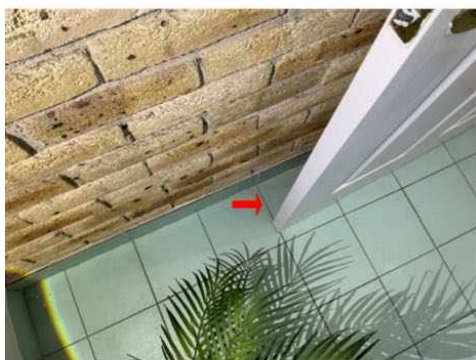
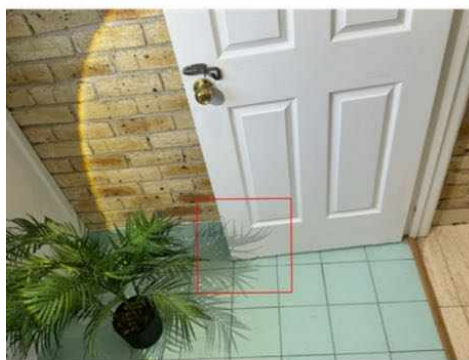
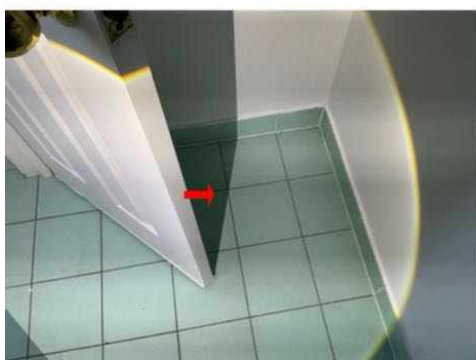
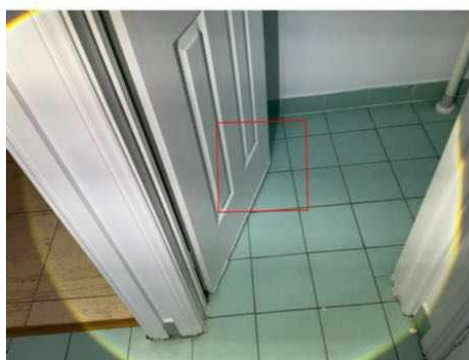
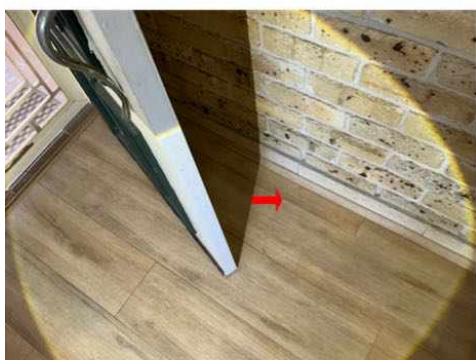
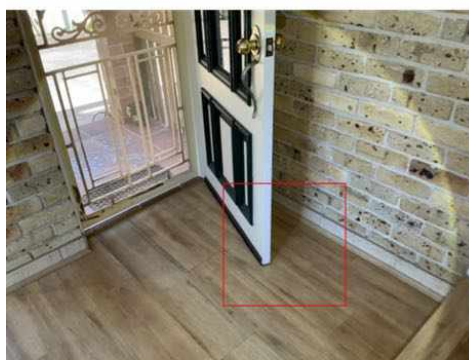
### Finding 3.04

Building:	Main Building
Location:	All Areas
Finding:	Door Stopper(s) - Missing
Information:	At the time of inspection, it was noted that a door stopper was missing in this area.

The absence of a door stopper can lead to potential damage to the door, wall, or surrounding finishes, as the door may swing open too far and impact the wall or adjacent objects. Over time, this can cause dents, scuffs, or even structural damage to the wall or door. It is recommended that a door stopper be installed to prevent further damage and ensure the protection of both the door and the surrounding area.

The client is advised to engage services of a handyman to install the door stopper.

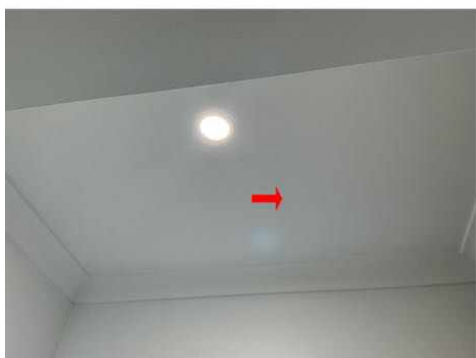
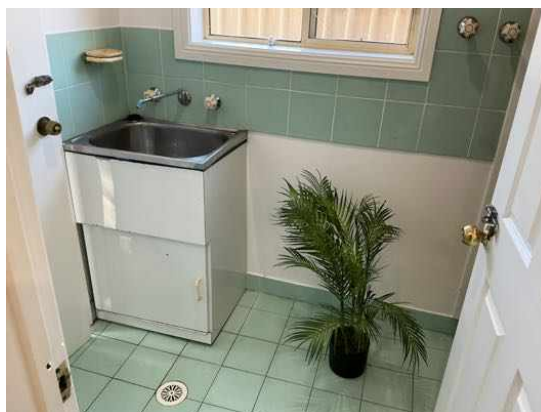
### Finding 3.05

Building:	Main Building
Location:	Laundry
Finding:	Laundry - No Exhaust Fan Installed
Information:	At the time of inspection, it was noted that the laundry area is not equipped with an exhaust fan.

The absence of mechanical ventilation in a confined space such as a laundry can lead to the accumulation of excess moisture and humidity, particularly during the use of washing machines and dryers. Over time, this can result in condensation build-up on walls and ceilings, increasing the risk of mould and mildew growth, which may cause health issues such as respiratory irritation and allergies. Additionally, persistent damp

conditions can contribute to the deterioration of paint, plaster, and other building materials, potentially leading to more extensive and costly repairs.

A licensed electrician should be appointed to carry out this work to ensure the fan is installed safely and in accordance with Australian electrical standards at clients own discretion.

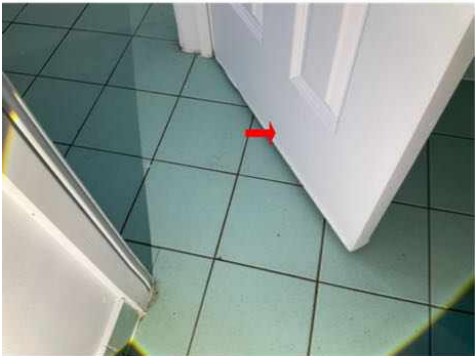
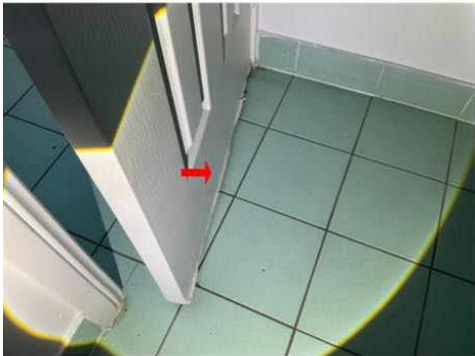
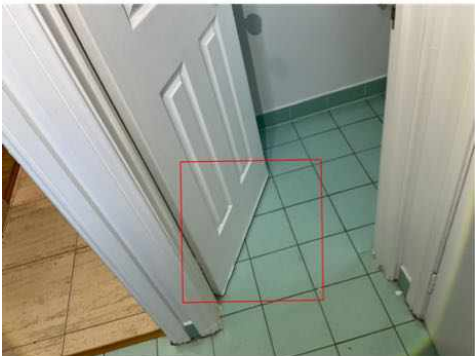
Building:	Main Building
Location:	Toilet (WC)
Finding:	Door - Water/Moisture Damage
Information:	At the time of inspection, water/moisture damage was noted on this/these door(s) within the property.

The affected doors exhibit signs of swelling, warping, and possible discolouration, which can impair their functionality and compromise their structural integrity. Prolonged exposure to moisture can cause the door material to deteriorate, leading to issues with closing and sealing, and increasing the likelihood of further damage over time. Moisture-damaged doors can also become a breeding ground for mould and mildew, which may pose health risks to occupants if left unaddressed. It is recommended that the damaged doors be repaired or replaced, and that any sources of moisture nearby be investigated and rectified to prevent recurrence.

The client is advised to engage services of a carpenter to rectify or replace the door.

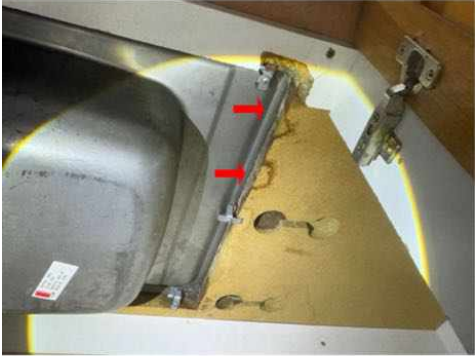
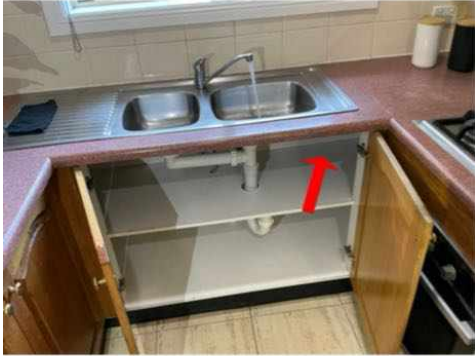
**Finding 3.07**

Building: Main Building  
Location: Kitchen  
Finding: Kitchen Benchtop - Water Damage  
Information: At the time of inspection, the kitchen benchtop was noted to be water damaged, with visible swelling and deterioration of the surface material. Prolonged water exposure can weaken the structure of the benchtop and reduce its serviceability. It is recommended that a suitably qualified carpenter or kitchen installer be engaged to repair or replace the benchtop at the client's discretion.

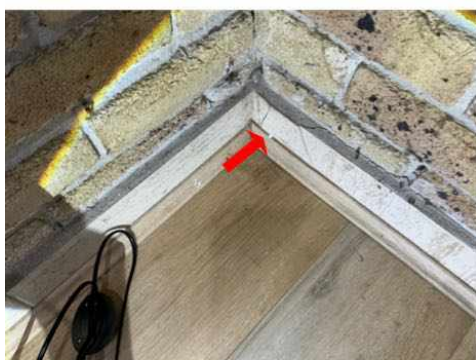
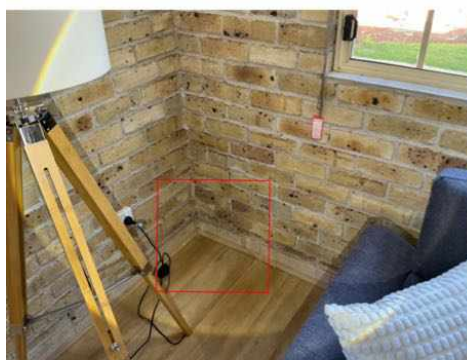
**Finding 3.08**

Building: Main Building  
 Location: Living Room  
 Finding: Tiles - Cracked (Common Areas)  
 Information: At the time of inspection, cracks and damage were noted on floor tiles in this area. The damage may have resulted from a combination of factors, including impact, poor surface preparation during installation, or minor building movement causing stress to the tiled surface. These cracks not only affect the appearance but may allow moisture to penetrate beneath the tiles, potentially leading to further deterioration over time.

It is recommended that a licensed tiler be engaged to replace them at own discretion.

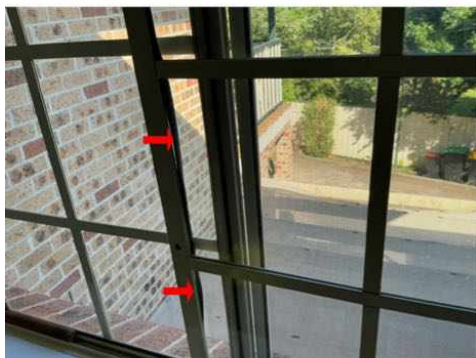
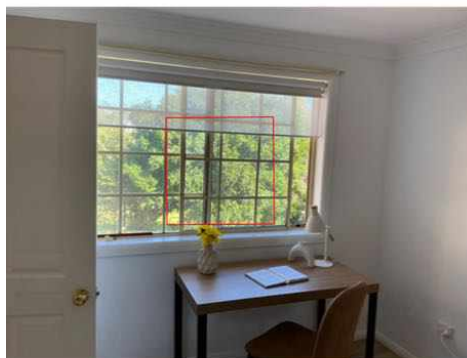
### Finding 3.09

Building: Main Building  
 Location: Bedroom 3  
 Finding: Maintenance and/or Wear and tear on building elements  
 Information: It was observed at the time of inspection that some building elements and areas around the property require general maintenance and/or exhibit signs of wear and tear. These typically include minor imperfections such as paint scuff marks, scratches on surfaces, small chips, nails or hooks left in walls from previous picture hanging, and other superficial blemishes.

These are generally considered minor items that are common in established homes. While they may be noticeable on visual inspection, they do not affect the structural integrity or functionality of the property. In most cases, these issues can be easily addressed by a qualified handyman as part of routine maintenance.

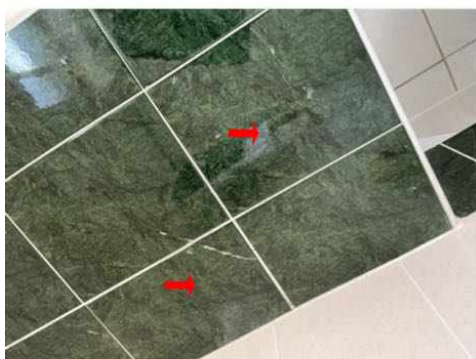
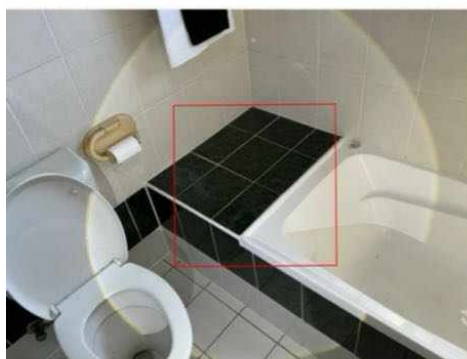
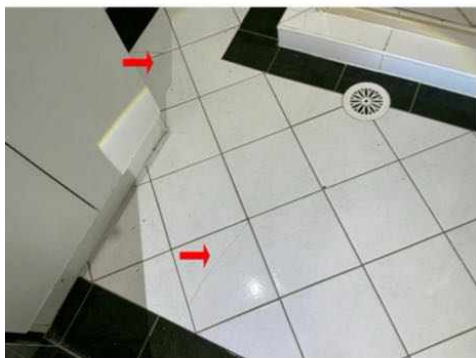
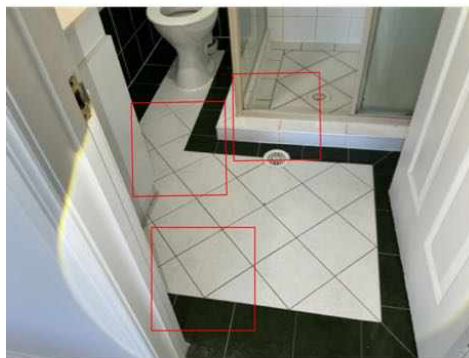
### Finding 3.10

Building:	Main Building
Location:	Bathroom, Master Bathroom
Finding:	Tiles - Cracked and/or Damaged
Information:	At the time of inspection, cracking in the tiles was evident in this area. It is suspected that this cracking has occurred as a result of minor settlement or material shrinkage.

While the cracking appears to be minor, this area may be exposed to water, allowing potential for water penetration into adjoining sections of walls or flooring. In wet areas particularly, cracked or compromised tiles can allow moisture to bypass the surface finish and place additional stress on the underlying waterproofing membrane. Over time, this may contribute to deterioration of the waterproofing system and shorten its effective service life.

While not considered a matter of urgency, replacement of cracked floor tiles is recommended at the client's discretion, particularly in wet areas to preserve the integrity and longevity of the waterproofing system. A licensed tiling contractor may be appointed to perform these works.

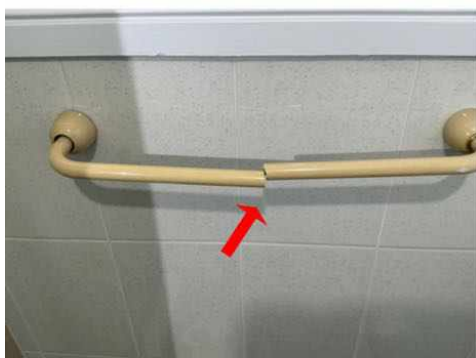
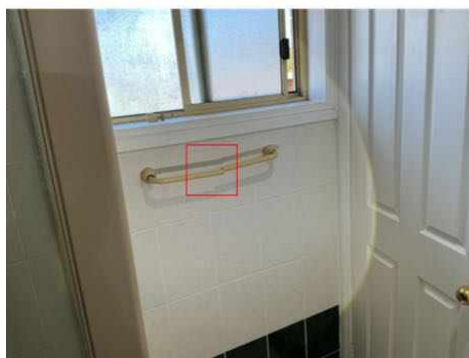
### Finding 3.11

Building:	Main Building
Location:	Ensuite - Master
Finding:	Building Element - Damaged - Assorted Items
Information:	Some of the assorted building elements were found to be damaged at the time of inspection.

Damage occurs generally when the building materials have either aged and decayed, or as a result of damage (accidental or deliberate).

Repair and/or replacement of broken elements is advised to ensure that additional secondary defects do not arise as a consequence. Such works are necessary, as all building elements play a key role in the operation and function of the overall structure and its performance.

A relevant tradesperson should be appointed to repair or replace the affected building element prior to any subsequent damage being caused.

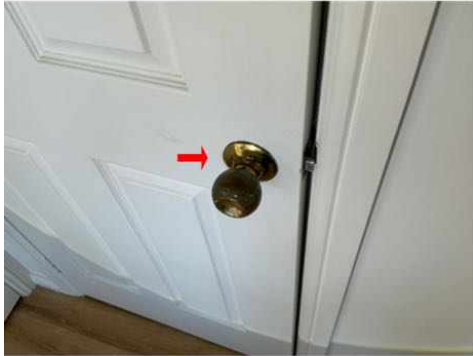
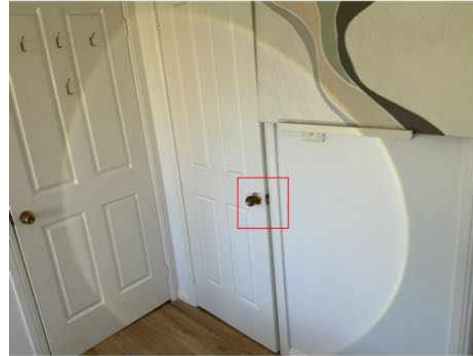
### Finding 3.12

Building:	Main Building
Location:	Bedroom - Master Closet
Finding:	Door Handle - Not Latching

**Information:** At the time of inspection, the door handle was found to be not latching properly, which may affect security and ease of use. This issue could be due to misalignment between the latch and strike plate or wear and tear of the handle mechanism. It is recommended that a handyman be engaged to assess and repair or realign the latch assembly to restore full functionality.

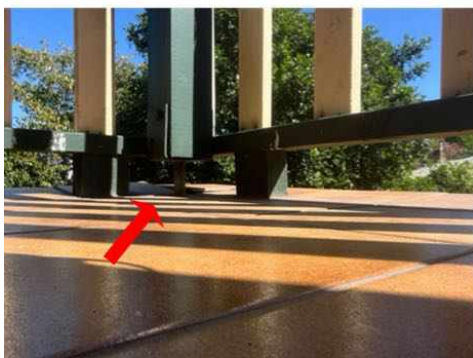
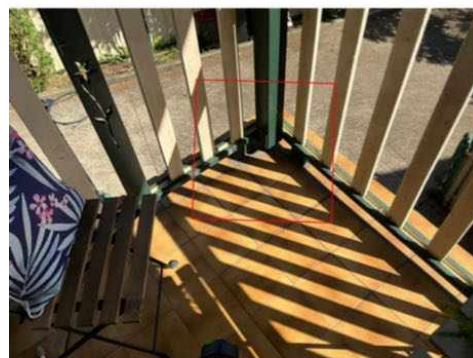
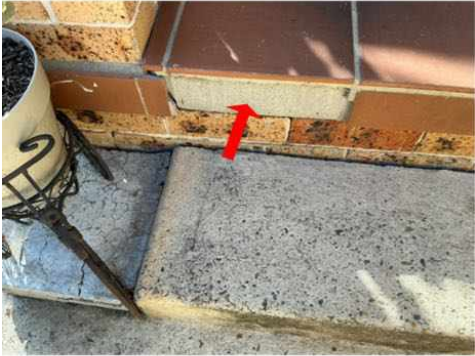
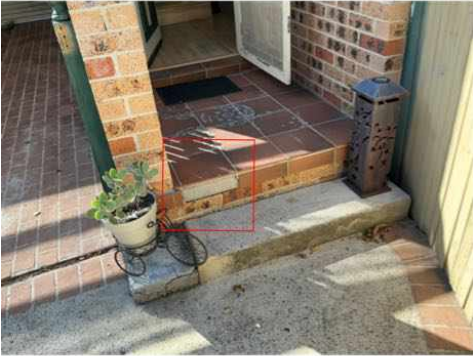
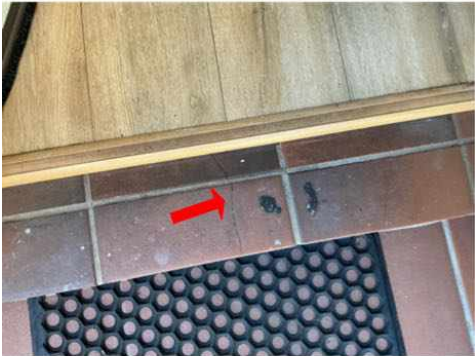
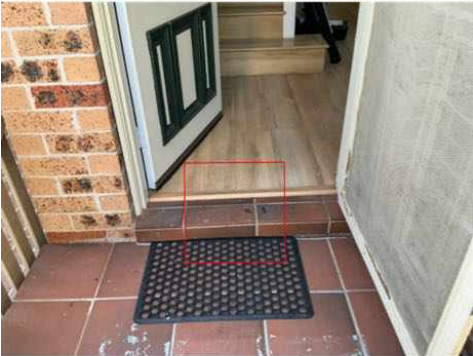
### Finding 3.13

**Finding:** Tiles Coming off, Cracked & Deteriorating Sealant/Grout (External)

**Information:** At the time of inspection, sections of external tiling were noted to be coming loose, with some tiles cracked and exhibiting missing or deteriorated grout and sealant in the affected area. As this condition is located externally, it is exposed to weather conditions, which can accelerate deterioration.

This condition may allow water to penetrate beneath the tiles, leading to potential moisture ingress, damage to the underlying substrate, and further tile displacement over time.

It is recommended that a qualified tiler be engaged to resecure or replace the loose and cracked tiles, and to reapply appropriate grout and external-grade waterproof sealant to restore the integrity and durability of the surface.

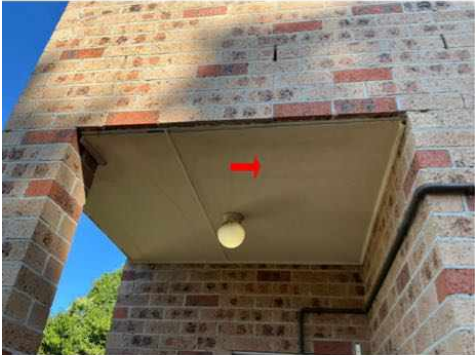
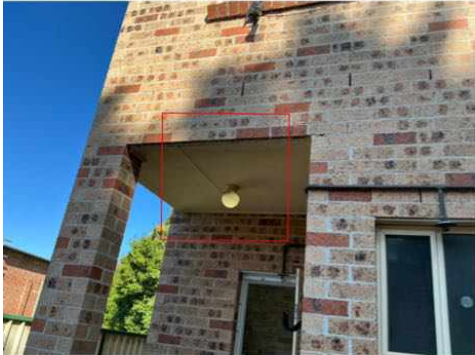
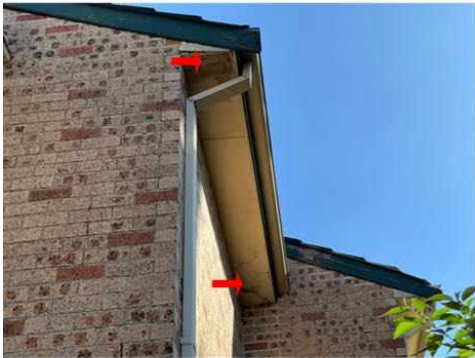
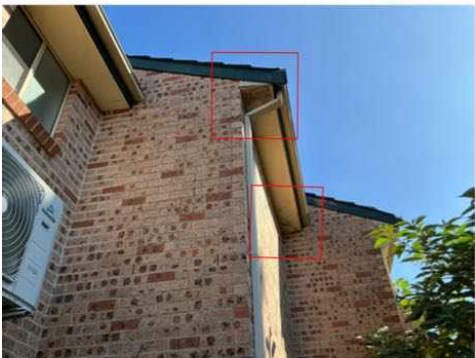
**Finding 3.14**

Building: Main Building  
Location: Eaves  
Finding: Eaves - Water stained  
Information:

Water staining to eaves linings in this area was evident at the time of inspection. Water staining indicates that surfaces have been exposed to excessive moisture over time. The minerals and other elements in the water lead to staining, which may graduate to corrosion and deterioration if left unmanaged.

While mostly an appearance defect, water staining can be indicative of more serious defects, which may be currently concealed by interior ceilings, even though they were

noted dry at the time of inspection.

Where water staining is active, a licensed plumber must be consulted to provide advice on any repairation works that may be required. Replacement of any damaged structures is advised.

Conversely, where water staining is old and inactive, affected building materials may be repaired or replaced at client discretion.

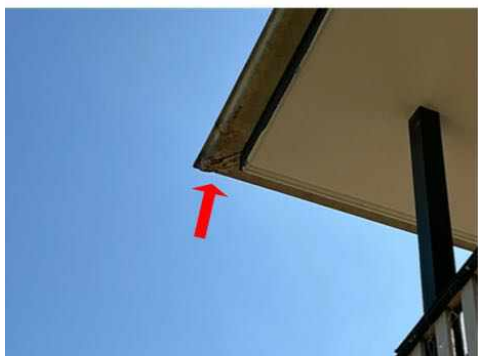
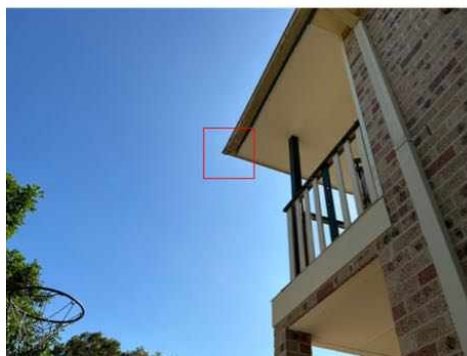
### Finding 3.18

Building:	Main Building
Location:	All Areas
Finding:	Gutters - Corroded/Rusted
Information:	At the time of inspection, sections of the gutters were observed to be corroded/showing visible rust. Corrosion typically occurs due to prolonged exposure

to moisture, standing water, or accumulated debris, which prevents proper drainage and allows water to sit in the gutter. Over time, rust can weaken the metal, leading to leaks, holes, and eventual gutter failure if not addressed.

It is recommended that a licensed roof plumber inspect the affected areas and replace the rusted gutter sections to restore proper function.

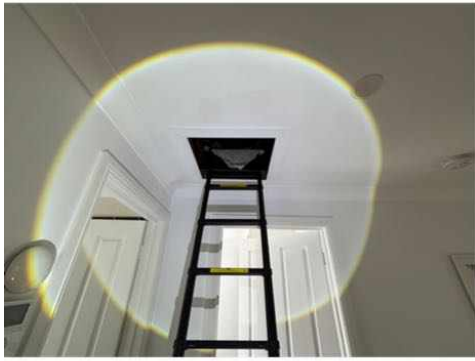
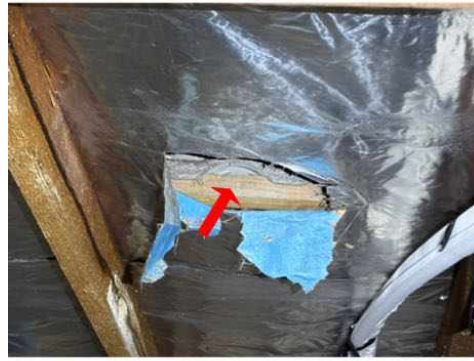
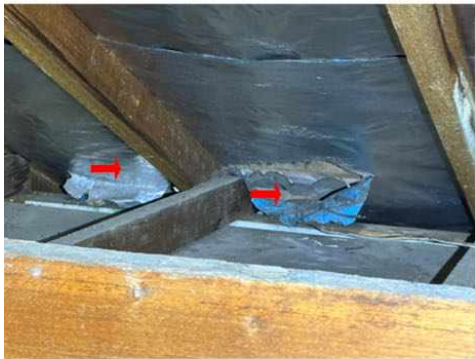
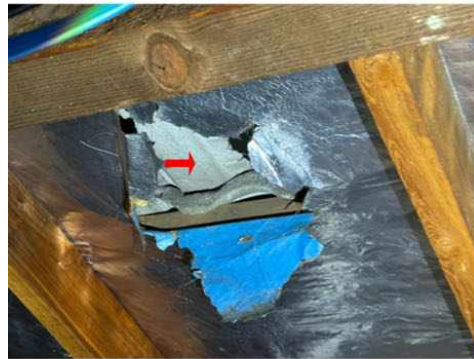
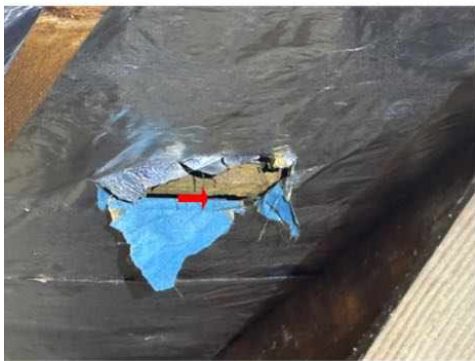
### Finding 3.19

Building:	Main Building
Location:	Roof Void
Finding:	Sarking - Damaged
Information:	Sarking, a laminated aluminium foil applied to the interior of the roof covering, assists in insulating the property and acting as a vapour-barrier to the roof void and, subsequently, to the household.

Where sarking is damaged, both insulation and moisture protection of the property are inhibited. This creates a loss of energy and thus negatively impacts the energy efficiency of the property, allowing potential for moisture ingress from condensation or leaking roof tiles.

It is important to repair any holes or damaged sections of sarking to ensure that the building material is fully functional. A registered roofer should be consulted to provide further advice on this defect and to perform rectification works at client discretion.

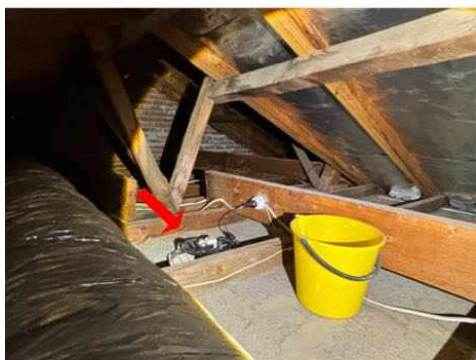
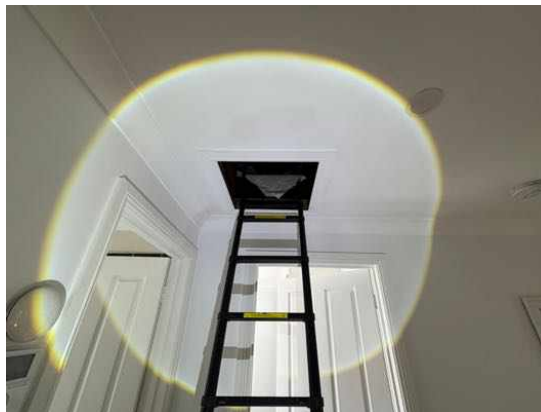
### Finding 3.20

Building:	Main Building
Location:	Roof Void
Finding:	Vent - Extracted into Roof Space
Information:	During the inspection, it was noted that the exhaust vent has been improperly terminated into the roof space instead of being ducted to the exterior of the property.

This configuration is a defect as it allows moist air to accumulate within the roof cavity, increasing the risk of condensation, mould growth, and deterioration of insulation or timber framing. Proper ventilation is essential to maintain a healthy indoor environment and protect the structural integrity of the building. It is recommended that the vent be appropriately re-routed to discharge externally in compliance with relevant building

standards.

A licensed mechanical ventilation contractor/electrician should be appointed as soon as possible to provide further consultation on the scope of these works and to provide quotations for any necessary works.

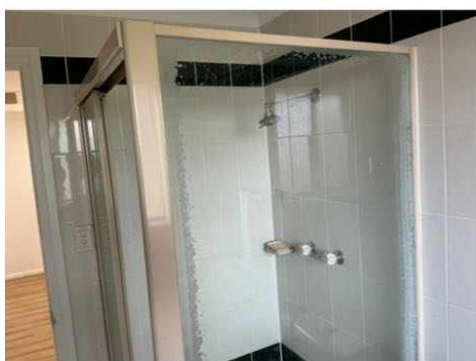
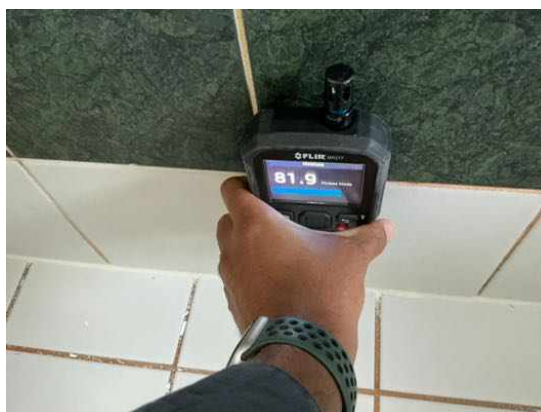
### Finding 3.21

Building:	Main Building
Location:	Both Bathrooms
Finding:	Excessive Moisture - Shower Damp
Information:	At the time of inspection, excessive moisture was noted within the shower area, which is a common issue in wet areas due to the continual exposure to water. This condition is typically caused by moisture seeping through grout lines and settling behind tiles, resulting in localised high-moisture zones. Provided there is no evidence of water staining or elevated moisture readings on the opposite side of the wall, this is considered a minor defect.

However, persistently damp conditions may act as conducive conditions for termite activity, as termites are strongly attracted to moisture-rich environments. It is recommended that the client ensures regular use of the exhaust fan and maintains adequate ventilation after shower use to promote drying and reduce long-term moisture build-up, thereby also reducing the risk of attracting termites.

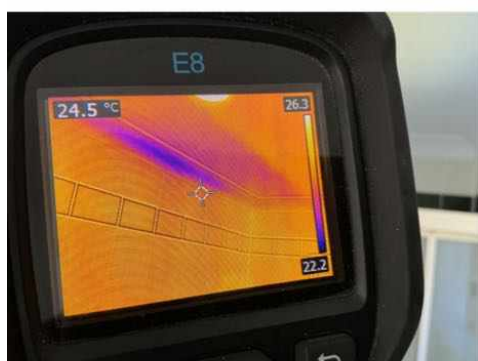
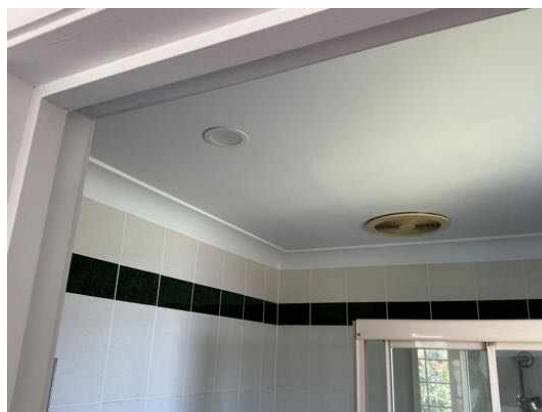
### Finding 3.22

Building:	Main Building
Location:	Ensuite - Master
Finding:	Potential Moisture Risk – Air Conditioning Ducting
Information:	At the time of inspection, no visible staining or damage was noted to the ceiling surface. However, thermal imaging indicated temperature variation consistent with possible condensation. Upon inspection of the roof space, it was noted that the air conditioning ducting was installed in direct contact with the plasterboard ceiling, with no visible insulation separating the ducting from the ceiling lining.

This installation increases the risk of condensation forming on the ducting, which may transfer moisture to the plasterboard over time and lead to future staining.

It is recommended that an air conditioning specialist be engaged to assess the duct installation to confirm there's no condensation.

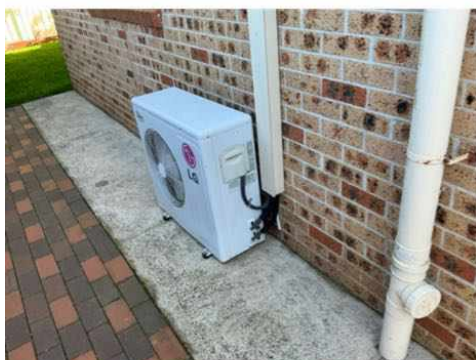
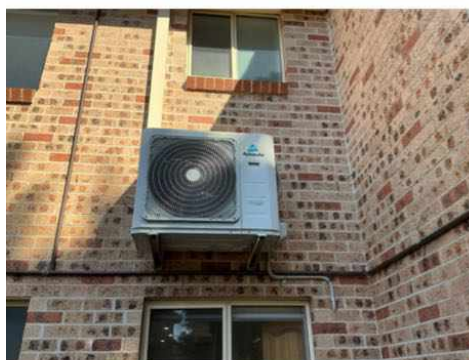
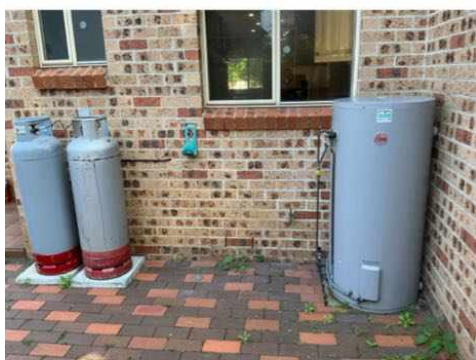
Where any part of an attachment to a building is not isolated and is not provided with a clear gap of not less than 25mm from the building, bridging occurs. Attachments to buildings such as hot water services, downpipes, verandahs, decks, steps, fences, service conduits and the like provide the opportunity for concealed entry.

Building attachments of this nature need to be frequently inspected for termite activity by a qualified inspector.

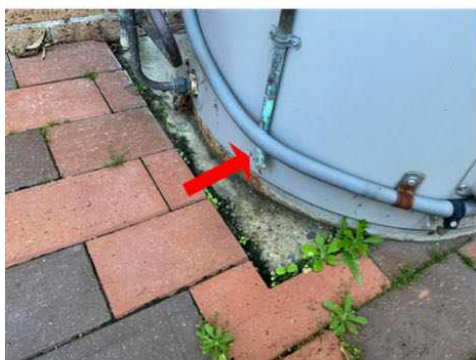
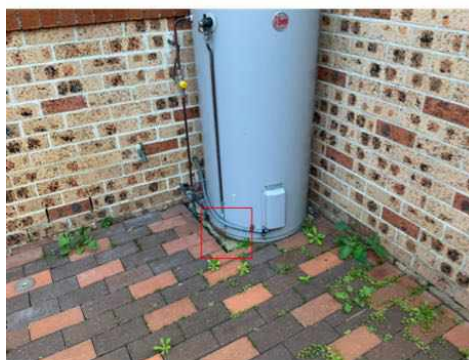
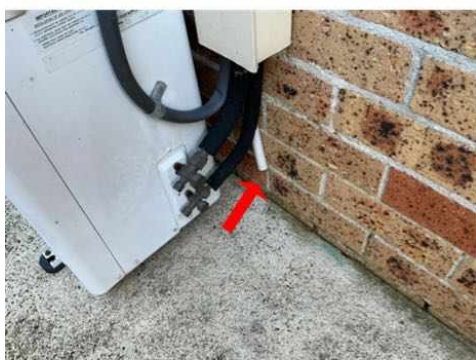
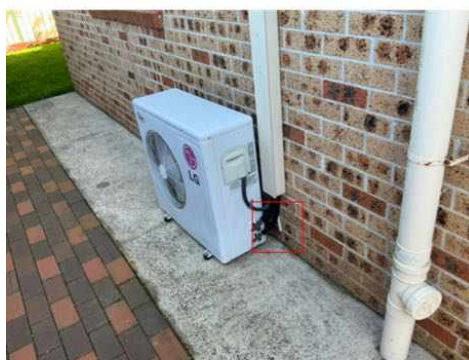
## Finding 6.02

Building:	Main Building
Location:	All Areas
Finding:	Overflow Disconnected - HWS/AC/Gas - Conducive Conditions to Termites
Information:	The overflow to this service was found to be disconnected from stormwater drainage and is creating excessive moisture in the surrounding area.

Such leaking creates an environment that is conducive to an array of defects, including water damage to associated building elements and the attraction of termite or timber pest infestation. These damp conditions can lead to secondary defects such as rot, rust, or corrosion of associated building elements, the formation of fungal decay, or even the creation of potential slip hazards. When coupled with poor site drainage, pooling of water may also attract termite activity to this area.

It is highly recommended that a licensed plumber be appointed to connect the overflow in order to prevent such an environment from being created. These minor works should be carried out as soon as possible.

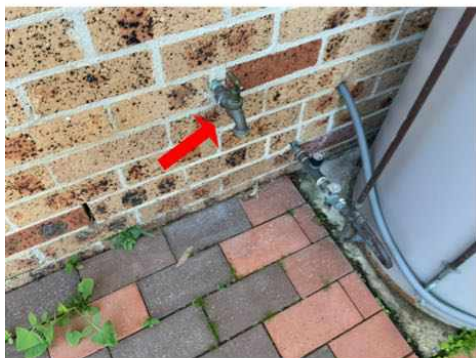
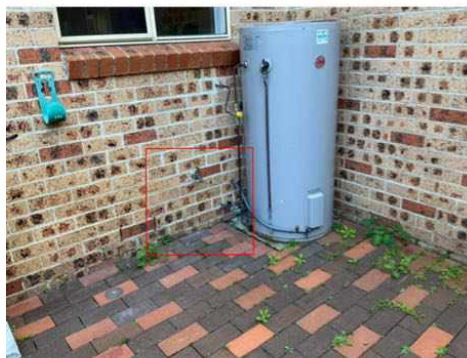
### Finding 6.03

Building:	Main Building
Location:	Exterior walls - rear
Finding:	No Stormwater Drain - Under Exterior Tap
Information:	The inspection identified that the exterior tap is not connected to a stormwater drainage system, allowing water to pool around the base. This can lead to moisture-related issues such as deterioration of nearby building materials, mould growth, and increased risk of termite activity—each of which may compromise the property's structural integrity and create health or safety concerns.

To prevent these risks, it is strongly recommended that a licensed plumber be engaged to assess the area and install appropriate drainage, such as a stormwater connection or splash block, to redirect water away from the property. Ongoing maintenance and monitoring of external water sources are also advised to ensure long-term protection.

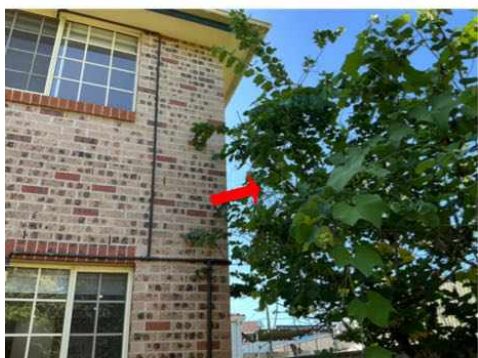
Building:	Main Building
Location:	Yard - Front
Finding:	Overhanging Trees/Branches/Roots
Information:	Overhanging trees and exposed roots were noted near the property, which pose potential risks to the structure and surrounding areas.

The overhanging branches can cause damage to the roof, gutters, or walls, particularly during storms or high winds. Additionally, the roots may pose a threat to

the foundation by causing ground movement, leading to cracks or uneven settling over time. The accumulation of leaves and debris in gutters and drainage systems can also lead to blockages, contributing to water overflow and potential water damage.

It is recommended that a qualified arborist be engaged to prune back the overhanging branches and assess any potential risks posed by the tree roots to prevent further damage to the property. It is advised to get this fixed as soon as possible. Regular maintenance should be carried out to ensure the trees are managed effectively and the property remains safe.

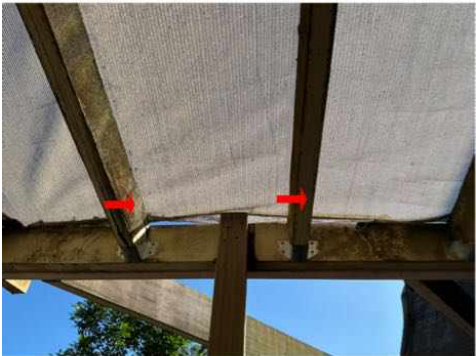
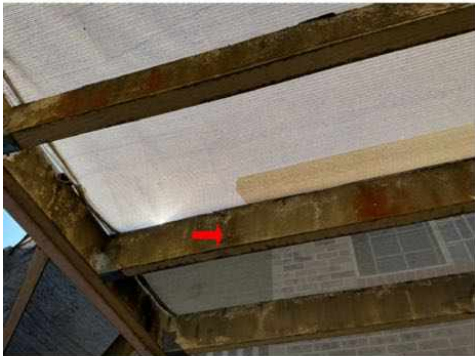
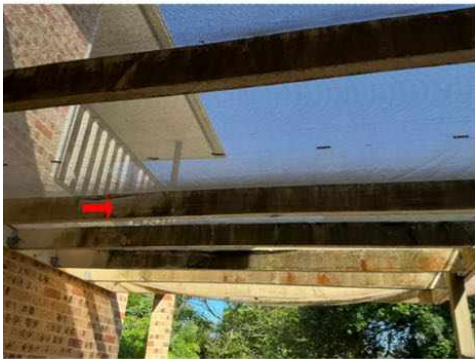
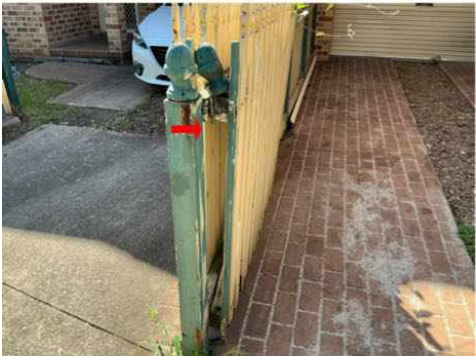
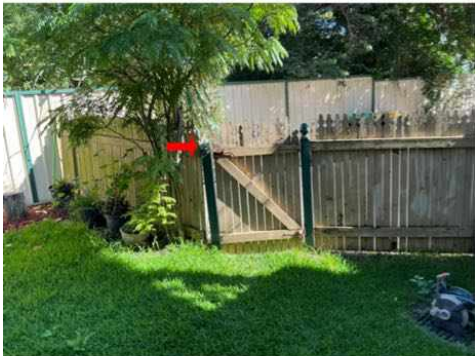
### Finding 7.01

Building:	Yard
Location:	Yard - Front
Finding:	Fungal Decay - Present (Localised)
Information:	Fungal decay, also referred to as wood decay or wood rot, typically occurs when timber elements are exposed to excessive moisture for extended periods. This deterioration process is accelerated by temperatures ranging between 5°C and 40°C, as well as the presence of oxygen. Fungal decay is commonly found in timber components used in external environments, particularly when they are exposed to rain or moisture penetration.

In this instance, although the timber element shows signs of decay, the visible damage appears to be localized to a specific area and has not yet spread to adjoining structures or other parts of the building element. As a result, the fungal decay is likely to be relatively superficial, with minimal impact on the structural integrity or tensile strength of the timber. However, it is advisable to monitor the affected area to prevent further deterioration and address the underlying moisture issue to mitigate future risk.
