# Building and Timber Pest Inspection Report

Inspection Date: Wed, 25 Mar 2026

Property Address: 5/9 Mason St, North Parramatta NSW 2151, Australia

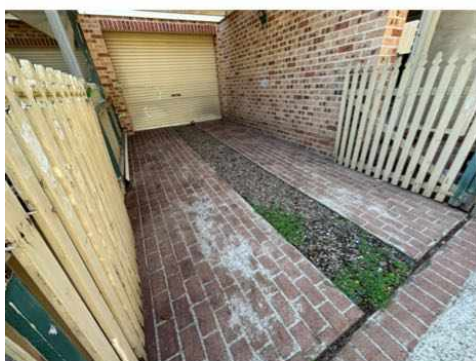
Building:	Main Building
Location:	All External Areas
Finding:	Obstructions and Limitations - External Areas
Information:	The attached photographs provide a visual representation of the obstructions and limitations that impeded a full inspection of the external areas of the property at the time of assessment. These obstructions, which may include vegetation, stored items, debris, or other physical barriers, can obscure potential defects and prevent a thorough evaluation of the property's condition. Obstructions of this nature can conceal a wide range of issues, such as structural damage, water ingress, pest infestations, or deteriorating building materials, which may not be visible during the initial inspection.

It is essential that these obstructions be cleared to allow for a comprehensive inspection of the external areas. Removing these barriers will enable a more accurate assessment of the property's condition and allow any hidden defects to be identified and addressed promptly. Failure to do so could result in undetected issues worsening over time, potentially leading to more costly repairs in the future.

Therefore, it is strongly recommended that the obstructions be removed and a re-inspection be scheduled once the affected areas are made fully accessible. This will ensure a complete evaluation of the property's exterior and provide the client with a clear understanding of any potential issues that may have been concealed during the initial inspection.

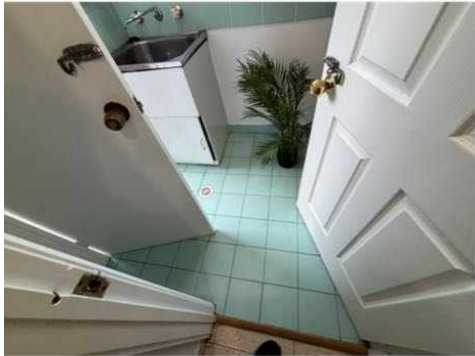
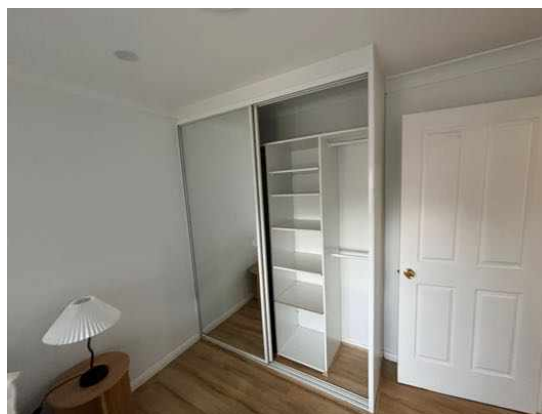
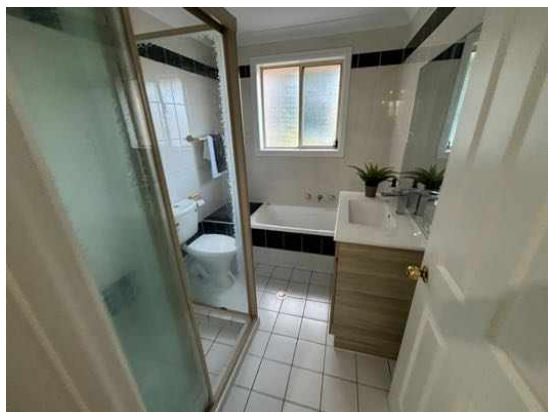
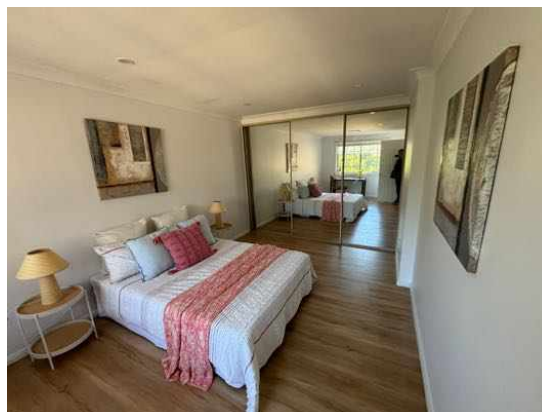
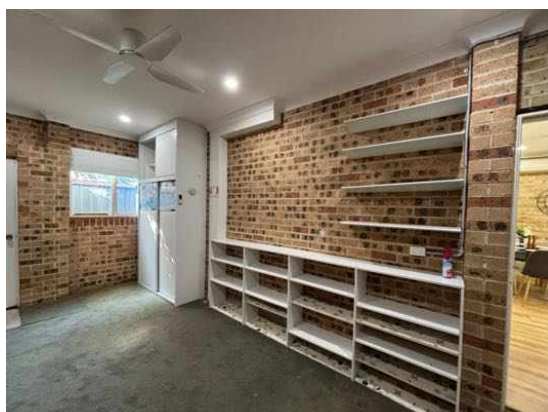
The presence of these impediments means that critical areas of the property were not accessible, and therefore, any underlying defects that may affect the integrity and safety of the property could remain undetected. These hidden defects, if left unaddressed, could worsen over time and may result in costly repairs or pose potential safety hazards to the occupants.

It is highly recommended that all obstructions be cleared to facilitate a complete and thorough inspection of the internal areas. Once the obstructions have been removed and full access is available, a re-inspection should be carried out to ensure that any

previously concealed issues can be properly identified and rectified. This follow-up inspection will provide a more accurate assessment of the property's internal condition and help the client make informed decisions about any necessary repairs or maintenance.

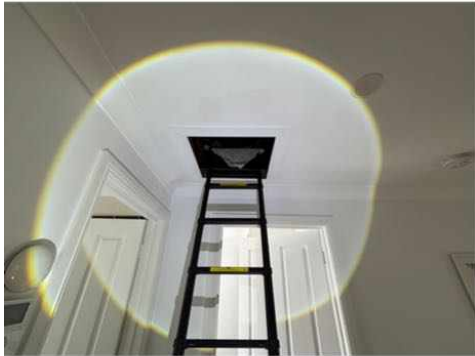
Building: Main Building  
 Location: Roof Void  
 Finding: Obstructions, Limitations, and General Roof Space Condition  
 Information: The photographs provided document both the general condition and the obstructions and limitations that were present in the roof cavity of the main building at the time of inspection. These obstructions—such as insulation materials, stored items, structural elements, or electrical wiring—restricted safe and adequate access to key areas within the roof space. As a result, a comprehensive inspection of all components could not be completed.

Obstructions of this nature may conceal a variety of potential defects, including

damaged framing, compromised insulation, evidence of moisture ingress, pest activity, or electrical hazards. While no major issues were observed in the visible areas, the presence of these limitations means that some defects may remain undetected.

It is recommended that these barriers be removed or repositioned to facilitate full and safe access to the roof space. Once clear, a follow-up inspection should be conducted to allow for a thorough assessment of all concealed areas. This will help ensure that the condition of the roof cavity is accurately evaluated and any hidden issues are appropriately identified and addressed.

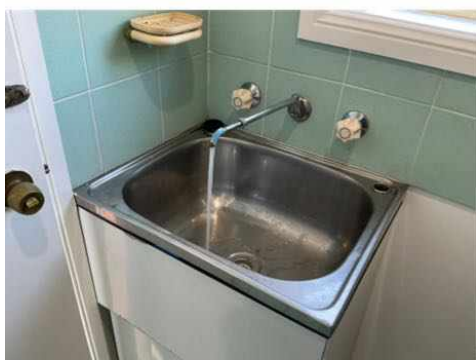
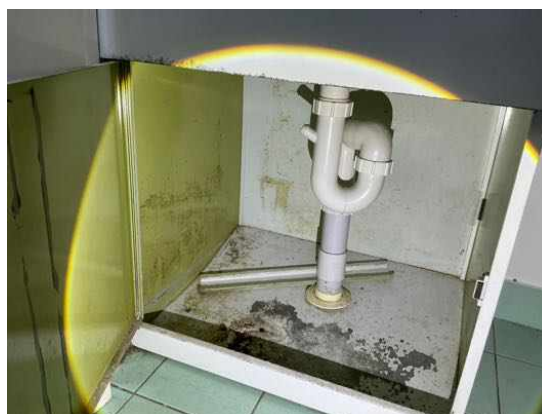
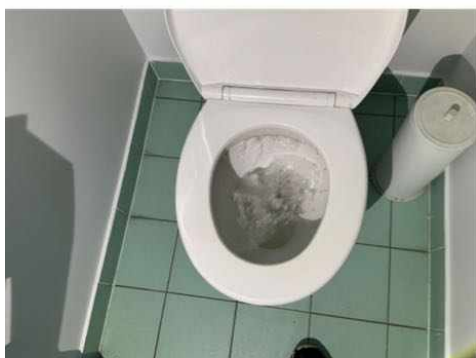
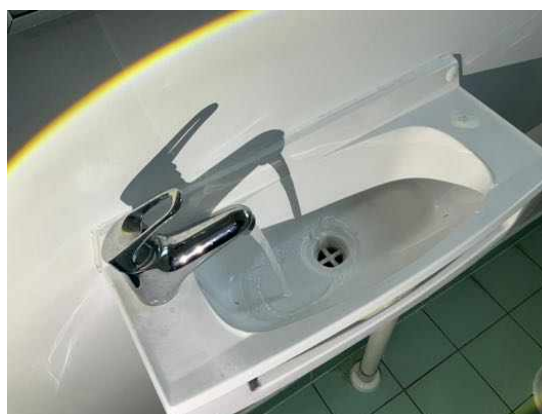
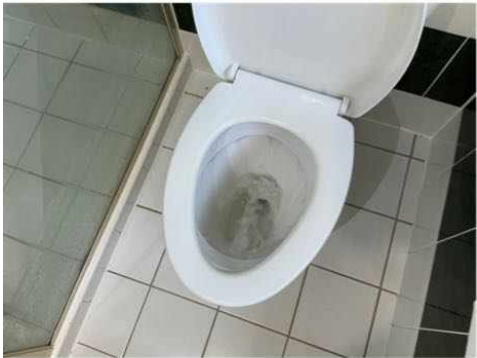
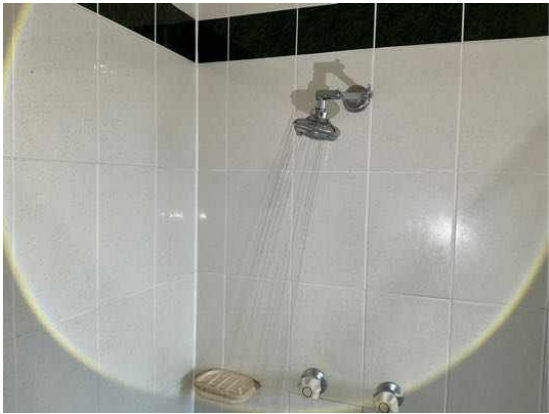
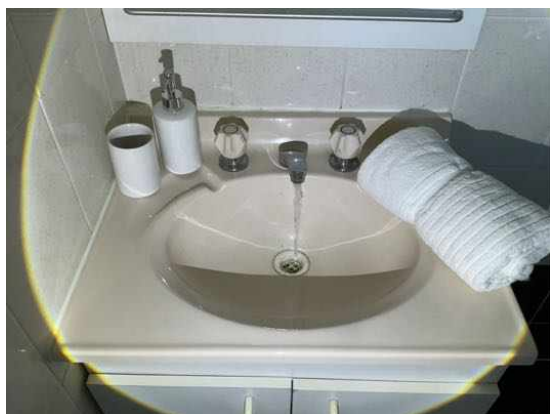
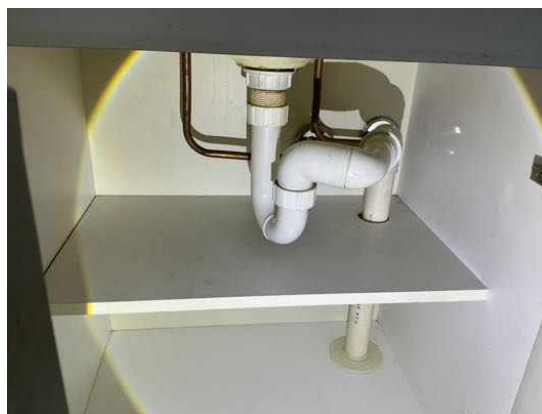
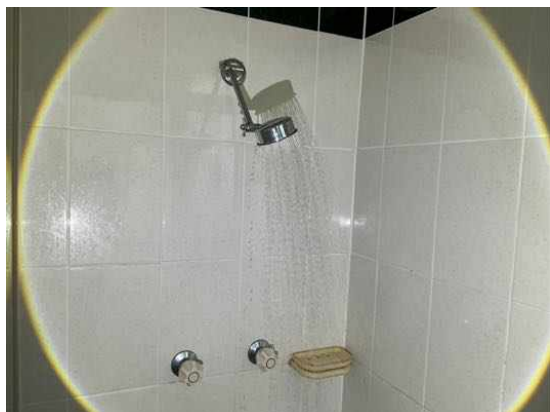
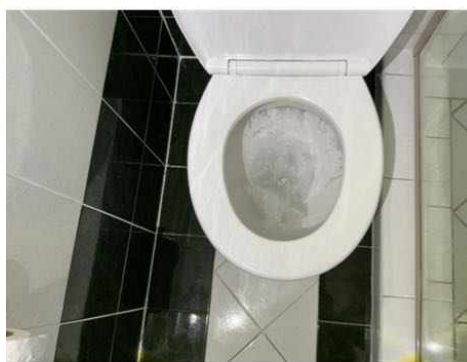
Building: Main Building  
Location: All Areas  
Finding: FYI - Taps, Drainage & Toilets Tested and Cabinetry Obstructions  
Information: During the inspection, all accessible taps, drainage systems, and toilets were tested for water flow and drainage efficiency, and checked for any visible signs of leakage. At the time of the inspection, no issues were noted in these areas. Unless highlighted in a separate defect statement, no immediate remedial work appears necessary. Supporting images may be found in the additional photos section for reference.

It is important to note that while a visual inspection of cupboards and cabinetry beneath sinks and vanities was undertaken, stored personal items and fixtures presented obstructions that limited full visibility of the internal areas. As per standard inspection practices, inspectors are not permitted to move or disturb personal belongings during the inspection process. Therefore, only visible and accessible sections were inspected, and concealed water damage or plumbing defects may not have been detected.

Given this, a re-inspection is recommended after all obstructions have been cleared to allow for a comprehensive assessment of these areas. Regular maintenance and monitoring of plumbing and drainage systems is also advised to ensure ongoing functionality and early detection of potential issues.

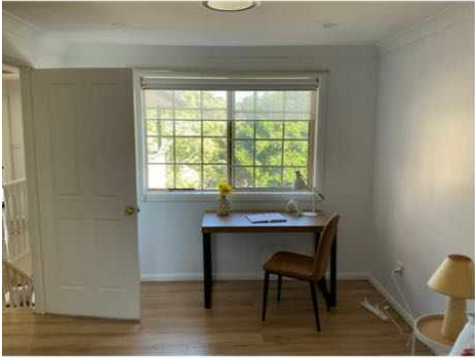
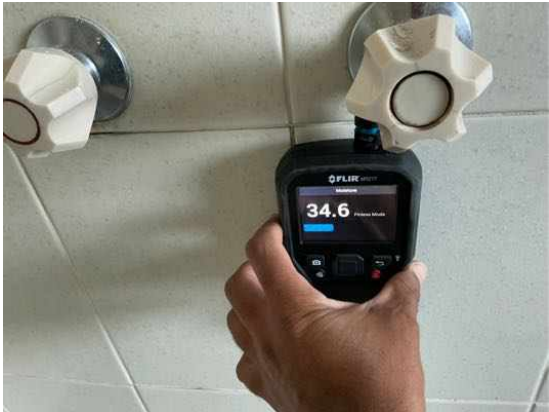
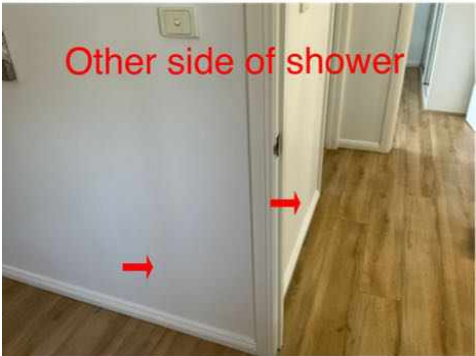
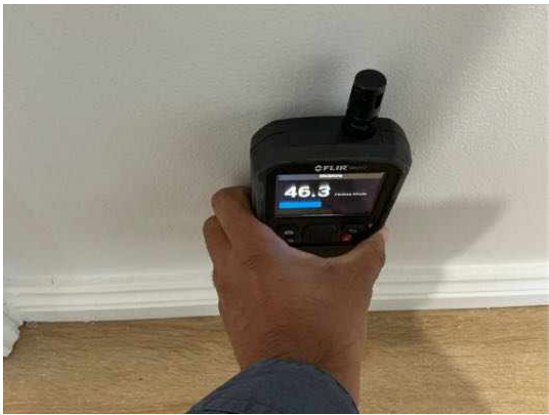
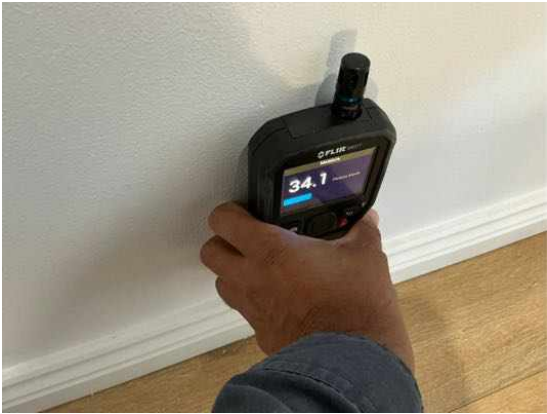
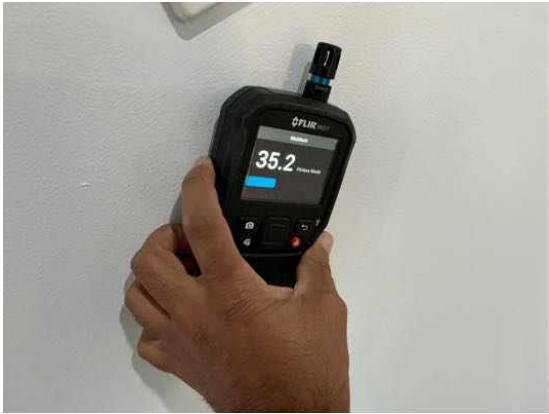
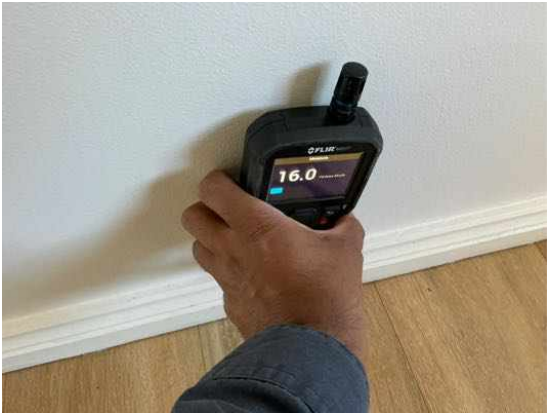
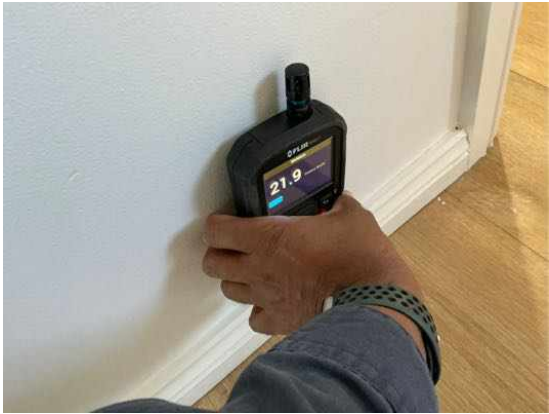
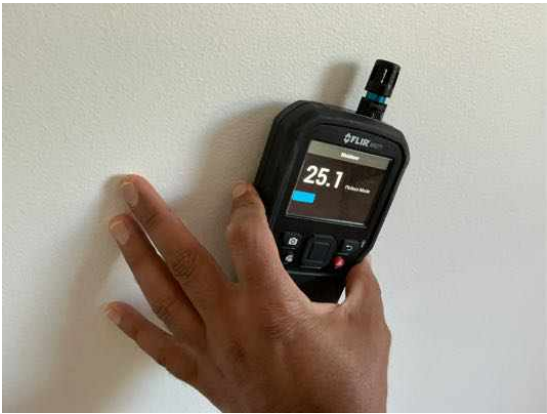
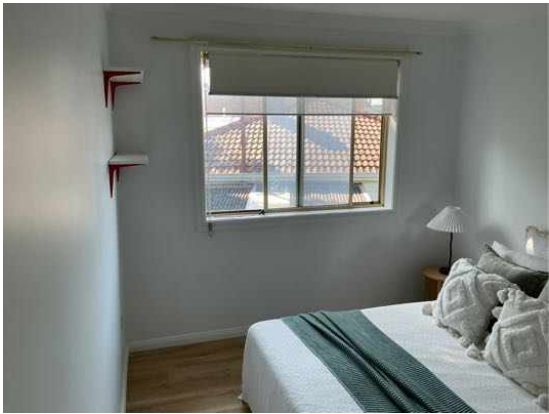
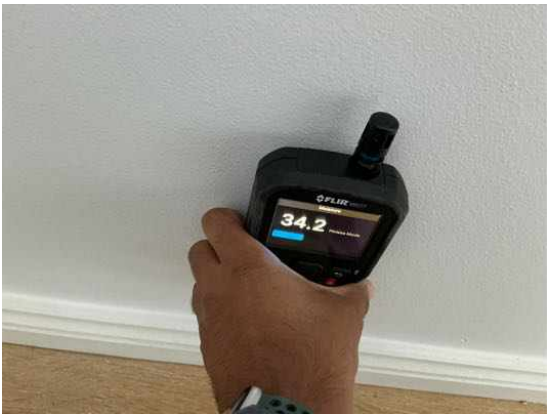
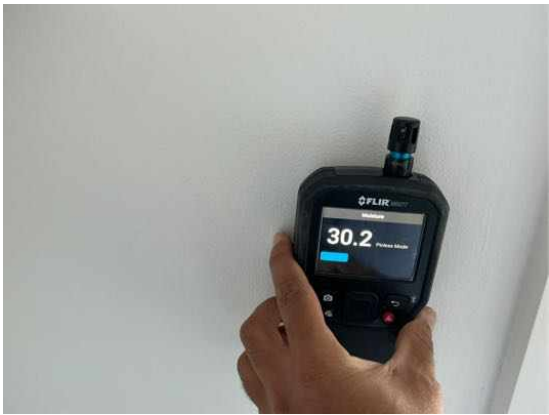
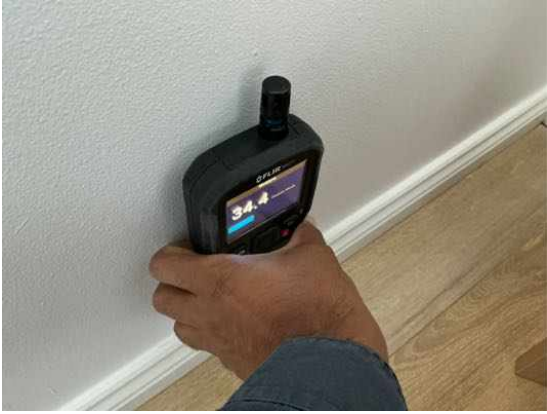
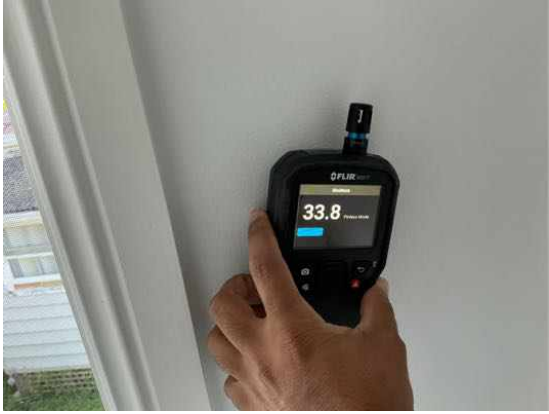
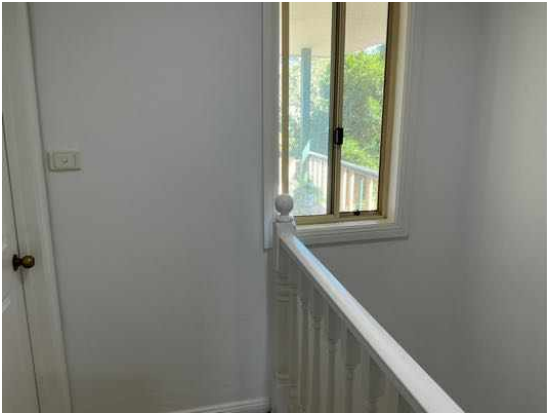
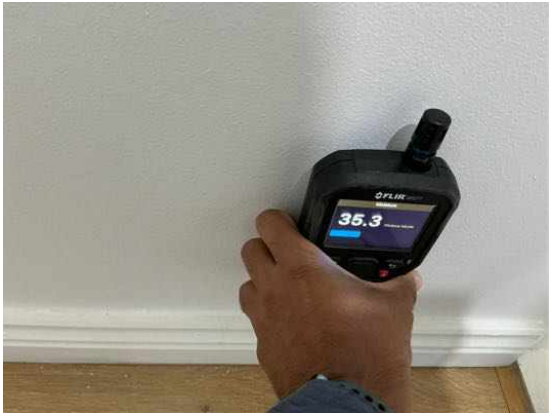
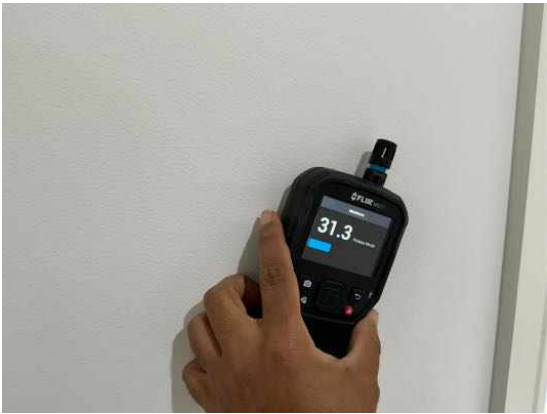
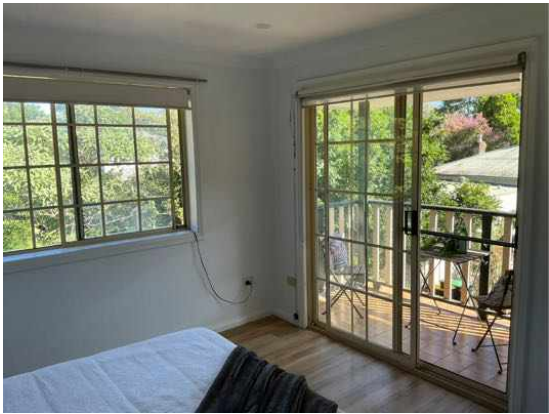
Building:	Main Building
Location:	All Areas
Finding:	Additional Photos - Moisture Meter Readings
Information:	Additional moisture meter reading photos have been provided for the property to offer further clarity on areas tested during the inspection. These photos are intended to give a visual reference for the specific locations where moisture levels were measured. These readings were taken at the time of the inspection to assess any potential moisture-related issues within the property. Any defects related to moisture that were identified during the inspection have been separately mentioned in the defect statements within the report.

It is important for the client to understand that moisture levels can fluctuate over time due to various factors, including changes in weather, humidity, and environmental conditions. While the readings reflect the property's moisture levels during the inspection, they may not represent future conditions, and increased moisture could lead to issues such as dampness, mould growth, or deterioration of building materials if left unmonitored.

For further clarification or additional information regarding the moisture readings, the client is encouraged to contact the building inspector directly. Regular monitoring of moisture-prone areas is recommended to ensure any emerging concerns are addressed promptly, particularly during wetter seasons or in high-humidity conditions.

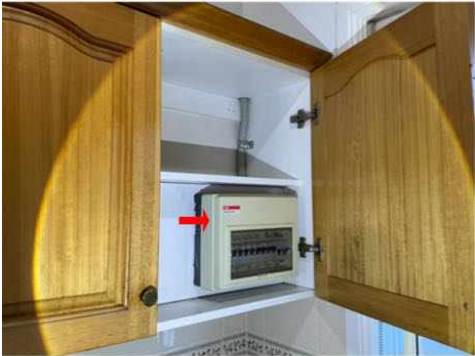
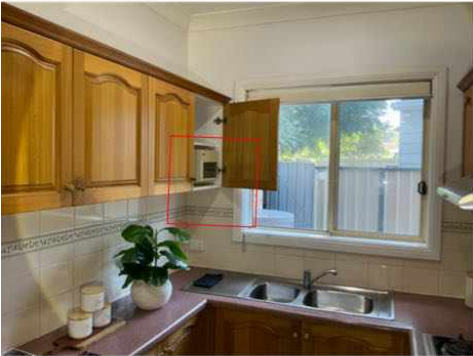
Building: Main Building  
 Location: Kitchen  
 Finding: Electrical Meter Box  
 Information: Electrical meter box is located in kitchen cabinets

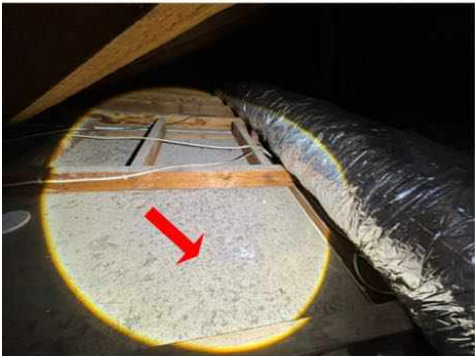
Building: Main Building  
Location: All Areas  
Finding: No Insulation - Roof Space  
Information: During the inspection, it was observed that there is no insulation installed in the roof space. This may result in reduced energy efficiency, higher heating and cooling costs, and less effective temperature regulation within the property.
