Building and Timber Pest Inspection Report

Inspection Date: Thu, 19 Feb 2026

Property Address: 10 Stephen St, Urbenville NSW 2475,
Australia

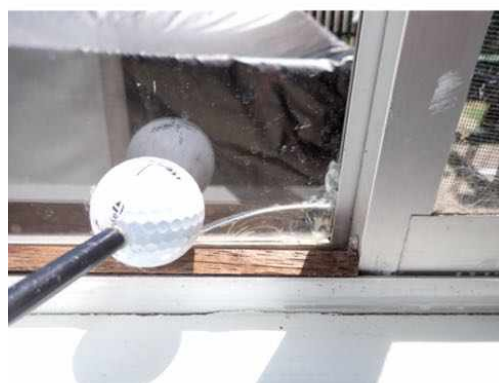
Finding 1.01

Building:	Main Building
Location:	Bedroom
Finding:	Small Crack To Bedroom Glass Window Pane
Information:	A small crack was identified to the glass pane of the bedroom window. This type of defect is commonly caused by minor impact, thermal stress or age-related movement. In plain terms, the bedroom window glass is cracked. Even small cracks can expand over time and may compromise the integrity and safety of the glazing. Preventative measures include timely replacement to avoid further cracking or potential breakage. A qualified glazier should assess and replace the affected pane as deemed necessary. Repair is recommended at the owner's discretion to maintain safety, weatherproofing and security.

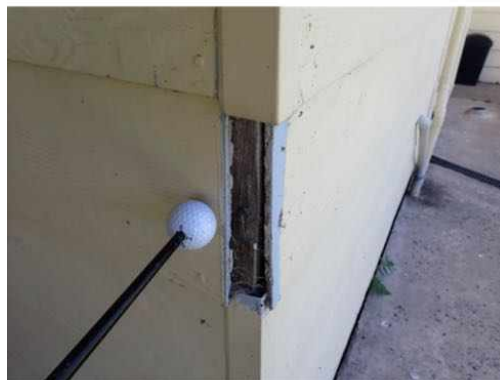
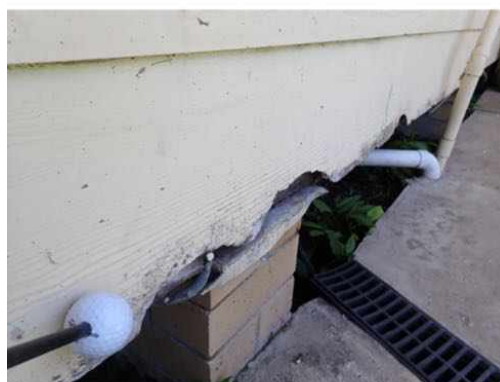
Finding 1.02

Building:	Main Building
Location:	External walls
Finding:	Damaged External Wall Cladding To Several Areas – Possible Asbestos Containing Material
Information:	Damage was identified to the external wall cladding at several locations. Based on the age and appearance of the material, the cladding may contain asbestos; however, confirmation is outside the scope of this visual inspection and laboratory testing would be required to verify. In plain terms, parts of the external wall sheeting are damaged and could be made from older asbestos-type material. Damaged cladding may allow moisture ingress and, if asbestos-containing, may pose a health risk if disturbed and fibres become airborne. Preventative measures include avoiding disturbance of the material and maintaining it in good condition. A licensed asbestos assessor and/or appropriately licensed removal contractor should be engaged to test and repair or

replace the affected cladding as deemed necessary. Rectification is recommended at the owner's discretion with appropriate safety controls in place.

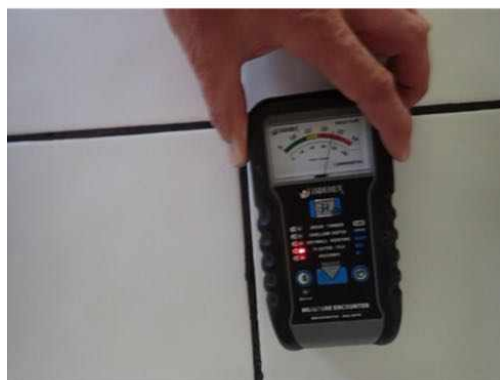
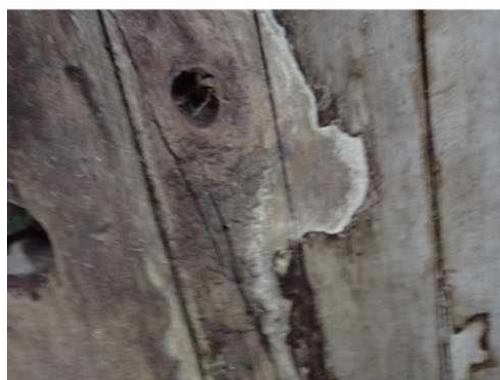
Finding 2.01

Building:	Main Building
Location:	Bathroom
Finding:	Elevated Moisture Readings And Water Staining To Subfloor With In The Bathroom Vicinity.
Information:	Higher than normal moisture meter readings were obtained around the top edge of the bath tub, with water staining observed to subfloor timber in the bathroom vicinity. This condition may be associated with failed or deteriorated silicone seals, plumbing leaks, splash-back from showering or bath use, or compromised waterproofing. In plain terms, elevated moisture levels were detected near the bath and there are signs that some water has reached the timber underneath. Ongoing moisture exposure can contribute to timber deterioration, mould growth and potential structural damage if left unaddressed. Preventative measures include maintaining effective sealing to bath edges and ensuring plumbing connections are watertight. A licensed plumber should investigate for leaks and a qualified bathroom or waterproofing contractor should assess and rectify as deemed necessary. Prompt investigation and repair is recommended at the owner's discretion to prevent further moisture-related damage.

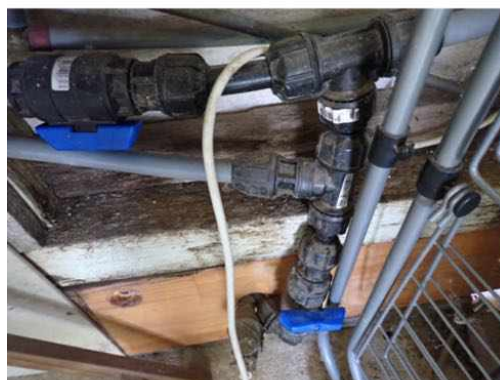
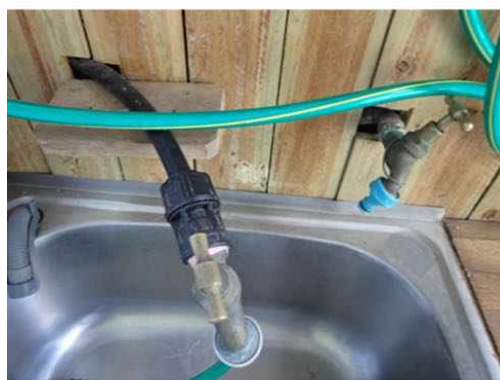
Finding 2.02

Building:	Main Building
Location:	Laundry
Finding:	Laundry Plumbing Appears Unprofessionally Installed
Information:	<p>The laundry plumbing installation appeared to be of a substandard and unprofessional standard, with poor alignment, inadequate support and/or untidy workmanship noted. This condition may be associated with non-licensed installation or previous DIY modifications. In plain terms, the plumbing under or around the laundry area looks poorly done. Poor workmanship can increase the risk of leaks, blockages or premature failure of fittings over time. Preventative measures include ensuring all plumbing work is carried out by a licensed plumber in accordance with relevant standards. A licensed plumber should assess the installation and rectify any non-compliant or defective work as deemed necessary through out the property. Rectification is recommended at the owner's discretion to ensure reliability, compliance and long-term serviceability.</p>

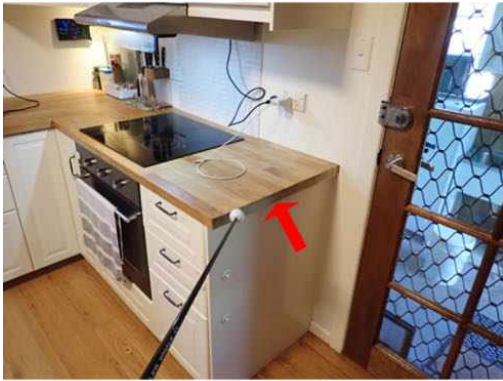
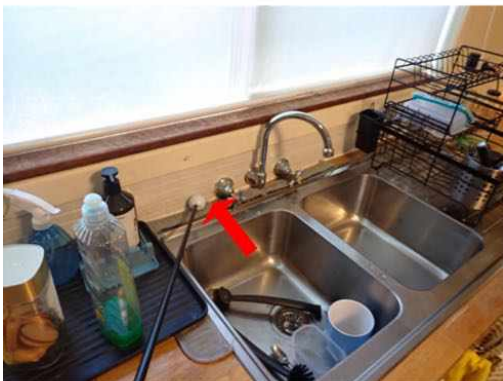
Finding 3.01

Building:	Main Building
Location:	Kitchen
Finding:	Kitchen In Fair Condition However Poor Installation Workmanship Noted
Information:	The kitchen was observed to be in generally fair condition; however, defects including the unsealed cut end of the timber benchtop and poor silicone application to tap penetrations and benchtop junctions indicate substandard installation workmanship. Exposed timber ends are susceptible to moisture ingress which may result in swelling, delamination or premature deterioration. In plain terms, parts of the benchtop have not been properly sealed and the silicone work is messy and inadequate, suggesting the kitchen was not finished to a high standard. Poor sealing around taps and junctions can allow water to enter cabinetry and surrounding materials over time. Preventative measures include properly sealing all exposed timber surfaces and ensuring neat, continuous silicone to wet area junctions. A qualified cabinet maker, carpenter or kitchen installer should assess and rectify the defective workmanship as deemed necessary. Repairs are recommended at the owner's discretion to prevent moisture damage and improve overall finish and durability.

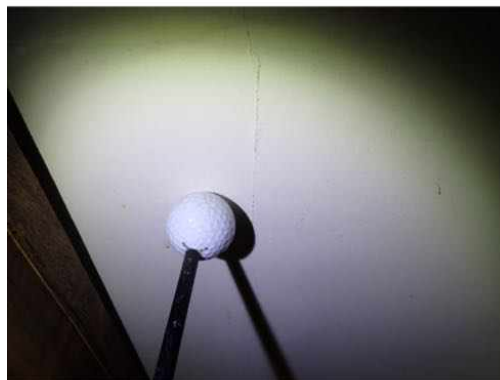
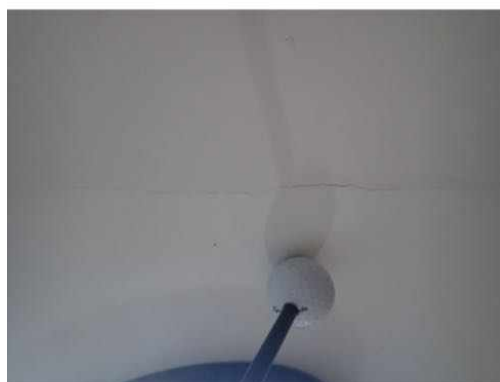
Finding 3.02

Building:	Main Building
Location:	All Areas
Finding:	Several Cracks Identified To Internal Wall And/Or Ceiling Cladding
Information:	Several cracks were identified to the internal wall and/or ceiling cladding surfaces. This is commonly associated with normal building movement, material shrinkage and age-related settlement and is considered a common defect for a property of this age. In plain terms, there are visible cracks in the internal lining boards or plaster surfaces. While often cosmetic, cracking can worsen if movement continues and may indicate minor substrate movement. Preventative measures include monitoring for further movement and maintaining stable internal conditions. A qualified plasterer or painter should assess and carry out patch repairs and repainting as deemed necessary. Repairs are recommended at the owner's discretion to maintain appearance and prevent further deterioration.

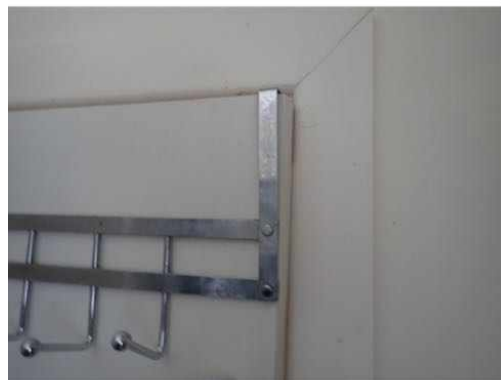
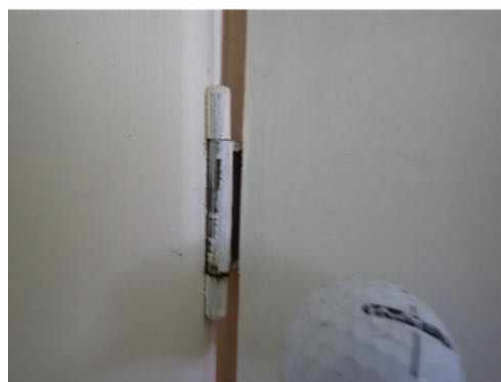
Finding 3.03

Building:	Main Building
Location:	Bathroom
Finding:	Bathroom Door Catching On Frame Due To Damaged Hinge
Information:	The bathroom door was observed to be catching on the door frame during normal operation, likely due to a damaged or worn hinge. This condition may be caused by hinge wear, loose fixings, minor door/frame movement or age-related deterioration. In plain terms, the door does not open and close properly because the hinge is damaged. Continued use in this condition may result in further damage to the door, frame or hardware. Preventative measures include ensuring hinges are properly secured and replaced when worn. A qualified carpenter or handyman should assess and repair or replace the damaged hinge and adjust the door as deemed necessary. Repairs are recommended at the owner's discretion to restore proper function and prevent further damage.

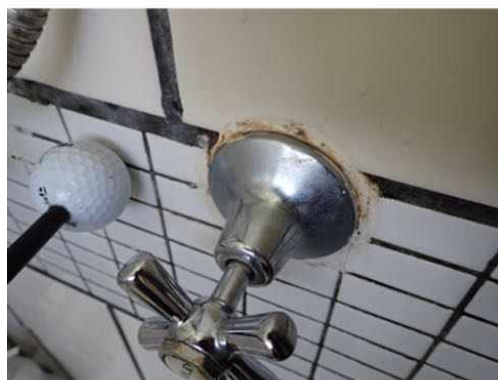
Finding 3.04

Building:	Main Building
Location:	Bathroom
Finding:	Poor Silicone Work Around Shower Plumbing Fittings
Information:	<p>Poor and inadequately applied silicone sealant was identified around the shower plumbing fittings. This is commonly caused by substandard workmanship or previous patch repairs and is considered a maintenance-related defect. In plain terms, the sealing around the shower fittings is messy and not properly finished. Inadequate sealing in wet areas can allow water to penetrate behind wall linings, potentially affecting waterproofing and causing concealed moisture damage over time. Preventative measures include ensuring neat, continuous and properly bonded silicone to all wet area penetrations. A qualified plumber, tiler or handyman should remove and reapply the silicone sealant as deemed necessary. Rectification is recommended at the owner's discretion to prevent moisture ingress and maintain waterproof integrity.</p>

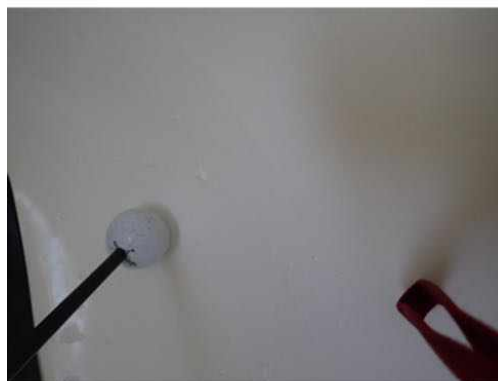
Finding 3.05

Finding: Poorly Applied Paint Finish To Bath Tub – Cosmetic Defect

Information: The bath tub was observed to have a poorly applied paint finish, with visible inconsistencies and cosmetic imperfections noted. This is typically associated with substandard preparation or application during resurfacing works. In plain terms, the bath has been painted but the finish is rough and does not look professionally done. While primarily cosmetic, poorly applied coatings may wear prematurely or peel over time. Preventative measures include proper surface preparation and application by a suitably qualified contractor. A bath resurfacing specialist or licensed painter should assess and refinish the bath as deemed necessary. Rectification is recommended at the owner's discretion to improve appearance and durability.

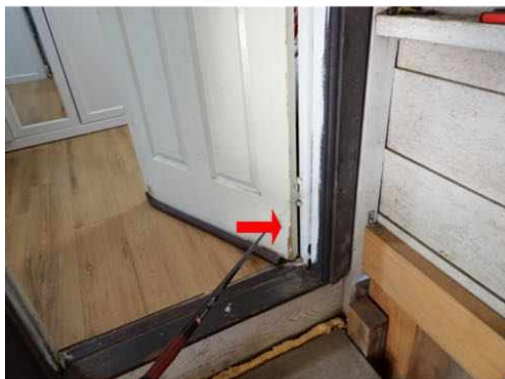
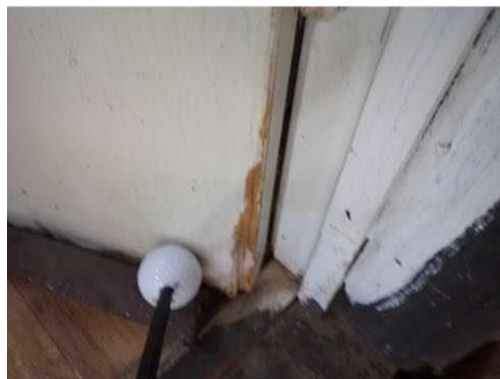
Finding 3.06

Finding: Bedroom To Garage Door In Poor Condition

Information: The door between the bedroom and garage was observed to be in poor condition, showing signs of wear and deterioration. This may be associated with age-related damage, moisture exposure or general use over time. In plain terms, the door is worn

and not in good shape. Continued deterioration may affect operation, security and overall serviceability. Preventative measures include maintaining door hardware and ensuring the door is properly aligned and sealed. A qualified carpenter or licensed builder should assess and repair or replace the door as deemed necessary. Rectification is recommended at the owner’s discretion to maintain functionality and security.

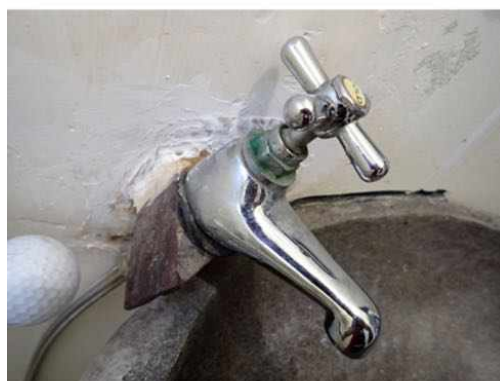
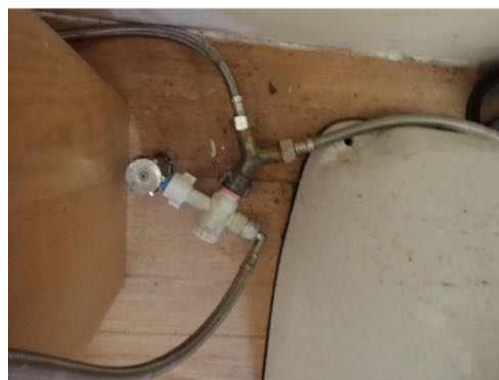
Finding 3.07

Building: Main Building
 Location: Toilet (WC)
 Finding: Toilet Vanity Tap Poorly Fitted
 Information: The vanity tap to the toilet WC was observed to be poorly fitted, with movement and/or inadequate securing noted at the base. This is commonly due to substandard installation or loose fixings over time. In plain terms, the tap is not properly secured and may wobble during normal use. A loose tap can allow water to penetrate around the base and potentially cause damage to cabinetry or surrounding materials. Preventative measures include ensuring taps are firmly secured and properly sealed at installation. A licensed plumber should assess and refit or secure the tap as deemed necessary. Rectification is recommended at the owner’s discretion to prevent moisture damage and ensure proper operation.

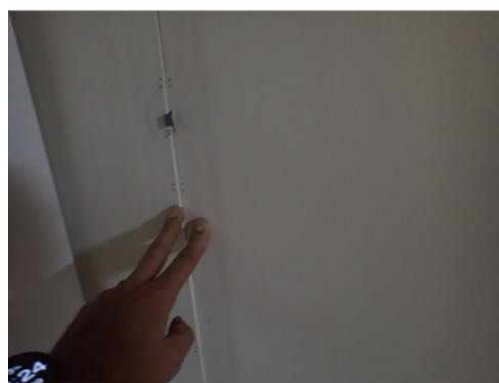
Finding 3.08

Building:	Main Building
Location:	Store room
Finding:	Store Room Cladding Poorly Fitted
Information:	The cladding within the store room was observed to be poorly fitted, with misalignment and/or inadequate fixing noted. This condition is typically associated with substandard installation or lack of proper securing to the framing. In plain terms, the wall lining in the store room has not been installed properly and does not sit or fix correctly. Poorly fitted cladding may loosen over time and affect the overall finish and durability of the wall surface. Preventative measures include ensuring cladding is properly aligned and securely fixed in accordance with manufacturer guidelines. A qualified carpenter or handyman should assess and refit or secure the cladding as deemed necessary. Rectification is recommended at the owner's discretion to improve finish and long-term performance.

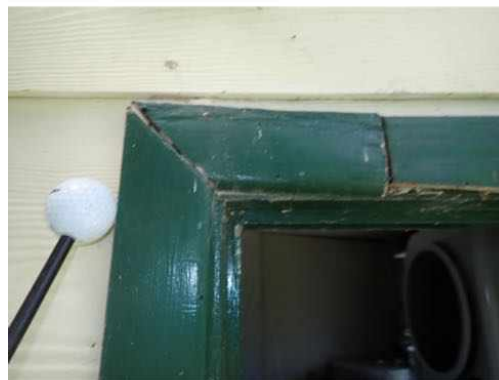
Finding 3.09

Building:	Main Building
Location:	Laundry
Finding:	Damaged External Door Architrave To Laundry
Information:	Damage was identified to the external door architrave at the laundry. This condition is commonly caused by moisture exposure, impact damage or age-related deterioration.

In plain terms, the timber trim around the laundry door is damaged. If left unrepaired, exposed timber can absorb moisture and lead to swelling or wood rot over time. Preventative measures include maintaining protective paint coatings and ensuring effective sealing around door frames. A qualified carpenter or handyman should assess and repair or replace the damaged architrave as deemed necessary. Repairs are recommended at the owner's discretion to prevent further deterioration and maintain weather resistance.

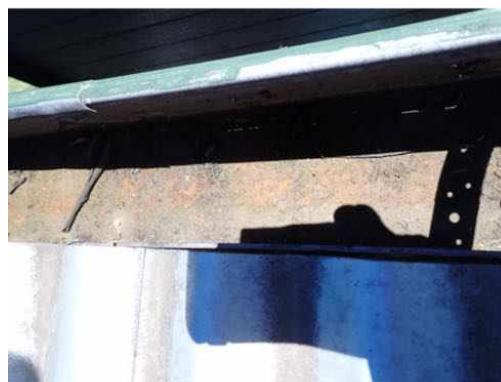
Building: Main Building
Location: Roof
Finding: Surface Rust Identified To Gutters
Information: Surface rust was identified to sections of the roof gutters. This condition is typically caused by prolonged moisture exposure, debris build-up and age-related deterioration of protective coatings and is considered a common defect for gutters of this age. In plain terms, the gutters are starting to rust on the surface. While currently superficial, untreated rust can progress and lead to perforation and water leakage over time. Preventative measures include regular cleaning of gutters and application of rust treatment and protective coatings. A qualified roofer, gutter contractor or handyman should assess and treat the affected areas or replace sections as deemed necessary. Repairs are recommended at the owner’s discretion to prevent further corrosion and maintain effective stormwater drainage.

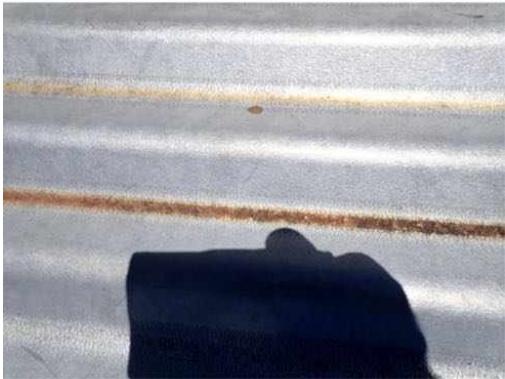
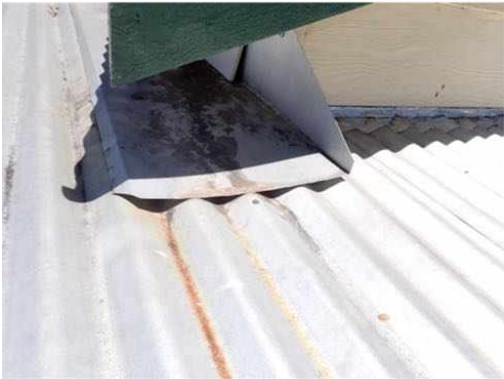
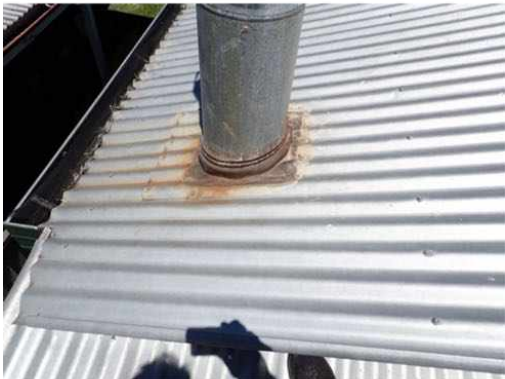
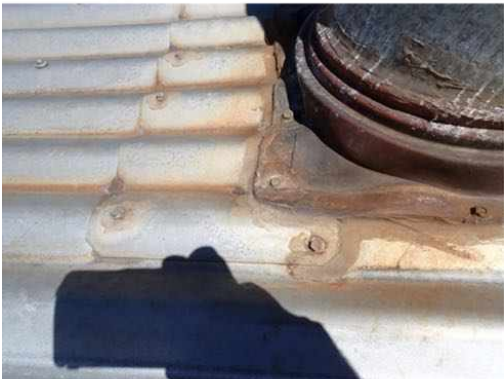
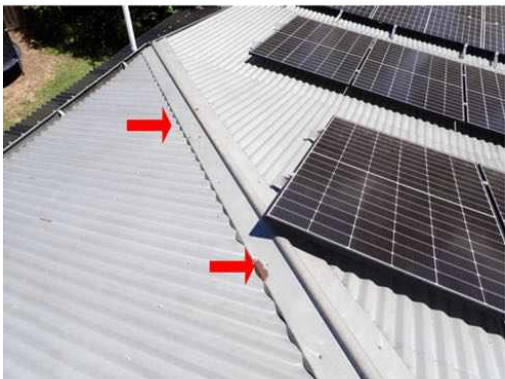
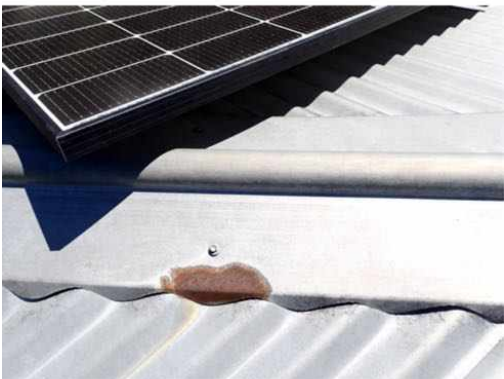
Finding 3.12

Building:	Main Building
Location:	Roof
Finding:	Surface Rust To Roof Fixings And Minor Isolated Rust To Roof Cladding
Information:	<p>Surface rust was identified to some roof fixings, along with minor isolated areas of surface rust and localised impact related damage to sections of the roof cladding. This condition is typically associated with age-related deterioration, long-term weather exposure and breakdown of protective coatings and is considered common for roofing materials of this age. In plain terms, some of the screws and small areas of the roof sheeting are starting to rust. While currently minor, ongoing corrosion can lead to loosening of fixings, water ingress and further deterioration of the roof covering. Preventative measures include treating rusted areas, replacing corroded fixings and maintaining protective coatings. A qualified roofer should assess and replace affected fixings and repair or treat rusted cladding as deemed necessary. Rectification is recommended at the owner's discretion to prevent further corrosion and potential leaks.</p>

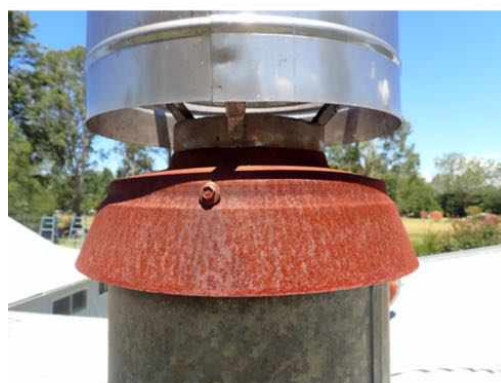
Finding 3.13

Building:	Main Building
Location:	Roof
Finding:	Rust Identified To Fireplace Flue
Information:	Rust was identified to the metal fireplace flue. This condition is typically caused by prolonged exposure to heat, condensation and external weathering and is common in flue components of this age. In plain terms, the metal chimney pipe is rusting. While surface rust may initially be cosmetic, progressive corrosion can lead to metal thinning, perforation and reduced performance or safety over time. Preventative measures include regular inspection and maintenance, including protective coatings where applicable. A qualified plumber, roofer or fireplace specialist should assess and repair or replace the affected flue sections as deemed necessary. Rectification is recommended at the owner's discretion to prevent further deterioration and ensure continued safe operation.

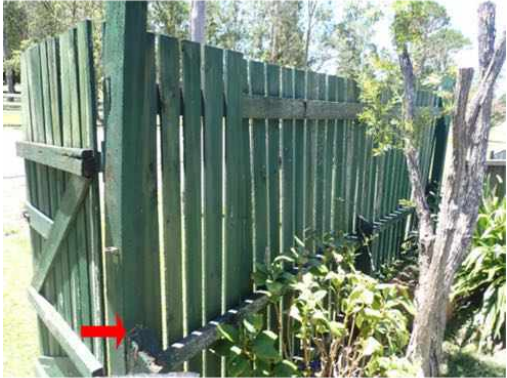
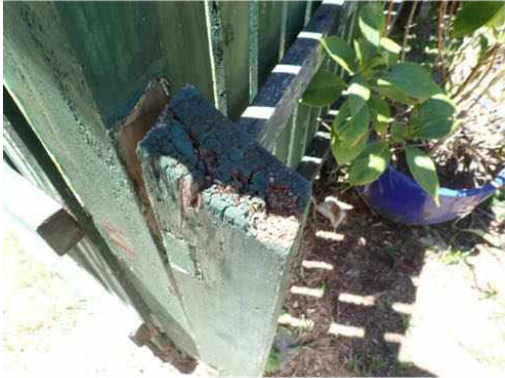
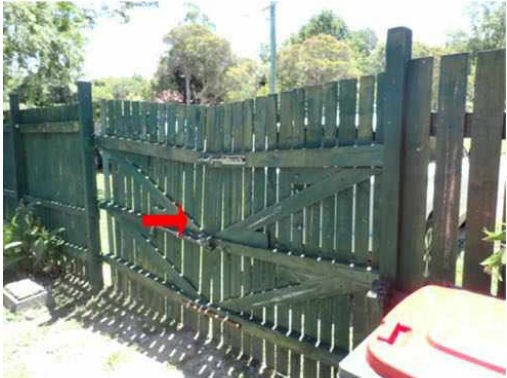
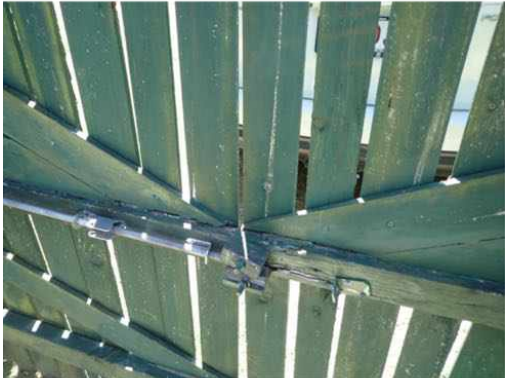
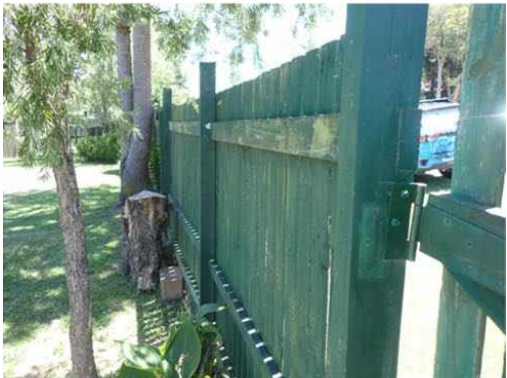
Finding 3.14

Building:	Yard
Location:	Front timber fence
Finding:	Front Timber Fence In Poor Condition
Information:	The front timber fence, although currently standing, was observed to be in poor condition with signs of age-related deterioration and wear. This is commonly caused

by prolonged weather exposure, moisture and lack of maintenance and is typical for timber fencing of this age. In plain terms, the fence is still upright but is worn and deteriorating. Timber fencing in poor condition may weaken over time and require partial or full replacement if not maintained. Preventative measures include regular sealing, painting and replacement of deteriorated components. A qualified fencing contractor or carpenter should assess and repair or replace affected sections as deemed necessary. Rectification is recommended at the owner's discretion to maintain stability and appearance.

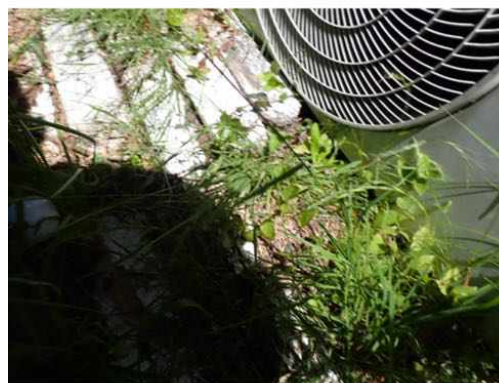
Finding 6.01

Building:	Yard
Location:	All areas
Finding:	Timber In Contact With Ground Around Yard Area – Conducive To Termite Attack
Information:	Timber elements were identified in contact with the ground around the yard area. This condition is conducive to termite activity as it provides concealed access and a moisture source, increasing the risk of infestation. In plain terms, some timber in the yard is touching the soil which makes it easier for termites to attack. Timber-to-ground contact is a common risk factor in properties of this type and age. Ongoing contact may also contribute to timber decay. Preventative measures include removing soil build-up, maintaining adequate clearances and ensuring a visible inspection zone is present where applicable. A licensed pest control contractor and/or qualified carpenter should assess and separate timber from soil, replace affected sections or remove as deemed necessary. Rectification is recommended at the owner's discretion to reduce the risk of termite attack and further deterioration.

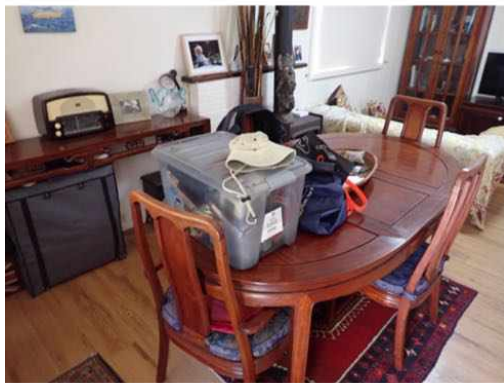
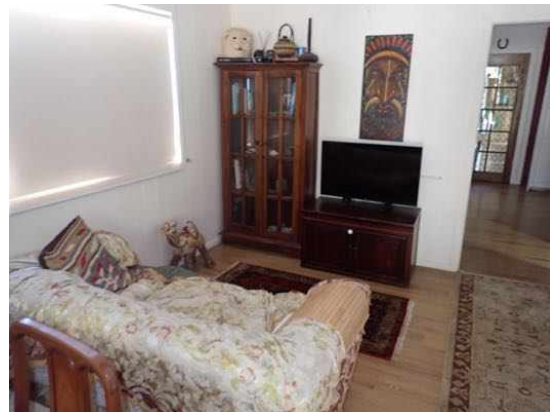
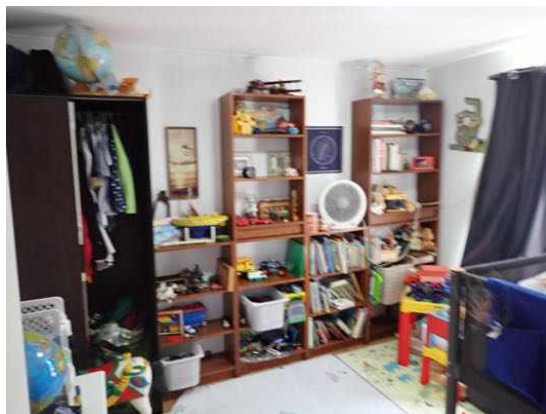
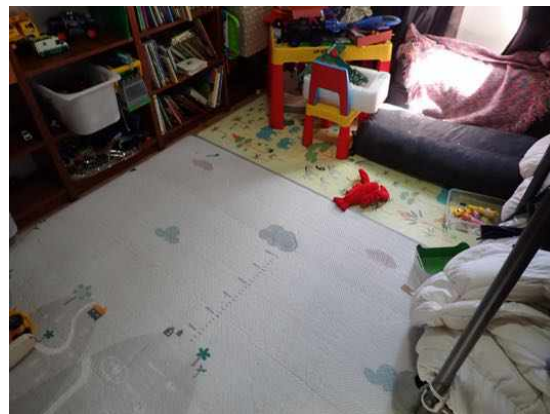
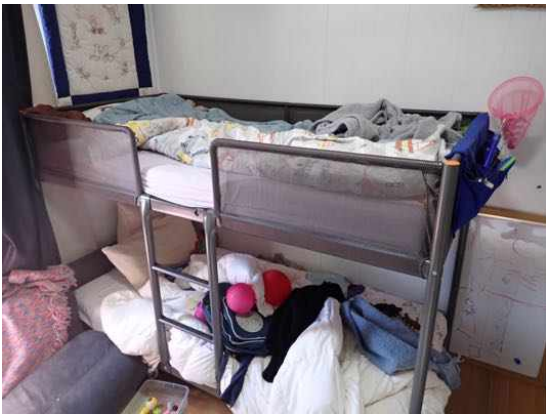
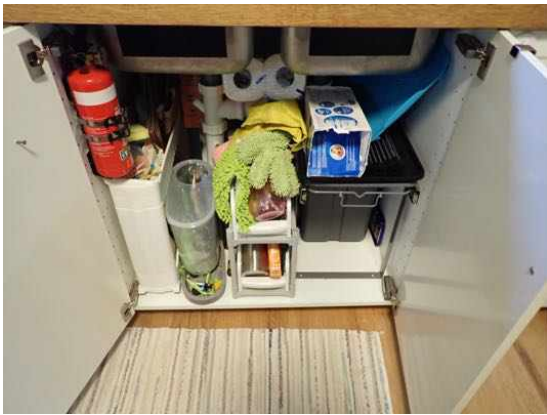
Noted Item

Building: Main Building
Location: All Areas
Finding: Additional Photos - Obstructions and Limitations
Information: These photographs are an indication of the obstructions and limitations which impeded full inspection of the area at the time of inspection. These obstructions can hide an array of defects and should be removed to allow full inspection to be carried out. A re-inspection is recommended once the areas are made accessible.
