# Building and Timber Pest Inspection Report

Inspection Date: Mon, 16 Feb 2026

Property Address: 890 Punchbowl Rd, Punchbowl NSW 2196,  
Australia

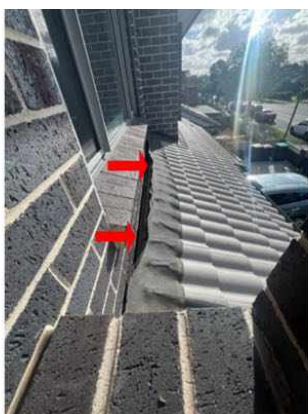
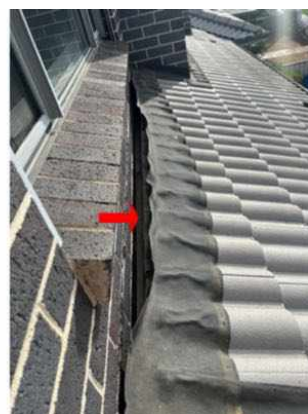
Building: Main Building  
Location: Roof Exterior  
Finding: Roof plumbing - Loose flashing (Moisture ingress risk)  
Information: Metal and other material flashings are applied to seals and intersections between roof coverings and building elements. They are designed to aid in weatherproofing of roof joints, and require regular inspection and maintenance as they are more subject to rust-related deterioration.

The flashing in this section of the exterior roofing appears to have come loose from its original fixing.

Re-fixing and potential replacement of certain areas of flashing is advised to promote adequate roof drainage and protection from water penetration. Failure to perform these works may result in water damage and accelerated deterioration of associated building elements.

A roofing contractor or roofing plumber should be appointed immediately to restore the flashing to a fully operational state.

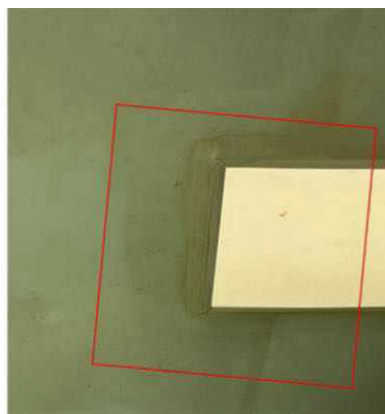
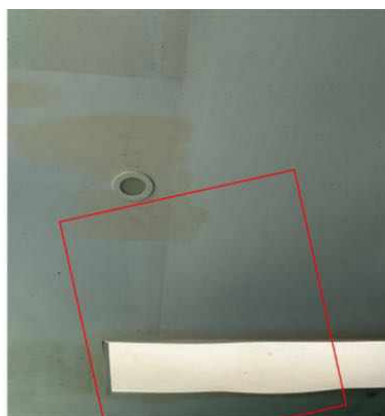
#### Finding 3.01

Building: Main Building  
 Location: All External Areas - Rear  
 Finding: Ceiling - Water damaged and evidence of past repairs  
 Information: Water damage to the ceiling lining is generally an indication of excessive moisture being present in the roof void, usually via a leak to the roof covering.

Where water damage is evident to the ceiling, the primary requirement is to identify and rectify the source of the leak. A roofing plumber should be appointed as soon as possible to identify the leak and perform rectification works as necessary, ensuring the water damage is restricted.

Once the leak is repaired, consultation with relevant tradespeople, including plasterers and painters, is advised. Rectification works may include replacement of ceiling lining or minor repainting, depending on the extent of the damage.

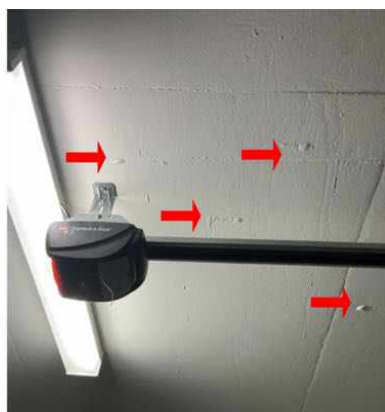
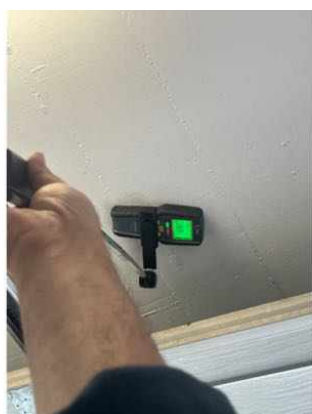
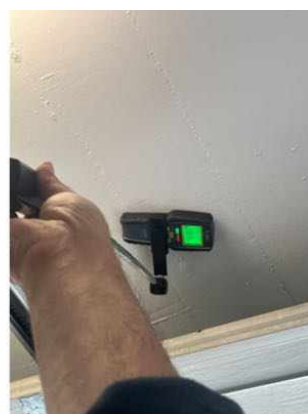
### Finding 3.02

Building: Main Building  
 Location: Garage  
 Finding: Elevated Moisture – Further Investigation Recommended  
 Information: Elevated moisture readings were detected with some areas also showing signs of localised bubbling/swelling to paint finish. While others did not present visible surface issues, although no significant structural damage was evident at the time of inspection,

dampness can contribute to deterioration if left unaddressed. A further investigation by a licensed plumber or waterproofing specialist is recommended to confirm the source and ensure no concealed issues are developing.

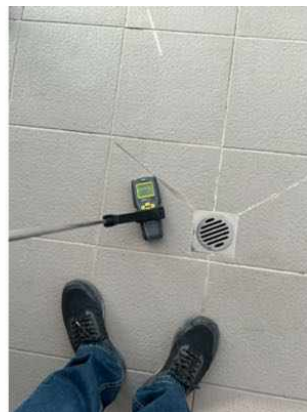
### Finding 3.03

Building:	Main Building
Location:	Balcony
Finding:	Balcony – Elevated Moisture to Tiled Floor Area
Information:	Elevated moisture readings were detected to the tiled balcony floor with visible minor efflorescence and discolouration to grout lines indicating prolonged or recurring moisture presence beneath the tile finish. This condition is commonly associated with failed grout or sealant joints, insufficient surface drainage and/or inadequate waterproofing allowing moisture to become trapped within the balcony substrate. While no internal water ingress was evident at the time of inspection, the readings exceed what would be expected under normal dry conditions and warrant further investigation. This issue is considered a minor defect at present, with the potential to escalate if moisture migration continues, and assessment by a suitably qualified waterproofing specialist is recommended.

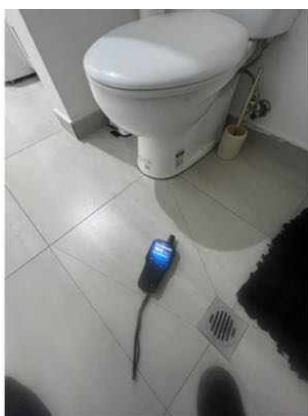
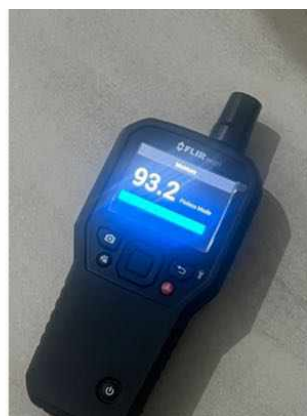
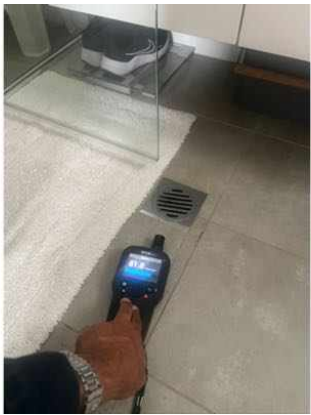
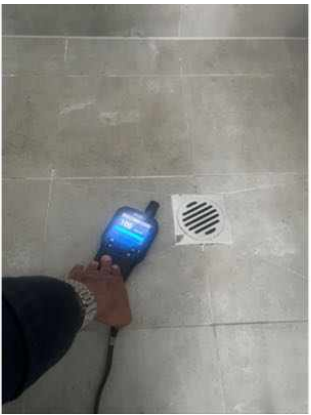
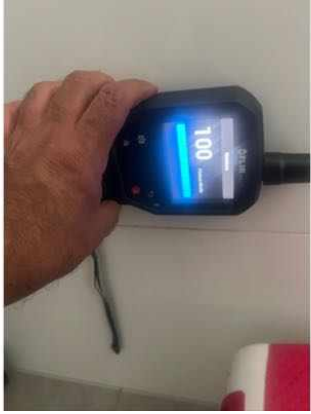
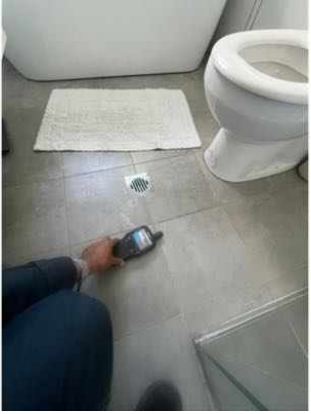
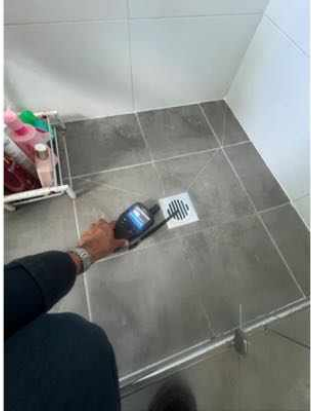
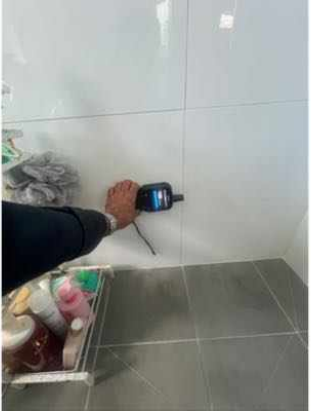
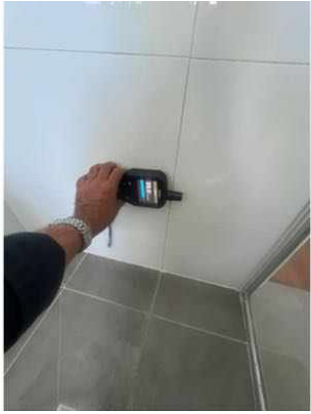
### Finding 3.04

Building:	Main Building
Location:	Bathroom , Laundry , Ensuite
Finding:	Elevated Moisture Bathroom (No visible deterioration noted)
Information:	Elevated moisture levels were detected to tiled surfaces in bathroom/shower areas. Persistent moisture ingress can lead to concealed damage, including timber rot and mould growth.

Elevated moisture readings in tiled wet areas can occur from normal shower use, age/deterioration of waterproofing membranes, plumbing leaks or moisture absorption through grout lines. While no damage was visible, elevated readings may indicate moisture retention behind tiles, which can be a conducive condition for future deterioration if not monitored.

. Monitor the area over time for signs of drumming, efflorescence, tile movement, or grout deterioration. If concerns arise, a licensed waterproofing specialist can perform further investigation (e.g., pressure testing, membrane assessment).

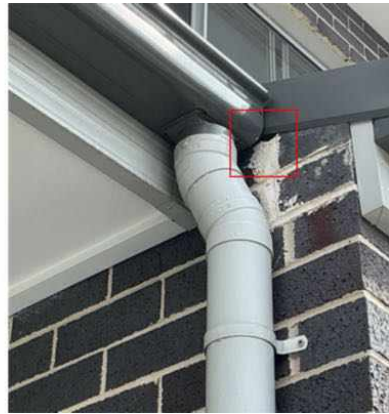
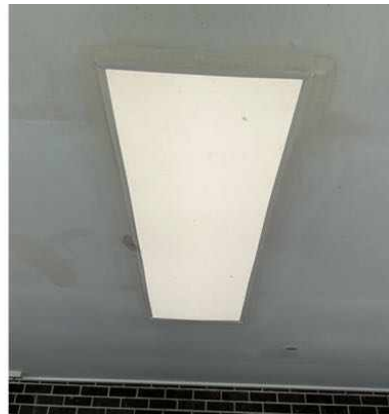
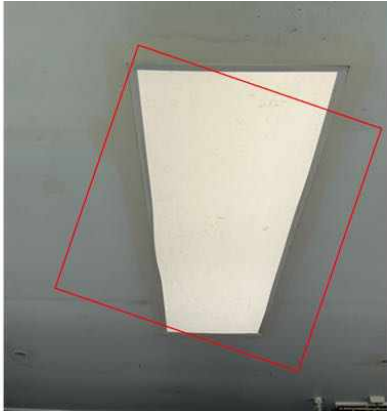
Finding 3.05

Building: Main Building  
Location: All External Areas  
Finding: Incomplete or substandard works - Unsealed gap (Possible Moisture ingress) , Ceiling lights incomplete repairs  
Information: The works to this area appear to be incomplete or have been completed to a substandard level.

Works that have not been completed to a satisfactory level create potential for the development of building defects and may impede on the safety and integrity of the overall structure.

It is highly recommended that the relevant trades be appointed to complete these works and ensure the safety of the area and the longevity of all associated building elements.

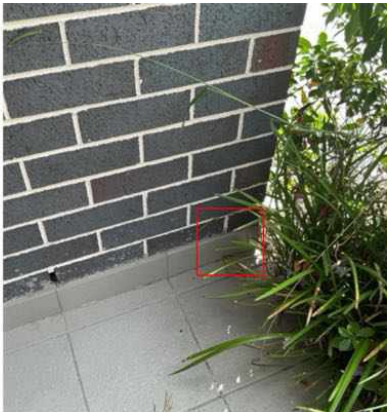
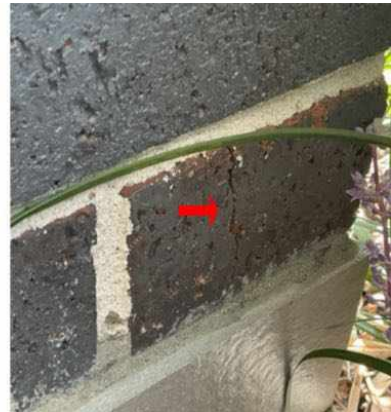
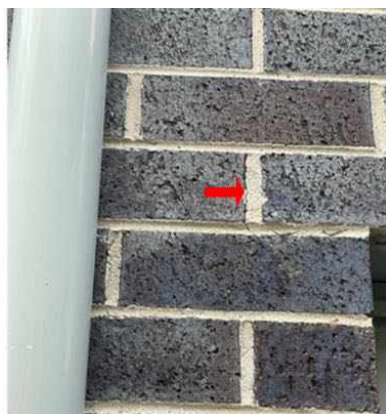
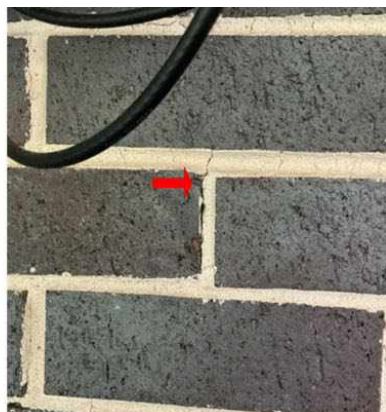
### Finding 3.06

Finding: Brickwork - Cracking [Fine] to some areas

Information: Although fine cracks are quite noticeable, they are often only considered to be an appearance defect and usually do not indicate any structural damage. Generally, the cause of a fine crack is indicative of a separation between brickwork and mortar throughout the structure, but single bricks may also show cracks of this nature.

Cracking of this nature can generally be repaired with minor filling and should be conducted by a qualified bricklayer.

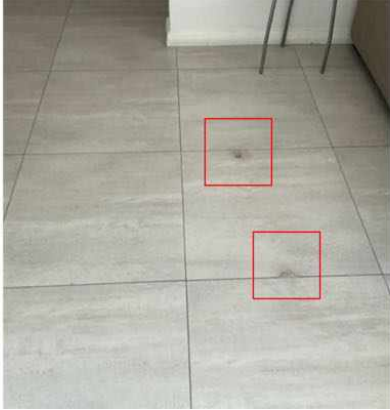
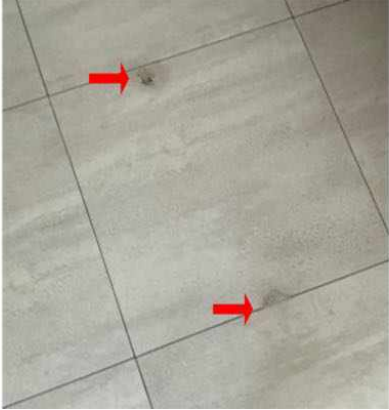
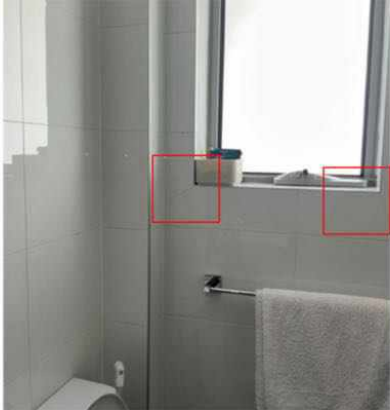
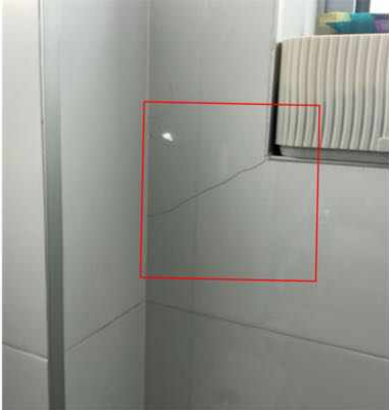
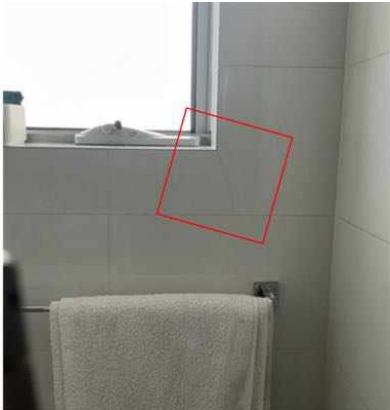
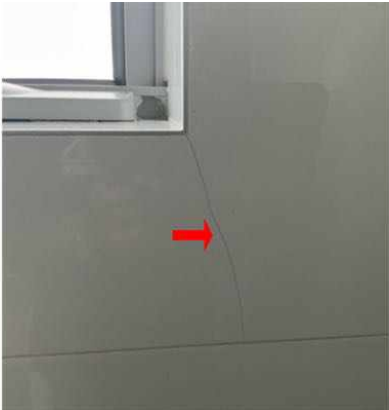
### Finding 3.07

Building: Main Building  
 Location: All Internal Areas - Lounge , ensuite  
 Finding: Tiles - Cracked or damaged  
 Information: Cracking was evident to the tiling in this area at the time of inspection. While the cracking appears to be minor, this area is frequently exposed to water, allowing potential for water penetration into adjoining sections of walls or flooring.

If left unmanaged, water penetration to these areas may lead to subsequent water damage, which is likely necessitate repair work to affected building elements.

A tiling contractor should be appointed to ensure that no further water damage

occurs. The re-application of silicone and grouting throughout remaining tile work is also advised, to further protect the area against water penetration.

Where water penetration has led to water damage, appointment of a relevant tradesperson may be required to repair damaged building elements.

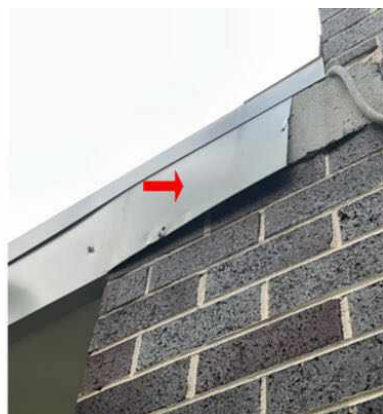
**Finding 3.08**

Building: Main Building  
Location: Roof Exterior  
Finding: Building element - Dam(Loose flashing possible moisture ingress)  
Information: Breakage occurs generally when the building materials have either aged and decayed,

or as a result of damage (accidental or deliberate).

Repair and/or replacement of broken elements is advised to ensure that additional secondary defects do not arise as a consequence. Such works are necessary, as all building elements play a key role in the operation and function of the overall structure and its performance.

A relevant tradesperson should be appointed to repair or replace the affected building element prior to any subsequent damage being caused.

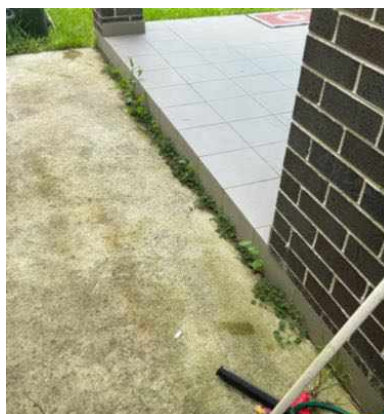
### Finding 3.09

Building:	Main Building
Location:	All External Areas
Finding:	Poor Surface Drainage & Vegetation Growth – Side Passage
Information:	The concrete pathway along the side of the dwelling appears to have visible organic staining, algae growth and vegetation along the slab edges, indicating prolonged moisture retention and inadequate surface drainage. No clear drainage outlet was observed within the inspected section. Poor drainage in this location may allow water to track toward the external wall, increasing the risk of rising damp, mortar deterioration, damp-proof course bridging and termite conducive conditions over time. While no immediate structural failure was evident, A further inspection by a licensed plumber is recommended along with removal of vegetation build-up and ensure

adequate exposure of the damp-proof course in accordance with good building practice.

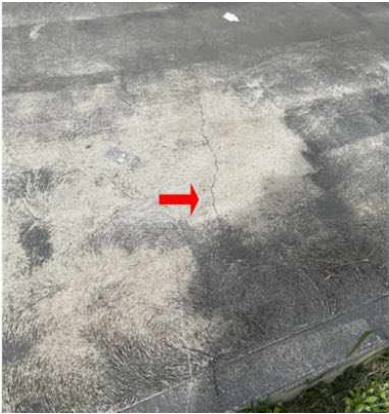
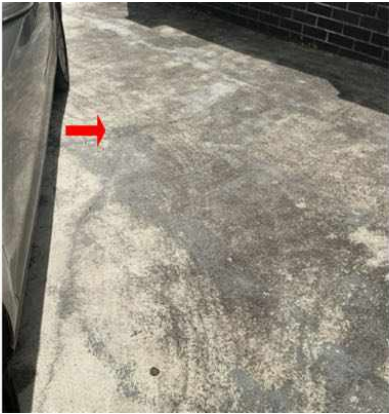
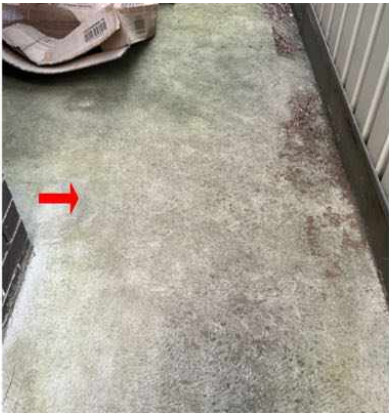
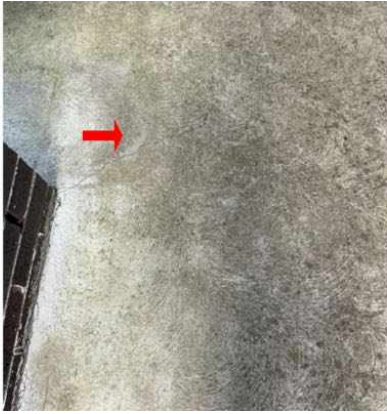
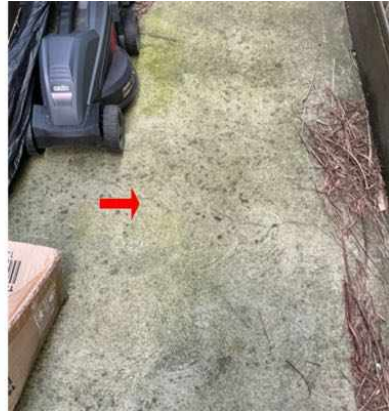
### Finding 3.10

Building:	Main Building
Location:	All External Areas
Finding:	Cracking - External Concrete Paving Damage Category 3 - Wide Cracks (2mm - 4mm)
Information:	Wide cracks were identified in external concrete paving Wide cracks are significant and are likely to lead to the development of safety hazards and secondary defects if left unmanaged.

General age and expected deterioration of the paved areas is a common cause of this type of cracking. However, expansion and contraction of the slab may also have occurred due to environmental factors. Such factors include variable moisture and weather conditions, the presence of trees and their roots having a settling or lifting affect on the soil, or the effect of load bearing, e.g. heavy vehicles over a sustained period of time.

Cracking to this degree may also be due to poor original installation of the concrete. Factors such as poor compaction of the sub surface and/or inadequate reinforcing of the slab may create cracking and other secondary defects. Wide cracks may also have a more significant structural cause, such as subsidence of soils.

Where the crack is located adjacent to structural elements of the building, the advice of a Structural Engineer is advisable before undertaking repairs. Significant repair and likely replacement of the concrete paving is probable.

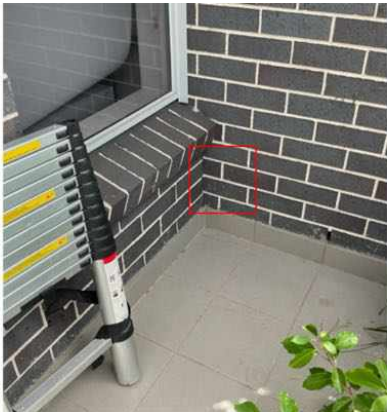
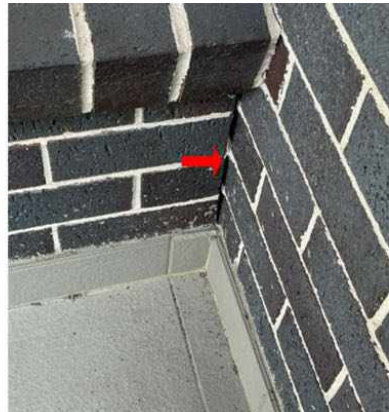
Building:	Main Building
Location:	All External Areas - Left
Finding:	Building element - Missing - Sealant missing
Information:	Although some building elements may seem irrelevant or unnecessary, all building elements play a key role in the operation and function of the overall structure and its performance.

Replacement of any missing building element should be conducted as soon as possible to ensure that no damage or functional issues occur to associated building materials.

The appropriate tradesperson should be appointed as soon as possible to replace the missing building element.

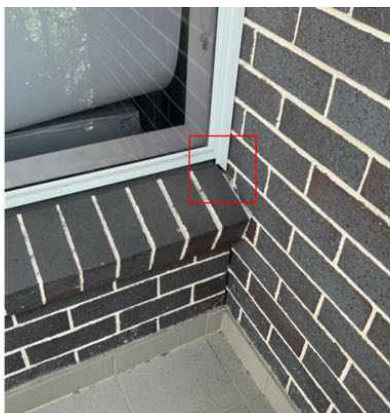
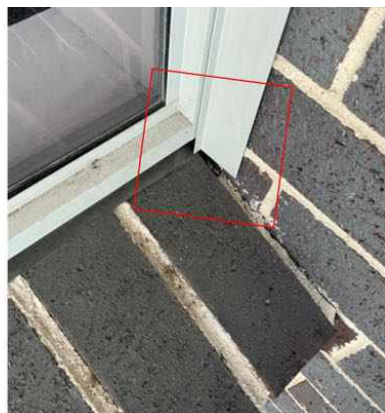
### Finding 3.12

Building:	Main Building
Location:	All External Areas
Finding:	Gap Between Window Frame and Masonry to some areas
Information:	A visible gap is present between the external window frame and the adjacent masonry wall. This gap may allow water ingress, air infiltration, and potential pest entry if not

adequately sealed. Over time, such exposure can contribute to frame deterioration, internal water damage, or reduced thermal performance. Sealing or filling the gap with a suitable weatherproof compound is recommended to maintain the integrity of the building envelope, in accordance with good building practice and AS 4349.1

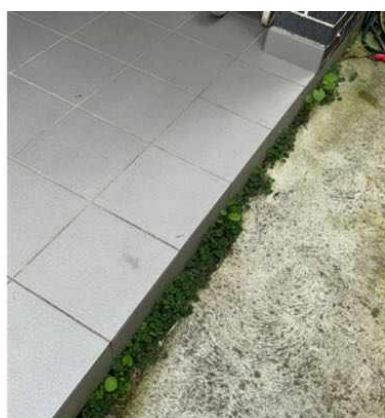
### Finding 3.13

Building:	Main Building
Location:	All External Areas
Finding:	Gap Between Concrete and External Wall - to some areas
Information:	Visible gaps were observed between the external masonry wall and adjacent concrete slab at the pathway.

This separation may permit water ingress and contribute to concealed moisture-related damage, pest ingress, or slab movement if left unsealed.

The defect appears consistent with common differential settlement or poor sealant detailing at the slab-to-wall junction. Recommend a licensed contractor seal the gap with an appropriate flexible, UV-stable exterior-grade sealant to prevent moisture entry and pest intrusion.

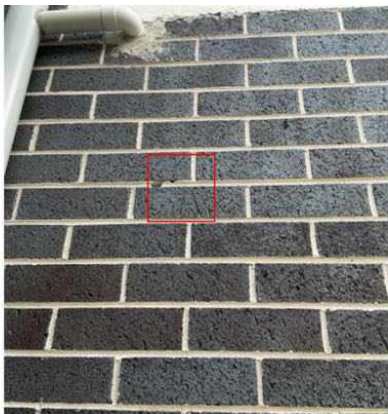
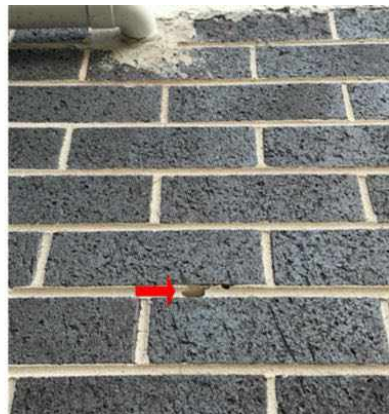
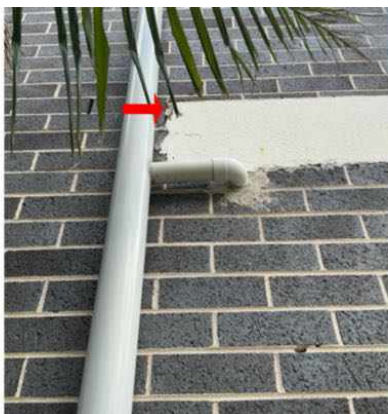
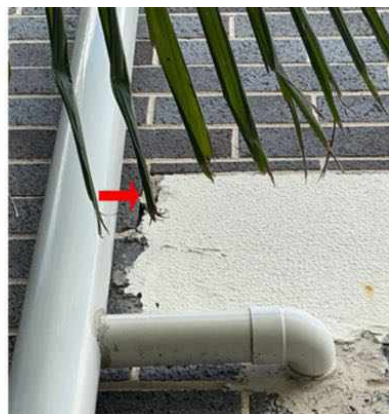
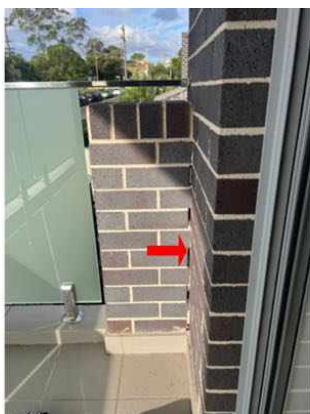
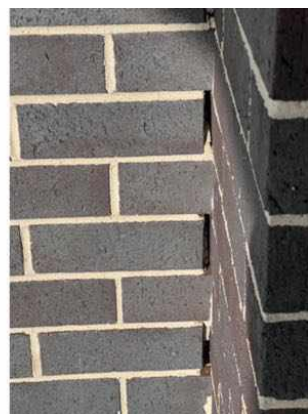
### Finding 3.14

Building:	Main Building
Location:	All External Areas
Finding:	Brickwork - Deteriorated mortar to some areas
Information:	Mortar, or 'bedding', is the material which fills joins and intersections between bricks in masonry walls and structures. Sections of mortar in this brickwork were identified as having deteriorated, which is generally expected for a property of this age and condition.

Mortar may deteriorate as a result of age of building materials, minor movement of bricks, or frequent exposure to weathering. Mortar should be replaced to ensure that bricks remain in their intended location and to prevent gaps, which would allow water or moisture ingress and secondary damage as a result.

Mortar deterioration can be addressed by a bricklayer where areas of deterioration are localised and easily accessible. Alternatively, appointment of a registered builder is advised, to repoint large areas of decaying mortar. Where secondary structural defects have become evident, consultation with a structural engineer may be required.

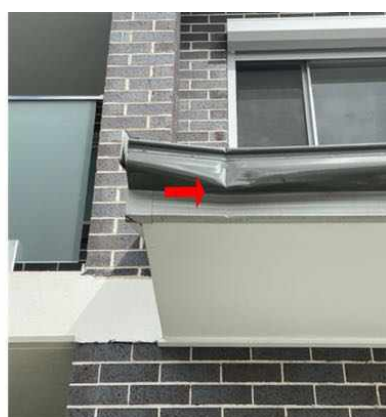
Building:	Main Building
Location:	All External Areas - Front
Finding:	Building element - Damaged - Gutter damaged , hole not sealed side
Information:	Breakage occurs generally when the building materials have either aged and decayed, or as a result of damage (accidental or deliberate).

Repair and/or replacement of broken elements is advised to ensure that additional secondary defects do not arise as a consequence. Such works are necessary, as all building elements play a key role in the operation and function of the overall structure and its performance.

A relevant tradesperson should be appointed to repair or replace the affected building element prior to any subsequent damage being caused.

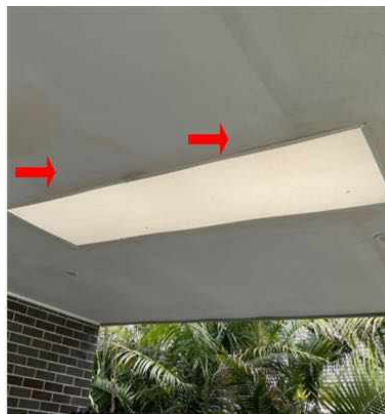
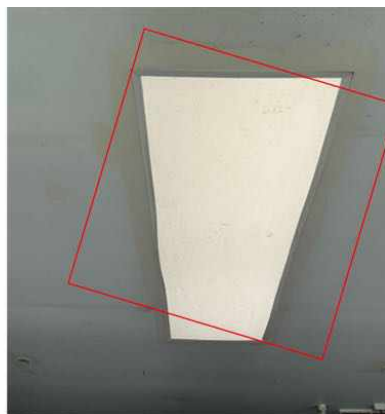
### Finding 3.17

Building:	Main Building
Location:	All External Areas - Rear
Finding:	Incomplete or substandard works - Poor workmanship and incomplete repair work
Information:	The works to this area appear to be incomplete or have been completed to a substandard level.

development of building defects and may impede on the safety and integrity of the overall structure.

It is highly recommended that the relevant trades be appointed to complete these works and ensure the safety of the area and the longevity of all associated building elements.

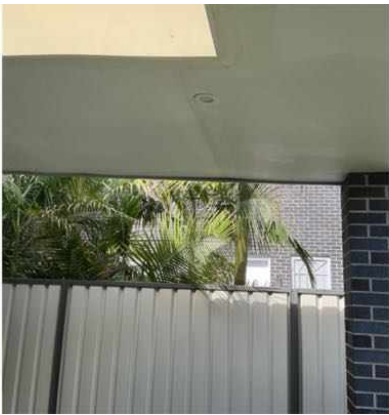
### Finding 3.18

Building:	Main Building
Location:	All External Areas - Rear
Finding:	Paint Defect - Shadowing
Information:	Minor cosmetic shadowing is visible on the alfresco ceiling, presenting as faint straight lines along the plasterboard joints, this is a common effect caused by raking light, normal thermal movement, and variations in paint or compound finish, with no signs of moisture ingress this is considered a minor defect under AS 4349.1, with improvement achievable through skim-coating and repainting if desired.

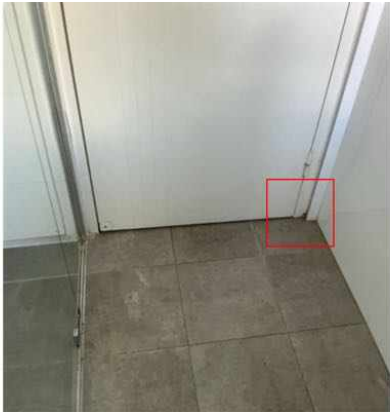
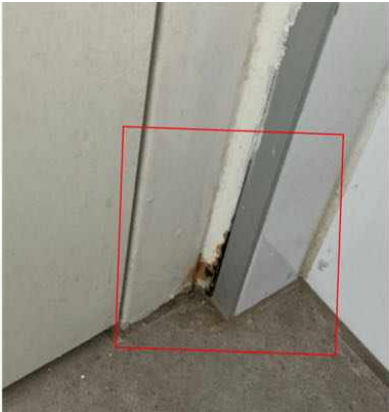
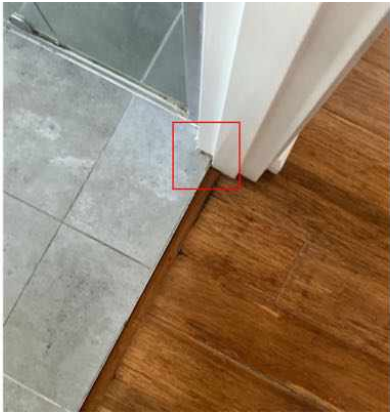
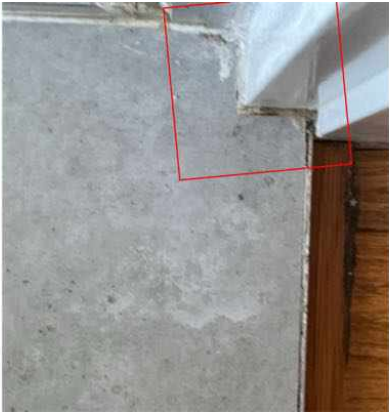
**Finding 3.19**

Building: Main Building  
Location: Bathroom  
Finding: Wet-Area Door Jambs – Moisture Staining / Decay  
Information: Minor moisture staining and deterioration were observed at the base of the wet-area door jamb and/or architraves. This is commonly due to water splashing or moisture tracking from the bathroom floor into adjacent joinery or inadequate waterproof transition at the bathroom threshold.

Further inspection by a licensed waterproofing contractor is recommended to verify exact cause and remedial measures.

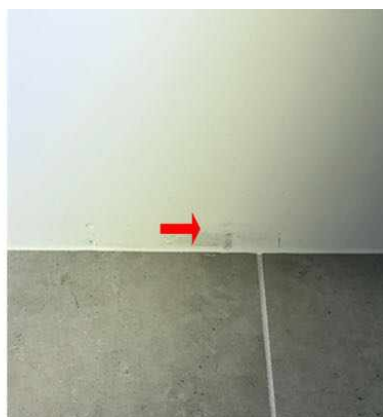
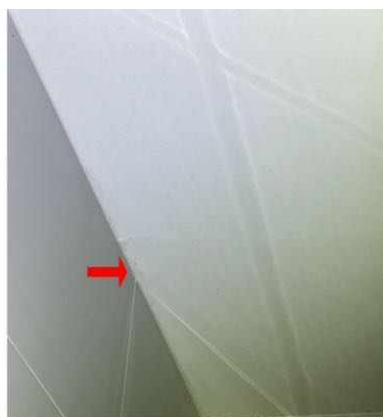
### Finding 3.20

Building:	Main Building
Location:	Bathroom
Finding:	Water Staining - Humidity or Ventilation
Information:	The ceiling surface shows faint darkened spotting or shadowing, commonly consistent with surface mould or humidity-related staining, often found in bathroom or wet area ceilings with insufficient ventilation. While there is no visible sagging or major water damage, the pattern suggests prolonged moisture exposure, possibly due to steam accumulation or minor condensation issues. According to AS 4349.1–2007 (Appendix C), this would be classified as a minor defect unless further deterioration or active leaks are found. Recommend improving mechanical or natural ventilation, cleaning the surface with mould treatment, and monitoring for recurrence.

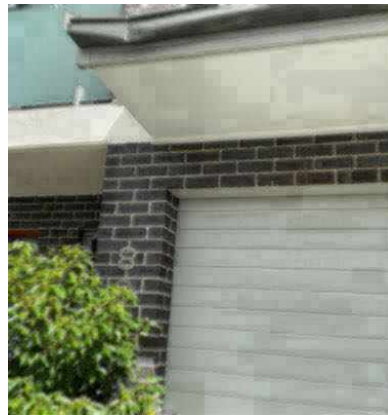
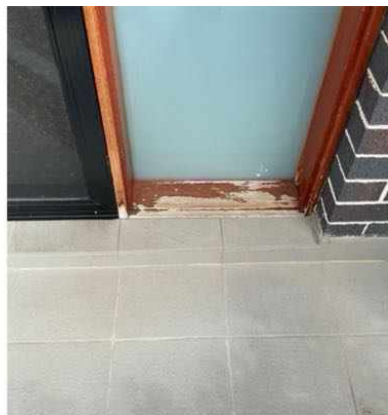
### Finding 3.21

Building:	Main Building
Location:	All Internal Areas
Finding:	Paint Finish & Hairline Cracking - To some areas
Information:	The paint finish in this area was identified as being incomplete or substandard at the time of inspection including some hairline minor cracking/separation. Monitoring is recommended where cracking and separation is evident.

Whilst incomplete or missing paint finish is generally an appearance defect, it can also lead to the development of secondary building defects over time. Incomplete areas of paint finish expose the area to moisture, potentially accelerating the deterioration of underlying building materials.

Incomplete paint finishes should be sanded back, filled, leveled and painted, as applicable. Where inadequate or missing paint protection has led to the deterioration of the associated building element, repair and/or replacement of this building element may be required.

A painting contractor should be appointed as soon as possible to perform necessary works to aid the appearance of the affected area and to ensure the area is protected against further deterioration. Alternatively, the homeowner following manufacturer instructions may perform these works.

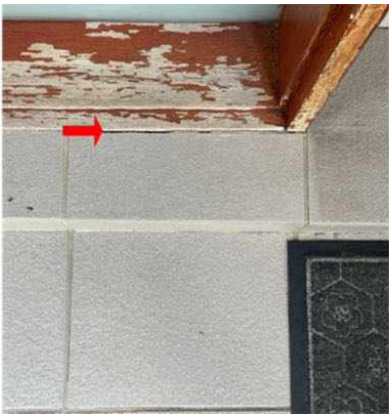
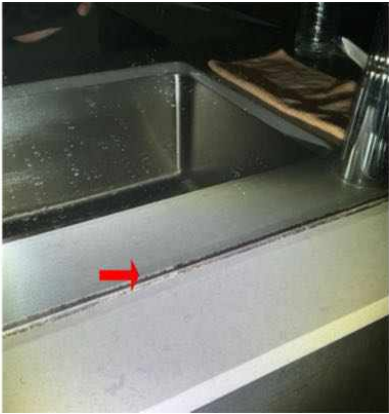
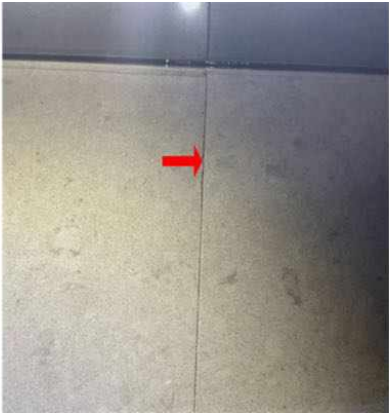
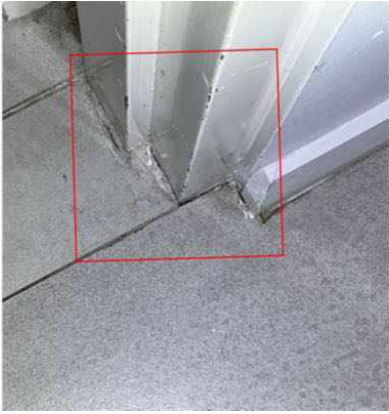
### Finding 3.22

Building:	Main Building
Location:	All Internal Areas and balcony
Finding:	Sealant and grouting - Missing or degraded to some areas
Information:	It was noted on inspection that sealant or grout is degraded.

Different materials and floor areas move at different rates, generally causing cracking to grout or sealant at this point. A flexible sealant is required to allow for expected expansion and contraction, while keeping the joint water tight and protective of all associated building materials.

Excessive mould to the sealant and grout may require scraping out and replacement.

Flexible and mould resistant materials should be applied to affected areas to prevent any subsequent water damage that is likely to occur. Regular maintenance and replacement of damage or missing or damaged sealant and grout is highly recommended to the wet areas, as this is a regular wear and tear defect. Sealant and grouting in areas that come into regular contact with water should be maintained for the long term care of your property.

A sealant specialist or tiling contractor should be appointed to complete these works as soon as possible

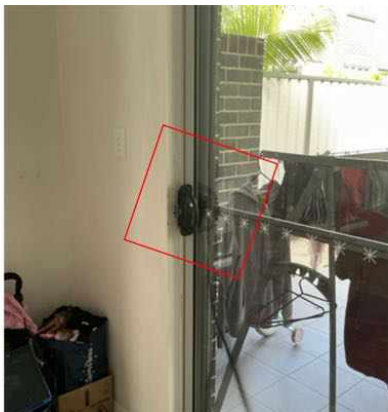
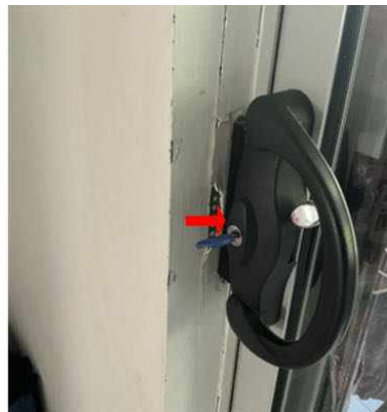
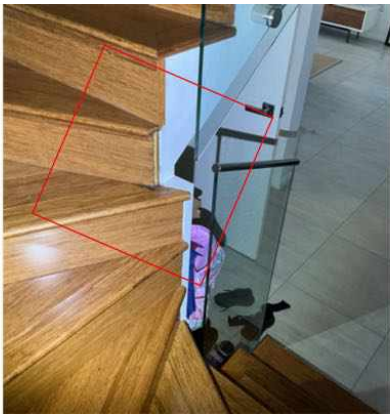
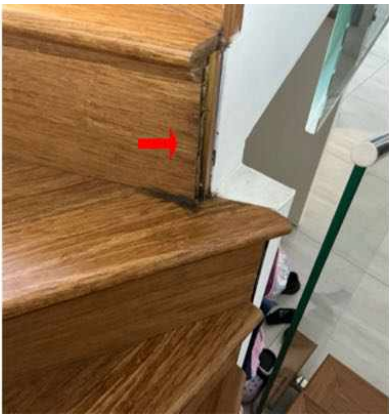
**Finding 3.24**

Building: Main Building  
Location: All Internal Areas - Bedroom Rear  
Finding: Building element - Damaged- (Door damaged bedroom, skirting loose upstairs rear )  
Information: Breakage occurs generally when the building materials have either aged and decayed, or as a result of damage (accidental or deliberate).

Repair and/or replacement of broken elements is advised to ensure that additional secondary defects do not arise as a consequence. Such works are necessary, as all building elements play a key role in the operation and function of the overall structure and its performance.

A relevant tradesperson should be appointed to repair or replace the affected building element prior to any subsequent damage being caused.

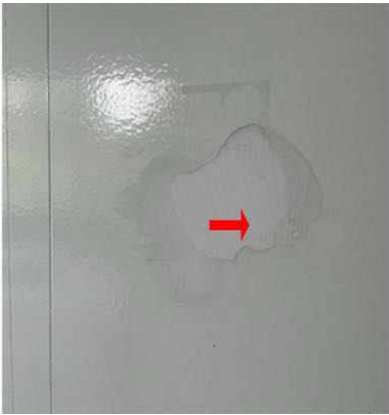
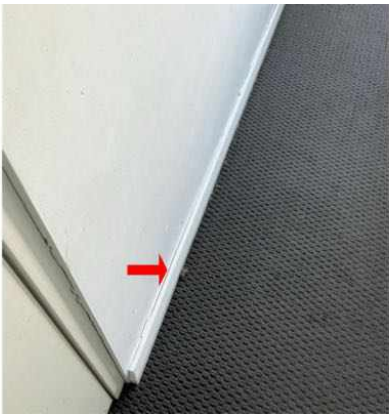
**Finding 3.25**

Building: Main Building  
Location: Lounge Room 2  
Finding: Gap between skirting and Floor  
Information: A localised gap is visible between the skirting board and the laminate/timber floor finish, indicating minor floor level variation or movement of the floating floor system. This condition is most consistent with minor slab/floor unevenness, floor finish movement or shrinkage. While primarily cosmetic/serviceability in nature, monitoring is recommended and further assessment may be warranted by a licensed builder if additional signs of structural movement become apparent.

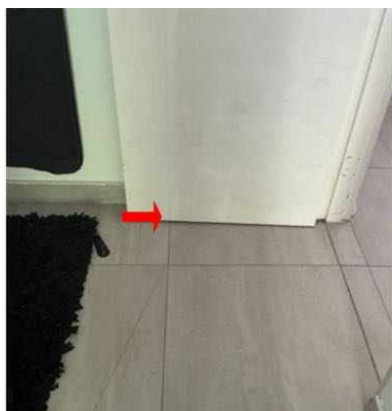
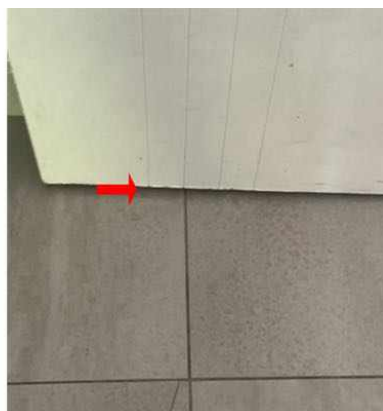
Building:	Main Building
Location:	Bathroom
Finding:	Delamination of timbers
Information:	Delamination is one means by which composite materials (e.g. layered timber composites) may fail over time. In laminated materials, repeated cyclic stresses may lead to the formation of mini-structures of separate layers, with significant loss of mechanical toughness. Water penetration or the presence of excessive moisture also generally contributes to delamination.

Where building materials have become delaminated, they lose their structural strength, and are likely to have a variety of appearance and serviceability defects as a result.

Delamination of timbers may be repaired where the area affected is minor and/or easily accessible, by gluing and screwing layers back together. However, this is an interim repair, and where delamination has occurred, the client should plan for the replacement of affected timbers sooner than would otherwise be expected.

All timber structures affected by delamination should be replaced as soon as possible to avoid any further damage. Repair and replacement estimates should be sought from a registered builder or qualified carpenter.

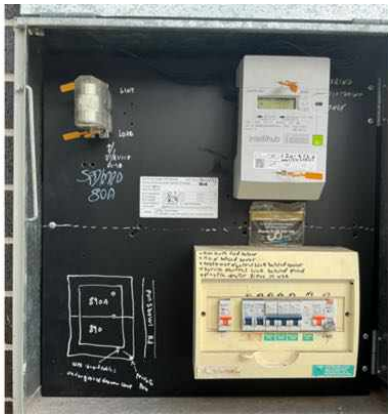
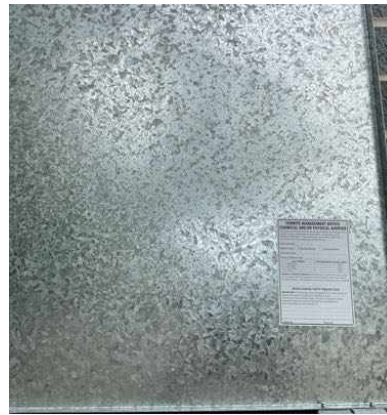
Building:	Main Building
Location:	All External Areas
Finding:	Termite Management System - no evidence of a chemical installation
Information:	The application of a post-construction chemical termite barrier is highly recommended for all properties, particularly if live termite activity has been found on the site previously. Such barriers are highly effective in preventing termite attack on any timber building elements throughout the property.

A durable notice should be placed in the switchboard unit to indicate current termite barriers. At the time of inspection, it appeared as though no termite management system has been installed, with no evidence to suggest preventative works taking place.

The client may consider gaining further advice from a pest controller as to the costs and procedures involved with this application. It is recommended that obtaining such advice be a short-term priority.

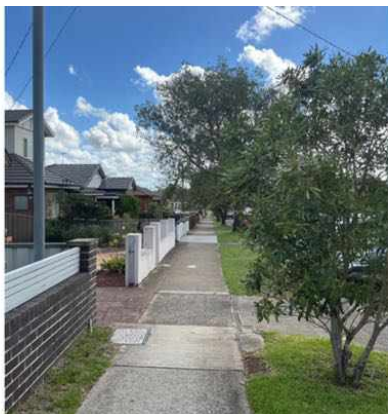
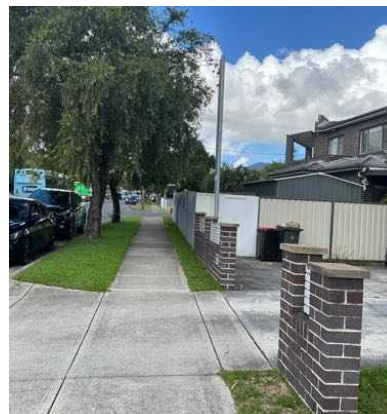
### Finding 6.02

Building:	Main Building
Location:	All External Areas
Finding:	Trees within 50m
Information:	Trees within 50m of the property can be conducive to termite activity. It is recommended an invasive inspection of all trees with 50m to the property be carried out by a qualified pest control expert.

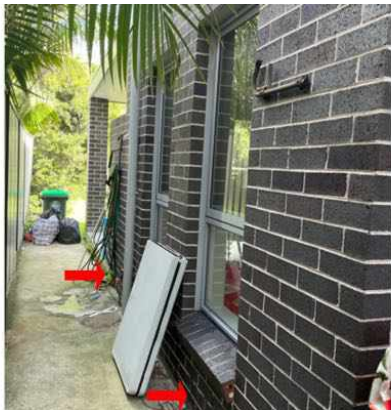
### Finding 6.03

Building:	Main Building
Location:	All External Areas
Finding:	Slab Edge - Exposure
Information:	An inspection zone of at least 75mm in relation to the exposed slab edge, between the bottom brick and the perimeter pavement, is required. This inspection zone should be maintained in order to force termites into the open where they can be detected more readily during regular inspections. The slab edge should not be concealed by anything that may prevent inspection of the area, including render, landscaping, soil, turf, paving, concrete cladding or other structures.
	If the slab edge is not properly exposed there is a high risk of termite attack. Sometimes, in order to determine the type of slab, a suitably qualified person such as

Where the slab edge cannot be properly inspected, it is highly recommended that termite or timber pest inspections be carried out every 6-12 months to aid protection of the property against infestation.

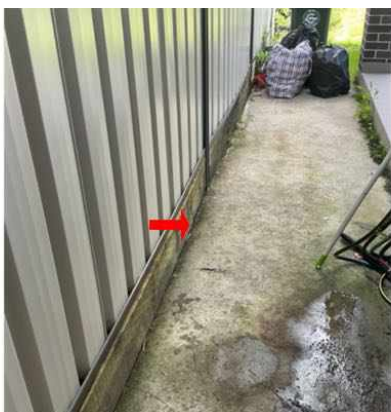
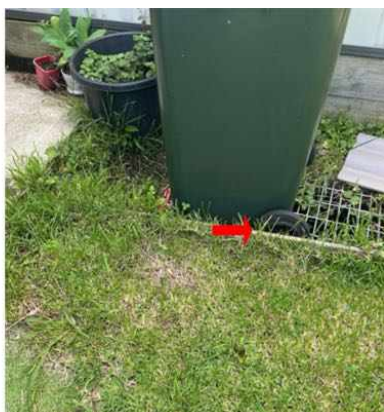
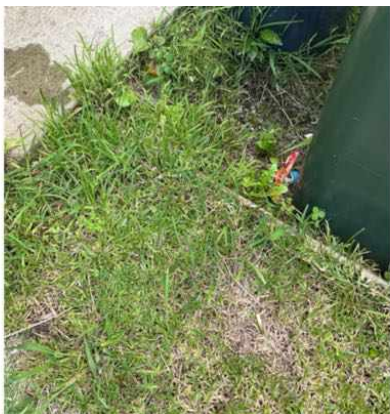
### Finding 6.04

Building:	Main Building
Location:	All External Areas
Finding:	In ground contact - Timber
Information:	Any timbers in direct ground contact provide opportunity for concealed termite entry and are likely to be subject to premature rot and decay as the soil retains moisture or damp conditions against the timbers.

Remove untreated timber that is in direct contact with external grounds. Consider replacement with more durable materials i.e. treated timber or non timber elements. Frequent pest inspections are advised to readily identify any termite activity in these areas.

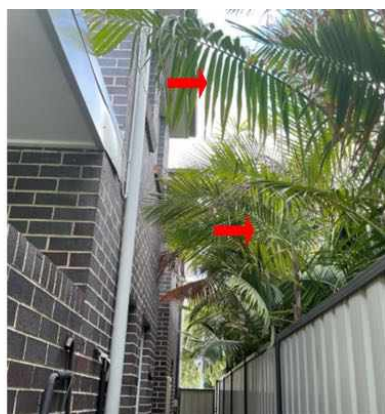
Building: Main Building  
 Location: All External Areas  
 Finding: Bridging - Vegetation  
 Information: Where vegetation obstructs inspection of building elements, also known as bridging as it provides a bridging point for the access of termites, full inspection can not be achieved. Consequently moisture or dampness may be present and the areas becomes conducive to termite activity. Plants against or very close to buildings provide cover, shade and can provide an environment that is attractive to termite infestation.

The removal and replanting of species that do not provide "cover" or cutting back of existing vegetation will assist greatly in preventing Bridging from occurring.

The removal of any such materials that may be conducive to termite activity should be carried out as soon as possible and arrange re inspection to minimize the risk of termite attack.

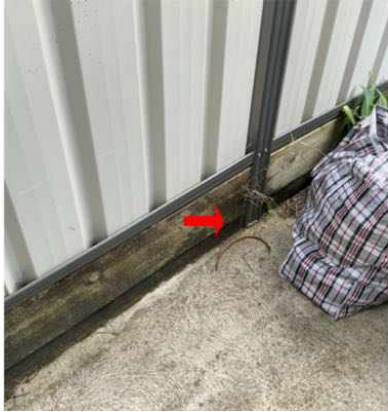
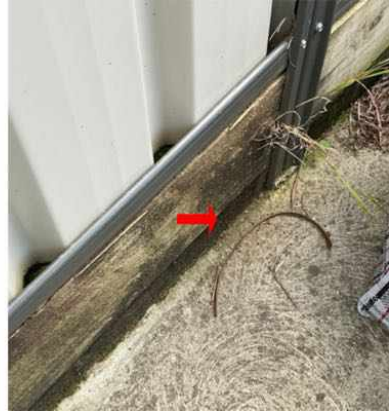
### Finding 7.01

Building: Main Building  
 Location: All External Areas  
 Finding: Fungal decay - present  
 Information: Fungal decay also known as wood decay or wood rot generally refers to the deterioration of timber elements when in contact with excessive levels of moisture for a prolonged period of time.

In this case although the affected timber element is in a decaying state the extent of any visible damage appears to be localised to a specific area and is yet to spread to other parts of the building element or affect adjoining structures. The fungal decay is therefore likely to be of a relatively superficial nature with minimal impact on the structural integrity or tensile strength of the timber element.

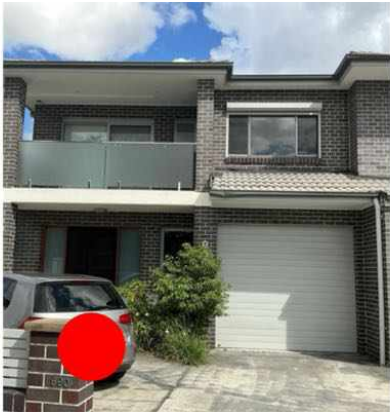
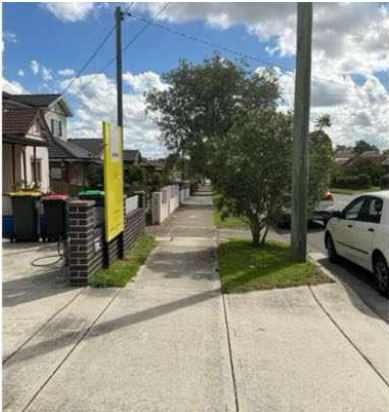
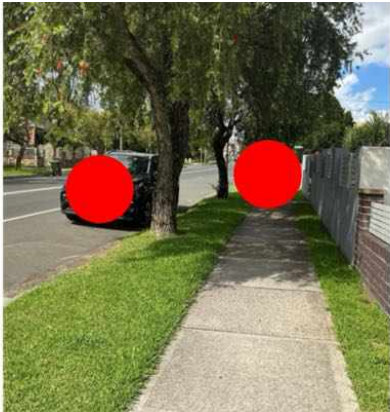
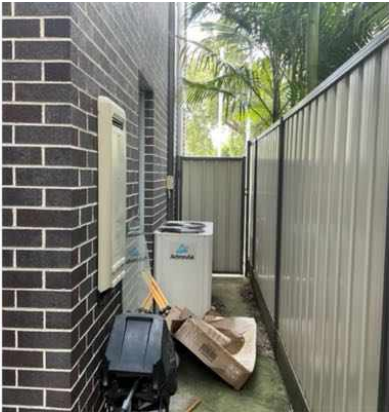
### Noted Item

Building: Main Building  
Location: All External Areas  
Finding: Additional Photos - Obstructions and Limitations  
Information: These photographs are an indication of the obstructions and limitations which impeded full inspection of the property at the time of inspection. These obstructions can hide an array of defects and should be removed to allow full inspection to be carried out. A re-inspection is recommended once the areas are made accessible.
