# Building and Timber Pest Inspection Report

Inspection Date: Mon, 16 Feb 2026

Property Address: 890 Punchbowl Rd, Punchbowl NSW 2196,  
Australia

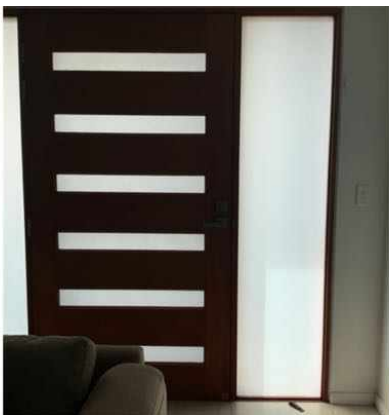
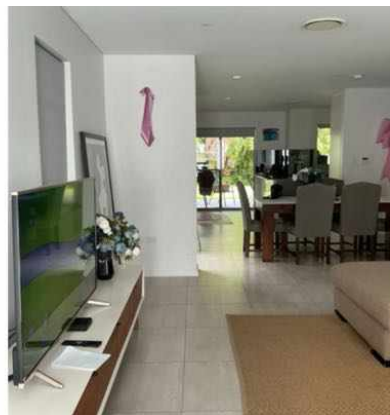
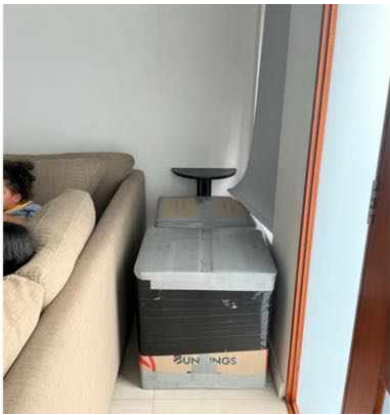
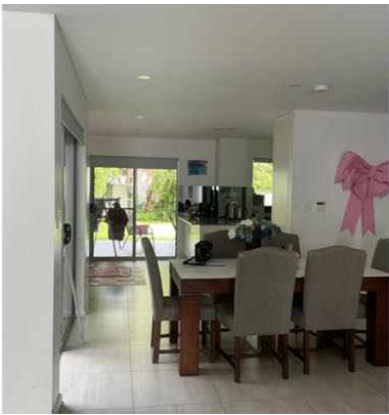
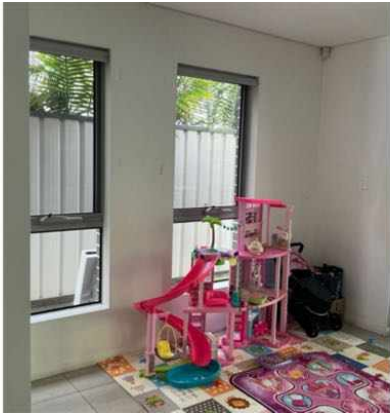
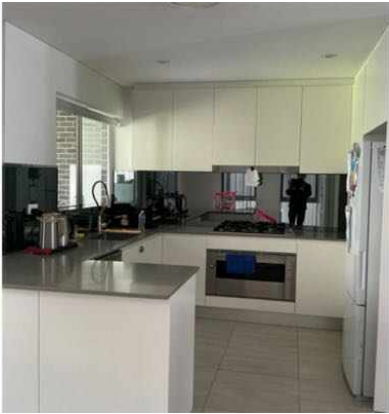
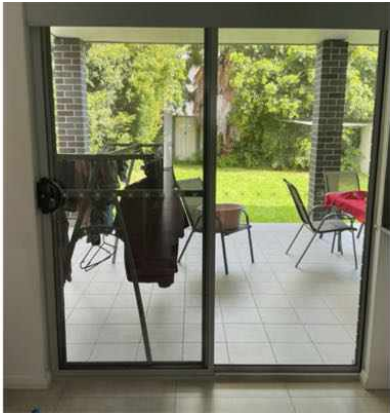
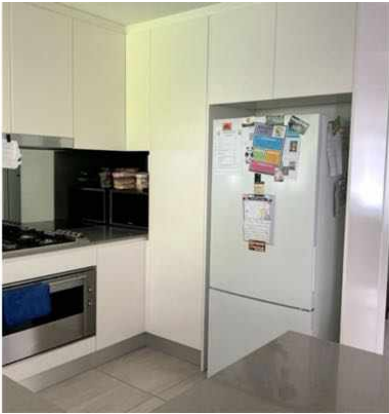
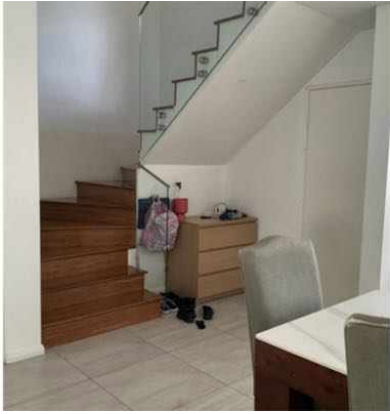
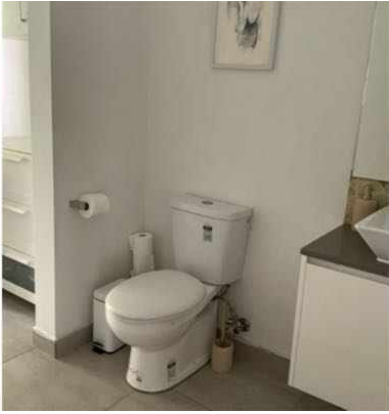
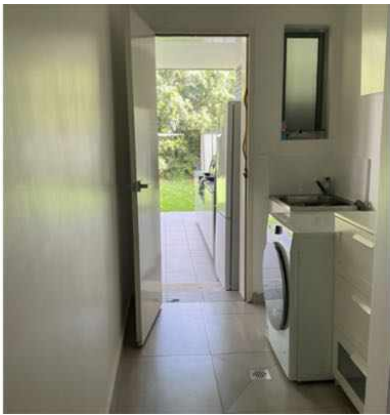
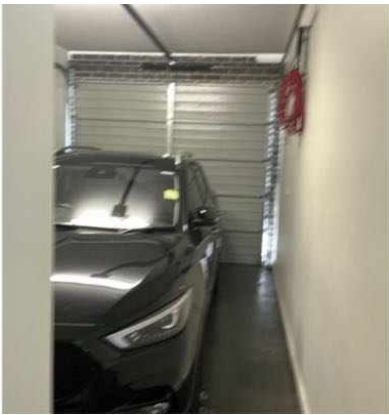
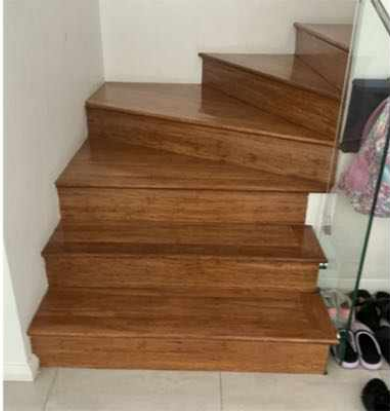
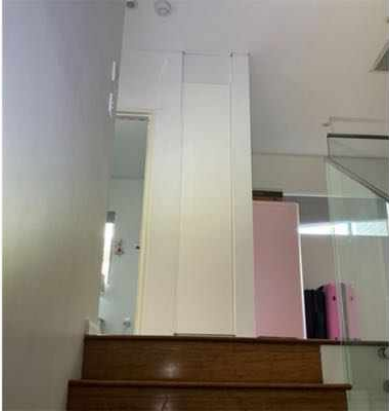
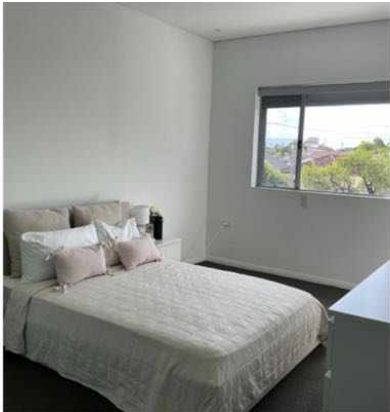
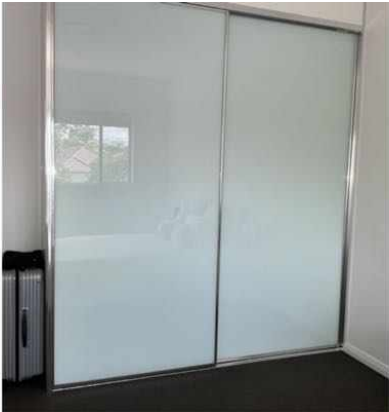
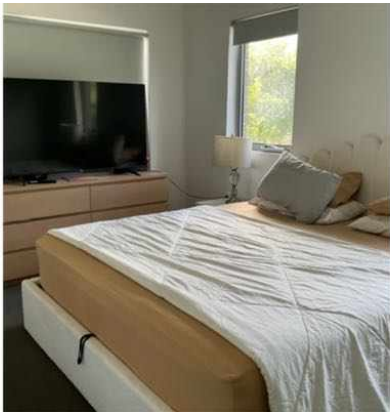
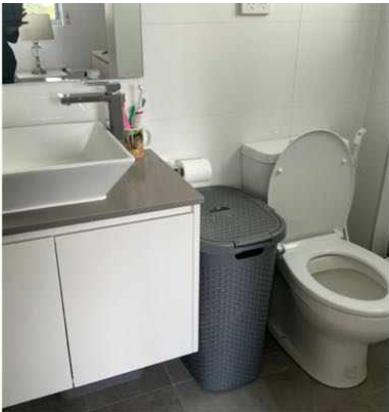
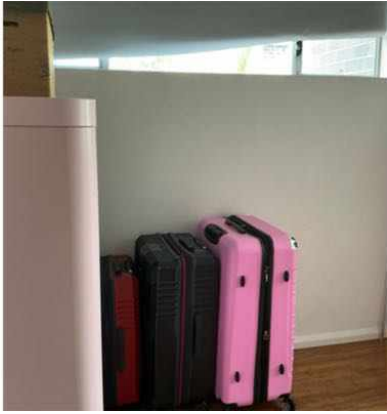
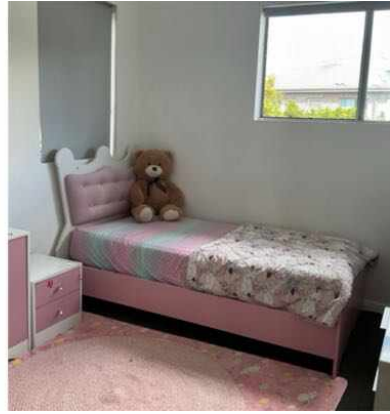
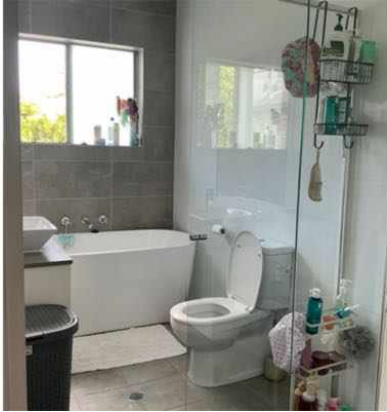
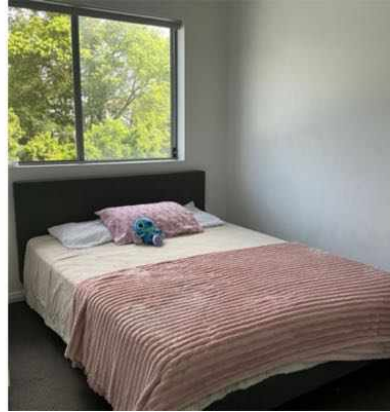
Building: Main Building  
 Location: All Internal Areas  
 Finding: Additional Photos - Obstructions and Limitations  
 Information: These photographs are an indication of the obstructions and limitations which impeded full inspection of the property at the time of inspection. These obstructions can hide an array of defects and should be removed to allow full inspection to be carried out. A re-inspection is recommended once the areas are made accessible.

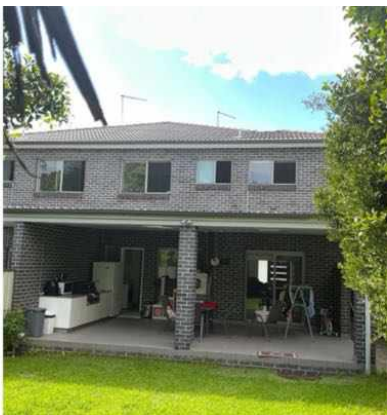
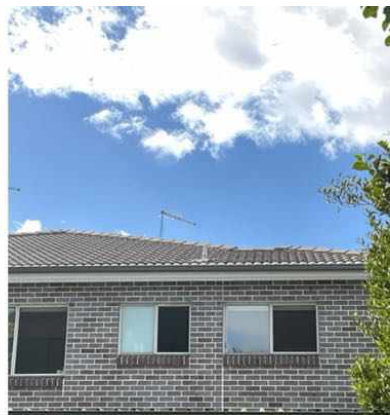
Building: Main Building  
 Location: Roof Exterior  
 Finding: Additional Photos - Obstructions and Limitations  
 Information: These photographs are an indication of the obstructions and limitations which impeded full inspection of the property at the time of inspection. These obstructions can hide an array of defects and should be removed to allow full inspection to be carried out. A re-inspection is recommended once the areas are made accessible.

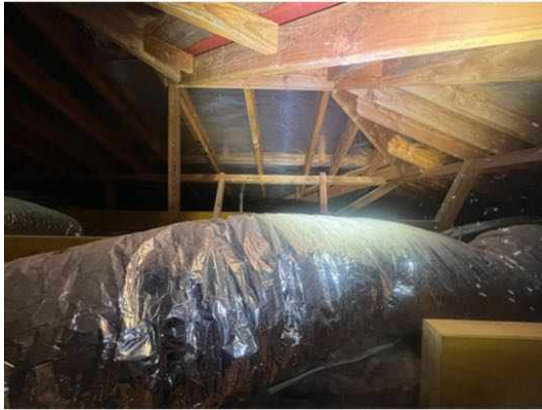
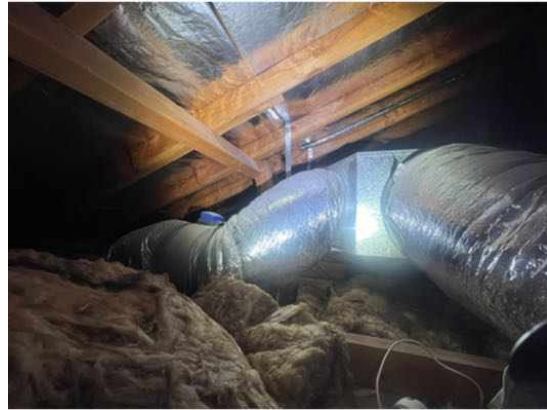
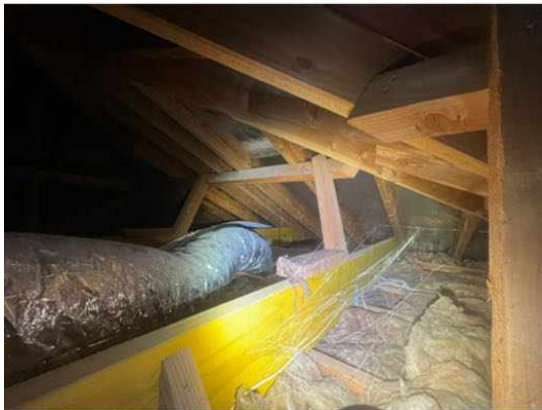
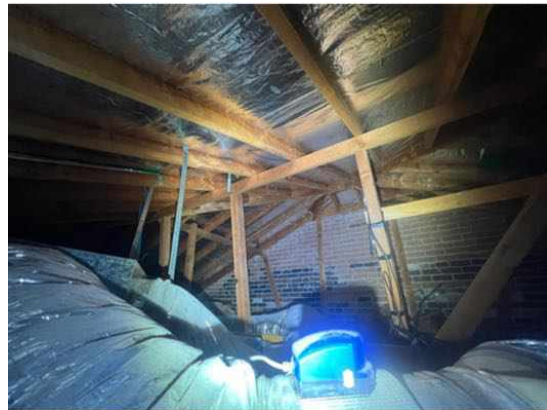
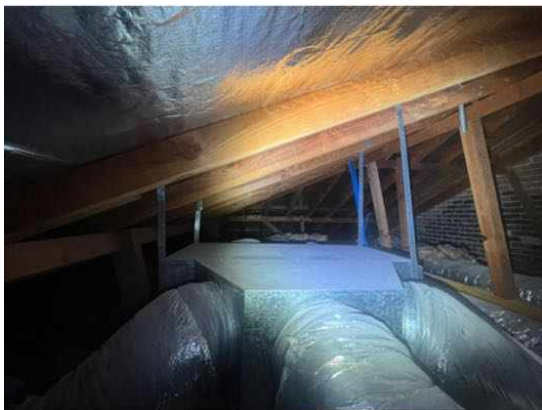
Building: Main Building  
Location: Roof Void  
Finding: Additional Photos - Obstructions and Limitations  
Information: These photographs are an indication of the obstructions and limitations which impeded full inspection of the property at the time of inspection. These obstructions can hide an array of defects and should be removed to allow full inspection to be carried out. A re-inspection is recommended once the areas are made accessible.

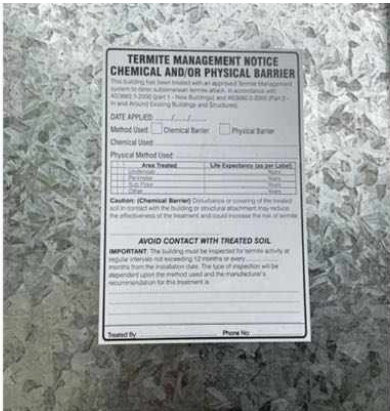
Where a Termite Management System has been identified you should refer to the type of barrier date of installation warranty conditions and any documentation provided by a builder or past owner. Consult the company who installed the barrier to confirm whether the system is still under warranty.

Most chemical termite management systems expire and require replenishment and all physical systems are primarily designed to prevent concealed entry.
