Building and Timber Pest Inspection Report

Inspection Date: Thu, 2 Apr 2026

Property Address: 13A Havelock Pl, Kiama Downs NSW 2533,
Australia

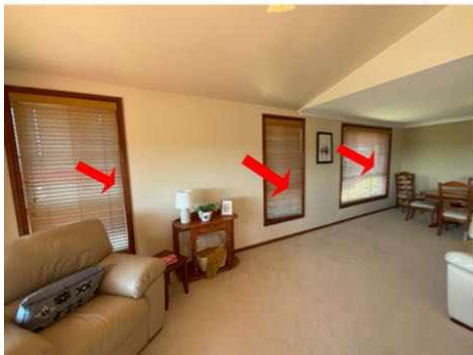
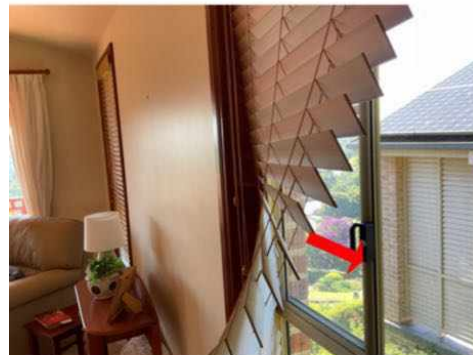
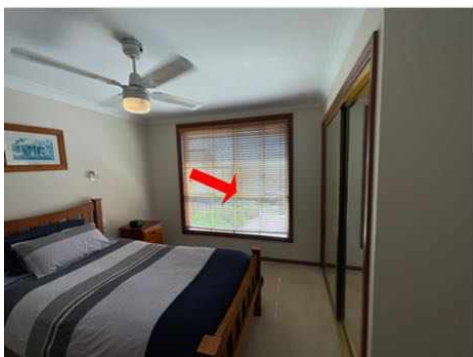
Building:	Building 1
Location:	Pictured upstairs windows
Finding:	Window opening restrictors missing.
Information:	Many upstairs windows are missing window restrictors. The Building Code of Australia rules require all openable windows (where the internal floor is more than 2m above the ground outside) in residential rooms to be fitted with a suitable screen or restrictor. Windows located 1.7m above the floor level do not require protection.

Window restrictors are required where people who are vulnerable to the risk of falling have access to windows. This means all windows above ground level which do not have another fall prevention safety measure in place, such as a balcony or balustrade should have a restrictor.

These need to be added urgently for the safety of all persons.

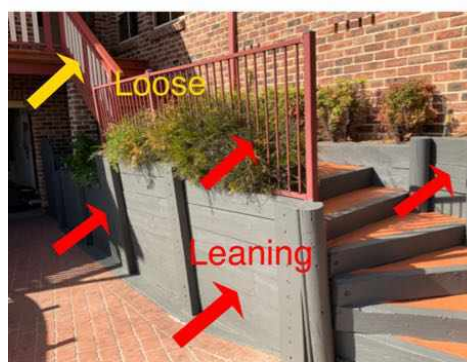
Finding 1.02

Building:	Building 1
Location:	Front Stairs Areas
Finding:	Balcony railing loose and metal railing leaning
Information:	The timber balcony railing in the front stairs area is loose, wobbling and requires additional support. The metal railing is leaning due to the retaining wall underneath also leaning. If left unmanaged, these railings will further deteriorate, causing potential for falls.

A carpenter should be appointed to perform these rectification works immediately.

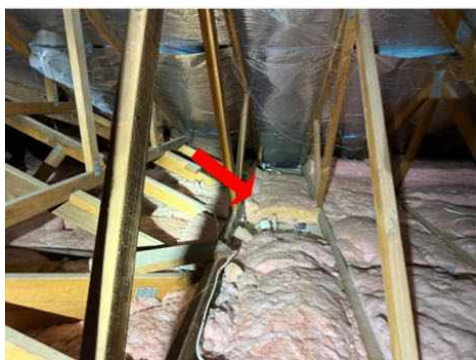
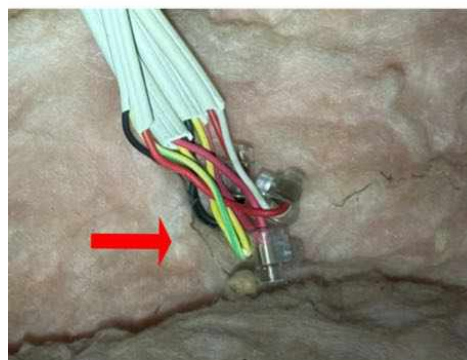
Finding 1.03

Building:	Building 1
Location:	Roof Cavity - rear middle area
Finding:	Electrical cables missing a junction box
Information:	The electrical fitting in this roof area was found to be missing a junction box at the time of inspection.

This missing fitting and loose cables does expose electrical works, and may create a safety hazard if there is potential contact with persons in the area.

A Licensed electrician should be appointed to rectify these areas immediately.

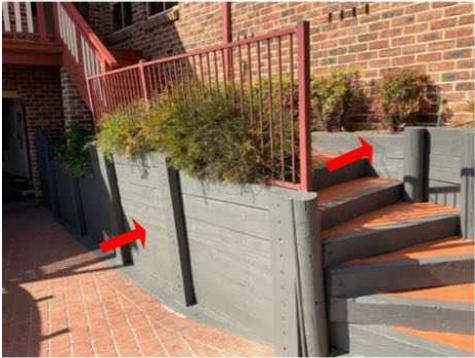
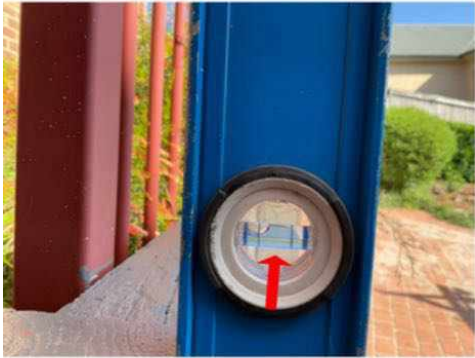
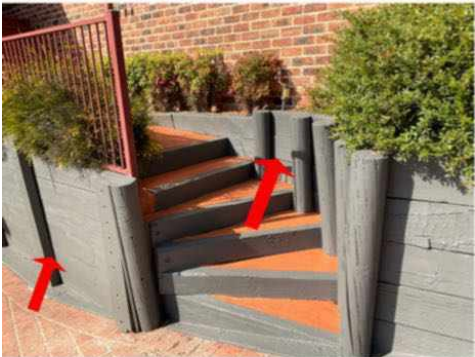
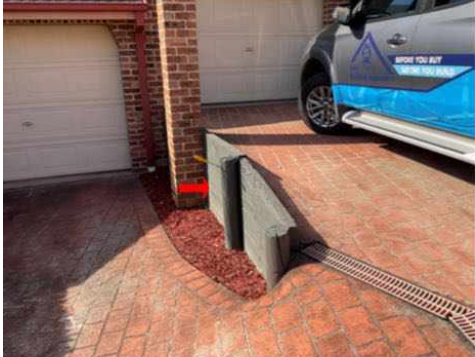
Finding 2.01

Building: Building 1
Location: Pictured front driveway and rear areas
Finding: Retaining walls - Defective
Information:

Most retaining walls were found to be defective at the time of inspection. Generally, defective retaining walls are caused by poor original design or material use. However, deteriorated retaining walls may also be a result of substandard construction, poor site drainage or unmanaged stormwater flows.

If left unmanaged, these retaining walls may become a safety hazard if it continues to destabilise. Where retaining walls further rot and decay, an environment is created that is conducive to termite and pest infestation.

Significant repair and replacement should be expected. Where retaining walls are considered structural walls, a structural engineer / surveyor should be consulted regarding required remedial works. Otherwise, a landscaper or retaining wall installer may be appointed to repair or replace the wall, at the discretion of the client.

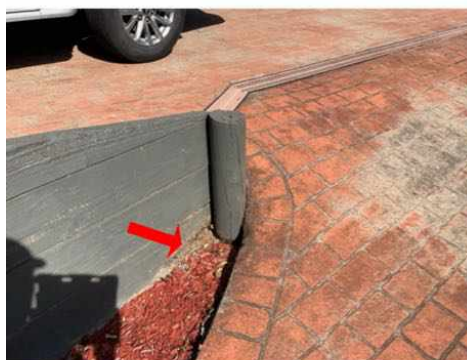
Building:	Building 1
Location:	Pictured retaining walls and railing
Finding:	Wood rot to external areas
Information:	These pictured areas show evidence of wood rot. Wood rot, also known as Fungal Decay, occurs when timbers and other cellulose building materials are exposed to damp conditions on an ongoing basis. This could be the result of exposure to weathering over a prolonged period of time, or the attraction of excessive moisture from other abutting building materials.

Early intervention and regular maintenance, particularly of exterior timbers, will prolong the useful life of these building elements. Prior to any works being performed, the cause of the moisture that has created the visible wood rot should be identified and addressed in a suitable manner. Replacement of affected timbers may then be a necessary step in protecting surrounding building elements from such deterioration.

A retaining wall installer may also be required to replace affected building materials in the near future.

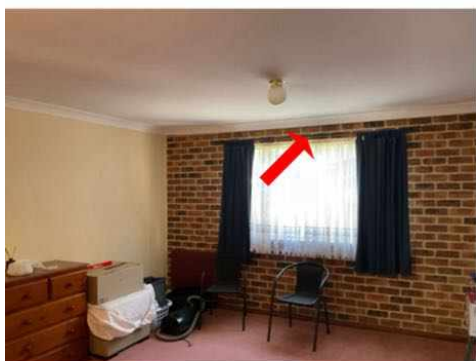
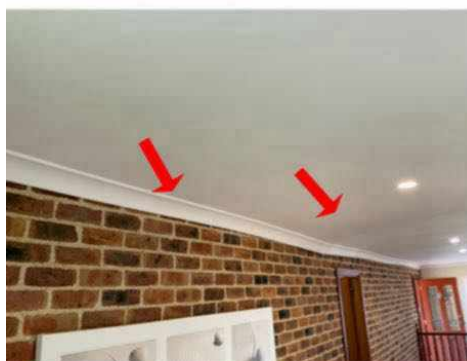
Finding 3.02

Building:	Building 1
Location:	Some upper and one lower room
Finding:	Ceiling - Sagging
Information:	Sections of four ceilings were found to be sagging at the time of inspection. Sagging to these fixed ceiling structures indicates that fixings (e.g. nails or glue) have become loose and require reattachment. This is the case in the middle of house areas and most likely in other areas. Some of these ceilings appear to have very little plaster glue applied.

Where minor sagging is evident, comparatively minor works, such as re-gluing of ceiling sheets, may be required. Such works may be performed by relevant tradespeople, such as plasterers and painters. If excessive moisture has caused the roofing structure to swell and sag in areas not accessible from the roof void, the source of any water leak should primarily be identified prior to any remedial works being performed.

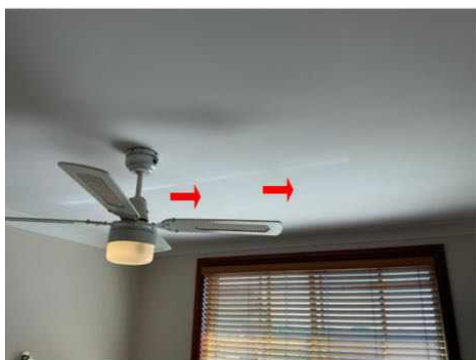
Finding 3.03

Building:	Building 1
Location:	Some upper and one lower room
Finding:	Ceiling nails - Popping
Information:	Random popped nails were identified in some internal ceilings at the time of inspection. Nails and screws hold simply by the friction between them and the surface they are applied to. Over time, the nails and screws can back out, which is often a result of general ageing and deterioration of the building structure.

If left unmanaged, the ceiling sheets may become loose and unstable, increasing the rate of deterioration of the internal ceiling and creating potential for the development of secondary defects.

Re-fastening of popped nails will help to maintain the stability of the internal ceiling and associated building elements. Such minor works will also help to improve the appearance of the affected area and secure the ceiling sheets, so as to prevent the onset of ceiling sagging. These works should be performed by a qualified carpenter or plasterer at client discretion.

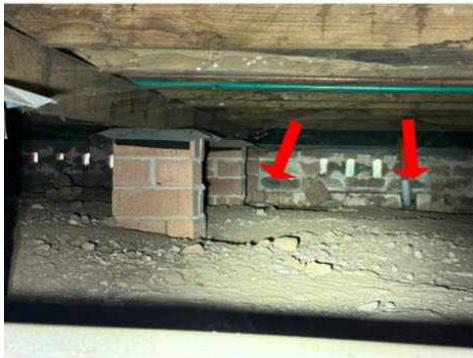
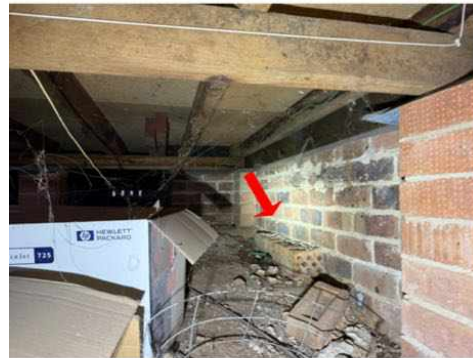
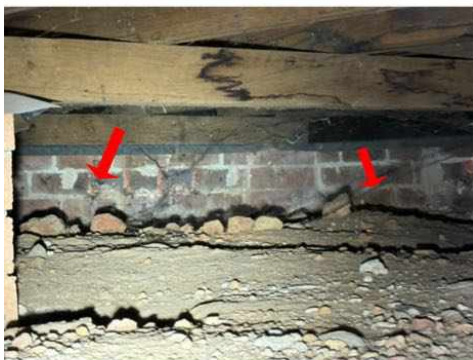
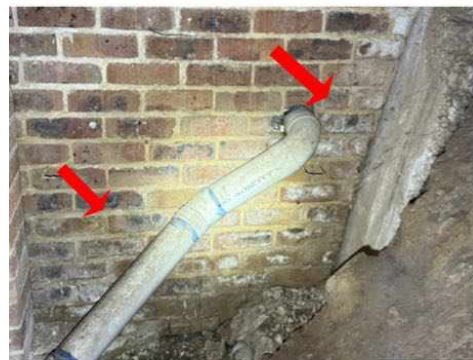
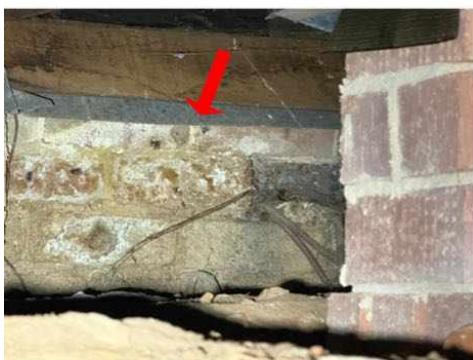
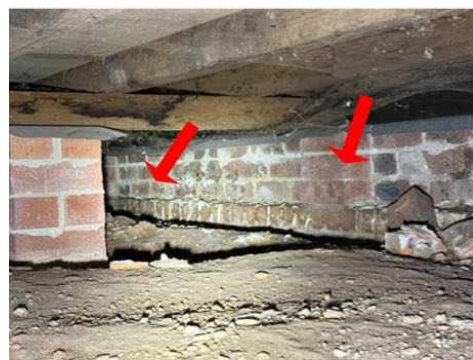
Finding 3.04

Building:	Building 1
Location:	Subfloor
Finding:	Damp - Rising
Information:	Rising damp was found in many rear wall areas. This describes the upward movement of water in low sections of building elements (e.g. walls) by capillary action - the movement of water through porous materials such as bricks and mortar. This was found mostly in the rear subfloor walls and likely due to these areas buried in landscaping material and thus, holding in rainwater moisture weeks after rain has occurred.

Rising damp is generally managed by the installation of a damp proof course during construction. A Damp Proof Course (DPC) is an impermeable barrier at the base of the wall above ground level. However, many 19th Century buildings have no damp course installed, or the materials have failed. The DPC may have been omitted as a consequence of poor workmanship, or it may have been bridged where materials built up against the side of the house allow moisture ingress above the DPC level.

The first step in addressing rising damp is to diagnose the cause. The identified cause

should be addressed first before addressing the appearance and other defects which have resulted from the rising damp. If the original cause is not resolved, further cases of damp are likely to ensue, resulting in secondary defects.

Consultation with a qualified plumber is advised immediately to identify the cause of the damp and perform remedial works as required. Removing rear vegetation, unblocking rear subfloor vents etc will assist in reducing this rising damp found.

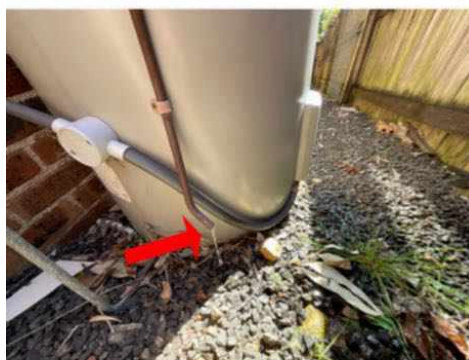
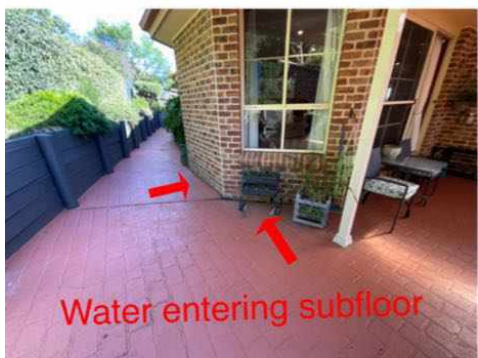
Finding 3.05

Finding: Site drainage - Inadequate

Information: The site drainage in the rear wall area was found to be inadequate at the time of inspection, creating potential for subsequent water damage to associated building elements.

No rear wall garden bed drainage was evident. The air conditioner, laundry floor waste and hot water system overflows run against the house walls. These defects are causing rising damp in the subfloor.

It is important that water does not lie against the base of walls; surrounding paths and ground levels should be sloped to drain water away from walls. Downpipes should not discharge stormwater onto lower walls or plinths. Stormwater should be carried away by large, regularly cleaned drains. Ground levels may need to be lowered to expose a buried DPC.

Where site drainage is inadequate, installation of an Agricultural (Aggie) Drain may be required. A qualified plumber should be appointed to further inspect the property and perform any remedial works as necessary. Secondary defects are likely to occur if left unmanaged.

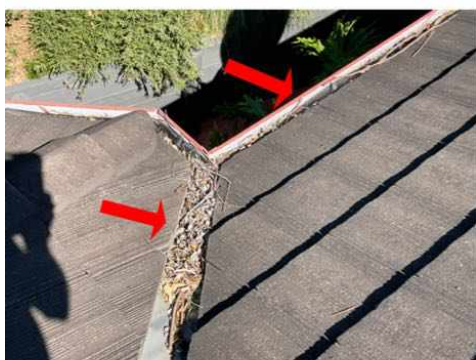
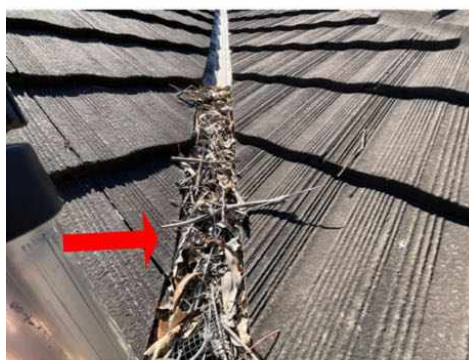
Building: Building 1
 Location: Roof exterior
 Finding: Gutters - Full and blocked
 Information: The guttering on around the roof was found to be blocked at the time of the inspection. Roof plumbing structures, such as guttering and downpipes, should be free of all debris to prevent blockages. Blockages of the guttering and downpipes will lead to pooling and accumulated water overflows, which is likely to subsequently flood eaves and exterior walls.

Blocked gutters are likely to lead to high levels of moisture in the affected areas which can cause rust and decay of the gutters and downpipes and wood rot to adjoining timber areas. Blockages in gutters should therefore be removed immediately to ensure dry conditions are maintained.

It is highly advised that gutters be cleaned by the homeowner or a general handyperson as a matter of urgency.

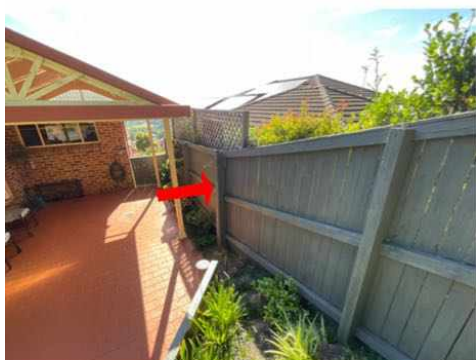
Finding 3.10

Finding: Fences damaged - leaning
 Information: Evidence of damage to the pictured left rear fences and gate was identified at the time of the inspection. The likely cause of this fence leaning is not enough concrete used in the post footings. The gate is held by wire. If left unmanaged these areas will deteriorate further.

It is suggest a fencing contractor be engaged for rectification when convenient.

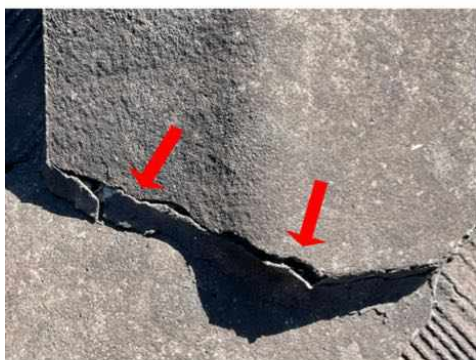
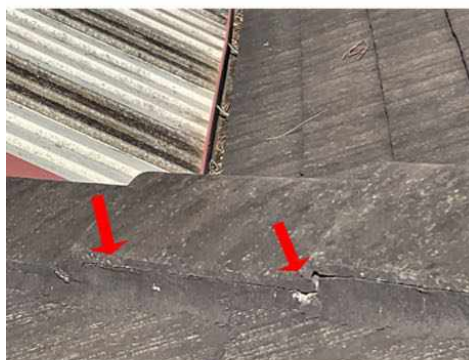
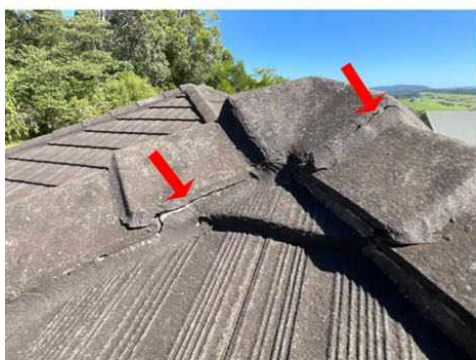
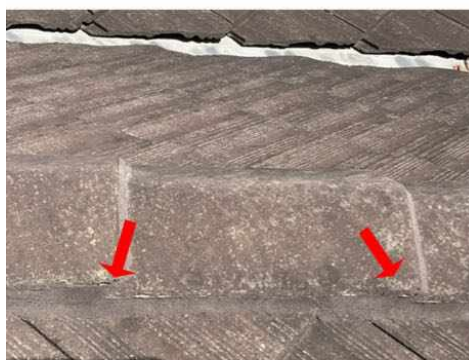
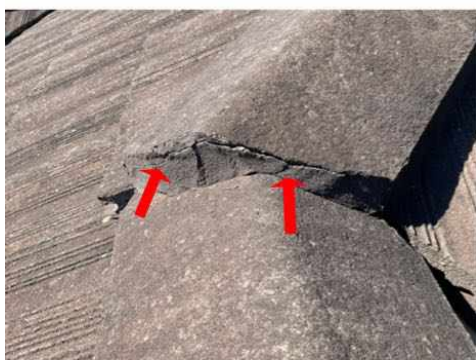
Finding 3.11

Building: Building 1
 Location: Roof Exterior
 Finding: Roof tiles - Weathered
 Information: Upon inspection of the exterior roofing, the majority of roof tiles were considered to be in a good condition. While weathering of the tiles is consistent with the age of the property, maintenance works are required.

Isolated areas of mortar show minor cracking present. Re-pointing and re-sealing the may be considered as an interim solution by the client to help preserve and extend the life span of the tiles. Where left unmanaged, deteriorating roof tiles are likely to lead to a number of secondary defects, including minor water leaks and weather exposure to internal roofing structures.

Consultation with a roofing contractor is highly advised to gain advice on cost of remedial works that may be required in the short to medium term. Remedial works are likely to increase the longevity of the exterior roofing structure.

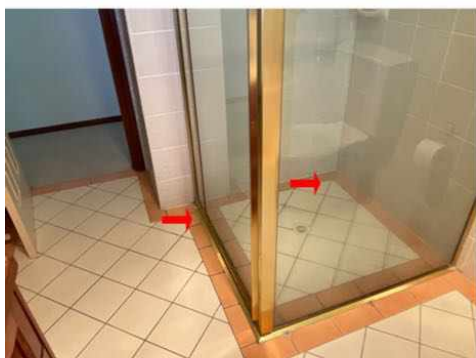
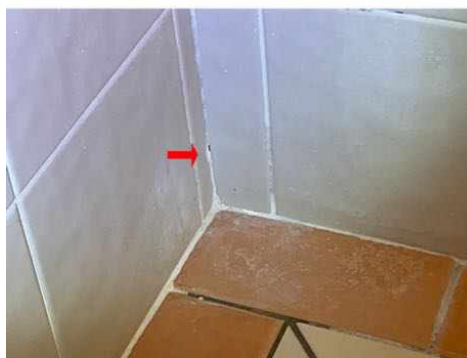
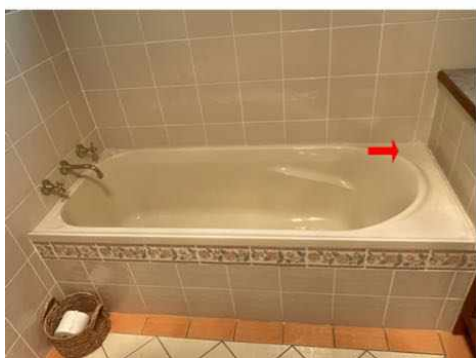
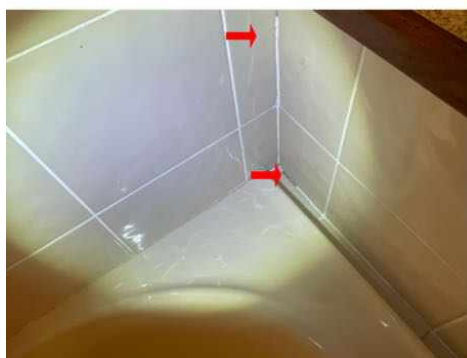
Building:	Building 1
Location:	Bathroom
Finding:	Sealant and grouting - Missing or damaged
Information:	It was noted on inspection that sealant or grout is degraded to these pictured areas.

Different materials and floor areas move at different rates, generally causing cracking to grout or sealant at this point. A flexible sealant is required to allow for expected expansion and contraction, while keeping the joint water tight and protective of all associated building materials.

any subsequent water damage that is likely to occur. Regular maintenance and replacement of damaged or missing or damaged sealant and grout is highly recommended to the wet areas, as this is a regular wear and tear defect. Sealant and grouting in areas that come into regular contact with water should be maintained for the long term care of your property.

A sealant specialist or tiling contractor should be appointed to complete these works as soon as possible

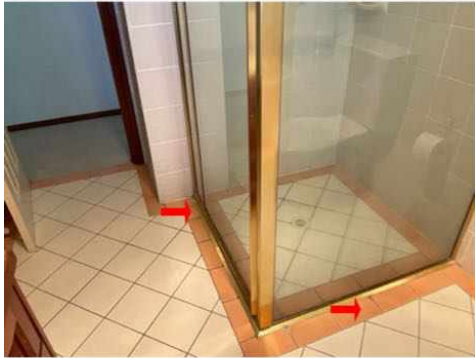
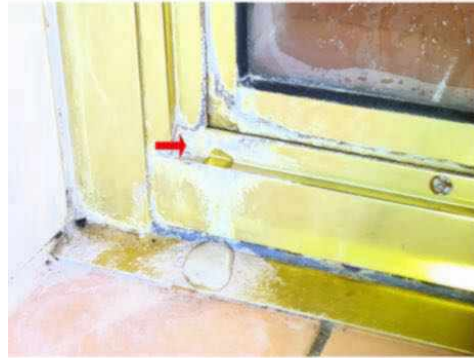
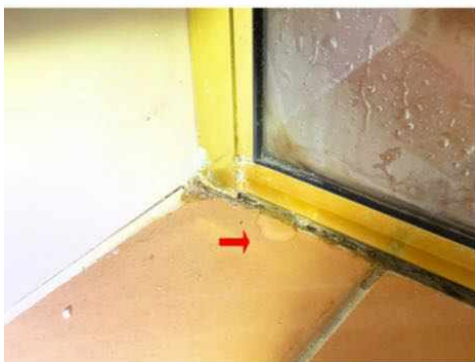
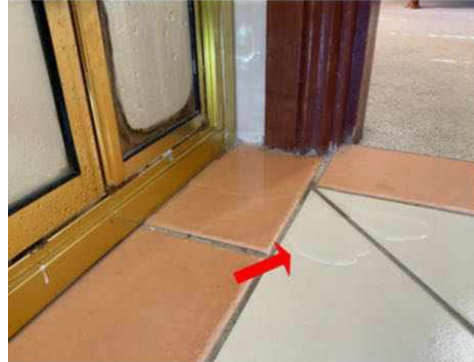
Finding 3.13

Building:	Building 1
Location:	Bathroom
Finding:	Shower screens - Leaking
Information:	Leaks were evident to two shower screens at the time of inspection. It is suspected that the leaking has occurred as a result missing sealant. Leaking from the shower , where left unattended, is likely to lead to water damage to adjoining flooring and walls. Such damage can lead to water damage and necessitate extensive remedial works being required. Active water leaks may also create an environment that is susceptible to the formation and development of mould.

Appointment of a sealant expert is required to repair or replace this missing sealant. Such works should be performed as soon as possible to ensure that no further

damage occurs.

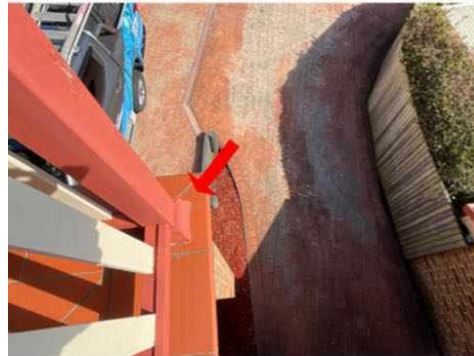
Finding 3.14

Building: Building 1
 Location: Verandah
 Finding: Tiles cracked

Information: A few cracked tiles were evident in these pictured areas at the time of inspection. It is suspected that this cracking has occurred as a result of minor settlement or impact damage. MCracked tiles throughout the household detract from the overall appearance of the affected areas. In wet areas of kitchens and bathrooms, it can lead to water damage of adjoining walls and floors.

Replacement of cracked tiles is recommended as soon as possible. A tiling contractor may be appointed to perform these works. Where cracks become more numerous, contact a licensed building inspector for further investigation.

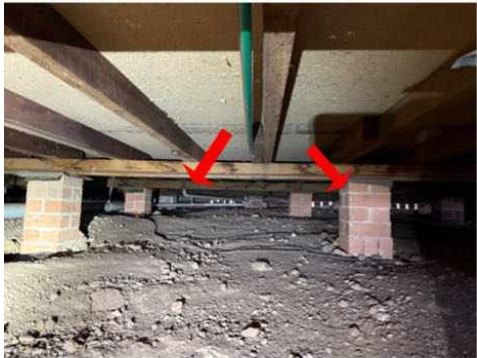
Building: Building 1
 Location: All Subfloor Areas
 Finding: Subfloor - Lack of ventilation
 Information: It was noted at the time of inspection that the subfloor area lacks adequate ventilation. Ventilation can be restricted by a variety of minor defects, including obstructions in the subfloor space, a lack of vents or a low clearance.

A well ventilated subfloor aids in maintaining dry conditions, preventing secondary damage such as wood rot and pest activity, as well as preventing the development of mould and mildew (which can lead to respiratory safety hazards for occupants).

The initial step in improving ventilation is to ensure that the subfloor area is free of any debris or stored items. Where ventilation is still inadequate, it is advised to ensure that all vents are clear of blockages, and additional vents may be installed.

The client may also consider mechanical ventilation (powered fans) to improve subfloor airflow. Remedial works should be conducted as a matter of urgency to protect against the development of potentially harmful subfloor conditions.

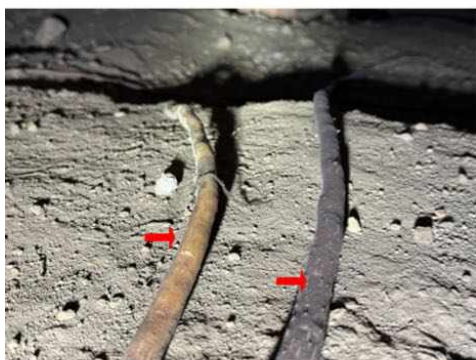
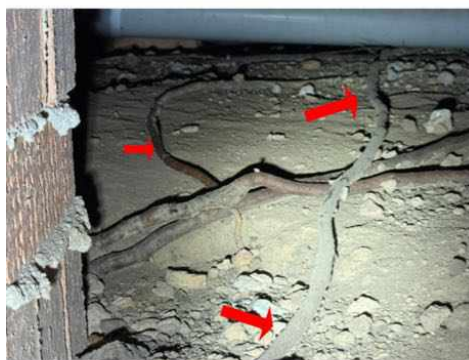
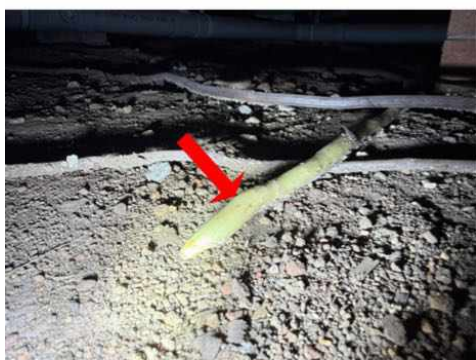
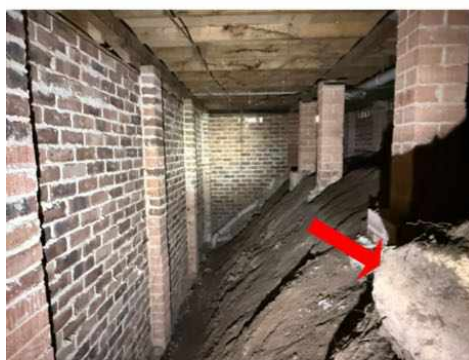
Finding 3.19

Building: Building 1
Location: Subfloor Areas
Finding: Tree roots and small boulder require removal
Information: Tree or plant roots have invaded the middle subfloor areas. These appear to originate near the front stairs. A small boulder is also located on the top of a slope above the lower rear room. Both these obstructions should be removed in the next few months to prevent further damage to subfloor pipes and the rear lower room rear wall respectively.

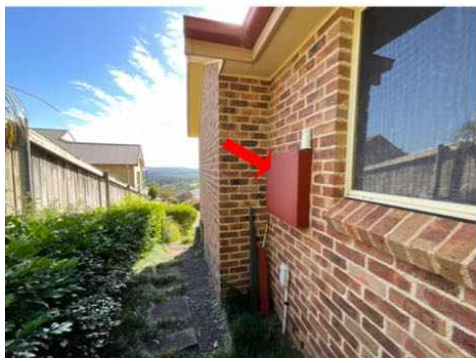
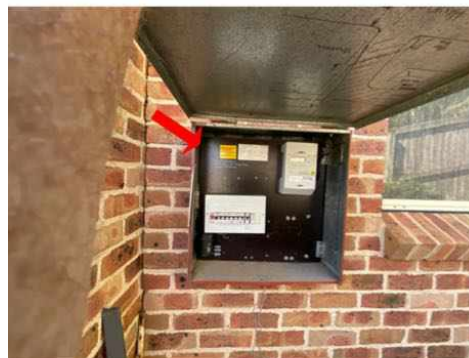
Building:	Building 1
Location:	Meter Box
Finding:	Termite Management System - no evidence of a chemical installation
Information:	The application of a post-construction chemical termite barrier is highly recommended for all properties. Such barriers are highly effective in preventing termite attack on any timber building elements throughout the property.

to suggest preventative works taking place since the property was built.

The client may consider gaining further advice from a pest controller as to the costs and procedures involved with a 'chemical' application. It is recommended that obtaining such advice be a short-term priority.

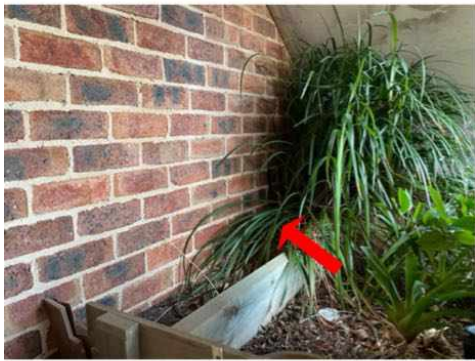
Finding 6.02

Building:	Building 1
Location:	Yard - front
Finding:	Bridging - Vegetation and decking
Information:	Where vegetation and decking obstructs inspection of building elements, also known as bridging as it provides a bridging point for the access of termites, full inspection can not be achieved. Consequently moisture or dampness may be present and the areas becomes conducive to termite activity. Plants and decks against or very close to buildings provide cover, shade and can provide an environment that is attractive to termite infestation.

The removal and replanting of plant species that do not provide "cover" or cutting back of existing vegetation and leaving a small gap between decking and the building walls will assist greatly in preventing Bridging from occurring.

The removal of any such stored building or plant materials that may be conducive to termite activity should be carried out as soon as possible and arrange re inspection to minimize the risk of termite attack.

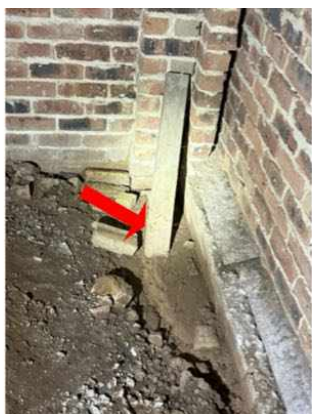
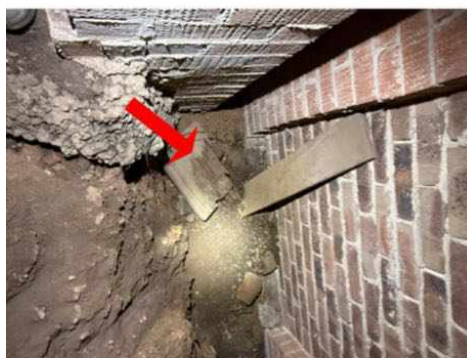
Finding 6.03

Building: Building 1
 Location: Subfloor & driveway
 Finding: Timber in contact with the ground
 Information: Any timbers in direct ground contact provide opportunity for concealed termite entry and are likely to be subject to premature rot and decay as the soil retains moisture or damp conditions against the timbers.

Removal of all waste and rotting timber that is in direct contact with ground is highly advised. This timber is promoting mould and wood rot and is very attractive to termites.

Frequent pest inspections are advised to readily identify any termite activity in these areas.

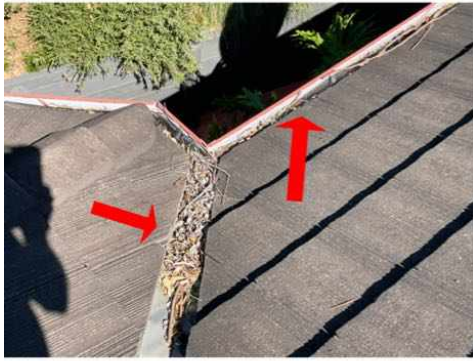
Finding 6.04

Building:	Building 1
Location:	Roof exterior
Finding:	Gutters - Full and blocked
Information:	The guttering on around the roof was found to be blocked at the time of the inspection. Roof plumbing structures, such as guttering and downpipes, should be free of all debris to prevent blockages. Blockages of the guttering and downpipes will lead to pooling and accumulated water overflows, which is likely to subsequently flood eaves and exterior walls.

Blocked gutters are likely to lead to high levels of moisture in the affected areas. Such moisture will not only cause rust and decay of the associated building materials, but can also provide conditions that are conducive to termite and timber pest activity. Blockages in gutters should therefore be removed immediately to ensure dry conditions are maintained.

It is highly advised that gutters be cleaned by the homeowner or a general handyperson as a matter of urgency.

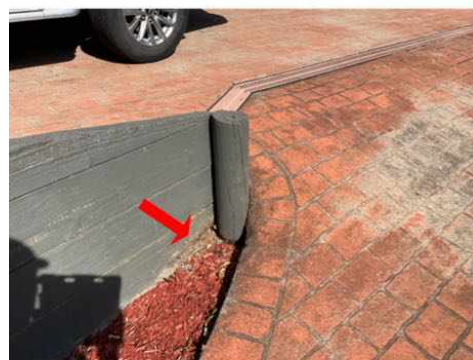
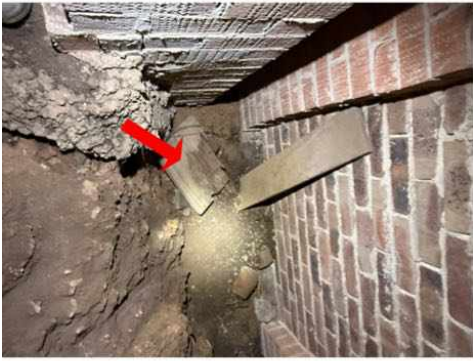
Finding 7.01

Building:	Building 1
Location:	Subfloor and driveway
Finding:	Fungal decay - present (localised)
Information:	Fungal decay also known as wood decay or wood rot generally refers to the deterioration of timber elements when in contact with excessive levels of moisture for a prolonged period of time.

The development of fungal decay is accelerated by temperatures from 5degreeC to 40degreeC as well as the presence of oxygen. Generally fungal decay develops on timber elements that are in use in an external environment which are exposed to rain penetration.

In this case, the affected timber element is in a decaying state and will need replacement by a carpenter or licensed builder.

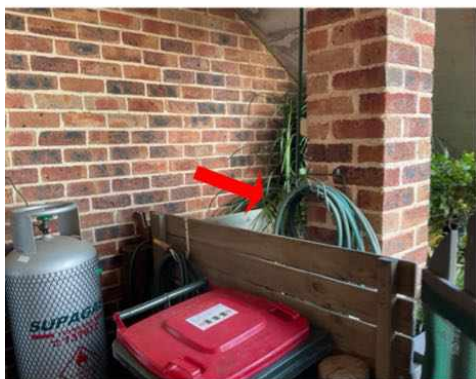
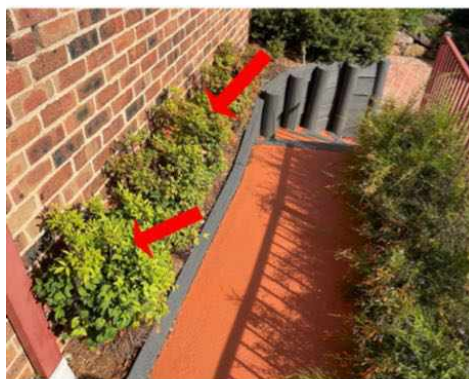
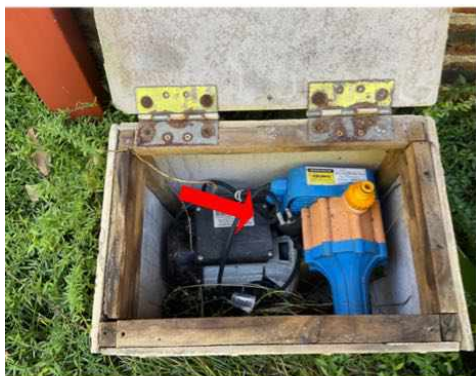
Building: Building 1
 Location: All External Areas
 Finding: Additional Photos - Obstructions and Limitations of EXTERNAL AREAS
 Information: These photographs are an indication of the obstructions and limitations which impeded full inspection of external areas at the time of inspection. These obstructions can hide an array of defects and should be removed to allow full inspection to be carried out. A re-inspection is recommended once the areas are made accessible.

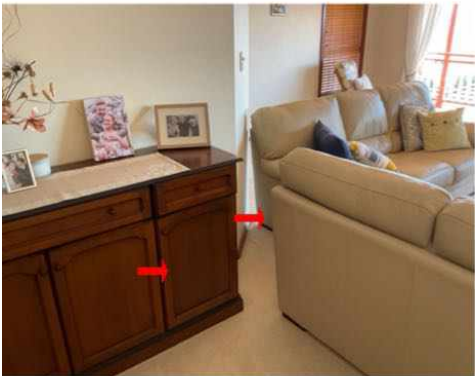
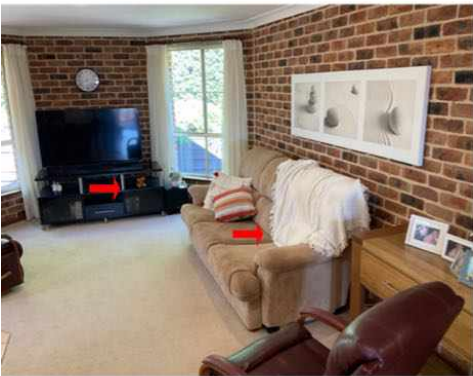
Building: Building 1
 Location: All Internal Areas
 Finding: Additional Photos - Obstructions and Limitations of INTERNAL AREAS
 Information: These photographs are an indication of the obstructions and limitations which impeded full inspection of Internal areas at the time of inspection. These obstructions can hide an array of defects and should be removed to allow full inspection to be

carried out. A re-inspection is recommended once the areas are made accessible.

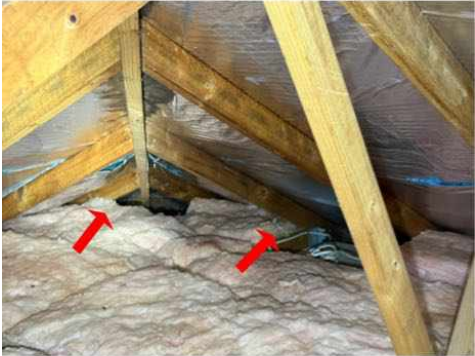
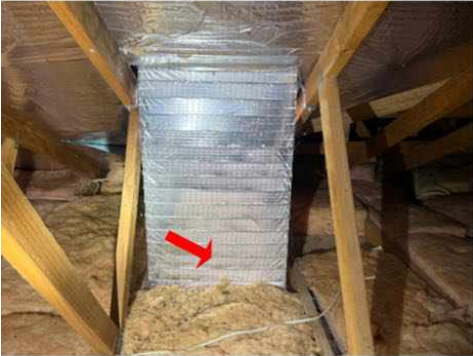
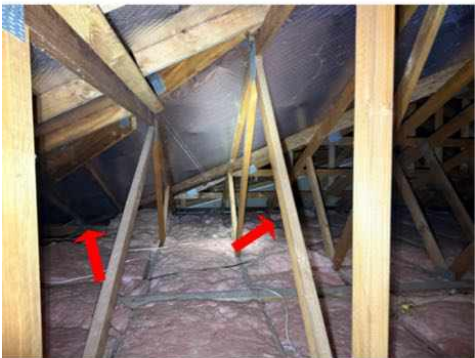
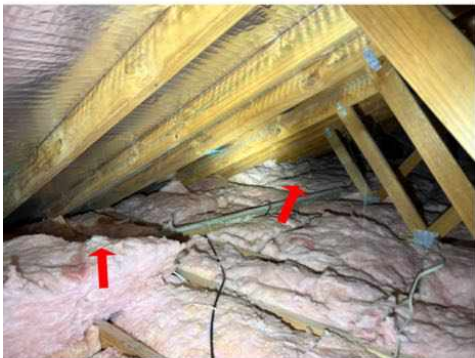
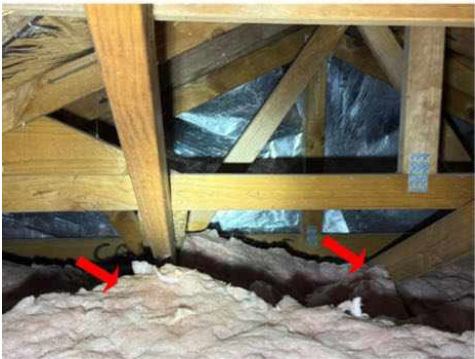
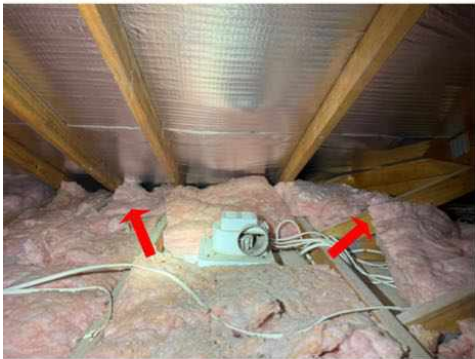
Building: Building 1
Location: All Roof cavity areas
Finding: Additional Photos - Obstructions and Limitations of the ROOF CAVITY
Information: These photographs are an indication of the obstructions and limitations which impeded full inspection of roof cavity areas at the time of inspection. These obstructions can hide an array of defects and should be removed to allow full inspection to be carried out if applicable. A re-inspection is recommended once the areas are made accessible.

The inspection was also limited to areas with an allowable crawl space of 600mm x 600mm, in particular towards the external walls where the roof line diminishes, these areas were not accessible.

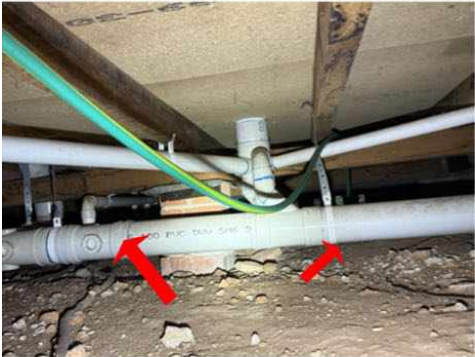
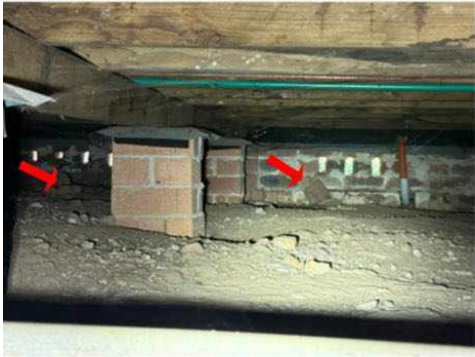
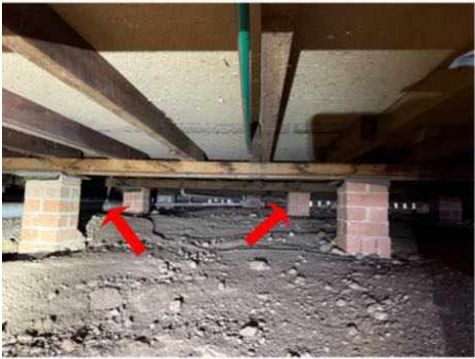
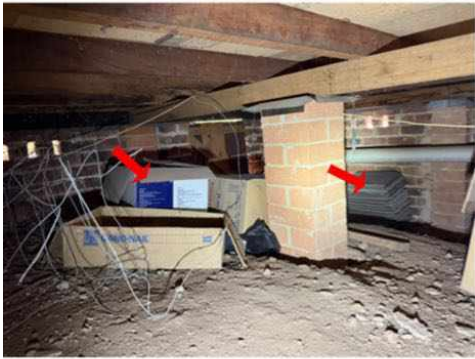
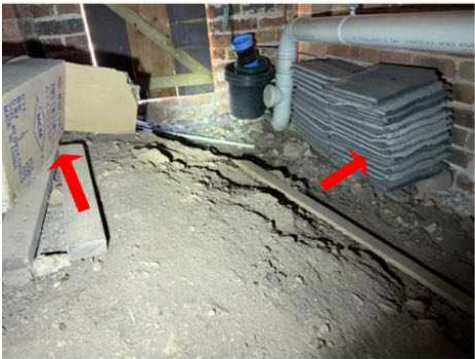
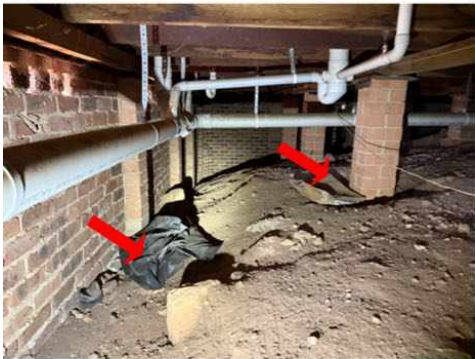
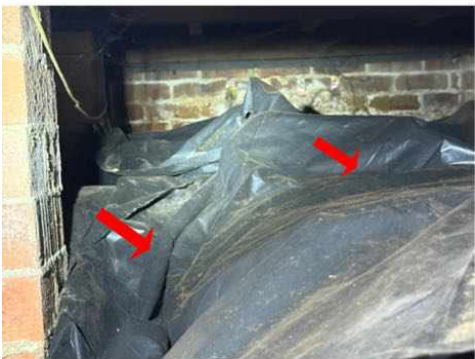
Building: Building 1
Location: All Subfloor Areas
Finding: Additional Photos - Obstructions and Limitations of SUBFLOOR AREAS
Information: These photographs are an indication of the obstructions and limitations which impeded full inspection of subfloor areas at the time of inspection. These obstructions can hide an array of defects and should be removed to allow full inspection to be carried out. A re-inspection is recommended once the areas are made accessible.

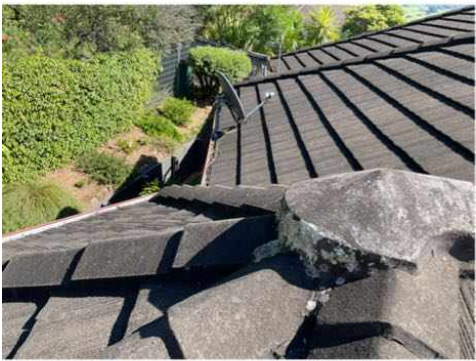
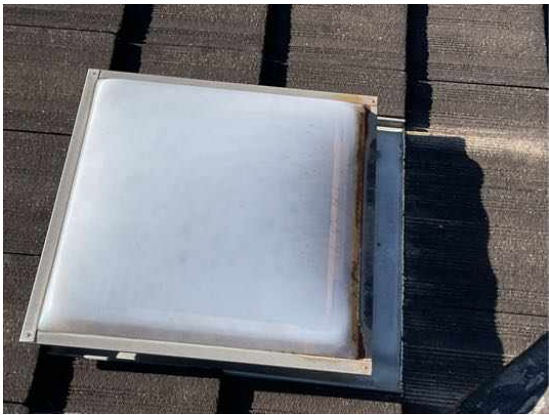
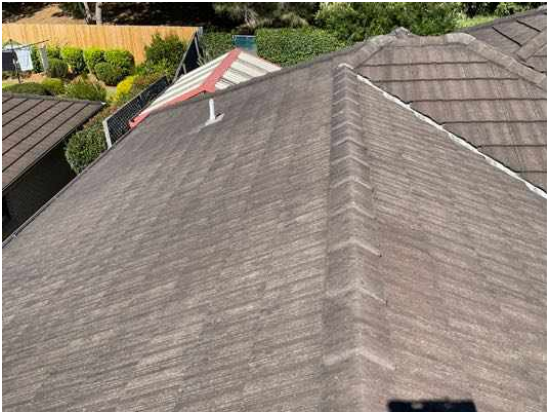
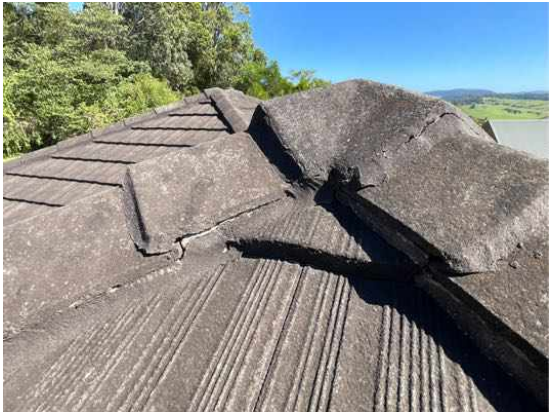
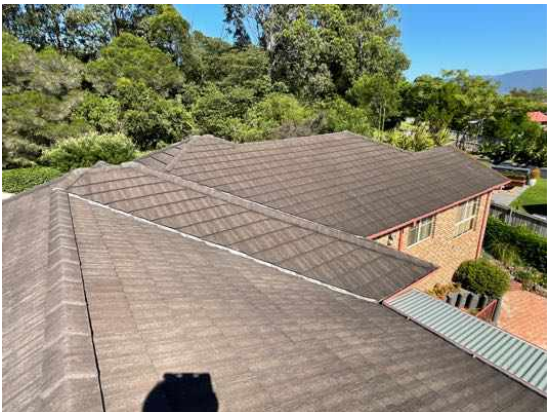
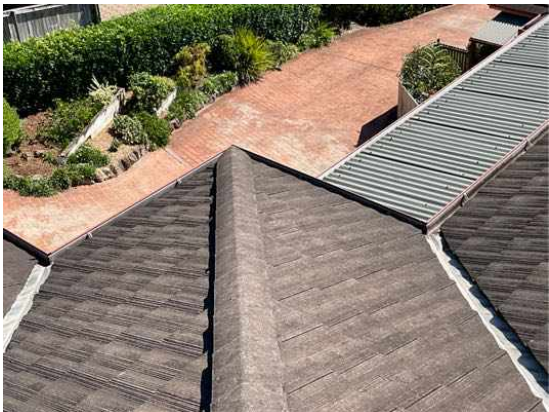
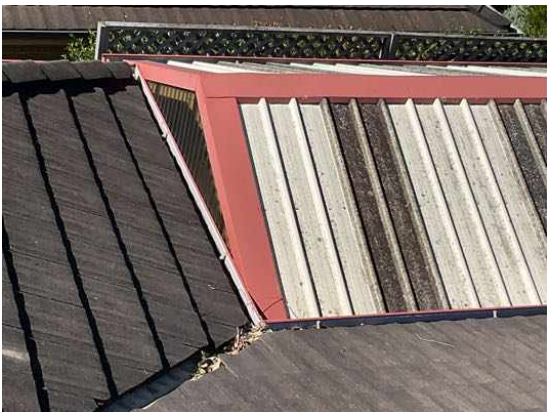
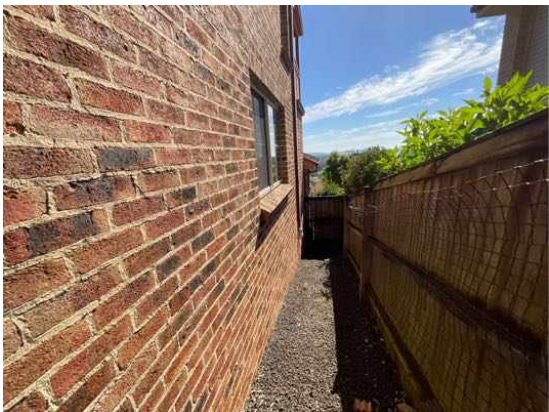
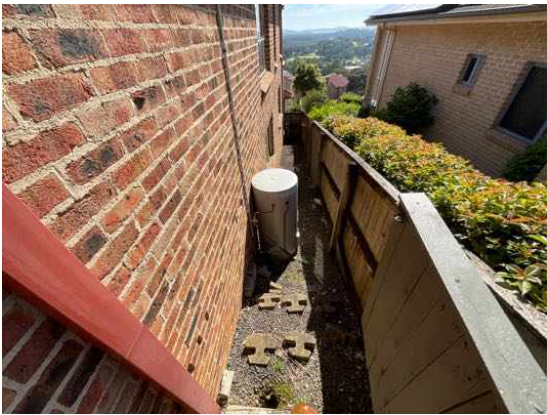
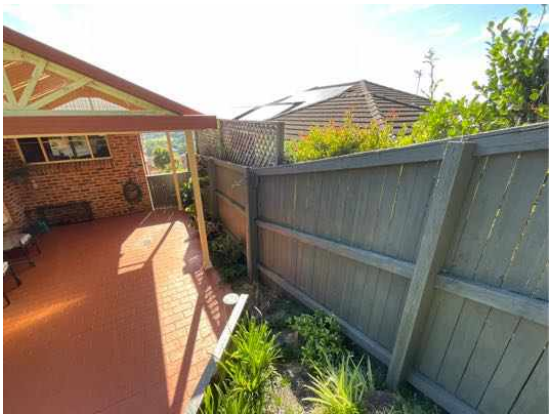
Building: Building 1
Location: All External Areas
Finding: Additional Photos
Information: Additional photos are provided for your general reference

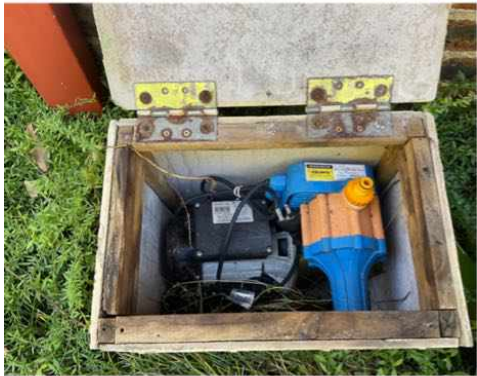
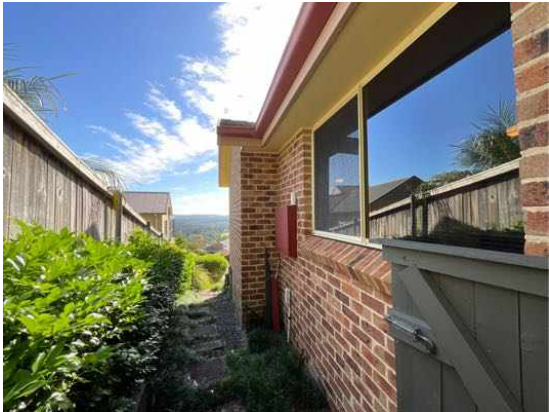
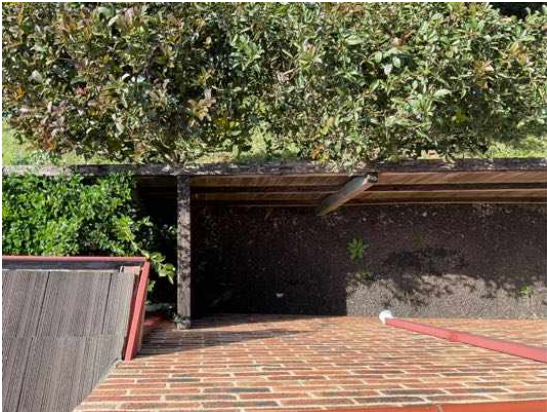
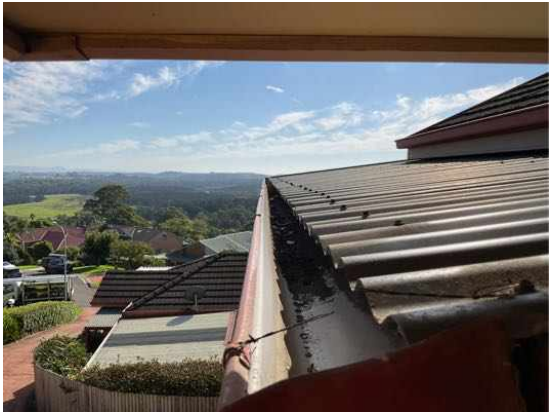
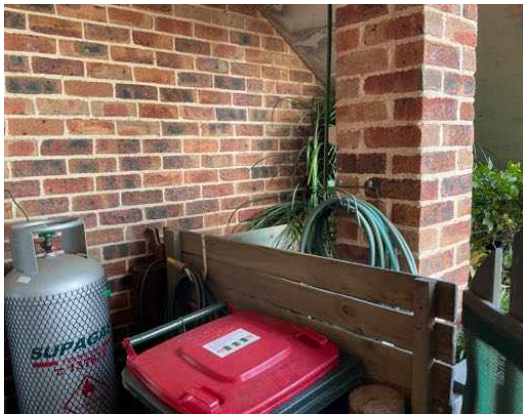
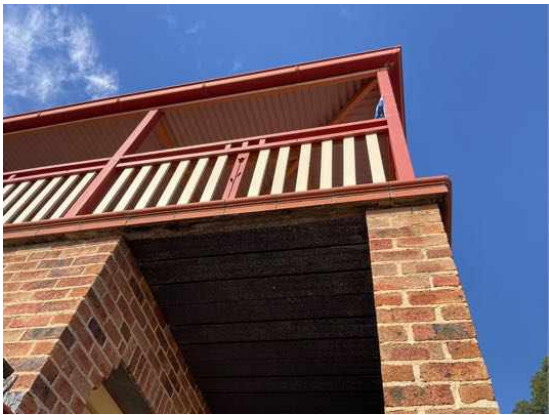
Building: Building 1
 Location: All External Areas
 Finding: Additional Photos
 Information: Additional photos are provided for your general reference
