Building and Timber Pest Inspection Report

Inspection Date: Thu, 2 Apr 2026

Property Address: 13A Havelock Pl, Kiama Downs NSW 2533,
Australia

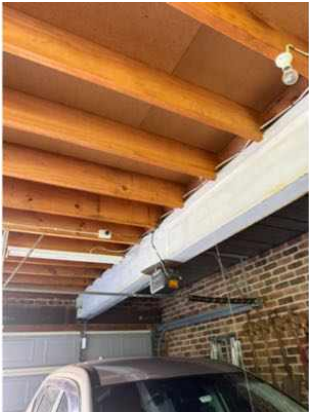
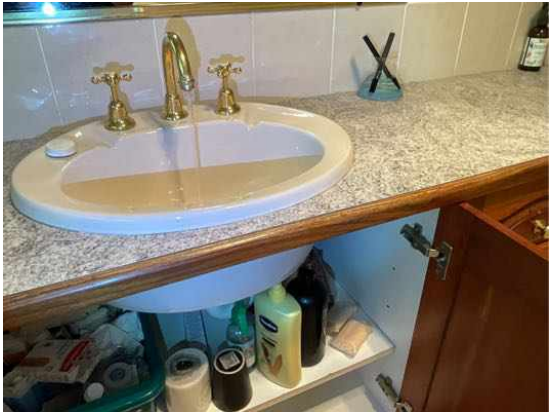
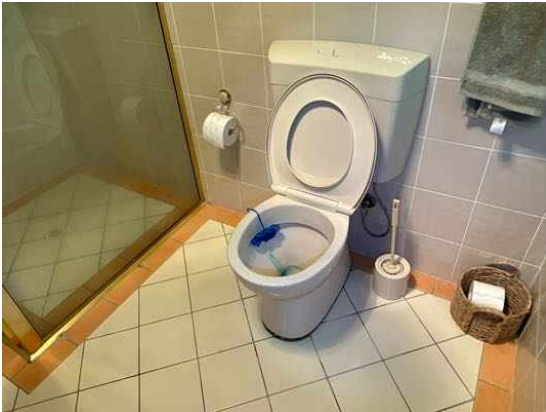
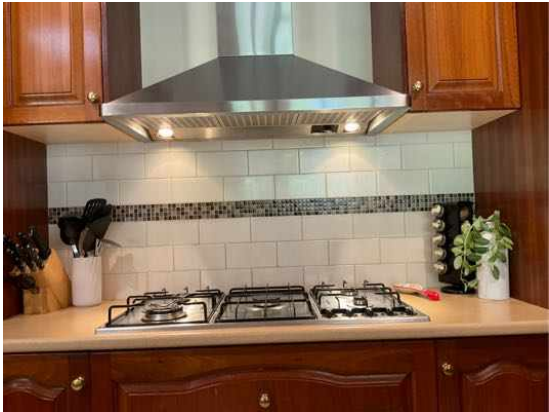
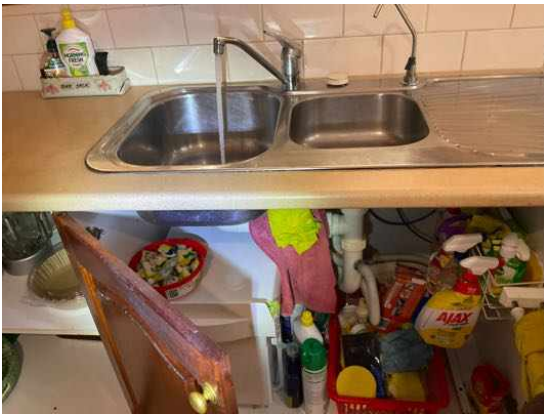
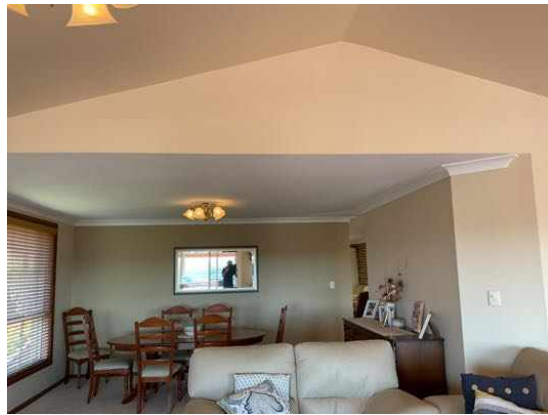
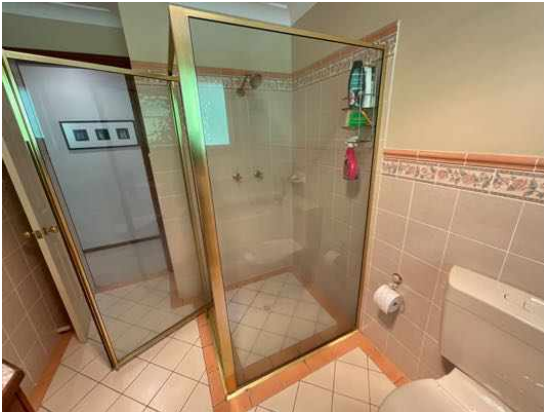
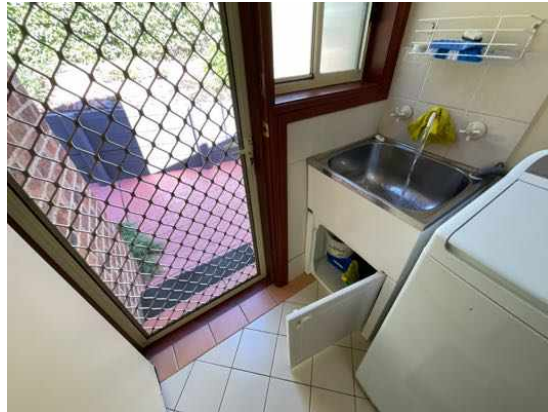
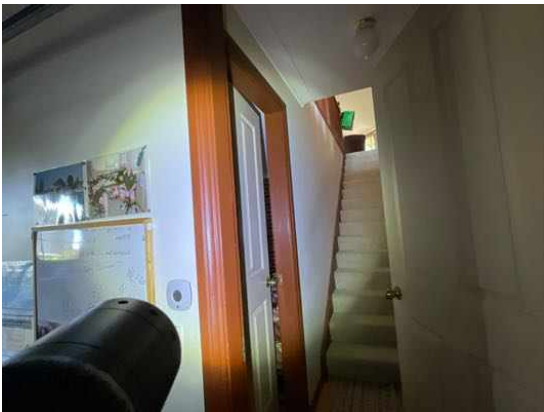
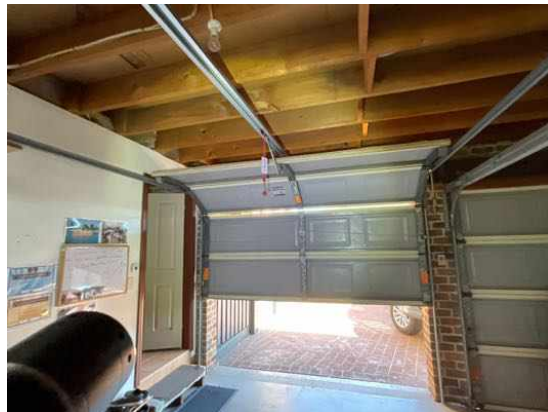
Building: Building 1
Location: All Internal Areas
Finding: Additional Photos
Information: Additional photos are provided for your general reference
