# Building and Timber Pest Inspection Report

Inspection Date: Thu, 19 Mar 2026

Property Address: 5/253 Chalmers St, Redfern NSW 2016,  
Australia

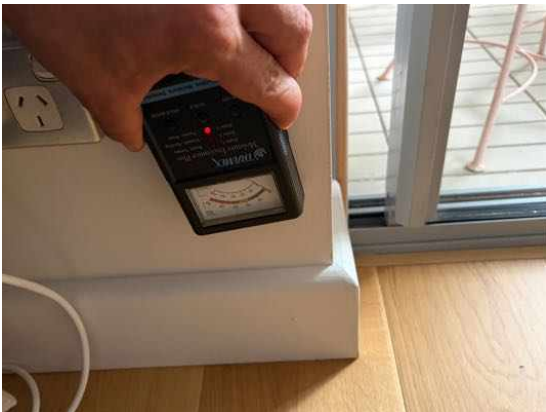
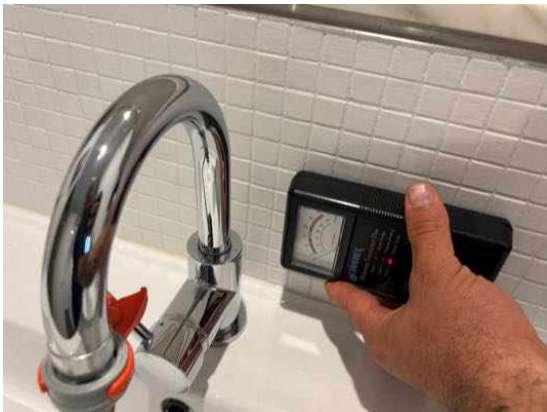
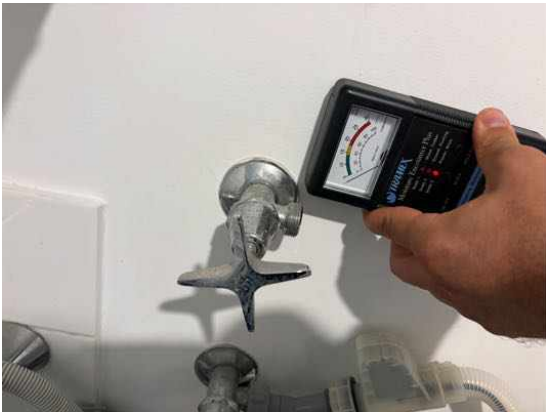
Building: Main Building  
Location: All Wet Areas  
Finding: Additional Photos  
Information:

Additional photos are provided for your general reference.

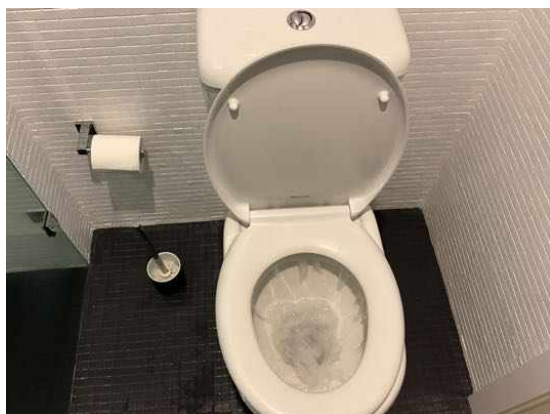
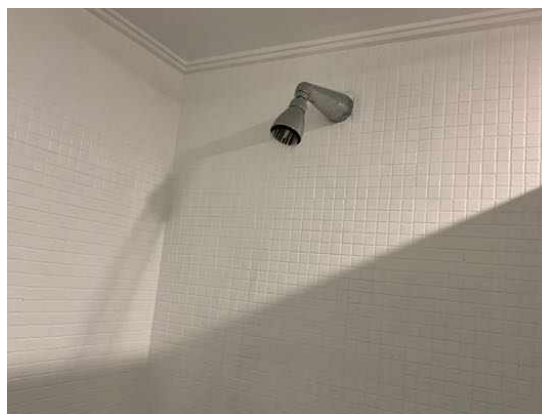
Building: Main Building  
 Location: Plumbing/electrical/gas/aircon/appliances/pool equipment/fire safety etc  
 Finding: Plumbing & Electrical  
 Information: Plumbing and electrical inspections including appliances are outside the scope of the building inspection and must be conducted by a Licensed and registered Trades person. It is highly recommended that the client makes immediate arrangements to have the gas appliances checked by a licensed gas plumber to ensure that the appliances are working safely and efficiently. We recommend all other installations be checked also. Whilst we note and comment of visually apparent defects that present during the building inspection, legislation requires the checking and documenting of compliance for plumbing and electrical requirements be done by licensed electrician and plumbers respectively to ensure they are functioning correctly.
