Building and Timber Pest Inspection Report

Inspection Date: Thu, 15 Jan 2026

Property Address: 93B Neville St, Carnegie VIC 3163, Australia

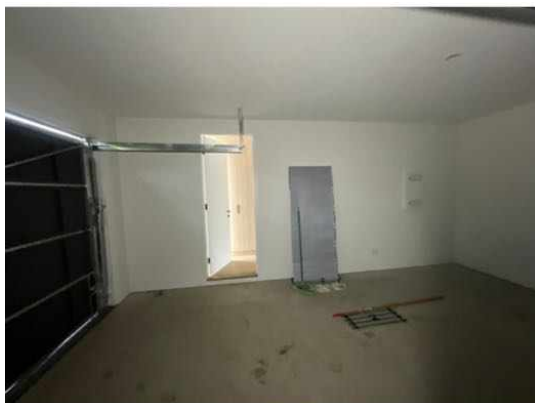
Information: It was observed that building elements throughout the property still require their final clean.

The property should be professionally cleaned prior to final handover.

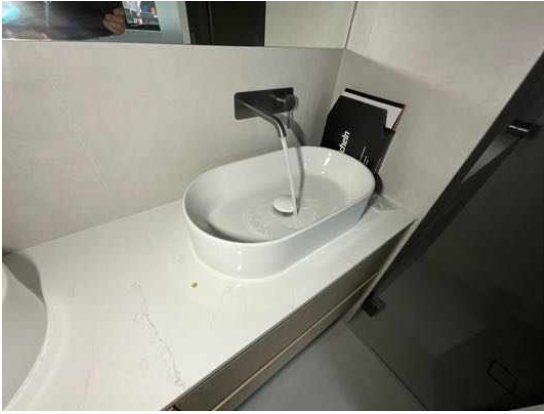
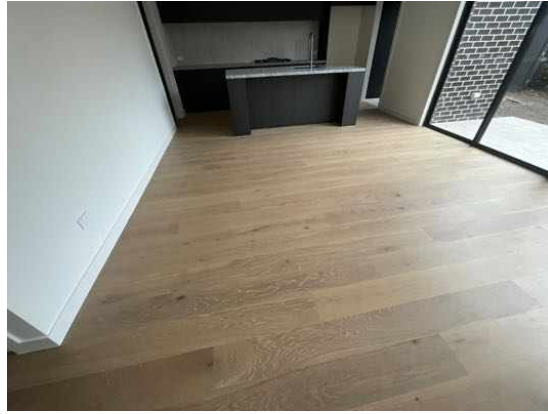
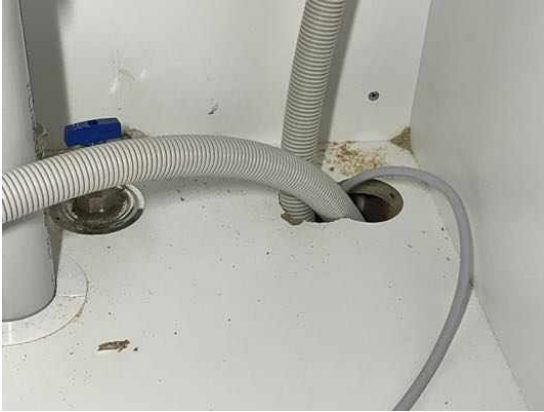
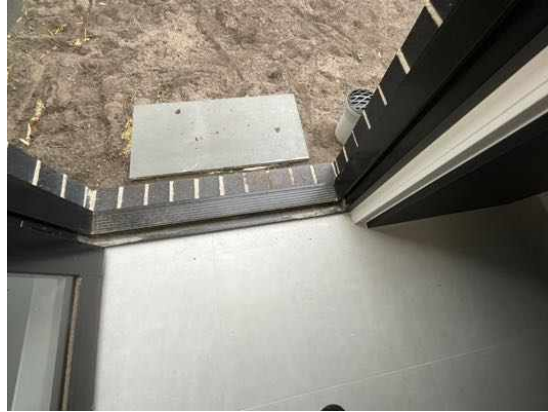
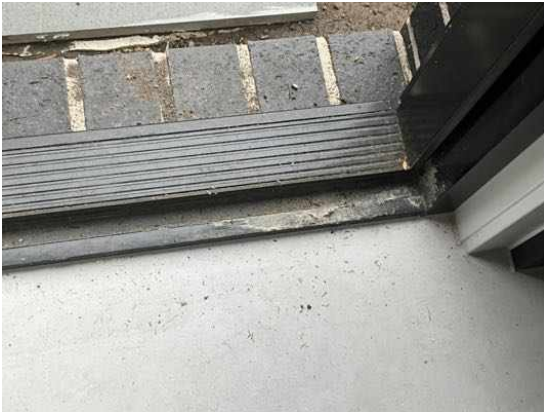
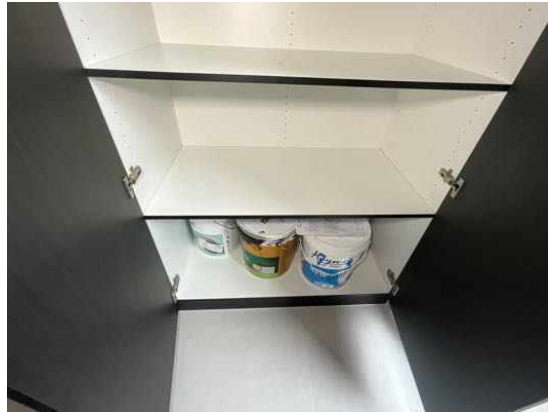
Finding 3.02

These defects are purely cosmetic and pose no ongoing issues

Please note: photos included are examples of marks and over spills. There may be other areas affected but not included in this report.

These blemishes should be removed by a cleaner prior to the handover.

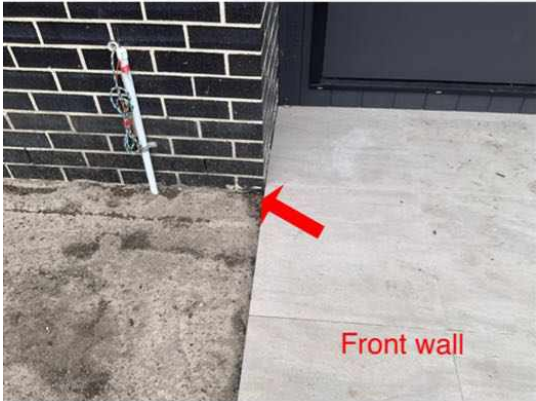
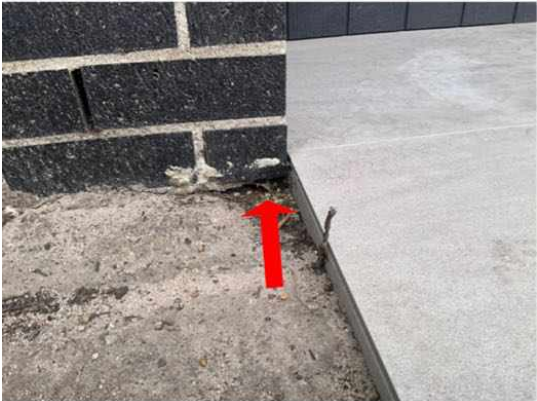
Noted Item

Building:
 Location: All External Areas
 Finding: Additional Photos for your information - brick overhang (new build)
 Information: There appeared to be a slight overhang of the brickwork in the exterior wall in this area . Upon inspection it was noted that it is within intolerance and is suspected to not be causing any structural issues.

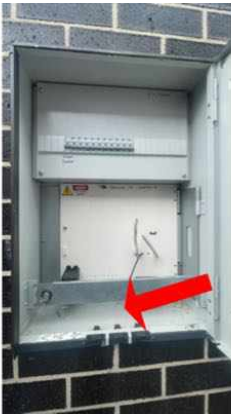
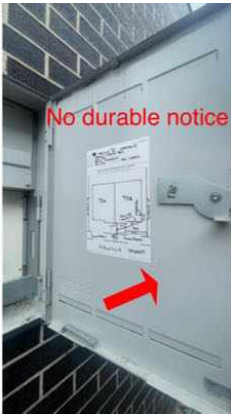
Building:
Location: Meter Box
Finding: Termite Management System - no evidence of a chemical installation
Information: A durable notice should be placed in the switchboard unit to indicate current termite barriers. At the time of inspection, no record of any termite management system being installed was noted. Enquiries should be made to determine what termite management system has been installed.

Regular inspections are also recommended for all properties, in particular those where chemical treatments are not possible.

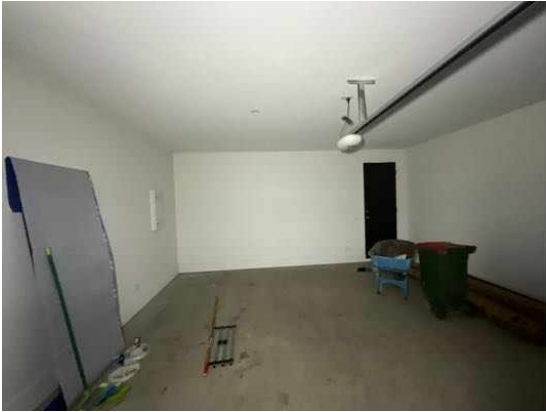
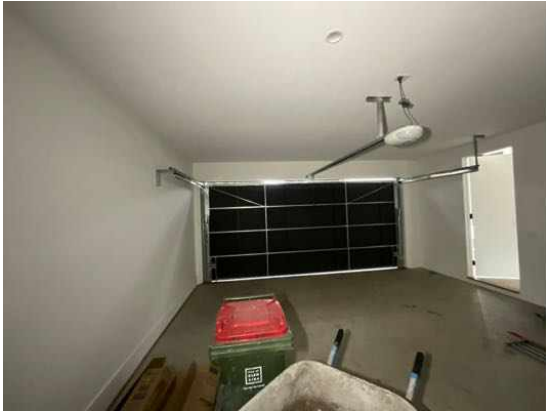
Noted Item

Building:
Location: All Areas > Ground Level
Finding: Area presented in good condition
Information: This area presented in a good condition at the time of inspection.

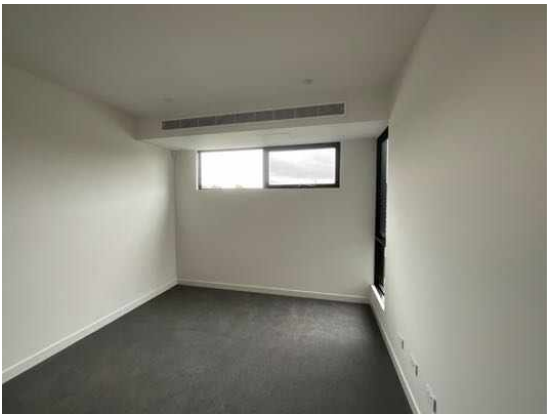
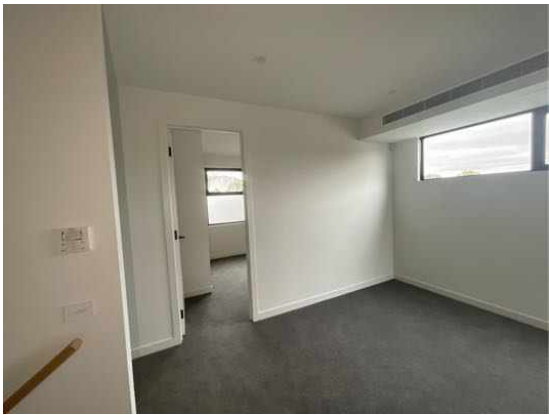
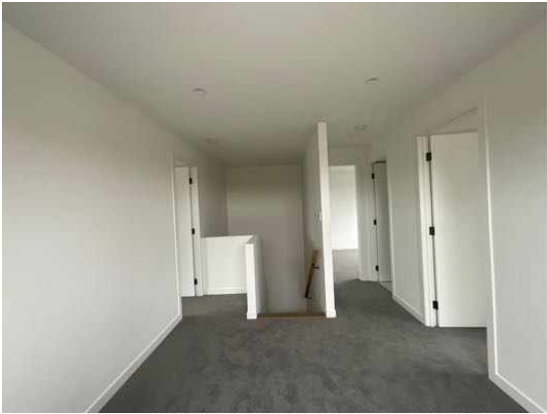
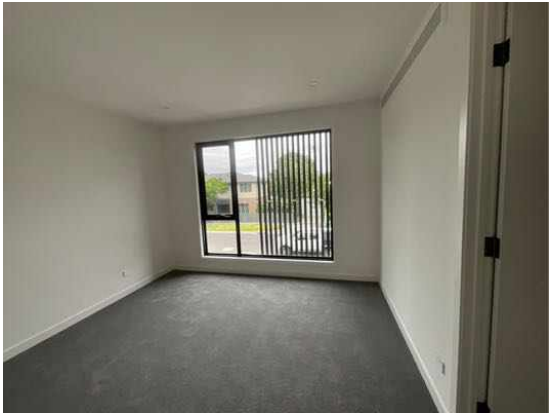
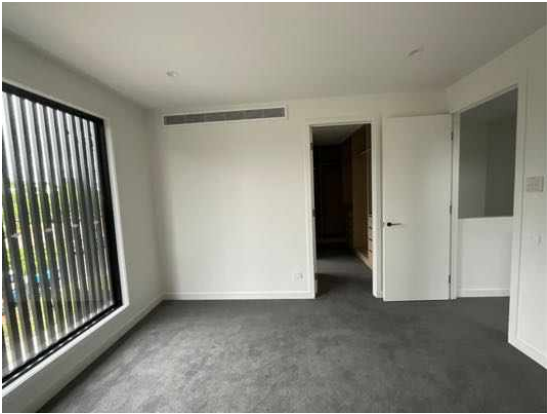
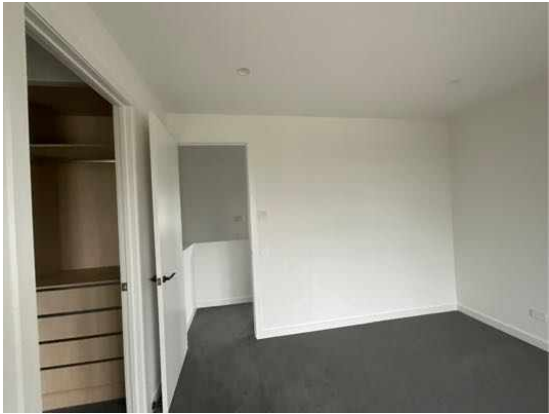
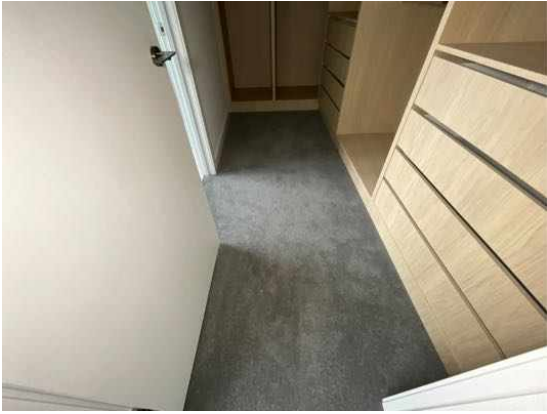
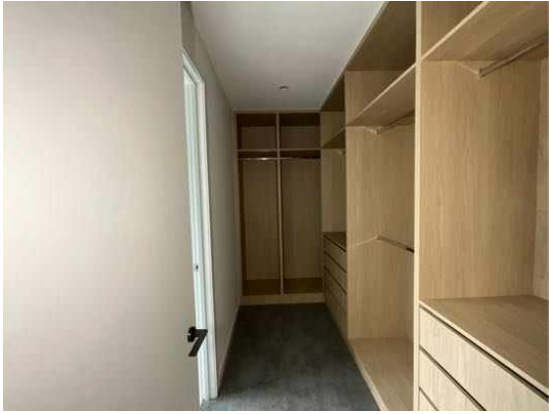
Building:
Location: All Areas > Upstairs
Finding: Area presented in good condition
Information: This area presented in a good condition at the time of inspection.

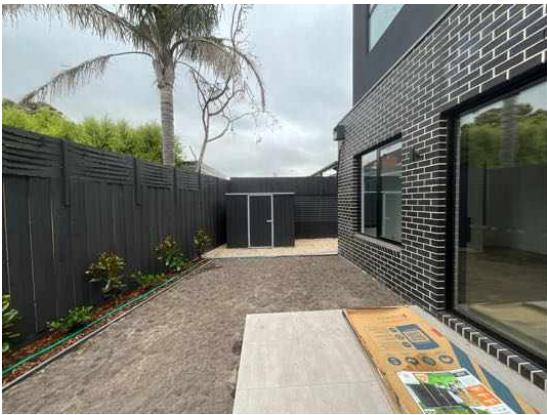
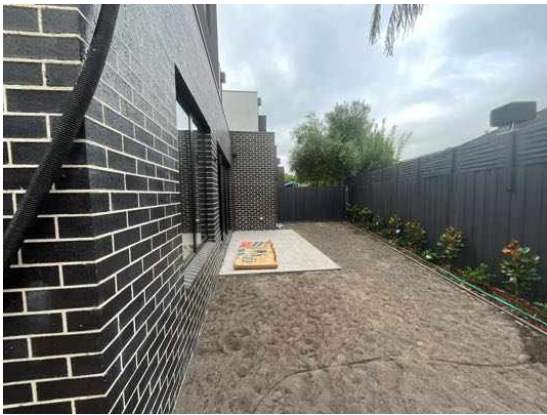
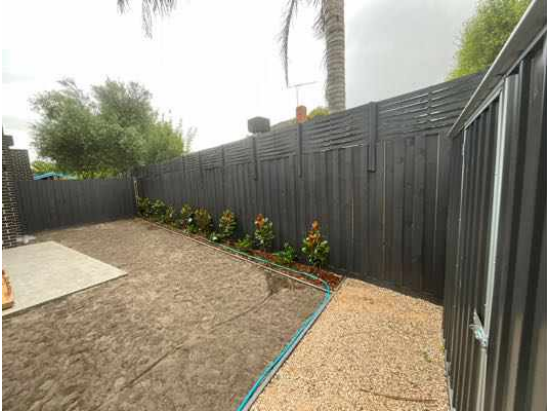
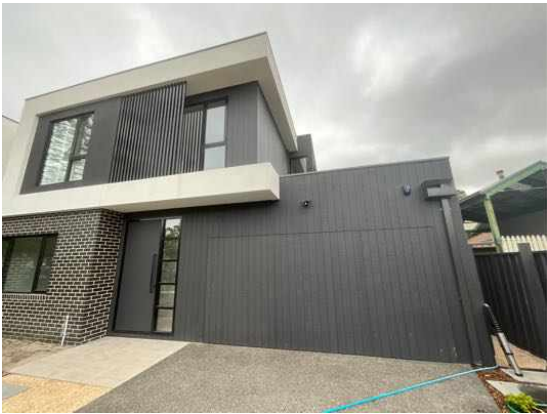
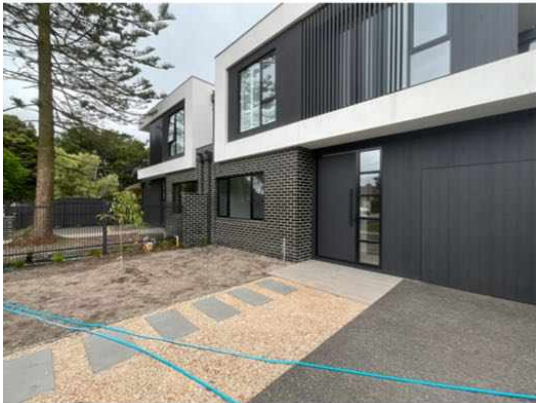
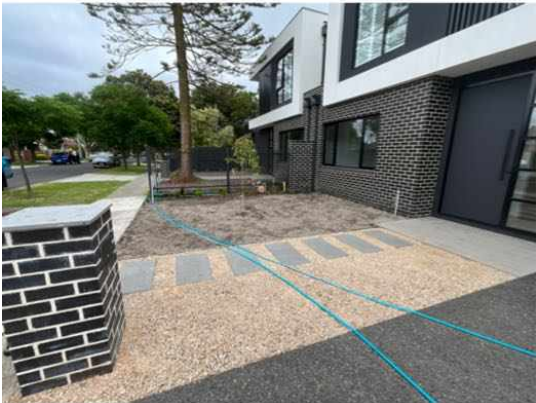
Building:
Location: All External Areas
Finding: Area presented in good condition
Information: This area presented in a good condition at the time of inspection.

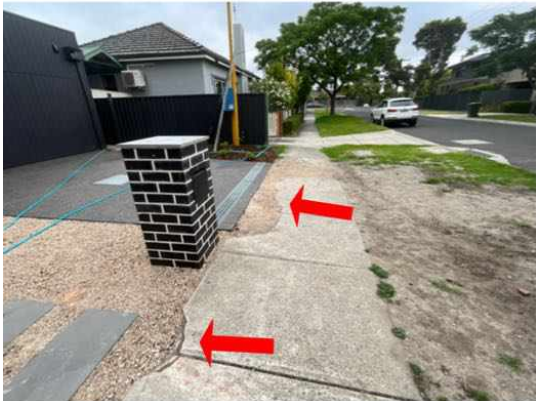
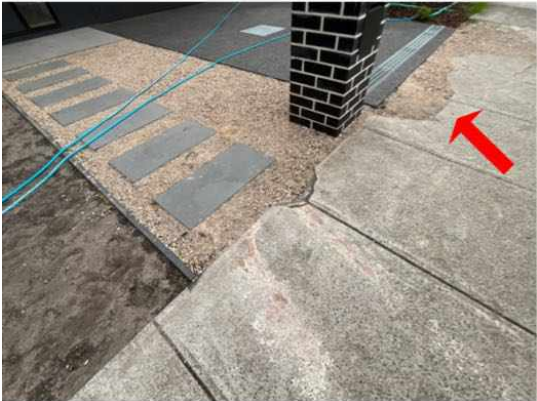
Building:
Location: The Site
Finding: Additional Photos for your information - pavement / council property
Information: Additional photos are provided for your general reference.

It was noted at the time of inspection that some damage had occurred to the pavement/council property, suspected to have been caused during the build process.

It is highly likely this may need to be addressed as part of the final sign off.

Your own enquiries should be made to determine whether this will be carried out.
