Building and Timber Pest Inspection Report

Inspection Date: Mon, 9 Feb 2026

Property Address: 5/72 Campbellfield Ave, Bradbury NSW
2560, Australia

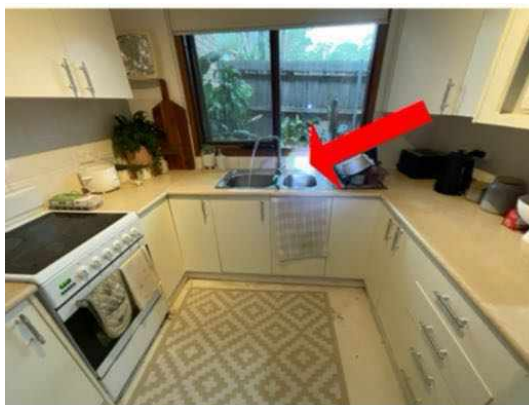
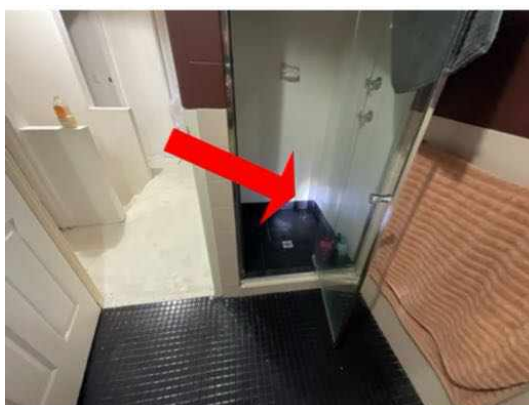
Finding 3.07

Building: Main Building
 Location: Kitchen
 Finding: Multiple Kitchen Cabinet and Benchtop Deficiencies
 Information: The kitchen exhibits several issues affecting both functionality and aesthetic consistency:

Lower cabinet doors display clear signs of moisture damage, including swelling, bubbling, and delamination of the surface finish. This is particularly evident near the kickboard where water exposure is likely more frequent.

One overhead cabinet door has been replaced with a mismatched flat white panel, differing noticeably in profile and colour from the original cream-toned routed doors. This impacts the uniformity of the kitchen's design and may indicate previous repair attempts.

Prolonged water exposure and inadequate sealing can compromise the structural integrity of cabinetry and benchtops. Unsealed joints and delaminated doors can harbour moisture and bacteria, and mismatched replacements may affect property presentation or resale value.

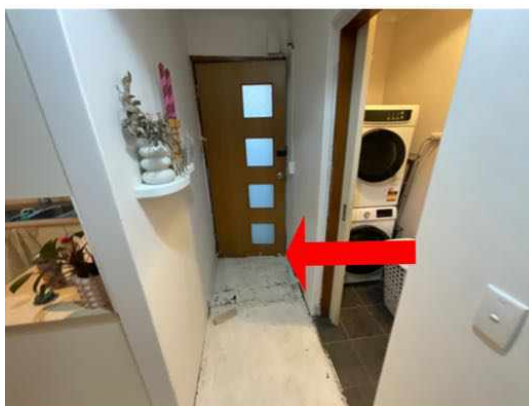
Finding 3.09

Building:	Main Building
Location:	All Internal Areas
Finding:	Door stop - Missing
Information:	The door stop is missing or is inadequate to stop the door handle from damaging the wall. Although some building elements may seem irrelevant or unnecessary, all building elements play a key role in the operation and function of the overall structure and its performance.

Re-installation or replacement of the door stop is advised as soon as possible to prevent any subsequent damage to the door or associated structures. A general handyman may be appointed to perform these works at client discretion.

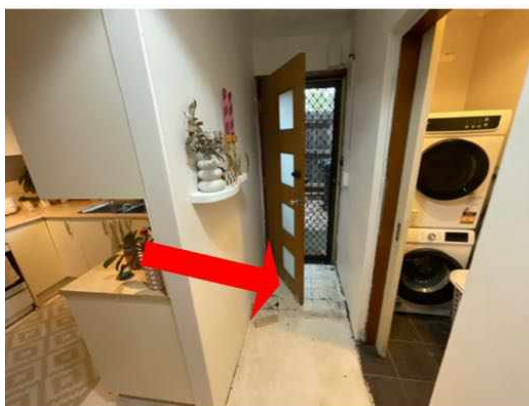
Finding 3.10

Building:	Main Building
Location:	All Internal Areas
Finding:	Door's Floor Guide - Missing
Information:	The door 's floor guide at kitchen area was missing at the time of inspection and not functional the door using as its performance.

Replacement of any missing door' s floor guide should be conducted as soon as possible to ensure that no damage or functional issues occur to associated building materials.

The appropriate tradesperson should be appointed as soon as possible to replace the missing building element.

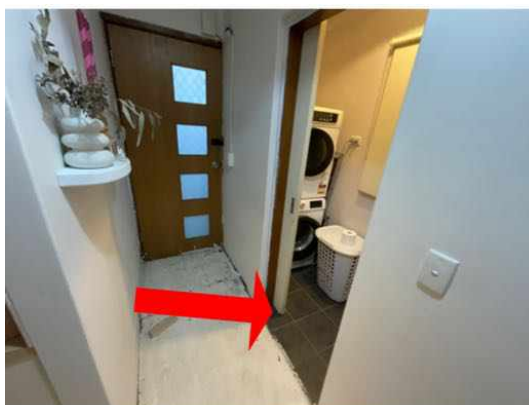
Finding 3.11

Building:	Main Building
Location:	All Internal Areas
Finding:	Cracking - Damage Category 1 - Fine (up to 1mm)
Information:	Although fine cracks are quite noticeable, they are often only considered to be an appearance defect, and usually do not indicate any structural damage. Generally, the cause of a fine crack is indicative of a separation between building materials and

Cracking of this nature can generally be repaired with minor sanding, filling and/or repainting. Such works should be performed by a qualified painter or a general handyman.

Monitoring of all cracking should be conducted frequently. Always contact a building inspector should cracks widen, lengthen, or become more numerous.

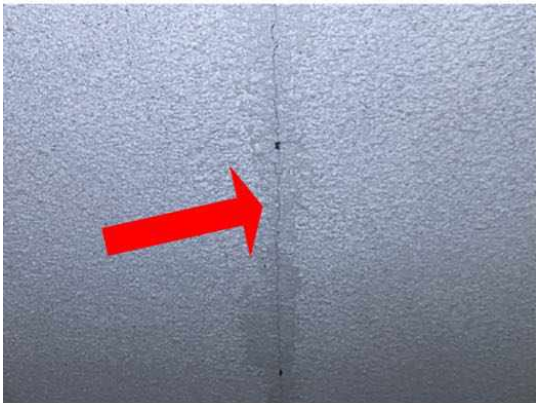
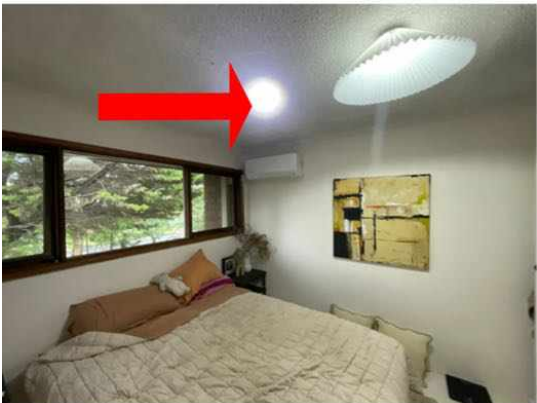
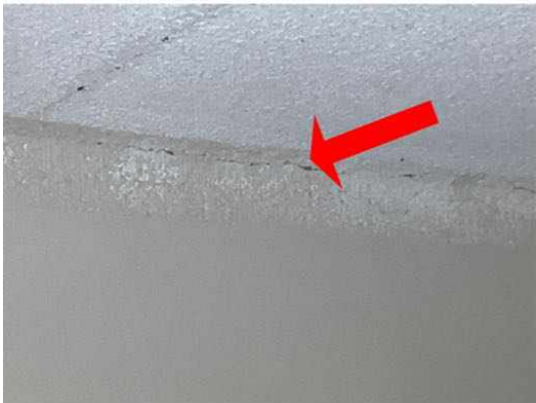
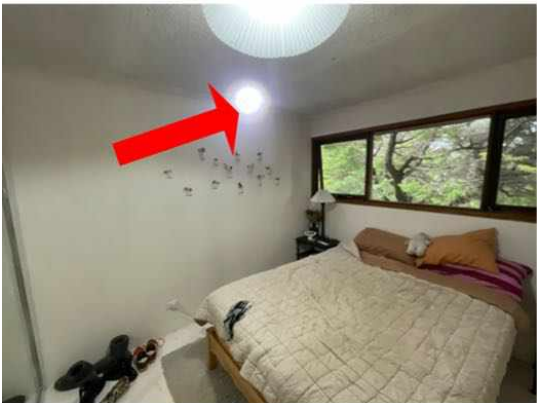
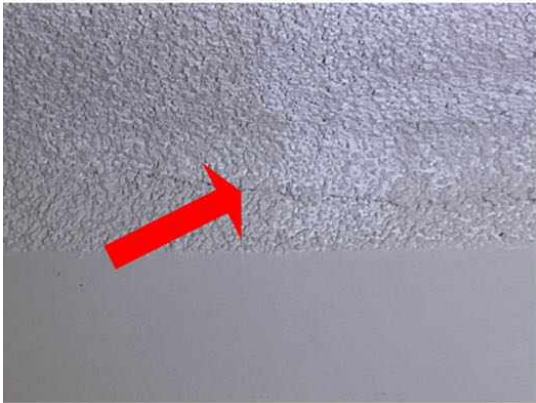
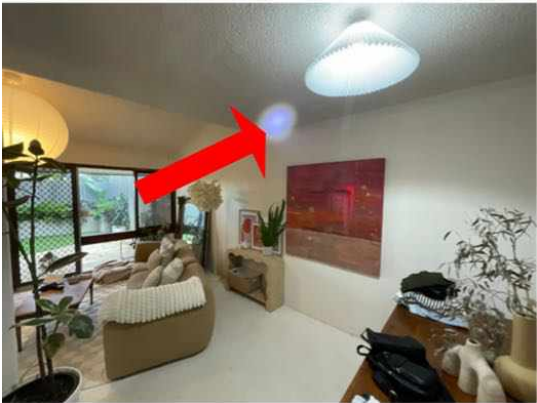
Finding 3.12

Information: The paint finish in this area was found to have been completed to a substandard level. Substandard painting is generally classified as an appearance defect. However, the substandard appearance may also be indicative of poor surface preparation and substandard workmanship.

If this applies, further areas of poor and incomplete finishes could develop over time. Furthermore, substandard paint finishes in areas exposed to moisture, e.g. external areas or wet areas, could lead to deterioration of underlying building materials.

Substandard paint finishes should be sanded back, filled, leveled and repainted, as applicable. Where inadequate paint protection has led to the deterioration of the associated building element, repair and/or replacement of this building element may be required.

A painting contractor should be appointed as soon as possible to perform necessary works to aid the appearance of the affected area and to ensure that the area is protected against further deterioration. Alternatively, the homeowner following manufacturer instructions may be able to provide this service.

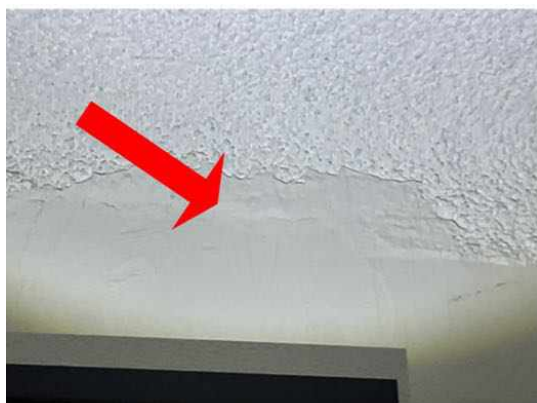
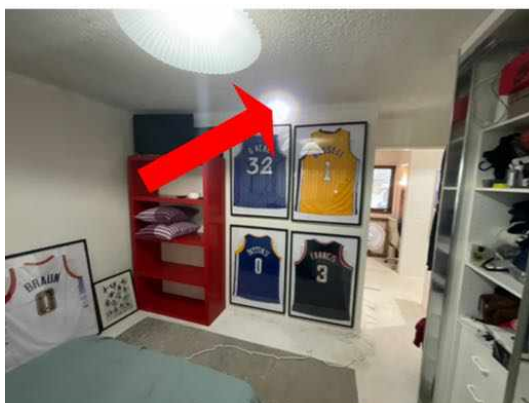
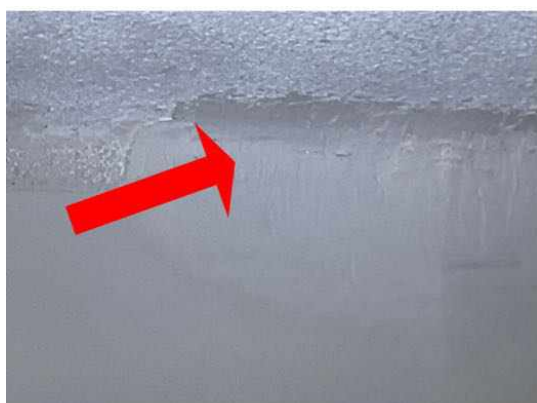
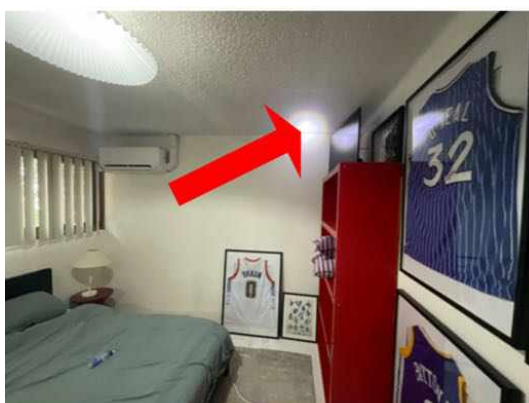
Finding 3.13

Location: All Internal Areas
Finding: Unfinished Floor Surfaces (Post Carpet Removal)
Information: Following the removal of the carpet, the underlying floor surfaces were observed to be unfinished and in poor condition in the inspected areas, including the stairwell. The exposed substrate is rough and patchy, with visible residue and inconsistent surface finish, indicating it was not intended to be a final floor surface.

In its current state, the flooring is not suitable for normal residential use and may impact presentation, ease of cleaning, and safe use, particularly to the stairs where a finished surface is typically required.

It is recommended that a suitably qualified flooring contractor be engaged to assess the condition of the substrate and carry out appropriate rectification works, including surface preparation and installation of a suitable finished floor covering.

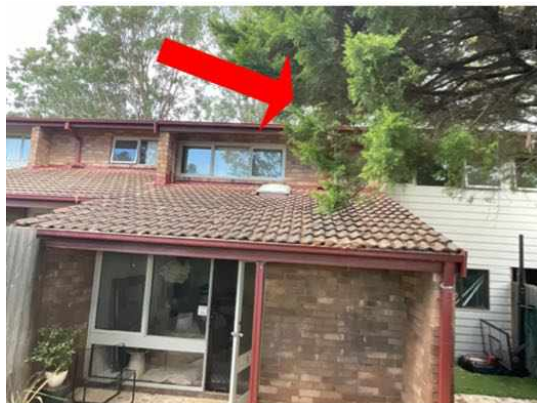
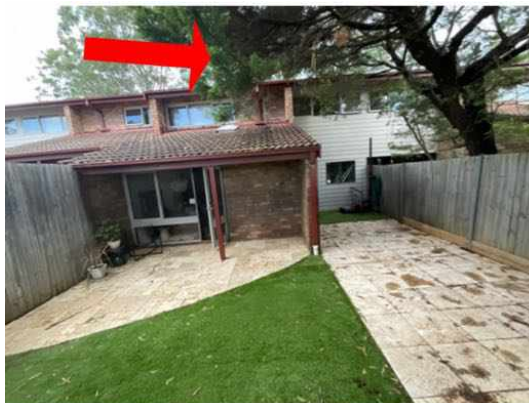
Gutters are a critical part of the building's management of storm water and rain. It is therefore important that they be kept clear to prevent secondary damage to associated building elements, including exterior and interior walls, ceiling linings and any adjoining building elements. Where gutters are blocked, pooling of rainwater is likely to occur, fast-tracking rust and corrosion of the roof plumbing elements.

It is highly advised that all overhanging tree branches be removed as soon as possible to prevent any further damage. Repair and/or replacement of sections of damaged guttering may also be required where the extent of the damage necessitates.

Such works should be performed by the homeowner; however, appointment of a landscape contractor or an arborist may be required. Consultation with a licensed roof plumber is required where guttering has been damaged.

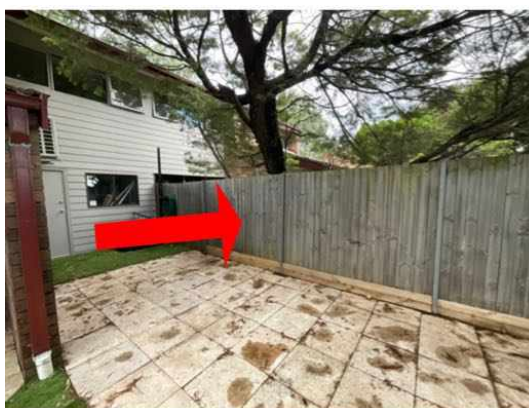
Finding 6.04

Building:	Main Building
Location:	All Areas
Finding:	Timber - exposed to weather
Information:	External timbers that are frequently exposed to harsh weather conditions require adequate protection in order to maintain their condition. Where timbers have not been painted or treated adequately, general deterioration is likely to occur at an accelerated rate.

If left unattended, replacement of these timbers is likely to be necessary in the short-term future. Adequate treatment of these timbers is required as soon as possible by a painting contractor or general handyman.

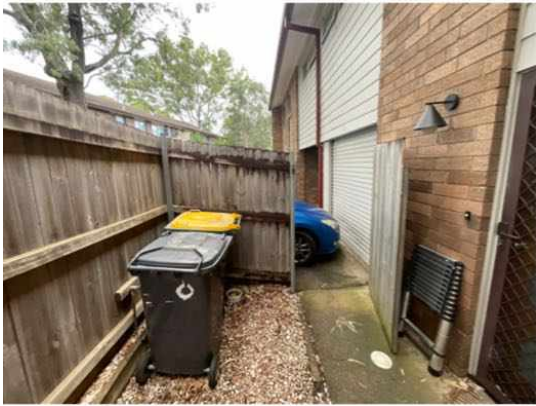
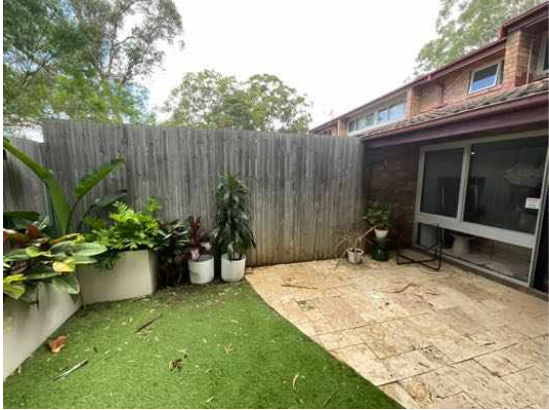
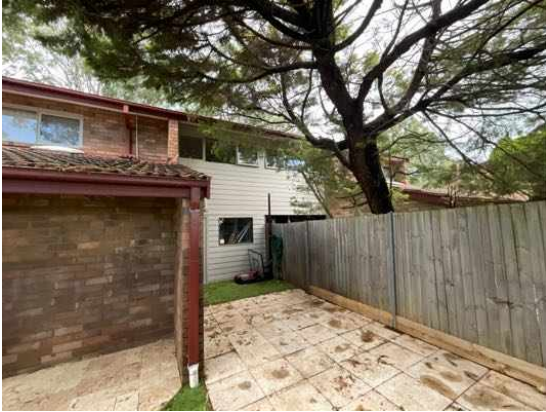
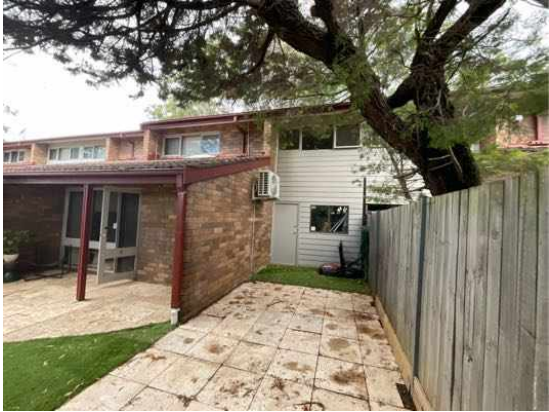
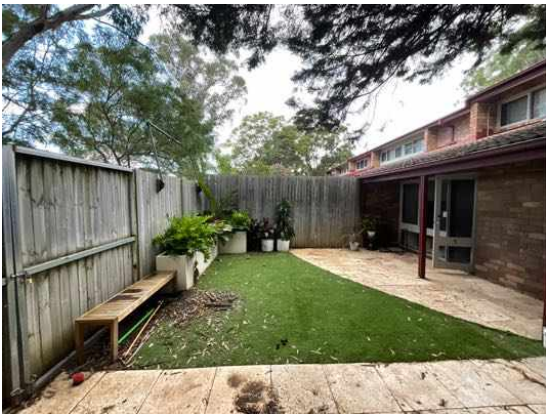
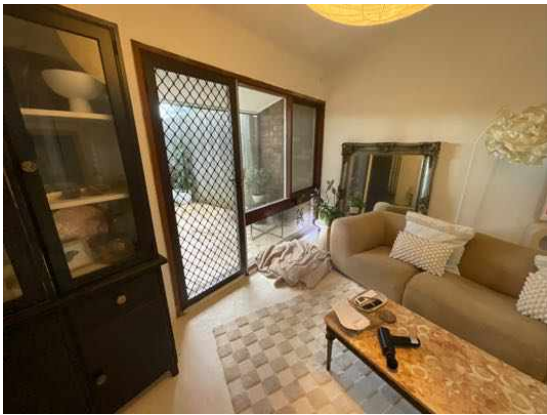
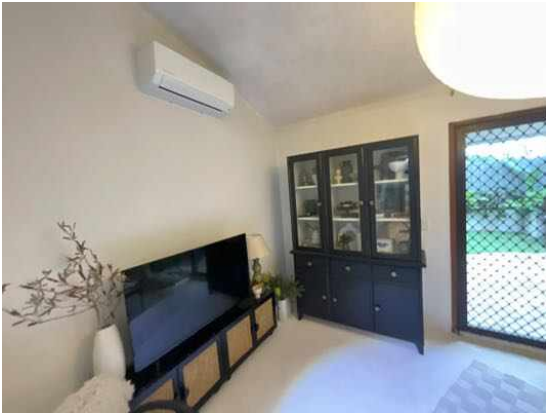
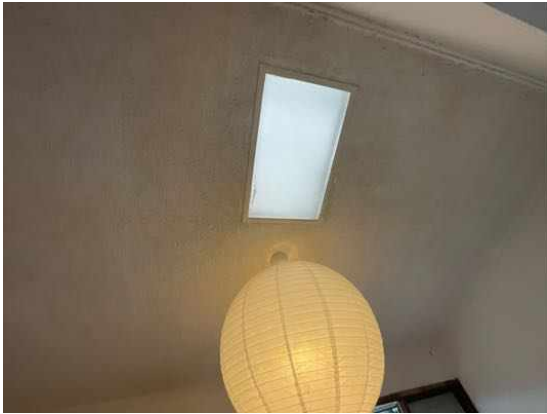
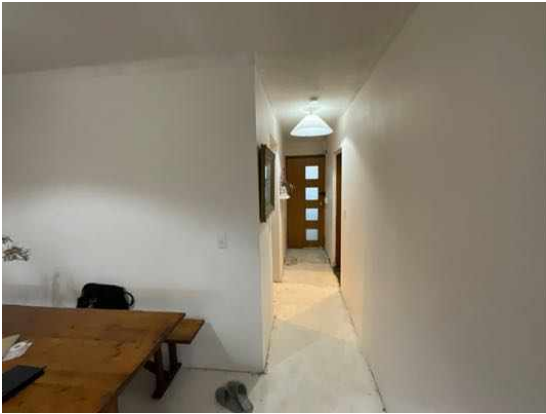
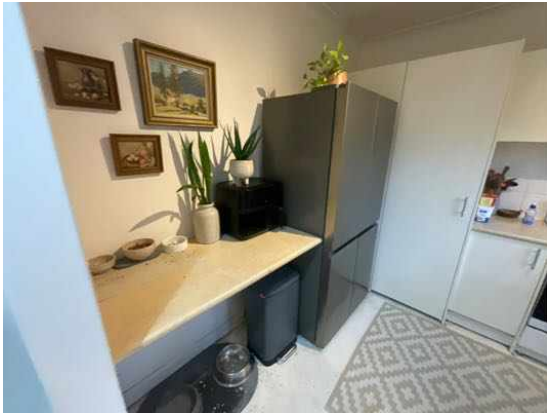
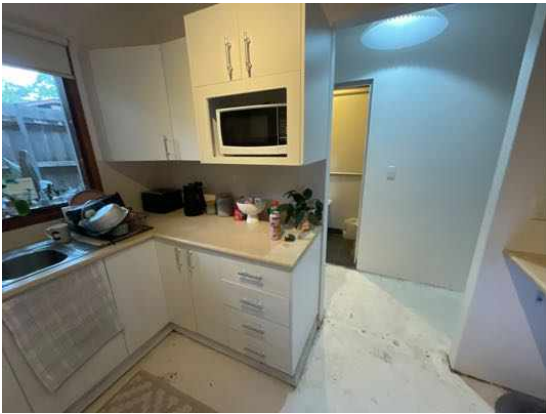
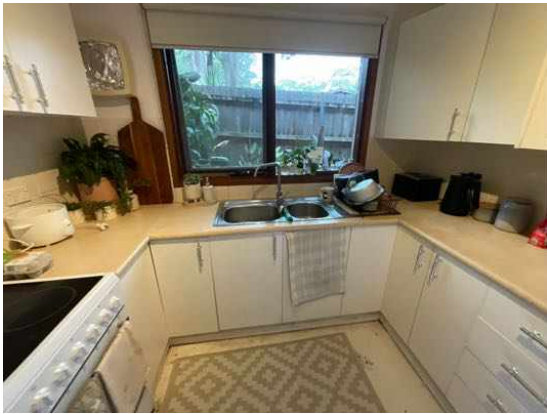
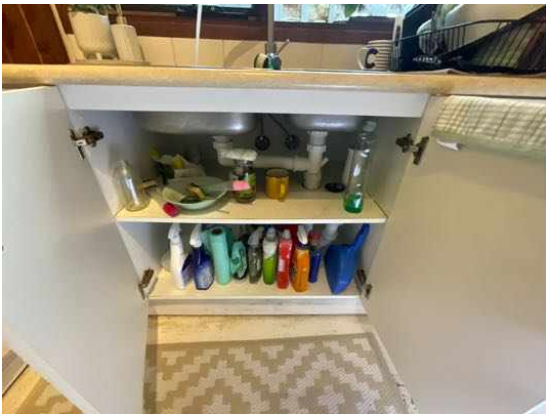
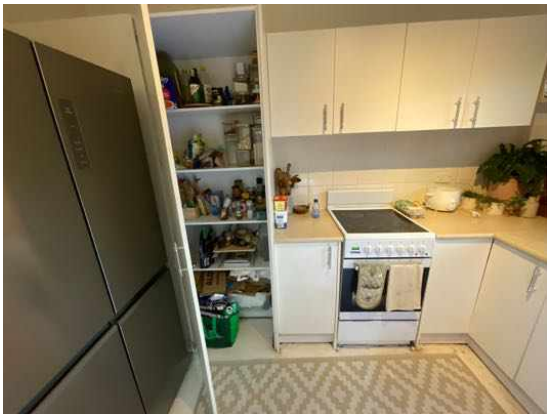
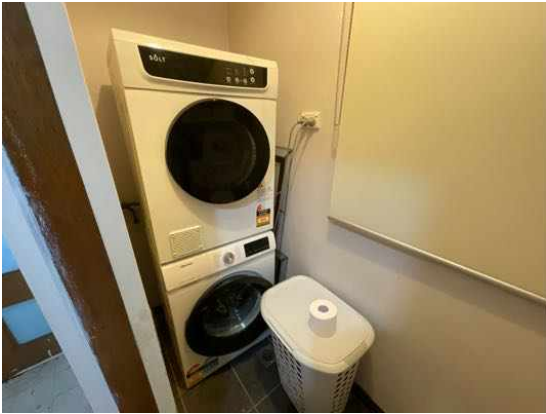
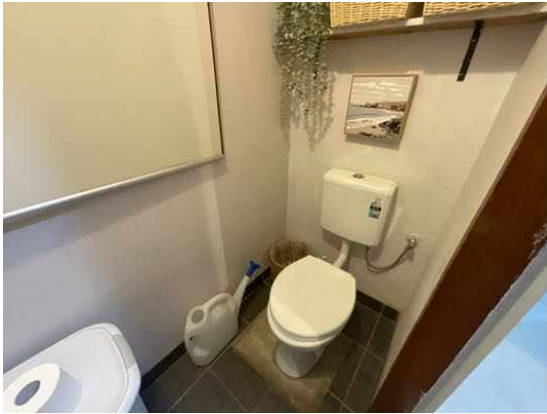
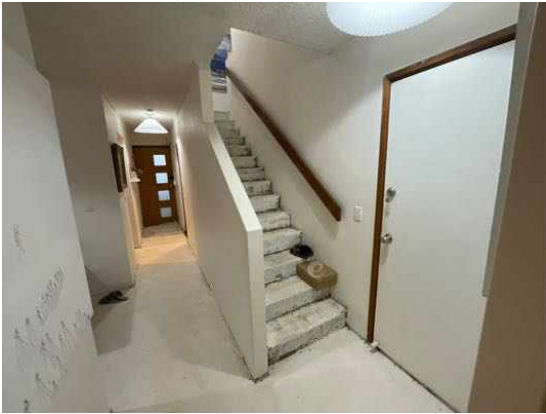
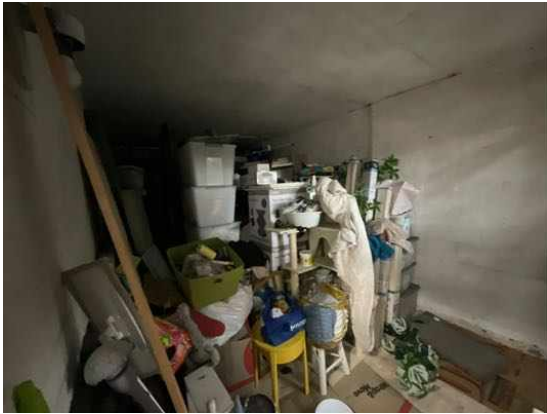
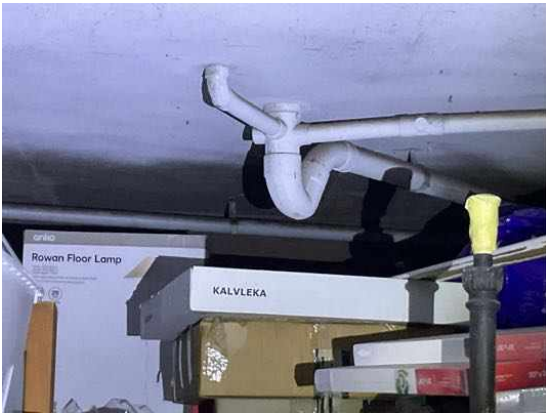
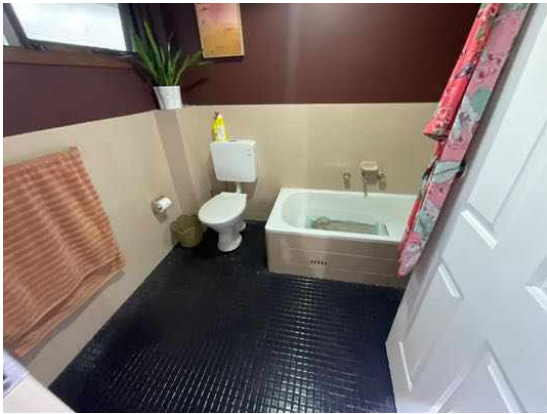
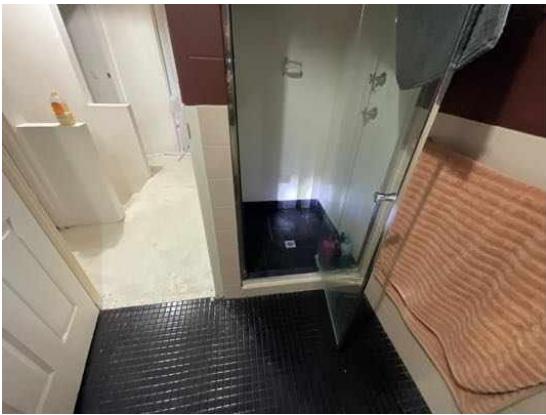
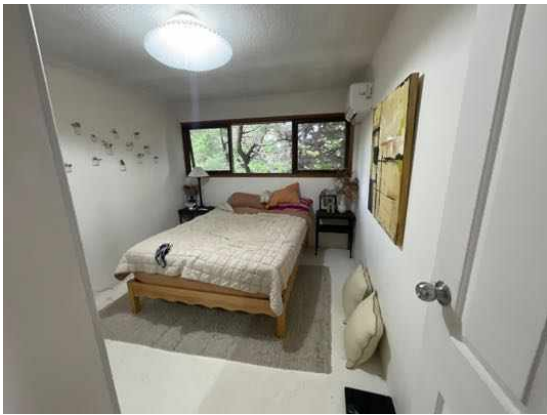
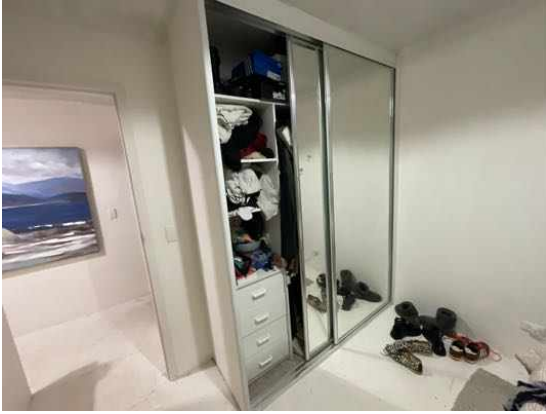
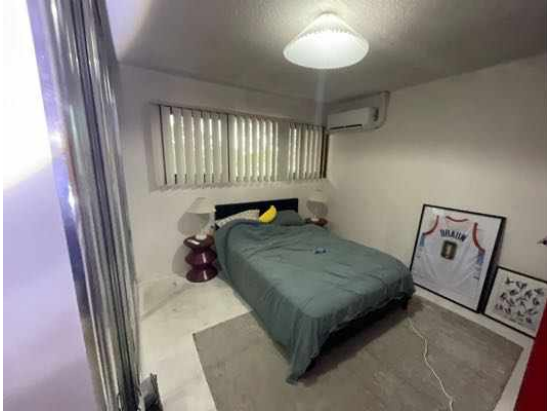
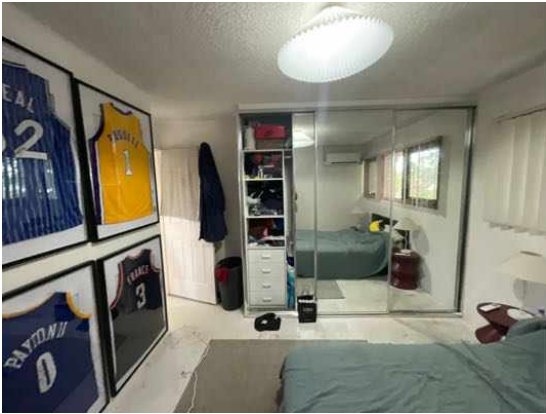
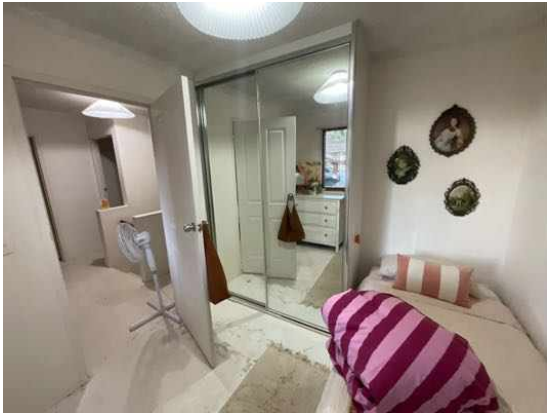
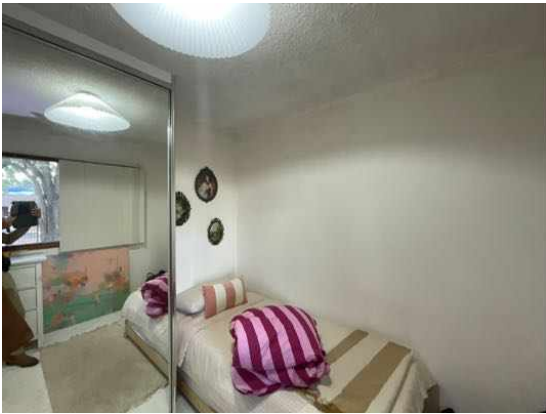
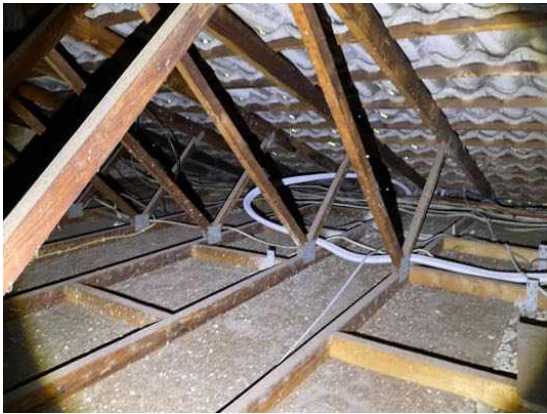
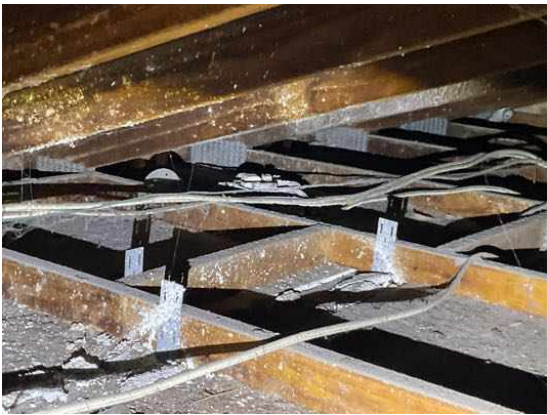
Building: Main Building
Location: All Areas
Finding: Additional Photos - Obstructions and Limitations
Information: These photographs are an indication of the obstructions and limitations which impeded full inspection of the property at the time of inspection. These obstructions can hide an array of defects and should be removed to allow full inspection to be carried out. A re-inspection is recommended once the areas are made accessible.

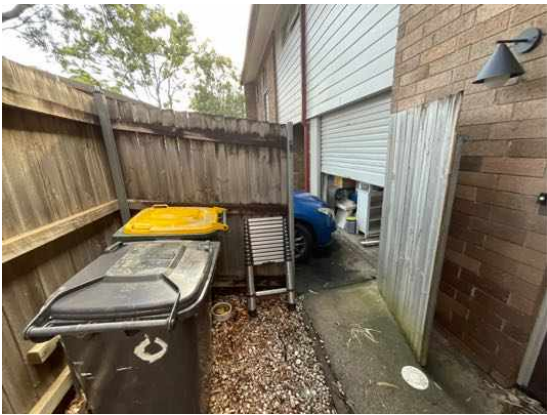
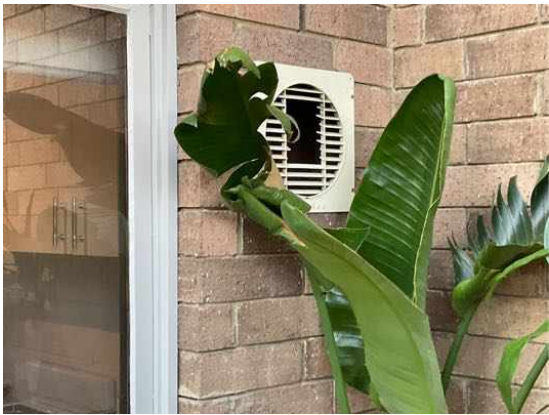
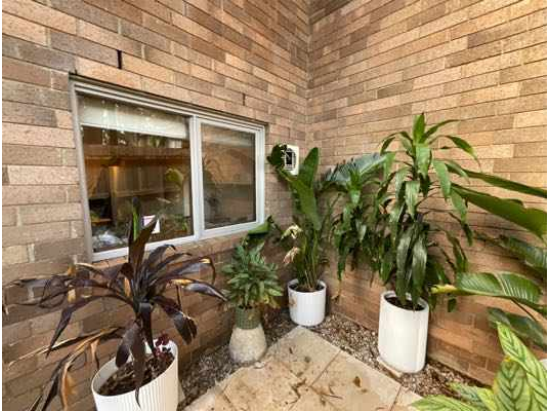
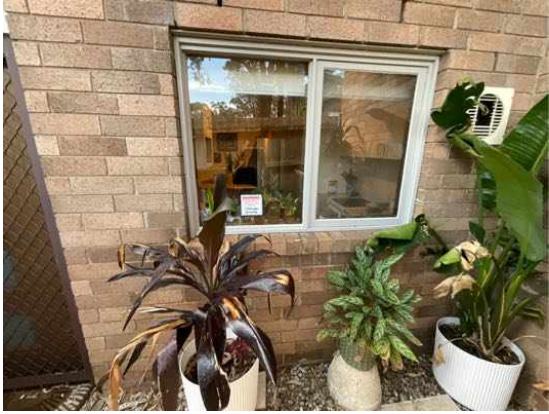
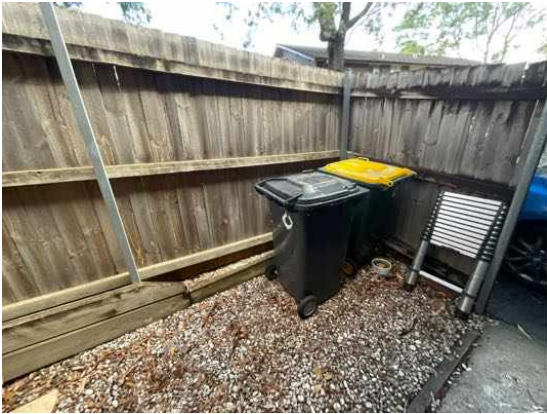
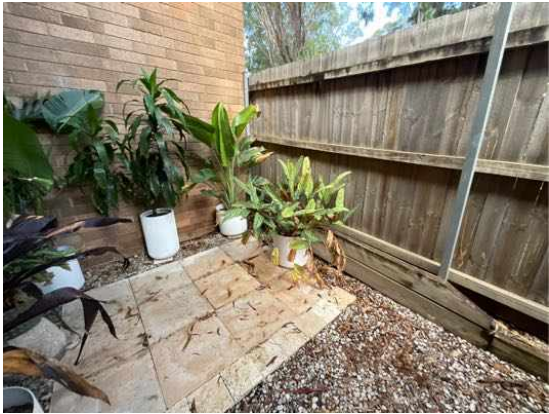
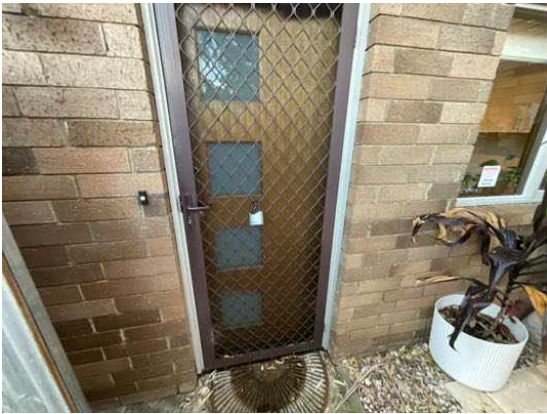
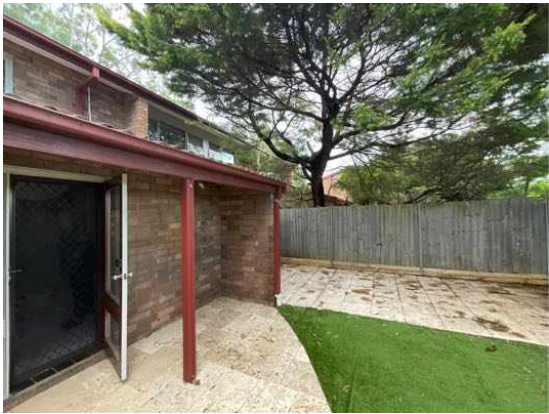
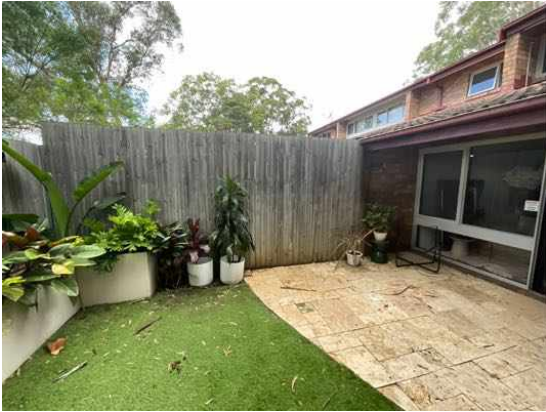
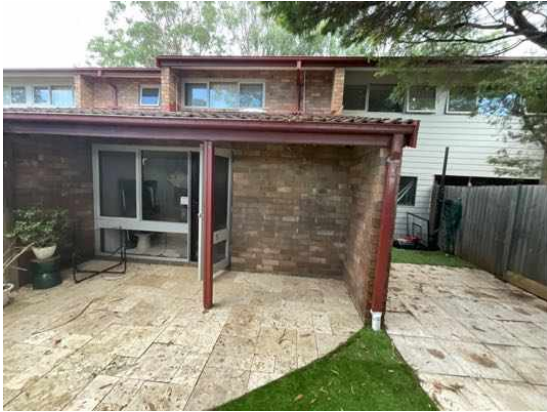
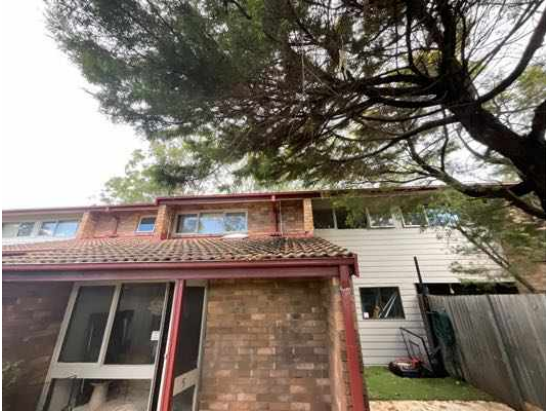
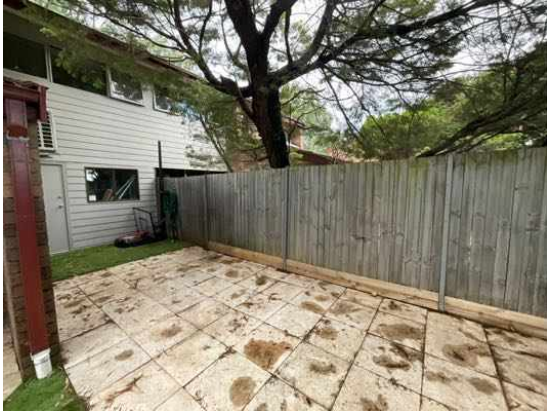
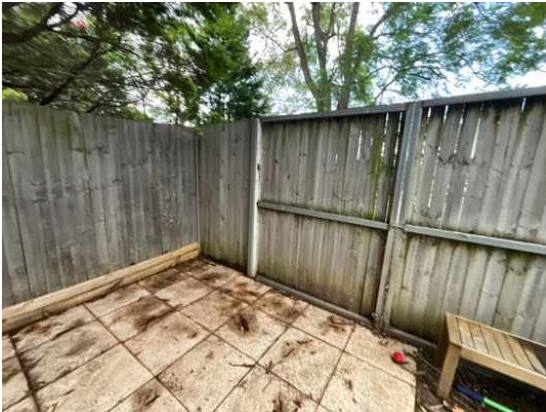
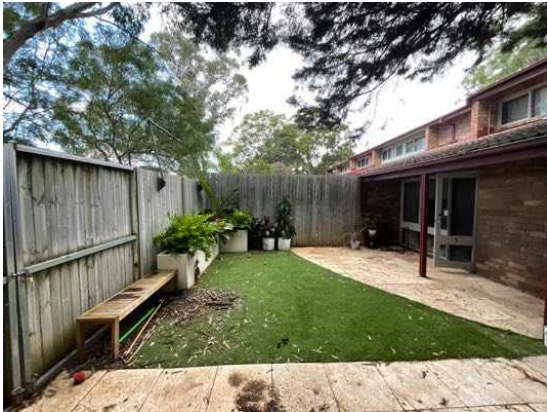
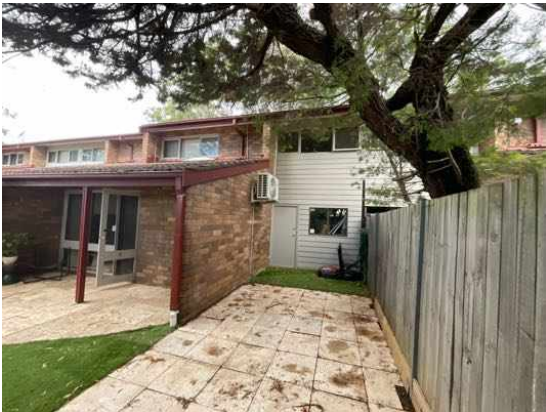
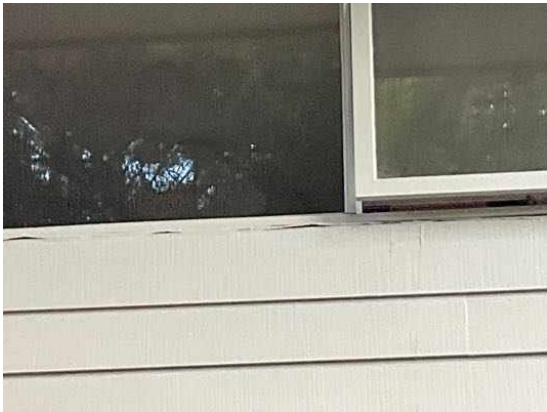
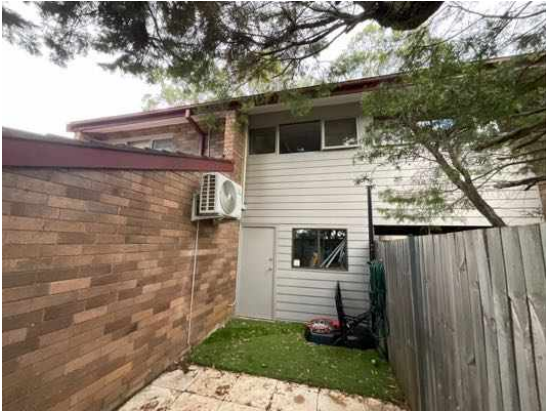
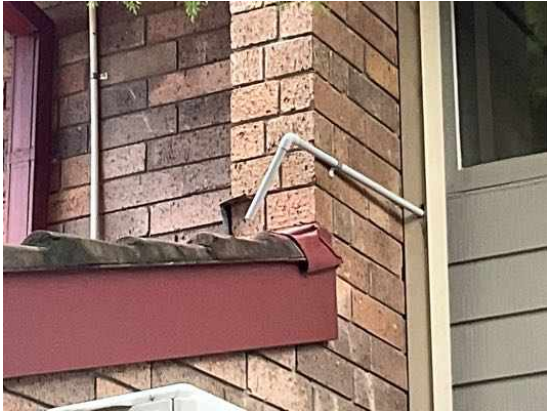
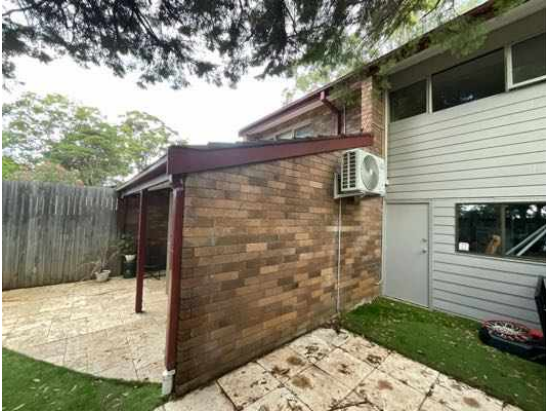
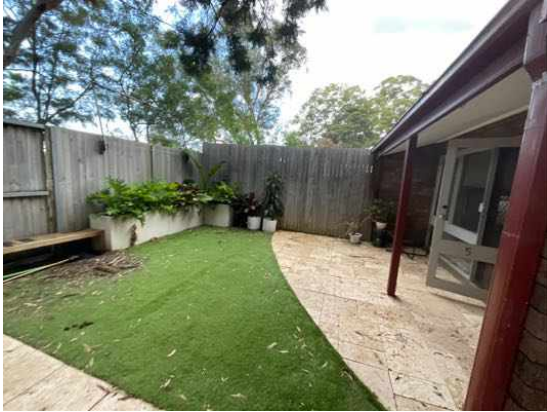
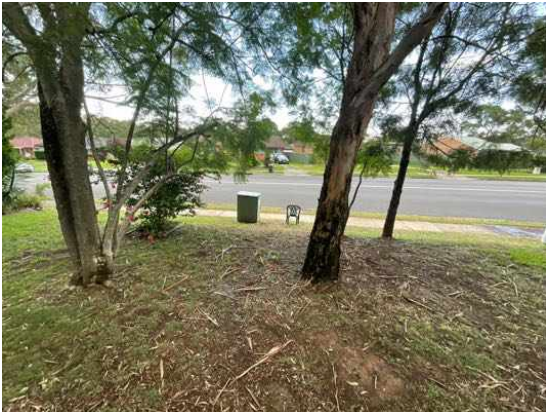
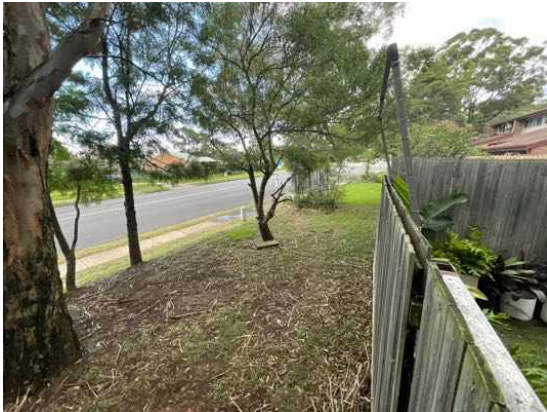
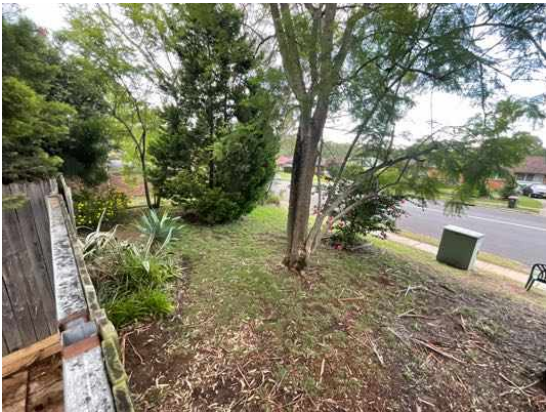
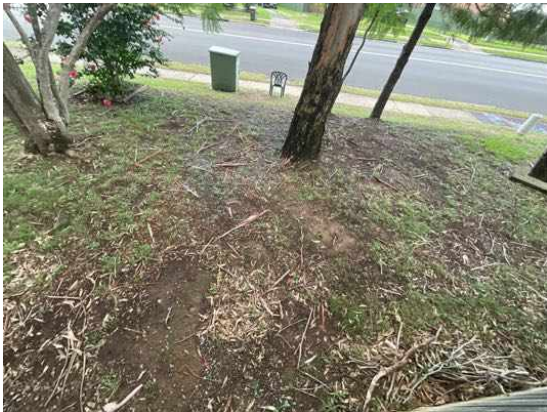
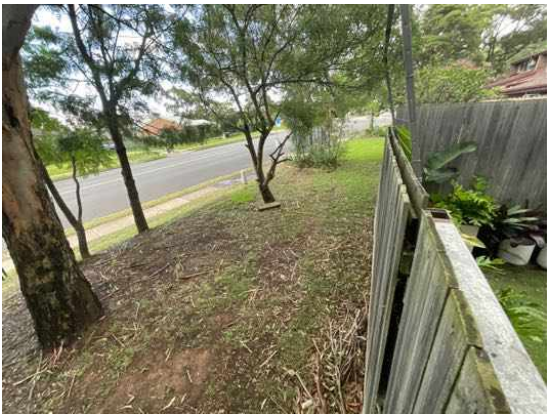
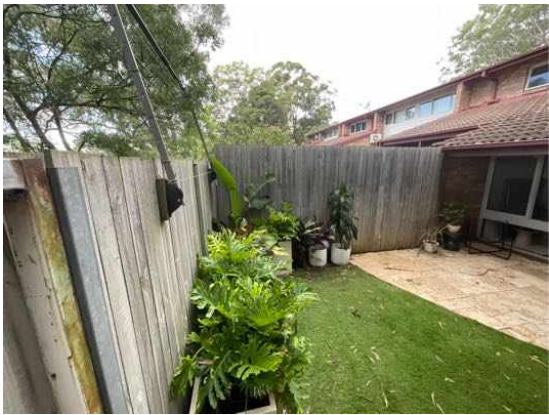
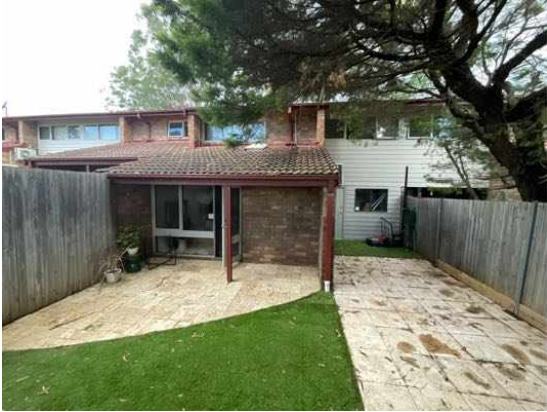
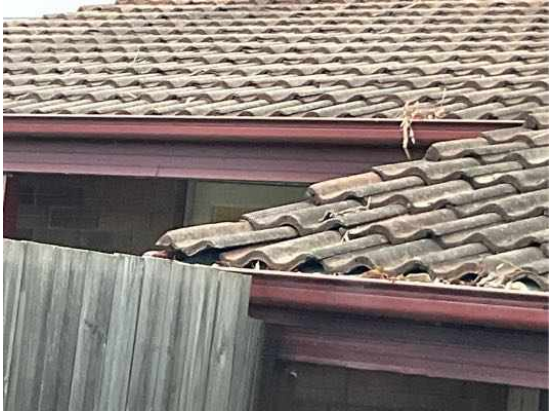
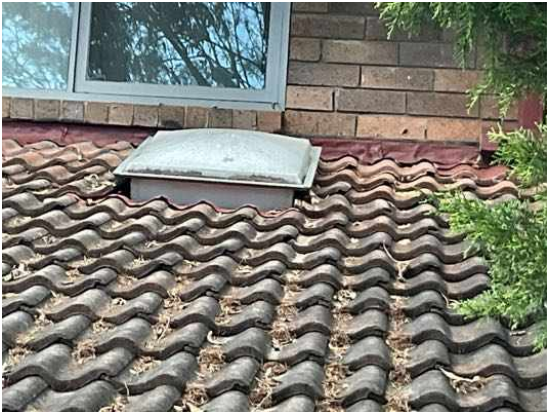
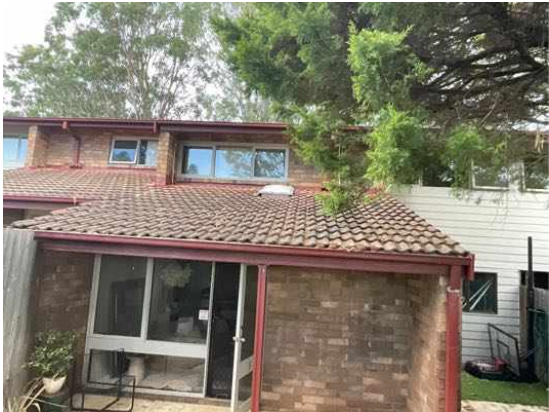
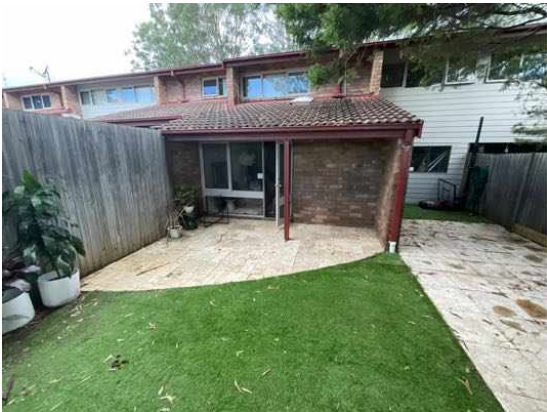
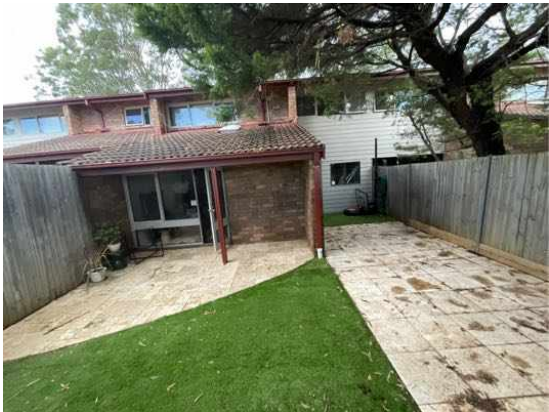
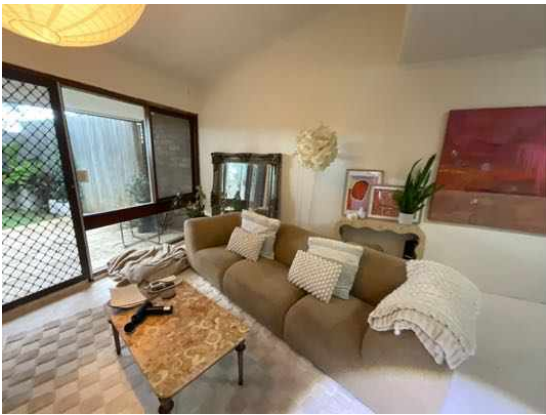
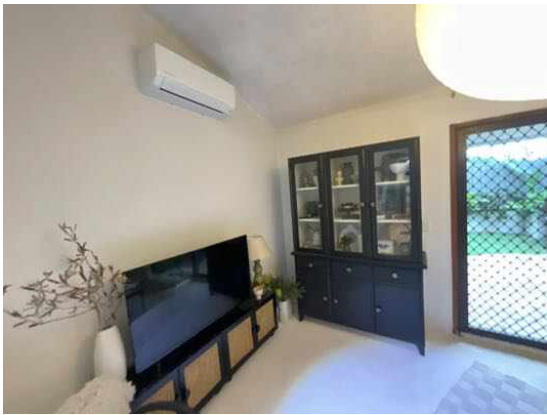
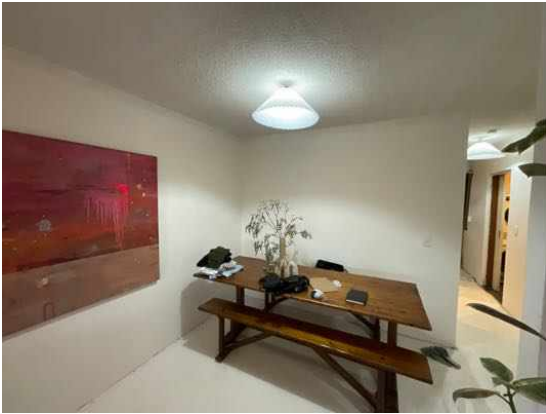
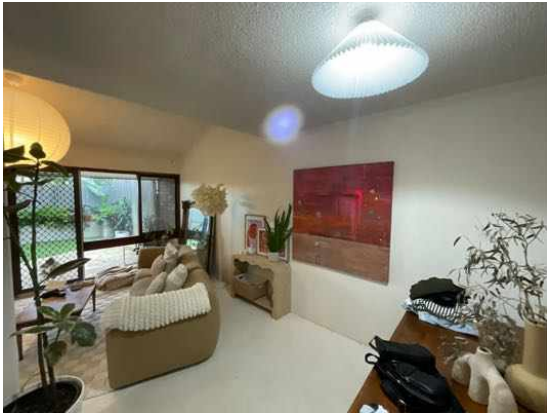
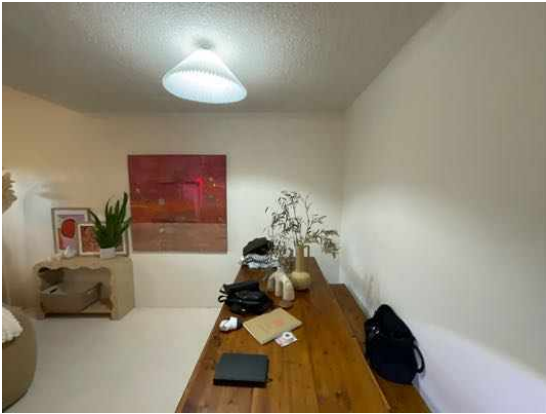
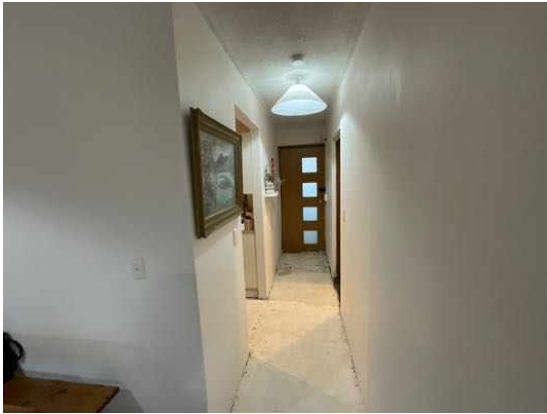
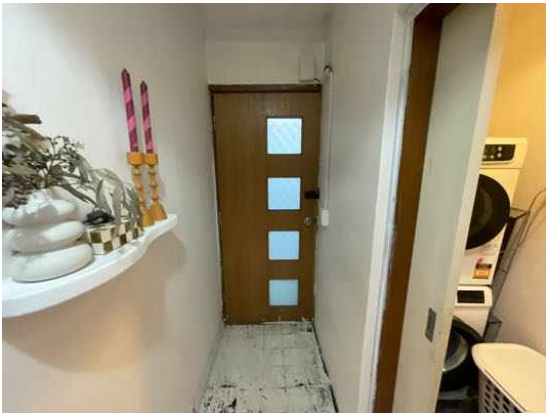
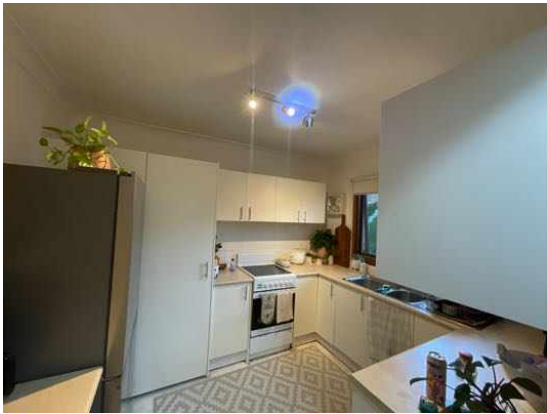
Building: Main Building
Location: All Areas
Finding: Additional Photos
Information: Additional photos are provided for your general reference
