Building and Timber Pest Inspection Report

Inspection Date: Mon, 9 Feb 2026

Property Address: 5/72 Campbellfield Ave, Bradbury NSW
2560, Australia

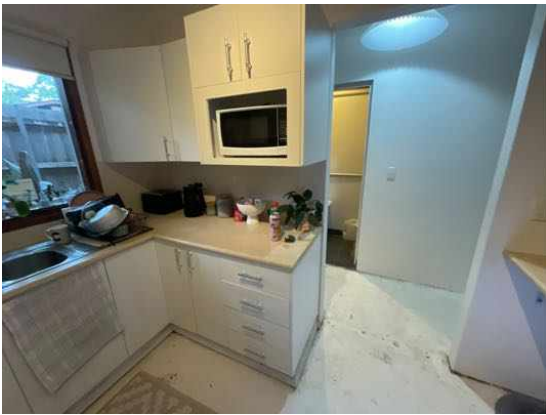
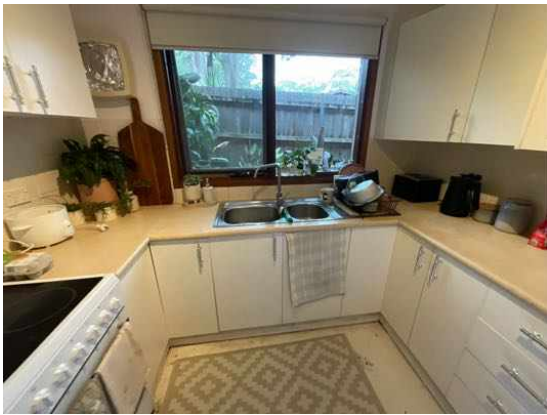
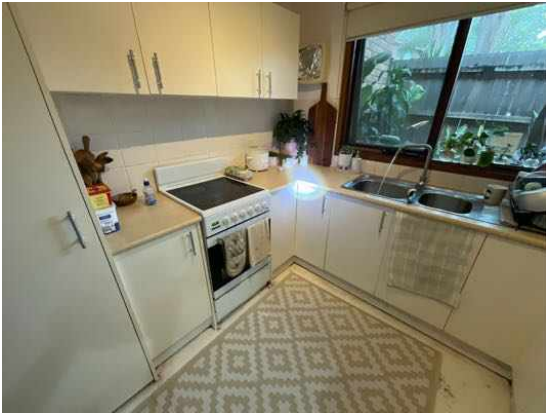
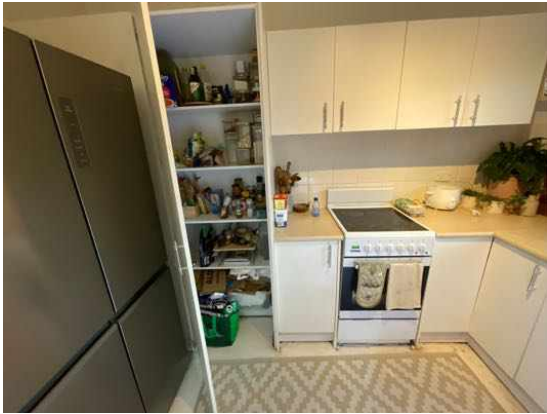
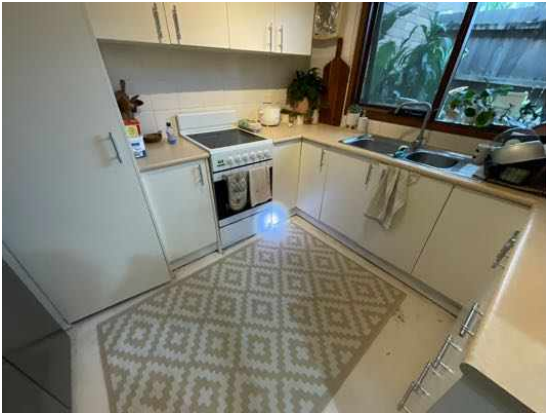
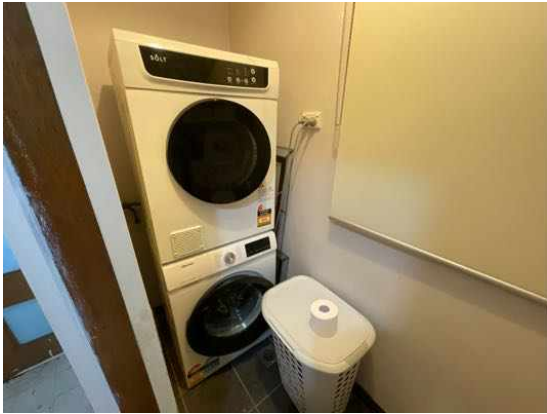
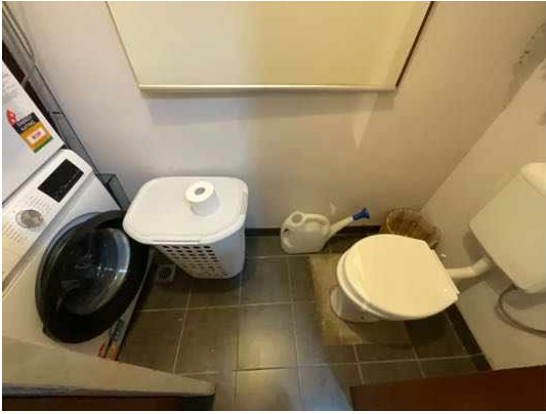
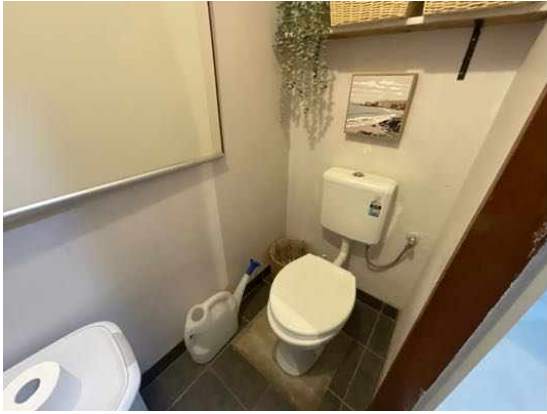
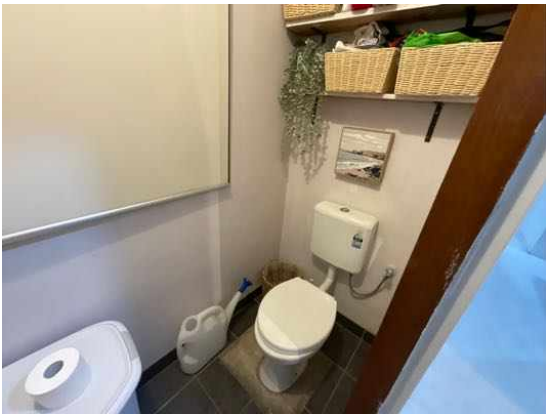
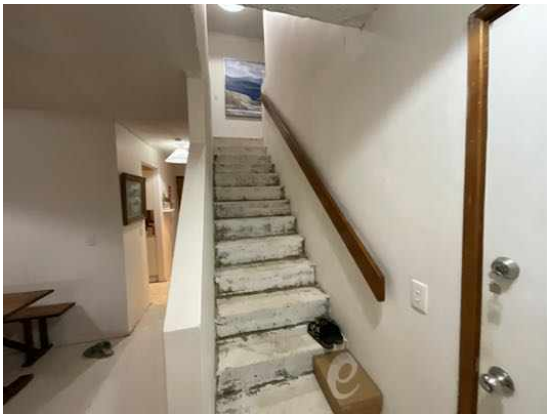
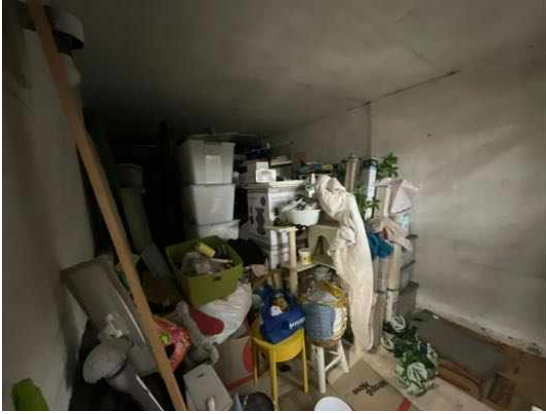
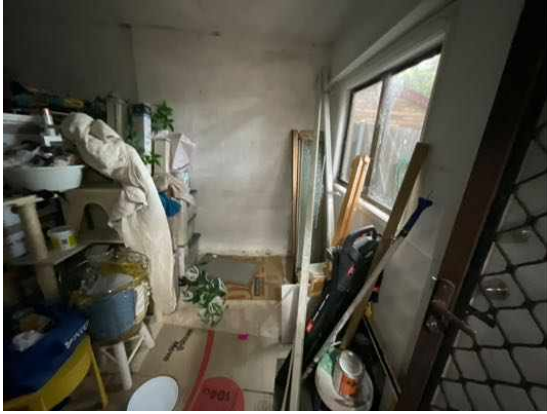
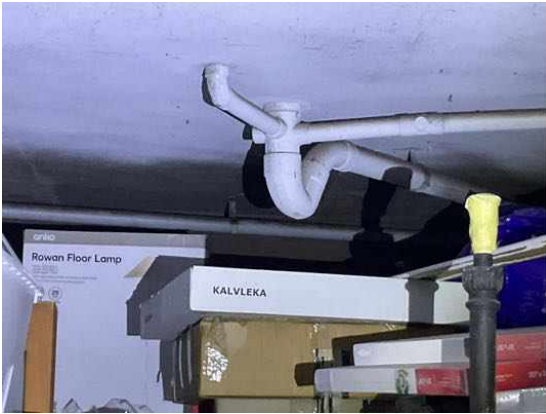
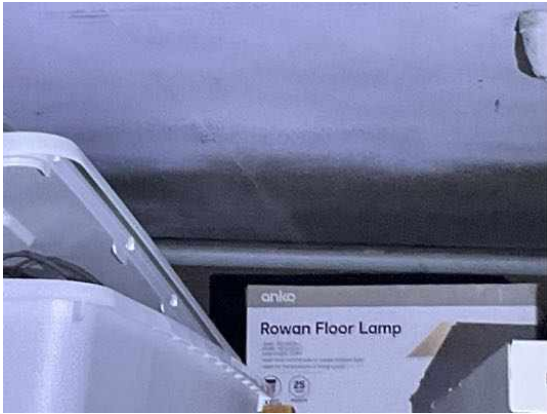
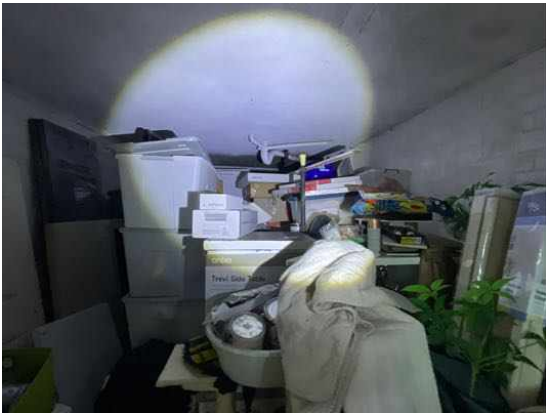
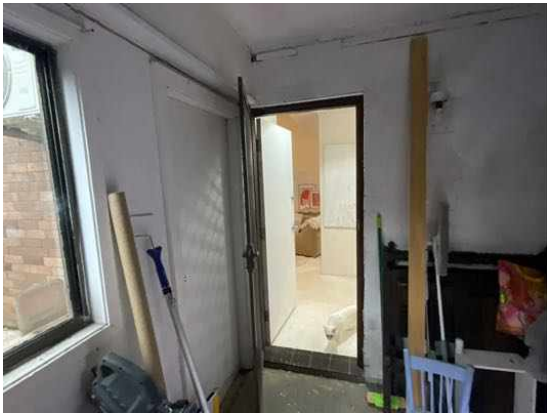
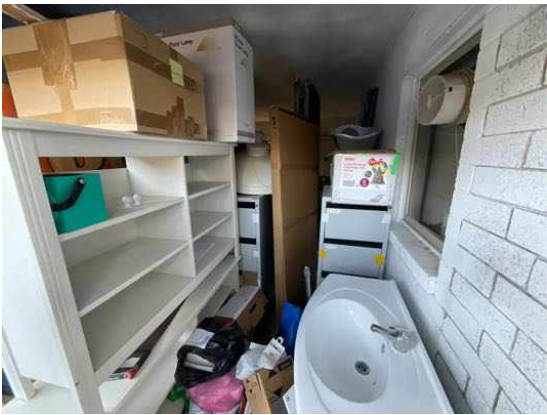
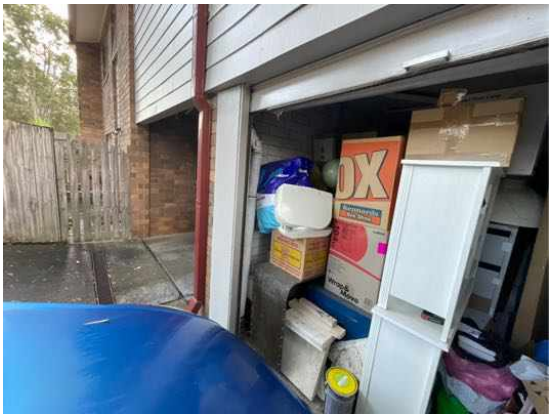
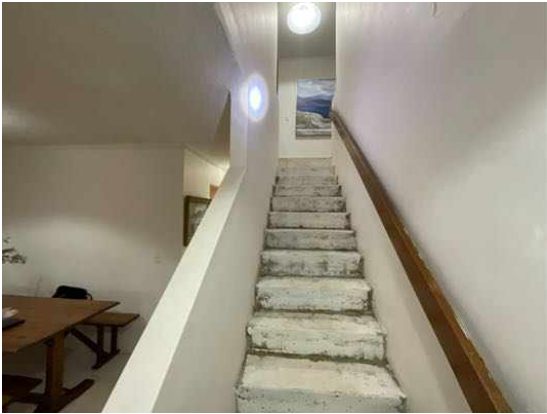
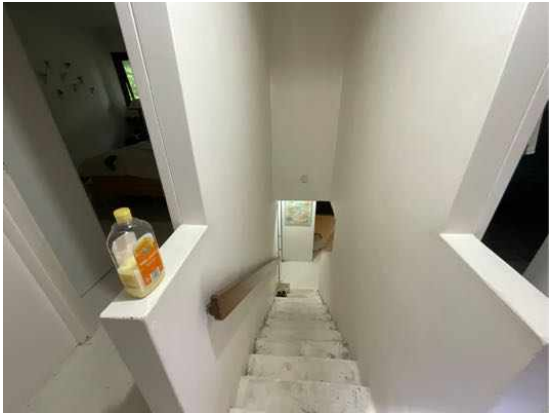
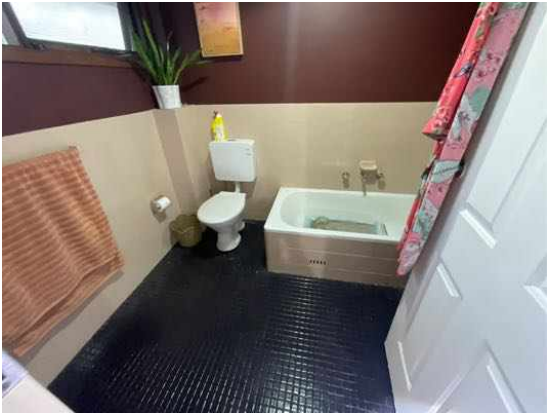
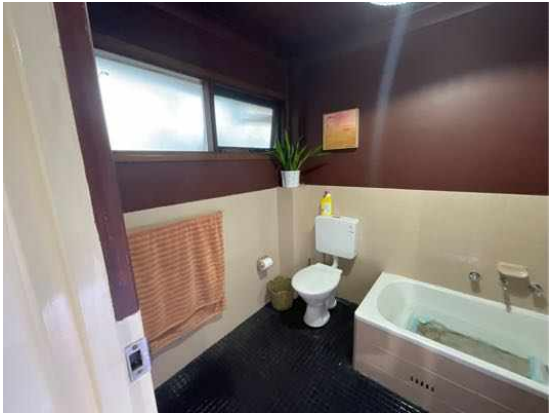
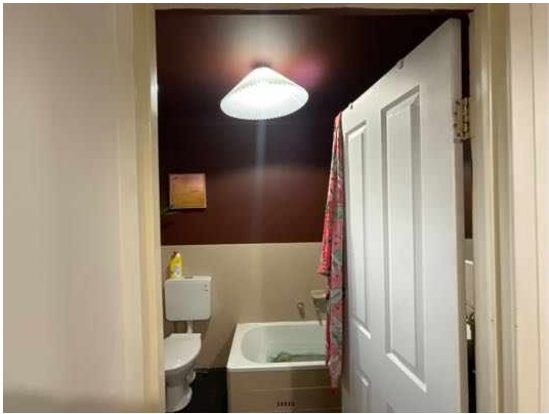
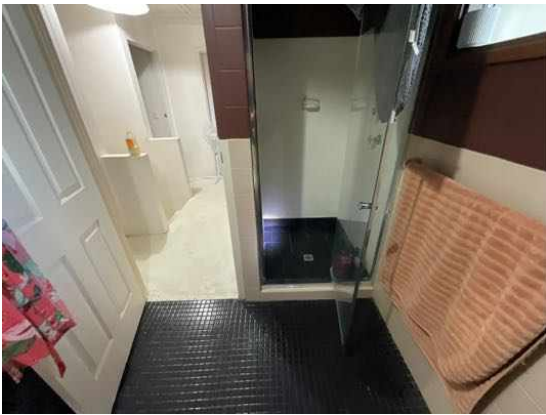
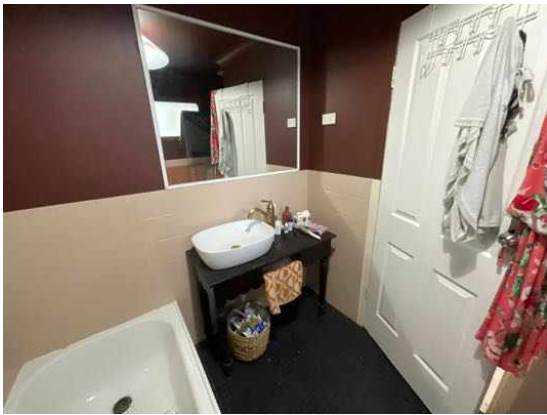
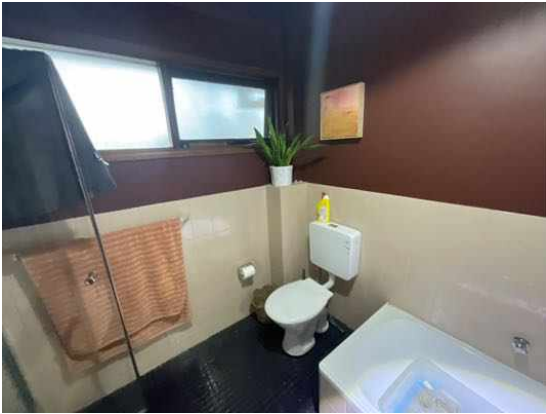
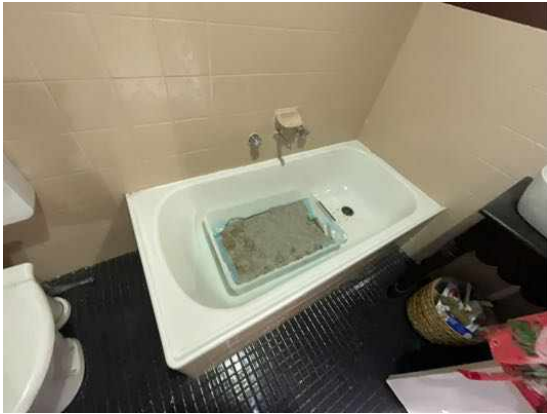
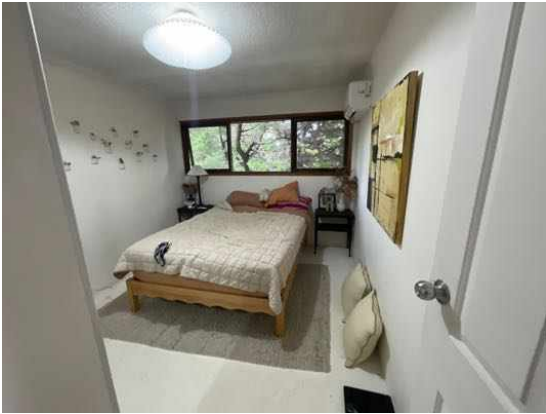
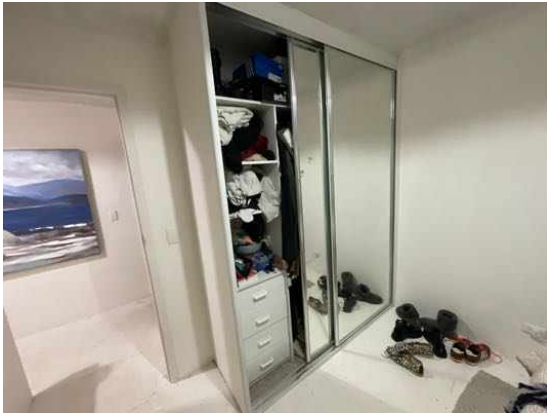
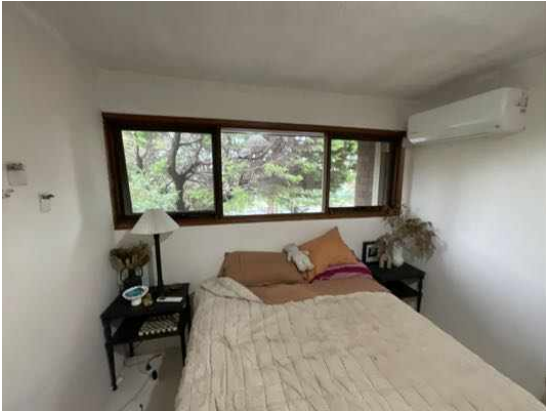
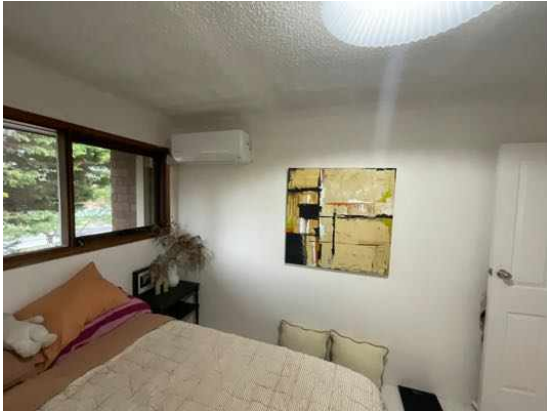
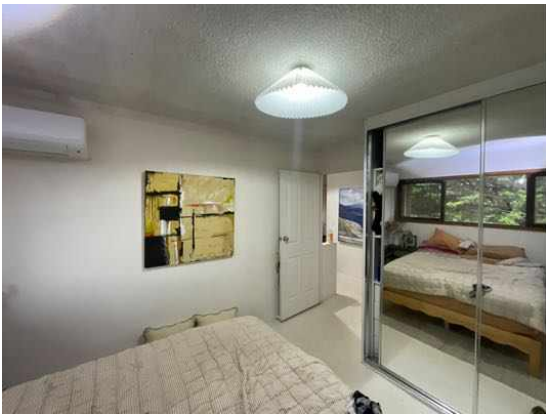
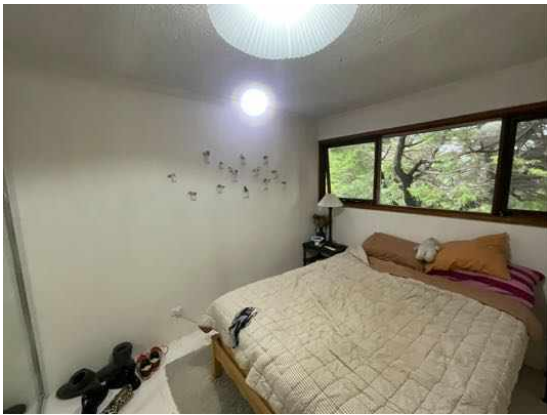
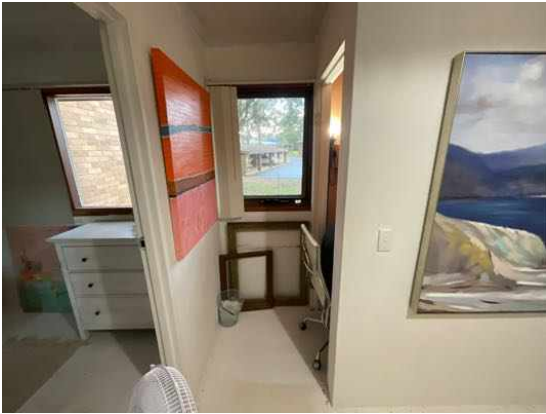
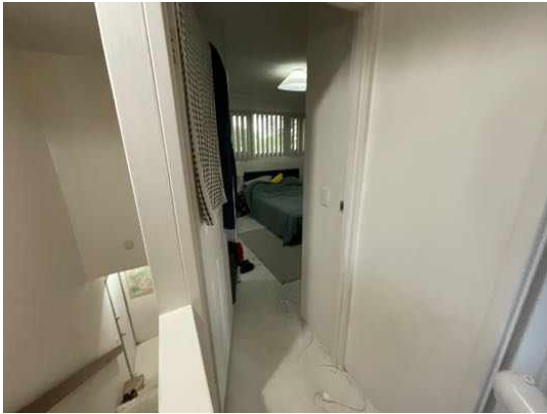
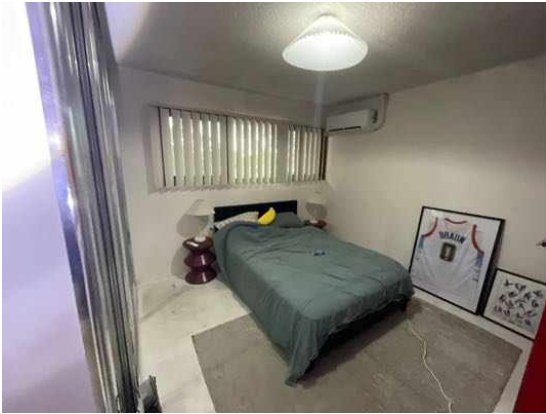
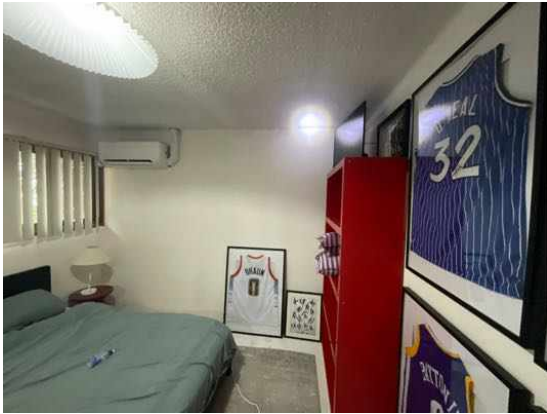
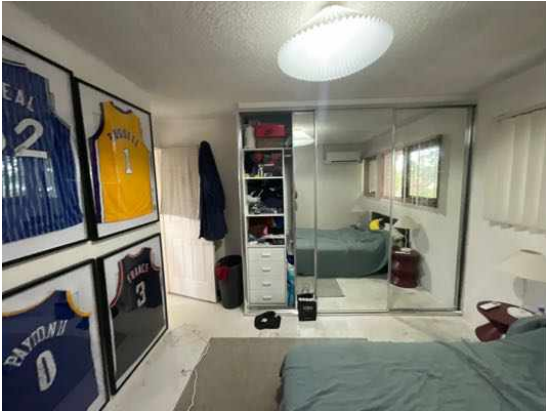
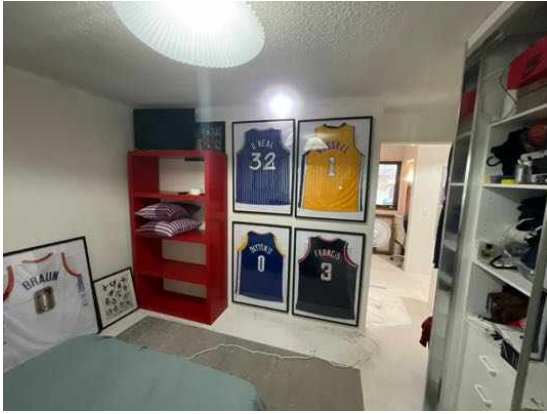
Building: Main Building
Location: All Areas
Finding: Additional Photos - Obstructions and Limitations
Information: These photographs are an indication of the obstructions and limitations which impeded full inspection of the property at the time of inspection. These obstructions can hide an array of defects and should be removed to allow full inspection to be carried out. A re-inspection is recommended once the areas are made accessible.

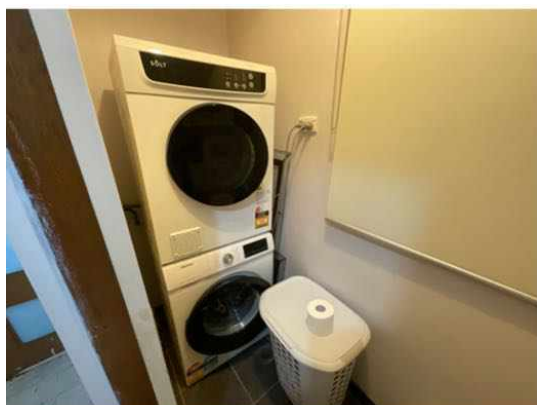
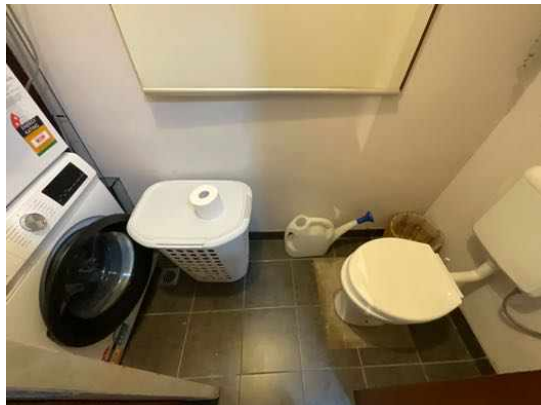
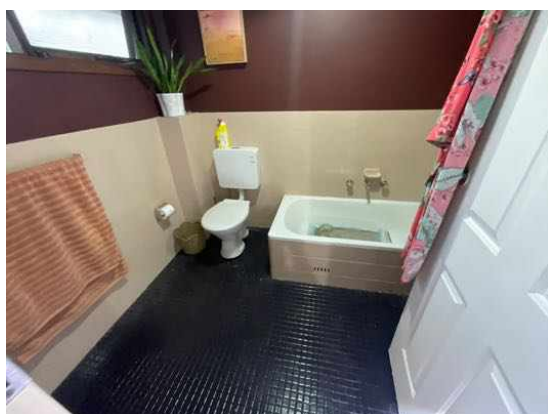
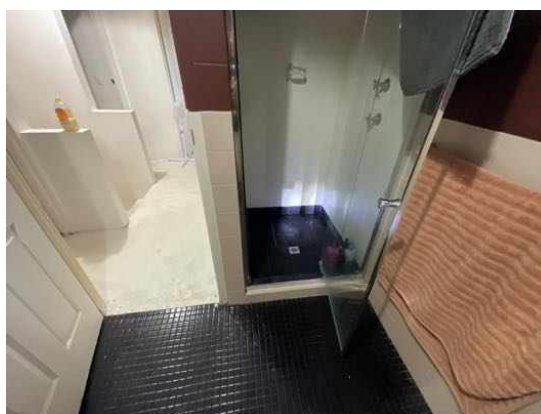
Building: Main Building
Location: All Areas
Finding: Water Proofing Membranes - Information Only
Information: Internal Water Proofing Membranes, are crucial in preventing water ingress into the property is important to know that the Membrane System used is to Australian Standards and has been installed correctly. Please refer to the original Building Documents or Maintenance Schedule for the relevant information including; - Membrane used and Manufacturers Specifications. - The Installer and Installation Certification. Especially with older property's where this information is unavailable, all wet areas should be monitored. Generally new waterproofing with a certificate may

only have a guarantee of 8yrs. If any leaks, water staining, peeling or bubbling of the paint become evident to any adjacent walls or ceilings below a licensed builder or waterproofing specialist is recommended to investigate further.
