# Building and Timber Pest Inspection Report

Inspection Date: Thu, 19 Feb 2026

Property Address: 20 Tandarra Cres, Lalor VIC 3075, Australia

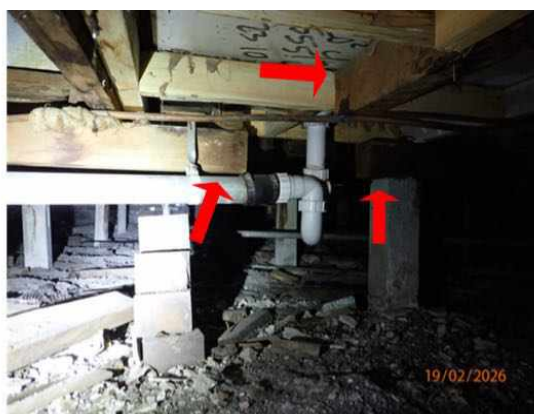
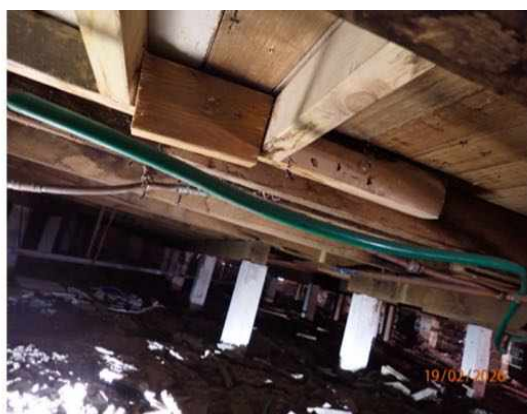
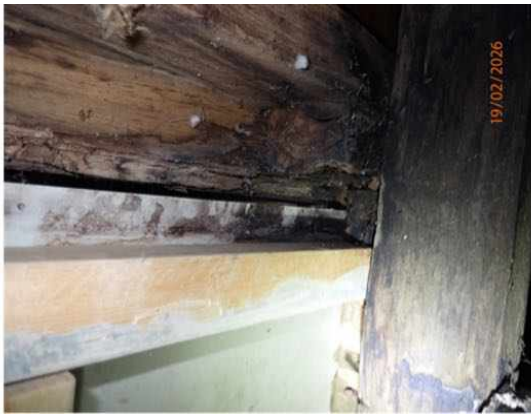
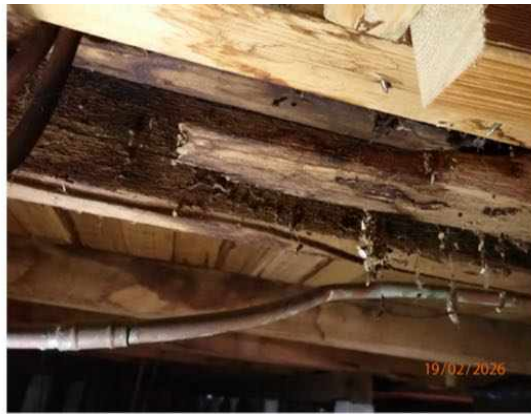
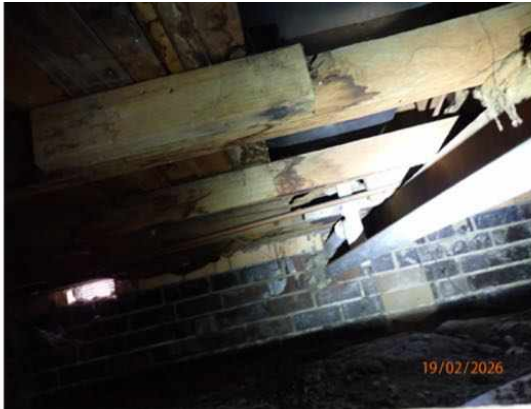
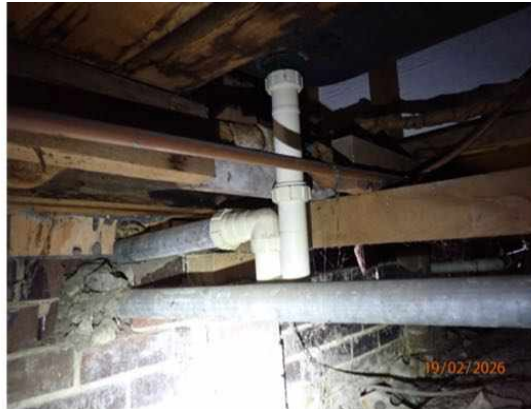
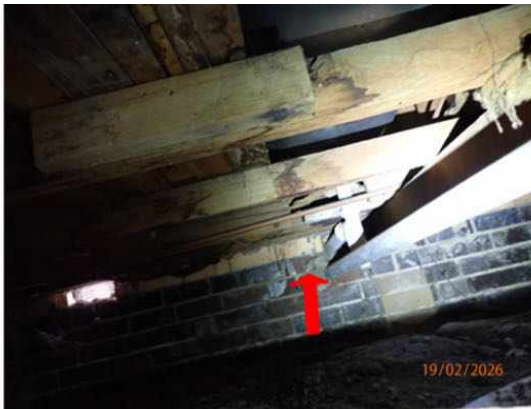
Building: Main Building  
Location: Subfloor  
Finding: Subfloor Structural Alterations  
Information: During inspection of the subfloor beneath the shower and bathroom areas, structural members were found to be altered and inadequately supported. A bearer had been cut to make room for plumbing, and evidence of a previous water leak was noted with a rotted joist present. New framing had been added to support the shower base; however, these timbers were only partially nailed to the older damaged joist and were not spanning properly from bearer to bearer. The joist located centrally beneath the shower base was noted cut and unsupported. In addition, a joist in another section of the bathroom had been cut to accommodate plumbing under the bath, and the joist beneath the vanity was also noted unsupported.

Cutting and inadequately supporting structural timbers compromises load-bearing capacity and may result in excessive movement, failure of wet area finishes, and further structural deterioration if not rectified. It is strongly recommended to engage a registered builder, and where required a structural engineer, to assess the extent of structural alterations and carry out compliant rectification works as a matter of urgency.

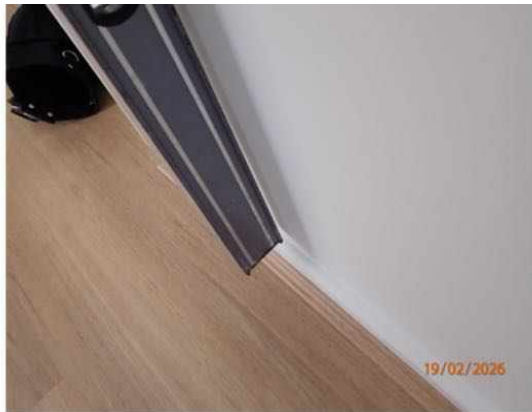
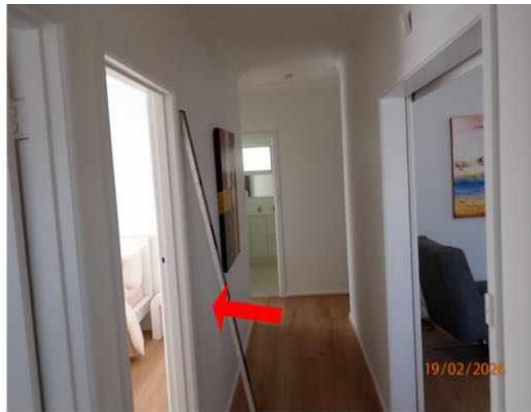
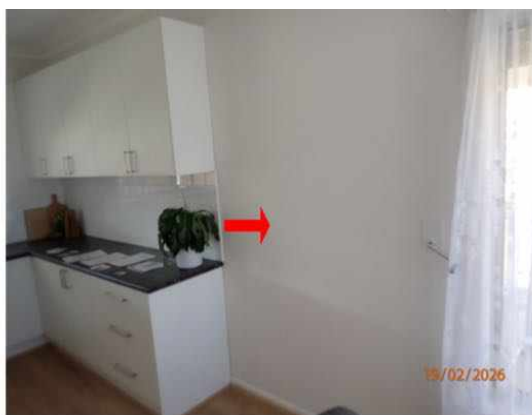
### Finding 3.01

Building:	Main Building
Location:	Entry
Finding:	Wall Leaning and Associated Brickwork Cracking
Information:	The internal wall in the entry area was noted leaning by approximately 10mm during inspection. The adjoining external wall near the kitchen was observed leaning by approximately 20mm, with a crack noted in the corresponding external brickwork. The deviation appears localised to this section only.

This condition may be the result of substandard construction practices at the time of original construction or minor settlement over time, rather than widespread structural movement. No significant associated distortion was observed in surrounding areas at the time of inspection.

It is recommended to monitor this section of the wall for any changes, including widening cracks, increased leaning, or difficulty in operation of nearby doors or windows. Should further movement be observed, a structural engineer should be engaged to assess the area and provide appropriate advice.

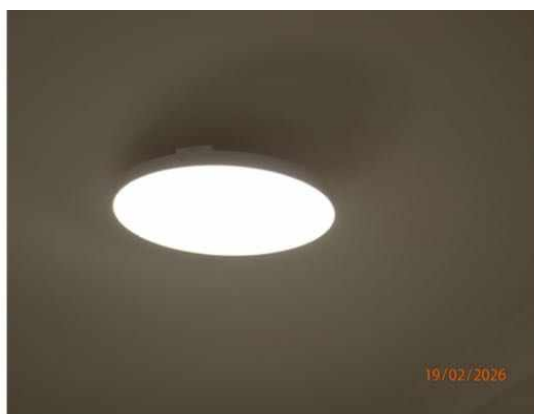
### Finding 3.03

Building: Main Building  
Location: Bathroom  
Finding: Bathroom Light Fitting Loose  
Information: The bathroom light fitting was noted loose and not securely fixed during inspection. Loose electrical fittings may pose a safety risk, including potential electrical hazard or failure of the fitting if left unattended.

It is recommended to engage a licensed electrician to secure and check the installation to ensure safe and compliant operation. Rectification is advised in the short term.

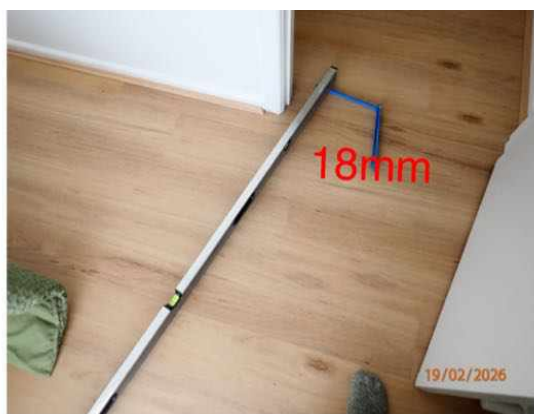
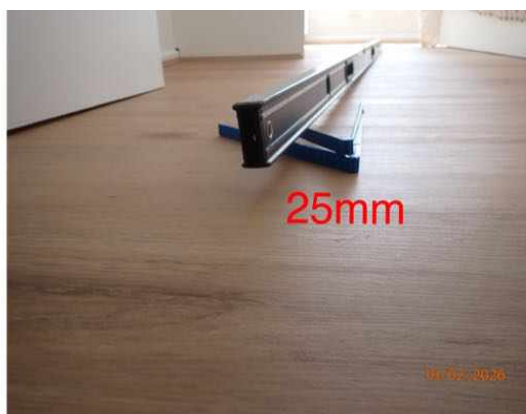
Building: Main Building  
Location: Bedroom 2 and 3  
Finding: Flooring - Uneven  
Information: The internal flooring in this area is out of level and uneven, more than what is typically expected. Uneven flooring can indicate minor defects such as movement of the foundations, but in this case, the extent of unevenness suggests potential subsidence of the associated subfloor stumps.

It is advised that further inspection of the subfloor structures and stumps be conducted to determine the cause of the excessive unevenness. This may involve a potentially invasive inspection to accurately assess the condition and stability of the subfloor components. This is noted as a minor defect with major implications.

Based on the findings, works to repair the flooring may be required. It is recommended that a registered builder specializing in re-stumping be engaged to carry out these necessary repairs to ensure the structural integrity and levelness of the flooring.

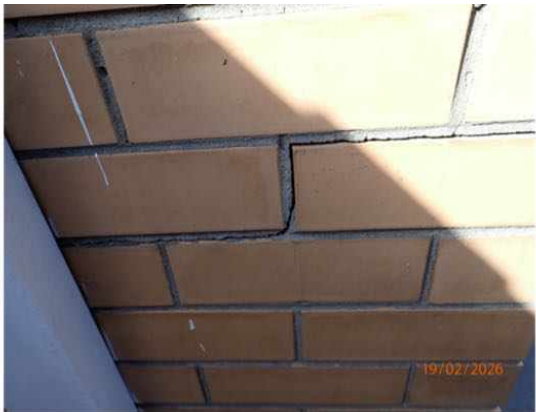
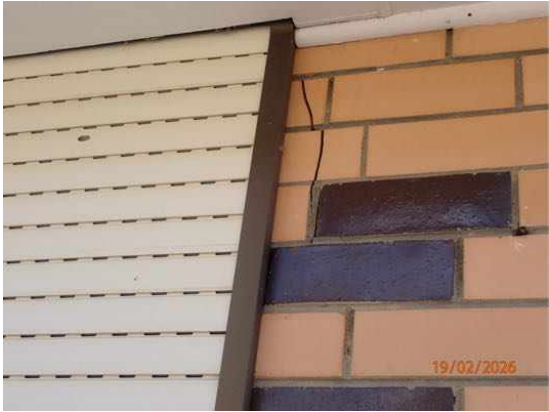
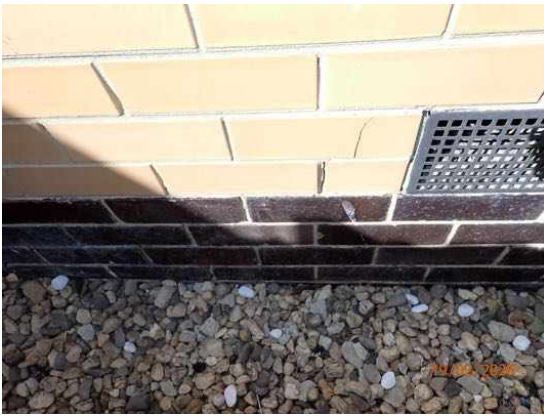
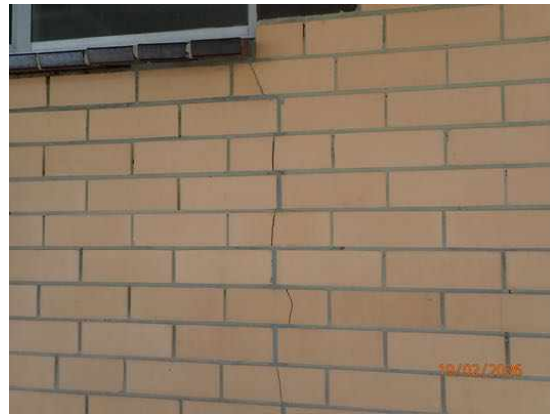
### Finding 3.04

Building:	Main Building
Location:	All External Areas
Finding:	Brickwork - Cracking Noticeable
Information:	Minor to moderate cracking was observed on the external brickwork during the inspection. The cracks were more than hairline and are suspected to be the result of structural movement or gradual settlement of the foundation over time, which is not uncommon in older homes.

While no immediate structural issues were evident at the time of inspection, it is important to closely monitor these cracks for any signs of progression, such as widening or lengthening. If any changes are observed, or if further concerns arise, it is recommended to engage a structural engineer to carry out a detailed assessment and provide guidance on any necessary remedial measures to ensure the ongoing stability of the structure.

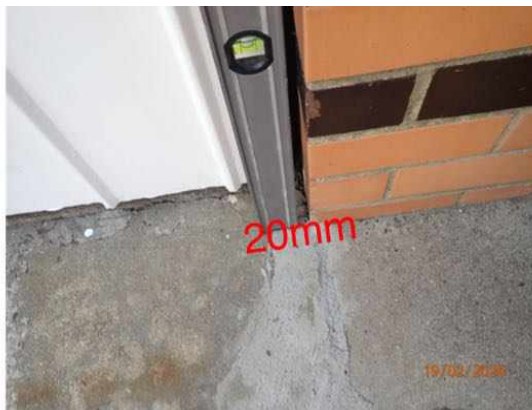
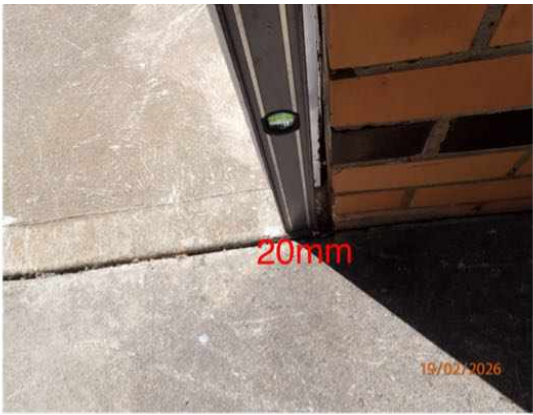
### Finding 3.05

Building: Main Building  
 Location: Exterior walls - rear  
 Finding: Garage Brickwork Movement & Leaning Piers  
 Information:

Cracking to the brickwork at the front of the garage was noted during inspection. Both supporting brick piers were observed to be out of plumb, leaning approximately 20mm. Separation cracking was also noted between the brickwork and the lintel, with visible movement and signs of rusting to the lintel, contributing to separation of the upper brick panel from the supporting pier.

This condition is indicative of structural movement and possible lintel deterioration, which may compromise the stability of the garage opening if left unmanaged. It is strongly recommended to engage a structural engineer to assess the extent of movement and lintel condition, with a qualified bricklayer or registered builder to carry out rectification works as directed. Prompt attention is advised.

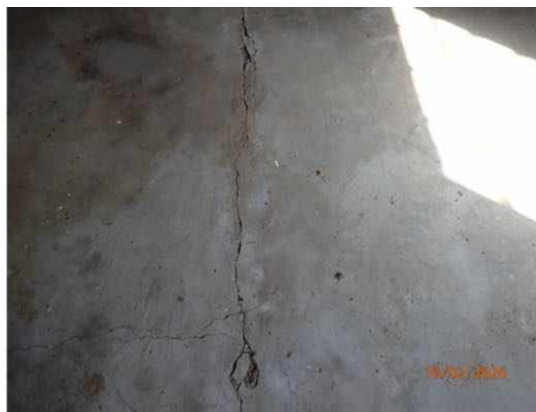
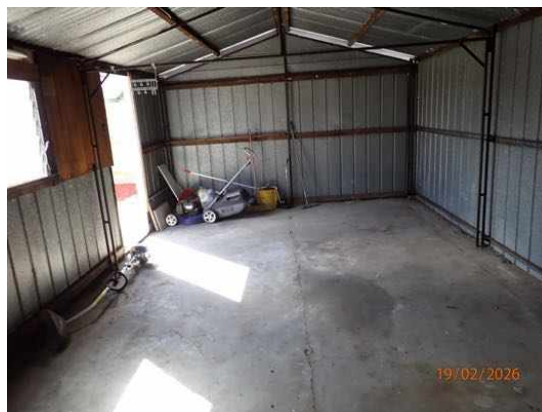
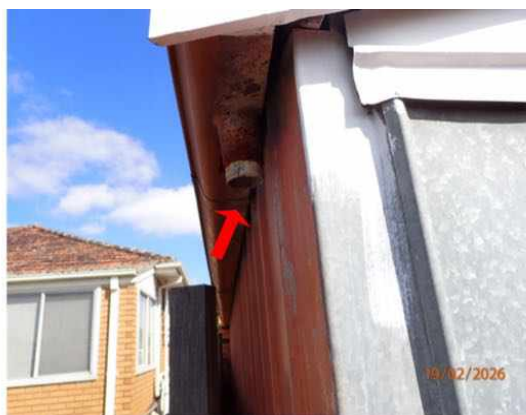
**Finding 3.06**

Building: Main Building  
 Location: Garage  
 Finding: Cracking to Garage Slab and Disconnected Downpipe  
 Information: Cracking to the garage concrete slab was noted during the inspection. The garage downpipe was also found disconnected, allowing roof water to discharge adjacent to the slab. Continued discharge of stormwater in this manner may contribute to moisture build-up and further movement or deterioration of the concrete over time. It is recommended to engage a licensed plumber to reconnect the downpipe to an appropriate stormwater discharge point and monitor the slab cracking for any signs of progression.

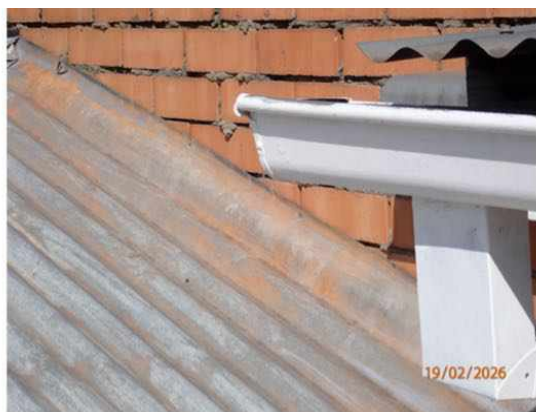
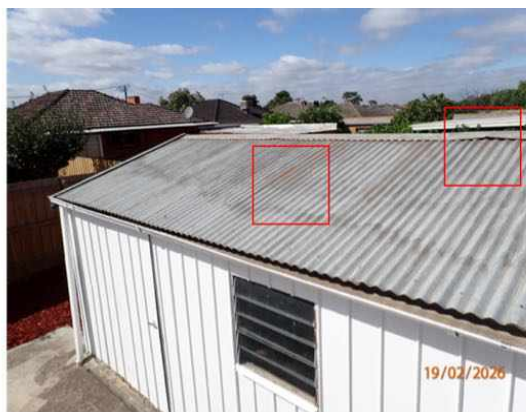
### Finding 3.07

Building:	Main Building
Location:	Garage
Finding:	Garage Roof Sheeting
Information:	The garage roof sheeting was noted requiring maintenance, with missing or inadequate roof fixings and areas of rust observed during inspection. Loose or insufficient fixings may allow sheets to lift in high winds and rusted sections can lead to premature deterioration and potential water ingress over time. It is recommended to engage a licensed roof plumber to secure the roof sheets, replace defective fixings, and address rusted areas to maintain the integrity of the roofing system.

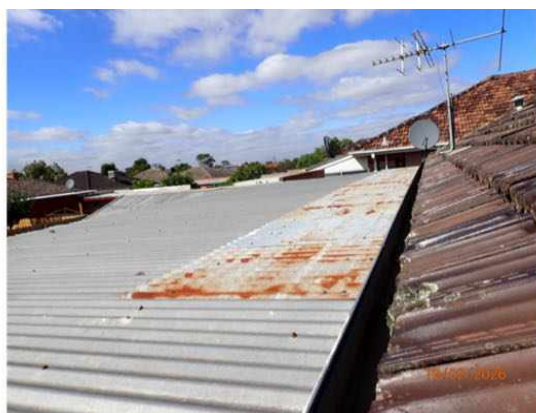
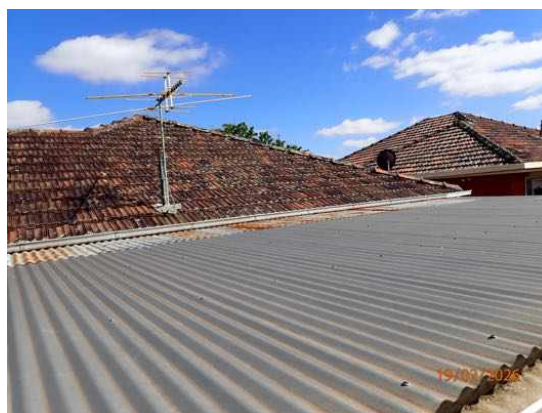
### Finding 3.08

Building:	Main Building
Location:	Pergola
Finding:	Roof sheets - Rusted
Information:	Rust on the roofing sheet was noted during the inspection. It is suspected that accumulation of debris and leaves, along with improper maintenance, may have caused water pooling, leading to the rusting of the sheeting.

This is a minor defect with major implications if not addressed immediately. If left unmanaged, the rust will continue to progress, potentially allowing water ingress into the internal roofing structures. This could lead to secondary damage of building elements and accelerate the deterioration of the roofing sheets and any associated components.

A licensed roof plumber or a roof restoration company should be engaged immediately to assess the condition of the sheets and perform any necessary rectification works. Remedial actions may include replacing severely affected roofing sheets or applying rust-retardant surface protectors to mitigate further rust development. Immediate attention is required to prevent further damage and ensure the longevity of the roofing structure.

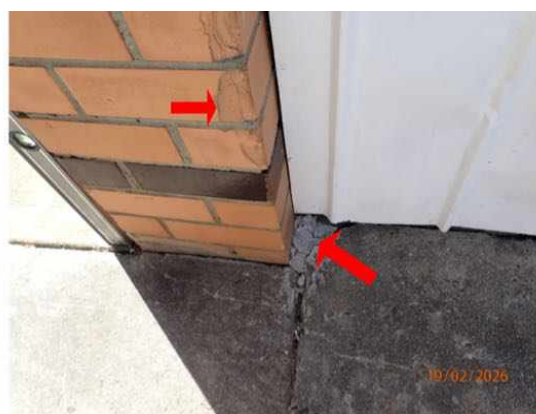
### Finding 3.09

Building: Main Building  
 Location: Garage  
 Finding: Garage Door Binding  
 Information: The metal garage door was noted binding against the adjacent brickwork during inspection and was difficult to open and close. Damage to the brickwork caused by ongoing rubbing of the door was also observed in this section.

This condition may be due to minor movement, misalignment of the door tracks, or deformation of the opening over time. Continued operation in this condition may result in further damage to both the door and surrounding brickwork. It is recommended to engage a garage door technician or registered builder to assess alignment and carry out necessary adjustments or repairs in the short term.

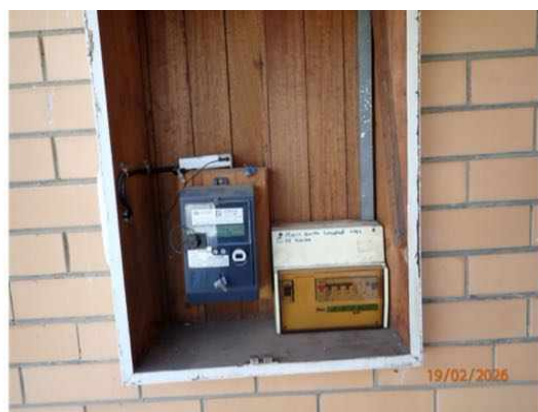
Building: Main Building  
 Location: Meter Box  
 Finding: Termite Management System - no evidence of a chemical installation  
 Information: The application of a post-construction chemical termite barrier is highly recommended for all properties, particularly if live termite activity has been found on the site previously. Such barriers are highly effective in preventing termite attack on any timber building elements throughout the property.

A durable notice should be placed in the switchboard unit to indicate current termite barriers. At the time of inspection, it appeared as though no termite management system has been installed, with no evidence to suggest preventative works taking place.

The client may consider gaining further advice from a pest controller as to the costs and procedures involved with this application. It is recommended that obtaining such advice be a short-term priority.

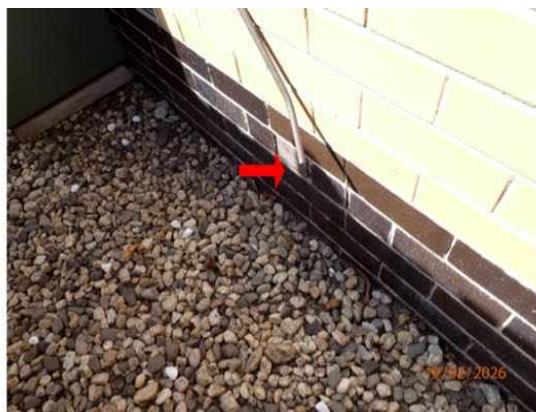
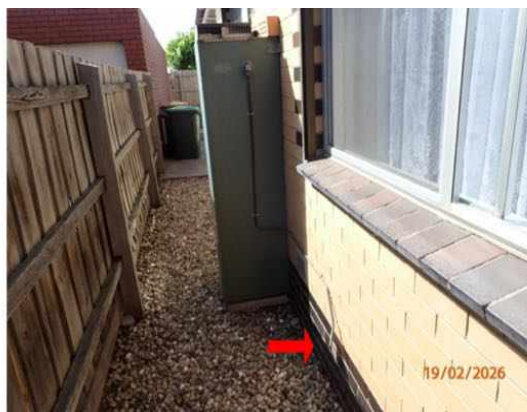
### Finding 6.02

Building:	Main Building
Location:	All External Areas
Finding:	HWS Overflow - Not Connected
Information:	The Hot Water System (HWS) overflow was found to be disconnected from storm water drainage and is creating excessive moisture in the surrounding area.

These damp conditions can lead to secondary defects such as rot, rust or corrosion of associated building elements, the formation of fungal decay, or even the creation of potential slip hazards. When coupled with poor site drainage, pooling of water may also attract termite activity to this area.

It is highly recommended that a licensed plumber be appointed to connect the HWS overflow in order to prevent such an environment from being created. These minor works should be carried out as soon as possible.

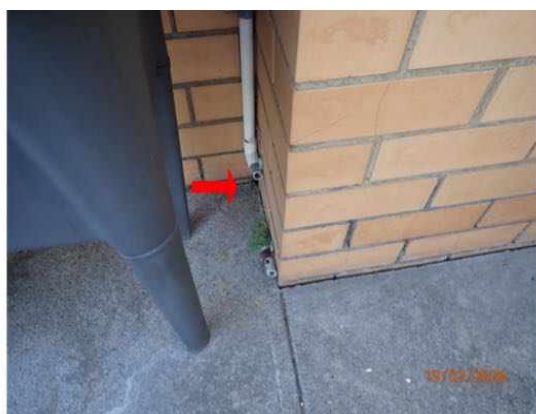
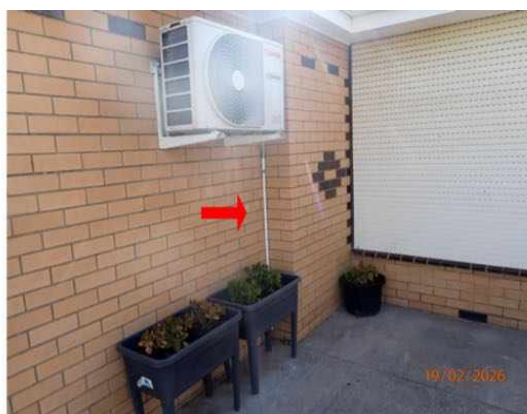
### Finding 6.03

Building:	Main Building
Location:	All External Areas
Finding:	Air condition discharge - Not plumbed for drainage
Information:	The Air condition discharge is not plumbed or connected to suitable drainage, which has resulted in the surrounding area becoming excessively damp. These damp conditions can lead to secondary defects such as rot, rust or corrosion of associated building elements, the formation of fungal decay, or even the creation of potential slip hazards. When coupled with poor site drainage, pooling of water may also attract termite activity to this area. It is highly recommended that a qualified plumber be appointed to install adequate drainage to the overflow. These works will ensure that the area remains dry and free of any secondary defects.

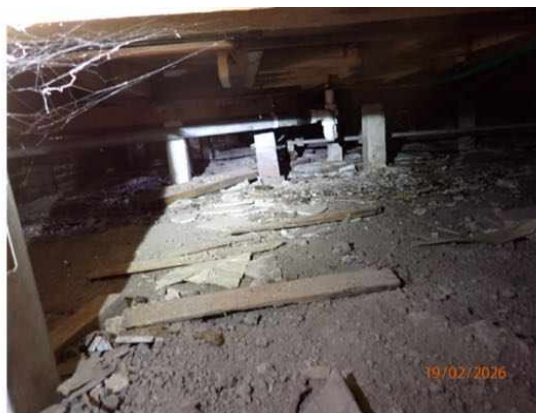
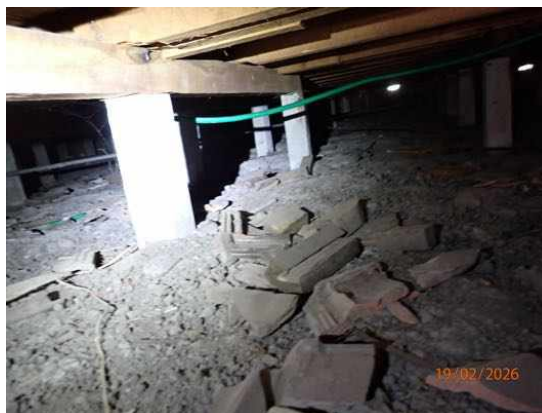
### Finding 6.04

Building:	Main Building
Location:	Subfloor
Finding:	Stored timbers - subfloor space or external area
Information:	The storing of timbers in the subfloor space increases the risk of termite activity being present. As they are likely to come into contact with weather conditions or excessive moisture wood rot is likely to develop on timbers that are not treated.

It is highly recommended that any stored timbers be immediately removed from areas in which they may attract any termite / timber pest attack. Minimisation of risk / prevention of termite attack is far more adequate than dealing with the presence of termite activity.

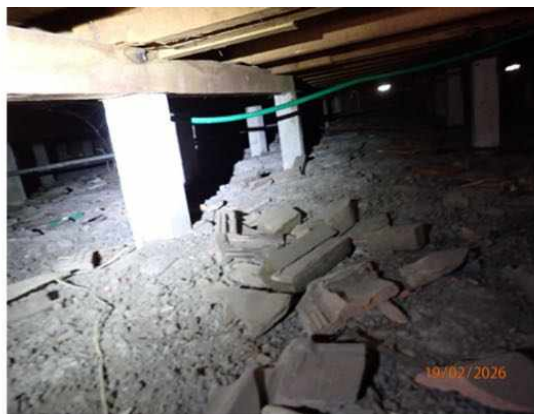
### Finding 6.05

Building:	Main Building
Location:	Subfloor
Finding:	Ant caps - Not installed
Information:	Ant caps have not been installed to the subfloor structure at the time of inspection. Generally, ant caps are installed to the intersection between the top of the stumps (or

Where ant caps have not been installed, frequent monitoring of these areas should be carried out in order to identify any signs of termite or timber pest workings.

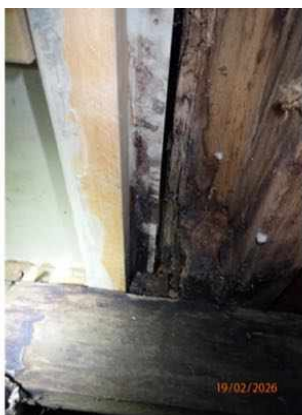
### Finding 7.01

Building:	Main Building
Location:	Subfloor
Finding:	Subfloor structure - Wood rot
Information:	The subfloor structures are showing signs of deterioration and wood rot (fungal decay) of the timbers. It is suspected that this defect has developed as a result of damp conditions in the subfloor.

Damp conditions cause the timbers to fail, resulting in the subfloor structures failing to bear the load (or weight) of the building as originally intended. Without repairs and maintenance, including potential replacement of affected elements, it is likely that serious structural faults will result, as well as an array of minor defects.

The presence of wood rot to the subfloor structure is also conducive to termite infestation. As timber stumps are in direct contact with the ground, concealed termite is made possible. Such entry is made easier if the timbers become non-durable due to even slight wood rot.

Where wood rot is present to any structural timber, rectification or replacement of the affected timber building element is required. The adequate timeframe for such works are dependent on the severity of the rot. Where rot has developed to become widespread, replacement of sections of the subfloor structure may be required. Consultation with a structural engineer or registered builder specialising in re-stumping

is highly advised as soon as possible.

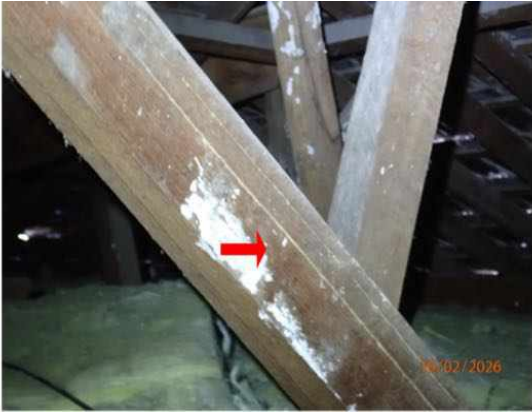
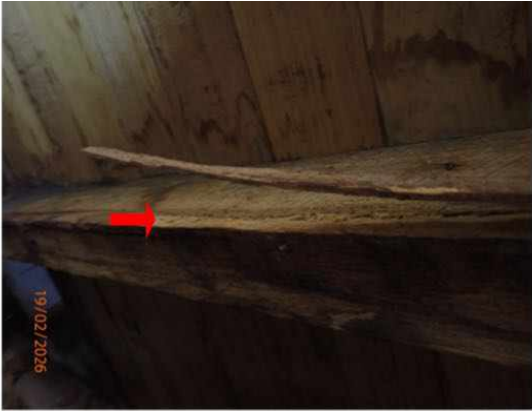
### Finding 8.01

Building:	Main Building
Location:	Subfloor and roof void
Finding:	Evidence of wood borer activity identified
Information:	Wood borers small beetles that colonise in exposed timber elements are a common timber pest that are regularly mistaken for termites. Although wood borer activity is generally not detrimental to the affected timber they may lead to serious damage and necessitate replacement of certain building elements if left unattended.

As no live wood borer activity was identified treatment is not required at this time. Replacement of affected timbers may be considered by the client for superficial

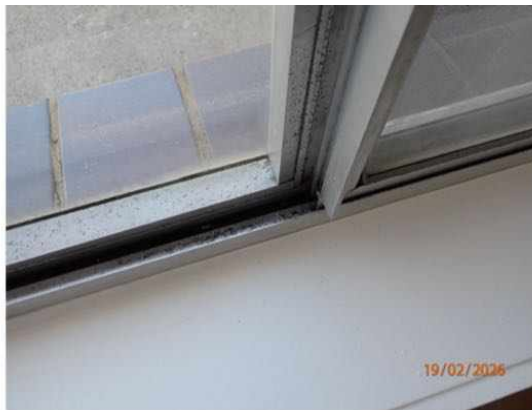
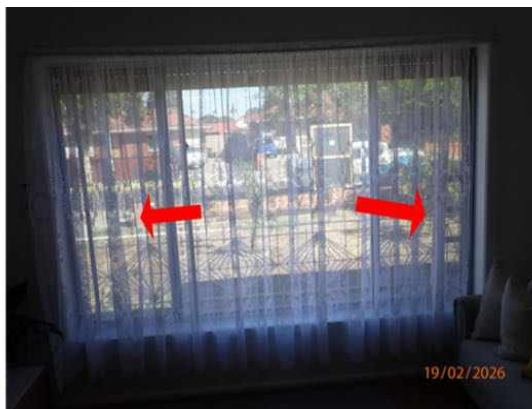
Building: Main Building  
 Location: Living Room  
 Finding: Binding Sliding Window and Sliding Door  
 Information: The aluminium sliding window in the living room was noted binding during operation at the time of inspection. In addition, the sliding door from the living room to the outdoor area was also observed binding and not operating smoothly.

Binding of sliding components is commonly caused by minor movement, track misalignment, wear to rollers, or buildup of debris within the track. If left unaddressed, this may result in further wear to hardware and difficulty in securing the openings properly.

It is recommended to engage a qualified carpenter or door/window specialist to inspect, service, and realign the affected window and sliding door as required to ensure smooth operation and proper latching.

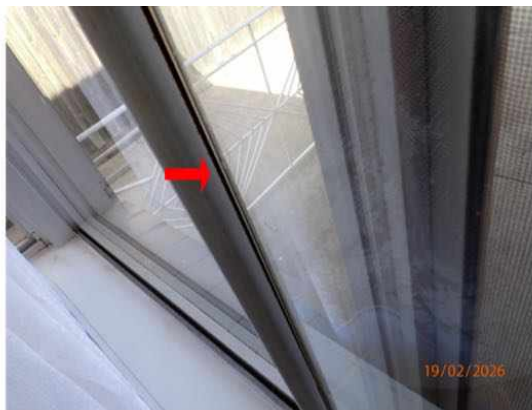
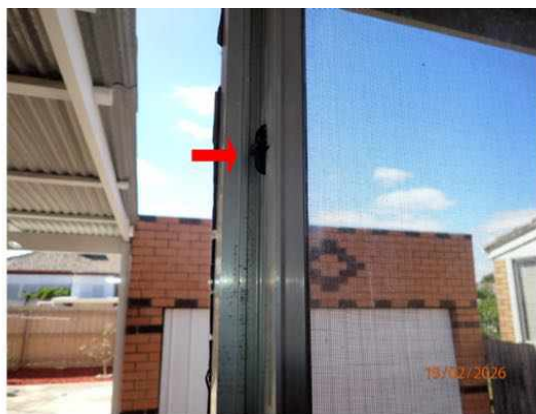
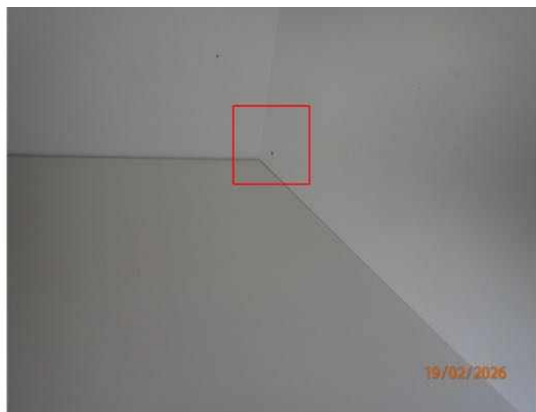
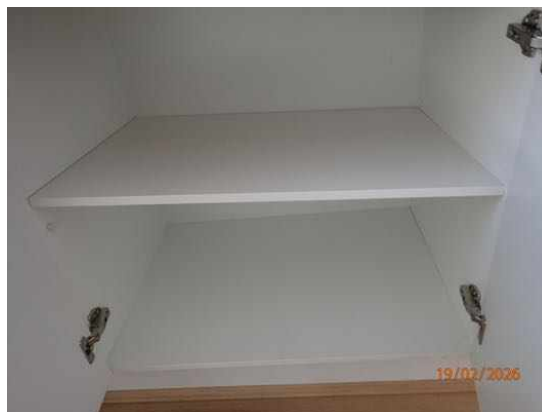
Information: The kitchen window seal was noted deteriorated during inspection, and the window latch was not able to be secured in the closed position. In addition, one of the internal shelf supports within the kitchen cabinet was noted missing or not installed, resulting in inadequate support to the shelf.

Deteriorated window seals can allow moisture ingress and air leakage over time, while a non-functioning latch may affect security and weather tightness. Missing shelf supports may lead to sagging or failure of the cabinet shelf under load.

It is recommended to engage a qualified carpenter or handyman to replace the window seal, repair or adjust the window latch, and install the missing shelf support to restore proper function and prevent further deterioration.

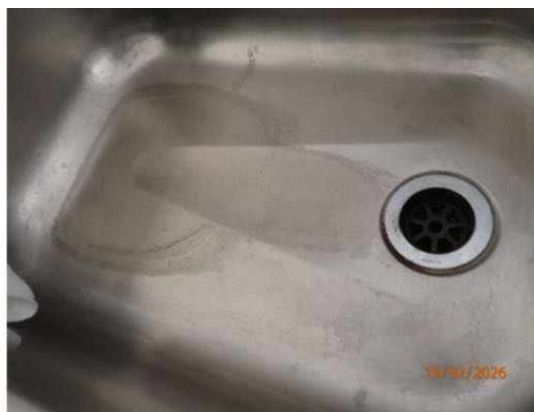
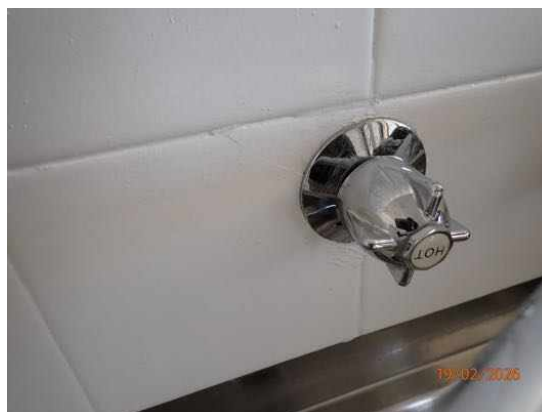
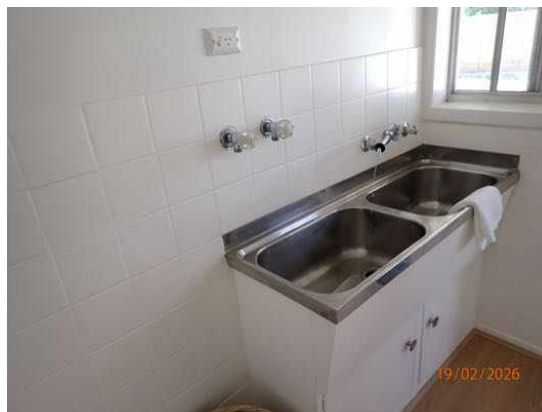
Building: Main Building  
 Location: Laundry  
 Finding: Laundry Sink Ponding & Wall Tile Condition  
 Information: Water ponding was noted at the base of one of the laundry sinks during inspection. The wall tiles above the sink were noted cracked and previously sealed and painted over, suggesting past moisture-related deterioration.

The ponding is suspected to be due to inadequate fall to the waste or improper installation. Ongoing ponding may contribute to moisture damage to surrounding building elements if not rectified.

It is recommended to engage a licensed plumber to assess and rectify the drainage issue. A tiling contractor or qualified tradesperson should also assess and repair the cracked tiles to prevent further deterioration.

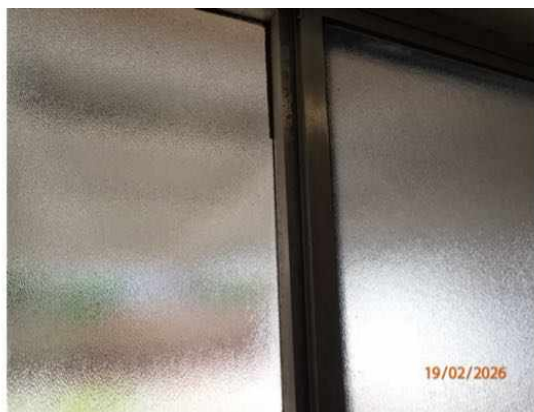
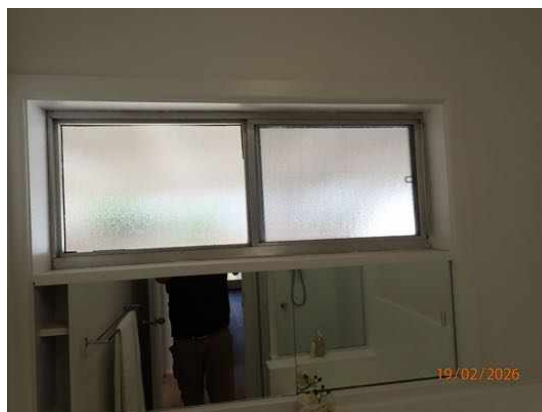
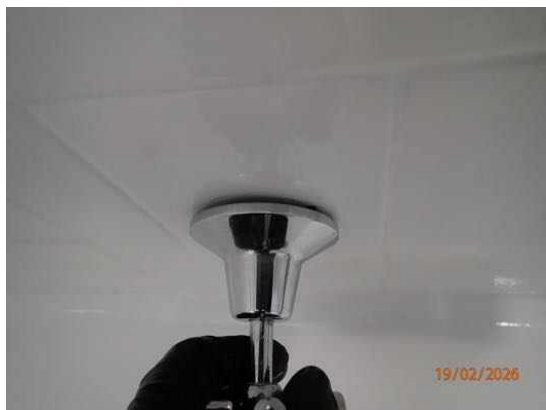
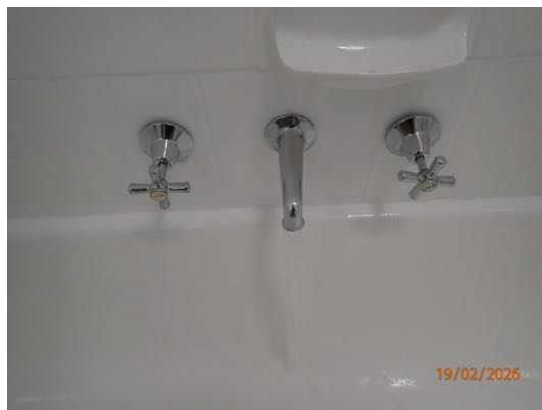
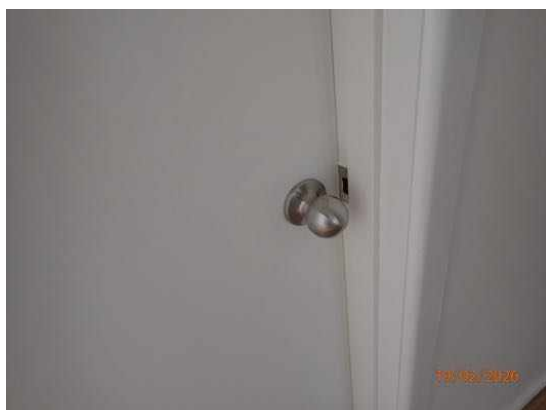
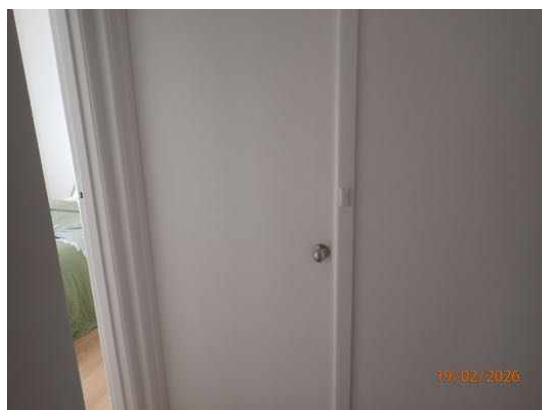
Building: Main Building  
 Location: Bathroom  
 Finding: Bathroom Window & Door Issues  
 Information: The sliding bathroom window latch was noted missing, preventing the window from being securely latched or locked during inspection. The sealant around the tap penetration above the bath was also noted missing, which may allow moisture ingress into surrounding building elements. In addition, the bathroom door was noted binding during operation.

It is recommended to engage a qualified carpenter or handy person to replace the window latch and rectify the door binding, and a sealant specialist or tiling contractor to reinstate proper sealant to the tap penetration to prevent potential moisture-related damage. Rectification is advised in the short term.

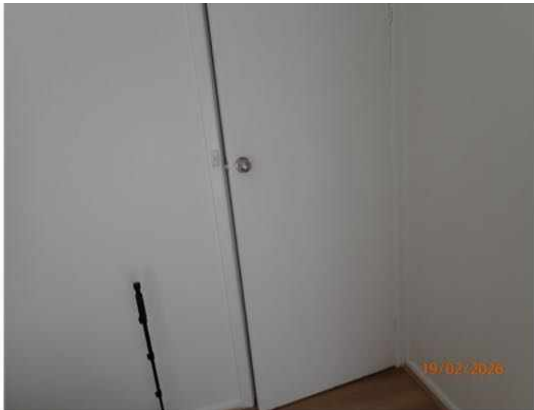
Building: Main Building  
 Location: Bedroom 1,2 and 3  
 Finding: Bedroom Door & Window Hardware  
 Information: During inspection of Bedrooms 1, 2 and 3, several door and window hardware issues were noted. The bedroom door to Bedroom 3 was binding during operation. The sliding window latch to Bedroom 2 was not engaging, and the striker plate to the Bedroom 2 door was misaligned. In Bedroom 1, the window latch was also not latching securely.

These defects affect normal operation and security of the doors and windows. It is recommended to engage a qualified carpenter or handy person to adjust, repair, or

replace the affected hardware to ensure proper function. Rectification is advised in the short term.

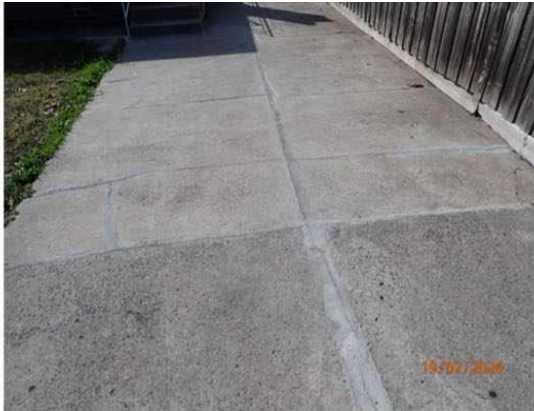
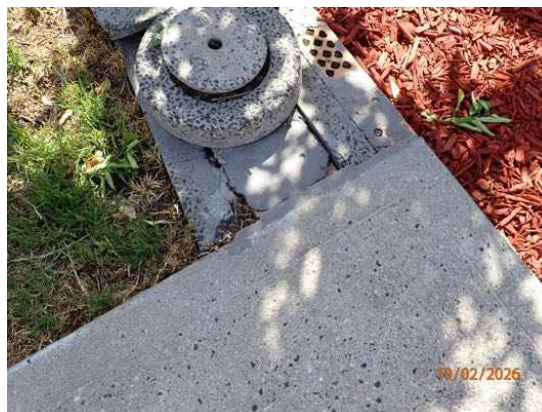
Building: Main Building  
Location: All External Areas  
Finding: Cracking Concrete- Noticeable  
Information: Noticeable cracks in the concrete were observed, likely caused by factors such as age, weather-related expansion and contraction, or minor installation issues. These cracks are typically straightforward to fill and repair.

It is recommended to consult a concreter or handyman for necessary remedial work and consider installing an expansion joint to accommodate future movement. Regular monitoring is advised, and if the cracks worsen, a building inspector should be consulted for further evaluation.

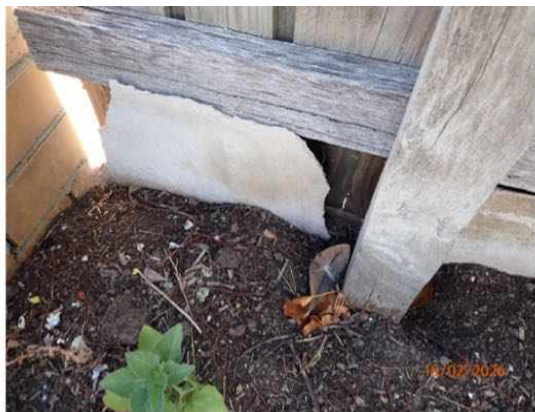
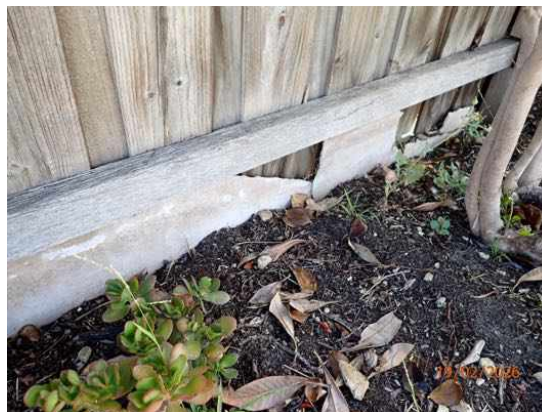
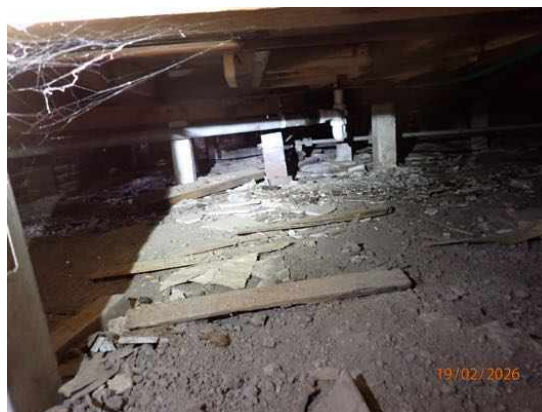
Building:	Main Building
Location:	All External Areas
Finding:	Asbestos - Suspected ACM Identified on Site
Information:	Reporting on Asbestos is outside the Scope of this Report. This suspected defect is highlighted as a caution only. We suspect, based on our experience in the building industry, that there is a higher risk of the identified building element containing asbestos.

As Asbestos Reporting is outside the scope of this report, we advise that you consider a separate Asbestos Inspection and Condition Audit, which can include the taking of samples for definitive confirmation of the presence of Asbestos.

In the interim, the client is advised to act with caution, especially when considering any damage to building materials general wear and tear renovations extensions demolition and general maintenance activities due to the suspected presence of Asbestos.

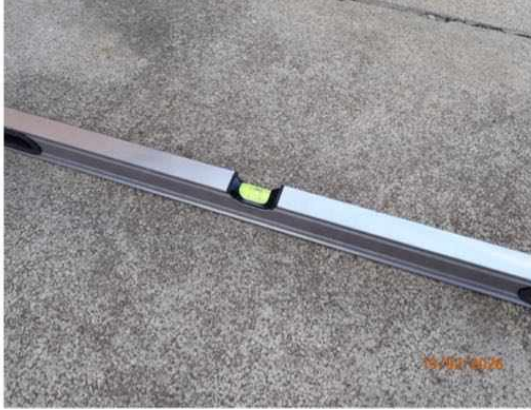
Building: Main Building  
 Location: Exterior walls - front  
 Finding: Site drainage - Inadequate  
 Information: The site drainage in this area was found to be inadequate at the time of inspection, creating potential for subsequent water damage to associated building elements.

It is important that water does not lie against the base of walls; surrounding paths and ground levels should be sloped to drain water away from walls. Downpipes should not discharge stormwater onto lower walls or plinths. Stormwater should be carried away by large, regularly cleaned drains. Ground levels may need to be lowered to expose a buried DPC.

Where site drainage is inadequate, installation of an Agricultural (Aggie) Drain may be required. A qualified plumber should be appointed to further inspect the property and perform any remedial works as necessary. Water damage and secondary defects are likely to occur if left unmanaged.

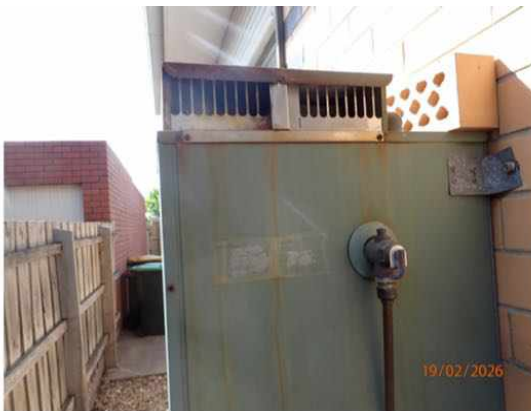
Building: Main Building  
 Location: Exterior walls - left side  
 Finding: Hot Water System Rusting  
 Information: The hot water system was noted rusted during inspection. Corrosion to the unit indicates age-related deterioration and may lead to leakage or failure if not addressed over time. It is recommended to engage a licensed plumber to assess the condition of the unit and advise on maintenance, repair, or replacement as required.

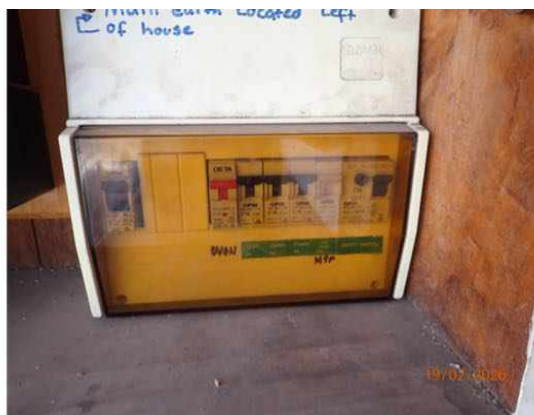
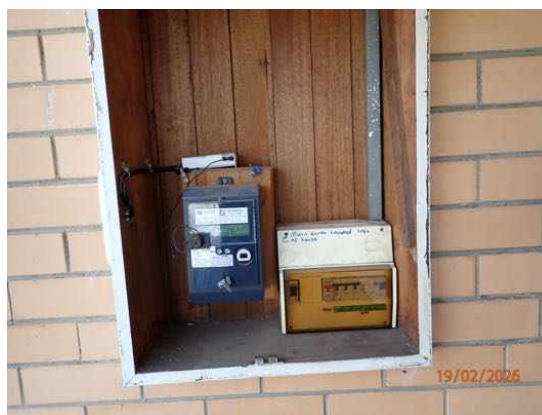
Building: Main Building  
 Location: Meter Box  
 Finding: Electrical Switch Box  
 Information: All electric wiring, meter boxes and appliances need to be checked by a licensed Electrician ensuring any work completed as part of a renovation or extension has been issued with a Certificate of electrical Safety (CES). The checking of any electrical items is out side the scope of this inspection.

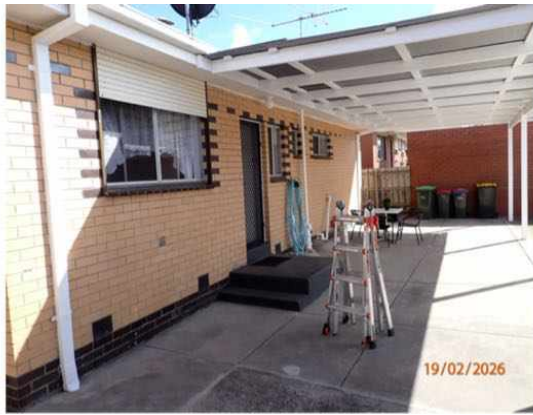
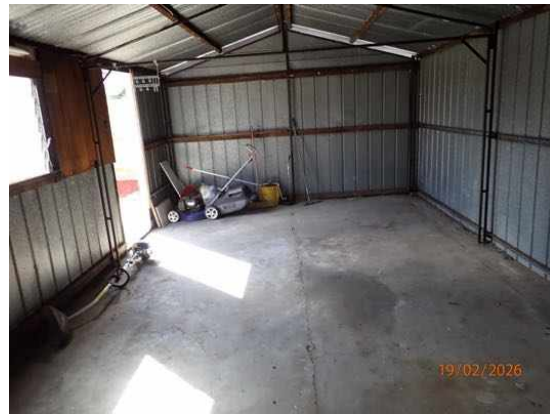
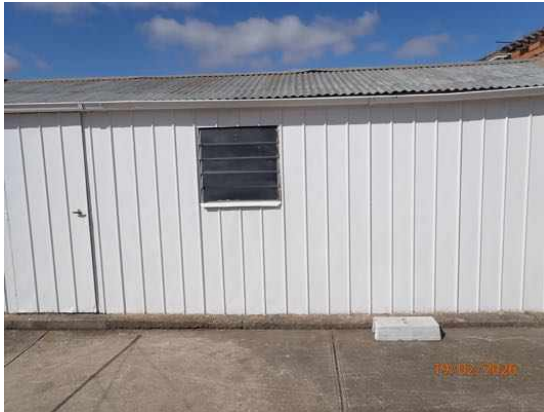
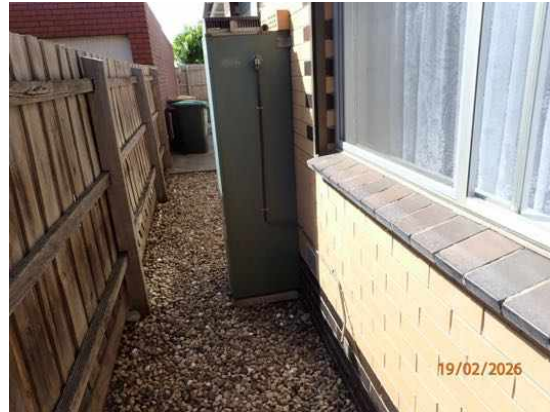
Building: Main Building  
 Location: All External Areas  
 Finding: Additional Photos - Obstructions and Limitations External Areas  
 Information: These photographs are an indication of the obstructions and limitations which impeded full inspection of the External areas of the property at the time of inspection. These obstructions can hide an array of defects and should be removed to allow full inspection to be carried out. A re-inspection is recommended once the areas are made accessible.

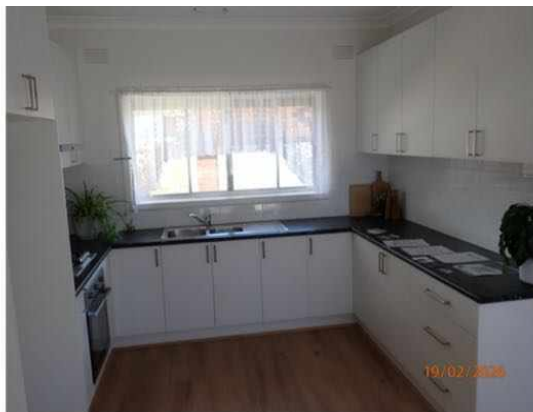
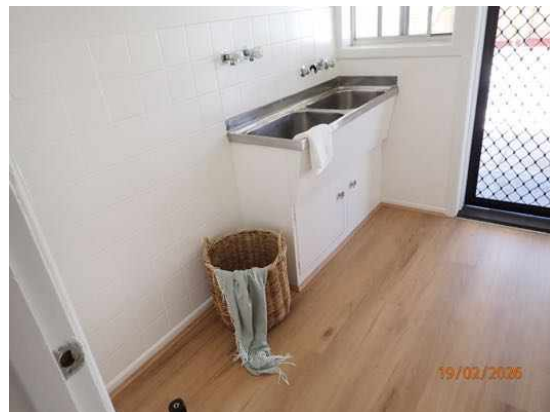
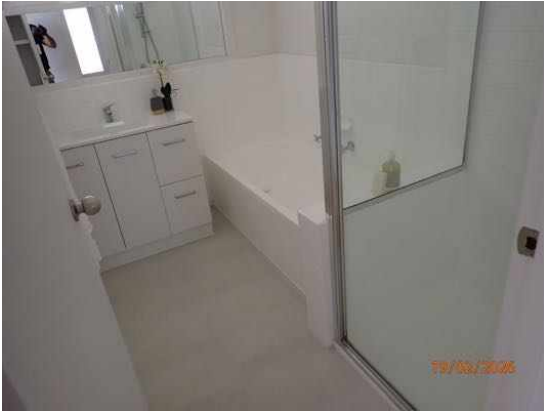
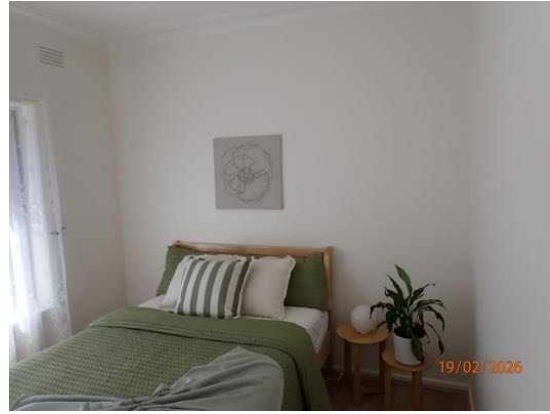
Building: Main Building  
 Location: All Internal Areas  
 Finding: Additional Photos - Obstructions and Limitations internal Areas  
 Information: These photographs are an indication of the obstructions and limitations which impeded full inspection of the internal areas of the property at the time of inspection. These obstructions can hide an array of defects and should be removed to allow full inspection to be carried out. A re-inspection is recommended once the areas are made accessible.
