# Building and Timber Pest Inspection Report

Inspection Date: Thu, 19 Feb 2026

Property Address: 20 Tandarra Cres, Lalor VIC 3075, Australia

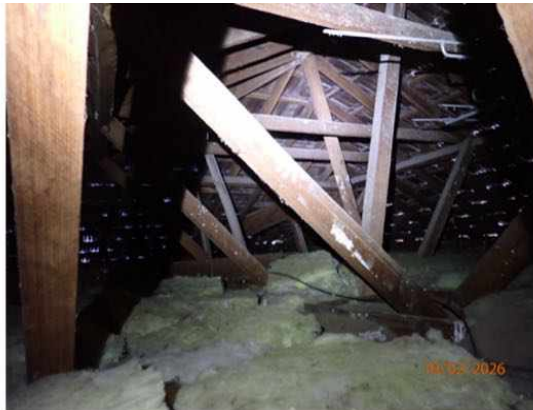
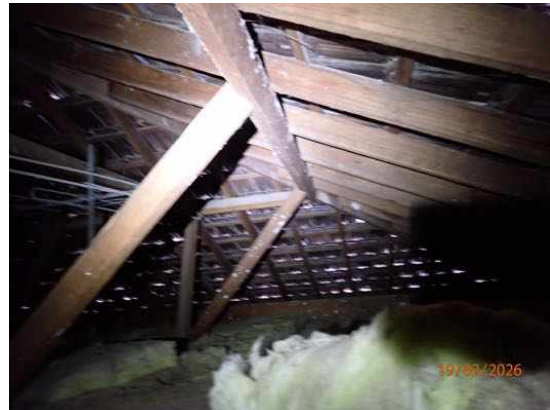
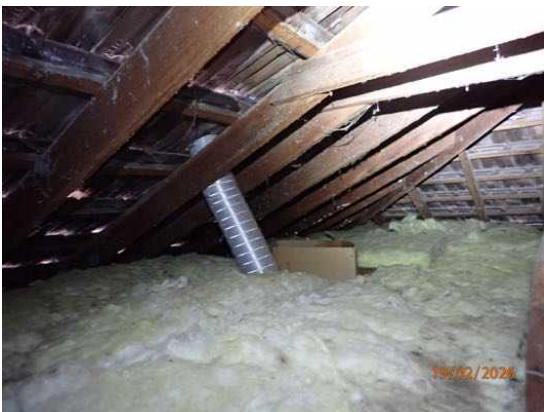
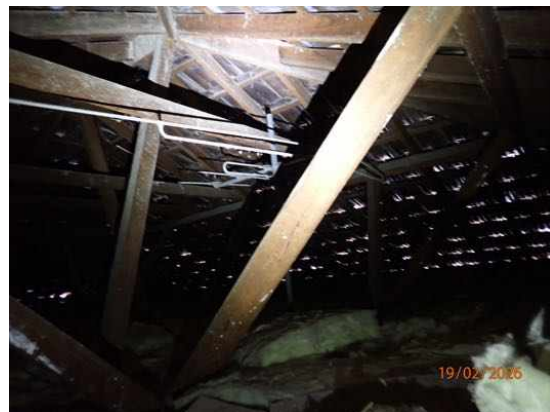
Building: Main Building  
 Location: Roof Void  
 Finding: Additional Photos - Obstructions and Limitations Roof Void  
 Information: These photographs are an indication of the obstructions and limitations which impeded full inspection of the Roof Void of the property at the time of inspection. These obstructions can hide an array of defects and should be removed to allow full inspection to be carried out. A re-inspection is recommended once the areas are made accessible.

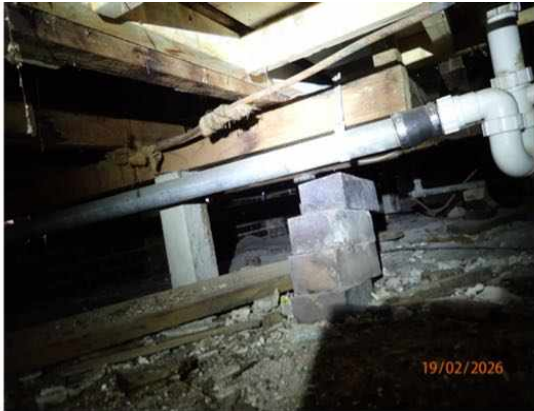
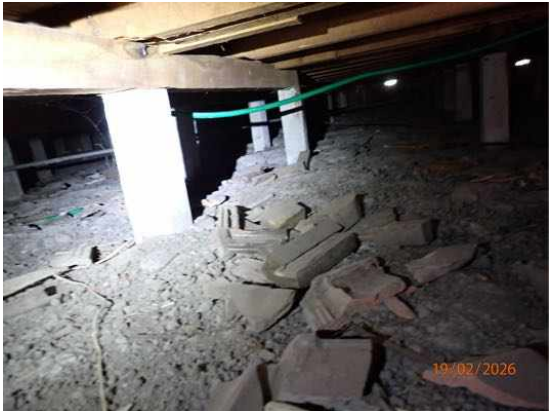
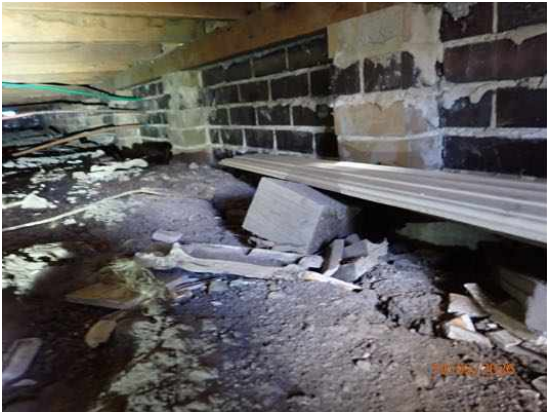
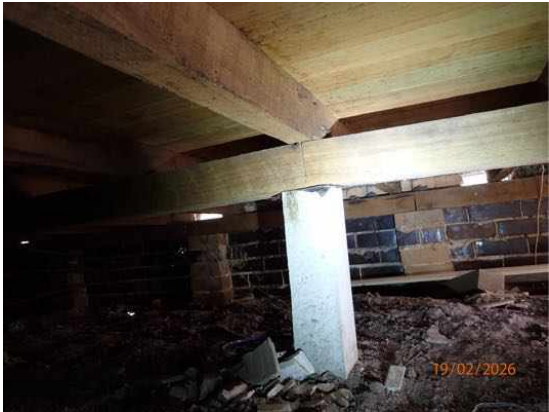
Building: Main Building  
Location: Subfloor  
Finding: Additional Photos - Obstructions and Limitations Subfloor Areas  
Information: These photographs are an indication of the obstructions and limitations which impeded full inspection of the subfloor areas of the property at the time of inspection. These obstructions can hide an array of defects and should be removed to allow full inspection to be carried out. A re-inspection is recommended once the areas are made accessible.
