Building and Timber Pest Inspection Report

Inspection Date: Tue, 17 Mar 2026

Property Address: 17 Poinciana Street Kingston

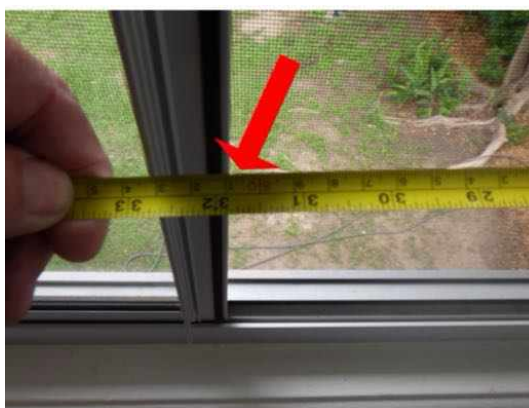
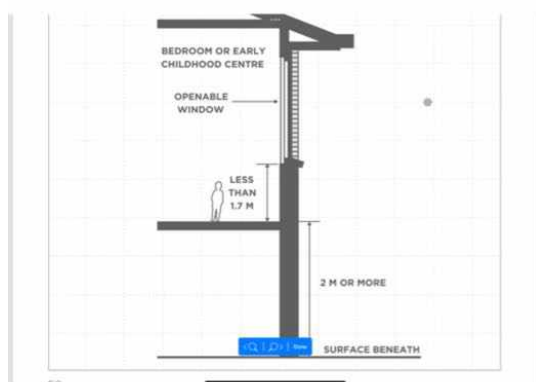
Building: Main Building
 Location: Bedroom 2 > Centre,Rear
 Finding: Window safety
 Information: It was noted that the window of the upper level bedroom 2 is less than 1.7m from the

This is noted as a safety concern and this regulation may not have been in place at the time of construction.

See NCC Vol2 Part 3.9.2.6 for further detail on this matter.

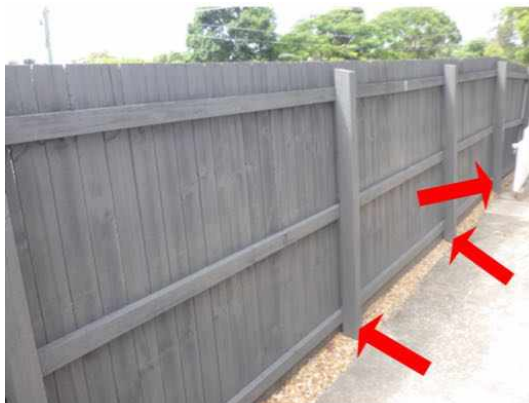
- Building: Main Building
- Location: Yard - Side > Centre Right
- Finding: Fencing - Deteriorated
- Information: It was noted at the time of inspection that the timber fence posts to the right side of the property appear to have deteriorated at ground level, resulting in significant fence movement when pushed on. Typically fencing deteriorates due to age and or wear, rot

and or rust which is generally expected for a structure of this age, due to prolonged exposure to weather conditions. Sometimes inadequate installation or maintenance can be to blame.

If left unattended, it is likely that further damage will occur. It is suspected that repair of several of the fence posts may be required however replacement may be a consideration of the client also.

A licensed fencing contractor should be appointed to provide further advice and perform rectification works as necessary.

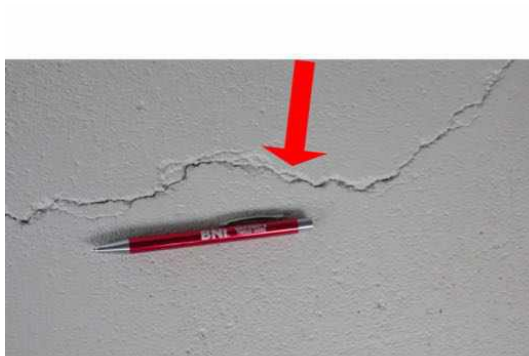
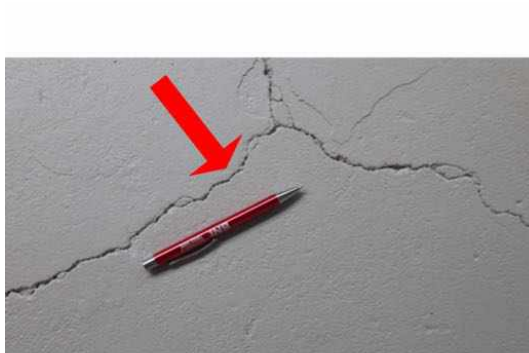
Finding 3.02

Building:	Main Building
Location:	Carport > Ground Level
Finding:	Cracking in concrete slab - Category 1 - 2
Information:	Cracking coded as Category 1 was identified in the carport concrete slab (as per example photos). A Category 1 crack is described as a fine but noticeable crack, with the slab at an otherwise reasonable level.

To be considered Category 1, the approximate width of the crack is less than 1.0mm, or a less than 10mm change in offset when a 3m straight edge is placed over the defect.

Category 1 cracks should be monitored for a period of 12 months. At the end of the monitoring period, identified cracks that are rated greater than Category 2 are considered defects, and require rectification.

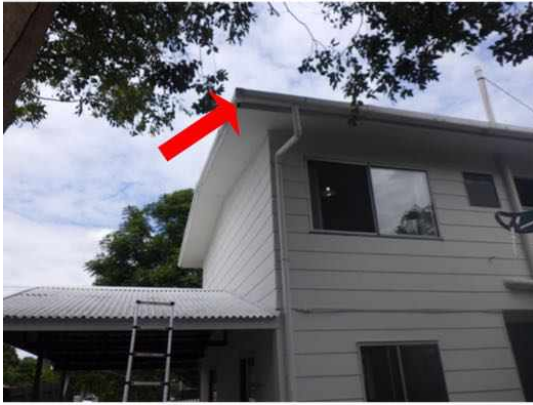
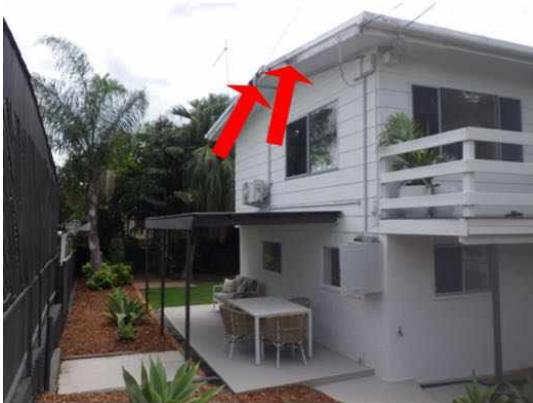
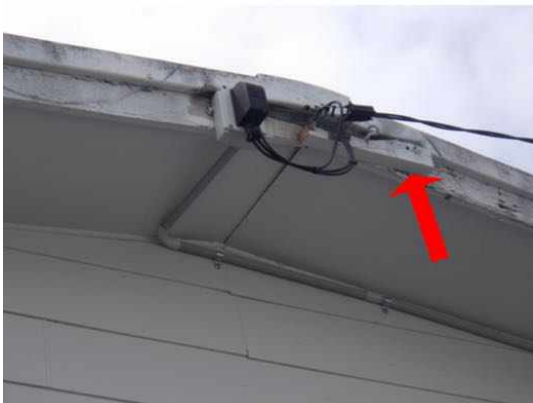
Finding 3.03

Building:	Main Building
Location:	Roof Exterior > Existing
Finding:	Fascias - Wood rot
Information:	Wood rot was found to be affecting fascias and barges, evidenced by the presence of mould on the surface in some areas (as per example photos). Wood rot, also known as Fungal Decay, occurs when timbers and other cellulose building materials are exposed to damp conditions on an ongoing basis.

Frequent exposure to rain and other weather conditions make fascias and barges susceptible to accelerated deterioration.

Early intervention and regular maintenance will prolong the useful life of these building elements. Prior to any works being performed, the cause of the moisture that has created the visible wood rot should be identified and addressed in a suitable manner.

A qualified carpenter or registered builder may be required to replace affected fascia's.

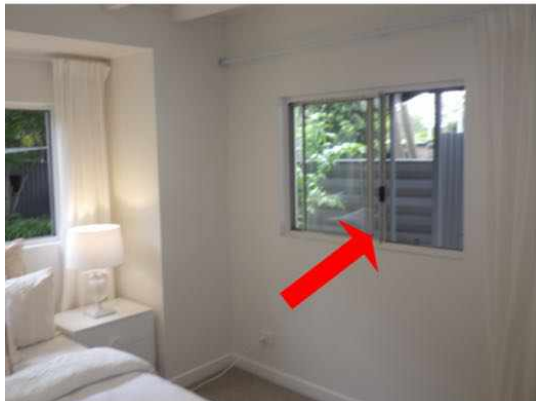
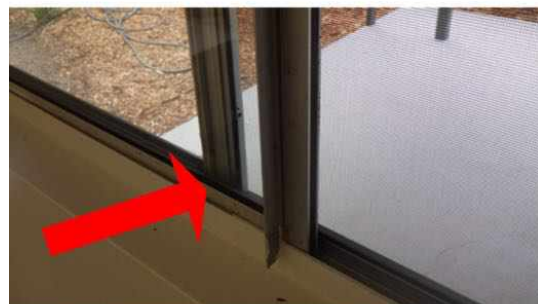
Building: Main Building
 Location: Bedroom 6 > Centre Right
 Finding: Window - Stiff to Slide
 Information: The aluminium sliding window in bedroom 6 was stiff to operate at the time of the inspection. Windows provide ventilation to the adjoining area and should be at a fully operational level to ensure user comfort. Restricted function of the window may also pose as a potential safety hazard if required for emergency egress from the building.

Generally, factors such as general age of the building element and a lack of maintenance are the usual causes for this type of defect.

An aluminium window service agent will be required to repair the affected windows.

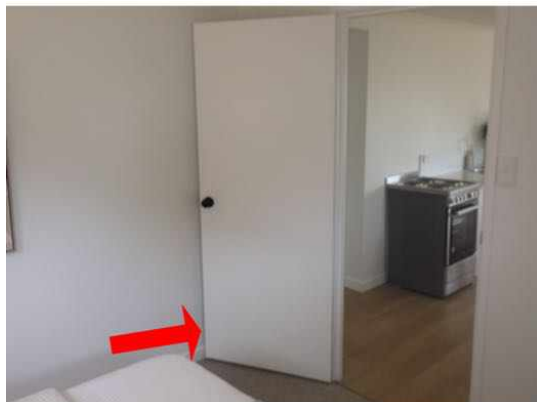
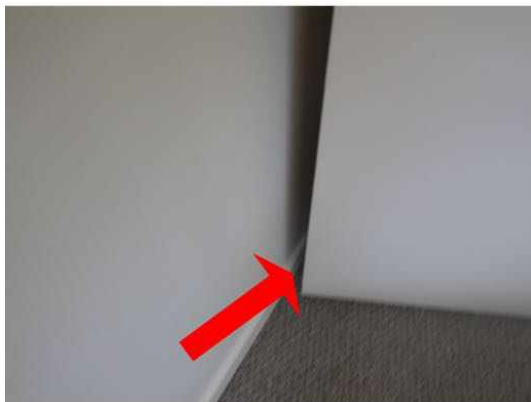
Finding 3.06

Building: Main Building
 Location: Bedroom 5 > Front
 Finding: Door stop - Missing
 Information: The bedroom 5 door stop is missing or is inadequate to stop the door handle from impacting the wall.

Re-installation or replacement of the door stop is advised to prevent any subsequent damage to the wall linings or associated structures.

A general handyman may be appointed to perform these works at client discretion.

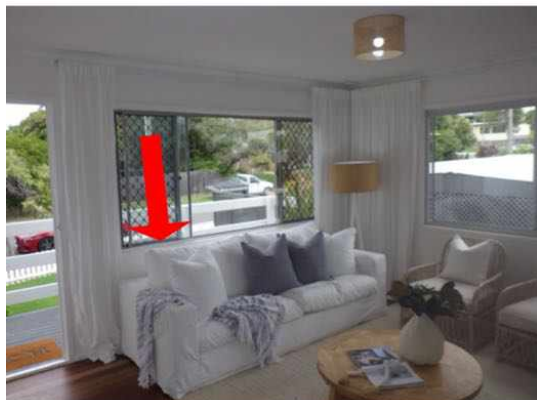
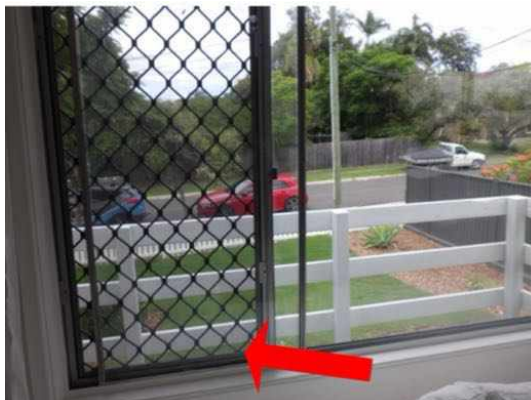
Finding 3.07

Building:	Main Building
Location:	Lounge Room > Front Left
Finding:	Window - Stiff to Slide
Information:	The left side aluminium sliding window in the lounge room area was stiff to operate at the time of the inspection. Additionally the right side sliding window sash was missing the handle.

Windows provide ventilation to the adjoining area and should be at a fully operational level to ensure user comfort. Restricted function of the window may also pose as a potential safety hazard if required for emergency egress from the building.

Generally, factors such as general age of the building element and a lack of maintenance are the usual causes for this type of defect.

An aluminium window service agent will be required to repair the affected windows.

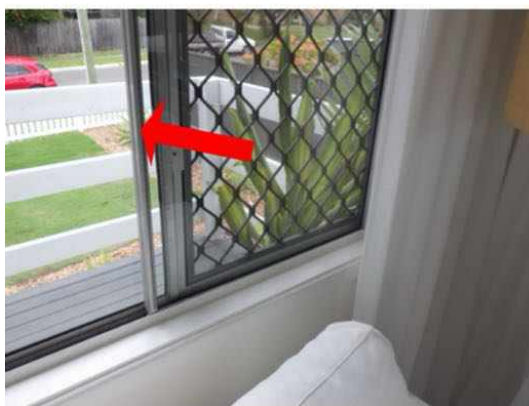
Finding 3.08

Building:	Main Building
Location:	Dining Room > Centre,Rear
Finding:	Window - Stiff to Slide
Information:	The aluminium sliding window in the dining room area was stiff to operate at the time of the inspection. Windows provide ventilation to the adjoining area and should be at a fully operational level to ensure user comfort. Restricted function of the window may also pose as a potential safety hazard if required for emergency egress from the building.

Generally, factors such as general age of the building element and a lack of maintenance are the usual causes for this type of defect.

An aluminium window service agent will be required to repair the affected windows.

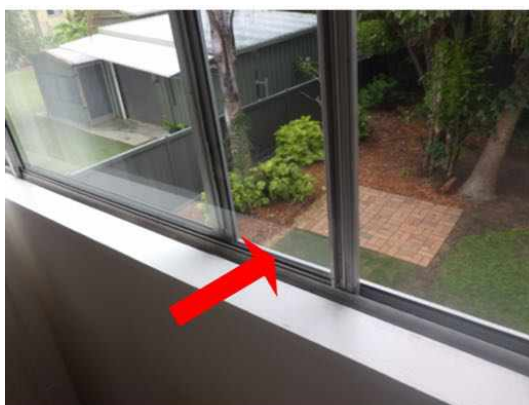
Finding 3.09

Building:	Main Building
Location:	Bedroom 3 > Centre,Rear
Finding:	Window - Stiff to Slide
Information:	The aluminium sliding window in bedroom 3 was stiff to operate at the time of the inspection. Windows provide ventilation to the adjoining area and should be at a fully

operational level to ensure user comfort. Restricted function of the window may also pose as a potential safety hazard if required for emergency egress from the building.

Generally, factors such as general age of the building element and a lack of maintenance are the usual causes for this type of defect.

An aluminium window service agent will be required to repair the affected windows.

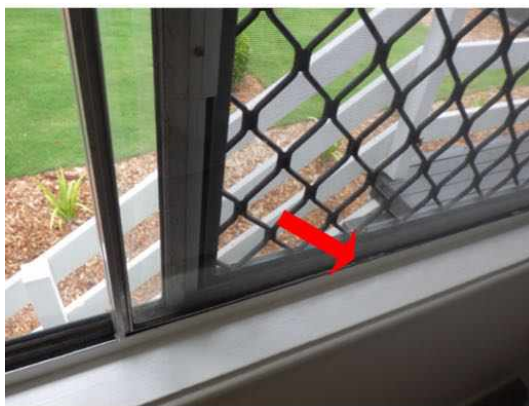
Finding 3.10

Building:	Main Building
Location:	Bedroom 1 > Centre,Rear
Finding:	Window - Stiff to Slide
Information:	The right side aluminium sliding window in the main bedroom area was stiff to operate at the time of the inspection. Additionally it was noted the left side sash was fixed in a closed position. Windows provide ventilation to the adjoining area and should be at a fully operational level to ensure user comfort. Restricted function of the window may also pose as a potential safety hazard if required for emergency egress from the building.

Generally, factors such as general age of the building element and a lack of maintenance or alterations are the usual causes for this type of defect.

An aluminium window service agent will be required to repair the affected windows.

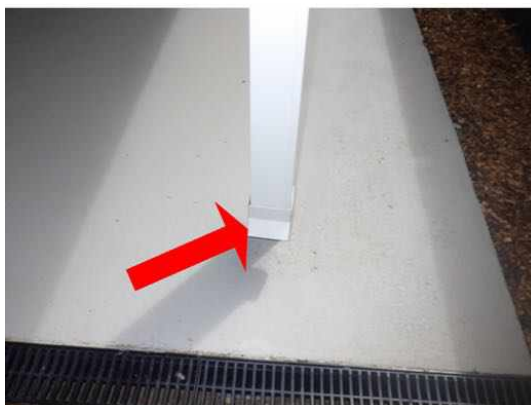
Finding 6.02

Building:	Main Building
Location:	Carport > Front Right
Finding:	Stormwater downpipes
Information:	The down pipe to the carport roof area at the front of the property is not connected to the stormwater drainage on the site. This disconnection negatively impacts the functional capacity of the downpipes and the surrounding ground area.

Where roof plumbing doesn't drain as required, the area at the base perimeter can become excessively damp, potentially creating an environment that is susceptible to flooding and rust or corrosion of surrounding building elements, as well as attracting termites and other pests.

It is recommended that a licensed plumber be appointed to further inspect and to

extend the down pipes to the properties stormwater line as necessary.

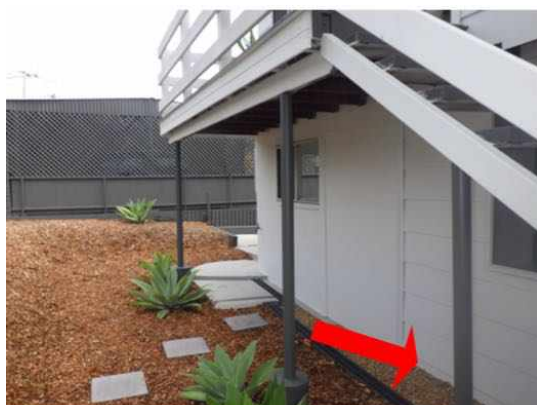
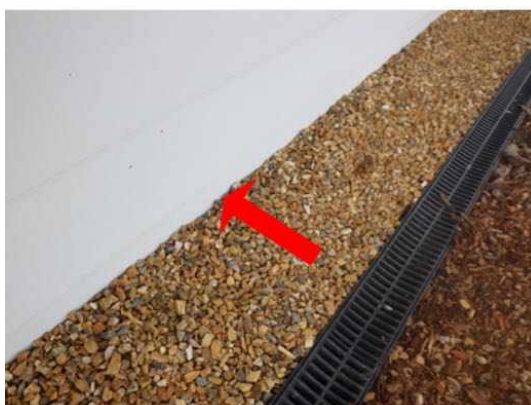
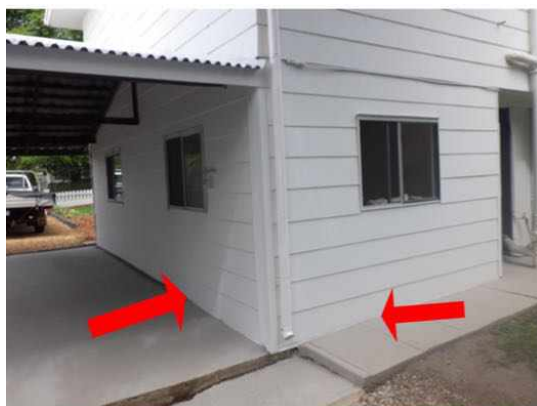
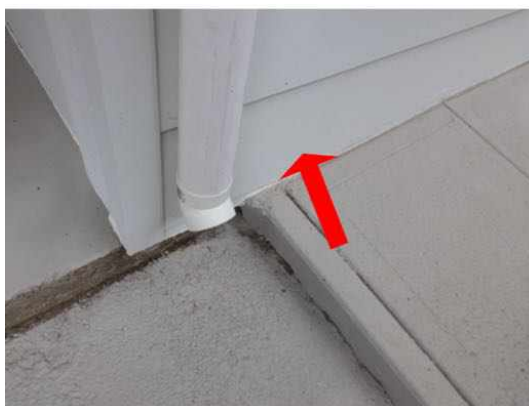
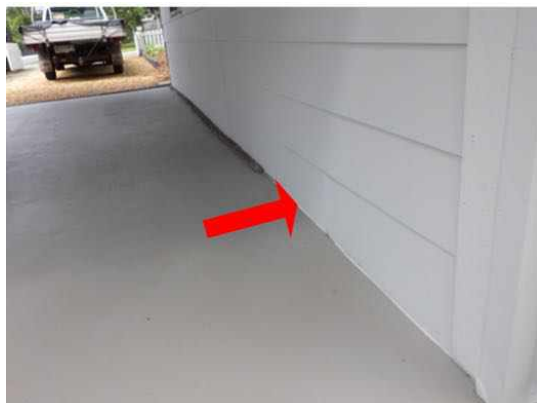
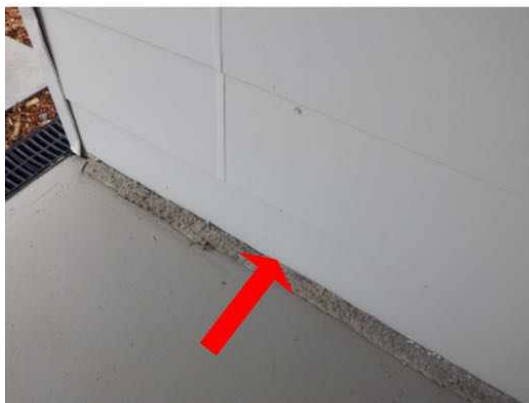
Finding 6.03

Building:	Main Building
Location:	Exterior walls - front & right side > Ground Level
Finding:	In ground contact
Information:	At the time of inspection it was noted the exterior wall cladding is in direct contact with the finished concrete slab and/or ground surfaces to the front, rear and right side of the property.

Any construction materials in direct ground contact provide opportunity for concealed termite entry and are likely to be subject to premature rot and decay as the ground retains moisture or damp conditions against the materials.

Ideally these types of construction members would be clear of the ground area by a minimum of 50 - 75mm to provide a clear inspection zone.

Frequent pest inspections are highly advised to readily identify any termite activity in these areas.

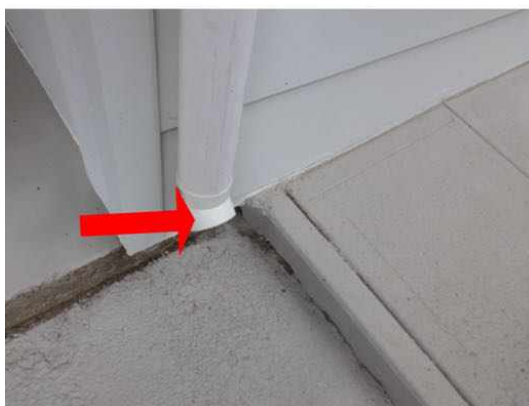
Finding 6.04

Building:	Main Building
Location:	Exterior walls - rear > Centre,Rear
Finding:	Stormwater downpipes
Information:	The down pipe at the rear right side of the property is not connected to the stormwater drainage on the site. This disconnection negatively impacts the functional capacity of the downpipes and the surrounding ground area.

Where roof plumbing doesn't drain as required, the area at the base perimeter can become excessively damp, potentially creating an environment that is susceptible to flooding and rust or corrosion of surrounding building elements, as well as attracting termites and other pests.

It is recommended that a licensed plumber be appointed to further inspect and to extend the down pipes to the properties stormwater line as necessary.

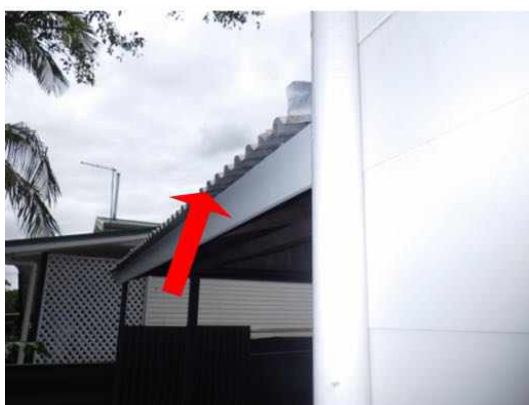
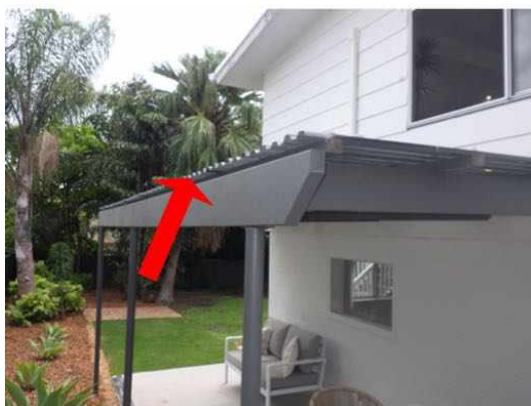
Finding 6.05

Building:	Main Building
Location:	Roof Exterior > Existing
Finding:	Roof Guttering Missing
Information:	At the time of inspection there was no roof guttering installed to Carport and patio area roofs.

Although some building elements may seem irrelevant or unnecessary, all building elements play a key role in the operation and function of the overall structure and its performance. Roof areas missing gutters are likely to lead to high levels of moisture in the ground areas directly below. Such moisture will not only cause rust and decay of the associated building materials, but can also provide conditions that are conducive to termite and timber pest activity.

Installation of roof guttering and stormwater downpipes should be conducted as soon as possible to ensure that no damage or functional issues occur to associated building materials.

A qualified roof plumber should be appointed to replace the missing guttering.

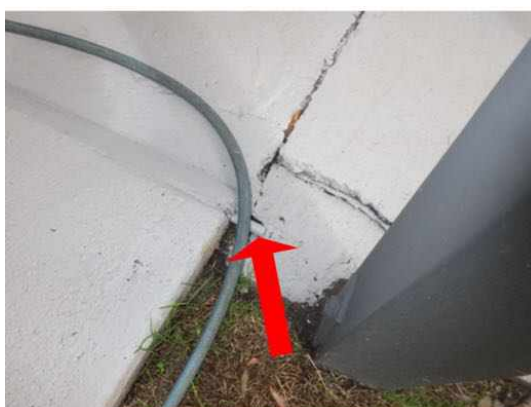
Finding 6.06

Building: Main Building
 Location: Exterior walls - rear > Ground Level
 Finding: Overflow - Not plumbed for drainage
 Information: The hot water system overflow is not plumbed or connected to suitable drainage, which can result in the surrounding area becoming excessively damp. These damp conditions can lead to secondary defects such as rot, rust or corrosion of associated building elements, the formation of fungal decay, or even the creation of potential slip hazards. When coupled with poor site drainage, pooling of water may also attract termite activity to this area. It is highly recommended that a qualified plumber be appointed to install adequate drainage to the overflow. These works will ensure that the area remains dry and free of any secondary defects.

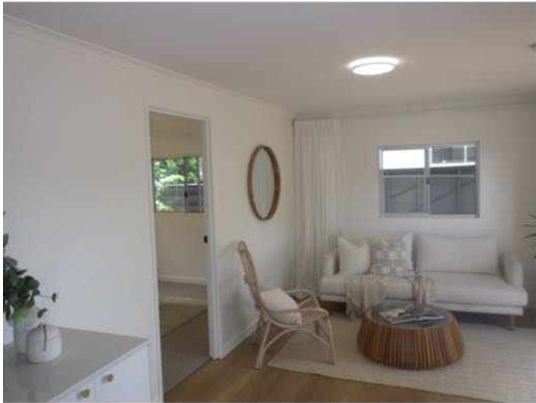
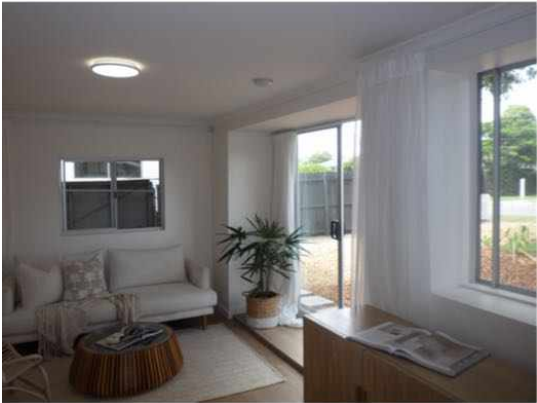
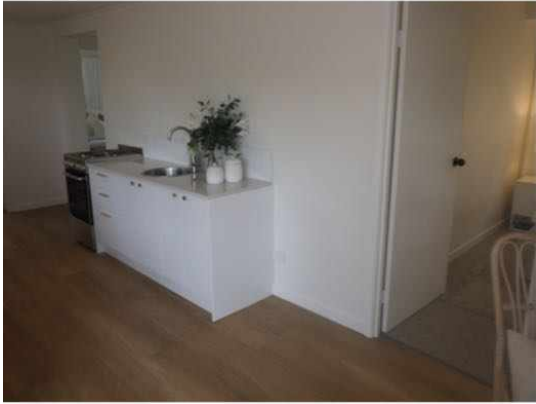
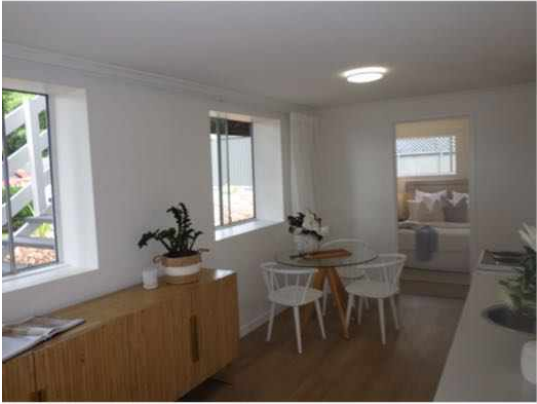
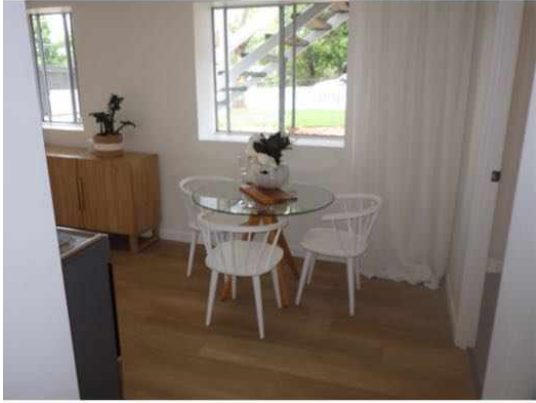
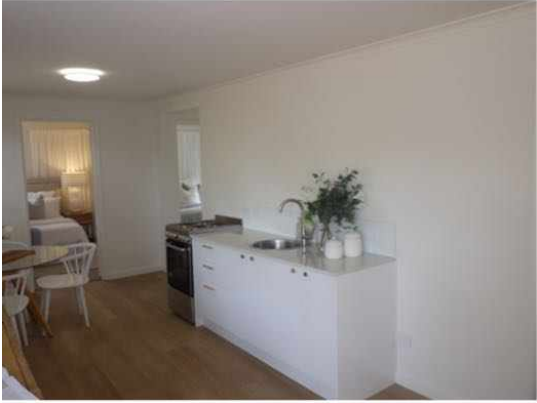
Building: Main Building
Location: Kitchenette/Living/Dining > Existing
Finding: No obvious defect
Information: No obvious defects found at the time of inspection.

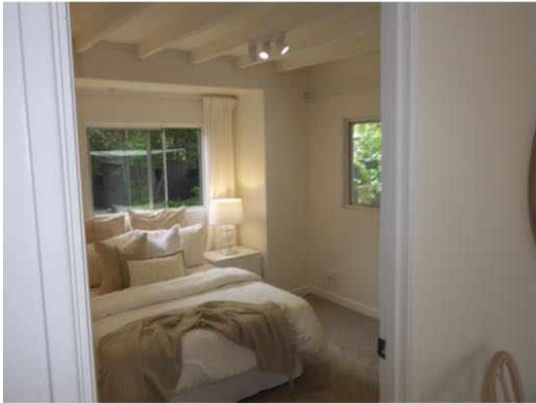
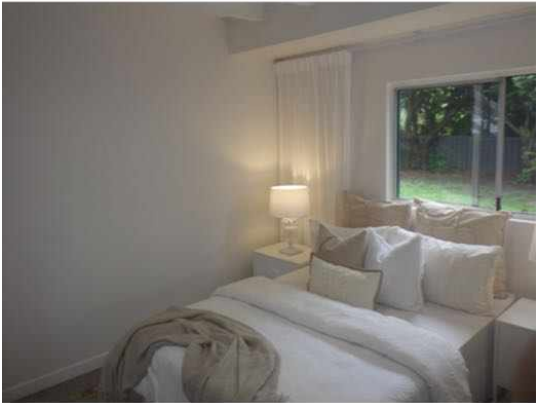
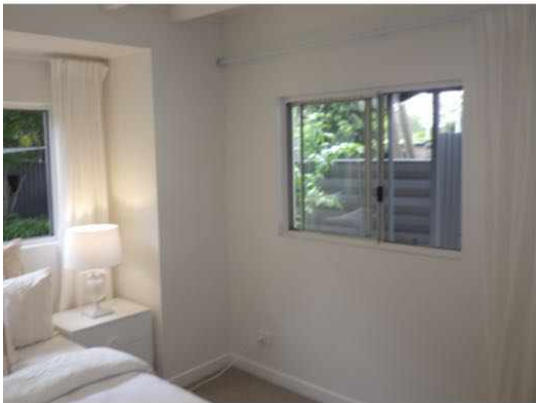
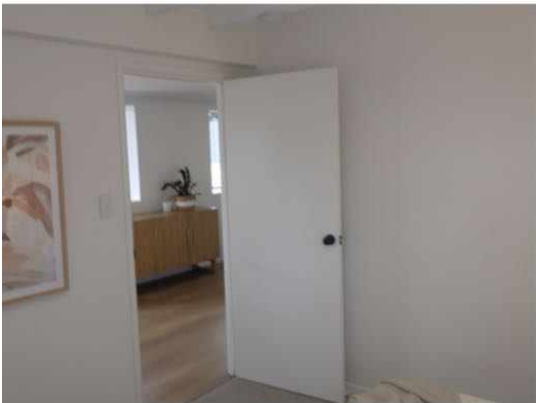
Building: Main Building
Location: Bedroom 6 > Existing
Finding: Additional Photos
Information: Additional photos are provided for your general reference

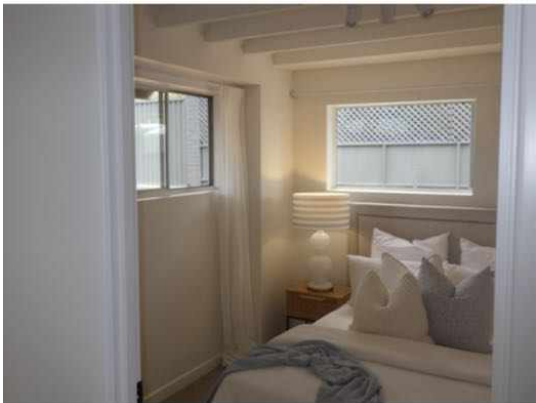
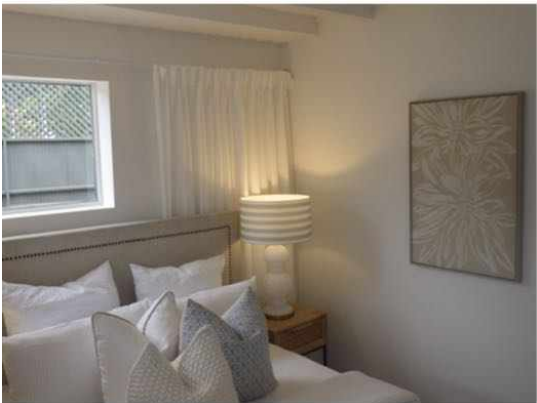
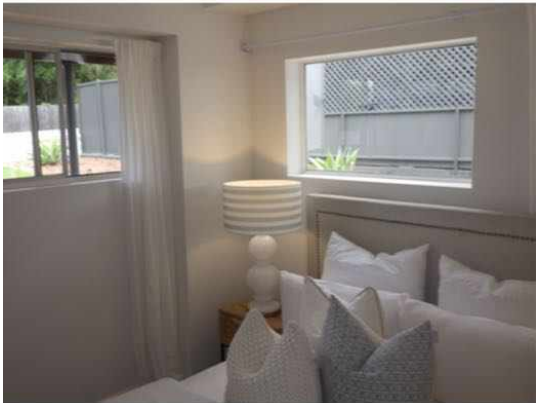
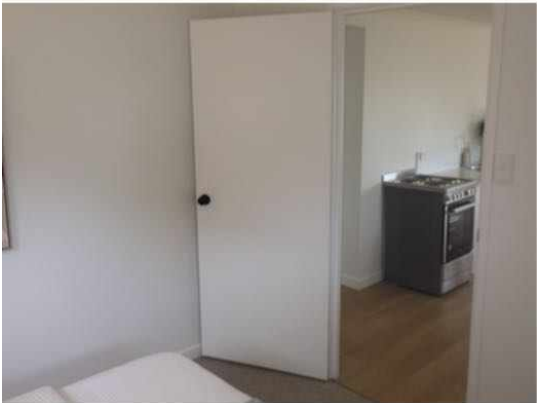
Building: Main Building
Location: Bedroom 5 > Existing
Finding: Additional Photos
Information: Additional photos are provided for your general reference

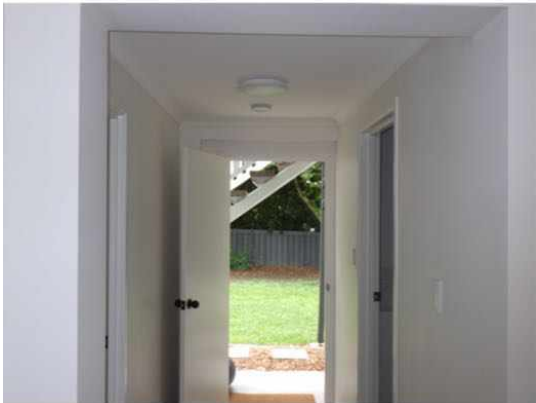
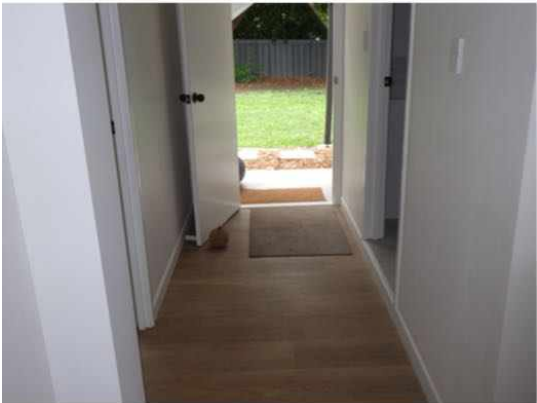
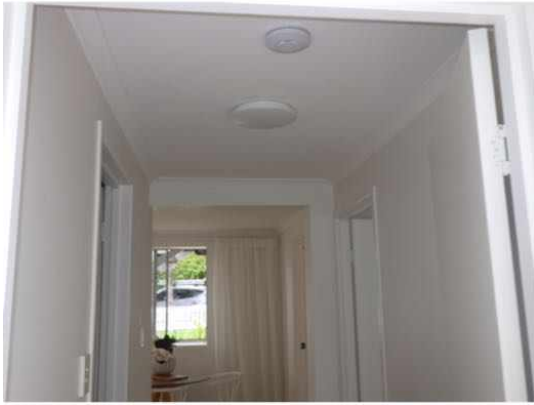
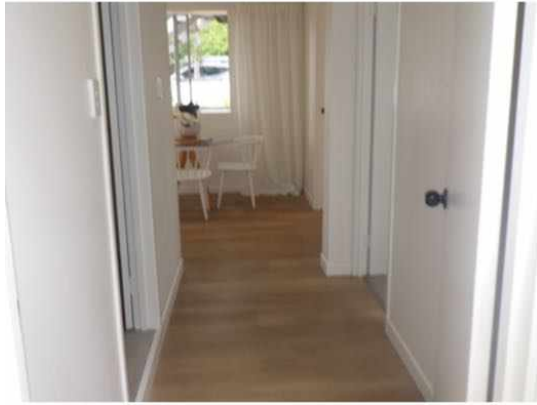
Building: Main Building
Location: Hallway > Existing
Finding: No obvious defect
Information: No obvious defects found at the time of inspection.

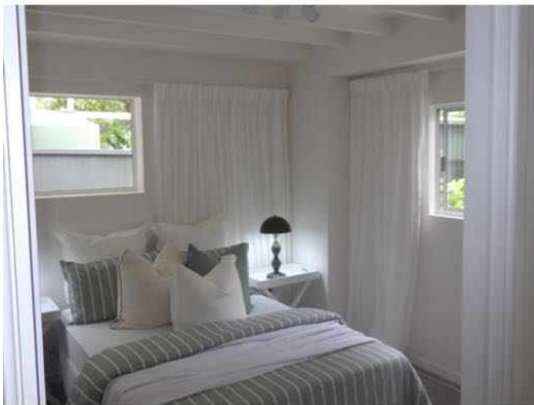
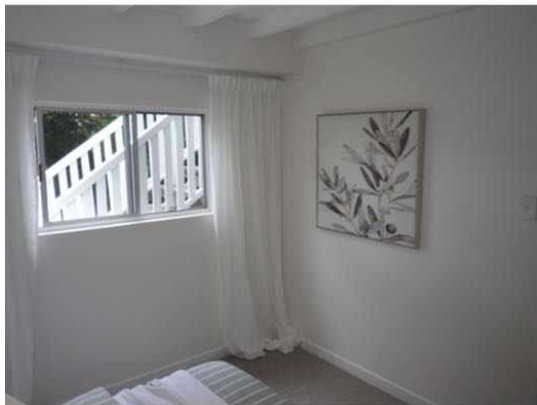
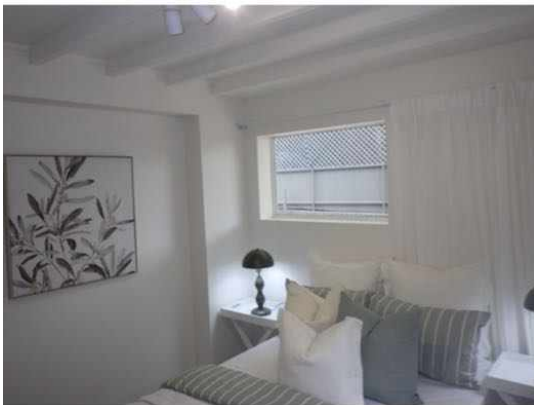
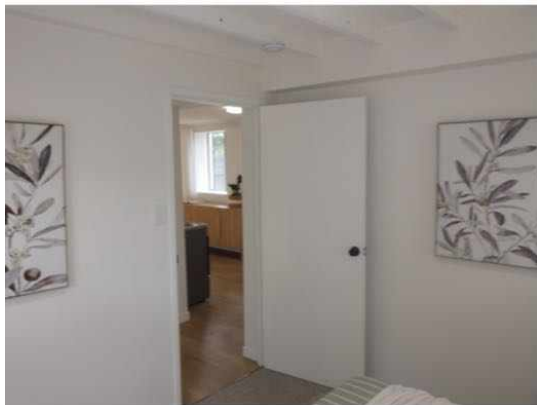
Building: Main Building
Location: Bedroom 4 > Existing
Finding: No obvious defect
Information: No obvious defects found at the time of inspection.

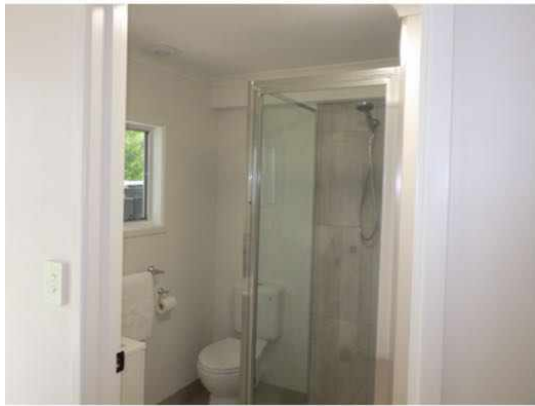
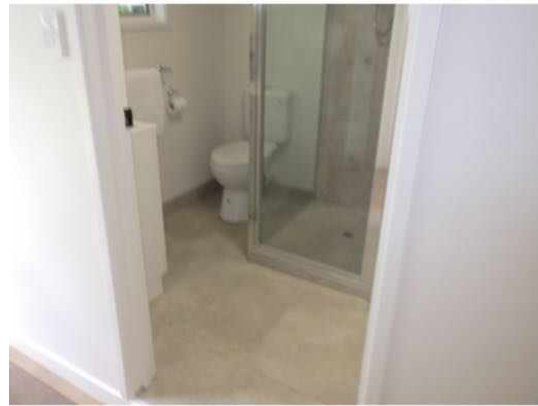
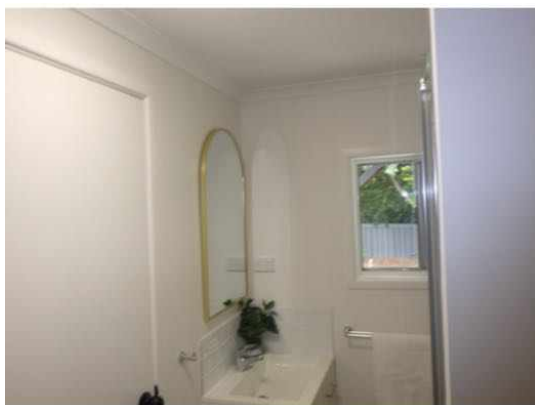
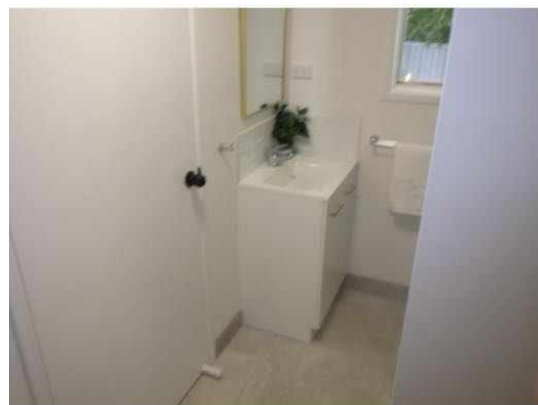
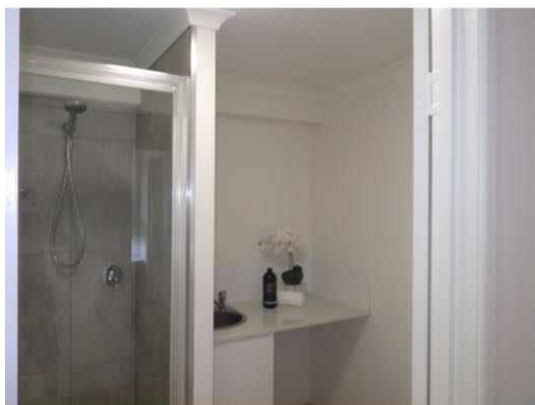
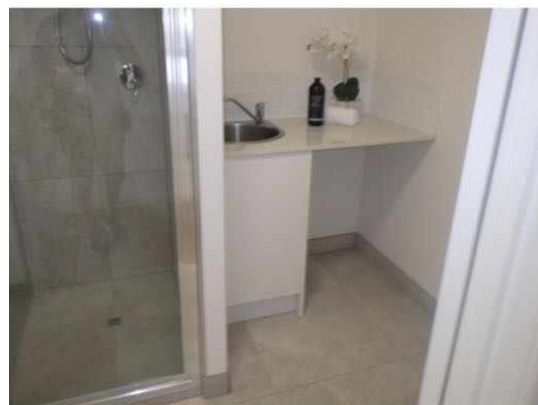
Building: Main Building
Location: Bathroom/Laundry > Existing
Finding: No obvious defect

Information: No obvious defects found at the time of inspection.

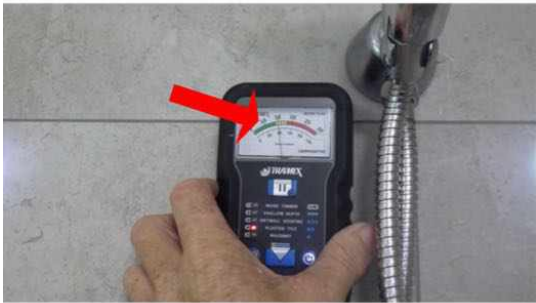
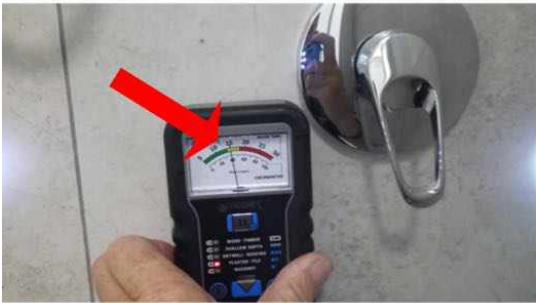
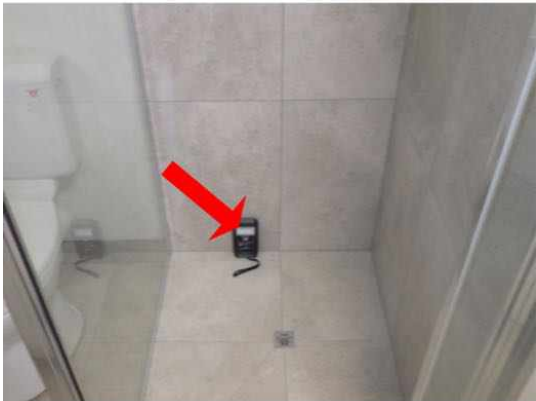
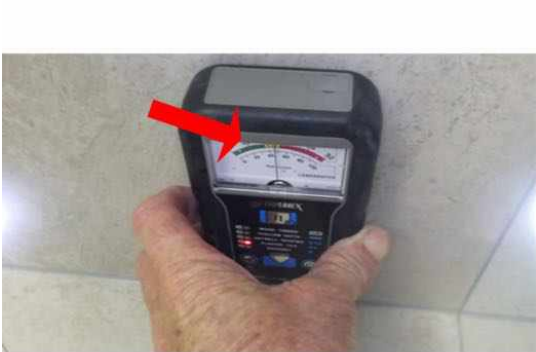
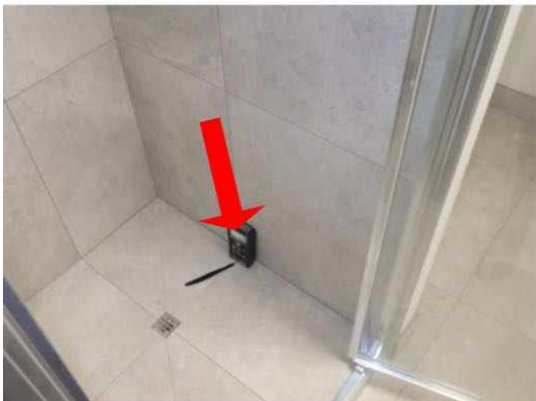
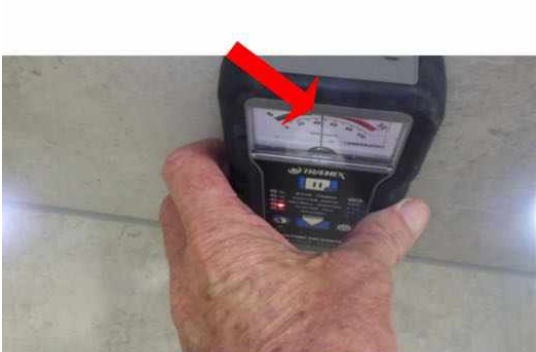
Building: Main Building
Location: Bathroom > Existing
Finding: Moisture Level Readings
Information: At the time of inspection the ground floor bathroom shower cubicle areas checked with the Tramex Moisture Meter returned low - normal moisture level readings.

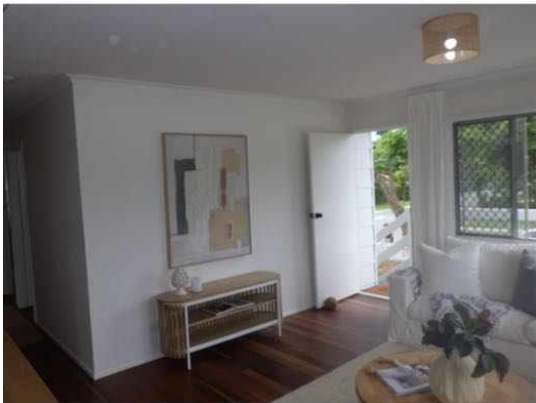
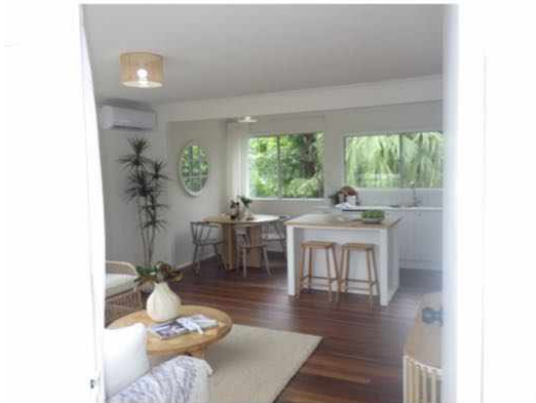
Building: Main Building
Location: Entry > Existing
Finding: No obvious defect
Information: No obvious defects found at the time of inspection.

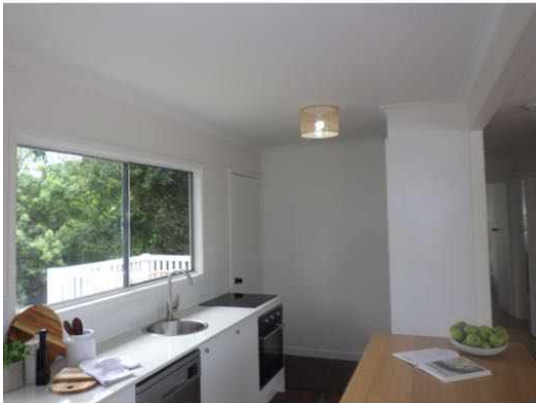
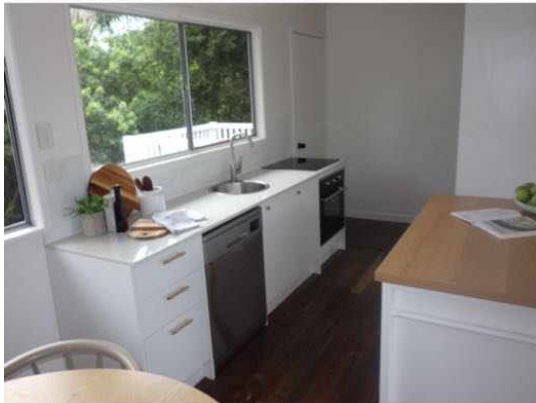
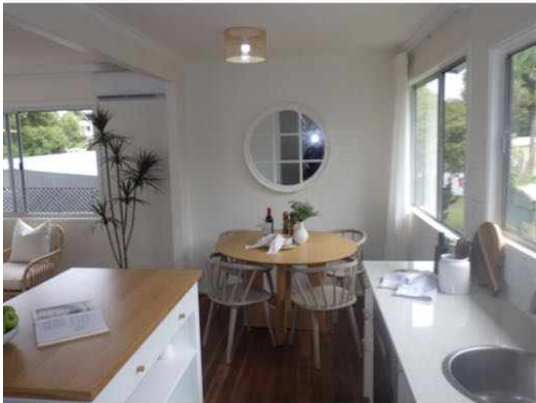
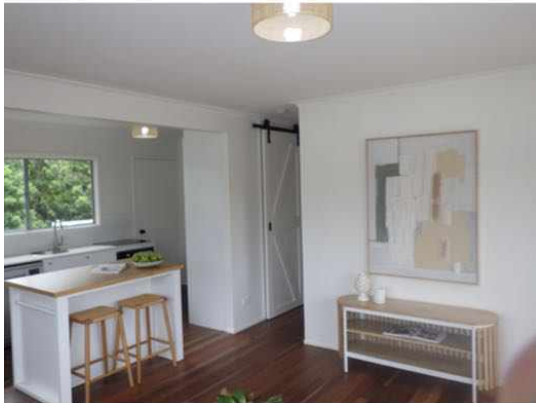
Building: Main Building
 Location: Kitchen > Existing
 Finding: No obvious defect
 Information: No obvious defects found at the time of inspection.

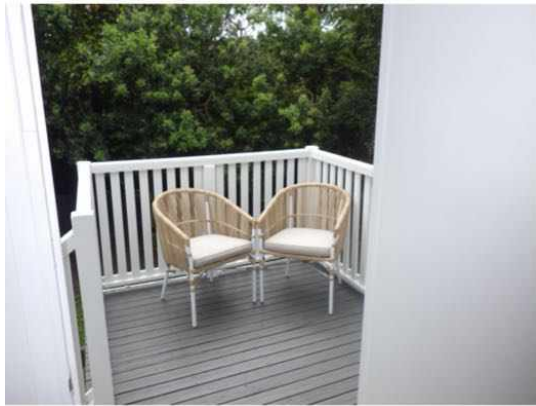
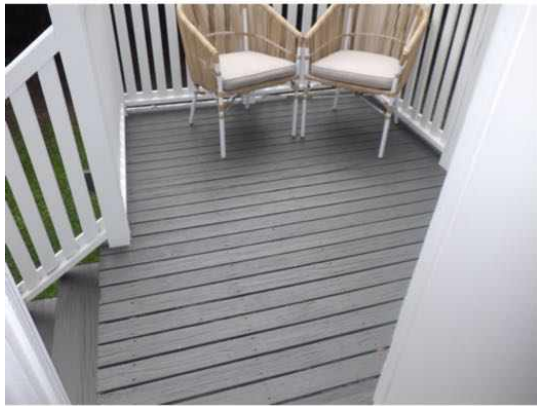
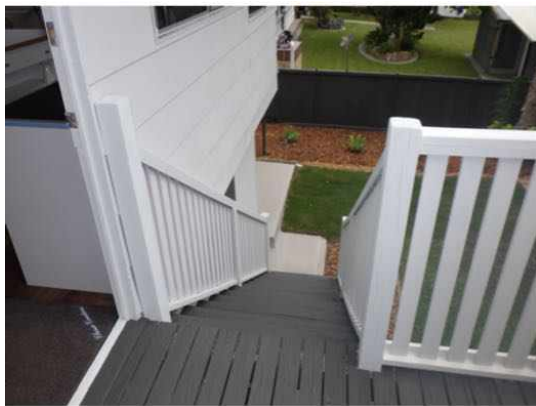
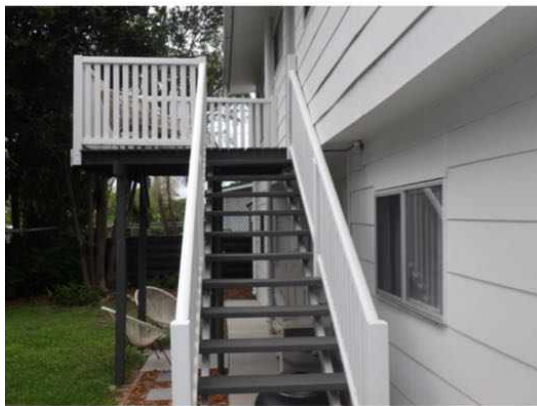
Building: Main Building
 Location: Balcony > Existing
 Finding: No obvious defect

Information: No obvious defects found at the time of inspection.

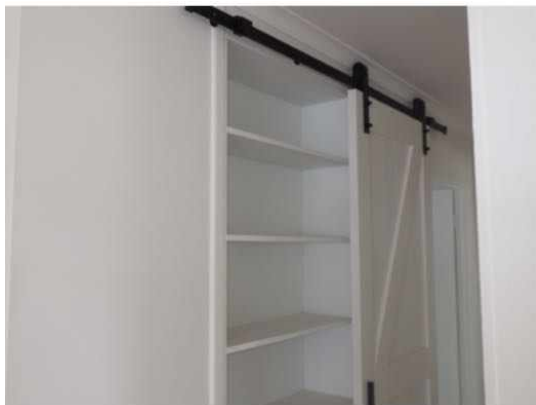
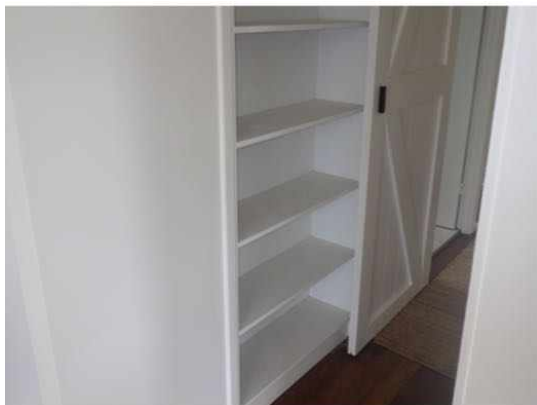
Building: Main Building
Location: Linen Cupboard > Existing
Finding: No obvious defect
Information: No obvious defects found at the time of inspection.

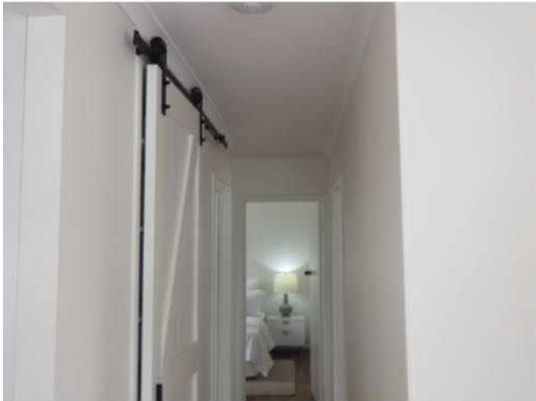
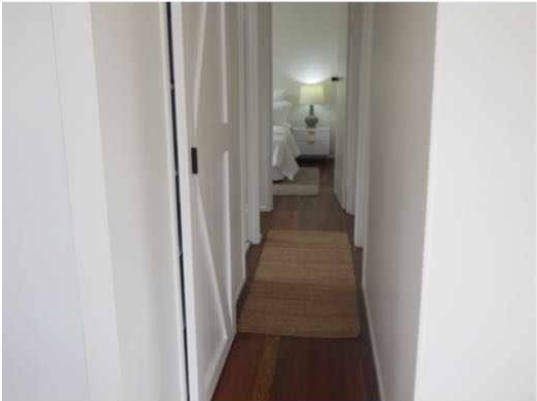
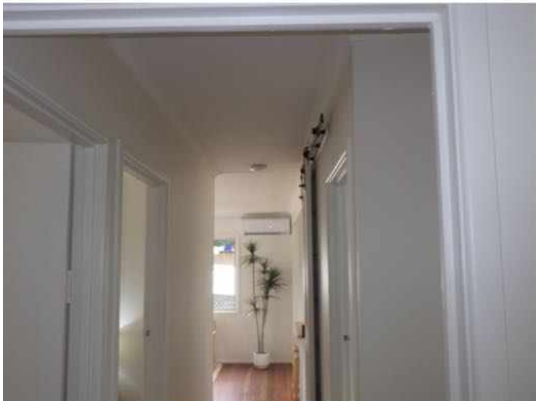
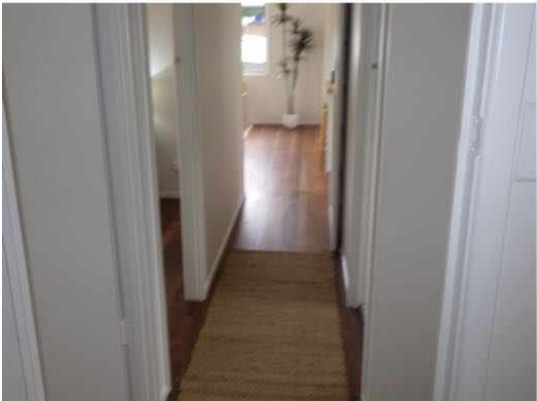
Location: Hallway 2 > Existing
Finding: No obvious defect
Information: No obvious defects found at the time of inspection.

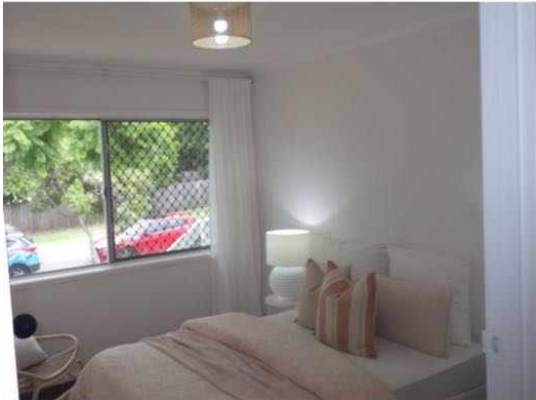
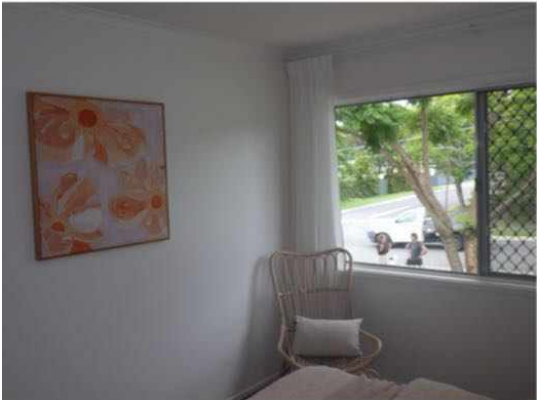
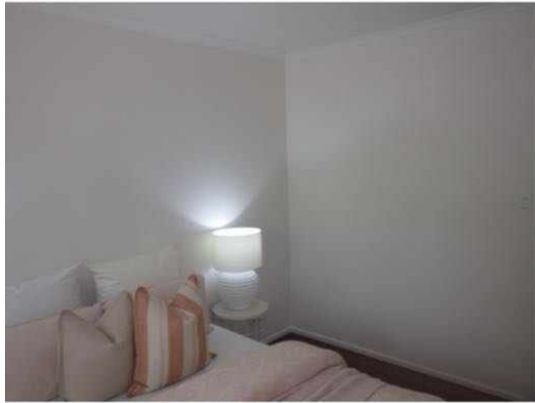
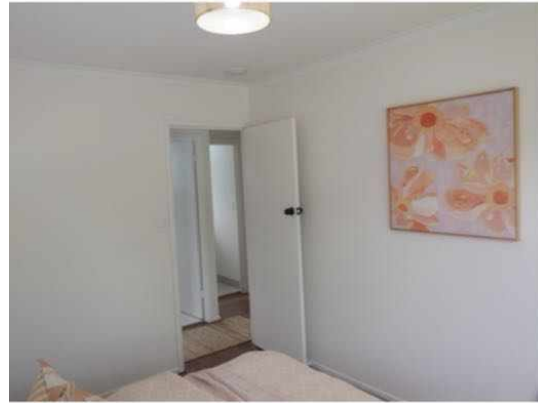
Building: Main Building
Location: Bedroom 3 > Existing
Finding: Additional Photos
Information: Additional photos are provided for your general reference

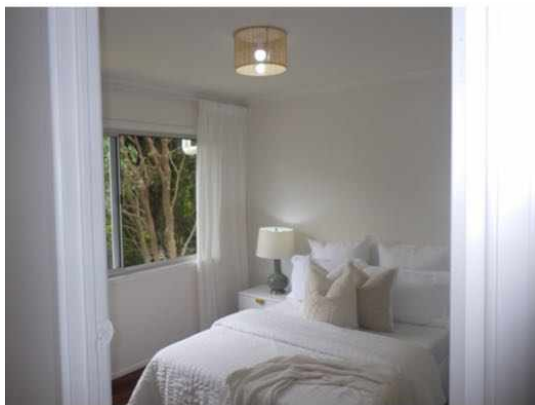
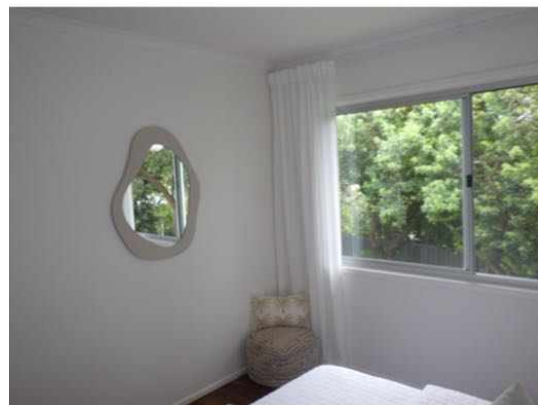
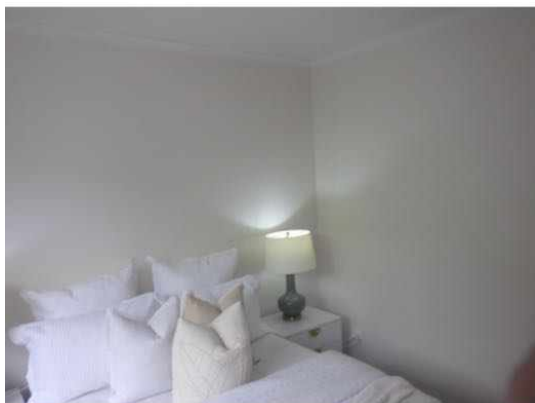
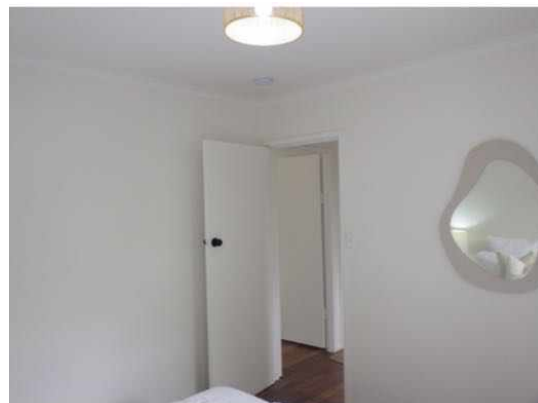
Building: Main Building
Location: Bedroom 2 > Existing
Finding: Additional Photos
Information: Additional photos are provided for your general reference

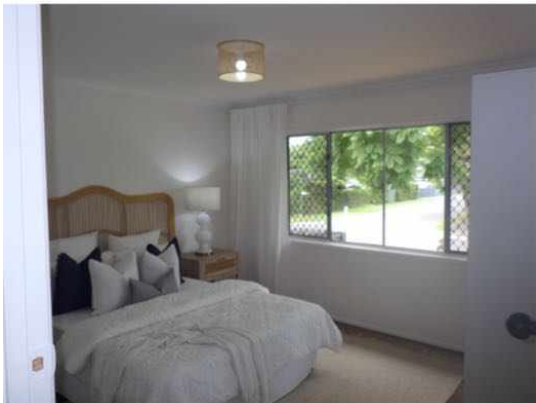
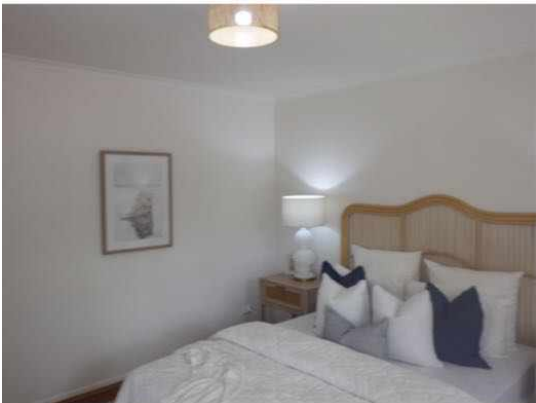
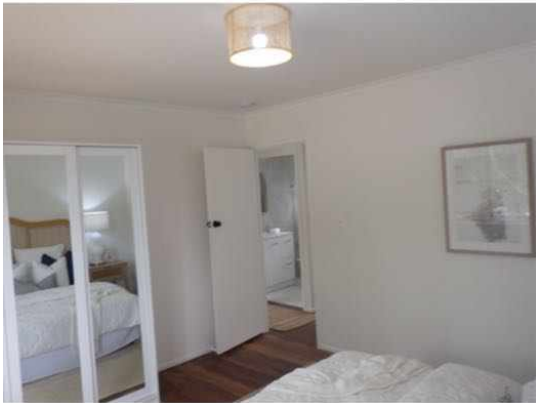
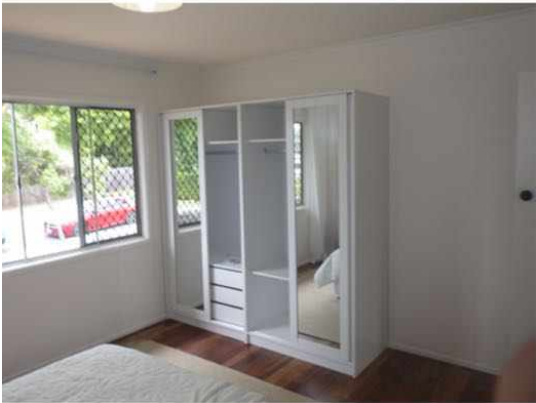
Building: Main Building
Location: Bedroom 1 > Existing
Finding: Additional Photos

Information: Additional photos are provided for your general reference
