Building and Timber Pest Inspection Report

Inspection Date: Tue, 17 Mar 2026

Property Address: 17 Poinciana Street Kingston

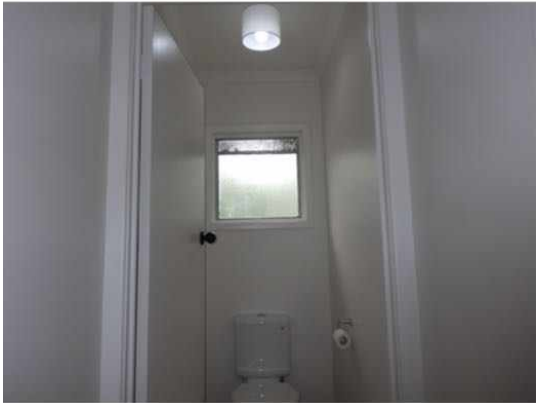
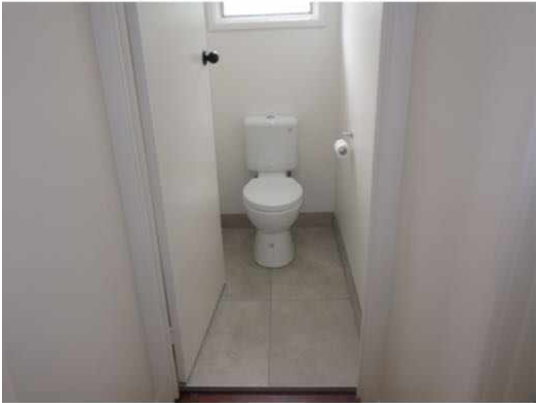
Building: Main Building
Location: Toilet (WC) > Existing
Finding: No obvious defect
Information: No obvious defects found at the time of inspection.

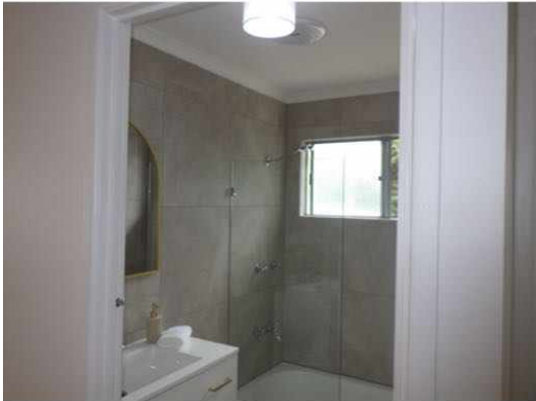
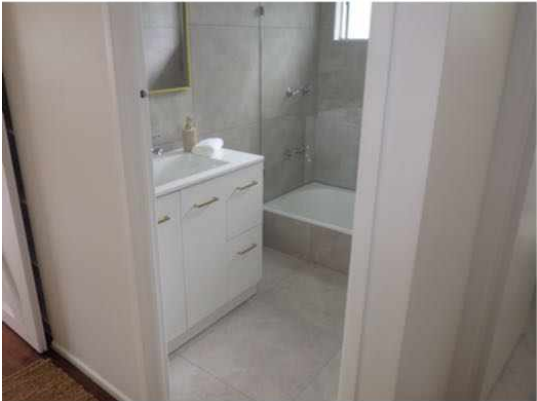
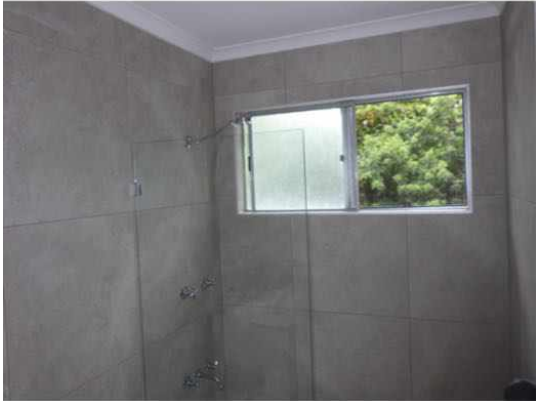
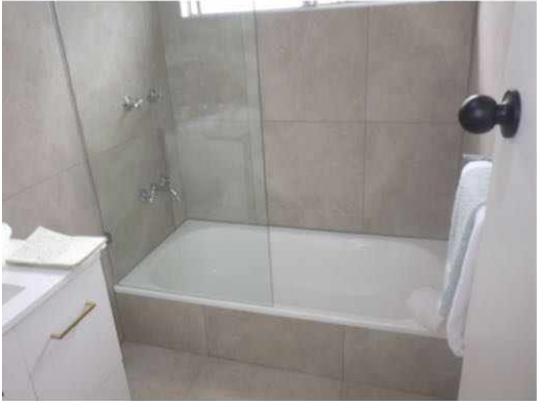
Location: Bathroom 2 > Existing
Finding: No obvious defect
Information: No obvious defects found at the time of inspection.

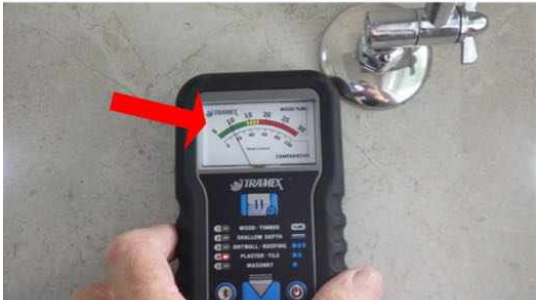
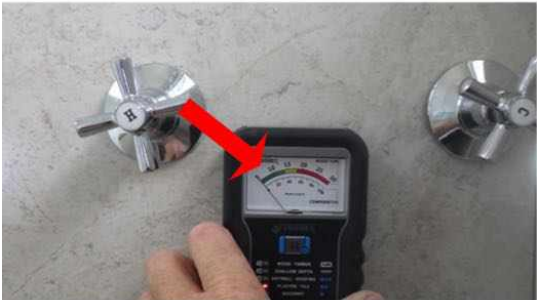
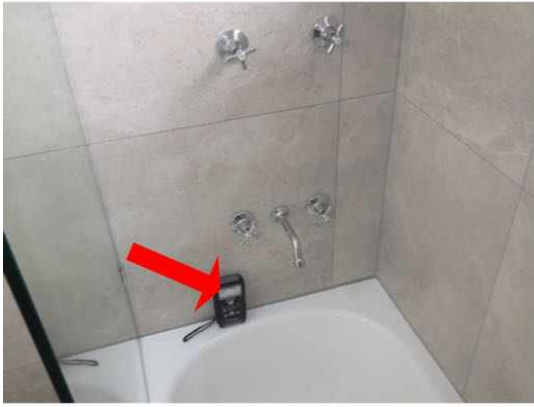
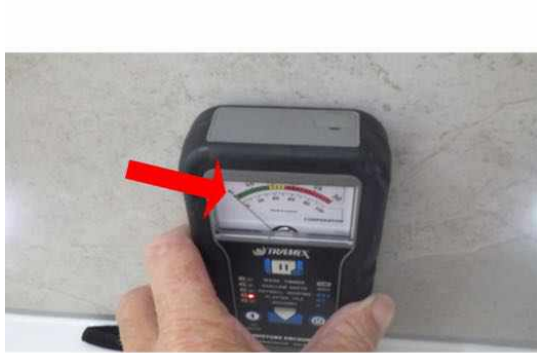
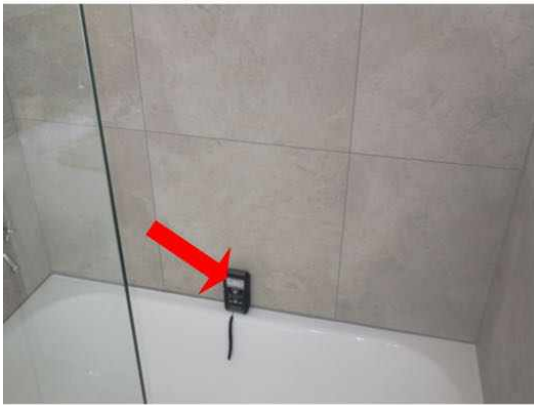
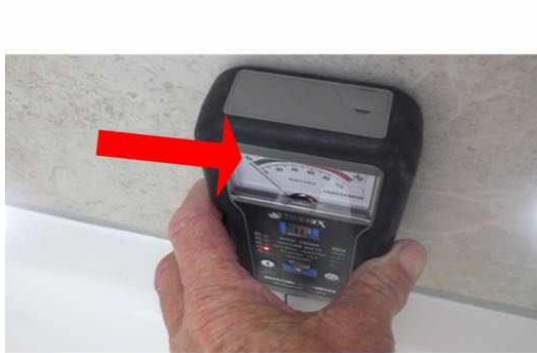
Building: Main Building
Location: Bathroom 2 > Rear
Finding: Moisture Level Readings
Information: At the time of inspection the upper level bathroom shower cubicle areas checked with the Tramex Moisture Meter returned low - normal moisture level readings.

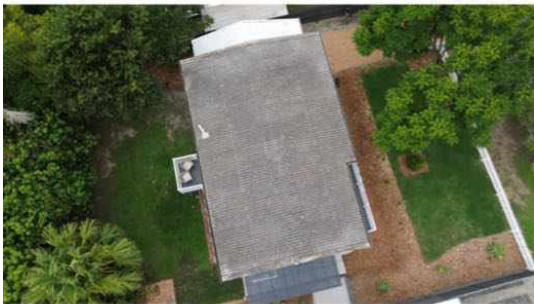
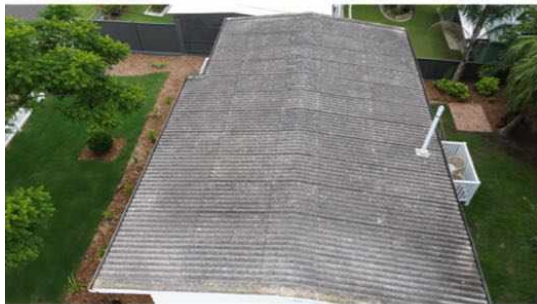
Building: Main Building
Location: Roof Exterior > Existing
Finding: Roof Photos
Information: Roof area photos were taken with the DJI Mini 3 Drone flown over the roof at the time of inspection.

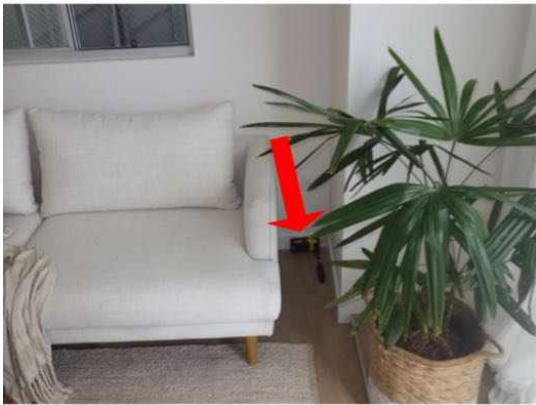
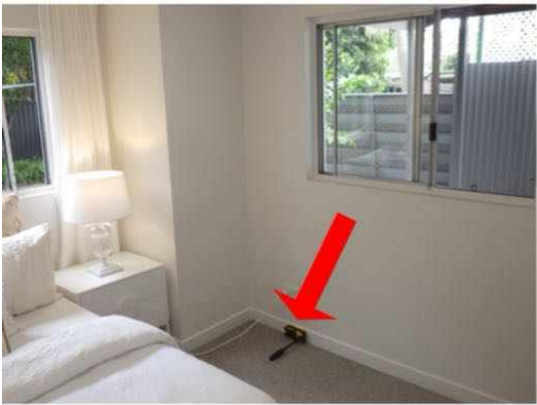
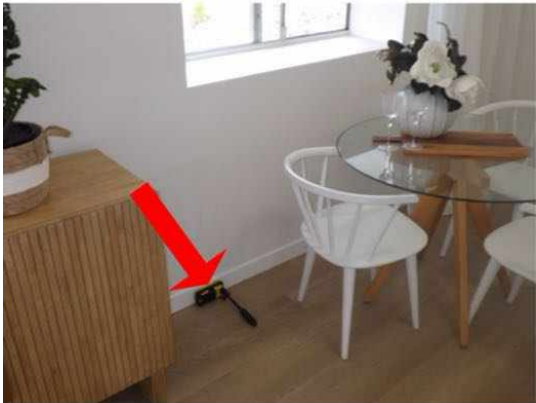
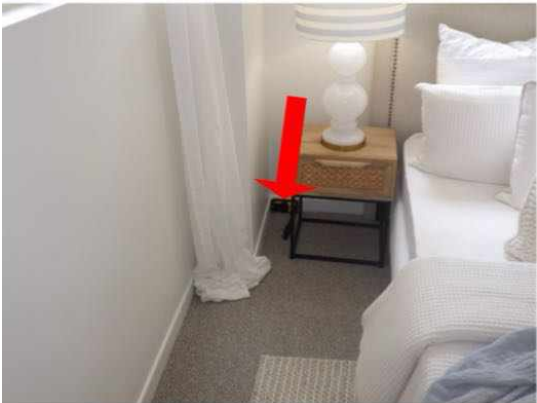
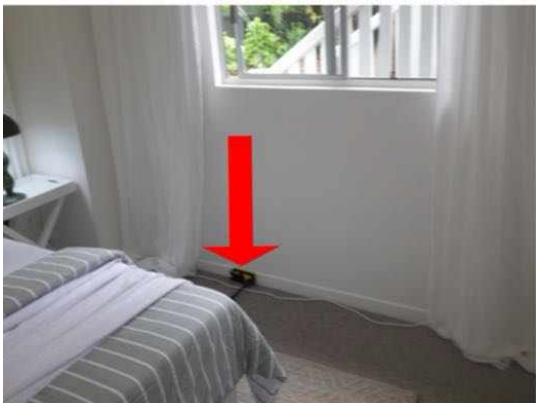
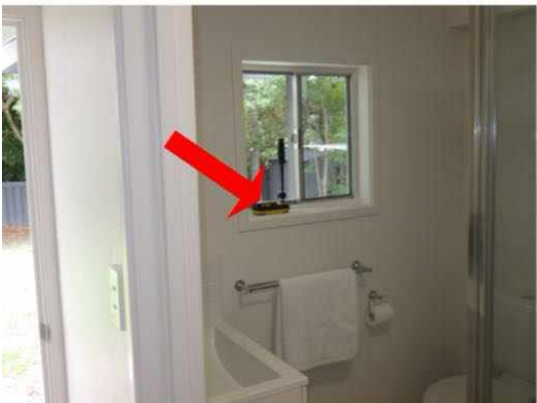
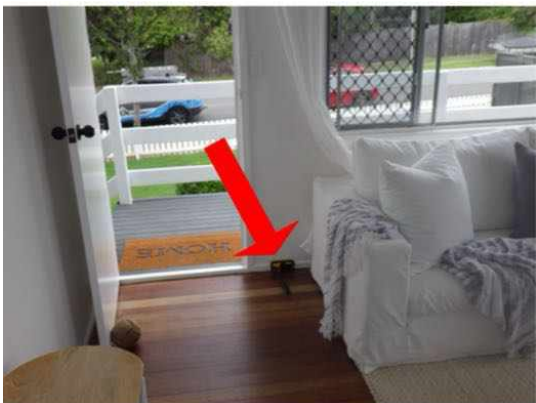
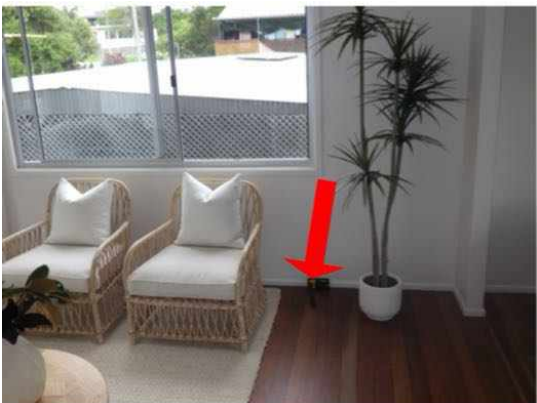
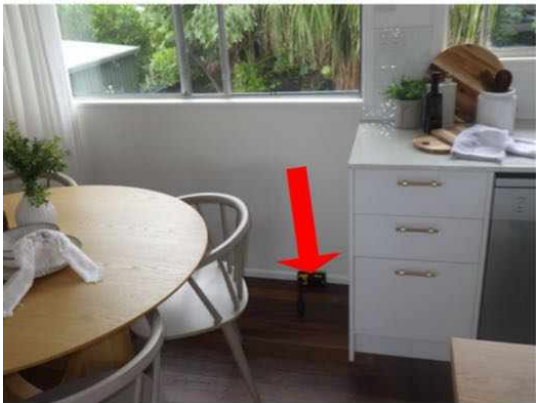
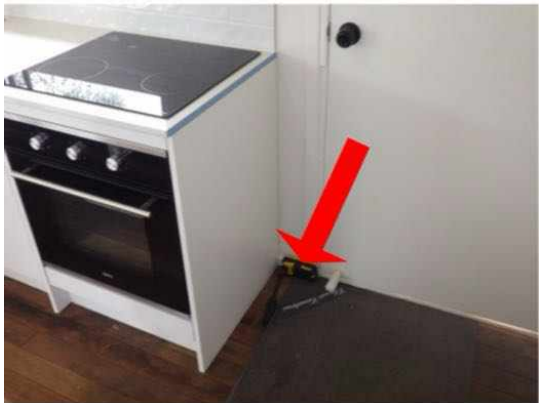
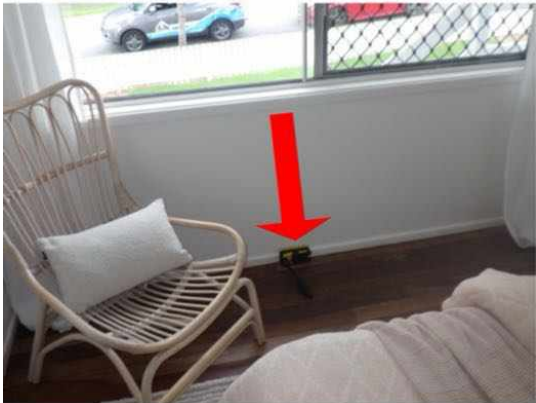
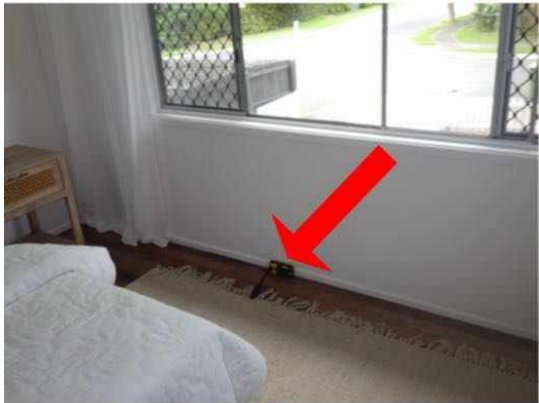
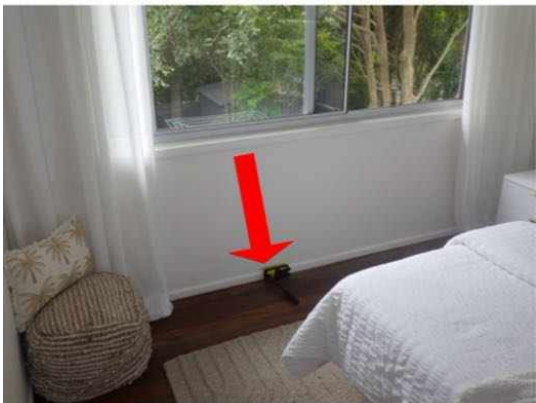
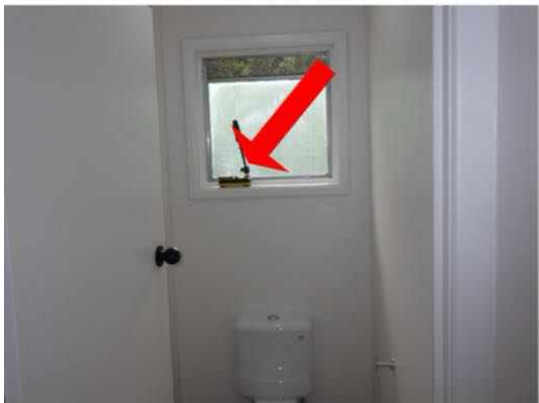
Building: Main Building
Location: Internal Areas > Existing
Finding: Termitracker
Information: The termitracker itracker was positioned randomly to internal wall, timber skirting and window frame areas checking for signs of termite activity.

No activity was recorded at the time of inspection.

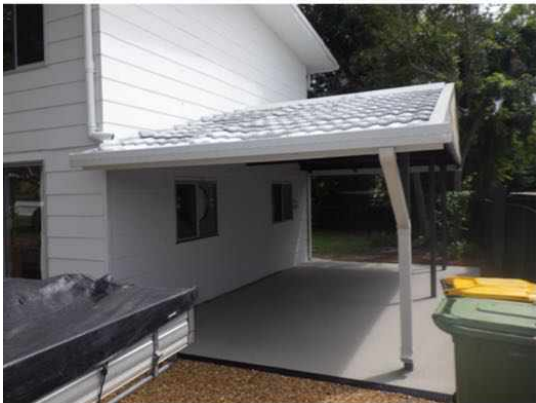
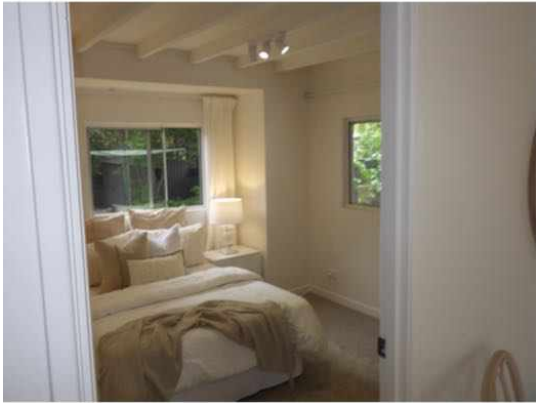
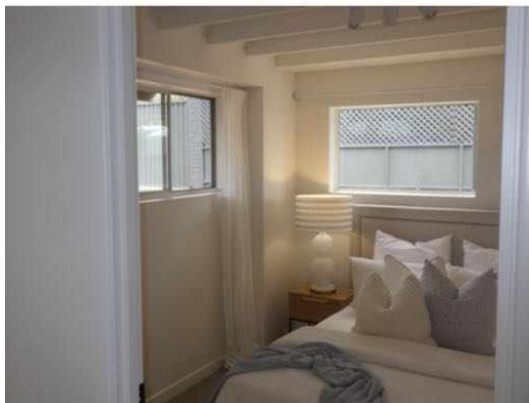
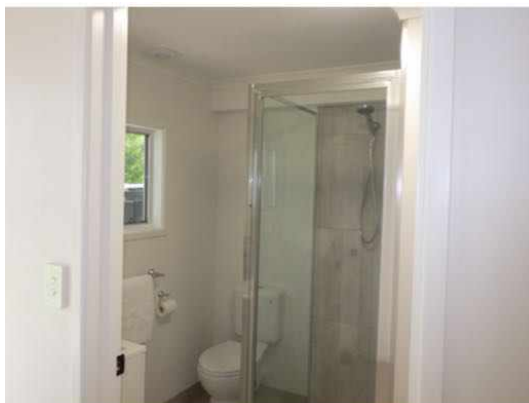
Building: Main Building
Location: Internal Areas > Ground Level
Finding: Suspected Non Compliance
Information: Renovation or alteration works to the dwelling may not comply with contemporary building practices and current Australian Standards. While the structure does not currently appear to be unsafe, compliance with such standards ensures the structural integrity of the dwelling.

If building standards have not been followed, these areas provide a heightened risk of the development of building defects. The structural integrity of the area may be compromised, which creates potential for the development or presence of major safety issues.

It is highly recommended that a search of the Local Council and QBCC records be made to determine what approvals have been granted for any renovation/alteration works to the property.

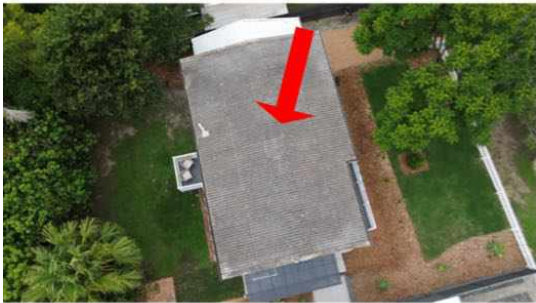
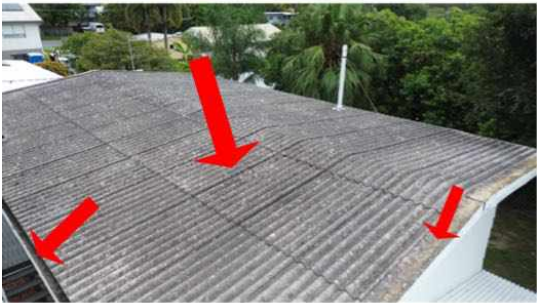
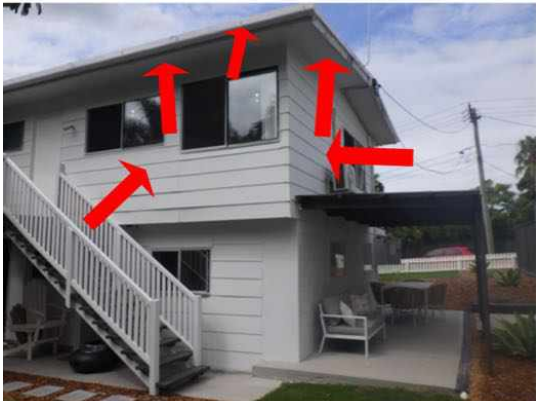
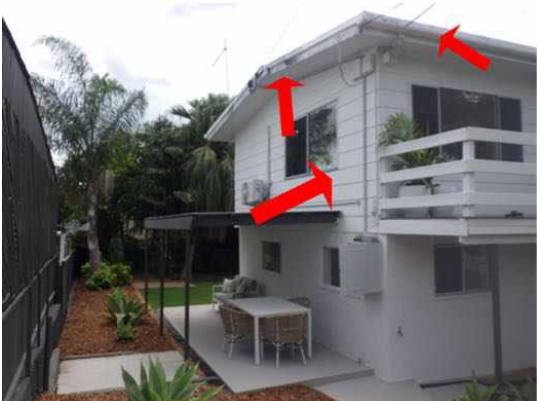
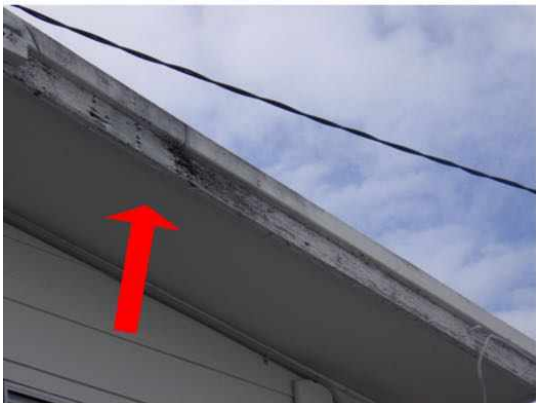
Building:	Main Building
Location:	External Areas > Existing
Finding:	Asbestos - Suspected ACM Identified on Site
Information:	At the time of inspection it was suspected the upper level exterior wall cladding, roof coverings, gutters and eaves linings may be of asbestos containing materials (ACM).

Reporting on Asbestos is outside the Scope of this Report. This suspected defect is highlighted as a caution only. We suspect, based on our experience in the building industry, that there is a higher risk of the identified building elements containing asbestos.

As Asbestos Reporting is outside the scope of this report, we advise that you consider a separate Asbestos Inspection and Condition Audit, which can include the taking of samples for definitive confirmation of the presence of Asbestos.

In the interim, the client is advised to act with caution, especially when considering any damage to building materials general wear and tear renovations extensions demolition and general maintenance activities due to the suspected presence of Asbestos.
