# Building and Timber Pest Inspection Report

Inspection Date: Wed, 25 Feb 2026

Property Address: 5 Cusack Pl, Blackett NSW 2770, Australia

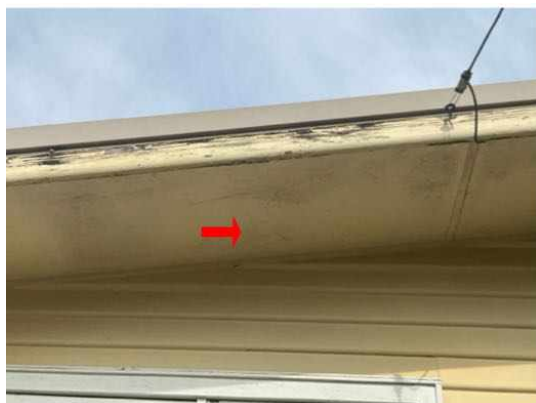
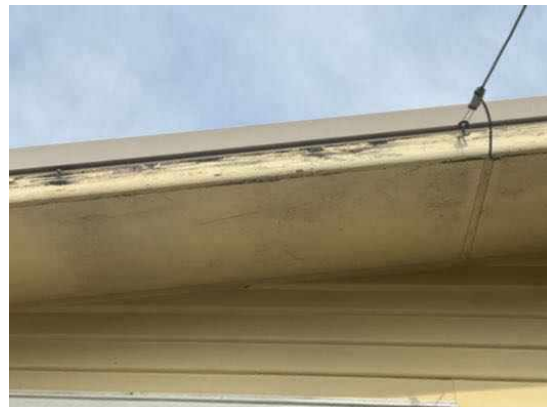
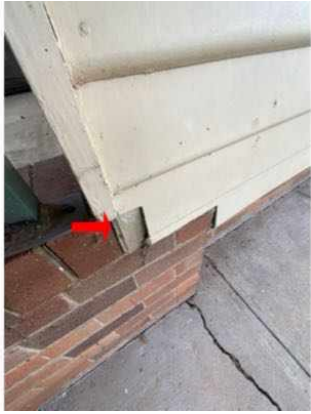
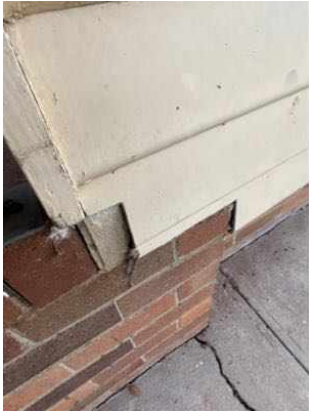
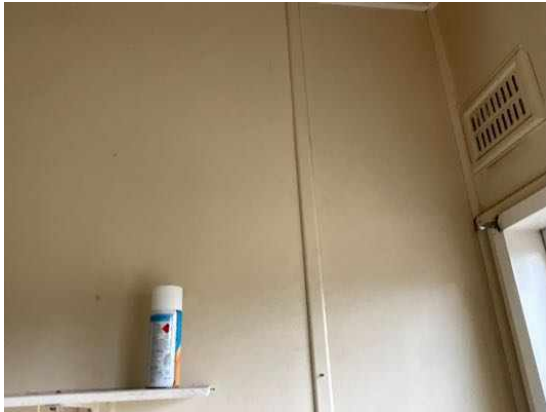
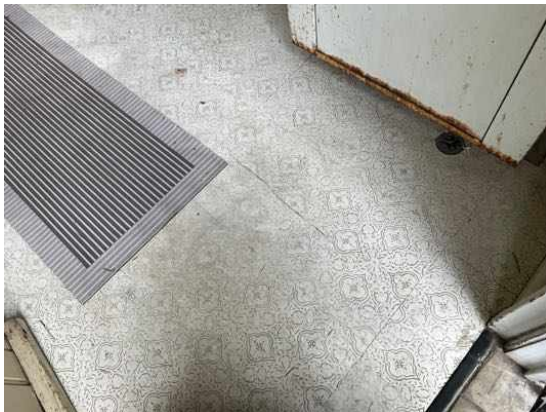
Building:	Main Building
Location:	All Areas
Finding:	Asbestos - Suspected ACM Identified on Site
Information:	Reporting on Asbestos is outside the Scope of this Report. This suspected defect is highlighted as a caution only. We suspect, based on our experience in the building industry, that there is a higher risk of the identified building element containing asbestos.

As Asbestos Reporting is outside the scope of this report, we advise that you consider a separate Asbestos Inspection and Condition Audit, which can include the taking of samples for definitive confirmation of the presence of Asbestos.

In the interim, the client is advised to act with caution, especially when considering any damage to building materials general wear and tear renovations extensions demolition and general maintenance activities due to the suspected presence of Asbestos.

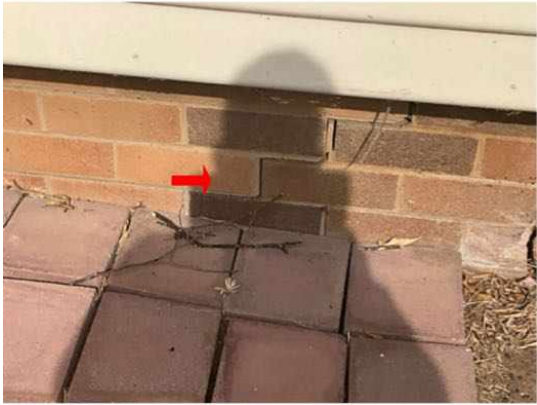
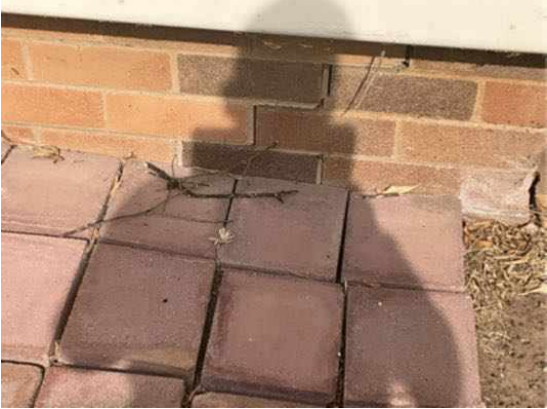
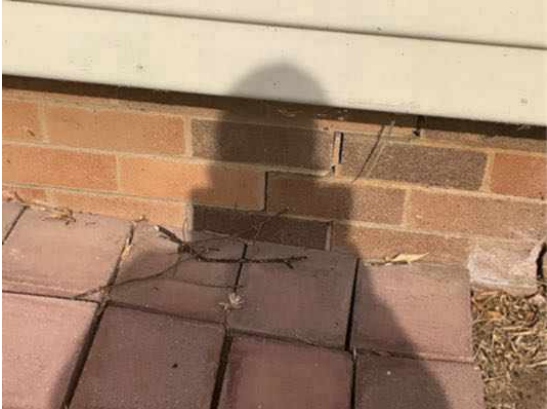
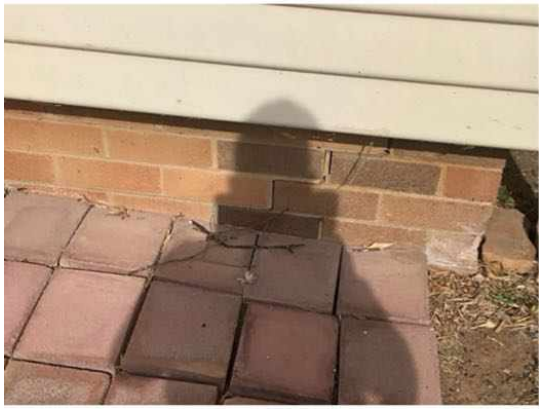
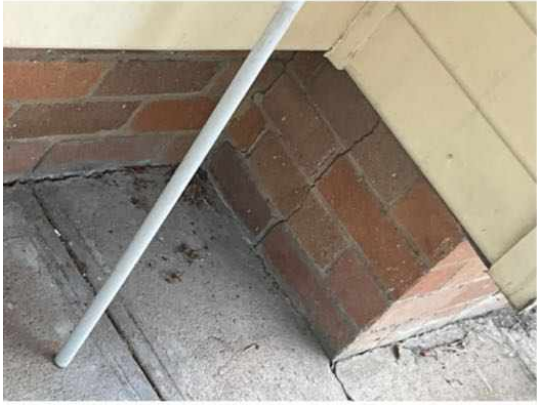
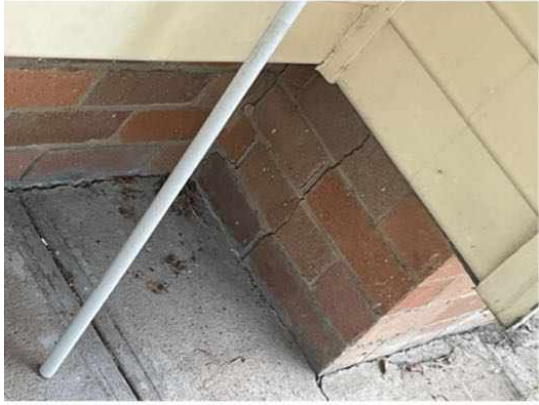
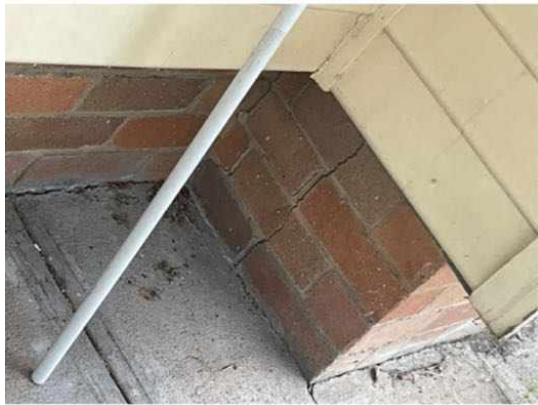
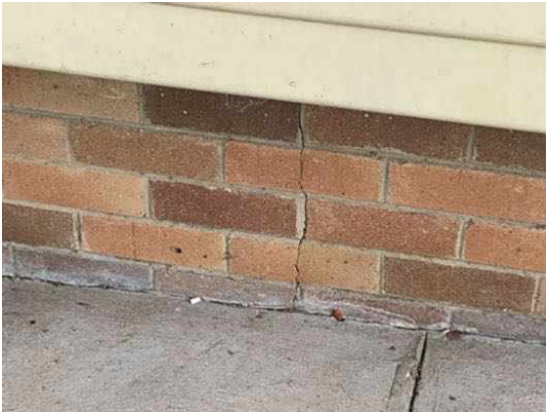
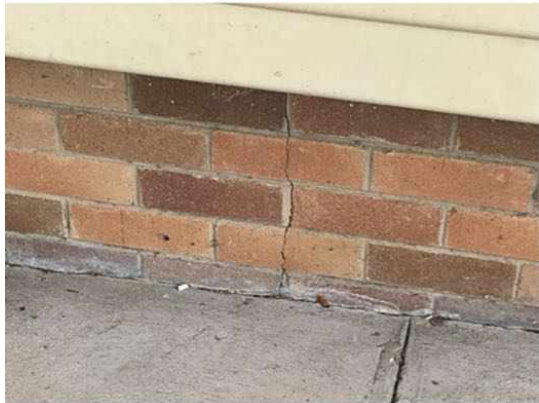
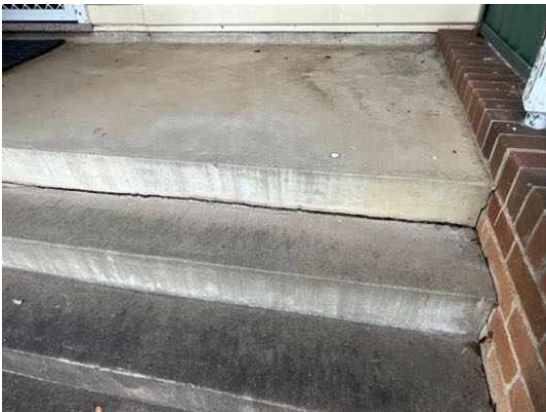
### Finding 2.01

Building:	Main Building
Location:	All Areas
Finding:	Brickwork - Cracking [Repair required]
Information:	Major cracking was identified to the brickwork in this area. Cracks of this type are likely to have been caused by minor expected movement of building elements, but may also have a structural cause that is more significant.

A crack of this size may be repaired by extensive filling. Additionally, further remedial works to associated building elements, such as eave sheeting or external door frames, is likely to be required.

A qualified bricklayer should be contacted immediately to estimate and perform repair and restoration works. Consultation with a structural engineer may be required where structural instability is found to be the underlying cause of the cracking.

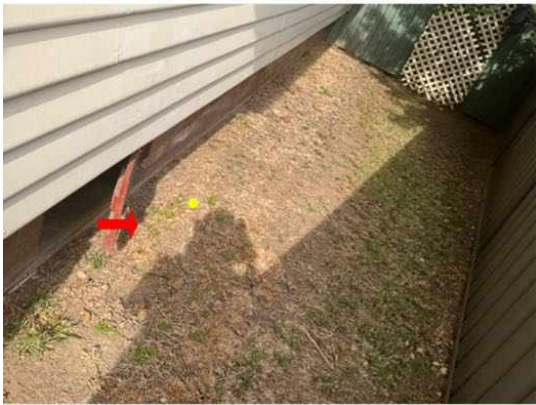
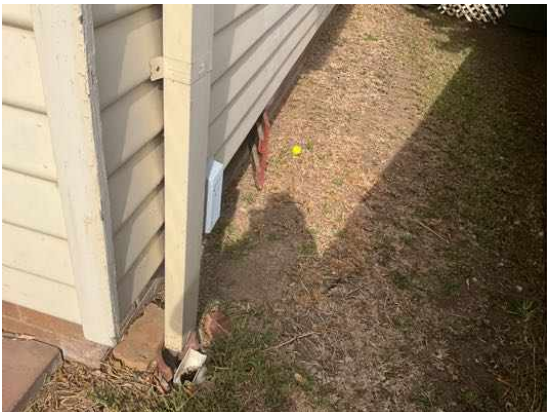
### Finding 3.01

Building:	Main Building
Location:	All Areas
Finding:	Perimeter - Insufficient Fall
Information:	The perimeter ground levels were found to have an inadequate slope away from the adjoining building structure, creating potential for water pooling in this area.

Perimeter is required to fall from the building by a minimum of 25mm in the first metre and bare ground should fall away from the house by 50mm in the first meter. This standard ensures that excessive moisture does not pool around the base of building structures, which creates potential for water and structural damage, as well as making the area susceptible to termite and timber pest activity.

Where ground levels do not have adequate fall, a licensed paving contractor should be appointed to install or remove and re-level pavement.

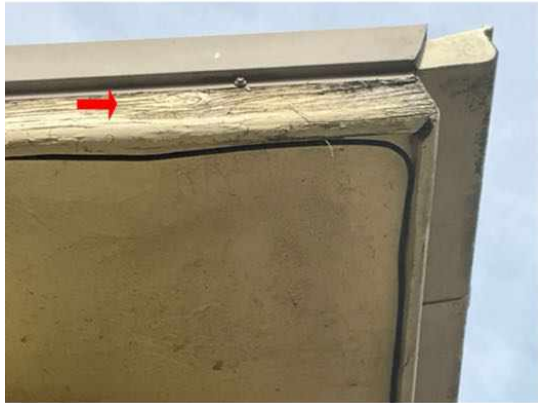
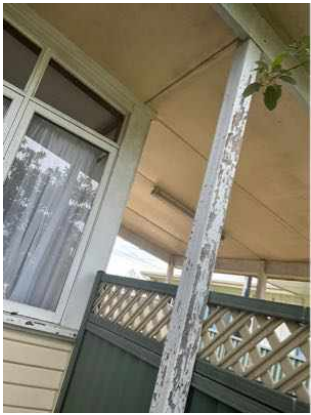
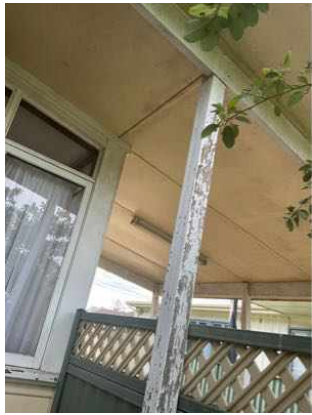
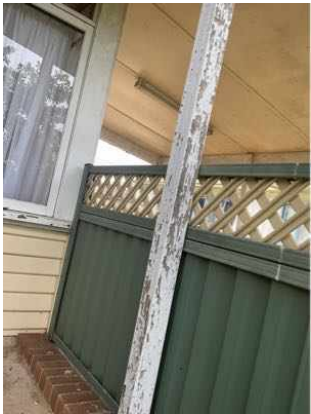
**Finding 3.02**

Building: Main Building  
Location: All Areas  
Finding: Timber - exposed to weather  
Information: External timbers that are frequently exposed to harsh weather conditions require adequate protection in order to maintain their condition. Where timbers have not been painted or treated adequately, general deterioration is likely to occur at an accelerated rate.

If left unattended, replacement of these timbers is likely to be necessary in the short-term future. Adequate treatment of these timbers is required as soon as possible by a painting contractor or general handyman.

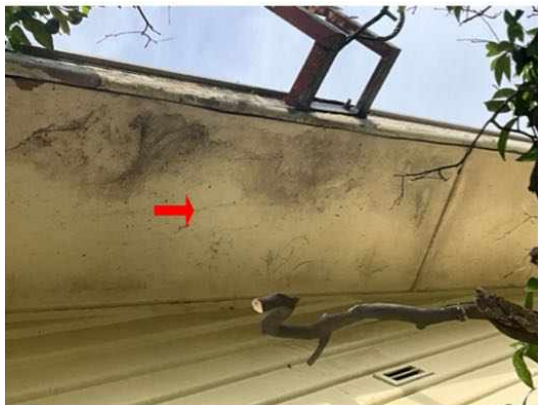
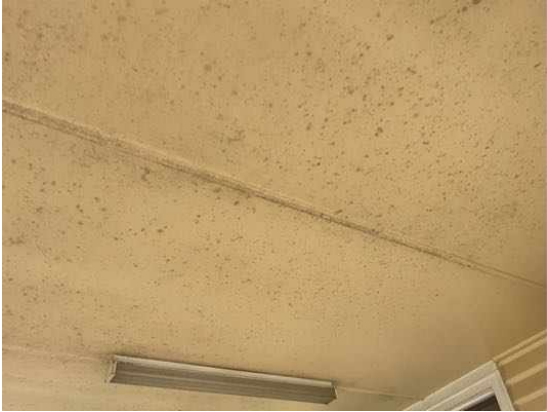
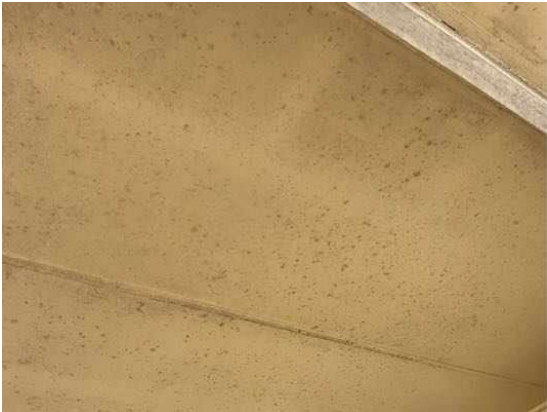
**Finding 3.03**

Building: Main Building  
Location: All Areas  
Finding: Eaves - water Stained  
Information: Water stains are present on eaves, indicating a potential water leak or seepage issue.

Prolonged water exposure can lead to structural damage, mold growth, and compromise the aesthetic appeal of the affected area. Additionally, it may indicate underlying issues that, if unaddressed, can escalate and result in more extensive damage.

A qualified plumber or water damage restoration specialist should investigate and address the source of the water stains. Repairing leaks, improving waterproofing, and, if necessary, restoring the affected surfaces are crucial to preventing further damage and maintaining the integrity of the space.

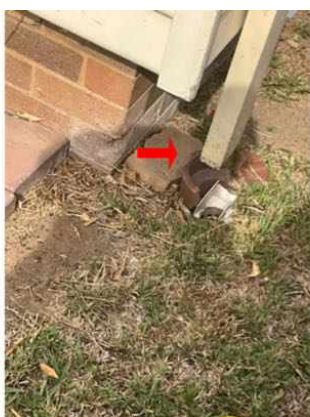
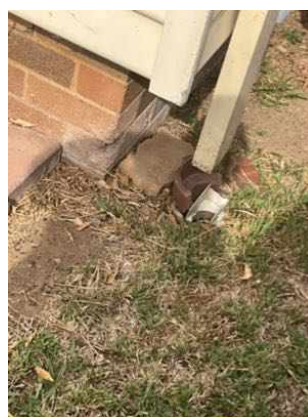
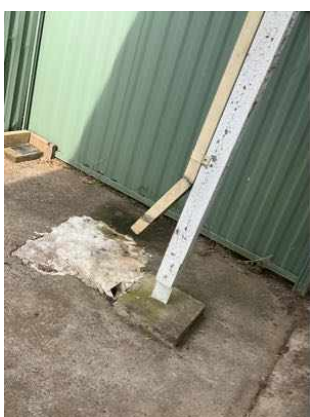
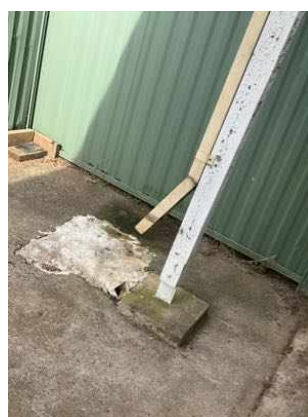
**Finding 3.04**

Building: Main Building  
Location: All Areas  
Finding: Disconnected downpipe  
Information: A notable defect with a disconnected downpipe, compromising the efficient drainage of rainwater from the roof. This disconnectivity poses an increased risk of water accumulation, potentially leading to foundation erosion, water damage to the property, and a conducive environment for mold growth.”

- 1. Foundation Erosion: Accumulated water around the foundation due to the

disconnected downpipe can lead to soil erosion, jeopardizing the stability of the property's foundation.

2. Water Damage: Uncontrolled water runoff can result in water penetrating the building envelope, causing interior water damage to walls, ceilings, and other structural components.

3. Mold Growth: The presence of excess moisture provides an ideal environment for mold growth, posing health risks and necessitating costly remediation.

Engage a qualified and licensed roofing or gutter specialist to address the disconnected downpipe. This professional will reconnect the downpipe to ensure proper water drainage, mitigating the associated risks and preserving the integrity of the property.

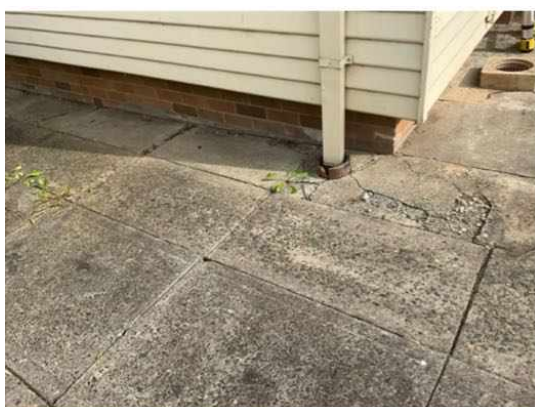
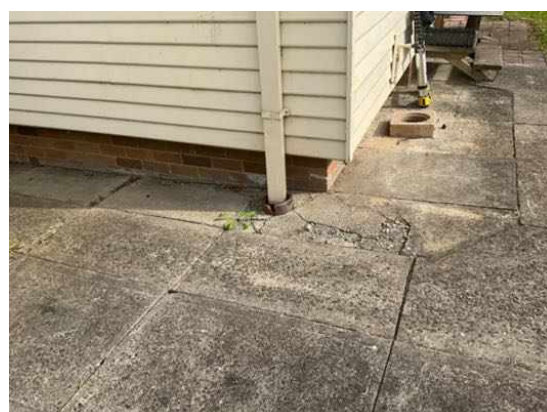
### Finding 3.05

Building:	Main Building
Location:	All Areas
Finding:	Noticeable Cracking in Concrete Slab
Information:	Noticeable cracking has been observed in the concrete slab, failing to meet the required construction and quality standards.

- Cracks are visible on the surface and may extend through the depth of the slab.
- Evidence of improper curing or inadequate reinforcement leading to cracking.

- Compromised structural integrity of the slab, potentially leading to failure under load.
- Water ingress through cracks, causing corrosion of reinforcement and further weakening the structure.
- Potential trip hazards and aesthetic issues, reducing the overall value and safety of the property.
- Increased maintenance and repair costs due to ongoing deterioration.

- A structural engineer should be engaged to assess the extent of the cracking and recommend appropriate repair methods.
- A licensed contractor or concrete repair specialist should carry out the recommended repairs under the guidance of the structural engineer.

A detailed inspection should be conducted post-repair to confirm compliance with the required standards and to ensure that the structural integrity of the concrete slab has been restored.

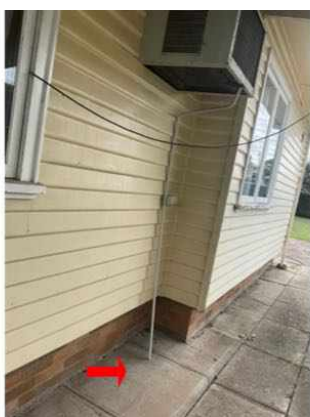
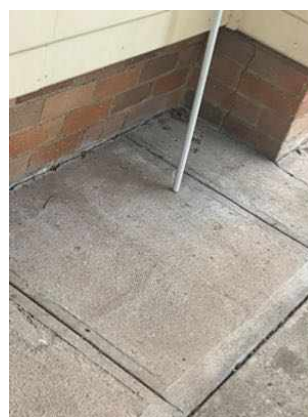
Building:	Main Building
Location:	All Areas
Finding:	Air conditioner - Disconnected overflow
Information:	The Air Conditioner (A/C) overflow was found to be disconnected from storm water drainage and is creating excessive moisture in the surrounding area.

Such leaking creates an environment which is conducive to an array of defects, including water damage to associated building elements and the attraction of termite or timber pest infestation.

It is highly recommended that a licensed plumber be appointed to connect the A/C overflow in order to prevent such an environment from being created. These minor works should be carried out as soon as possible.

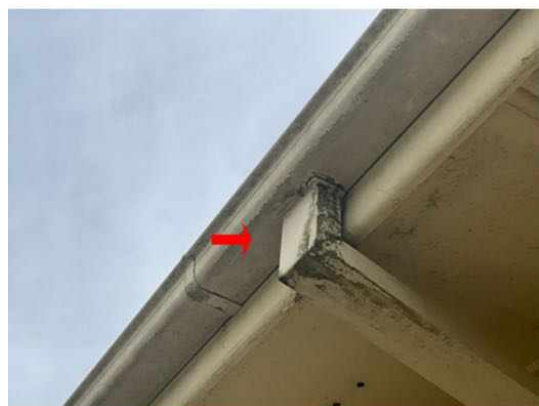
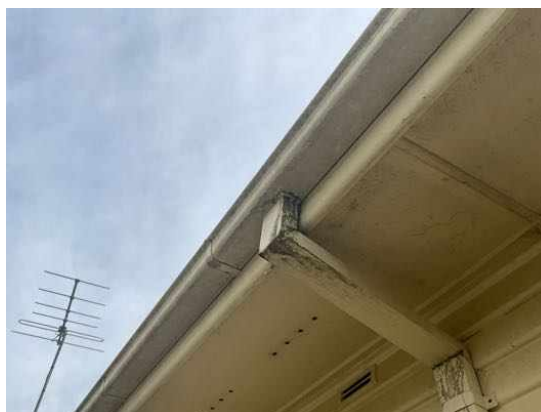
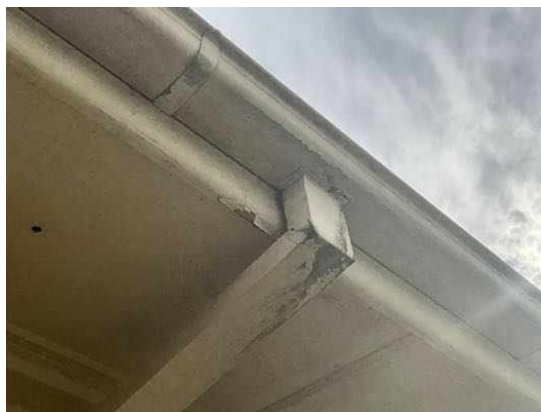
### Finding 3.07

Building:	Main Building
Location:	All Areas
Finding:	Downpipe leakage
Information:	The downpipes in the drainage system exhibit leaking water.

The leaking downpipes pose a risk of water damage to the building's foundation, exterior walls, and surrounding landscape. Prolonged exposure to moisture can lead to structural deterioration, mold growth, and compromised drainage.

A qualified plumber or roofing specialist should inspect and replace the leaking downpipes. Repair or replacement may involve fixing the areas, applying protective coatings, or installing new downpipes to ensure proper drainage and prevent further water damage. Early intervention is crucial to avoid escalating issues.

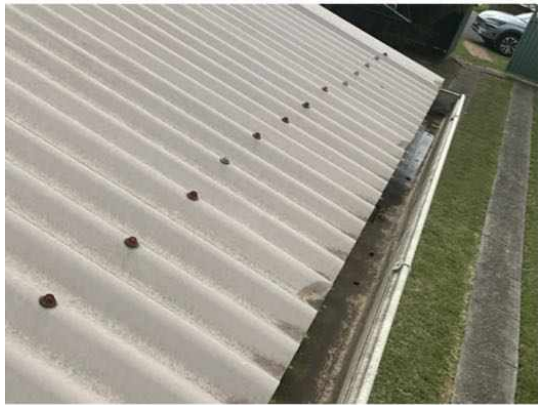
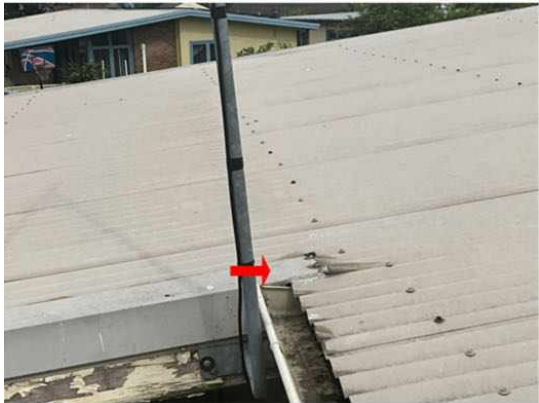
### Finding 3.08

Building:	Main Building
Location:	All Areas
Finding:	Roof Weathered - metal roof sheeting
Information:	The roof sheeting shows visible weathering, surface oxidation, and deterioration of fastener washers. Some sheet overlaps appear uneven and may not provide adequate weatherproofing at joints near the dormer. The sealant and flashing junctions also show signs of age and deterioration.

Prolonged weather exposure and rusting can lead to corrosion, potential roof leaks, and reduced lifespan of the sheeting. Deteriorated fasteners may allow water ingress, particularly around joints and penetrations.

Engage a licensed roofing contractor to inspect and maintain the affected areas. Replace rusted screws and washers, resecure loose or uneven sheets, and apply protective roof coating or repainting as required. Check flashings and sealants to ensure watertightness.

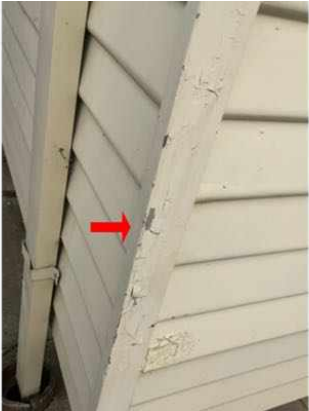
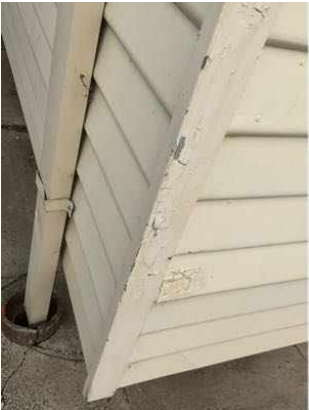
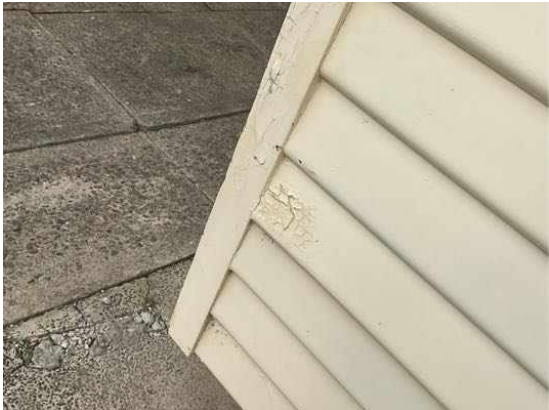
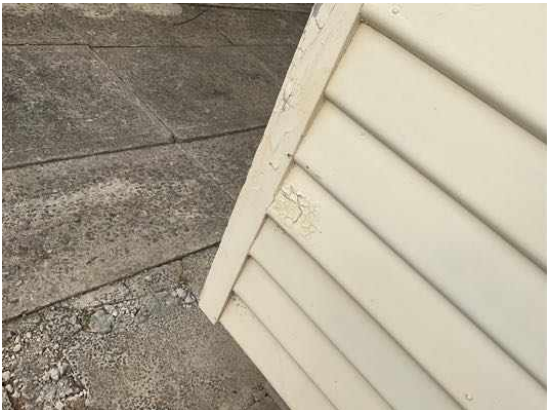
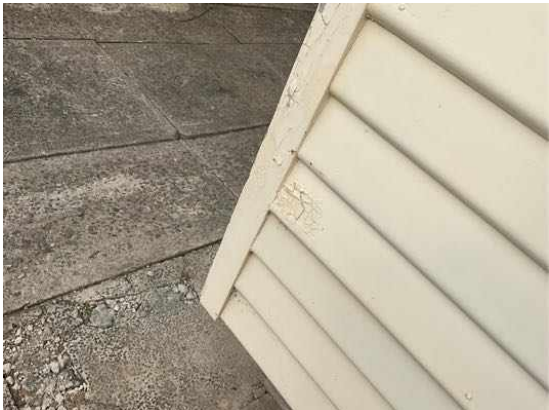
**Finding 3.09**

Building: Main Building  
Location: All Areas  
Finding: Flaky Paint  
Information: Sections of the paint in this area was found to have deteriorated. Paint deteriorating is generally an indication of excessive moisture in the area that is currently hidden by the painted surface.

The presence of excessive moisture can have major implications on associated building elements if left unattended. While only seemingly minor at this stage, the damage cannot be determined due to the paint, obstructing any further inspection of the damage.

It is highly advised that the affected paint to be cleaned to allow a further, more invasive inspection by a licensed builder/painter. Failure to act on this defect may necessitate major works in the future.

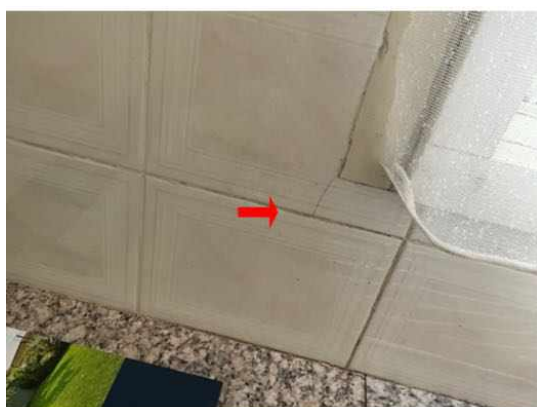
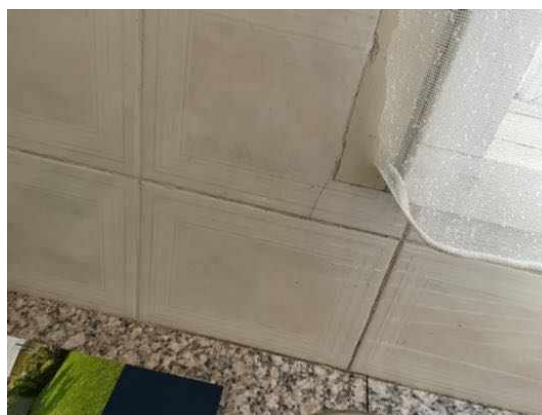
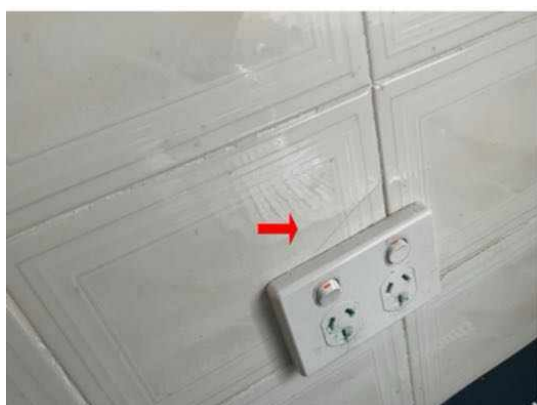
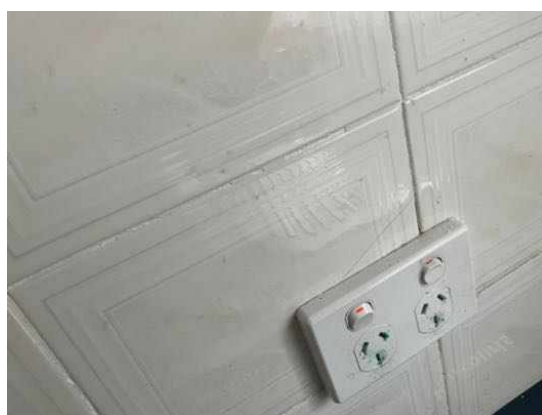
**Finding 3.10**

Building: Main Building  
Location: Kitchen  
Finding: Tiles - Cracked or damaged  
Information: Cracking was evident to the tiling in this area at the time of inspection. While the cracking appears to be minor, this area is frequently exposed to water, allowing

If left unmanaged, water penetration to these areas may lead to subsequent water damage, which is likely necessitate repair work to affected building elements.

A tiling contractor should be appointed to ensure that no further water damage occurs. The re-application of silicone and grouting throughout remaining tile work is also advised, to further protect the area against water penetration.

Where water penetration has led to water damage, appointment of a relevant tradesperson may be required to repair damaged building elements.

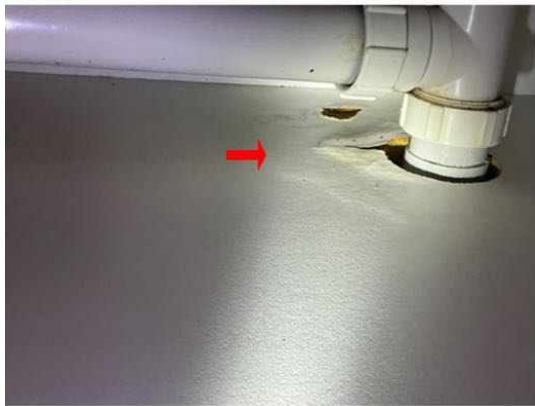
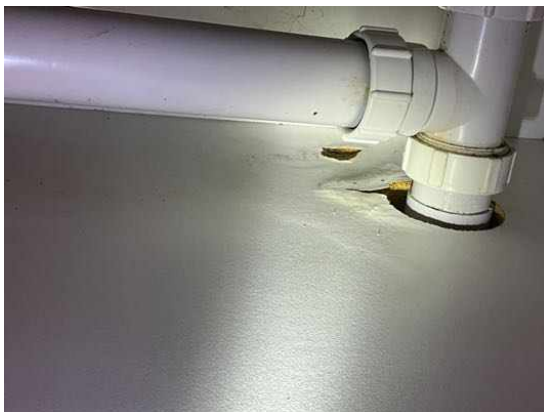
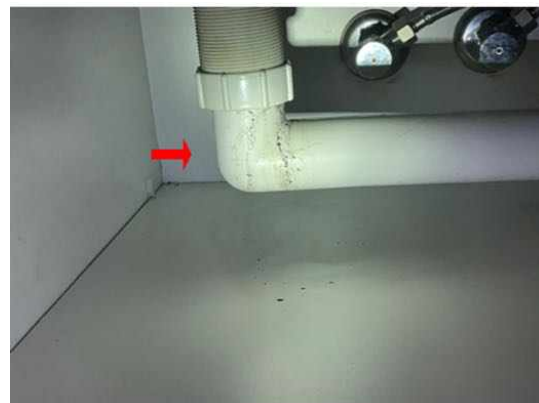
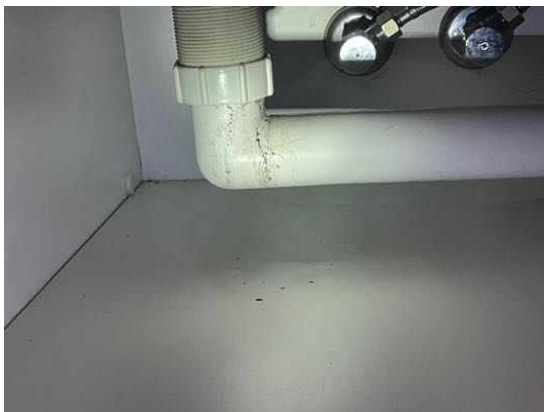
### Finding 3.11

Building:	Main Building
Location:	Kitchen
Finding:	Water damage / Vanity
Information:	"The vanity in the shower area has sustained water damage, resulting in swelling and discoloration of the wood, as well as potential structural issues. This damage compromises both the aesthetic and functional aspects of the vanity."

2. **Plumber:** If the water damage is due to plumbing issues, a plumber can fix leaks and ensure there are no further water-related problems.

3. **General Contractor:** If the damage is extensive and affects the surrounding area, a general contractor can coordinate the repair work, including both the vanity and any related structural or cosmetic repairs.

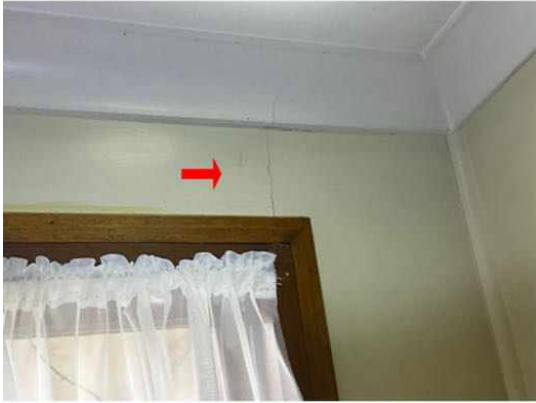
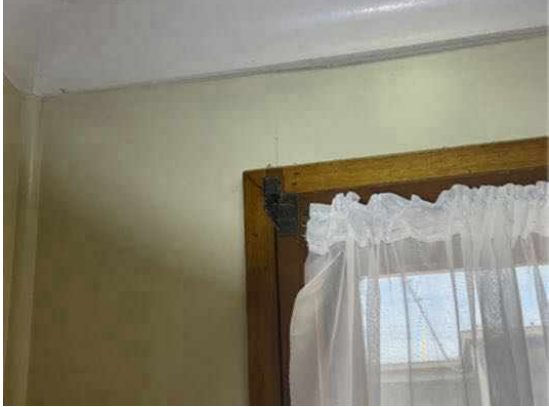
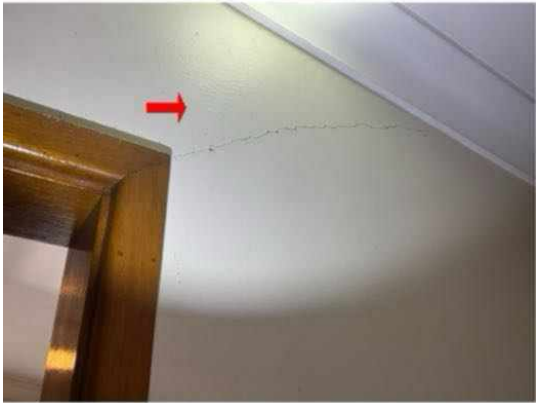
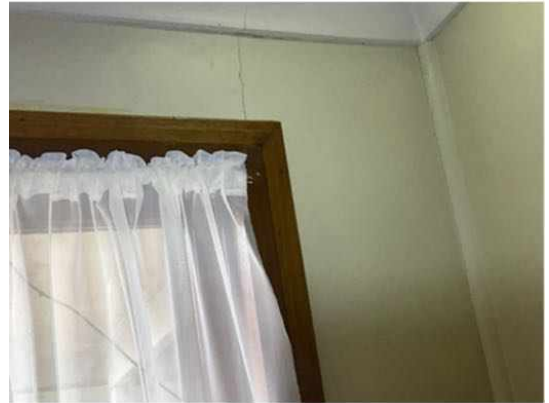
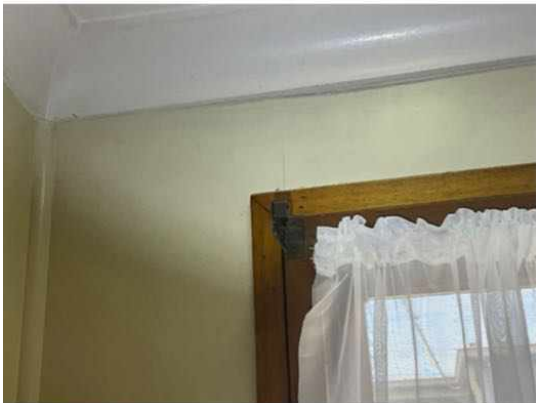
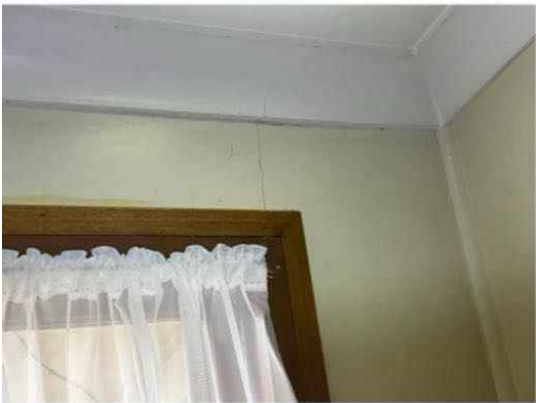
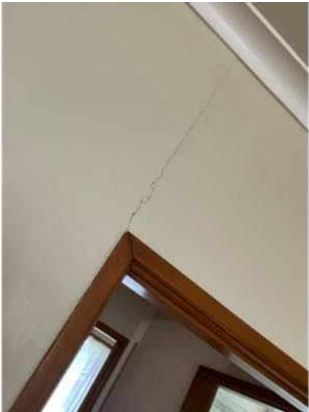
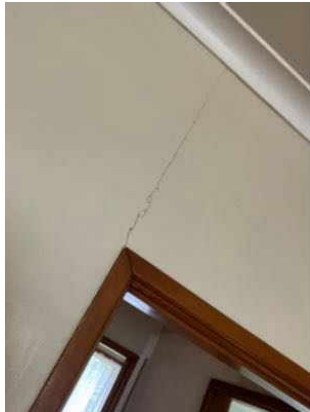
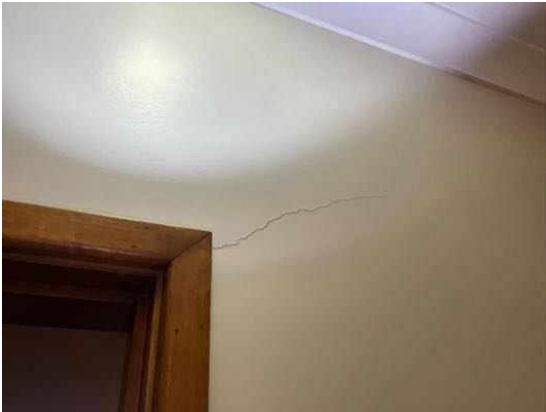
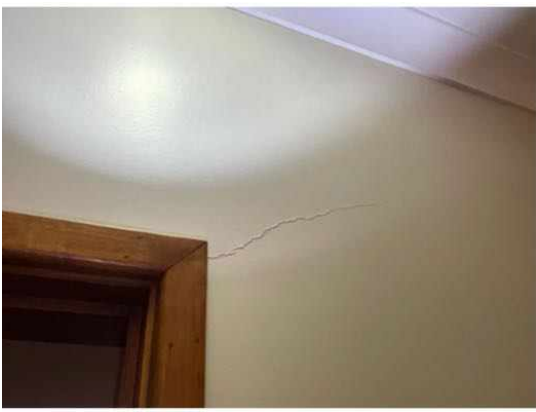
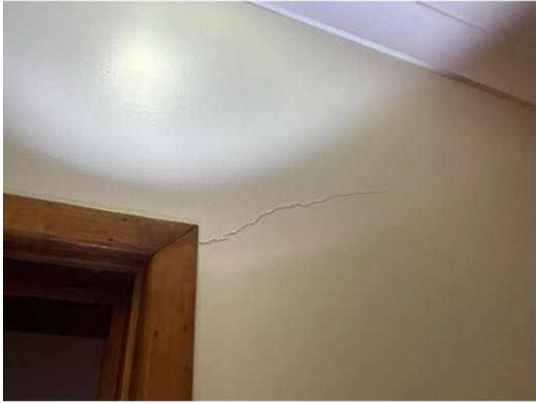
**Finding 3.12**

Building: Main Building  
Location: All Areas  
Finding: Gyprock - Crack ( Fine )  
Information: Fine cracks have appeared in the gyprock of the ceiling, suggesting potential issues with settling or structural movement.

The fine cracks in the gyprock ceiling pose a risk of further widening, compromising the aesthetic appeal of the space, and potentially indicating underlying structural problems.

A skilled plasterer or a contractor specializing in drywall repairs should assess the extent of the cracks and address them promptly. Identifying and fixing the root cause of the issue, whether related to settling or structural concerns, is essential to prevent further damage and maintain the integrity of the ceiling.

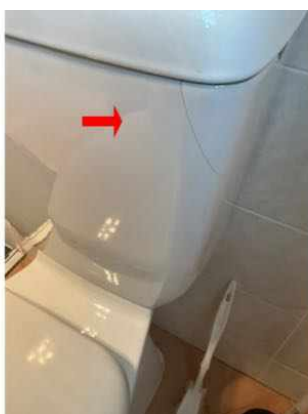
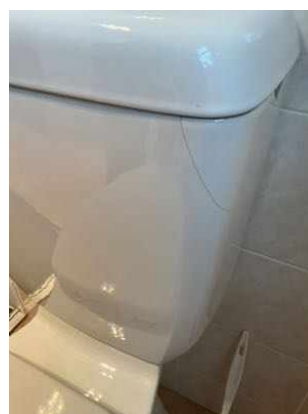
Finding 3.13

Building: Main Building  
 Location: Bathroom  
 Finding: Toilet flush tank cracked  
 Information: A crack has been identified in the flush tank, compromising its structural integrity and potentially causing water leakage.

Risk: The presence of a crack in the flush tank poses a risk of water leakage, leading to water wastage and potential damage to surrounding structures. If left unattended, it may result in increased water bills and damage to the bathroom or adjacent areas.

Resolution: A licensed plumber or a qualified technician should be contacted to assess and repair the cracked flush tank. Prompt action is necessary to prevent further water damage and ensure efficient functioning of the toilet. Ignoring the issue may lead to increased water consumption and additional repair costs.

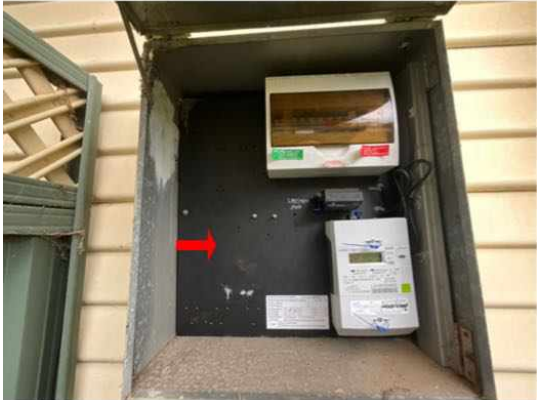
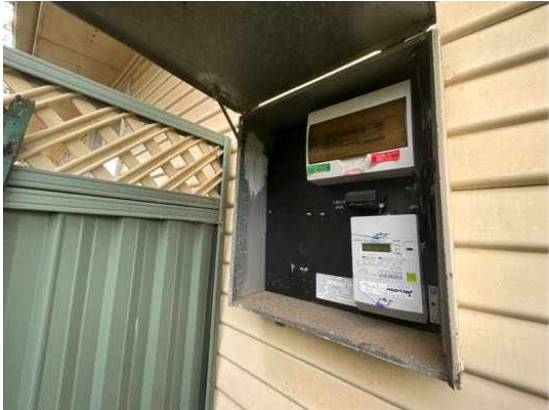
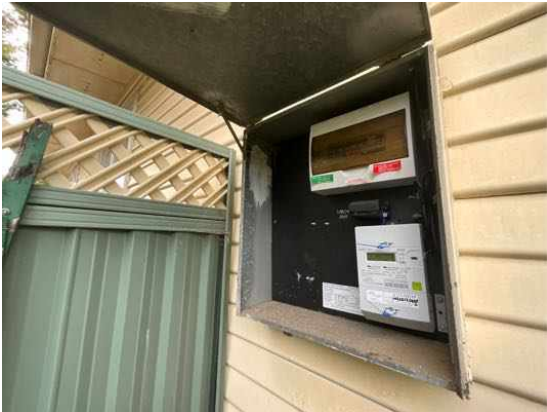
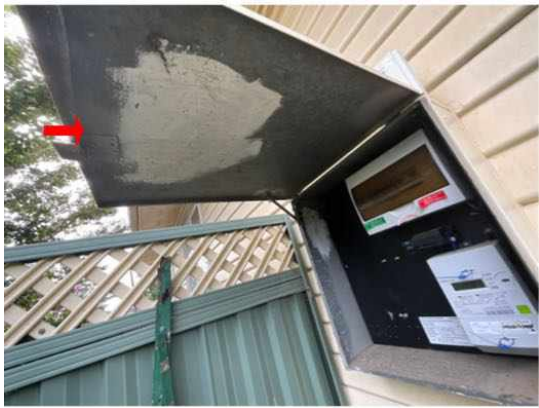
Building: Main Building  
 Location: Exterior walls - right side  
 Finding: No Evidence of Termite Management System - Durable notice / Legible Sticker  
 Information: The application of a pre & post-construction chemical termite barrier is highly recommended for all properties. Such barriers are highly effective in preventing termite attack on any timber building elements throughout the property.

A durable notice was not placed in the switchboard unit to indicate current termite barriers is legible at the time of inspection.

Client must seek further information from the vendor or real estate agent if the conditions of termite management systems were maintained.

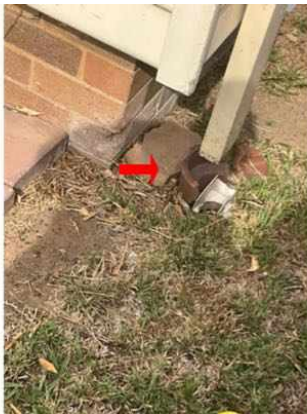
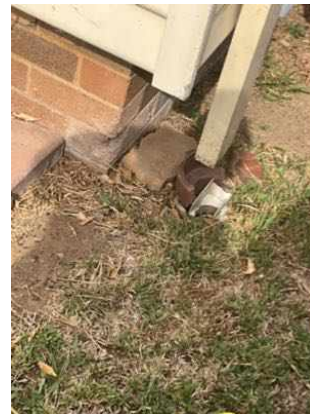
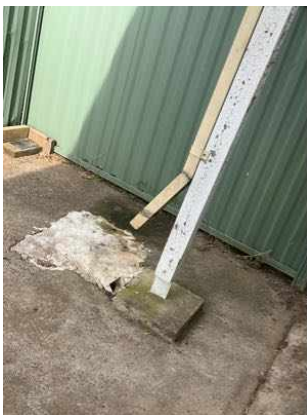
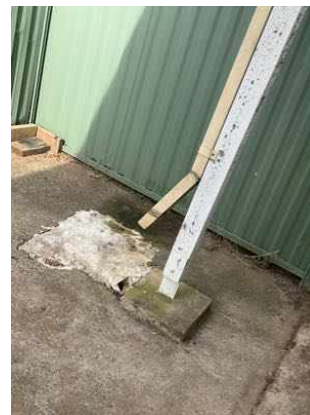
Building: Main Building  
Location: All Areas  
Finding: Downpipes not connected- Conducive conditions for timber pest  
Information: Unconnected downpipes can indeed pose a risk for attracting termites, as they

provide a source of moisture near a building's foundation. Termites are attracted to moisture and wood, so it's important to address this issue to prevent potential infestations. Connecting downpipes to the stormwater system or ensuring proper drainage away from the building can help mitigate this. A licensed plumber is the most qualified professional to handle plumbing-related tasks, including connecting downpipes to the stormwater system. They have the necessary expertise and tools to ensure proper installation.

Please remember that proper installation is essential to ensure effective drainage and prevent future issues, so it's often best to hire a qualified professional, especially for complex or extensive downpipe installations.

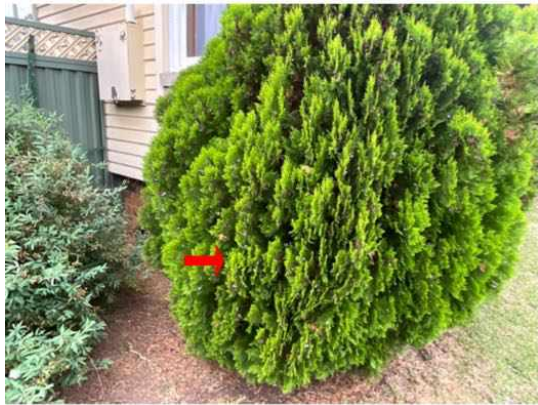
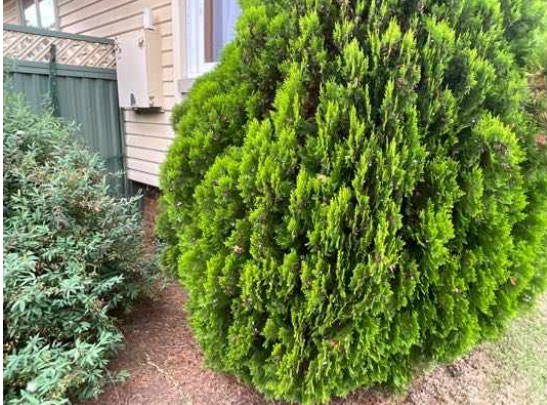
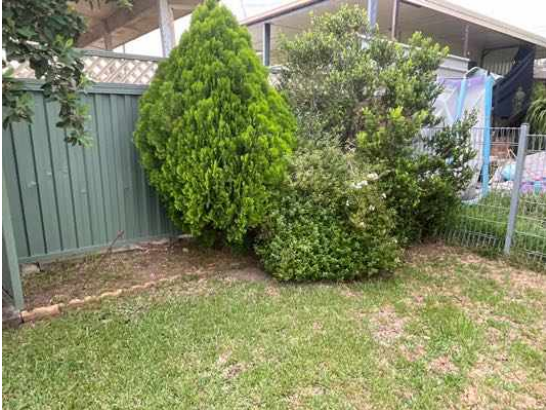
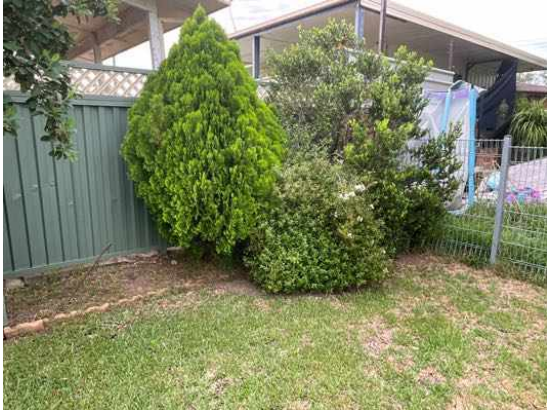
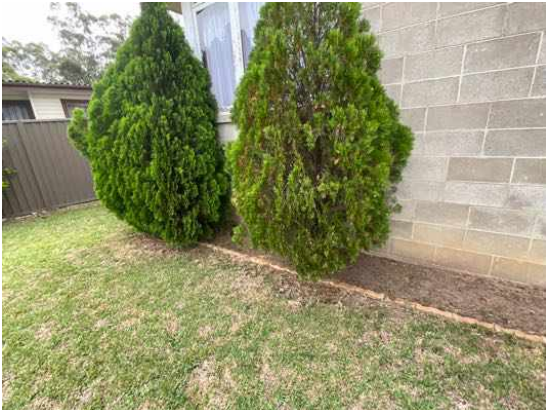
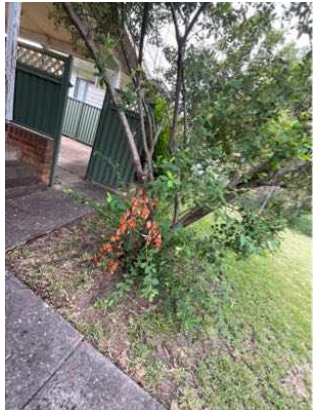
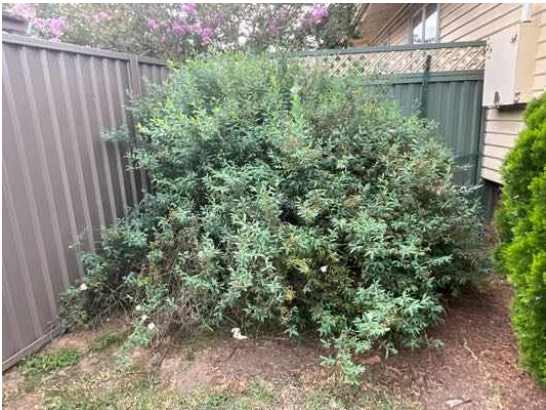
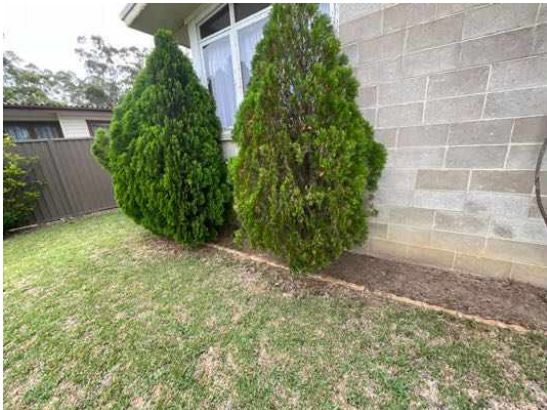
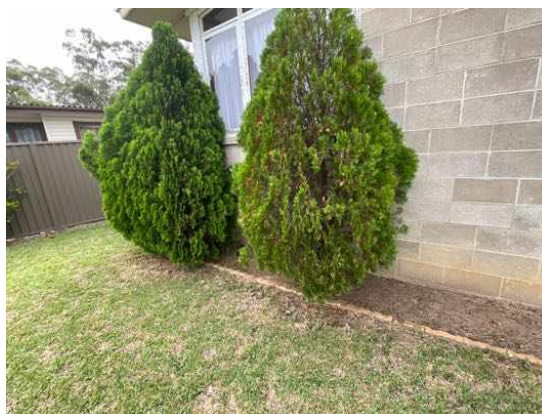
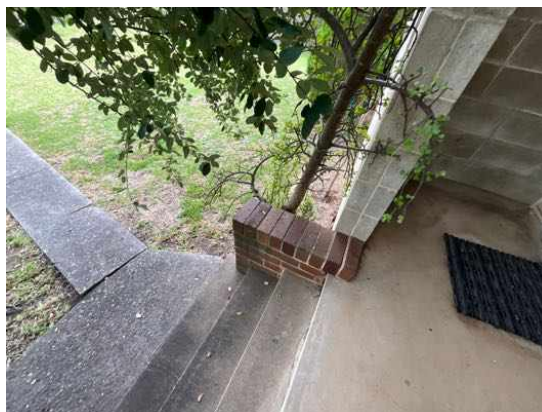
### Finding 6.03

Building:	Main Building
Location:	All Areas
Finding:	Dense vegetation around a property can increase the risk of termite infestation
Information:	The presence of dense vegetation around a property can increase the risk of termite infestation, as it provides a conducive environment for them. To address this, consider maintaining a clear space between the vegetation and your home. If you suspect a termite issue, it's advisable to consult with a licensed pest control professional for inspection and treatment.

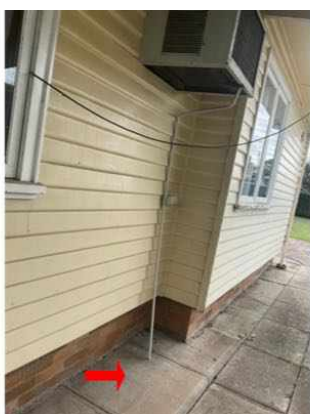
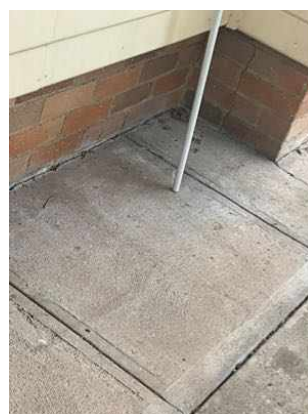
### Finding 6.04

Building:	Main Building
Location:	All Areas
Finding:	Aircon - Excessive moisture conducive condition near Air-conditioner
Information:	<p>Excessive moisture near an air conditioner can indeed create conducive conditions for termites. Termites are attracted to damp and decaying wood, which can be found in areas with high moisture levels. To fix this issue:</p> <ol style="list-style-type: none"> <li>1. Fix Leaks: Check for any leaks or condensation around your air conditioning unit. Repair any damaged pipes, drains, or insulation that may be causing moisture buildup.</li> <li>2. Proper Drainage: Ensure that your air conditioner has proper drainage. Make sure the condensate drain line is clear and directed away from your home's foundation.</li> <li>3. Ventilation: Improve ventilation around the unit. Ensure that the area is well-ventilated to reduce humidity levels.</li> <li>4. Regular Maintenance: Schedule regular maintenance for your air conditioning system. This can help prevent leaks and ensure</li> </ol>

5. Please consult a HVAC Technician: HVAC (Heating, Ventilation, and Air Conditioning) technicians are trained to diagnose and

repair a wide range of air conditioning problems. They can handle issues with the cooling system, refrigerant, electrical components, and more.

6. Consult an appropriate and Qualified Professional: For severe moisture issues or persistent termite problems, consult with a

pest control professional who can provide targeted solutions.

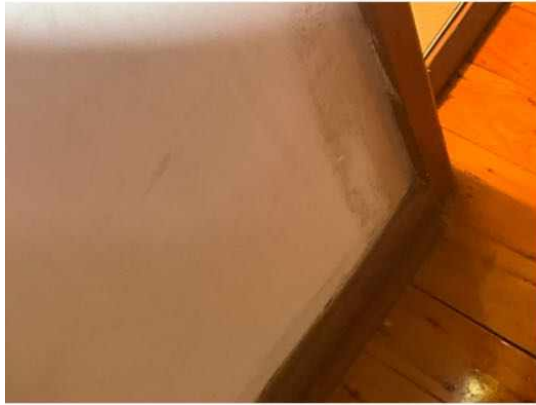
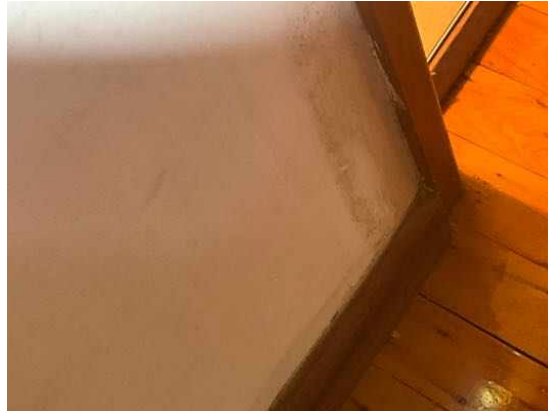
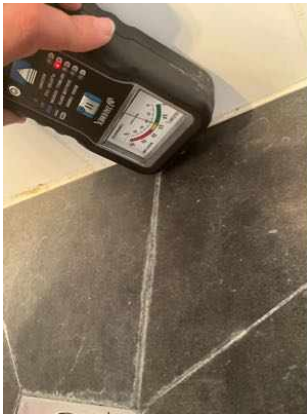
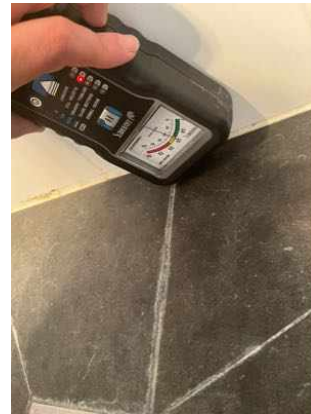
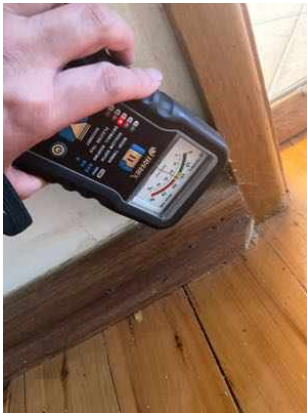
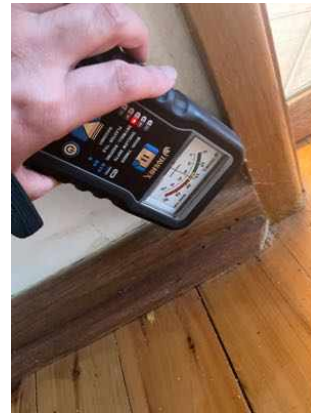
### Finding 6.05

Building:	Main Building
Location:	Bathroom
Finding:	Excessive moisture - Conducive to Timber pest
Information:	Excessive moisture can attract termites and produce conditions that promote fungal growth and wood decay.

Excessive moisture is generally caused by deteriorated inadequate or missing roof drainage leaking plumbing pipes or fixtures poorly plumbed HWS overflows or condenser units and poor site drainage.

If mould growth has been found there may be environmental biological or health issues involved. In these cases an appropriately qualified inspector should also be contacted.

Prior to any remedial works being performed a qualified plumber should be appointed to further inspect the property and to identify the cause of the excessive moisture. Works to remove affected building elements may then be necessary and should be performed by an appropriate tradesperson.
