# Building and Timber Pest Inspection Report

Inspection Date: Wed, 25 Feb 2026

Property Address: 5 Cusack Pl, Blackett NSW 2770, Australia

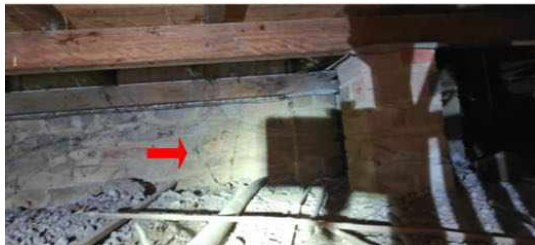
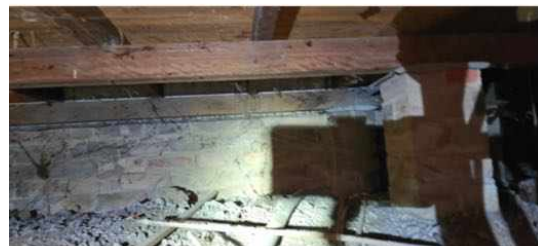
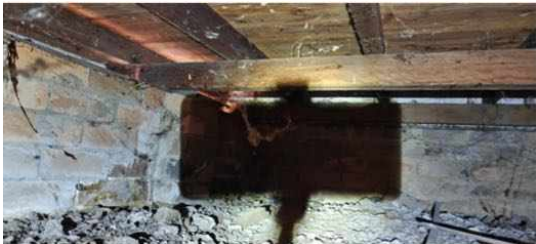
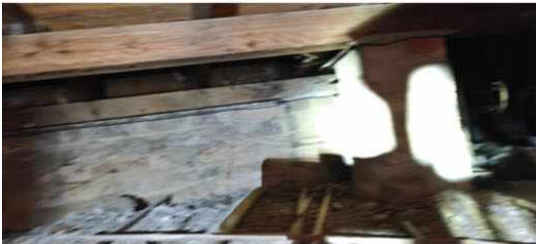
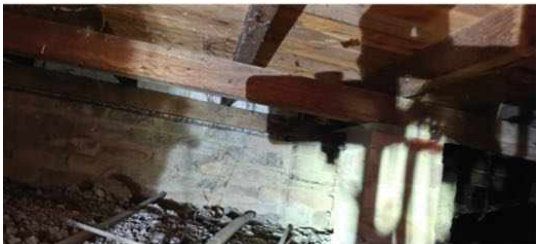
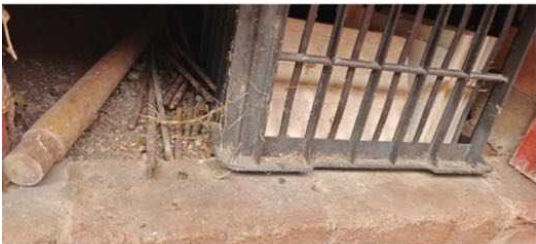
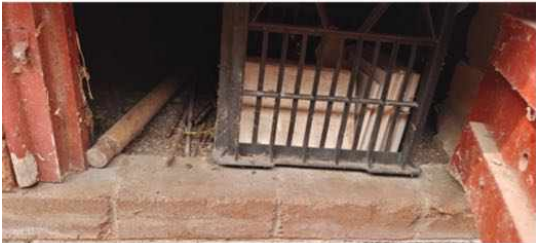
### Finding 6.06

Building: Main Building  
 Location: Bathroom  
 Finding: Subfloor - poor ventilation, inadequate site drainage, water stains  
 Information: The subfloor lacks adequate ventilation, suffers from inadequate site drainage, exhibits water stains, creating conducive conditions for timber pests such as termites.

Risk: The combination of poor ventilation, inadequate drainage, water stains significantly increases the risk of timber pest infestations. Termites are attracted to moist environments and can thrive in subfloors with high humidity levels and water

damage. The lack of proper ventilation and drainage exacerbates moisture retention, providing an ideal habitat for timber pests to establish colonies and cause extensive damage to the subfloor structure. Additionally, water stains indicate previous or ongoing moisture issues, which further attract timber pests and contribute to the deterioration of timber materials.

A licensed pest control professional specializing in timber pest management should be consulted to assess the extent of the infestation and develop a comprehensive treatment plan. They can implement strategies to eliminate existing timber pests, such as termites and prevent future infestations by addressing underlying moisture issues. Additionally, a qualified plumber or builder may be needed to improve subfloor ventilation, enhance site drainage, repair water-damaged areas. Regular inspections and maintenance are essential to ensure ongoing protection against timber pests and maintain the structural integrity of the subfloor.

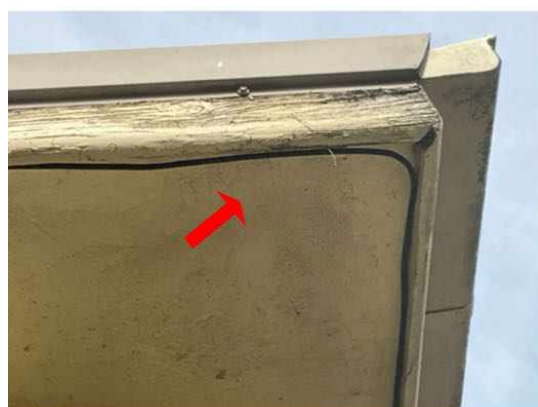
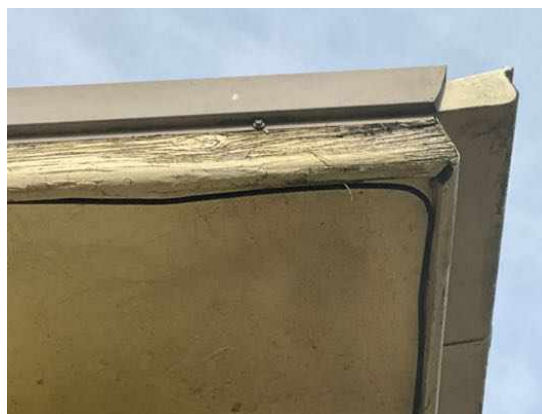
### Finding 7.01

Building:	Main Building
Location:	All Areas
Finding:	Wood rot
Information:	This building element shows evidence of wood rot. Wood rot, also known as Fungal Decay, occurs when timbers and other cellulose building materials are exposed to damp conditions on an ongoing basis. This could be the result of exposure to weathering over a prolonged period of time, or the attraction of excessive moisture from other abutting building materials. Contributing factors also include poor air ventilation in the area.

Wood rot is often associated with general damp problems and is evidenced by a 'musty' smell or mould and mildew occurring on surfaces. If left unmanaged, damp conditions can lead to further health problems and the decay of timbers will continue.

Early intervention and regular maintenance, particularly of exterior timbers, will prolong the useful life of these building elements. Prior to any works being performed, the cause of the moisture that has created the visible wood rot should be identified and addressed in a suitable manner. Replacement of affected timbers may then be a necessary step in protecting surrounding building elements from such deterioration.

A qualified plumber may be appointed to assess the cause of excessive moisture and to provide advice on any remedial works as required. A qualified carpenter or registered builder may also be required to replace affected building materials.

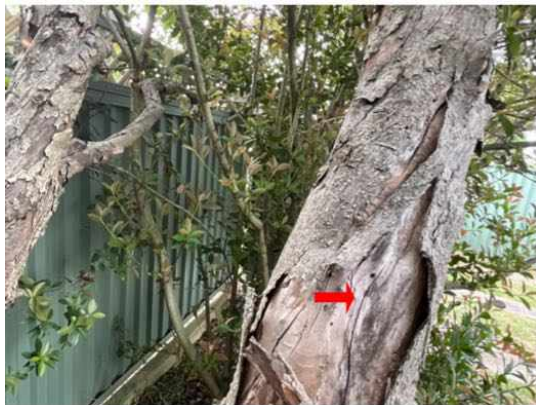
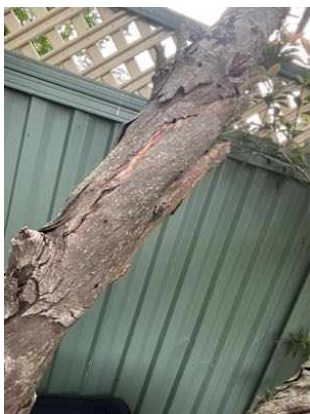
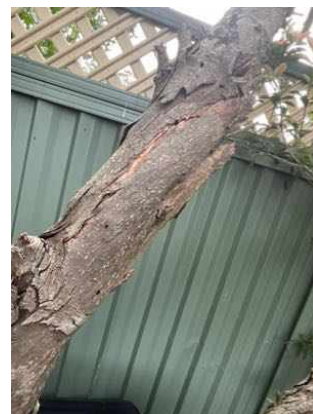
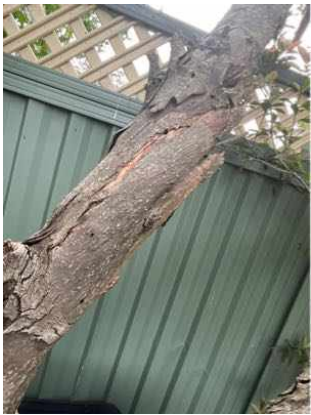
Building:	Main Building
Location:	Yard - Front
Finding:	Wood Borer Activity - Trees
Information:	Numerous small to medium-sized exit holes and surface tunnelling marks were noted along the trunk and branches of a dead standing tree. The pattern and shape of the damage are consistent with wood borer infestation. No live activity was observed at the time of inspection, though damage is clearly evident.

- The tree maybe structurally compromised and may pose a fall or safety hazard, especially during wind events.
- Proximity to structures or power lines may increase the risk of damage or injury.
- Although native borers are not typically a threat to treated structural timbers, their presence indicates decay and weakened wood that could attract secondary pests.

- Engage a qualified arborist to assess the structural integrity of the tree and arrange for safe removal if required.
- If the tree is within falling distance of a building, fence, or utility infrastructure, urgent removal is recommended.
- Regular site monitoring is advised for surrounding trees to detect any early signs of similar pest activity.

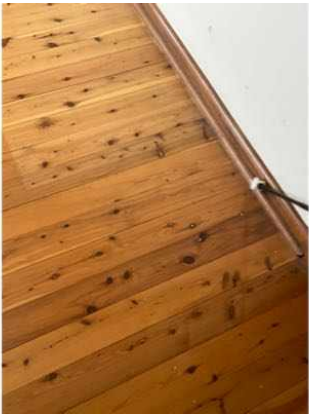
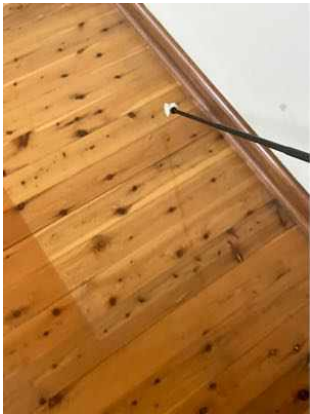
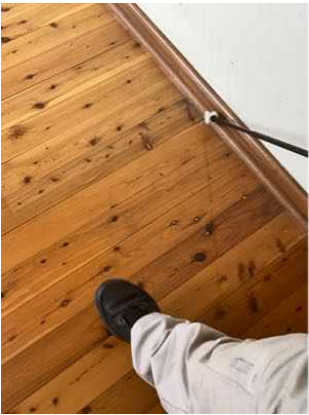
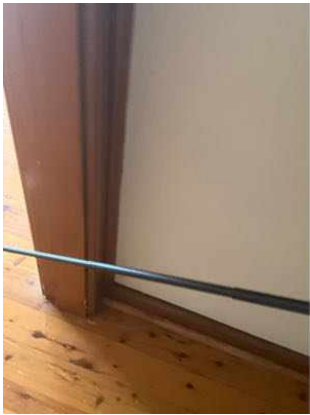
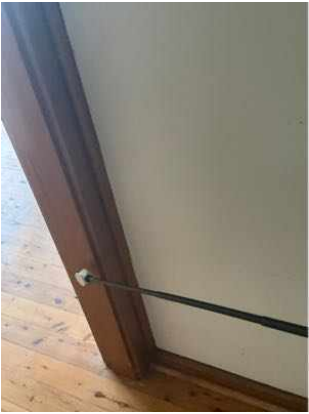
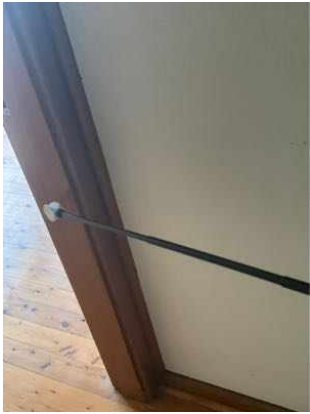
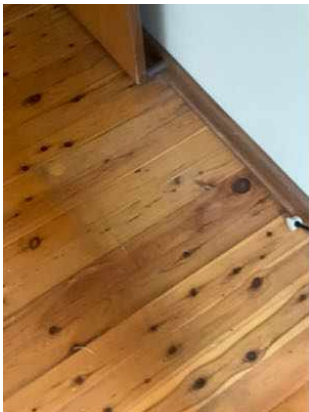
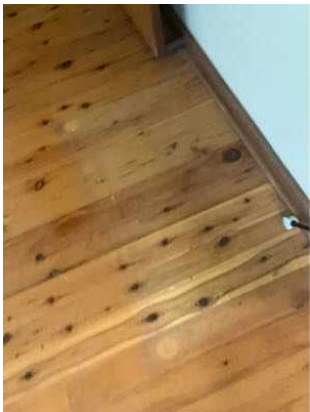
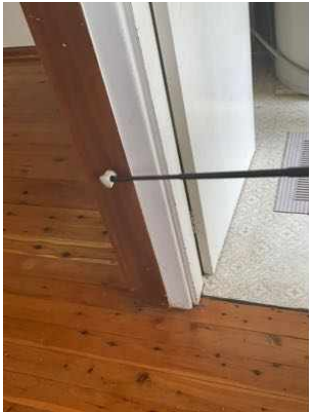
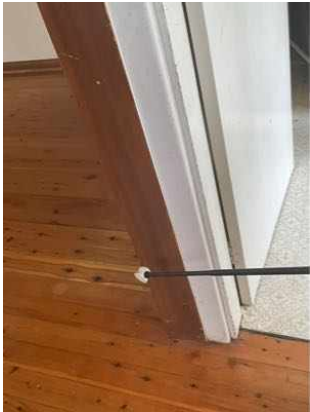
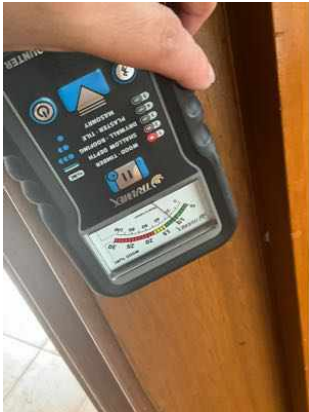
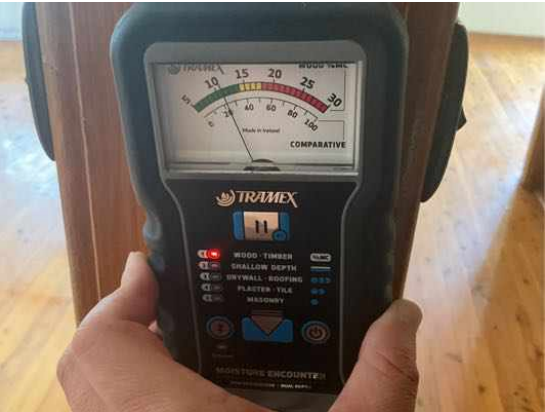
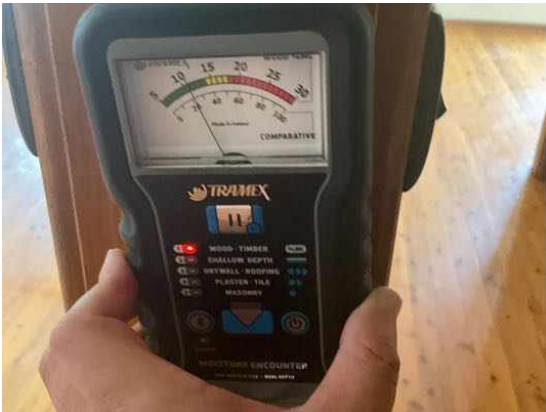
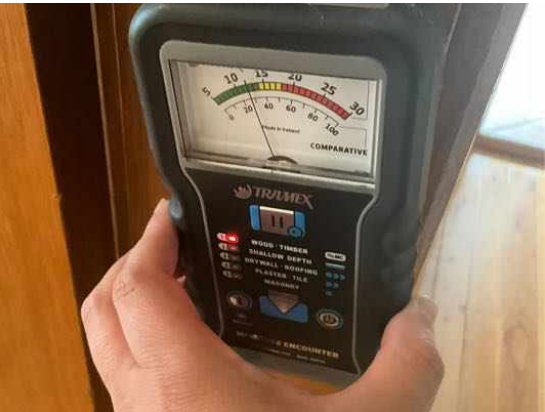
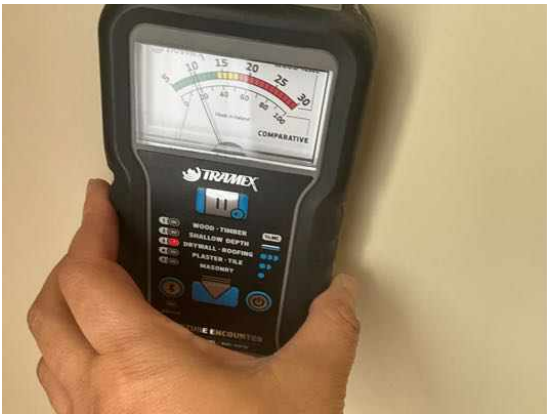
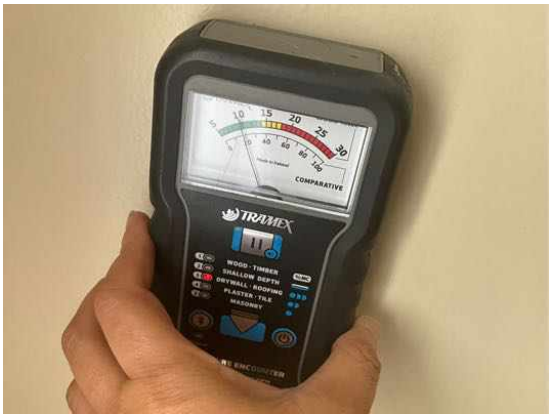
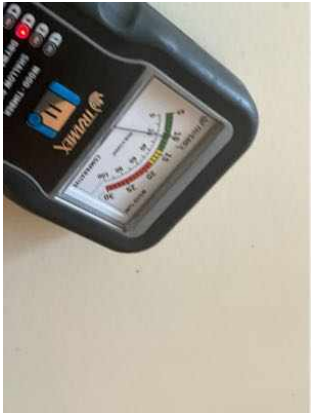
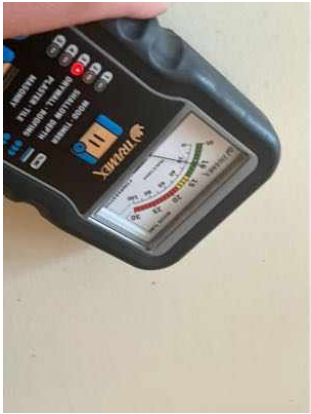
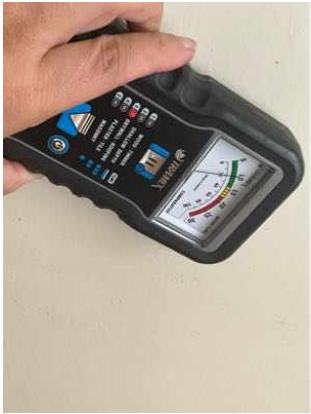
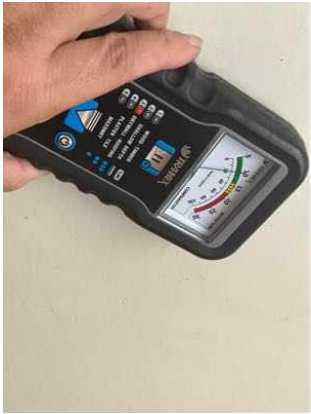
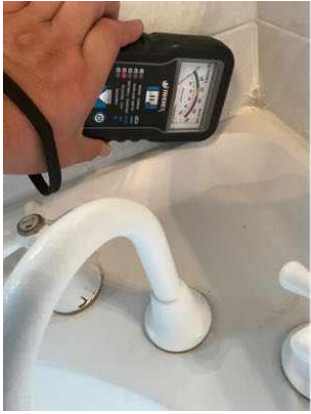
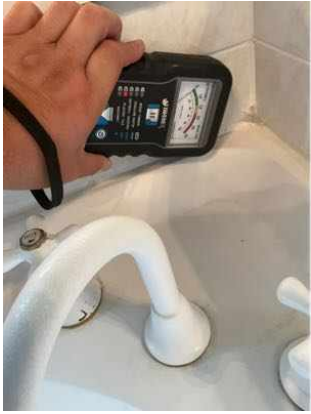
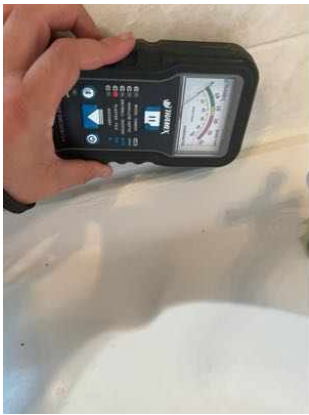
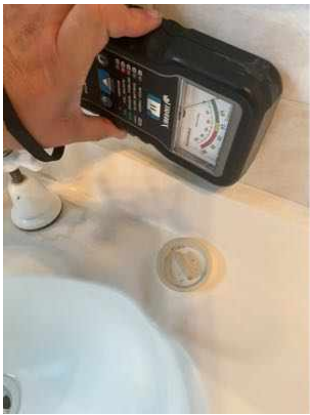
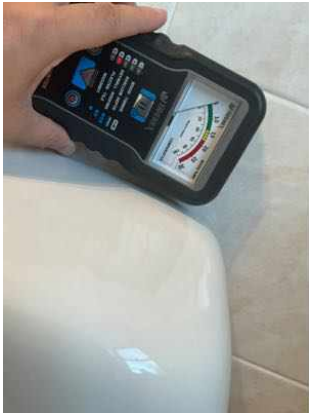
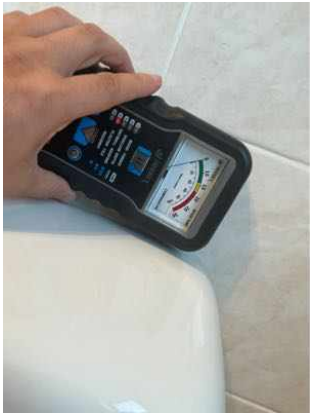
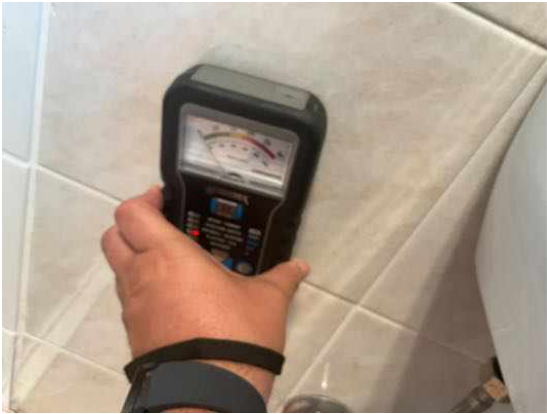
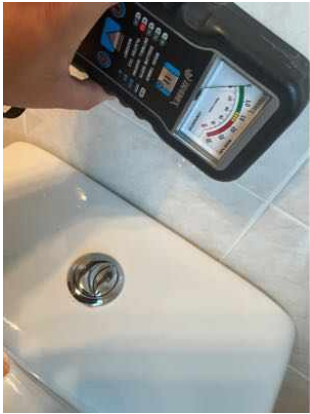
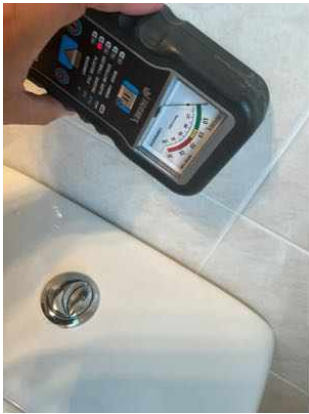
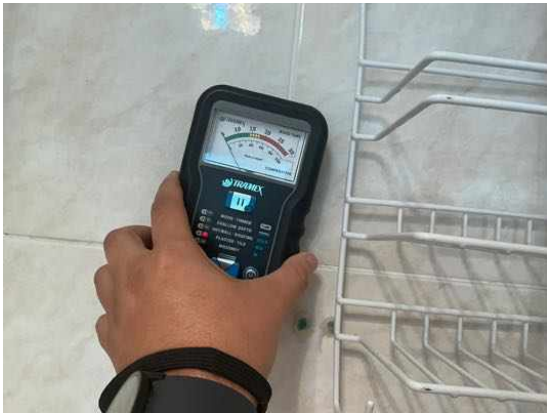
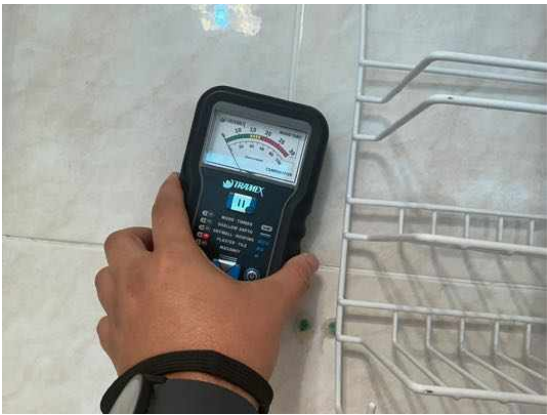
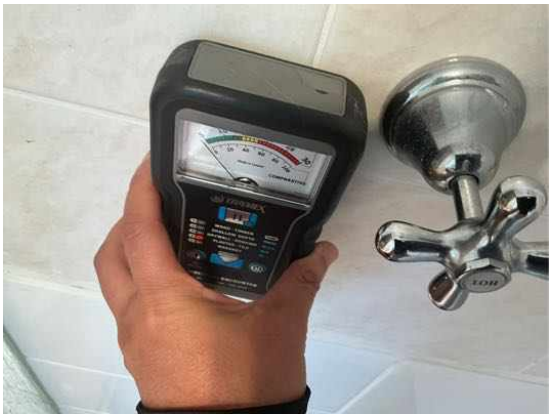
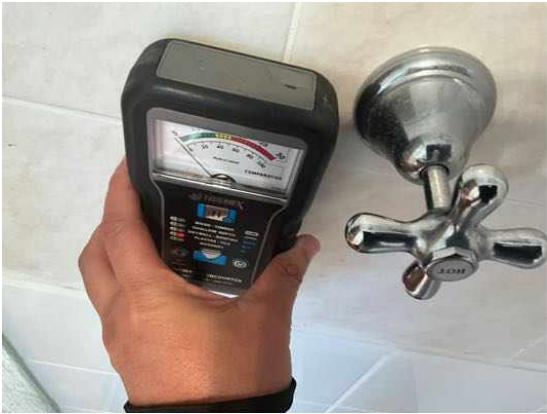
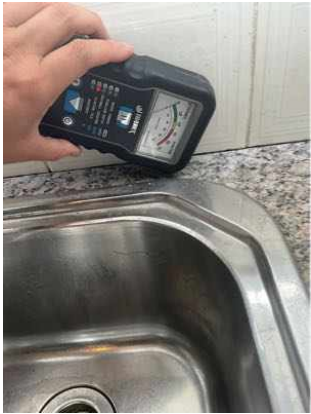
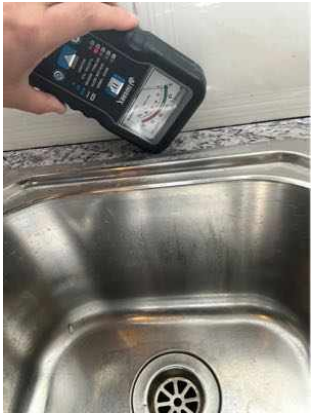
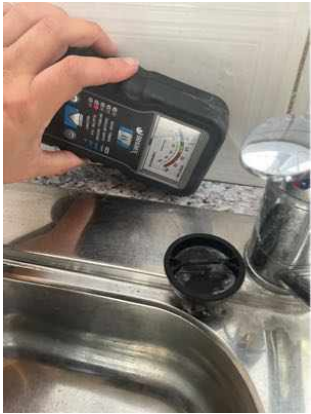
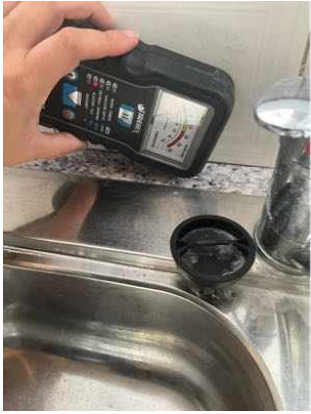
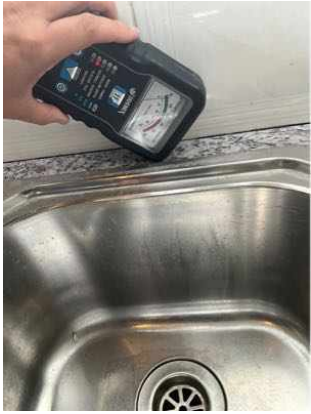
Building: Main Building  
Location: All Areas  
Finding: Additional Photos  
Information: Additional photos are provided for your general reference

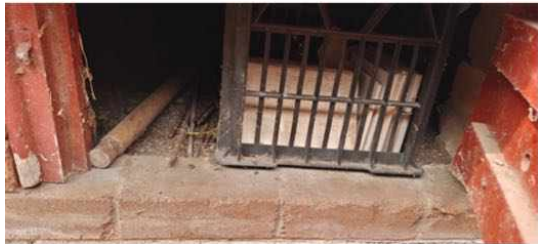
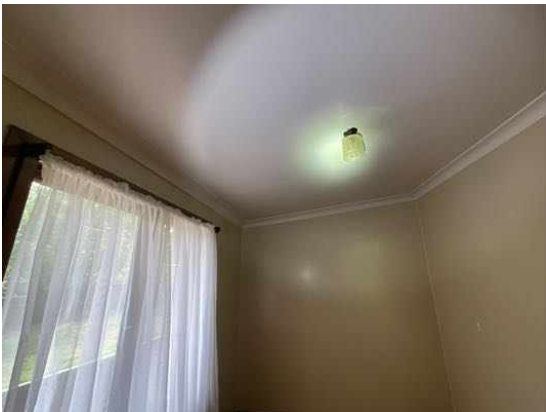
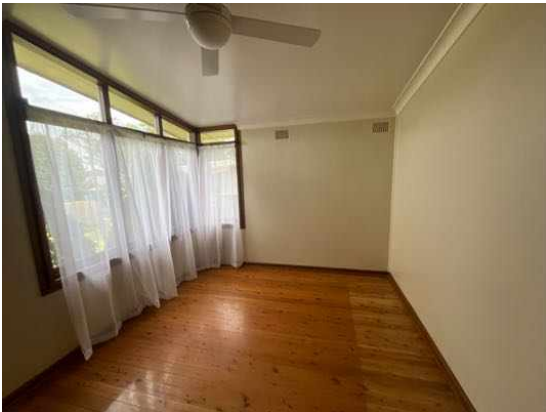
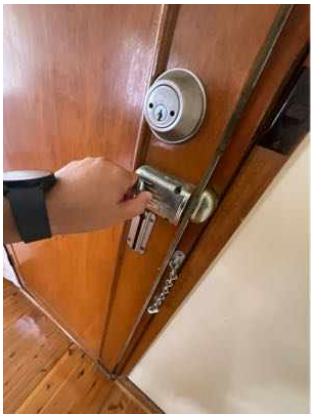
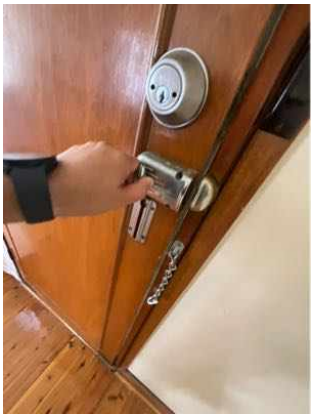
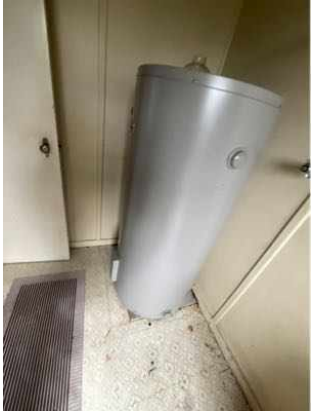
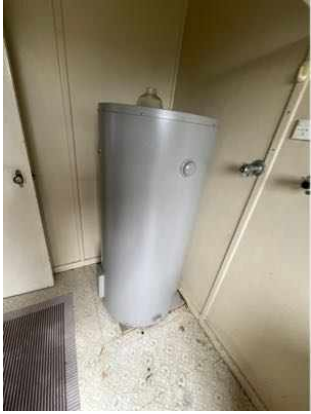
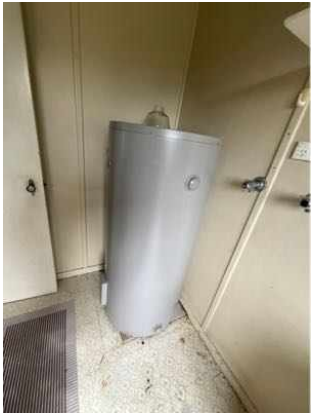
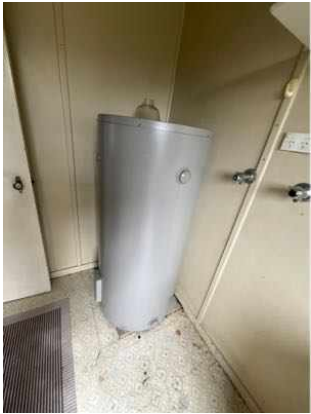
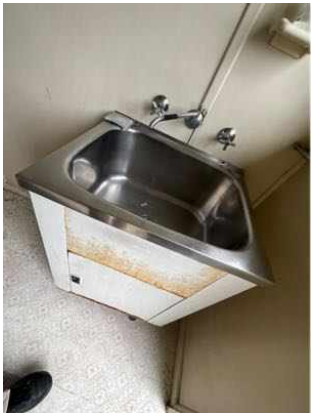
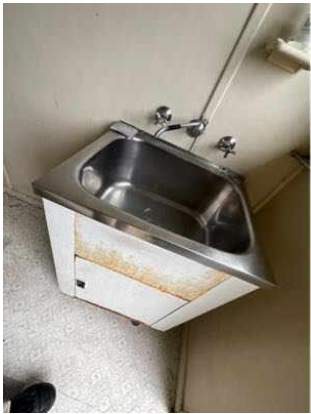
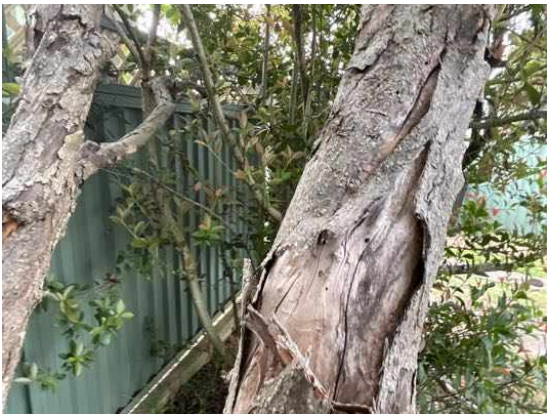
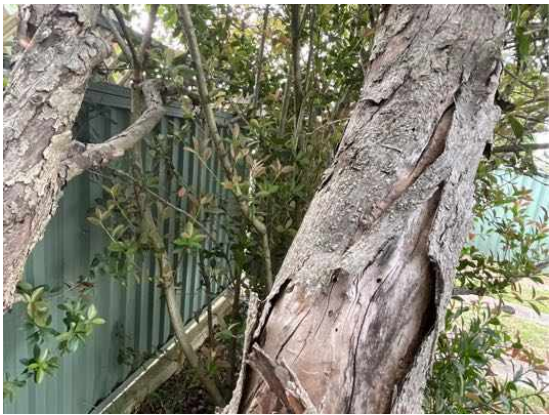
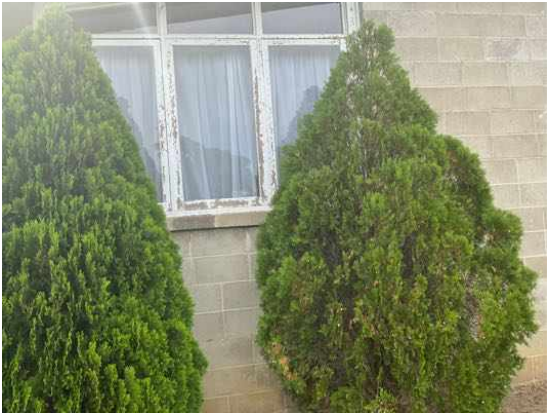
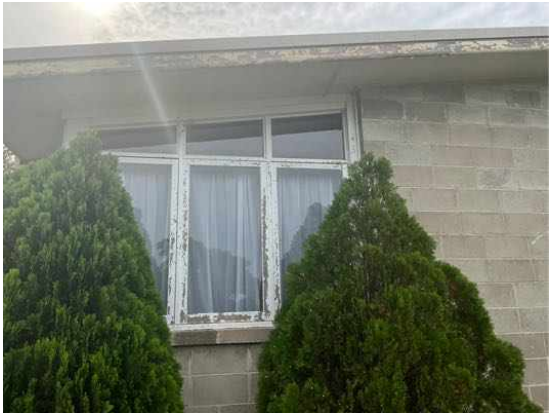
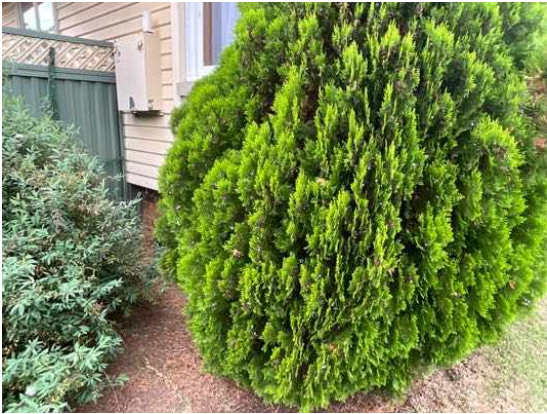
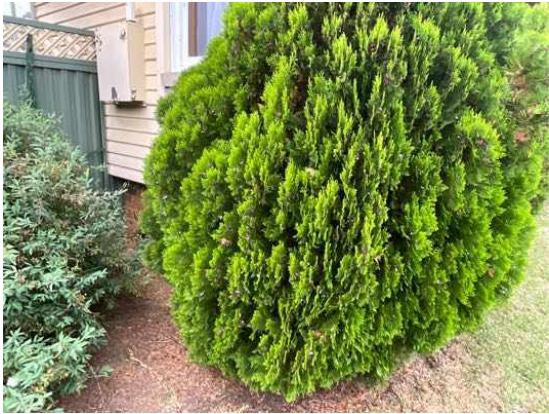
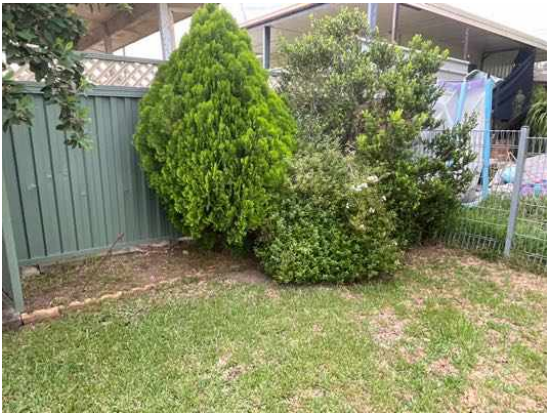
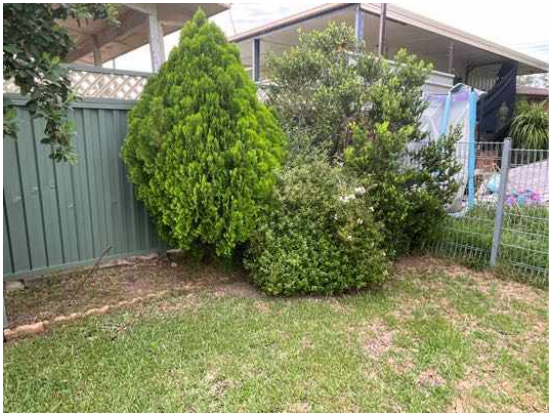
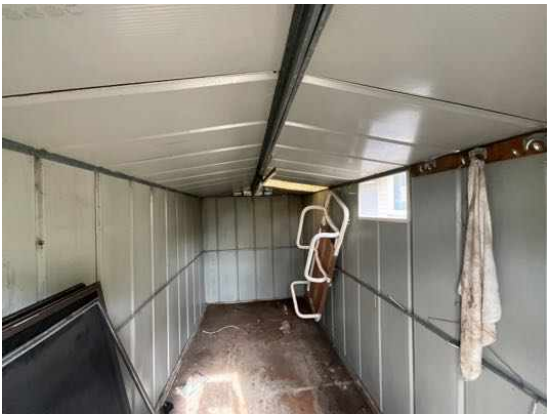
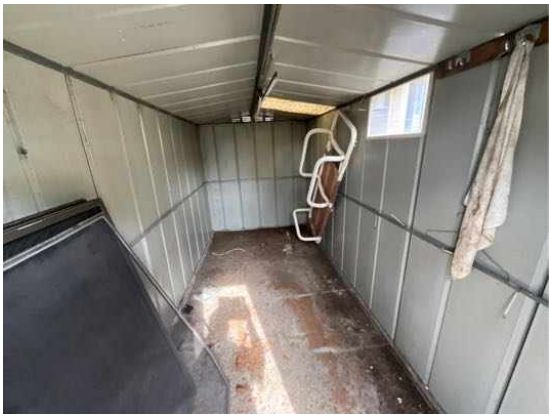
Building: Main Building  
 Location: All Areas  
 Finding: Additional Photos - Obstructions and Limitations  
 Information: These photographs are an indication of the obstructions and limitations which impeded full inspection of the property at the time of inspection. These obstructions can hide an array of defects and should be removed to allow full inspection to be carried out. A re-inspection is recommended once the areas are made accessible.
