# Building and Timber Pest Inspection Report

Inspection Date: Thu, 12 Feb 2026

Property Address: 17 Jindabyne Ave, Baulkham Hills NSW  
2153, Australia

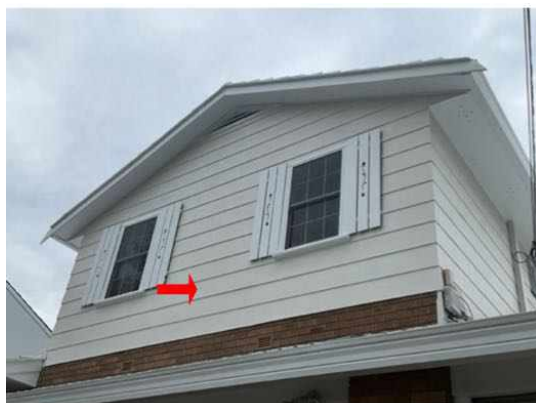
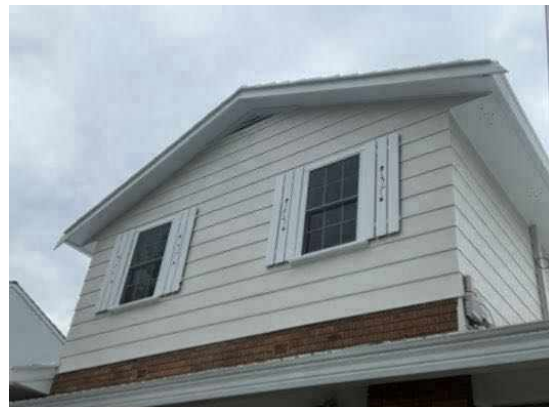
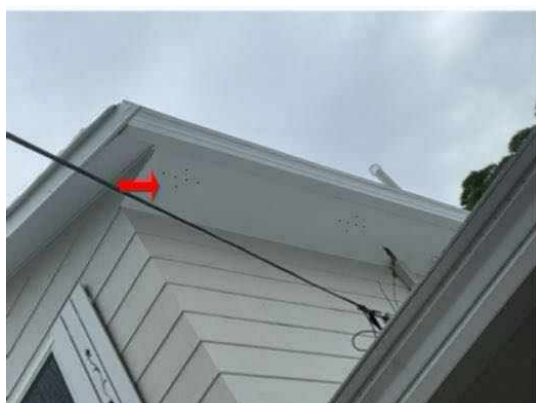
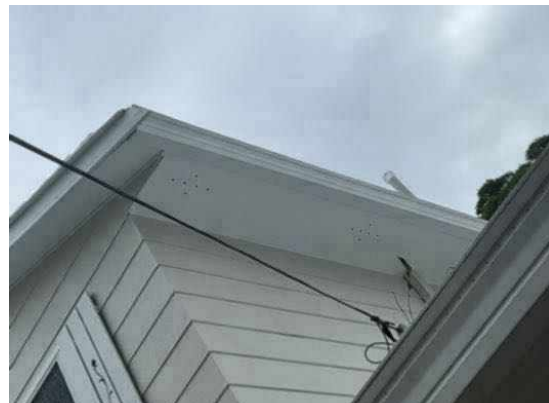
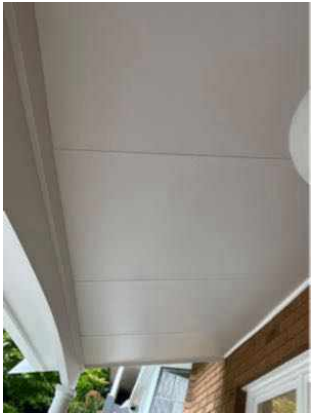
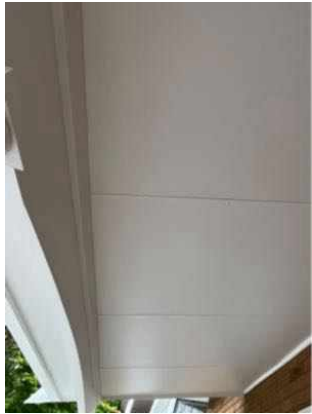
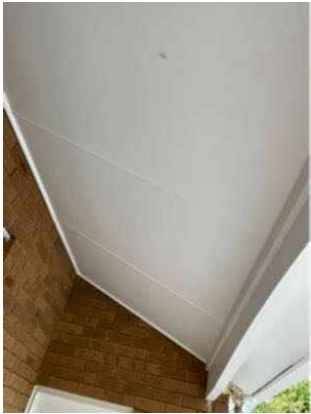
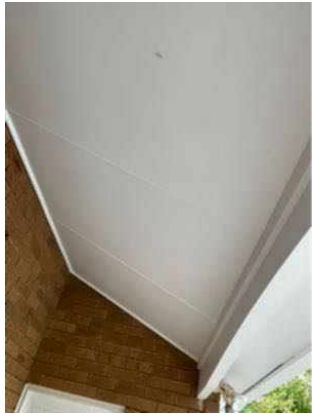
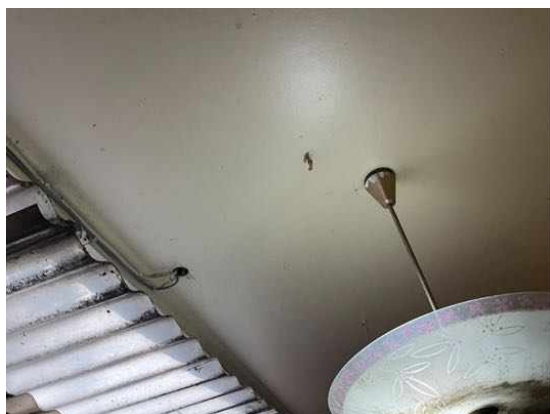
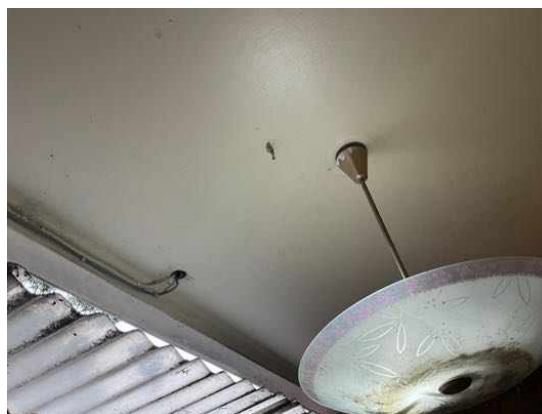
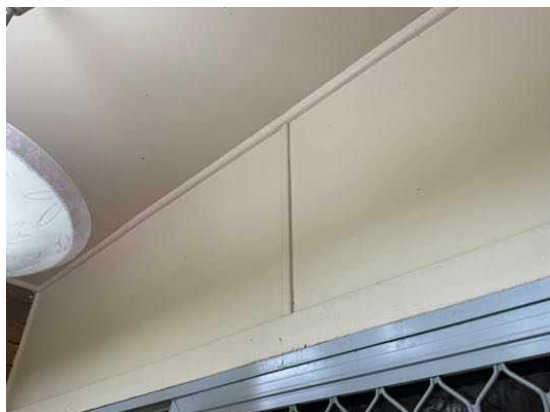
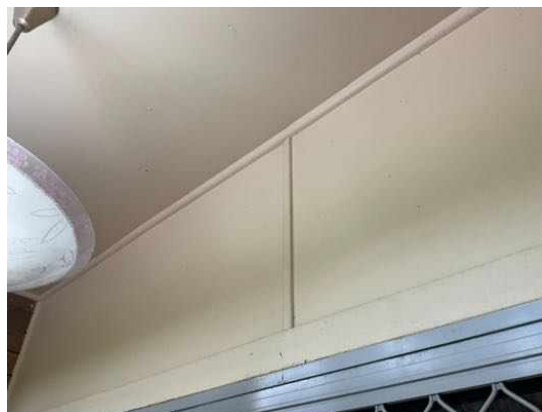
Building:	Main Building
Location:	All Areas
Finding:	Asbestos - Suspected ACM Identified on Site
Information:	Reporting on Asbestos is outside the Scope of this Report. This suspected defect is highlighted as a caution only. We suspect, based on our experience in the building industry, that there is a higher risk of the identified building element containing asbestos.

As Asbestos Reporting is outside the scope of this report, we advise that you consider a separate Asbestos Inspection and Condition Audit, which can include the taking of samples for definitive confirmation of the presence of Asbestos.

In the interim, the client is advised to act with caution, especially when considering any damage to building materials general wear and tear renovations extensions demolition and general maintenance activities due to the suspected presence of Asbestos.

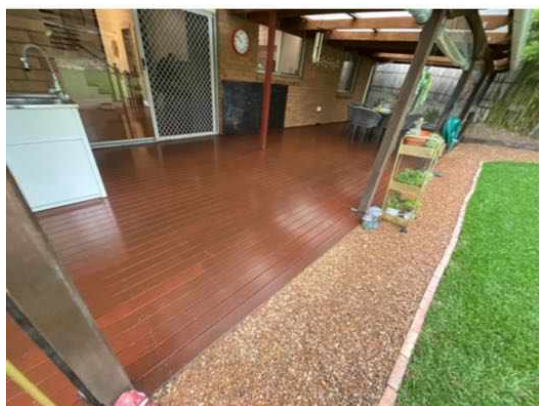
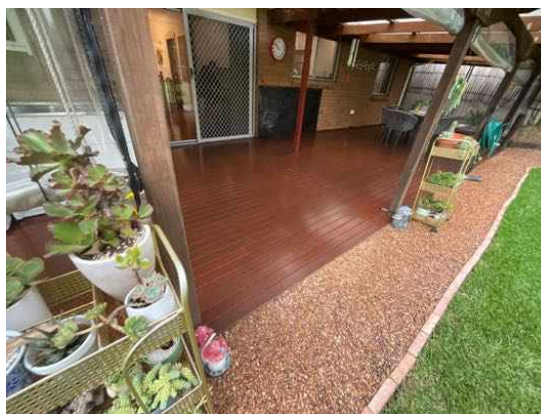
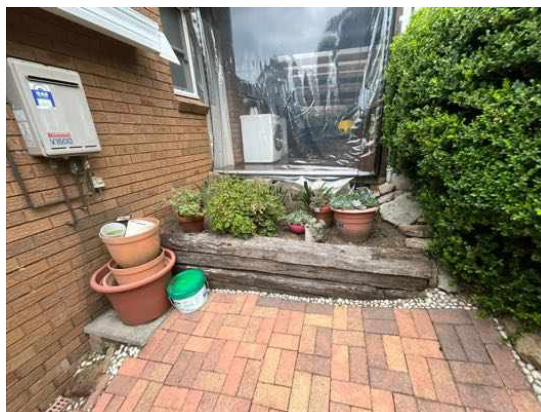
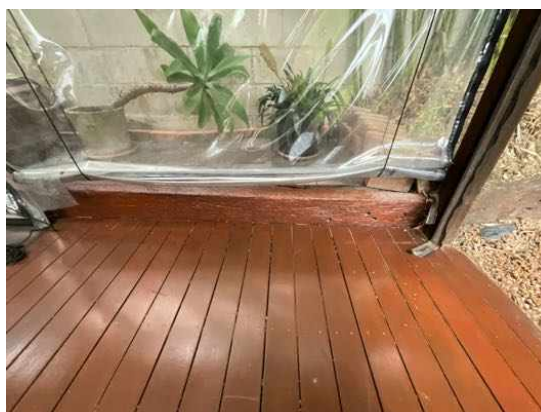
### Finding 1.02

Building:	Main Building
Location:	Deck
Finding:	External timber balcony or deck-structural stability
Information:	The load capacity of the external balcony or deck could not be verified during the inspection.

External timber structures are also constantly exposed to weather deteriorates in an exhilarate manner, ongoing assessments are required.

It is highly recommended that a structural engineer further, assess the external timber balcony or a deck to inform the client of its load capacity.

Regular maintenance inspections by competent practitioners is needed.

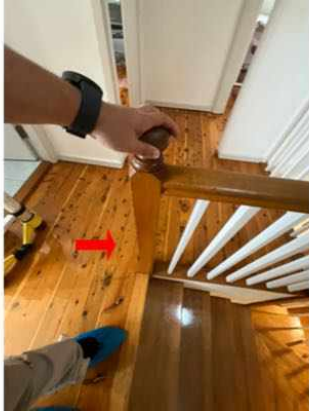
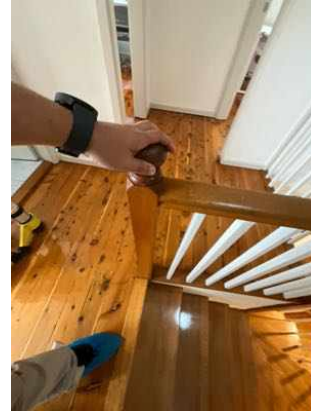
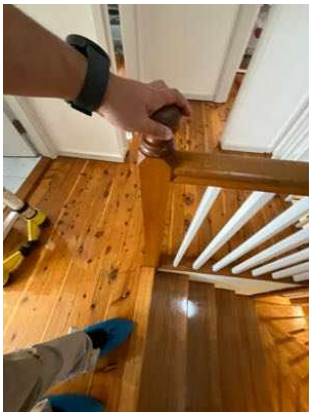
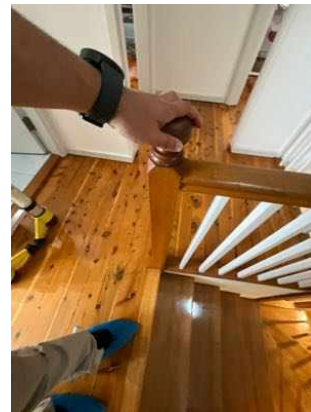
### Finding 1.03

Building: Main Building  
 Location: Stairs - Internal  
 Finding: Handrail - Loose  
 Information: At the time of inspection, the handrail in this area was found to be loose and requires adjustment to tighten.

Where a building element is installed in such a way that it fails to achieve the required minimum standard or level of finish at the time of the inspection, the builder needs to rectify the defect as soon as possible and complete works to the required standard prior to handover.

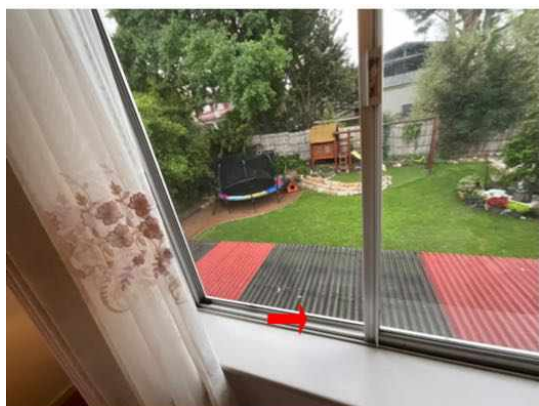
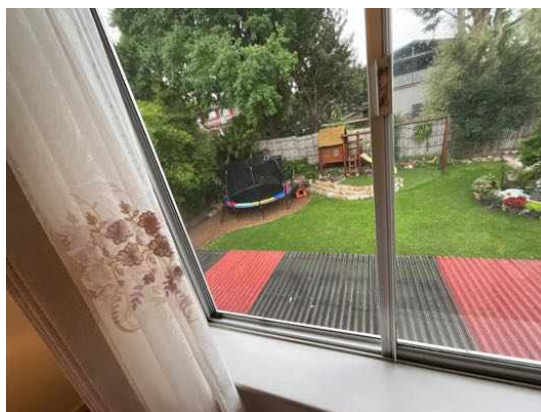
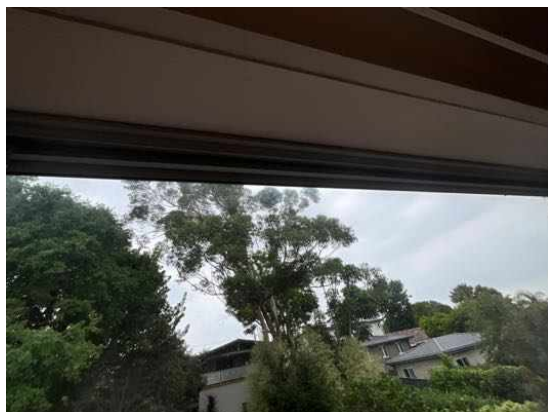
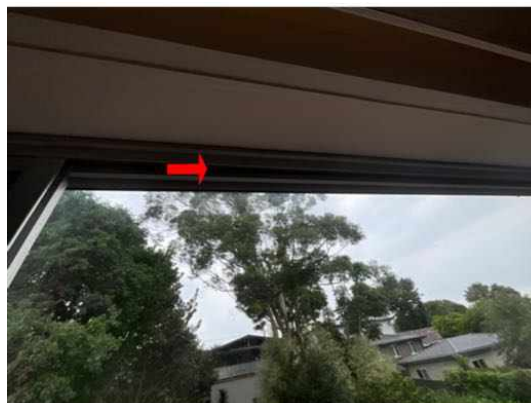
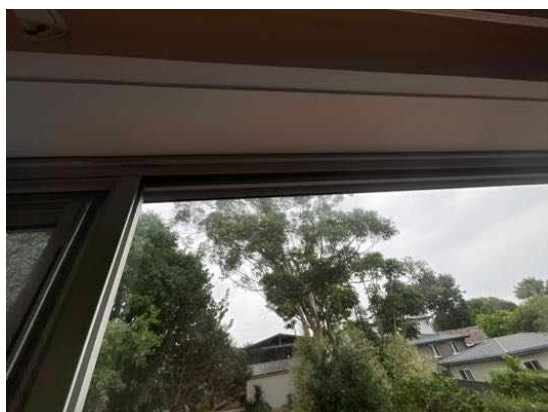
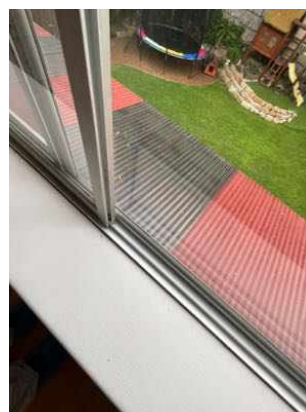
### Finding 1.04

Building:	Main Building
Location:	All Areas
Finding:	Window child lock missing
Information:	The window in question lacks a child lock mechanism, which poses a potential safety risk to young occupants in the premises. As per Australian Standards windows accessible to children should be equipped with appropriate child safety locks to prevent accidental opening, reducing the risk of falls and ensuring compliance with safety regulations.

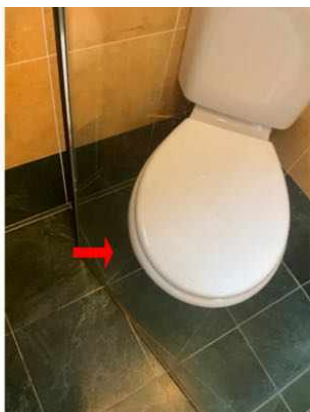
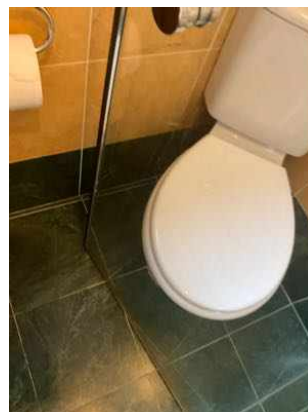
### Finding 1.05

Information: A safety hazard was identified in the bathroom of the property. The issue pertains to the shower screen, which, when fully opened, makes contact with the adjacent toilet. This situation poses an immediate risk to the safety and well-being of occupants due to the potential for accidents and injuries.

Collision between the shower screen and the toilet can cause injury to individuals using the bathroom, particularly if the shower screen shatters upon impact. The repeated contact between the shower screen and the toilet can also result in damage

to both fixtures, leading to costly repairs or replacements.

This is to be addressed prior to handover.

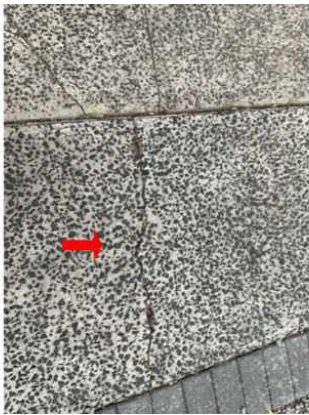
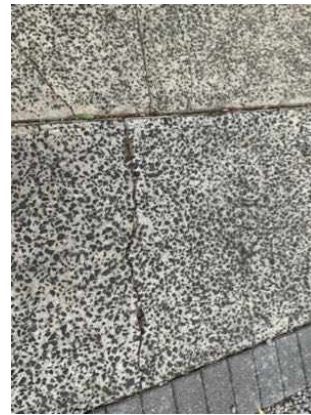
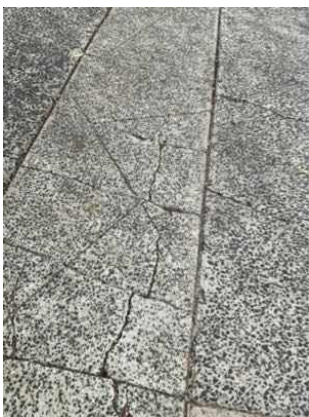
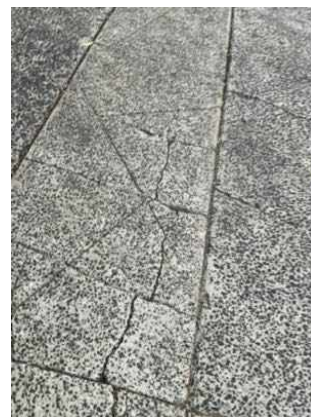
Building:	Main Building
Location:	All Areas
Finding:	Noticeable Cracking in Concrete Slab
Information:	Noticeable cracking has been observed in the concrete slab, failing to meet the required construction and quality standards.

- Cracks are visible on the surface and may extend through the depth of the slab.
- Evidence of improper curing or inadequate reinforcement leading to cracking.

- Compromised structural integrity of the slab, potentially leading to failure under load.
- Water ingress through cracks, causing corrosion of reinforcement and further weakening the structure.

- A structural engineer should be engaged to assess the extent of the cracking and recommend appropriate repair methods.
- A licensed contractor or concrete repair specialist should carry out the recommended repairs under the guidance of the structural engineer.

A detailed inspection should be conducted post-repair to confirm compliance with the required standards and to ensure that the structural integrity of the concrete slab has been restored.

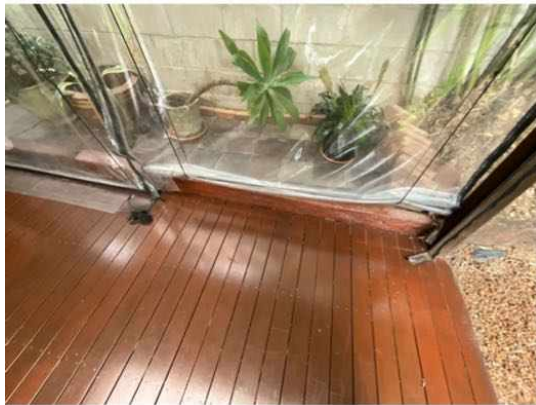
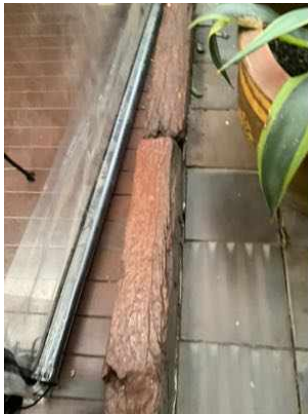
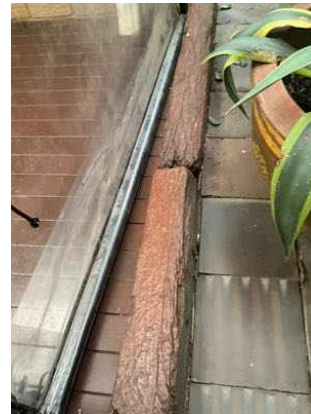
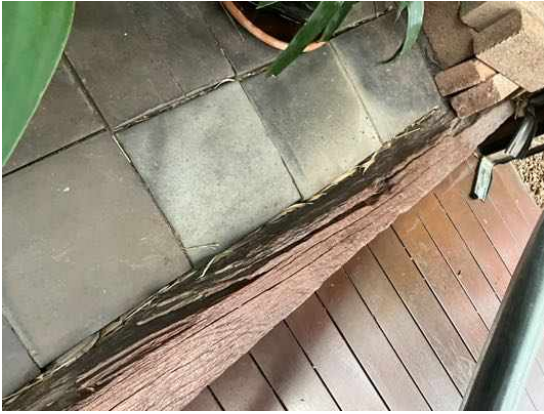
**Finding 3.03**

Building: Main Building  
Location: Pergola

Finding: Retaining wall - Defective

Information: The retaining wall in this area was found to be defective at the time of inspection. Generally, defective retaining walls are caused by poor original design or material use. However, deteriorated retaining walls may also be a result of substandard construction, poor site drainage or unmanaged stormwater flows.

If left unmanaged, the retaining wall may become a safety hazard if it continues to destabilise. Where retaining walls further rot and decay, an environment is created that is conducive to termite and pest infestation.

Significant repair and replacement should be expected. Where retaining walls are considered structural walls, a structural engineer / surveyor should be consulted regarding required remedial works. Otherwise, a landscaper or retaining wall installer may be appointed to repair or replace the wall, at the discretion of the client.

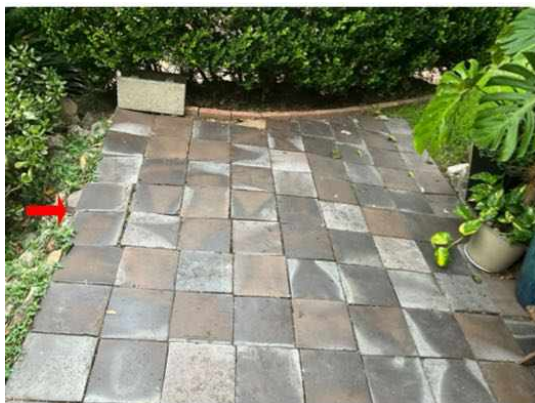
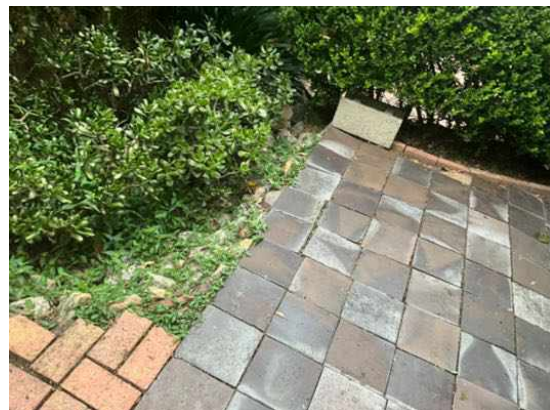
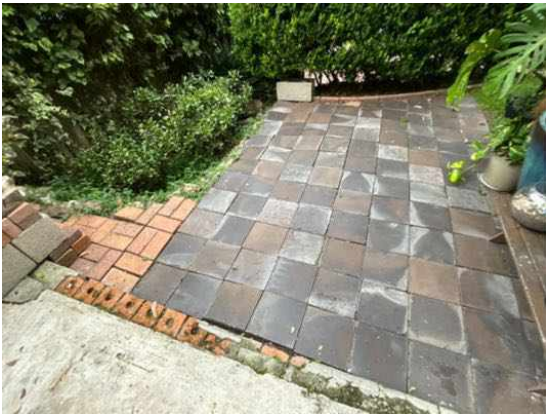
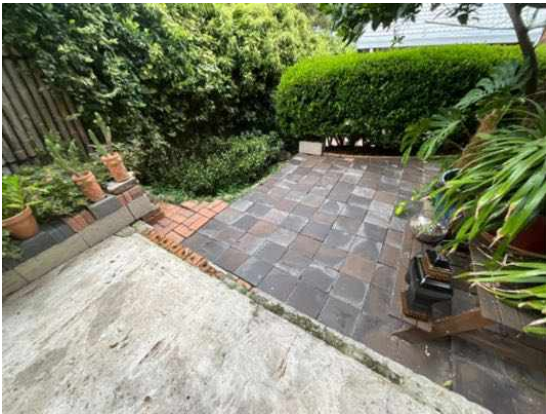
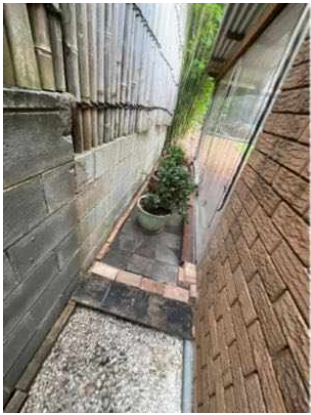
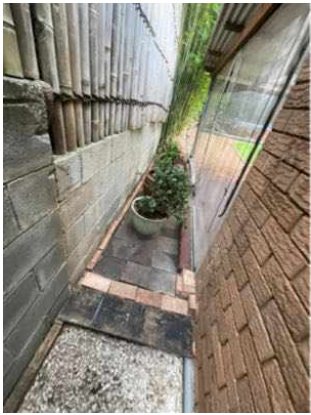
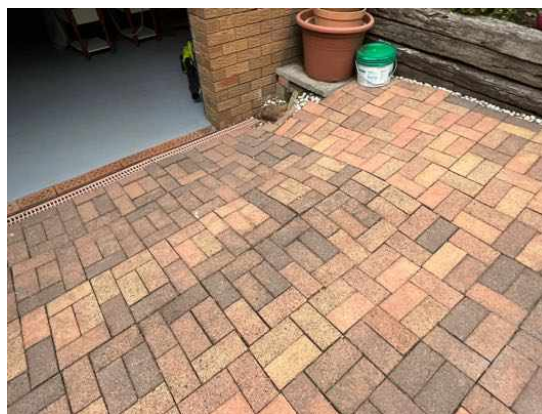
### Finding 3.04

Building: Main Building  
 Location: Pergola  
 Finding: Bricks / Pavers uneven and displaced....  
 Information: Cracked, uneven, and displaced pavers were observed. Several pavers appear loose, misaligned, or deteriorated.

The uneven surface poses a significant trip hazard for pedestrians and may impact the usability of the driveway. Displacement and cracking can worsen over time due to vehicle traffic, poor subbase compaction, or water ingress. Wall cracking may lead to moisture entry or structural wear if left untreated.

- A qualified paving contractor should be engaged to lift, relevel, and relay the affected pavers with proper bedding and compaction.
- A licensed builder or bricklayer should repair and seal the masonry wall crack around the pipe to prevent further water ingress and deterioration.
- Drainage should also be checked to ensure water is not contributing to the issue.

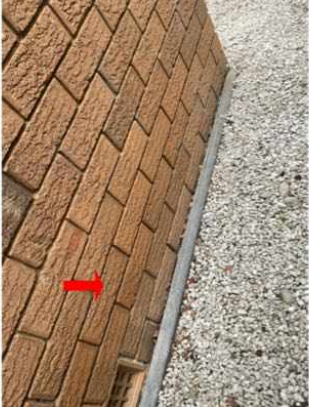
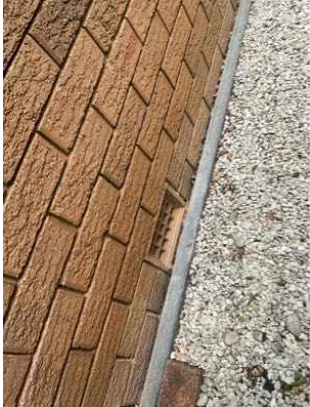
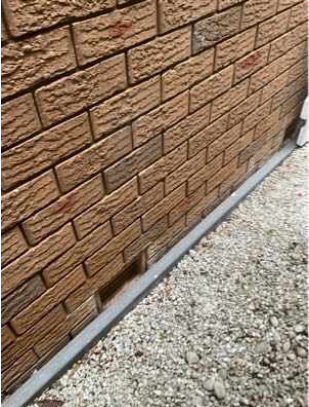
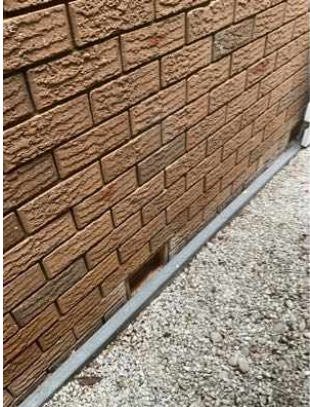
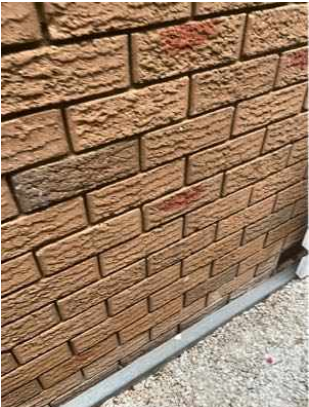
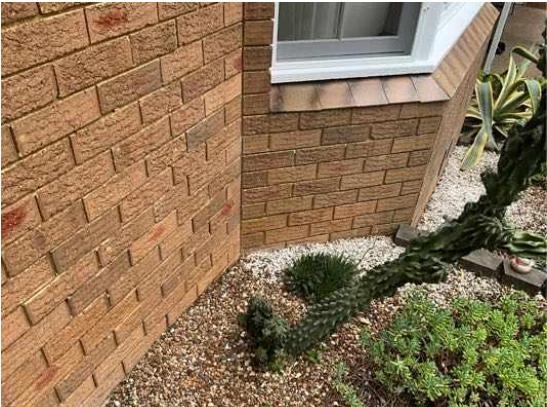
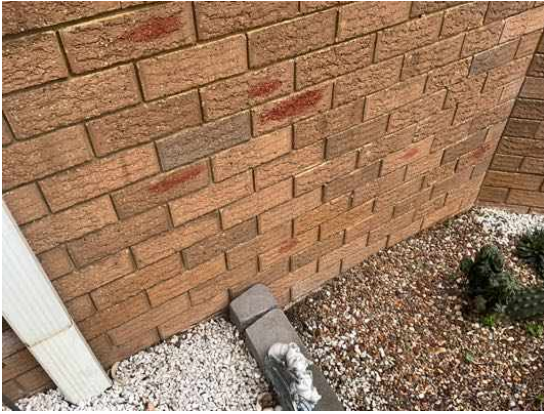
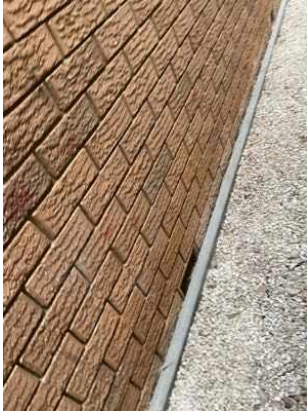
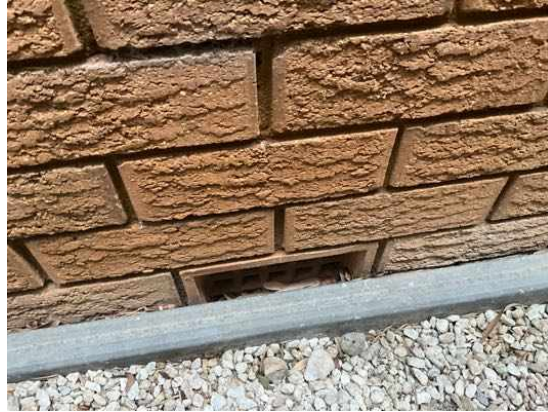
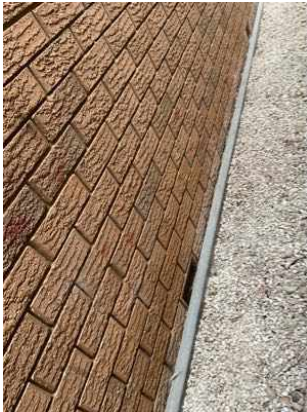
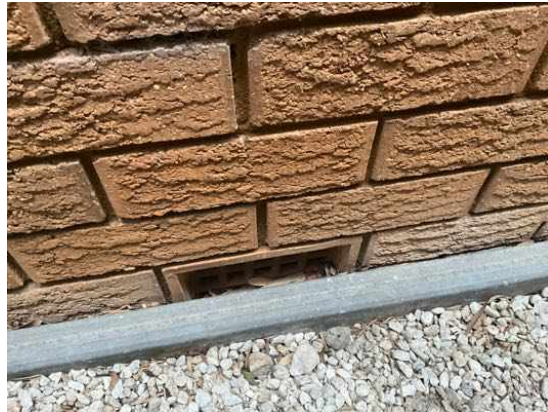
### Finding 3.05

Building:	Main Building
Location:	All Areas
Finding:	Weep holes - Missing
Information:	The external masonry wall of the building lacks the necessary weepholes, which are crucial for the drainage and ventilation of the wall cavity.

1. **Moisture Accumulation:** Without weepholes, moisture can accumulate within the wall cavity, leading to dampness and potential water damage to the building structure.
2. **Mold and Mildew Growth:** The trapped moisture creates an ideal environment for mold and mildew, which can cause health issues for occupants and degrade building materials.
3. **Structural Damage:** Prolonged exposure to moisture can weaken the structural integrity of the wall, causing deterioration of bricks, mortar, and internal framing.
4. **Efflorescence:** The absence of proper drainage can lead to the formation of efflorescence (white salt deposits) on the surface of the masonry, which can be unsightly and indicative of moisture problems.
5. **Pest Infestation:** Inadequate ventilation and moisture control can attract pests such as termites, leading to further damage and potential infestation.

A qualified bricklayer or masonry contractor should be contacted to assess and install the missing weepholes. They will:

the National Construction Code (NCC) requirements for weephole placement and spacing.

- Inspect the wall cavity for any existing moisture damage and recommend additional repairs if necessary.

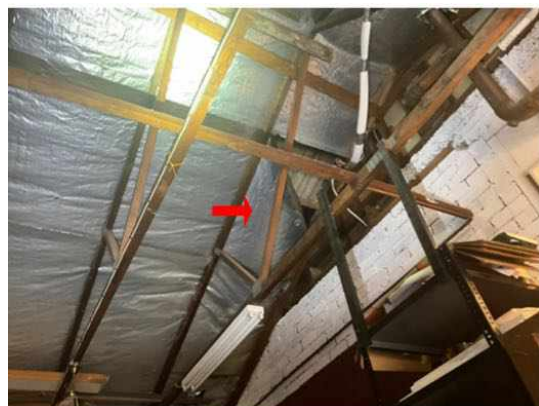
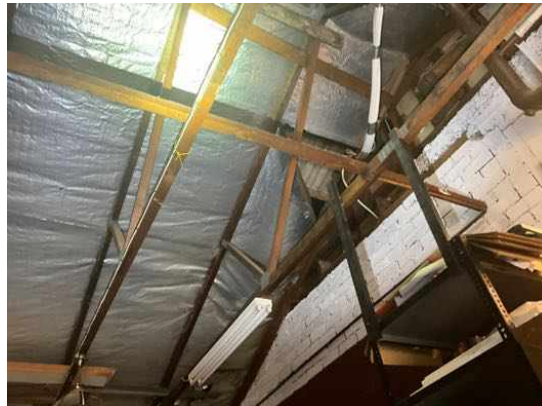
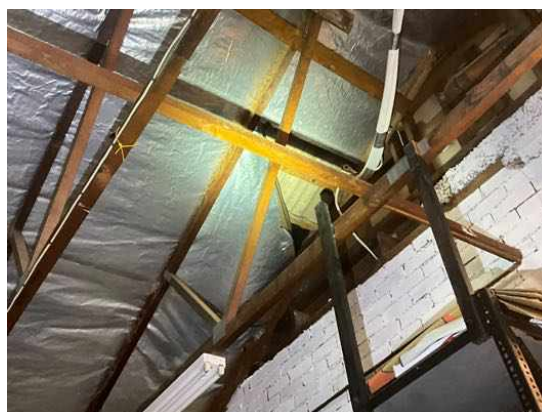
### Finding 3.06

Building: Main Building  
 Location: Garage  
 Finding: Sarking - Damaged  
 Information: Sarking, a laminated aluminium foil applied to the interior of the roof covering, assists in insulating the property and acting as a vapour-barrier to the roof void and, subsequently, to the household.

Where sarking is damaged, both insulation and moisture protection of the property are inhibited. This creates a loss of energy and thus negatively impacts the energy efficiency of the property, allowing potential for moisture ingress from condensation or leaking roof tiles.

It is important to repair any holes or damaged sections of sarking to ensure that the building material is fully functional. A registered builder or qualified carpenter should be consulted to provide further advice on this defect and to perform rectification works at client discretion.

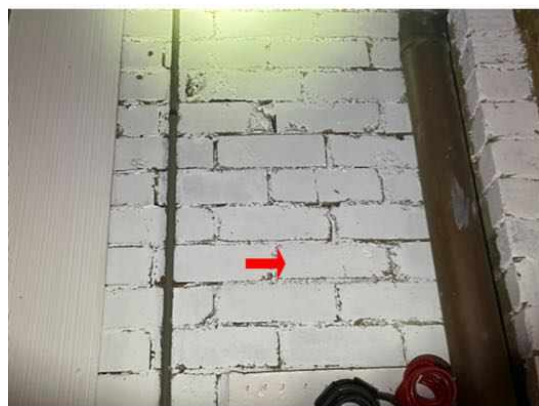
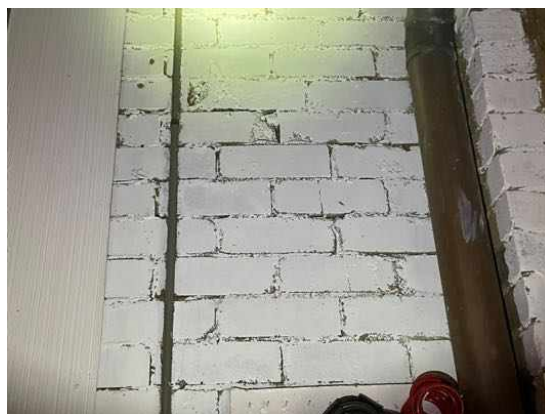
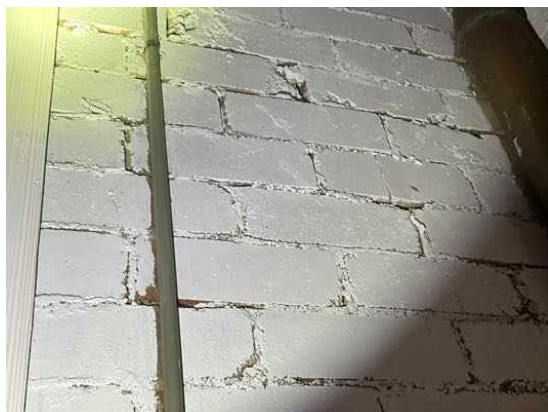
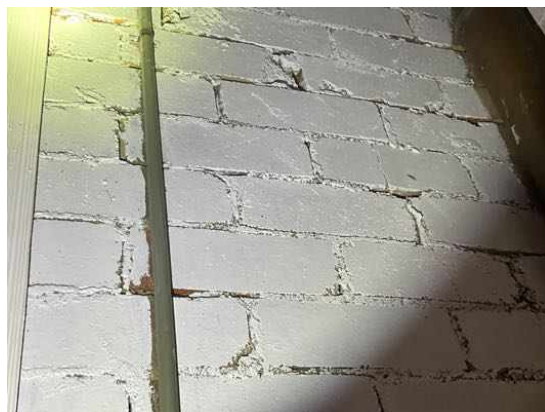
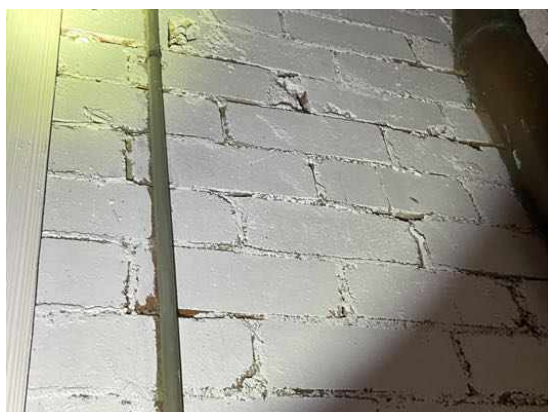
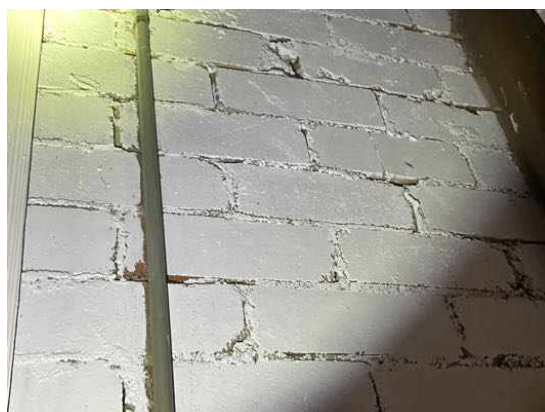
### Finding 3.07

Finding: Brickwork - Cracking [Fine]

Information: Although fine cracks are quite noticeable, they are often only considered to be an appearance defect and usually do not indicate any structural damage. Generally, the cause of a fine crack is indicative of a separation between brickwork and mortar throughout the structure, but single bricks may also show cracks of this nature.

Cracking of this nature can generally be repaired with minor filling and should be conducted by a qualified bricklayer.

Always contact a building inspector should cracks widen lengthen or become more numerous.

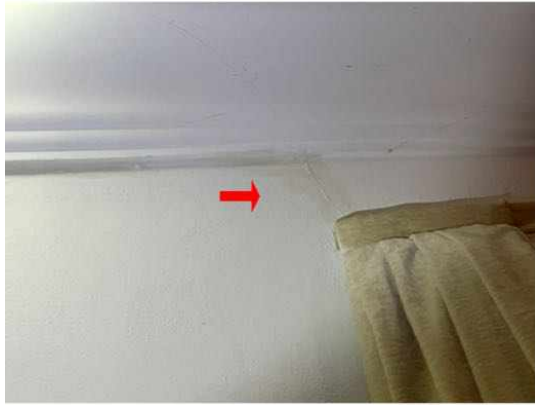
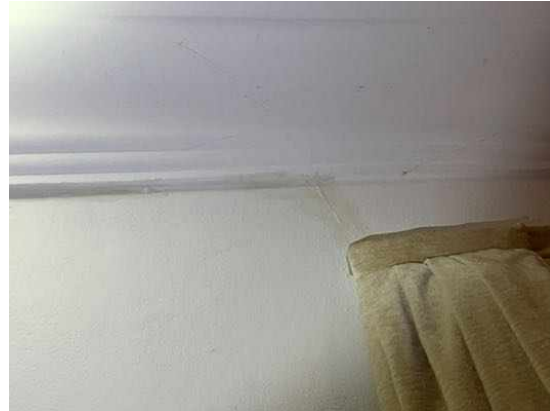
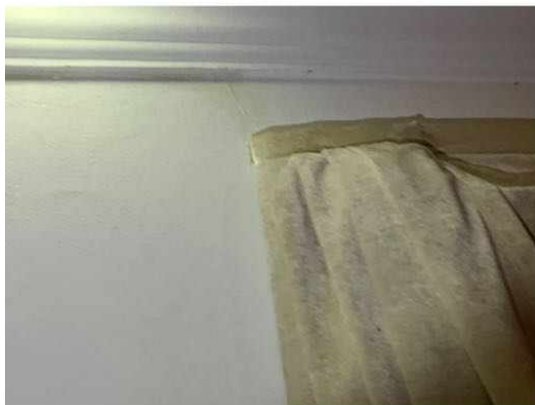
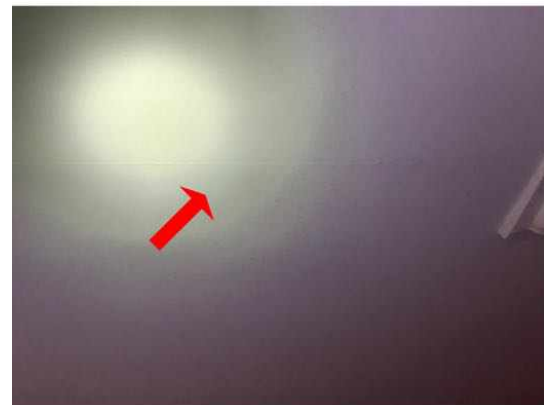
### Finding 3.08

Finding: Gyprock - Fine Cracking

Information: Fine cracks were observed in the plasterboard wall. These cracks are likely due to minor building movement or settlement and are generally considered cosmetic in nature.

- A licensed plasterer or painter can fill the cracks with a flexible compound and repaint the affected area.

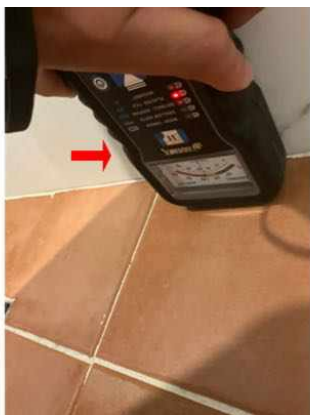
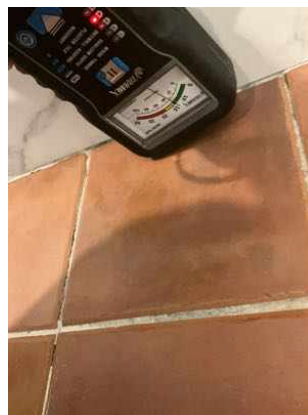
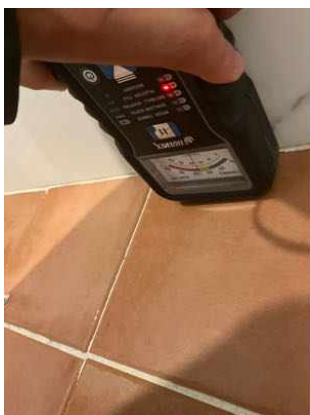
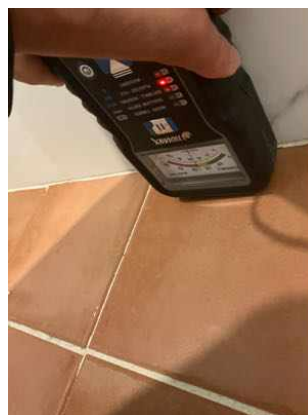
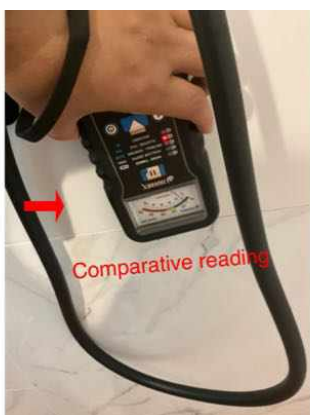
Building:	Main Building
Location:	Bathroom downstairs
Finding:	Shower - Damp
Information:	Damp is evident to the lower 300mm of wall to the shower alcove. This defect is quite common, and is suspected to have been caused by moisture permeating through the grouting in this area, which shows evidence of deterioration. Leaking pipes within the adjoining wall is also a possible cause.

Damp (or structural damp) refers to the presence of unwanted moisture in the structure of a building, either as the result of intrusion from outside, or condensation from within the structure. In the shower area, internal water leaks or other sources of excessive moisture are generally the cause of damp.

Unmanaged damp in the shower recess is likely to facilitate the formation and development of mould and fungi growth, decaying associated building materials and compromising their structural integrity. It is important to address damp conditions, as the World Health Organisation notes that excess moisture leads - on almost all indoor materials - to growth of microbes such as moulds, fungi and bacteria, which subsequently emit spores and other matter into the indoor air. Exposure to these contaminants is associated with a wide range of respiratory and other health-related problems.

Consultation with a qualified plumber or bathroom specialist is advised immediately to identify the cause of damp and to perform remedial works as required. Where excessive mould growth is present, further inspection by a specialist environmental health inspector should also be considered.

Always ensure that sealant and grout is in good condition to prevent any moisture issues occurring in the future.

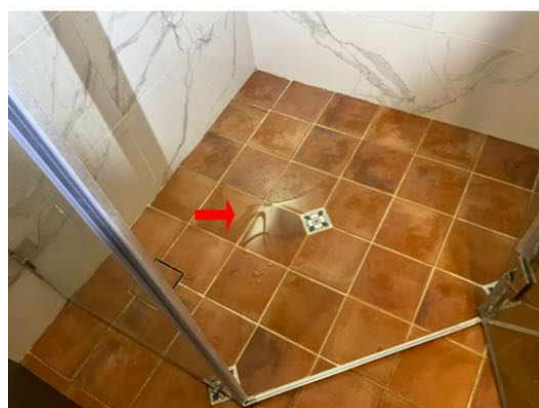
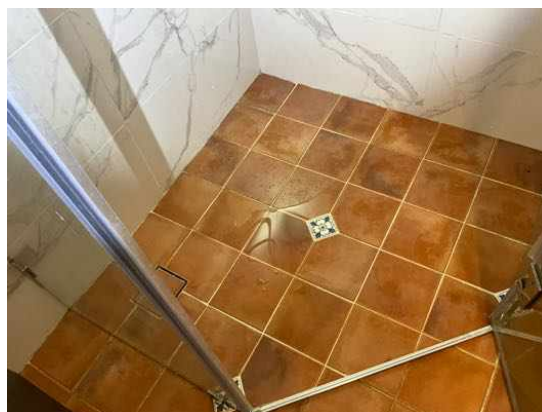
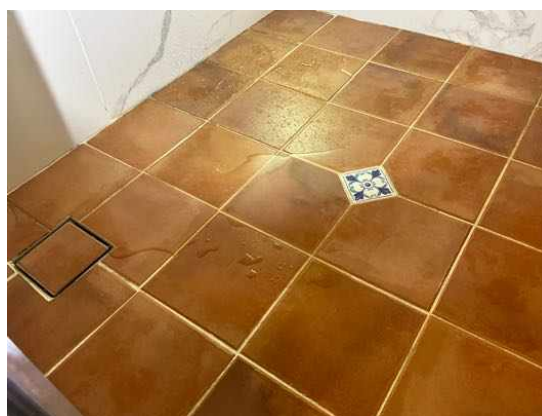
### Finding 3.11

Building: Main Building  
Location: Bathroom downstairs

Finding: Shower base - Water pooling  
 Information: Evidence of water pooling around the floor waste in the shower recess was noticed at the time of inspection. It is suspected that this excessive moisture is attributed to insufficient fall in the shower floor tiles.

This pooling is minor overall but is still considered unsatisfactory, as standard tiling practices would not permit this situation to occur. Pooling water around floor wastes can create a slip hazard in extreme cases and create conditions that are conducive to mould growth over time. Where left unmanaged, the degradation of sealant and grouting is also likely to occur, possibly necessitating further repair works.

Remedial works may involve some sections of tiling and flooring repair and replacement. A tiling contractor or bathroom specialist should be appointed to provide further advice on reparation options and to perform works as necessary.

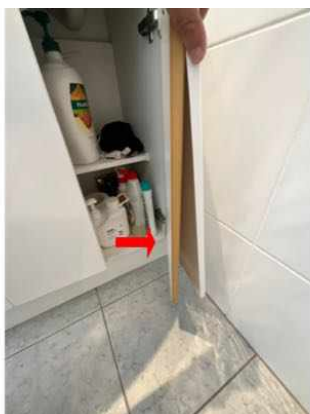
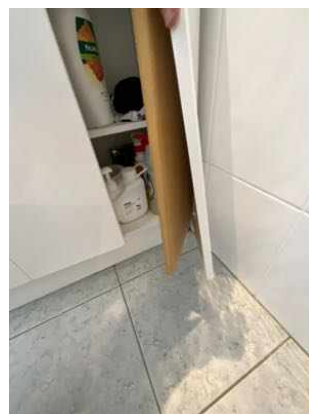
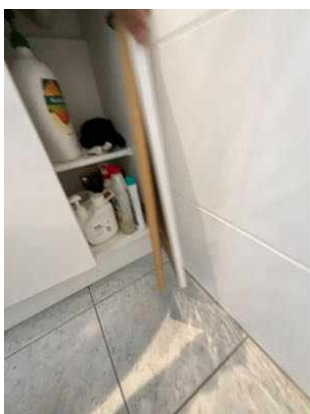
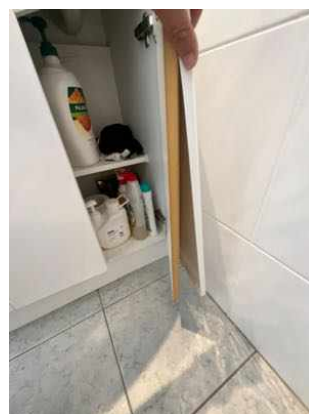
### Finding 3.12

Building: Main Building  
 Location: Bathroom  
 Finding: Damaged vanity  
 Information: A damaged vanity poses a risk of functional issues, reduced aesthetics, and potential further deterioration if left unaddressed.

Seeking assistance from a skilled carpenter or cabinet repair specialist is advisable to assess and repair the damaged vanity, ensuring proper restoration and maintaining the functionality and appearance of the cabinetry.

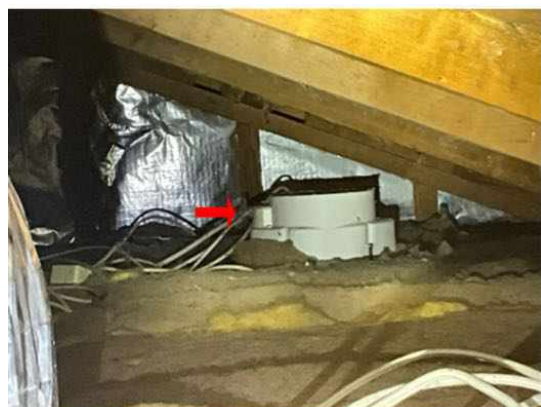
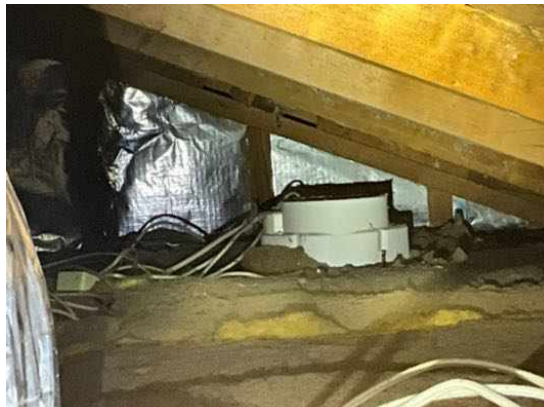
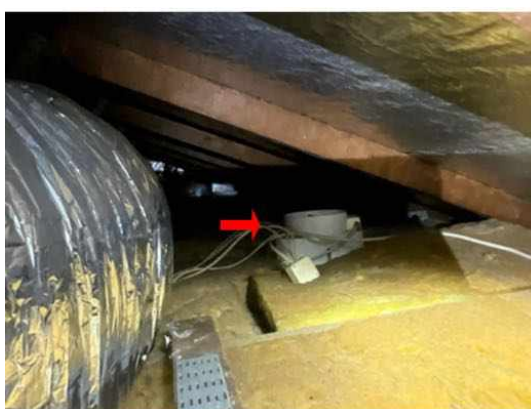
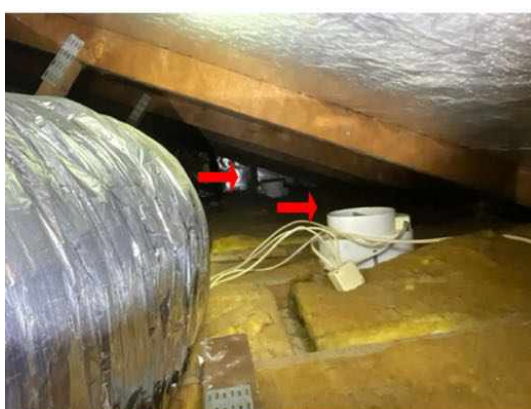
### Finding 3.13

Building:	Main Building
Location:	Roof Void
Finding:	Exhaust fan not vented out
Information:	The exhaust fan located within the roof void is not appropriately ducted to the external atmosphere and is currently discharging moist air directly into the roof space. This is considered a defect under AS 4349.1, as it does not meet the minimum standard of residential building performance expected under normal residential building practices.

This condition may lead to excessive condensation within the roof void, increasing the risk of mould growth, deterioration of insulation, timber decay, and overall reduced durability of building elements. It may also result in poor indoor air quality, potentially affecting occupant health.

It is recommended that the exhaust fan be modified by a licensed HVAC contractor or

qualified builder, ensuring it is properly ducted to discharge externally in accordance with manufacturer specifications, the National Construction Code (NCC), and applicable Australian Standards.

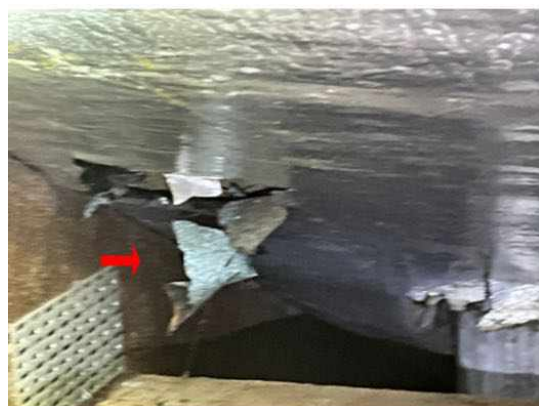
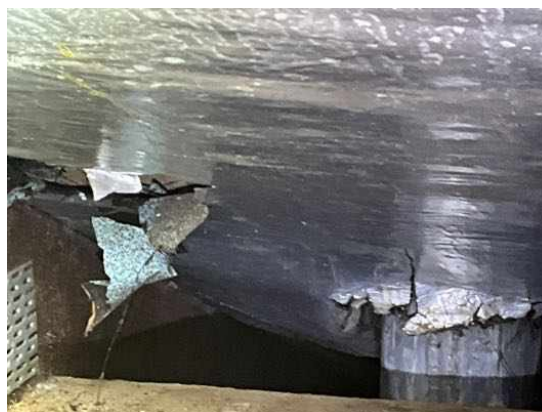
### Finding 3.14

Building:	Main Building
Location:	Roof Void
Finding:	Sarking - Damaged
Information:	Sarking, a laminated aluminium foil applied to the interior of the roof covering, assists in insulating the property and acting as a vapour-barrier to the roof void and, subsequently, to the household.

Where sarking is damaged, both insulation and moisture protection of the property are inhibited. This creates a loss of energy and thus negatively impacts the energy efficiency of the property, allowing potential for moisture ingress from condensation or leaking roof tiles.

It is important to repair any holes or damaged sections of sarking to ensure that the building material is fully functional. A registered builder or qualified carpenter should be consulted to provide further advice on this defect and to perform rectification works at client discretion.

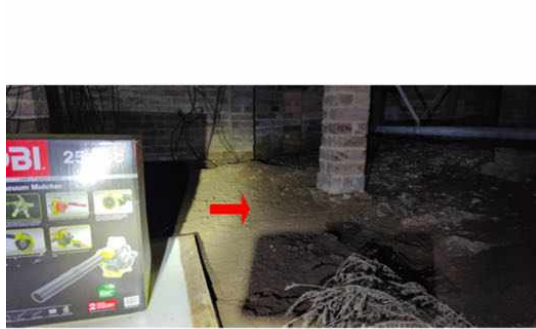
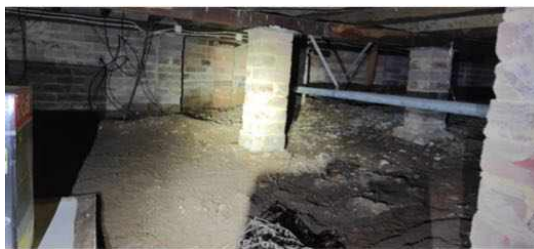
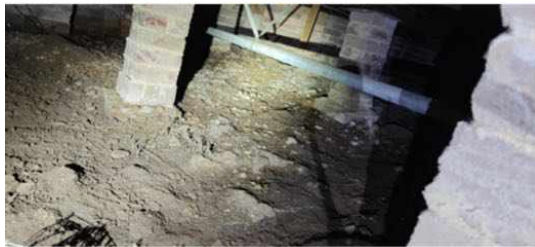
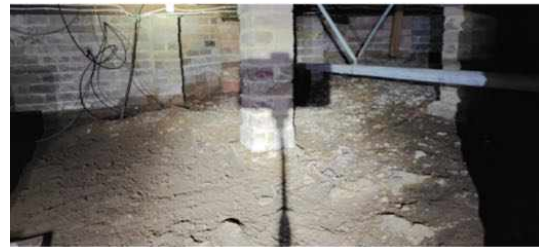
### Finding 3.15

Building: Main Building  
 Location: Subfloor  
 Finding: Subfloor - Site drainage - Inadequate  
 Information: The site exhibits poor drainage under the subfloor, leading to several critical issues. Water accumulates and does not properly drain away from the subfloor area, creating a hazardous condition.

1. Frequent water pooling and stagnation under the subfloor.
2. Risk of subfloor structural damage due to prolonged moisture exposure.

4. Safety hazard for occupants due to slippery surfaces and potential electrical hazards.

The poor site drainage under the subfloor poses a significant safety risk to the occupants, as it can lead to structural damage and health hazards.

This issue requires immediate attention and rectification. A licensed and experienced plumber or licensed builder specialising in drainage and foundation work should be engaged to assess the problem and implement necessary drainage solutions, such as improved grading, installation of drainage systems, and moisture barrier enhancements. Regular maintenance and inspections should also be scheduled to prevent future occurrences. Water damage and secondary defects are likely to occur if left unmanaged.

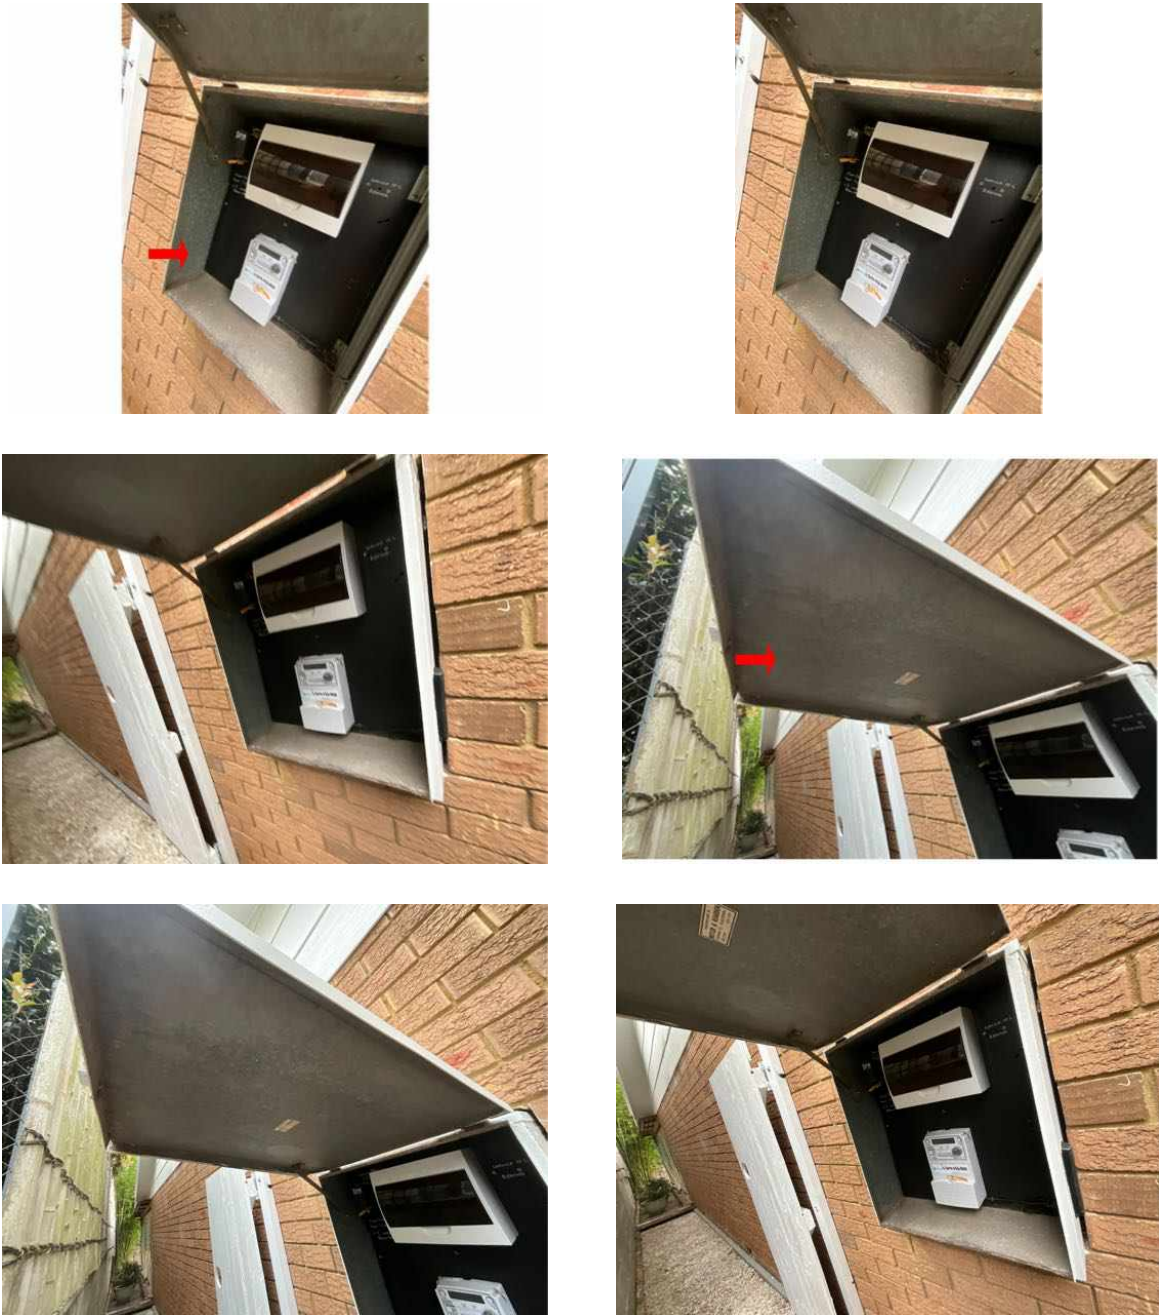
Building: Main Building  
 Location: Exterior walls - left side  
 Finding: No Evidence of Termite Management System - Durable notice / Legible Sticker  
 Information: The application of a pre & post-construction chemical termite barrier is highly recommended for all properties. Such barriers are highly effective in preventing termite attack on any timber building elements throughout the property.

Client must seek further information from the vendor or real estate agent if the

conditions of termite management systems were maintained.
