# Building and Timber Pest Inspection Report

Inspection Date: Thu, 12 Feb 2026

Property Address: 17 Jindabyne Ave, Baulkham Hills NSW  
2153, Australia

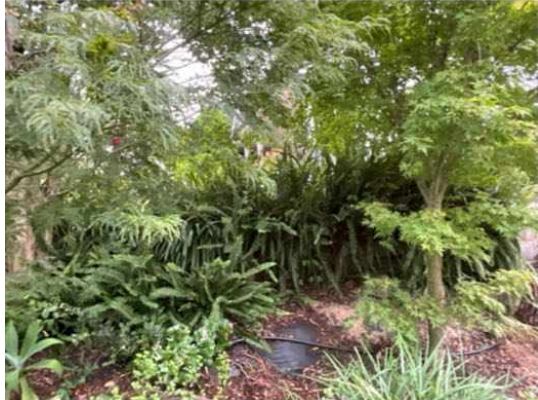
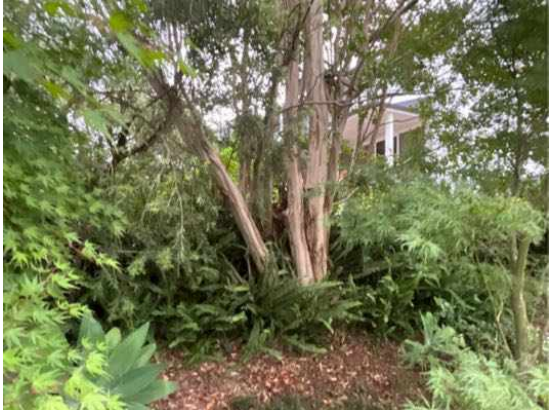
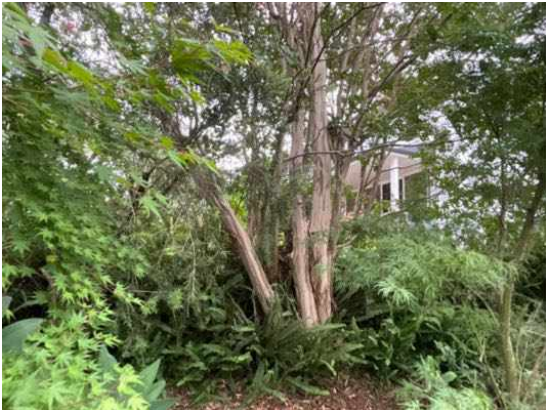
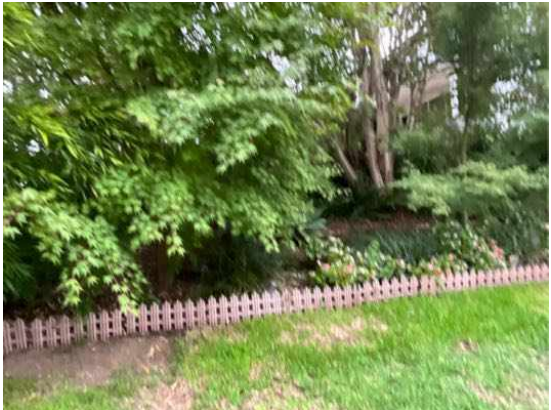
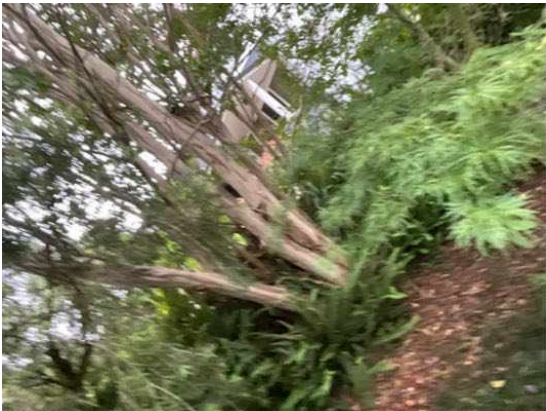
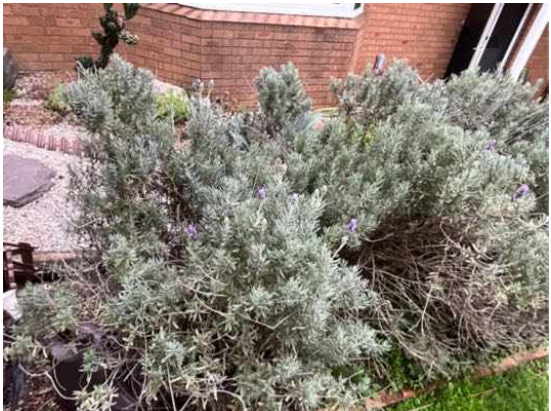
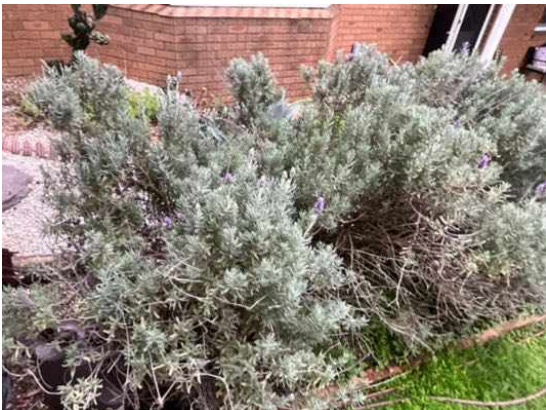
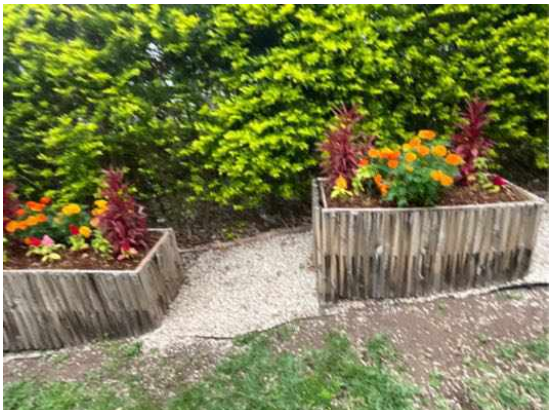
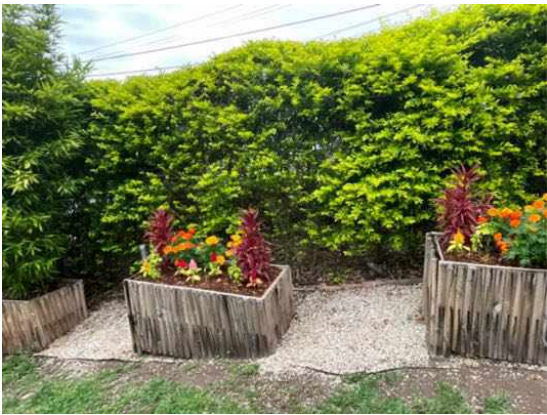
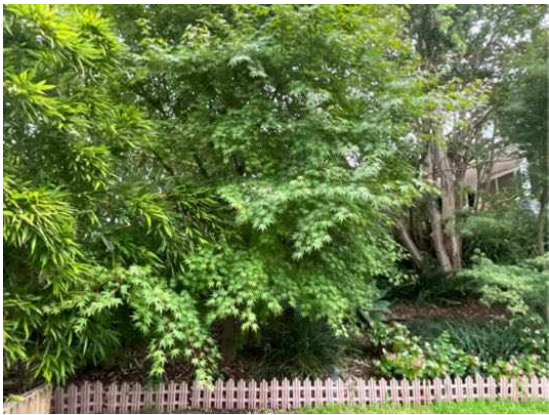
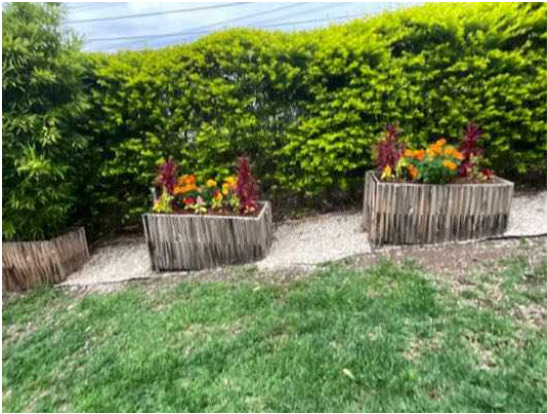
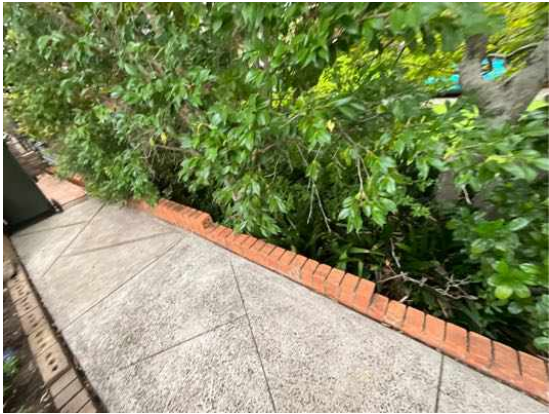
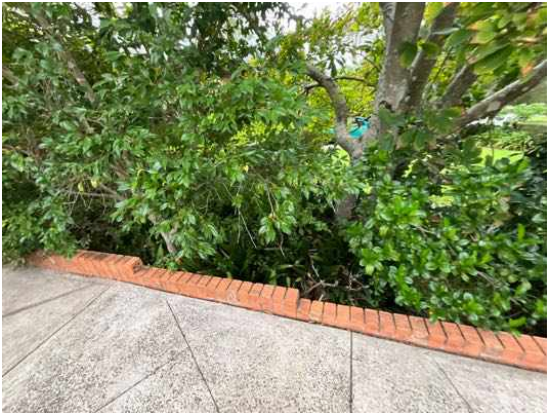
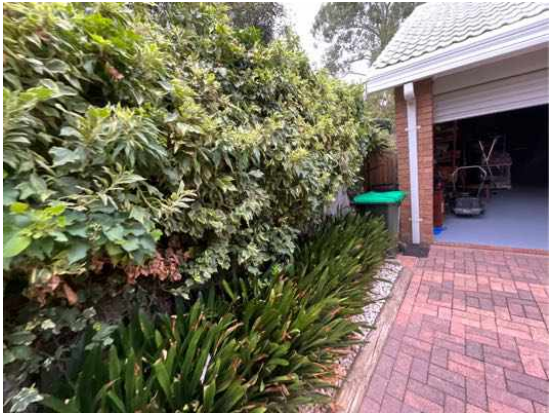
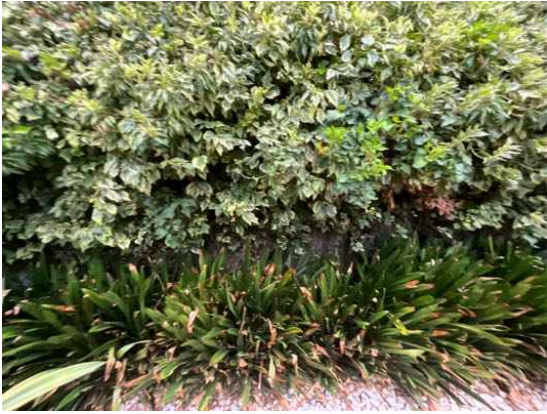
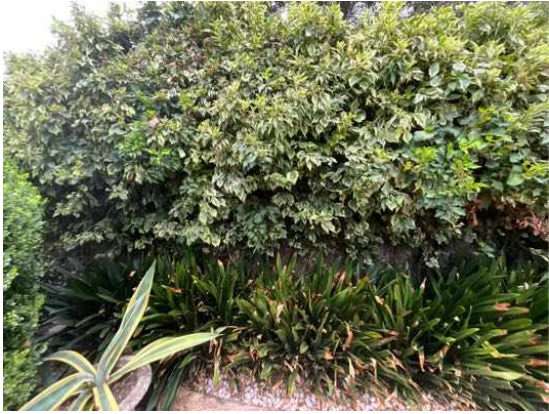
**Finding 6.02**

Building: Main Building  
Location: All Areas  
Finding: Dense vegetation around a property can increase the risk of termite infestation  
Information: The presence of dense vegetation around a property can increase the risk of termite infestation, as it provides a conducive environment for them. To address this, consider maintaining a clear space between the vegetation and your home. If you suspect a termite issue, it's advisable to consult with a licensed pest control professional for inspection and treatment.

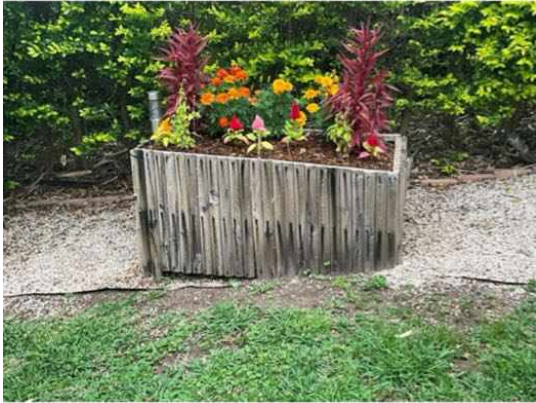
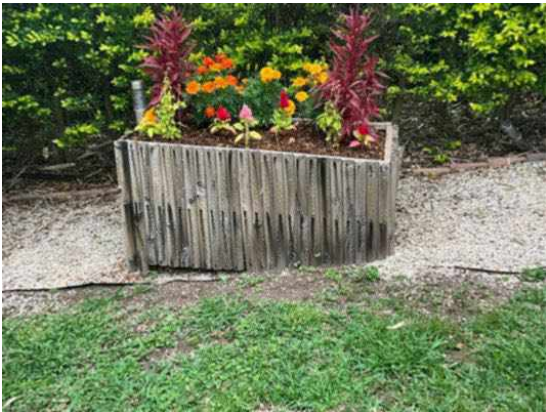
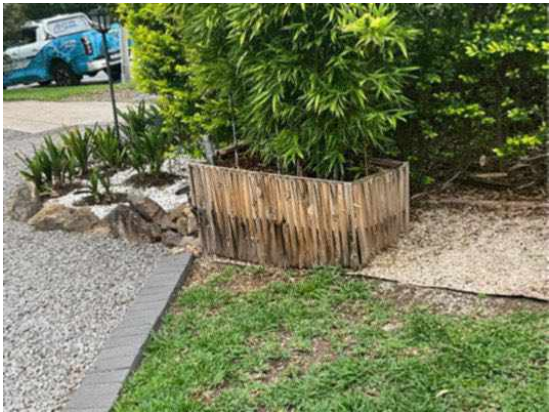
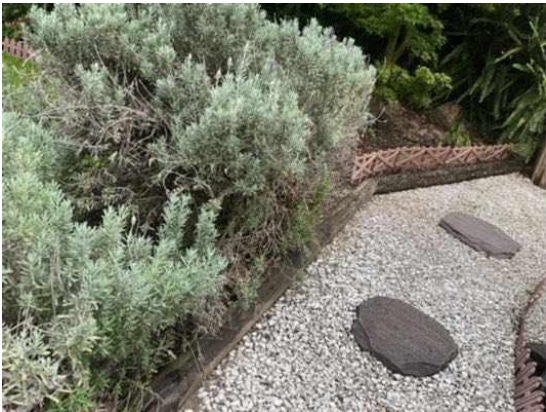
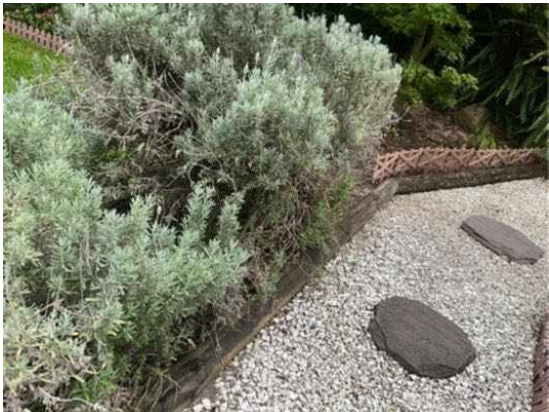
Finding 6.03

Building: Main Building  
Location: All Areas  
Finding: Timber on ground / conducive conditions to termite damage  
Information: Timber on the ground is indeed conducive to termite damage. Termites are known to thrive in moist environments, and wood in contact with soil or moisture is more susceptible to infestation.

To prevent this, it's important to keep timber elevated and away from direct ground contact. Regular inspections and proper termite control measures are also essential to protect your wooden structures from termite damage.

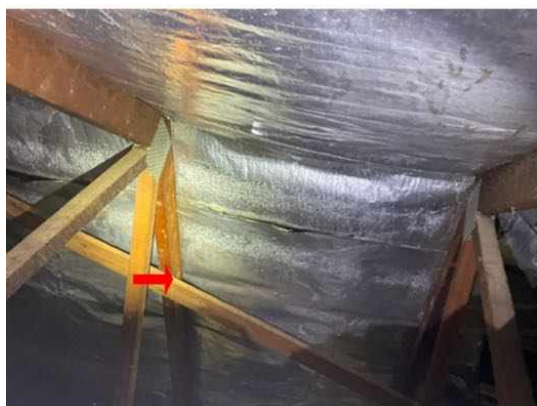
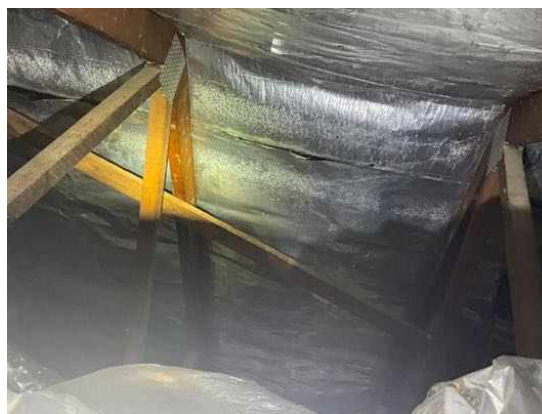
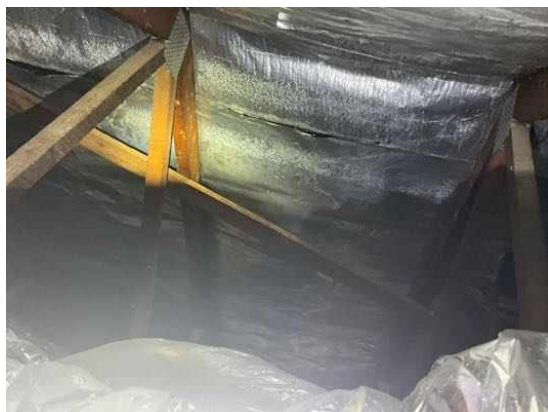
Building:	Main Building
Location:	Roof Void
Finding:	Roof void exhibits conspicuous signs of excessive moisture
Information:	The roof void exhibits conspicuous signs of excessive moisture, evident through water staining within the sarking material.

Risk in Terms of Timber Pest: The excessive moisture within the roof void poses a significant risk for timber pests such as termites, as it creates an ideal environment for infestation and proliferation. The damp conditions promote wood decay, making the structure susceptible to damage by these pests.

A qualified roofing contractor and a professional pest control service specialized in timber pest management should be engaged to rectify the issue. They can assess the extent of moisture damage, address any underlying structural issues, and implement effective solutions to mitigate the risk of timber pest infestation.

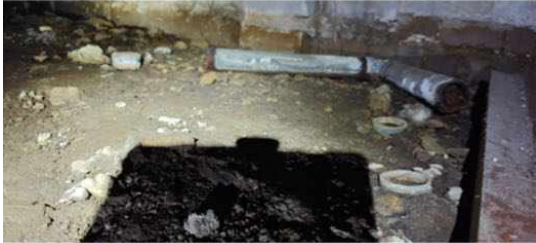
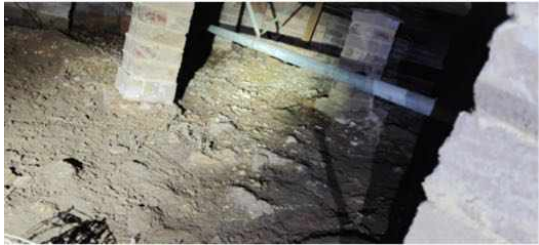
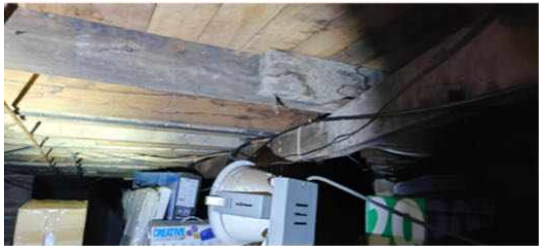
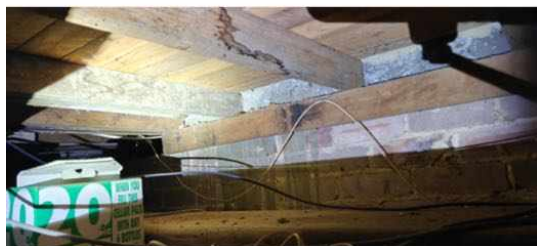
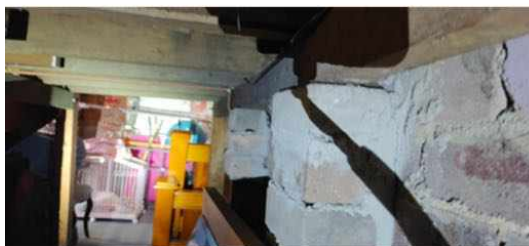
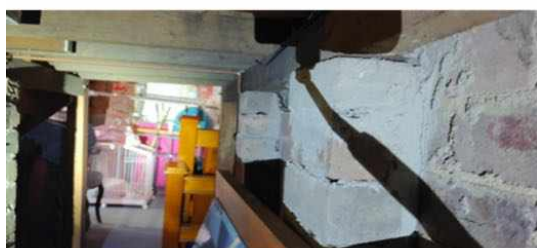
### Finding 6.06

Building:	Main Building
Location:	Subfloor
Finding:	Subfloor - poor ventilation, inadequate site drainage, water stains, and no ant caps
Information:	The subfloor lacks adequate ventilation, suffers from inadequate site drainage, exhibits water stains, and lacks ant caps, creating conducive conditions for timber pests such as termites.

Risk: The combination of poor ventilation, inadequate drainage, water stains, and absence of ant caps significantly increases the risk of timber pest infestations. Termites are attracted to moist environments and can thrive in subfloors with high humidity levels and water damage. The lack of proper ventilation and drainage exacerbates moisture retention, providing an ideal habitat for timber pests to establish colonies and cause extensive damage to the subfloor structure. Additionally, water stains indicate previous or ongoing moisture issues, which further attract timber pests and contribute to the deterioration of timber materials.

A licensed pest control professional specializing in timber pest management should be consulted to assess the extent of the infestation and develop a comprehensive treatment plan. They can implement strategies to eliminate existing timber pests, such as termites and prevent future infestations by addressing underlying moisture issues. Additionally, a qualified contractor or builder may be needed to improve subfloor ventilation, enhance site drainage, repair water-damaged areas, and install ant caps to

prevent pest entry points. Regular inspections and maintenance are essential to ensure ongoing protection against timber pests and maintain the structural integrity of the subfloor.

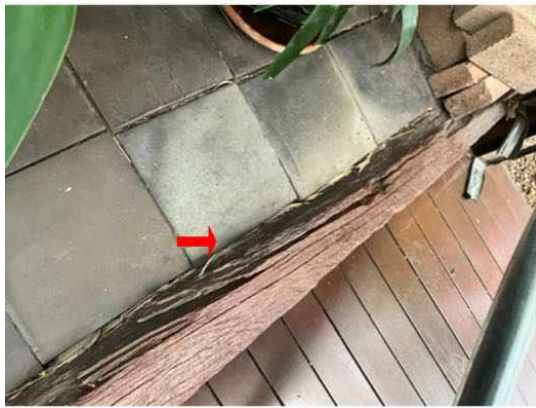
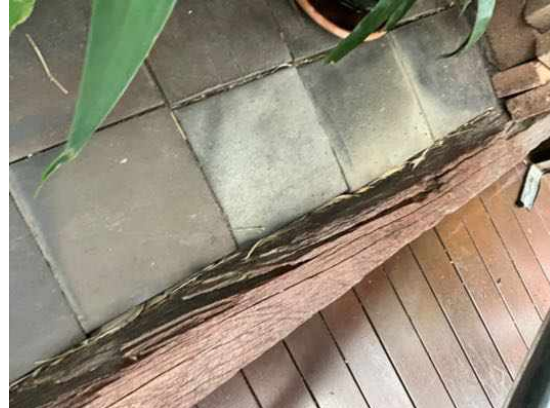
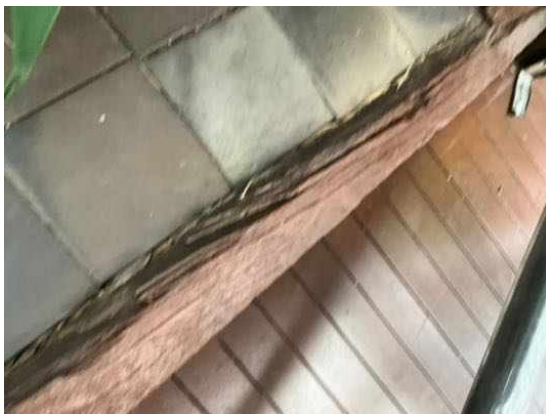
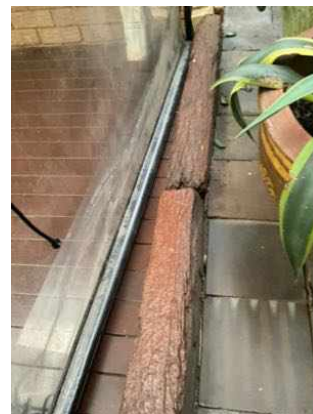
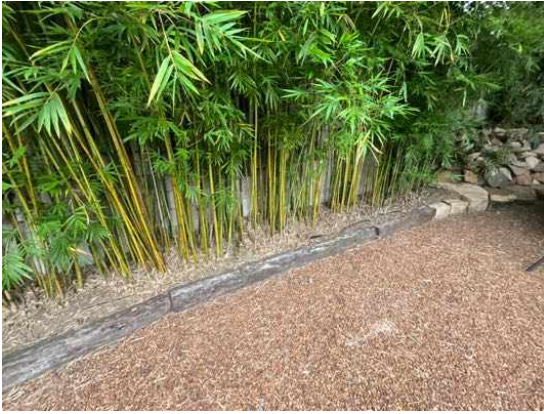
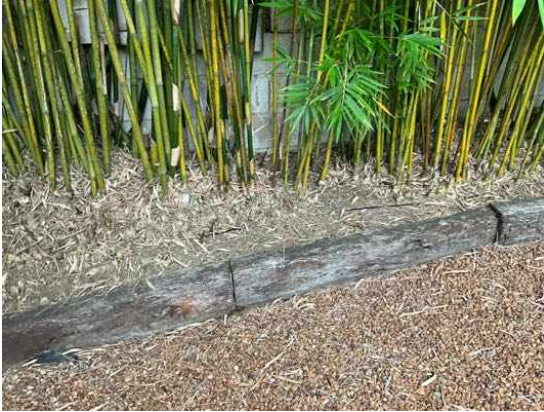
### Finding 7.01

Building:	Main Building
Location:	All Areas
Finding:	Wood rot
Information:	This building element shows evidence of wood rot. Wood rot, also known as Fungal Decay, occurs when timbers and other cellulose building materials are exposed to damp conditions on an ongoing basis. This could be the result of exposure to weathering over a prolonged period of time, or the attraction of excessive moisture

Wood rot is often associated with general damp problems and is evidenced by a 'musty' smell or mould and mildew occurring on surfaces. If left unmanaged, damp conditions can lead to further health problems and the decay of timbers will continue.

Early intervention and regular maintenance, particularly of exterior timbers, will prolong the useful life of these building elements. Prior to any works being performed, the cause of the moisture that has created the visible wood rot should be identified and addressed in a suitable manner. Replacement of affected timbers may then be a necessary step in protecting surrounding building elements from such deterioration.

A qualified plumber may be appointed to assess the cause of excessive moisture and to provide advice on any remedial works as required. A qualified carpenter or registered builder may also be required to replace affected building materials.

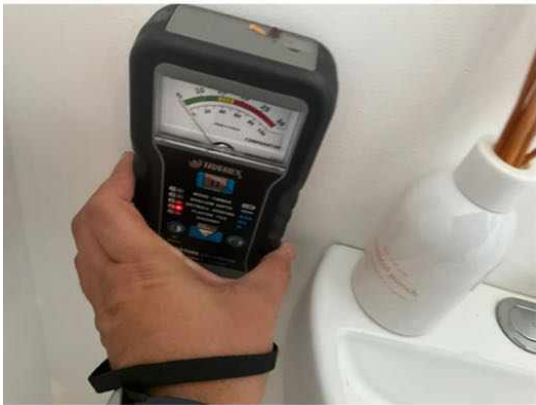
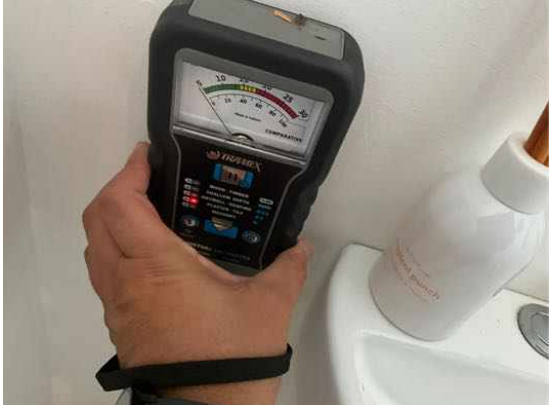
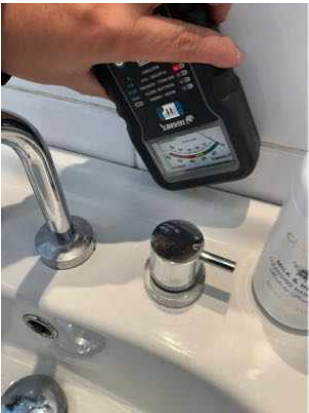
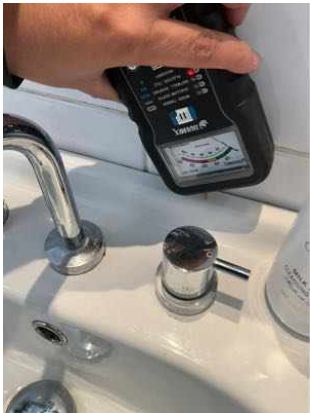
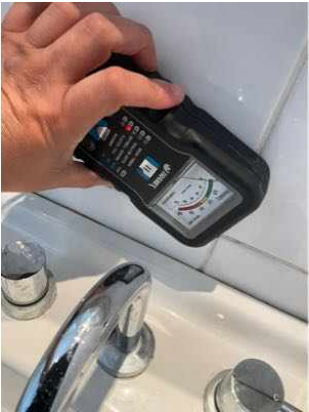
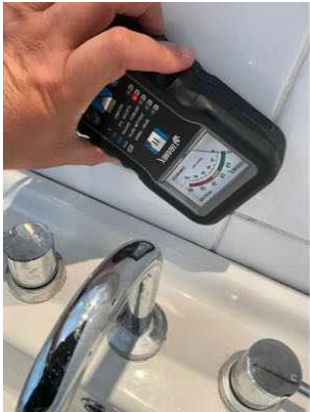
Building: Main Building  
Location: All Areas  
Finding: Additional Photos  
Information: Additional photos are provided for your general reference

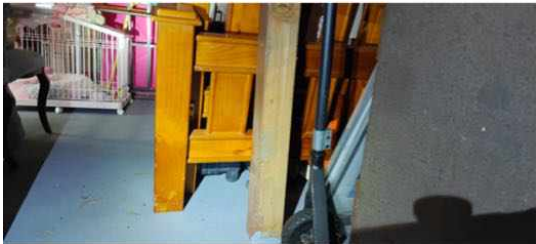
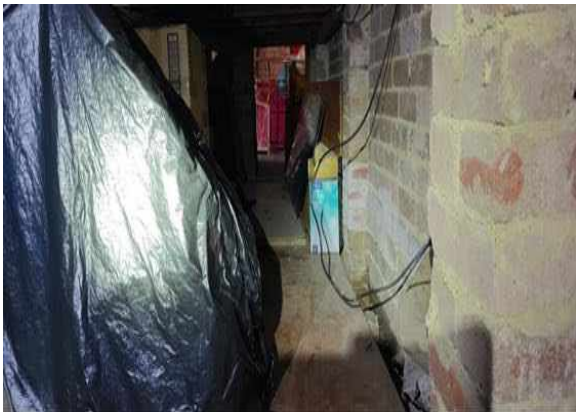
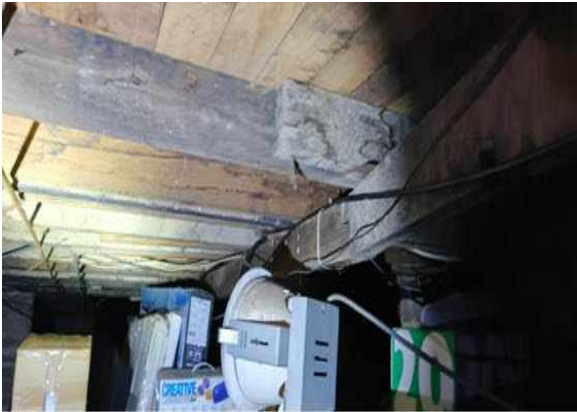
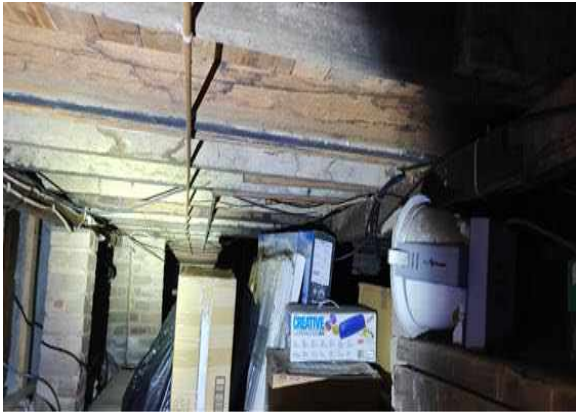
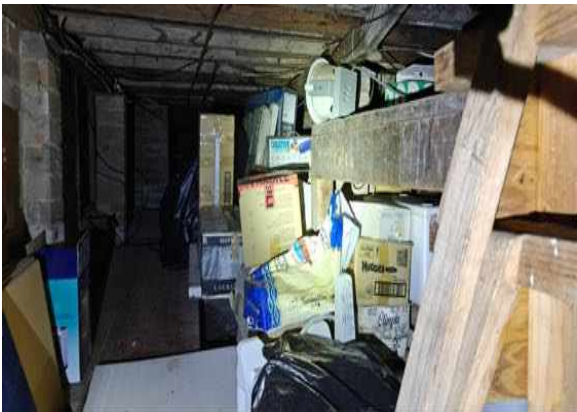
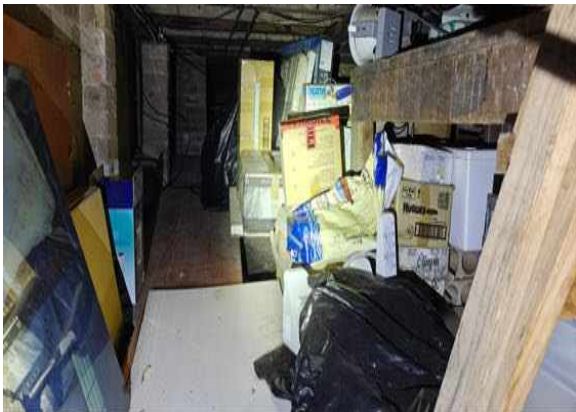
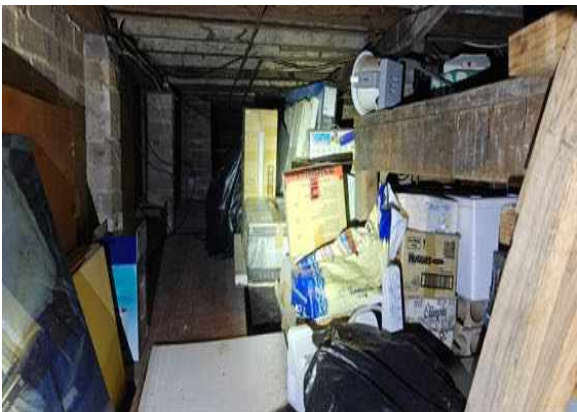
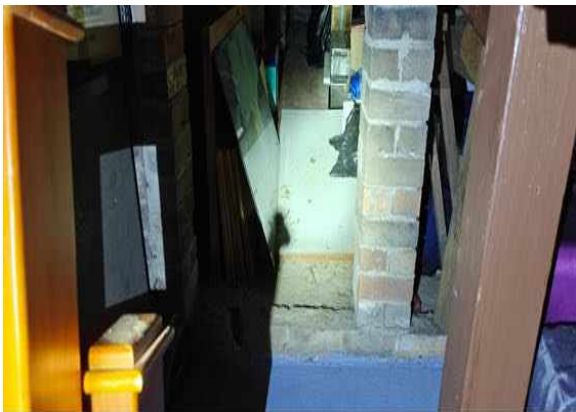
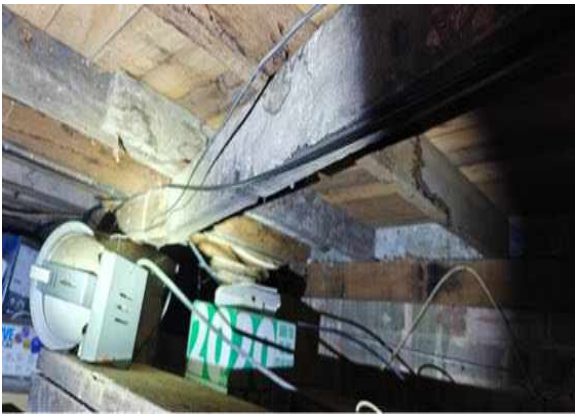
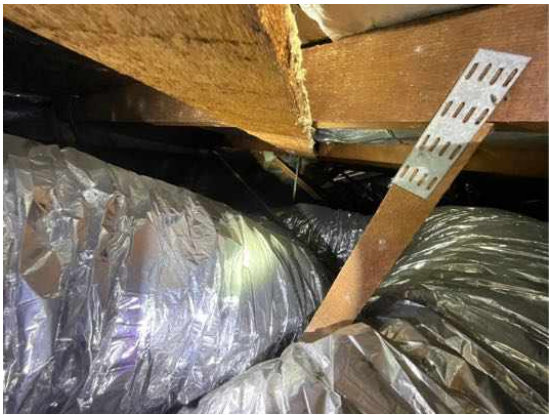
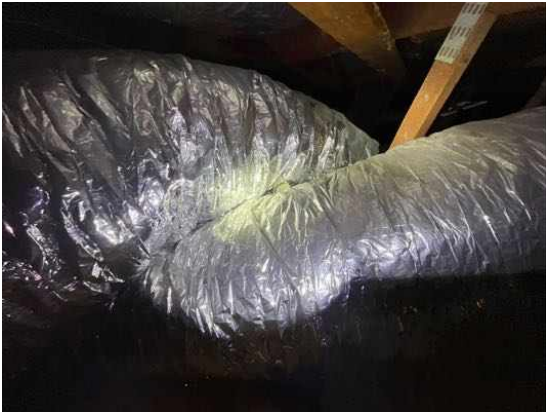
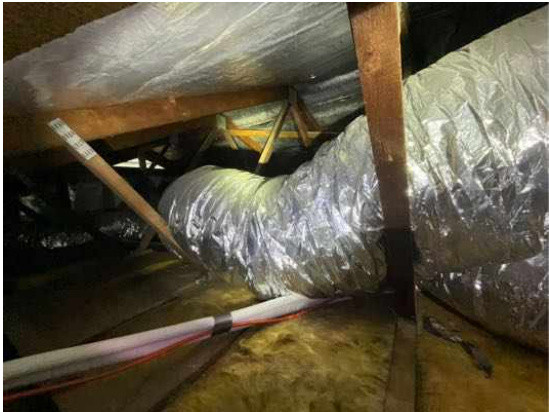
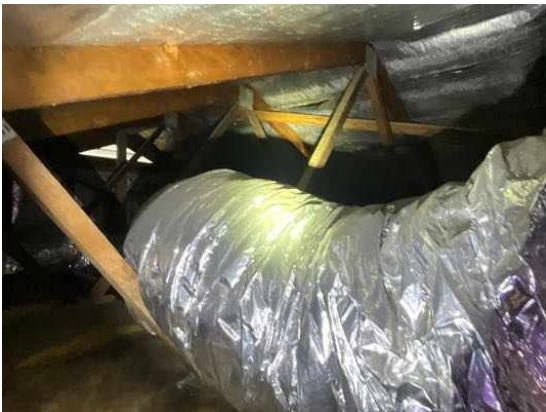
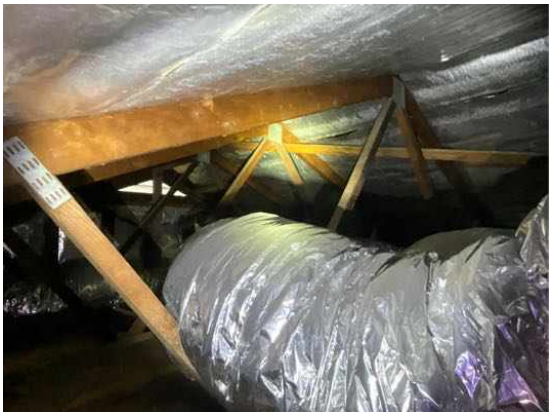
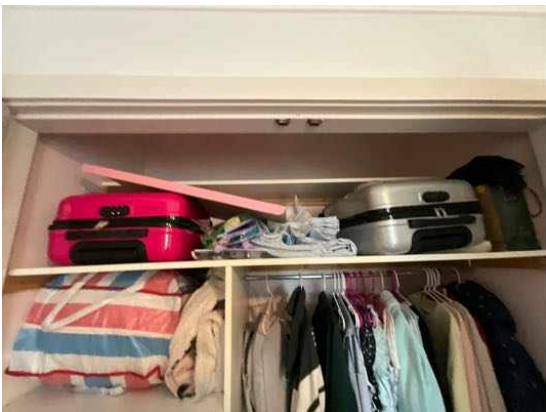
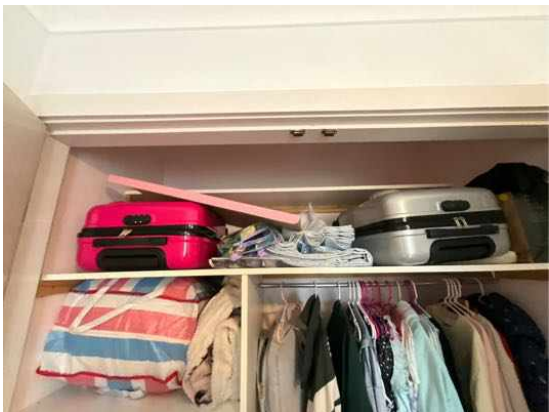
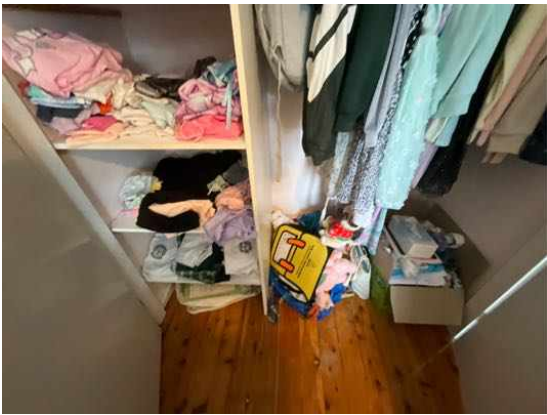
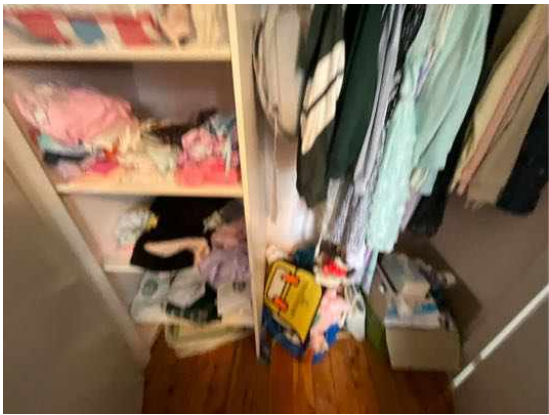
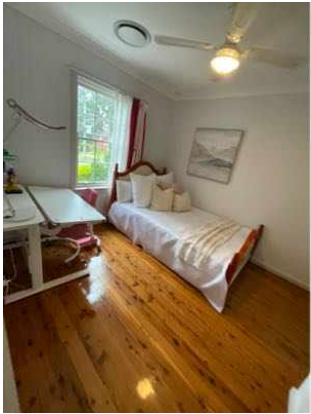
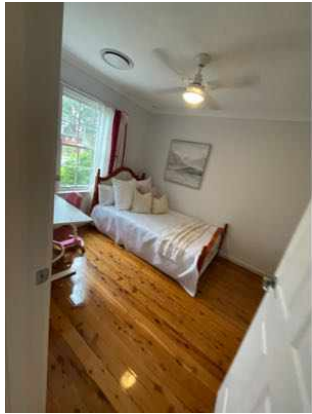
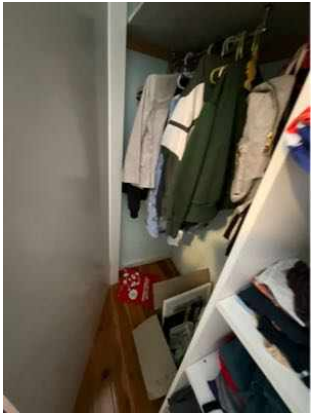
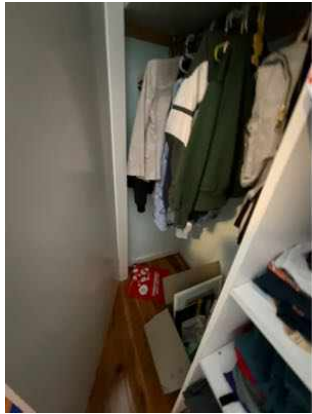
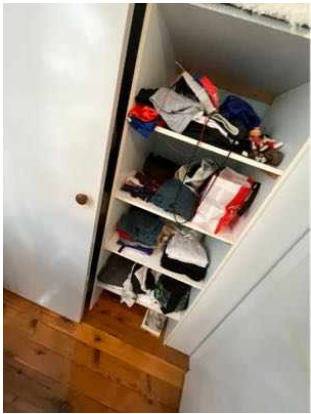
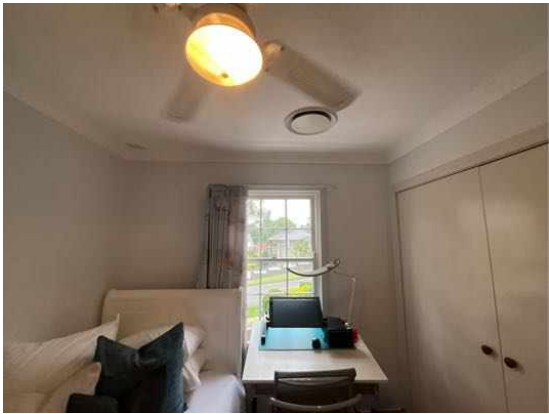
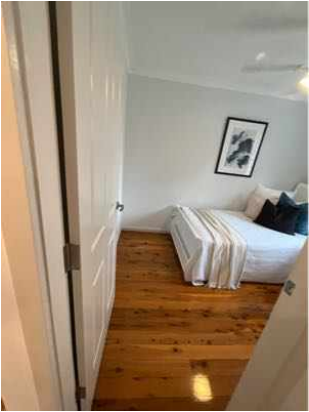
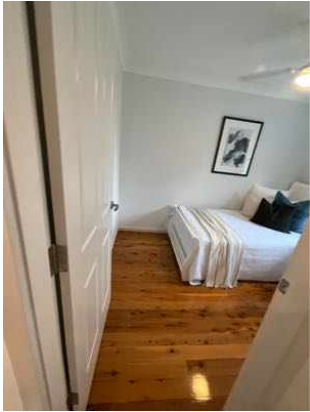
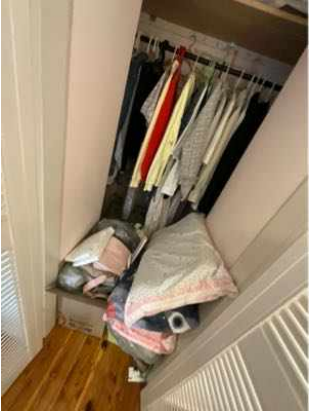
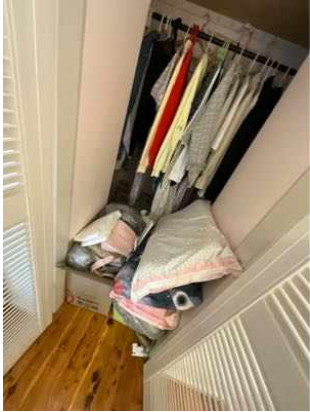
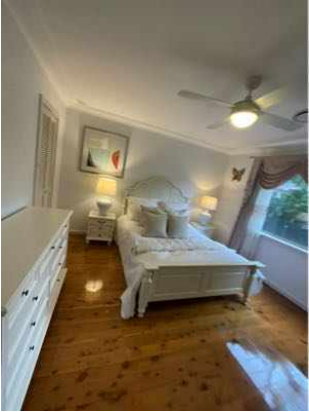
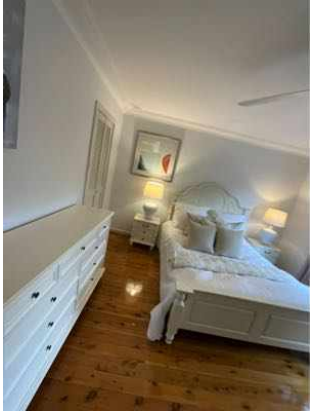
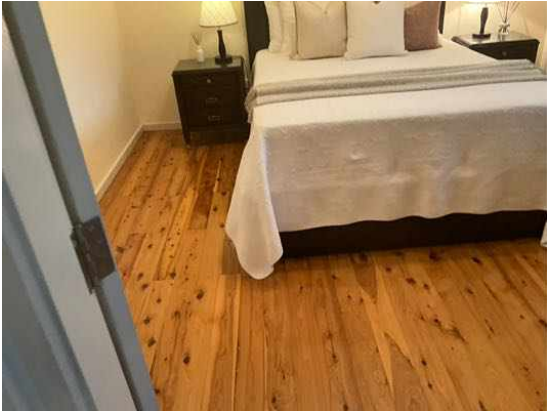
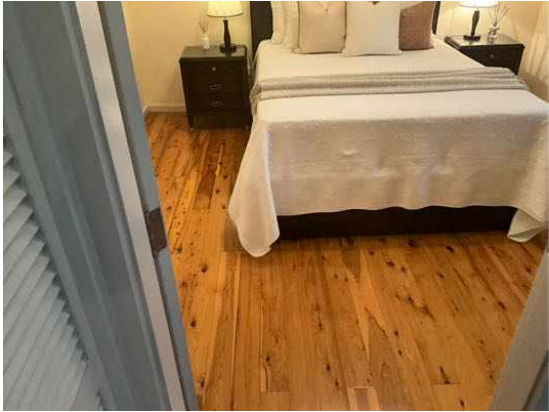
Building:	Main Building
Location:	All Areas
Finding:	Additional Photos - Obstructions and Limitations
Information:	These photographs are an indication of the obstructions and limitations which impeded full inspection of the property at the time of inspection. These obstructions can hide an array of defects and should be removed to allow full inspection to be carried out. A re-inspection is recommended once the areas are made accessible.
