# Building and Timber Pest Inspection Report

Inspection Date: Thu, 12 Feb 2026

Property Address: 17 Jindabyne Ave, Baulkham Hills NSW  
2153, Australia

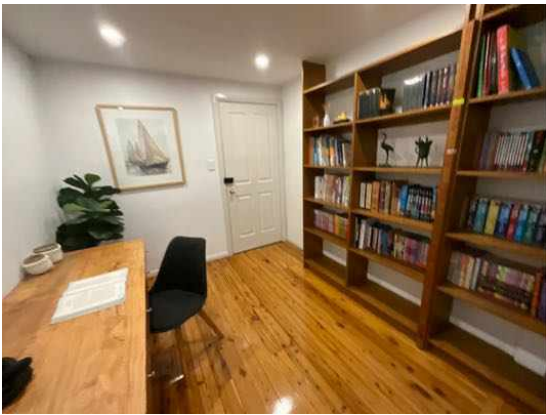
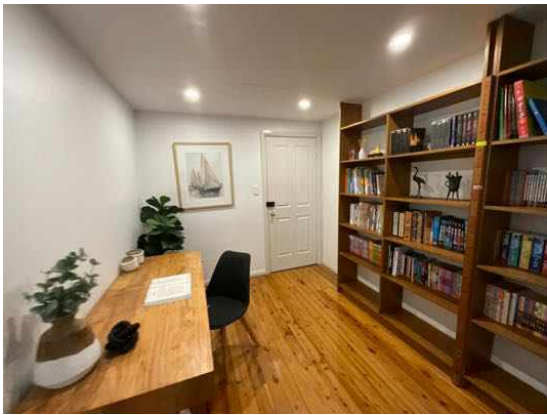
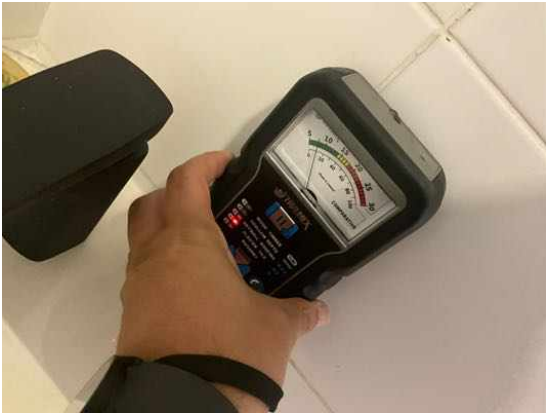
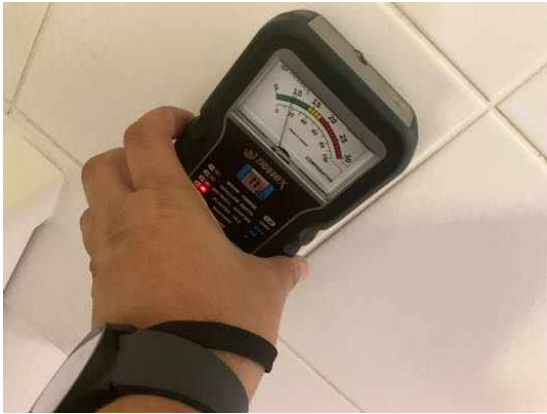
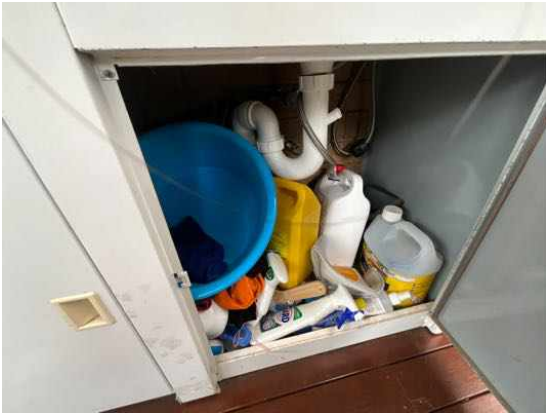
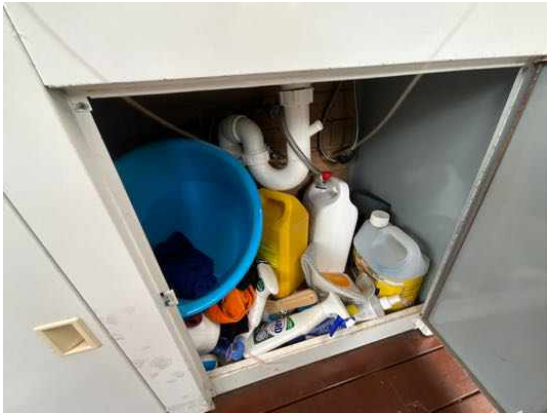
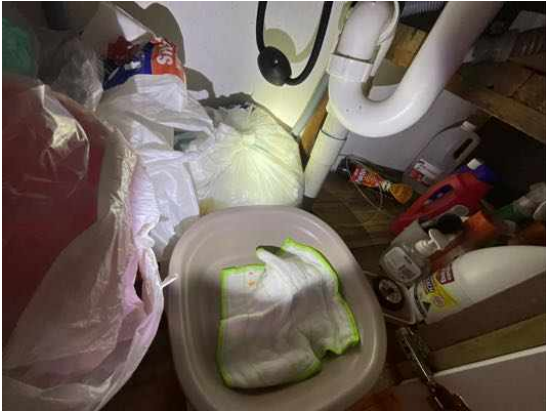
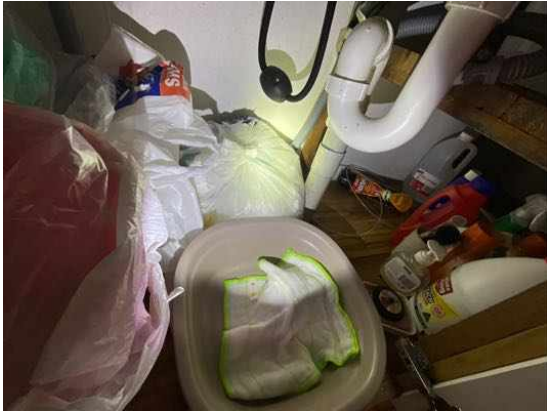
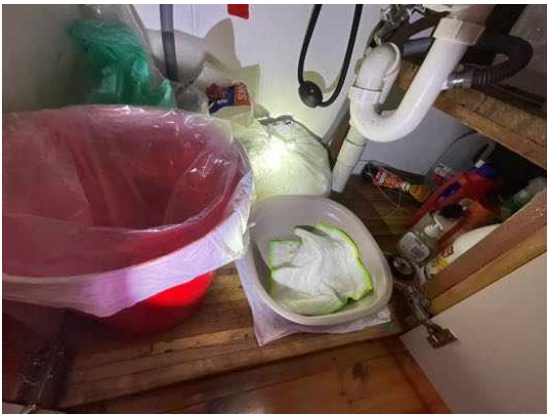
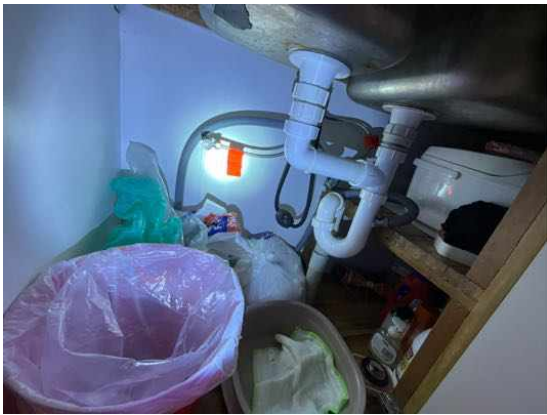
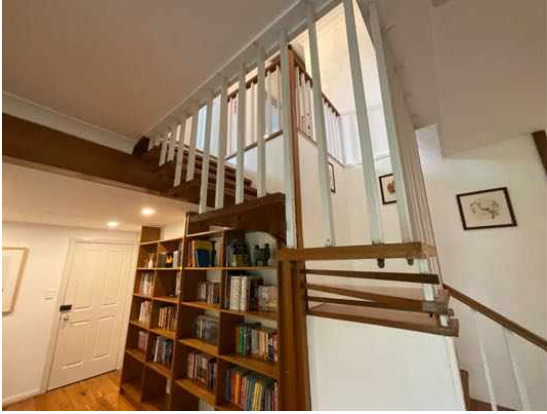
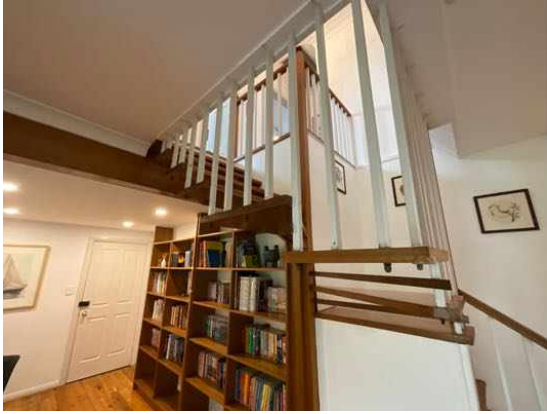
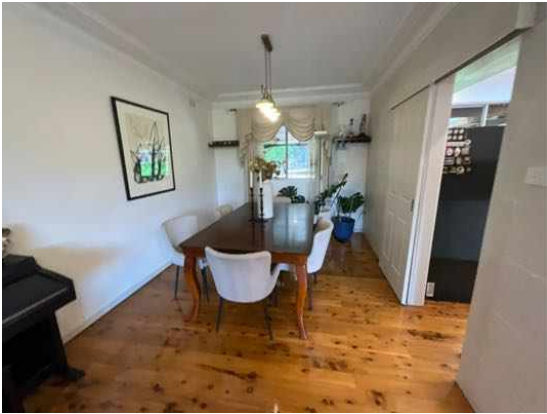
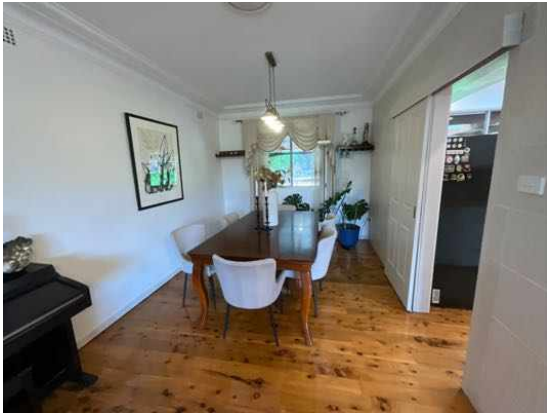
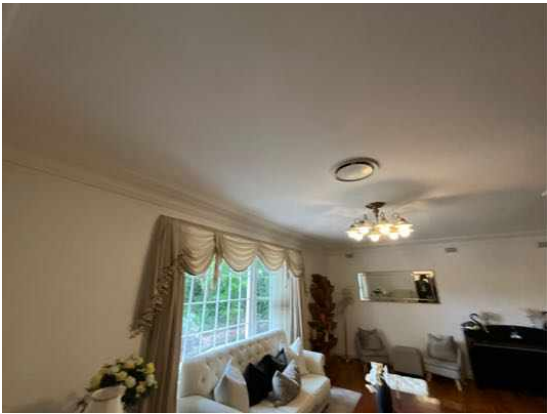
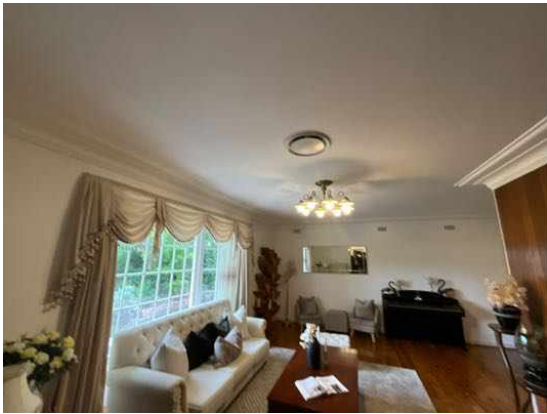
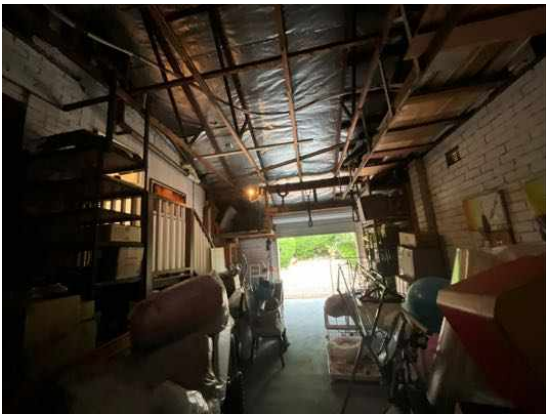
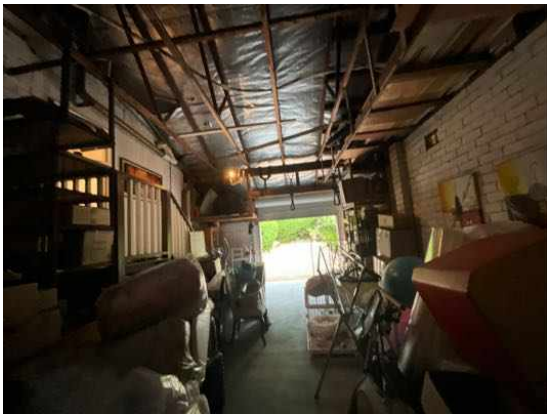
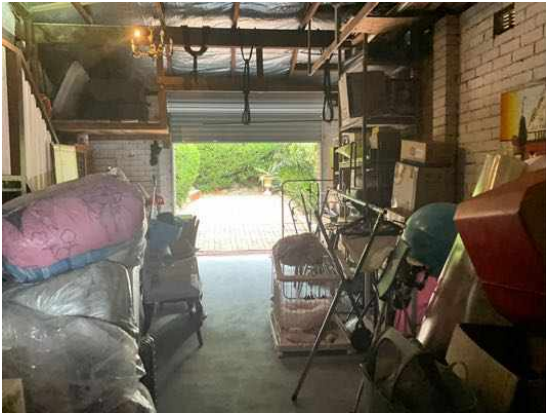
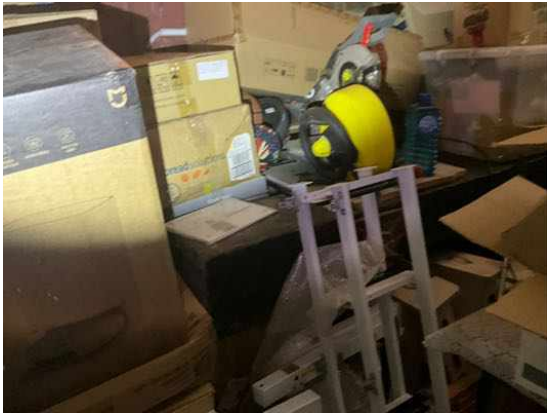
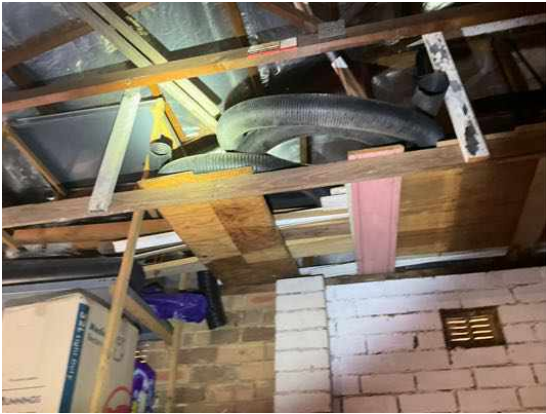
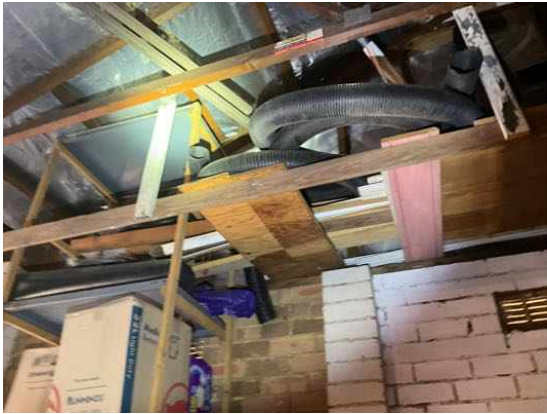
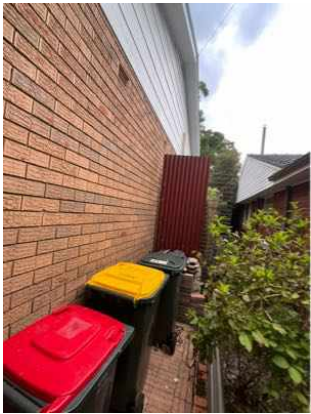
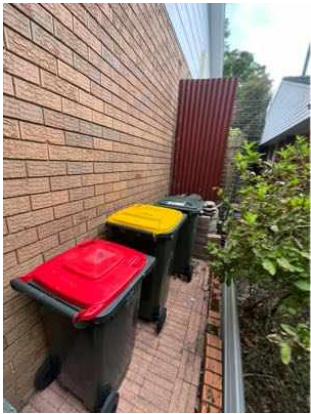
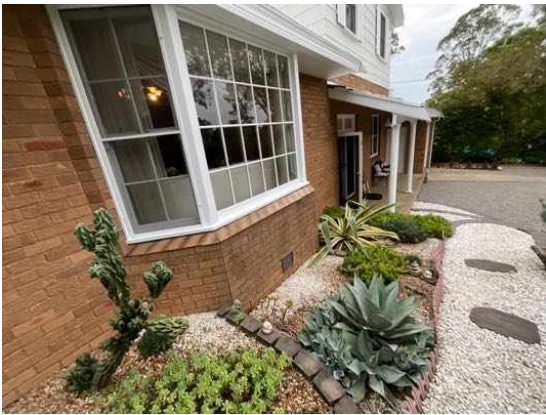
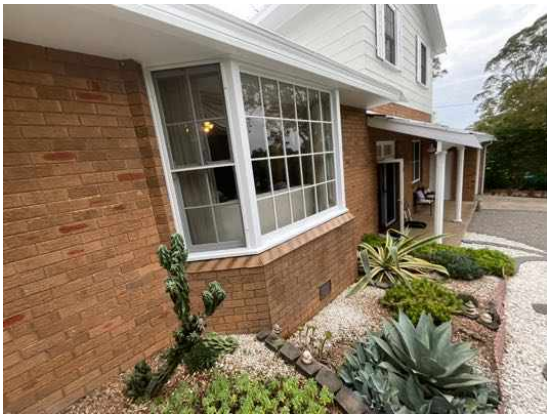
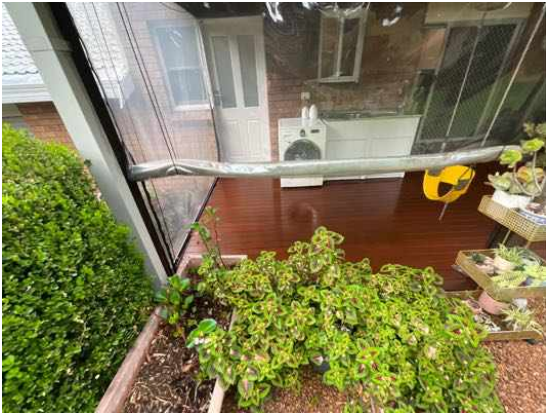
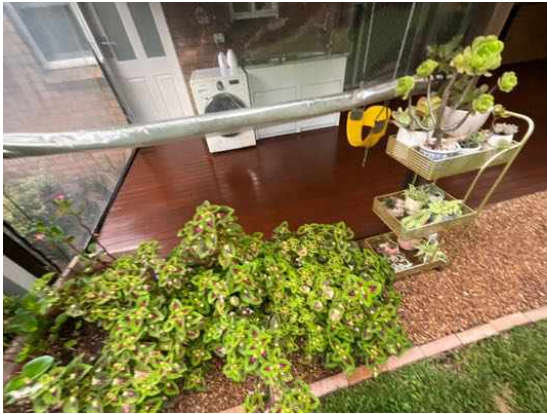
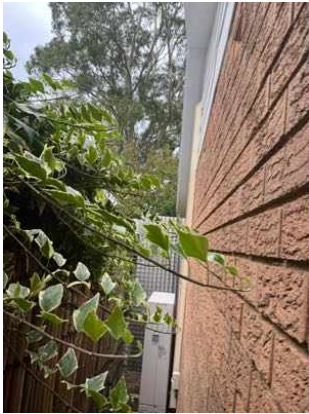
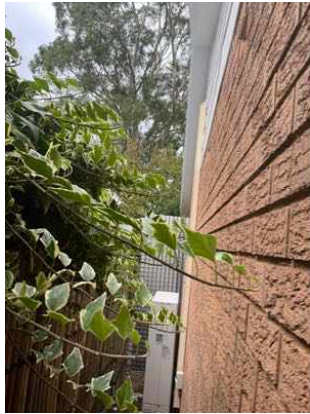
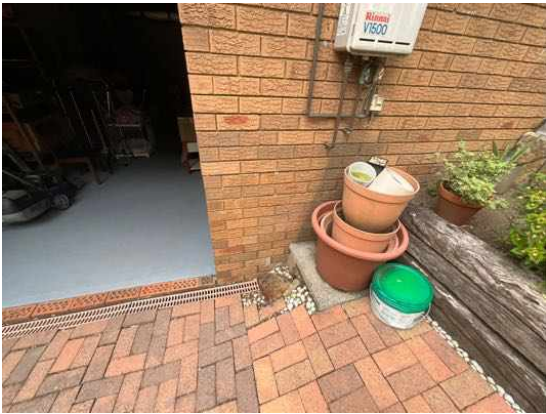
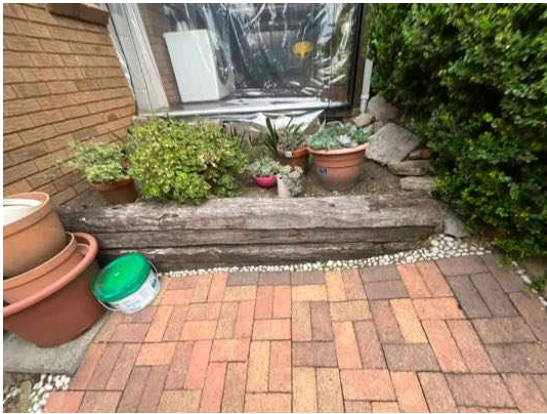
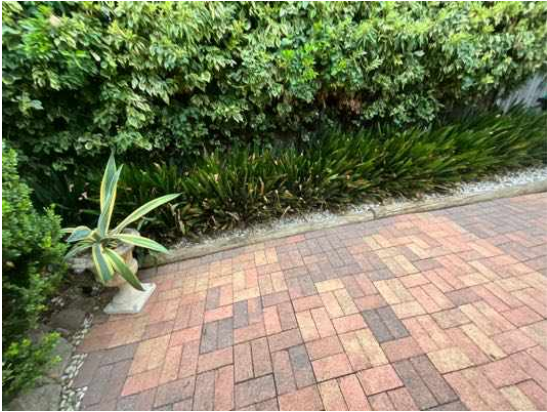
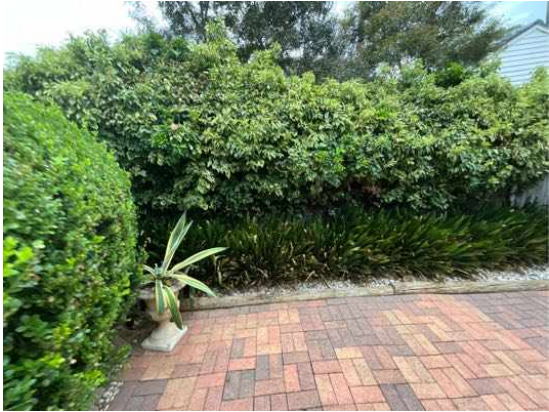
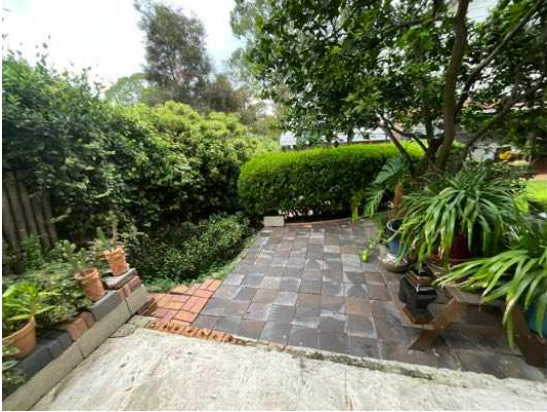
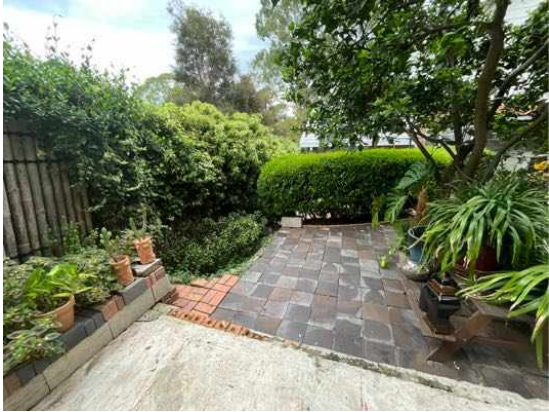
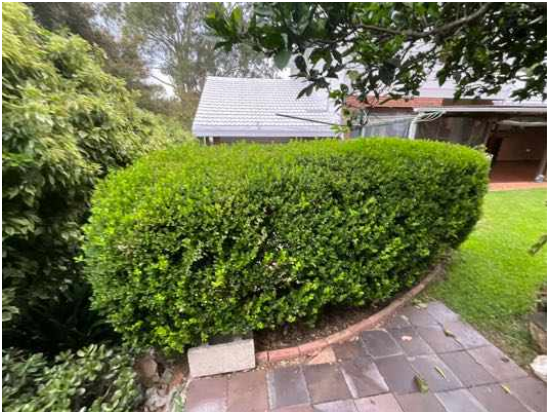
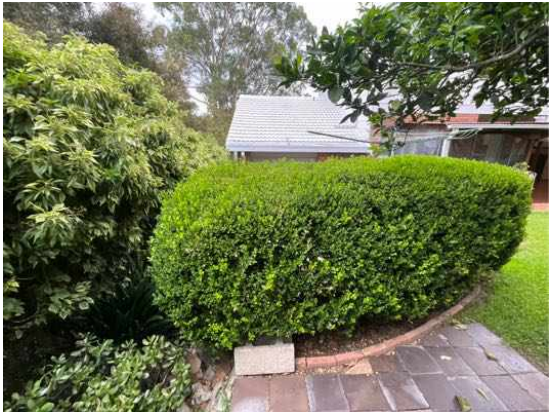
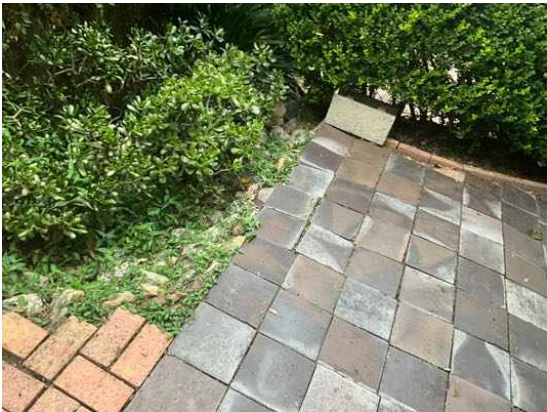
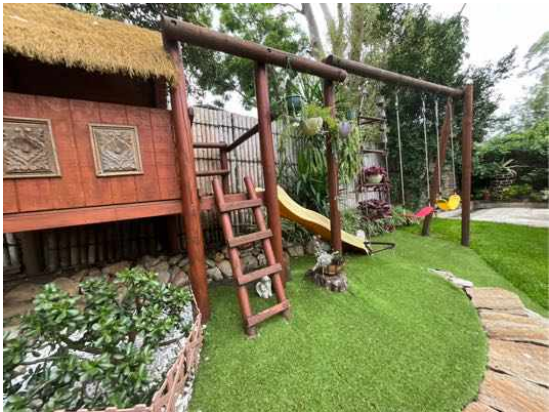
Building:	Main Building
Location:	All Areas
Finding:	Additional Photos - Obstructions and Limitations
Information:	These photographs are an indication of the obstructions and limitations which impeded full inspection of the property at the time of inspection. These obstructions can hide an array of defects and should be removed to allow full inspection to be carried out. A re-inspection is recommended once the areas are made accessible.
