# Building and Timber Pest Inspection Report

Inspection Date: Fri, 20 Mar 2026

Property Address: 96 Bradley St, Glenmore Park NSW 2745,  
Australia

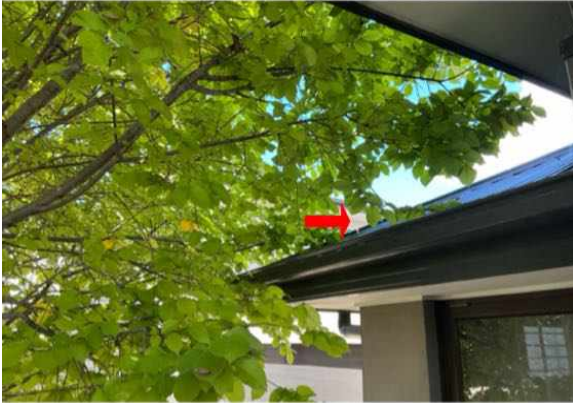
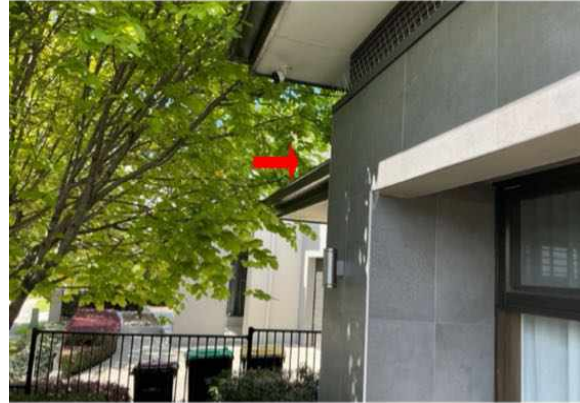
gutters are removed or trim back. Such works should be performed by a landscape contractor or an arborist.

Alternatively, if this is not an option, the client is advised to install gutter guards to avoid ongoing maintenance and cleaning.

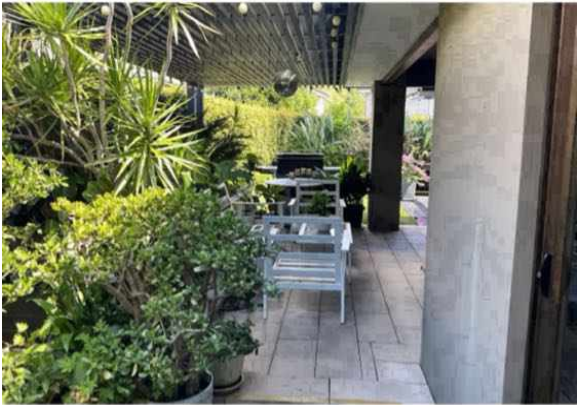
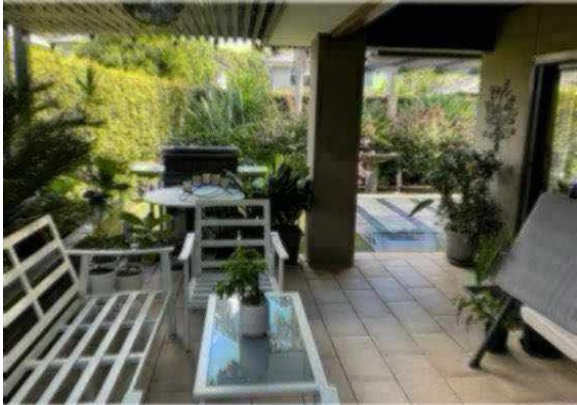
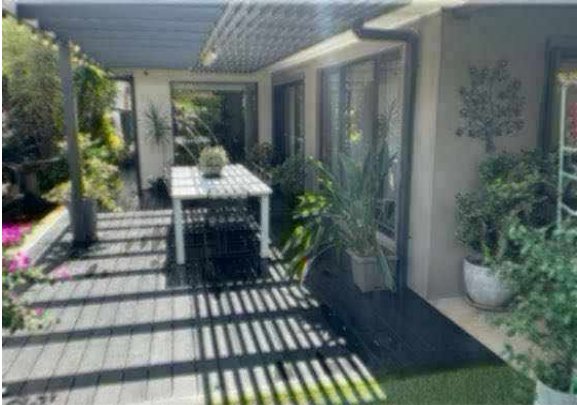
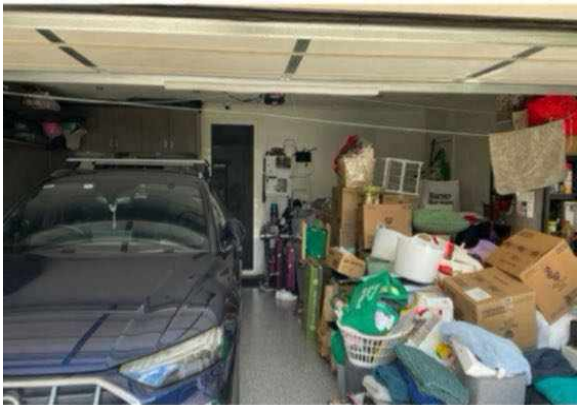
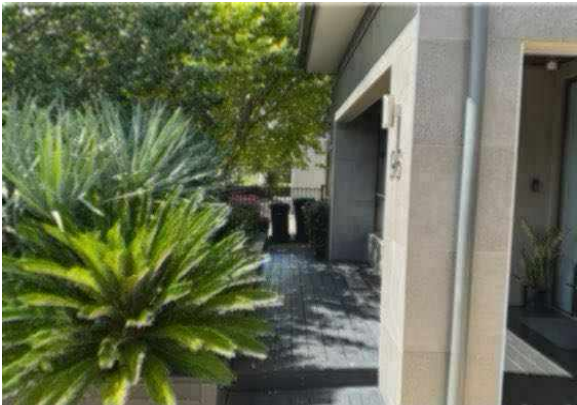
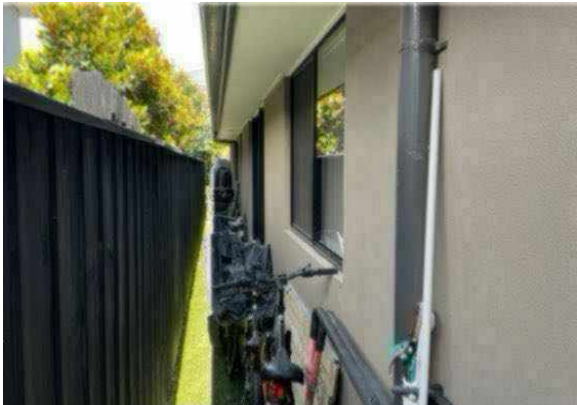
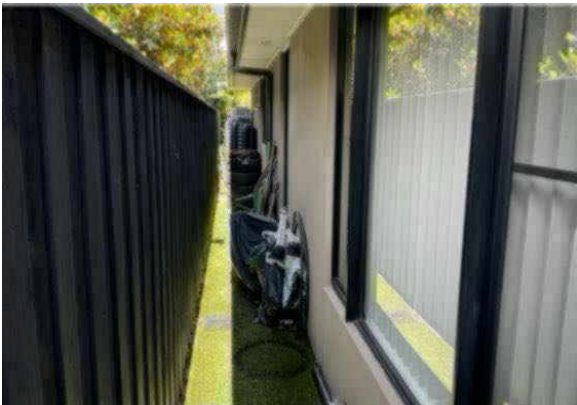
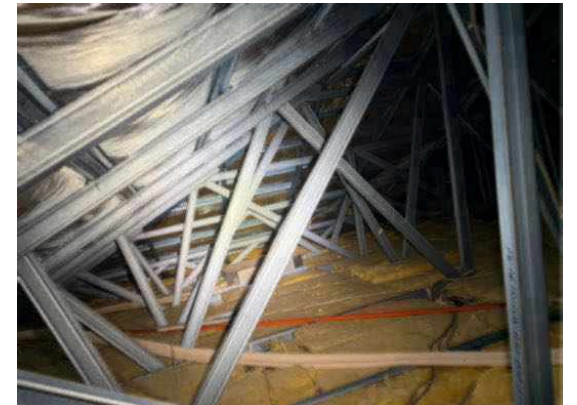
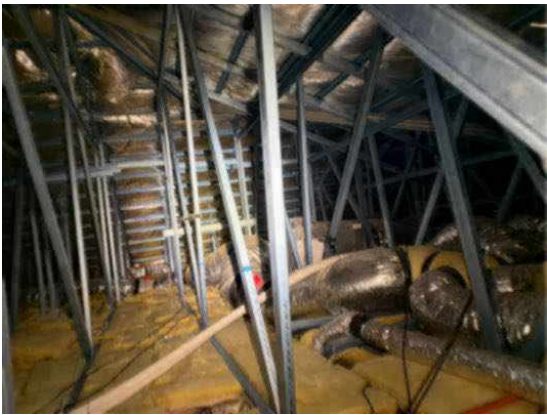
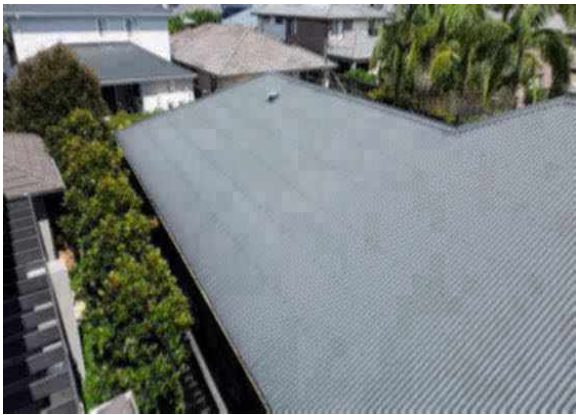
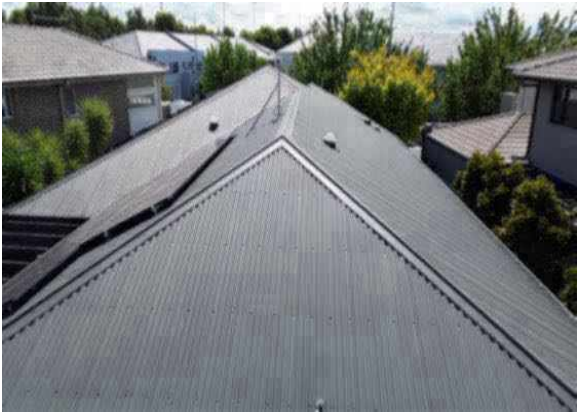
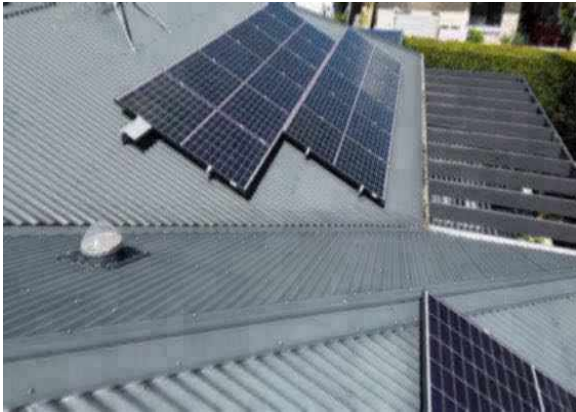
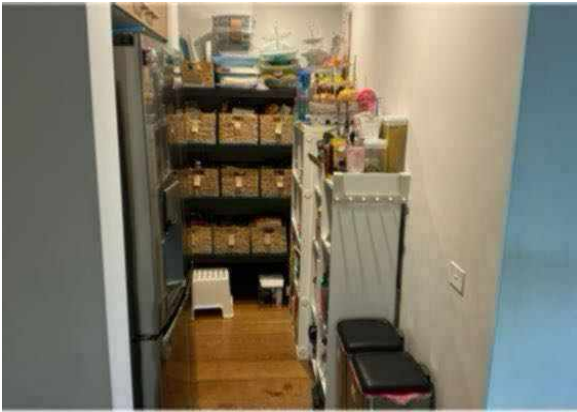
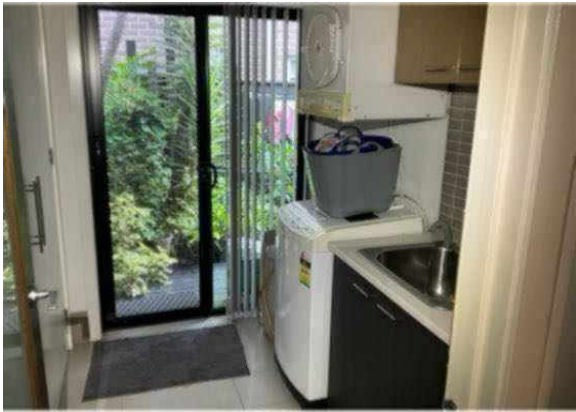
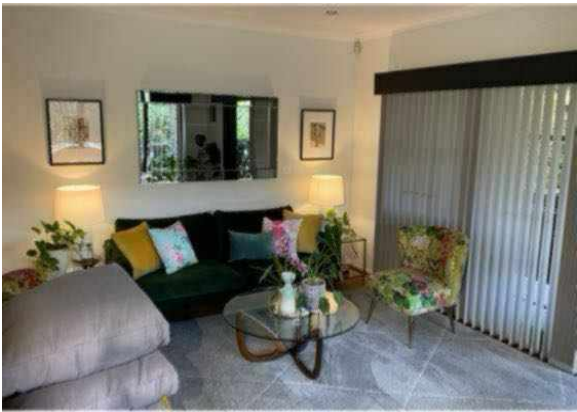
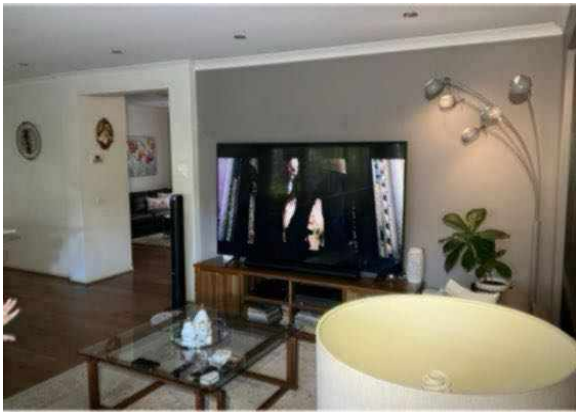
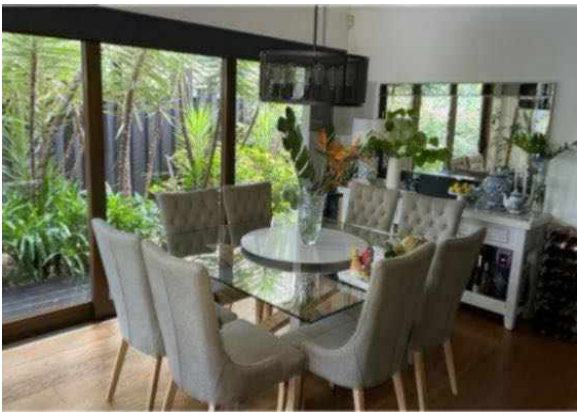
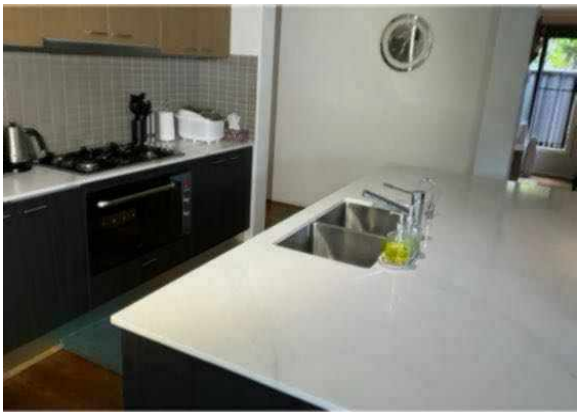
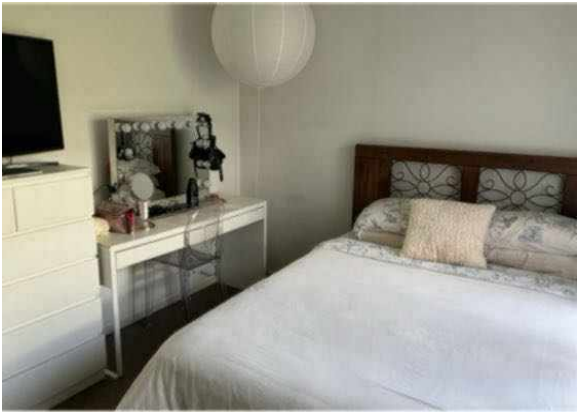
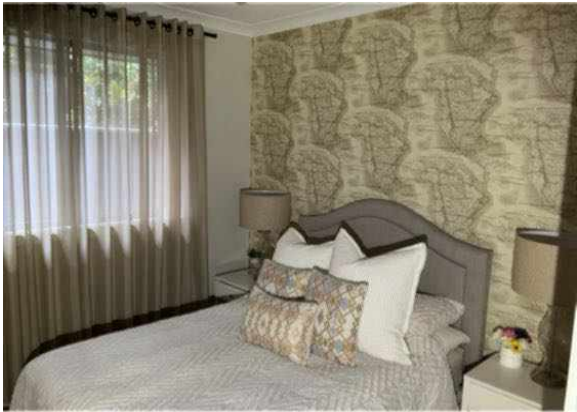
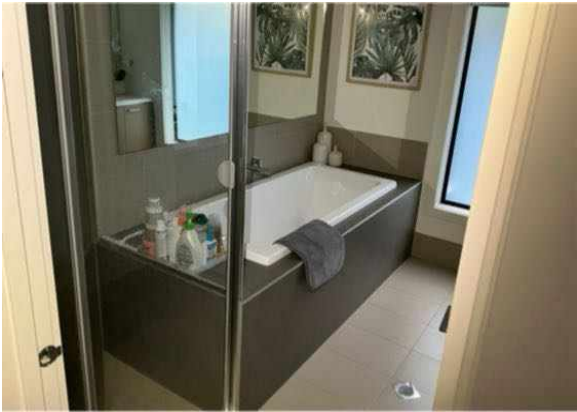
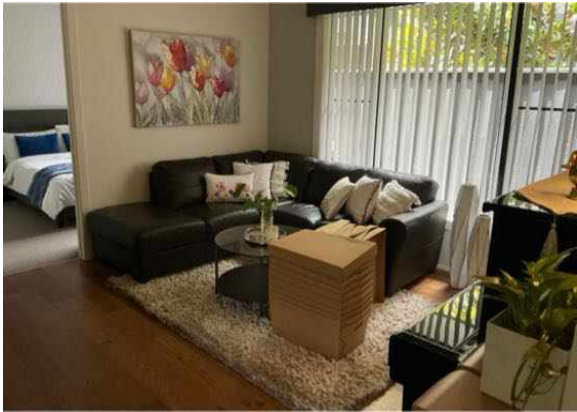
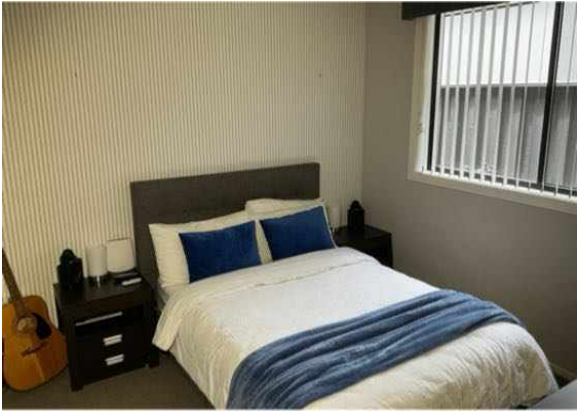
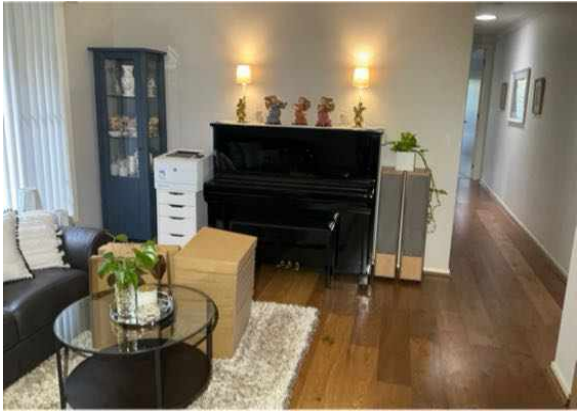
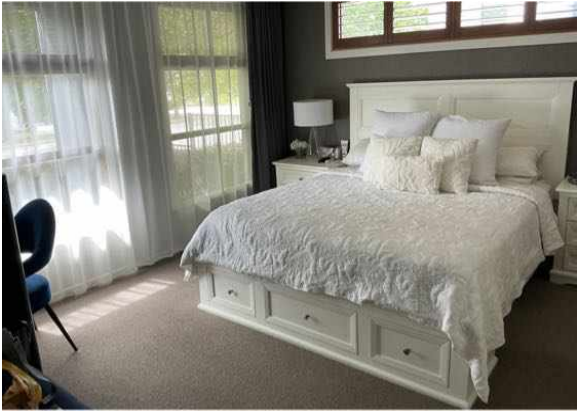
### Noted Item

Building:	Main Building
Location:	All Areas
Finding:	Inspection Photos (Obstructions and Limitations)
Information:	Additional photos have been provided for your general reference, depicting the areas that were accessible during the inspection. Please note that this visual inspection was limited to readily accessible areas, as defined by the report's terms and conditions. The photos demonstrate the obstructions and limitations encountered, which may have impeded a comprehensive inspection and could potentially conceal various defects. For a more detailed and accurate assessment, a special-purpose inspection is recommended.
