# Building and Timber Pest Inspection Report

Inspection Date: Thu, 2 Apr 2026

Property Address: 28 Churchill Ave, Flora Hill VIC 3550,  
Australia

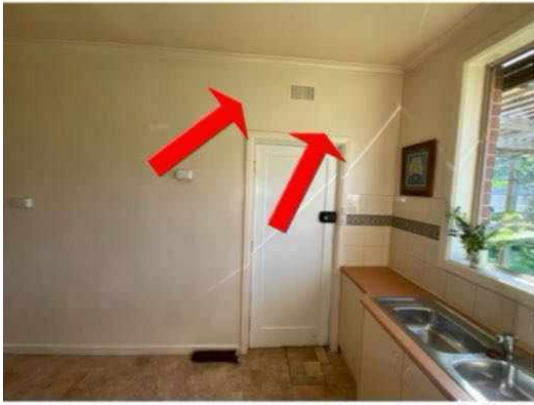
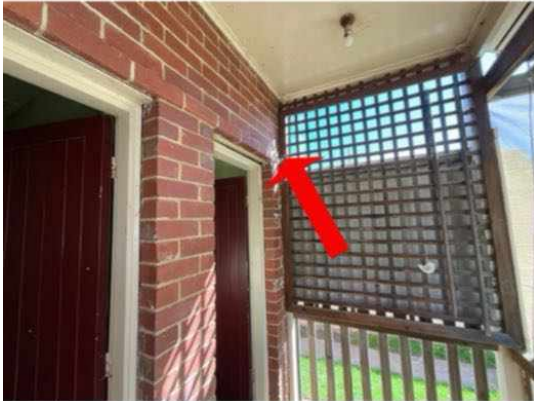
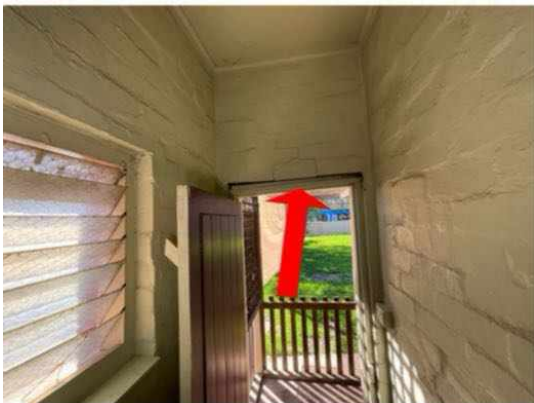
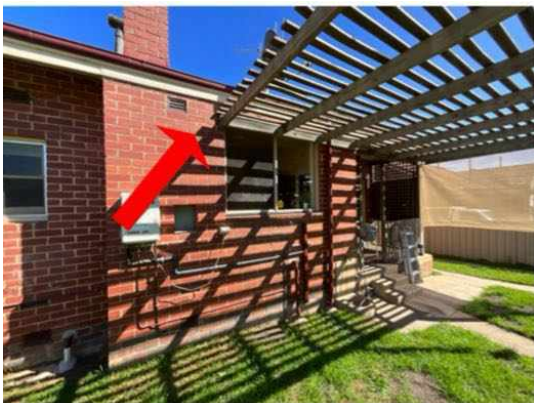
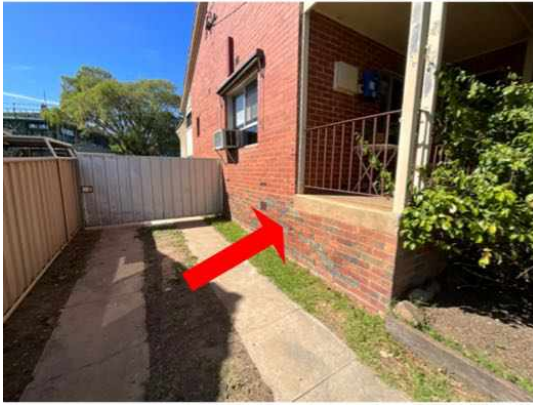
Building: Building 1  
Location: Kitchen, Wc, back wall, driveway side  
Finding: Brickwork- Step cracking  
Information: Step cracking was identified to the brickwork in this area at the time of inspection. Step cracking, which is similar to other forms of cracking, has a variety of possible causes. However, the most common is the subsidence of adjacent footings.

Step cracking is a relatively common defect, and is most likely to occur adjacent to windows, doors and other openings. Mortar failure in the gaps between affected bricks indicates the stresses and tensions affecting the wall.

Minor step cracking can be used as a warning sign to address factors causing stress to the wall, which can include the effect of surrounding trees, water leaks, soil erosion, or even the presence of reactive soils in the surrounding area.

If cracks increase in size or number contact a Licensed builder immediately to make all needed repairs.

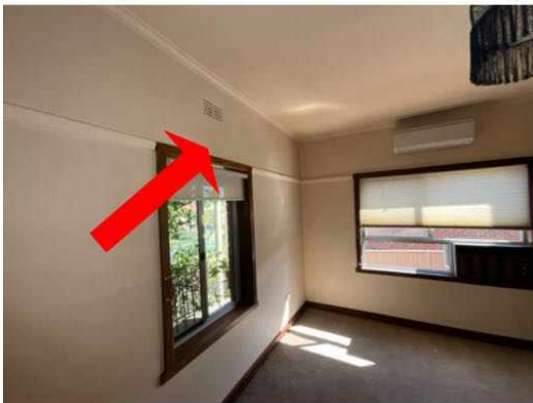
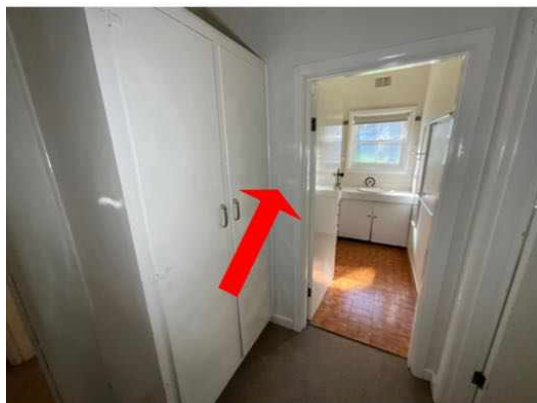
### Finding 3.02

Building: Building 1  
 Location: Living Room, hall  
 Finding: Cracks to internal render - Category 2  
 Information: It has been observed that cracking to internal rendered surfaces has occurred. The degree of damage falls within Category 2, described as noticeable cracks which are easily filled. Cracking of this size are generally less than 5mm in width.

Category 2 damage is required to be monitored for a period of 12 months. After the monitoring period, a crack rated at Category 2 or above is considered a defect requiring rectification.

The extent of cracking would suggest that this is a Major defect.

Always contact your building inspector should cracks widen, lengthen, or become more numerous.

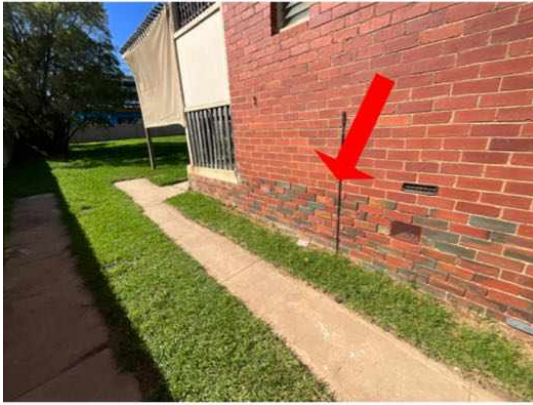
### Finding 3.03

Building:	Building 1
Location:	Driveway
Finding:	Brickwork - Deteriorated mortar
Information:	Mortar, or 'bedding', is the material which fills joints and intersections between bricks in masonry walls and structures. Sections of mortar in this brickwork were identified as having deteriorated, which is generally expected for a property of this age and condition.

Mortar may deteriorate as a result of age of building materials, minor movement of bricks, or frequent exposure to weathering. Mortar should be replaced to ensure that bricks remain in their intended location and to prevent gaps, which would allow water or moisture ingress and secondary damage as a result.

Mortar deterioration can be addressed by a bricklayer where areas of deterioration are localised and easily accessible. Alternatively, appointment of a registered builder is advised, to repoint large areas of decaying mortar. Where secondary structural defects have become evident, consultation with a structural engineer may be required.

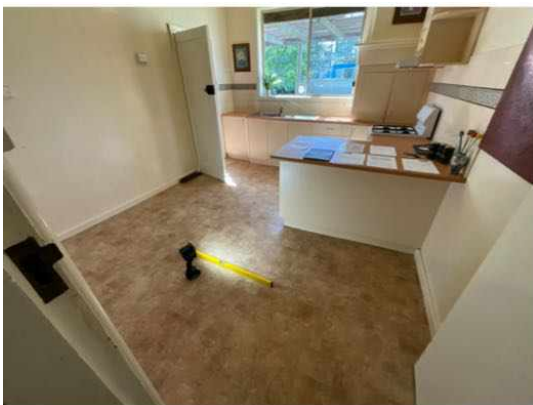
### Finding 3.04

Building: Building 1  
 Location: All Internal Areas  
 Finding: Flooring - Uneven  
 Information: The internal flooring in this area is out of level and uneven. Uneven flooring is likely to indicate minor defects such as expected movement of the foundations of the property, but may also indicate subsidence of the associated subfloor stumps.

It is advised that the flooring be closely monitored to identify any further movement. Where flooring remains relatively unchanged for an extended period of time (i.e. several months), it is likely that this defect has been caused by expected movement of the foundations of the property.

However, where flooring is uneven further, potentially invasive inspection of the subfloor structures and stumps in this area is required. In this case, works to repair are likely to be required, and would be carried out by a registered builder specialising in re-stumping.

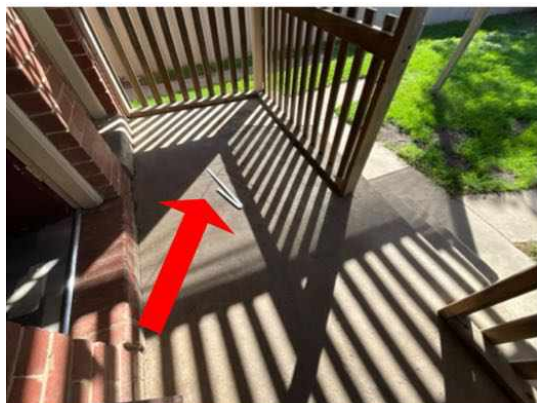
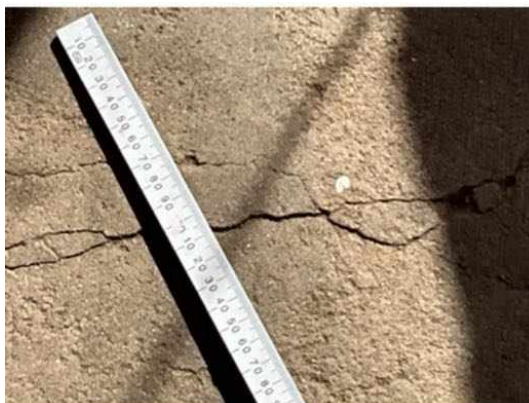
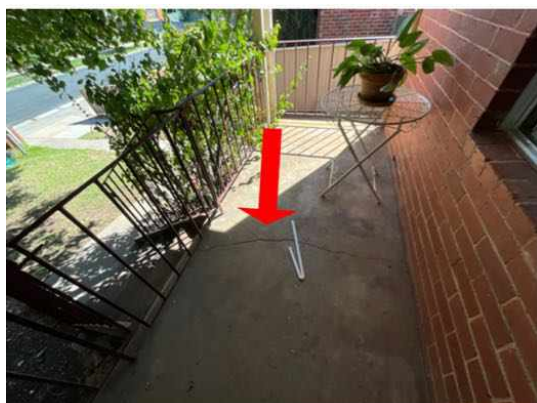
Building:	Building 1
Location:	Verandah front and back
Finding:	Cracking - External Concrete Paving Damage Category 3 - Wide Cracks (2mm - 4mm)
Information:	Wide cracks were identified in external concrete paving Wide cracks are significant and are likely to lead to the development of safety hazards and secondary defects if left unmanaged.

General age and expected deterioration of the paved areas is a common cause of this type of cracking. However, expansion and contraction of the slab may also have occurred due to environmental factors. Such factors include variable moisture and weather conditions, the presence of trees and their roots having a settling or lifting affect on the soil, or the effect of load bearing, e.g. heavy vehicles over a sustained period of time.

Cracking to this degree may also be due to poor original installation of the concrete. Factors such as poor compaction of the sub surface and/or inadequate reinforcing of the slab may create cracking and other secondary defects. Wide cracks may also have a more significant structural cause, such as subsidence of soils.

Where the crack is located adjacent to structural elements of the building, the advice of a Structural Engineer is advisable before undertaking repairs. Significant repair and likely replacement of the concrete paving is probable.

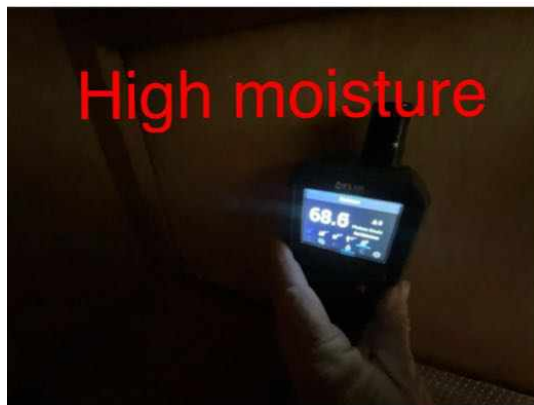
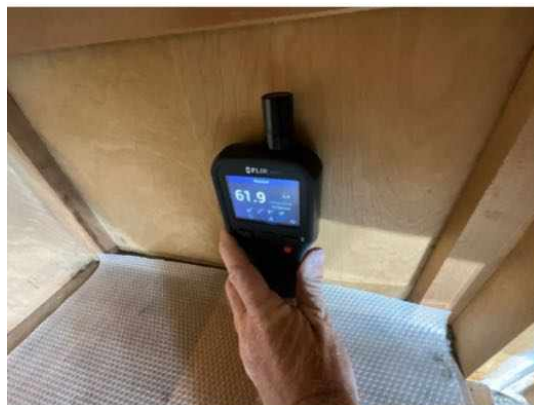
Building:	Building 1
Location:	Bathroom
Finding:	Showers Damp- Major
Information:	Damp is evident to the lower 300mm of wall to the Shower Alcove. This is suspected to have been caused by moisture permeating through the grouting in this area, which shows evidence of deterioration.

High levels of moisture were observed on the outside of the shower walls in the opposite wall.

Damp (or structural damp) refers to the presence of unwanted moisture in the structure of the building, either as a result of intrusion from outside, or condensation from within the structure. In the Shower area, internal water leaks or other sources of excessive moisture are generally the cause of damp.

Consultation with a qualified Plumber or Bathroom Specialist is advised immediately to identify the cause of damp and to perform remedial works as required.

Always ensure that sealant and grout is in good condition to prevent any moisture issues occurring in the future.

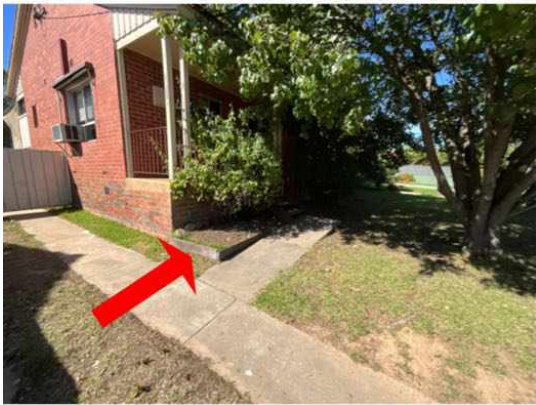
Building: Building 1  
Location: Yard - Back, front  
Finding: Untreated or non-durable timbers in a hazardous environment  
Information: To reduce the risk of timber pest attack it is essential that timber used in a hazardous environment (e.g. in direct contact with the ground or frequently exposed to damp conditions) is of sufficient durability and/or is adequately preservative treated.

Untreated timbers in direct contact with the ground are likely to develop severe wood rot and/or fungal decay if left unattended creating attraction for subterranean termites to infest the timbers from surrounding areas.

If untreated or non-durable timbers are found to be in a hazardous environment it is highly advised that replacement of these building elements be performed as soon as possible to aid the protection of the property against termite / timber pest attack.

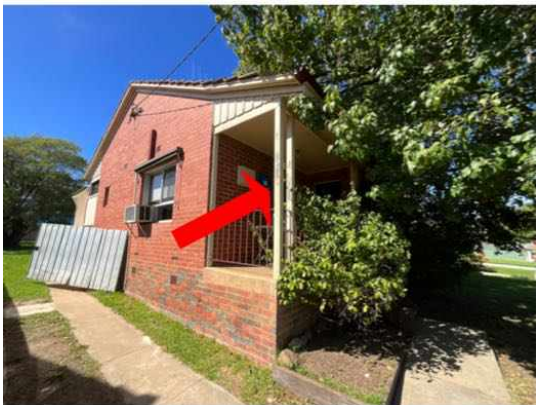
**Finding 6.04**

Building: Building 1  
 Location: All External Areas  
 Finding: External painting deteriorated  
 Information: Much of the external paintwork including but not limited to windows, fascias, guttering, veranda and other external fitments have been neglected and require attention to prepare and re-paint.

Degraded paint finishes should be sanded back, filled, leveled and painted, as applicable. Where inadequate or missing paint protection has led to the deterioration of the associated building element, repair and/or replacement of this building element may be required.

A painting contractor should be appointed as soon as possible to perform necessary works to aid the appearance of the affected area and to ensure the area is protected against further deterioration. Alternatively, the homeowner following manufacturer instructions may perform these works.

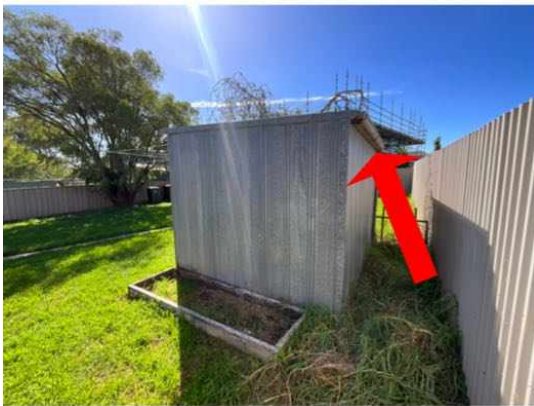
### Finding 6.05

Building:	Building 1
Location:	Shed
Finding:	Gutters- Deteriorated
Information:	The guttering and some downpipes have deteriorated.

Although not a major problem now, they will deteriorate further if left for an extended period.

Sagging can be seen in the gutter.

A Licensed Plumber should be engaged as soon as possible to advise on any repairs or maintenance that may be required.

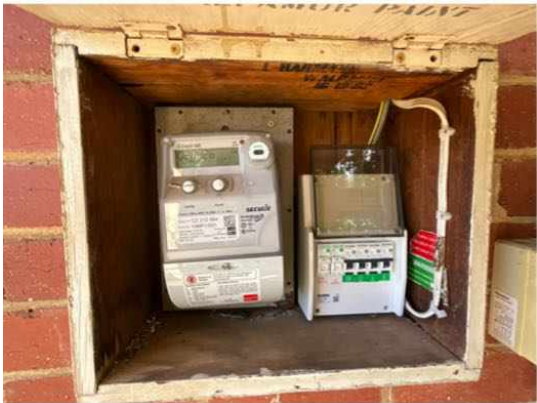
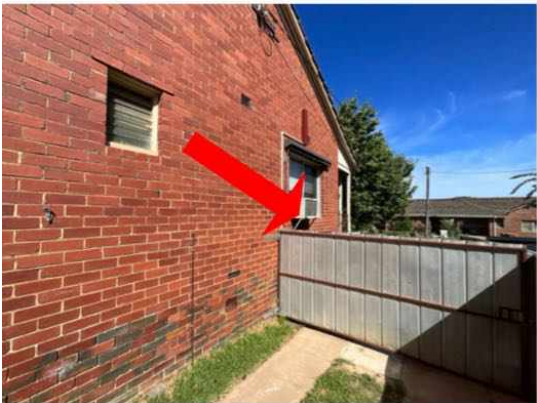
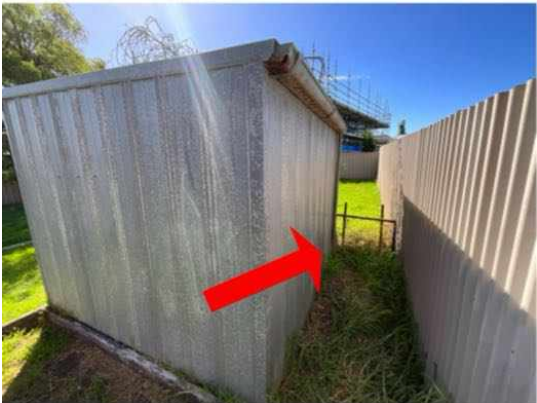
A durable notice should be placed in the switchboard unit to indicate current termite barriers. At the time of inspection, it appeared as though no termite management system has been installed, with no evidence to suggest preventative works taking place.

The client may consider gaining further advice from a pest controller as to the costs and procedures involved with this application. It is recommended that obtaining such advice be a short-term priority.

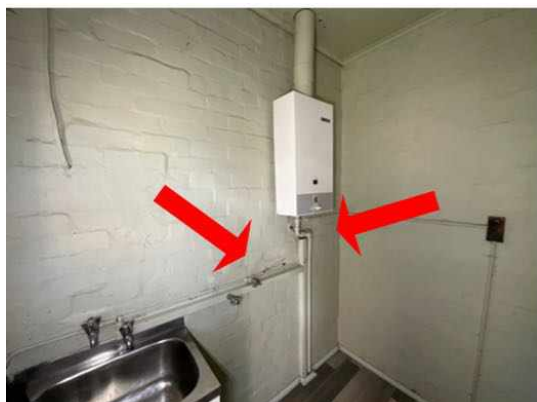
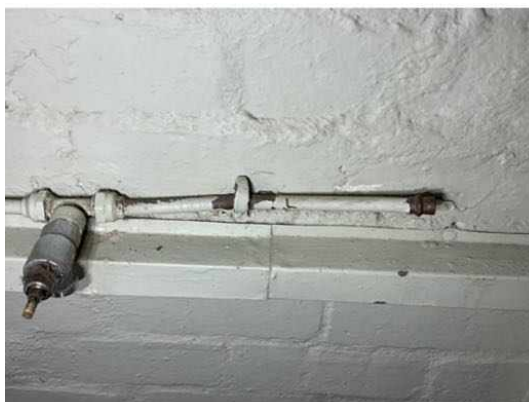
Location: Laundry  
Finding: Gas water heater  
Information: This unit has been permanently disabled.

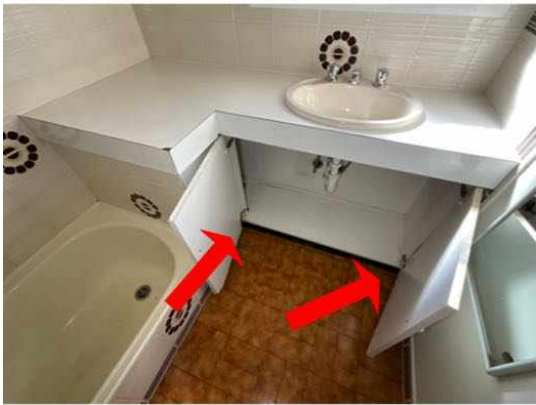
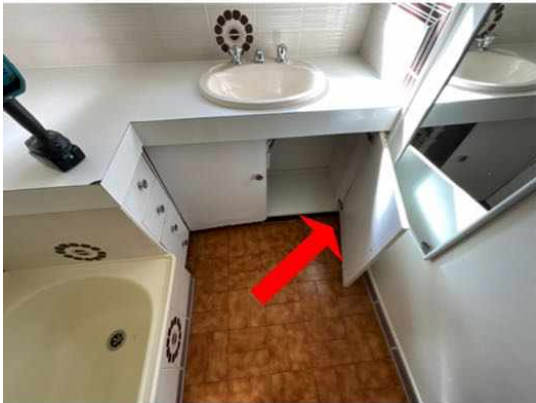
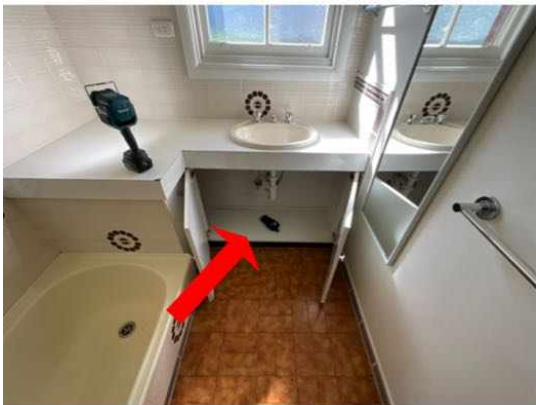
Building: Building 1  
Location: Bathroom  
Finding: Cabinets- moisture affected.  
Information: The structure of the Cabinets in this area was found to be deteriorating due to the effects of excessive moisture. Replacement of any damaged board materials is recommended. Parts of the Cabinetry not badly damaged or swollen may be re-sealed or painted.

The source of the moisture must be identified and rectified before repairs and replacement is carried out. The services of a Cabinet maker or General Handy Person should be sought at the discretion of the owner.

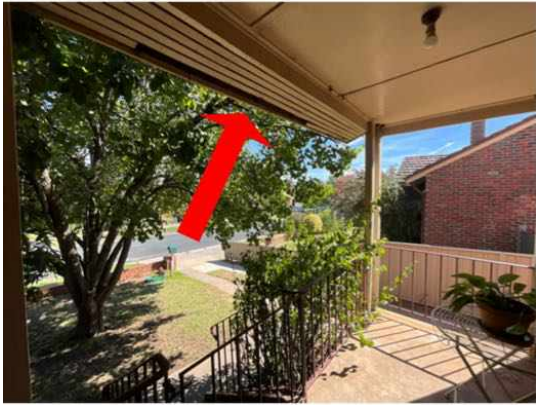
Building: Building 1  
Location: Eaves  
Finding: Incomplete or substandard works  
Information: The works to this area appear to be incomplete or have been completed to a substandard level.

It is highly recommended that the relevant trades be appointed to complete these

works and ensure the safety of the area and the longevity of all associated building elements.

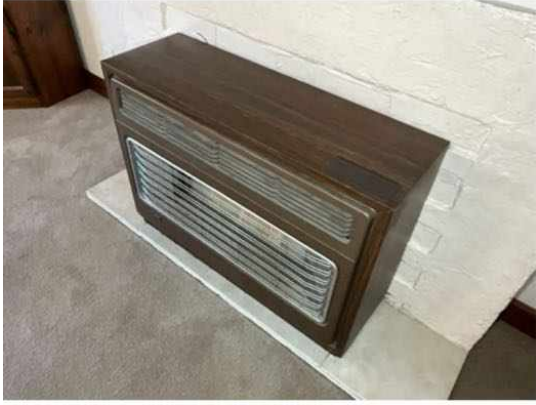
Building: Building 1  
Location: All Areas  
Finding: Additional Photos - Obstructions and Limitations  
Information: These photographs are an indication of the obstructions and limitations which impeded full inspection of the property at the time of inspection. These obstructions can hide an array of defects and should be removed to allow full inspection to be carried out. A re-inspection is recommended once the areas are made accessible.
