## Building Inspection Report

Inspection Date: Tue, 7 Apr 2026

Property Address: 2/3 Dagola Ave, Nunawading VIC 3131,  
Australia

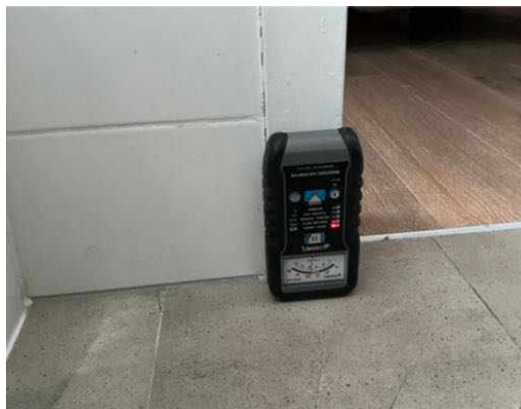
### Defects 3.04

Building:	Main Building
Location:	Ensuite - Master
Finding:	Building element - Swollen
Information:	Swollen building elements generally indicate that the building materials have been affected by excessive moisture over a prolonged period of time, and have swollen as a result. The formation and development of mould/fungi or mildew is also a likely consequence of excessive moisture, which may pose major respiratory issues for occupants, particularly the elderly, the very young and those with existing illnesses and could be potential health safety hazards. In these cases an appropriately qualified inspector/tester should also be contacted for advice and/or technical assistance.

The structural integrity of swollen building elements can not be guaranteed, and further damage is likely to develop if left unmanaged. Excessive moisture is likely to lead to the development of secondary damage to any associated building elements, which may necessitate major reparation works if prolonged.

Rectification of the cause of the water leak should be addressed prior to any remedial works to the swollen building elements. A licensed plumber should be appointed

immediately to identify the cause of the leak and provide advice on remedial works as necessary, Repair and/or replacement of swollen building elements should be conducted as a matter of urgency by a registered builder or qualified carpenter.

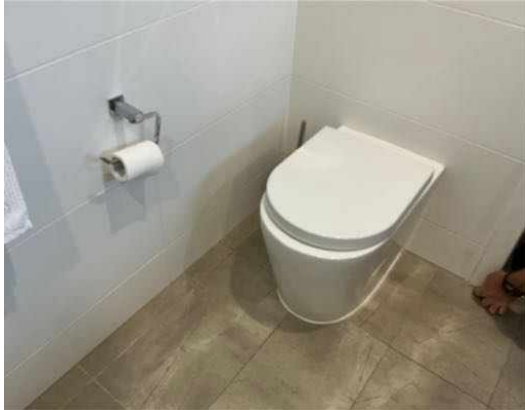
### Defects 3.08

Building: Main Building  
 Location: Ensuite - Master  
 Finding: Toilet- Cracked  
 Information: Cracking was evident to the toilet base at the time of inspection, which is suspected to have been by minor impact damage and age. While the cracking appears to be minor, this will continue to deteriorate and may leak if not replaced.

As the cracking provides potential for water leaks, secondary water damage may occur to associated cabinetry, walls or flooring, if the cracking is left unmanaged.

Consultation with a plumber regarding replacement is required. Remedial works may be required to protect against any further damage.

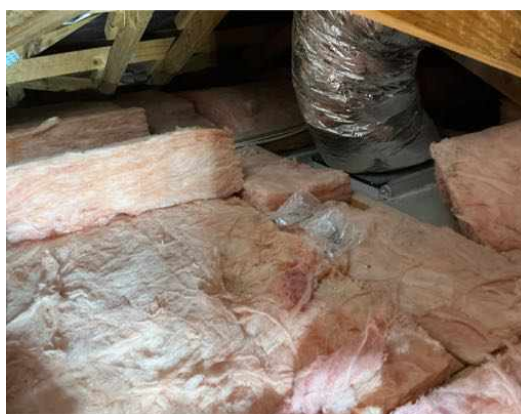
As a general rule, a 5% gap in the insulation creates potential for a 50% decrease in the energy efficiency of the property.

All insulation batts should be reinstated prior to final handover to comply with standards and to ensure maximal energy efficiency within the property. Failure to do so results in non-compliance with AS4859.1 Materials for Thermal Insulation of Buildings.

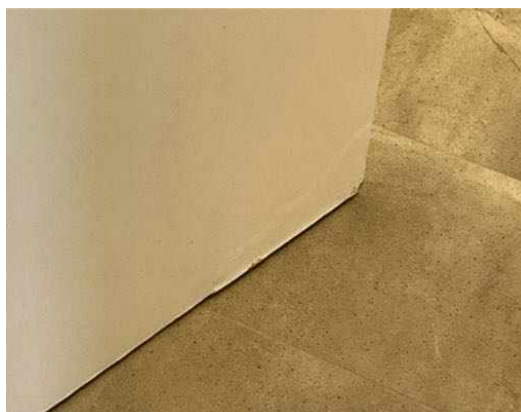
### Defects 3.16

Building:	Main Building
Location:	Bathroom
Finding:	Building element - Swollen
Information:	Swollen building elements generally indicate that the building materials have been

The structural integrity of swollen building elements can not be guaranteed, and further damage is likely to develop if left unmanaged. Excessive moisture is likely to lead to the development of secondary damage to any associated building elements, which may necessitate major reparation works if prolonged.

Rectification of the cause of the water leak should be addressed prior to any remedial works to the swollen building elements. A licensed plumber should be appointed immediately to identify the cause of the leak and provide advice on remedial works as necessary. Repair and/or replacement of swollen building elements should be conducted as a matter of urgency by a registered builder or qualified carpenter.

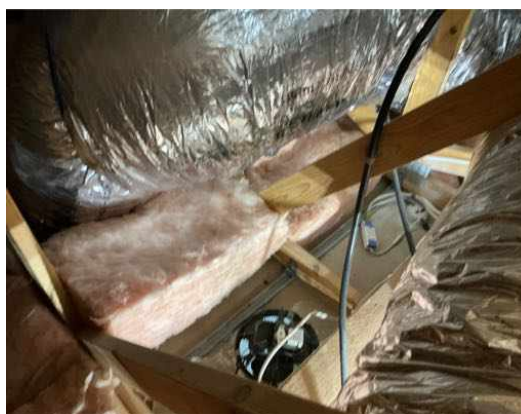
### Defects 3.17

Building:	Main Building
Location:	Roof Void
Finding:	Exhaust fan - sarking on roof

(B) is covered by roof tiles WITHOUT SARKING or similar materials which would prevent venting

through gaps between the tiles.

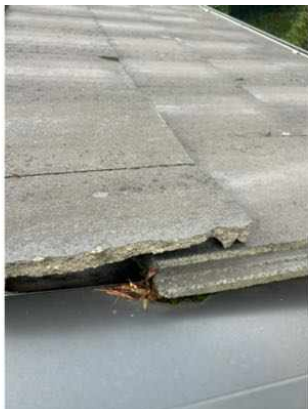
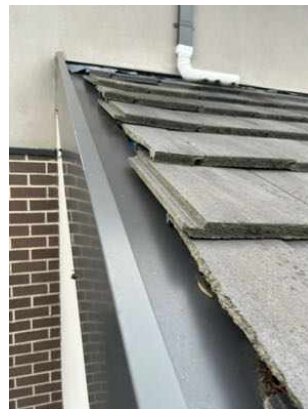
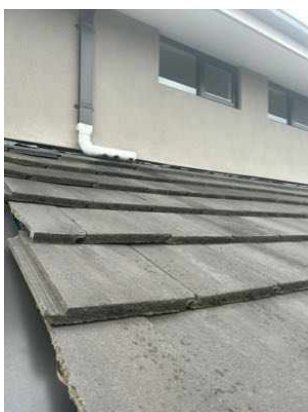
### Defects 3.18

Building: Garage  
 Location: Front Elevation  
 Finding: Roof plumbing - Flashing inadequate  
 Information: Some sections of the roof are missing or have inadequate roof flashings. Flashings are metal and other materials which are applied to seals and intersections between roof coverings and building elements. They are designed to aid in weatherproofing of roof joins.

is missing or inadequately installed. Additionally, water pooling also creates an environment that is susceptible to termite and pest infestation.

A roofing plumber should be appointed as soon as possible to install relevant roof plumbing materials, ensuring that no further damage is sustained.

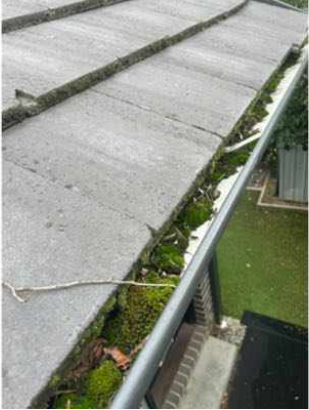
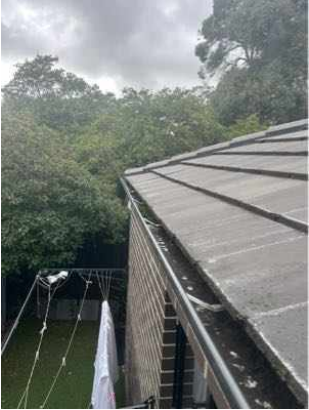
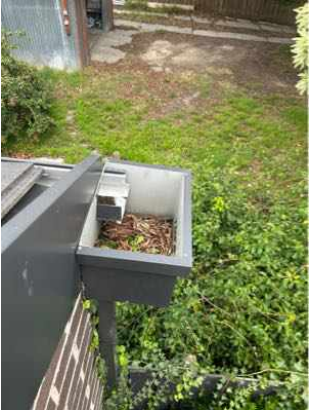
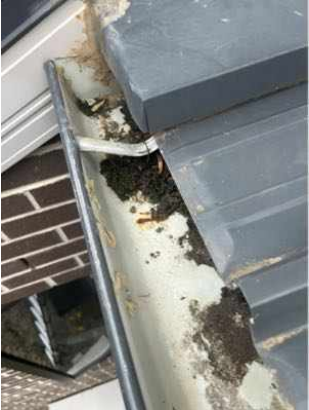
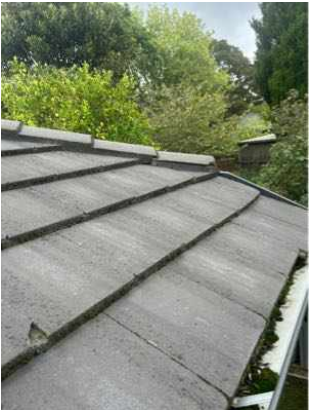
### Defects 3.19

Building:	Garage
Location:	All Areas
Finding:	Gutters - Blocked
Information:	Roof plumbing structures, such as guttering and downpipes, should be free of all debris to prevent blockages. Blockages of the guttering and downpipes will lead to pooling and accumulated water overflows, which is likely to subsequently flood eaves and exterior walls.

Consult a Licensed Plumber for further specific advice on remedial works that may be required. In the interim, it is highly advised that blocked gutters be removed by the homeowner or a general handyperson as a matter of urgency.

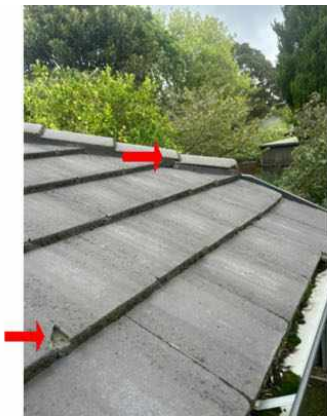
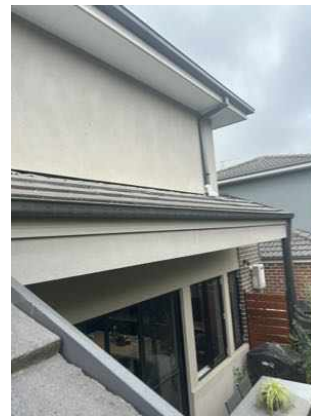
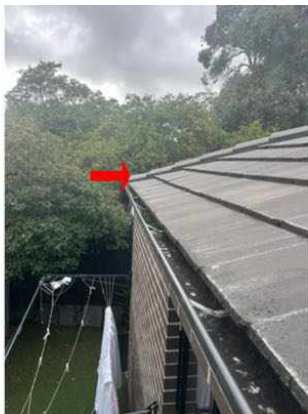
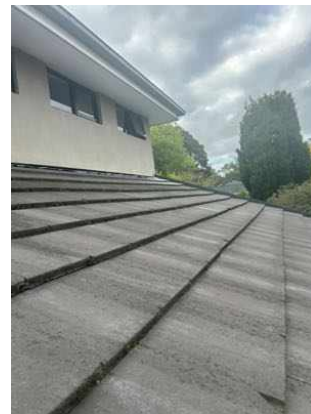
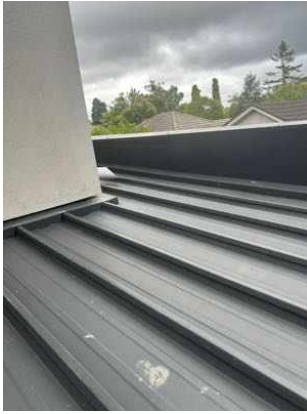
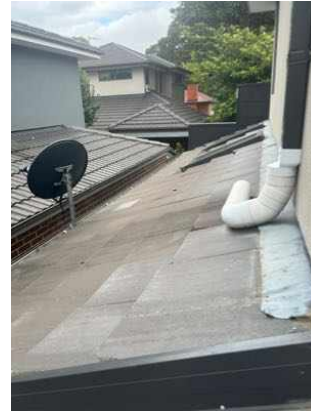
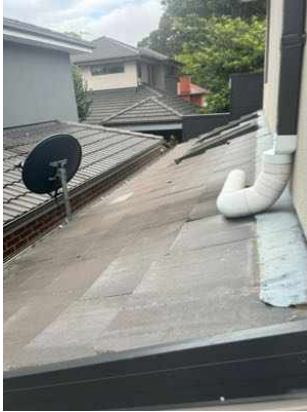
**Defects 3.20**

Building: Garage  
Location: All Areas  
Finding: Roof tiles - Weathered  
Information: Upon inspection of the exterior roofing, the majority of roof tiles were considered to be

Where left unmanaged, deteriorating roof tiles are likely to lead to a number of secondary defects, including minor water leaks and weather exposure to internal roofing structures.

Consultation with a roofing contractor is highly advised to gain advice on cost of remedial works that may be required in the short to medium term. Remedial works are likely to increase the longevity of the exterior roofing structure.

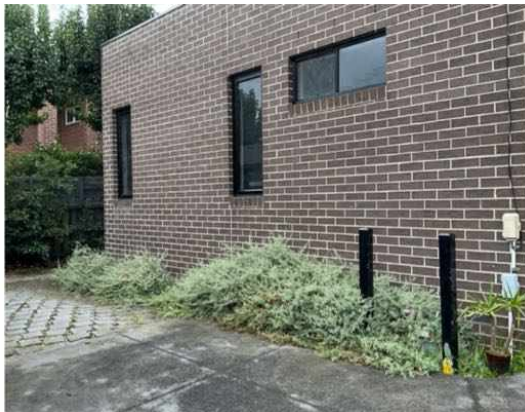
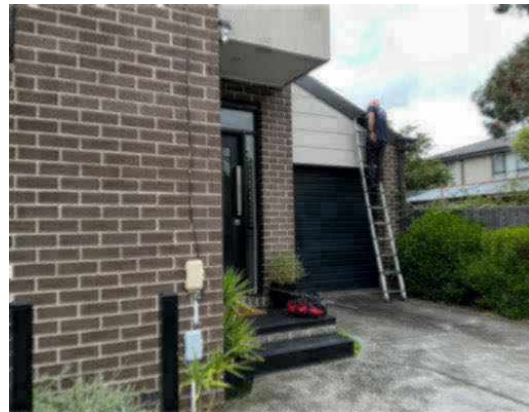
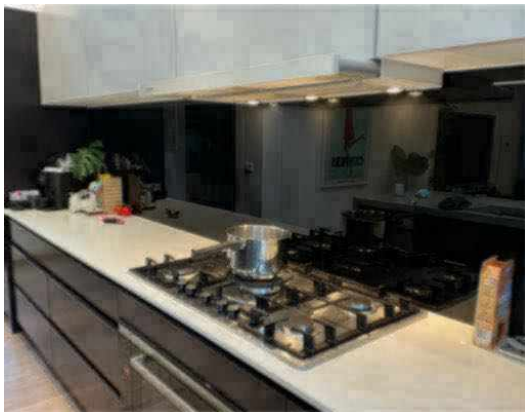
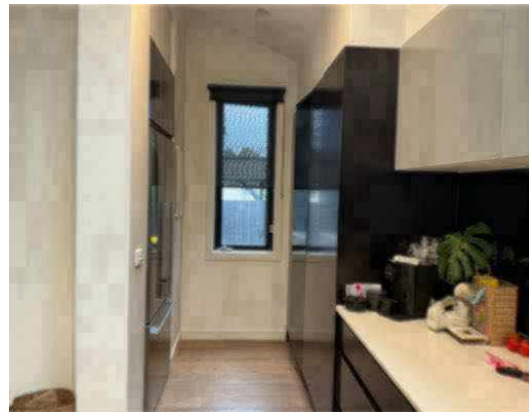
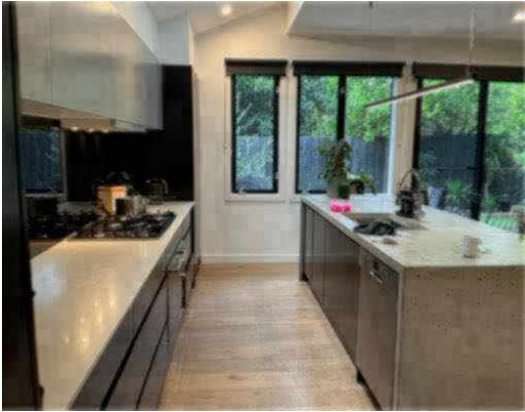
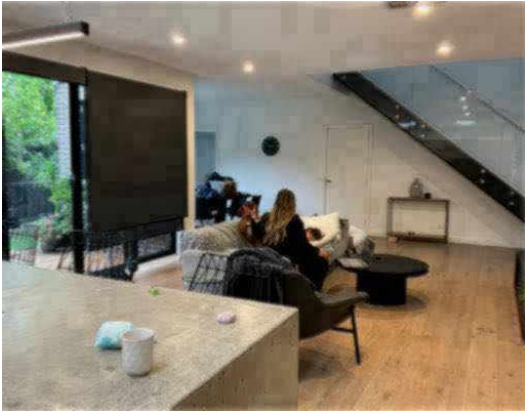
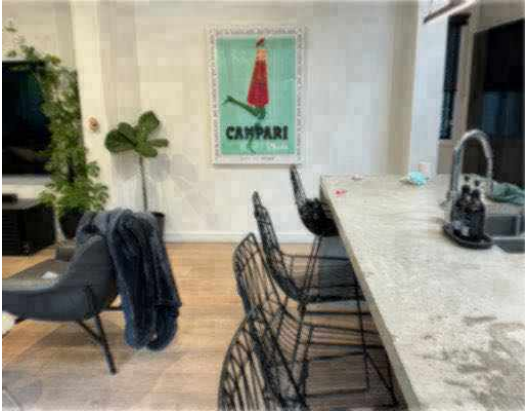
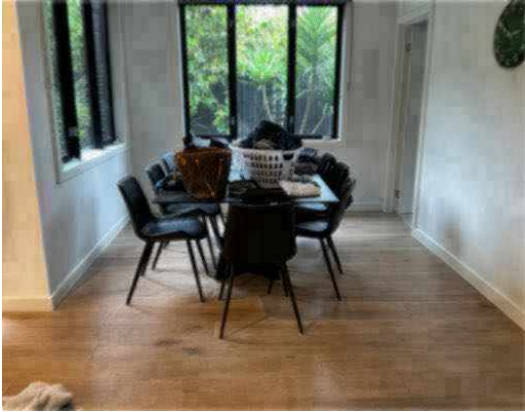
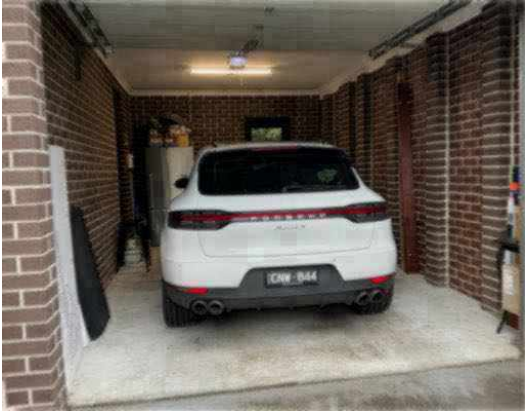
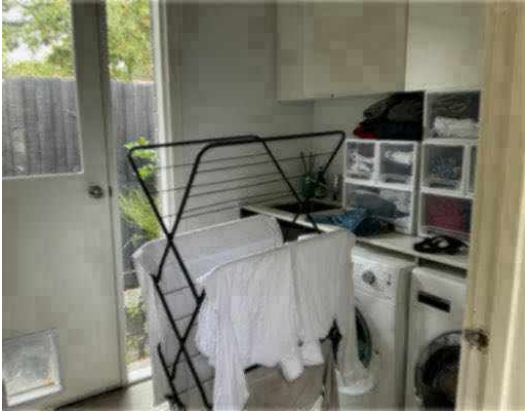
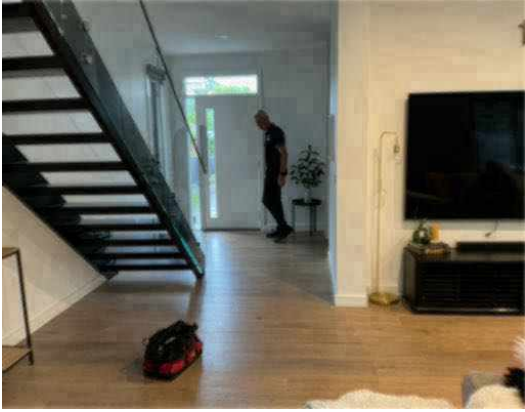
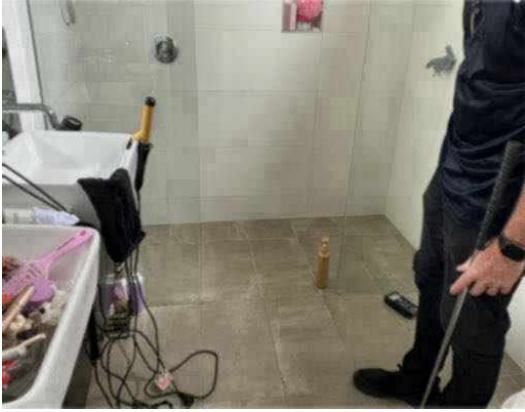
#### Noted Item

Building: Main Building  
Location: All Areas  
Finding: Additional Photos - Obstructions and Limitations  
Information: These photographs are an indication of the obstructions and limitations which impeded full inspection of the property at the time of inspection. These obstructions can hide an array of defects and should be removed to allow full inspection to be carried out. A re-inspection is recommended once the areas are made accessible.

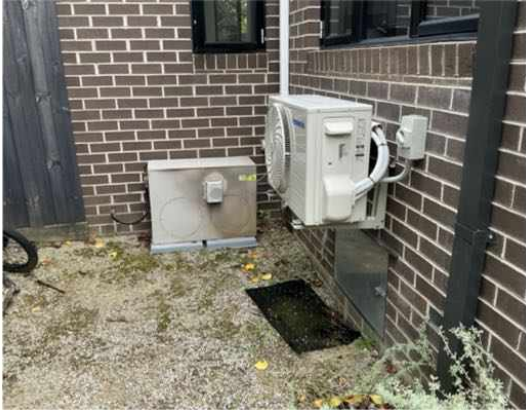
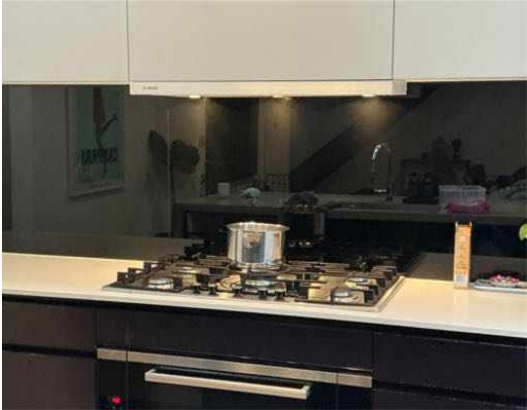
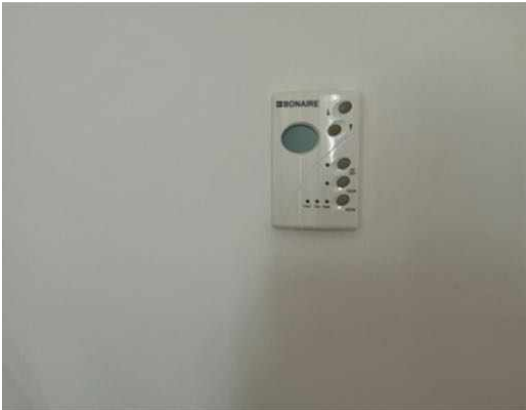
Location: All Areas  
Finding: Warranty - Expired  
Information: Where appliances are beyond their warranty period, the owner should be prepared to meet the cost of replacement or repair of the item at any time. The operation of the appliance can not be guaranteed and further inspection by an appropriately qualified tradesperson may be required.
