# Building and Timber Pest Inspection Report

Inspection Date: Wed, 18 Mar 2026

Property Address: 2/35 Surrey Rd, Mount Waverley VIC 3149,  
Australia

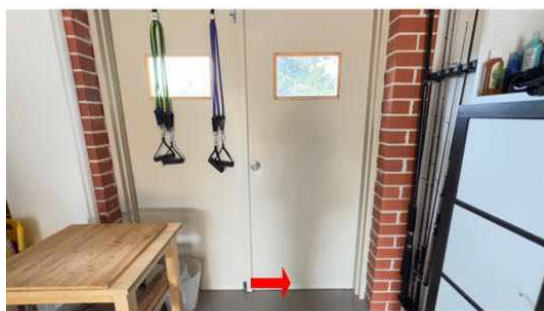
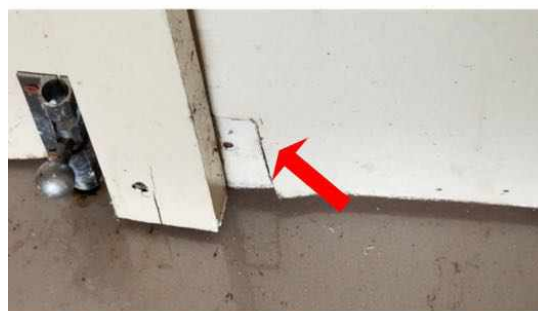
Building: Main Building  
 Location: Garage  
 Finding: Doors - Damaged Doors  
 Information: The inspection identified doors with visible damage, including cracks, dents and splits. The damaged doors may affect operation, convenience, security, weatherproofing, and appearance.

The damage appears to be caused by age-related wear, poor maintenance such as inadequate painting or sealing, and minor structural movement affecting door alignment.

When practical, a qualified carpenter or door specialist should be engaged to repair, replace, or refinish the damaged doors. Prompt rectification will ensure safe operation, maintain security, and protect weatherproofing.

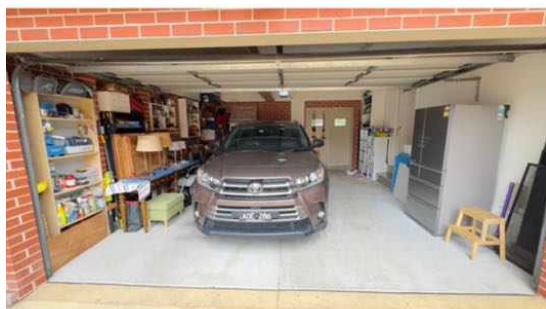
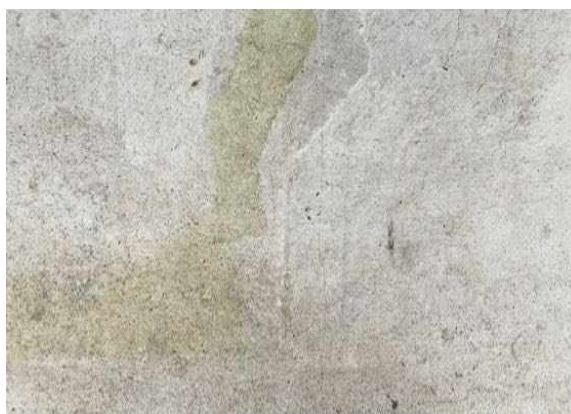
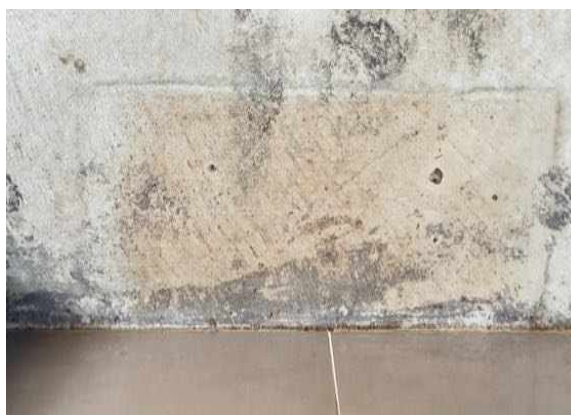
#### Finding 3.02

Building: Main Building  
 Location: Garage >  
 Finding: Garage - Stains To Concrete Slab

Information: The garage floor was observed to have stains in this area. While primarily a cosmetic issue, these stains can reduce slip resistance and may indicate leaks from vehicles or stored equipment.

The staining appears to be caused by spillage or leakage from vehicles, machinery, or general maintenance activities.

When practical, a qualified cleaning or maintenance professional should be engaged to remove the oil stains using appropriate methods. Regular cleaning and monitoring will help maintain the appearance of the floor, reduce slip hazards, and minimise potential long-term damage to the concrete surface.

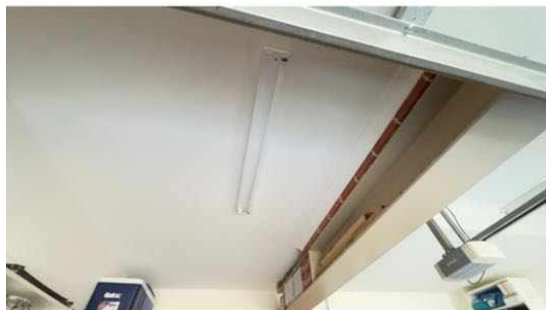
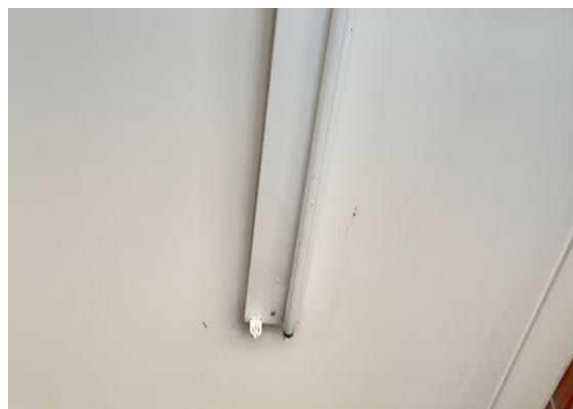
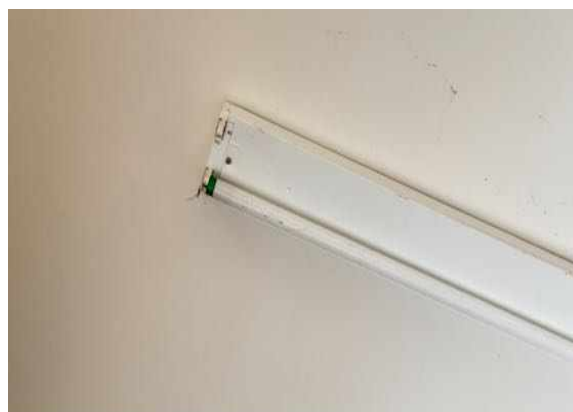
### Finding 3.03

Building: Main Building  
 Location: Garage >  
 Finding: Ceilings - Light Fittings Not Operational  
 Information: The ceilings were inspected and non-operational light fittings were observed in this area. Defective light fittings can pose electrical hazards, increase the risk of fire, and create potential injury risks if fixtures detach.

This may be due to age-related deterioration of fixings, poor installation, mechanical impact or vibration, or lack of regular inspection and maintenance.

A licensed electrician should be engaged immediately to inspect, repair, or replace the affected light fittings. Prompt action will prevent electrical hazards and ensure safe operation of ceiling-mounted fixtures.

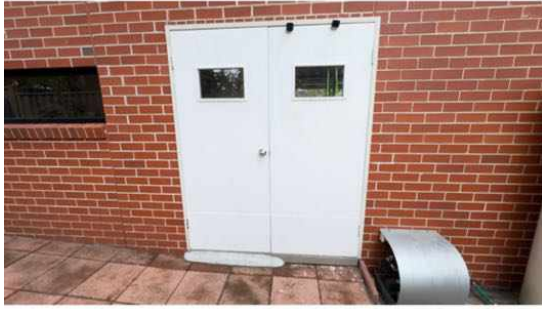
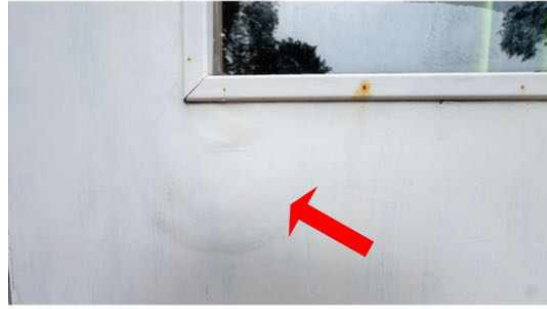
### Finding 3.04

| Finding: | Doors - Damaged Doors |
| Information: | The inspection identified doors with visible damage, including cracks, dents and splits. The damaged doors may affect operation, convenience, security, weatherproofing, and appearance. |

The damage appears to be caused by age-related wear, poor maintenance such as inadequate painting or sealing, and minor structural movement affecting door alignment.

When practical, a qualified carpenter or door specialist should be engaged to repair, replace, or refinish the damaged doors. Prompt rectification will ensure safe operation, maintain security, and protect weatherproofing.

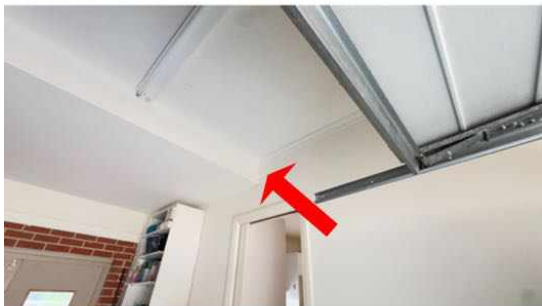
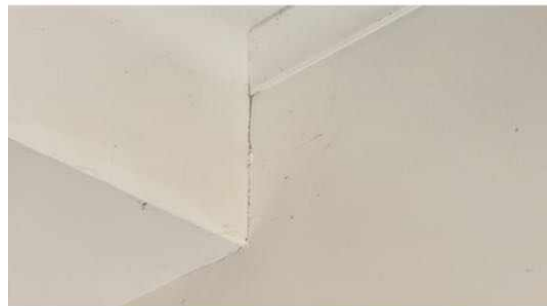
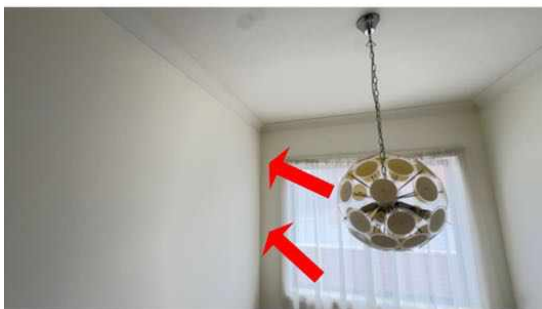
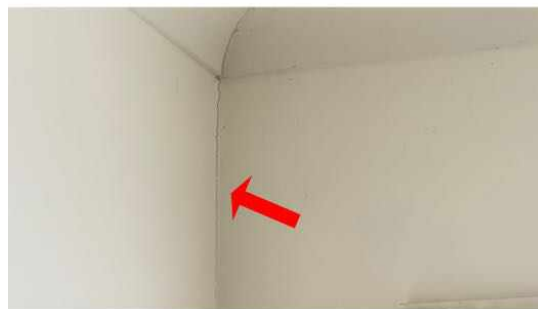
### Finding 3.05

Finding: Ceilings - Minor Plaster Cracking

Information: The ceilings were inspected and cracking in the plaster was observed in this area. Cracks can affect the appearance of the ceilings and may worsen over time if left unaddressed.

When practical, a qualified plastering contractor should be engaged to assess and repair the cracked plaster. Prompt action will improve the appearance of the ceilings and help prevent further deterioration.

Cracking should be monitored over time to determine whether movement is ongoing. Where cracks are purely cosmetic, patching and repainting by a qualified plasterer may be undertaken as part of routine maintenance. If cracks widen, reappear after repairs, or are accompanied by other structural signs, further investigation by a registered builder or structural engineer is recommended immediately.

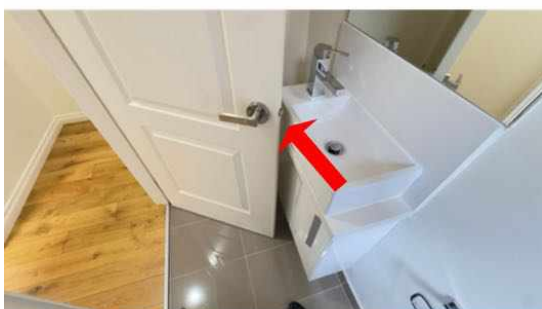
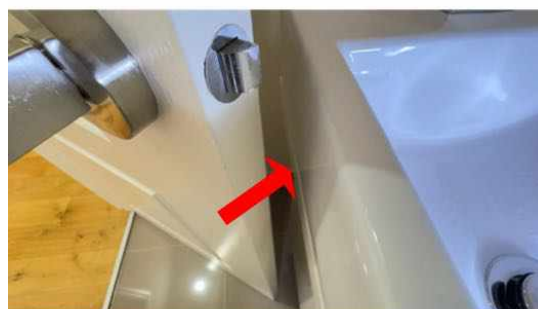
### Finding 3.06

Finding: Doors - Missing Door Stops

Information: The inspection identified missing door stops in this area. Missing door stops can lead to damage to walls or doors and may impair the proper operation of the doors.

The absence of door stops may be due to them not being installed during construction or having been removed after installation.

It is recommended that a qualified carpenter or competent handyman be engaged promptly to install the missing door stops. Correct installation will protect doors and walls and ensure proper door functionality.

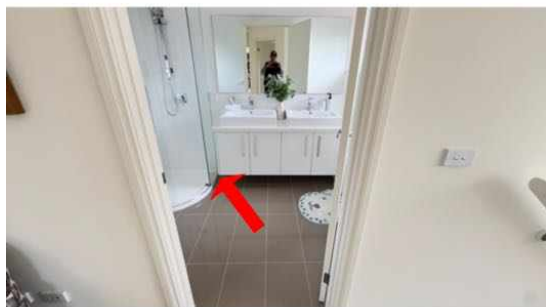
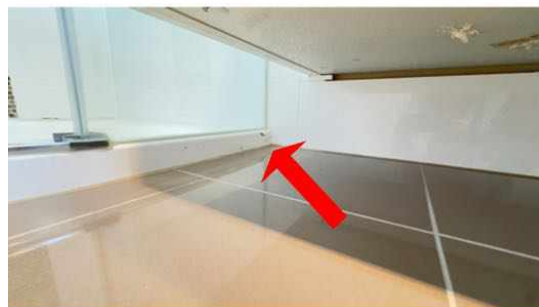
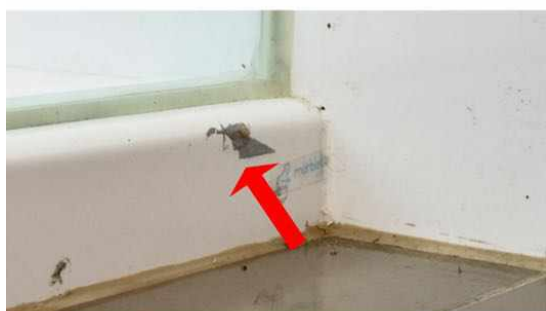
### Finding 3.07

Finding: Shower Base - Damaged

Information: Damaged was observed to the shower base at the time of inspection, which is suspected to be due to minor impact damage. While the damage appears minor, further impact may cause cracking.

The damage may allow water to penetrate, potentially causing damage to surrounding cabinetry, walls, or flooring if left unaddressed.

A plumber should be engaged as a matter of urgency to assess the shower base and carry out any necessary repair or replacement to prevent further damage.

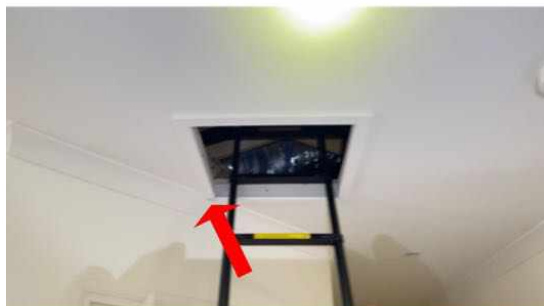
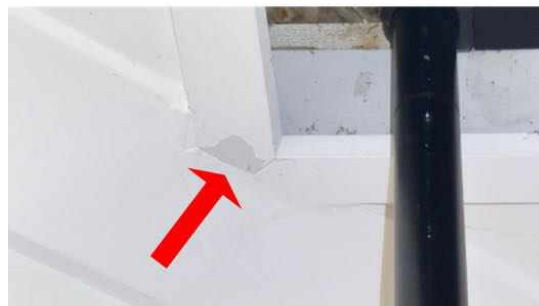
**Finding 3.09**

Building: Main Building  
Location: All Areas >  
Finding: Ceilings - Paint Finishes Damaged  
Information: The ceilings were inspected for paint condition, and damaged paint finishes were observed in this area. While primarily a cosmetic issue, damaged paint may indicate age-related wear, poor surface preparation, or previous repairs.

This may be due to age-related degradation of paint layers, poor surface preparation, or previous patching with incompatible paint.

When practical, a qualified painter should be engaged to prepare and repaint the affected areas. Addressing paint deterioration will improve the appearance of the ceilings and protect the surfaces from further wear.

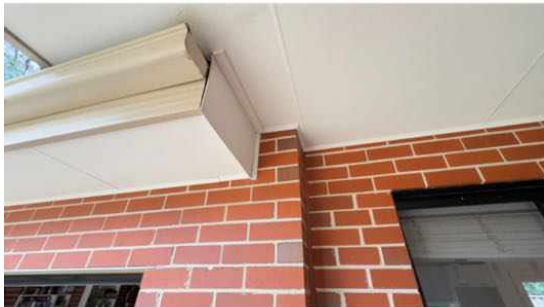
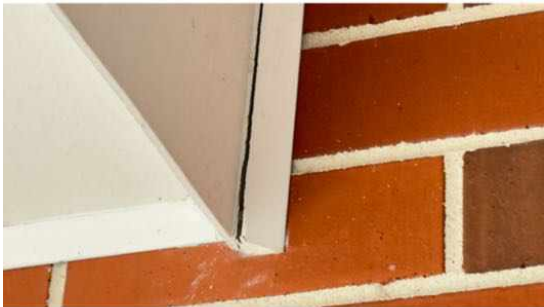
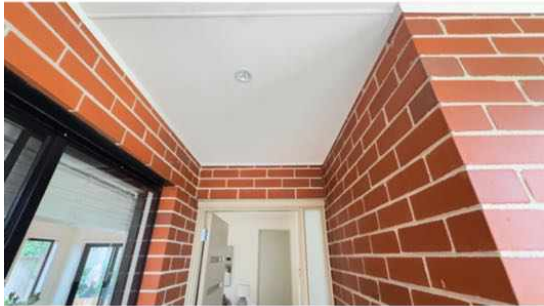
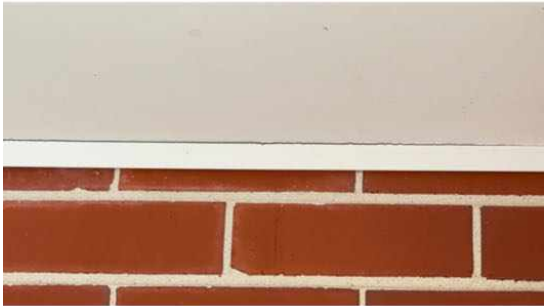
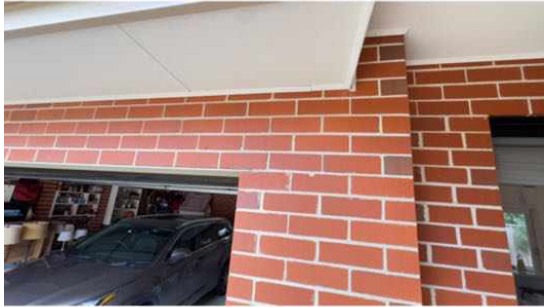
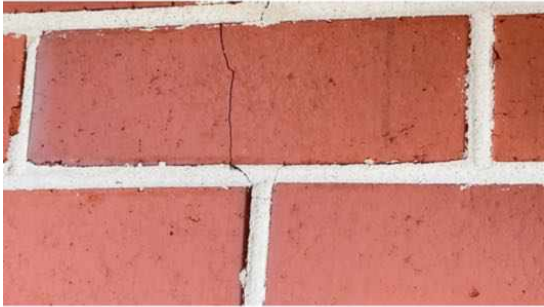
### Finding 3.12

| Finding: | External Walls - Minor Cracking To Wall Claddings |

When practical, a registered builder should assess and repair the cracking, which may include sealing and repainting. The area should be monitored, and any increase in

cracking or signs of movement should be further investigated immediately by a Structural Engineer.

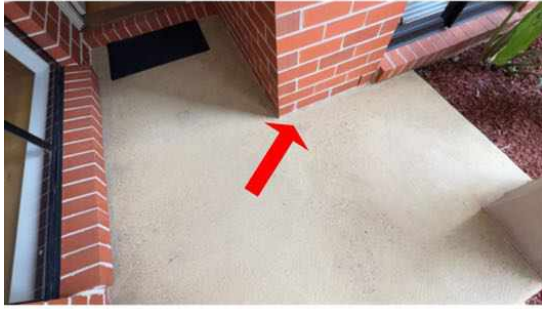
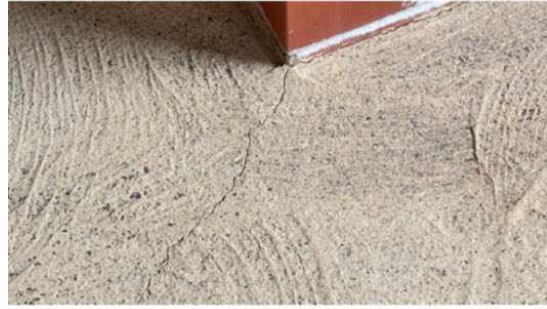
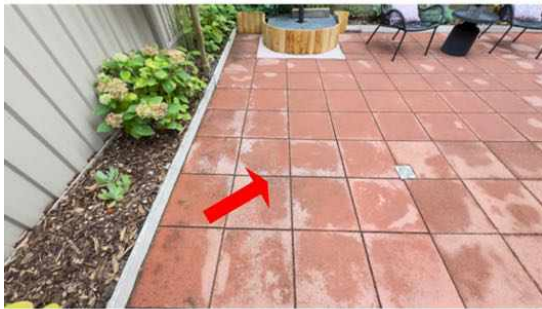
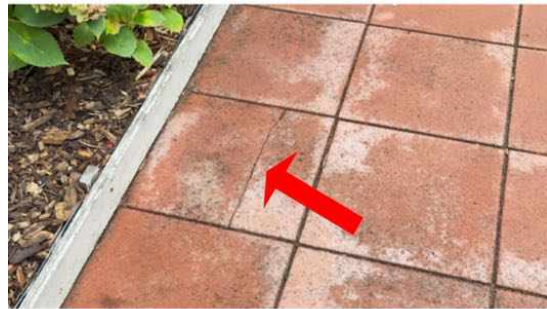
### Finding 3.16

| Finding: | Driveway - Minor Cracking & Surface Imperfections |
| Information: | The external driveway was visually inspected. Minor cracking, surface settlement, and minor unevenness was observed in this area. While these defects do not currently compromise structural safety, they may affect long-term durability, appearance, and vehicle access. |

These issues may be caused by age-related wear, soil movement or settlement beneath the driveway, possible tree root intrusion, or inadequate original construction or reinforcement.

A qualified concreter should be engaged when practical to repair or resurface affected areas. Prompt rectification will restore a smooth surface, improve appearance, and prevent further deterioration.

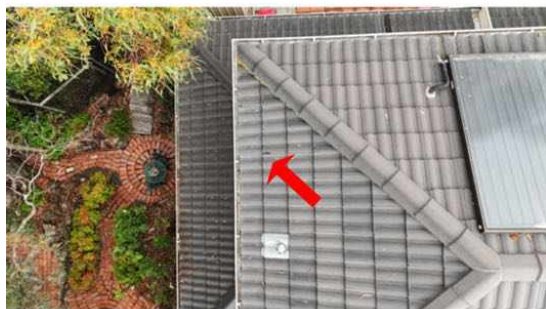
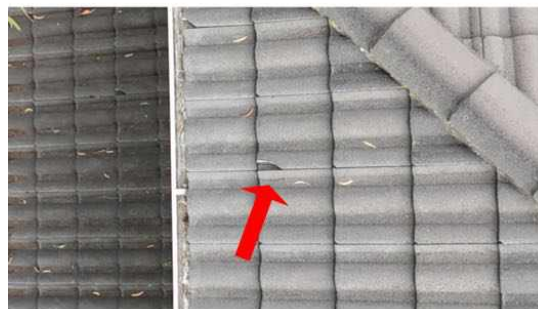
| Finding: | Roof Plumbing - Roof Tiles Cracked |
| Information: | Roof tiles in this area are cracked and may no longer provide full protection. The issue is observed across the roof surface where damaged tiles are present. |

This has likely occurred due to impact, weathering, or poor installation. Cracked tiles may allow water to penetrate, causing leaks, water damage to internal structures, or deterioration of surrounding tiles.

A licensed roof plumber is required to inspect and repair or replace the cracked tiles in this area. This should be rectified immediately to prevent water ingress and further damage.

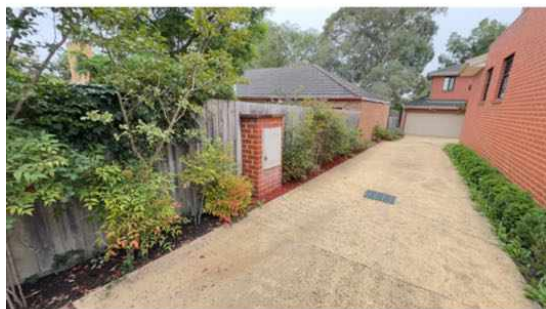
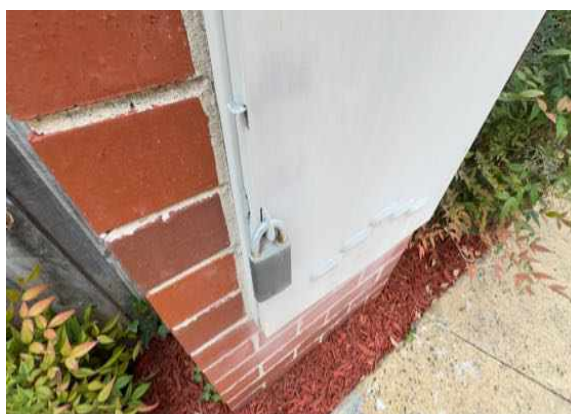
Building: Main Building  
 Location: All External Areas  
 Finding: Timber Pests - Durable Notice Not Identified  
 Information: During the inspection, no durable notice relating to a termite management system was observed on the property. A durable notice is required to identify the type of termite management system installed, the date of installation, and any ongoing maintenance or inspection requirements. The absence of this notice makes it difficult to confirm the presence, effectiveness, or maintenance status of any termite protection measures.

Without a durable notice, there is an increased risk that termite management systems may not be adequately maintained or may have expired, particularly in the case of chemical barriers that require periodic replenishment. This uncertainty increases the likelihood of undetected termite activity and potential damage to timber elements within the building.

The lack of a durable notice may be due to removal during renovations, age of the property, or the absence of a compliant termite management system at the time of construction. Regardless of the cause, this represents a gap in termite risk management and ongoing building protection.

It is recommended that a licensed pest management technician be engaged immediately to assess whether a termite management system is present and

functioning. Where a system exists, the technician should confirm its type, condition, and maintenance requirements and install a compliant durable notice in accordance with current standards.

If no termite management system is identified, it is strongly recommended that an appropriate termite protection system be installed and documented. Regular inspections and maintenance should then be undertaken to reduce the risk of future termite infestation and associated structural damage.

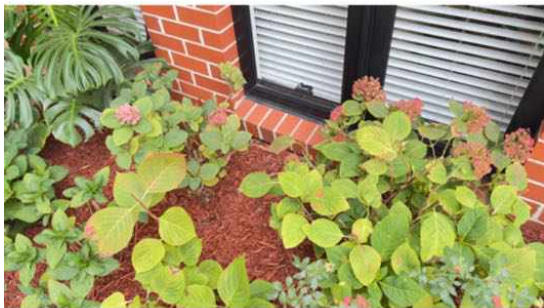
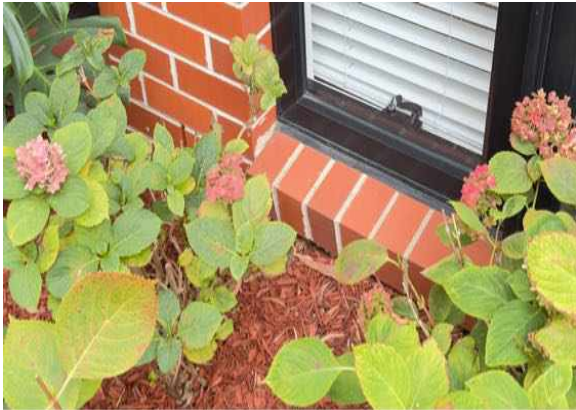
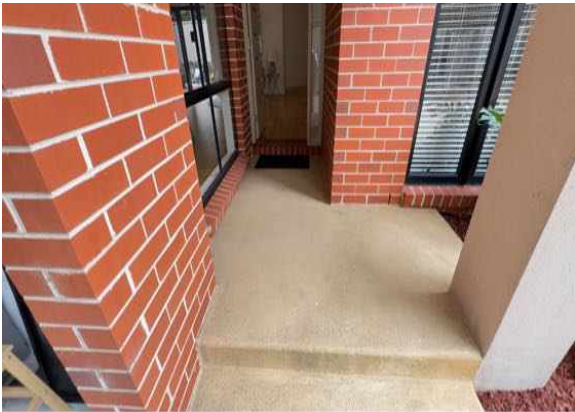
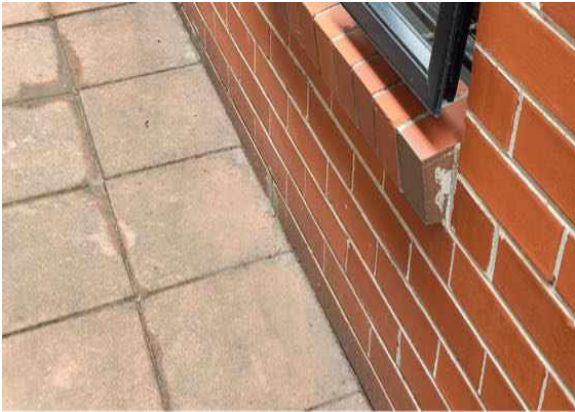
## Finding 6.02

| Finding: | Timber Pests - Bridging Of Termite Barrier Found |
| Information: | During the inspection, bridging of the termite barrier was observed in certain areas. Bridging occurs when external elements, such as soil, vegetation, garden beds, or timber, make direct contact with the termite management system, effectively bypassing the barrier's protective function. This compromises the barrier's ability to prevent termites from accessing the building and can increase the risk of infestation. |

The possible causes of bridging include poor landscaping practices, where soil or mulch is piled too high around the perimeter of the building, or growth of plants with roots extending into the barrier area. In some cases, structural movement or settling of the soil may also cause previously effective barriers to become bridged. The presence of bridging provides a direct path for termites to bypass the chemical or physical barrier, potentially leading to hidden infestation.

\*Bridging is a significant issue as it negates the effectiveness of termite barriers, leaving the building vulnerable to termite attacks. If left unaddressed, termites can find entry points through the bridged areas, leading to structural damage and potential long-term problems for the property. Since termites can go undetected for extended periods, the damage caused by such infestations can be costly to repair.

It is strongly recommended that a licensed pest management specialist or termite professional be engaged immediately to assess the termite barrier and address the

bridging issue. This may involve removal of bridging materials, adjustment or repair of the barrier, and ensuring that the area around the barrier is clear of any materials that could facilitate termite entry.

In addition to addressing the bridging issue, it is also crucial to inspect the property for signs of termite activity immediately and consider replacing or reapplying the termite barrier to ensure it is still effective. Regular maintenance and monitoring of the barrier are recommended to prevent future issues and ensure long-term protection against termites.

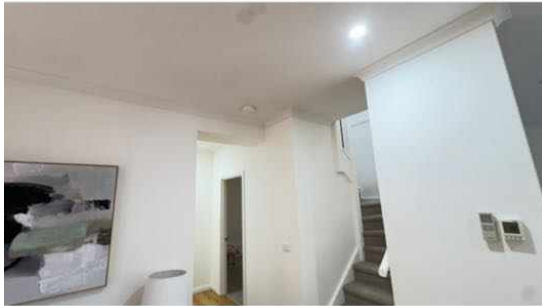
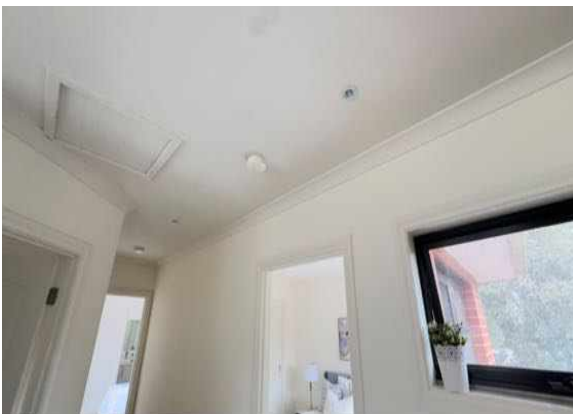
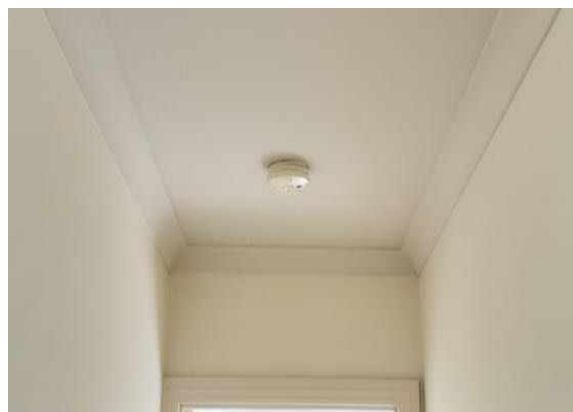
Building: Main Building  
Location: All Internal Areas  
Finding: Smoke Detectors - Advisory  
Information: During the inspection, smoke detectors were noted for advisory purposes only. The operation, age, type, and compliance of smoke detectors could not be fully verified as part of this inspection.

Smoke detectors are critical life-safety devices, and non-compliant, outdated, or non-operational units may not provide adequate warning in the event of a fire.

It is recommended that a licensed electrician be engaged immediately to test, service, and upgrade smoke detectors as required to ensure correct operation and compliance with current safety requirements.

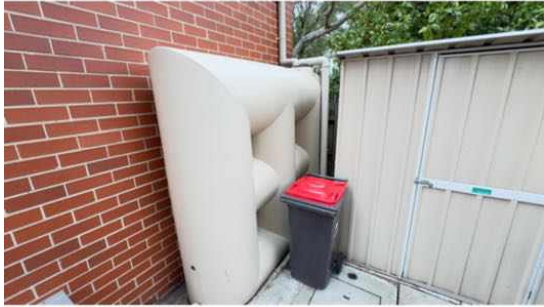
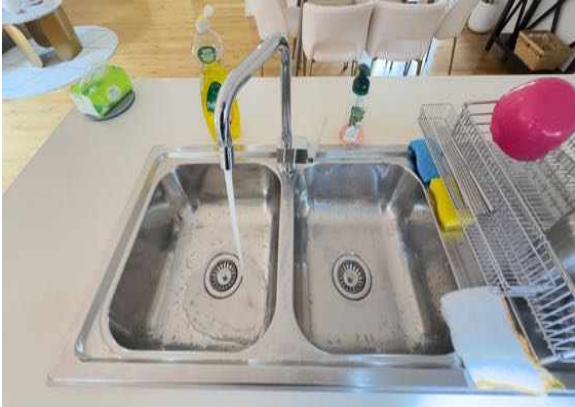
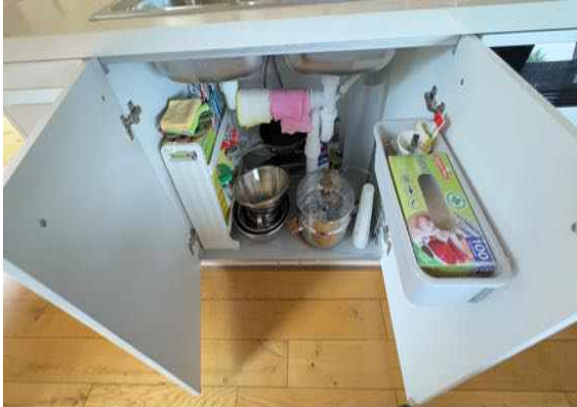
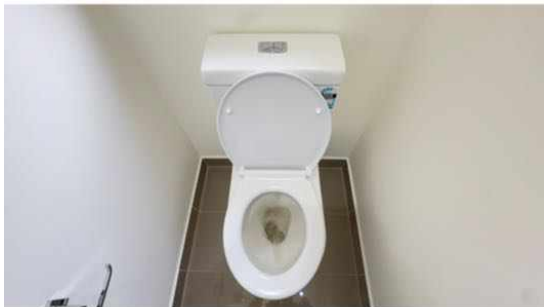
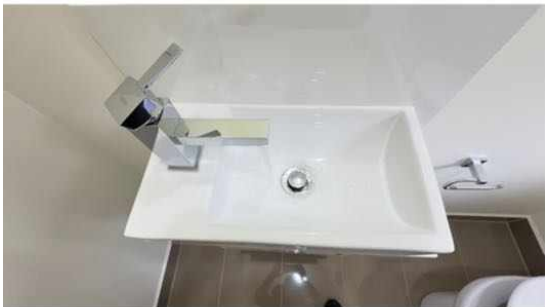
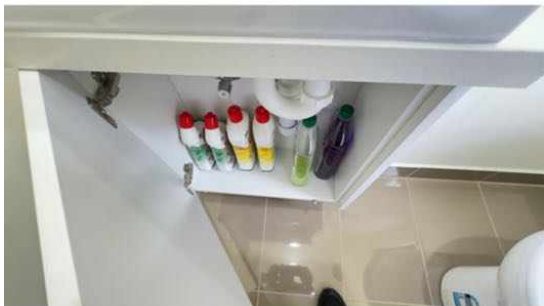
Building: Main Building  
 Location: All Internal Areas  
 Finding: Water Supply & Drainage - Shower, Basins, Toilets, & Plumbing Fixtures  
 Information: The shower recess was tested, and no visible water penetration to surrounding areas was observed at the time of inspection, except where noted as a separate defect elsewhere in this report. Water appeared to flow freely toward the floor waste. Moisture detected to the shower walls is documented separately in the report. The shower floor waste appeared clear during inspection.

Flushing the toilet revealed no visible leaks, and the fixture appeared to operate normally unless otherwise noted as a separate defect. No water damage was observed to the vanity unit unless specifically stated elsewhere in the report. Basins, bathtubs, laundry tubs, vanities, and sinks were tested and inspected with no evidence of leaks, blockages, or drainage issues at the time of inspection unless otherwise noted. All internal taps and shower heads were tested with no leaks observed, unless documented as a separate defect.

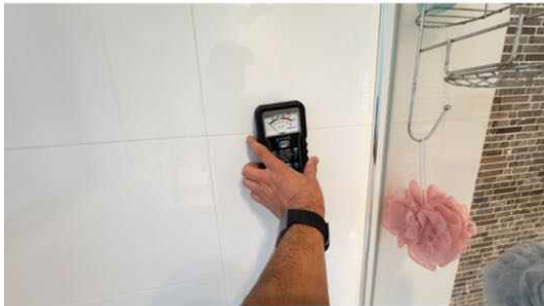
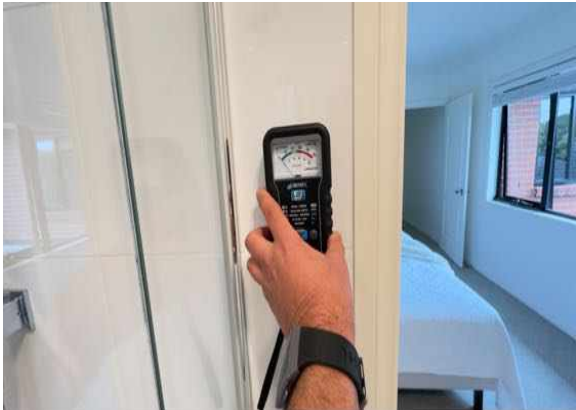
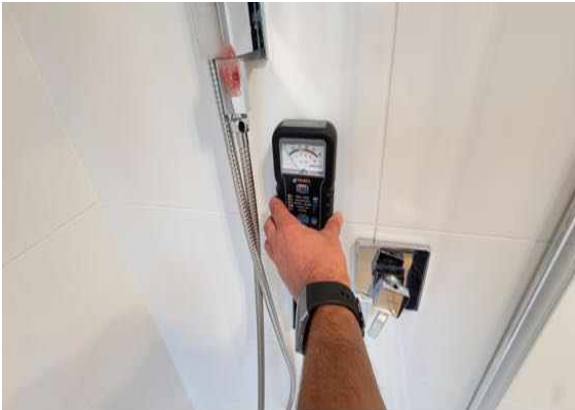
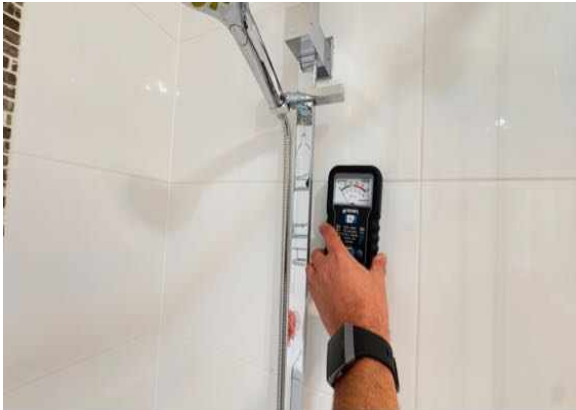
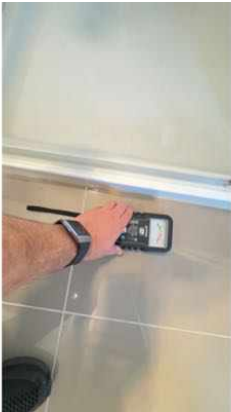
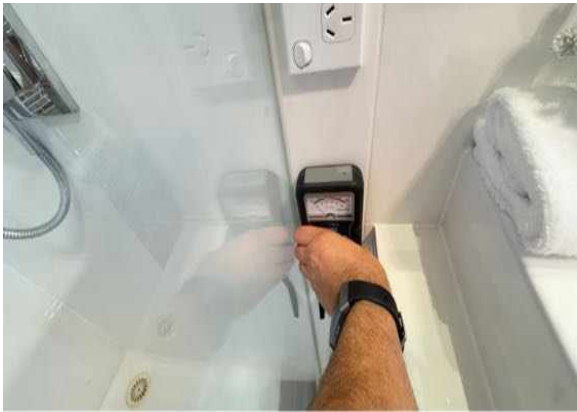
Building: Main Building  
Location: All Areas Interior & Exterior  
Finding: Moisture Levels - Advisory - No Elevated Moisture Levels Present  
Information: At the time of inspection, no elevated moisture levels were detected in these areas. Moisture readings were taken (using a Tramex Moisture Meter) and non-invasive testing methods and reflect conditions present at the time of inspection only. This item is noted for advisory purposes and should not be relied upon as a guarantee that moisture issues are not present elsewhere or may not occur in the future.

Ongoing monitoring of the property is recommended, and further investigation by a qualified tradesperson should be considered if signs of water ingress, dampness, staining, mould growth, or material deterioration become apparent.

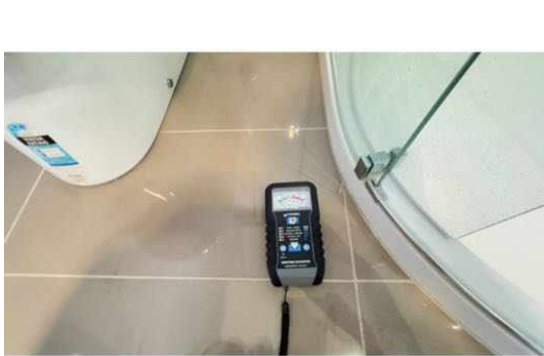
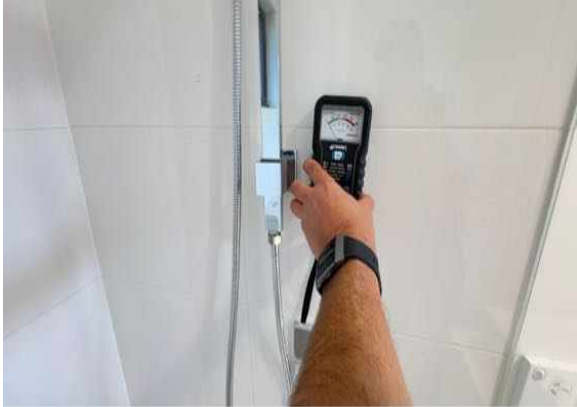
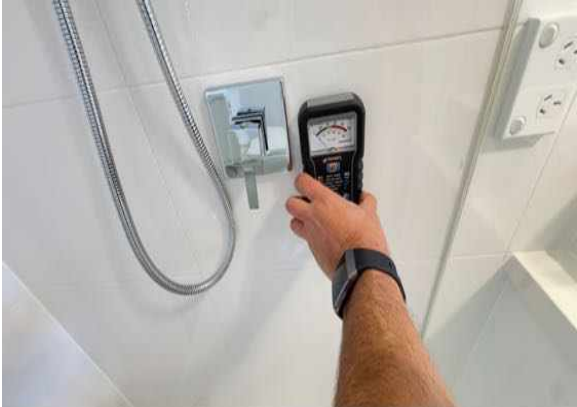
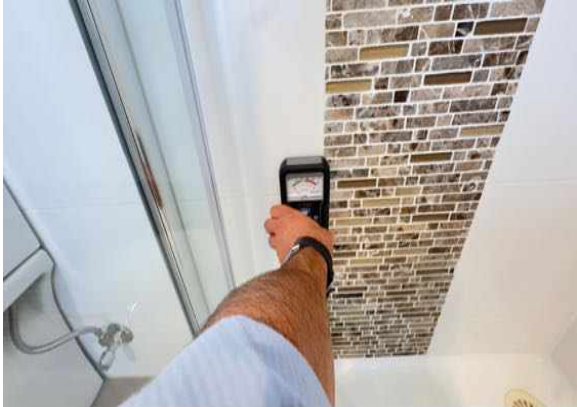
Building: Main Building  
Location: All Areas Interior & Exterior  
Finding: Thermal Scanning & Diagnostic - Advisory - No Elevated Moisture Levels Present  
Information: During the inspection, a thermal imaging camera was utilised as a non-invasive diagnostic tool to assist in identifying potential irregularities associated with moisture ingress, heat loss, insulation deficiencies, or concealed building defects. Thermal imaging detects surface temperature variations that may indicate abnormal conditions within building elements.

Any thermal anomalies identified during the inspection were further assessed where accessible using visual inspection methods and moisture testing. It is noted that thermal imaging is an indicative tool only and does not confirm the presence of defects or moisture without supporting evidence.

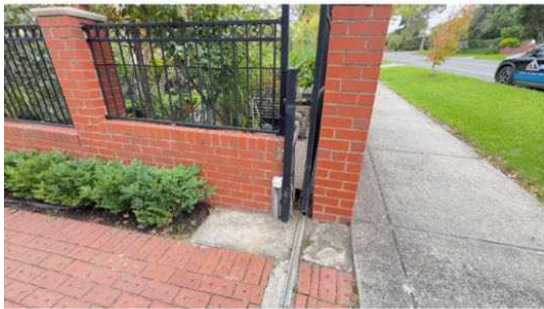
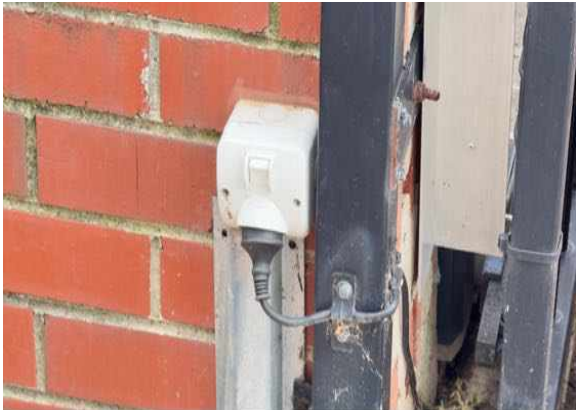
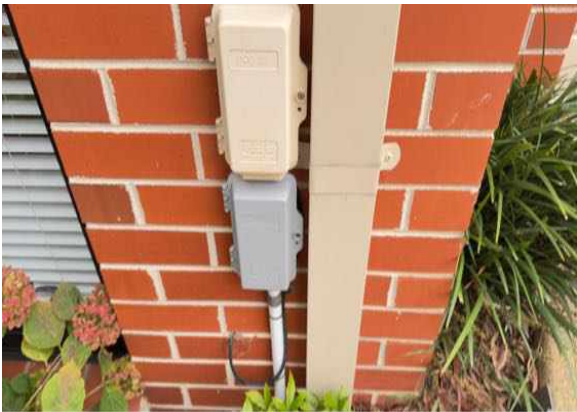
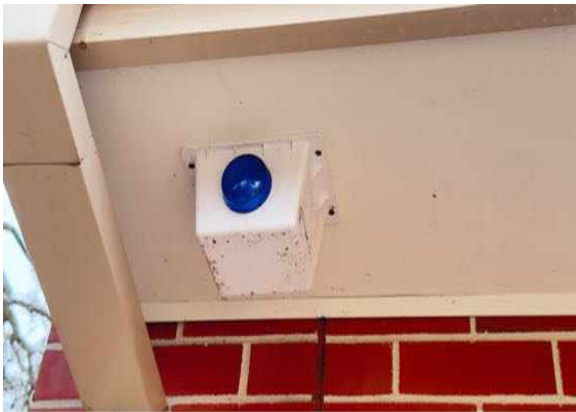
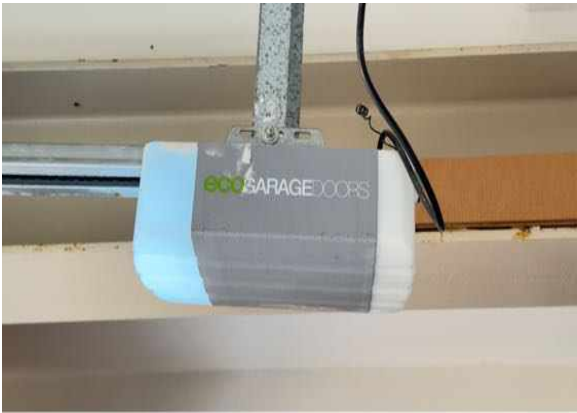
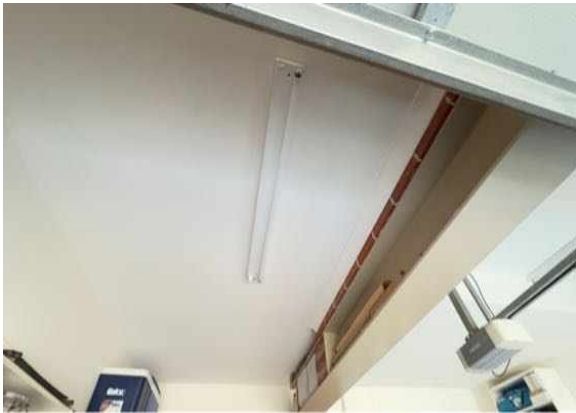
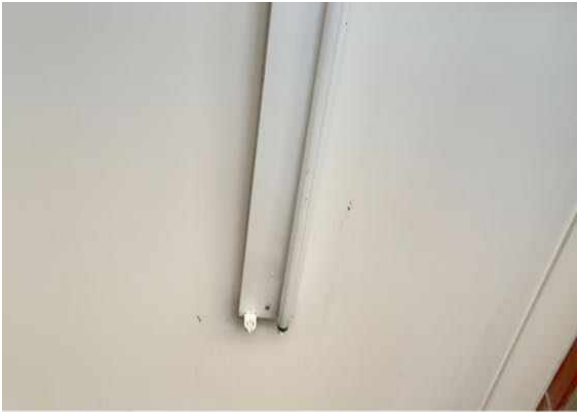
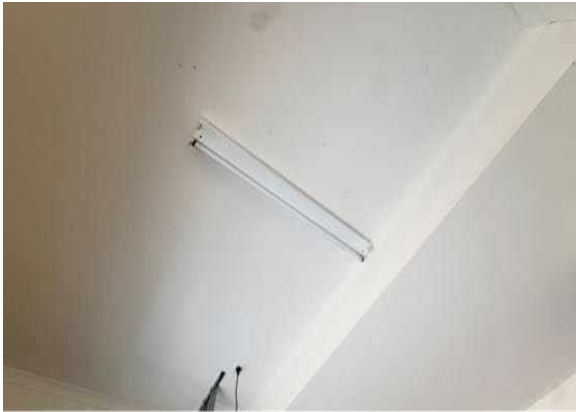
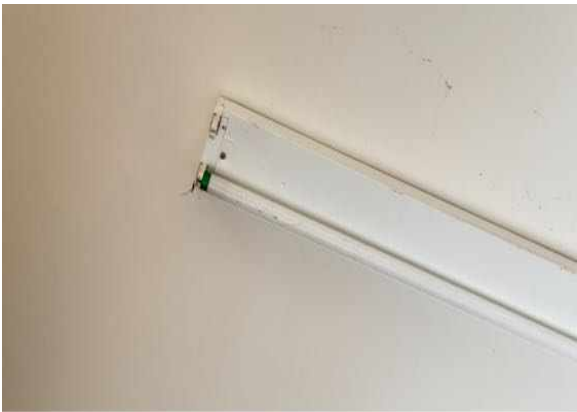
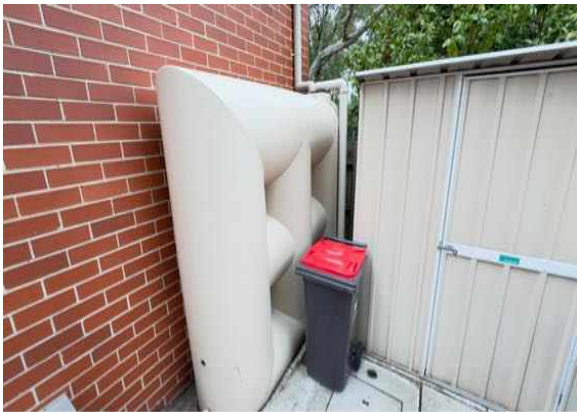
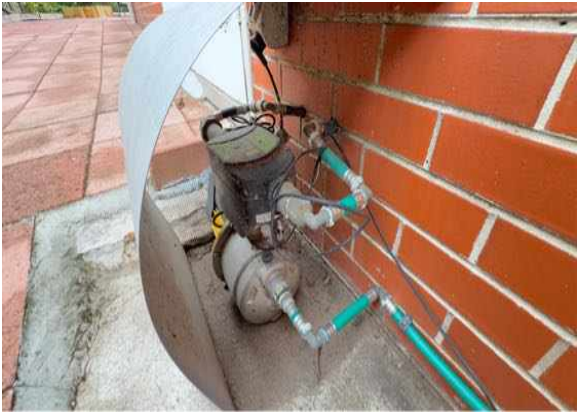
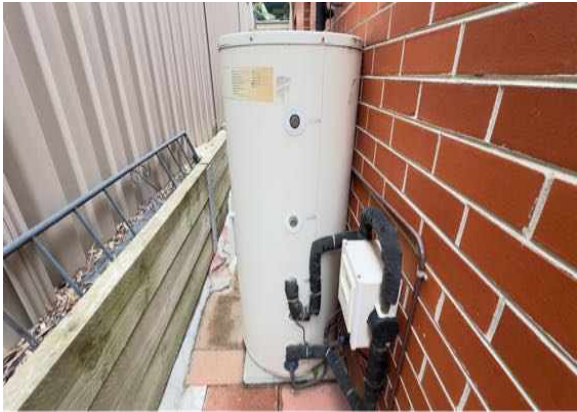
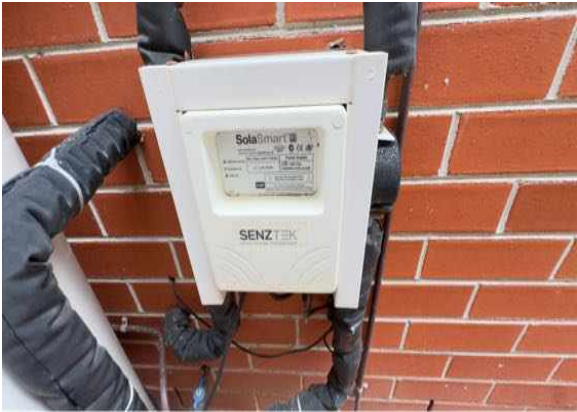
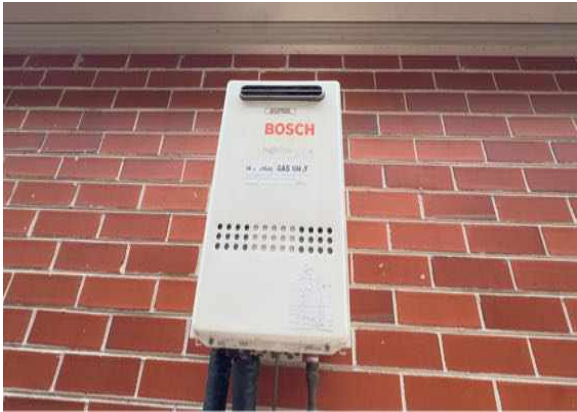
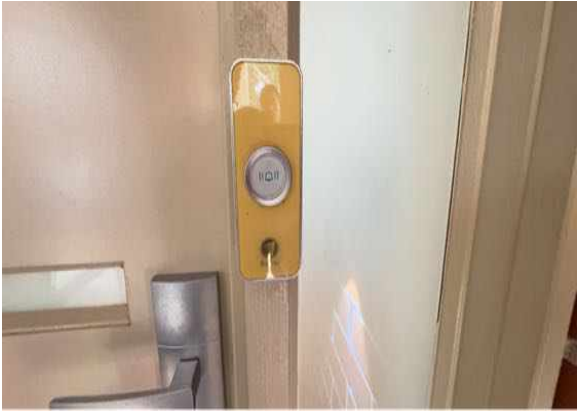
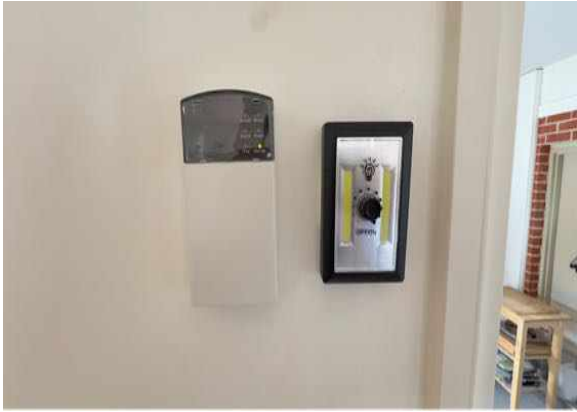
| Information: | The inspection did not include testing, operation, safety, or assessment of any installed or portable appliances or mechanical systems. This includes, but is not limited to, ovens, cooktops, microwaves, rangehoods, dishwashers, ducted vacuum systems, air-conditioning units, heating systems, hot water services, ceiling fans, exhaust fans, intercoms, security systems, fireplaces, and solid fuel heaters. |

Appliances may be worn, damaged, or malfunctioning. Electrical or gas appliances can pose serious safety hazards if incorrectly installed or maintained.

Service, repair, or replace equipment as necessary, particularly where service history or warranty coverage is unknown.

Inspect any water, gas, or electrical connections associated with appliances to ensure safety and compliance.

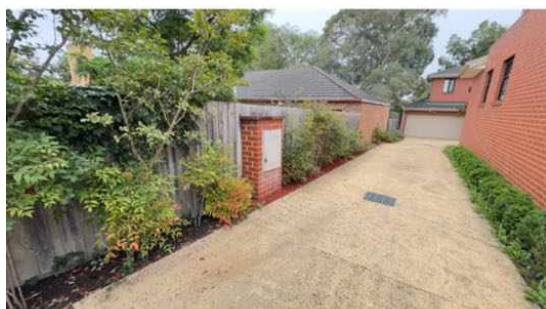
Building: Main Building  
 Location: All External Areas  
 Finding: Electrical Switch Board - Location  
 Information: For your information, the main electrical switchboard was visually inspected. No intrusive testing or detailed electrical assessment was performed as part of this inspection.

For full compliance and safety verification, a licensed electrician should be engaged to inspect the switchboard, test all circuits, and ensure all components are functioning correctly. This will help maintain electrical safety and prevent potential hazards.

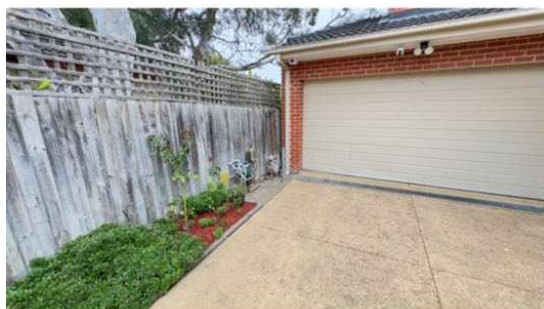
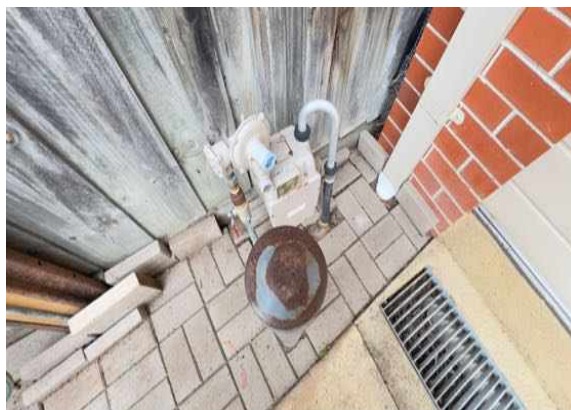
Building: Main Building  
 Location: All External Areas  
 Finding: Gas Meter - Location For Your Information  
 Information: The gas meter was inspected and photographed for reference and location purposes

Gas meters can be affected over time by age, environmental exposure, or accidental impact, which may lead to corrosion, physical damage, leakage, or non-compliance with current regulations. Regular checks are recommended to ensure ongoing safe operation.

Observations are for informational purposes only and do not constitute a full safety or compliance inspection.

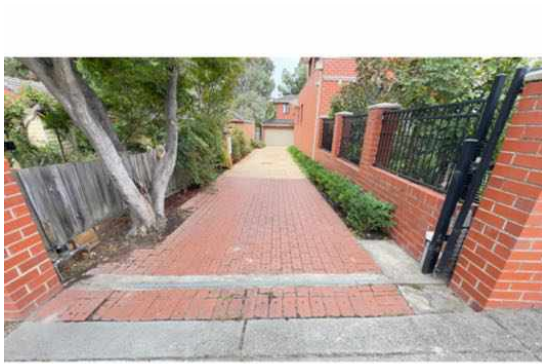
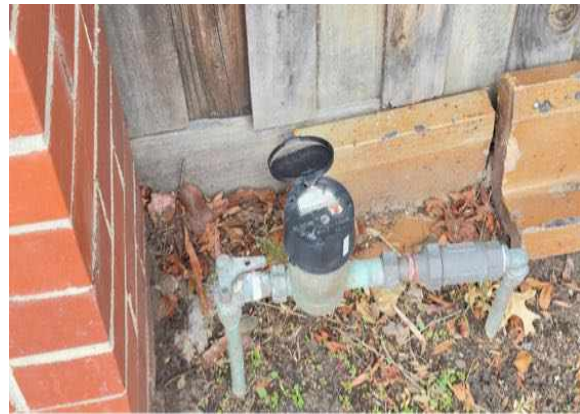
Water meters can be affected over time by age, environmental exposure, accidental impact, or poor maintenance. Potential issues could include leaks, corrosion, or malfunction that may impact water supply or cause water damage.

It is recommended that a licensed plumber carry out routine inspections and maintenance to ensure continued safe and compliant operation. Observations are for informational purposes only and do not form part of a full safety or compliance inspection.

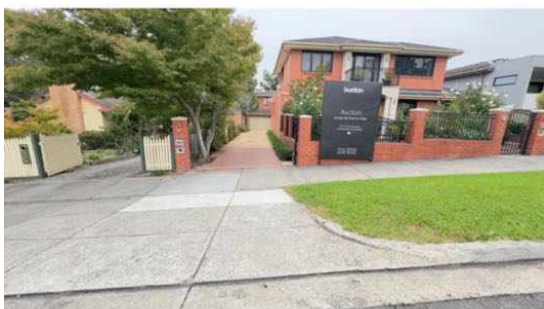
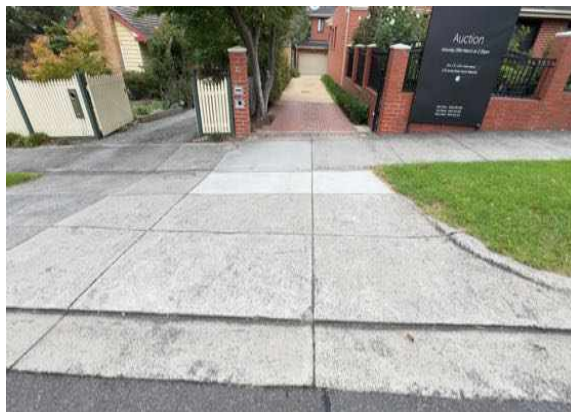
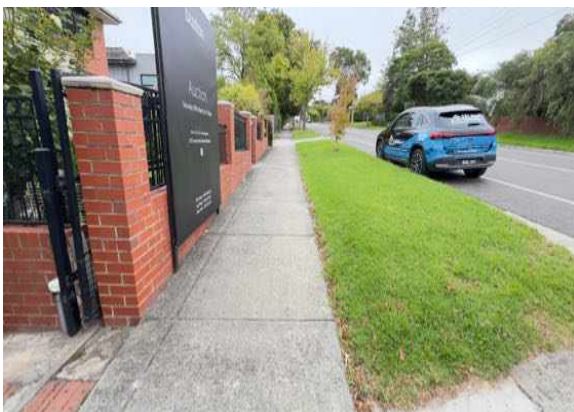
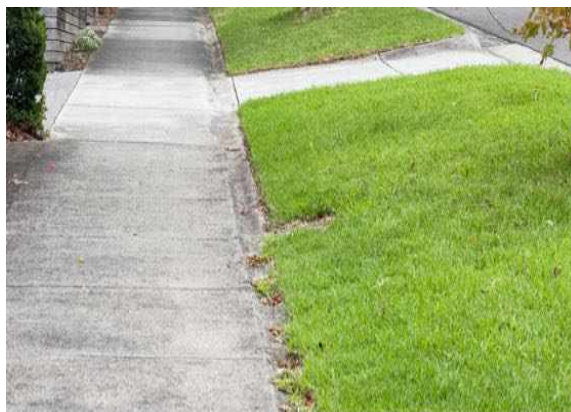
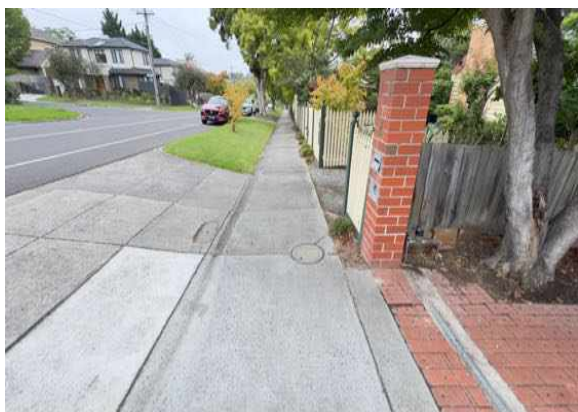
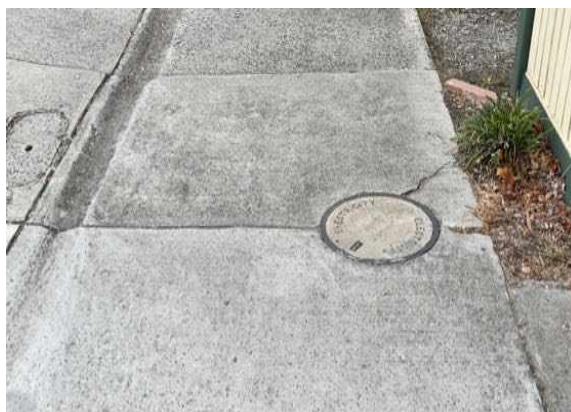
Building:  
Location: Limited Areas  
Finding: Council Assets - Footpaths, Crossovers, & Adjacent Infrastructure  
Information: For your information, council-owned assets located on or adjacent to the property, including footpaths, vehicle crossovers, kerbs, drainage pits, street signage, and other infrastructure, were visually inspected where accessible.

During the inspection, minor cracking, surface wear, or uneven sections were observed on footpaths or crossovers. Some accessible metal components, such as street signage or grates, showed signs of rust or deterioration. Debris accumulation and vegetation encroachment were also noted around council infrastructure. Access or visibility was limited to certain council-owned assets.

These areas should be monitored, and for detailed assessment, maintenance, or compliance verification, the relevant local council authority should be contacted immediately. Regular monitoring of adjacent council assets is recommended to ensure ongoing safety and proper maintenance.
