# Building and Timber Pest Inspection Report

Inspection Date: Wed, 18 Mar 2026

Property Address: 2/35 Surrey Rd, Mount Waverley VIC 3149,  
Australia

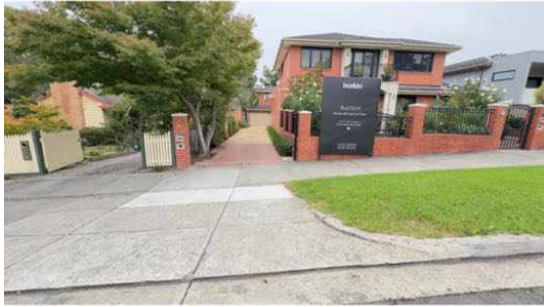
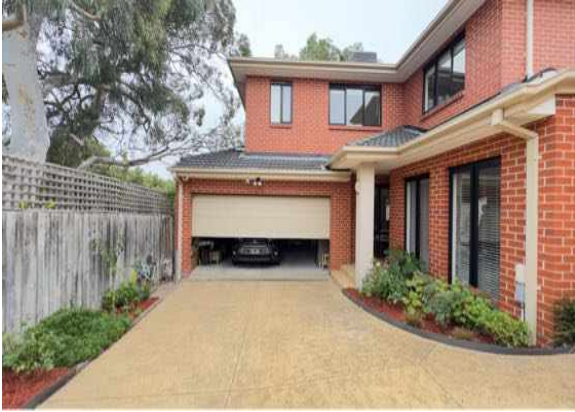
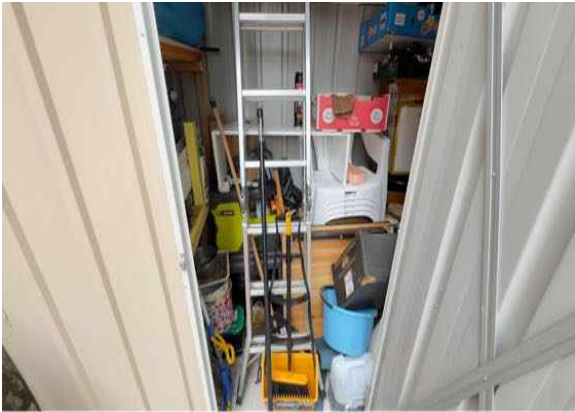
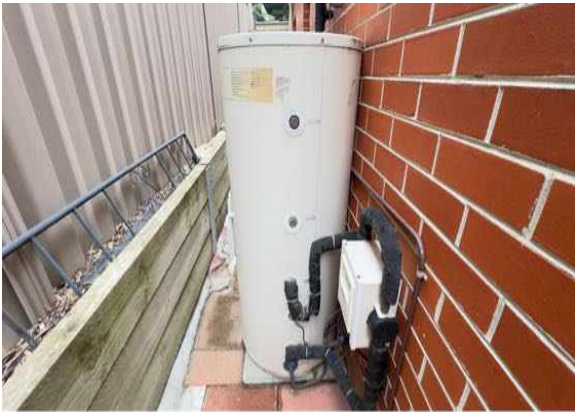
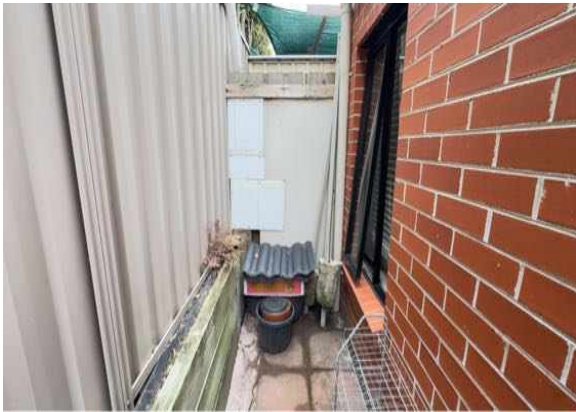
It is important to note that these restrictions can conceal a wide range of building defects, including but not limited to:

Because these areas could not be visually assessed, no comment can be made on their condition within this report.

It is strongly recommended that obstructions be removed and concealed areas made fully accessible immediately. A re-inspection should then be carried out to allow a complete assessment of the property's condition. This is particularly important prior to purchase, as defects in concealed areas can carry significant rectification costs.
