# Building and Timber Pest Inspection Report

Inspection Date: Thu, 22 Jan 2026

Property Address: 60 Wolseley St, Fairfield NSW 2165,  
Australia

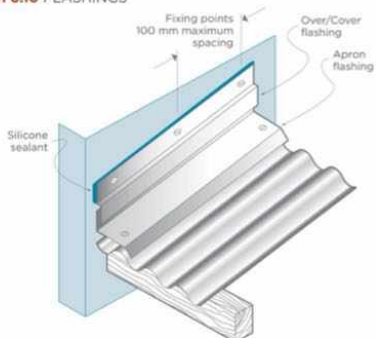
DIAGRAM 8.10 FLASHINGS

Building:	Main Building
Location:	Roof Exterior
Finding:	Flashing - Defective
Information:	Instances where flashings are defective were noted. Overflashings were missing at the time of inspection. It is expected the silicon to wear out causing water leaks in this area.

Flashings that are not installed adequately or are missing are likely to result in water penetration to the interior of the property, as well as creating excessively damp conditions against the exterior surfaces and around the base perimeter of the building.

Premature ageing and secondary building defects are imminent where roof plumbing is missing or inadequately installed. Additionally, water pooling also creates an environment that is susceptible to termite and pest infestation.

The client is highly advised to ensure the manufacturer installation guide is followed.

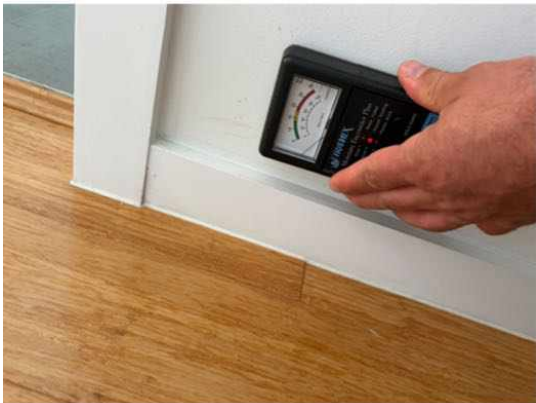
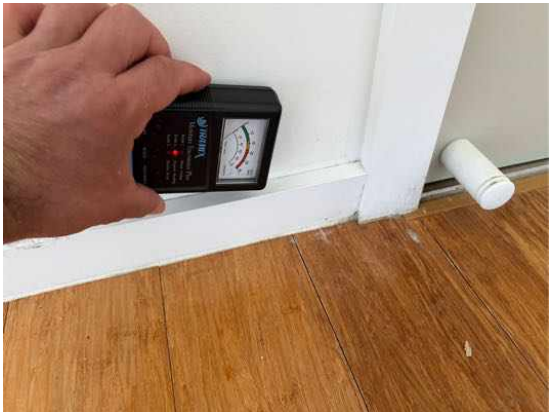
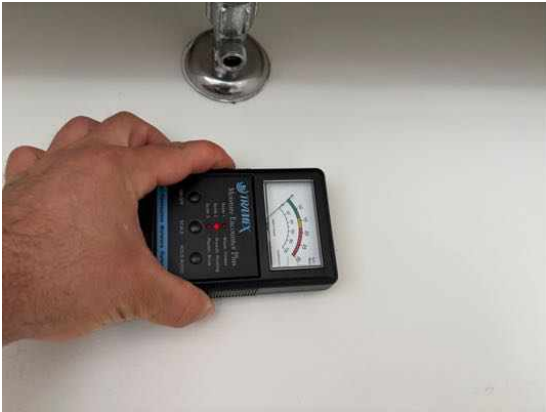
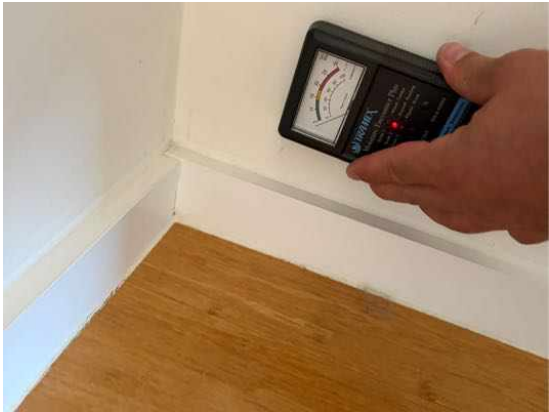
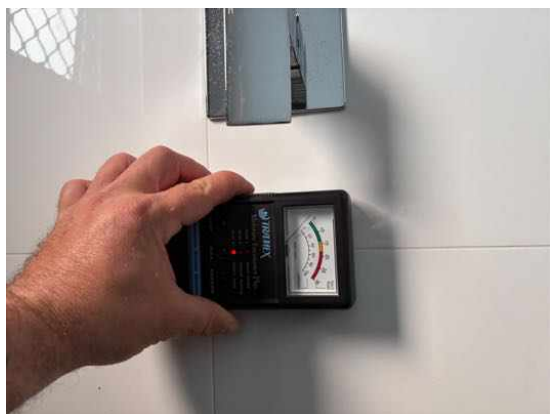
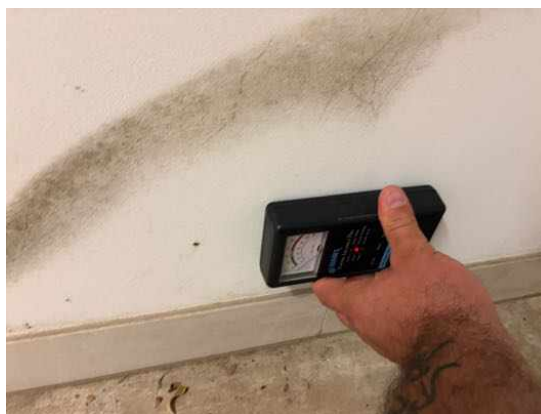
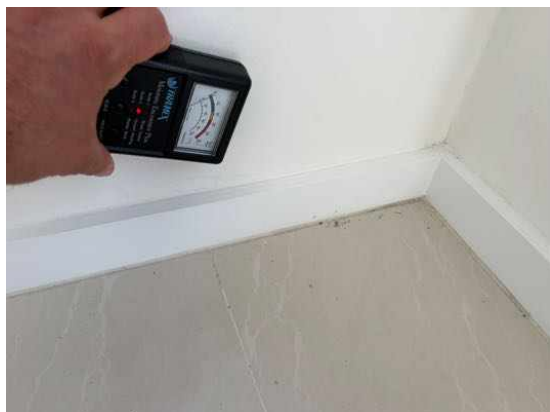
Building: Main Building  
Location: All Areas  
Finding: Moisture metre  
Information: During the inspection the property was checked for moisture using a moisture metre.

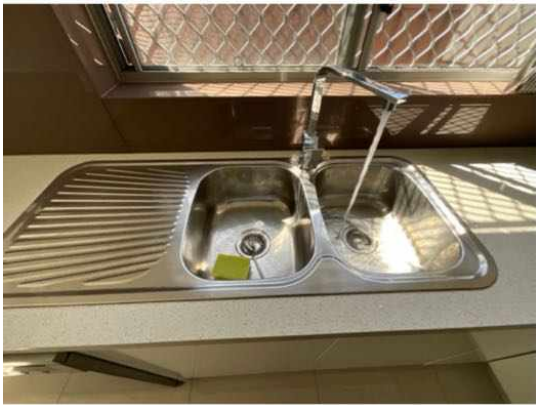
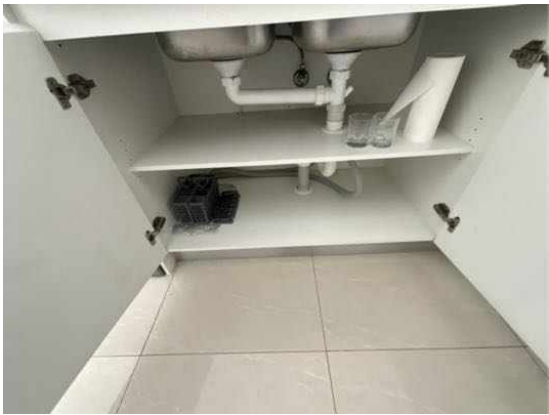
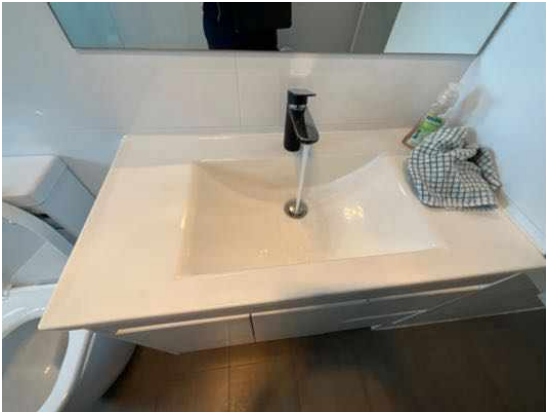
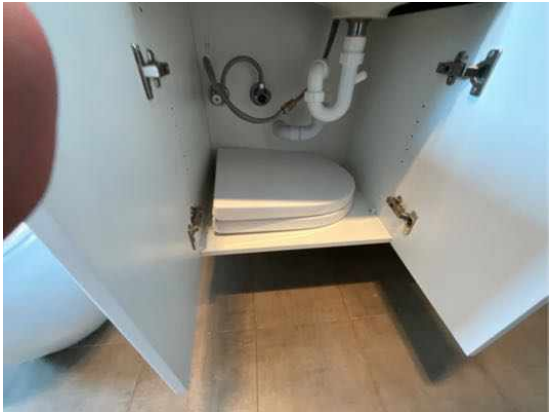
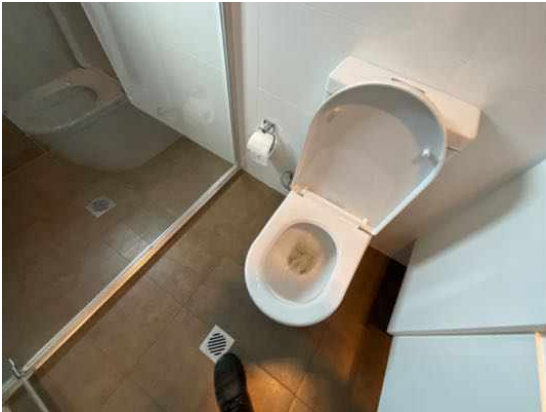
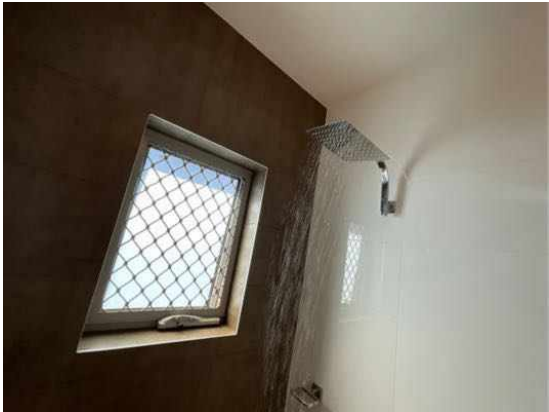
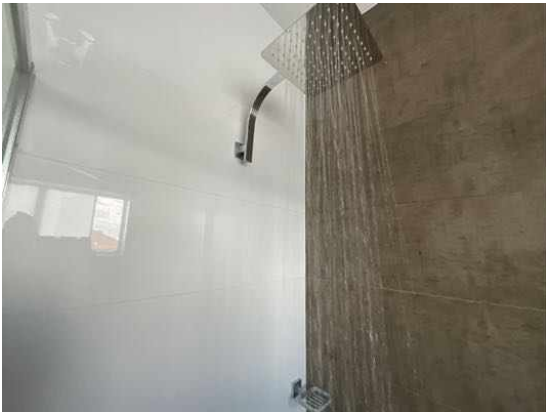
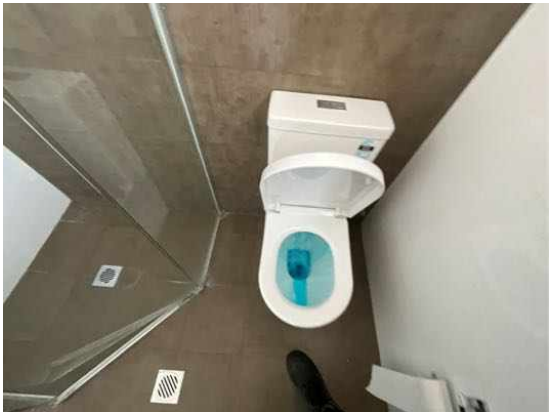
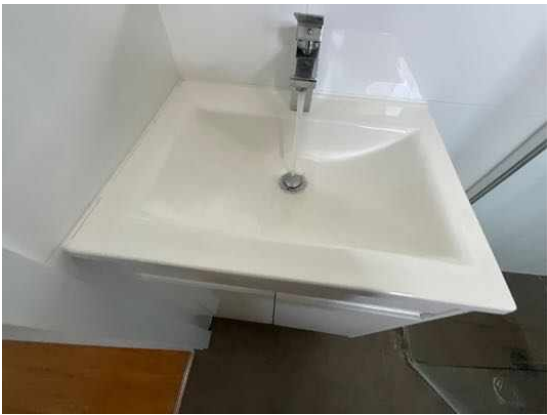
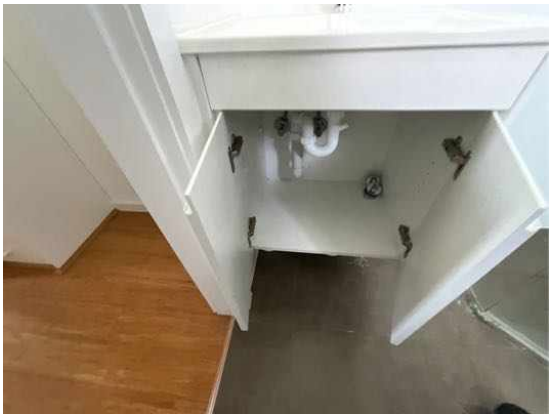
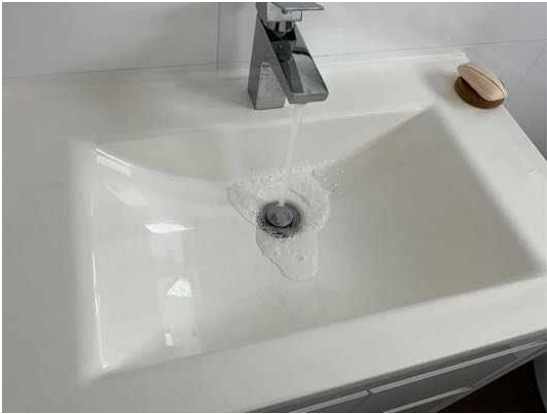
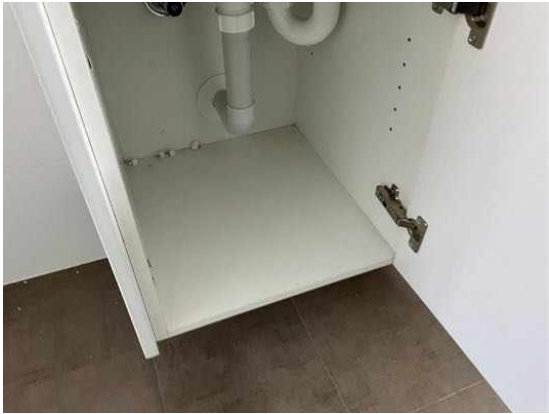
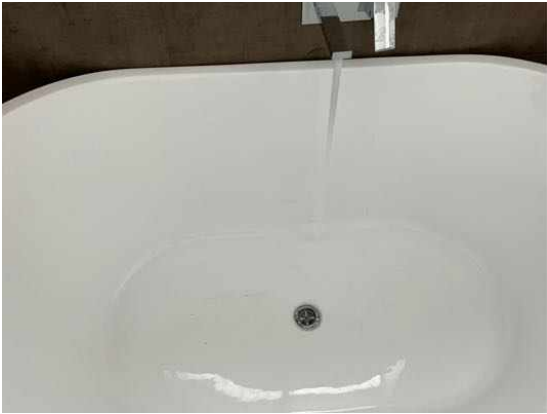
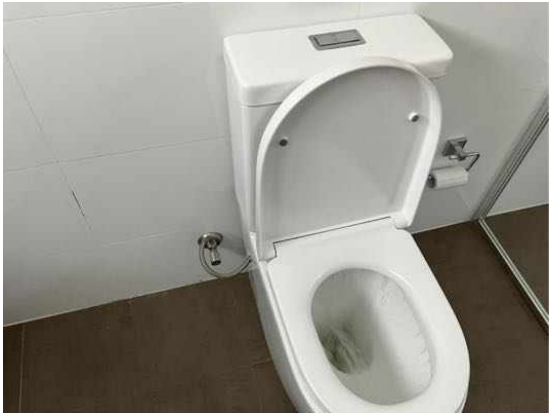
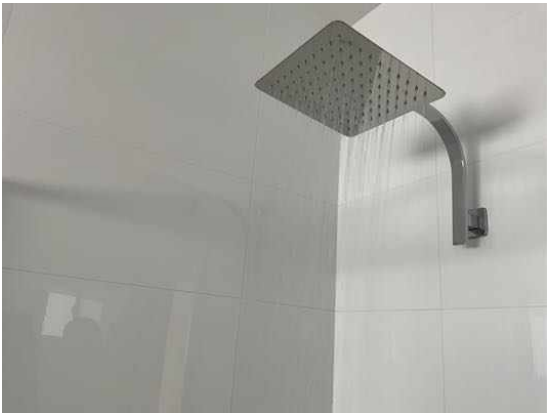
Building: Main Building  
 Location: All Wet Areas  
 Finding: Waterproofing  
 Information:

All taps, mixers and toilets were tested for operation, except for those obstructed. The waterproofing to the shower recess was assessed by checking the walls in and around the shower recess for varying moisture content. There were no significant variations across the tested areas. No sign of recent water damage was evident upon a visual inspection of the surrounding walls, where the visual nature of the inspection was possible.

Consequently, there is no conclusive evidence of any current shower recess leakage other than those which may have already been mentioned earlier in this report. It is reasonable to assume the shower waterproofing is sound. Note that if the shower is not used, or has not been used for some time, moisture readings would not vary significantly and this can lead to erroneous results. It is not possible under the visual inspection criteria (under which a prepurchase inspection is carried out) to categorically determine if there are leaks. If a more accurate assessment is required, a special purpose inspection should be requested. Alternatively, the assumption should be made that the shower may leak.

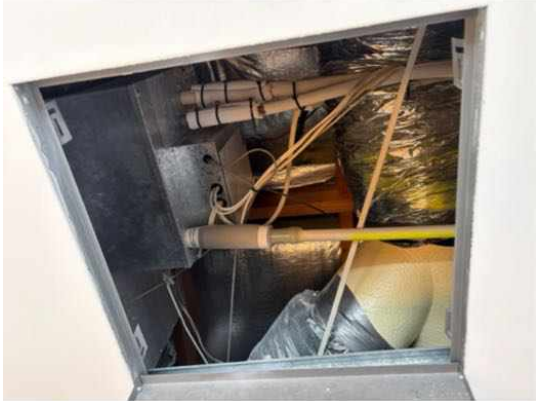
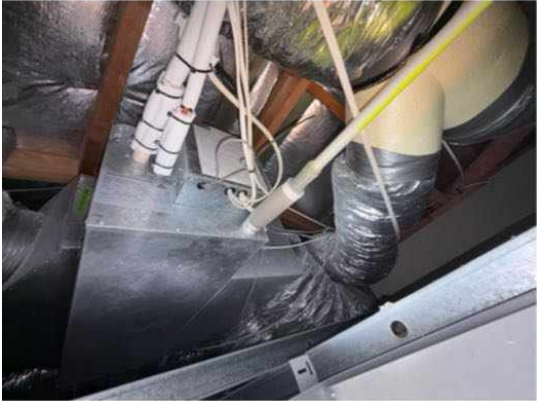
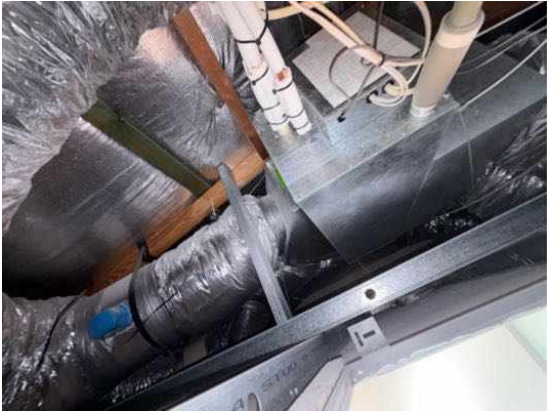
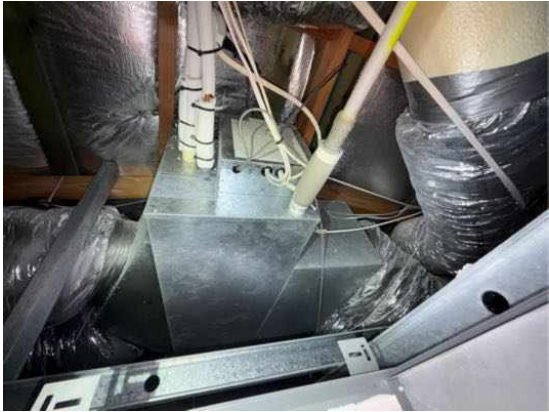
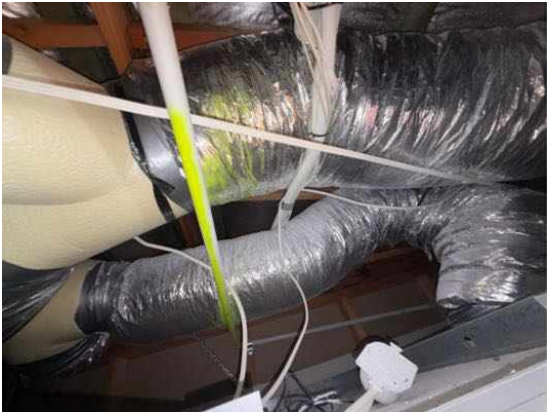
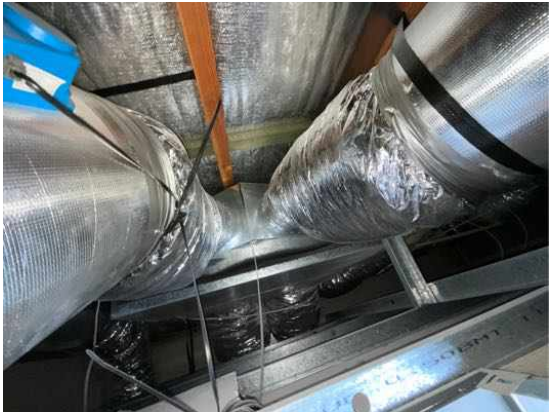
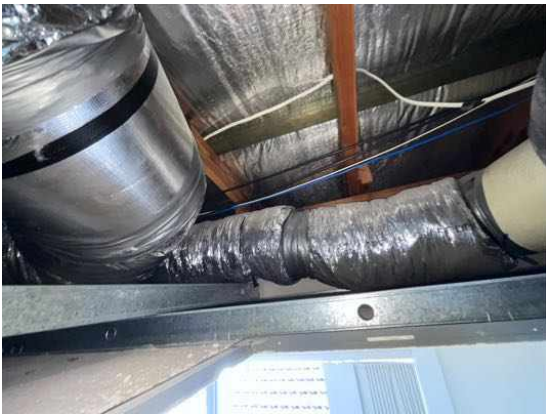
Building: Main Building  
Location: Roof Void  
Finding: Additional Photos  
Information:

Additional photos are provided for your general reference.

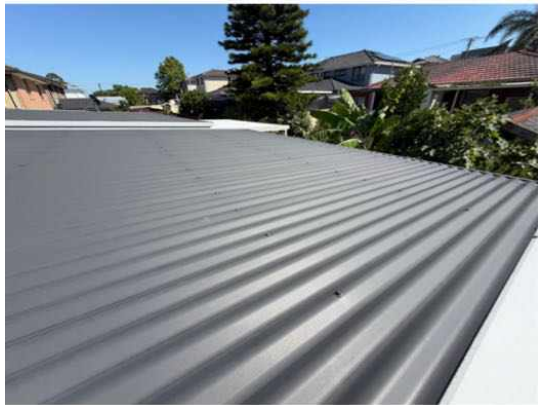
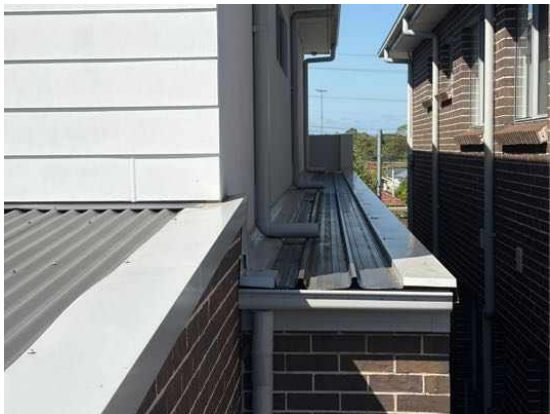
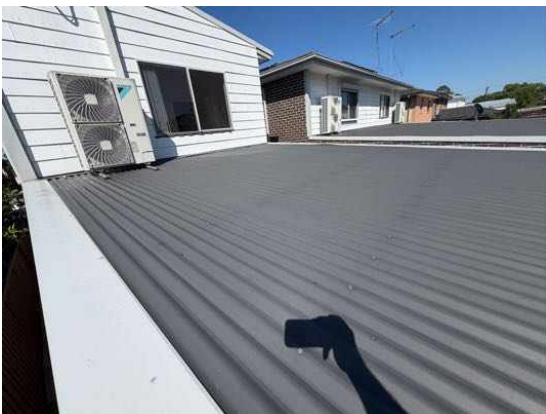
Building: Main Building  
Location: Roof Exterior  
Finding: Additional Photos  
Information:

Additional photos are provided for your general reference.

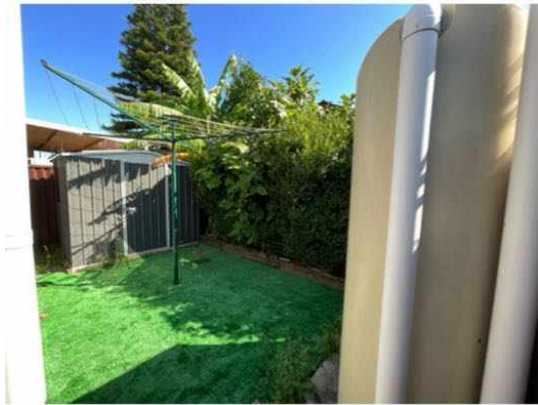
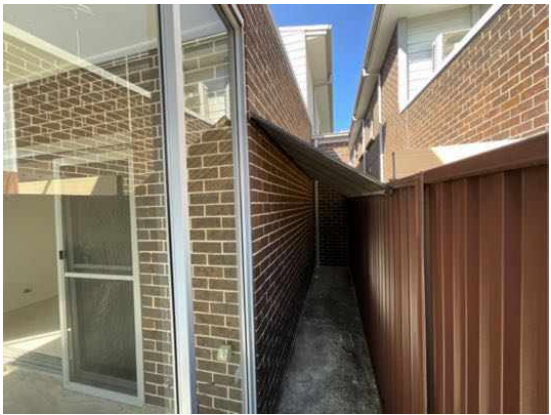
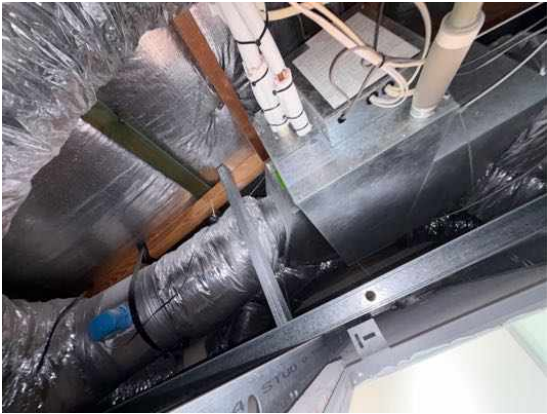
Building: Main Building  
 Location: All Areas  
 Finding: Additional Photos - Obstructions and Limitations  
 Information: These photographs are an indication of the obstructions and limitations which impeded full inspection of the property at the time of inspection. These obstructions can hide an array of defects and should be removed to allow full inspection to be carried out. A re-inspection is recommended once the areas are made accessible.
